State and Local Laws and Regulations Exhibit

Cascade Renewable Transmission

Wasco, Hood River, and Multnomah Counties, Oregon

Submitted to
Oregon Energy Facility Siting Council

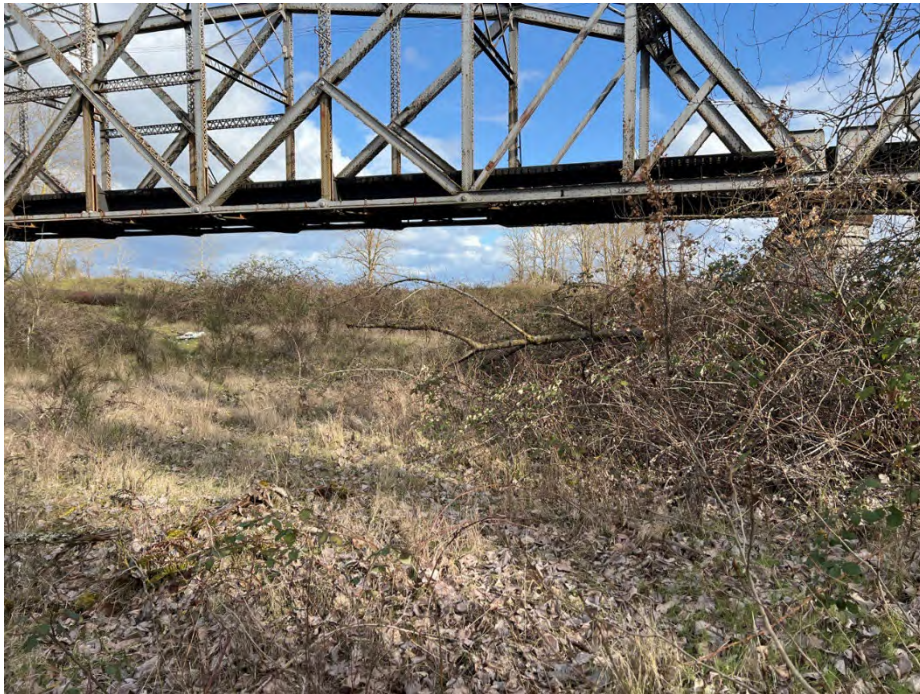
Photo 15	Verification Plot (VP-7); depressional area determined to be upland.
Date: 03/12/24	
Direction: East

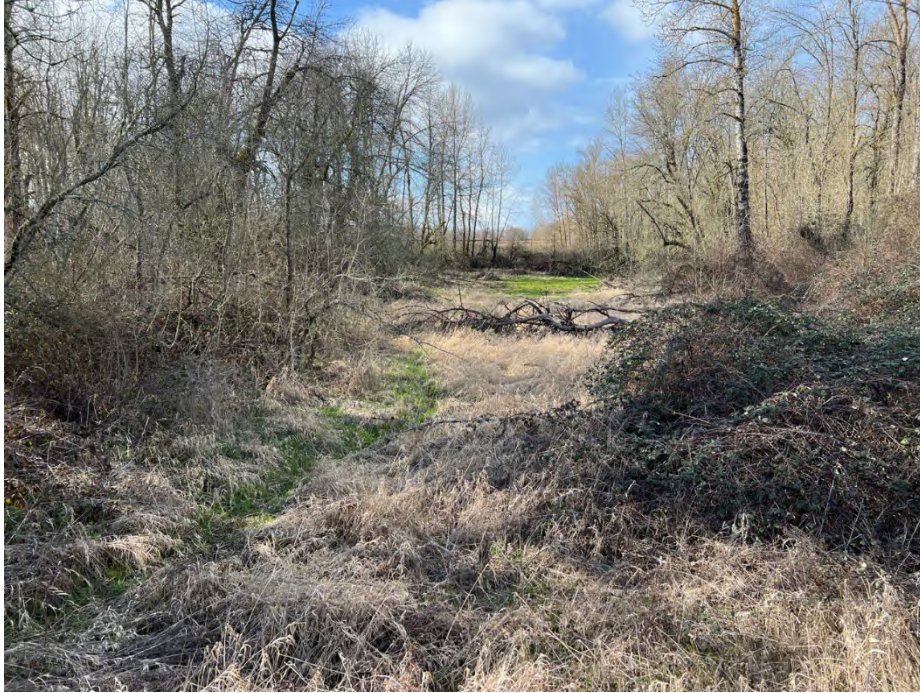
Photo 16	Verification Plot 8 (VP-8). Sample plot taken just outside survey area at NWI-mapped wetland boundary but not within wetland.
Date: 03/12/24	
Direction: Northwest

Photo 16	Verification Plot 8 (VP-8). Sample plot taken just outside survey area at NWI-mapped wetland boundary but not within wetland.
Date: 03/12/24	
Direction: Northwest

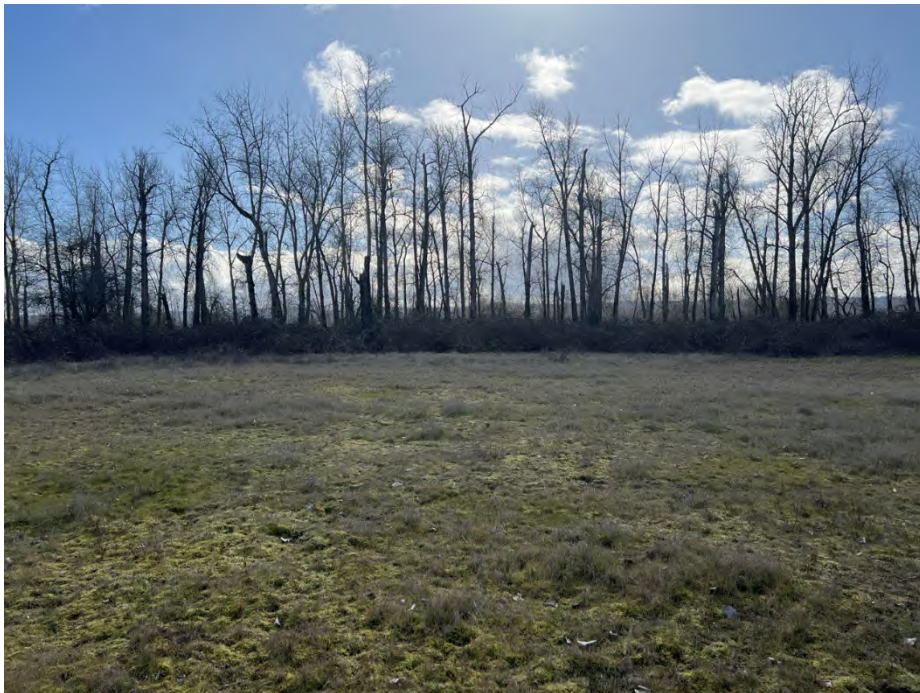
Photo 17	Verification Plot 9 (VP-9); area determined to be upland.
Date: 03/12/24	
Direction: Southwest

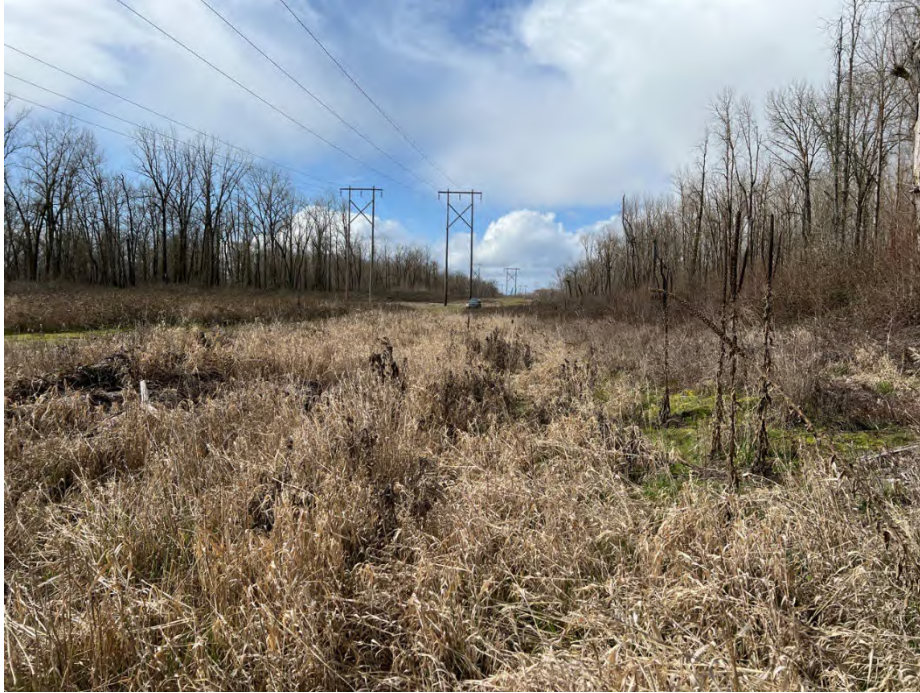
Photo 18	Sample Plot W1-P1 (W). Wetland 1 is a small depressional wetland with no outlet.
Date: 03/12/24	
Direction: West

Wetland 1 (0.06 acres) occurs in a small closed depressional area on Hayden Island within the Hayden Island – Columbia River watershed (HUC 170800030200; OSU 2025) (Figure 5, page 31, Appendix A; Photos 18 and 19, Appendix C). This wetland is mapped in the NWI as PEM1C, and within the Hayden Island wetland priority site (GeoHub 2023). Dominant vegetation within the wetland includes reed canarygrass (*Phalaris arundinacea*) and Fuller's teasel (*Dipsacus fullonum*). Vegetation in Wetland 1 was classified in the field as palustrine emergent (PEM) (Cowardin 1979). Soil profiles within the wetland meet the hydric soil indicator for redox dark surface. Soils are silt loam across three layers with matrix colors of 10YR 3/3, 7.5YR 3/1, and 2.5Y 3/3. Redox concentrations of 5YR 3/4, 7.5YR 3/3, 7.5YR 2.5/3, 10YR 3/4, and 2.5Y 3/1 begin 2 inches below the surface in the bottom two layers and are located in the matrix and pore linings. Wetland hydrology indicators include the primary indicators for inundation visible on aerial imagery. Secondary indicators for saturation visible on aerial imagery, geomorphic position, and FAC-neutral test are met. Wetland hydrology is attributed to groundwater and precipitation inputs.

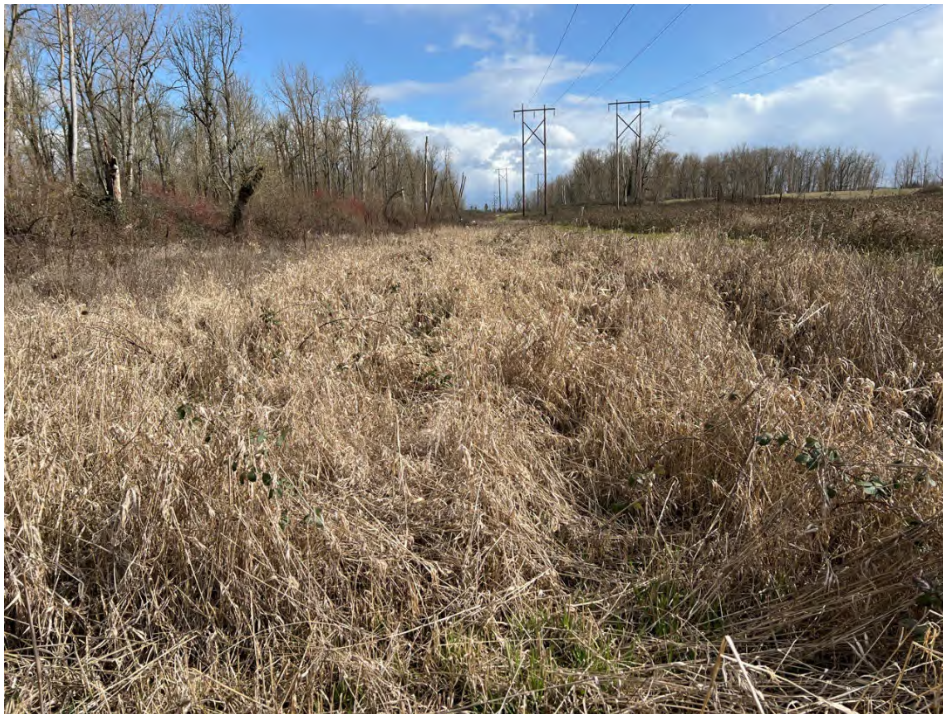
Photo 19	Wetland 1 looking east.
Date: 03/12/24	
Direction: East

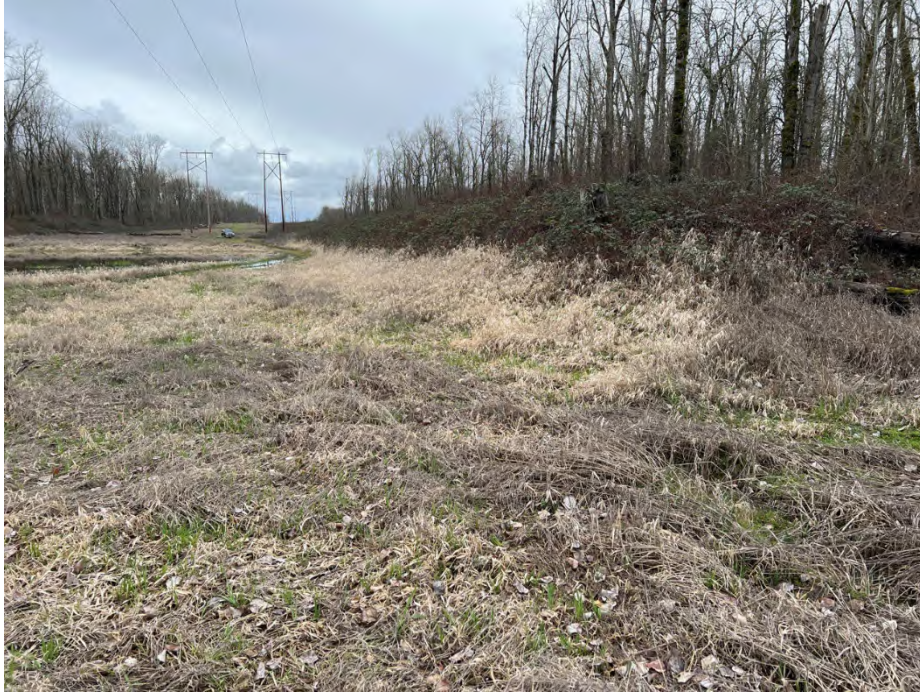
Photo 20	Sample Plot W2-P1 (W). Wetland 2A is a relatively large palustrine emergent wetland with a perennial pond.
Date 03/12/24	
Direction: Southeast

Wetland 2A (0.06 acres) occurs in a small depressional area located to the south of Wetland 2B on Hayden Island within the Hayden Island – Columbia River watershed (HUC 170800030200; OSU 2025) (Figure 5, pages 29, Appendix A; Photos 20 and 46, Appendix C). The wetland is mapped in the NWI as PUBT and within the Hayden Island wetland priority site (GeoHub 2023). Dominant vegetation in the wetland is reed canarygrass. Vegetation in Wetland 2A was classified in the field as PEM (Cowardin 1979). Soil profiles within the wetland meet the hydric soil indicator for sandy redox. Soils are sandy loam, loamy sand or sand, with a matrix color of 10YR 2/1 or 10YR 4/1 and redox concentrations of 5YR 3/4 or 10YR 4/3 as concentrations in the matrix or along pore lining and root channels. Wetland hydrology indicators include visible inundation and saturation on aerial imagery and geomorphic position. Wetland hydrology is attributed to groundwater and precipitation inputs.

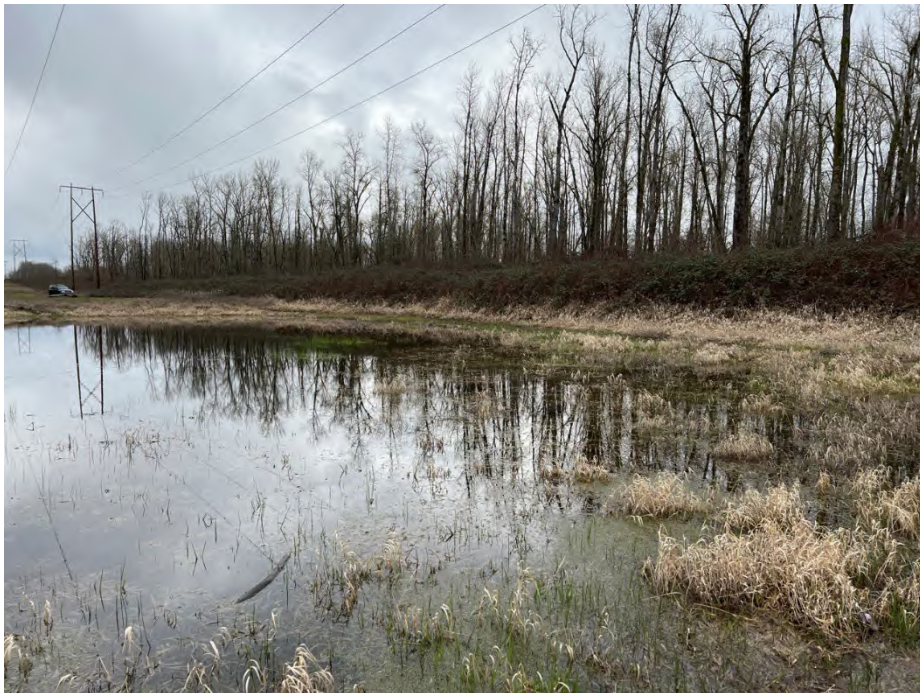
Photo 21	Perennial pond within Wetland 2B boundary with surface water roughly 2-3 feet deep.
Date: 03/12/24	
Direction: South

Wetland 2B (0.71 acres) occurs in a depressional ponded area located on Hayden Island within the Hayden Island – Columbia River watershed (HUC 170800030200; OSU 2025) (Figure 5, page 29, Appendix A; Photos 21, 22a and 22b, Appendix C). The wetland is mapped in the NWI as PUBT and within the Hayden Island wetland priority site (GeoHub 2023). Dominant vegetation within the wetland includes reed canarygrass and an unidentified bluegrass species (*Poa ssp.*). Vegetation in Wetland 2B was classified in the field as PEM (Cowardin 1979). Soil profiles within the wetland meet the hydric soil indicators for sandy redox. Soils are sandy loam, sand, and loamy sand with matrix colors of 10YR 2/2, 10 Y/R 3/2, 2.5Y 3/2, 2.5Y 4/1 and 5Y 3/1 and redox concentrations of 5YR 3/4 as concentrations in the matrix or along root channels. Wetland hydrology indicators include surface water, high water table, saturation, surface water visible on aerial imagery. According to current and historic aerial imagery, the ponded area within Wetland 2B is permanently flooded. The depth of surface water was roughly 2 to 3 feet deep at the time of the delineations. Wetland hydrology is attributed to groundwater and precipitation inputs.

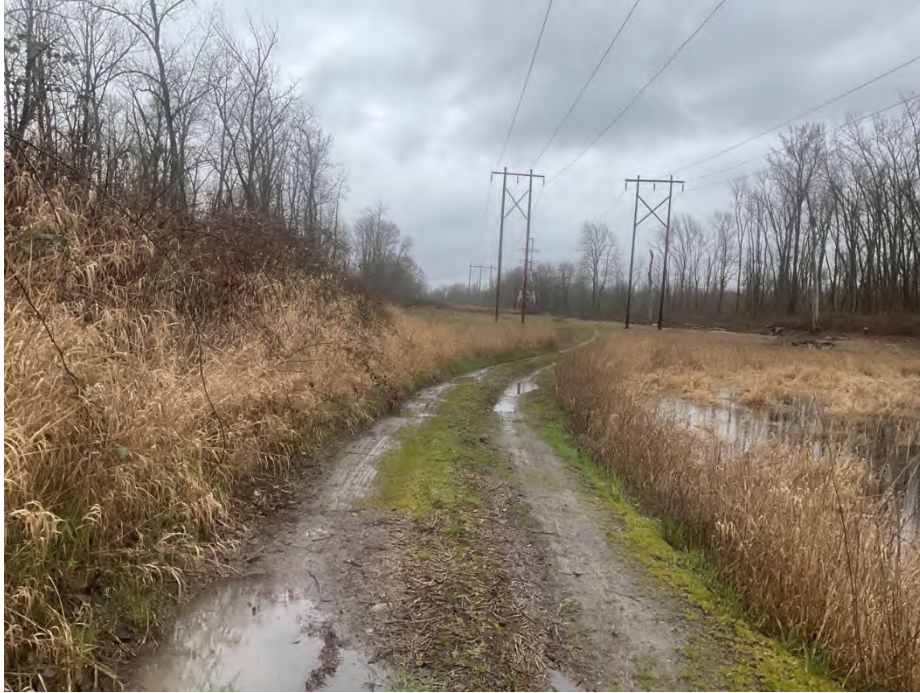
Photo 22a	Existing access road along the southern boundary of Wetland 2B. This area determined to be upland.
Date: 03/20/2025	
Direction: NW

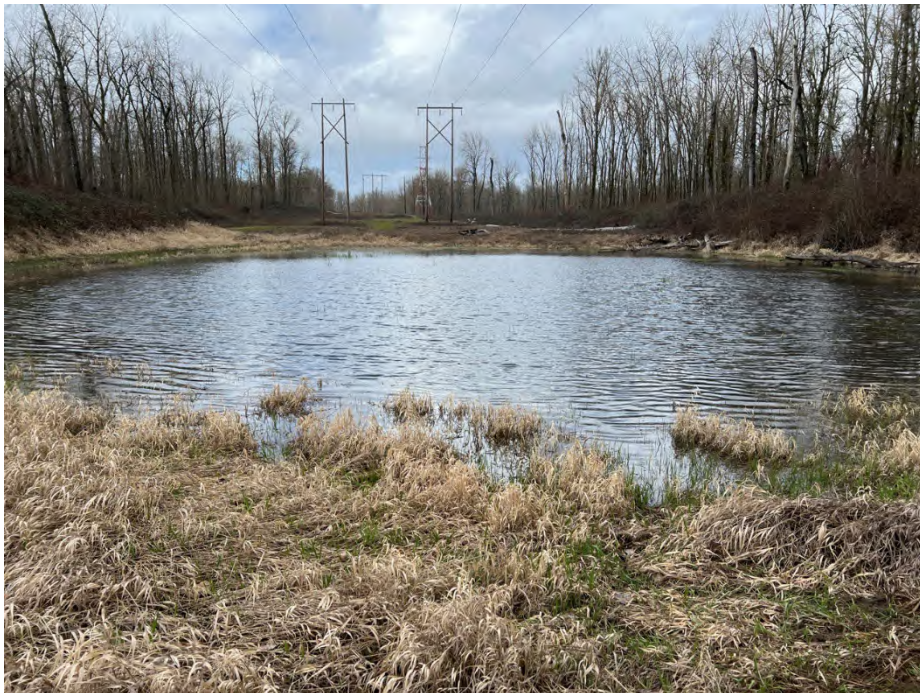
Photo 22b	Sample Plot W2-P3 (W). Large perennial pond within the boundary of Wetland 2B.
Date: 03/12/24	
Direction: Northwest

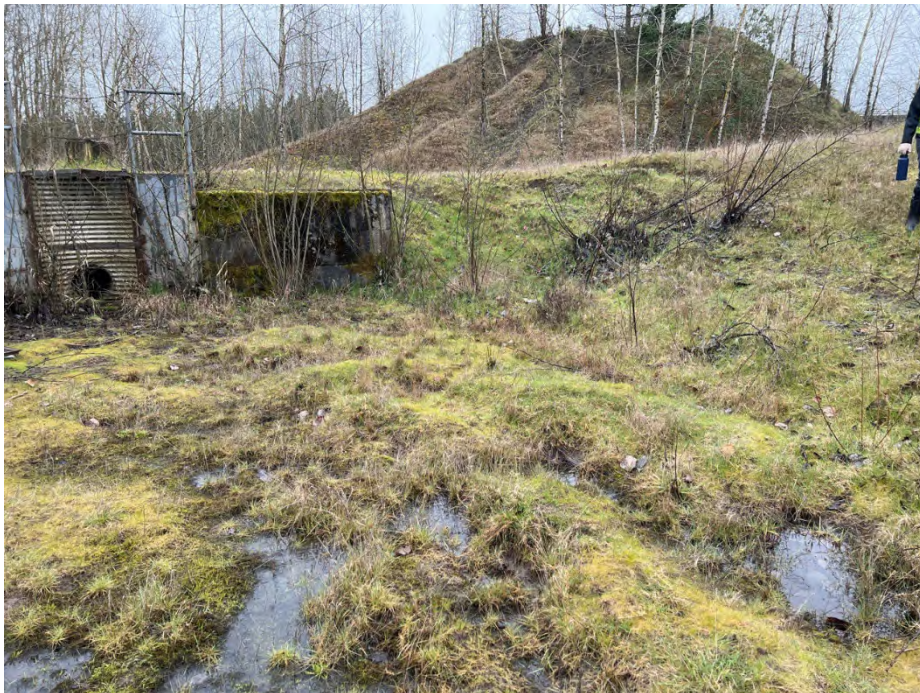
Photo 23	Verification Plot 10 (VP-10). Small depressional area determined to be upland.
Date: 03/12/24	
Direction: West

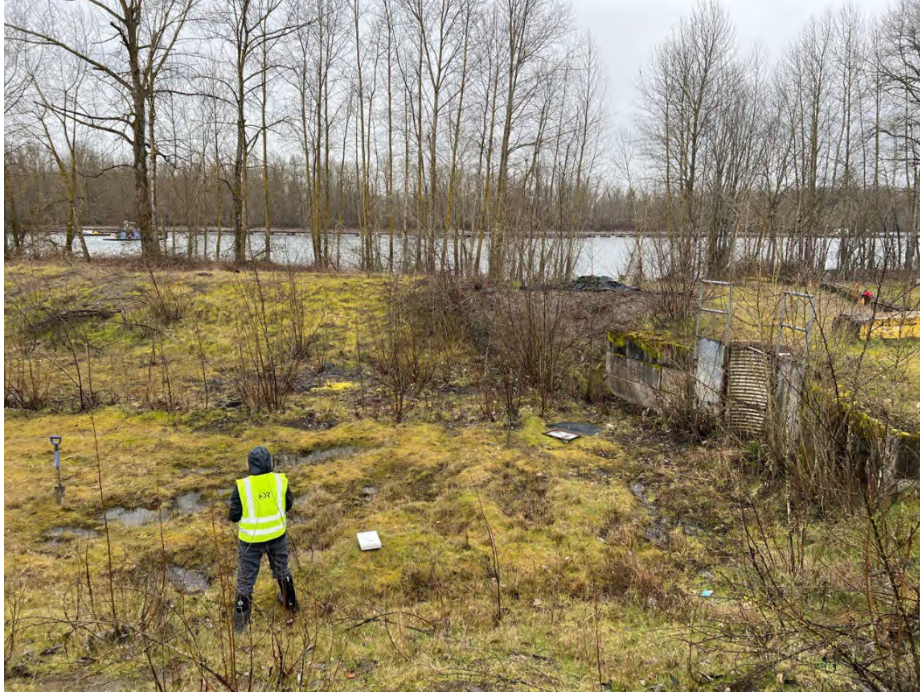
Photo 24	Sample Plot Area A-P1 (W) taken within suspect depressional area in human-made stormwater feature. Culvert discharge to 12-inch pipe to Columbia River shoreline. No evidence of flow observed.
Date: 03/11/24	
Direction: Southeast

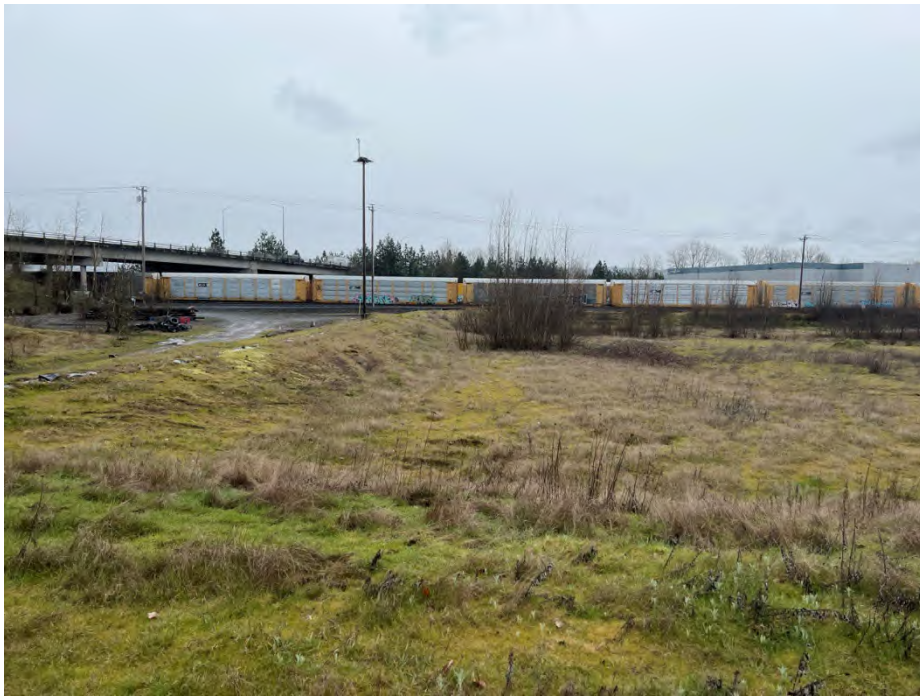
Photo 25b	Overview of Area B.
Date: 03/11/24	
Direction: Southwest

Area B (0.01 acres) occurs in a depression area within a historic dredged fill placement located southwest of Area B and within the Lake River – Frontal Columbia River watershed (HUC 170800030104; OSU 2025) (Figure 5, pages 35 and 36, Appendix A; Photos 25 and 26, Appendix C). This feature is not mapped in the NWI. Dominant vegetation includes an unidentified

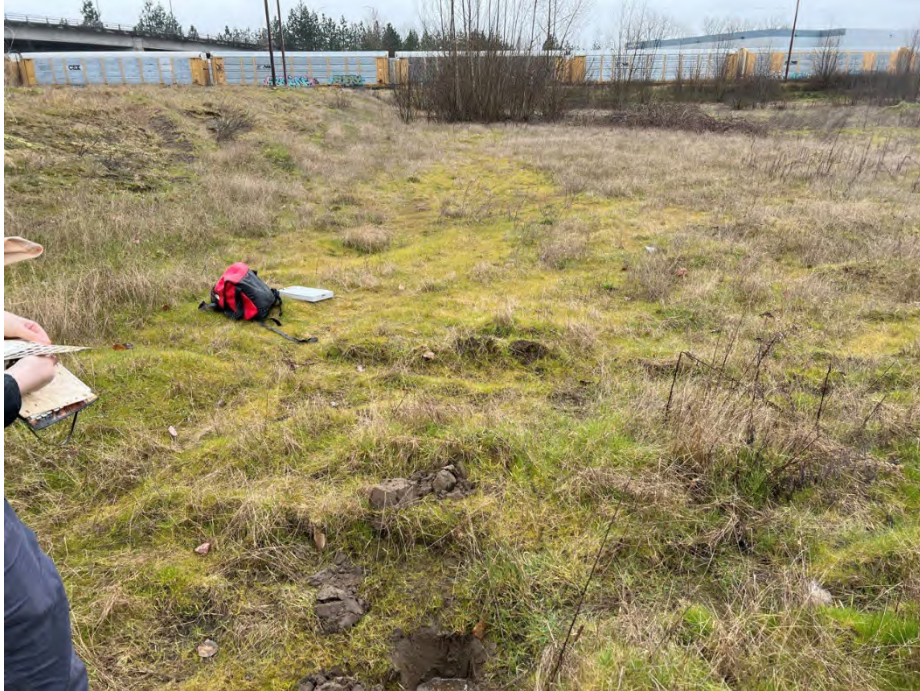
Photo 26	Sample Plot Area B-P1 (W) taken within suspect depressional area in human-made stormwater feature with no outlet. Geomembrane liner encountered 12 inches below ground surface.
Date: 03/11/24	
Direction: Southwest

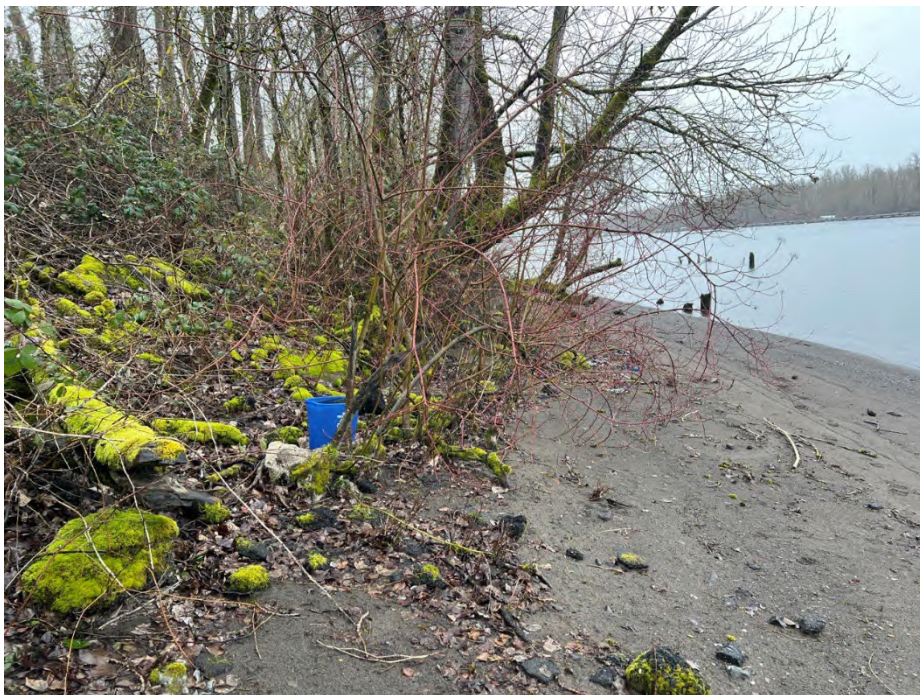
Photo 27	Columbia River shoreline within the survey area near the eastern landing site alternative at the Port of Portland.
Date: 03/11/24	
Direction: West

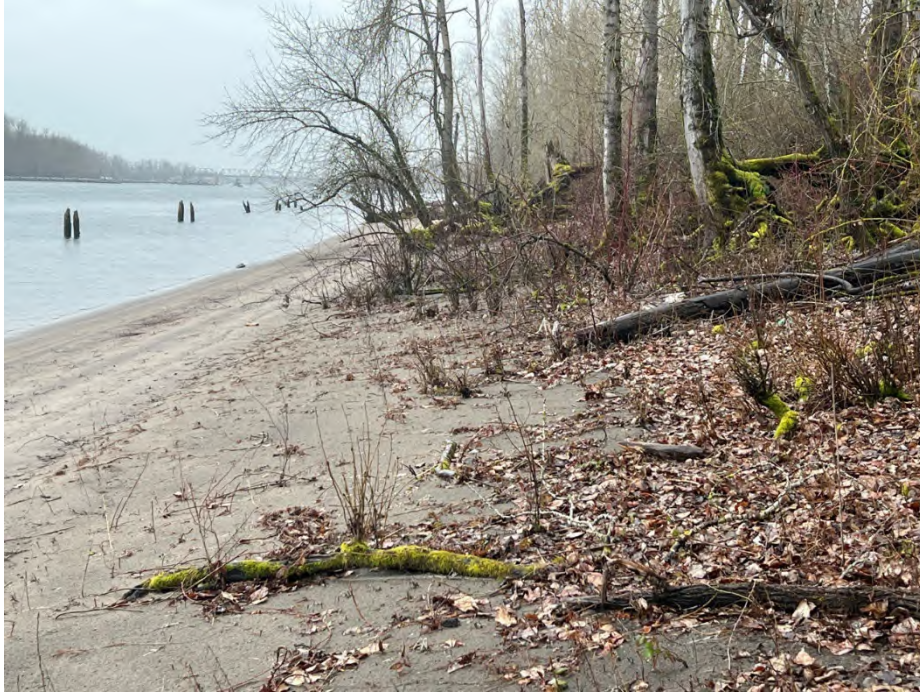
Photo 28	Columbia River shoreline within the survey area near the western landing site alternative at the Port of Portland.
Date: 03/11//24	
Direction: East

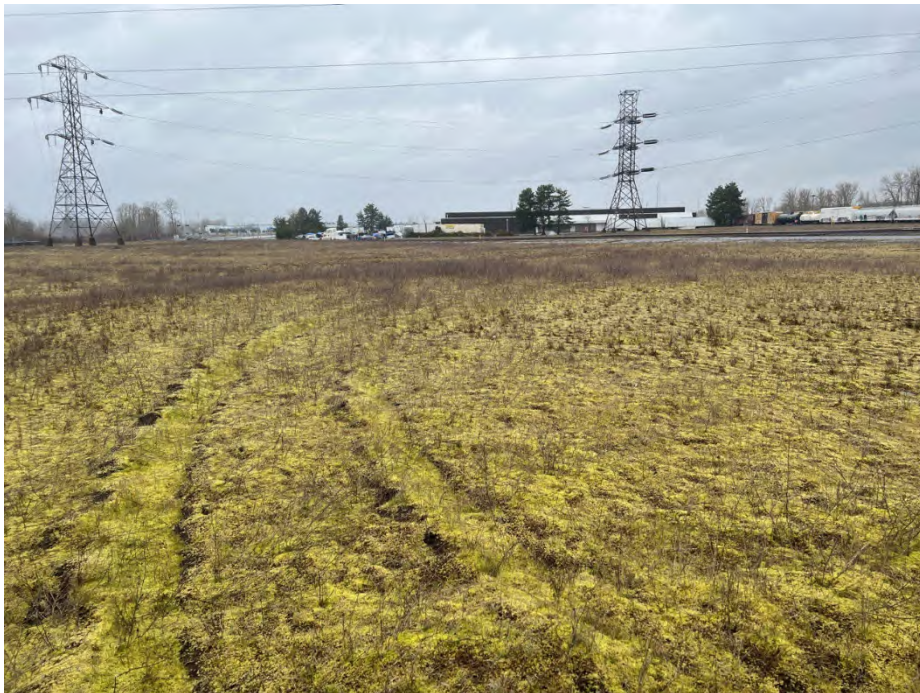
Photo 29	Verification Plot 11 (VP-11) at proposed western alternative landing site at the Port of Portland. Area determined to be upland.
Date: 03/11/24	
Direction: Northwest

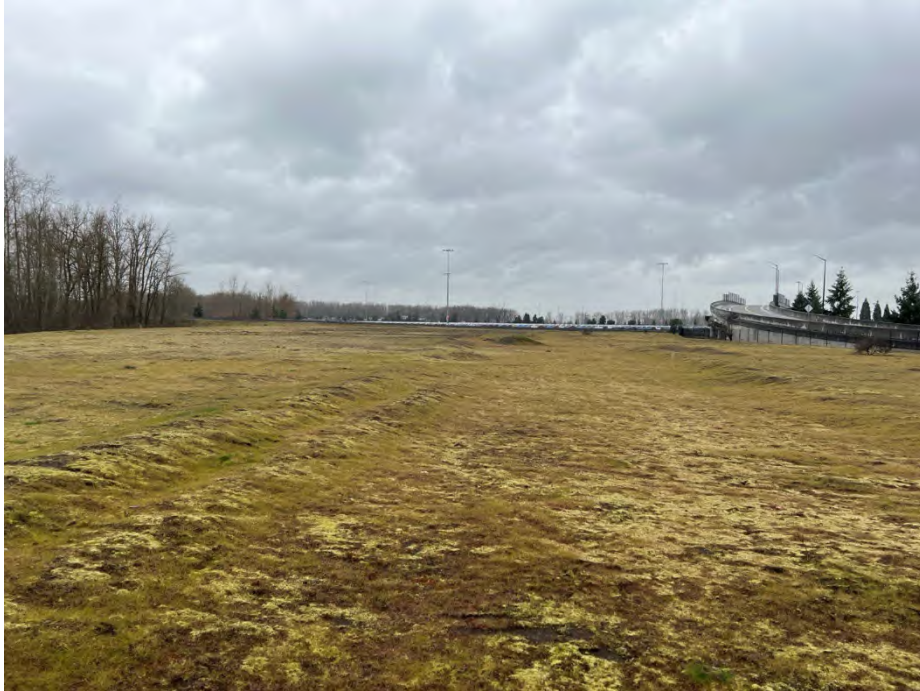
Photo 30	Verification Plot 12 (VP-12) taken at proposed western converter station site. Area determined to be upland.
Date: 03/11/24	
Direction: Northwest

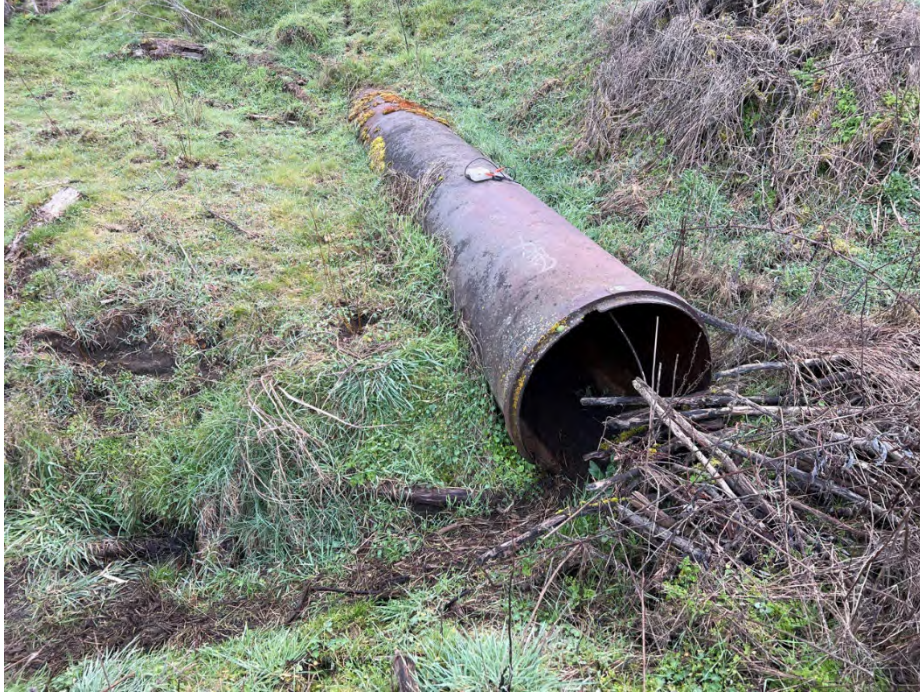
Photo 31	Columbia Slough high tide line.
Date: 03/11/24	
Direction: Northwest

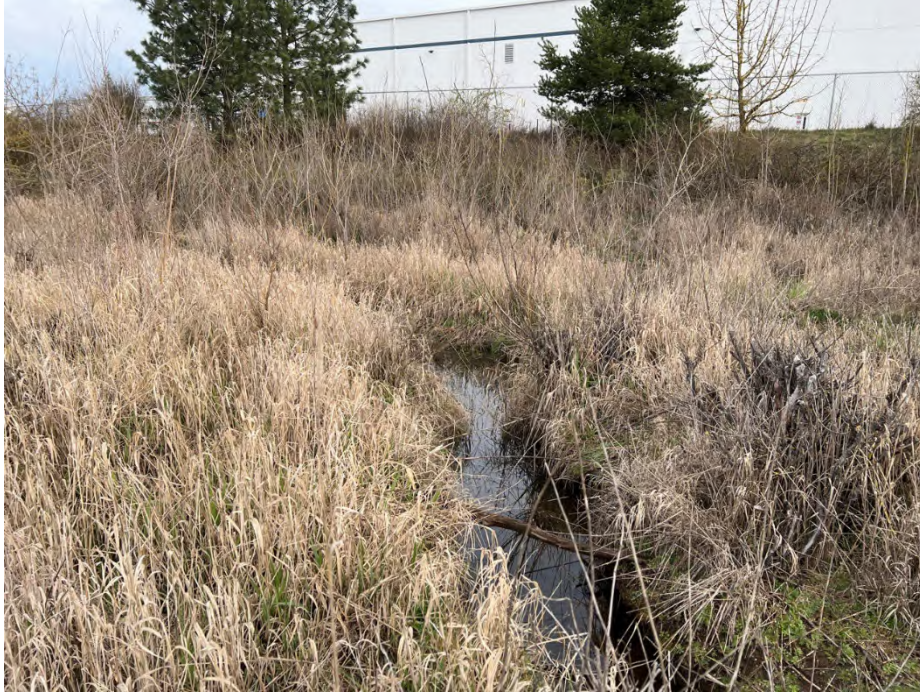
Photo 34	A series of water channels conveys hydrology around Wetland 3.
Date: 03/13/24	
Direction: West

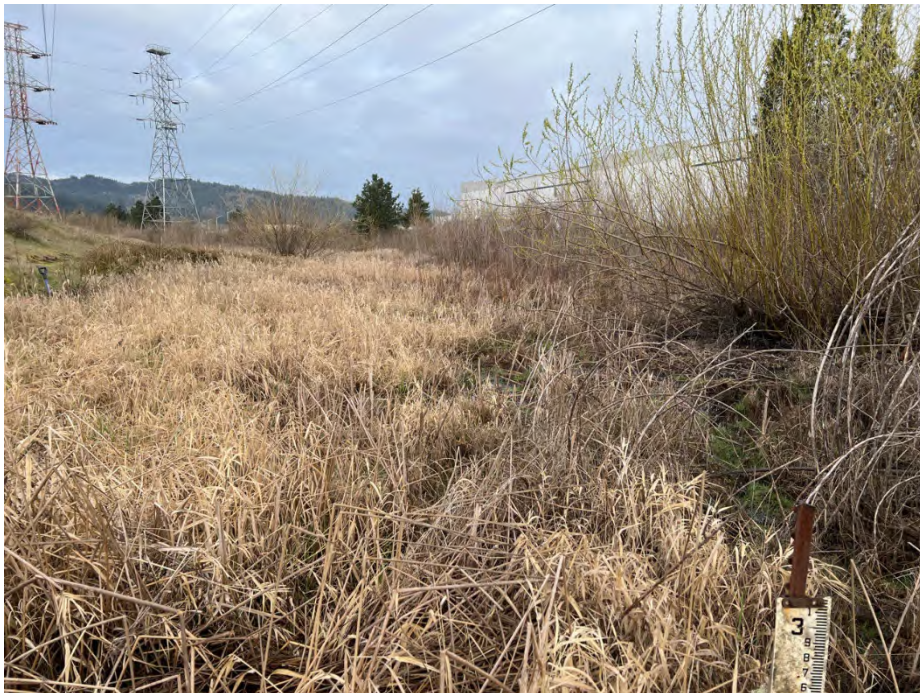
Photo 35	Overview of Wetland 3 from near Sample Plot W3-P1 (W); palustrine emergent wetland with shrub/scrub fringe along northern boundary.
Date: 03/13/24	
Direction: Northwest

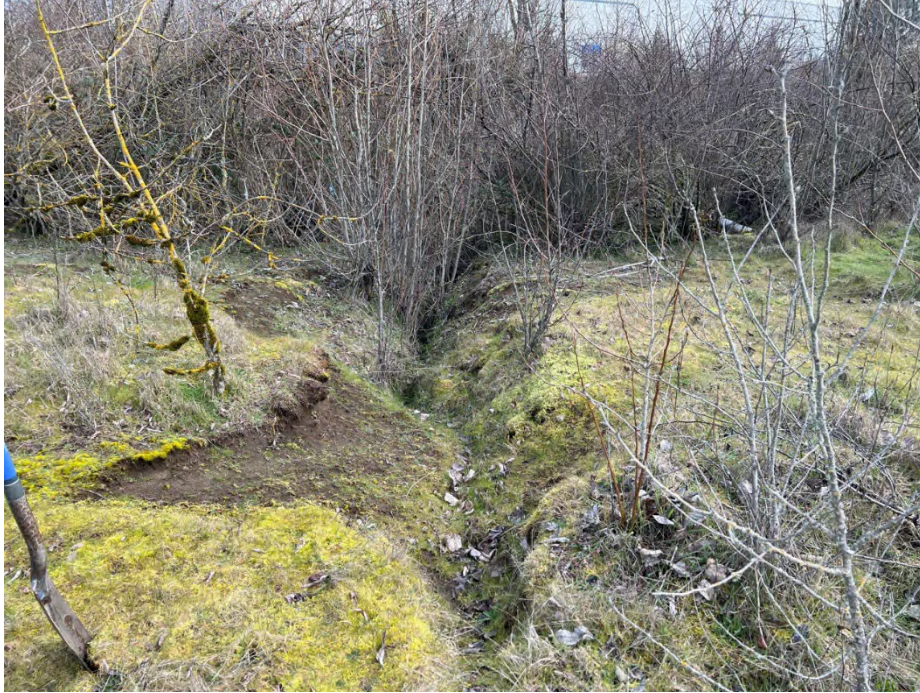
Photo 36	A series of water channels conveys hydrology around Wetland 3.
Date: 03/13/24	
Direction: Southwest

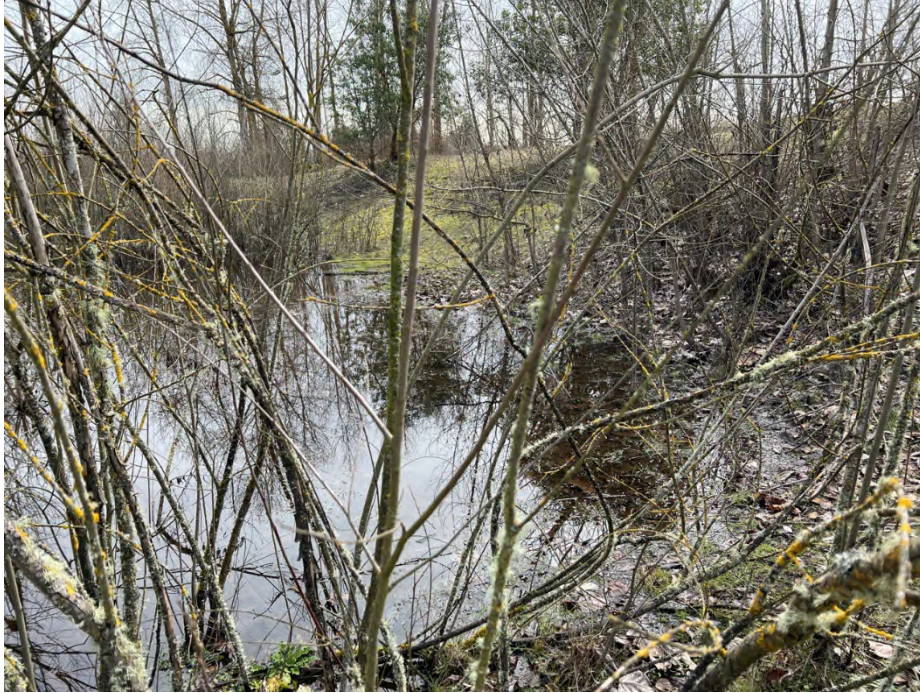
Photo 37a	Sample Plot W3-P3 (W) take at the edge of a large perennial pond with surface water roughly 2-3 feet deep.
Date: 03/13/24	
Direction: Northeast

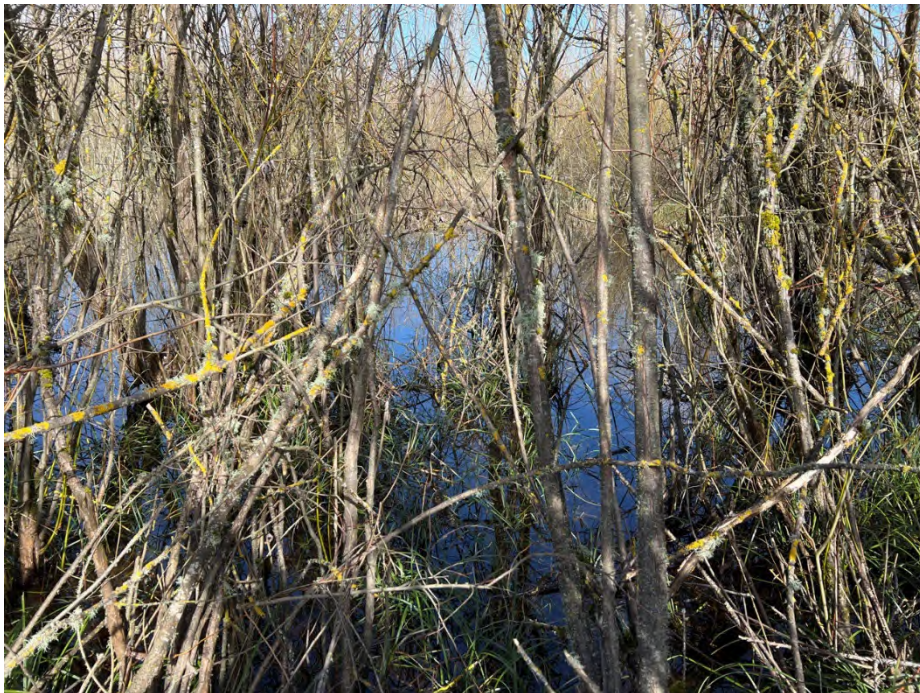
Photo 37b	Sample Plot W3-P3 (W); wetland condition changes rapidly to upland with elevation rise on graded slopes around depressional area.
Date: 03/11/24	
Direction: East

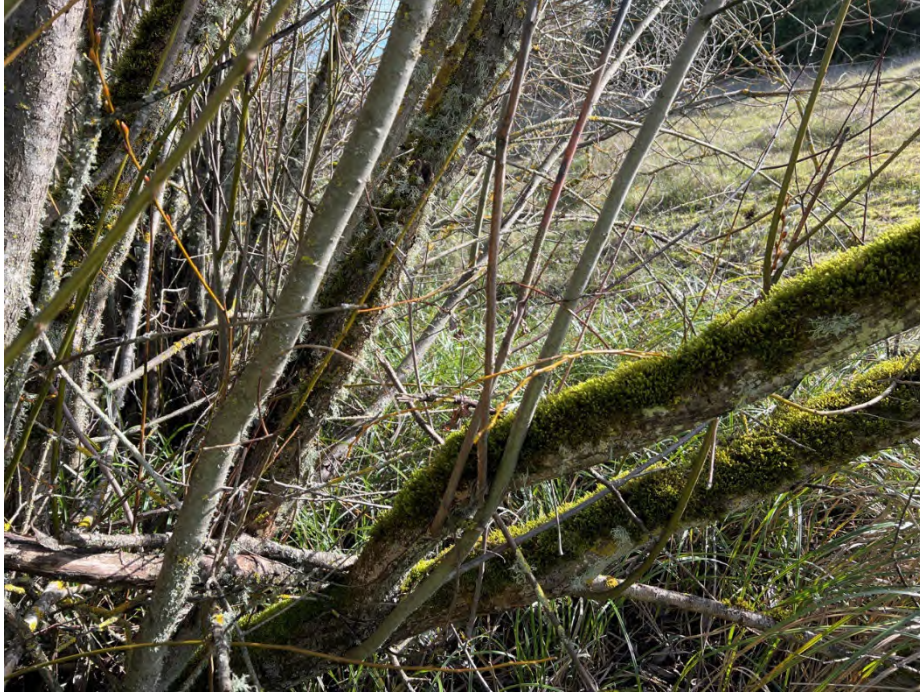
Photo 38a	Sample Plot W3-P5 (W) taken at topographic break where wetland condition in depressional area transitions to upland on steeply graded slopes at wetland boundary.
Date: 03/13/24	
Direction: Northwest

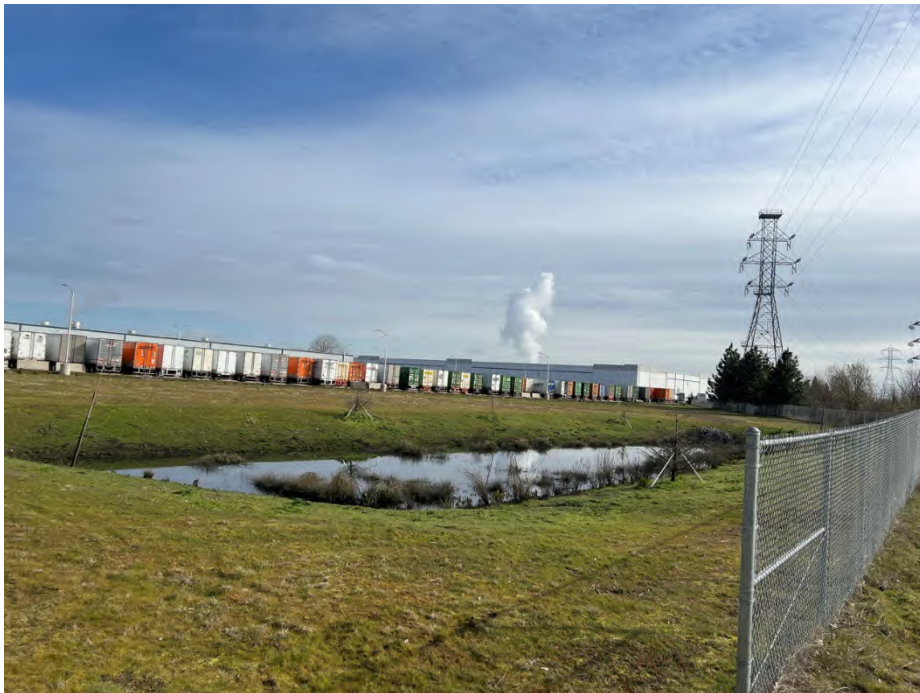
Photo 38b	Steeply graded slope around depressional stormwater feature create distinct break from wetland to upland condition.
Date: 03/13/24	
Direction: Northeast

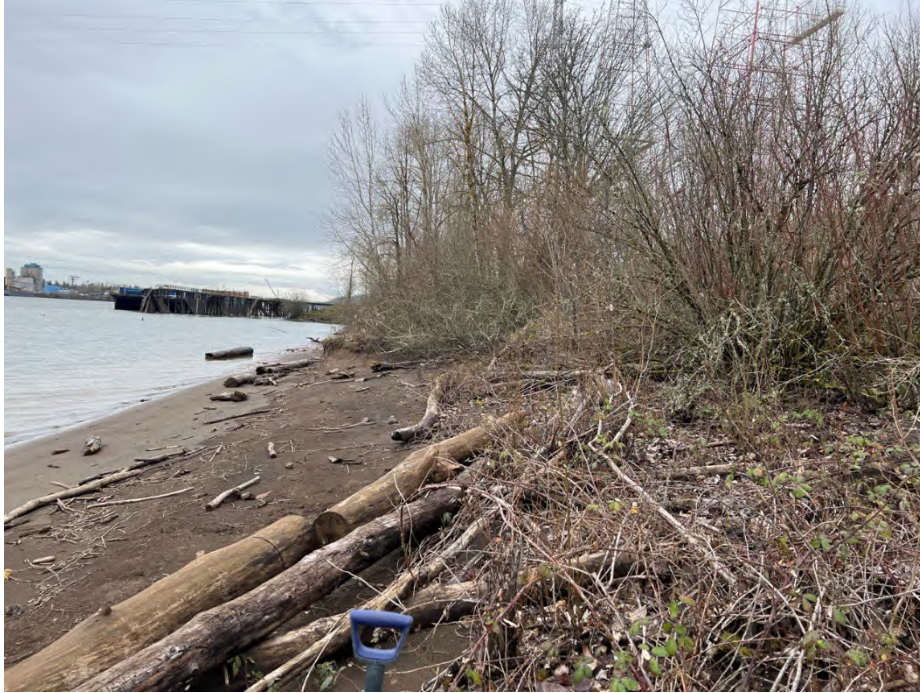
Photo 40	High tide line of the Willamette River within survey area near Harborton Substation.
Date: 03/11/24	
Direction: Southeast

The Willamette River is located at the west end of the SA in Portland, Oregon (Figure 5, pages 2 through 4, Appendix A; Photograph 40, Appendix C). In the SA, the river is mapped in the NWI as R1UBV and PFO1R, and in the NHD as a perennial waterbody. The Willamette River is located in the Balch Creek-Willamette River watershed (HUC 170900120202; OSU 2025). The Willamette River originates in the mountains south and southeast of Eugene and flows northward through Portland to its confluence with the Columbia River. The Willamette River riparian corridor is characterized generally as a riparian forest with forested wetlands, freshwater marshes and mudflats, with diverse vegetation of species and structure, though the riparian area within the SA

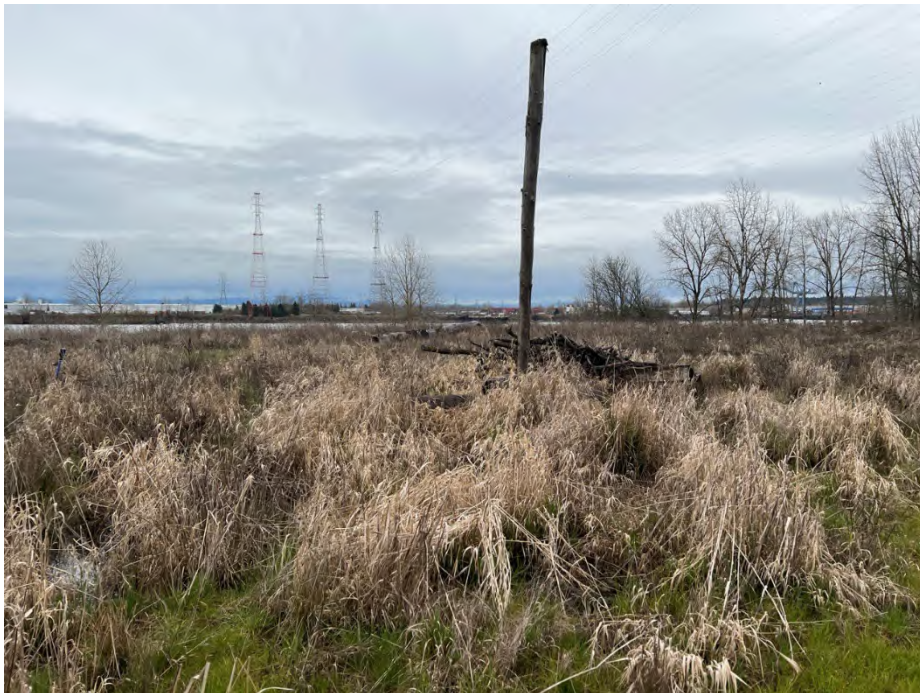
Photo 41a	Sample Plot Area C-P2 (U) taken from top of large fill material stockpile excavated from wetland restoration project on adjacent property.
Date: 03/11/24	
Direction: Northeast

Area C (0.10 acres) occurs in a depressional area located within a man-made berm and is located within the Birch Creek – Willamette River watershed (HUC 170900120202; OSU 2025) (Figure 5, pages 1 and 2, Appendix A; Photo 41, Appendix C). This depressional area formed in fill material from the Harborton Restoration Project completed in 2020 (PGE 2025). The fill material was excavated from dredging and restoration of the Harborton Wetlands located to the north. Fill was placed just east of the Harborton substation in order to create upland habitat. The area is not mapped as a wetland by NWI. USGS hydric soils are mapped; however, these soils are likely associated with the relic floodplain to the Willamette River located several feet below the fill material. Permission to excavate soils was denied so hydric soil indicators could not be evaluated. Dominant vegetation includes reed canarygrass, yarrow (*Achillea millefolium*), and *Poa ssp.* The primary wetland hydrology indicator for surface water was observed collected in equipment tire tracks (Photo 41b, Appendix C). High water table and saturation are assumed but could not be confirmed in the field. Hydrology is attributed to precipitation inputs and poor drainage due to soil compaction that likely occurred during fill placement and grading.

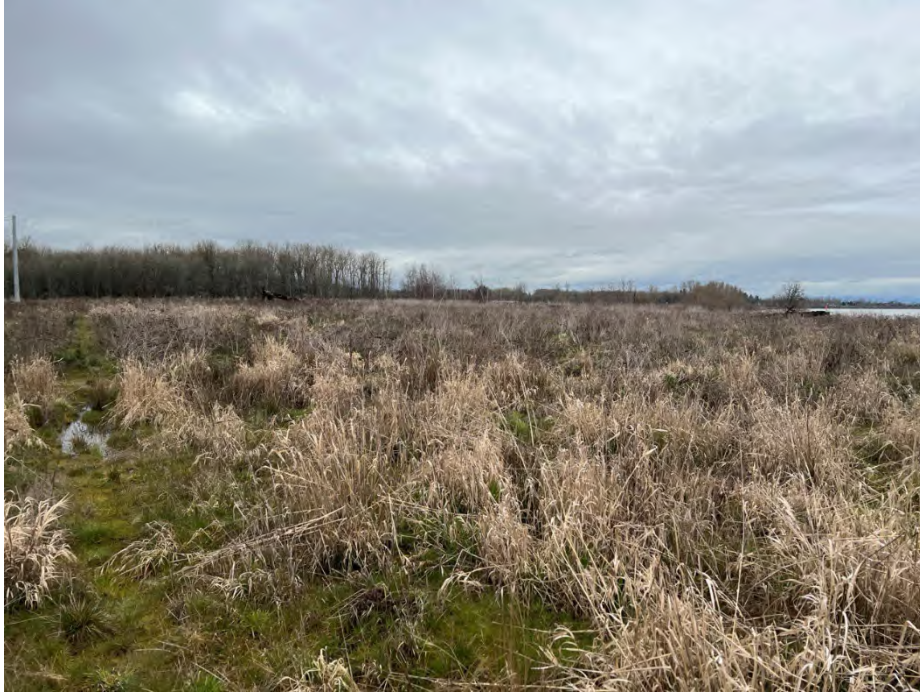
Photo 41b	Overview of Area C. Wetland vegetation likely attributed to relic seed load in material excavated from wetland restoration project on adjacent property.
Date: 03/11/24	
Direction: Northwest

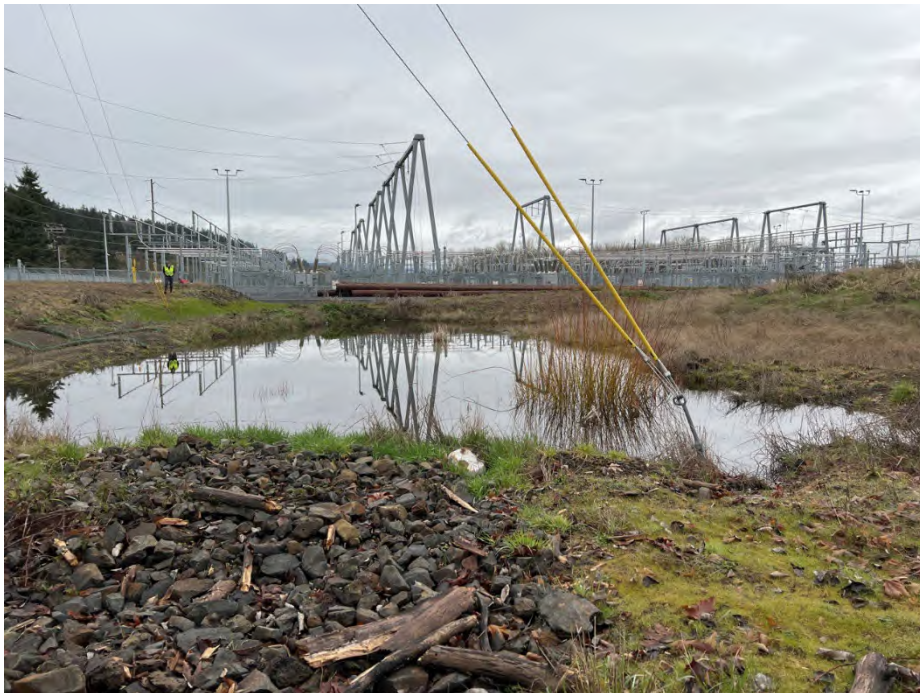
Photo 42	Stormwater collection pond located south of Harborton substation.
Date: 03/11/24	
Direction: North

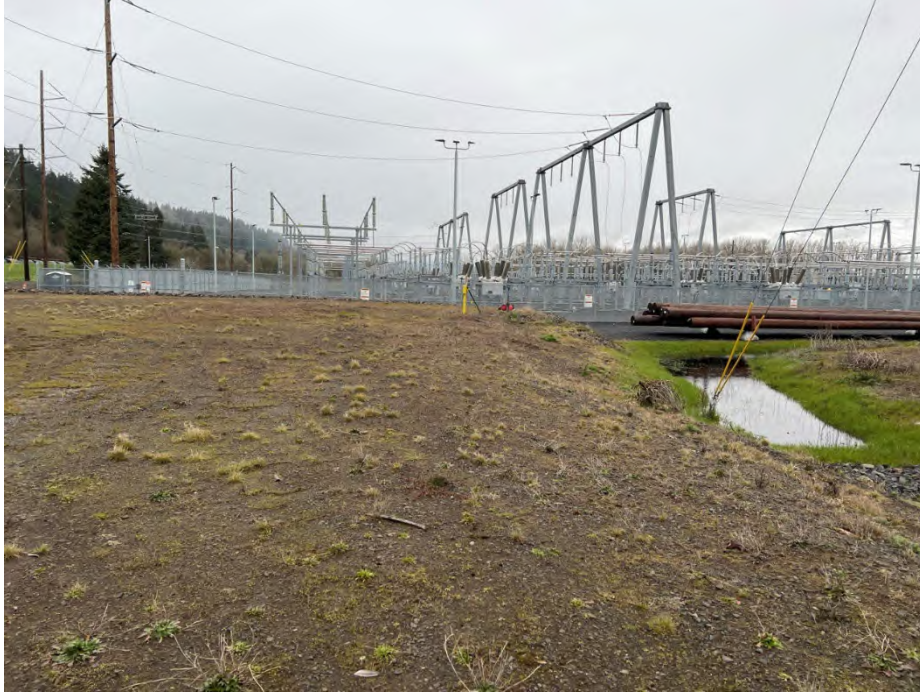
Photo 43	Stormwater collection canal (Ditch 1) located south of Harborton substation. Parallels substation fence line outside southern fence boundary.
Date: 03/11//24	
Direction: North

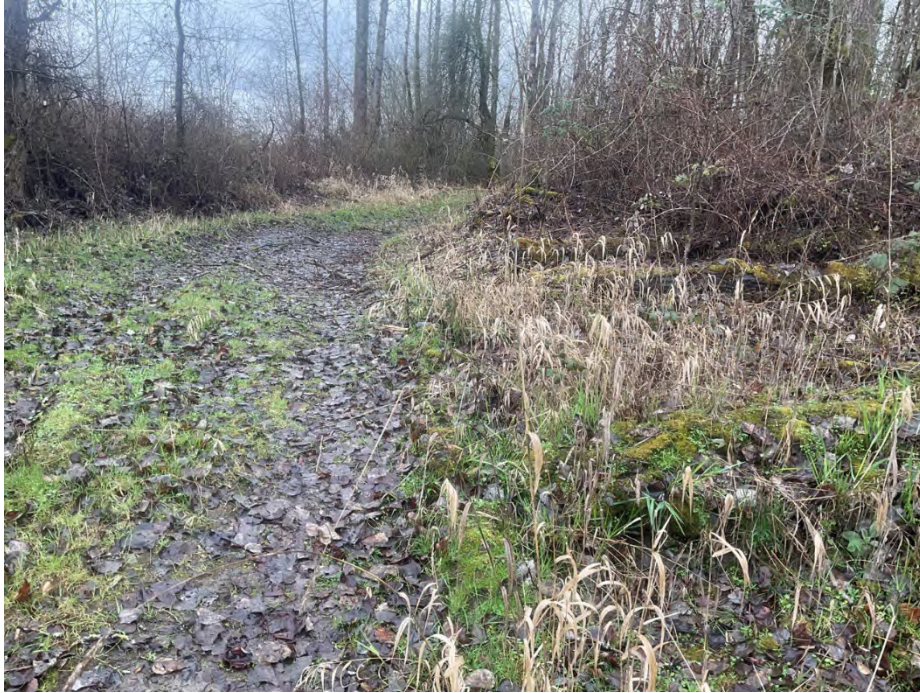
Photo 45	Verification Plot 13 (VP-13) located south of Wetland 2A. This area determined to be wetland but occurs outside the survey area.
Date: 03/20/25	
Direction: Southwest

South of Wetland 2A and outside the SA, a verification plot (VP-13, Appendix B) confirmed wetland conditions. Dominant vegetation in the area is reed canarygrass. Soils were sandy and meet the sandy redox indicator for hydric soils. Positive wetland hydrology indicators include visible inundation on aerial imagery and the FAC-neutral test. No additional hydrology indicators were observed in the field. The wetland boundary was estimated from field observation and included on Figure 5, page 29 (Appendix A) and a ground-level photograph is included in Appendix C, photo 45.
