State and Local Laws and Regulations Exhibit

Cascade Renewable Transmission

Wasco, Hood River, and Multnomah Counties, Oregon

Submitted to
Oregon Energy Facility Siting Council

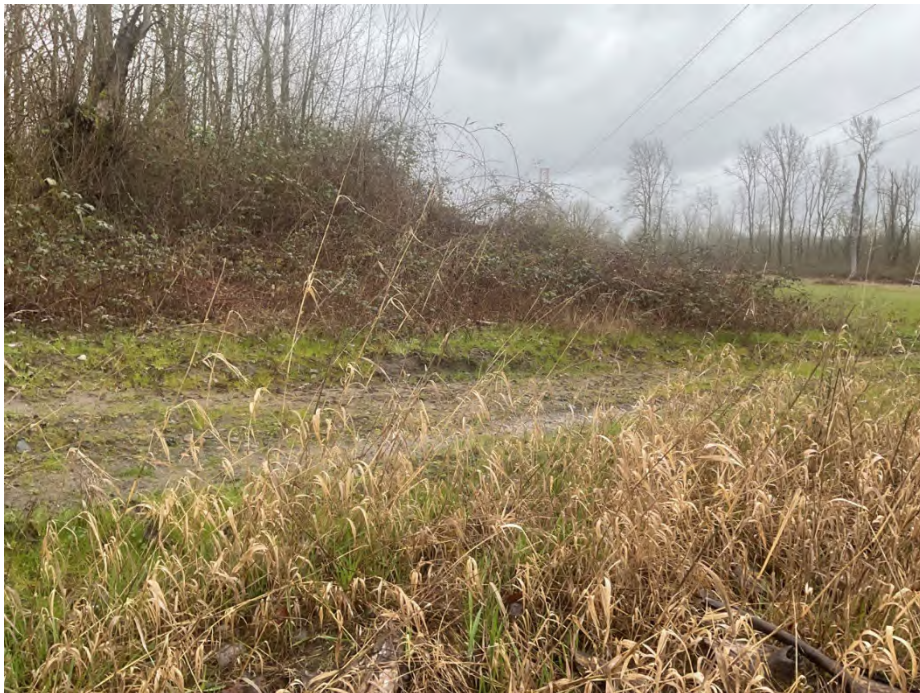
Photo 46	Verification Plot 14 (VP-14) located south of Wetland 2A. This area determined to be wetland.
Date: 03/20/25	
Direction: Northwest

Wetland 2A (0.06 acres) occurs in a small depressional area located to the south of Wetland 2B on Hayden Island within the Hayden Island – Columbia River watershed (HUC 170800030200; OSU 2025) (Figure 5, pages 29, Appendix A; Photos 20 and 46, Appendix C). The wetland is mapped in the NWI as PUBT and within the Hayden Island wetland priority site (GeoHub 2023). Dominant vegetation in the wetland is reed canarygrass. Vegetation in Wetland 2A was classified in the field as PEM (Cowardin 1979). Soil profiles within the wetland meet the hydric soil indicator for sandy redox. Soils are sandy loam, loamy sand or sand, with a matrix color of 10YR 2/1 or 10YR 4/1 and redox concentrations of 5YR 3/4 or 10YR 4/3 as concentrations in the matrix or along pore lining and root channels. Wetland hydrology indicators include visible inundation and saturation on aerial imagery and geomorphic position. Wetland hydrology is attributed to groundwater and precipitation inputs.

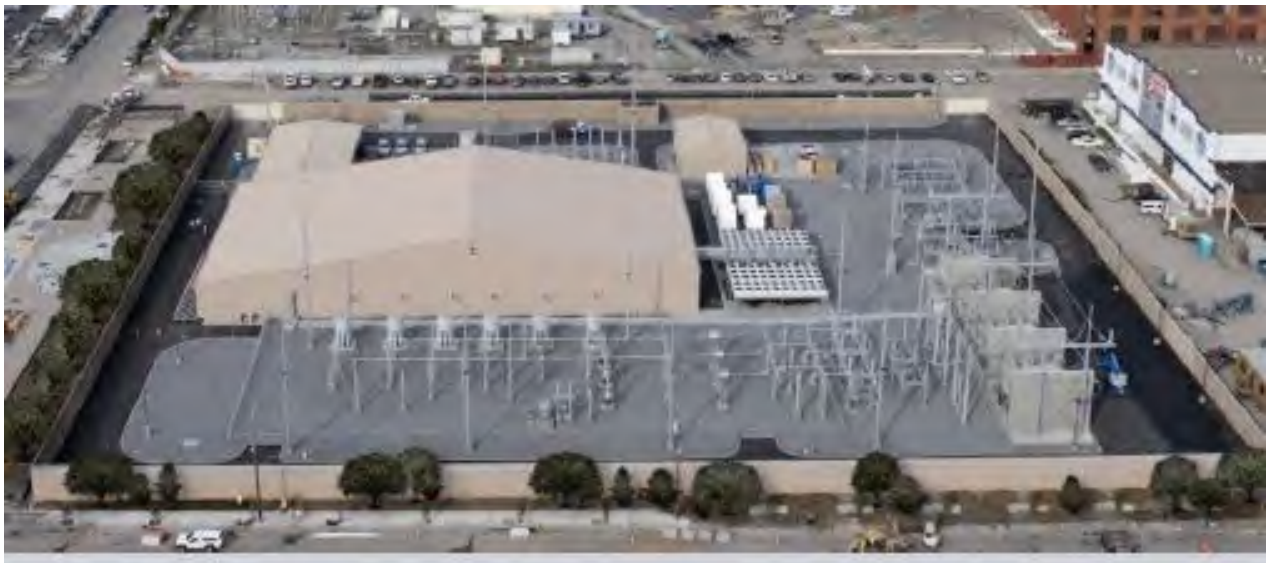
Figure 1. Typical Converter Station Layout

Each converter station would permanently disturb approximately 5 acres material laydown areas would temporarily disturb an additional 5 acres. The converter station sites would be predominately graveled and fenced with minimal parking and appropriate site-specific stormwater management. These converter stations would include conventionally designed transformers and protective circuit breakers and would include a control room for operating the facility as well as basic facilities for staff (bathroom/kitchen). Final design at each converter station will be in accordance with approved site plans that account for local zoning requirements. For illustrative purposes, a typical general arrangement diagram for the project converter station is shown in Figure 1.

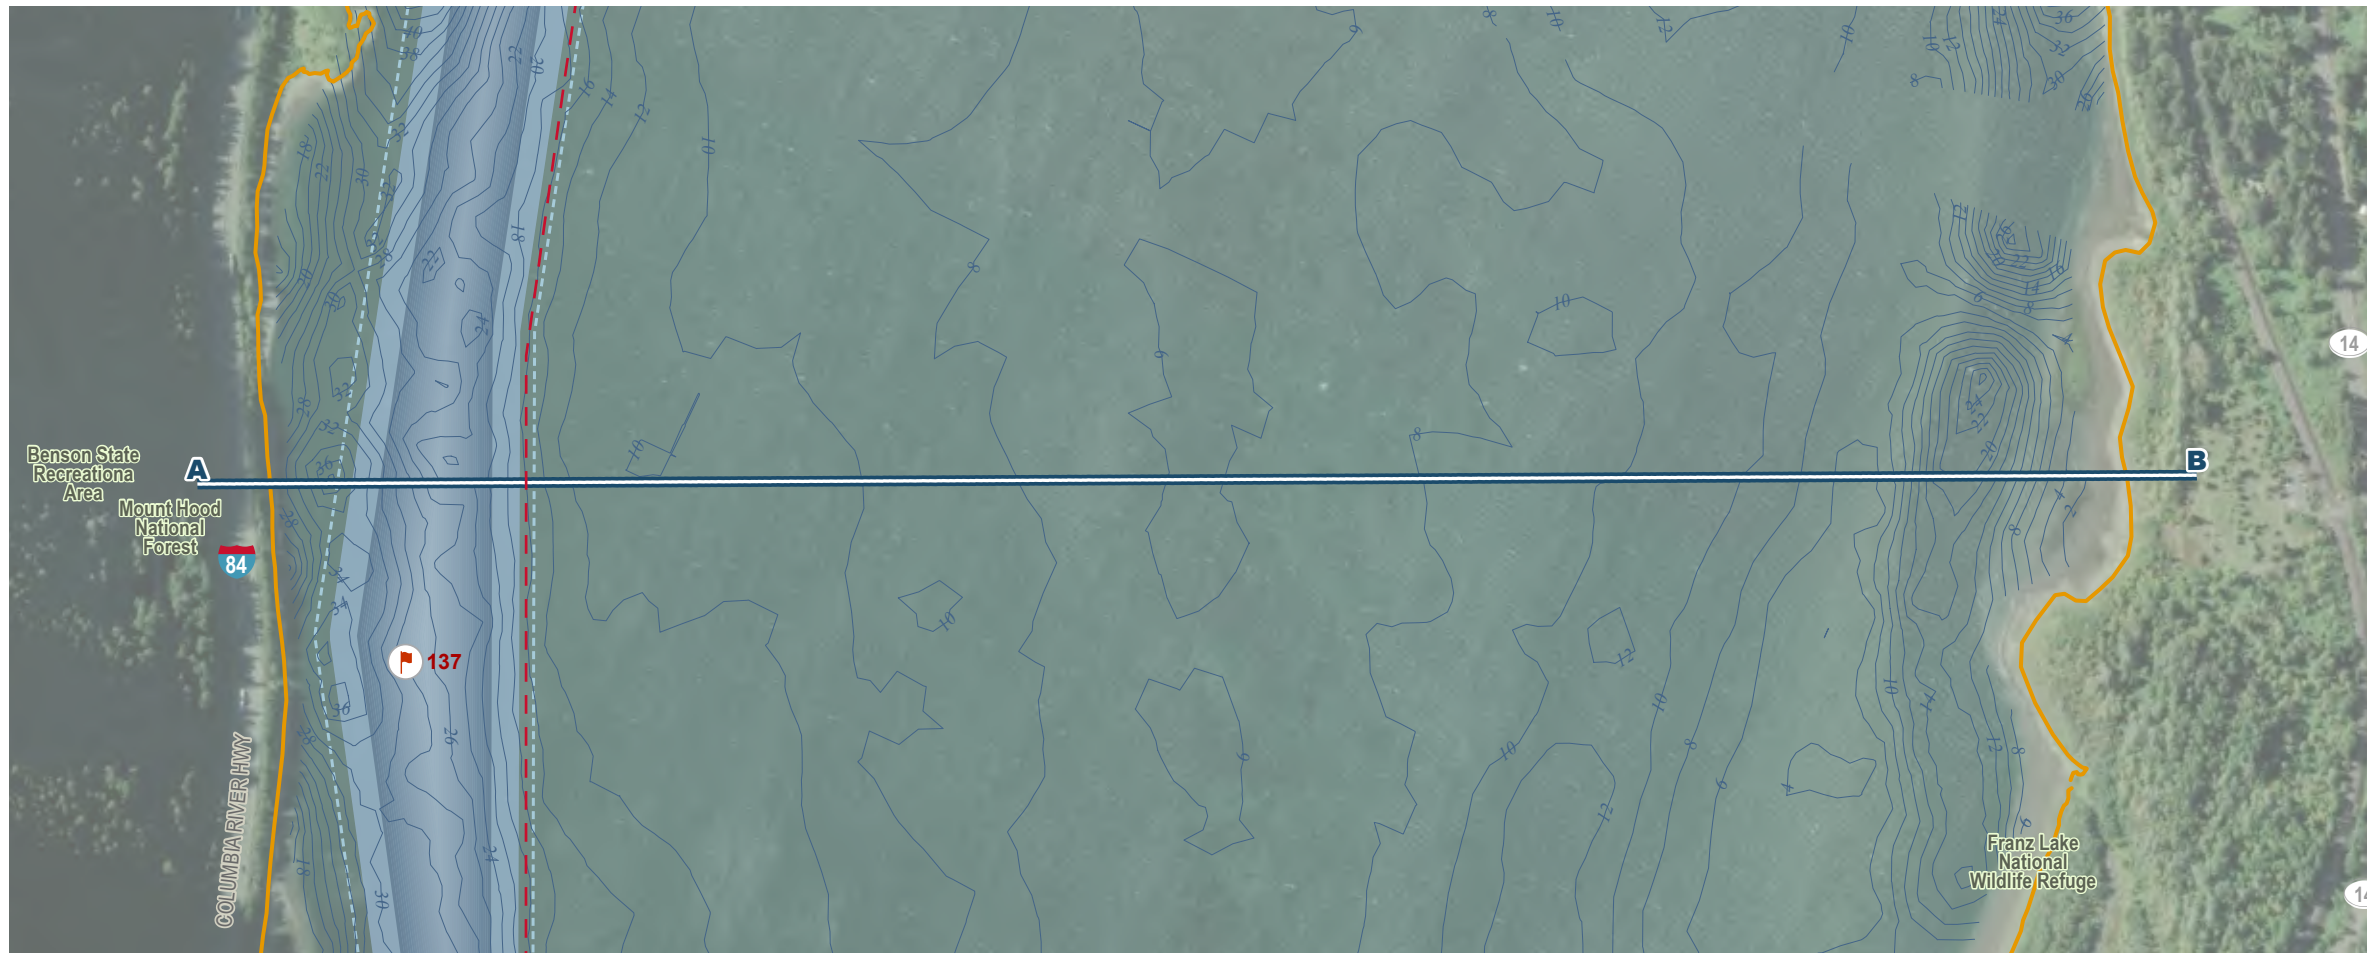
CROSS SECTION VIEW: RM 137
PAGE 3 OF 9

- A-B** CROSS SECTION LINE
- PROPOSED ALIGNMENT - HVDC HYDROFLOW
- RIVER MILES (USACE)
- ESTIMATED OHW
- BATHYMETRY CONTOUR (2FT)
- FEDERAL NAVIGATION CHANNEL
- FEDERAL NAVIGATION CHANNEL BUFFER (50FT)
- FEDERAL NAVIGATION CHANNEL OVERWIDTH (100FT)

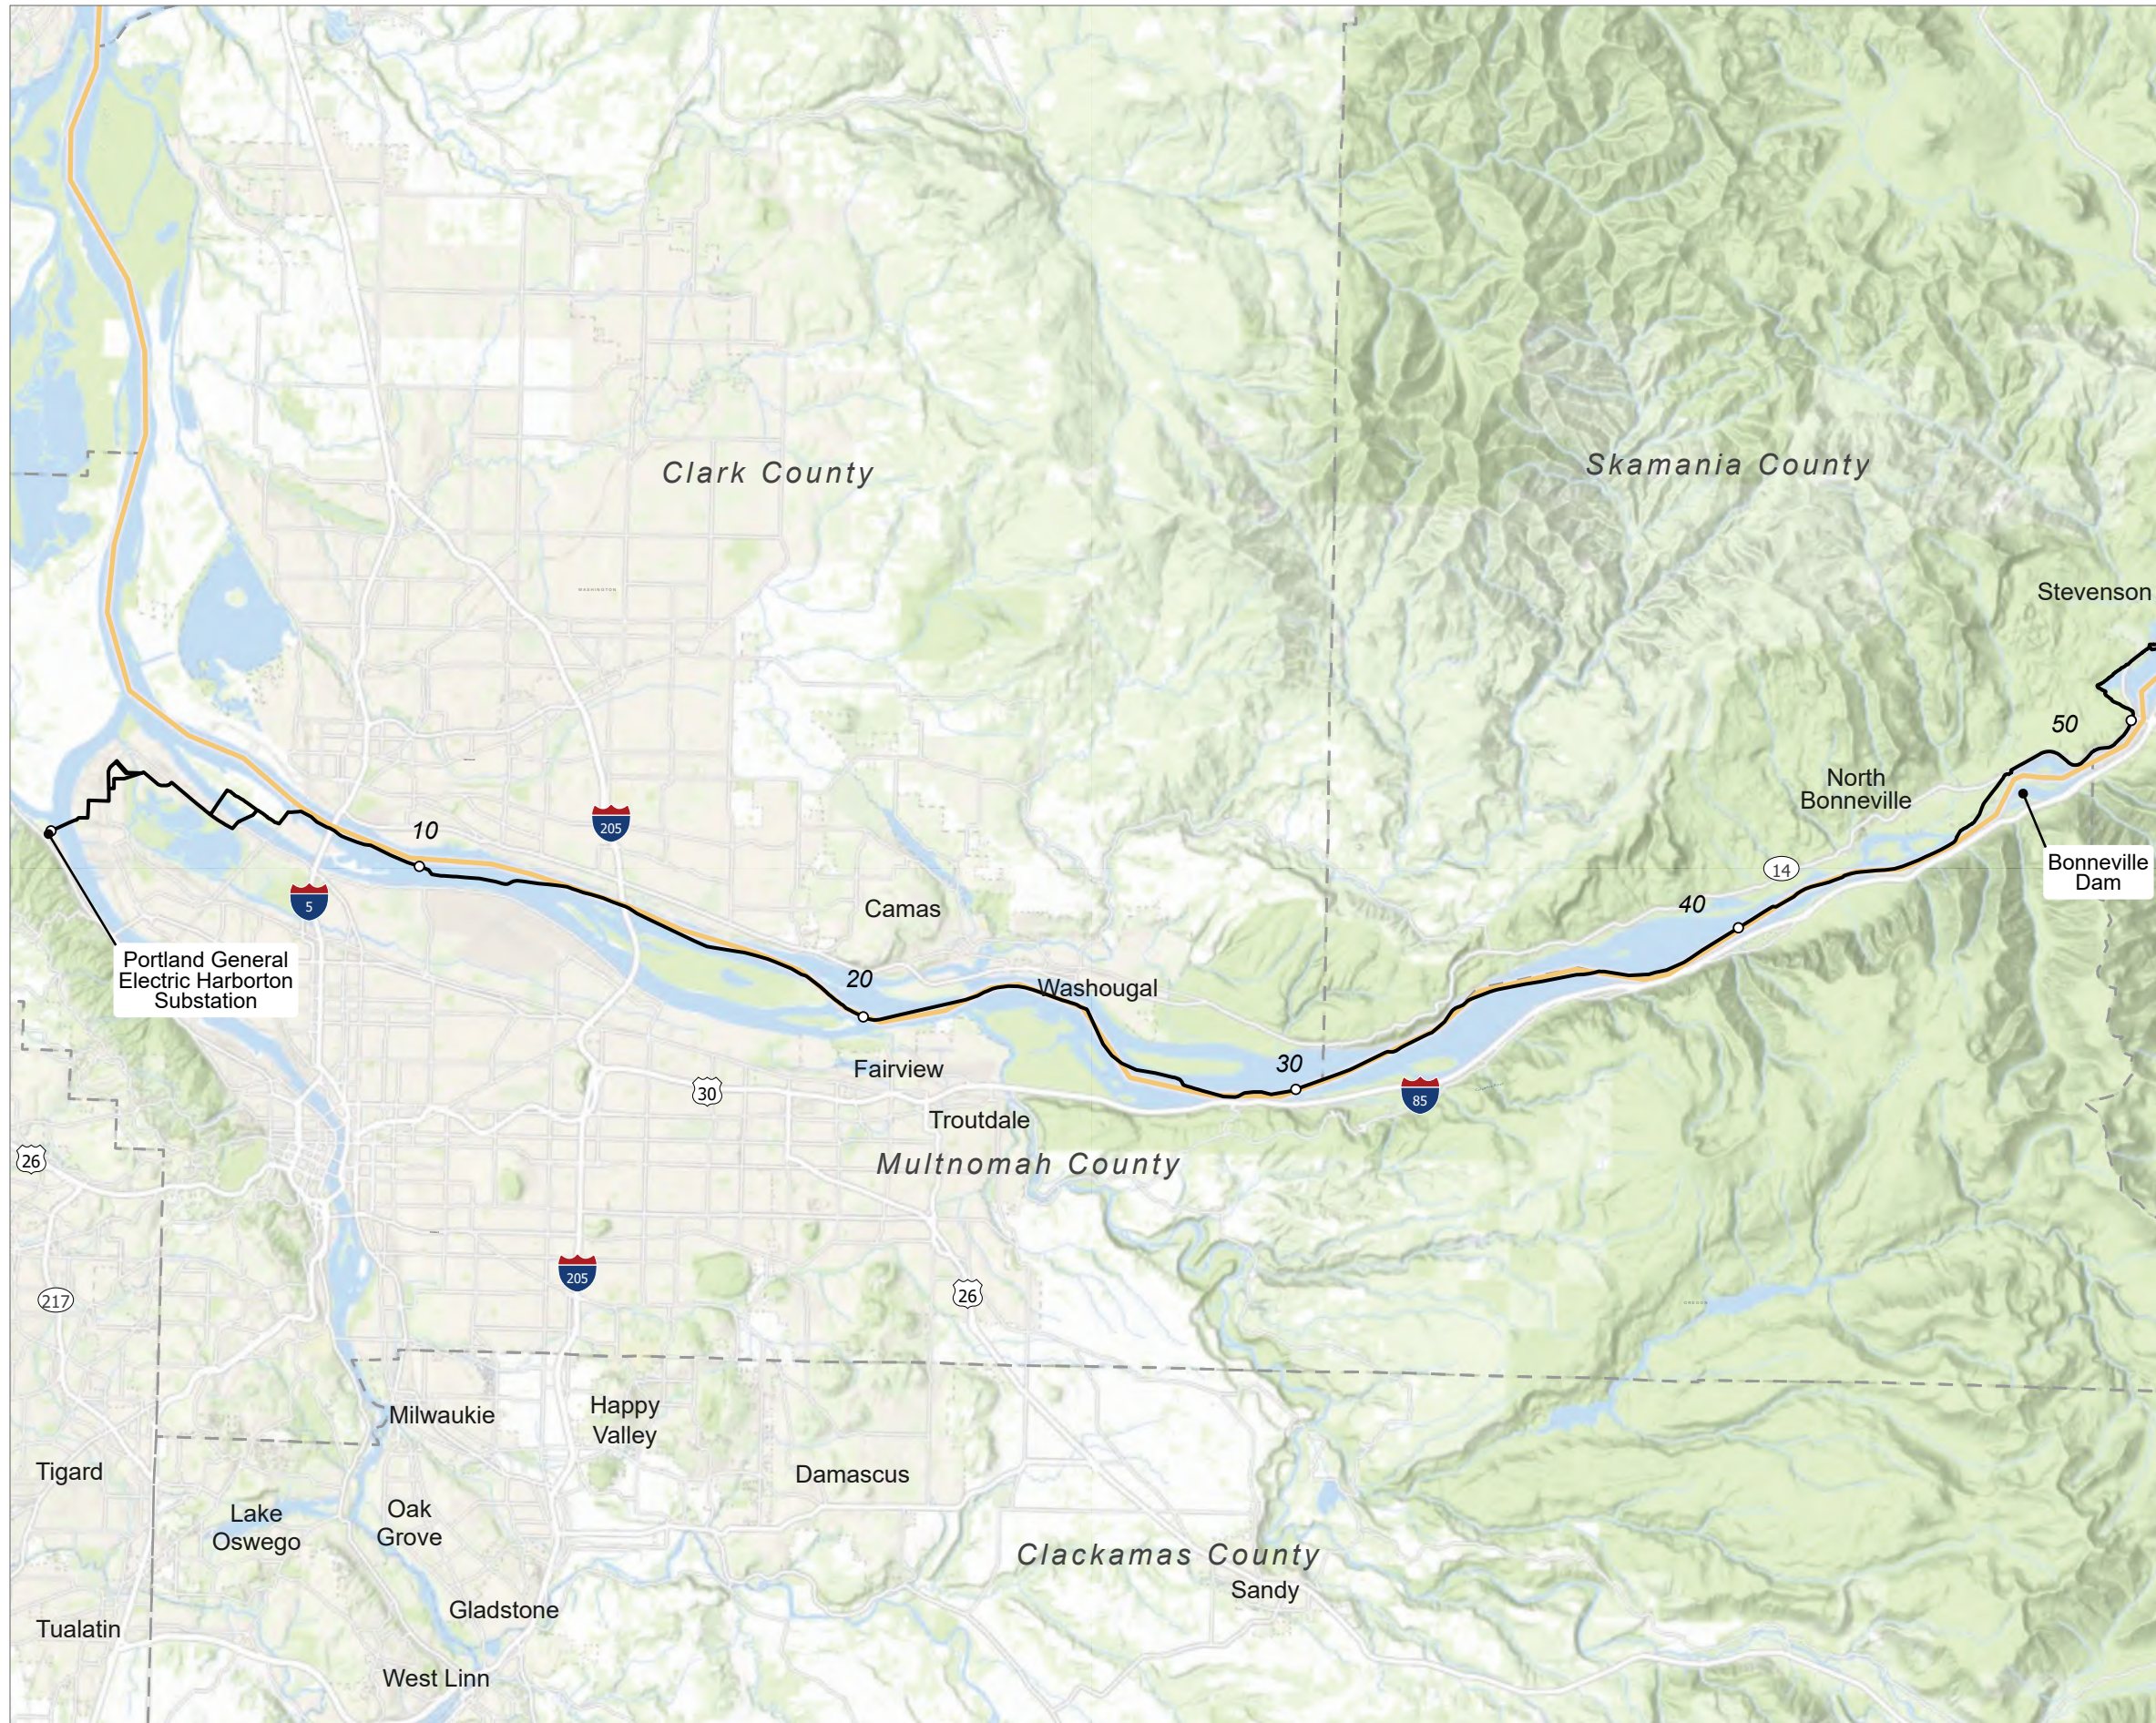
FIGURE 1. VICINITY MAP
BONNEVILLE DAM TO
PGE HARBORTON SUBSTATION

- River Miles (Miles)
- Proposed Alignment
- - - County Boundary
- ▭ State Boundary

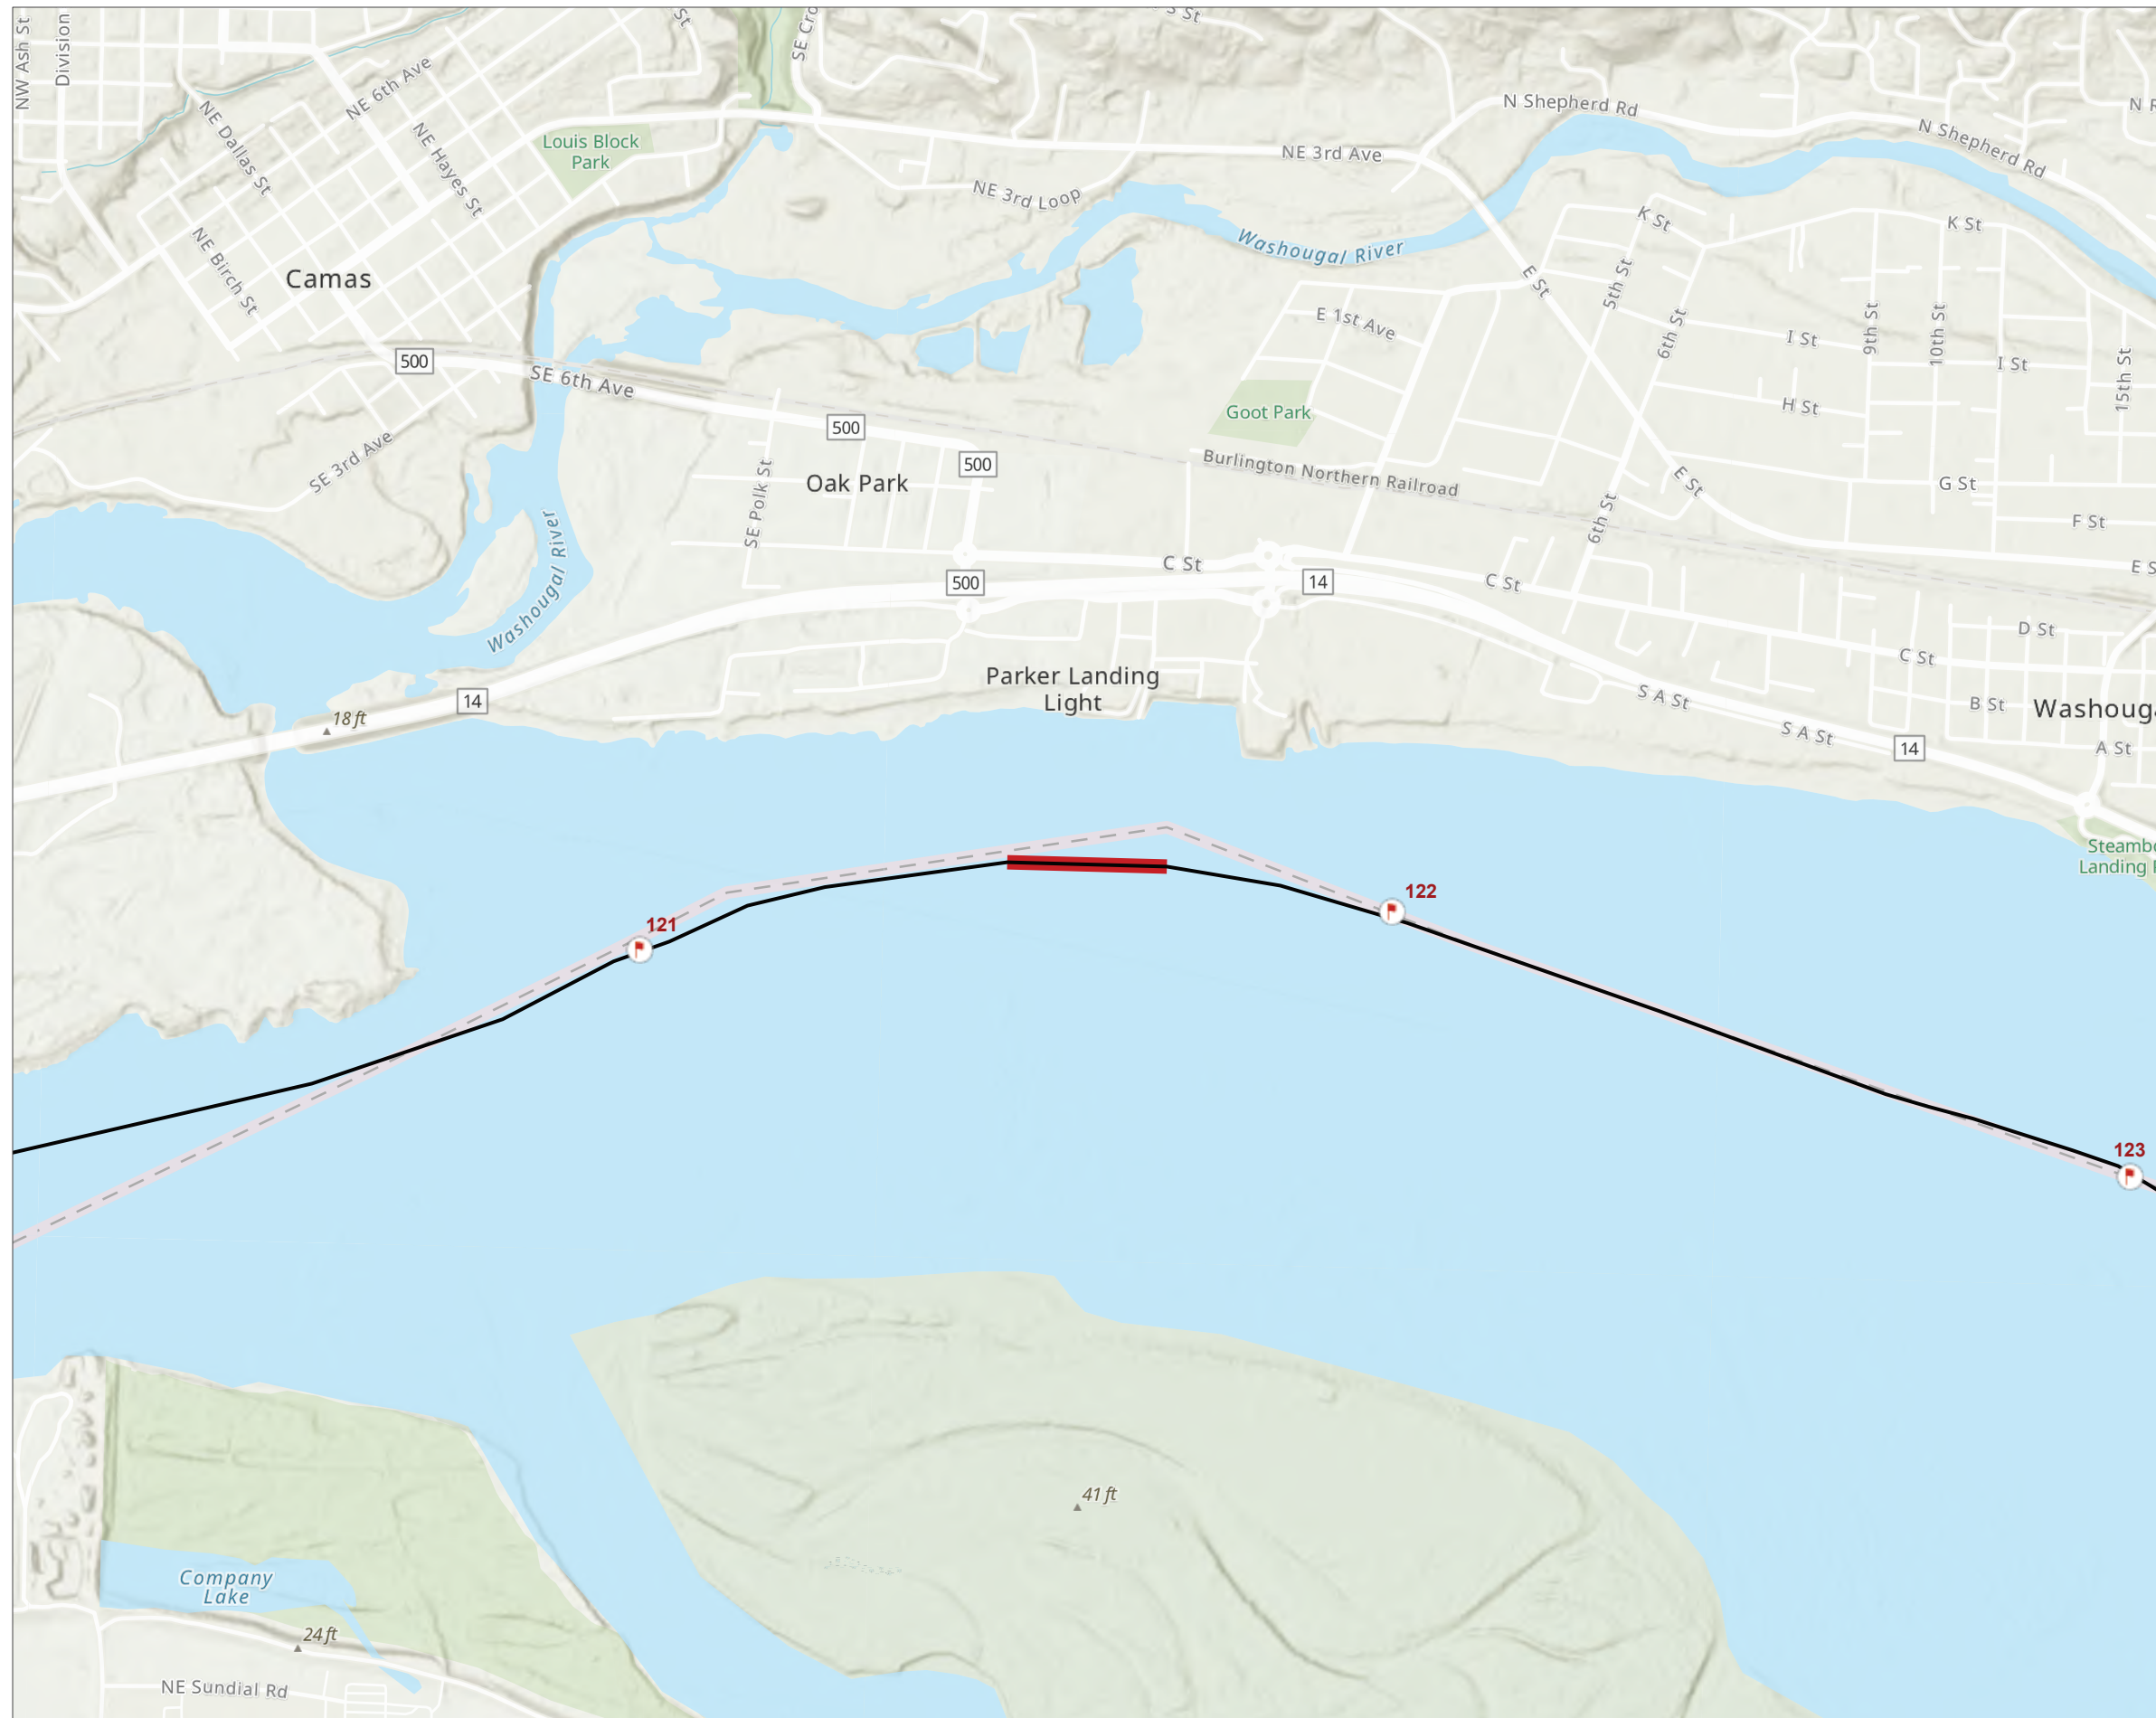
Figure 2. Cable Protection Locations

- RIVER MILES (USACE)
- PROPOSED ALIGNMENT
- CABLE PROTECTION LOCATION

Cable protection (i.e., cable protection or rock berm) is proposed in three locations and would be placed over the cable protect it from damage (Figure 1-2). Cable protection would be used where there is little or no sediment over bedrock, as such there would be negligible impacts to sediments. Benthic communities colonizing bedrock in the immediate vicinity of the cable protection may be physically impacted by the placement of the rock or ACB mattress. Benthic communities recover at varying rates depending on species composition and substrate. The addition of the mattress would result in a loss of habitat within the installation footprint but would likely be recolonized in the short term and has the potential to provide additional habitat complexity (Dernie et al. 2003). In sites where burial depth is shallow and the mattresses are needed such as utility crossings, they would introduce hard substrate in areas that may have existing sand or fines and would alter benthic habitats. Re-colonization of these areas could take longer due to the surrounding benthic community being adapted to soft substrates. The cable protection is not anticipated to have any noticeable effect on river discharge due to its shallow profile and narrow footprint.

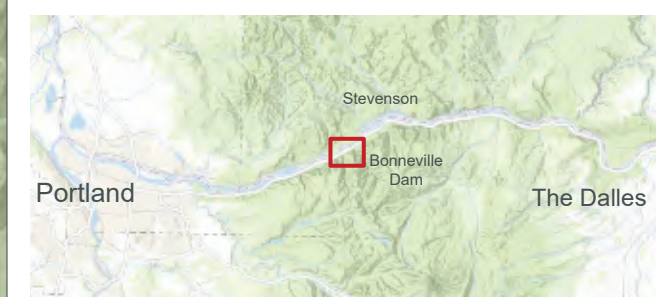
**Figure 3 SFAM
Project Alignment
Page 14 of 24**

- RIVER MILES (USACE)
- PROPOSED ALIGNMENT - HDD
- PROPOSED ALIGNMENT - HYDROFLOW
- PROPOSED ALIGNMENT - UPLAND INSTALLATION (E.G., TRENCHING)
- TEMPORARY 3-SIDED WET COFFERDAM
- TEMPORARY HORIZONTAL AUGER BORE (HAB)
- TEMPORARY HORIZONTAL DIRECTIONAL DRILLING (HDD) AREA
- UPSTREAM PROXIMAL ASSESSMENT AREA
- UPSTREAM EXTENDED ASSESSMENT AREA
- DOWNSTREAM PROXIMAL ASSESSMENT AREA
- DOWNSTREAM EXTENDED ASSESSMENT AREA

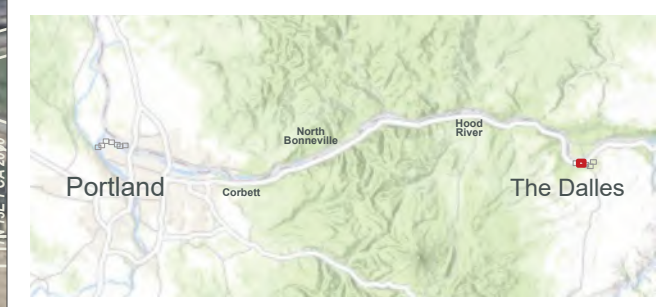
FIGURE 2 TAXLOT MAP
PAGE 10 OF 12
DATE: 4/1/2025
TOWNSHIP AND RANGE: T01N R13E
SECTION: 1, 6
USGS QUAD NAME:
THE DALLES SOUTH

- PROPOSED ALIGNMENT
- TEMPORARY HORIZONTAL DIRECTIONAL DRILLING (HDD) AREA
- TEMPORARY HORIZONTAL AUGER BORE (HAB)
- WETLAND AND WATERS SURVEY AREA
- DESKTOP AND VISUAL SURVEY ONLY
- TAXLOT
- STATE BOUNDARY

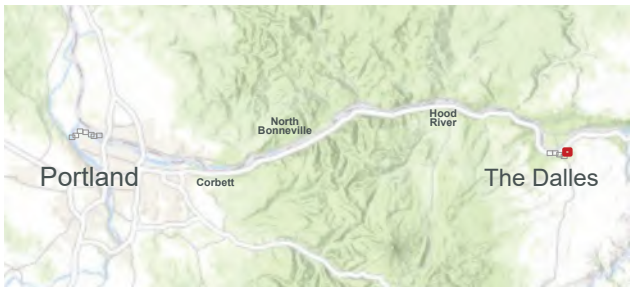
FIGURE 3: NWI AND NHD MAP
PAGE 1 OF 12
DATE: 4/1/2025
TOWNSHIP AND RANGE: T02N R01E/R01W
SECTION: 34, 35
USGS QUAD NAME:
LINNTON

- PROPOSED ALIGNMENT
- CONVERTER STATION
- WETLAND AND WATERS SURVEY AREA
- DESKTOP AND VISUAL SURVEY ONLY
- TAXLOT
- STATE BOUNDARY

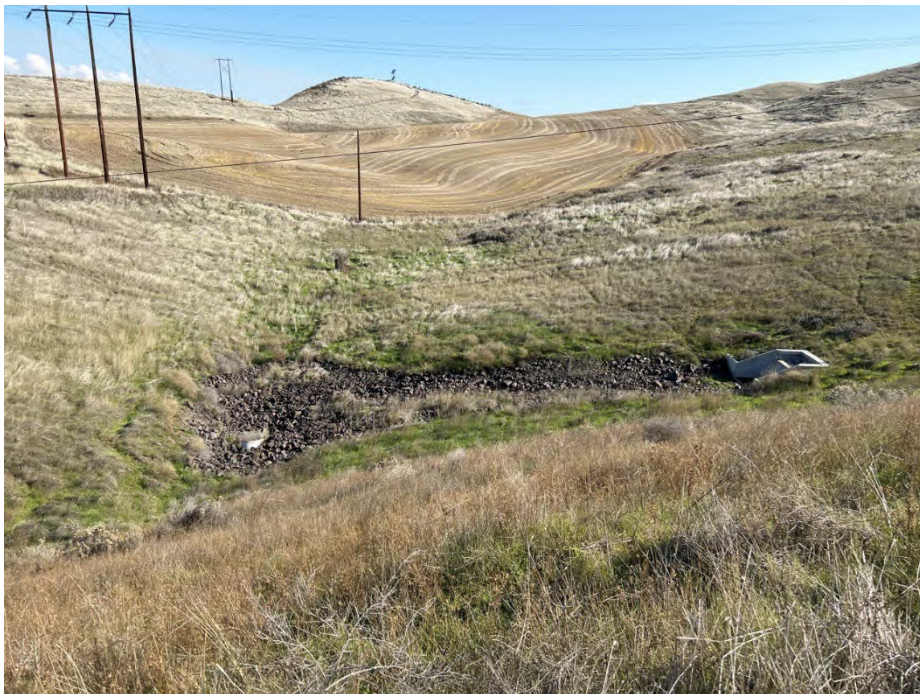
Photo 3b	Looking upstream at an ephemeral drainage (Drainage 1) beneath Columbia View Drive, culvert occurs roughly 75 feet below road grade.
Date: 11/08/23	
Direction: Northeast

See Appendix A, Figure 6, Page 59 for map of drainage. Ground level photographs (Photos 3a and 3b) are found in Appendix C.

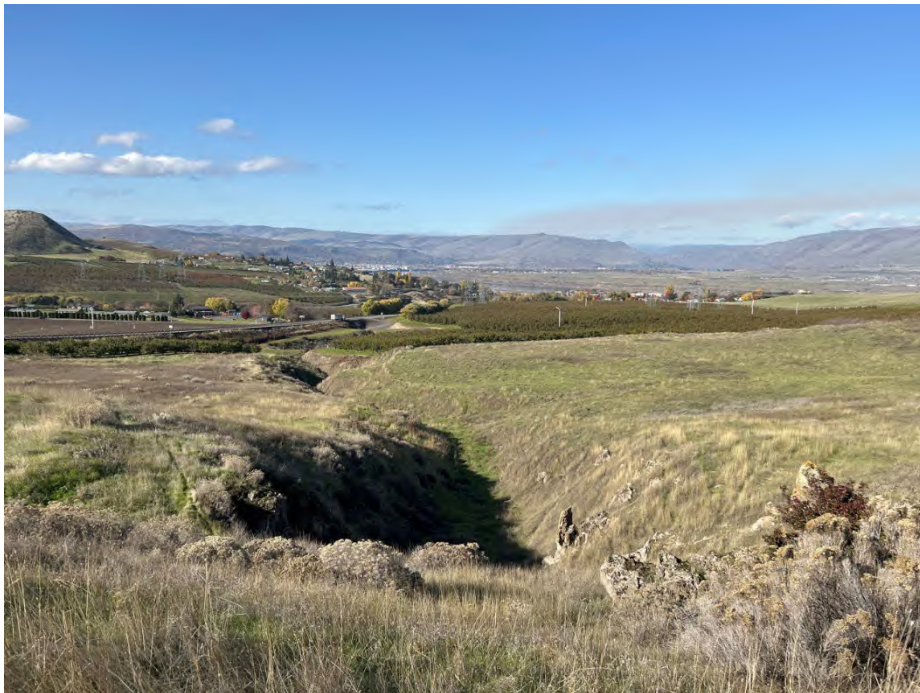
Photo 4b	Looking downstream at an ephemeral drainage (Drainage 2) to Threemile Creek beneath Columbia View Drive; culvert present roughly 30-40 feet below road grade.
Date: 11/08/23	
Direction: Northwest

See Appendix A, Figure 6, Page 54 and 55 for map of drainage. Ground level photographs (Photos 4a. 4b. and 5) are found in Appendix C.

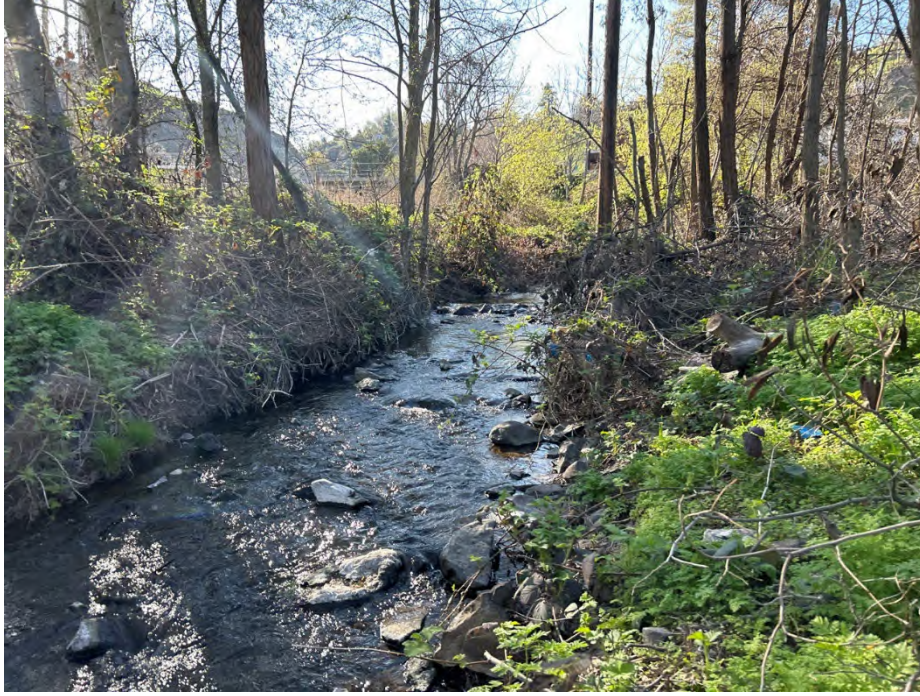
Photo 7	Threemile Creek, looking upstream.
Date: 04/02/24	
Direction: South

Photo 7	Threemile Creek, looking upstream.
Date: 04/02/24	
Direction: South

Threemile Creek is located within the SA at multiple locations along the east end of the project in The Dalles, Oregon (Figure 5, pages 49 through 52, Appendix A; Photos 6 through 8, Appendix C). In the SA, the creek is mapped in the NWI as PSS1C and in the NHD as an intermittent waterbody. Threemile Creek is located in Threemile Creek Watershed (HUC 170701050402; OSU 2025). The creek originates in the foothills of the east side of Mt. Hood and generally flows northeast to its confluence with the Columbia River. The stream gradient within the survey corridor varied between 2 and 10 percent with steeper gradients occurring upslope and adjacent to US 197. The existing riparian area has been truncated by urban development through the majority of the SA and generally consisted of an overstory of Russian olive (*Elaeagnus angustifolia*), Himalayan blackberry, and a varied herbaceous layer. Threemile Creek flows beneath US 197 between HDD Area 17 and 18 (Figure 5, page 52, Appendix A) and south of HDD Area 16 via culvert, and again beneath OR 30 west of HDD Area 14 via culvert (Figure 5, page 50 and 51, Appendix A). In these locations, both US-197 and OR 30 are elevated from the ground surface due to road fill while Threemile Creek flows beneath them. Threemile Creek also flows parallel to the proposed trench location south of I-84 (Figure 5, page 49, Appendix A). In this location, the OHW of Threemile Creek is approximately 100 feet east of the proposed cable location. Threemile Creek has an associated wetland within the SA, Wetland 4, near the northeast portion of the SA. Threemile Creek and Wetland 4 continue off site to the north.

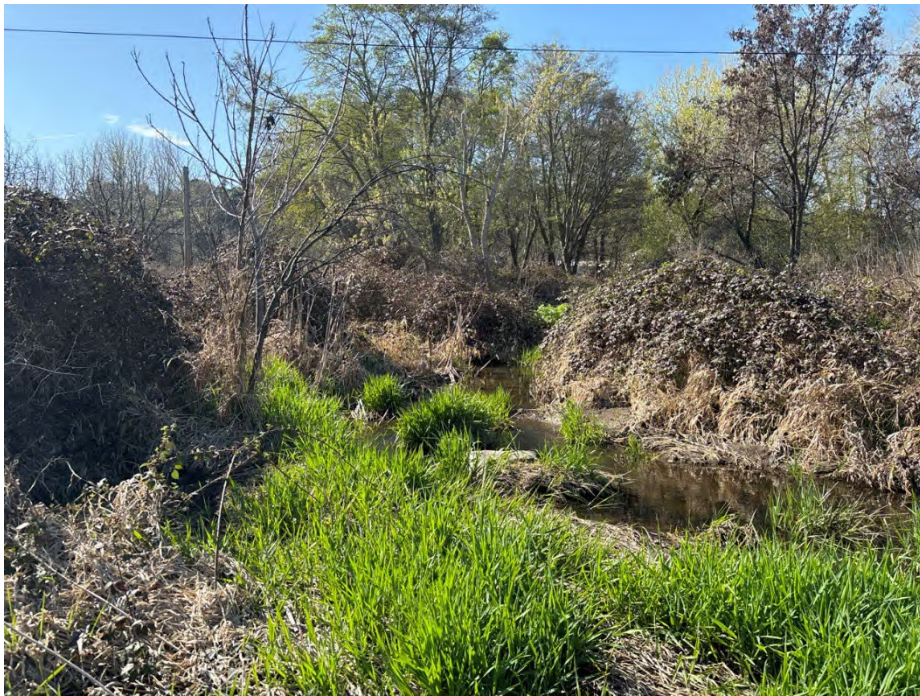
Photo 8	Looking upstream at Threemile Creek and Wetland 4. Mosaic of reed canary grass and broadleaf cattail occur within the ordinary high water mark.
Date: 04/02/24	
Direction: South

Photo 8	Looking upstream at Threemile Creek and Wetland 4. Mosaic of reed canary grass and broadleaf cattail occur within the ordinary high water mark.
Date: 04/02/24	
Direction: South

Wetland 4 (0.05 acres) is a riverine wetland located within the OHW of Threemile Creek and is within the Threemile Creek watershed (HUC 170701050402; OSU 2025) (Figure 5, pages 49, Appendix A; Photos 8, Appendix C). The wetland is mapped in the NWI as PSS1C. Dominant vegetation includes reed canarygrass and cattail (*Typha latifolia*). Red alder and Himalayan blackberry occur at the edges of the wetland and stream. Vegetation in Wetland 4 was classified in the field as PSS (Cowardin 1979). Wetland hydrology indicators include surface water, high water table, and saturation and are attributed to the wetland proximity to Threemile Creek. Soil pits were not dug for Wetland 4; hydric soils are assumed present.

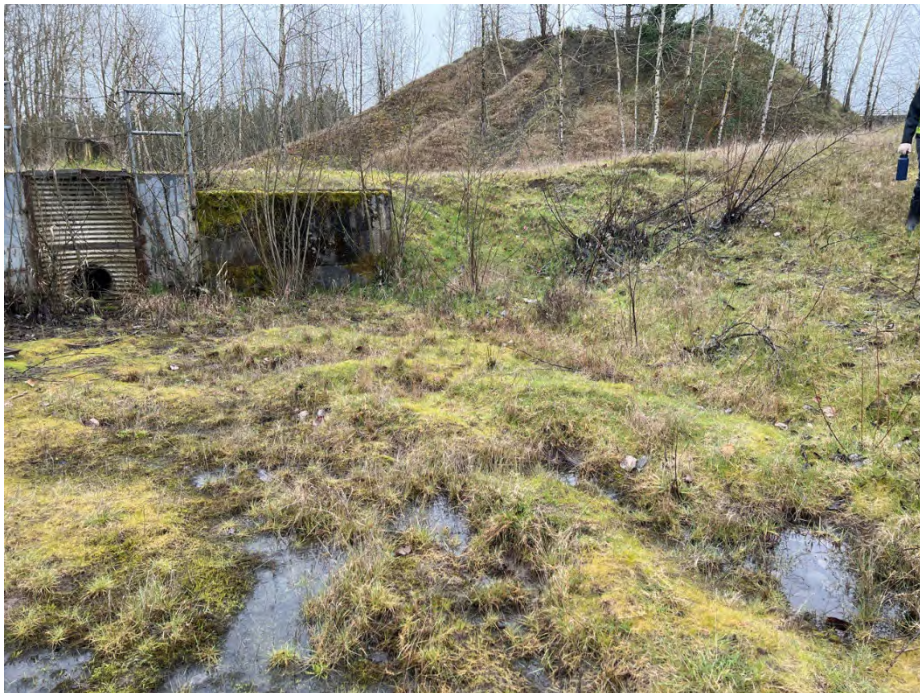
Photo 23	Verification Plot 10 (VP-10). Small depressional area determined to be upland.
Date: 03/12/24	
Direction: West

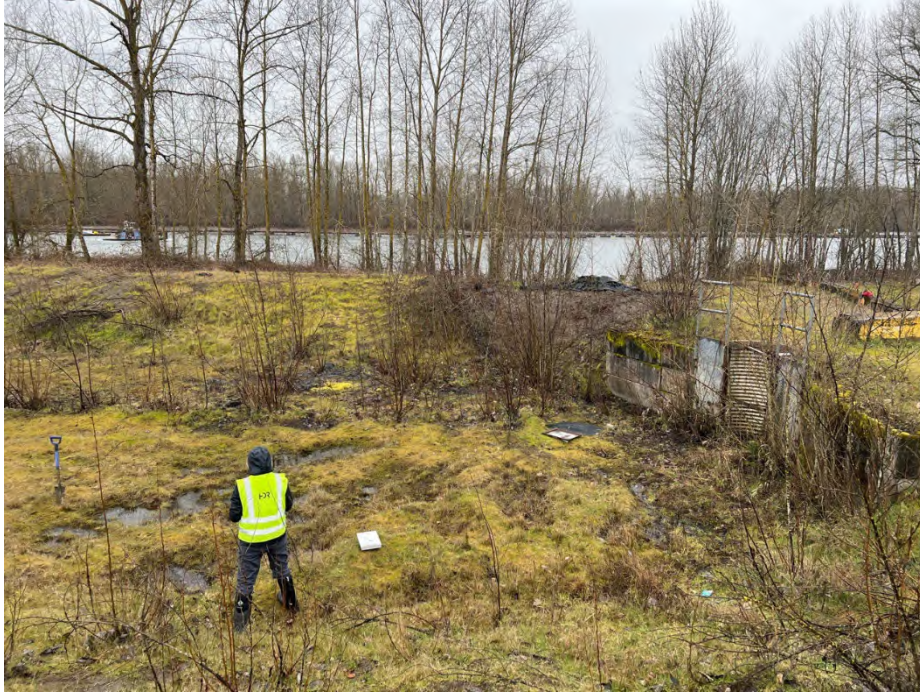
Photo 24	Sample Plot Area A-P1 (W) taken within suspect depressional area in human-made stormwater feature. Culvert discharge to 12-inch pipe to Columbia River shoreline. No evidence of flow observed.
Date: 03/11/24	
Direction: Southeast

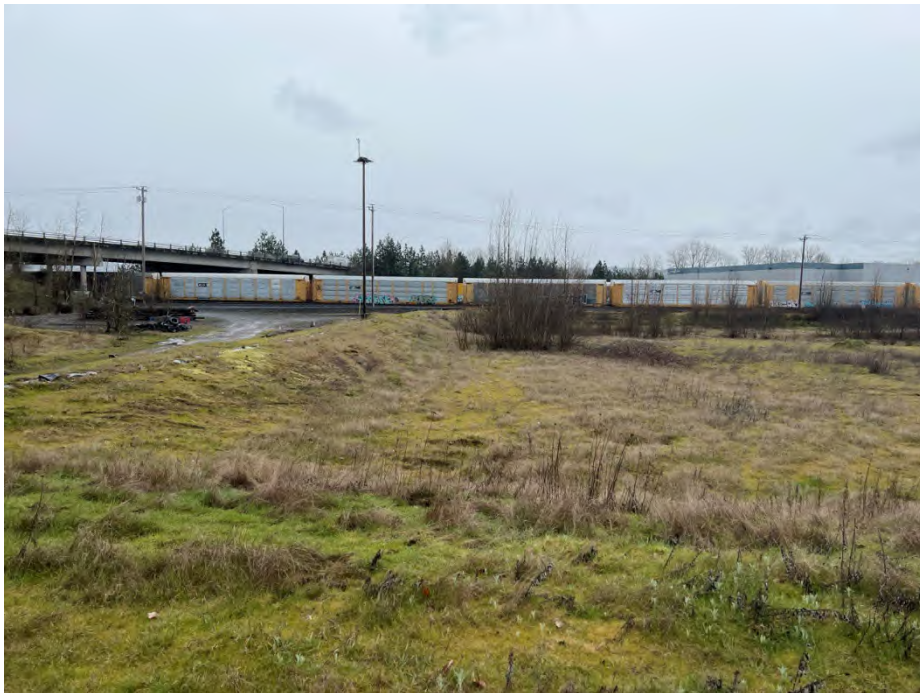
Photo 25b	Overview of Area B.
Date: 03/11/24	
Direction: Southwest

Photo 25b	Overview of Area B.
Date: 03/11/24	
Direction: Southwest

Area B (0.01 acres) occurs in a depression area within a historic dredged fill placement located southwest of Area B and within the Lake River – Frontal Columbia River watershed (HUC 170800030104; OSU 2025) (Figure 5, pages 35 and 36, Appendix A; Photos 25 and 26, Appendix C). This feature is not mapped in the NWI. Dominant vegetation includes an unidentified

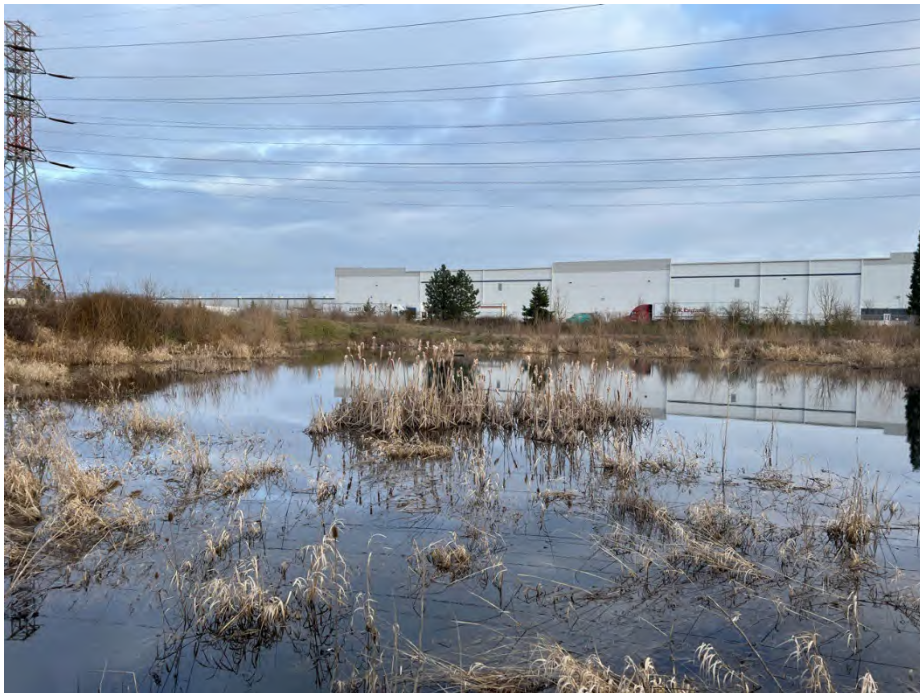
Photo 32	Roughly 24-inch culvert inlet to Wetland 3; a large stormwater feature. Signs of recent flow observed.
Date: 03/13/24	
Direction: East

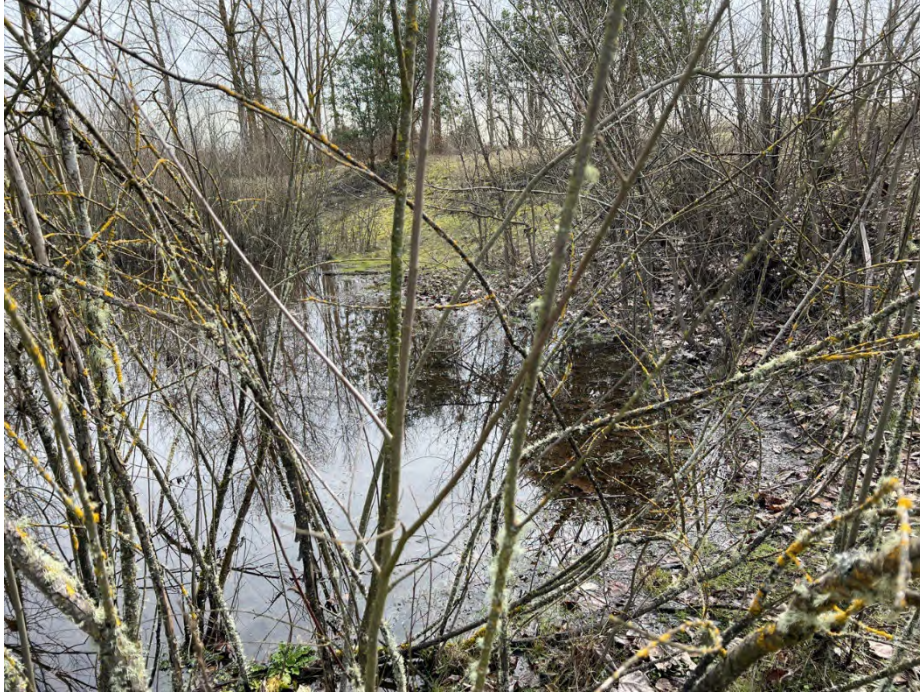
Photo 37b	Sample Plot W3-P3 (W); wetland condition changes rapidly to upland with elevation rise on graded slopes around depressional area.
Date: 03/11/24	
Direction: East

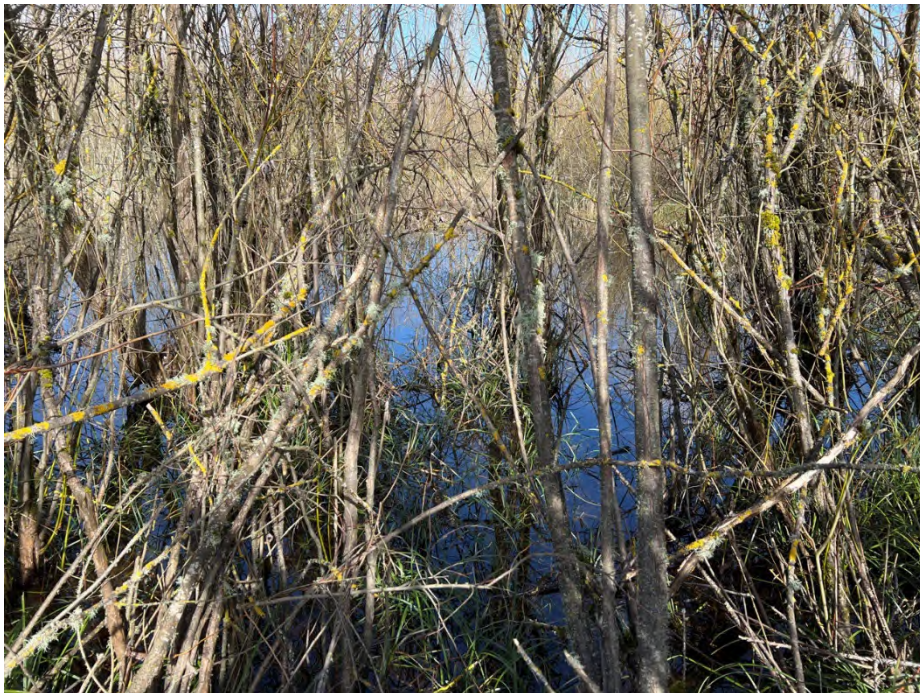
Photo 38a	Sample Plot W3-P5 (W) taken at topographic break where wetland condition in depressional area transitions to upland on steeply graded slopes at wetland boundary.
Date: 03/13/24	
Direction: Northwest

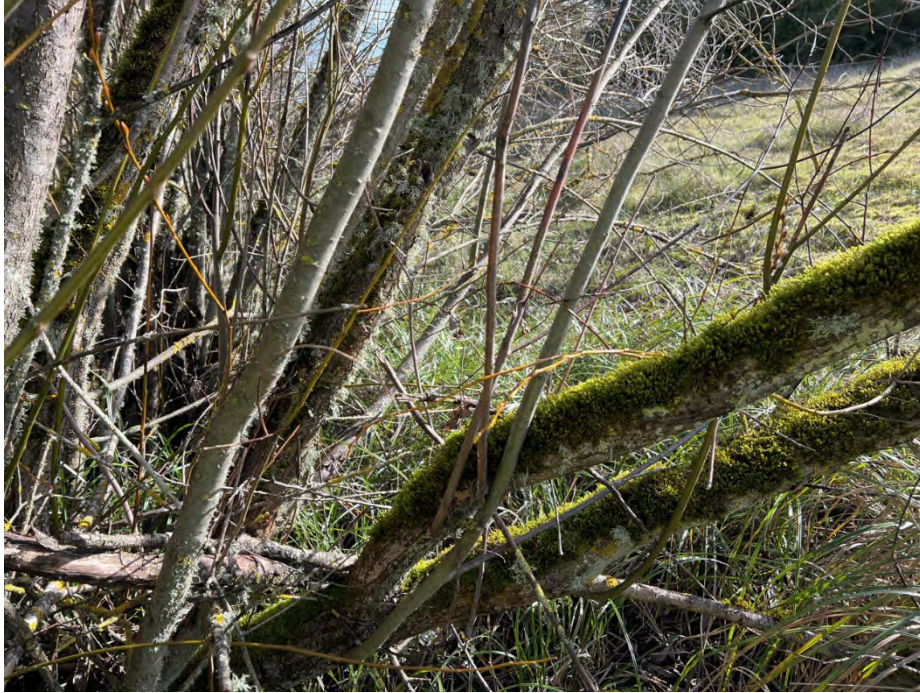
Photo 38b	Steeply graded slope around depressional stormwater feature create distinct break from wetland to upland condition.
Date: 03/13/24	
Direction: Northeast

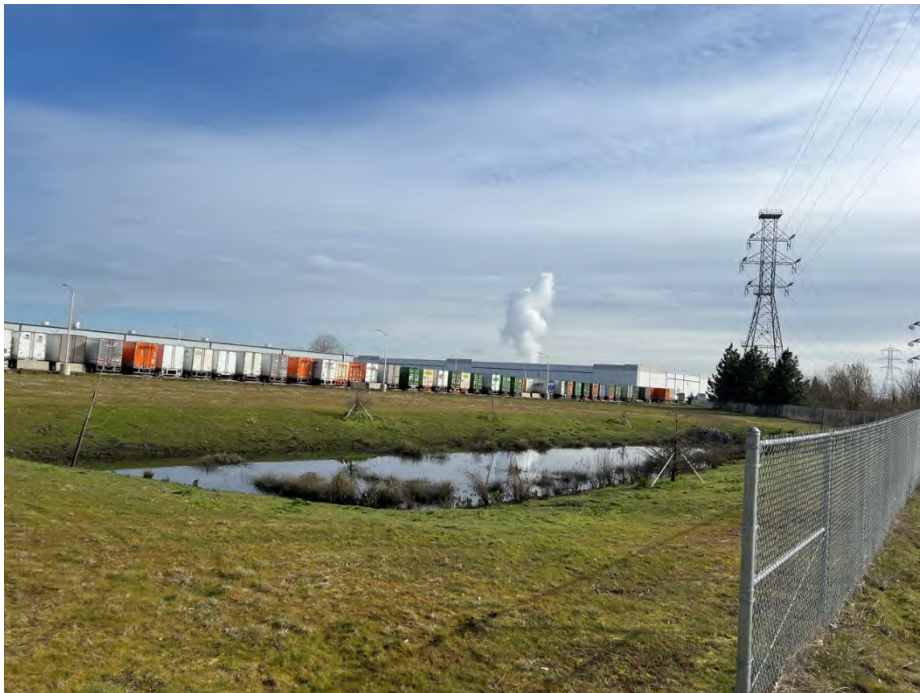
Photo 39	Stormwater feature near landing site on the east side of the Willamette River.
Date: 03/13/24	
Direction: Northeast
