# NEWPORT BEACH ACCESS RESILIENCY PLAN

**JUNE 3, 2021**

This report contains concept level designs and estimated construction costs for each of the three access points as well as discussion of structural, geotechnical, site design and regulatory/permitting considerations. The designs are concept level and are based on a general assumption of soil conditions and approximate site grades. No engineering modelling/analysis, survey, or geotechnical investigations were performed in the development of these concept designs.

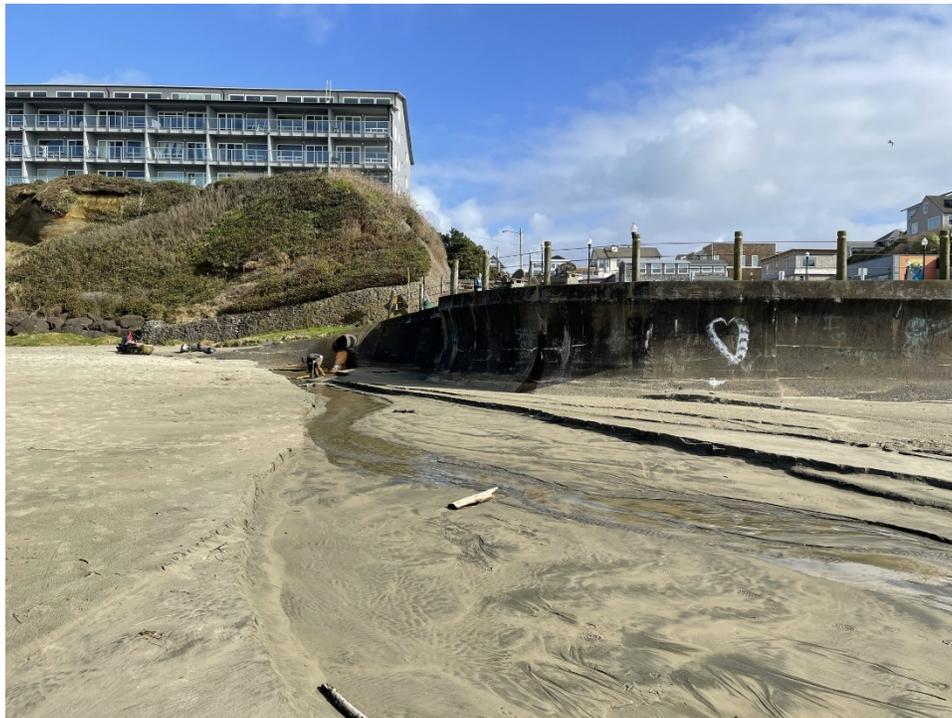
**Figure 1: Nye Beach Turnaround**

1. The approximately 12-foot differential between the Nye Beach turnaround and the beach.

2. Potential for the adjacent existing masonry wall (associated with an early-20<sup>th</sup> Century Natatorium facility that existed at the site) to fail during a large earthquake and partially or fully obscure the existing access ramp.
3. The location of a storm drain outfall to the south of the turnaround.
4. Potential to provide access for a large number of people due to the popularity of this location.
5. Opportunity for this site to be connected to the Sam Moore Parkway Trail to provide additional pedestrian circulation benefits supporting passive recreation for residents as well as for potential tourism value.

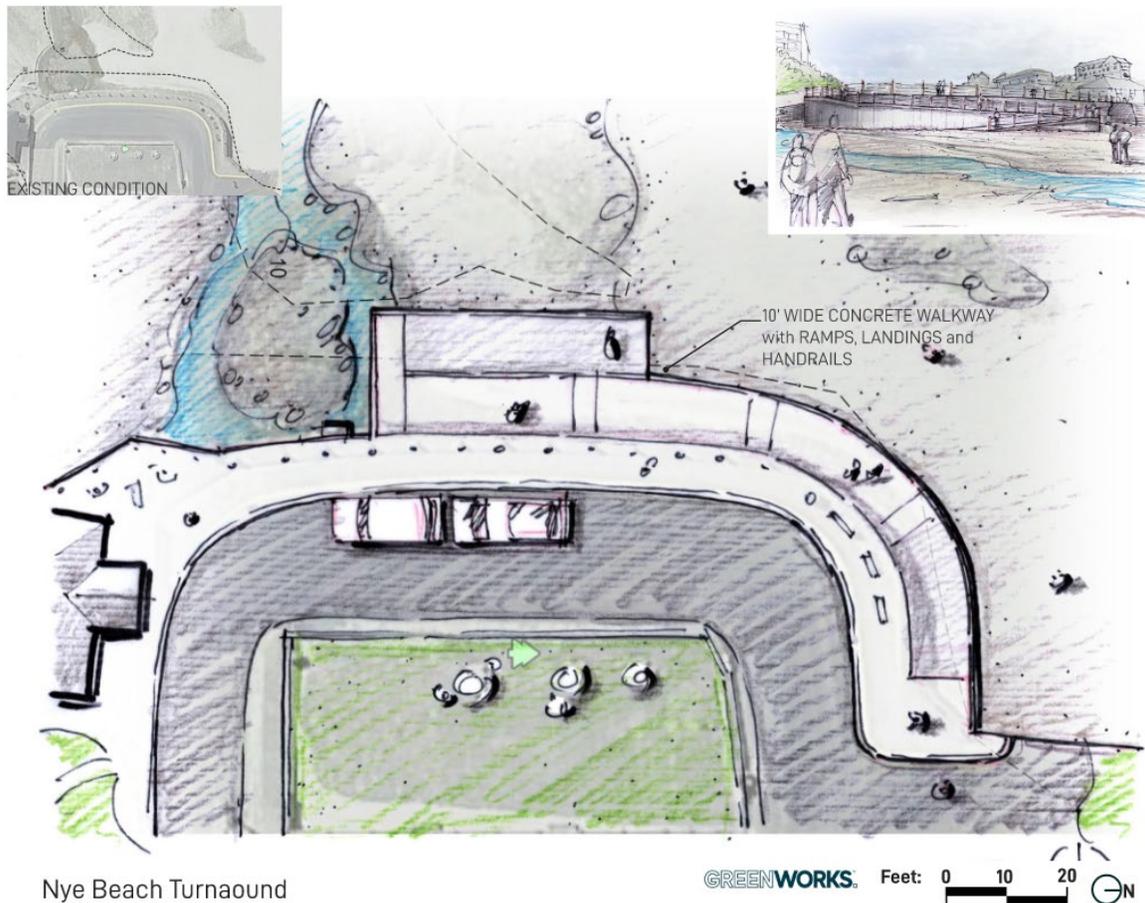
**Figure 2: Concept Plan**

The proposed access is anticipated to consist of a reinforced concrete structure with a 10-foot-wide pedestrian path consisting of four ADA-compliant ramps, five landings, and a section nearest the beach running at five percent. Total length is approximately 250 feet. The lowest section would land approximately two feet below grade to provide resilience to shoreline erosion. The structure would be designed to wrap around the existing wall and present consistently in terms of matching existing materials. Additional evacuation signage is recommended on the streets to guide people out of the Tsunami Inundation Zone efficiently.

The proposed access retrofit concept plan and structural section is shown in Figure 2 and Figure 3, with suggested improvements to tsunami evacuation signage shown in Figure 4.

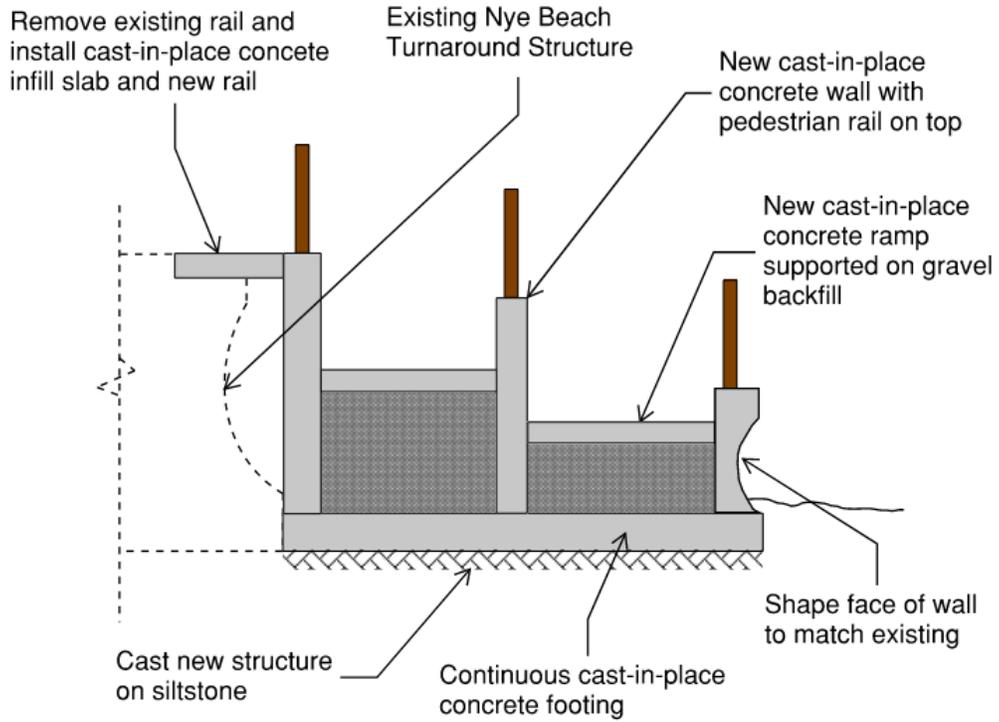
**Figure 3: Concept Structural Section**

The new reinforced concrete walkway would be designed to remain operational after a major seismic event. Stabilization or reconstruction of the adjacent existing concrete wall at the perimeter of the turnaround roadway may also be necessary, as its current seismic resilience is unknown and may present a hazard to life safety and the operation of the new access ramp if it were to fail.

Reconstruction of the existing wall could be accomplished with a conventional reinforced concrete wall at the same height and in the same location as the existing wall. Replacement of the existing wall would affect the adjacent turnaround roadway during construction. Alternatively, strengthening could be accomplished by using the new access ramp to buttress the existing wall.

Subsurface conditions observed at the Nye Beach access indicate new foundations for the concrete walkway/ramp can likely be founded on shallow spread footings bearing on the native siltstones currently exposed at the base of the existing wall. Foundations would need to be sufficiently embedded to provide both lateral passive resistance as well as below the anticipated depth of scour. In general, the exposed siltstone soils have low to moderate erosion/scour potential compared to the beach sand nearby. Additional geotechnical site investigation would be necessary to verify that the siltstone exposed is sufficiently thick and to verify its presence where obscured by near surface beach sand.

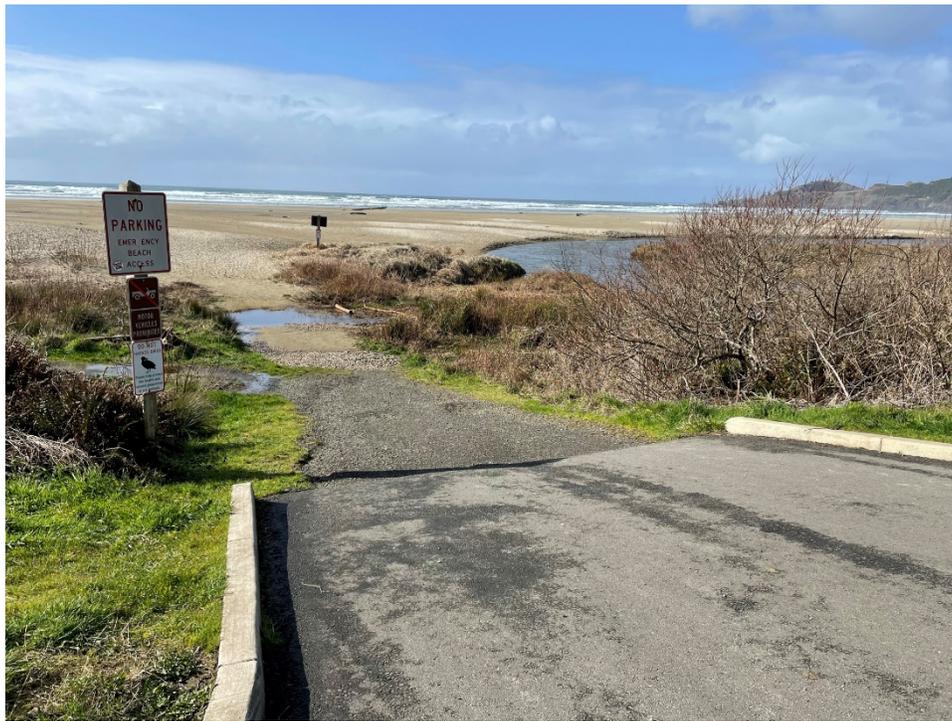
Figure 5: Existing Agate Beach Access

1. Minimal grade issues at this site.
2. The slough coming from the south that drains to Big Creek, as well as a wetland between the existing ramp and the beach.
3. Potential to provide access for a large number of people due to the popularity of this location.

Existing access at Agate Beach consists of a relatively gently sloped on grade path down to the beach. Due to the presence of shallow/standing water at times and relatively loose sands at the surface, liquefaction is a hazard at this site for a CSZ earthquake. Considering the seismic hazard and review of available geological maps, we anticipate the boardwalk would be supported on driven or drilled piles such as pipe piles or helical piles, founded in the underlying dense sands and/or siltstone. Foundations would likely need to extend sufficiently deep to provide lateral resistance during shaking, resist downdrag, and to mitigate scour potential from the adjacent creek. Additional geotechnical site investigation would be necessary to confirm the depth of dense sand/siltstone as well as constructability considerations for various foundation types.

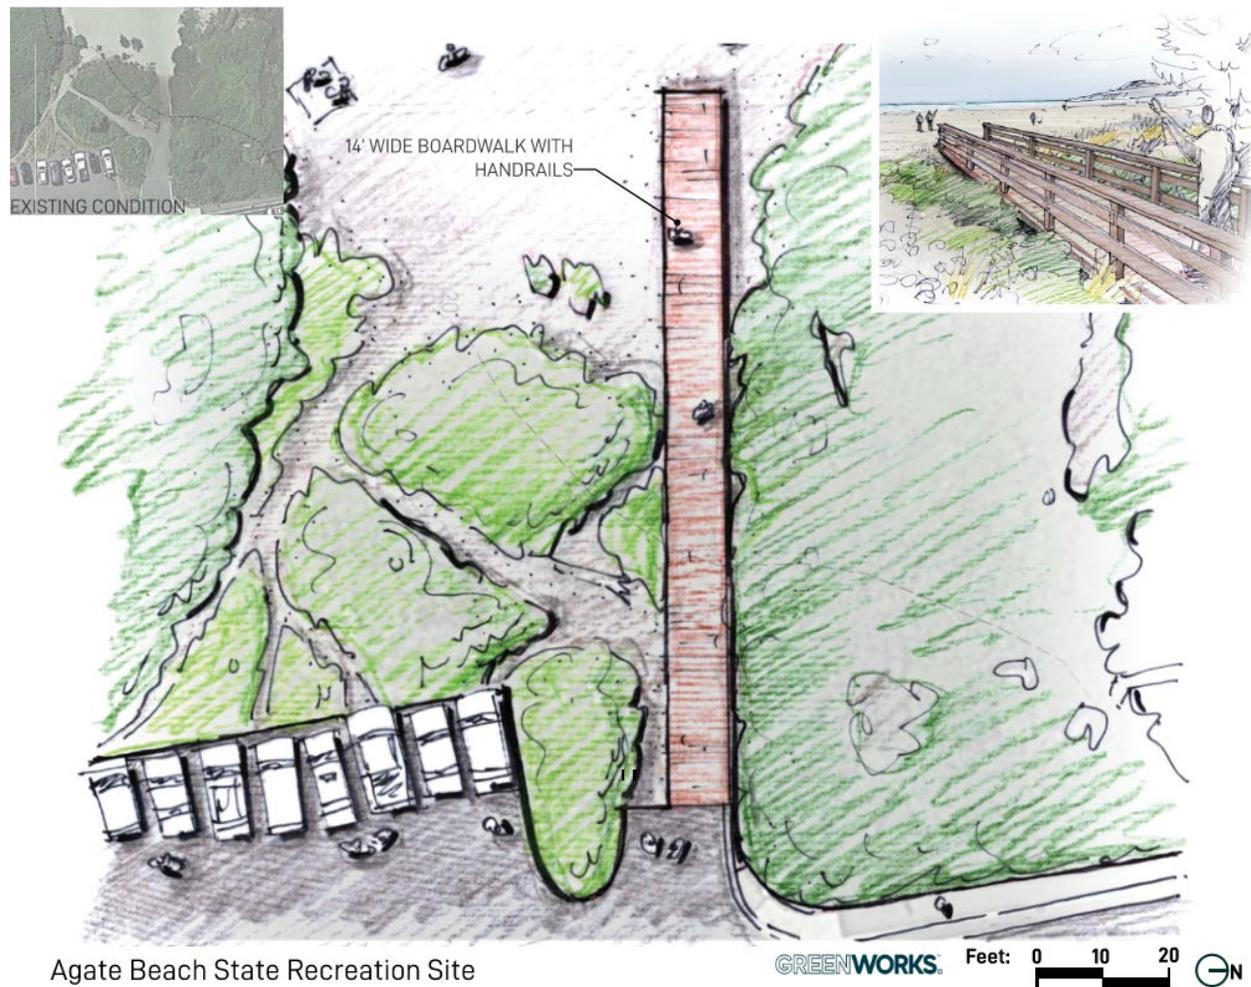
Figure 6: Concept Plan

The proposed access is anticipated to consist of a concrete framed boardwalk with a minimum 14-foot-wide path beginning at the end of the existing parking lot ramp and running approximately 120 feet onto the beach. The boardwalk would serve mobility-impaired users. The structure could be designed in a Cascadian architectural style to blend materially with nearby state park facilities. Additional evacuation signage is recommended to guide people across Ocean Avenue and out of the Tsunami Inundation Zone efficiently.

The proposed access retrofit concept plan and structural section is shown in Figure 6 and Figure 7, with suggested improvements to tsunami evacuation signage shown in Figure 8.

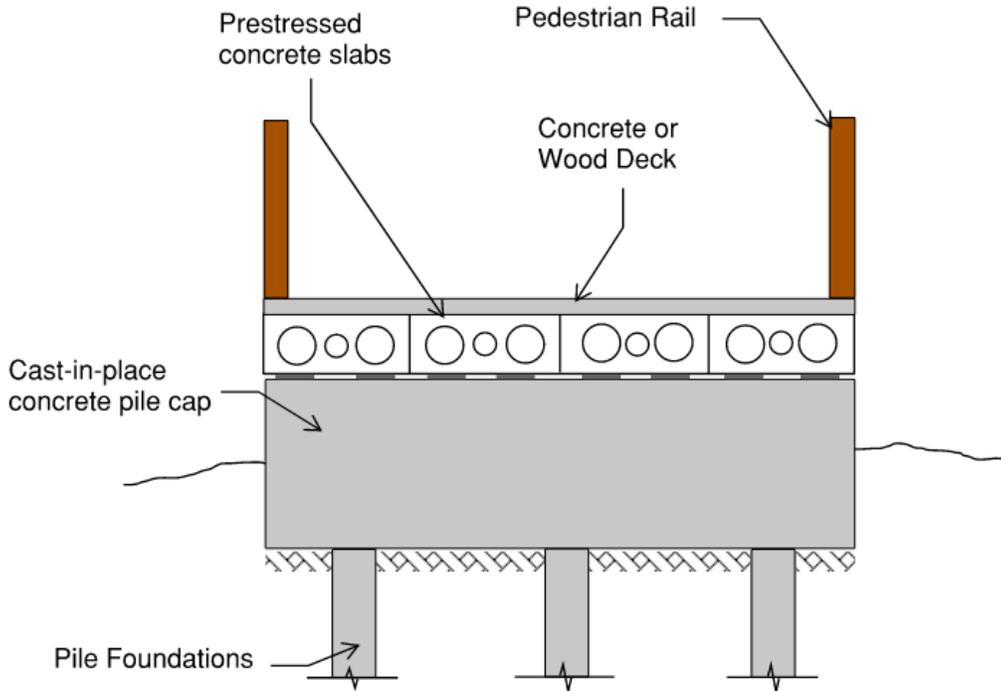
**Figure 7: Concept Structural Section**

The structural design of the boardwalk will need to consider partial inundation during high water and storm surge, the corrosive marine environment, and the need to remain operational after a major seismic event. Reinforced concrete piers and prestressed concrete slabs would accomplish this goal. The deck would likely be a concrete deck to support pedestrian and vehicular traffic (emergency vehicles and beach maintenance vehicles).

The structure would be subject to tidal energy and loading from large wood debris washing up on the beach. The structural design will need to accommodate this additional loading. While the concrete structure would be sufficiently robust, the pedestrian guardrail would be more susceptible to damage. The final design should consider developing ramp grades that minimize the need for rails and, where rails are required, incorporate a rail design that can be easily repaired or replaced if damaged.

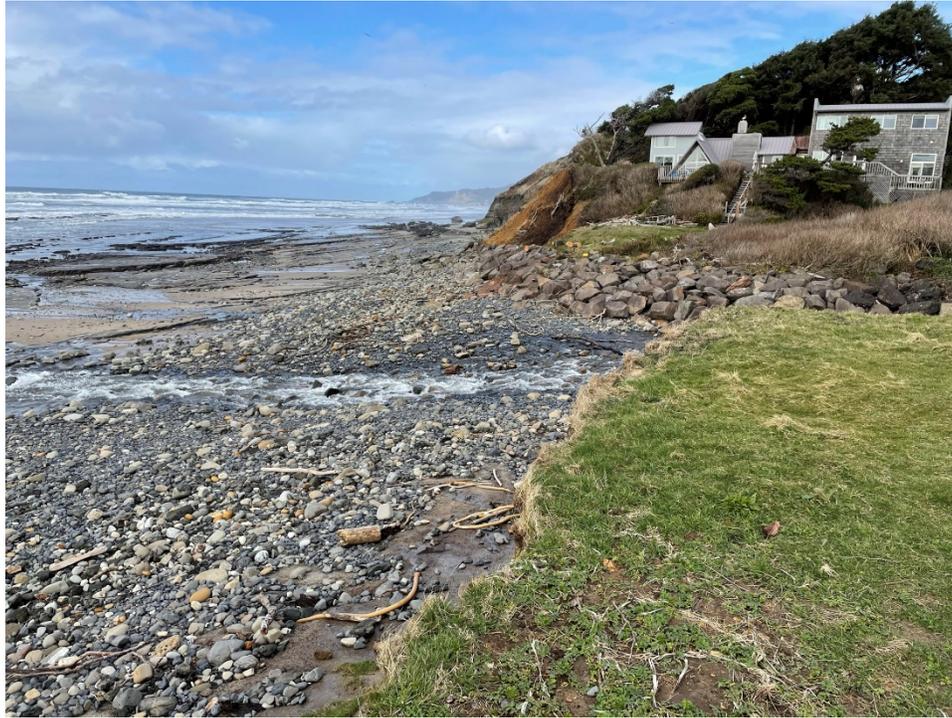
**Figure 9: Existing Schooner Creek Outlet**

1. Schooner Creek runs immediately north of the existing ramp and there is potential for debris flow during a Cascadia Subduction Zone Earthquake that could partially or fully obscure the existing access.
2. Tightly constrained public right-of-way.
3. An approximately eight-foot grade difference between the existing gravel turnaround and the beach.
4. Improvements to this site would tie in nicely with the following opportunities identified in the Park System Master Plan: proposed Highway 101 undercrossing and connection to Nautical Hill Open Space and a potential future trail back to the Ernest Bloch/Lucky Gap.

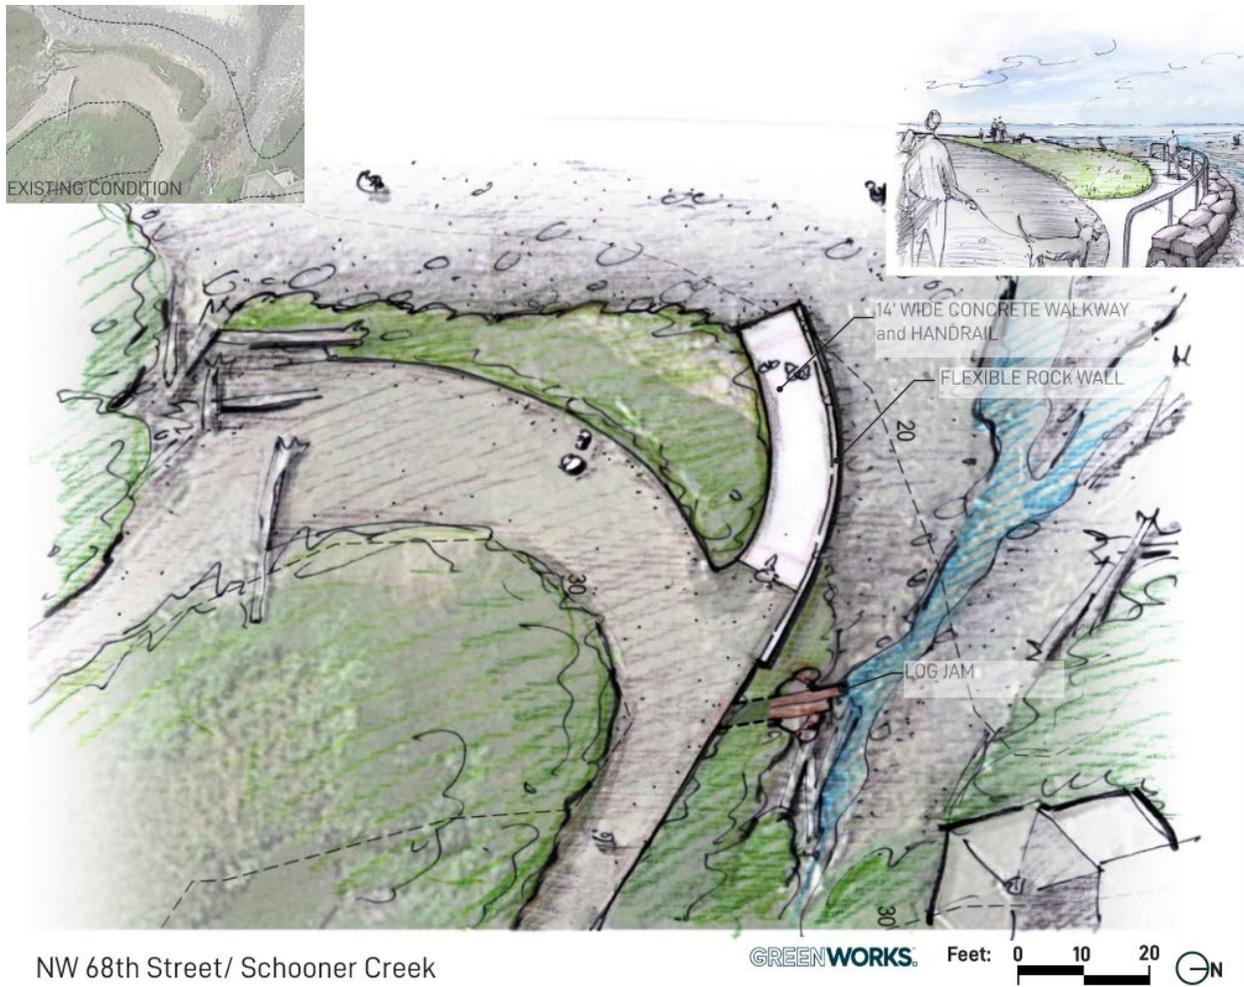
Figure 10: Concept Plan

The proposed access is anticipated to consist of a 10-foot wide path (potentially a reinforced concrete walking surface) adjacent to a rock/boulder retaining wall. The lowest section would land approximately two feet below grade to provide resilience to shoreline erosion. The proposed path could impact existing private right-of-way and is proposed steeper than 5% to minimize these right-of-way impacts. It will also incorporate a log jam structure to protect the access point from debris that may flow from Schooner Creek.

The proposed access retrofit concept plan and structural section is shown in Figure 10 and Figure 11, with suggested improvements to Tsunami Evacuation signage shown in Figure 12.

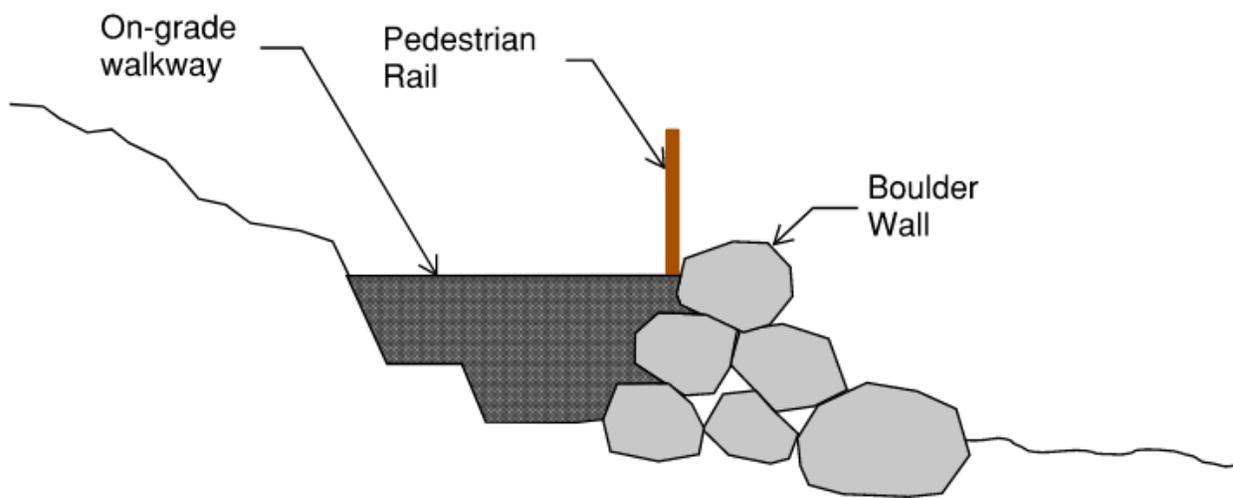
Figure 11: Concept Structural Section

This on-grade walkway is supported behind rock/boulder walls. The wall can accommodate the potential movements of the underlying soils. In addition to resisting future soil movements, the wall should be sufficiently embedded to accommodate future scouring of the surrounding grade. It is anticipated that the walkway surface would utilize a material that can accommodate movements of the underlying soils and can be easily repaired by City maintenance crews.

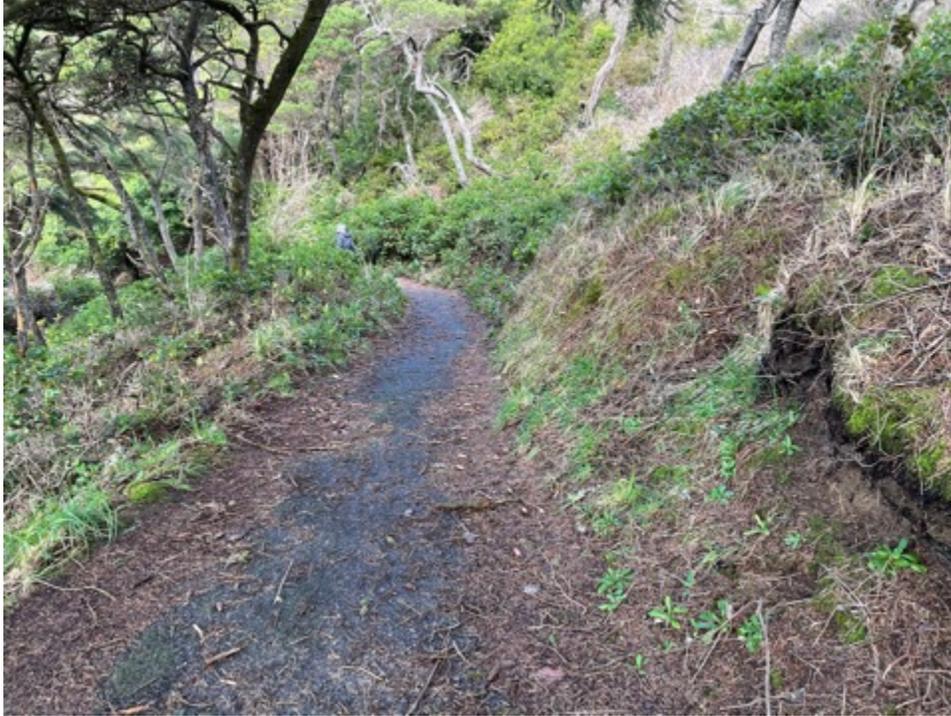
**Photo 1: Access Site 1 – Steep Slopes Adjacent to Trail**

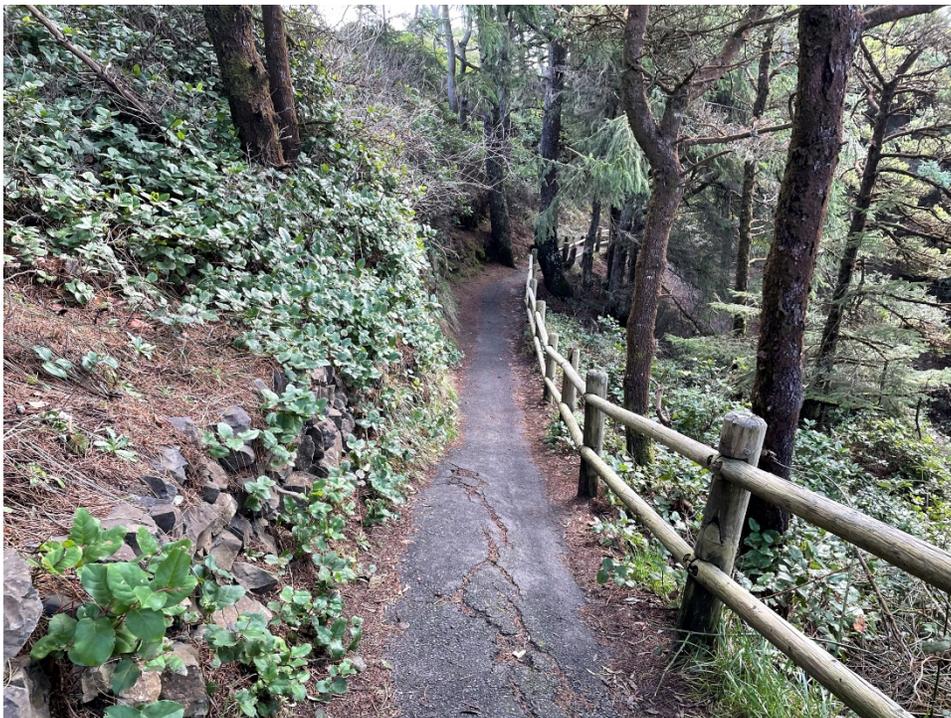
**Photo 2: Access Site 2 – Steep Slopes Adjacent to Trail**

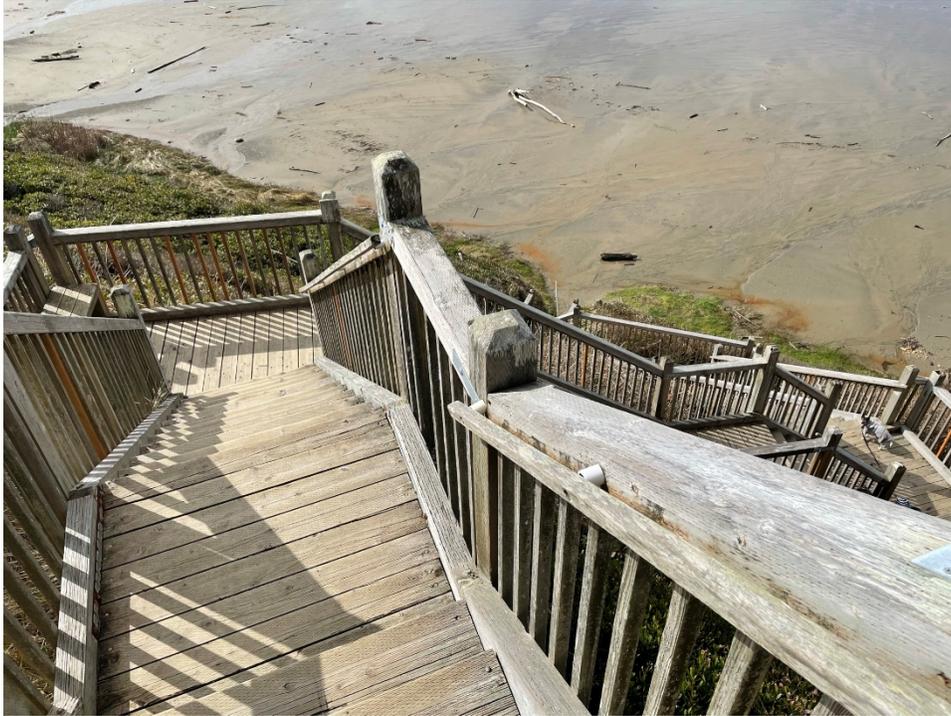
**Photo 3: Access Site 3 – Access Structure on Steep Slope**

The timber staircase appears to be founded on concrete piers embedded into the slope. As-built information regarding the piers is currently not available, however erosion of the near surface soils has exposed a steel pipe around the concrete pier in one of the upper slope foundations. Slopes are generally steep with an average slope of approximately 1.3 to 1.4H:1V which is slightly steeper than the approximate angle of repose (static stability) for tertiary sedimentary rocks (Astoria Formation) and marine terrace sands.

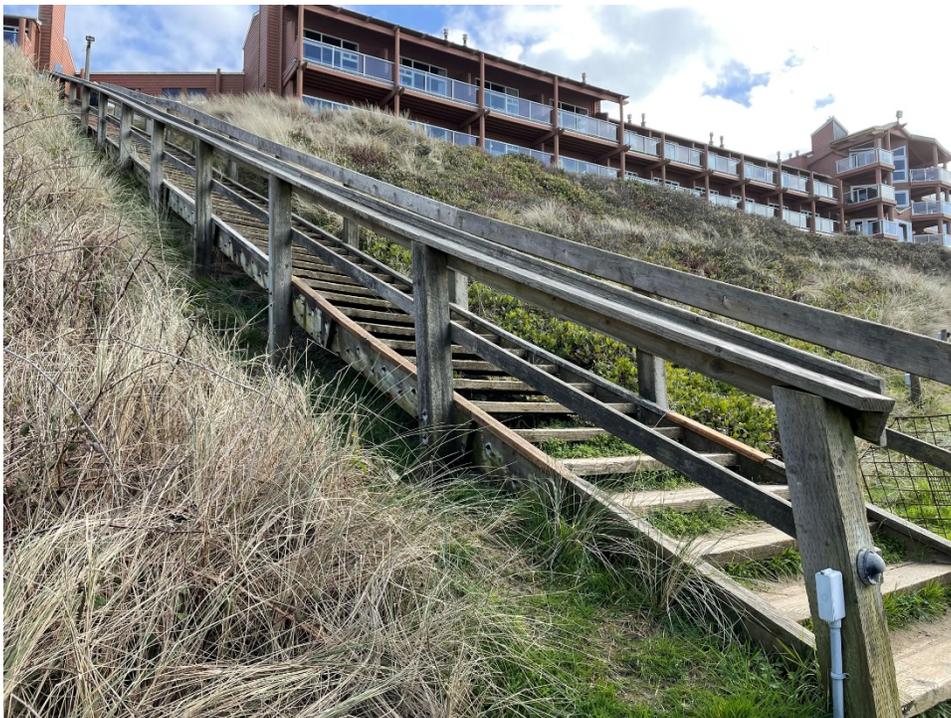
**Photo 4: Access Site 4 – Access Structure on Steep Slope**

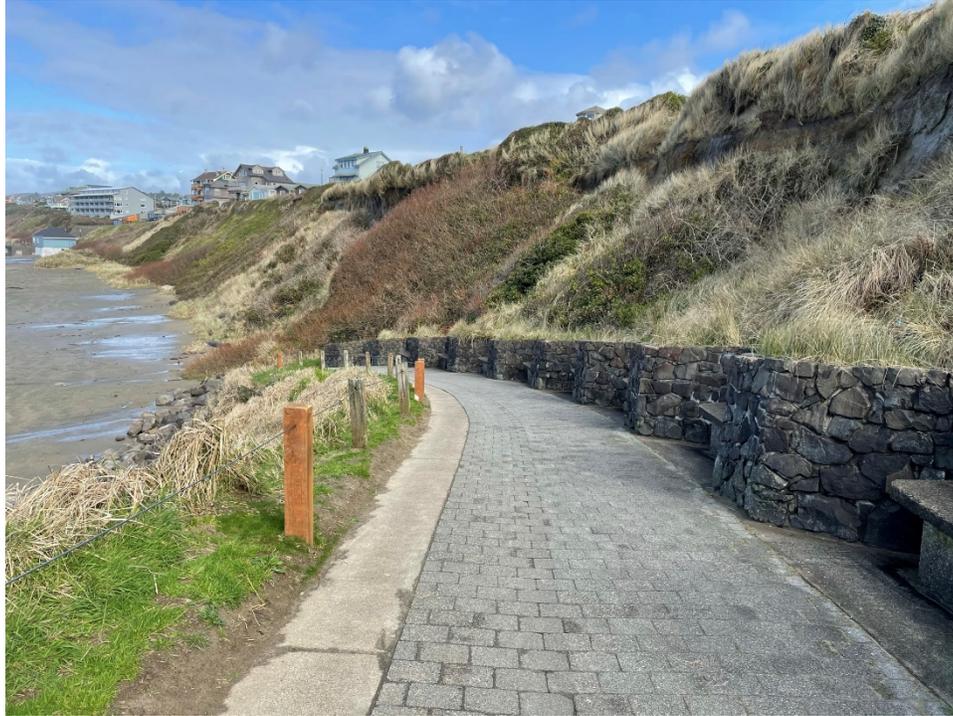
**Photo 5: Access Site 5 – Paved Walkway Adjacent to Steep Slope**

Review of geologic information and site observations indicated the upper portions of the slope consist of marine terrace deposits overlying the Astoria Formation. Portions of the slope above the trail consist of a near vertical exposure of moderately cemented marine terrace sand. Heights of the vertical exposure vary from approximately 0 to about 8 to 10 feet in height. These exposed near vertical faces exhibited moderate weathering and several large fractures. While global stability of the access route appears stable, the upper, near vertical portions of the slope present a hazard of surficial block failures during a design earthquake. These risks could be reduced by regrading the upper portions of the slope to the angle of repose (about 1.5H:1V) or regular inspection/scaling of the slope.

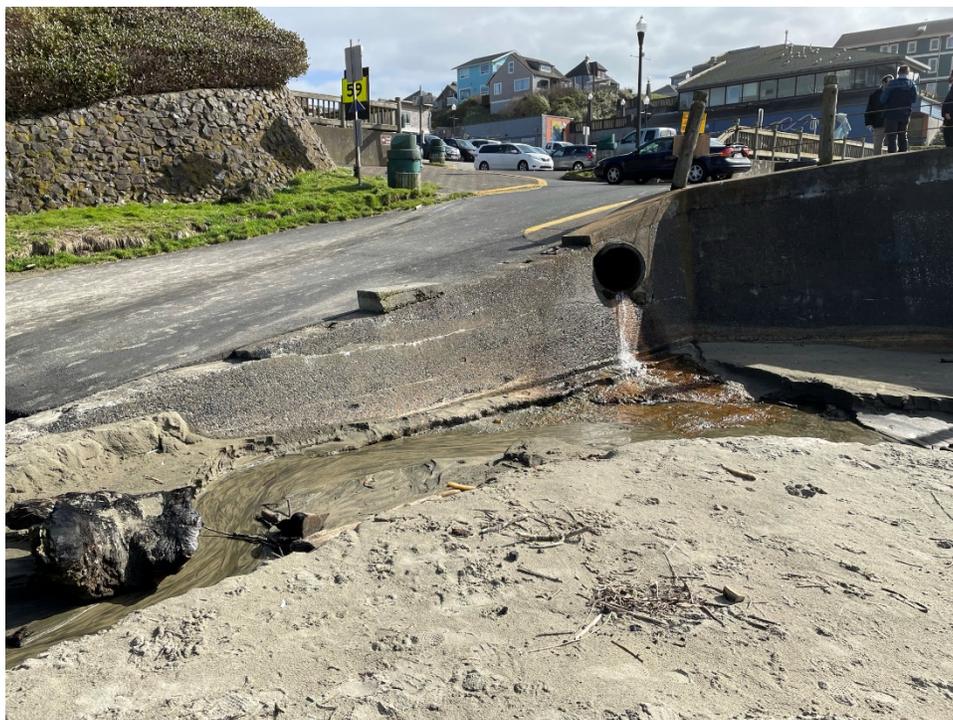
**Photo 6: Access Site 6 – Ramp to Beach Adjacent to Retaining Walls**

The western extent of the loop road is supported on a concrete wharf founded on siltstone of the Astoria Formation with the remaining portions of the road supported on Holocene age alluvial soils overlying marine terrace deposits and the Astoria Formation. The slope of Beach Drive is relatively gentle with an average slope of approximately 7H:1V. The surrounding slopes near the beach access are typically steep to moderately steep (up to 1.5H:1V) and are less than the angle of repose except for a retaining wall located on the north side of the access loop road. Details of the retaining wall construction are currently unknown; however, due to the width of the access route, emergency egress could route to the south side of the loop to avoid hazards associated with the wall.

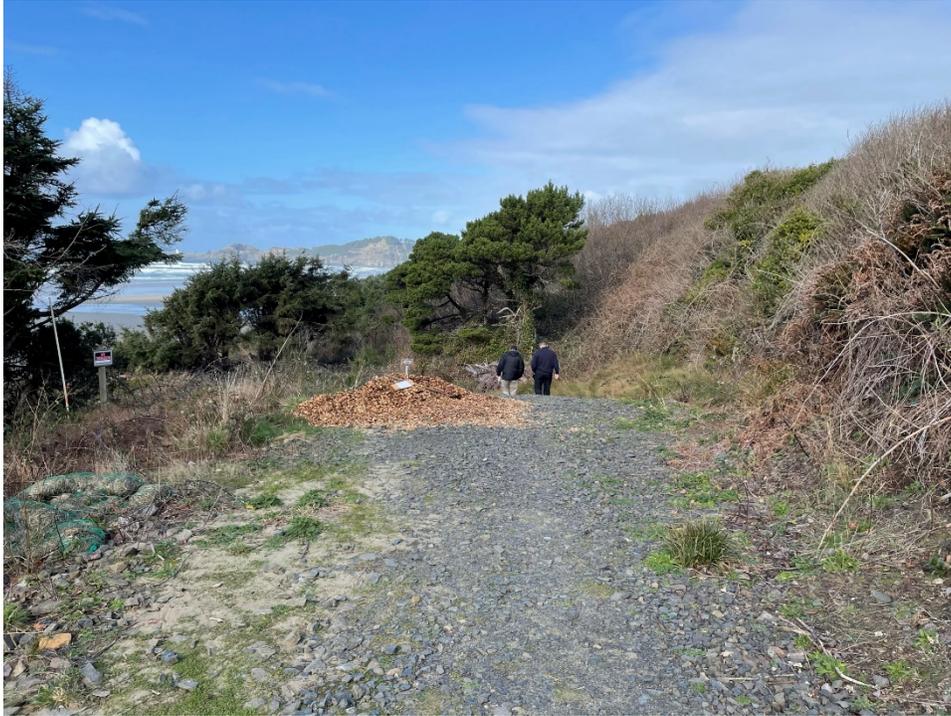
**Photo 7: Access Site 7 – Gravel Trail to Beach**

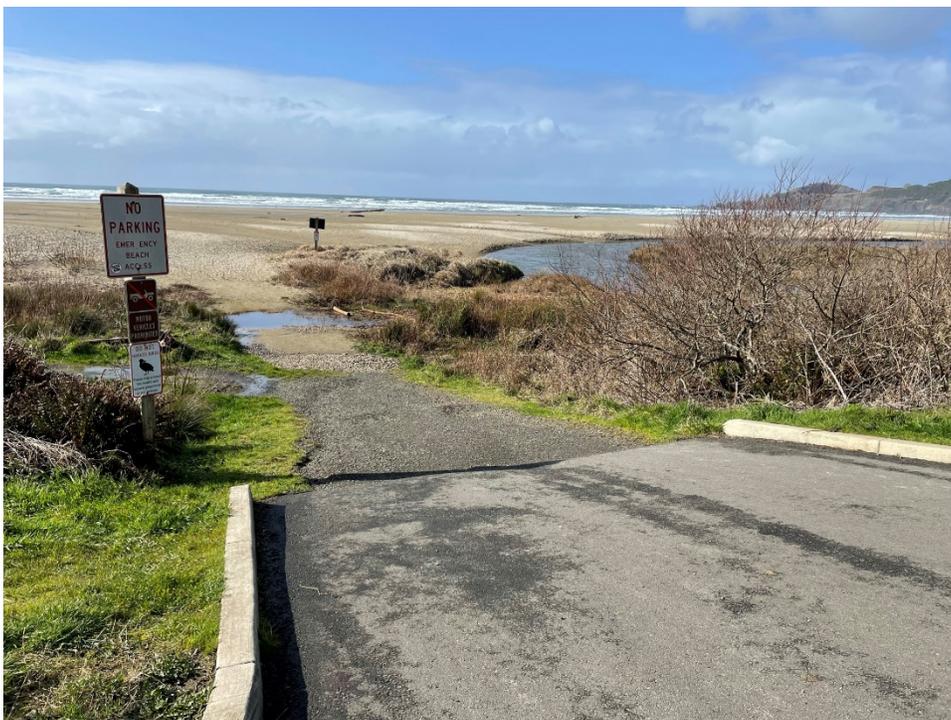
**Photo 8: Access Site 8 – Ramp and Creek Crossing**

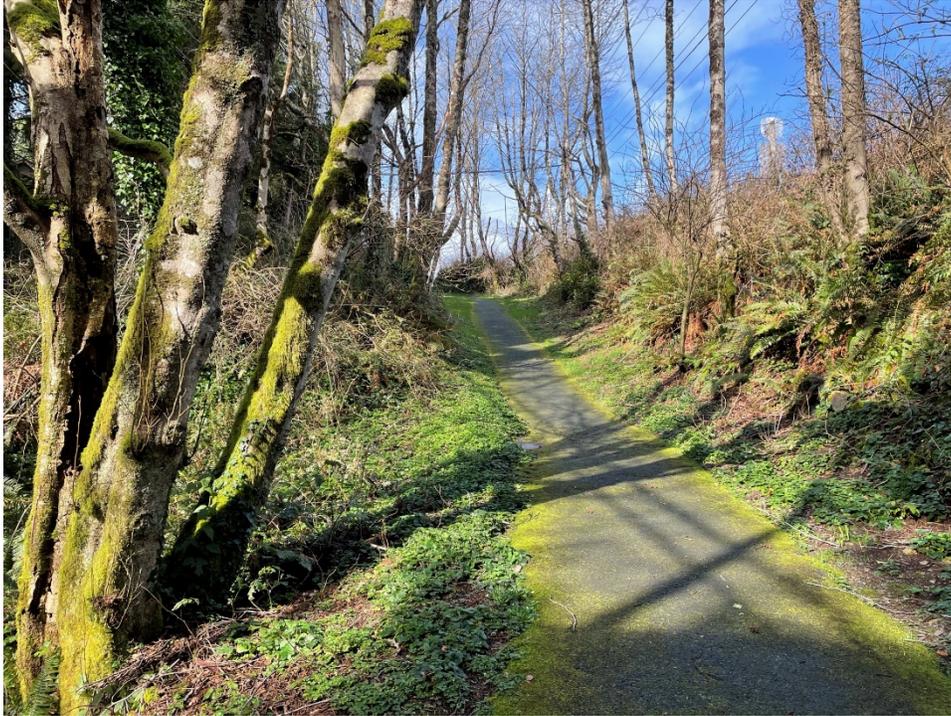
**Photo 9: Access Site 9 – Steep Slopes Adjacent to Trail**

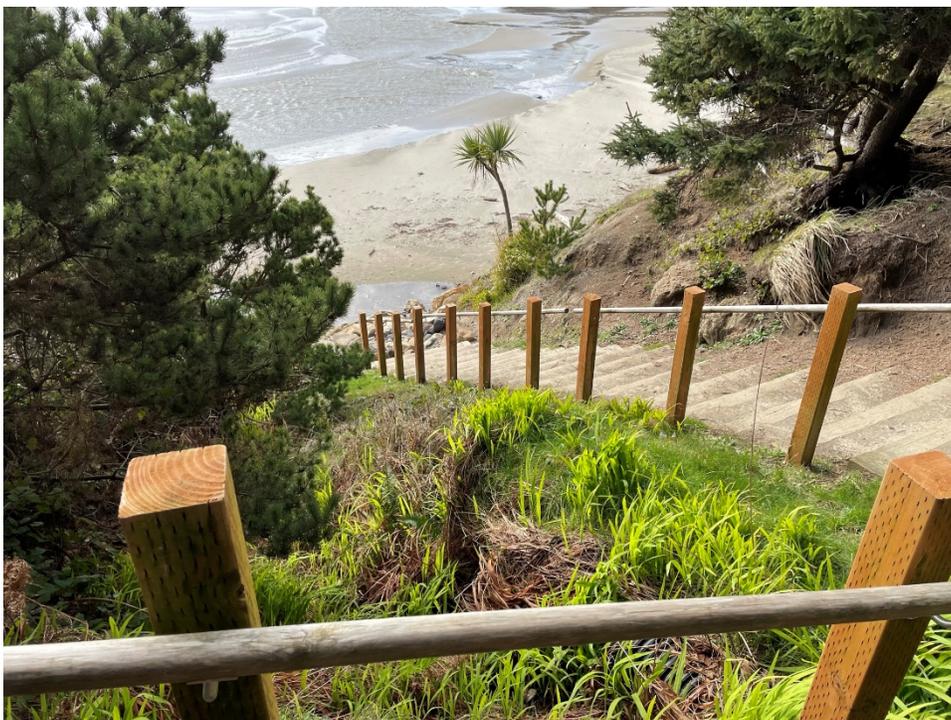
**Photo 10: Access Site 10 – Access Along Steep Slope**

Based on review of geologic mapping and the site reconnaissance, active slope movements were observed along the trail. Geologic maps indicate the trail is located entirely within a zone of historical and active landslide.

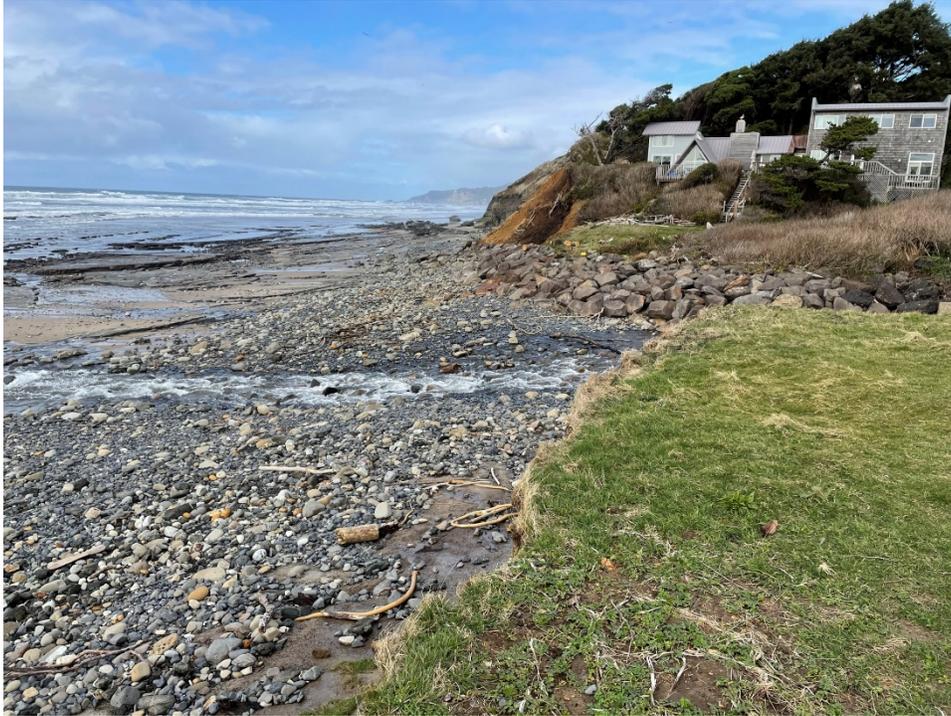
**Photo 11: Access Site 11 – Adjacent to Creek Outlet**

Observations while on site indicate regular erosional wear of the bank likely due to storms and/or king tides and would need to be considered for any permanent structures located in this location.

This location is a moderately active use area near Yaquina Head. The existing surfaces are in good condition. However, the debris flow materials onsite and the adjacent Schooner Creek Landslide present increased risks and raise a question about what improvements might need to be made so that this access could serve as an effective evacuation route. Should the assessment of landslide vulnerability be favorable, making improvements here would tie in nicely with the following opportunities identified in the Park System Master Plan: proposed Highway 101 undercrossing and connection to Nautical Hill Open Space, and via a potential future trail back to the Ernest Bloch/Lucky Gap Trail.
