**Attachment C: Stormwater Report
-for Corps and DEQ submittals only
-not included in DSL submittal**

STORMWATER MANAGEMENT PLAN

To: Carrie Warren, WFLHD Project Manager
From: James Neighorn, P.E., WFLHD Hydraulics Engineer
Date: July 17, 2023
Project: Oregon Dunes Trail, OR FLAP Douglas 251(1)

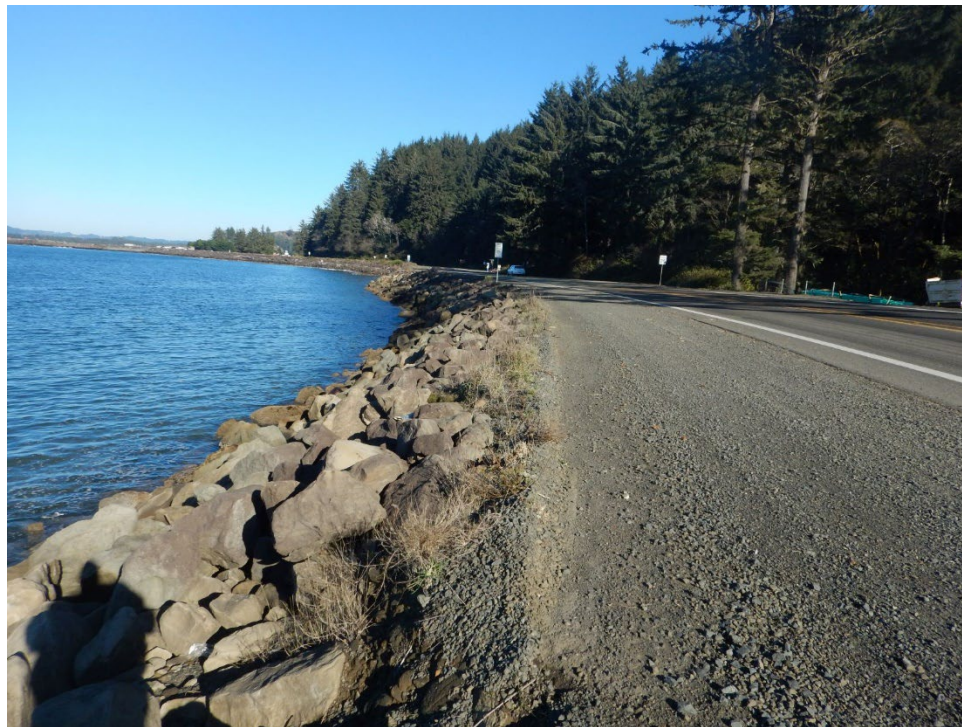
Widened gravel shoulder used by OHV directly along rocky shoreline (looking East)

OHV use will be directed away from the shoreline of the bay and onto the new dedicated OHV path along the south side of the road. A portion of Salmon Harbor Drive will be re-aligned and reconstructed to eliminate the over-widened shoulders. The north shoulder will consist of a narrower paved/gravel shoulder which will be limited to bicycle and pedestrian use. This will significantly reduce compaction and erosion issues which have contributed to pollutants directly entering the bay. Proposed vegetation establishment and increased infiltration along the buffer area between the roadway and bay will also reduce the volume of direct runoff and associated pollutants from entering the ocean waters.

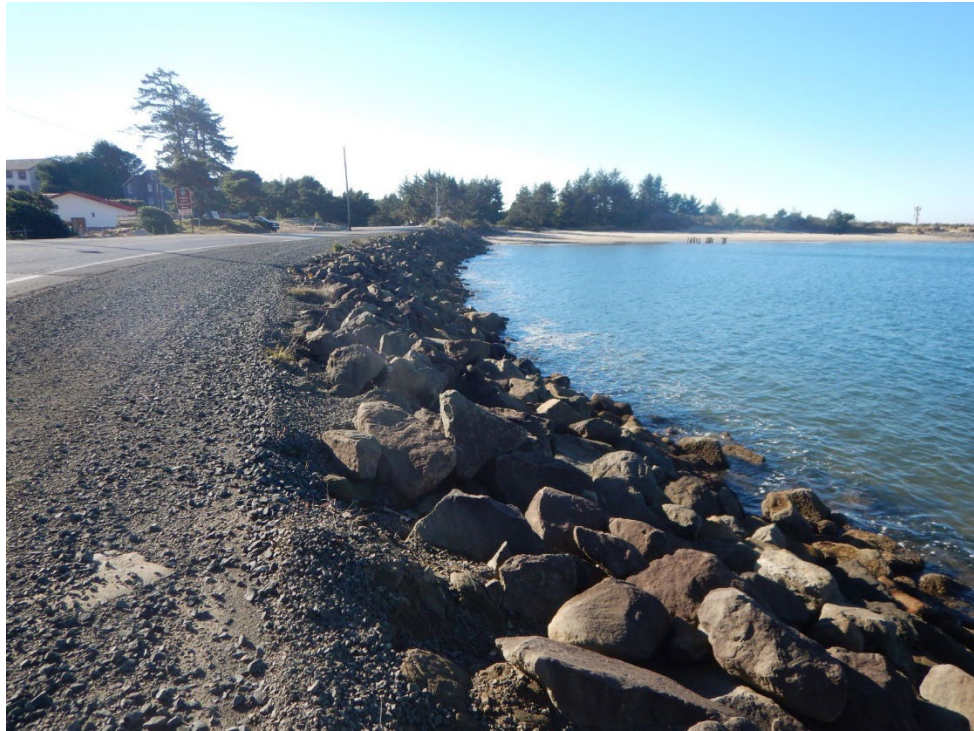
Widened gravel shoulder used by OHV directly along rocky shoreline (looking West)

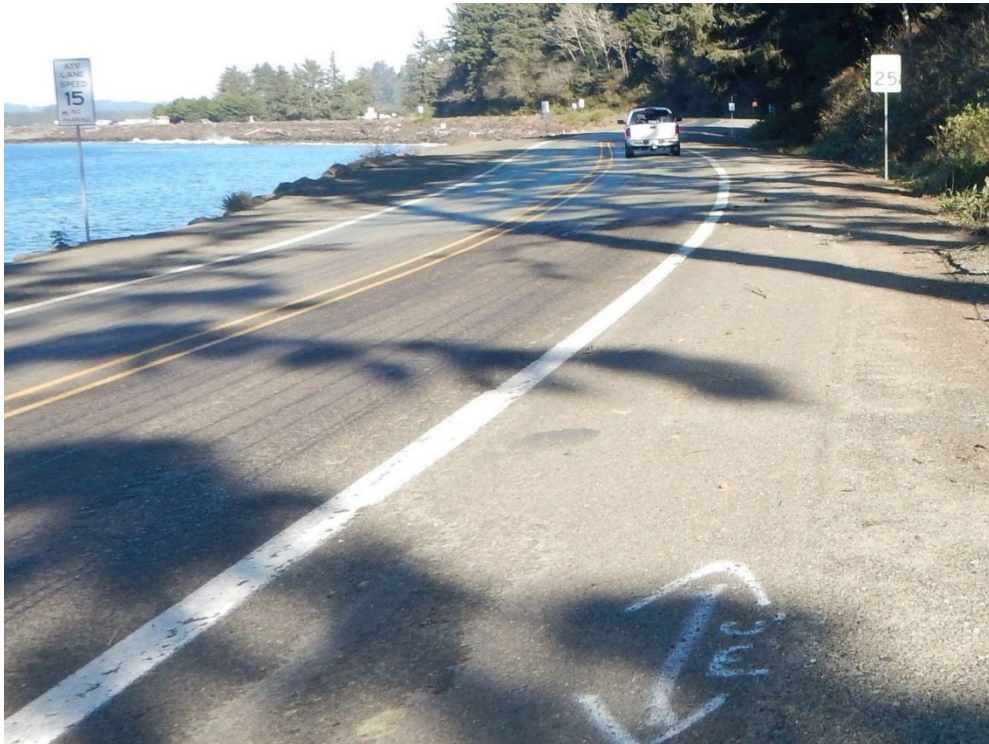
Widened paved/gravel shoulder used by OHV southeast side of road (looking Northeast)

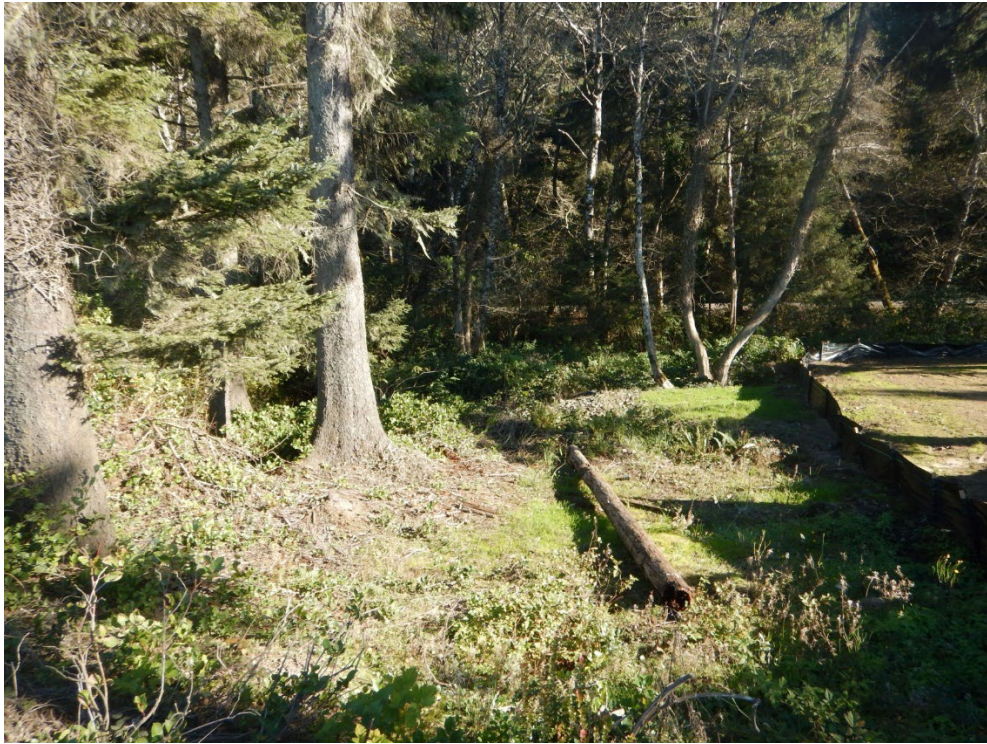
Wooded area south of roadway (looking south)

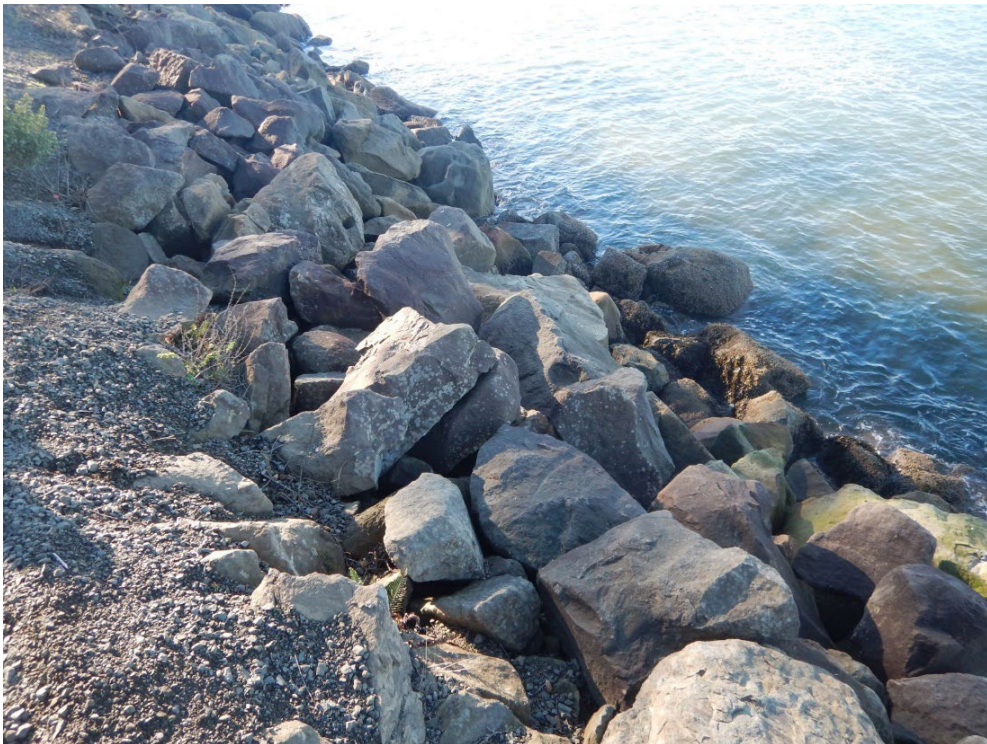
Rock armoring along bay shoreline

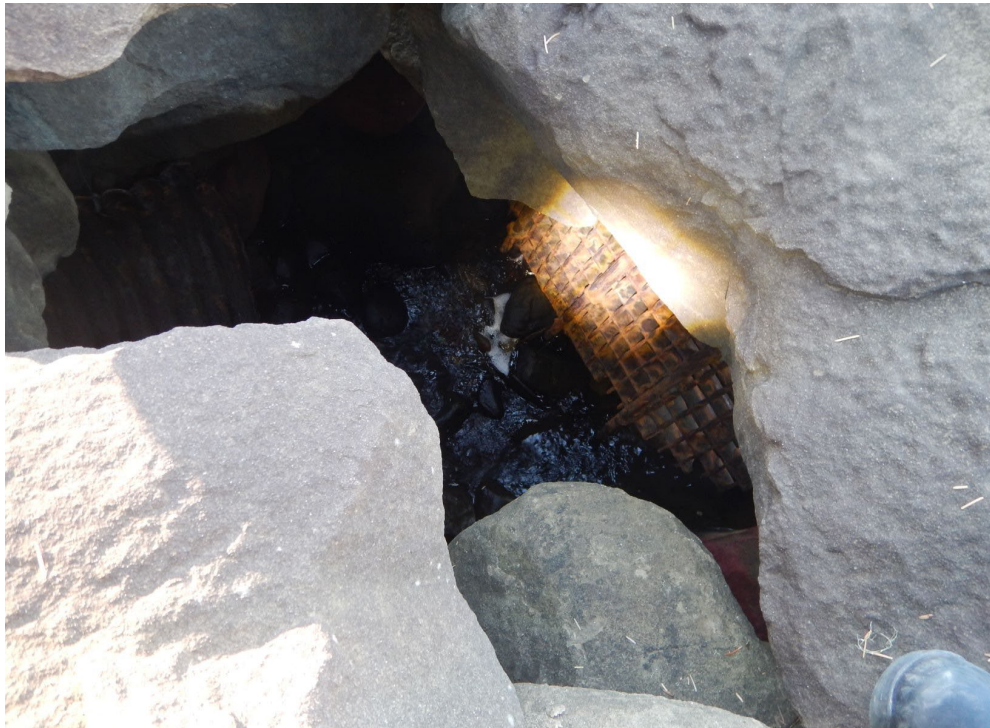
Unnamed stream south of Lighthouse Drive - culvert outlet into bays rocky shore

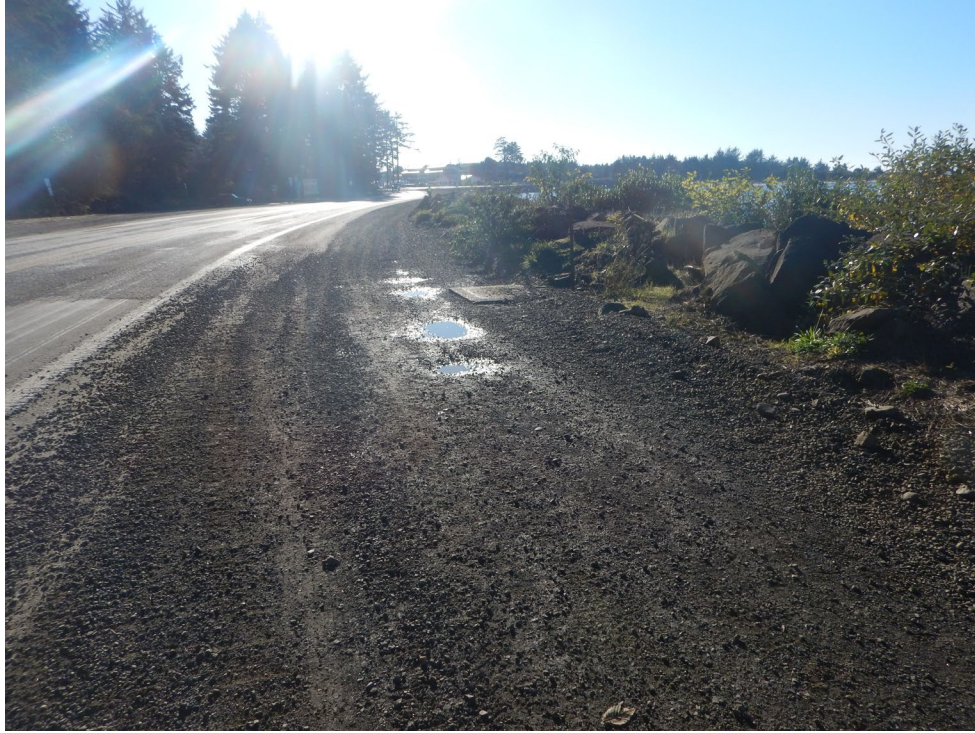
Widened gravel shoulder used by OHV and gravel parking to the left (looking Southwest)

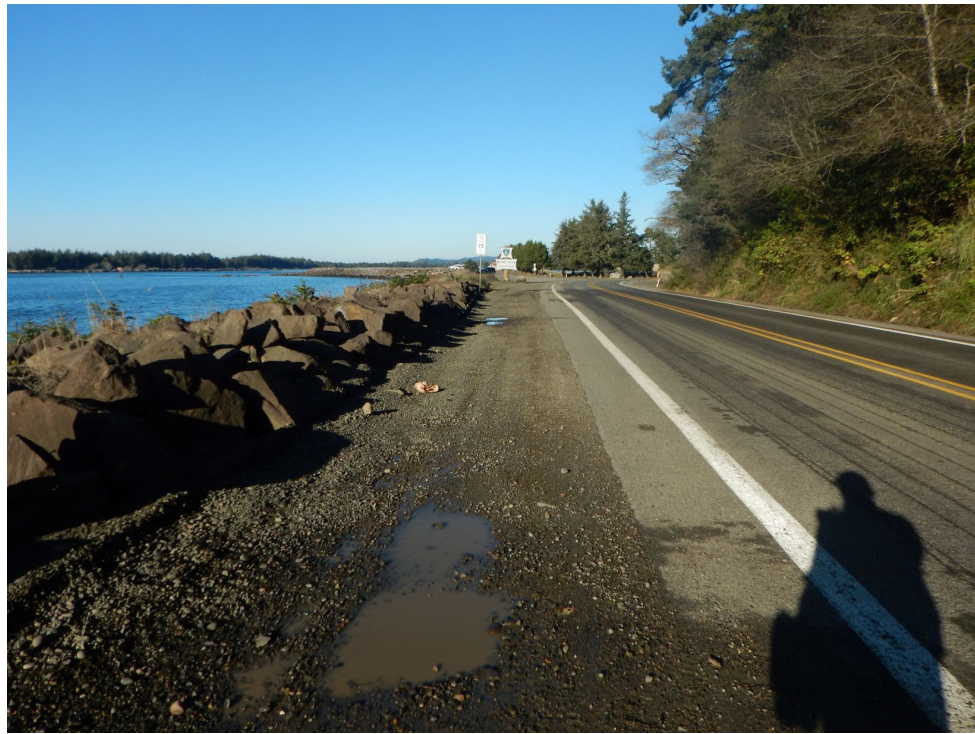
Widened gravel shoulder with rutting, ponding, and erosion (looking North)

A primary pollutant generated from this site is sediment/total suspended solids. The project will limit and reduce the amount of potential sediment generated along the road and OHV corridor by correcting roadway deficiencies and providing a paved durable surface that can withstand OHV use. The improved pavement surface will help maintain proper sheet flow off the travelway and reduce maintenance. The paved surface will also eliminate sediment produced by the rutting and pumping of fine soils previously induced by OHV use during wet weather.

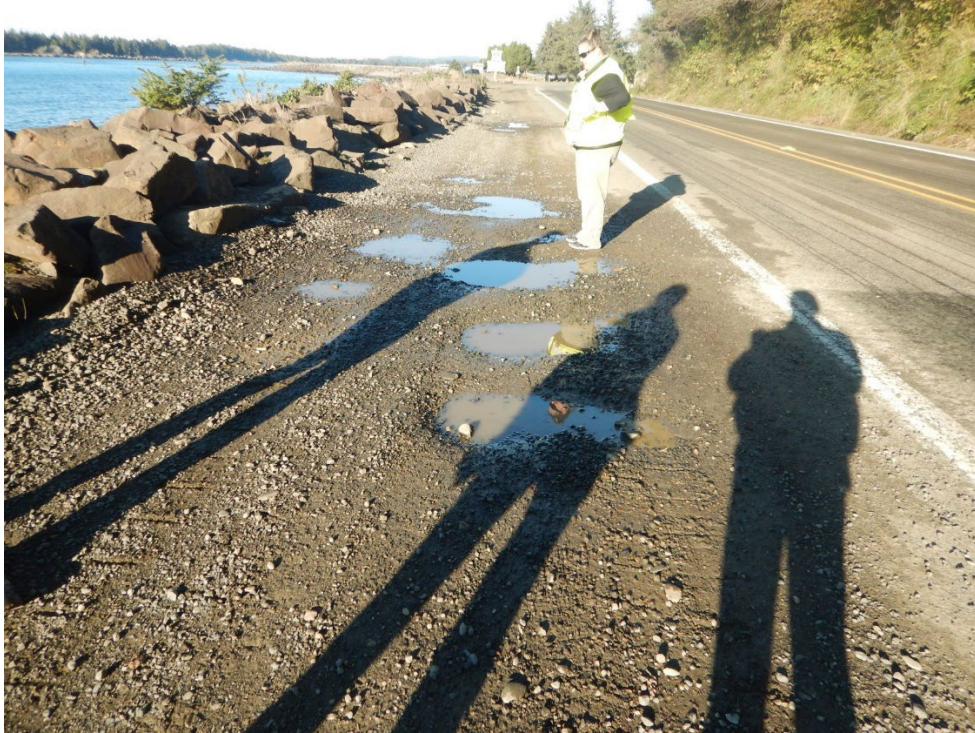
Widened gravel shoulder with rutting, ponding, and erosion (looking North)

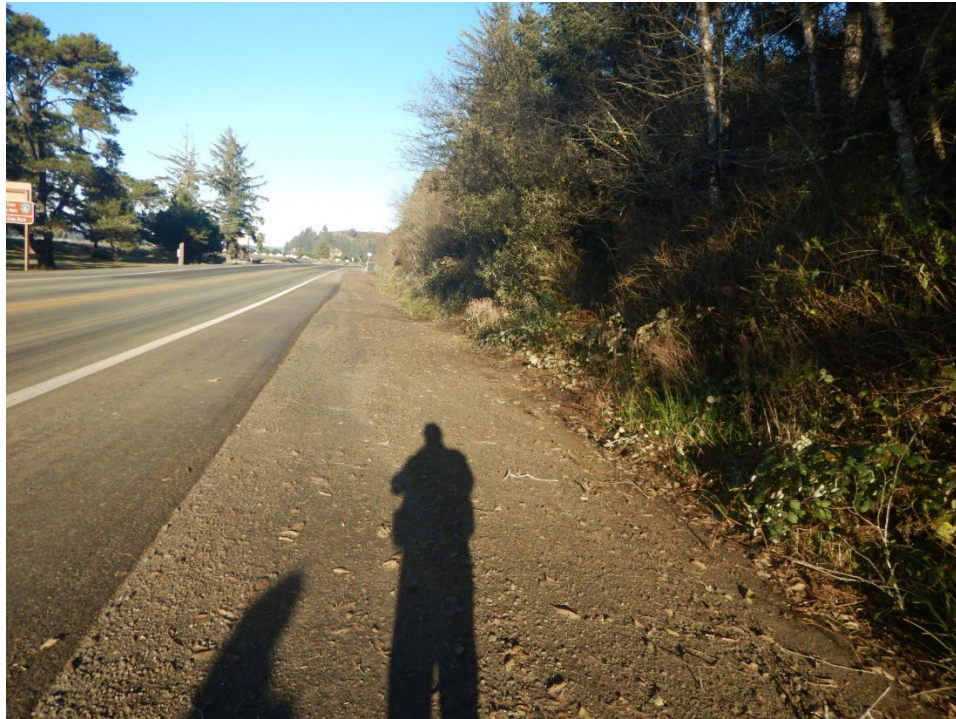
Widened paved/gravel shoulder and ditch adjacent to wooded hillside (looking Northeast)

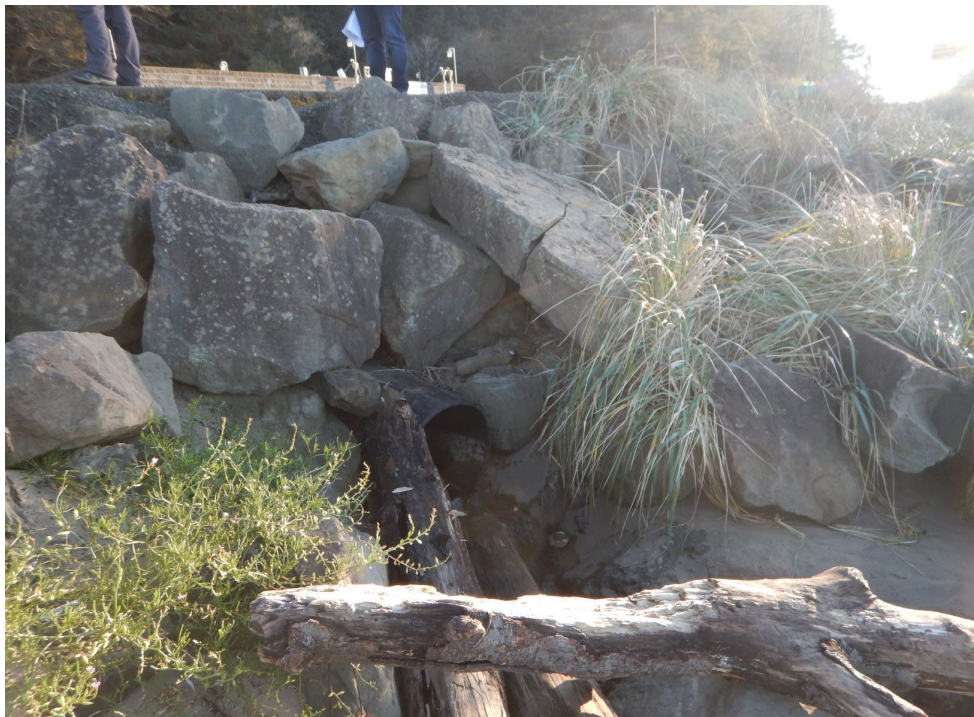
Unnamed stream outlet pipe at Winchester Bay Sanitary District (looking Southeast)

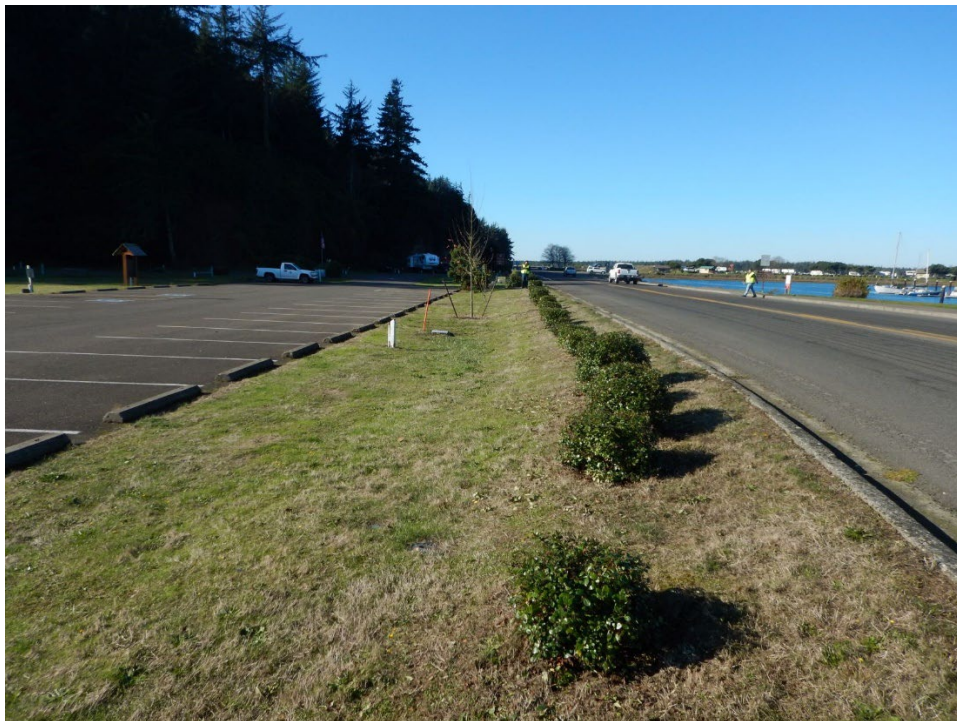
Curb & inlet storm system to be removed and landscape area south of road (looking West)

Approximately 600-feet of curb and gutter inlet collection system will be removed on the northeast end of the project. This will allow 0.42 acres of offsite impervious area from the Ork Rock Road intersection, which previously discharging untreated into the bay, to sheet flow, disperse, and infiltrate onto landscape areas to the south.
