REPORT
ON
COLUMBIA HIGHWAY
HOOD RIVER CO.
1914

REPORT
ON
COLUMBIA HIGHWAY
HOOD RIVER COUNTY
1914

October 2, 1913 the County Court of Hood River County asked for a survey to be made of that portion of the Columbia Highway passing through Hood River County. The general route for this survey was up the Columbia River through the Cascade Mountains and therefore over a rough and broken country. The beginning point was the Multnomah County line, this being approximately the summit of the Cascade Range. In the sixties the old Military Road was built through here but has been abandoned for many years. Traces and portions of this road can still be seen in many places through the county. When the Oregon Railroad and Navigation Company built down the river, they tore out or rendered impassable many sections of this road without providing a new one. The high water of 1894 washed out the old road and also the track below Cascade Locks. In rebuilding the railroad all available ground at the foot of the hills was utilized leaving no room for the wagon road from a point one mile west of Cascade Locks.

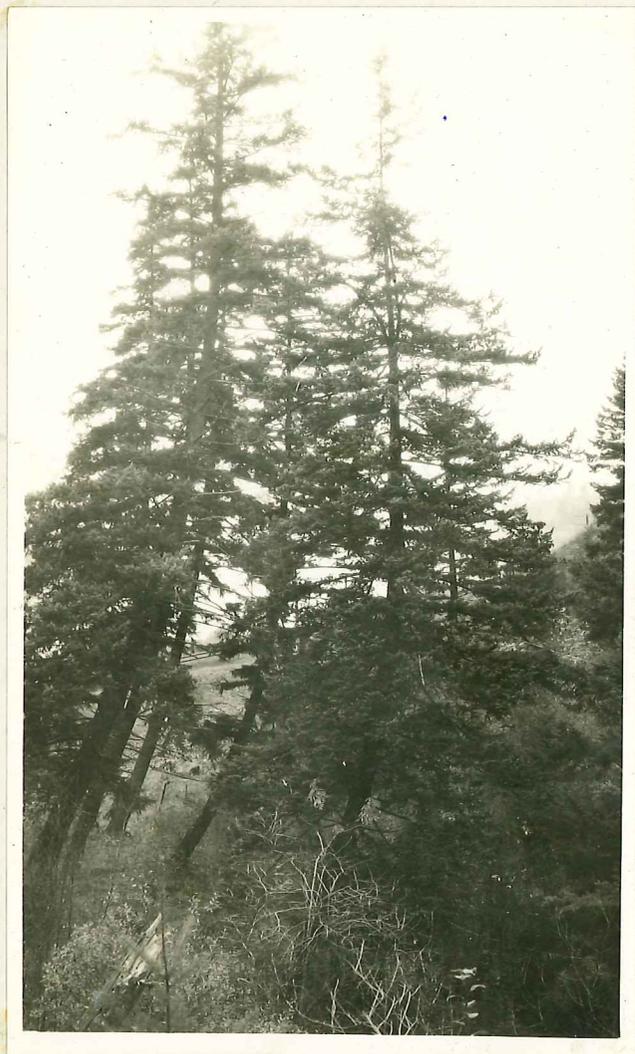
Fig. 1. Showing Effect of Slide Upon Growth of Trees.

seen. Trees are leaning in all directions and in many places are growing in a curve, the top always pointing up while the base is sliding out tending to fall the trees. Figure 1 is a picture of some of these trees. In the movement, the moun-

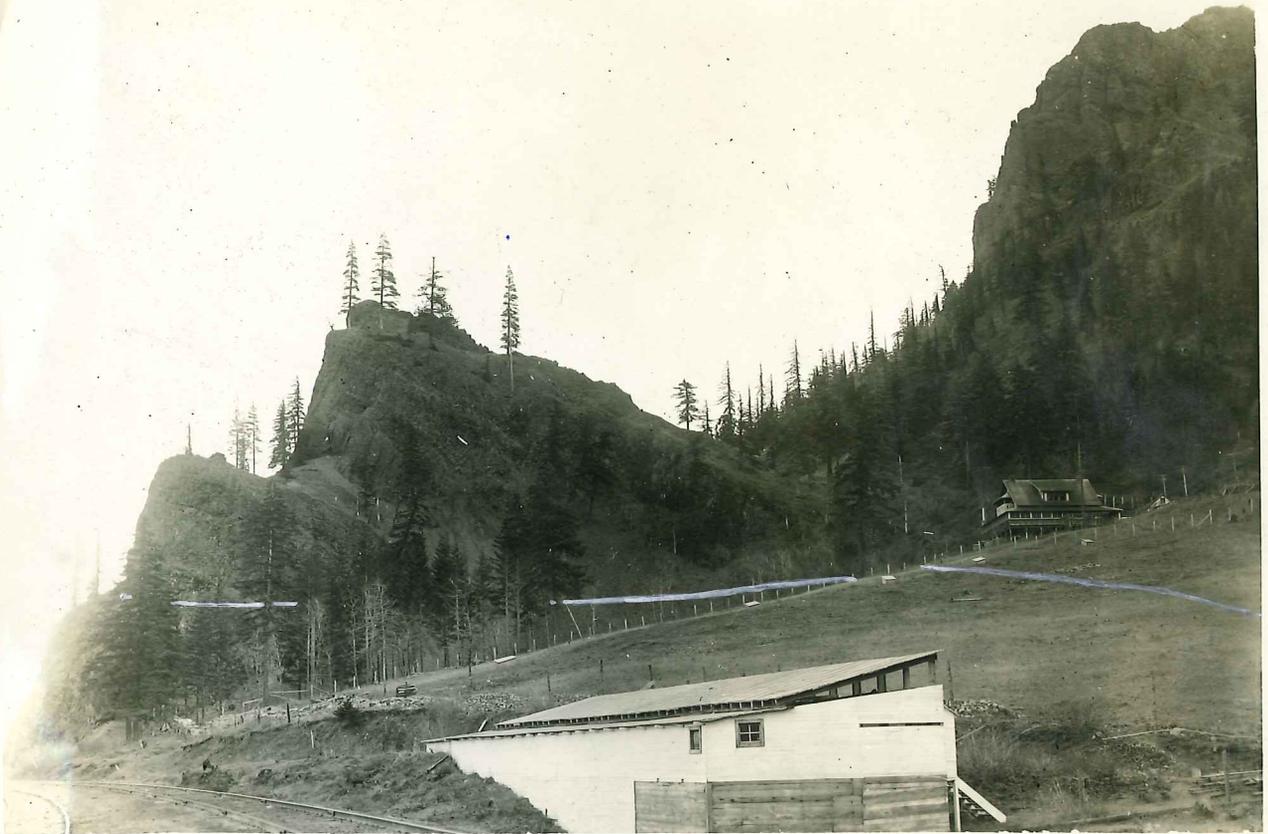
Fig. 2 Showing General View Of Mitchell Point from the West and Location of Highway.

At Mitchell Point the location follows around the face of the point, undercutting the cliff, tunneling two small ribs then crossing by concrete viaduct a slide into a tunnel 435 feet long. Providing this rock proves suitable about one half of this tunnel will be open on the side, the openings being large arch windows with heavy natural columns between and a four foot wall in front. This, when completed, will make one of the rare pieces of road construction. Figures 2, 3 and 4 show the proposed line of construction around this point.

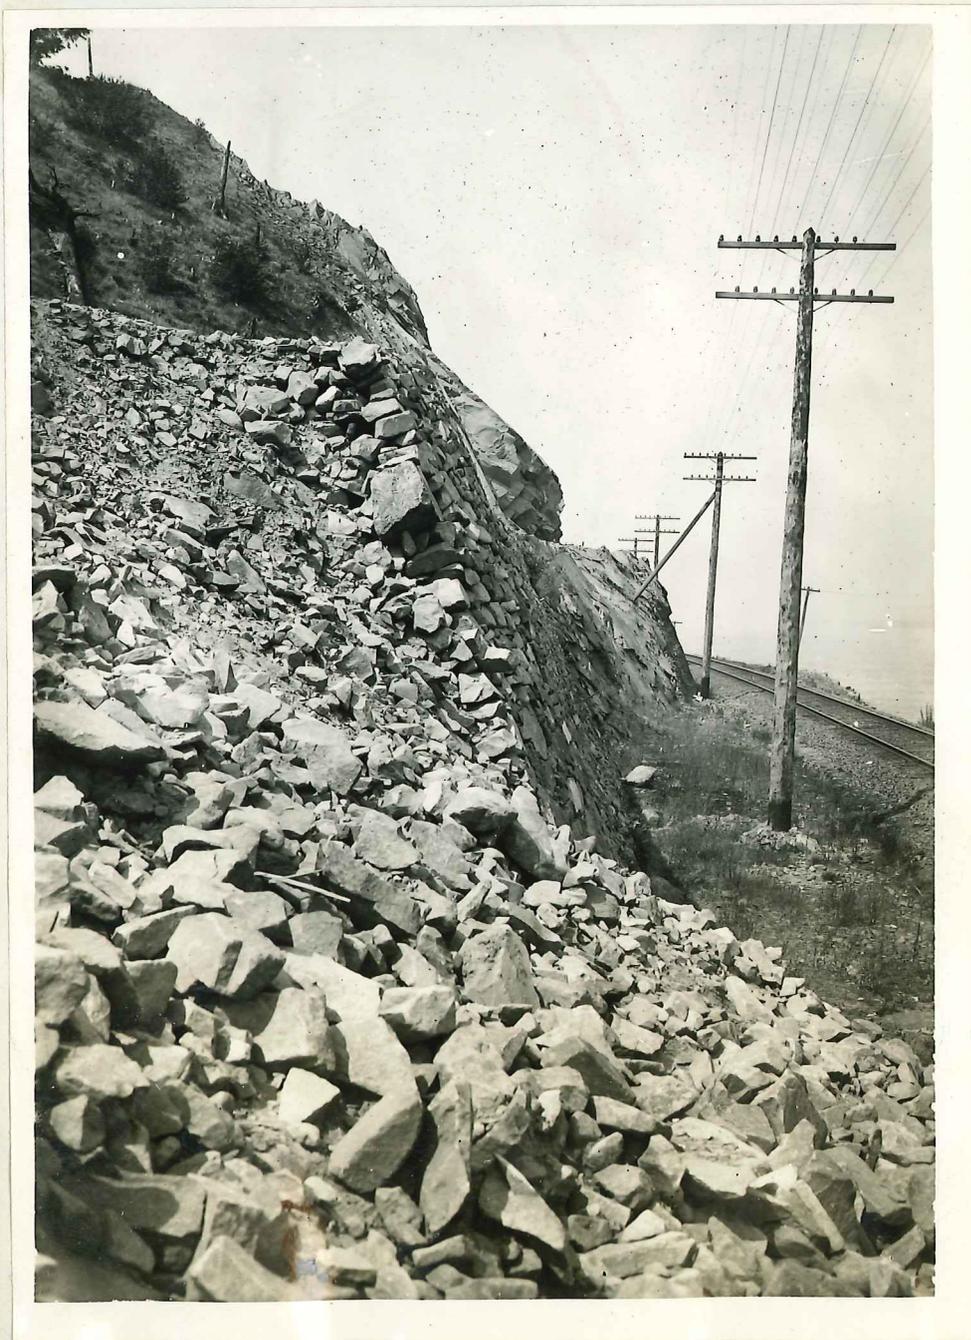
Fig. 5 Showing Type of Construction of Convict Wall.

as inside. A borrow was made in one place to make a fill instead of widening the 14 foot road bed about 100 feet distant. The wall construction was a poor handplaced rip rap. No hammers were used and the wall was layed as loose as possible with the apparent idea of making each rock go as far as it would. Figure 5 shows the end construction of this wall , and figure 6 how the foundation for a twenty foot wall was prepared. A section of this

Work was begun on September 18th. On November 1st, practically all the clearing is completed and the grading well started. The 92-foot rock cut at Benson Point has been shot. Figure 11 shows the Point before and figure 12 the Point after shooting. Some new wall has been laid replacing the old convict wall. Figure 13 shows a section of this completed wall with the old wall just behind. Figure 14 shows the end construction of this wall. Compare these pictures with those of the old wall figures 5, 6 and 7.

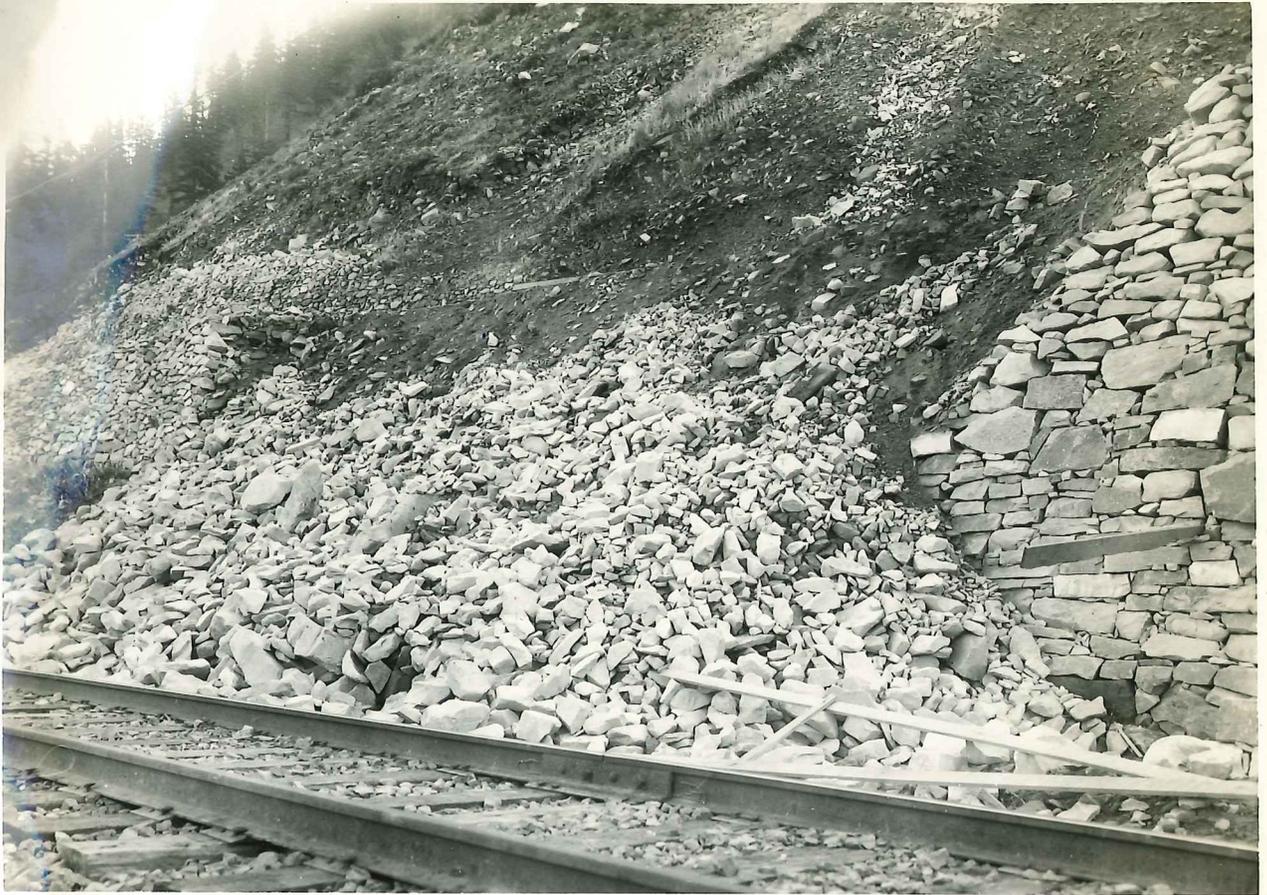
Fig. 7 Showing Section of Convict Wall After Failure.

fell six months after being built and before the road received any traffic. Figure 7 is a view of the failure. Many places an excess of wall was built over that which was necessary for safer construction. Figure 8 shows cross sections of the old and present roadbed as being built.

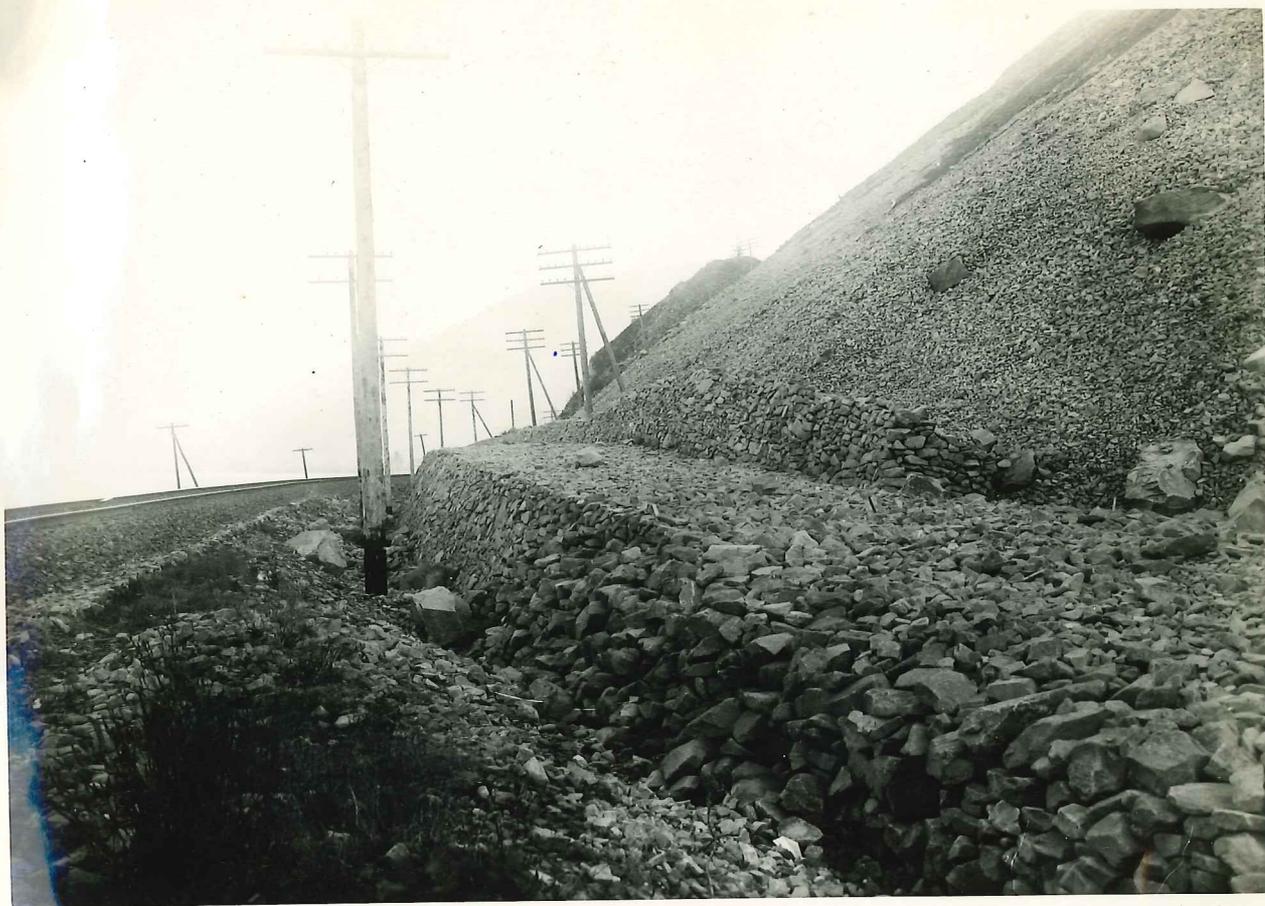
Fig. 9. Showing West End of Convict Work.

The convict work besides being poor in quality increases the cost of the present construction materially. New walls have to be built where the old ones stand necessitating the removal of the old one and fill behind it before the new wall can be started. In some places, particularly on the west end of the convict road, the tearing down of the old wall has been avoided by building toe walls outside the old for the slope to catch on. This feature is shown in figure 8 also. Figure 9 shows the West end of the convict work which will be rebuilt as shown by figure 8 .

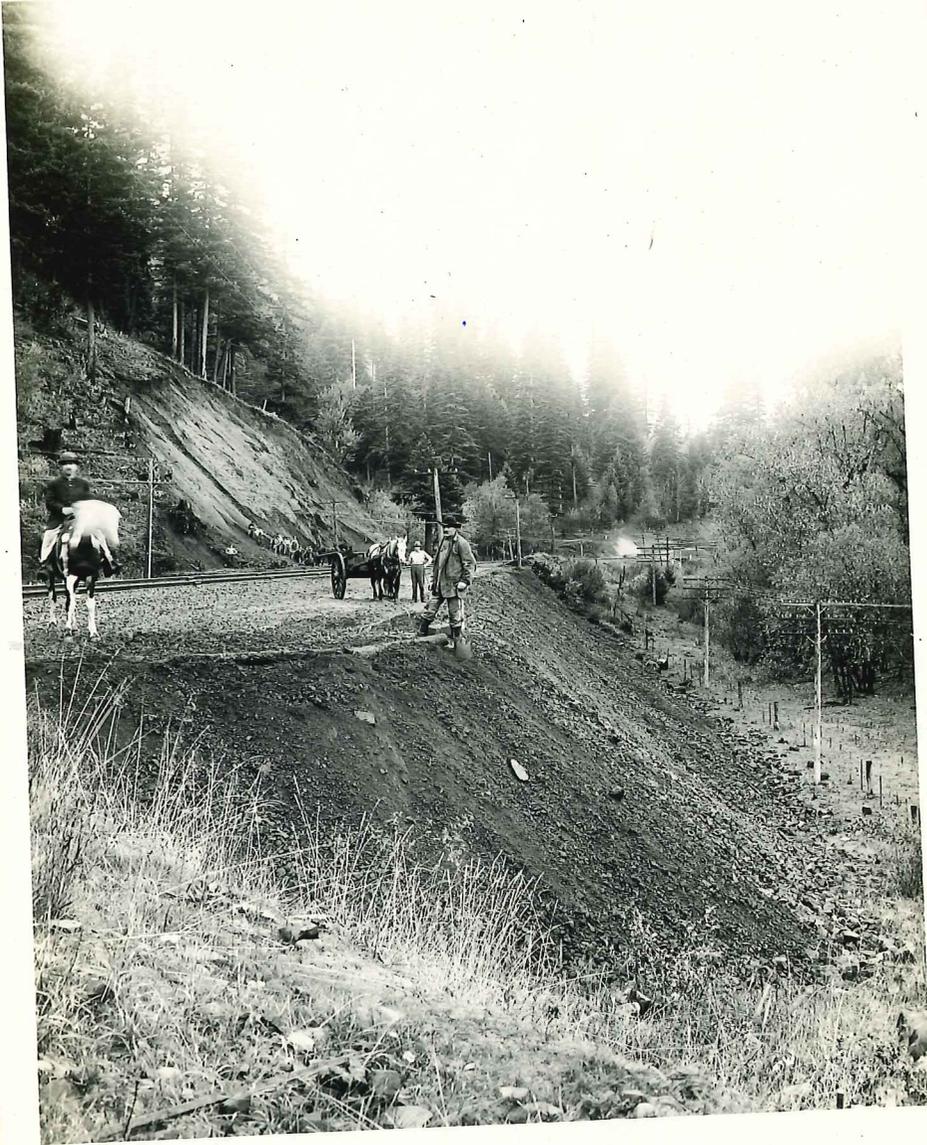
Fig. 15 Railroad Fill at Lindsey Nearing Completion.

The fill for the railroad change at Lindsey is practically completed. Figure 15 shows this fill nearing completion. This fill has been made with dump carts loaded by men shoveling.

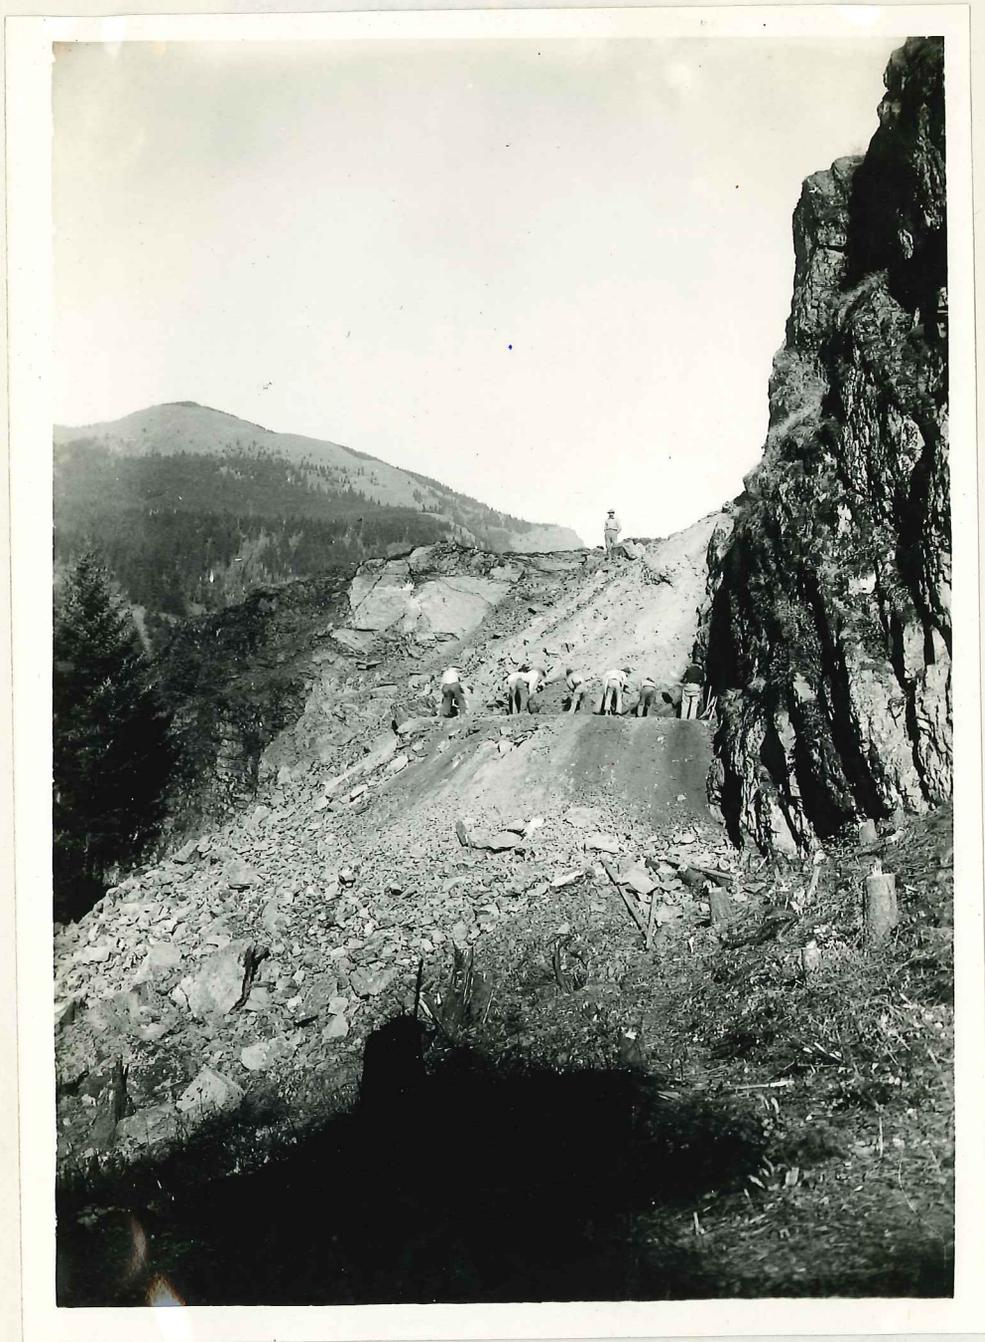
Fig. 17 48-foot Rock Cut and 40-foot Fill.

Figure 17 is a rock cut 48 feet deep on one side and a fill 40 feet high on the other . This picture was taken two days after the cut was shot. Figure 18 is a view taken up the grade during construction and figure 19 is a section of roadbed practically finished. Figure 20 is a piece of road bed just west of Shellrock Mountain. The placing of face walls in the shell rock slides has been very successful. By building the wall up close behind the excavation no large amount of material has come down. A very little obstruction is necessary to hold this shell rock up as the action of the shell rock slide is from top down - a rolling action- as differing from earth which moves in a mass from the bottom.

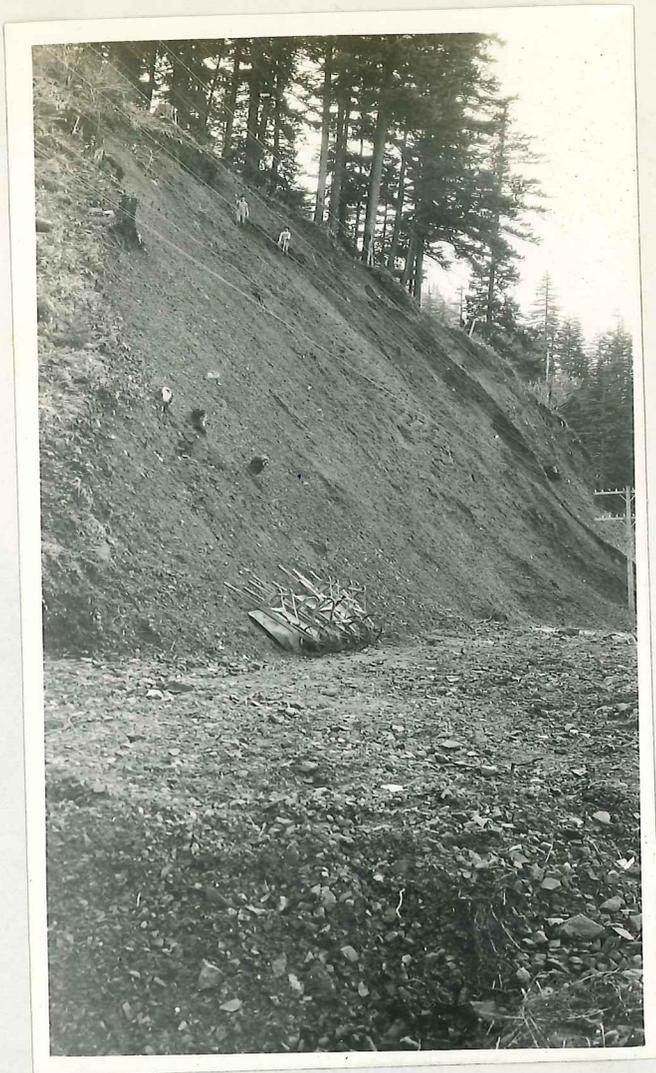
Fig. 16 82½ foot cut for railroad fill and roadbed.

Figure 16 shows the 82-foot cut from which the material was taken.
