INNER POWELL BOULEVARD

SE 9th to I-205 State of Good Repair Study

Final Report | December 2019

Oregon Department of Transportation

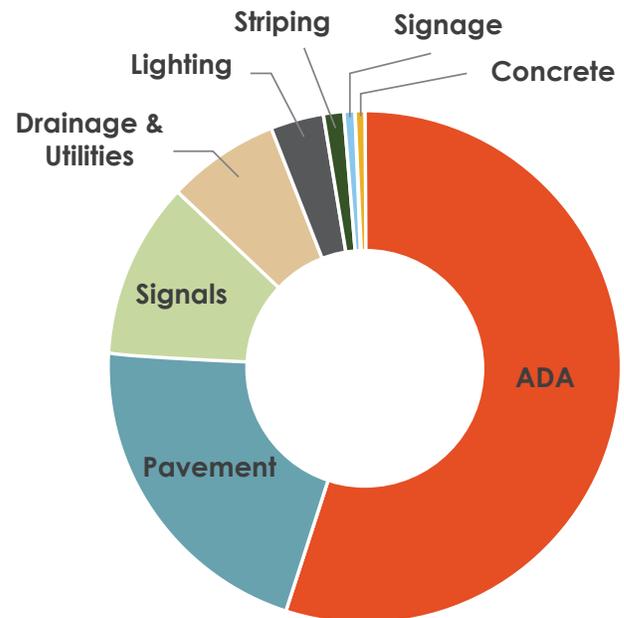
Breakdown of estimated costs by corridor element. ADA costs are approximately 57% of the total base cost estimate.

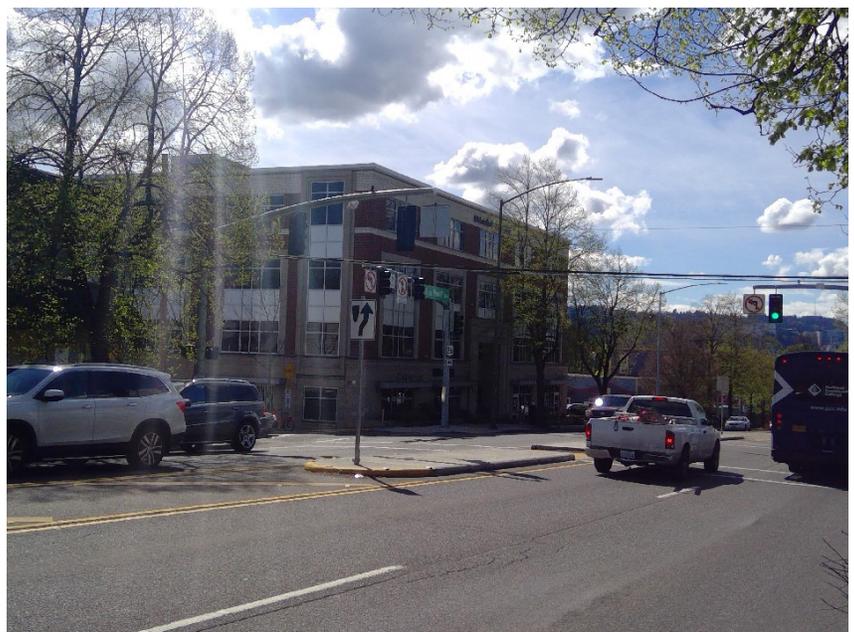
Figure 1. Typical conditions along Inner Powell.

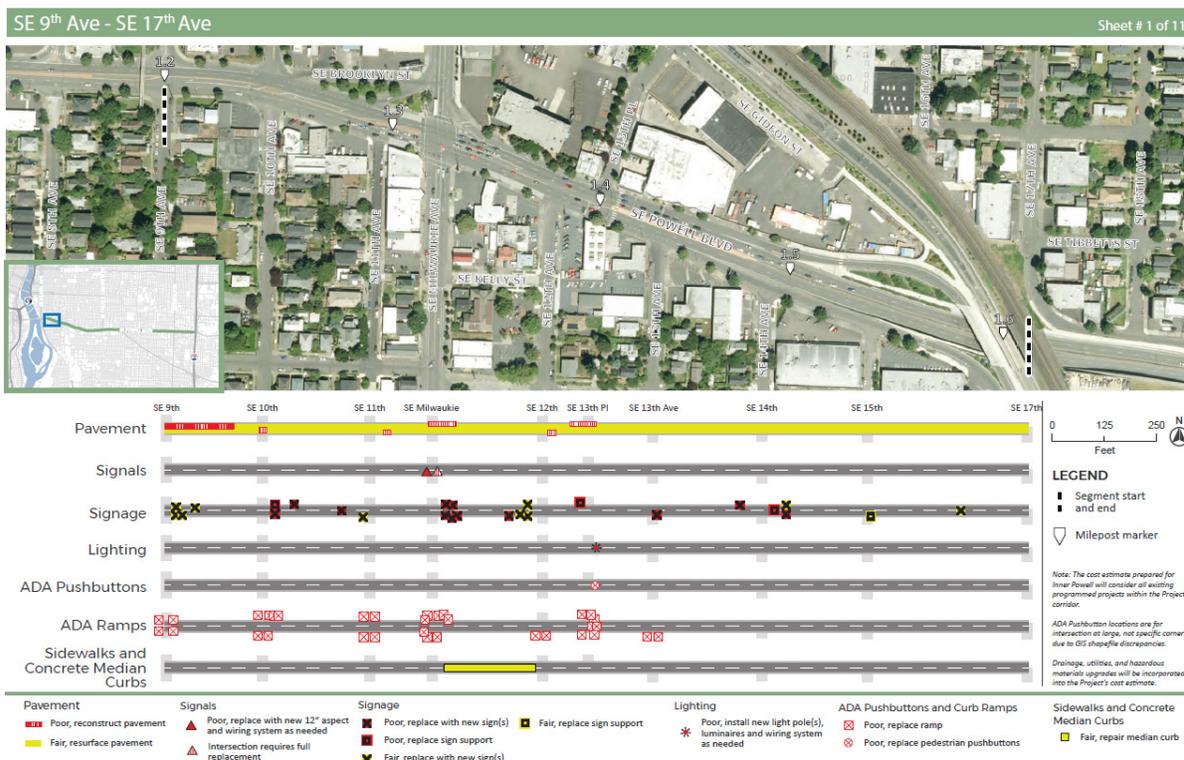
Figure 3. Example roadway diagram

The study team divided the study corridor into 11 segments, each approximately 2,000 feet long, for ease of visualization. The 11 pages at the end of Section 4 each show an aerial map of a segment with mileposts. Below the aerial map is a roadway diagram for each corridor element listed below. The recommended upgrades for each element that was rated as "fair" or "poor" in the existing conditions analysis have unique icons that align with the aerial map to represent recommended repairs to bring the element to a state of good repair. If a segment does not have a specific element roadway diagram, it is

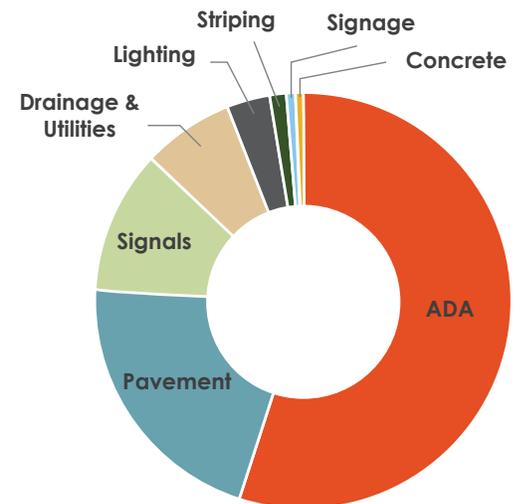
Figure 4. Breakdown of estimated costs by corridor element. ADA costs are approximately 57% of the total base cost estimate.

The estimated total cost to achieve a state of good repair on Inner Powell, including program costs and contingencies, is approximately \$30,837,557 (in 2019 dollars). The cost is subject to change depending on construction year. The breakdown of costs is shown in Table 2 and Figure 4. As shown in Table 2 and Figure 4, ADA costs are approximately 57% of the total base cost estimate.

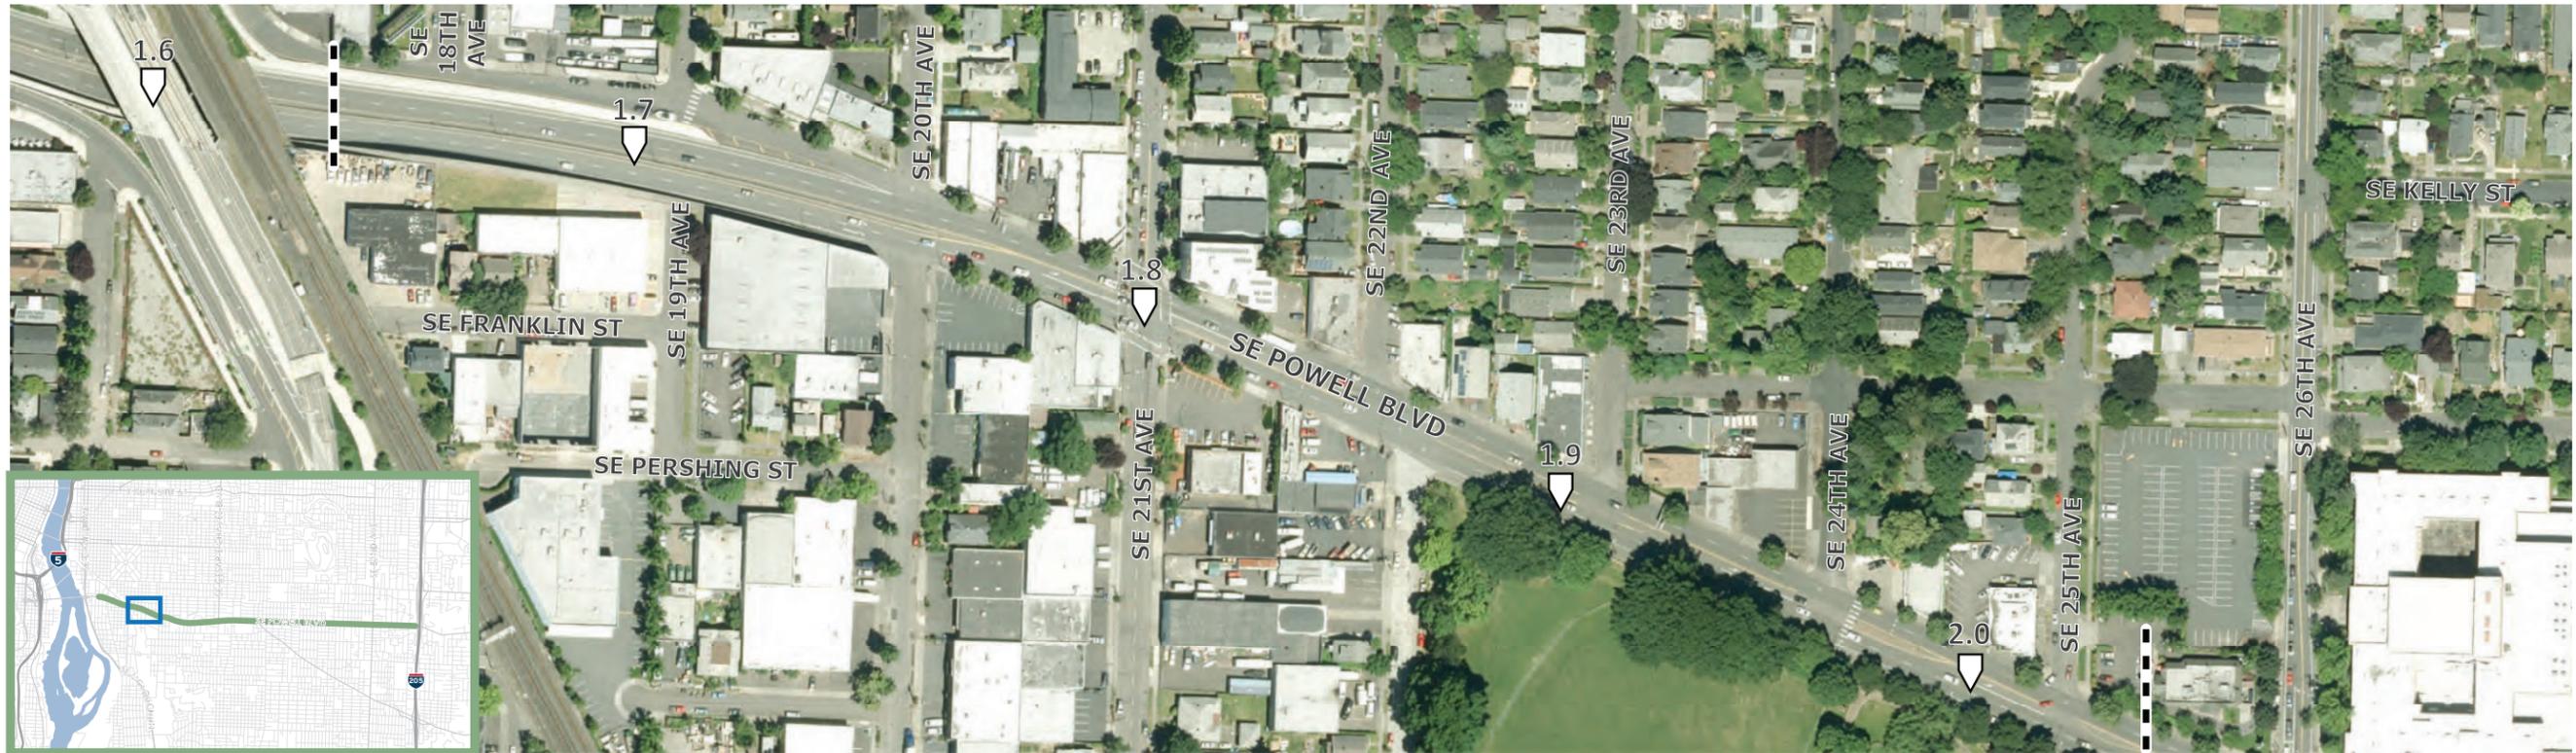
<p>Pavement</p> <ul style="list-style-type: none"> ▨ Poor, reconstruct pavement ▨ Fair, resurface pavement 	<p>Signals</p> <ul style="list-style-type: none"> ▲ Poor, replace with new 12" aspect and wiring system as needed ▲ Intersection requires full replacement 	<p>Signage</p> <ul style="list-style-type: none"> ✖ Poor, replace with new sign(s) ▨ Poor, replace sign support ✖ Fair, replace with new sign(s) ▨ Fair, replace sign support 	<p>Lighting</p> <ul style="list-style-type: none"> * Poor, install new light pole(s), luminaires and wiring system as needed 	<p>ADA Pushbuttons and Curb Ramps</p> <ul style="list-style-type: none"> ✖ Poor, replace ramp ✖ Poor, replace pedestrian pushbuttons 	<p>Sidewalks and Concrete Median Curbs</p> <ul style="list-style-type: none"> ▨ Fair, repair median curb
---	---	--	--	---	--

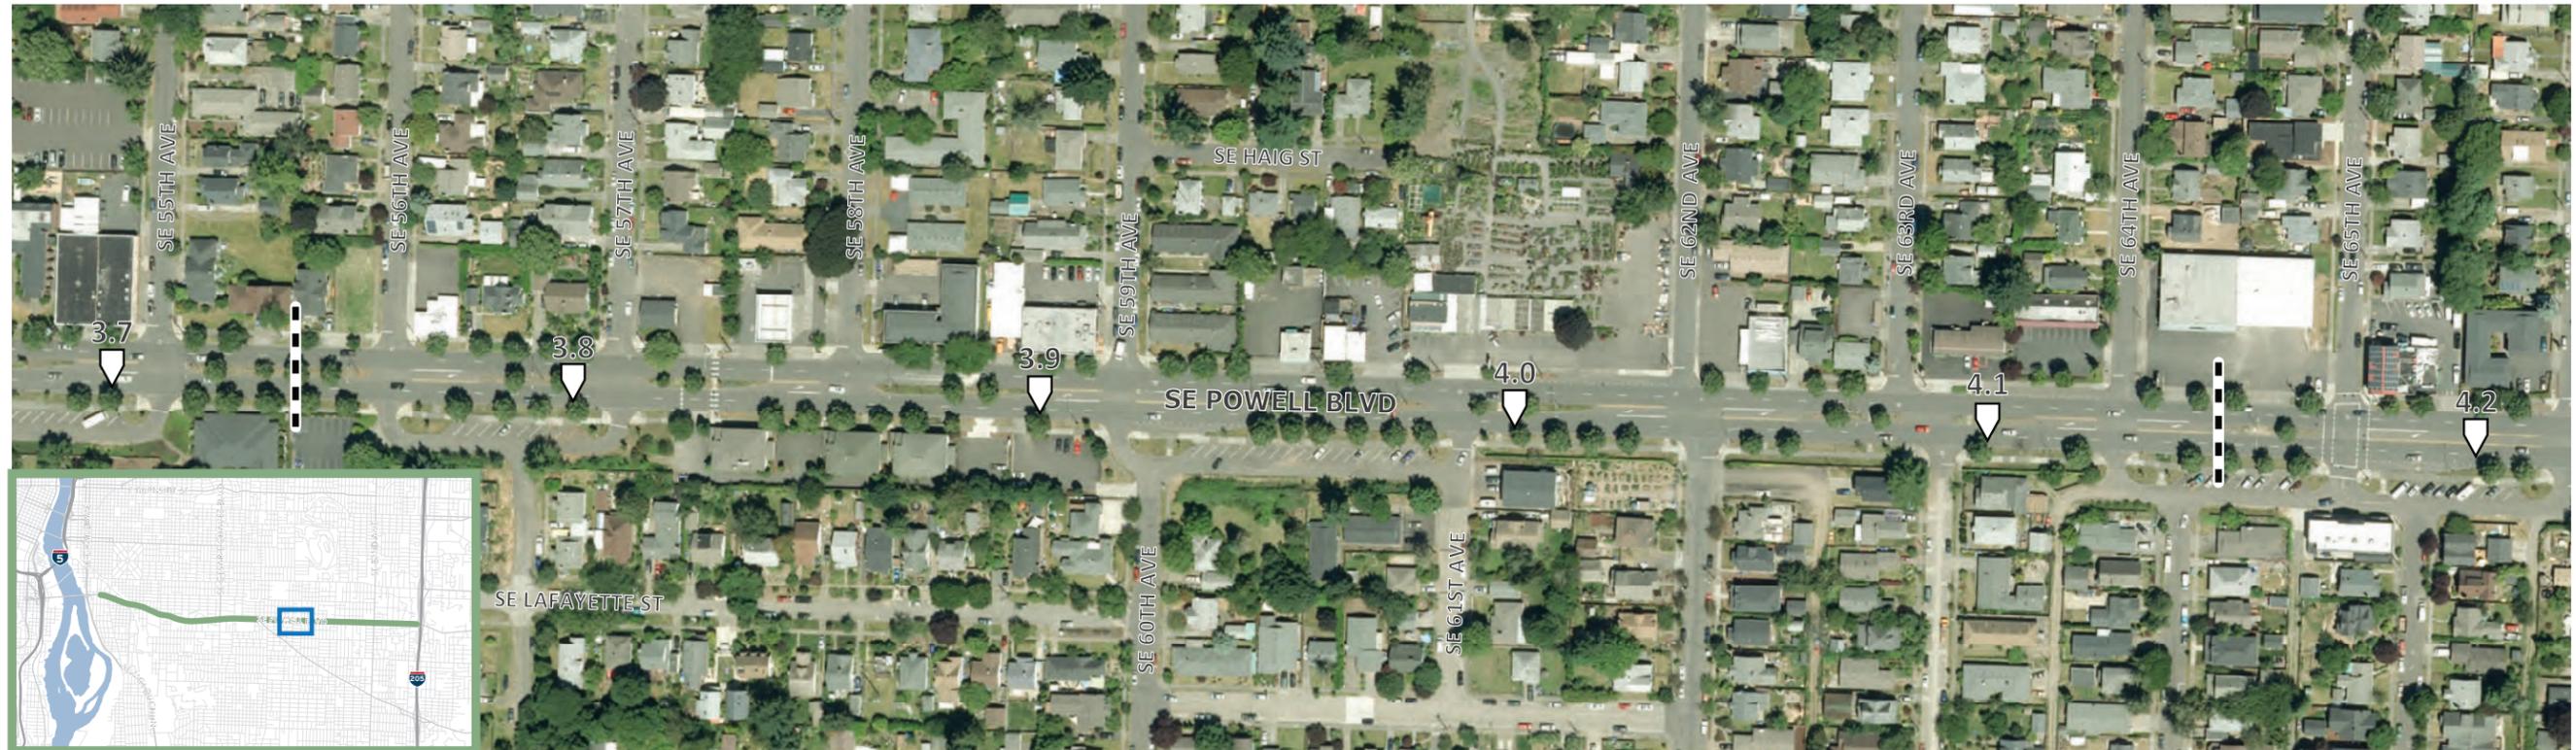
<p>Pavement</p> <ul style="list-style-type: none"> Poor, reconstruct pavement Poor, resurface pavement Fair, resurface pavement Fair, apply joint sealing 	<p>Striping</p> <ul style="list-style-type: none"> Poor, remove existing striping and restripe entirely 	<p>Signage</p> <ul style="list-style-type: none"> Poor, replace with new sign(s) Poor, replace sign support Fair, replace with new sign(s) Fair, replace sign support 	<p>Lighting</p> <ul style="list-style-type: none"> Poor, install new light pole(s), luminaires and wiring system as needed 	<p>ADA Pushbuttons and Curb Ramps</p> <ul style="list-style-type: none"> Poor, replace ramp Poor, replace diagonal ramp with 2 ramps Poor, replace pedestrian pushbuttons Fair, clean, maintain or relocate pushbuttons
---	--	--	---	---

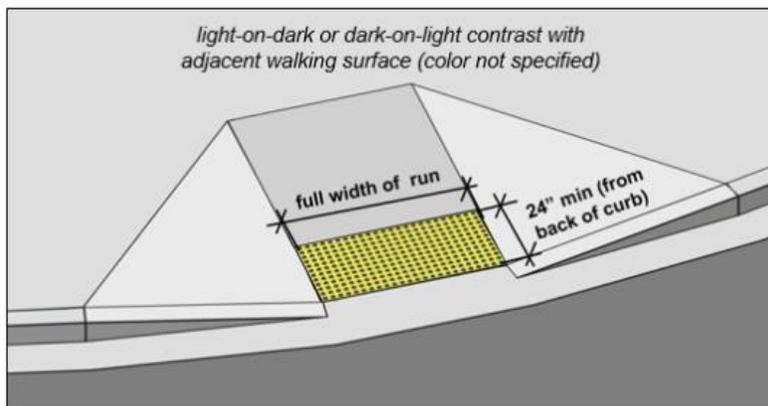
Figure 3: Detectable warning device (truncated domes)

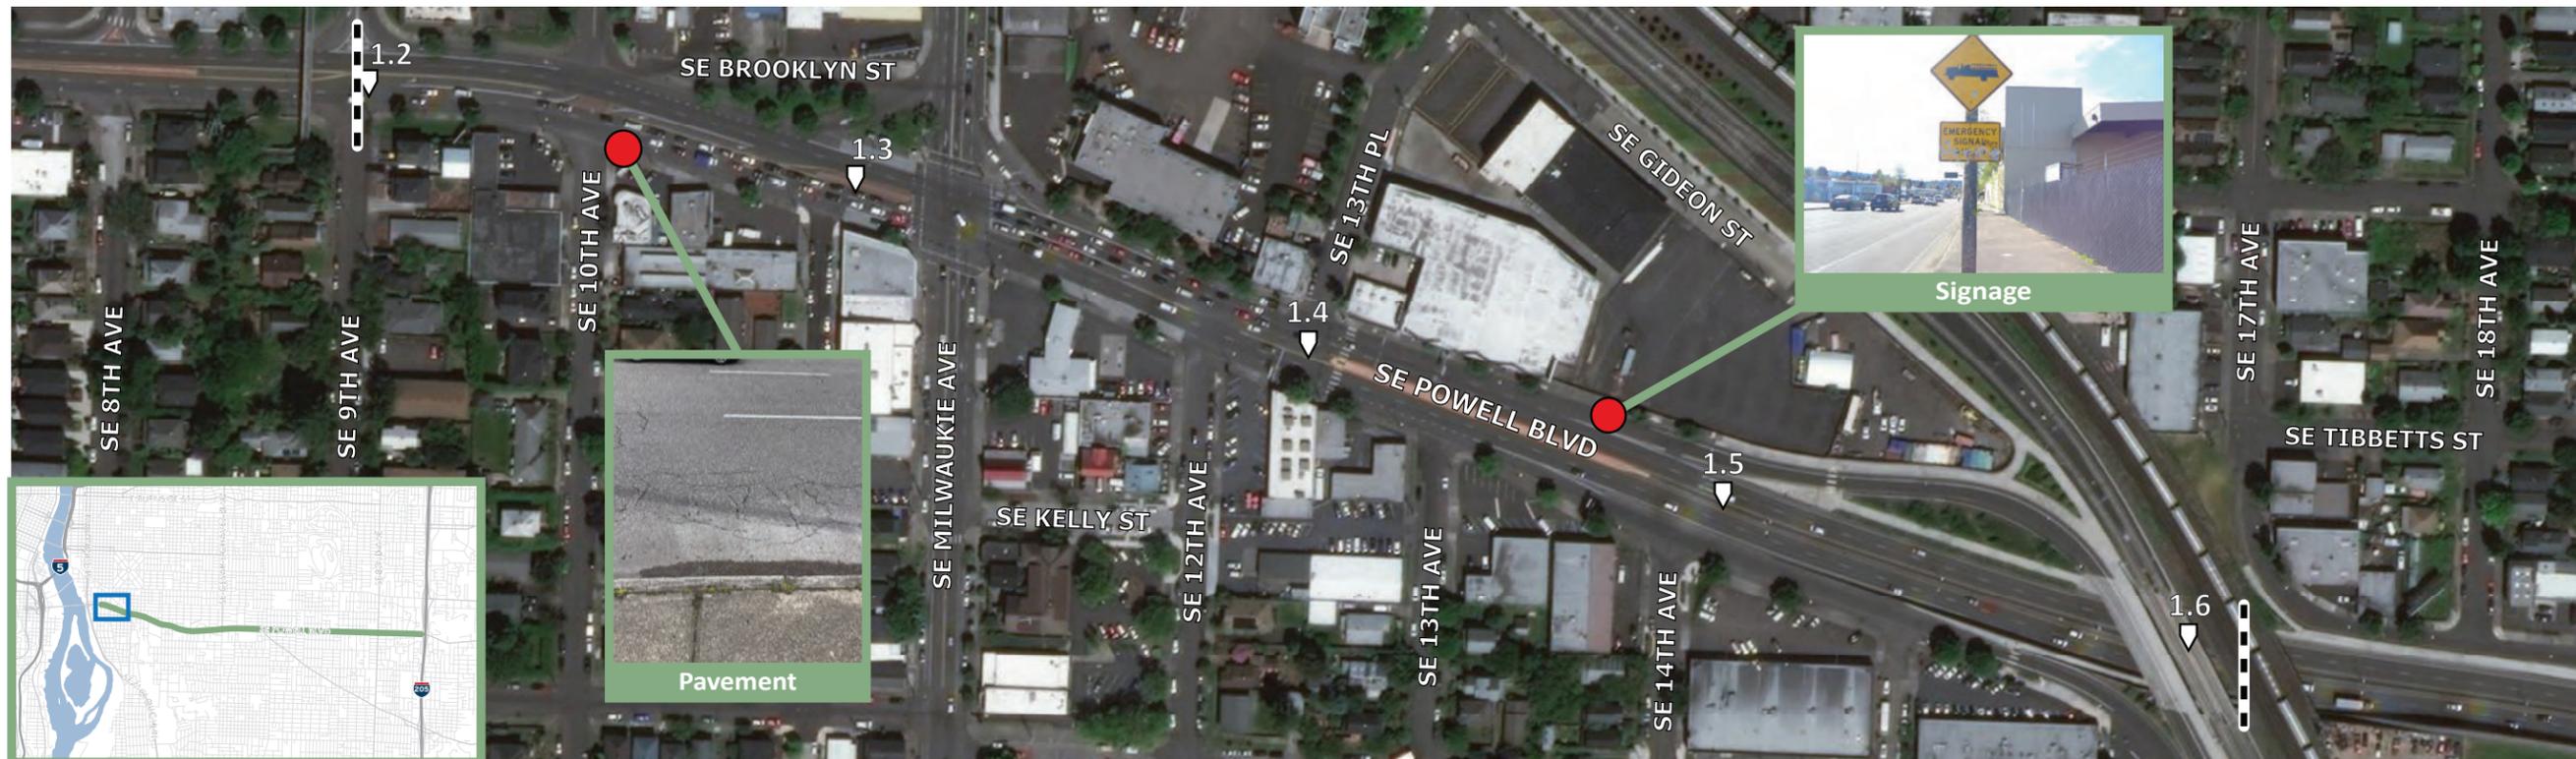
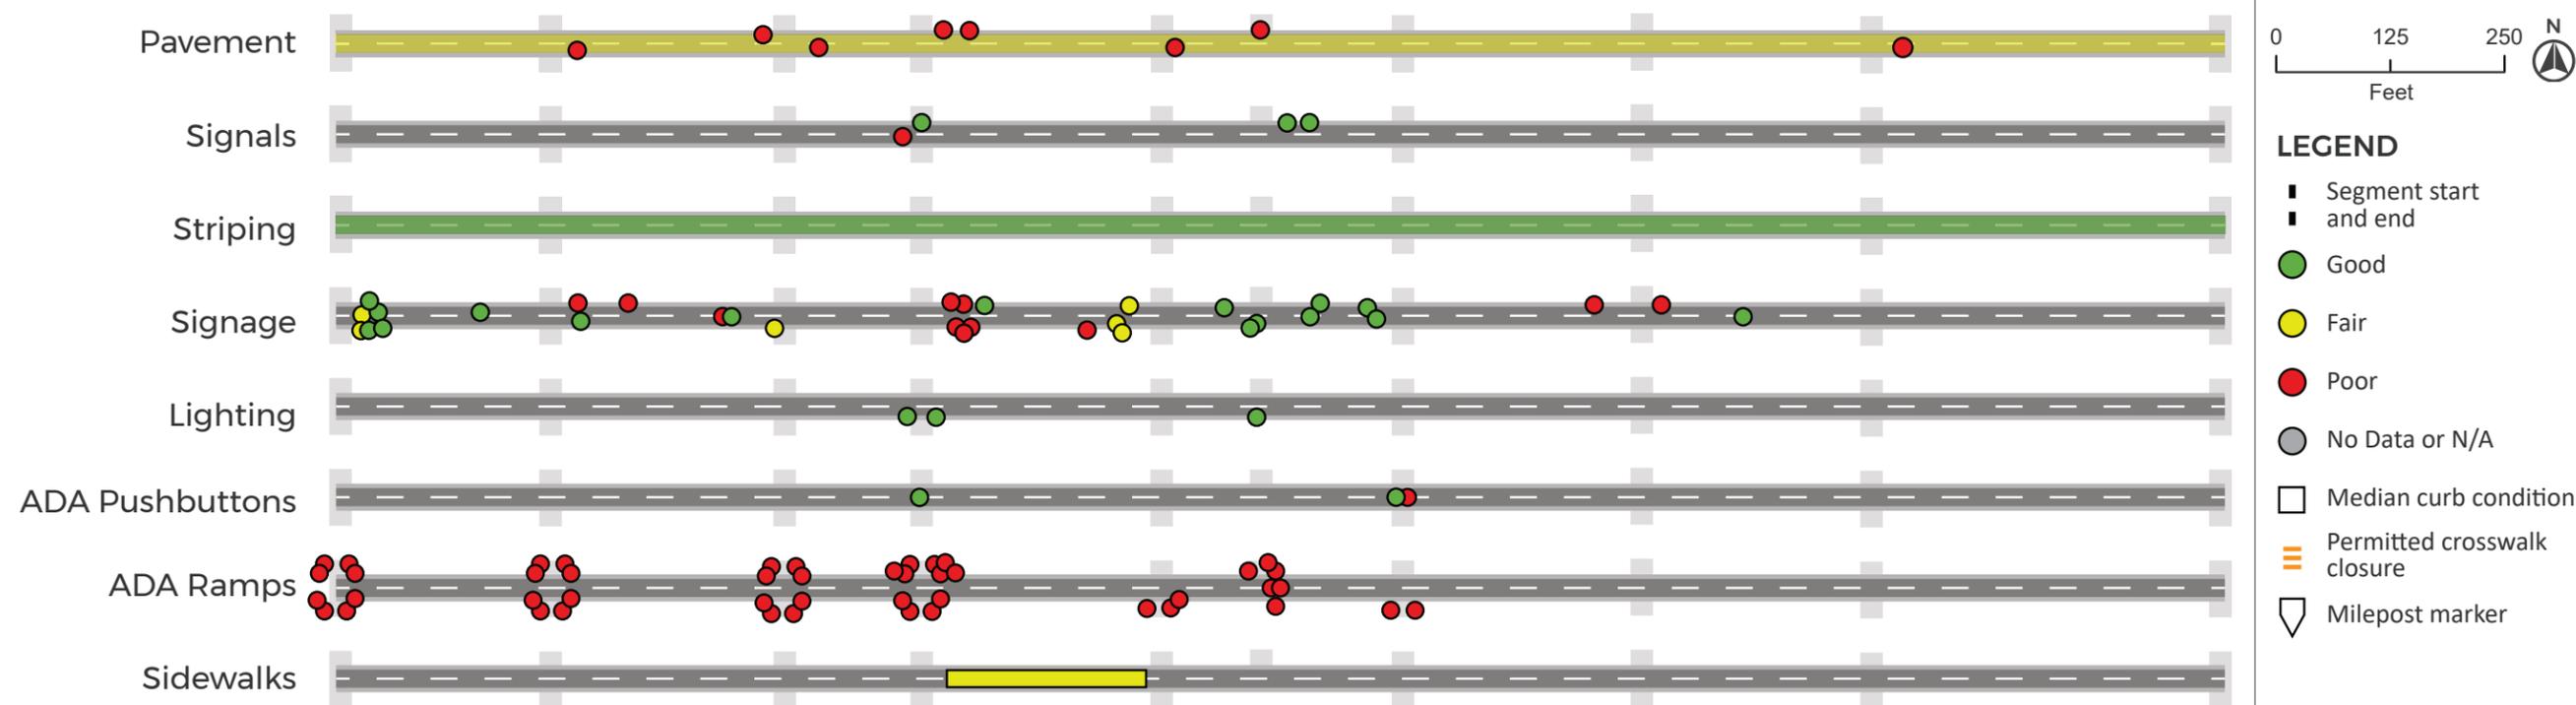
ODOT does not have jurisdiction over sidewalks in this segment. No inventory was completed. Rectangular icons indicate existing median curb condition.

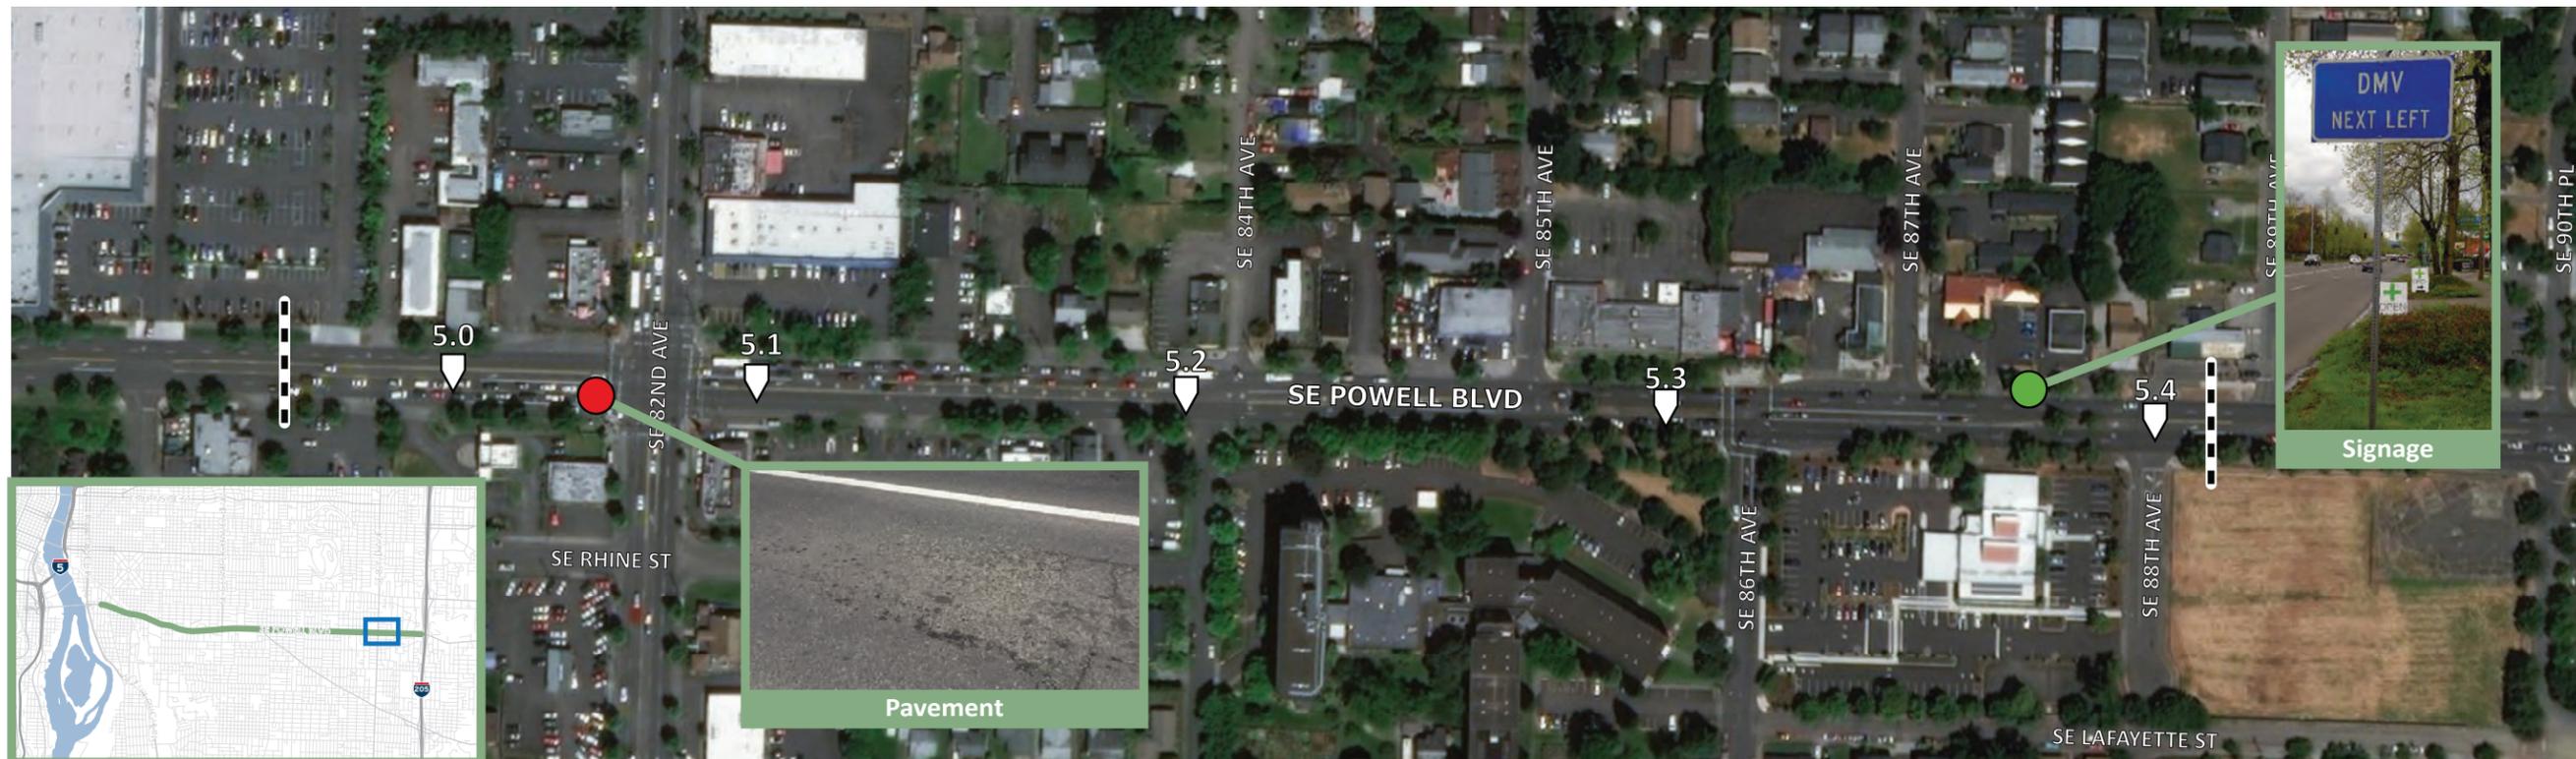
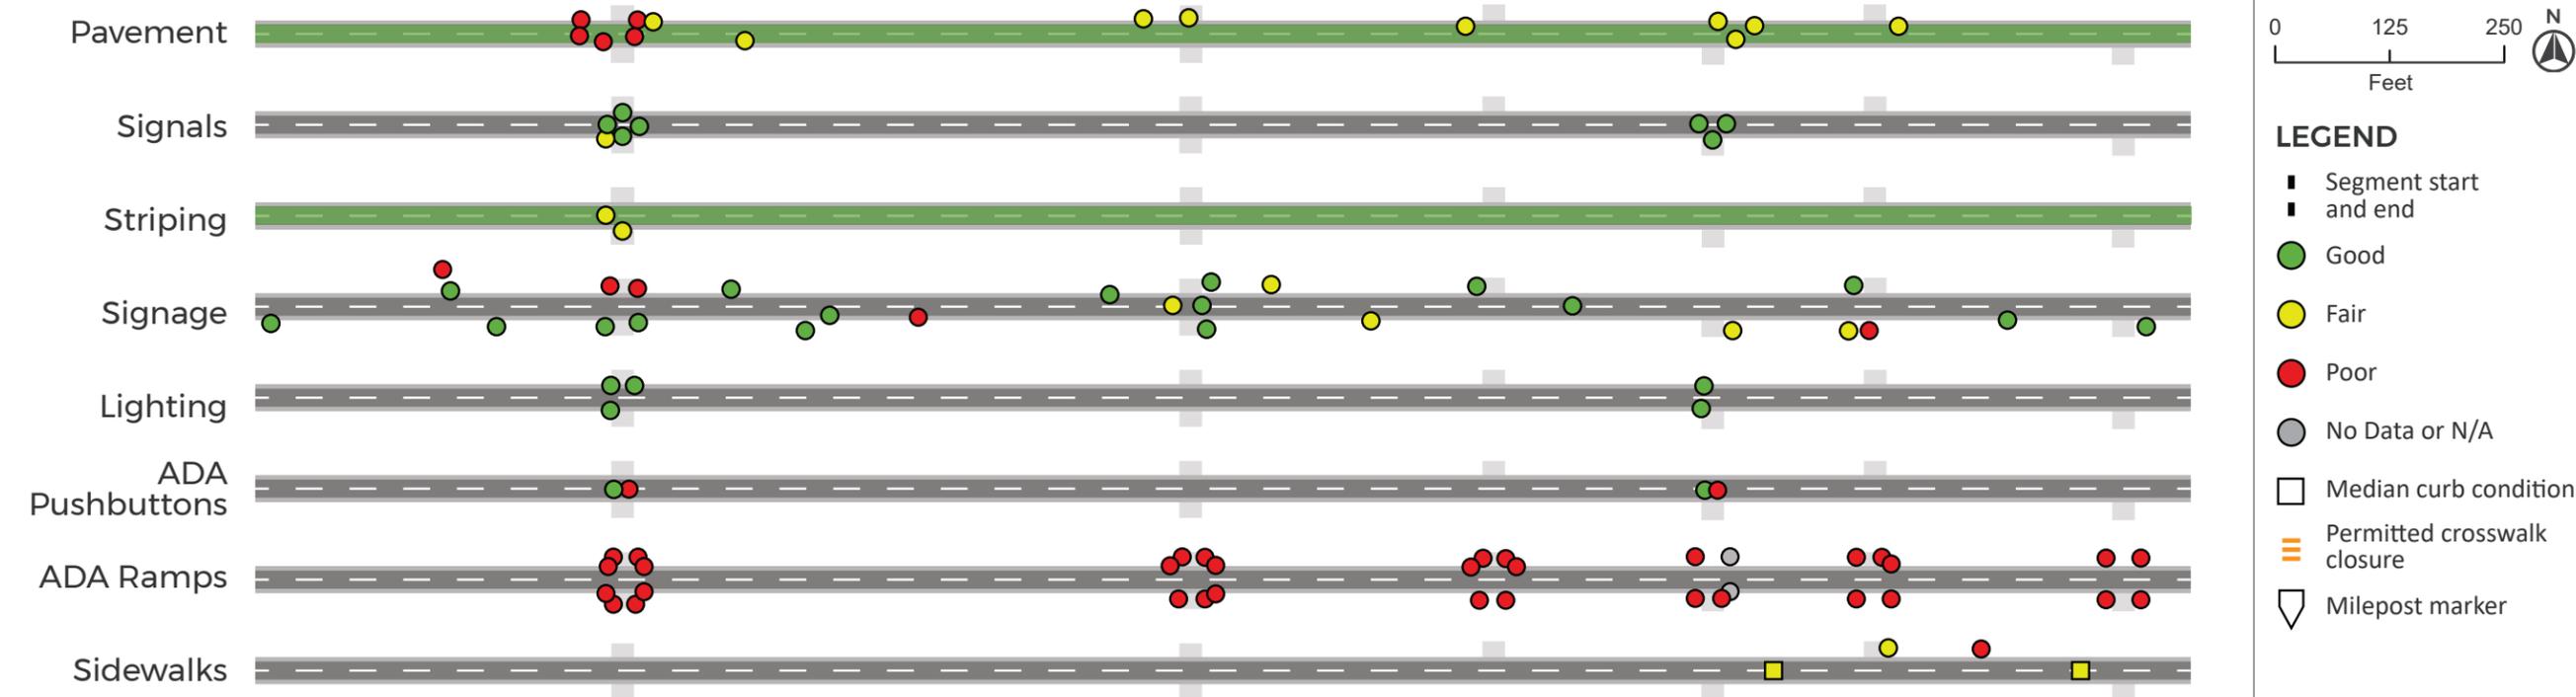
ODOT does not have jurisdiction over sidewalks west of SE 86th Ave. Inventory was completed for sidewalks from SE 86th Ave to I-205. Rectangular icons indicate existing median curb condition.
