# 2025 BRIDGE CONDITION REPORT & TUNNEL DATA

Compilation by Michael McDonald  
Astoria-Megler Bridge by Bert Hartman, P.E.  
Major Bridge Maintenance Program article by Orren Jennings, P.E.  
Bridge Preservation Program article by Bjorn Miller, P.E.  
Seismic Program article by Albert Nako, P.E.  
Load Rating Program article by Jon Rooper, P.E.  
Tunnel Data by Bjorn Miller, P.E.  
Photos courtesy of ODOT Flickr team unless noted by instance  
Lead editing by Jill Pearson  
Publication design by Carlee Justis

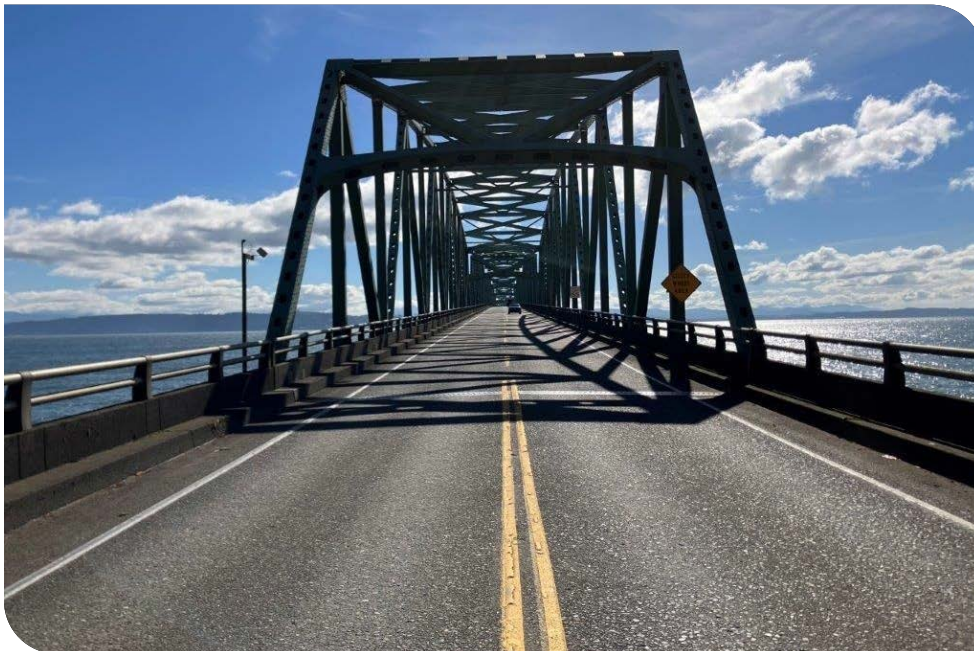
Starting in Washington, the first portion of the bridge has some spans supported with steel girders, and some spans with trusses that are over the roadway as shown in the photo below.

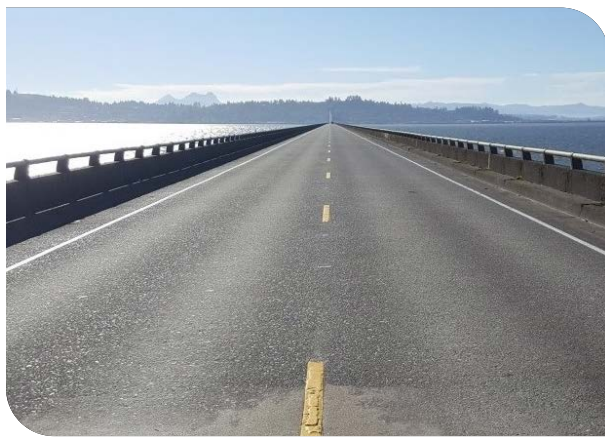
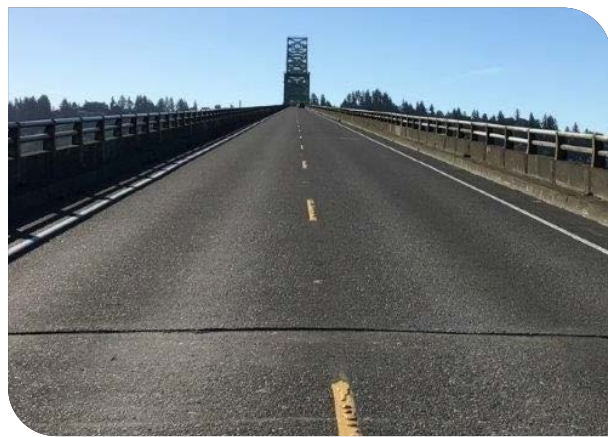
The next portion of the bridge is 140 spans of prestressed concrete girders as shown in the photos below. This is the longest portion of the bridge. The climb to the main spans over the shipping channel can be seen in the distance.

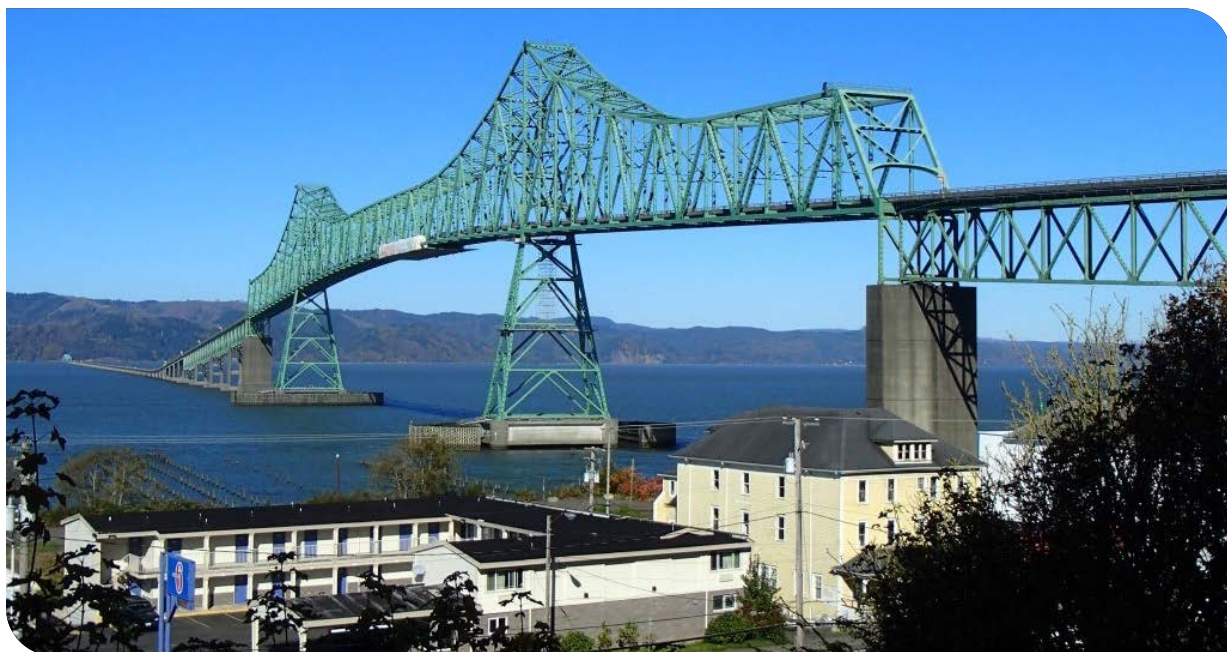
The photo below, taken from the Oregon approach, shows the main truss over the shipping channel and the spans on either side. These three spans are recognized as the longest continuous truss bridge in North America and is 2,465 feet long, including the 1,233 feet long span over the shipping channel.

The photo above was taken during a painting project on the underside of the main truss. The enclosed containment area staged in the middle of the span was needed to keep the lead paint that was removed from being released into the environment.

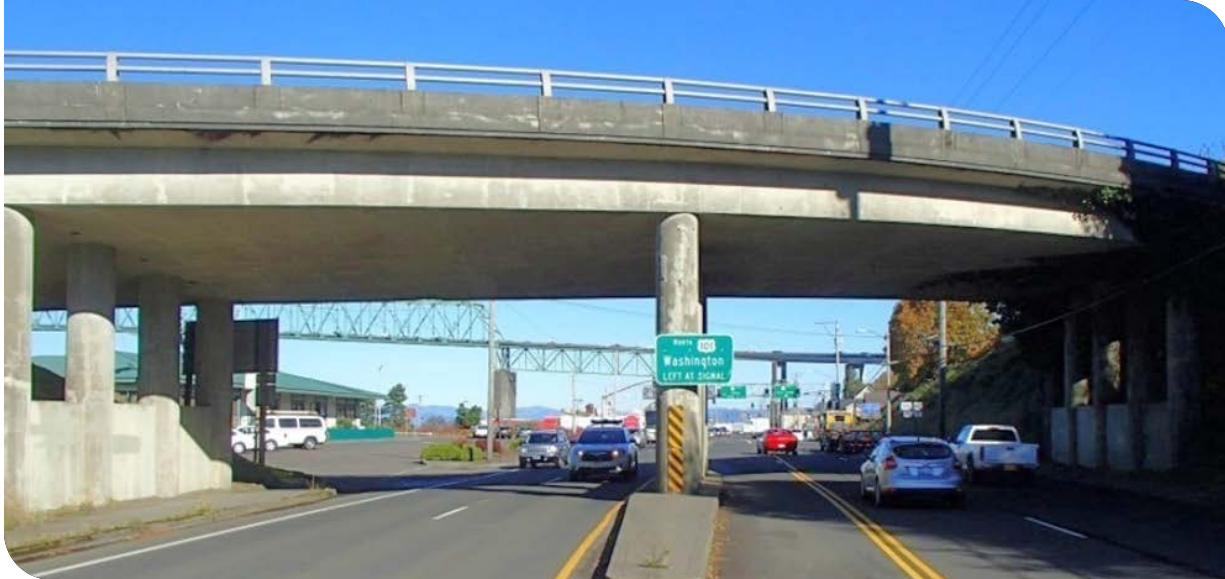
The Oregon approach is shown above, in both the foreground and background as it crosses the highway twice.

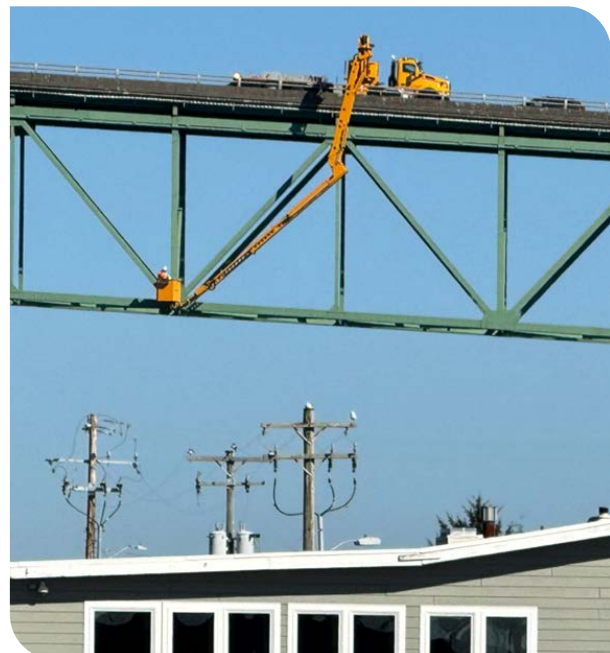
An inspection team completed a steel inspection on a portion of the Astoria-Megler Bridge in October 2025. They used an "under bridge inspection truck" with a moveable arm and a bucket to hold the inspector as they closely inspected the steel. The picture to the right is from that inspection.

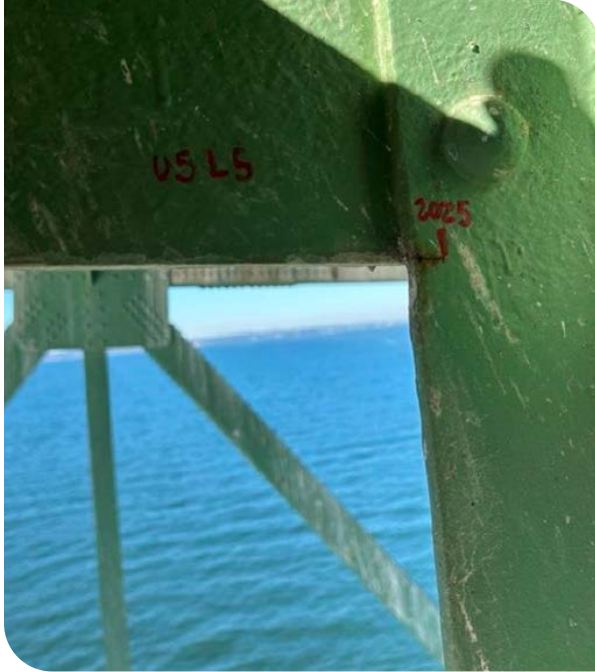
The inspectors found some cracks that had formed since the last inspection (bridges are inspected every two years). The crack in the photos below is half an inch long. The location and extent of the cracks are marked on the bridge.

Some cracks have not grown since the last inspection.

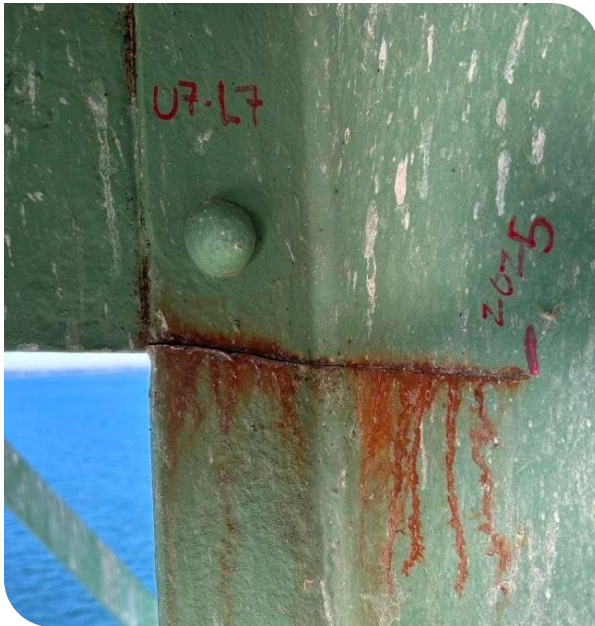
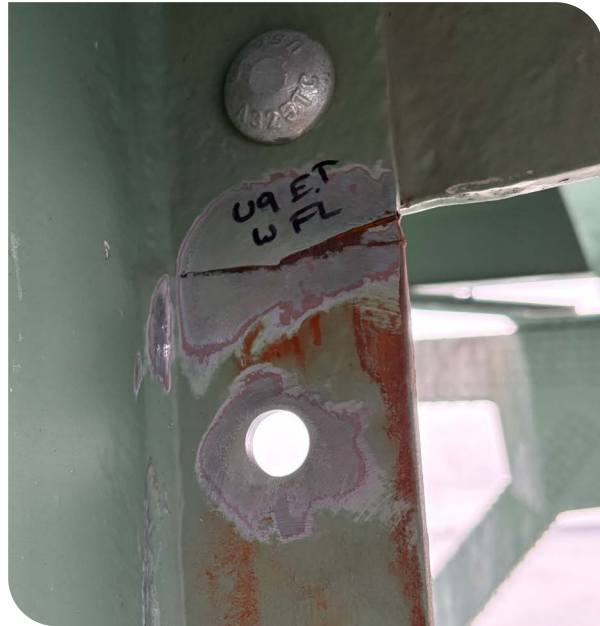
Other cracks have grown since the last inspection. The crack shown above grew from 4 inches to 9 inches between the 2023 inspection and the 2025 inspection.

The very tip of the crack has a very high stress concentration. Many cracks can be prevented from future growth by drilling a small hole at the tip to greatly reduce stress concentration. Significant cracks like the one shown on the previous page will need to be repaired so the bridge can continue to function as designed. The photo on the previous page, lower right shows the grinding of the paint near a crack, and the smooth hole that is drilled at the crack tip.

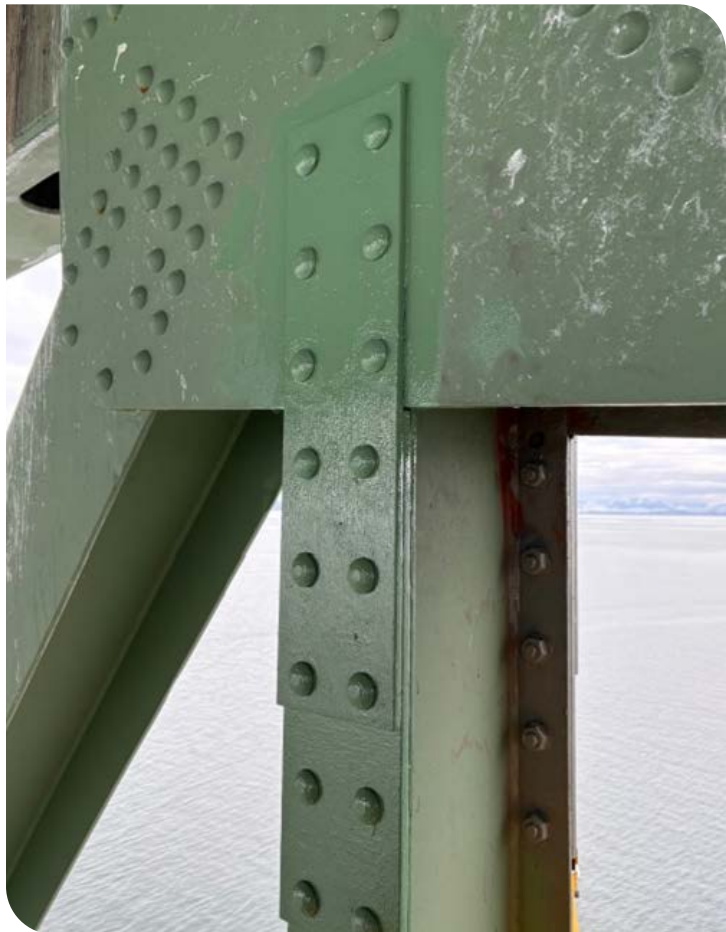
The photo to the right was taken in December 2025, shows the completed repair.

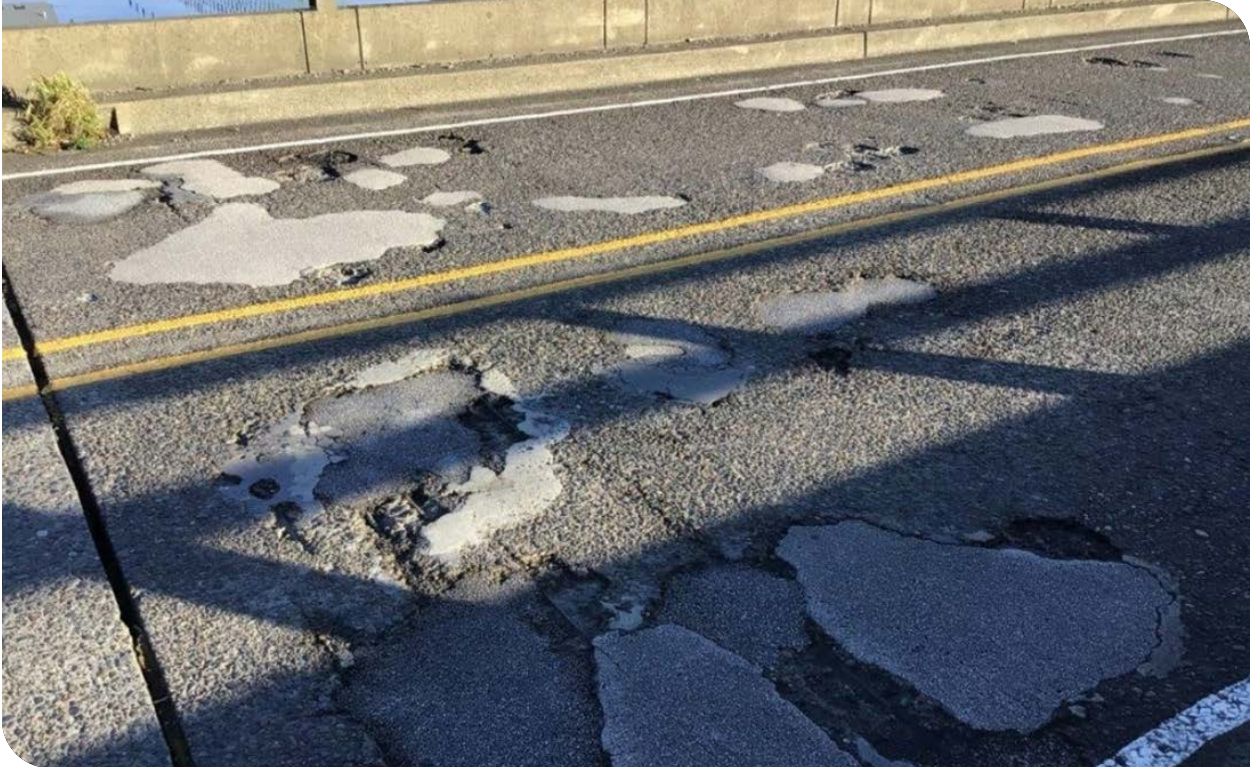
Currently, there is insufficient concrete to cover the top level of deck reinforcement. There are portions of the bridge that have exposed and rusted reinforcement. Due to the length of the bridge, there will need to be a series of concrete overlay projects. The estimate to remove the top layer of concrete and place new concrete on the Oregon approach and update the deficient bridge rails, is \$13.5 million. This represents 8.7% of the deck area for the entire bridge. Based on the cost of overlaying the Oregon approach, the preliminary estimate to overlay the entire bridge and update the deficient bridge rails is \$155 million. Due to the high cost, we will need to program a series of projects to address the deck and the deficient bridge rails.

The photo below is of the Oregon approach. It shows portions of the deck that have failed, some of which have been patched. A few of the earlier patches have failed and been replaced with new patches.

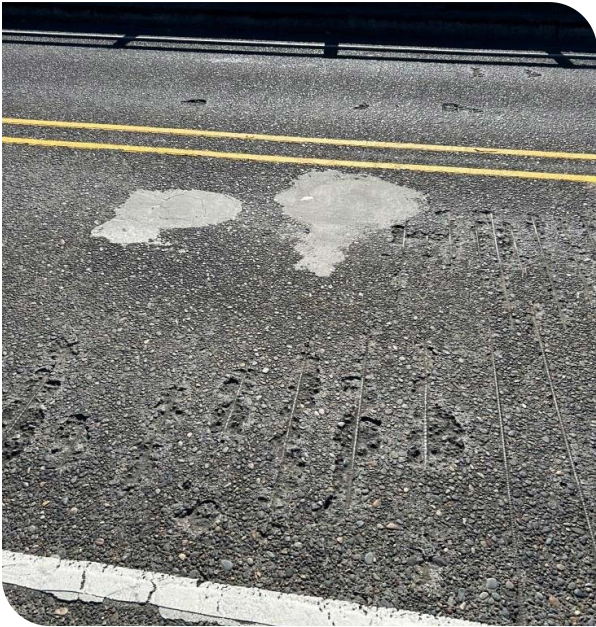
As shown in the photos below, there is a widespread issue of not enough concrete covering the steel reinforcement under the driving surface. Portions of the exposed steel reinforcement have been covered with concrete patches; however, it's a temporary measure at best. The top layer of concrete on the bridge has been contaminated by salt from the ocean for the past 60 years and must be removed. Once this is complete, we will add a new layer of concrete to provide the protective layer of concrete to the reinforcement that was intended when the bridge was built.

*Looking northeast at the deck surface.*

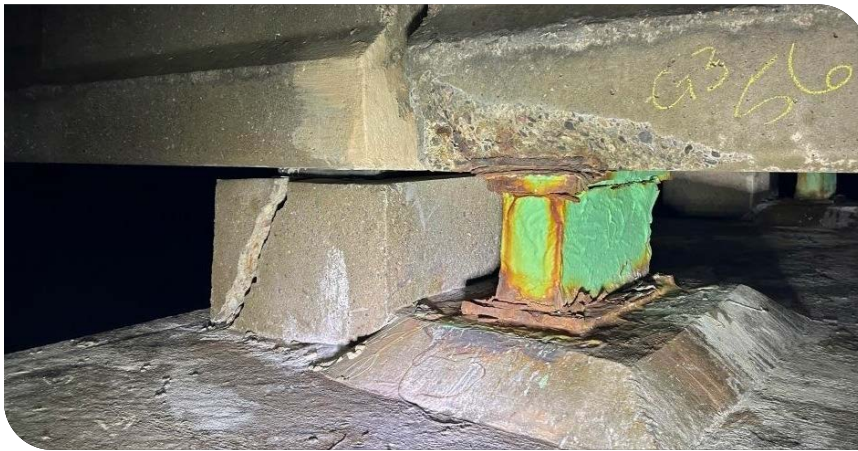
The 140 prestressed girder spans are supported by a combination of fixed concrete bearings and moveable steel bearings that allow the bridge to expand and contract with changes in temperature. All 136 steel bearings have extensive corrosion, with 12 of the bearings no longer able to move due to the buildup of corrosion. The bridge needs to be able to expand and contract but can no longer do so at the steel bearing locations and this is causing the concrete bearings to crack.

The photo below shows the paint placed on the bearing to prevent corrosion has failed. There is corrosion at both the upper and lower surfaces of the bearing, and the steel base plate is disintegrating. This bearing, designed to allow for the expansion and contraction of the prestressed concrete girders, no longer functions. Above the bearing a portion of the prestressed concrete girder has broken off, exposing the steel reinforcement. The photo also shows the concrete support for the girder in the next span has a significant portion that has separated. The crack is due to the stress on the concrete support that was caused by the steel bearing at the other end of the span being unable to provide movement as the bridge expands and contracts due to daily temperature changes. As portions of the concrete support separate, the intact concrete that is left to support the girders is reduced and is under a greater load.

*The photo left shows a corroded steel bearing and a cracked concrete support.*

The Major Bridge Maintenance Program estimated it would require \$2.2 million to address the four movable steel bearings and the four cracked concrete supports at 13 locations. Due to both Oregon and Washington funding constraints, there is a contract underway to address four of the 13 locations that have the most deteriorated bearings.

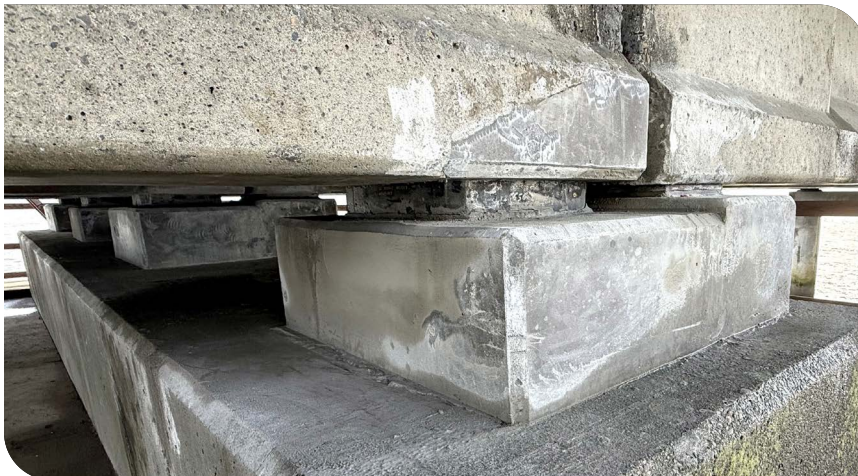
*The photo left is an example of a completed repair on one of four cracked concrete supports on the Astoria-Megler Bridge*

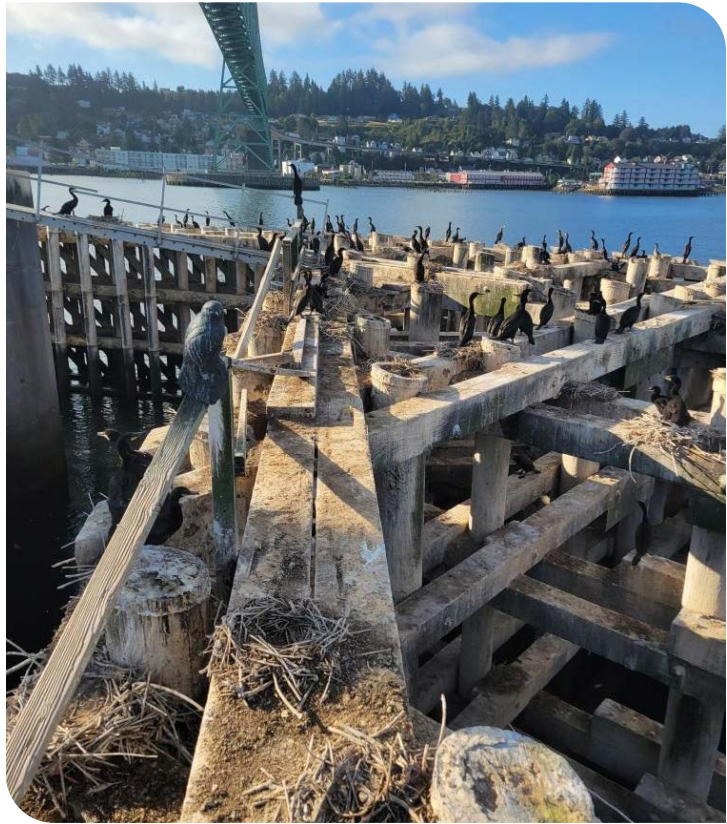
The photo to the right was attached to an email from Dan McFadden, ODOT Bridge crew supervisor, on Aug. 28, 2024. The foreground shows a detail of the fender system that is used to protect the main piers of the shipping channel. The background has a complete picture of the fender system for the other main pier. This photo also shows a portion of the cormorant colony on the bridge, and the working conditions for those who maintain the bridge. Part of the vessel collision analysis will be to determine the ability of the fender system to protect the bridge from an impact from a large container ship or cruise ship. With some of these ships being over 1,000 feet long, the bow of the ship may hit the bridge prior to the fender system being engaged.

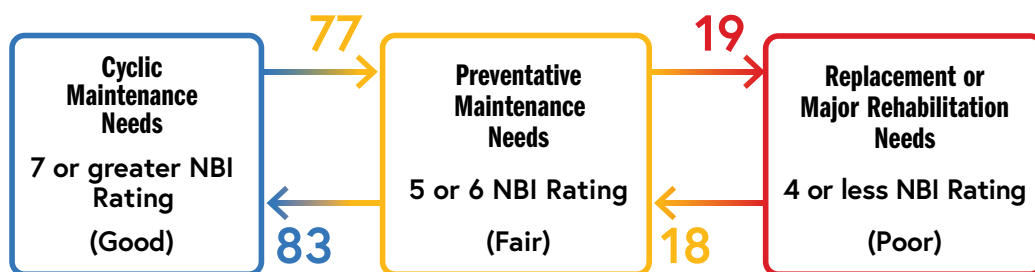
The following chart shows both the dynamic nature of bridge conditions and the growing backlog of work for those bridges that have changed conditions. The period from 2023 – 2025 reflects bridge conditions over one full inspection cycle (24 months). In a balanced state, the number of bridges moving from blue to yellow and red (deteriorating conditions) would be equal to the number moving from red to yellow and blue (improving conditions.)

A few more bridges had improving conditions (83+18=101, bottom line) than bridges with deteriorating conditions (77+19=96, top line). However, it should be noted that the number of bridges in poor condition show a net increase.

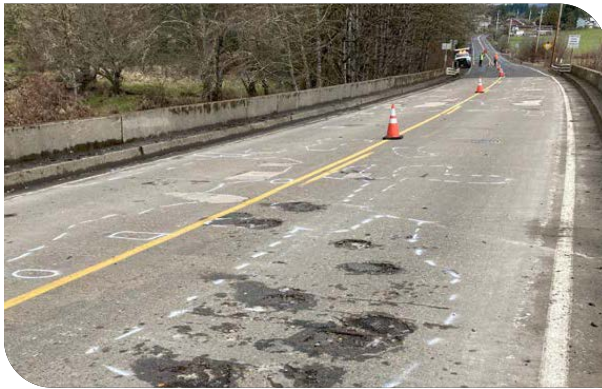
*Failed Deck*

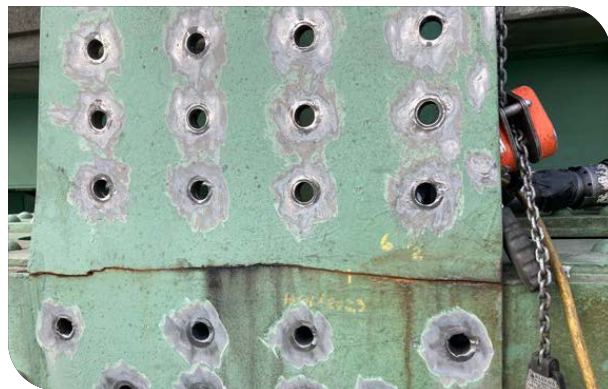
*Steel Fatigue Crack*

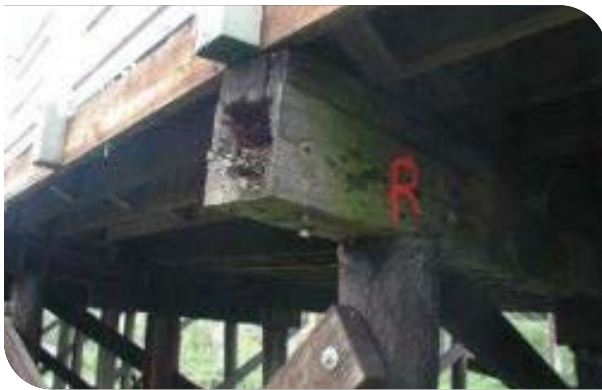
*Distressed Timber*

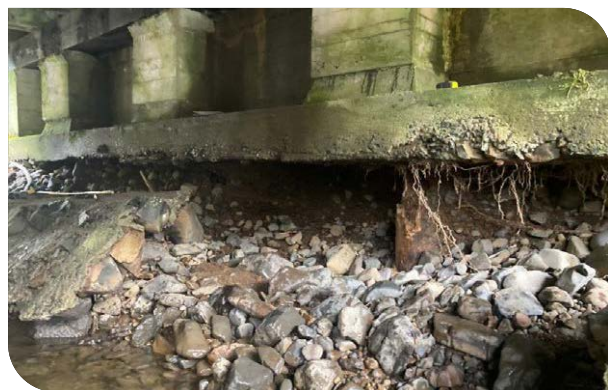
*Foundation Scour*

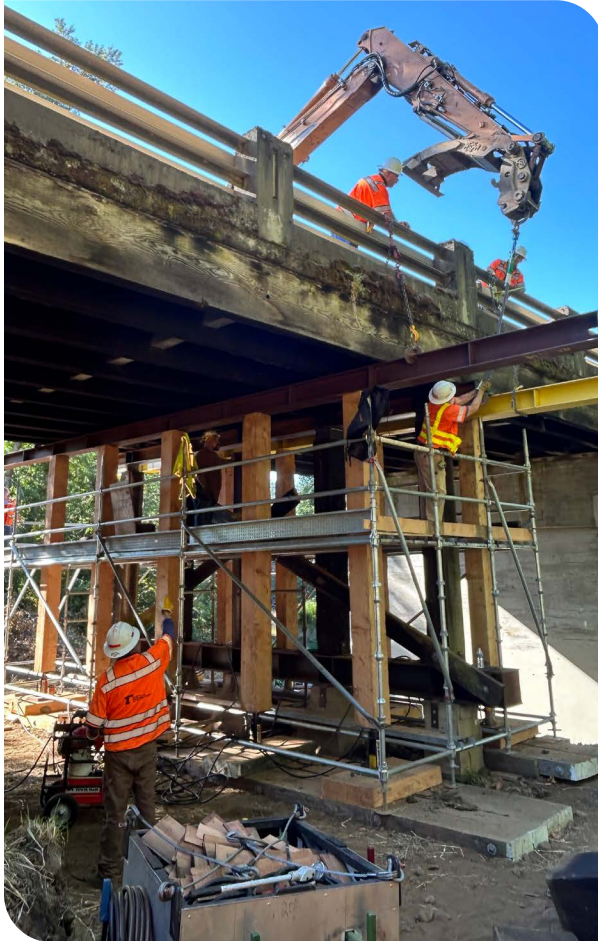
*Abiqua Creek, Oregon 213.*

The Abiqua Creek Bridge was constructed in 1934, is 167 feet long and consists of six spans. During a routine inspection in 2023, ODOT found two timber pile caps that needed to be replaced. State forces were able to remove the decayed timber and replace it with steel.

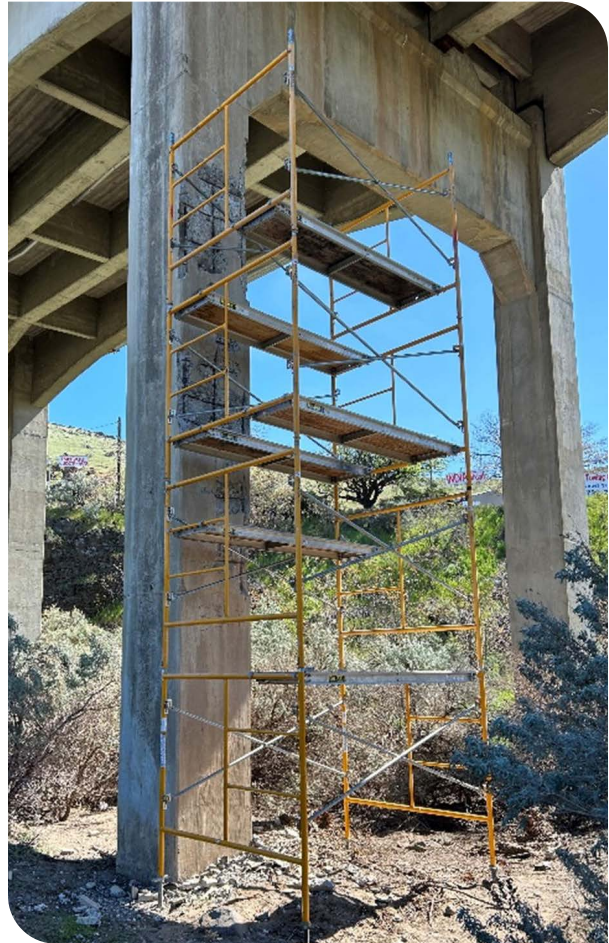
*Spanish Hollow Creek, Interstate 84 Frontage Rd.*

The Spanish Hollow Creek Bridge was constructed in 1936. Several of the concrete columns had spalling and exposed rebar. Due to the concrete's age, it lost the high alkalinity needed to protect the rebar. State forces patched the damaged portions of concrete. The columns will continue to be monitored for future deterioration.

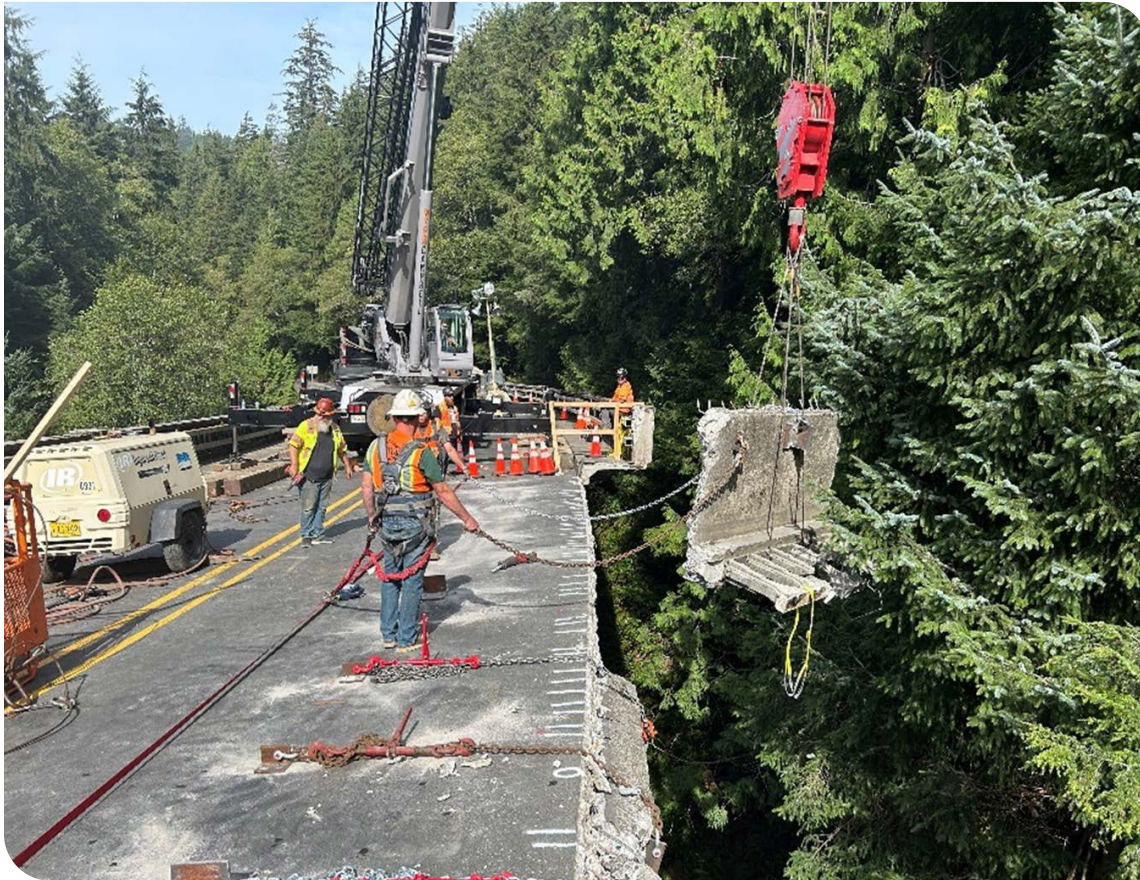
*Necarney Creek Bridge, U.S. 101.*

The U.S. 101 Necarney Creek Bridge is located on a curve between Tillamook and Seaside. It was built in 1937. The bridge is well above the terrain. The rails that keep out-of-control vehicles from going over the bridge do not meet modern design standards. To increase safety, two rectangular steel tubes were added to the rail in 2008. A vehicle hit this rail in August 2024. The original rail and sidewalk failed, with only the steel tubes remaining after the crash. The MBM program repaired this portion of the rail at a cost of \$1,244,257.

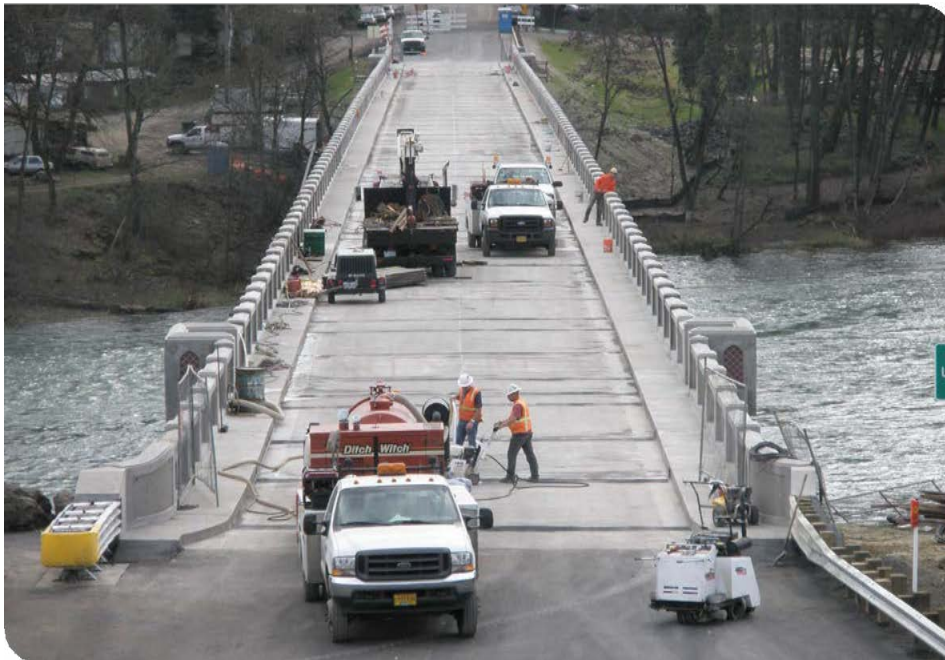
*Winchester Bridge over the North Umpqua River (Roseburg, OR) – bridge rail and widening work (2008).*

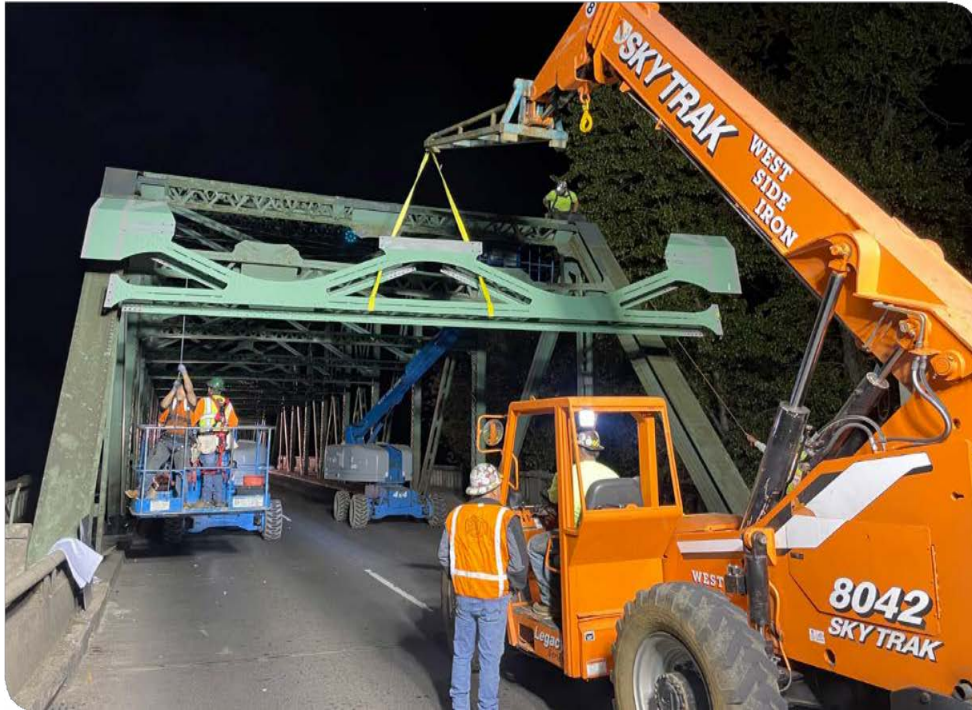
*Ellsworth Bridge over the Willamette River – Portal bracing replacement (2024).*

We can take steps to reduce damage to our historic bridges from vehicular collisions by modifying and replacing the existing bracing system. The bracing system over the roadway, also known as cross bracing, is a structural system that uses diagonal supports to keep a structure stable under side forces like wind or seismic activity. Modified bracing systems provide increased vertical clearance. They must be designed carefully to meet structural loading requirements and consider construction sequencing and erection tolerances.

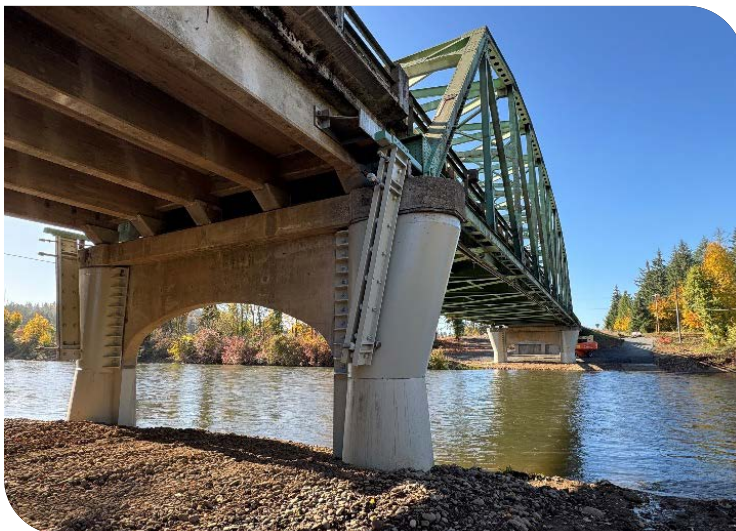
*Coast Fork Willamette River Bridge - The truss span has been secured from falling off its supports.*

Another seismic retrofit project is also complete; Oregon 58: Coast Fork [Willamette River to Lower Salt Creek Bridges](#). This project provides another seismically resilient corridor that will allow traffic flow from U.S. 97 to the Willamette Valley immediately after a major seismic event. Four bridges were strengthened under this project: Coast Fork Willamette River Bridge at milepost 2.4, Willamette River (Barnard) Bridge at milepost 33.2, Salmon Creek Bridge at milepost 36, and Lower Salt Creek Bridge at milepost 38.2.

This project was met with a few challenges. The design for the strengthening was based on the existing plans for the bridge. However, the design needed to be changed when it became apparent that the existing plans did not entirely match what was built. The project caused only minimal traffic impact (single lane nighttime closure) as most of the work was performed below the bridge deck.

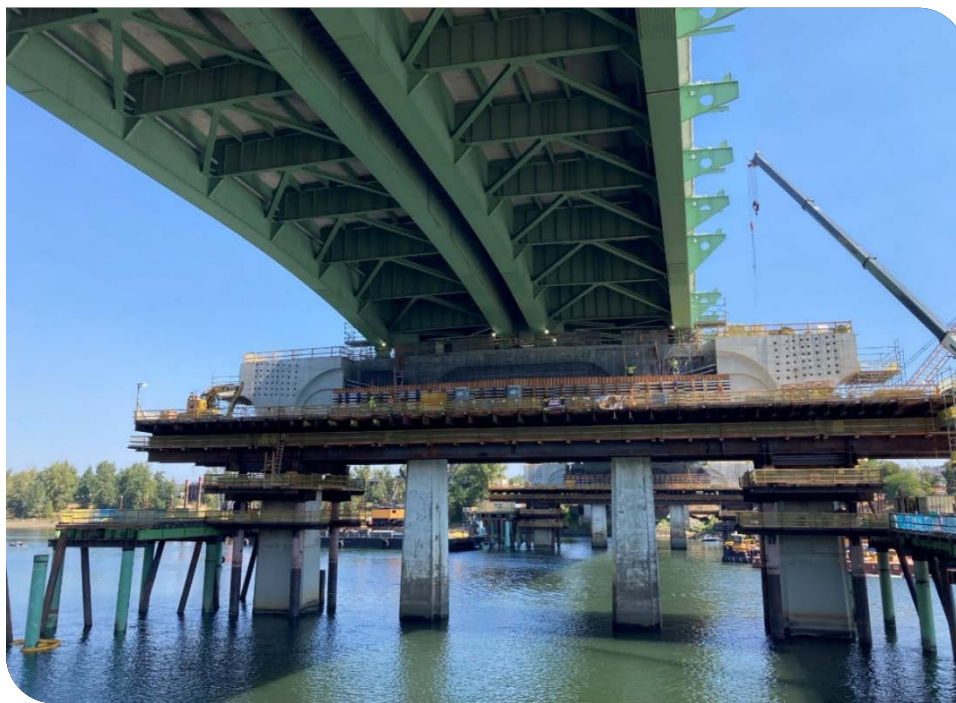
*Abernethy Bridge - Construction of the crossbeams is nearing completion.*

The existing support replacement work is primarily associated with supports in the water or near the water's edge. These support replacements have reinforced concrete drilled shafts as large as 12 feet in diameter and all this work is now complete. All new bridge columns for support replacement or support widening have also been constructed, and removal of existing columns is currently underway. Construction of crossbeams for the supports is nearly complete.

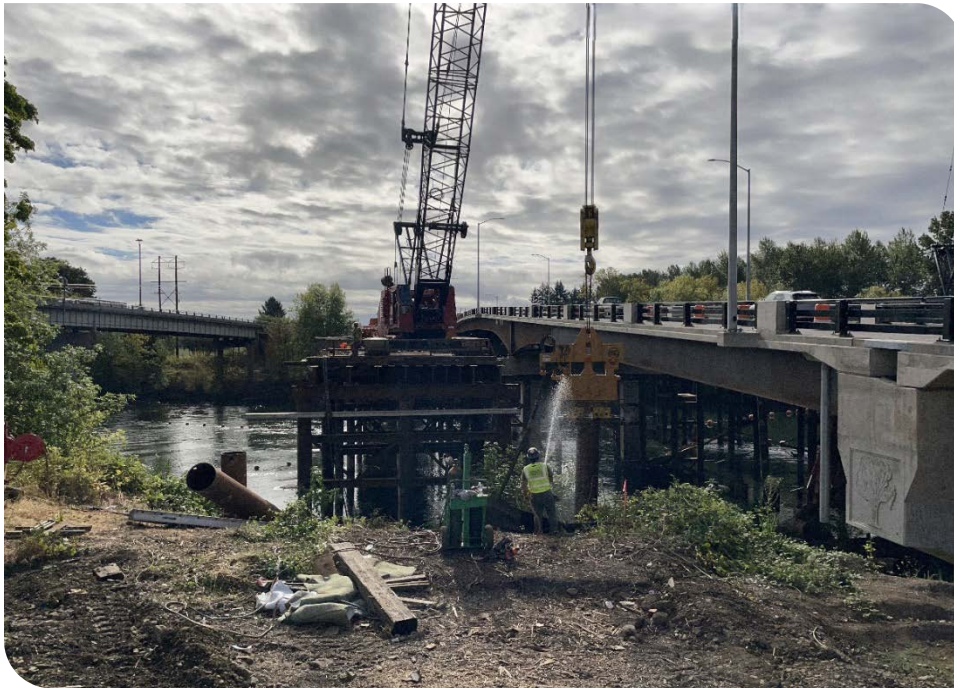
*Van Buren Bridge – Traffic using the new bridge while work continues to remove the temporary structures.*

Construction completed in 2025 included the drilled shafts, which serve as the foundation for the bridge, the bridge columns and the crossbeams at the support locations, placing the bridge girders, pouring the concrete bridge deck, and installing specialized expansion joints and all bridge rails.

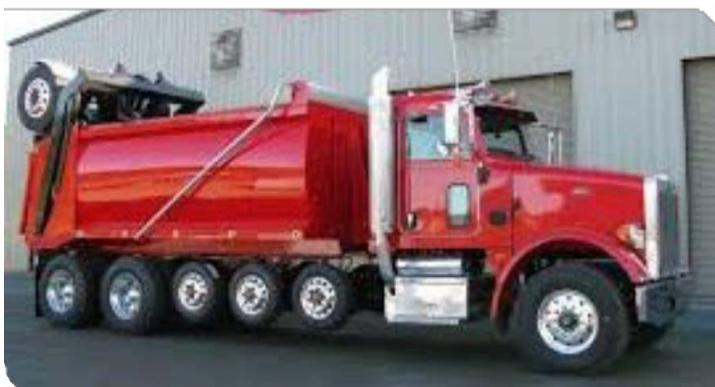
*Specialized hauling vehicle (SHV).*

As trucks grew heavier in the 1950s and 1960s, ODOT had to do something to protect bridges. The solution was to link allowable weights to the number and spacing of axles and using the bridge formula to establish limitations. Limiting the weight-to-length ration of a vehicle crossing a bridge is accomplished by either spreading the weight over additional axles or by increasing the distance between axles. One unintended consequence of the bridge formula is a new class of trucks that are called specialized hauling vehicles (SHVs.) These trucks are a single unit with many axles spaced closely together to comply with the requirements of the bridge formula.

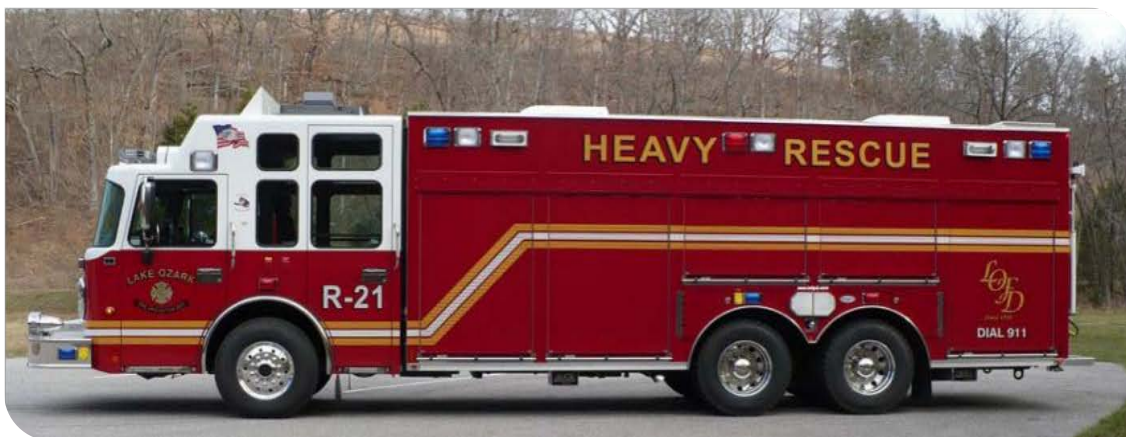
*Firetruck. (Emergency vehicle.)*

The truck shown on this page is an example of the EVs legalized by the FAST Act. These EVs can have a tandem axle weighing nearly double that of the traditional legal tandem. The weight on the two rear axles of this firetruck is equal to the weight that a five-axle dump truck can carry,
