**Subject:** Review of Enhanced Traffic Control Measures (TCM)

**Project:** I-5: Woodburn to Salem - Contract 15137 | Safety Pilot Project

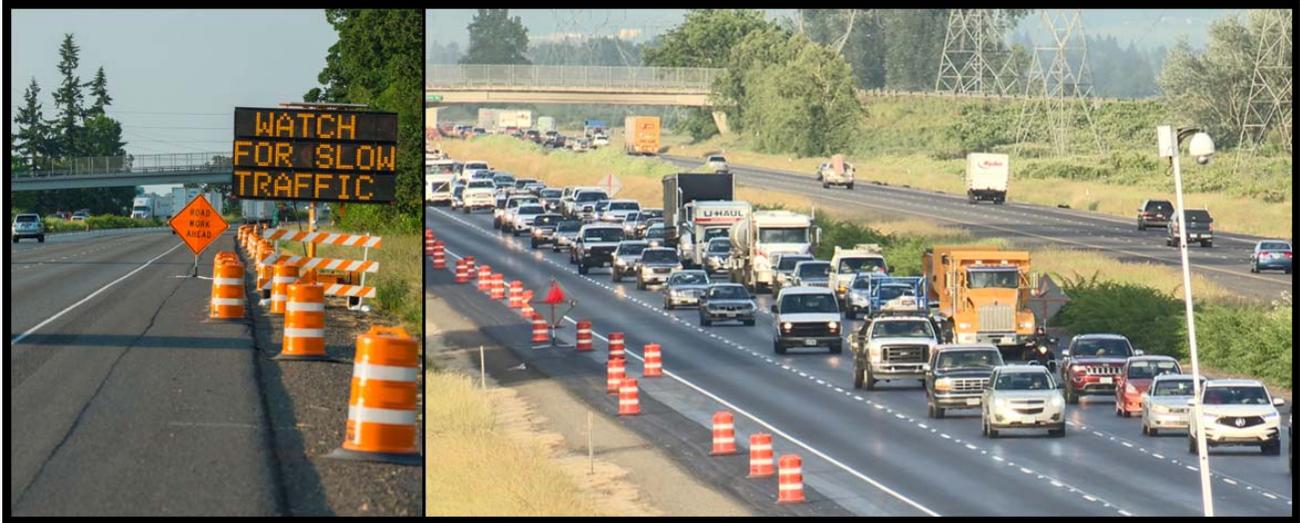
Figure 1. Real-time (left) PCMS message board with radar unit. Video tower in right photo.

The system does provide for real-time data and reporting/summarization of traffic conditions in terms of speed. The system comes with various static monitoring stations equipped with real-time video, radar surveillance, and GPS. The video surveillance has the capability to rotate 180 degrees to monitor opposing traffic, and the GPS system provides tracking of the equipment's location. The system can be accessed remotely so long as there is internet access. Real-time advance warning messages can be communicated to motorists of traffic conditions as they traverse the work zone.

The system's configuration remains static unless monitoring stations are manually moved by the Contractor. Projects with long closures or queuing that extends for miles run the risk of dead zones or areas with minimal monitoring because of the system's layout. Paving projects where the work-zone is quickly moving may find itself working in low to no coverage areas, because construction activities may migrate in-between monitoring stations. The system was set up primarily to monitor the work zone and 1 to 2 miles before and after. On I-5, traffic delays extended well beyond those limits. Moreover, there did not appear to be sufficient monitoring units within the 12 mile project limits. The RE office resorted to outside assistance such as maintenance support, Trip Check, News Flash Alerts, and ODOT overhead VMS's to provide additional real-time messaging beyond the project limits. The online portion of the system did have some periodic glitches that made access and use somewhat difficult. In order to realize the full benefit of this type of system, the Contractor must fully buy into its use and the vendor must monitor the system's performance on a regular basis. This was the first experience of a Smart Work Zone system utilized by this contractor and there was much challenges with set up and take down early in the project.

One suggestion to improve the system's effectiveness is additional specification language that requires the smart work zone technician to perform and report systems testing on a weekly basis and to report all data collected weekly. With that, there would need to be language that suspends work until the vendor and Contractor comply. It would also be better if more effort was made to determine optimal placement of the static monitoring stations. Locations were randomly selected and they remained as such for the duration of that side of work on the highway. The system is only good for one side of the highway due to its placement along the shoulder. Placement was such that they were only moved when the opposing side of the highway was ready to begin work. It would have been better if placed strategically in the median because of this being a divided highway. We further recommend and highly suggest that the Traffic designer have more input on where and how many monitoring stations are to be placed.

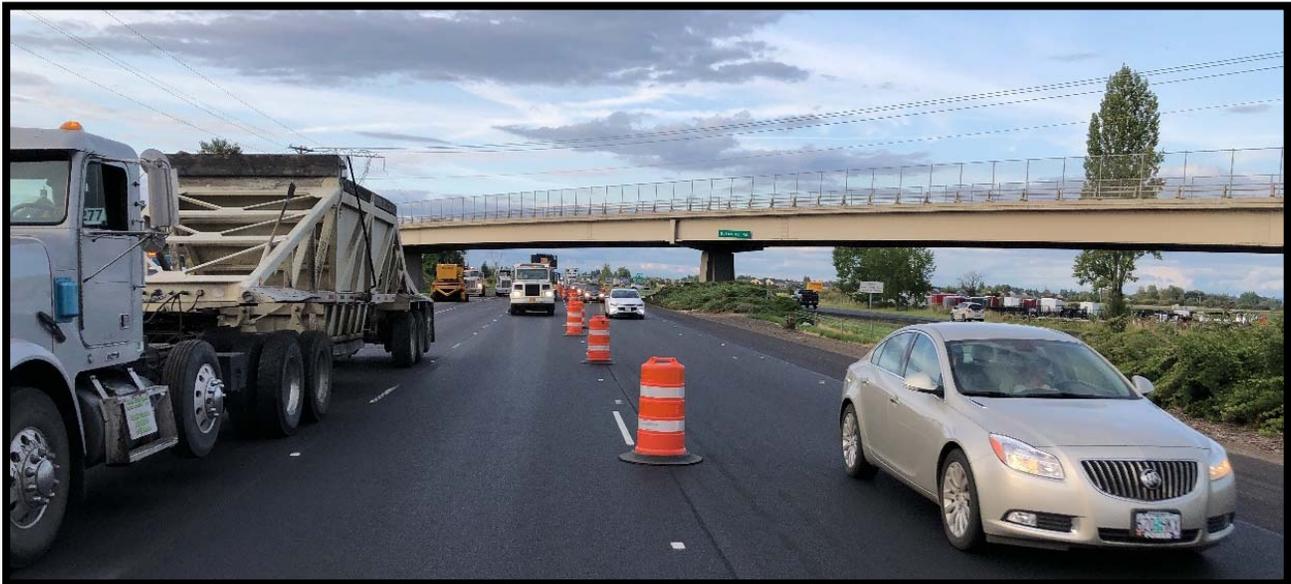
Figure 2. Haul lane adjacent to open lanes with shoulder usage.

As shown in the depiction above, motorists unaccustomed to shoulder usage avoided the outside lane. We witnessed on multiple occasions where two lanes were intended to be used, one being the shoulder, yet drivers were not using the shoulder as a lane. Periodically a pilot car or an Incident Response (IR) Unit

From a design stand point the plans were largely sufficient and adequate. One suggestion to the traffic control detail would be to utilize W1-4b signs instead of the W1-4 to better illustrate that two lanes are to be used instead of one and add a custom “Drive in Shoulder” sign for large projects of this type. The challenges mentioned were more of an issue for construction staff needing to be aware of the potential lack of shoulder use and increased queuing and make adjustments. Adjustments were made, such as early use of a pilot car as assistance or adding additional or more explicit signs depicting “shoulder in use.”

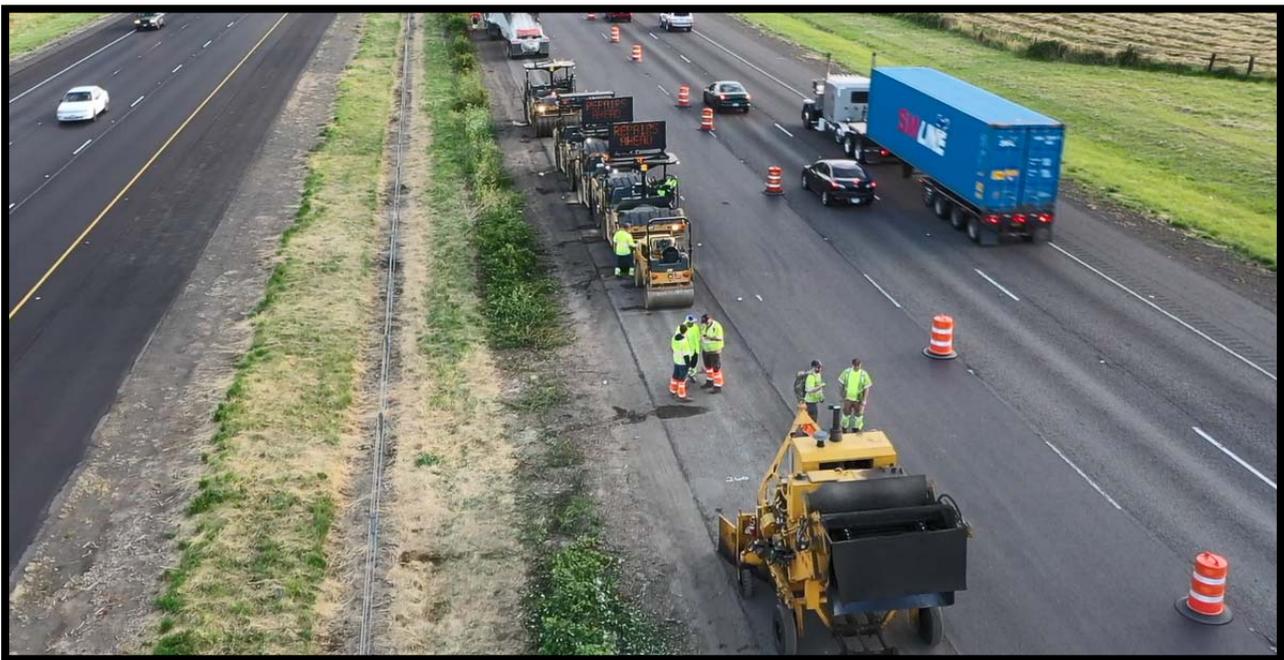
**Figure 3. Rollers with PCMS just prior to shift start.**

Standardized messages to use. Best visibility at nighttime. Roller-mounted PCMS units can present a safety concern on smaller projects because they reduce visibility and field for the roller operator.

Should be used on all larger projects, with multiple lanes.

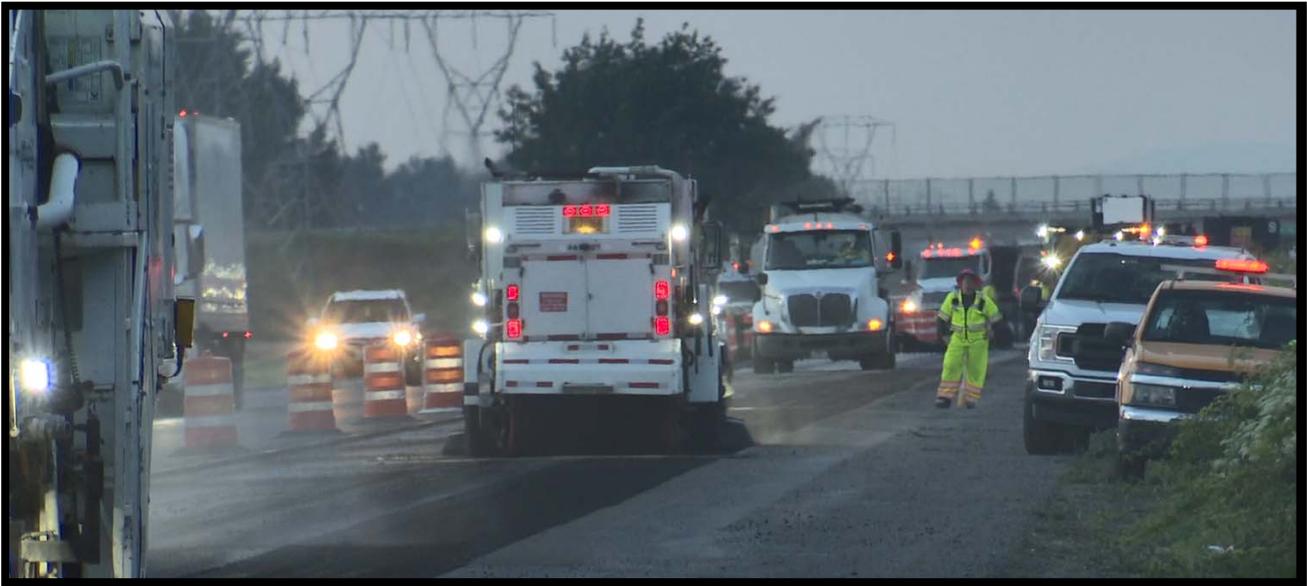
**Figure 4. Tight drum spacing made challenges for haul vehicles entering and exiting the work area.**

The delivery method of ACP to the project site was the use of long Belly Dump trucks. The primary construction activities were milling and paving where the delivery and removal of material by haul vehicles is critical. This is magnified by the frequency of their entering and exiting the project site. Issues with accessibility for the haul vehicles were immediately apparent. The Contractor requested to change the drum spacing to the typical 40' because drivers were having challenges decelerating and accelerating to enter or exit the work site due to the reduced spacing. The issue was greatest when entering the work site. Trucks were slowing down in the travel lanes in order to negotiate and navigate between the drums increasing queuing and public delays.

In this instance the traditional spacing of 40 feet proved to be more favorable. If the project had moved forward with the original crossover alternative, the reduced spacing would have been more suitable because there would have been no need to accommodate any vehicles traversing the wall of drums to enter or exit the work zone.

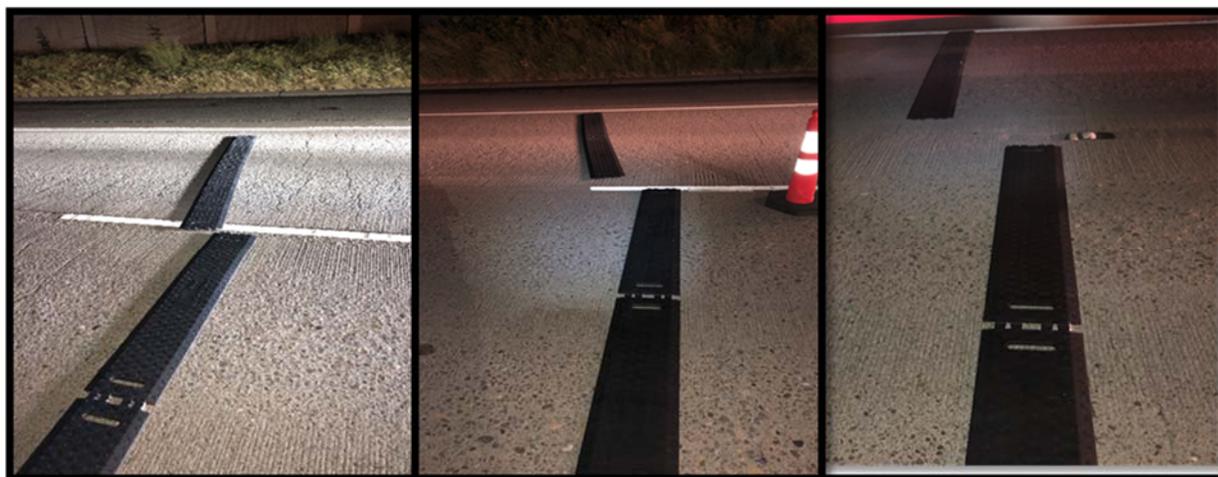
As shown in the figure(s) below, the cluster of portable temporary rumble strips that were placed moved in a unique motion pending how traffic engaged them. Originally these were all placed in a uniform position

forming a single line across three lanes of highway. Within 30 minutes of placement they would rotate in a skewing fashion, move laterally, and/or perpendicular to travel. Some movements were in excess of the recommended 3 feet skew, 2 feet lateral or 5 feet perpendicular. For comparison, the photo below at the time had only one lane (the travel lane) under traffic. The adjacent lane (center lane) not yet open to traffic. The left photo shows lateral and skew movements while making a continued encroachment into the adjacent lane. The center photo shows skew of over 3 feet, while the last photo shows a perpendicular movement that had reached about nearly 4 feet. All occurred within 20 to 30 minutes.

**Figure 5. Movement of portable temporary transverse rumble strips.**

The Contractor installed the transverse rumble strips on the first paving shift. To install the rumble strips a rolling slowdown was utilized and within minutes three strips were placed across the active lane at the required spacing. After +/-25 minutes of traffic flow it became apparent that this enhanced TCM was more maintenance and could create longer queues if having to straighten and adjust on 30 minutes intervals. As motorist traveled across the rumble strips they immediately began to rotate and shift. Their movement was mostly induced by the heavy trucks travelling at higher speeds, 45 mph and above. In some cases the rumble strip gradually moved off the lane. These rumble strips had to be adjusted once or twice an hour utilizing a rolling slowdown each time adding to traffic delays. Additionally, the blunt ends of the strip was a concern for motorcycles.

The benefit of hearing the rumble strips as a warning measure for workers was not realized because of their placement relative to the physical work within the work zone. The rumble strips would have been better if used in a slower traffic environment and where traffic volumes and speeds are significantly less. In hindsight, these strips could have been more effective in warning construction workers of oncoming trucks if placed in the haul/buffer lane within the work zone. Notwithstanding, the rumble strips inability to maintain proper positioning made them an unsuitable enhancement measure for this Freeway project.

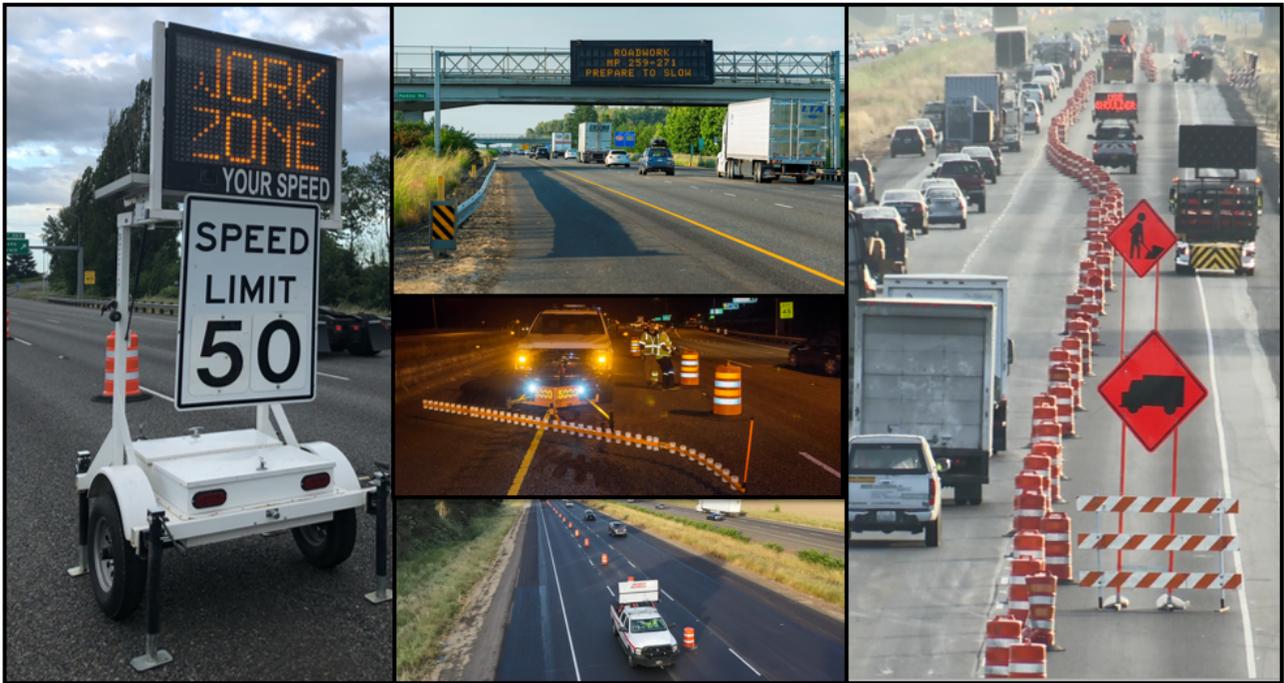
was used to help motorists recognize and use the outside lane. In figure 6, (right photo) an IR unit displays “USE SHOULDER” to help motorists make the lane shift. We began placing additional messages as part of the Smart work zone informing motorists that there were “2 lanes in use”. The lack of use of the outside lane resulted in increased queues. Temporary pavement markings (stick & stomps) were used to help delineate the shoulder, but several vehicles with driver assisted lane guidance systems had issues detecting and maintaining their lane. Ultimately, we outlined edge of pavement with cones for delineation which helped.

Figure 6. Beginning from left moving Clockwise: (Left) Portable Radar Speed Trailer, (Top) Overhead Variable Sign Message board, (Right) IR unit with PCMS assist with shoulder lane shift, and (bottom) IR unit with PCMS. In the middle is the contractor's Traffic Control work truck with a front mounted barrel mover.

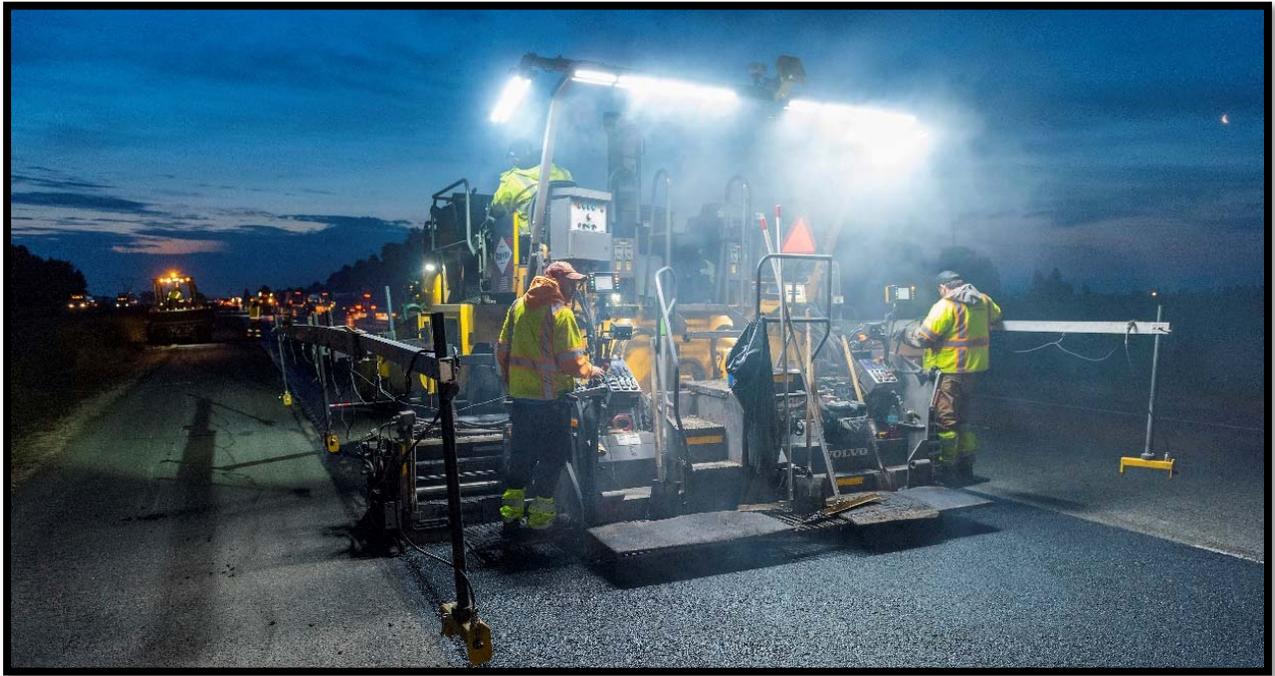
Figure 7. Paver outfitted with flashing Blue strobes above work lights (hard to see).

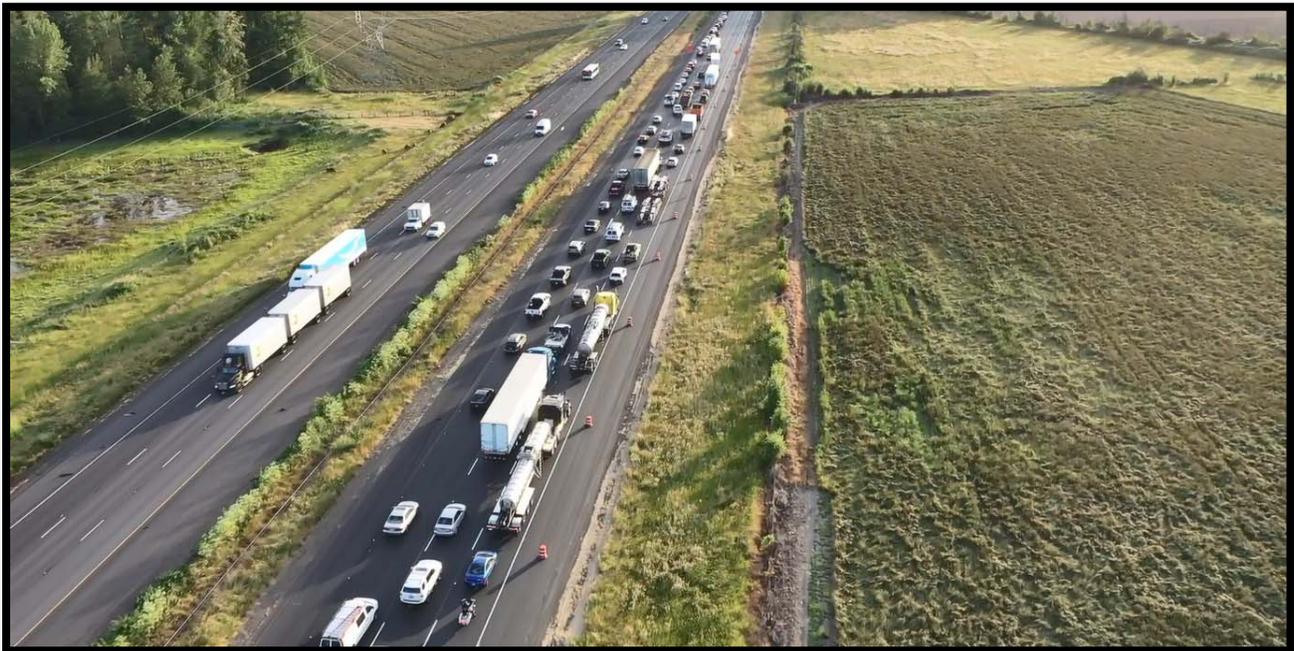
The extended closure time was expected to maintain a maximum 30 minute delay threshold for motorists traveling through the work zone. The peak evening traffic delays were generally within the threshold, though there were some days with motorists experiencing more significant delay. The morning commute was very challenging. Delays ranged from 10 to 50 minutes on average. Queues were very significant. In some instances 4 to 7 miles long. The delays were compounded when incidents or accidents occurred within the queue. The biggest help to this project was the use of a **Dedicated Incident Response Unit**. Although worker safety was important, we know that public safety is equally important. This project by large was an “incident management project”. Our ability to get the work done was in part due to how well we could keep incidents from occurring so as not to create further delays.

Figure 8. Lengthy queues during peak travel periods.

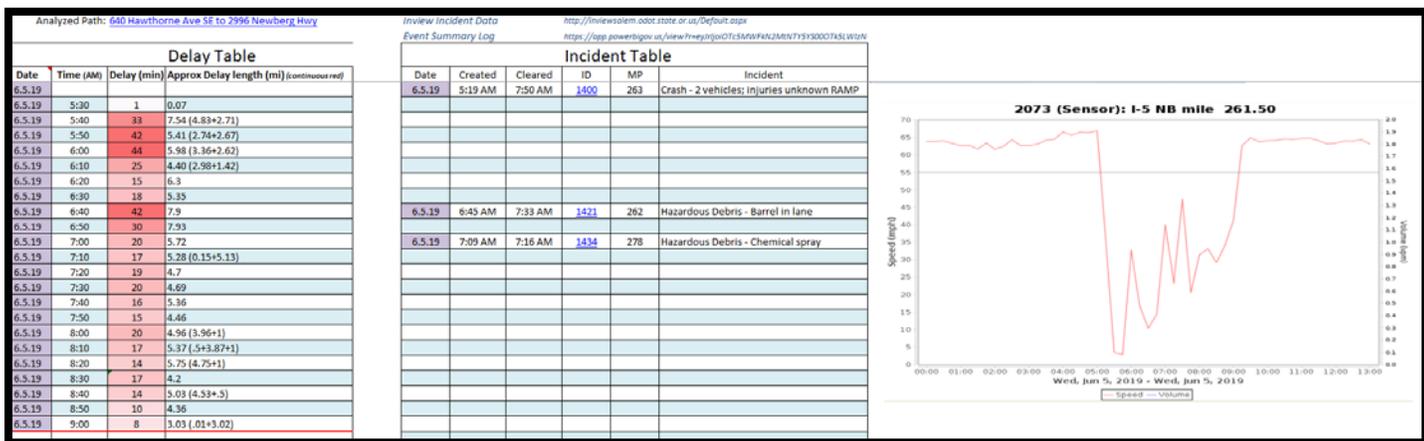
**Table 1. Morning work zone travel data collected on 06-05-2019**

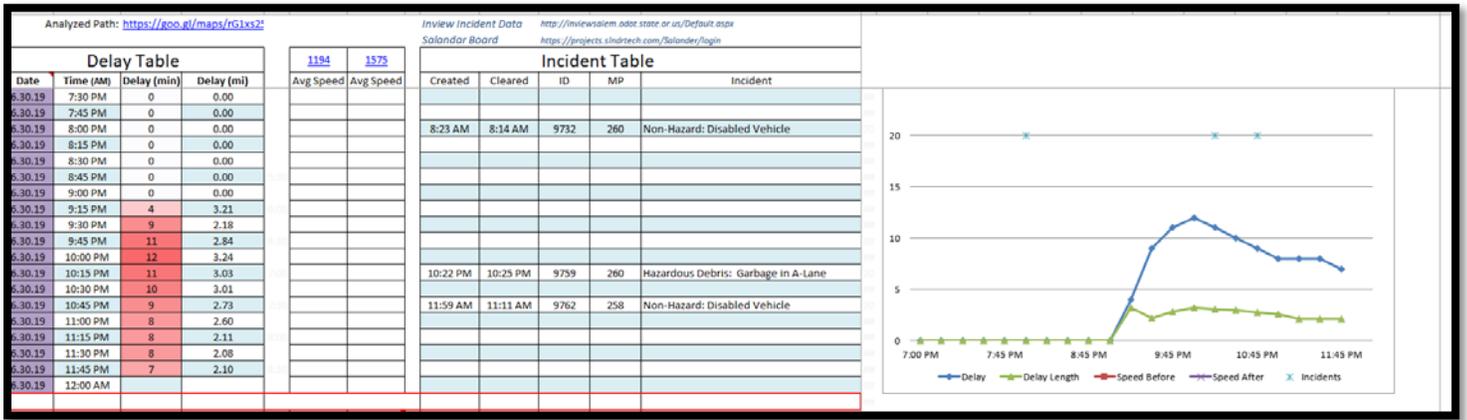
Table 6. Evening peak work zone travel data collected on 06-30-2019

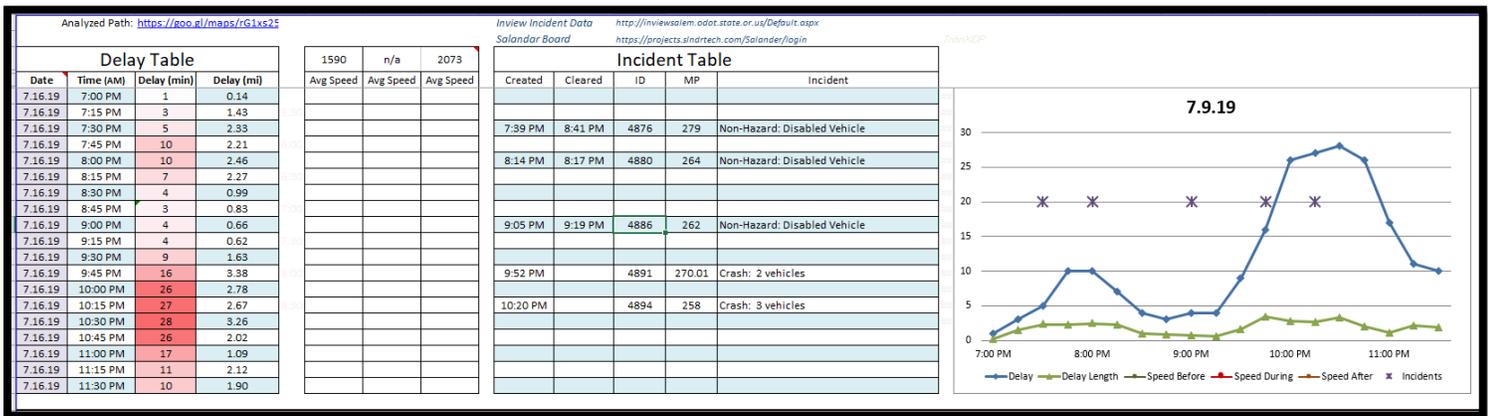
Table 7. Evening peak work zone travel data collected on 07-16-2019

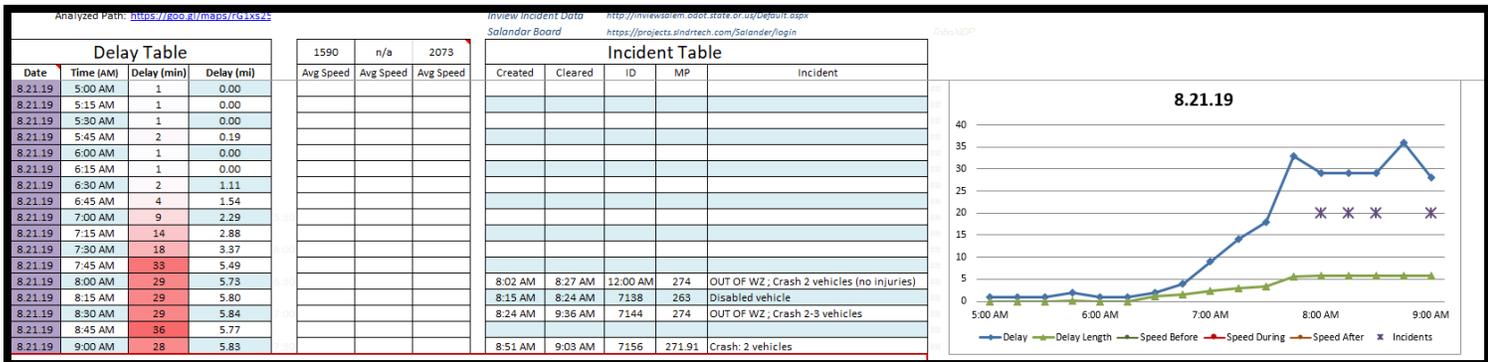
Table 8. Morning peak work zone travel data collected on 08-21-2019
