OREGON DEPARTMENT OF TRANSPORTATION

# OREGON SMART MOBILITY NETWORK EVALUATION

SEPTEMBER 2025

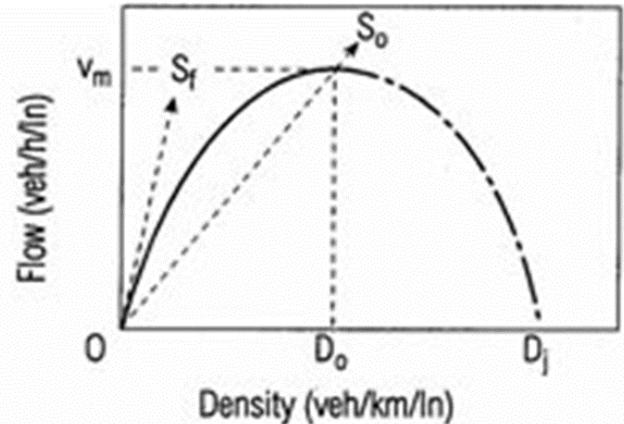
**FIGURE 2.2: GENERALIZED RELATIONSHIP BETWEEN FLOW AND DENSITY ON UNINTERRUPTED FLOW FACILITIES**

To determine if the segment is accommodating more vehicles at the same service level, DKS compared the relationship between volumes and densities in the before and *after* conditions, showing a generalized relationship between flow (volume) and density on freeways.

Theoretically, data points of volume-density values for a specific facility would fall on a curve similar to Figure 2.2. When comparing the volume-density relationships from the *before* and *after* conditions, the data points would form two different curves representing the *before* and *after* conditions, respectively. Increased volumes at the same density level would indicate that more vehicles were being accommodated at the same service level. That is, if the volumes in the *after* conditions were higher than the *before* conditions, relative to the same density values, the findings indicate that the vehicles are being accommodated at the same service level.

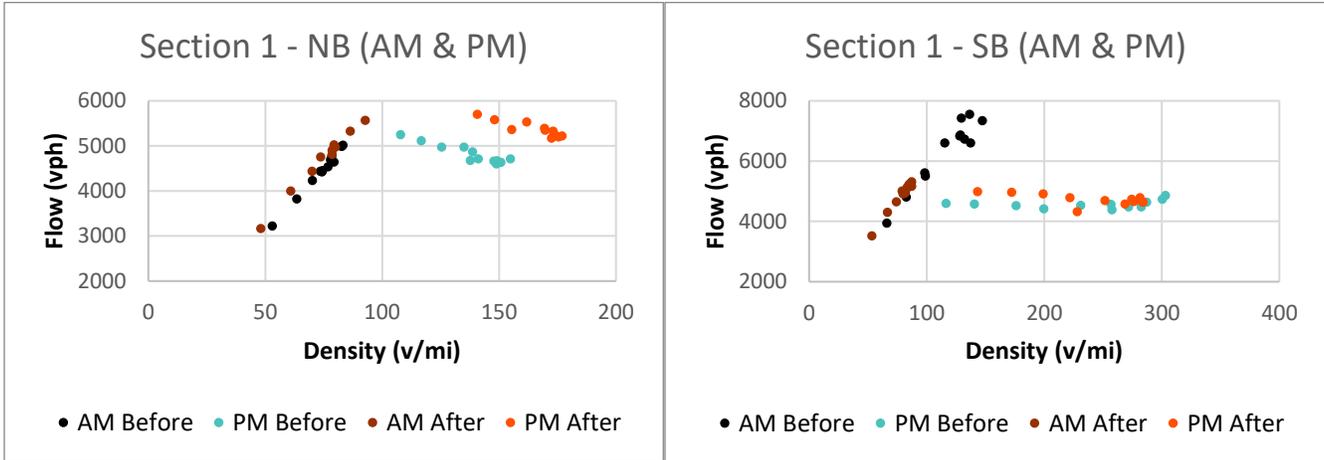
**FIGURE 2.3: SECTION 1 FLOW AND DENSITY SCATTER PLOT**

In Section 1, the data showed higher volumes in the *after* conditions relative to densities, for both directions, and in both the a.m. and p.m. peak periods. In the southbound direction, the a.m. peak period volumes were lower in the *after* condition. When the flow exceeds 6,000 vph, densities cannot be compared due to having no data in the *after* condition. At data points where comparable densities exist in the a.m. peak period (between 50-100 v/mi), volumes were higher in the *after* conditions.

Therefore, the results indicate that both directions of Section 1 were able to accommodate more vehicles at the same service level in the *after* conditions.

The scatter plots include discrete data points that would reflect the facility’s flow-density relationship, similar to what is shown in Figure 2.3. The scatter plots show that volumes are generally higher in the *after* condition relative to the density level.

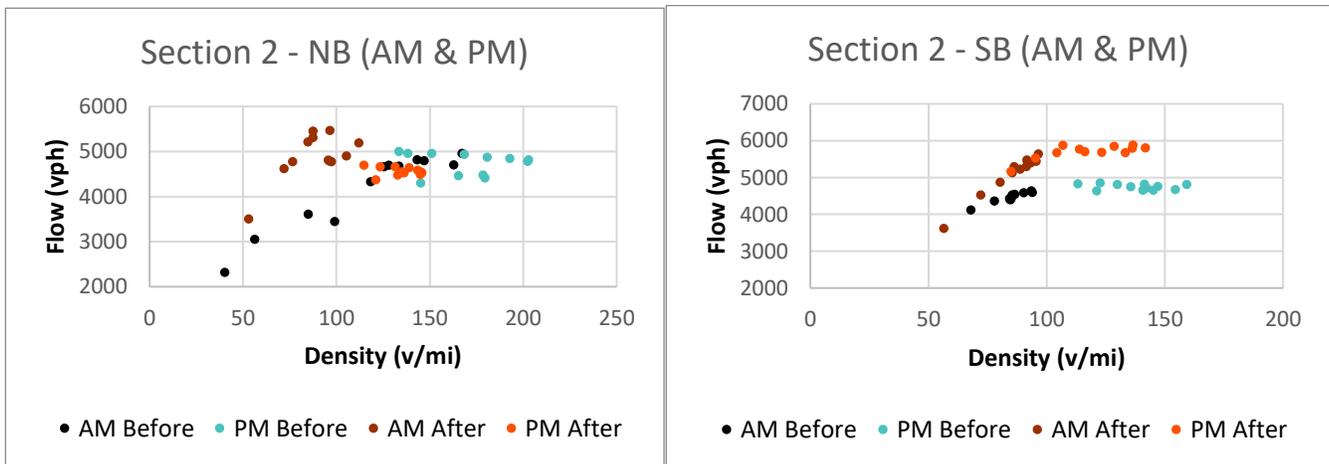
**FIGURE 2.4: SECTION 2 FLOW AND DENSITY SCATTER PLOT**

In Section 2, the northbound direction also showed higher volumes in the *after* conditions, relative to densities, for the a.m. peak period. However, no significant increase in volumes was shown for the p.m. peak period.

The southbound direction clearly showed higher volumes in the *after* conditions, relative to densities, in both the a.m. and p.m. peak periods.

Overall, the data showed that both directions of Section 2 were able to accommodate more vehicles at the same service level in the *after* period.

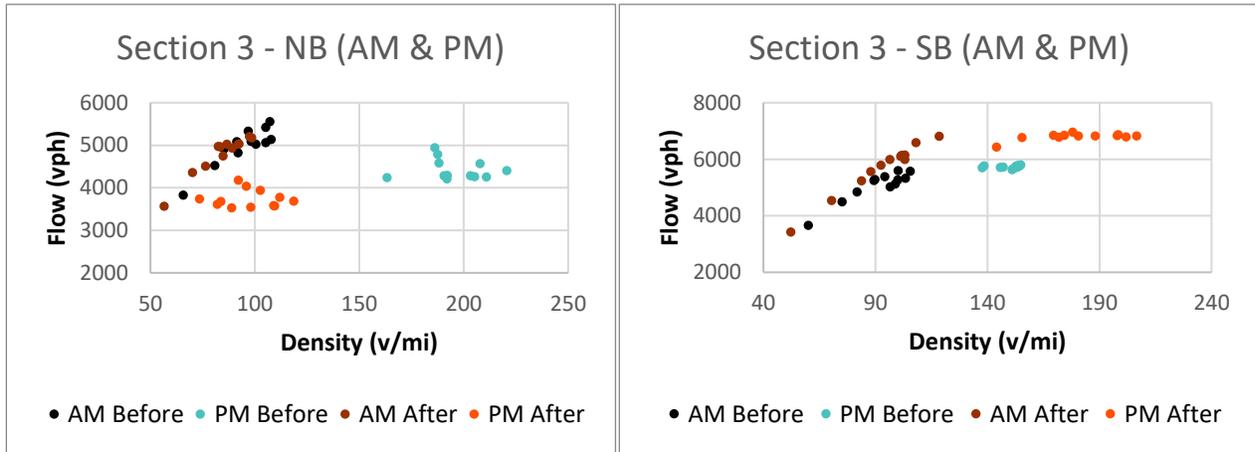
**FIGURE 2.5: SECTION 3 FLOW AND DENSITY SCATTER PLOT**

In Section 3, similar volumes were accommodated in the *after* conditions in the northbound a.m. peak period at similar densities. The northbound p.m. peak period had lower volumes at lower densities in the *after* conditions. Due to the different density ranges for the p.m. periods, it was inconclusive whether the northbound direction was able to accommodate more vehicles at the *same* service level.

The southbound direction accommodated higher volumes at similar density levels in the *after* conditions in both the a.m. and p.m. peak periods.

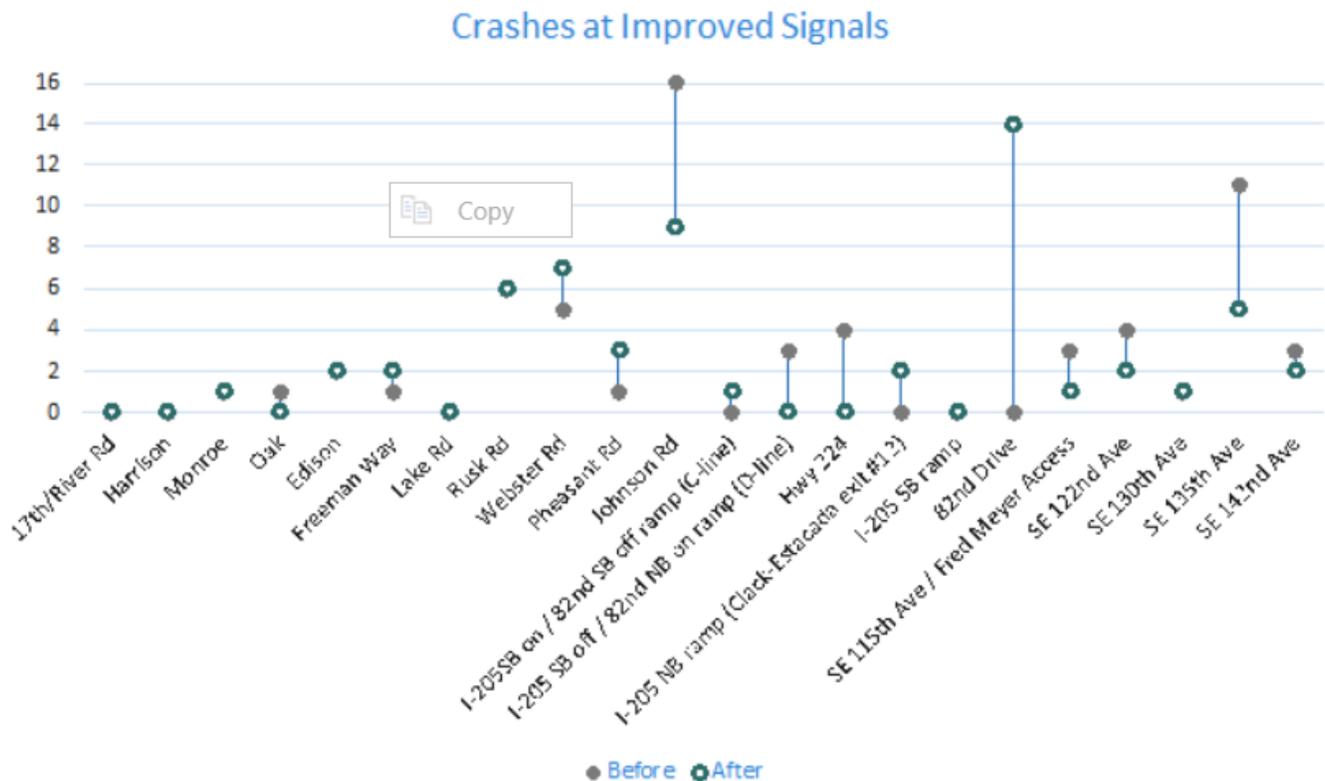
**FIGURE 3.1: CRASHES AT SIGNALIZED INTERSECTIONS BEFORE AND AFTER**

In the *before* period, Johnson Road had the greatest number of crashes, with 16. In the *after* period, 82<sup>nd</sup> Drive had the greatest number of crashes.

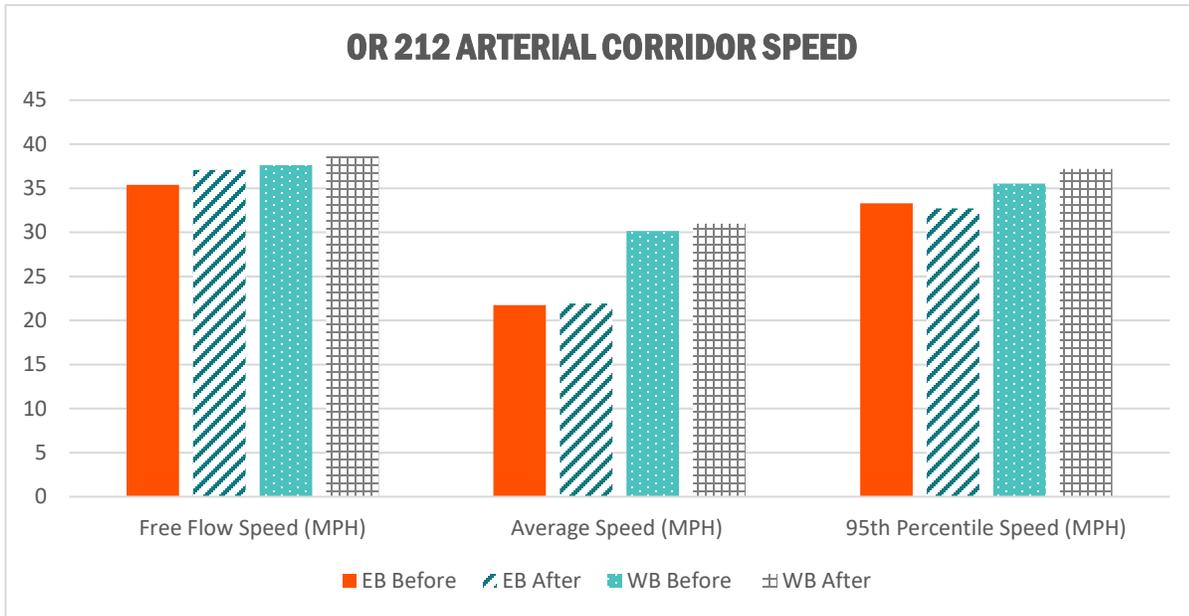
FIGURE 3.2: OR 212 ARTERIAL CORRIDOR SPEED

Figure 3.2 and Figure 3.3 show the changes in speeds and travel times, respectively. These are the same values as Table 3.10 but shown as a histogram for comparison of the relative differences.

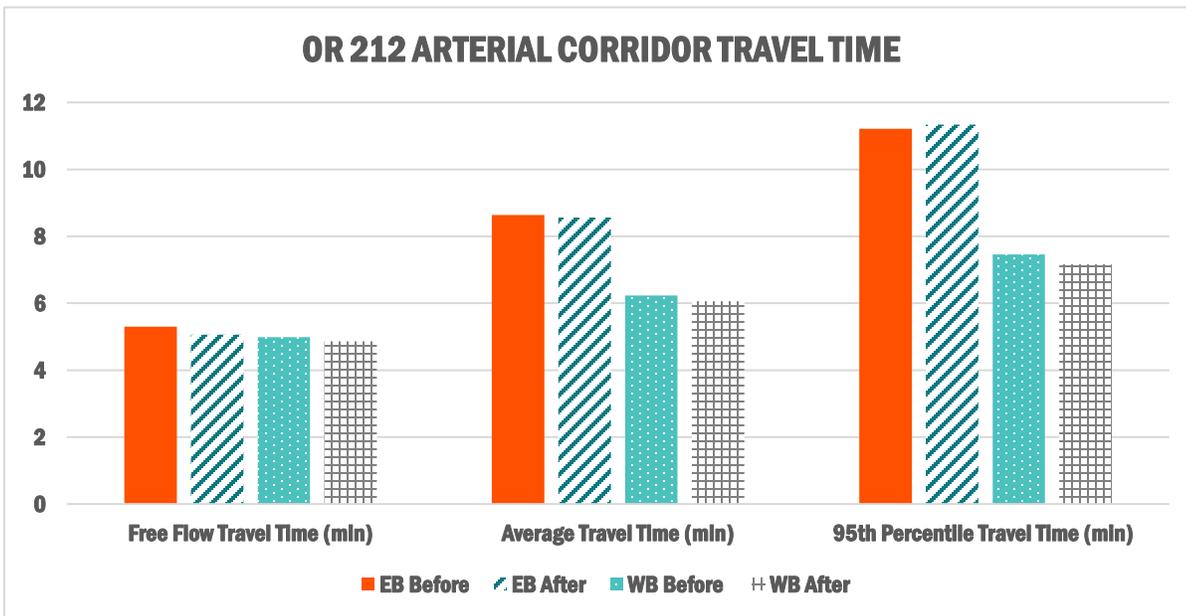
FIGURE 3.3: OR 212 ARTERIAL CORRIDOR TRAVEL TIME

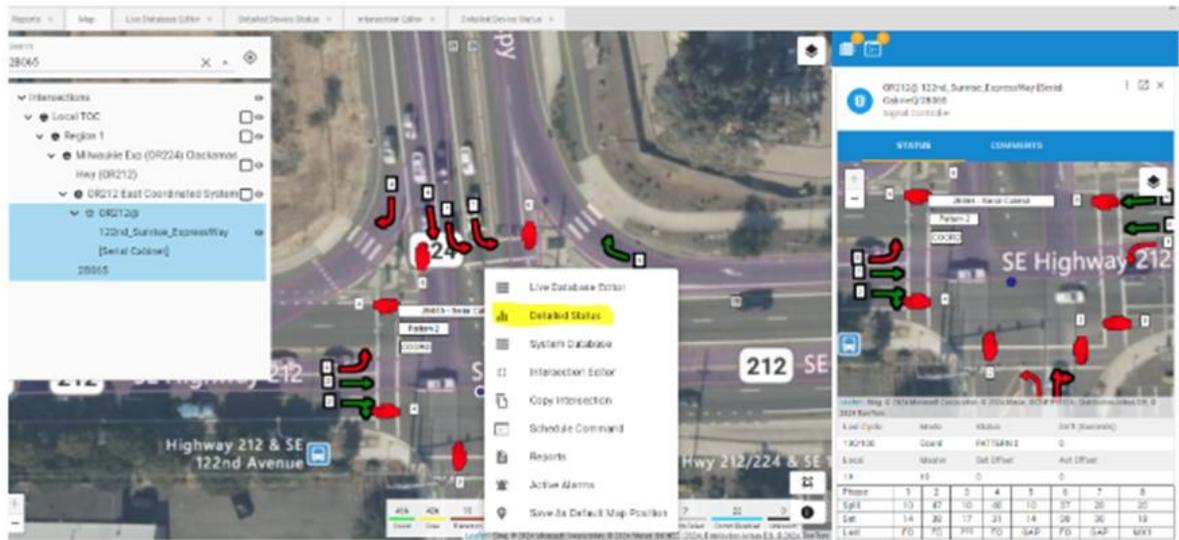
FIGURE 3.6: EXAMPLE KINETICS SCREEN

The staff looked at the detector tools, including looking for alarms. They began troubleshooting to determine if the problem was detector-based or operational. They might ask signal maintenance staff to replace cables or reset detectors.

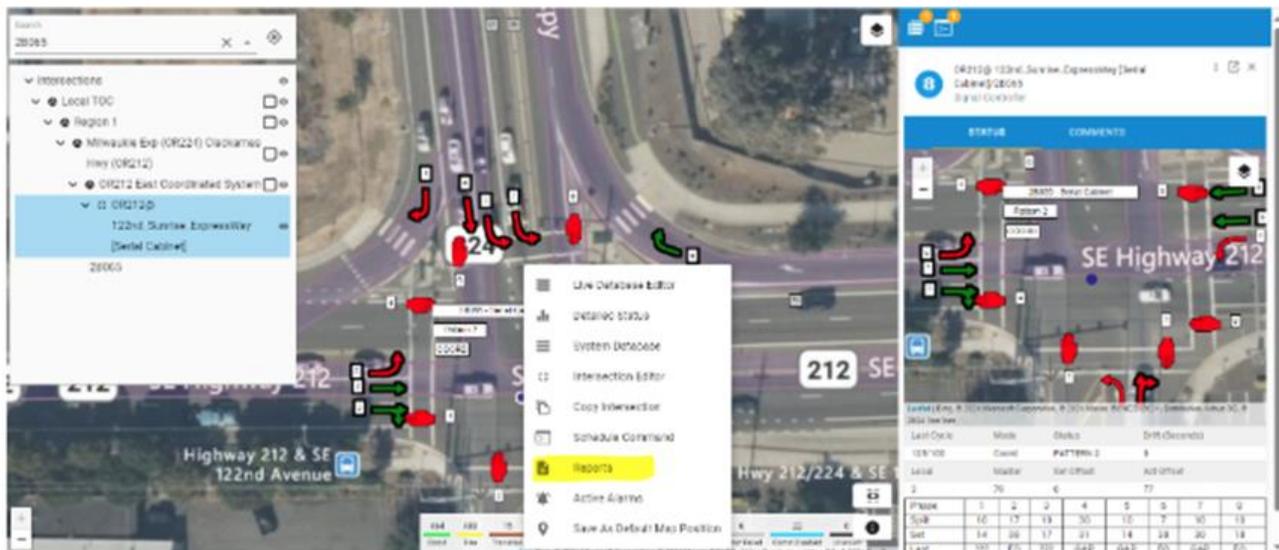
The screen shot in Figure 3.8 shows a report that signal operations staff could use to begin troubleshooting whether the problem was operational or detector-based. For instance, if a signal was maxing out, it could be either detector or heavy traffic on a particular phase of the intersection. If the signal was gapping out on the mainline, it could be a detector, based on the time of day. During peak periods, the signal was unlikely to gap out on the mainline. If there were many force offs, signal timing may needed to be adjusted.

FIGURE 3.8: ATSPM REPORT SCREEN

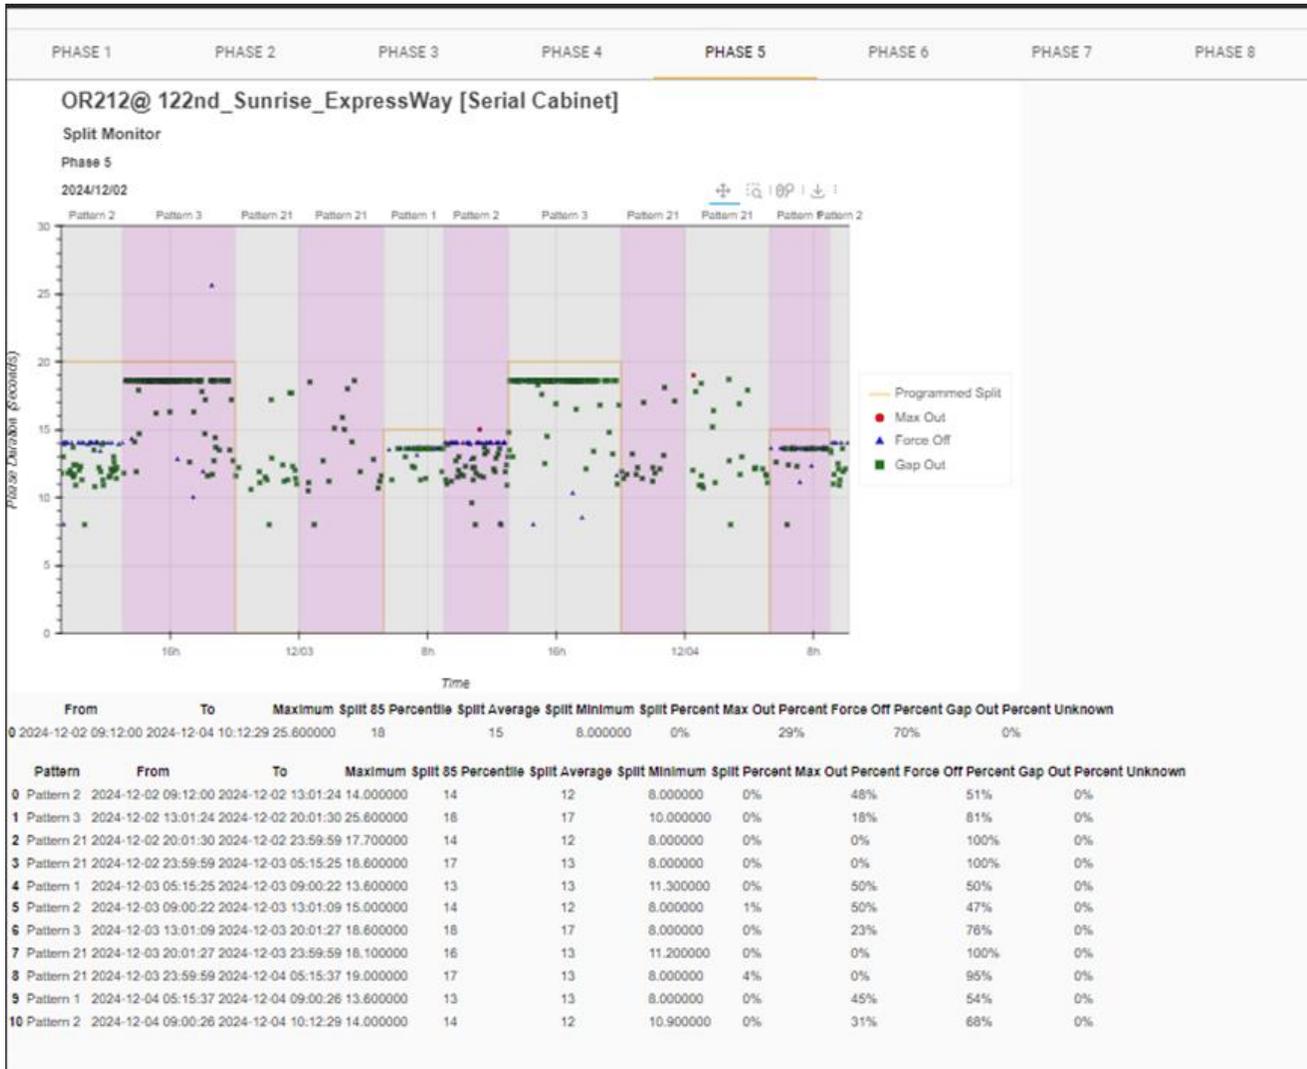
Figure 3.9 below shows the phase termination data of specific phases at a given signal. This helped operation staff determine whether the signal was operating as expected, if there was a timing issue or if there were potential detector issues. As an example, Pattern 1 was gapping out for the side street (Phase 5). If the side street was consistently maxing out, it may have meant a detector was stuck on.

FIGURE 3.9: PHASE TERMINATION

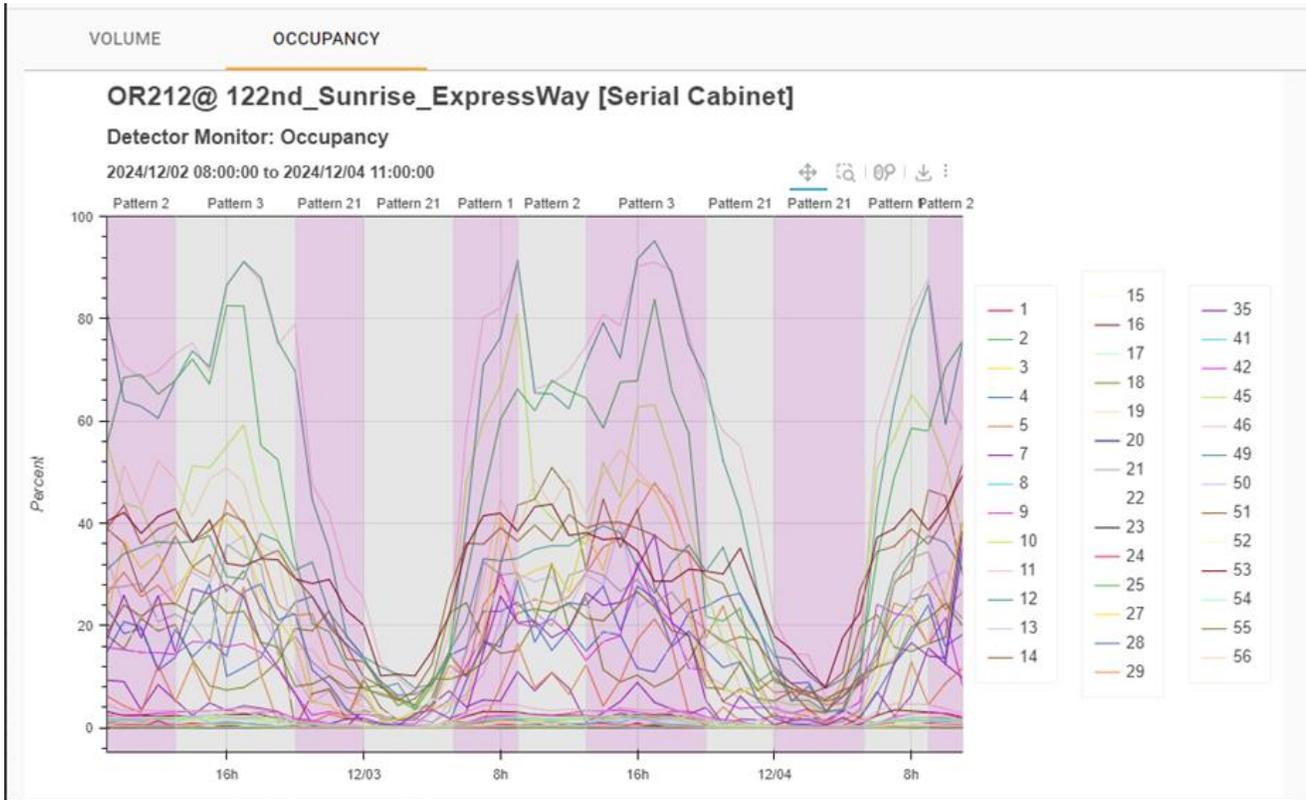
Figure 3.10 shows the occupancy of detectors. Signal operations staff would use this in combination with cabinet prints to look for anomalies in detector occupancy. For example, low levels of occupancy on a mainline detector would be indicative of a problem. Similarly high levels of occupancy on a side street approach at times of low traffic could be indicative of a problem as well. Anomalies could be identified by looking at the time of day and expected traffic on an approach. Individual lanes or approaches could be evaluated by selecting only the detectors from the desired approach or lane.

FIGURE 3.10: DETECTOR OCCUPANCY

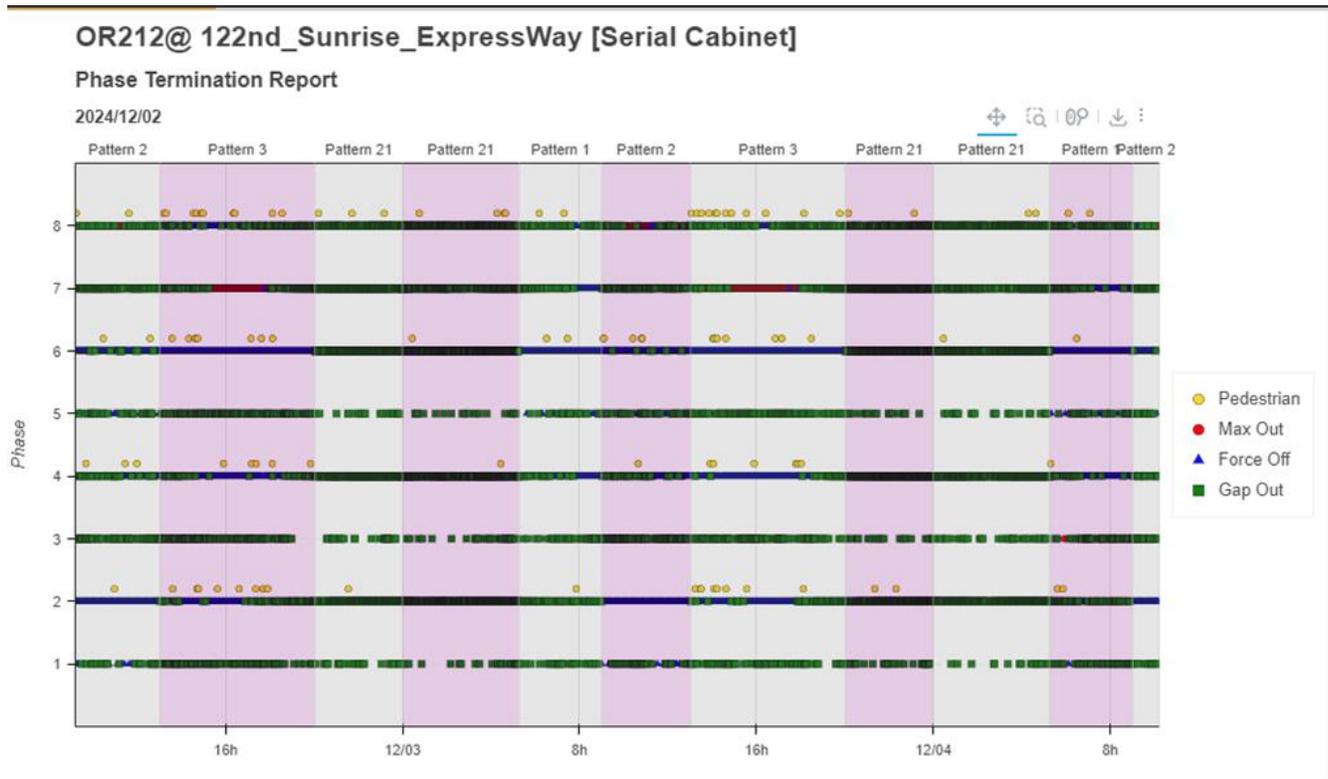
Figure 3.12 and Figure 3.13 show more detailed phase termination data. Again, this could be used to look at specific phase and time of day to determine if there were anomalies in the data and whether those anomalies might have been detection based or operational. For instance, if the phase was always terminated by a pedestrian in suburban area, that could indicate that the pedestrian push button had failed and had failed “On.” Likewise, Max Outs at low volume periods could indicate that a vehicle detector was stuck on.

**FIGURE 3.12: PHASE TERMINATION REPORT**

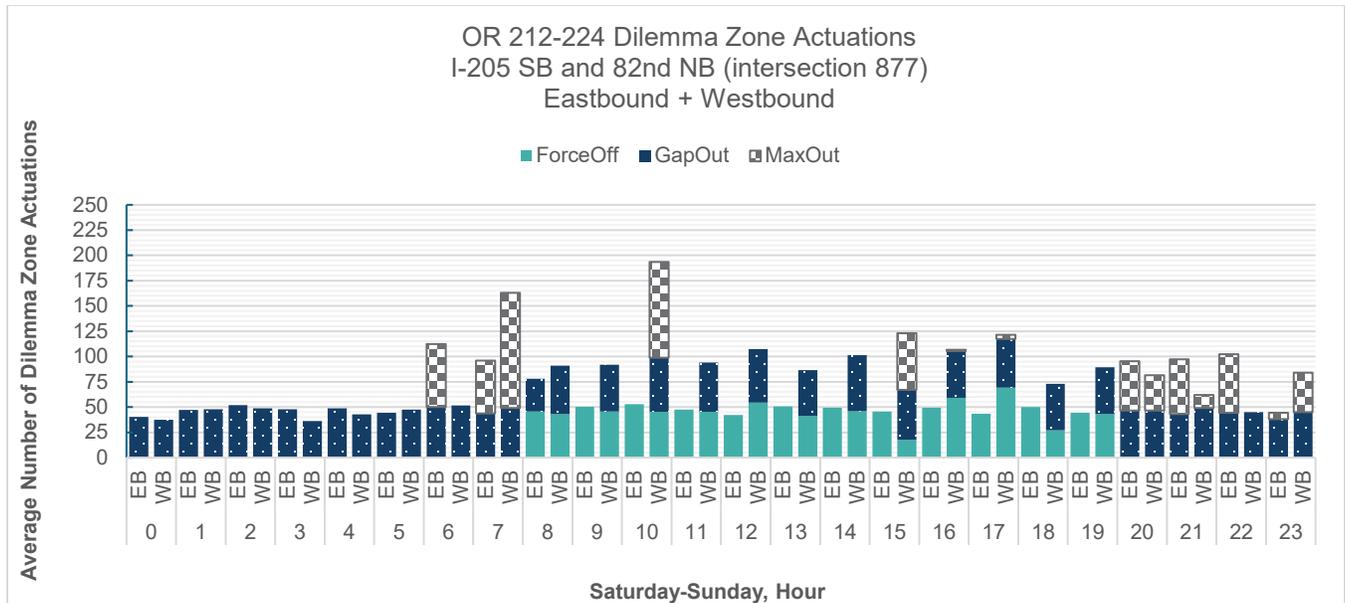
shown in Figure 3.15 below at the intersection of 82<sup>nd</sup> Drive and OR 224, where an Interstate 205 on ramp begins.

**FIGURE 3.15: WEEKENED DILEMMA ZONE ACTIVATIONS ALONG OR 212/224 AND 82ND DR**

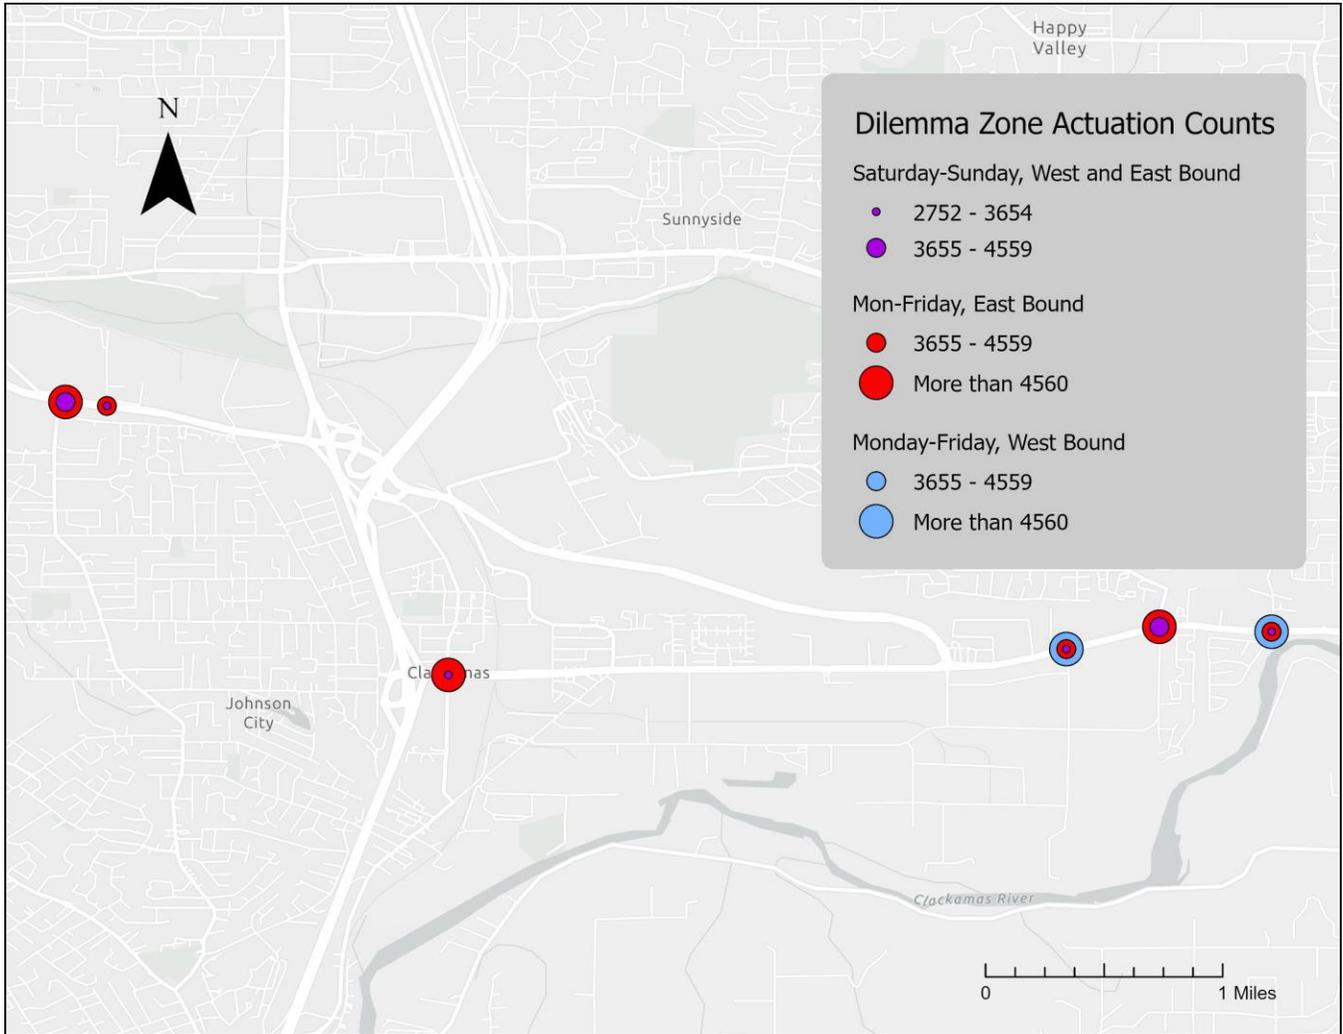
Even with both west and east bound directions combined during the weekend periods (seen in purple), the number of dilemma zone actuations was far lower than during Monday through Friday in either direction for any of the five intersections studied. Counts were comparable during weekdays for both directions with the exception of SE 130<sup>th</sup> Avenue and SE 142<sup>nd</sup> Avenue, where there were fewer dilemma zone actuations for east bound travel lanes.

FIGURE 3.16: TOTAL NUMBER OF ACTUATIONS PER WEEKDAY AND WEEKDAY, BY DIRECTION OF TRAVEL

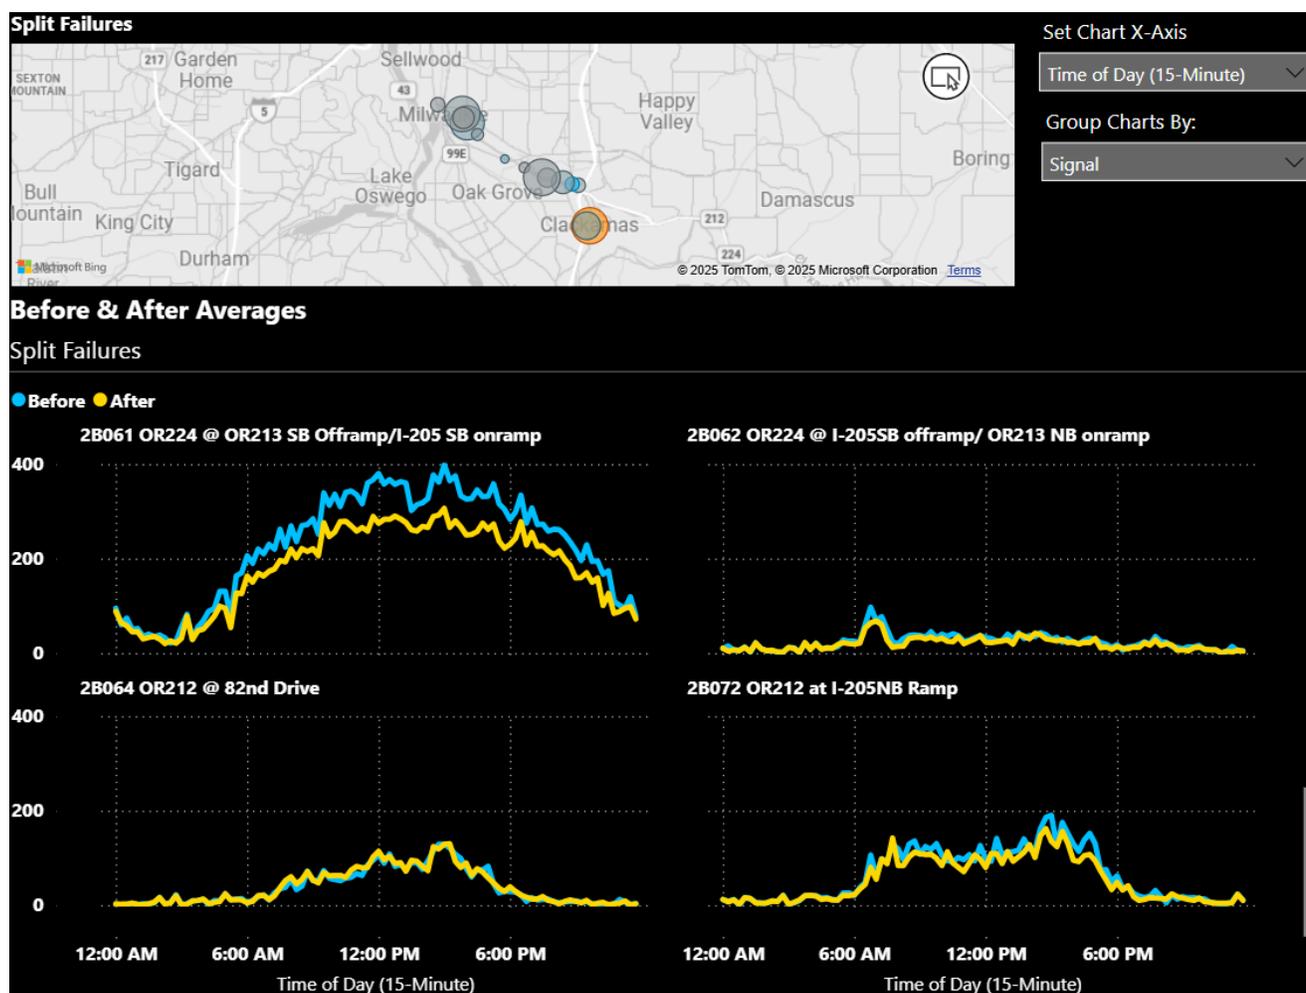
Figure 3.17 shows an example of a Power BI report used by ODOT for ATSPMs. The example shows split failures at a specific traffic signal.

**FIGURE 3.17: POWER BI REPORT**

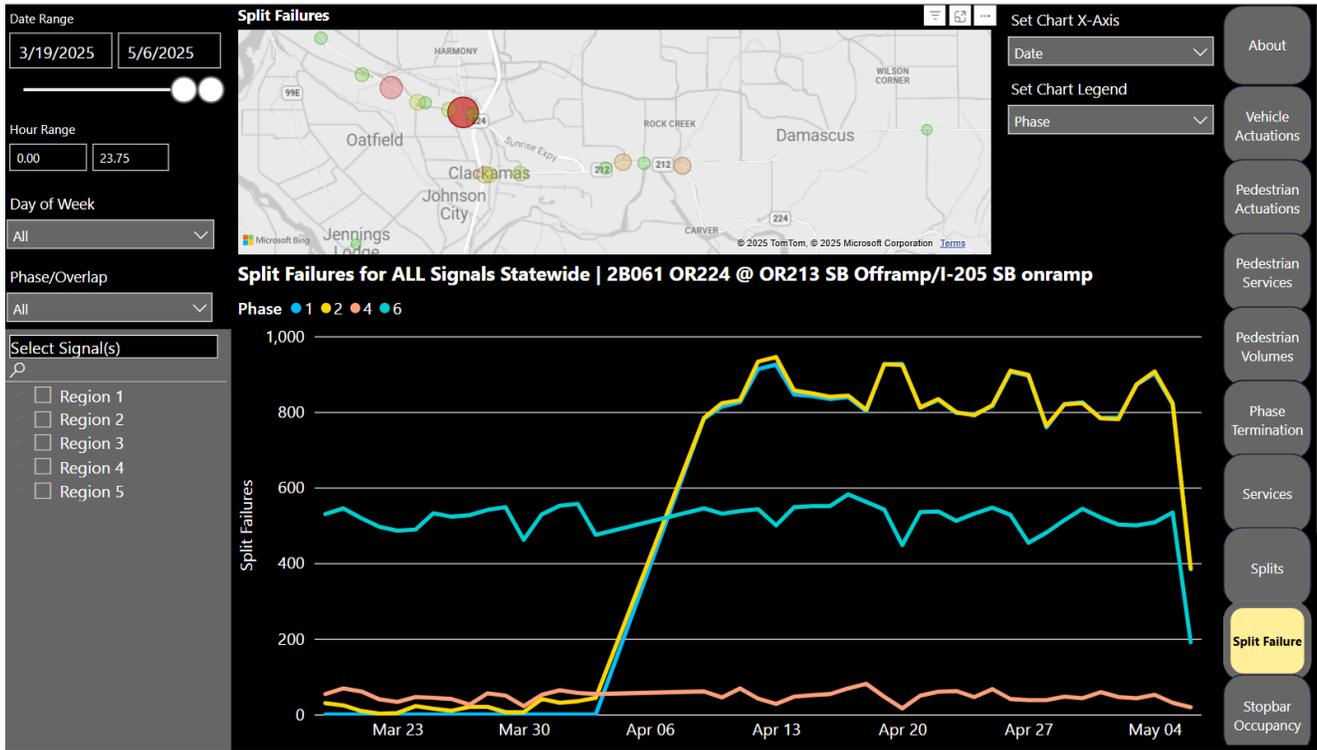
Additionally, Figure 3.18 provides a clear visualization of typical split failure. There was a significant spike in split failures between March 27 and April 6, most prominently in Phase 1 and 2, followed by sustained high levels through late April. This abrupt increase suggested a potential operational issue which could have caused an excessive number of max outs, preventing proper phase termination.

**FIGURE 3.18: POWER BI SPLIT FAILURE**

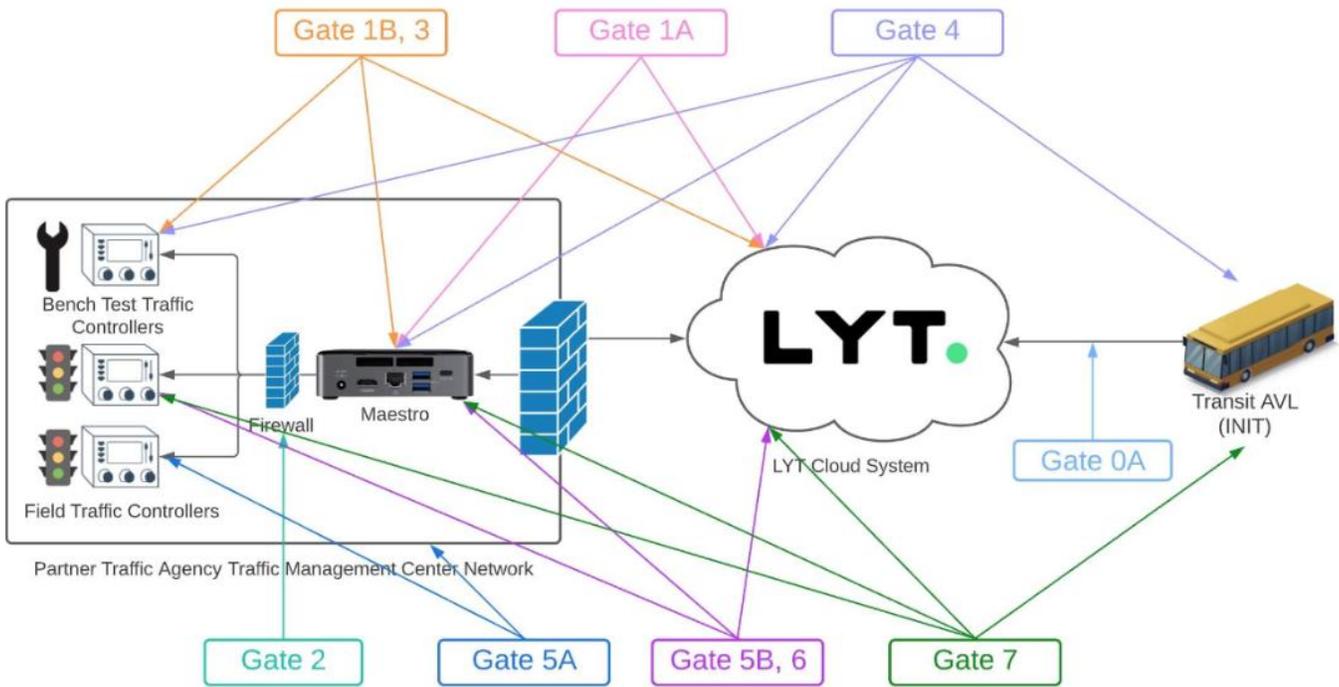
- **Gate 7 – Full System Test:** Verified ability of traffic agency field controller(s) to correctly process and receive multiple TSP requests/ETA updates from deployed TriMet buses with differing levels of priority.

**FIGURE 5.1: TRIMET CLOUD-BASED TSP MULTI-GATE TESTING PROCESS<sup>11</sup>**

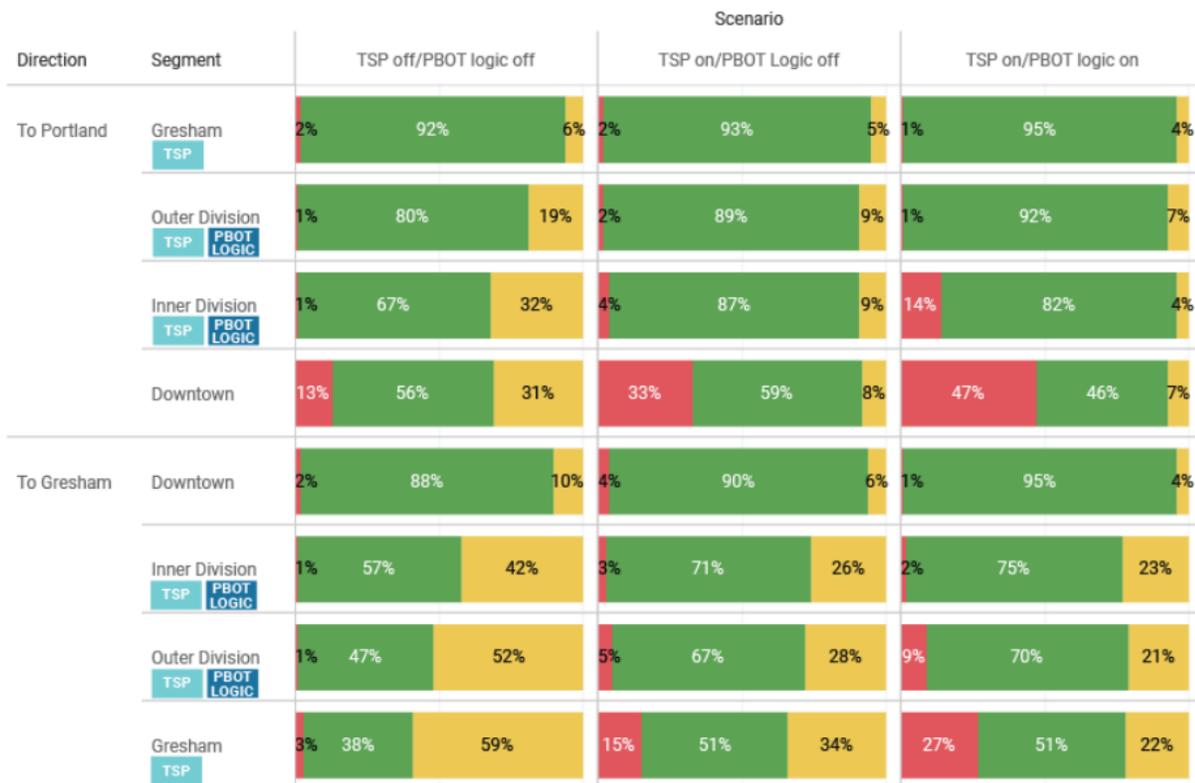
The percentage of early arrivals increased with TSP and PBOT logic. The largest increases occurred in the Downtown segment to Portland (from 13 percent of buses to 47 percent) and the Gresham segment to Gresham (from three percent of buses to 27 percent). The percentage of late arrivals decreased in all segments with TSP and PBOT logic. The largest decrease on the percentage of late arrivals was from 59 percent of buses to 22 percent in the Gresham segment to Gresham.

FIGURE 5.3: BUS ON-TIME PERFORMANCE

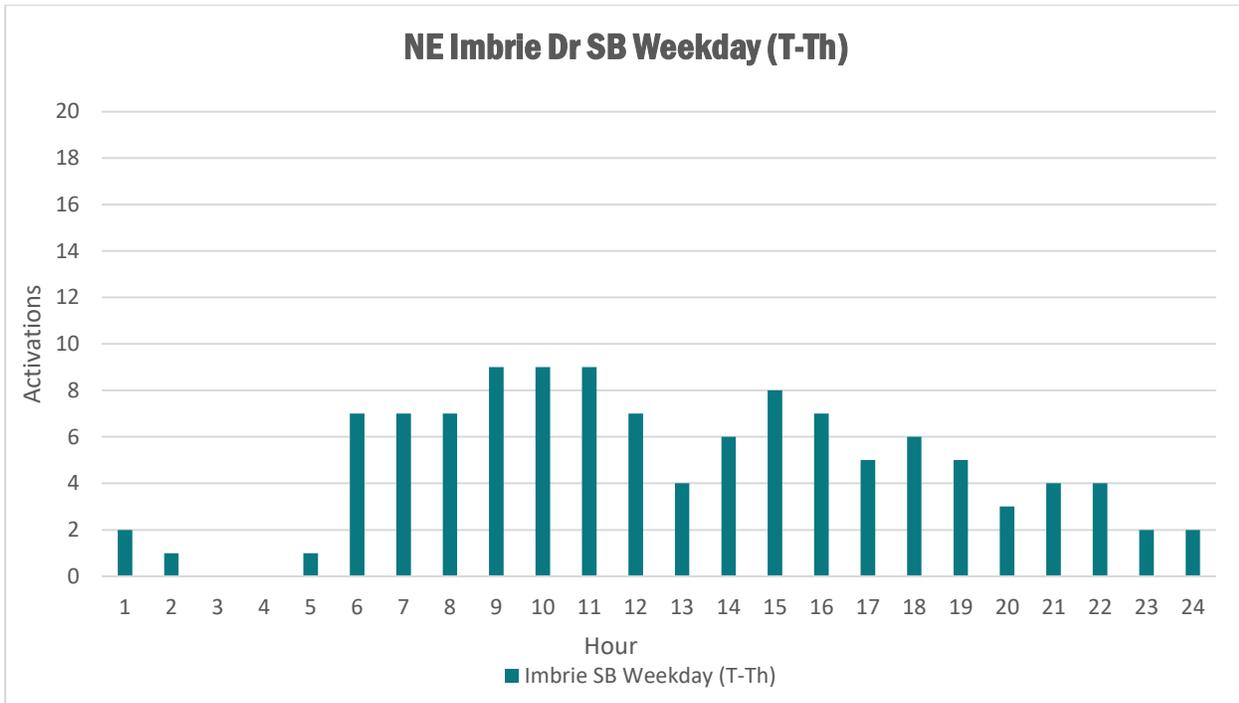
NE Imbrie Drive saw more RCEs in the southbound direction than other movements at the intersection, particularly during the weekday morning peak. Weekend activity was lower, indicating possible commuter-related traffic patterns or a relationship between higher traffic volumes in the peak period with increased RCE. The southbound direction had random arrivals since this was the beginning of the coordinated section for the southbound direction. This may lead to more activations of the RCE than northbound. This was the end of the coordinated section for the northbound direction and most of the northbound arrivals were within the green band. Further investigation into volumes, speeds, and detector placement could clarify this directional trend.

**FIGURE 6.4: SOUTHBOUND RCE ACTIVATIONS AT NE IMBRIE DRIVE**

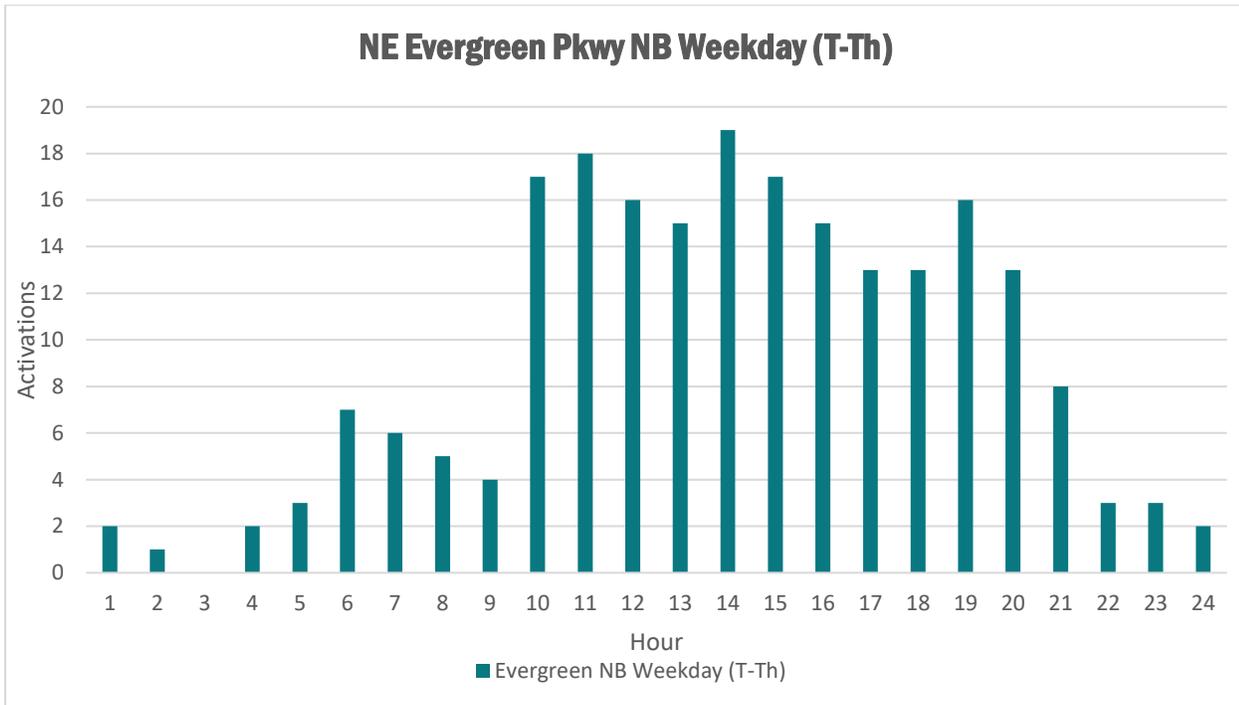
NE Evergreen Parkway showed a consistently higher number of RCEs than other signals along Cornelius Pass Road, especially in the northbound direction, with activity increasing during the midday and tapering into the night. Southbound RCEs were lower but steady throughout the day. This pattern was similar on both weekdays and weekends. Despite being a large, high-volume intersection (similar to Cornelius Pass Road & NE Cornell Road), NE Evergreen Parkway had significantly more RCEs, suggesting possible issues with driver behavior, detection setup, or signal operations. Additional data on 85th percentile speeds, vehicle types, crash history, and detector configuration would help explain the elevated RCEs. The intersection was very large and was in the middle of the corridor. Balancing progression in both the northbound and southbound directions may lead to an entire platoon not making it through the intersection, resulting in activation of the RCE. False calls, especially at night, may also be contributing factors.

**FIGURE 6.5: NORTHBOUND RCE ACTIVATIONS AT NE EVERGREEN PARKWAY**

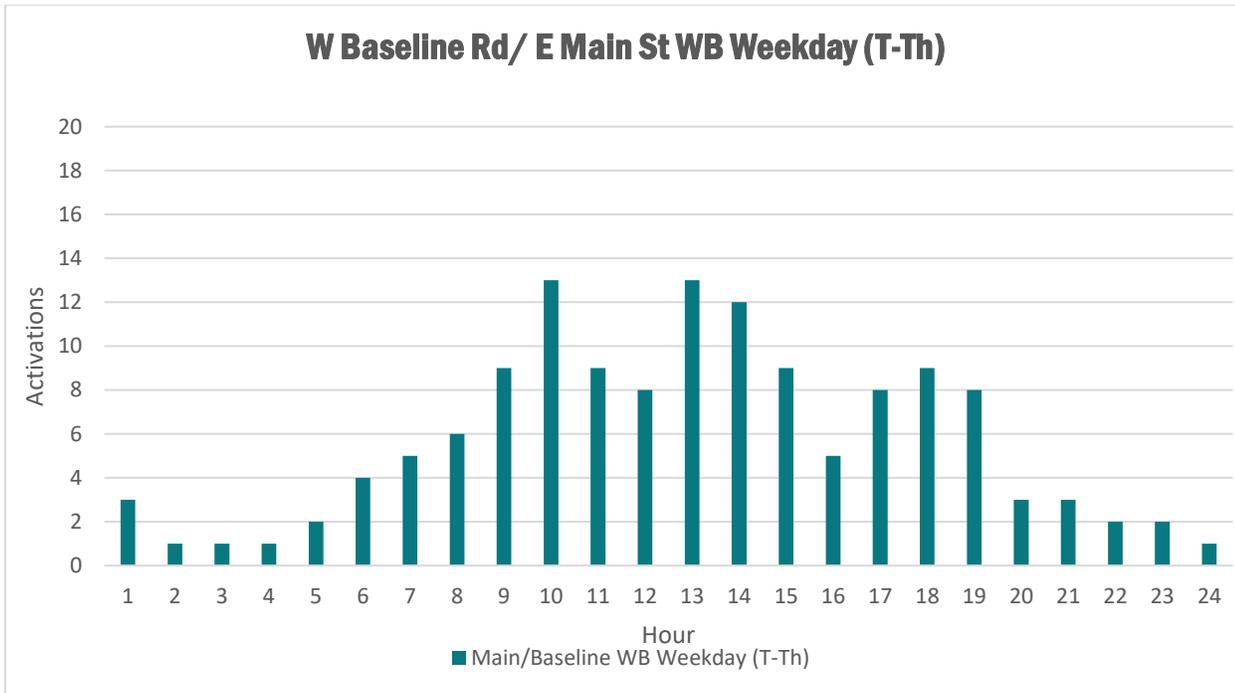
W Baseline Road experienced an increase in the number of RCEs as volumes increased throughout the morning. This could indicate high speeds, or detection issues. The westbound approach also showed higher numbers of RCEs during the midday, which suggested that review of traffic behavior, detection zones, and timing settings on that leg could determine the cause.

**FIGURE 6.6: WESTBOUND RCE ACTIVATIONS AT W BASELINE ROAD/E MAIN STREET**

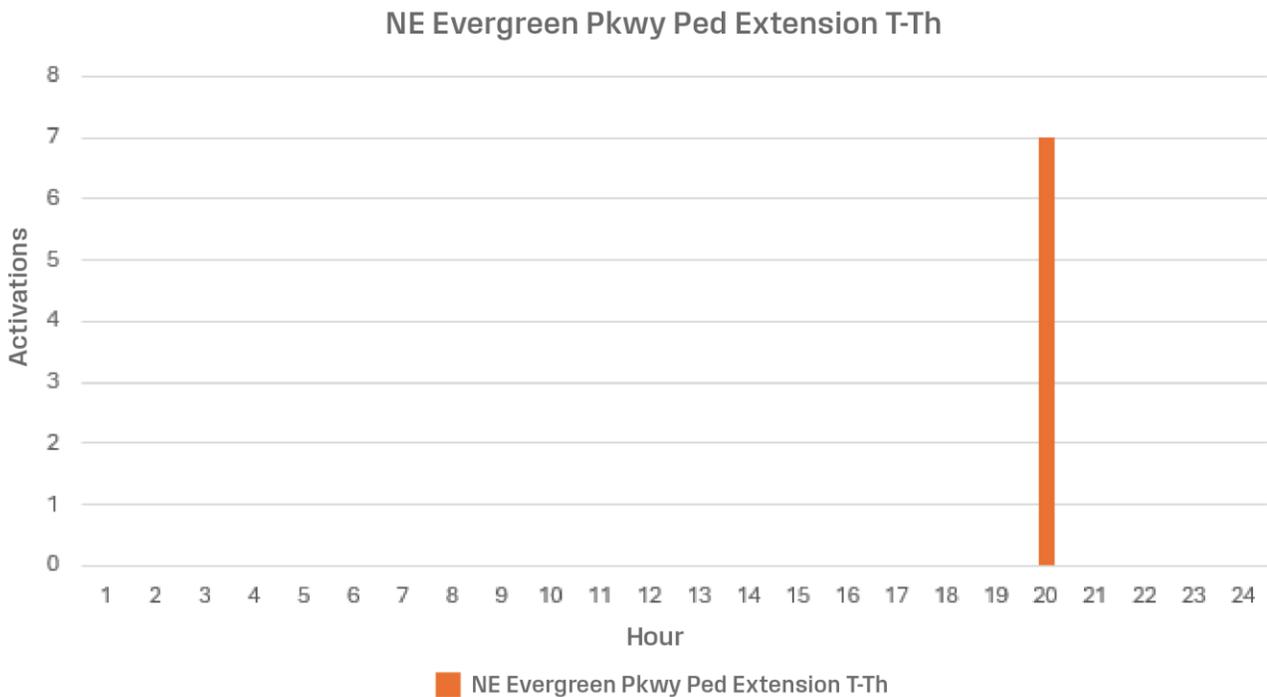
Staff at Washington County provided a week of pedestrian extension data at the intersections of Cornelius Pass Road and NE Evergreen Parkway and W Baseline Road/E Main Street for the week of March 31, 2025. On weekdays, extension was only required in the 8 p.m. hour. This may indicate the pedestrian extension zone was stuck on for a part of the hour. The extension would likely stick because of a sensor error. If the pedestrian sensor malfunctioned and stuck on, the pedestrian extension would come on every time the push button was activated. See Figure 6.7.

**FIGURE 6.7: CORNELIUS PASS ROAD AT NE EVERGREEN PARKWAY WEEKDAY PEDESTRIAN EXTENSIONS**
