OREGON DEPARTMENT OF TRANSPORTATION

# OREGON SMART MOBILITY NETWORK EVALUATION

SEPTEMBER 2025

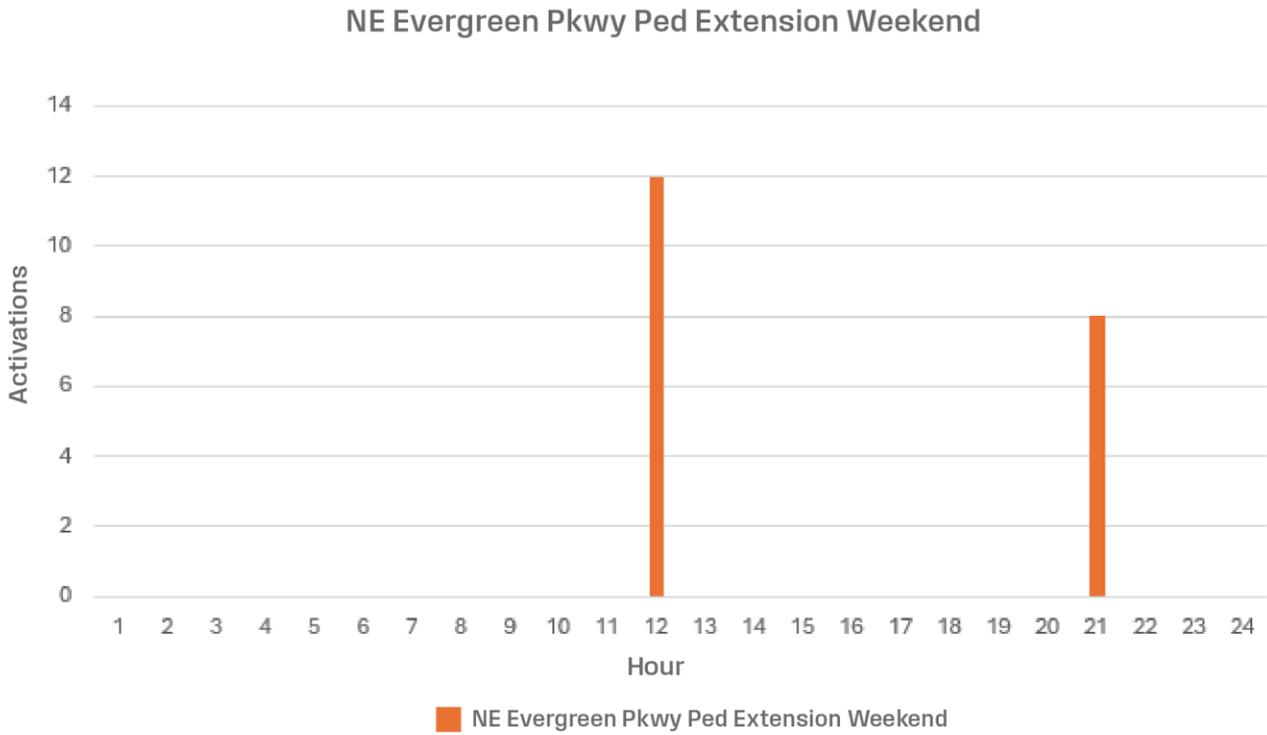
On the evaluation weekend there was more demand for pedestrian extension, but the calls were confined to the noon and 9 p.m. hours. Again, this may indicate an issue with the pedestrian extension zone being stuck on during these periods. See Figure 6.8.

**FIGURE 6.8: CORNELIUS PASS ROAD AT NE EVERGREEN PARKWAY WEEKEND PEDESTRIAN EXTENSIONS**

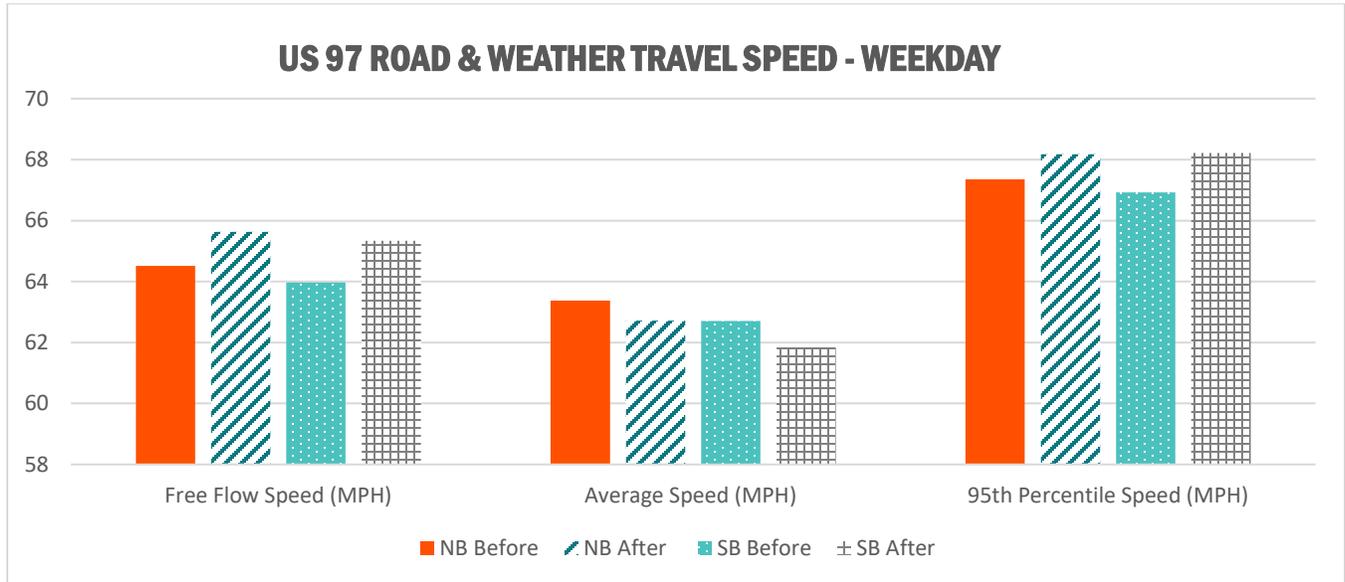
FIGURE 7.5: US 97 SPEED PERFORMANCE MEASURES FOR NB AND SB DIRECTIONS DURING WEEKDAY PEAK HOURS

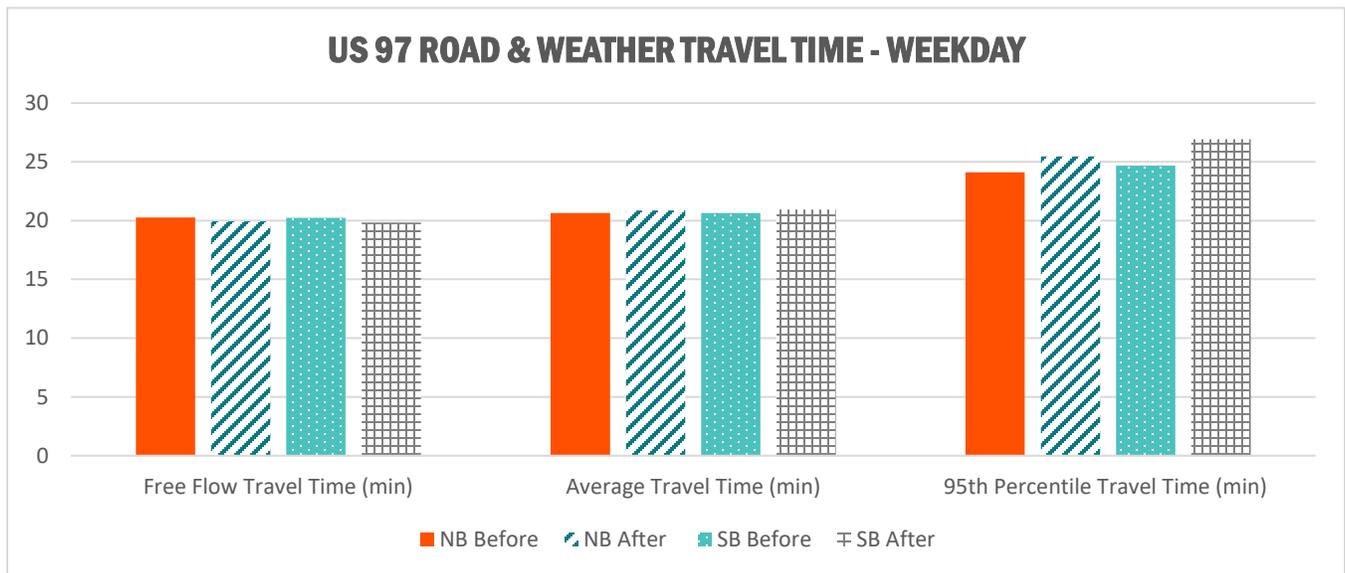
FIGURE 7.6: US 97 TRAVEL TIME PERFORMANCE MEASURES FOR NB AND SB DIRECTIONS DURING WEEKDAY PEAK HOURS

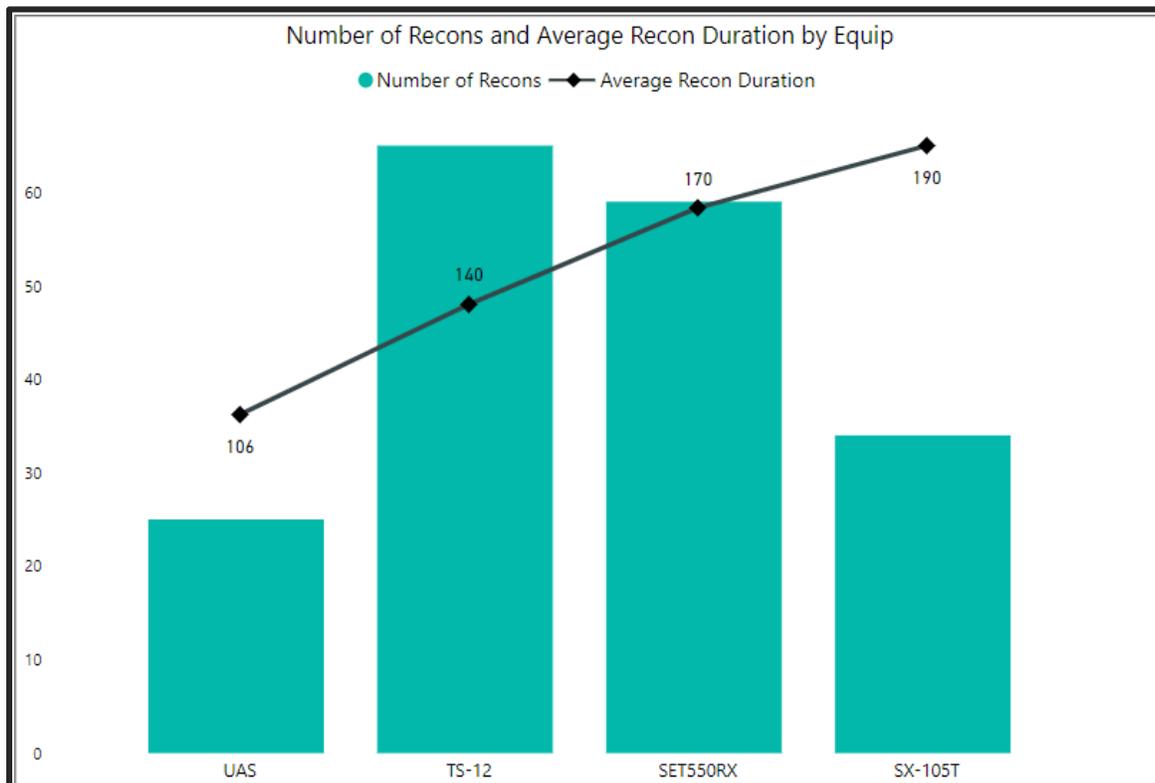
FIGURE 9.2: EQUIPMENT TYPE AND THEIR AVERAGE RECONSTRUCTION TIMES

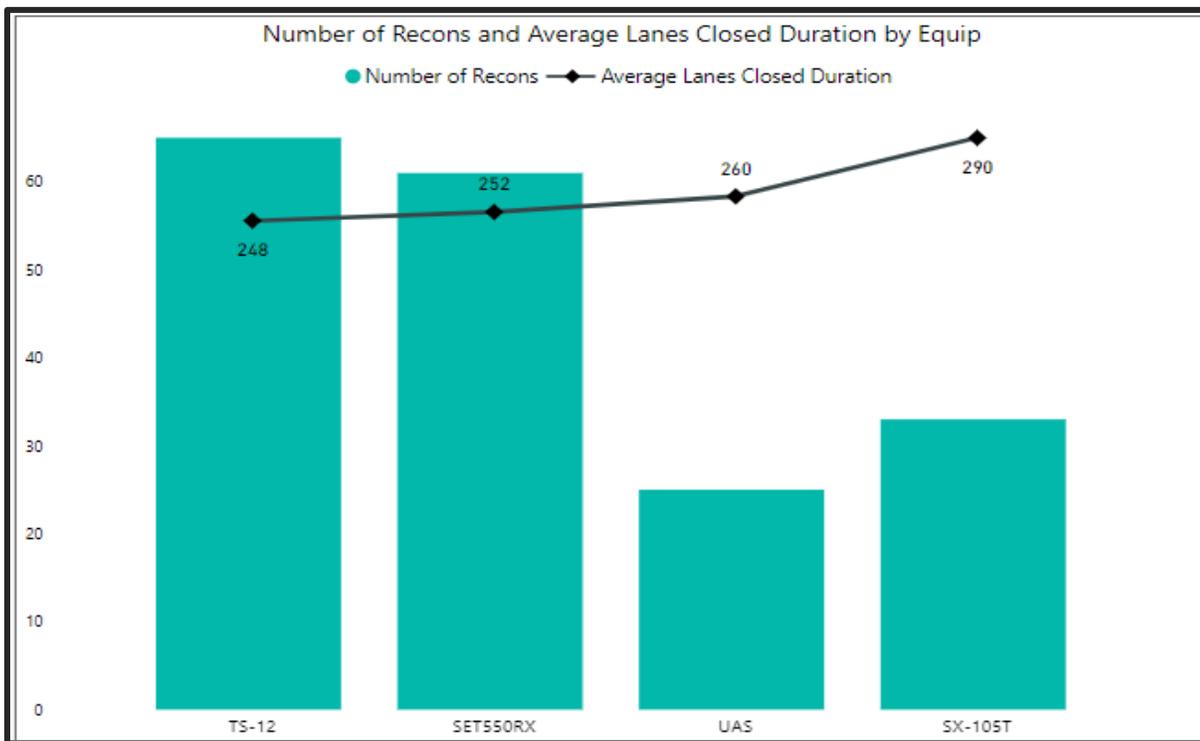
**FIGURE 9.3: EQUIPMENT TYPE AND THEIR RESPECTIVE LANE CLOSURE DURATIONS**

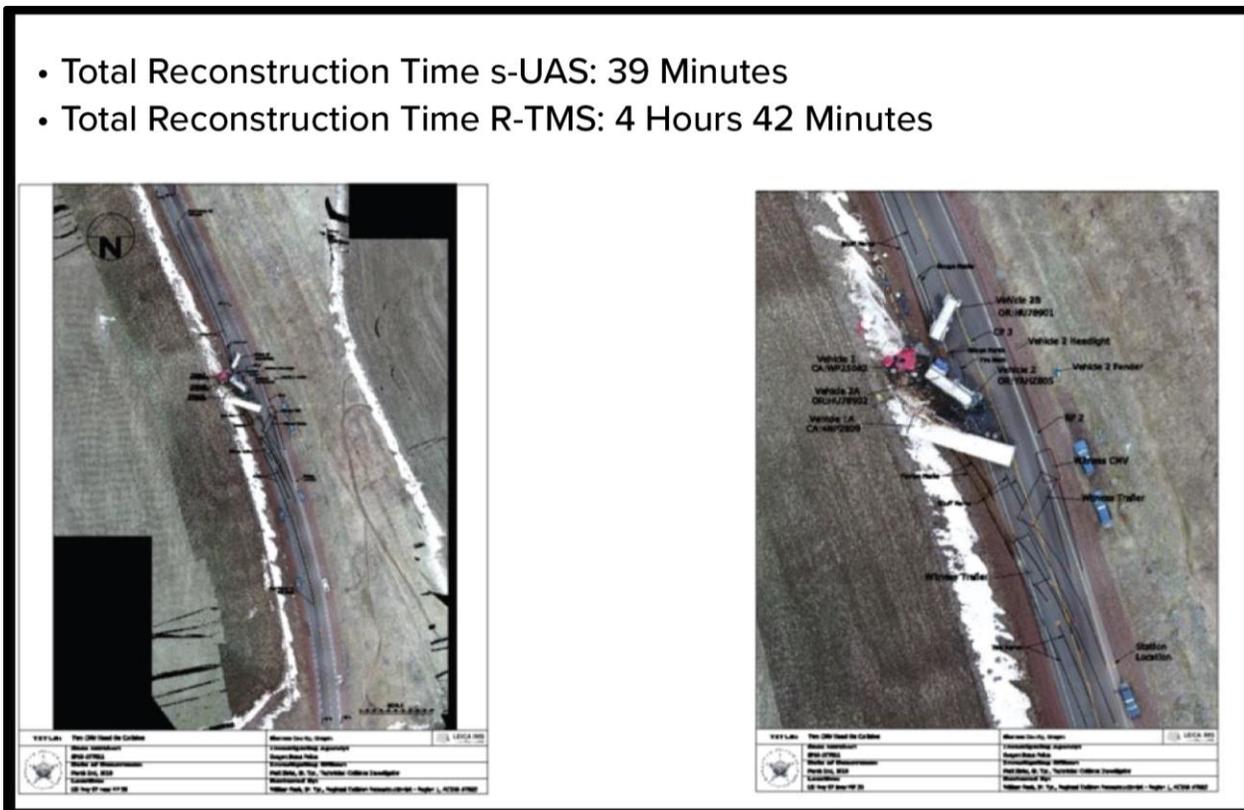
**FIGURE 9.6: COMPARISON OF SUAS TO ROBOTIC TOTAL MEASURE STATION**
