# **USE OF FLASHING AMBER-WHITE LIGHTS ON PAVING EQUIPMENT IN WORK ZONES**

**Final Report**

**PROJECT ODOT Order No. 19-15**

Oregon Department of Transportation

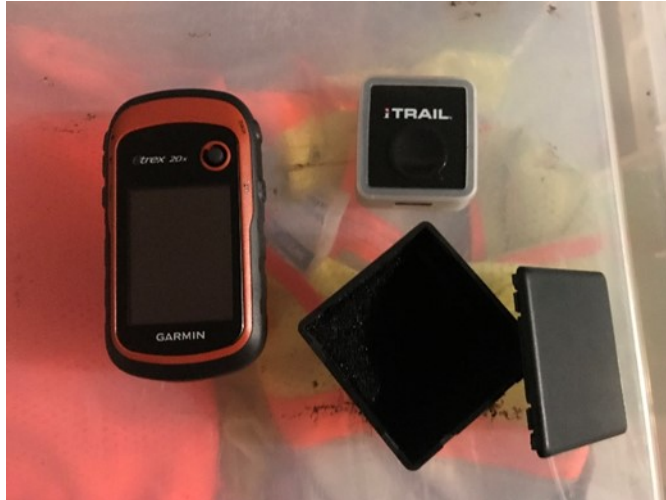
**Figure 2.7: Handheld GPS device (left), and GPS tracker and casing for GPS tracker (right)**

Figure 2.7 also shows a hand-held GPS device used in the data collection process. The GPS tracker, which is accurate to 3 m, was used to record the longitude and latitude of the traffic sensors placed on the road. These values were later used during the analysis after the study period to provide a location of the sensors on each day.

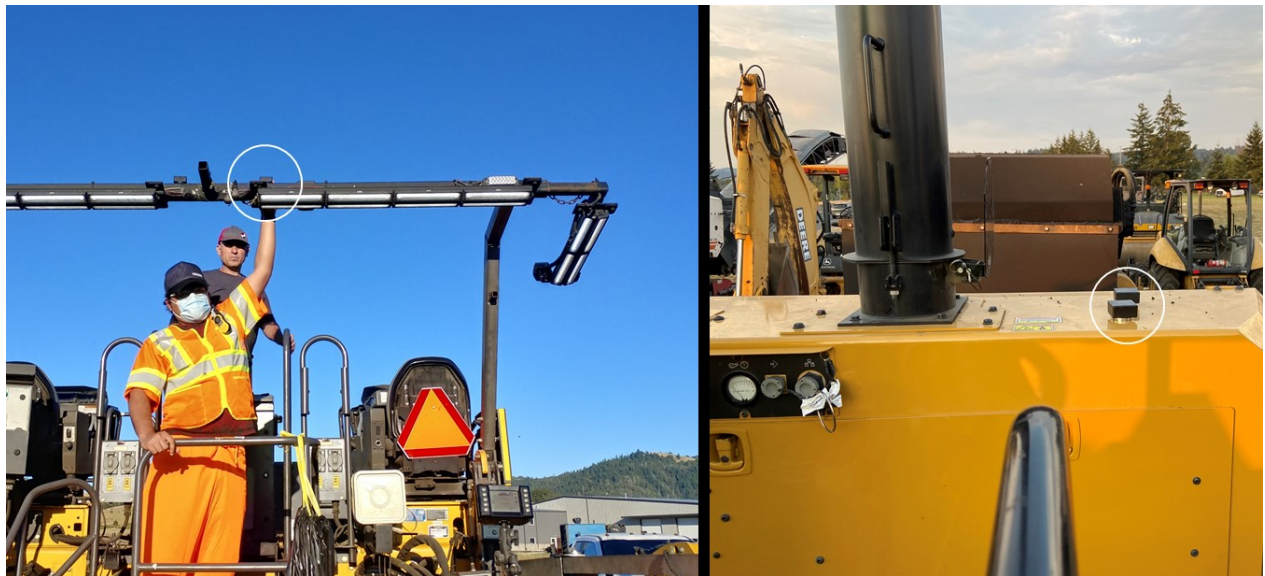
**Figure 2.8: GPS sensor location on the paver light bar (left) and on top of paver (right)**

Figure 2.8 shows the GPS sensor placement on the pavers. The 1.5"x1.5" devices were protected using a casing with magnetic attachment that attached the casing to the metal light bar on the paver or on top of the engine cover in front of the operator's chair. After retrieving the GPS trackers from the paver, time stamped GPS data (longitude and latitude) was downloaded using the iTrail software in .csv format for analysis.

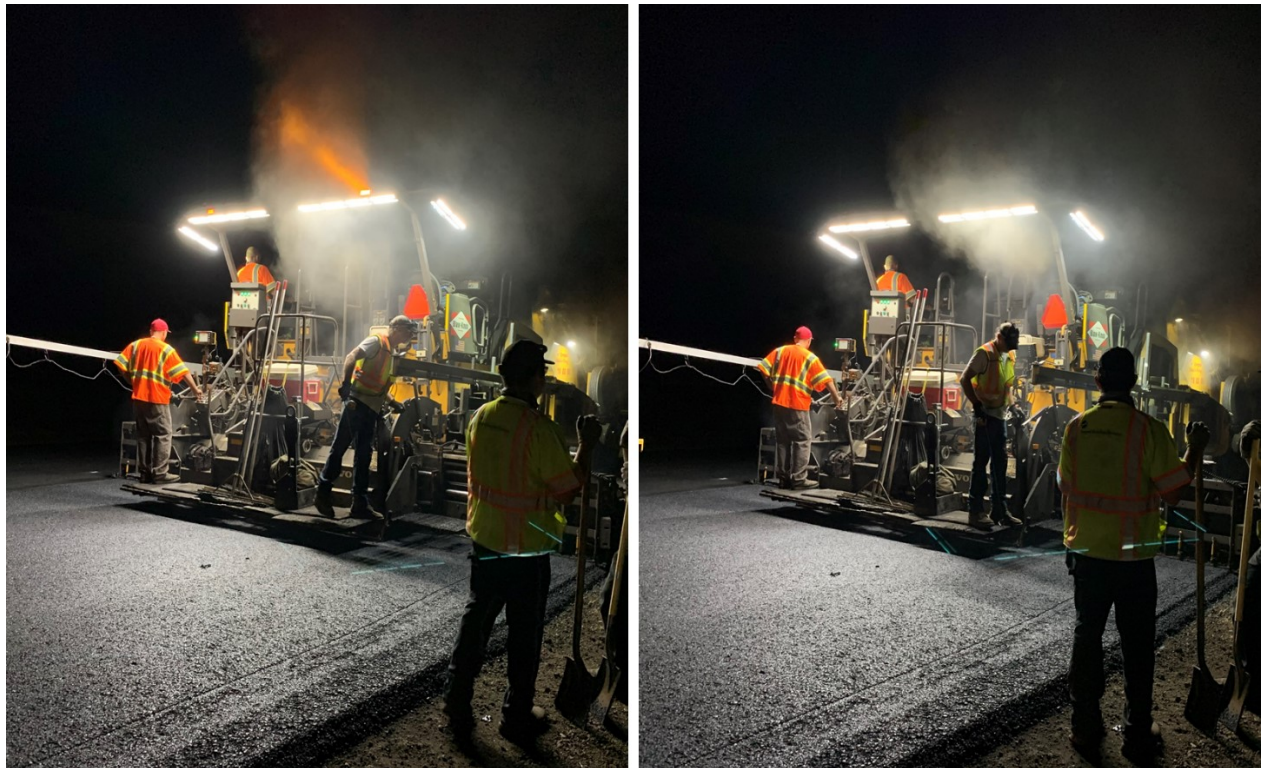
**Figure 3.1: Paver with flashing amber lights on (left) and amber lights off (right) (case studies 1 and 3)**

As previously described, traffic sensors were placed on the road surface and GPS trackers were placed on the paver. The control was the condition when the flashing amber or amber-white lights on the paver were turned off, and the treatment was the flashing amber lights or amber white-lights turned on (Figure 3.1). The type of flashing amber-white lights was different in Case Study 2 than in Case Studies 1 and 3. In Case Studies 1 and 3, a pair of flashing LED amber lights were installed on the overhead light bar of the paver. The overhead light bar has static white LED lights installed as displayed in Figure 3.1. A close-up view of a pair of the amber lights installed on the light bar of the paving equipment is displayed in Figure 3.2.

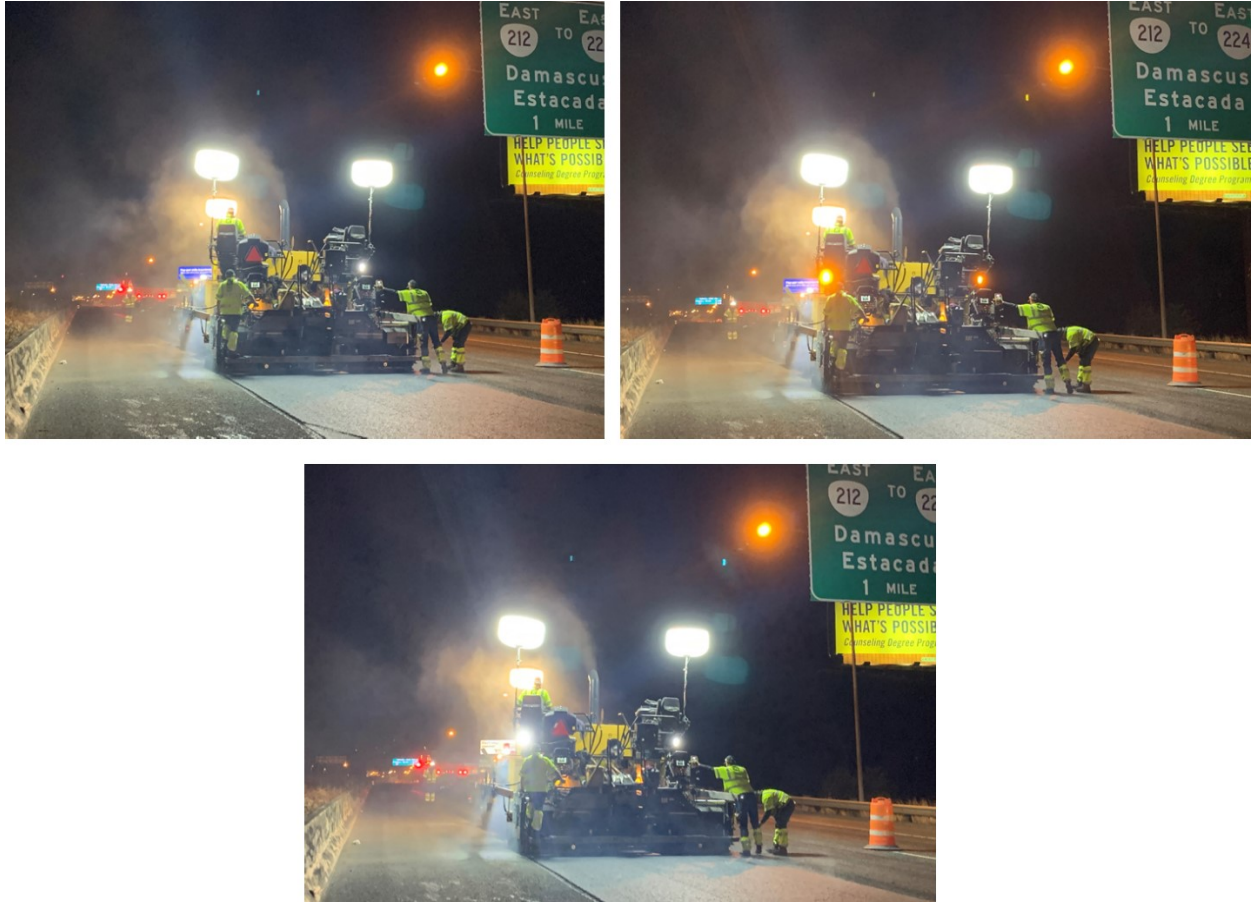
**Figure 3.3: Only balloon lights on (top-left), amber lights on (top-right), and white lights on (bottom) (case study 2)**

The paving equipment was different in Case Study 2 than Case Studies 1 and 3. In Case Study 2, similar shaped LED alternating amber and white flashing lights were installed on both sides of the paver under the vehicle operators' seats as displayed in Figure 3.3. Alternating amber and white lights flash in this light installation. The paver in Case Study 2 is illuminated with three overhead balloon lights in addition to the amber-white lights (see Figure 3.3). In Figure 3.4, the location of the flashing light is indicated on one side of the paver by the white circle. A similar light is installed on the other side of the paver as well.

For the amber-white light combination shown in Figure 3.3 and 3.4, immediately adjacent to and downstream of the paver, there was a statistically significant reduction in speed when the lights were turned on. The amount of reduction in mean speed varied from 2.5 to 10.1 mph right at the paver (250-0 ft. to 0-250 ft.). At a statistical confidence level of 95%, these differences were all found to be significant. The research team concludes from this finding that the flashing amber-white lights contributed to sustained speed reduction throughout the work zone activity area.

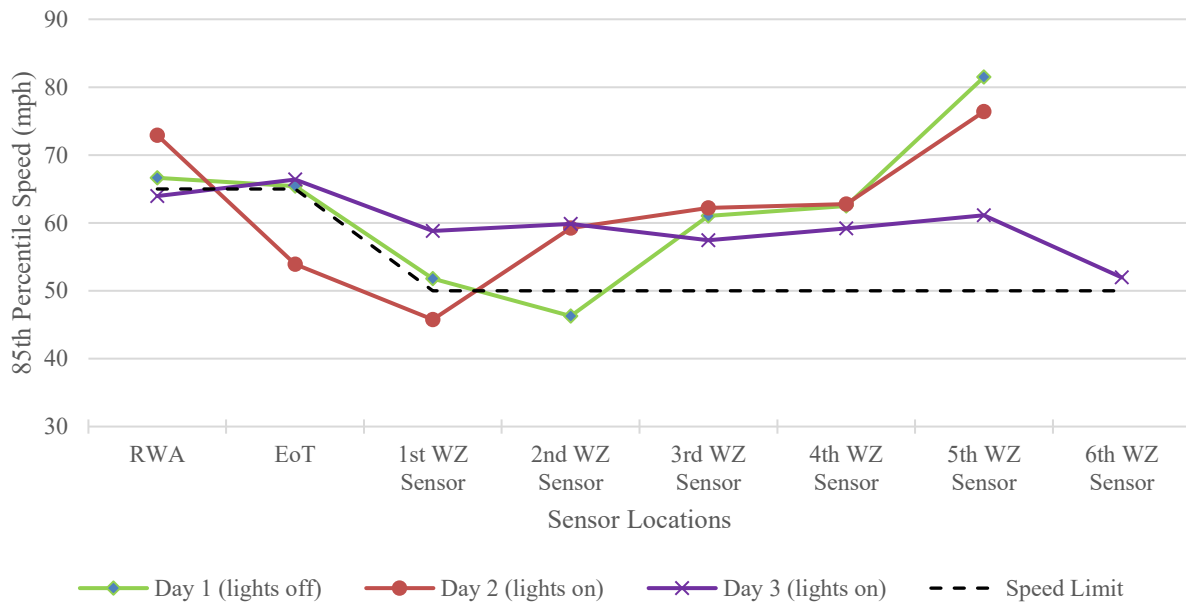
**Figure 4.3: Free flow vehicle speed (85<sup>th</sup> percentile) at different locations for all days (case study 1)**

The 85<sup>th</sup> percentile vehicle speed at different locations in the work zone on different days is shown in Figure 4.3. The paver moves through the active work area during the work shift, starting near the 1<sup>st</sup> work zone sensor and moving downstream towards the last work zone sensor. Therefore, the paver passed each work zone sensor at different times in the work shift. The data presented in the figure represents all of the vehicle speeds recorded at each sensor over the entire work shift.

As shown in the figure, the 85<sup>th</sup> percentile speeds of the vehicles recorded at the Road Work Ahead (RWA) sign were within 10 mph of the posted speed limit and reduced at the end of the taper. The reduction in speed at the RWA sign is higher on Day 2 (lights on), while the speed on the other two days clustered around the 65-mph speed limit. There is a steady reduction in speed inside the work zone until the 3<sup>rd</sup> work zone sensor. Days 1 and 2 show an increase in speed at the 5<sup>th</sup> work zone sensor. The posted speed limit was 65 mph which was reduced to 50 mph in the work zone. Visual inspection of Figure 4.3 suggests that there is no clear pattern regarding the 85<sup>th</sup> percentile speed. However, many locations inside the work zone had higher 85<sup>th</sup> percentile speeds than the recommended speed limit in the work zone.

66.6 mph to 82.1 mph throughout the test period. It should be noted that the values presented in in Figure 4.13 are different than those presented in Figure 4.3 above. Figure 4.13 shows the hourly speed distribution recorded by one sensor at the RWA sign. Multiple sensors were placed at this location, one in each travel lane. Figure 4.3 presents a weighted average (by traffic volume) of the 85<sup>th</sup> percentile speed of all hours at all RWA sensors.

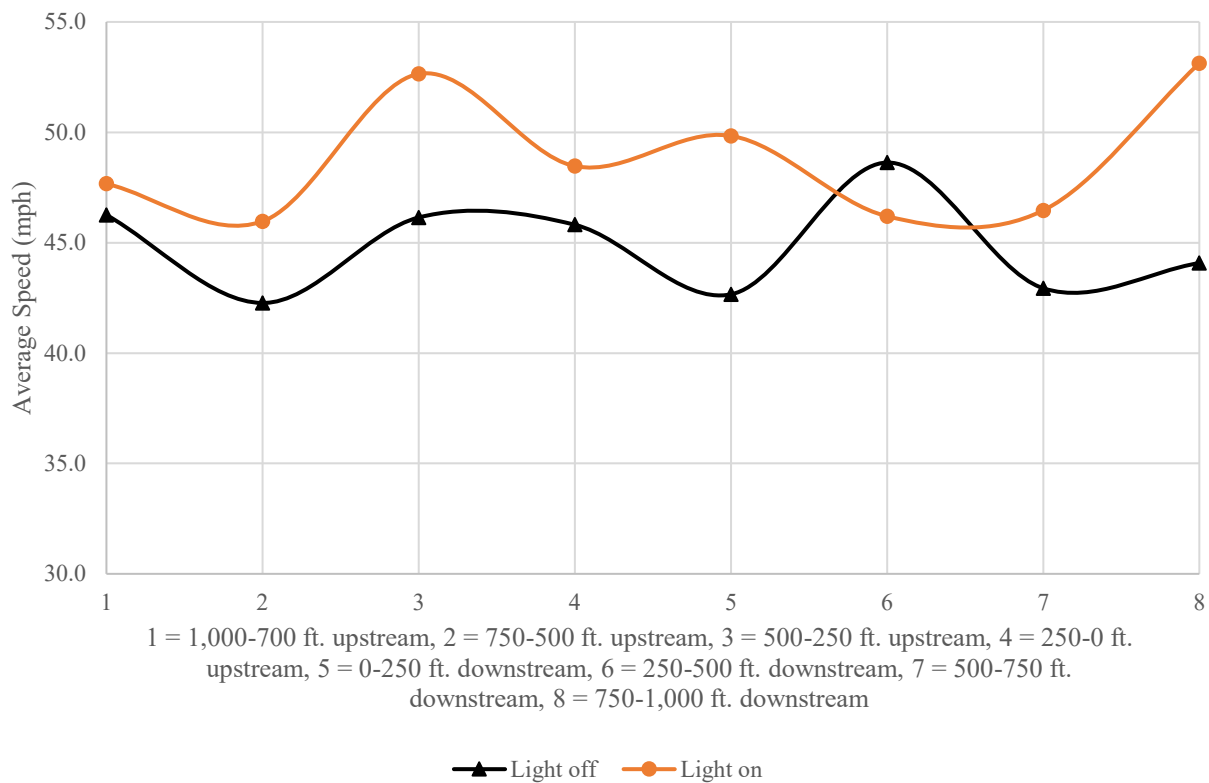
**Figure 4.19: Free flow speed distribution across the work zone at 250 ft intervals (case study 1)**

were on, average speed was higher, although the differences were not statistically significant at most locations.

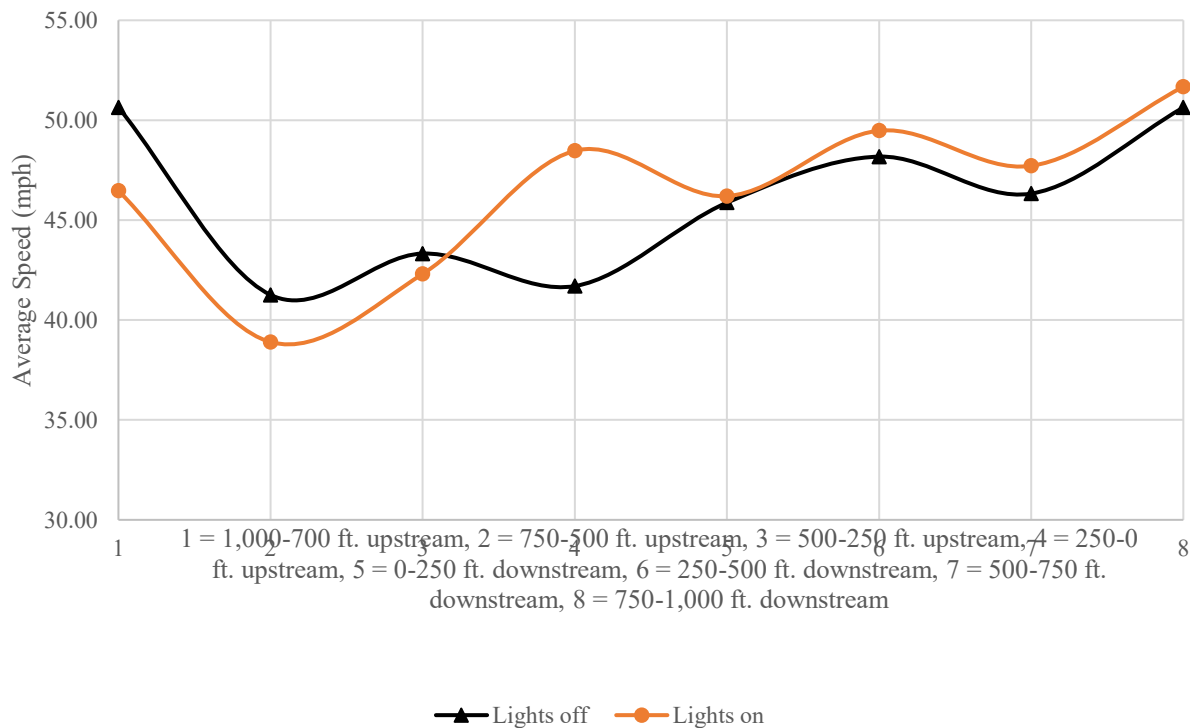
**Figure 4.21: Free flow speed distribution across the work zone at 250 ft. intervals (case study 3)**

The results shown in Table 4.5 are depicted in Figure 4.21. It can be observed visually that the two plots progress within a narrow margin of each other. At location 4 (150-0 ft. upstream of the paver), a greater difference in mean speed is observed, and higher mean speed was observed for the days in which the flashing amber light was on. No halo effect was observed for either of the progressions.
