EVALUATION OF RADAR SPEED DISPLAY FOR MOBILE MAINTENANCE OPERATIONS

Final Report

REPORT #OR-RD-16-09

Oregon Department of Transportation

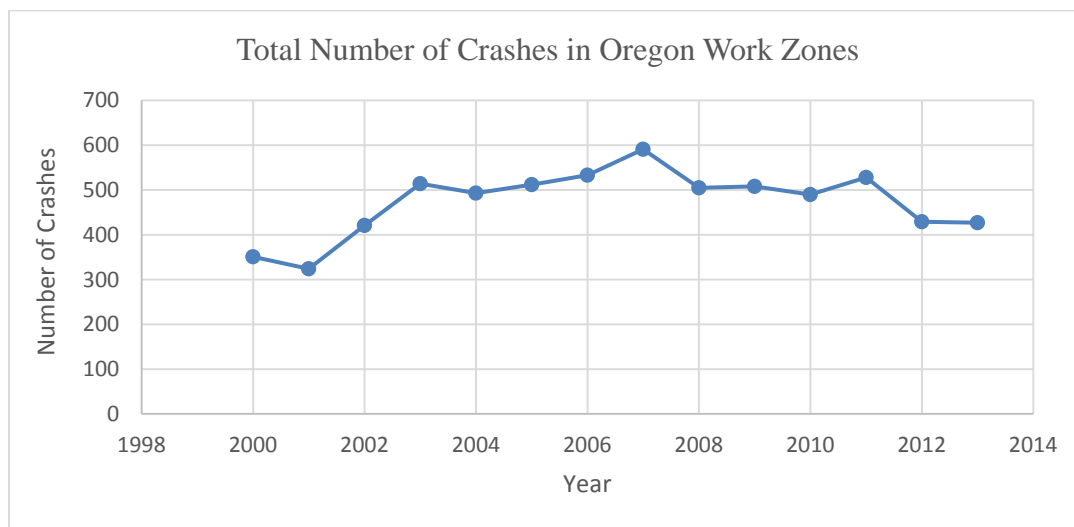
**Figure 1.1: Crashes in Oregon Work Zones (ODOT 2014)**

Table 1.1 indicates that the majority of work zone fatalities over the 14 year period occurred in construction zones. Maintenance zone fatalities represent approximately 10% of all work zone

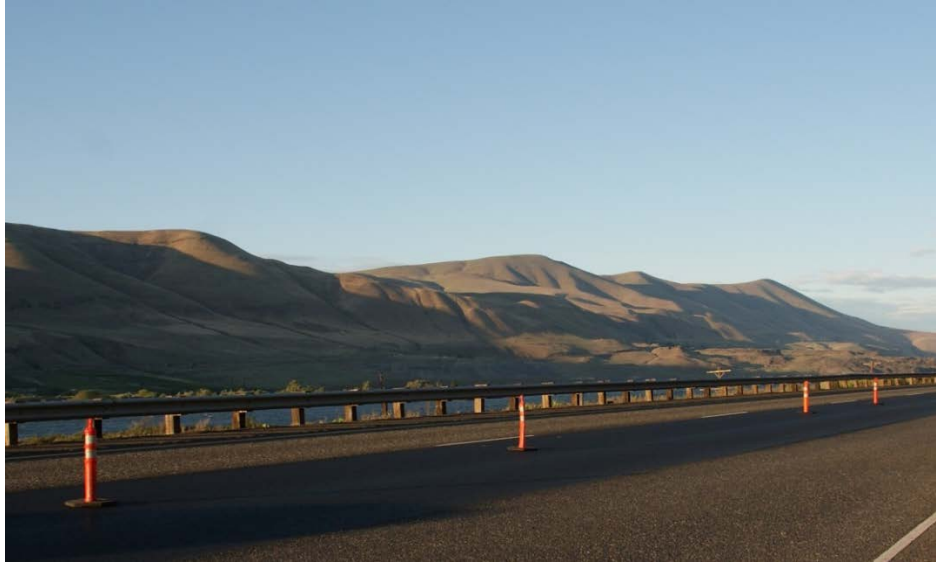
Tubular and Conical Markers – Tubular and conical markers (tubes and cones) are the most commonly-used channelizing devices for delineating the roadway and directing traffic through a work zone. These devices are effectively used to override existing pavement markings for short-duration applications (less than three days). Figure 2.2 shows tubular markers being used to delineate an edge of a travel lane on the I-84 case study project as part of a prior ODOT study (SPR-751).

Figure 2.2: Tubular Markers on Roadway

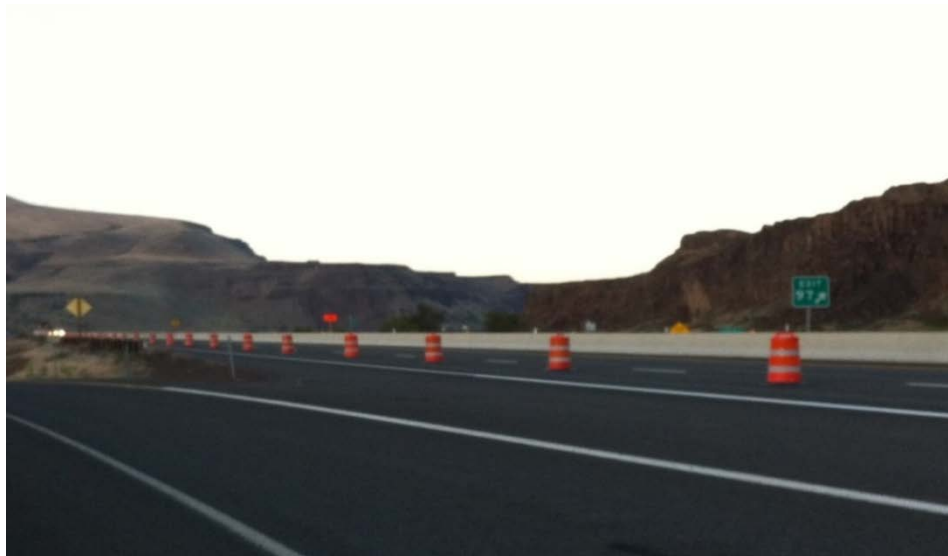
Temporary Plastic Drums – Plastic drums (barrels) are the largest, most visible deformable channelization devices. Plastic drums are usually used to delineate travel lanes, identify work areas, construct lane closure tapers, and delineate portable changeable message sign (PCMS) and temporary traffic signal installations (ODOT 2014). Figure 2.3 shows plastic drums in use on the I-84 case study project as part of a prior ODOT study (SPR-751). While designed primarily for channelization, both tubular markers and drums may also be employed for vehicle speed reduction. Channeling the traffic in a certain direction or location may cause reduction in speeds. In addition, tubular markers and drums can be located to narrow down a lane, giving the impression of a tighter driving lane and thus promoting slower speeds.

Figure 2.3: Plastic Drums on Roadway

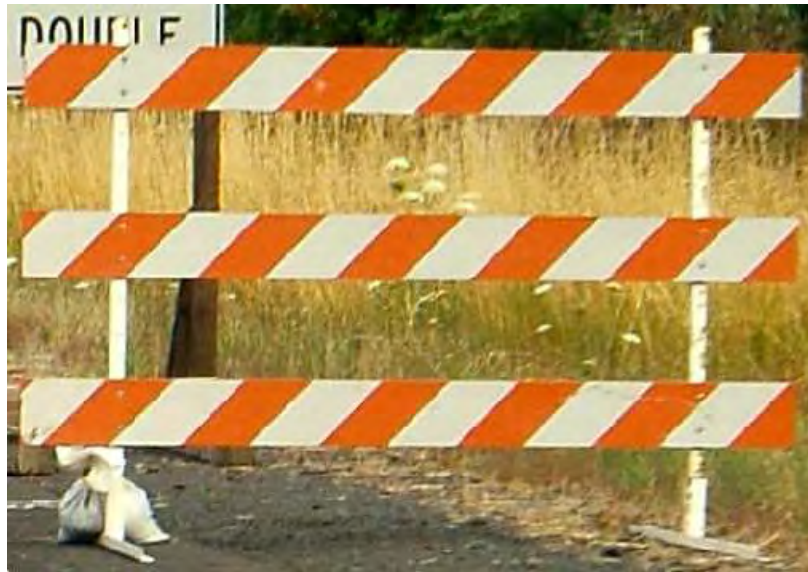
intervals within a closed lane to remind drivers that the lane is unavailable to them, and placed at the point of closure. Figure 2.4 shows an example of a Type III barricade.

Figure 2.4: Type III Barricade (ODOT 2014)

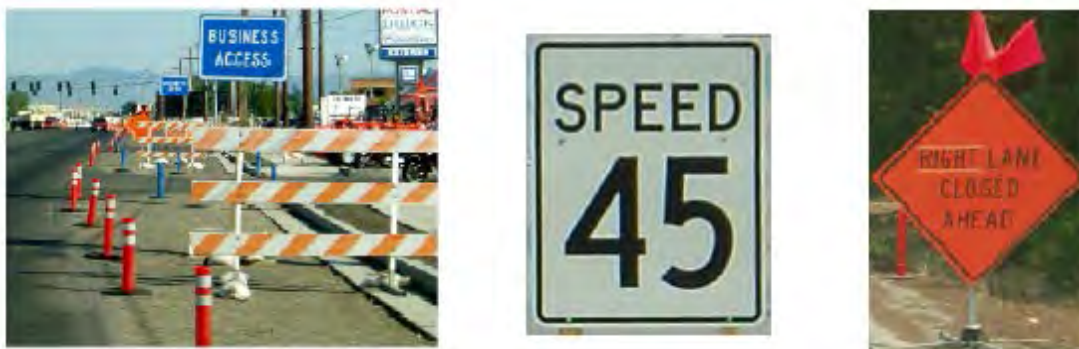
Temporary Signs – Temporary signage is used to convey regulatory, guidance, and warning messages in place of permanent signage during roadway construction and maintenance operations. Figure 2.5 shows several examples of temporary signs.

Figure 2.5: Examples of Temporary Signs (ODOT 2014)

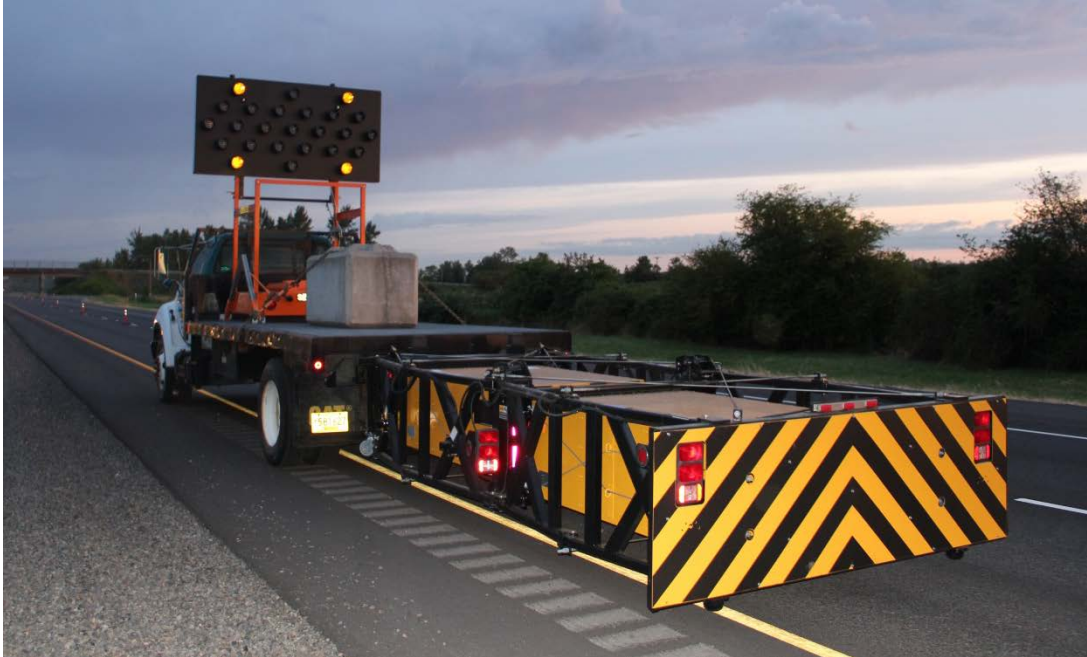
Temporary Impact Attenuators – Temporary impact attenuators, also called crash cushions, are crashworthy systems that mitigate the effects of errant vehicles that strike obstacles. When struck by a vehicle, an impact attenuator is designed to lessen the impact of the crash on the traveling vehicle and on the supporting structure. A truck mounted attenuator (TMA) is a mobile impact attenuator attached to a work or shadow vehicle that is used to temporarily protect objects or a work area. One or more TMAs are usually located in advance of an object, work area, equipment, or workers. A TMA should not be used for long-term protection of barriers or other fixed objects. Figure 2.6 shows an example of a TMA attached to the rear of a truck.

Figure 2.6: Truck Mounted Attenuator and Sequential Arrow Board

Sequential Arrow Signs – Sequential arrow signs or arrow boards are large truck- or trailer-mounted lighted signs used to indicate the direction which traffic needs to merge as part of a lane closure. These devices are not to be used to indicate a lane closure. Figure 2.6 above shows an example of a sequential arrow board mounted on top of a truck.

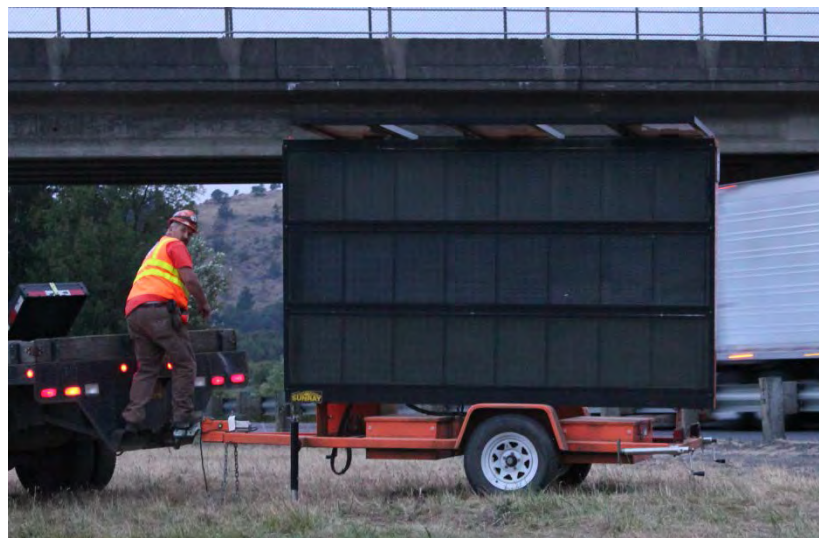
Portable Changeable Message Sign (PCMS) – PCMS's are large, lighted signs used to display programmable, dynamic messages that reflect work zone conditions to be encountered by approaching traffic. PCMS's can be mounted on either a trailer or work vehicle. Figure 2.7 shows an example of trailer-mounted PCMS. Figure 2.8 shows an example of a work vehicle-mounted PCMS.

Figure 2.7: PCMS on Trailer

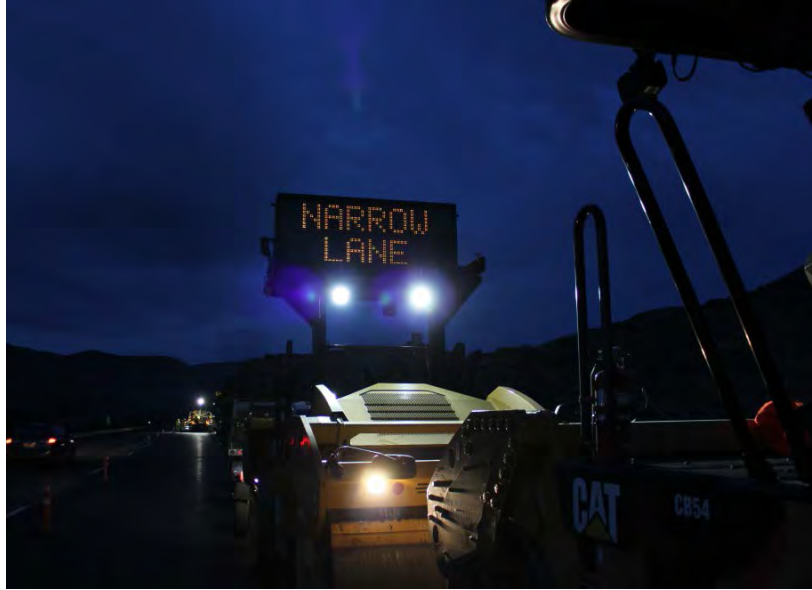
Figure 2.8: PCMS on Roller

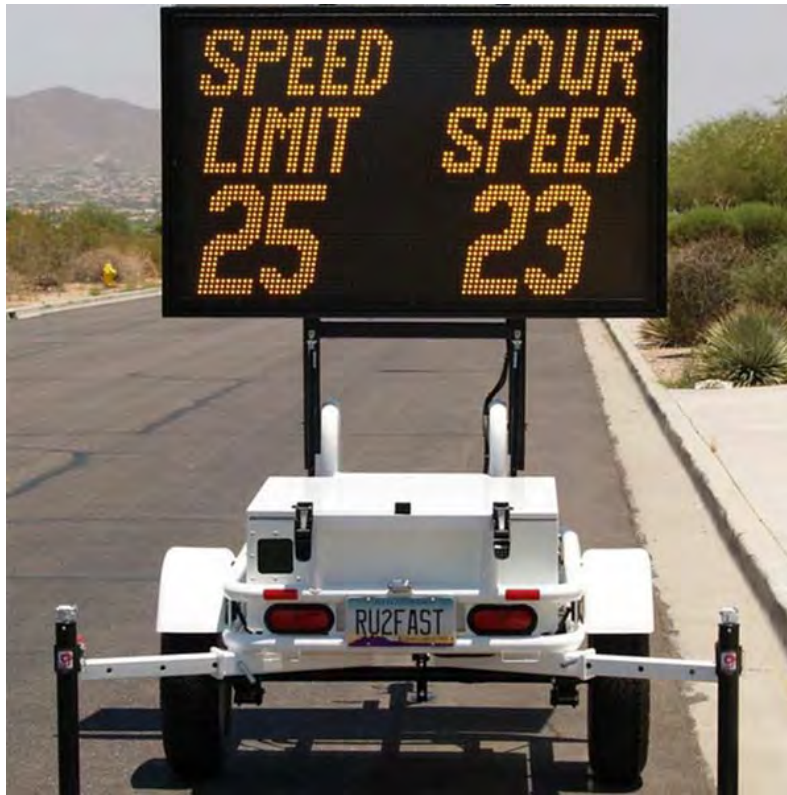
Radar Speed Trailer - These units use radar technology to measure the speed of oncoming vehicles and display the vehicle speed to the drivers. The vehicle speed is usually displayed along with the regulatory or advisory speed and/or a message alerting the drivers to use caution. Figure 2.9 shows an example of a radar speed trailer.

Figure 2.9: Radar Speed Trailer

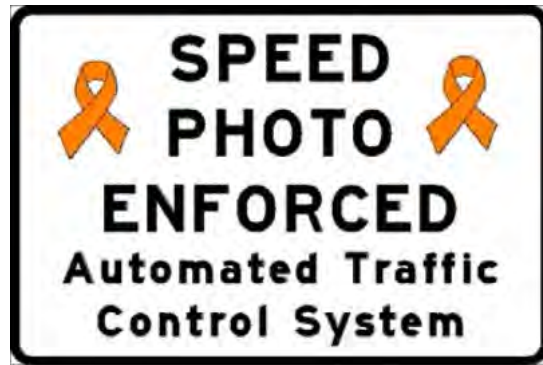
Figure 2.10: Special Signs for Speed Photo Enforcement (*Benekohal et al. 2010*)

The Illinois DOT conducted a research study to explore the effect of speed photo-radar enforcement (SPE), also referred to as “automated speed enforcement”. In this research study, an advanced warning sign (shown in Figure 2.10) was placed on roadways with 50 mph regulatory speeds to inform the motorists of the implementation of SPE in the work zone. A self-contained van was used to implement the SPE as shown in Figure 2.11. Figure 2.12 provides a graphical view of how the SPE system works.

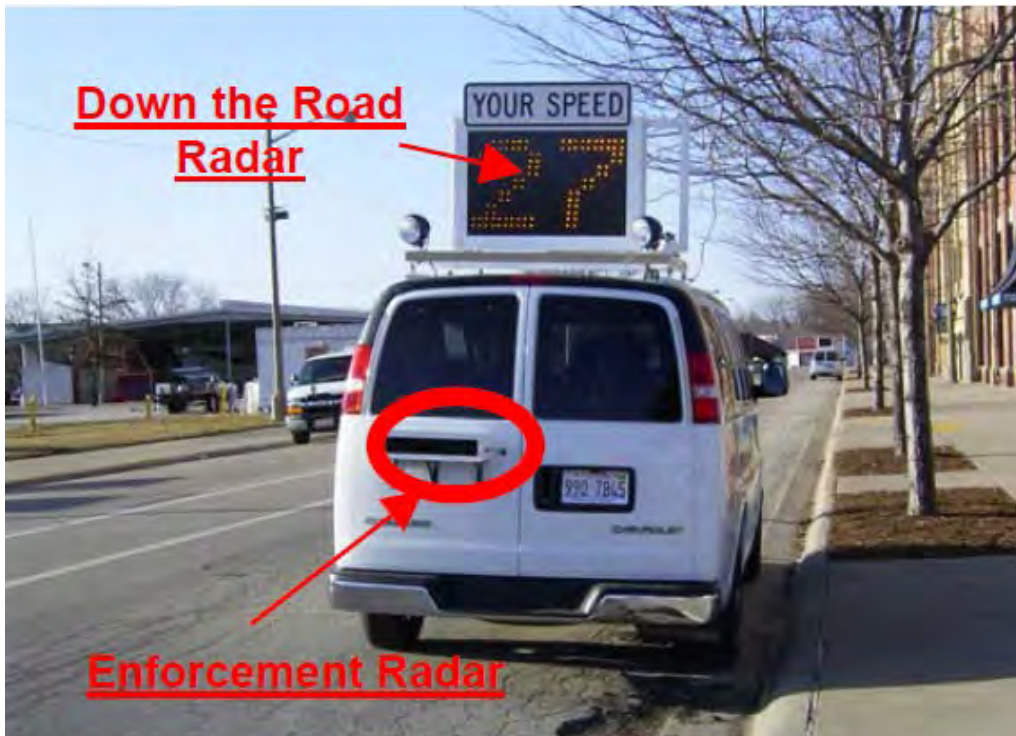
Figure 2.11: Photo Enforcement Vehicle (*Benekohal et al. 2010*)

The enforcement radar speed reader measured the vehicle speed at about 150 feet upstream from the van. If the speed of the vehicle is greater than a specified value, the two onboard cameras are activated to take pictures of the driver and rear license plate of the vehicle. The vehicle owner's address is then determined based on the license plate number, and a ticket is mailed to the address.

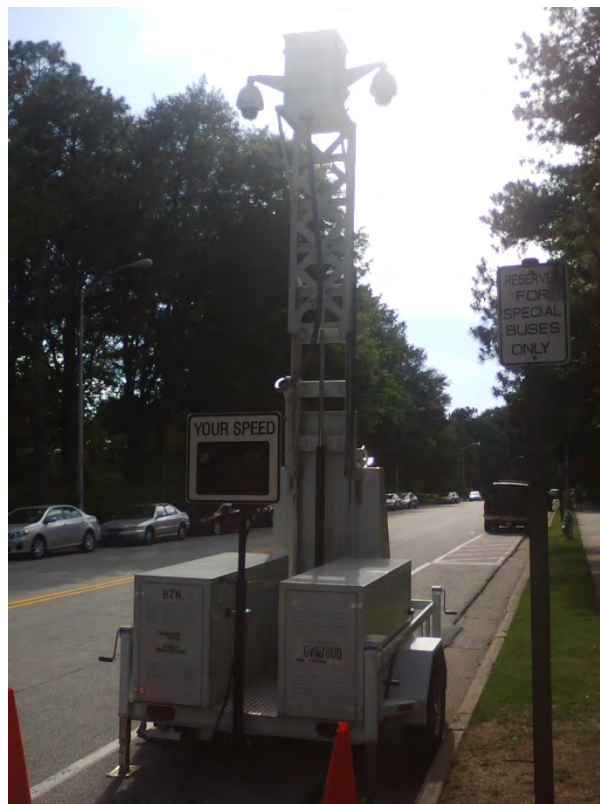
Figure 2.13: Photo Enforcement Equipment

The research revealed that the SPE significantly reduced the speeds of cars and trucks by 3 to 8 mph in work zones where the regulatory speed was 50 mph. The percentage of free-flowing vehicles (with headways greater than 4 seconds) exceeding the speed limit at the treatment location was reduced drastically (*Tobias 2011*). The presence of the SPE system also reduced the speeds of vehicles 1.5 miles downstream of the van location by 2 to 5 mph. Another type of speed photo enforcement equipment is shown in Figure 2.13.

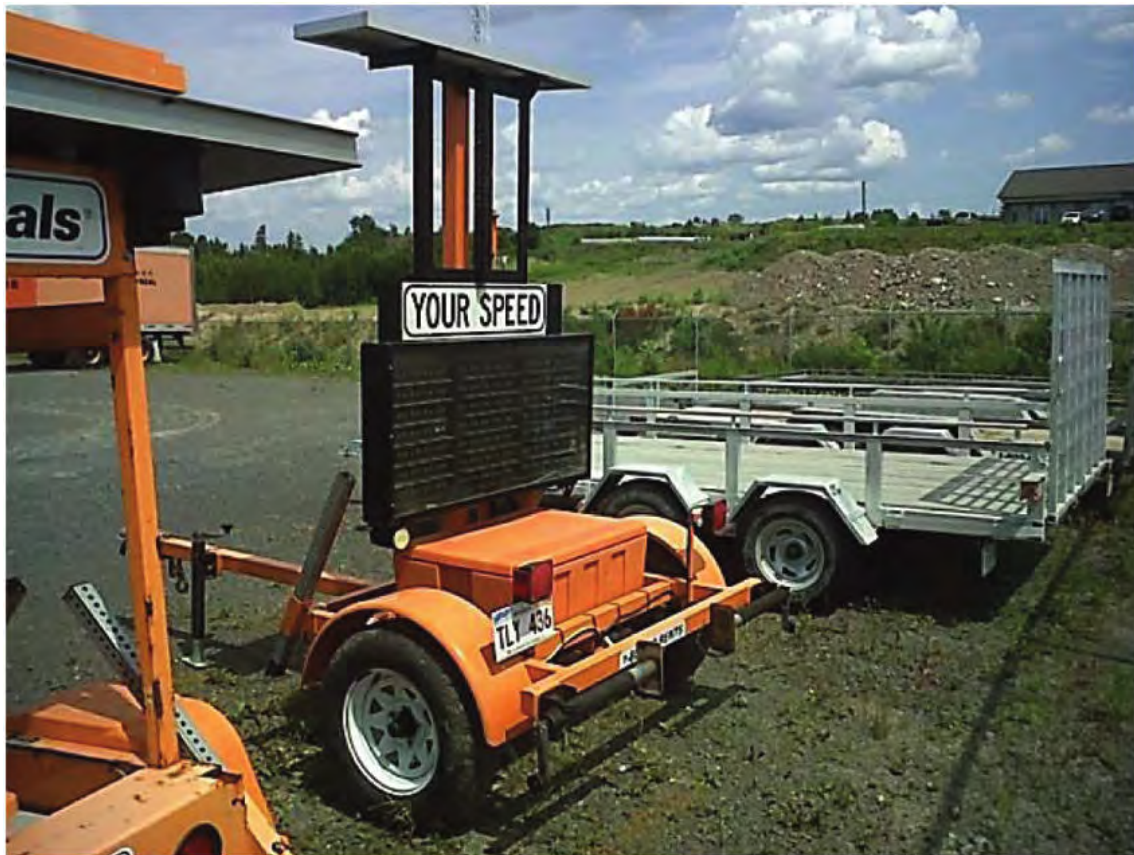
board was equipped with a sign above the display that read “YOUR SPEED” (shown in Figure 2.14).

Figure 2.14: Radar Speed Display Board (*Hildebrand and Mason 2014*)

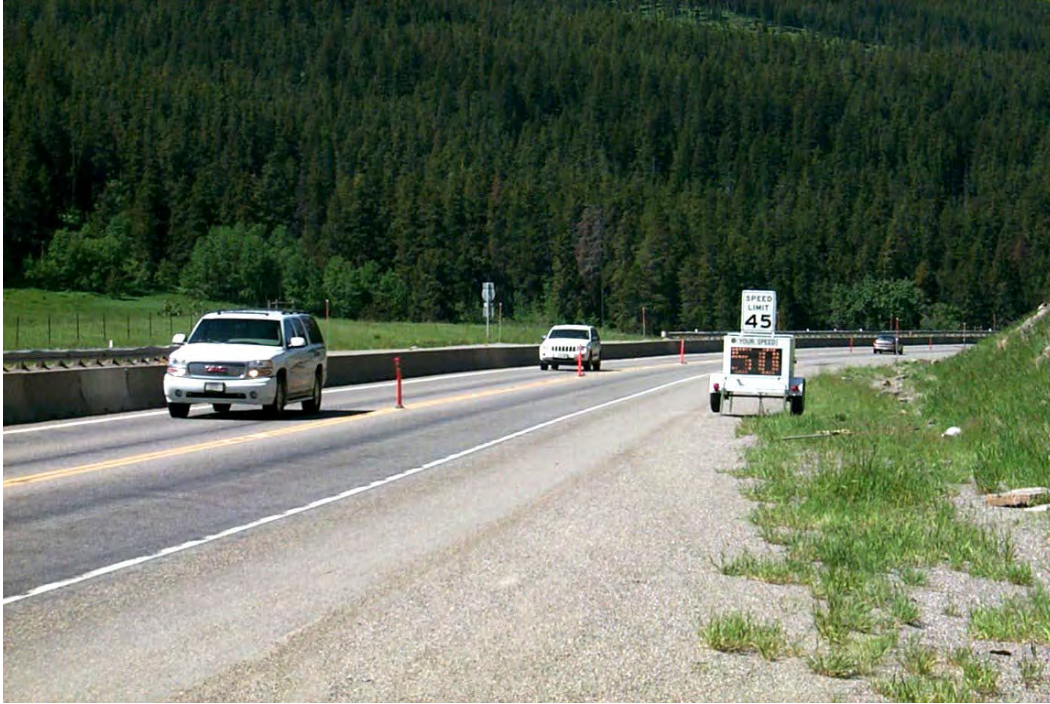
Figure 2.15: I-90 Westbound Radar Speed Display Location

As part of its research program, the Montana Department of Transportation conducted an experimental research study in 2006 in which the researchers investigated the effectiveness of trailer mounted radar speed display devices in reducing speeds in the Bear Canyon construction work zone on I-90. The evaluation consisted of collecting data with automatic traffic recorders (ATR) to determine if the devices are a factor in speed reductions (Figure 2.15). ATR data was collected at evenly spaced distances throughout the work zone crossover (Figure 2.16). ATR speed data was collected prior to initiating the radar speed displays (RSD) to provide baseline data for comparison. The average length of the work zone was 5 miles. Average travel speed (ATS), as determined by the 85th percentile speed data, in the eastbound lanes prior to the placement of the RSD's was 49 mph, and the average speed after the installation of the RSD's was 47 mph (rounded to the nearest MPH). Average travel speed in the westbound lanes prior to the placement of the RSD's was 55 mph, with an average travel speed after the installation of the RSDs of 52 mph. Table 2.5 shows a summary of the 85th percentile speeds at the five ATR placement locations. The speed data revealed that the placement of the RSD's reduced the average travel speed by 2-3 mph. The researchers suggest that these units be used in other work zones of differing construction types to ascertain their overall efficiency.

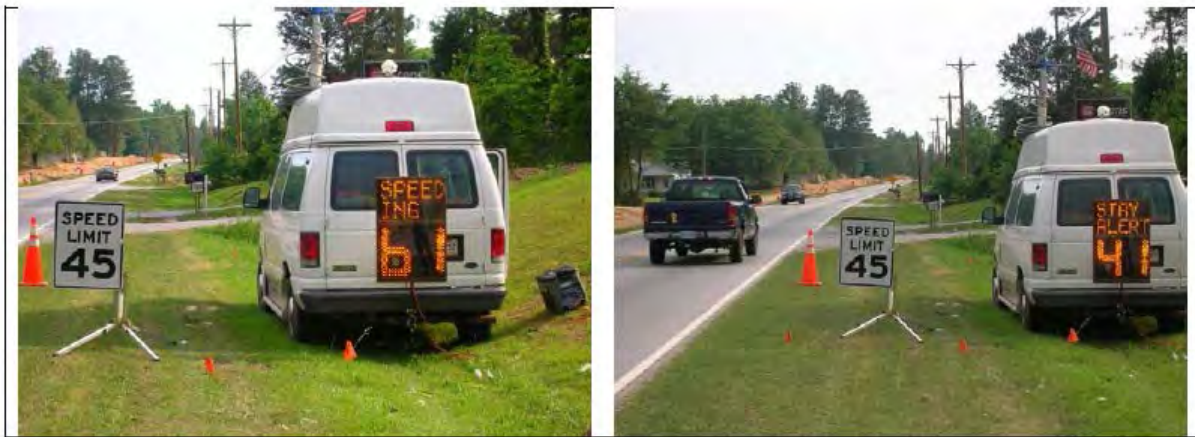
The first message sequence was programmed for continuous display, while the latter two were triggered whenever a vehicle exceeded a preset threshold. Figure 2.17 shows the typical setup with examples of both types of message sequences.

Figure 2.17: Setup Showing Speed Triggered Message and Continuous Message

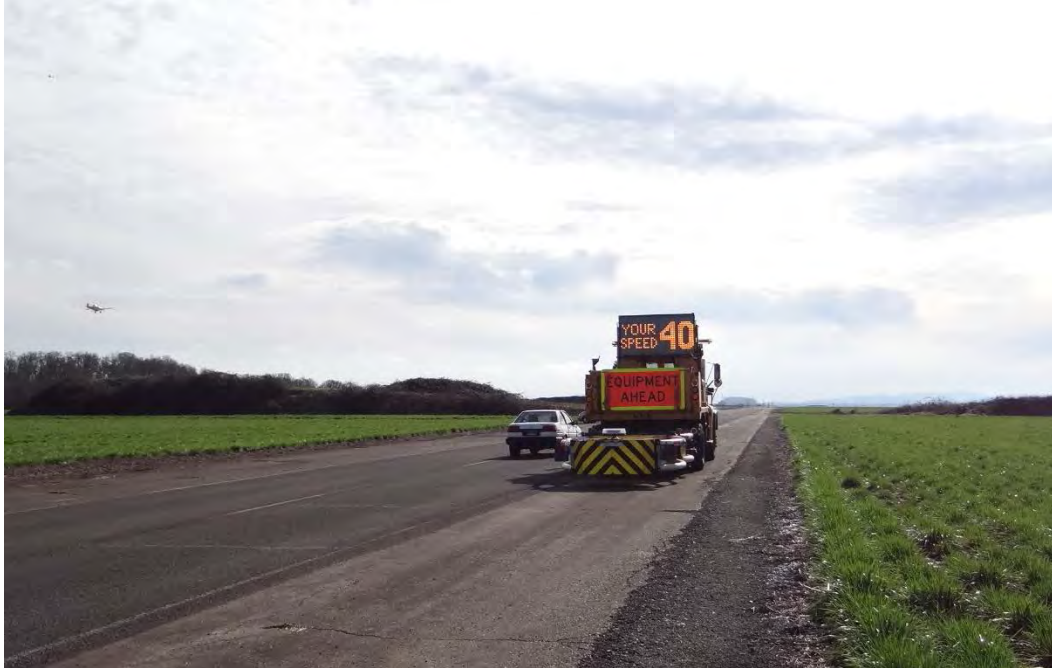
The radar speed display purchased by ODOT was manufactured by LiteSys, Inc. The display is a 1030F-4W-1 full matrix model with 3 lines of 10-inch characters and 8 characters per line. The display has the capability of showing different messages, plus arrow and chevron functions. The radar speed display is connected to a compact, multi-piece, radar detachable display unit and SpeedView traffic analyzer inside the truck cab. The multi-piece radar display has the ability to show speed in both moving and stationary modes. Building on the capabilities of MPH's DS-4 ranging radar, the SpeedView can accurately count vehicles once and only once. Its memory can hold more than a year's worth of traffic data. More information about these two units is provided in Appendix. Figures 3.1 to 3.5 show the different units of the truck-mounted radar speed display.

Figure 3.1: Truck-Mounted Radar Speed Display

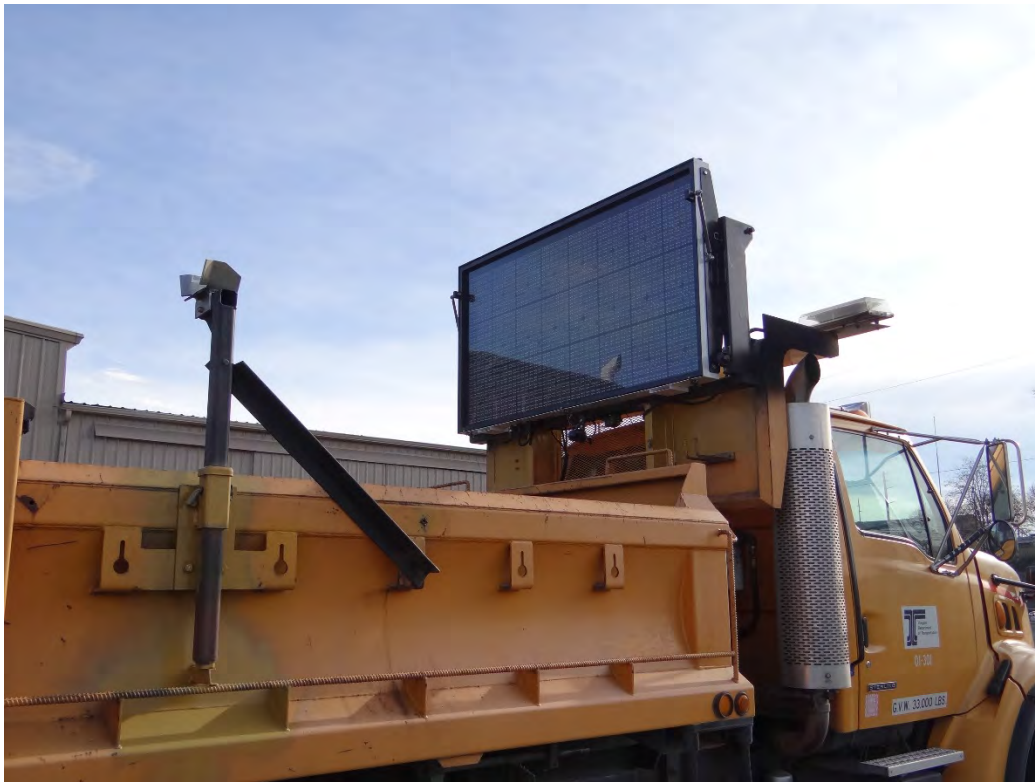
Figure 3.2: 1030F-4W-1 Full Matrix Speed Display

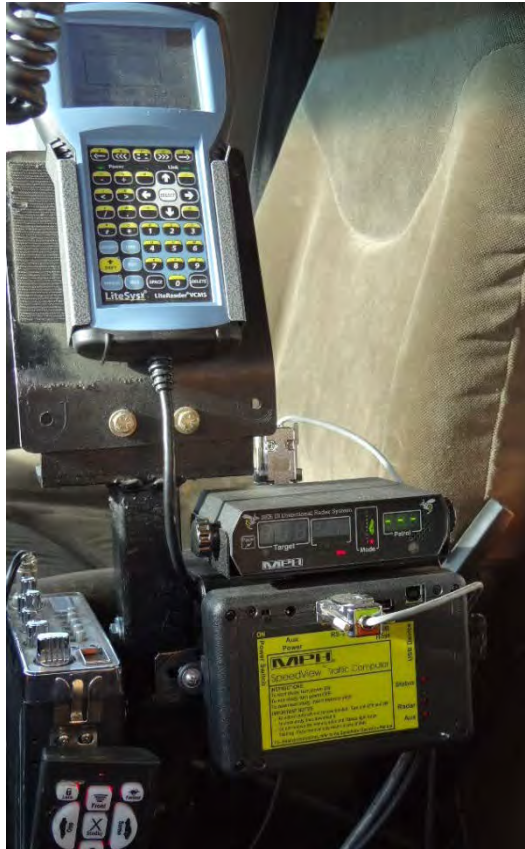
Figure 3.3: Radar Speed Display Units inside Truck Cab

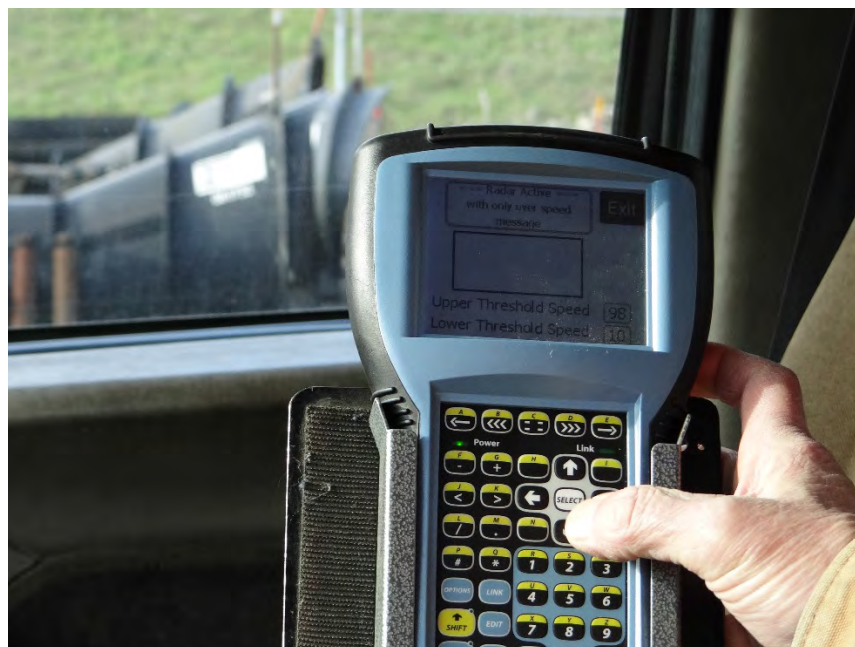
Figure 3.4: Radar System Keyboard inside Truck Cab

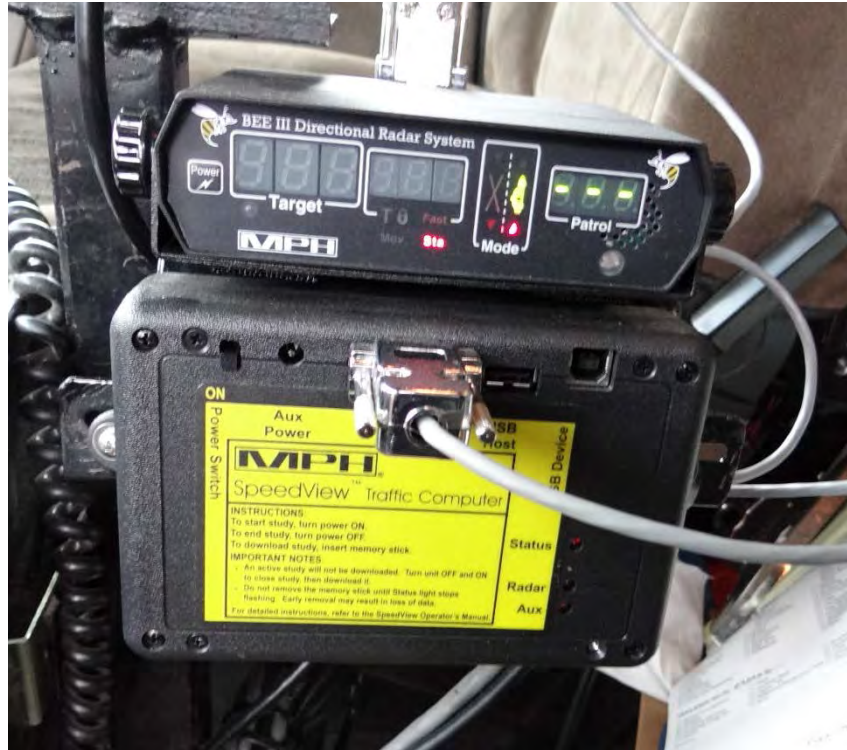
Figure 3.5: SpeedView Traffic Analysis Unit inside Truck Cab

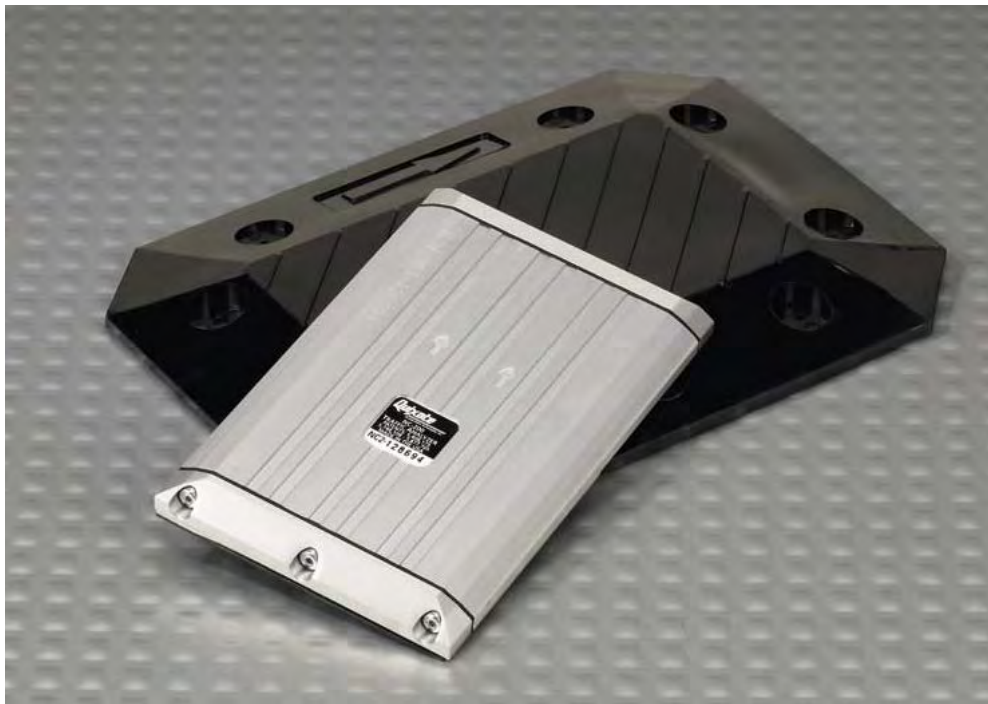
NC-200 portable traffic analyzers manufactured by Vaisala were used to collect vehicle data on the roadways. Figure 3.12 shows an example of the traffic analyzer and a cover used to protect it on the roadway.

Figure 3.12: Portable Traffic Analyzer NC-200 (Vaisala 2012)

The traffic analyzer is designed to provide accurate traffic counts, speed, and classification (vehicle length) data. The analyzer is placed directly in the traffic lane to measure and record the passing traffic. The sensor utilizes Vehicle Magnetic Imaging (VMI) technology to count the number of passing vehicles and detect vehicle speed and length (Vaisala 2012). Table 3.1 shows the technical specifications of the NC-200 portable traffic analyzer.

Technical Specifications	
Housing Material	Extruded/anodized aluminum
Ultimate Bearing Strength	88,000 psi (607 MPa)
Dimensions	7.125 x 4.625 x 0.5 inches
Weight	1.3 lbs
Operating Temperature	-4 °F to +140 °F
Sensor	GMR magnetic chip for Vehicle Magnetic Imaging
Memory	Micor Serial Flash: 3MB
Battery	Lithium-ion rechargeable (can last for up to 21 days without recharging)
Capacity	up to 300,000 vehicles or 21 days per study, whichever occurs first
Vehicle Detection	Detects vehicles between 8 to 120 mph
Accuracy length classification	+/- 4 ft, 90% of the time
Accuracy speed classification	+/- 4 mph, 90% of the time
Accuracy vehicle count determination	+/- 1%, 95% of the time

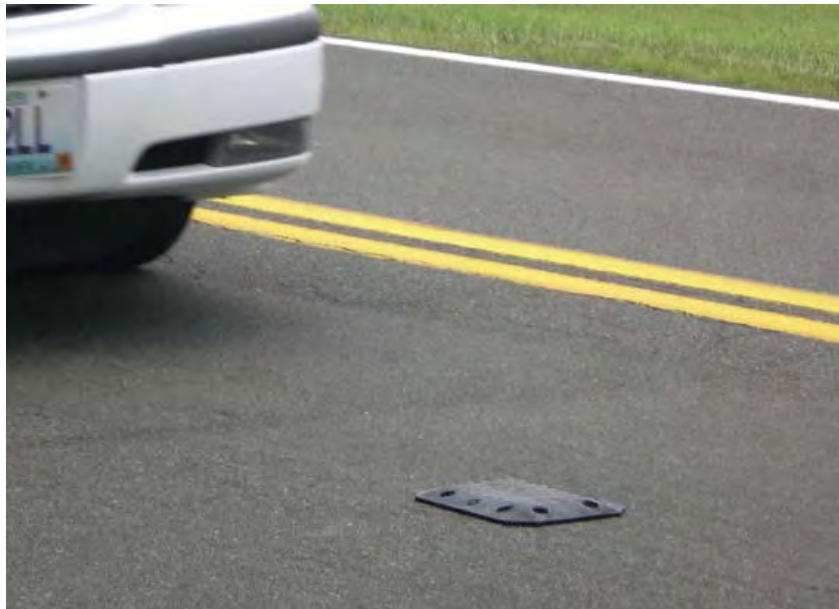
The traffic analyzer manufacturer suggests that the analyzer be nailed down to the pavement through nail holes on the cover as shown in Figure 3.13. However, for highway maintenance projects, the short duration of use (one night of work) each time the analyzer is used makes it inefficient to nail down the analyzers. Therefore, an alternative method to fix the analyzer on the roadway was used. The analyzers were secured to the pavement using adhesive tape which completely covered the analyzer cover and the analyzer. Figure 3.14 shows an example of how adhesive tape is used to keep the analyzer at the desired location.

**Figure 3.13: Placement of Portable Traffic Analyzer using Nails (Vaisala 2012)**

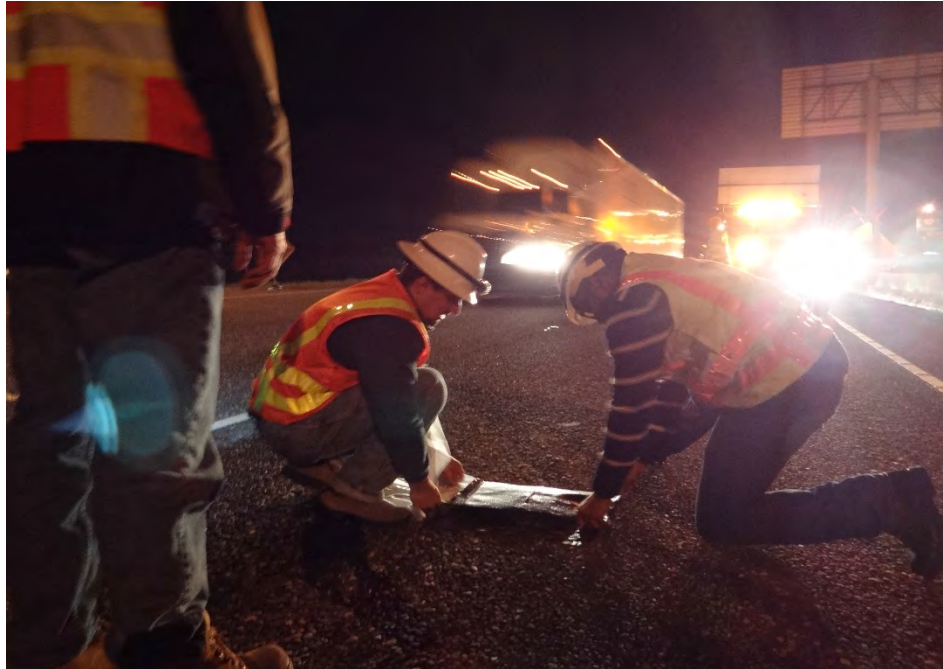
Figure 3.14: Placement of Portable Traffic Analyzer using Adhesive Tape

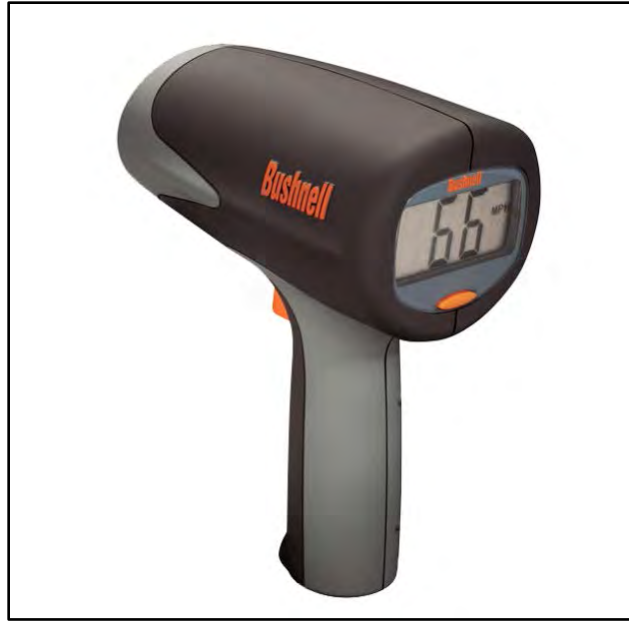
A radar speed gun was also used to measure and confirm vehicle speeds at specific locations in the work zone. The researchers selected several locations within the work zone to monitor traffic speeds. The researchers held the speed gun for a 5-minute period of time and recorded free flow traffic speeds. Using the speed gun is an auxiliary method to provide supplementary data for further analysis and verification of the speeds recorded by the portable traffic analyzers and radar speed display. The speed gun was also used to spot check the accuracy of the RSS during the operations. Figure 3.16 shows a speed gun used in the research. The accuracy of the speed gun is ± 1 mph and the speed range is 10-200 mph.

Figure 3.16: Radar Speed Gun

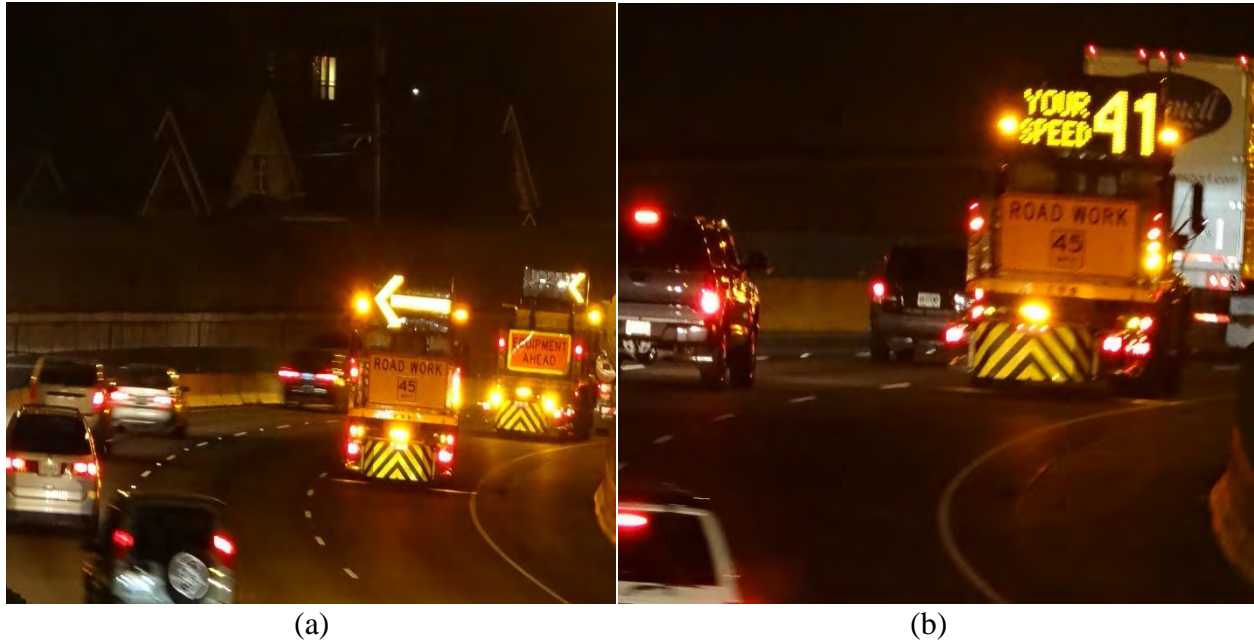
For this case study, in addition to the RSS sign or arrow sign, an advisory speed sign was also mounted on the back of the RSS truck or arrow truck (Figure 3.20). The advisory sign included the words “Road Work” and an advisory speed of 45 mph. Additionally, the information displayed on the RSS was as follows:

Figure 3.20: Advisory Speed Sign during (a) First Night of Testing and (b) Second Night of Testing (Case Study #3)

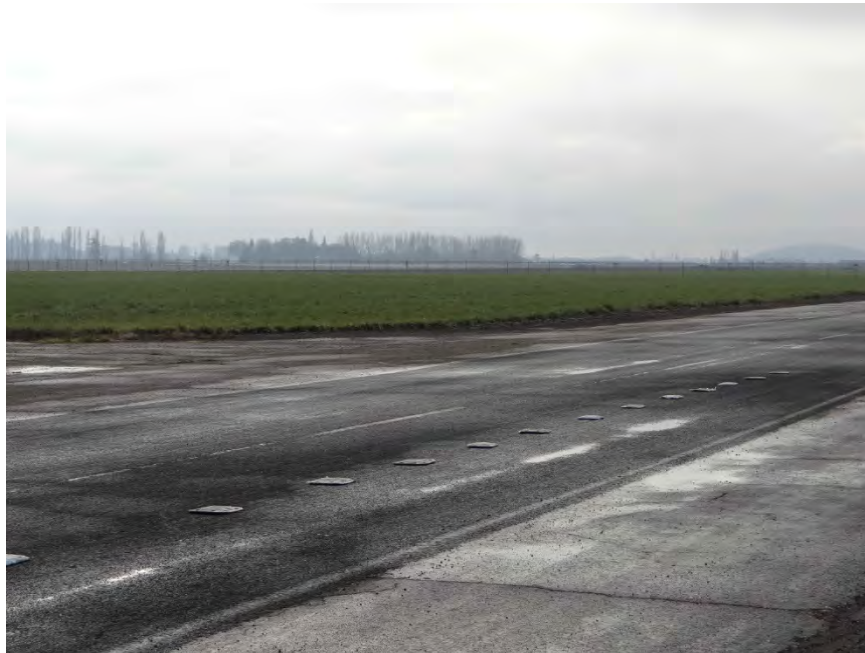
To conduct the testing, the 14 sensors used for the data collection in the case studies were placed on a roadway in the center of the lane approximately 2 feet apart in a straight line during the first preliminary test. Figure 3.23 shows the layout of the sensors for pre-testing. The researchers then drove over the sensors multiple times at different speeds. In addition, the researchers recorded the vehicle speed at the sensor location using the RSS unit and radar speed gun in order to verify the actual speed of the vehicle. The researchers drove over the sensors three times at each of the following speeds: 20 mph (average of 21, 19, and 20 mph), 29.67 mph (average of 29, 30, and 30 mph), 40 mph (average of 40, 40, and 40 mph), 48.67 mph (average of 46, 50, and 50 mph), and 58.67 mph (average of 60, 57, and 59 mph). The data collected from the portable traffic analyzers was downloaded for analysis. Figure 3.24 shows the results of this testing. The figure shows the average of three actual speeds recorded at each of the test speeds for each sensor (identified by the sensor number).

Figure 3.23: Sensor Layout for Sensor Testing

Tests of the accuracy of the traffic analyzers were conducted to calibrate the analyzers and determine how far off the speeds recorded by the analyzers were from the actual vehicle speeds. Having this information then allows for adjusting the speeds recorded during each case study to the actual vehicle speeds.

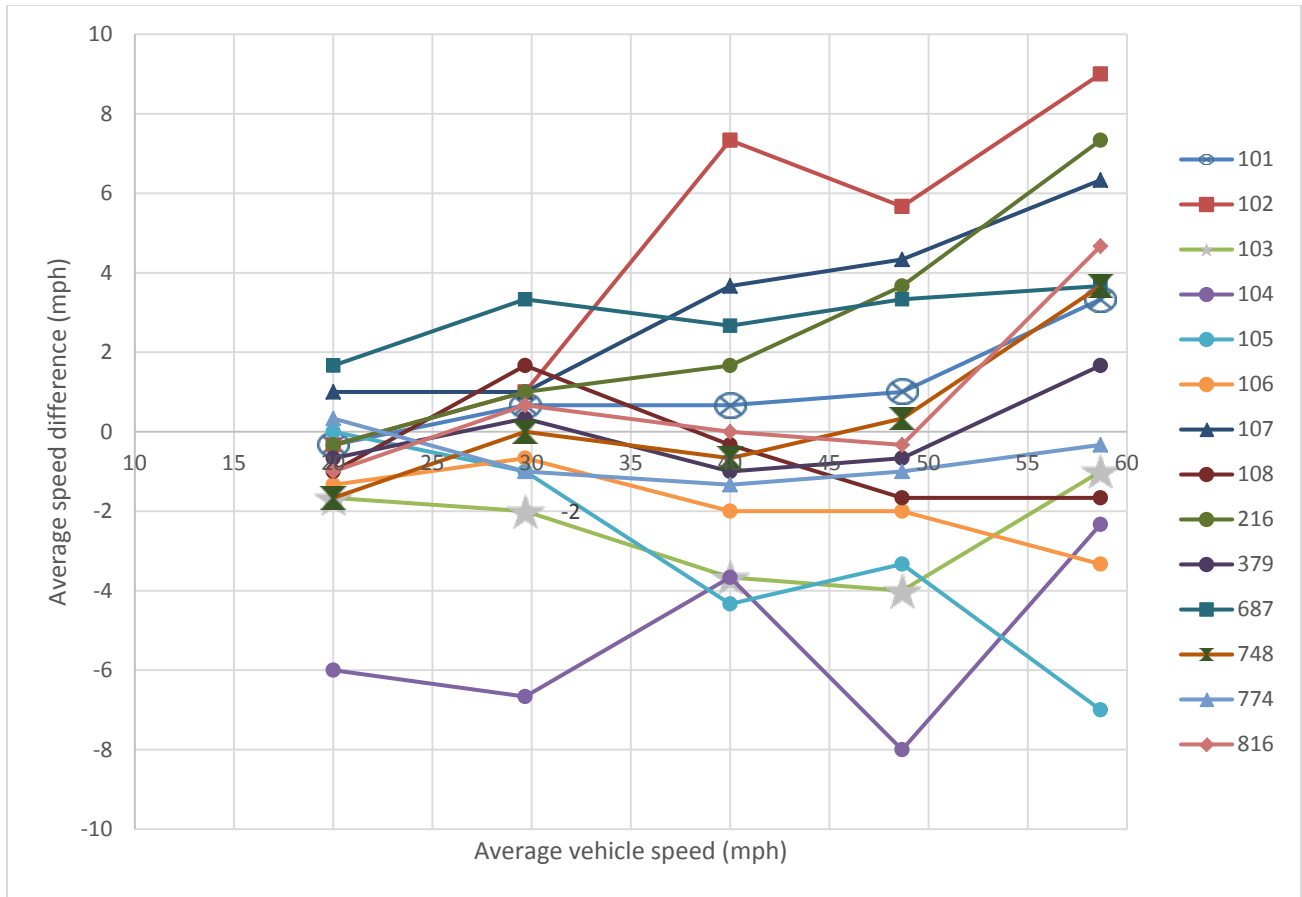
Figure 3.25 displays the difference between the average speed recorded by the sensor and the average actual speed of the vehicle. The x-axis represents the average of the actual vehicle speed. Each line represents data from one sensor. The last three digits of the sensor serial number are used here to identify the different sensors. As seen in the figure, for most sensors, the difference in speed becomes larger as the vehicle speed increases. Sensors #102, #104, #105, and #107 produced significantly more inaccurate results than the other 10 sensors.

Figure 3.25: Sensor Testing – Average Speed Difference from Actual Speed

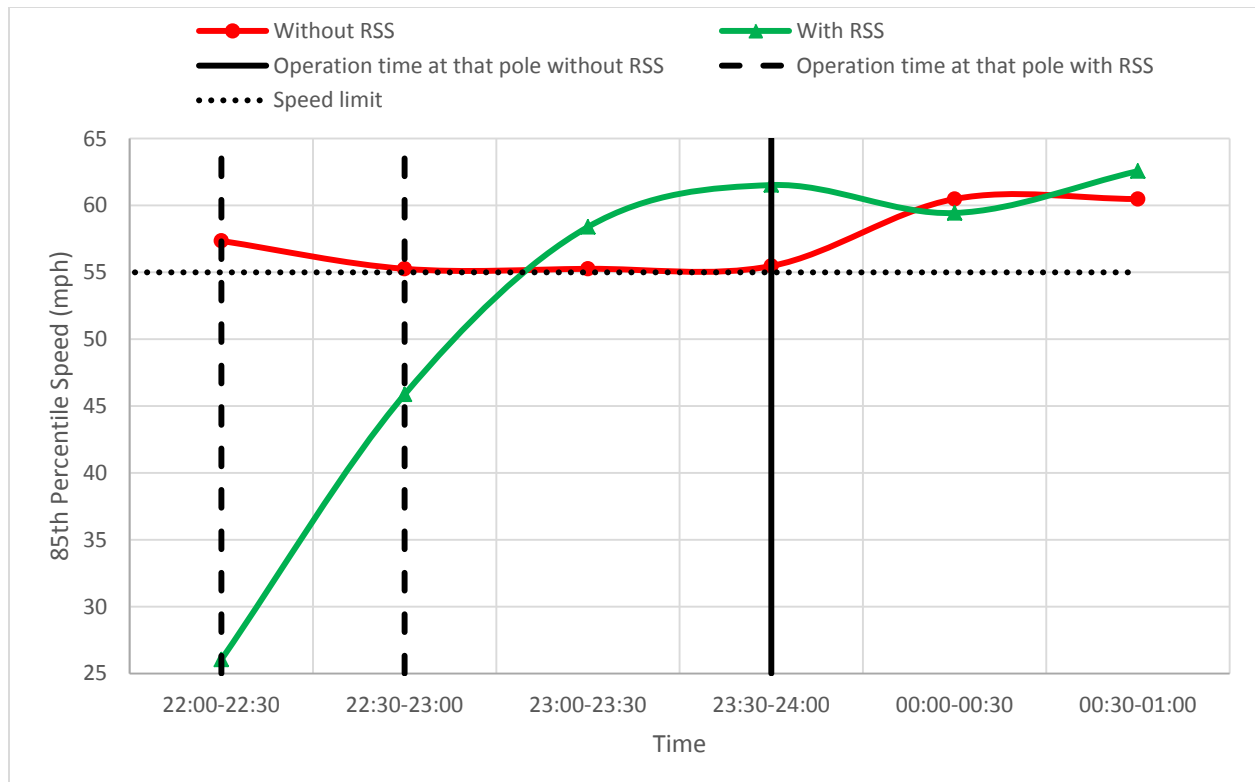
Figure 4.4 also shows that the vehicle speeds are lower when adjacent the work equipment. For example, between 23:30 and 24:00 on Day 1 without the RSS turned on, the work took place at Pole #5. At this time, the 85th percentile speed was approximately 55 mph, the same as the posted regulatory speed limit. On the second day of testing (with the RSS turned on), the work on Pole #6 took place earlier in the evening. From 23:30-24:00 on Day 2 there was no work going at Pole #6 and the 85th percentile speed was approximately 62 mph, which was higher than on the prior day at the adjacent Pole #5.

Figure 4.4: Vehicle Speed (85th Percentile) at Pole 5 (Without RSS) and Pole 6 (With RSS) during Operation Time, I-205, Relamping
