**BASELINE DATA FOR ASSESSING
CLIMATE CHANGE AND FUTURE
ENHANCED SURFACE WATER
PASSAGE IMPACTS ON THE SALMON
RIVER ESTUARY**

Final Report

PROJECT SPR-719

Oregon Department of Transportation

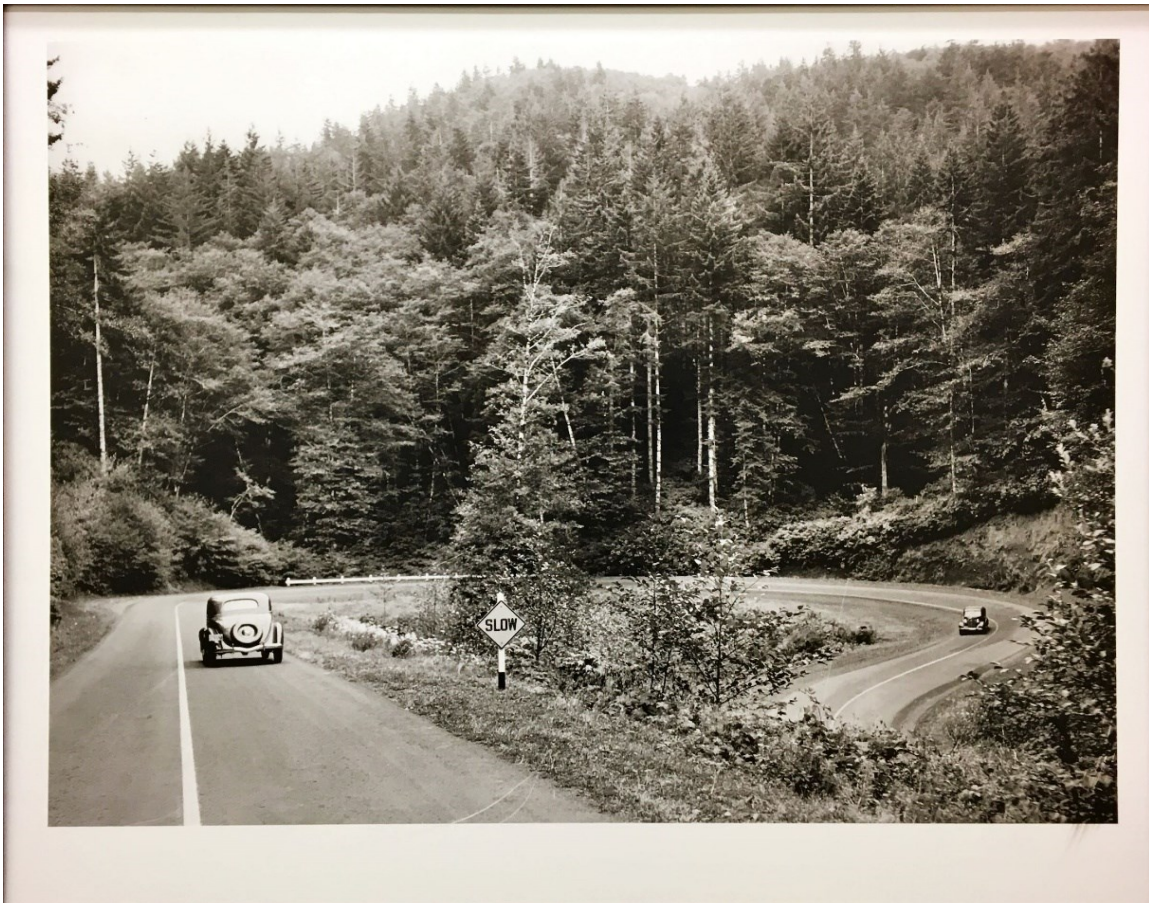
Figure 1.1: A portion of the original US Route 101 north of the Salmon River Estuary, circa 1939.

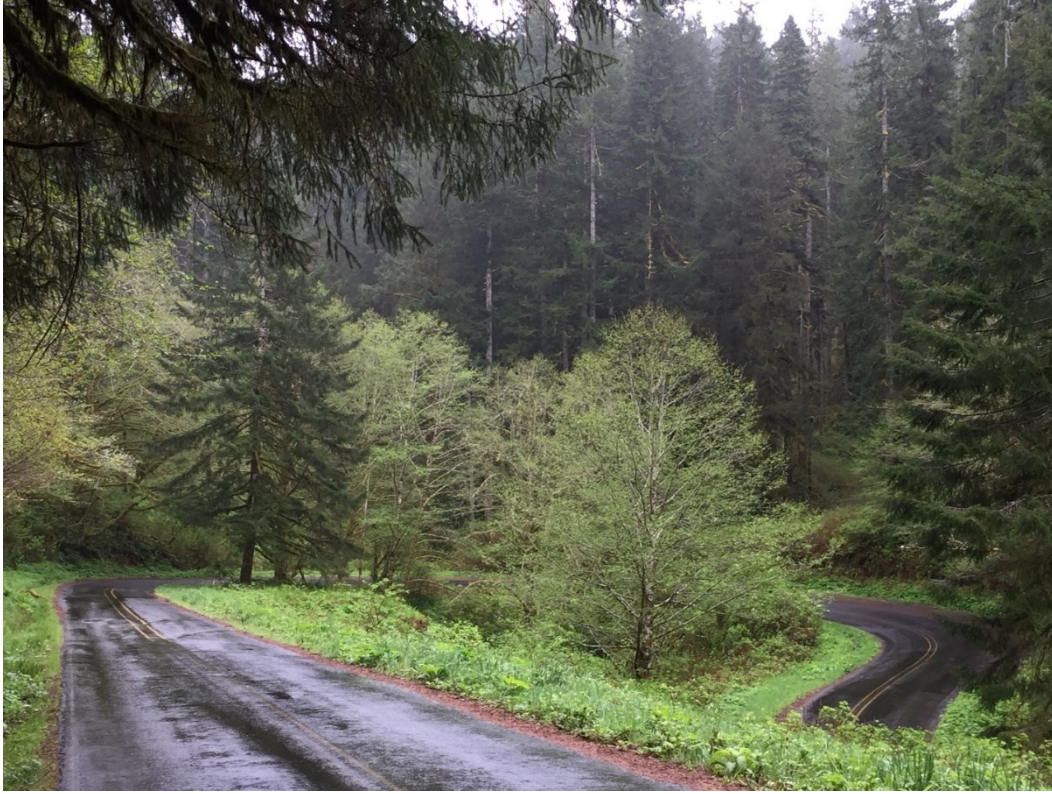
Figure 1.2: The same portion of the original (now former) US Route 101 as shown in Figure 1.1, as it was in 2019.

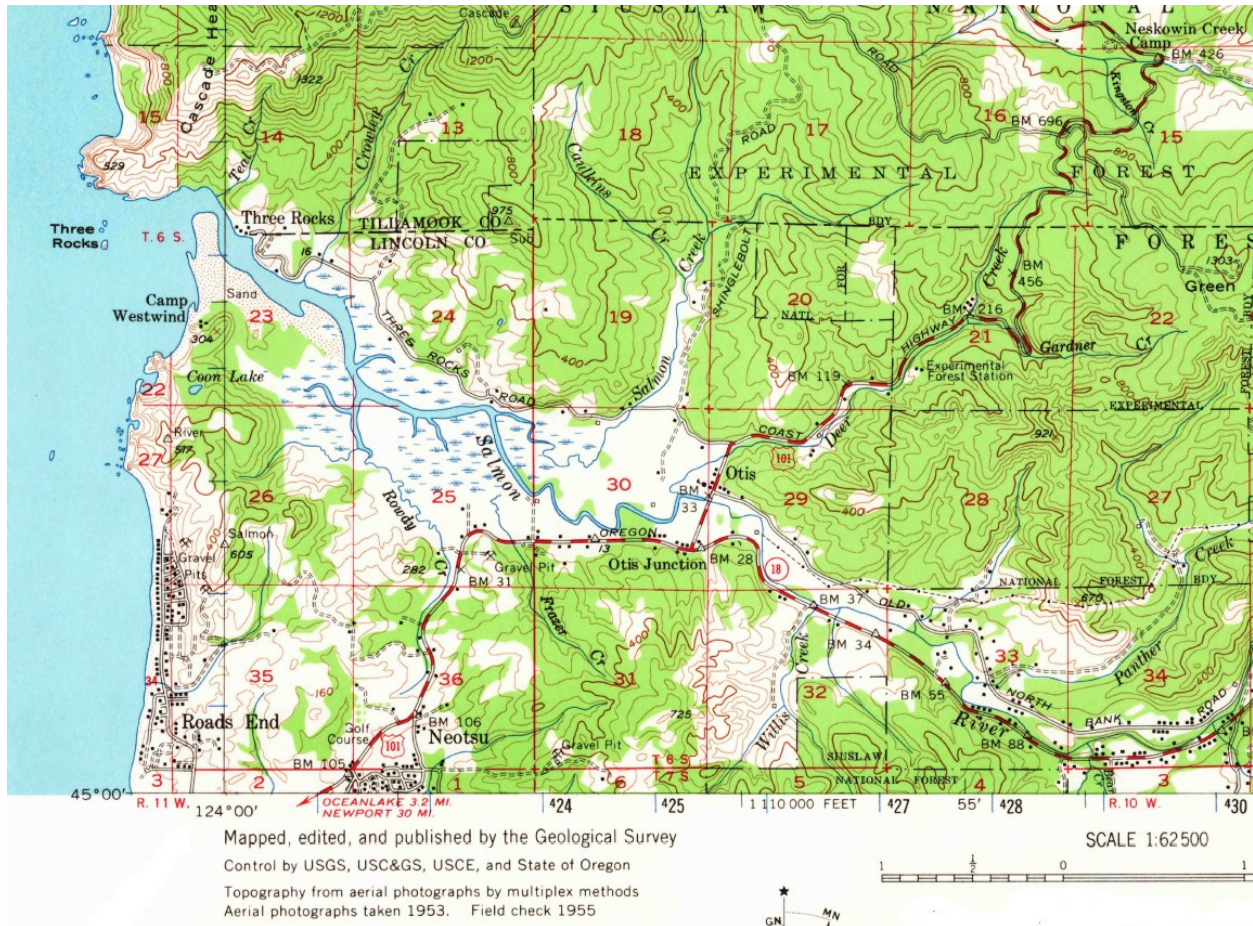
Figure 1.3: Excerpt of 1955 US Geological Survey Topographic Map showing the Salmon River Estuary prior to the construction of the new alignment of US Route 101.

The Salmon River Estuary is far from the largest estuary on the Oregon coast, but it is similar to many estuaries up and down the coast. It is located in a drowned stream valley that has filled with sediment. The topographic map shown in Figure 1.3 does not have sufficient elevation resolution to establish precisely the outline of the estuary. However, the area around the Salmon River west of Otis that is white, lacking both brown topographic contours and forest cover (indicated by green) gives a fair sense of its extent. Three-Rocks Road marks the approximate limit of the estuary to the north. (Oregon) State Route 18 similarly approximates the boundary to the south. The current estuary is a product of the shift from the most recent sea-level low-stand 20,000 years ago, during the last ice age, into the current interglacial climate (Komar, 1997). The estuary is shielded from direct wave action by a sand-spit at the coast where the river empties into the open ocean through an outlet much narrower than the drowned stream valley.

The Salmon River zigzags through the estuary marsh (see Figure 1.3). The term “meander” is intentionally not used due to the apparent stability of the channel location during the period of written history. Several tributary streams join the Salmon River within the area of the estuary. Named streams are Salmon Creek, Frazer Creek, Rowdy Creek and Crowley Creek (Deer Creek joins Salmon River at the upstream edge of the estuary). In addition to the named streams, there are drainages from upland areas that commonly, or constantly, have water running in a channel that drains into the estuary marsh. Usually these connect to one of the several tidal channels. Some tidal channels do not have any connection to an upland stream.

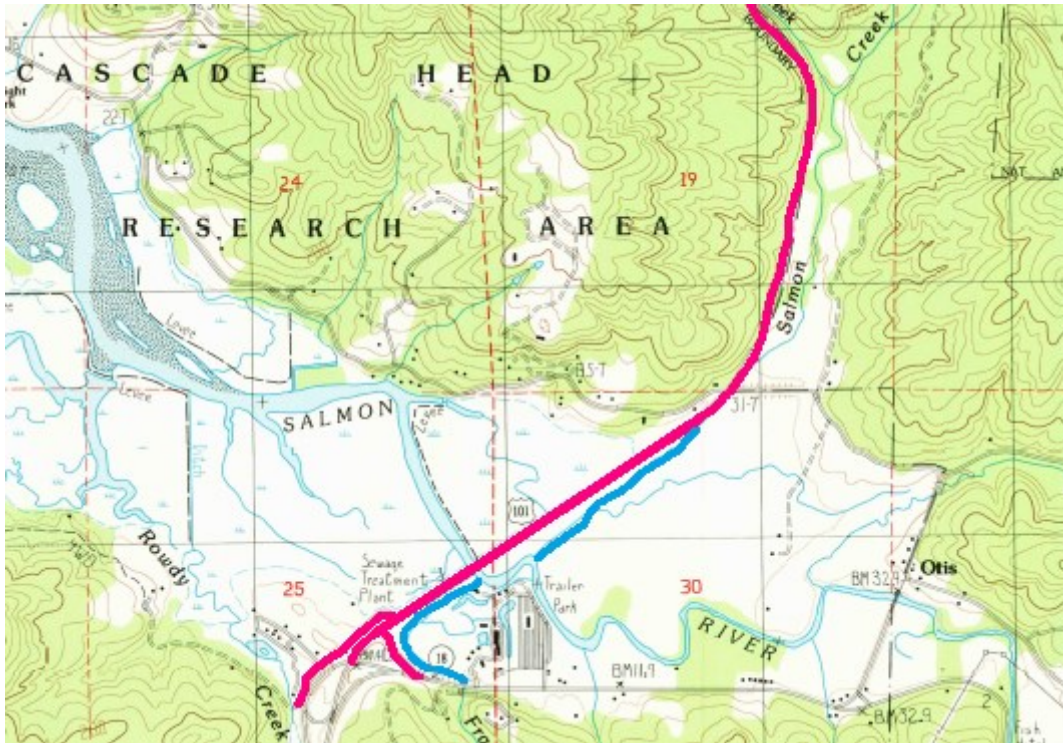
Figure 1.5: Map highlighting the relocated US 101 (wide pink lines) and changes to the course of Salmon Creek and Frazer Creek (wide blue lines)

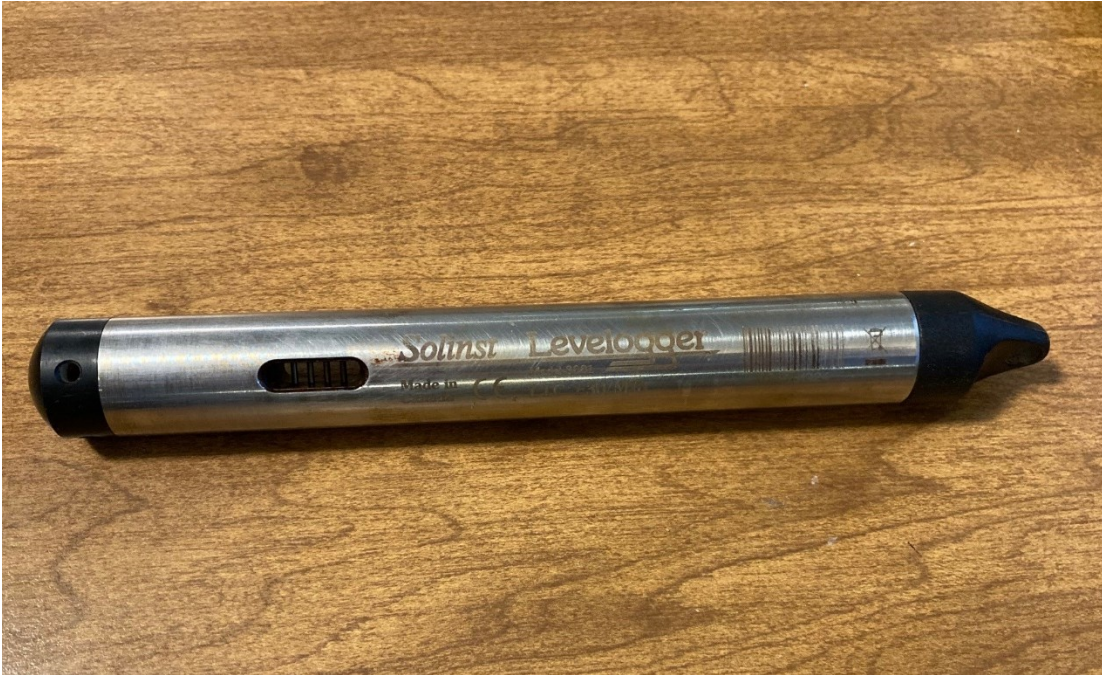
Figure 2.1: Solinst LTC Levellogger Junior devices.

Figure 2.1 shows an LTC Levelogger Junior. The hole visible in the black end on the left is an opening to the pressure transducer. On the right end is the black, screw-on cap that protects the optical data-download interface and provides an attachment point for suspending the instruments when deployed. The metal body of these instruments was stainless steel. The pressure transducers were piezoresistive silicon in 316L stainless steel. The manufacturer's specifications for the LTC Levelogger Junior are as follows:

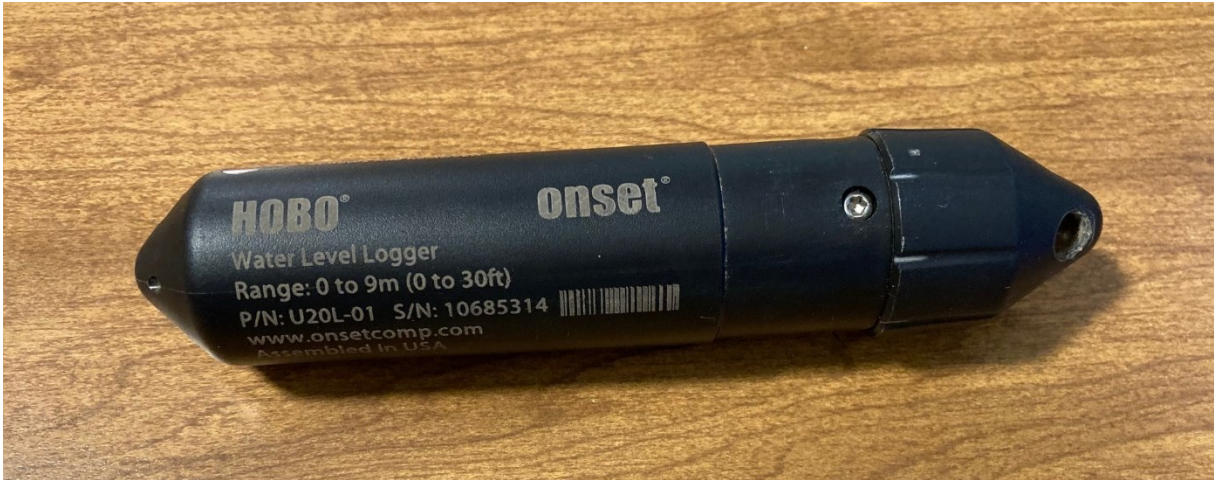
Figure 2.2: Onset HOBO U20L Water Level Logger device.

A combination of U20L (see Figure 2.2) and U20Ti (which have a titanium case, see Figure 2.3) loggers were acquired.

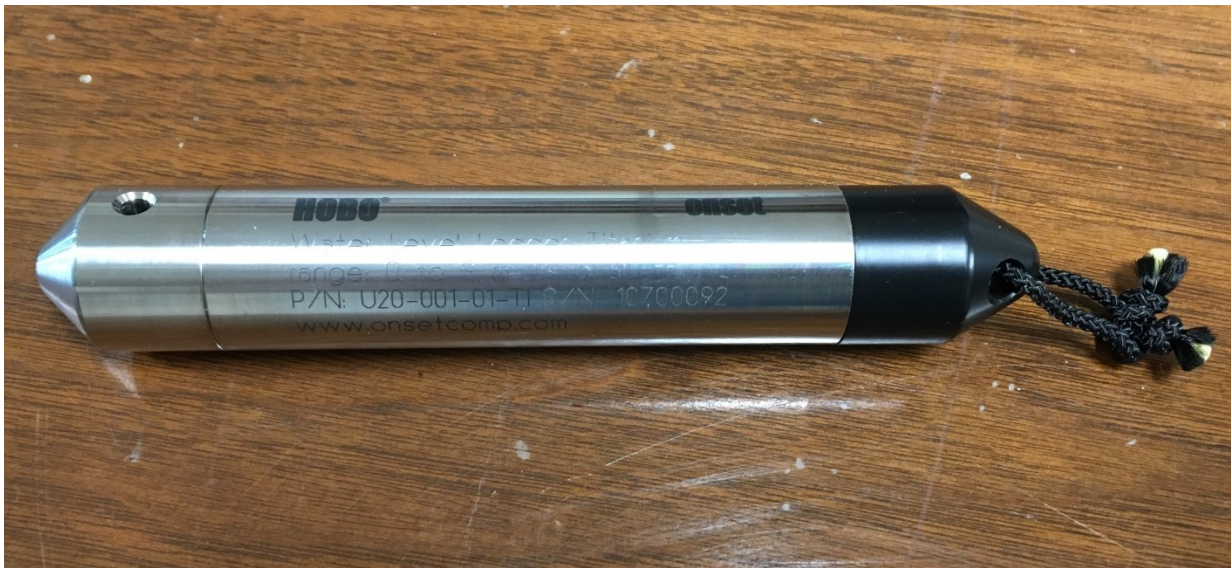
Figure 2.3: Onset HOBO U20Ti Water Level Logger device.

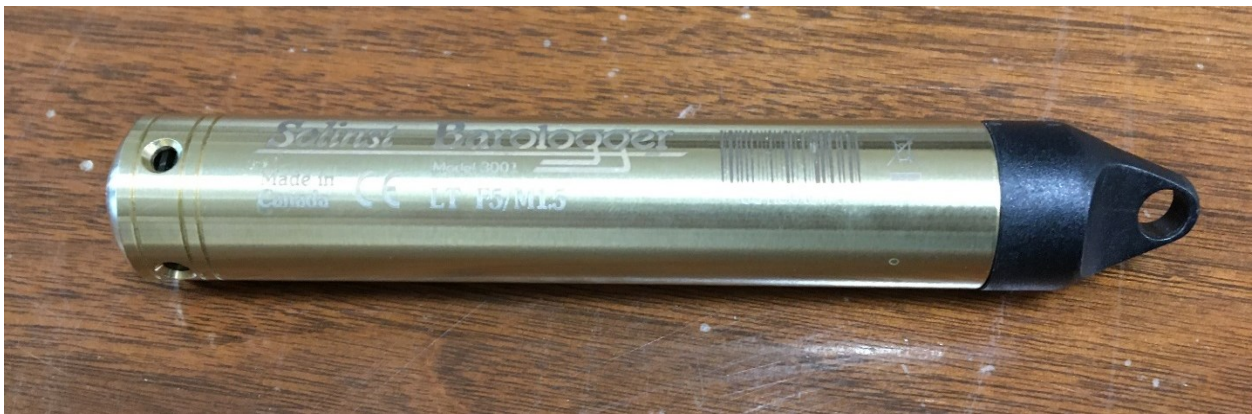
Figure 2.4: Solinst Barologger Gold device.

Using absolute pressure measuring instruments to record water level requires correcting the data for barometric pressure variations. Two Solinst Barologger Gold devices were purchased to record barometric pressure for this purpose. Figure 2.4 shows one of these Barologgers. These devices can record 40,000 sets of values (barometric pressure and temp.) and have a published accuracy of 0.1 cm (0.002% of full scale, which was 1.5 m). By being deployed in the air above the water these instruments allow the varying atmospheric pressure to be subtracted from the total pressure recorded by the water level instruments.

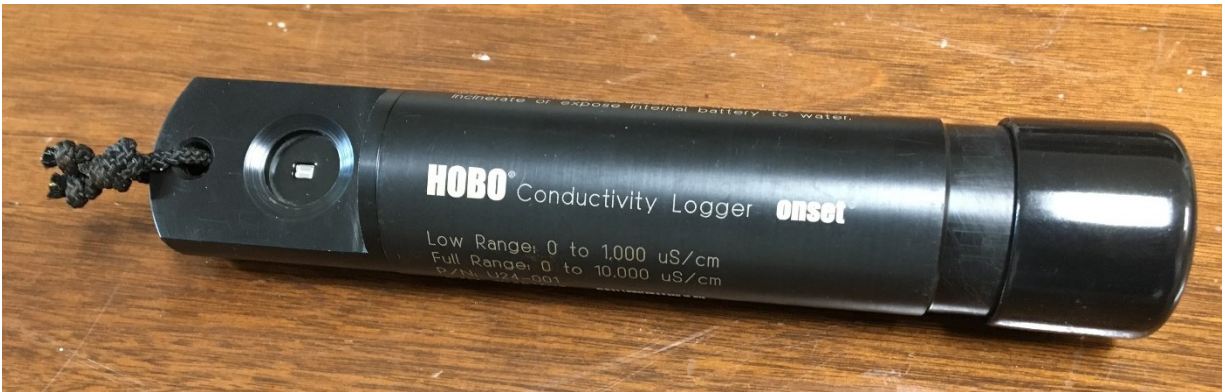
Figure 2.5: HOBO Conductivity Logger device.

Figure 2.5 shows a HOBO Conductivity logger. The small silver-colored rectangle on the left is the conductivity sensor. The black cap on the right covers the optical data-download interface.

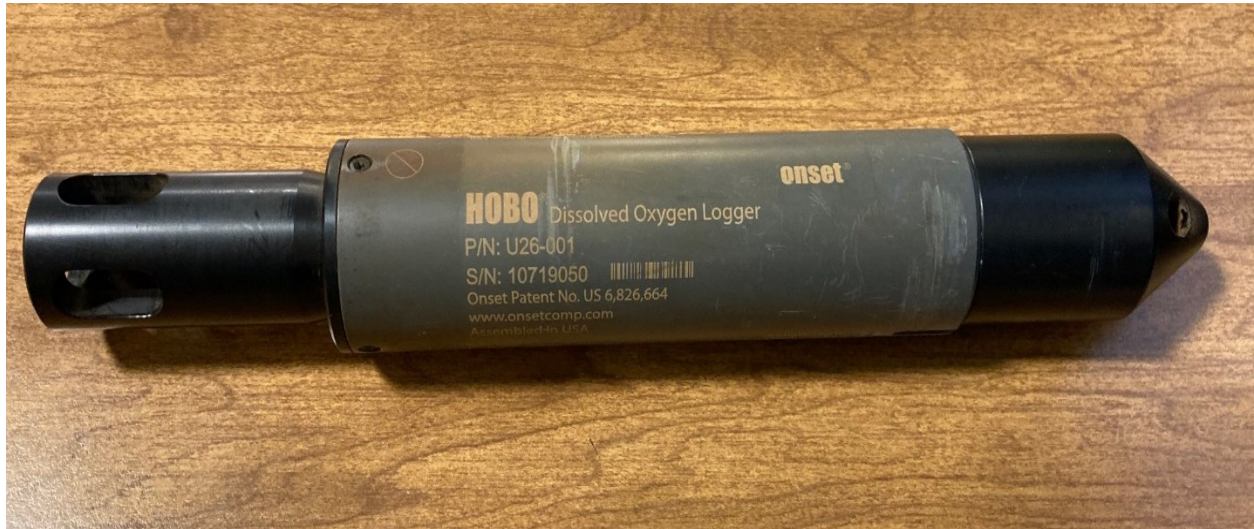
Figure 2.6: HOBO Dissolved Oxygen Logger

Figure 2.6 shows the HOBO Dissolved Oxygen Logger. To the left is the removable guard that protects the replaceable RDO® (Rugged Dissolve Oxygen) sensor. Water passes over the sensor through the openings that can be seen in the photo. To the right is a removable cap that covers the optical data download interface and provides an attachment point.

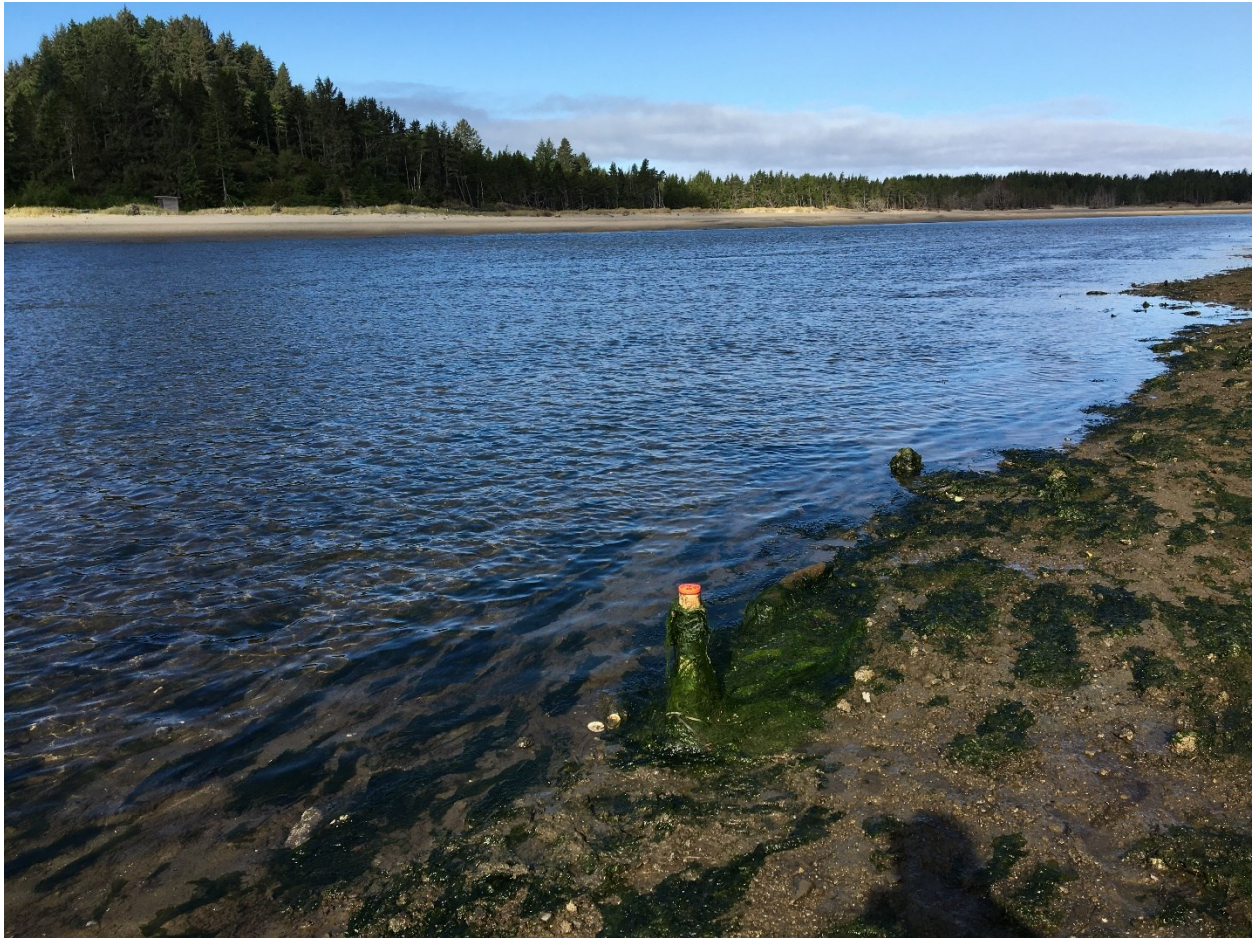
Figure 3.3: Photograph of the Salmon River at Knight Park B station looking to the southwest.

The first station at Knight Park was wiped-out after three downloads, or about 6 months, and the logger was lost. The first station at Knight Park was upstream of the boat ramp and dock and designed to be accessed at any tide (i.e., the PVC extended more than six feet above the riverbed that was exposed at low tide). A second station near Knight Park (referred to as Knight Park B) was established later 2016. Knight Park B was located downstream of the dock and could only be accessed at low tide because it only extended about 1.5 feet above the riverbed at low tide. This was intended to make it a smaller

target for driftwood. Knight Park B survived until the end of the project. Figure 3.3 shows the Knight Park B station. No photograph was taken of the original Knight Park station before it disappeared.

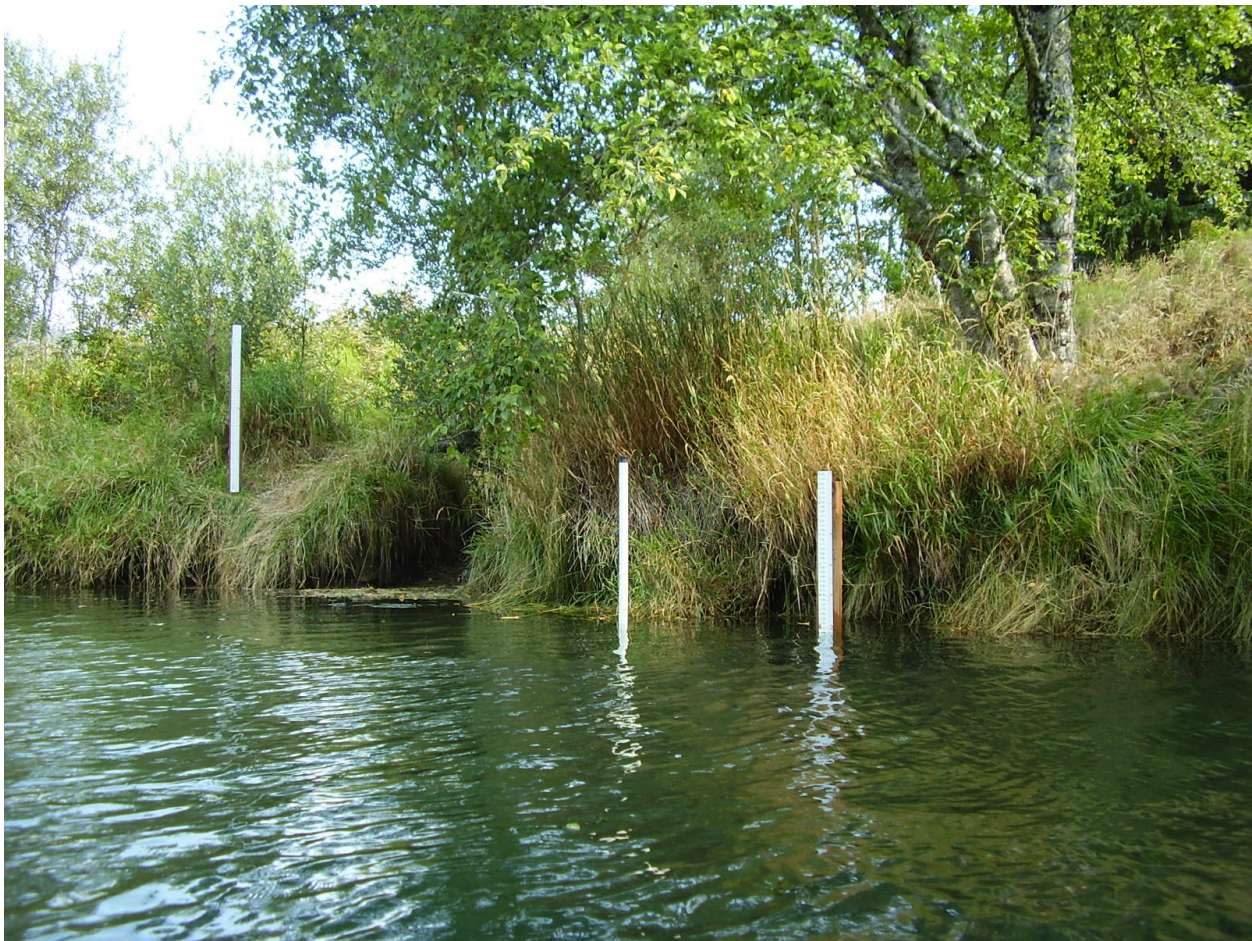
Figure 3.4: Photograph of the Salmon River at US Route 101 station. Photograph taken looking downstream, facing north.

Figure 3.4 shows the station at the US Route 101 bridge. It should be noted that this station shows what was originally envisioned for all the station installations. The plan was to install two 4"x6" pressure treated posts with staff gauges attached. They were to be positioned at different elevations so as to cover the complete range of tides possible. The PVC pipe, which would act as a stilling well and protection for the logging devices was to either be attached to the lower post or driven into soft sediment. The soft nature of the sediments in the estuary made the posts with staff gauges impractical at most stations. At the lower position, a posthole would often not stand open long enough to allow a post to be properly set. At the US Route 101 bridge station, the upper post was immediately put into use by anglers as an aid to climbing the bank. It was quickly knocked out of position by the load and the erosion of the stream bank caused by their scrabbling. The lower post was washed away or knocked out of position by driftwood shortly thereafter. This same thing happened at several other stations where posts were installed. Driving the PVC into the soft sediment proved to be generally successful and very stable. In some locations, the sediments were gravel and attempts at driving the PVC did not succeed. The solution at those locations will be described later in this report.

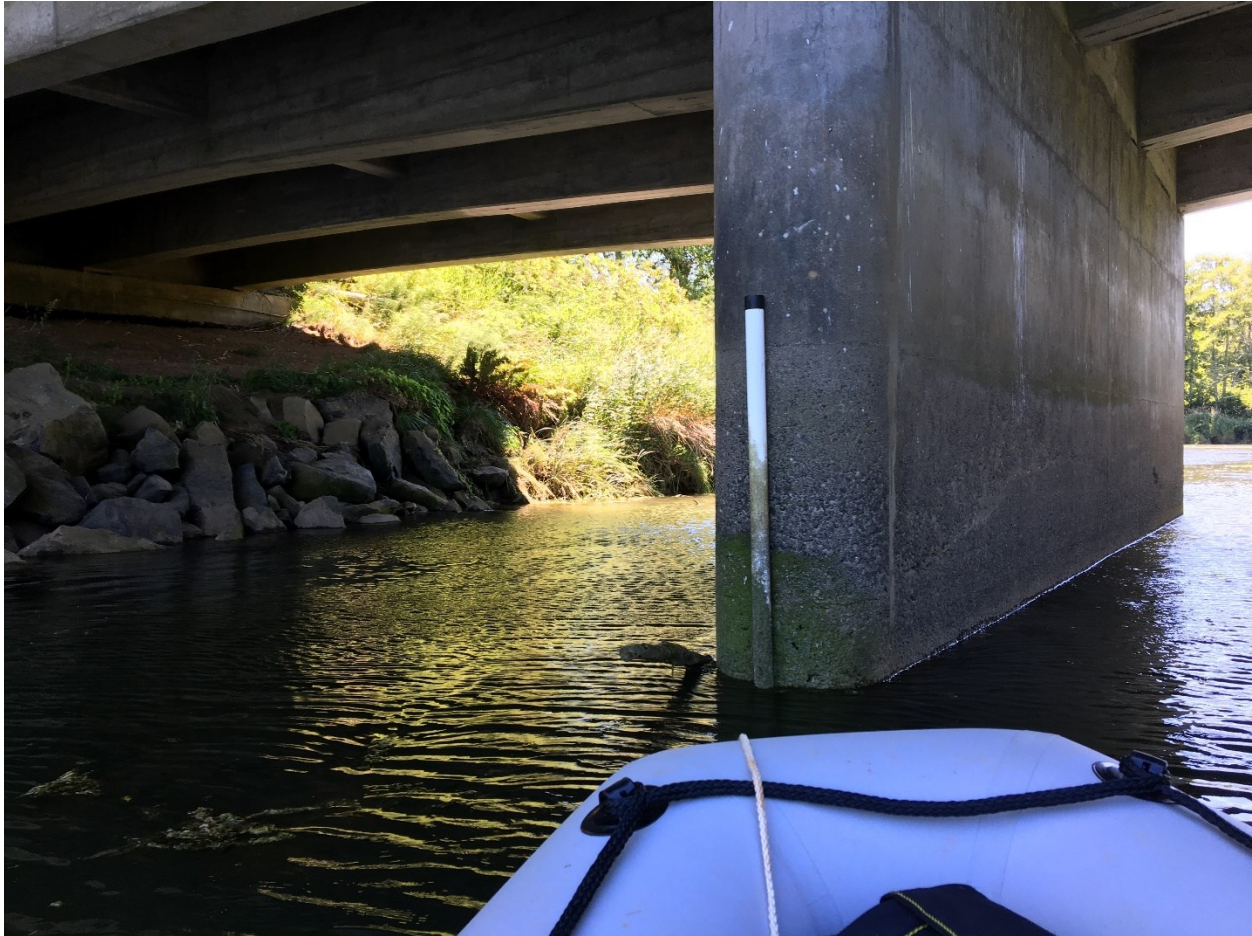
Figure 3.5: Photograph of the station installed on the bridge that carries US Route 101 over Salmon River. The photograph was taken looking upstream, facing southeast.

Figure 3.5 shows the station installation on the bridge. The PVC was secured to the bridge pier with adhesive. This mounting was less vulnerable to driftwood and streambed/stream-bank erosion, but it had the disadvantage of only being accessible by boat or very low river stage. Even at when the river was at low stage, reaching the pier on foot was difficult.

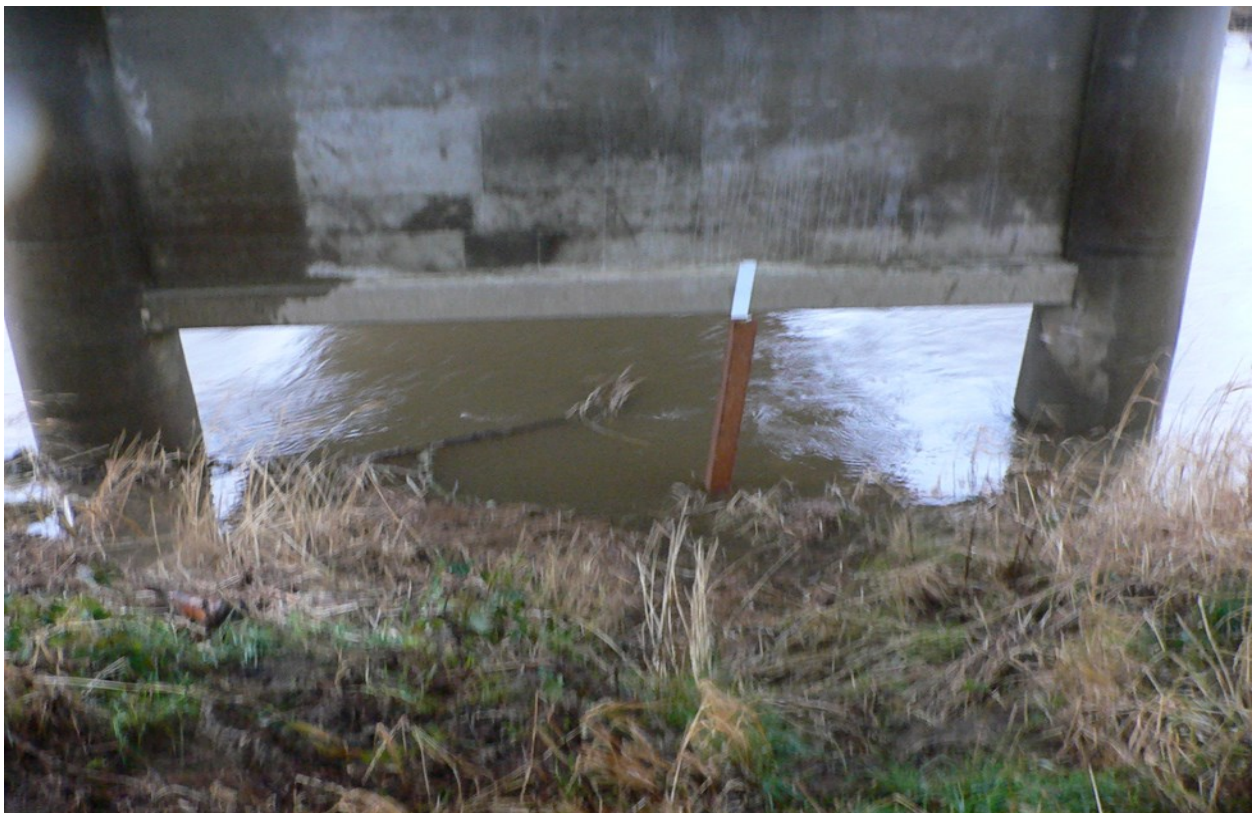
Figure 3.6 shows part of the original Lincoln County bridge station. The post is the upper post of the configuration described earlier. The lower post and PVC were adjacent to the column on the right. Either they were just outside the frame of this photo, behind the column, or they were submerged by the high water.

Figure 3.6: Photograph showing the original Lincoln County bridge station. Photograph taken facing southwest.

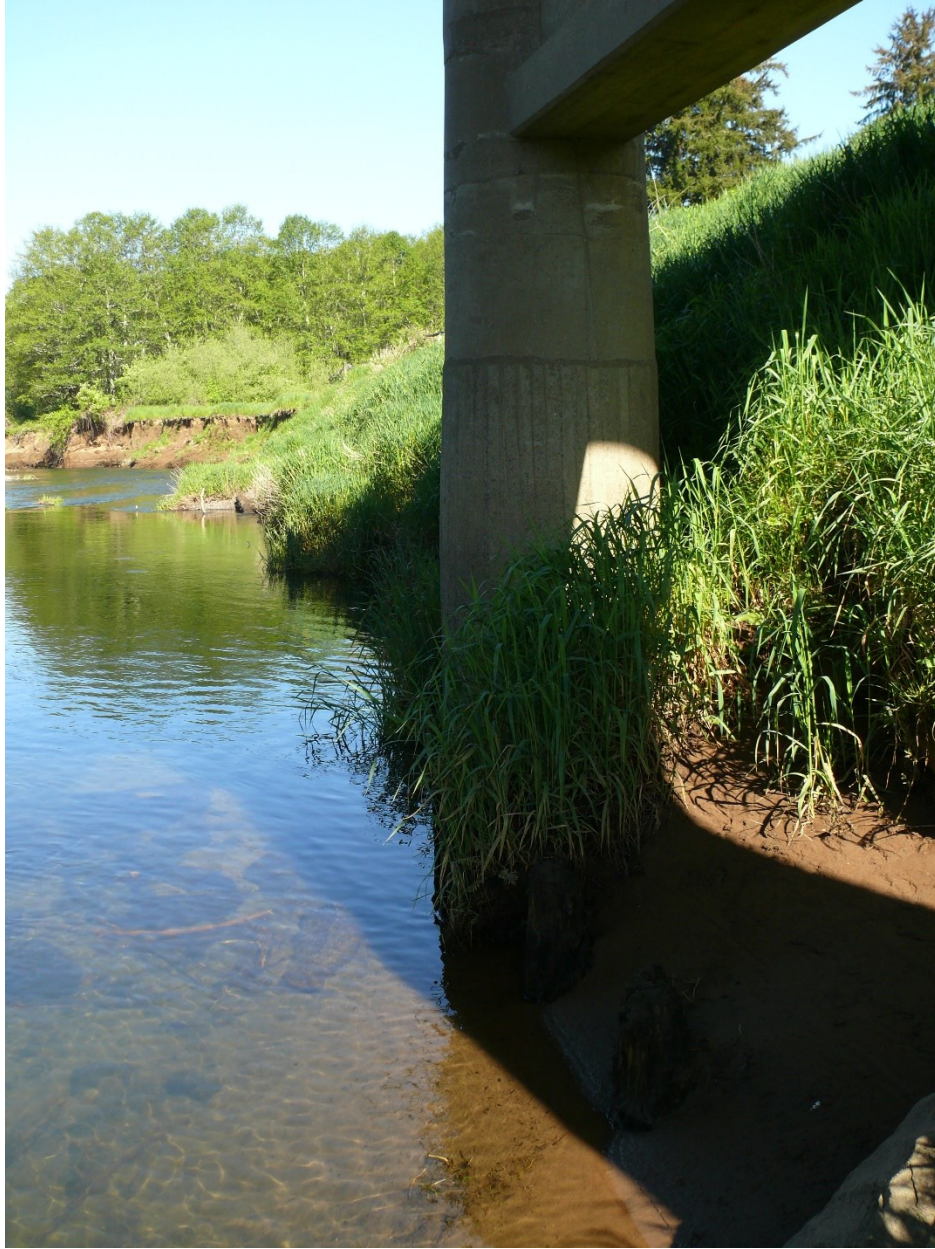
Figure 3.7 shows the location of the Lincoln County Bridge station prior to installation. The lower staff gauge post and PVC were installed to the left, and downstream of the column from the perspective of this photograph. The upper staff gauge was installed on the bank to the right of the column, at the edge of the photograph. The water level in Figure 3.6 was approximately at the level of the pour seam that can be seen in the column in Figure 3.7 and the post was installed in the water of the river for the stage shown in this photograph.

Figure 3.7: Photograph of Salmon River at Lincoln County bridge station location prior to installation. Photograph taken looking downstream, facing west.

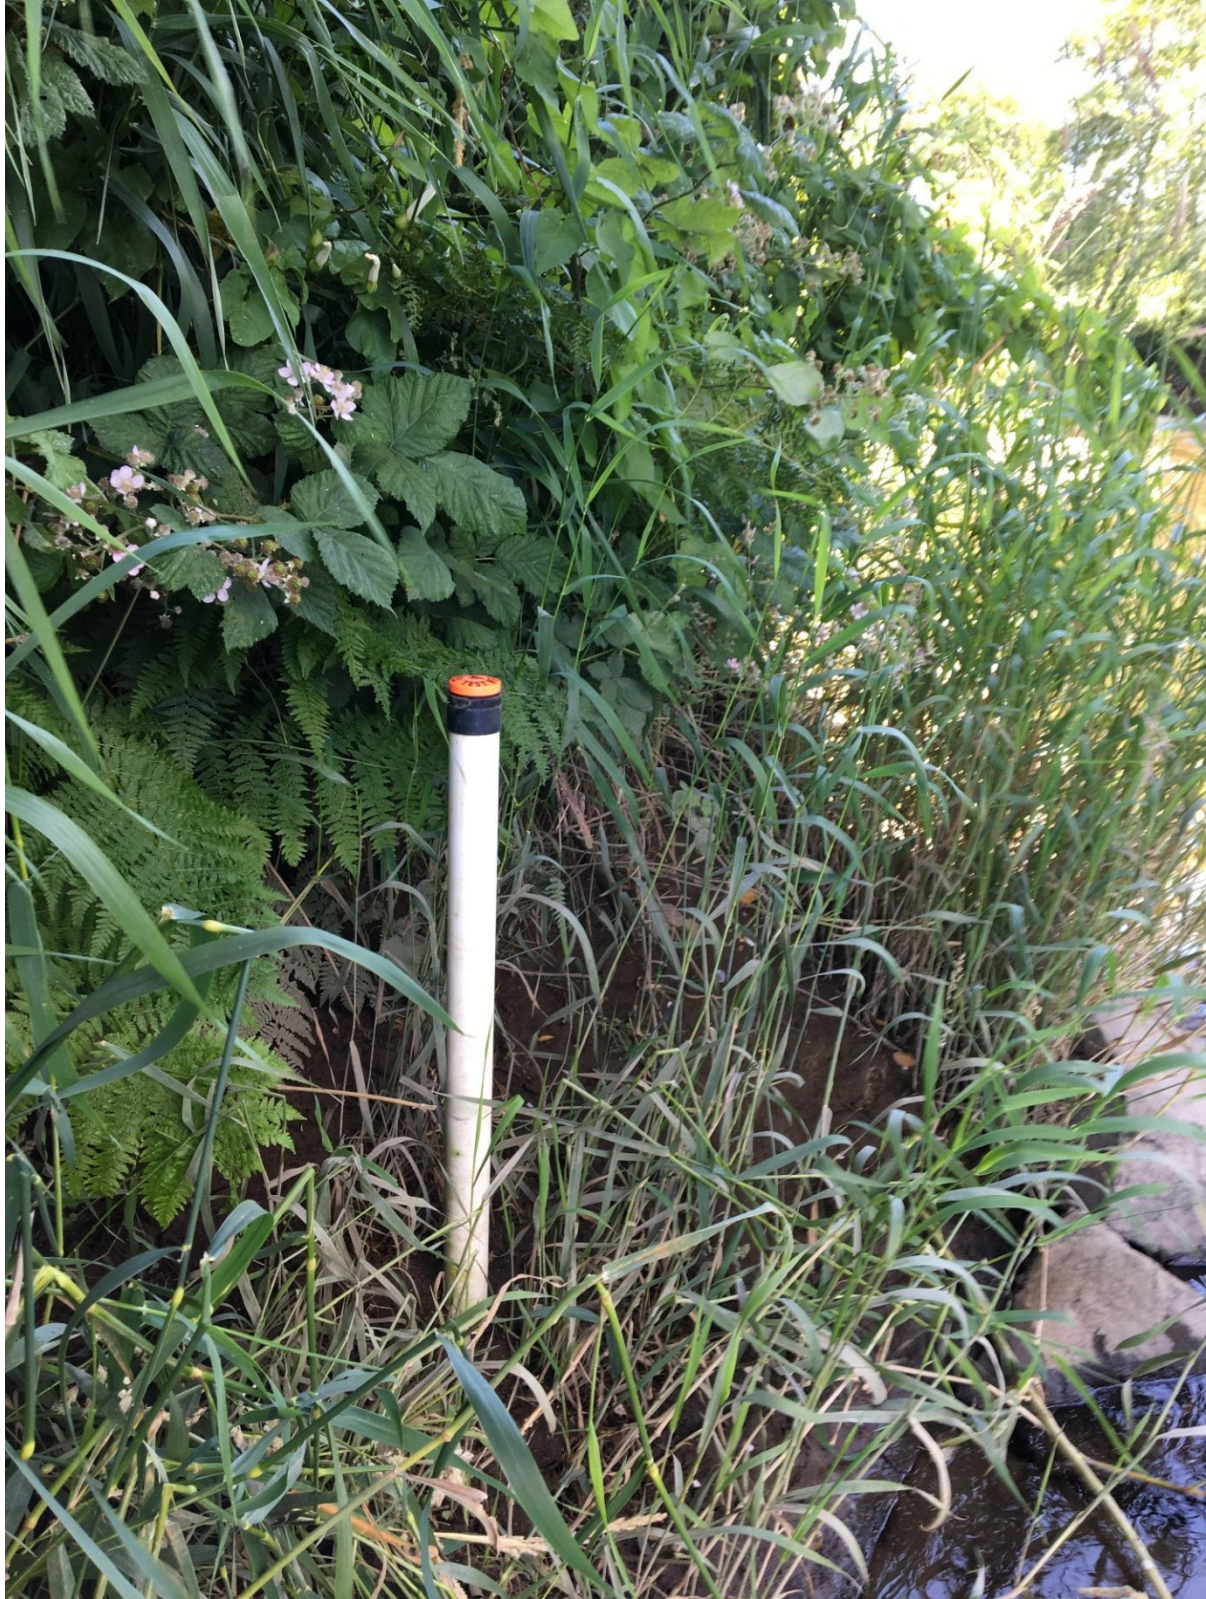
Figure 3.8 shows the second PVC installation at Lincoln County's bridge. In this photo, the accreted sediment has been stabilized by reed canary grass (*Phalaris arundinacea*). When the station was installed, the location was active streambed, with the bed at an elevation several inches lower. It is likely that the bank had been eroded by the same high-water event that destroyed the original station. Riprap can be seen in the lower right of the photograph.

Figure 3.8: Photograph of the second installation of the Salmon River at Lincoln County Bridge station. The photograph is taken looking upstream, and the bridge pier is out of frame to the upper left. Photograph taken looking upstream, facing east.

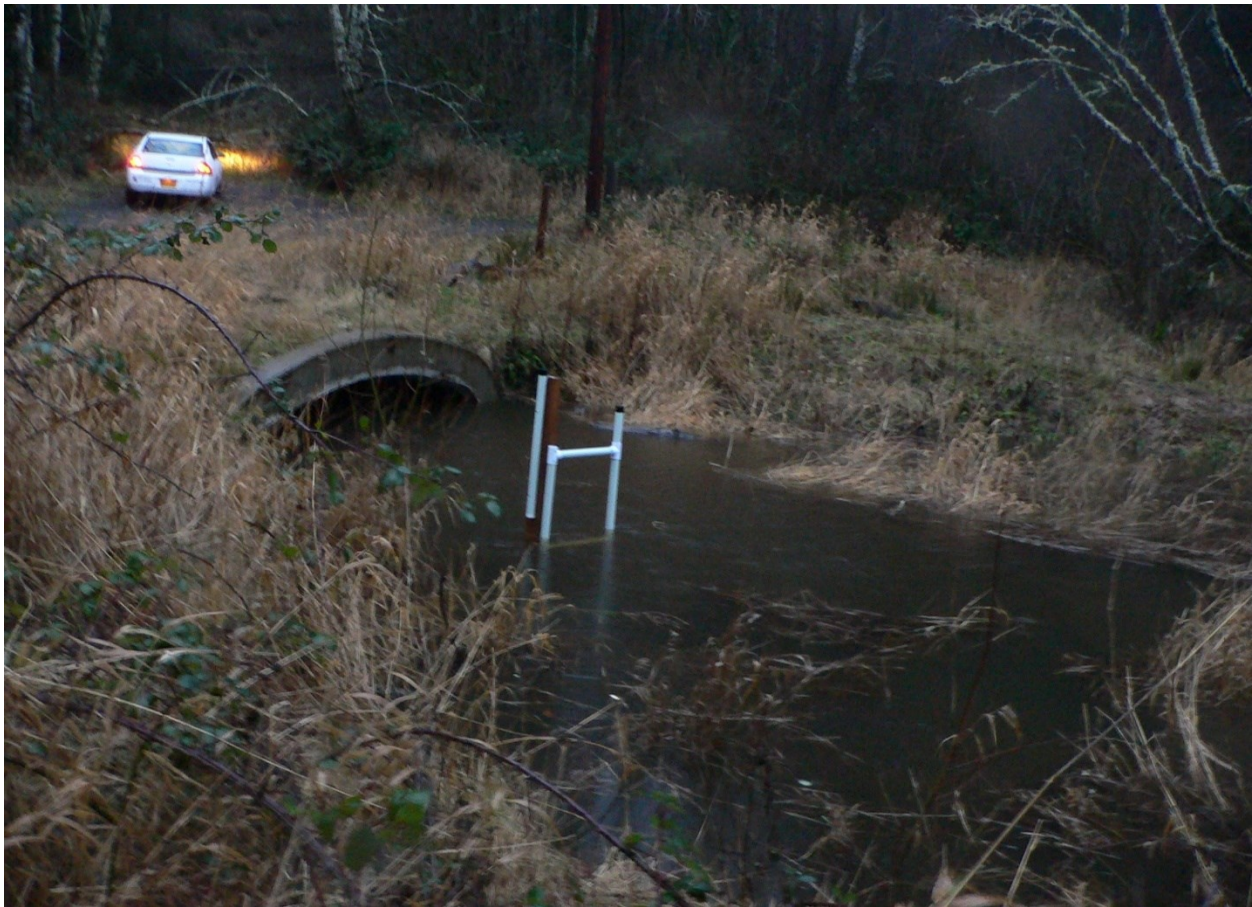
The Rowdy Creek Culvert station was installed at the downstream outlet of the recently completed streambed-simulation culvert on the ODOT frontage road that provides access to some private property. Figure 3.9 shows the station during a high-water event. At the time of this photograph, the vegetation at this location was still reestablishing itself.

Figure 3.9: Photograph of the station at the Rowdy Creek Culvert during a high-water period. Photograph taken looking upstream, facing southwest

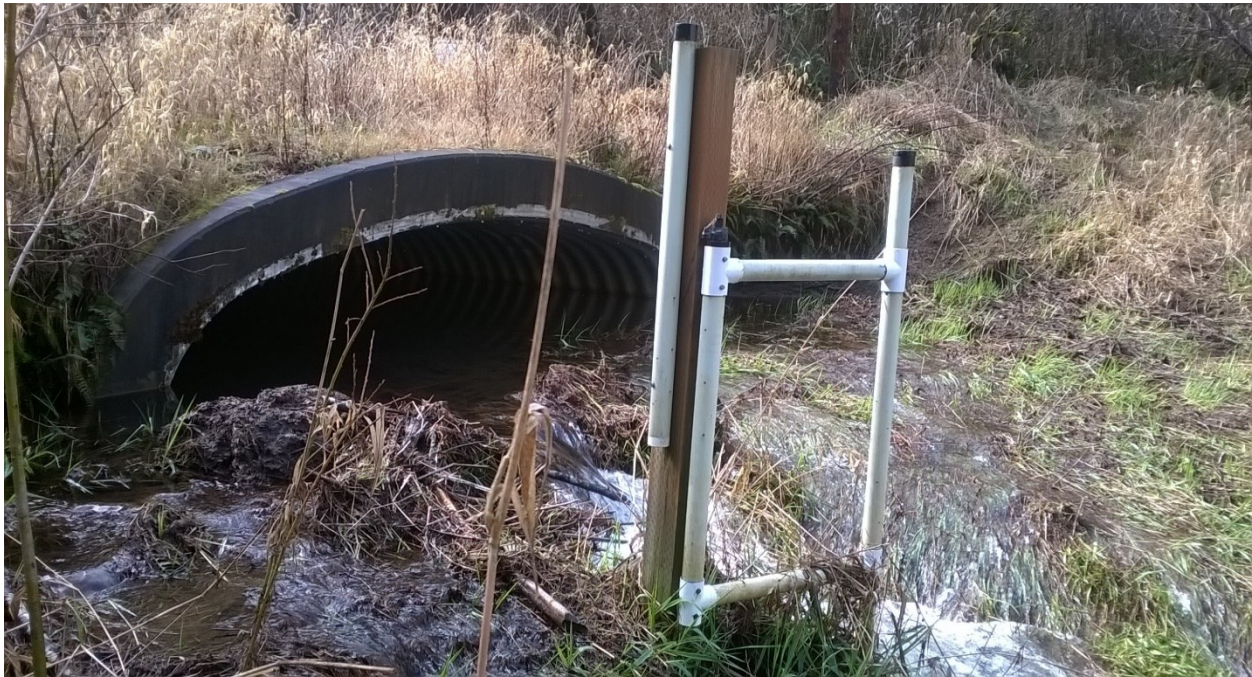
Figure 3.10: Photograph of the station at the Rowdy Creek Culvert showing the Beaver dam that was built and changed normal flow conditions. Photograph taken looking upstream, facing southwest.

Figure 3.10 shows the Rowdy Creek Culvert station during low water, but after a beaver had built a dam at the culvert outlet. The construction of this dam changed the flow conditions at the station and the streambed down-cut several inches at the PVC relative to where it was before the dam was built.

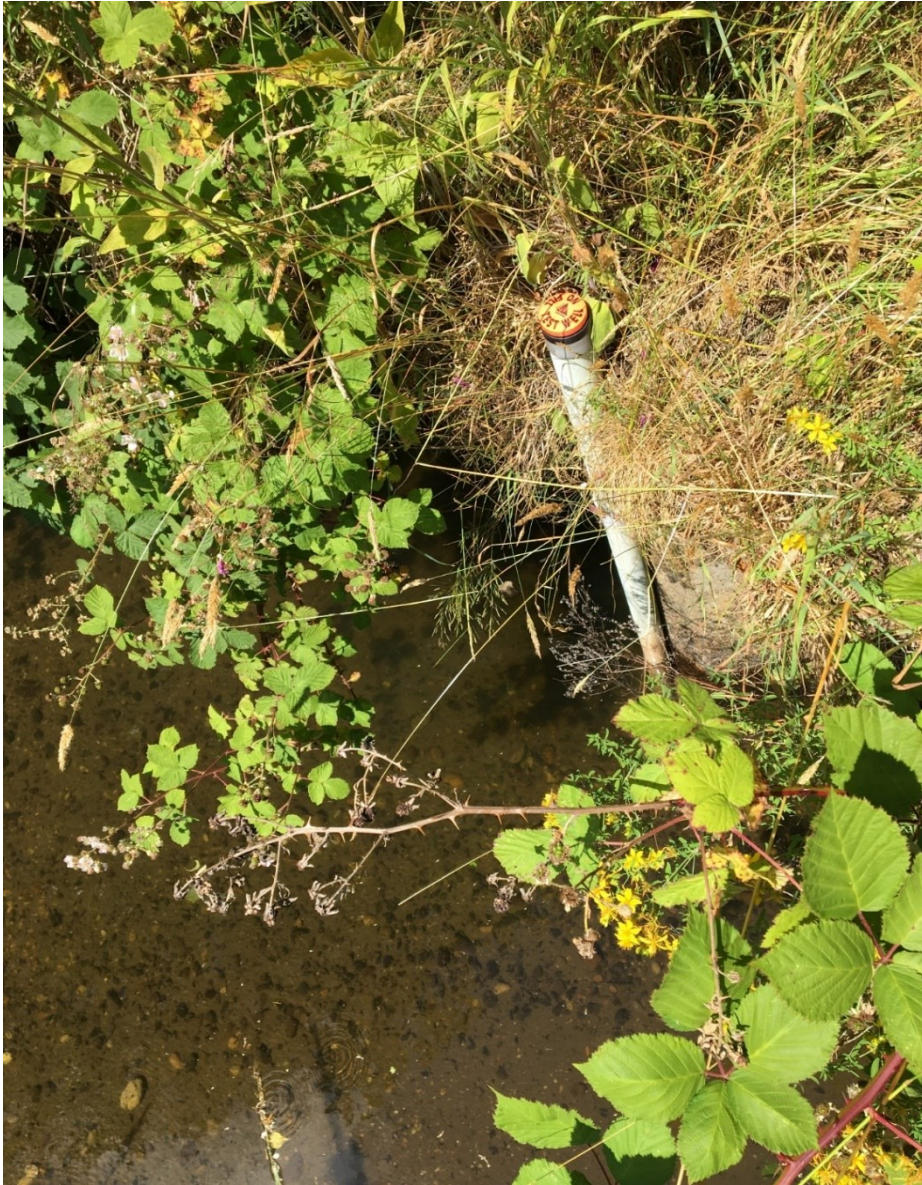
Initially, the station for Salmon Creek at Three-Rocks Road was built using the post method in a gravel bar. The post was washed away before a logger was even installed, even though immediately after that occurrence the gravel bar immediately grew back larger and persisted for the entire remainder of the project. Later, permission was granted to attach PVC to the culvert that carries Salmon Creek under Three-Rocks Road. Figure 3.11 shows this installation. This station is down in the vegetation above the culvert and the caps are not easy to remove without the specialized tool for loosening them. Despite this, on two occasions the logger disappeared from this station, presumably stolen.

Figure 3.11: Photograph of the Salmon Creek at Three-Rocks Road station. Photograph taken looking at the culvert outlet, facing northwest.

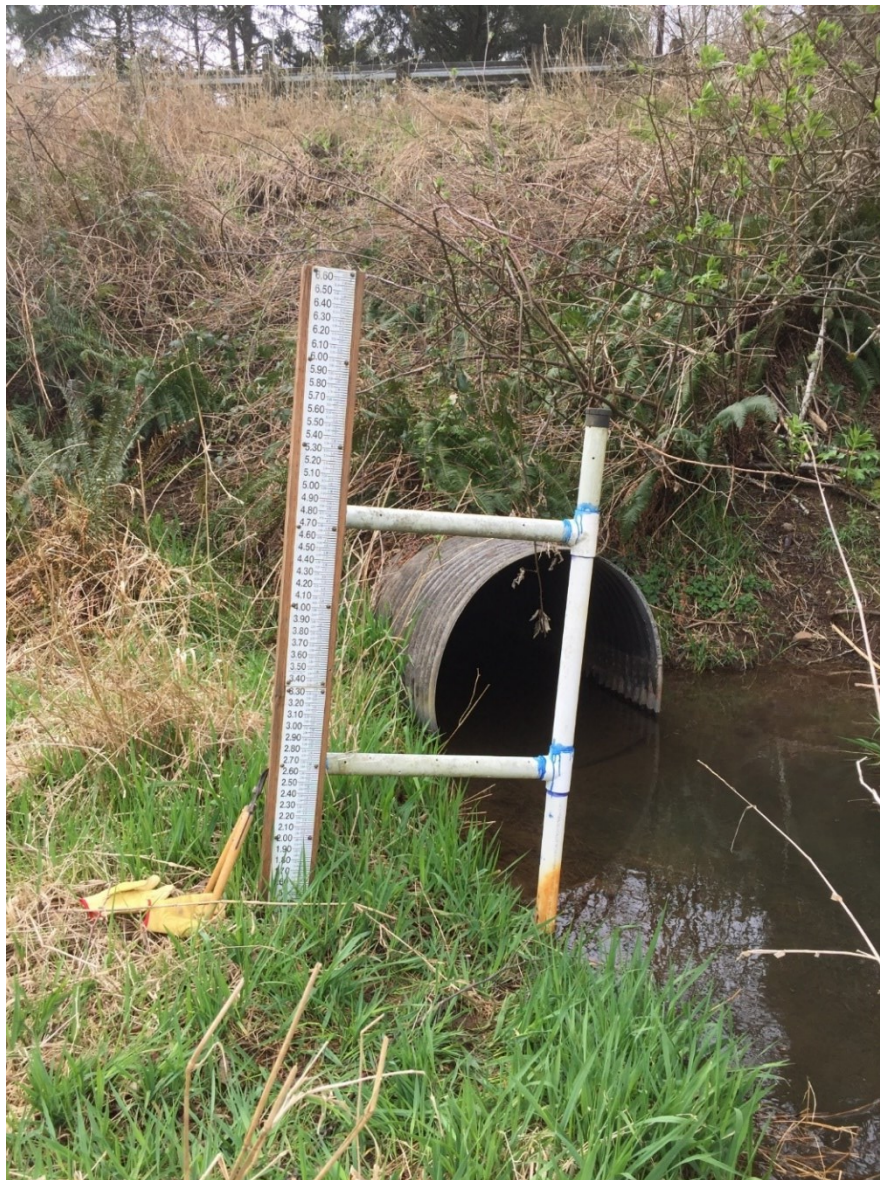
Figure 3.12: Photograph of the Frazer Creek at Oregon Route 18 station.

Figure 3.12 shows the station where Frazer Creek crosses under Oregon Route 18. This photograph was taken in March of 2019. This is when the leaning of the post was first observed. The blue and purple staining of the PVC cement and primer is evidence of the rebuilding of the station after the PVC was broken in the Spring of 2018, presumably due to debris that came through the culvert. The logger was recovered from downstream. In January of 2020, the station was discovered completely washed out. Again, the logger was recovered downstream. The station was not rebuilt after this.
