**BASELINE DATA FOR ASSESSING
CLIMATE CHANGE AND FUTURE
ENHANCED SURFACE WATER
PASSAGE IMPACTS ON THE SALMON
RIVER ESTUARY**

Final Report

PROJECT SPR-719

Oregon Department of Transportation

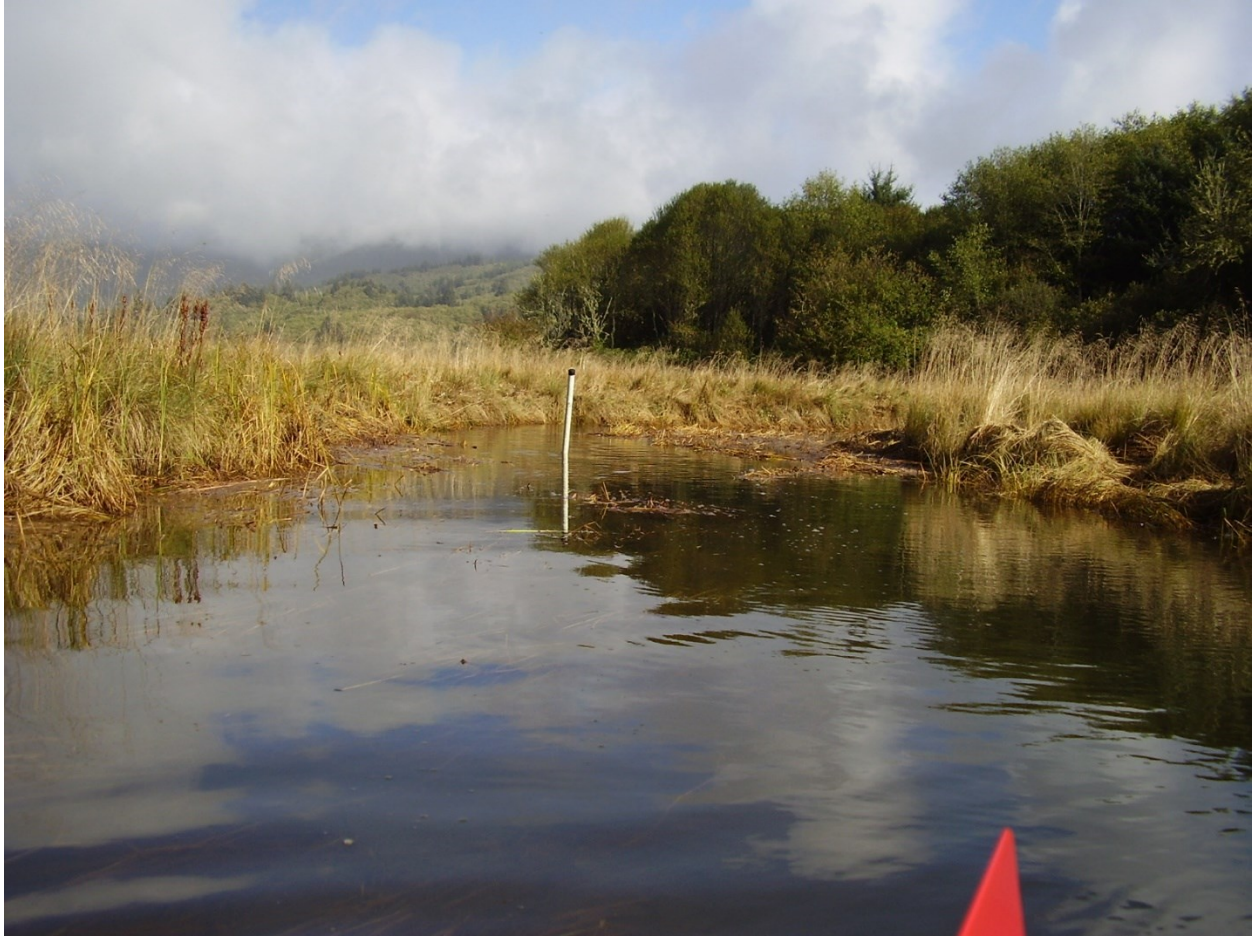
Figure 3.13: Photograph of the Rowdy Creek Upstream station. The photograph was taken looking in the upstream direction, facing north.

Figure 3.13 shows the Rowdy Creek Upstream station. This station was apparently struck by debris coming down Rowdy Creek shortly after installation and leaned slightly downstream from that point until the station was broken off during the winter of 2013-2014. The logger was lost at that point. New PVC was installed in April of 2016 and survived to the end of the project.

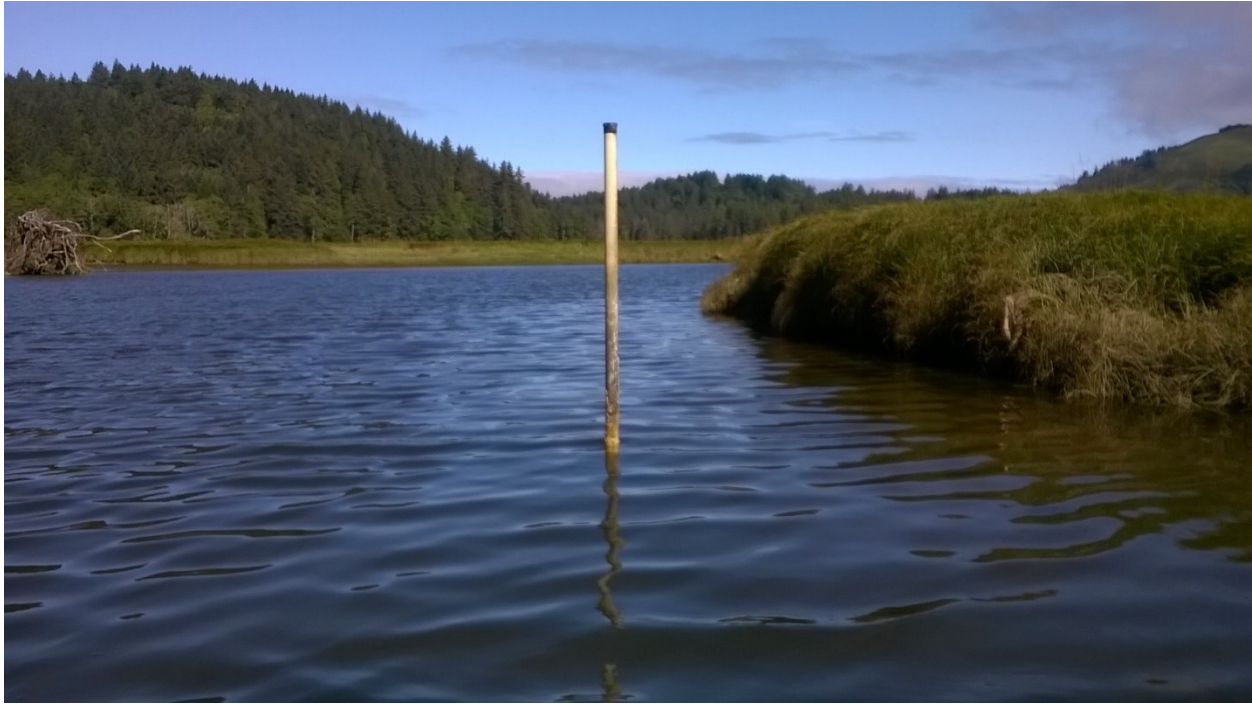
Figure 3.14: Photograph of the Rowdy Creek Downstream station. The photograph was taken looking in the downstream direction, facing west.

Figure 3.14 shows the Rowdy Creek Downstream station. This station remained in place for the entire duration of the project. The four data gaps in this station's record are due to the cleaning and calibration exercise in the summer of 2012, two logger failures, and one failure of the download device. The PVC pipe installed for the dissolved oxygen logger at this station is not shown in this photograph. This station was selected as one to host a dissolved oxygen logger because it is one of the channels in the estuary with a constant source of fresh water. This would be the situation for the area to the west of US 101 and north of the Salmon River if Salmon Creek were to be restored to its former course.

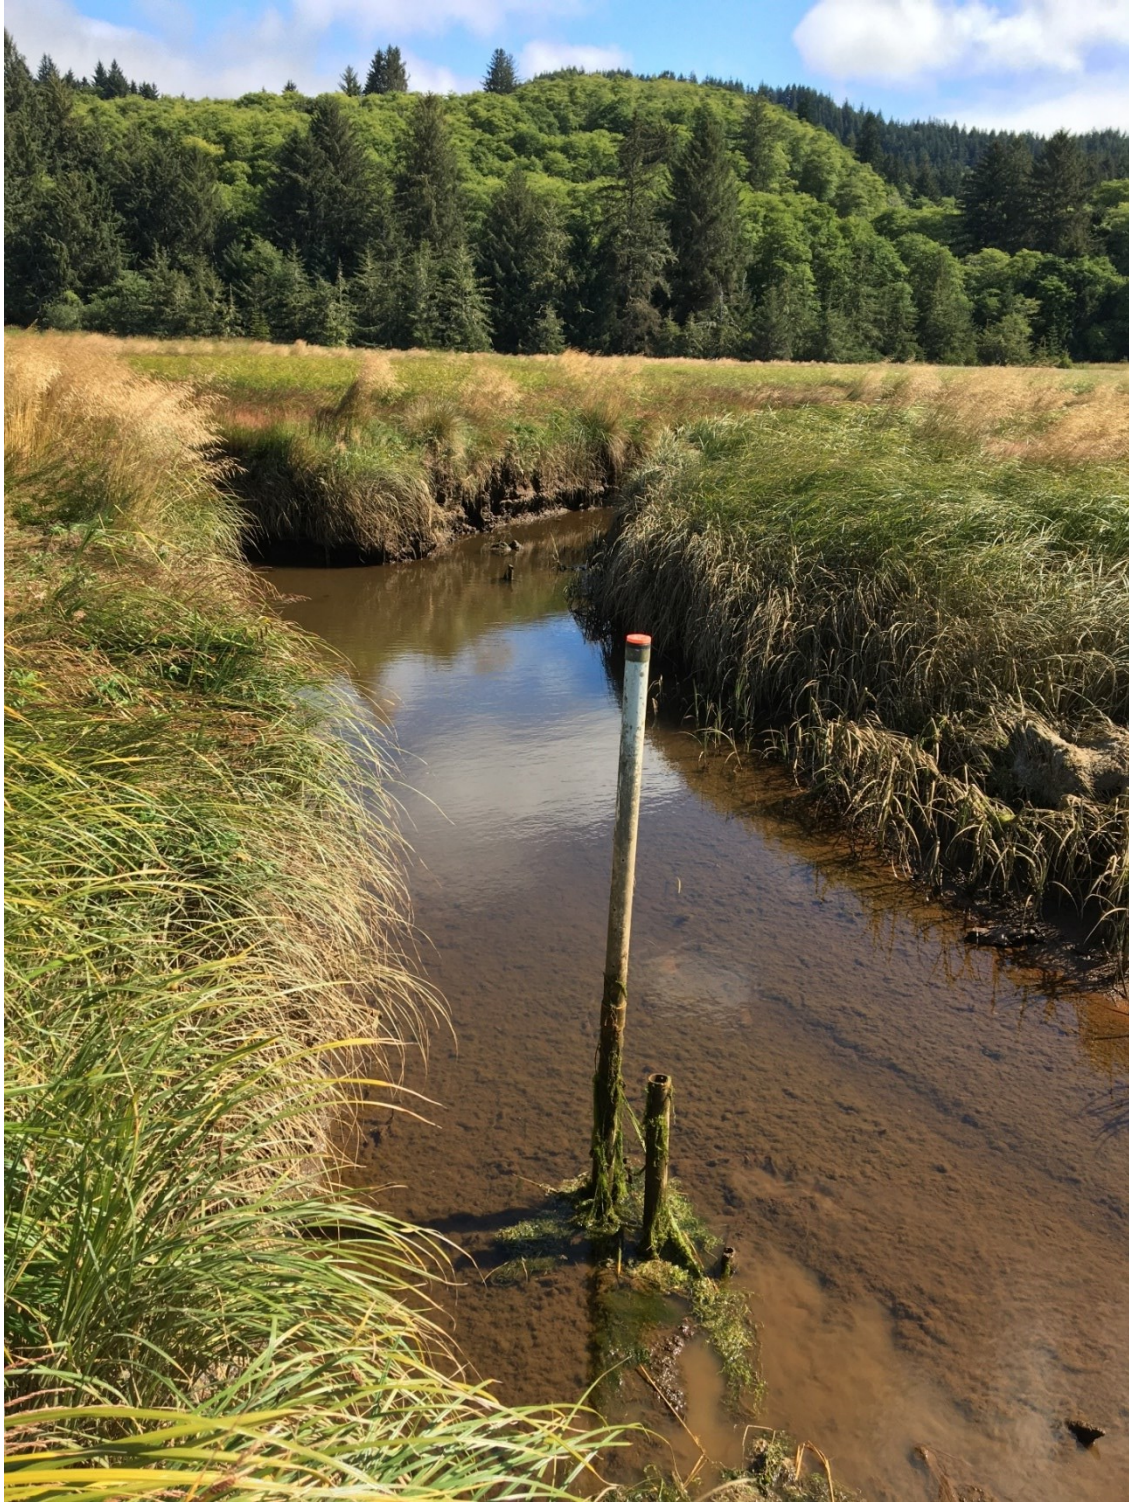
Figure 3.15 shows the 70s Marsh station. The second, shorter piece of PVC pipe next to the primary installation was added to house the dissolved oxygen logger that was described in section 2.3 Dissolved Oxygen Instruments. This station was selected as one to host a dissolved oxygen logger because it is one of the channels in the estuary with a constant source of fresh water. This would be the situation for the area to the west of US 101 and north of the Salmon River if Salmon Creek were to be restored to its former course.

Figure 3.15: Photograph of the 70s Marsh Station. The photograph was taken looking in the upstream direction, facing northeast.

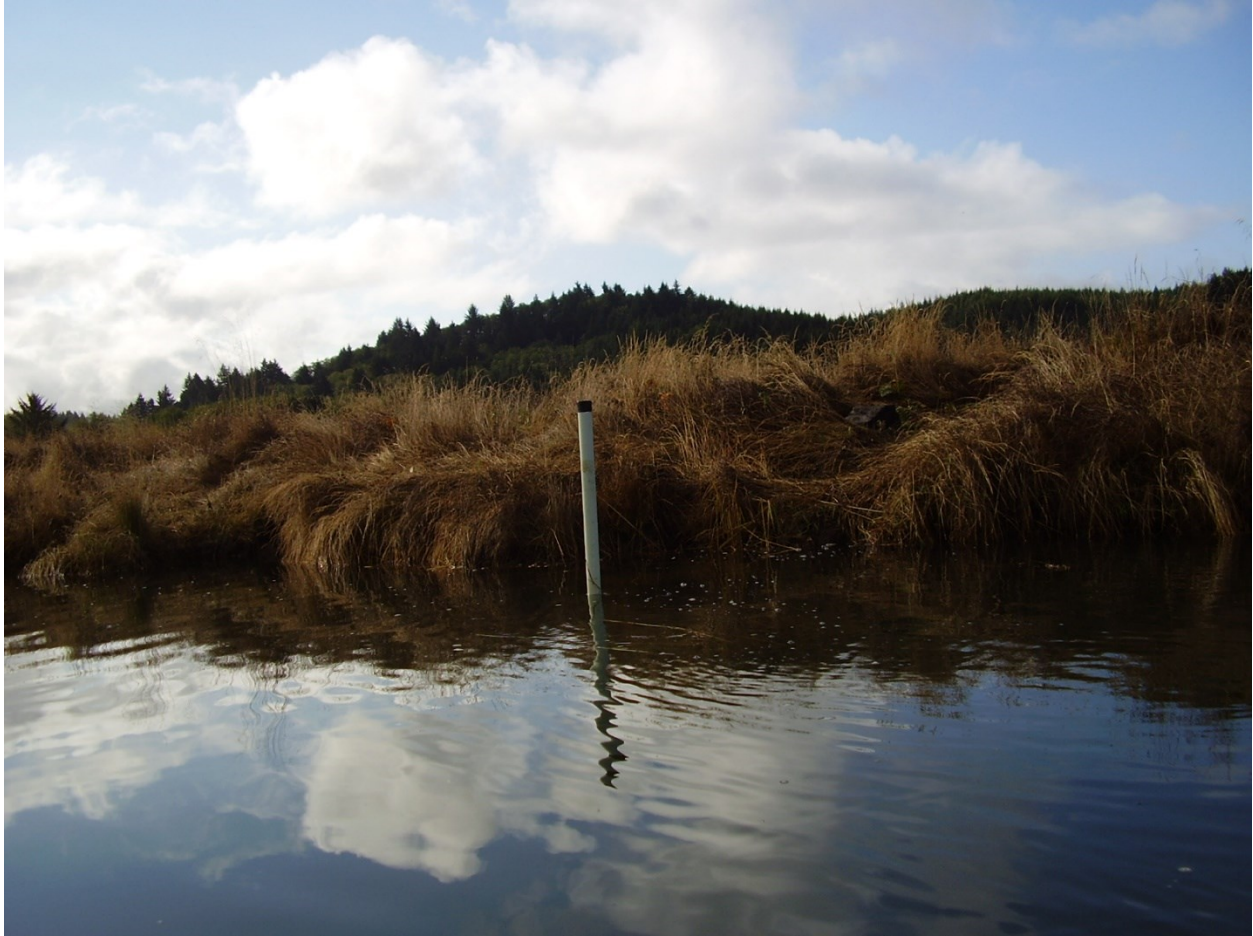
Figure 3.16 shows the Reference Marsh South Downstream station. This location is such that the channel bottom is near the low water, low tide level of the Salmon River. The pipe was driven into the ground at the edge of the water at such a time. This means that there is frequently water in the channel throughout the day. However, at extremely low tides with extremely low water in the river the channel does become separated from the river. At the time of its installation, our presumption was that the large driftwood trees seen in the estuary moved rarely, in extreme flood events. This presumption was quickly disproven with the loss of this station. The station was not rebuilt in the belief that it was a vulnerable spot. In retrospect, at the end of this 10-year project, driftwood destroying the PVC pipes is a random event and all the stations with PVC in the midst of a channel were equally vulnerable.

Figure 3.16: Photograph of the Reference Marsh South Downstream station. Photograph was taken facing southeast.

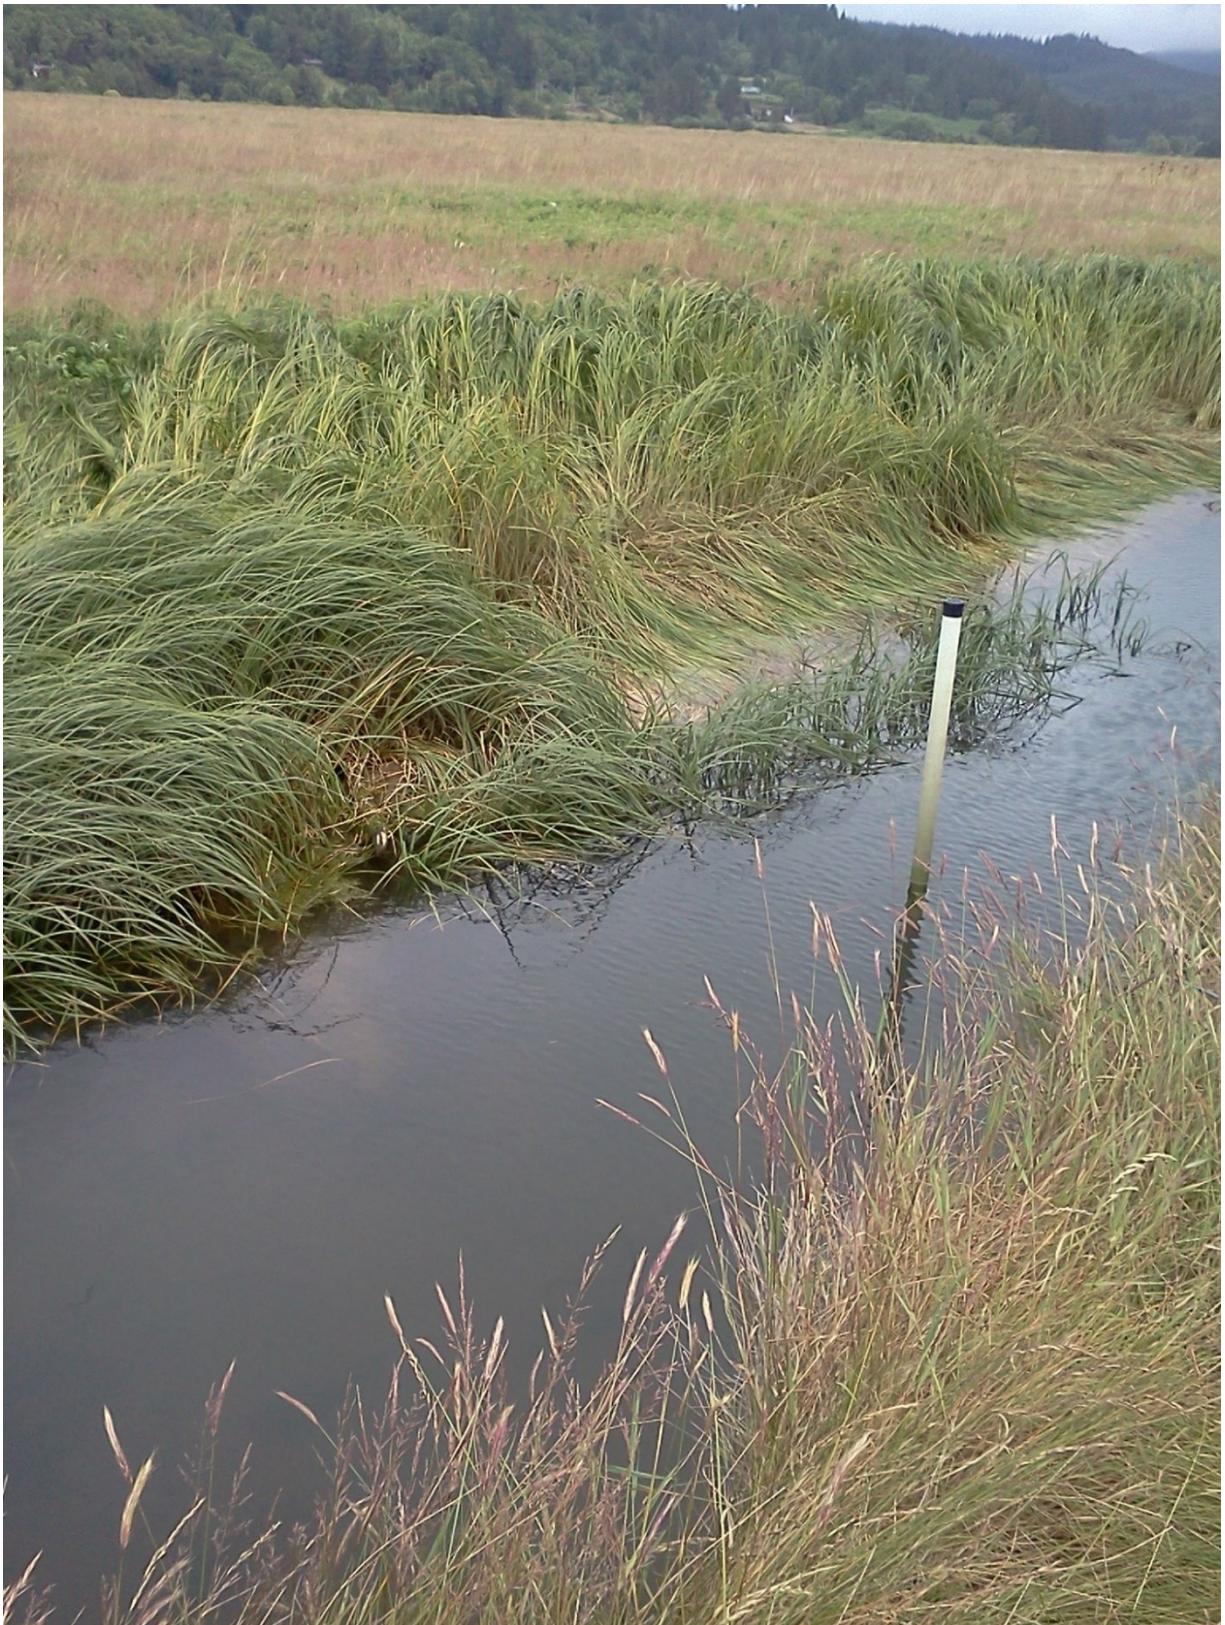
Figure 3.17 shows the Reference Marsh South Upstream station. This station survived the entire duration of the project. The location had the advantage of being the most easily accessed of the Reference Marsh stations at low tide, being a short walk into the estuary marsh from the Tamara Quays high ground. Easiest, but not easy. There were two channels that had to be jumped and the ground in the estuary is generally very uneven and hidden by tall grasses, reeds, and sedges. At low tide, during low water in the river, this channel becomes just a trickle of water draining out of the marsh. The time between high tides is not sufficient for the marsh to ever completely drain, but the width of the flowing water becomes less than a foot and the depth becomes an inch or less.

Figure 3.17: Photograph of the Reference Marsh South Upstream station. Photograph was taken facing northeast.

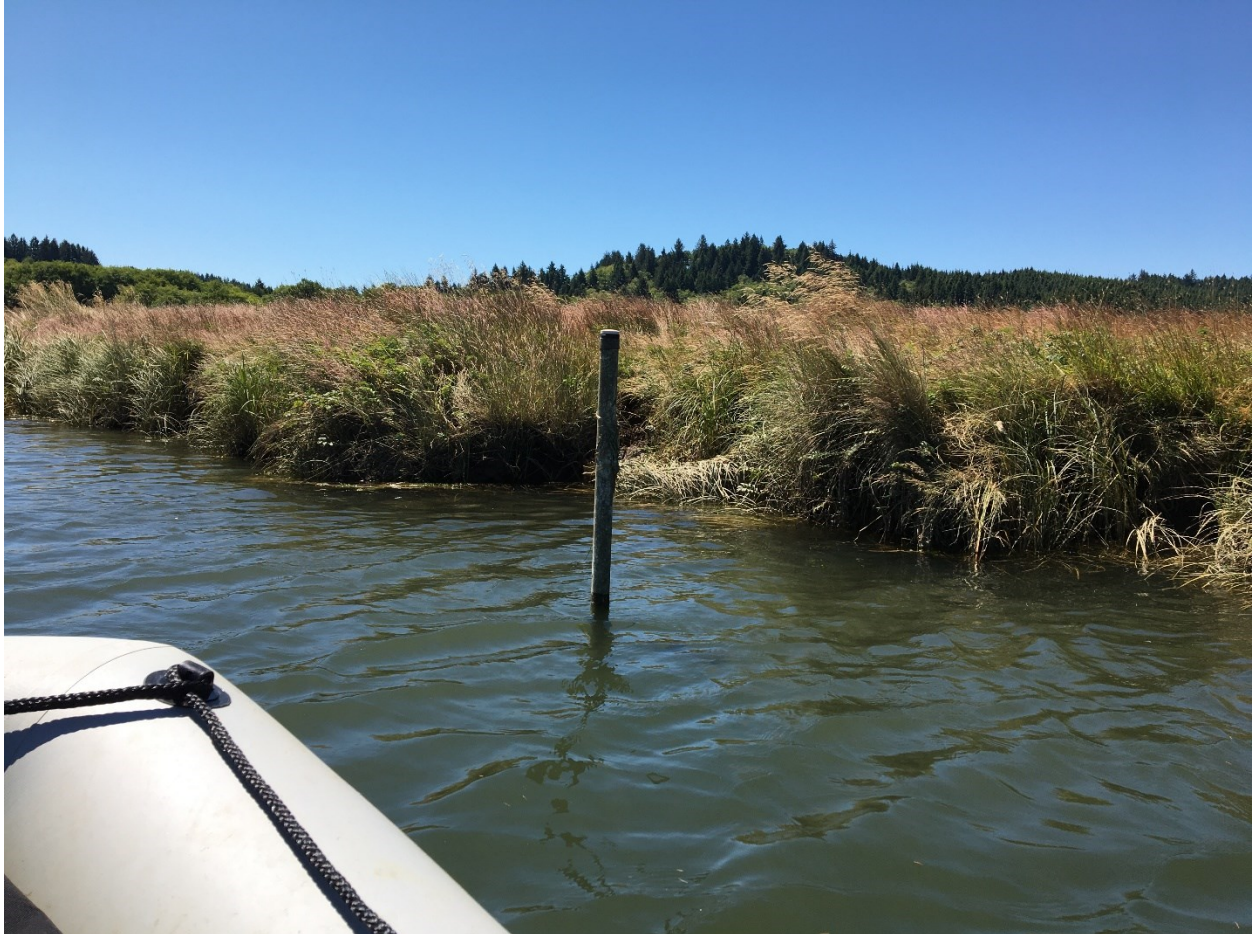
Figure 3.18 shows the Reference Marsh North Downstream station. This station survived the entire duration of the project. It is located where the tidal channel's bed is at about the low tide, low water level of the Salmon River and thus there is almost always water in the channel, and it is often connected to the river throughout the day.

Figure 3.18: Photograph of the Reference Marsh North Downstream station. Photograph was taken facing south.

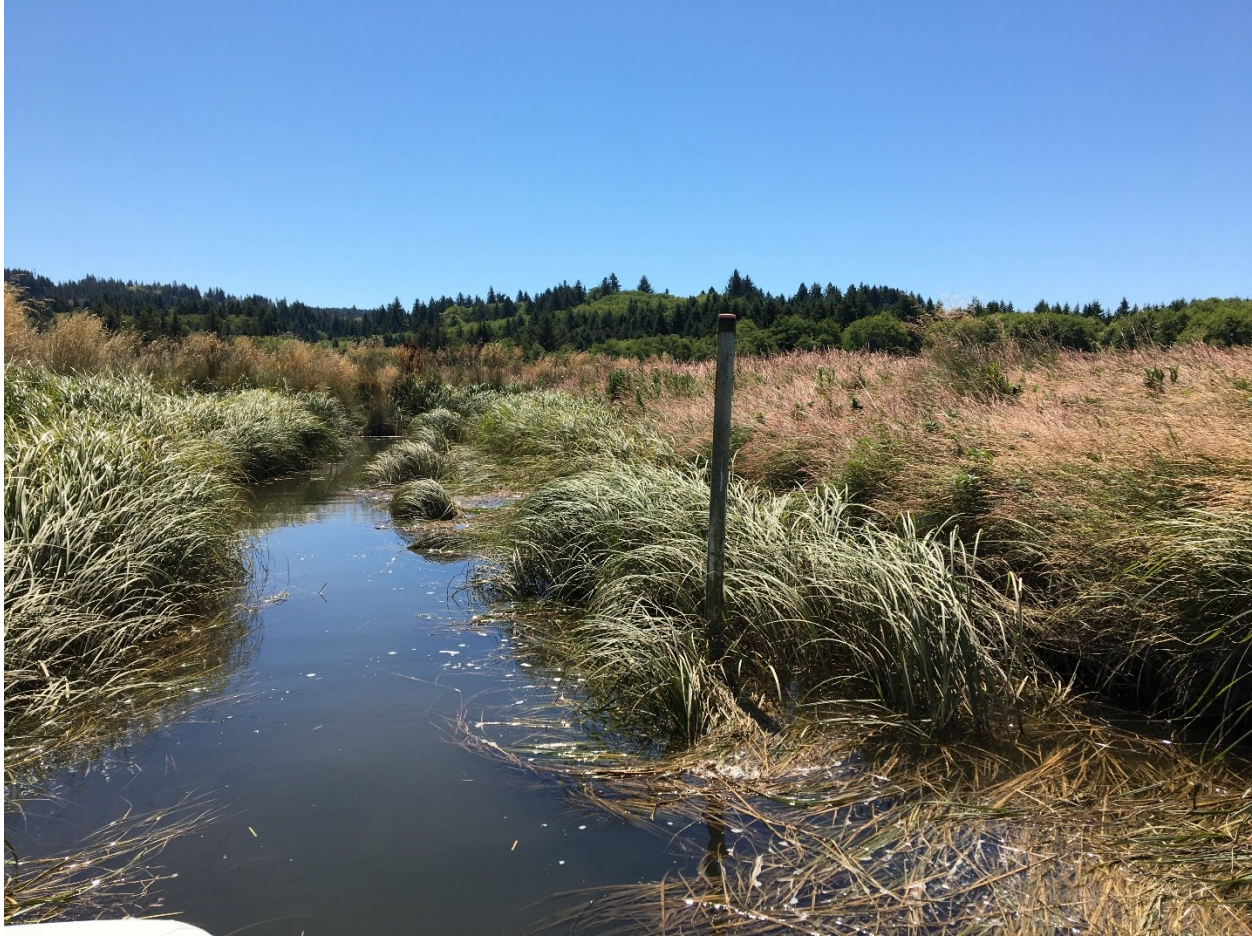
Figure 3.19 shows the Reference Marsh North Upstream station. This station survived the entire duration of the project. The station is located where the channel bottom is above the low tide, low water level of the Salmon River. Thus, at low tide on most days the water in the channel is reduced to the trickle of water draining out of the marsh. The time between high tides is too short for the marsh to drain completely and thus there is always some water in the very bottom of the channel, but it is narrow, shallow, and slow moving. During high water events on the Salmon River, it was possible to travel in a boat or kayak across the marsh, directly from the Reference Marsh North Upstream station to the Reference Marsh South Upstream station.

Figure 3.19: Photograph of the Reference Marsh North Upstream station. Photograph was taken facing southeast.

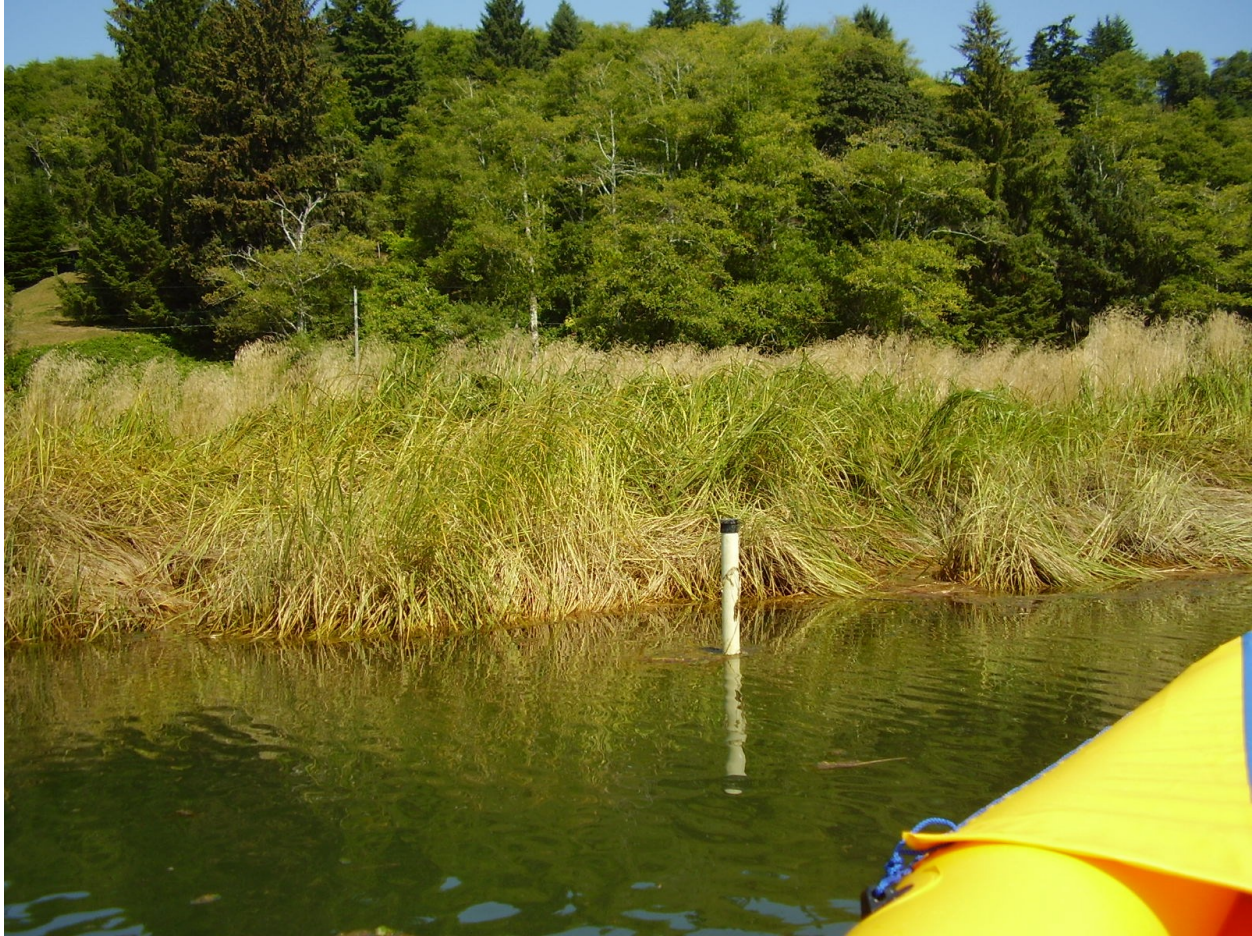
Figure 3.20 shows the Former Salmon Creek Main station. This station was roughly mid-way along the straight section of the tidal channel from where it joins the Salmon River. This station only produced data for two downloads before the logger failed. While the logger was out of the station for repairs, driftwood, presumably, wiped-out this station and it was abandoned.

Figure 3.20: Photograph showing the Former Salmon Creek Main station. Photograph taken facing north.

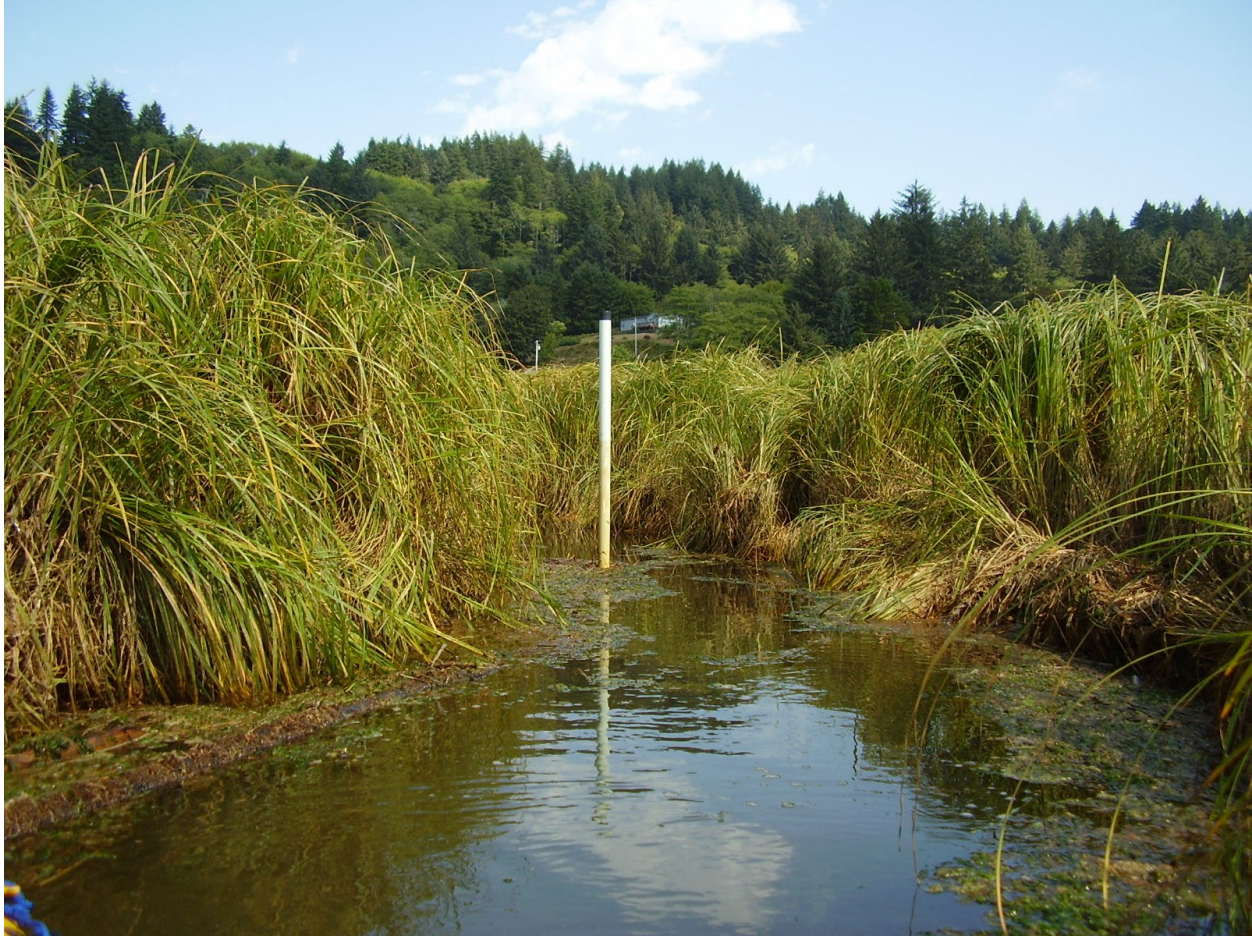
Figure 3.21 shows the Former Salmon Creek North station. This station was located at a branch in the channel of the former Salmon Creek where the channel of the former Salmon Creek turns and heads south and a secondary channel heads to the north. The station is a short distance up the smaller, north-directed channel. This station recorded data for two downloads before the logger failed. The logger was sent in for repairs and then reinstalled. It operated for one download and then failed again. A replacement logger (the repaired logger from Former Salmon Creek Main) was then installed. This logger produced data for four downloads before the logger failed. The station was unoccupied when it was destroyed, presumably by driftwood, in the winter of 2013-2014. It was abandoned at that point.

Figure 3.21: Photograph showing the Former Salmon Creek North station. Photograph taken looking northeast.

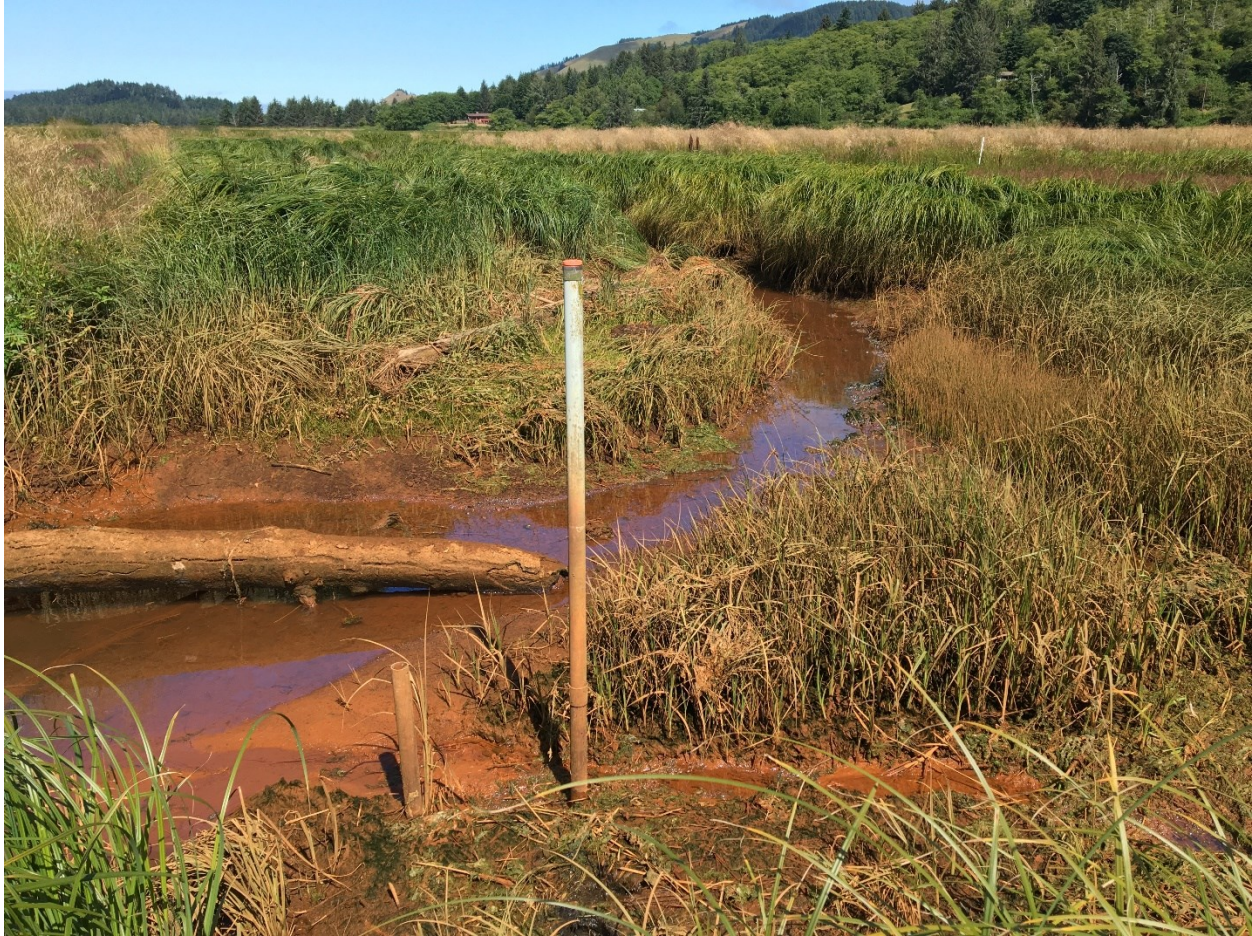
Figure 3.22 shows the Former Salmon Creek South station. This station was further along the former Salmon Creek where the channel is headed along a nearly straight course to the southeast. This means it is headed directly toward a nearly perpendicular intersection with US Route 101. This station was named Former Salmon Creek South. Even though large tree trunk driftwood moved in and around the area, this station survived for the entire project. As can be seen in the photograph, this station experiences an abundance of iron oxide deposition. While it was a constant concern with respect to the instruments, they seemed to endure it well and it seemed to be less of a problem than the corrosion that was present at all the stations within the estuary. In the photograph, a second, much shorter piece of PVC can be seen to the left. This, as was also indicated for the 70s Marsh station, was installed to house a dissolved oxygen logger. This station was selected to host a dissolved oxygen logger because it only receives significant volumes of water from water being forced up the channel from the Salmon River. It would be reconnected to a direct source of fresh water if Salmon Creek is restored to its former course.

Figure 3.22: Photograph showing the Former Salmon Creek South station. Photograph taken facing northwest

little higher than the length of the logger itself. Figure 3.22 shows the Former Salmon Creek South station with a second, shorter, piece of PVC pipe installed beside the taller water level and conductivity logger pipe. The idea was to have the logger be inside a pipe that would hold water while the tide is out and thus keep the logger submerged. This is less than ideal, but the hope was that the current of the water flowing inward on the rising tide and outward with the falling tide would induce a fair amount of mixing in the PVC.

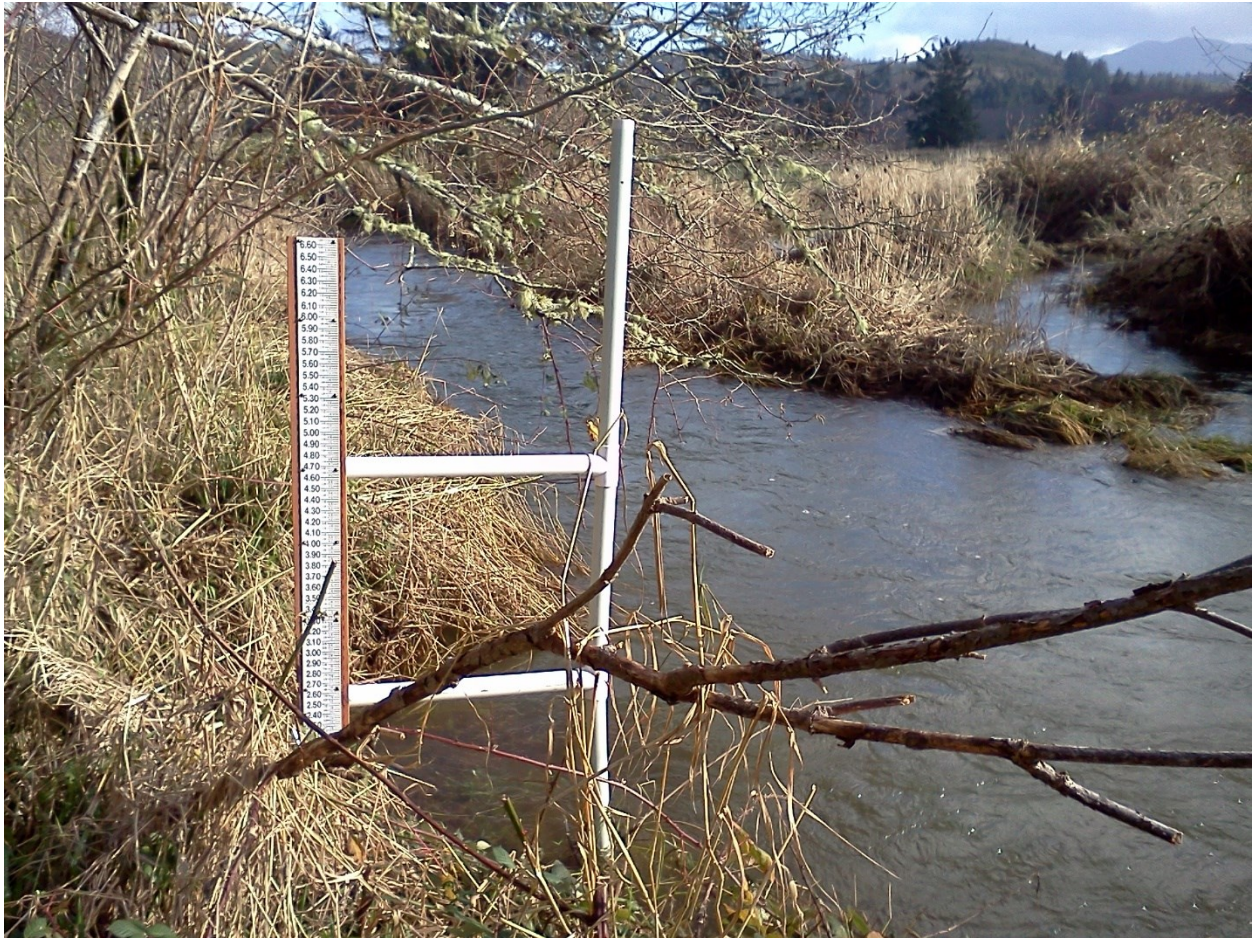
Figure 3.23 shows the station on Salmon Creek near where a future culvert could be built. As can be seen, the cantilevered station construction was used. Salmon Creek has a gravel bed in this area, just as it did at Three-Rocks Road.

Figure 3.23: Photograph of station on Salmon Creek near future culvert. Photograph taken facing east.

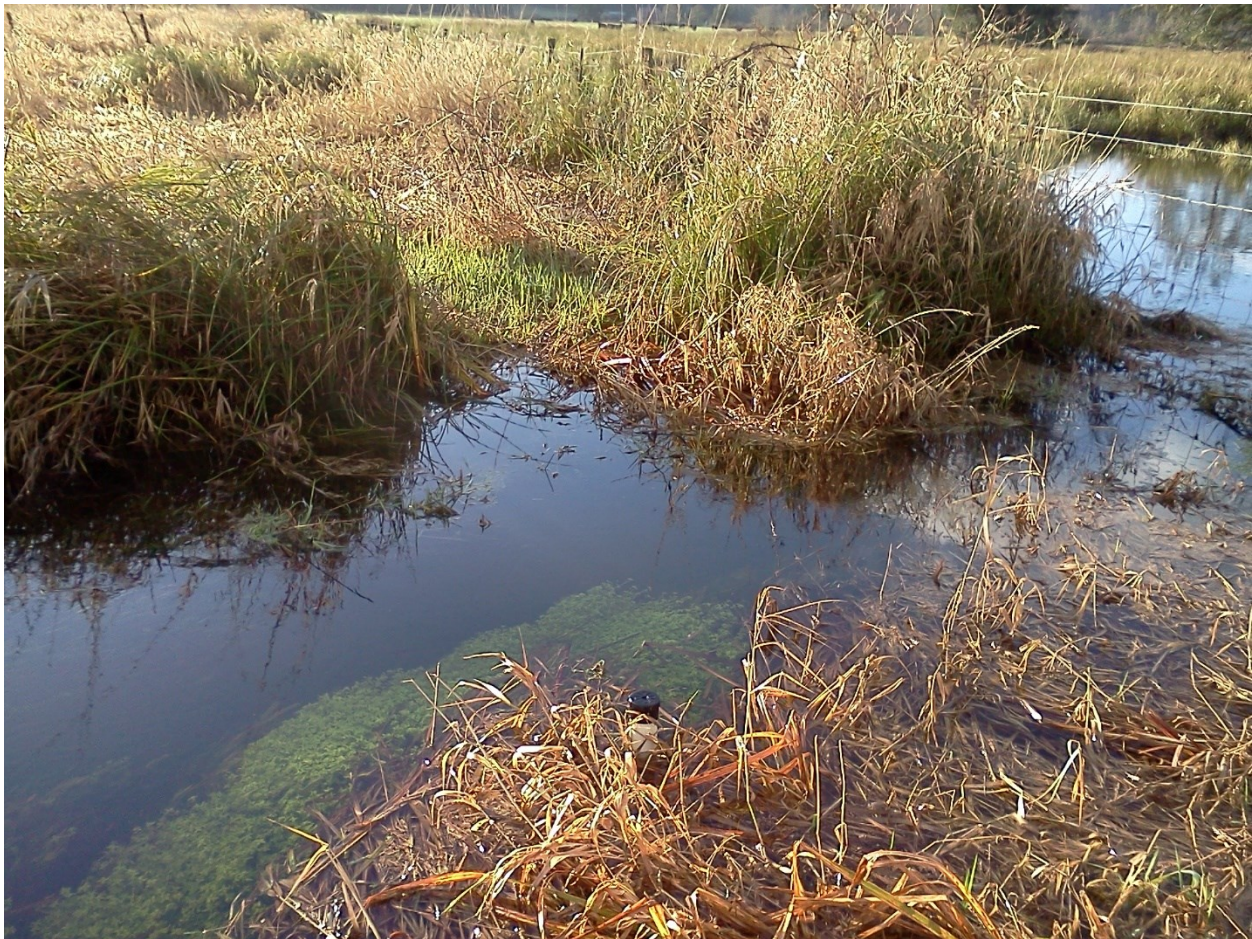
Figure 3.24: Photograph of the station in the USFS ditch. The black cap and white pipe can be seen in the lower center of the photograph, at the edge of the grass. Photograph taken facing southwest. The fence runs slightly east of due south.

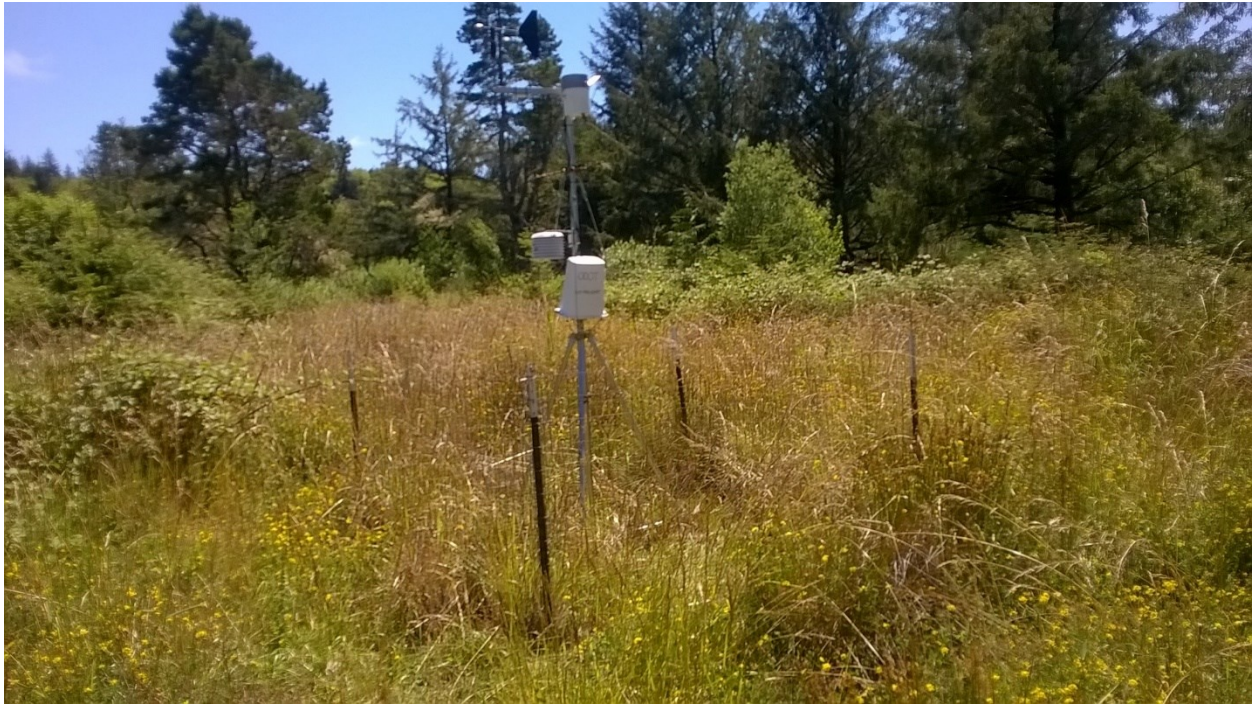
Figure 3.26: Pixieland Weather Station equipment.

Figure 3.26 shows the Pixieland Weather Station. The broad, open clearing in which it stood is clearly evident in this photo.

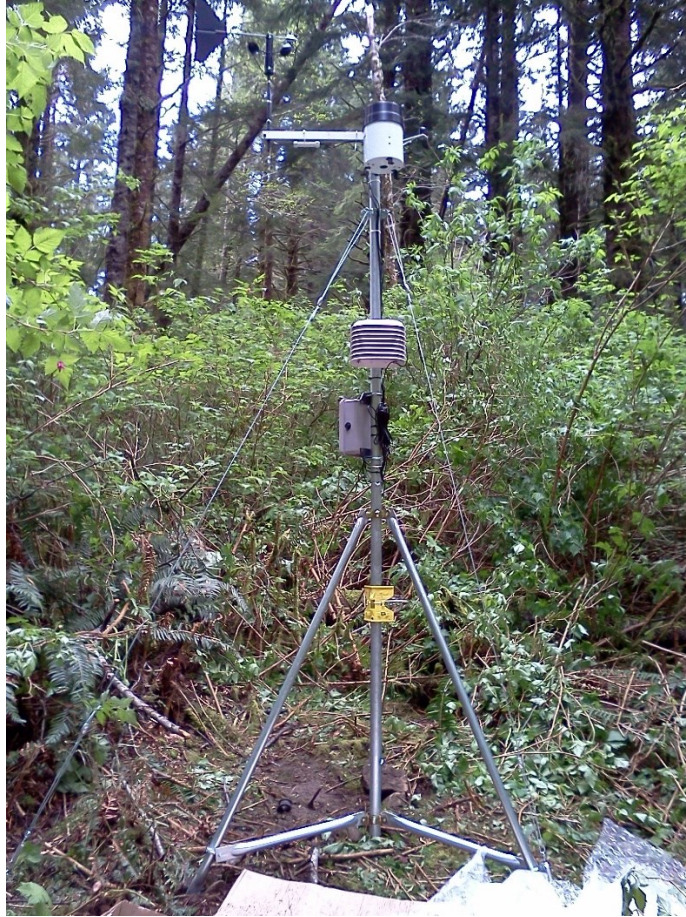
Figure 3.27: Highlands Weather Station equipment.

Figure 3.27 shows the Highlands Weather station installed. The tall surrounding trees can be clearly seen in the background. It should also be noted that the lower vegetation, closer to the station, increased considerably in height over the duration of the project.

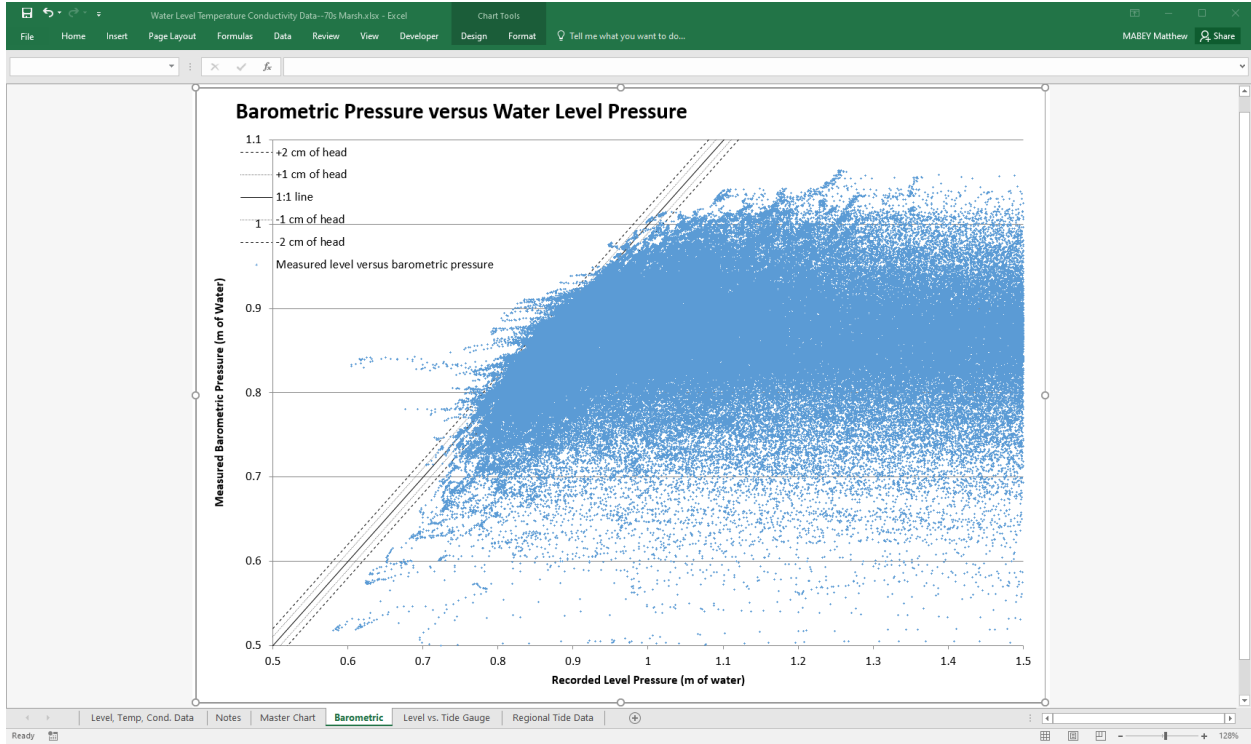
Figure 4.10: Graph of measured barometric pressure versus measured level at a station. A line of 1:1 with +/- 1 and 2 cm lines are included for reference.

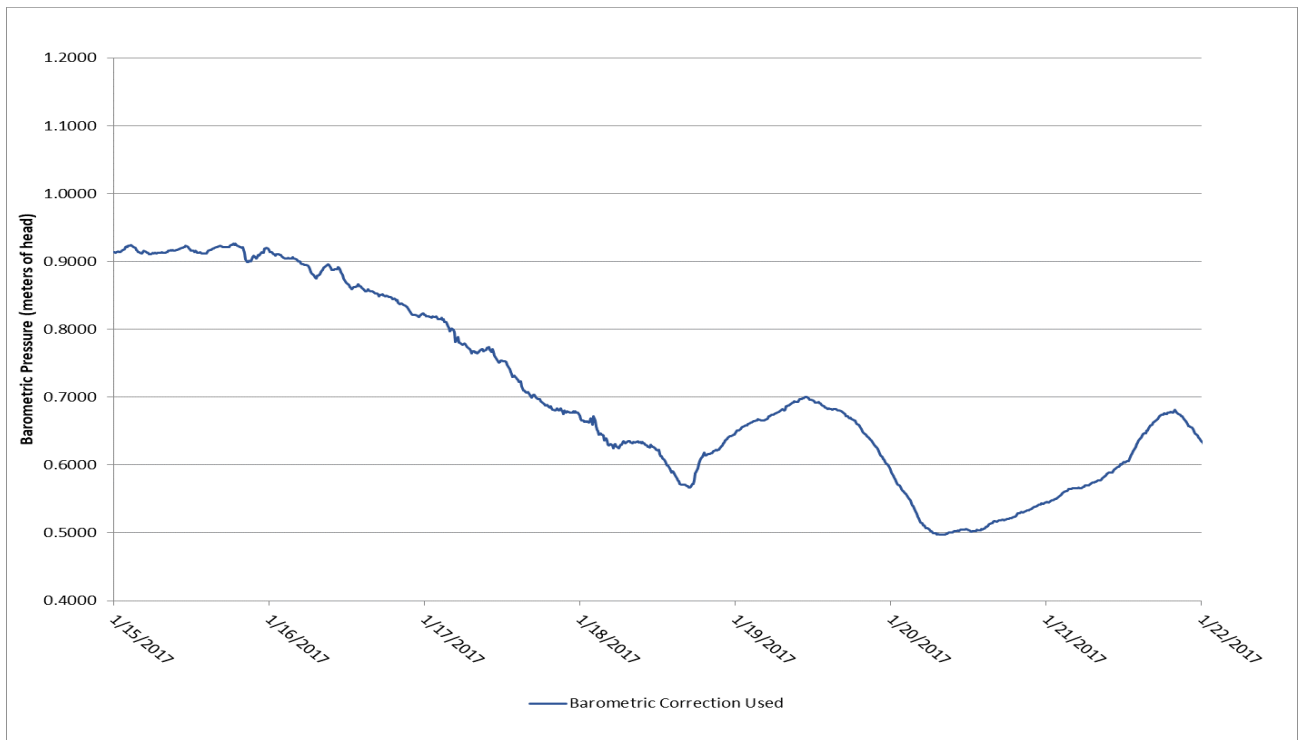
Figure 6.2: Plot of barometric pressure correction used. This plot shows data of one week.

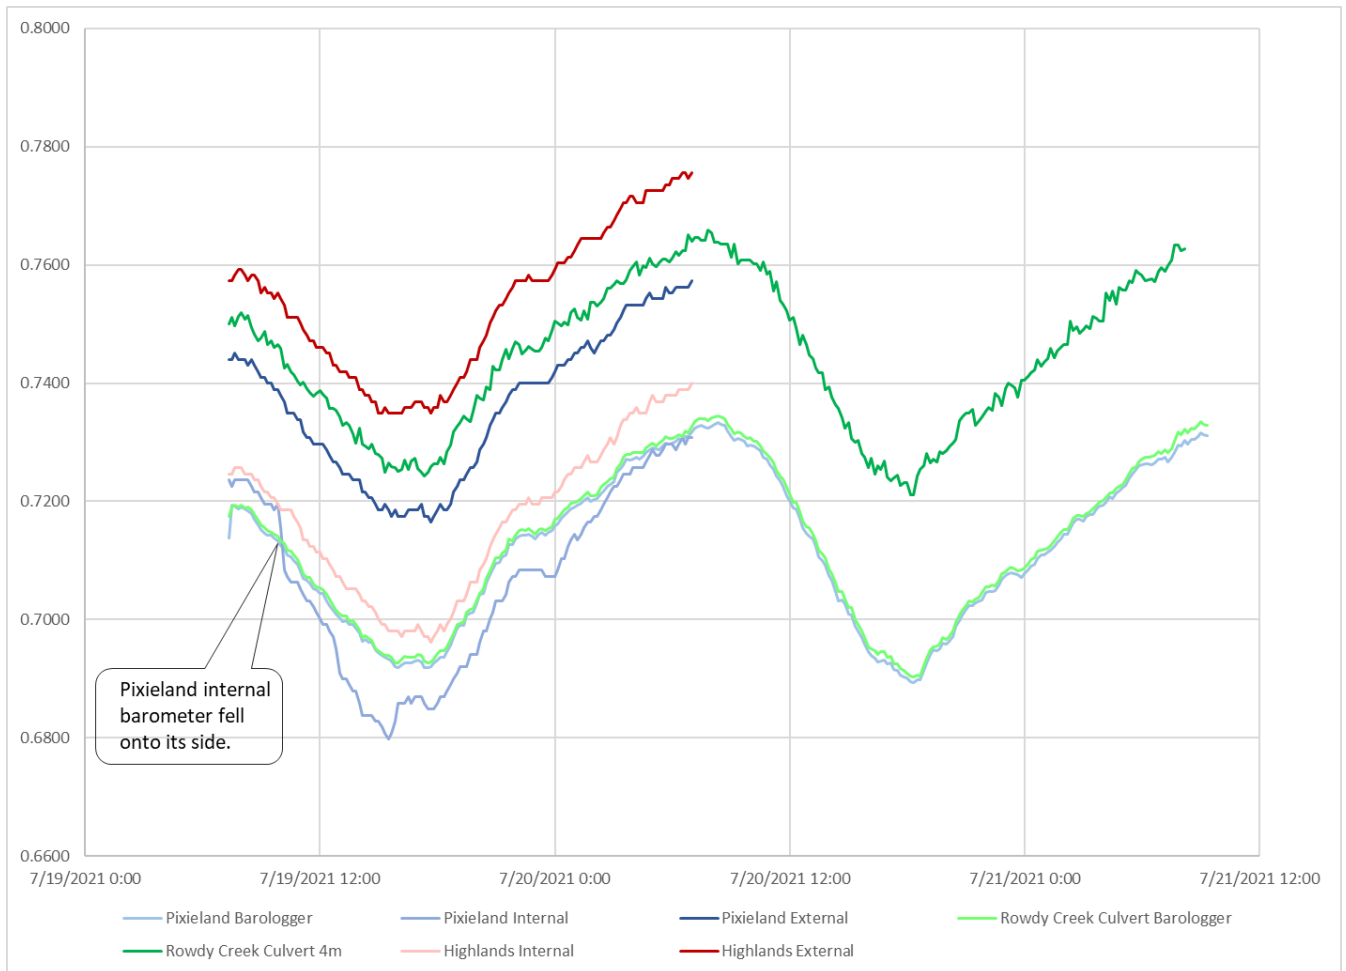
Figure 6.7: Comparison of side-by-side readings at conclusion of project
