**BASELINE DATA FOR ASSESSING
CLIMATE CHANGE AND FUTURE
ENHANCED SURFACE WATER
PASSAGE IMPACTS ON THE SALMON
RIVER ESTUARY**

Final Report

PROJECT SPR-719

Oregon Department of Transportation

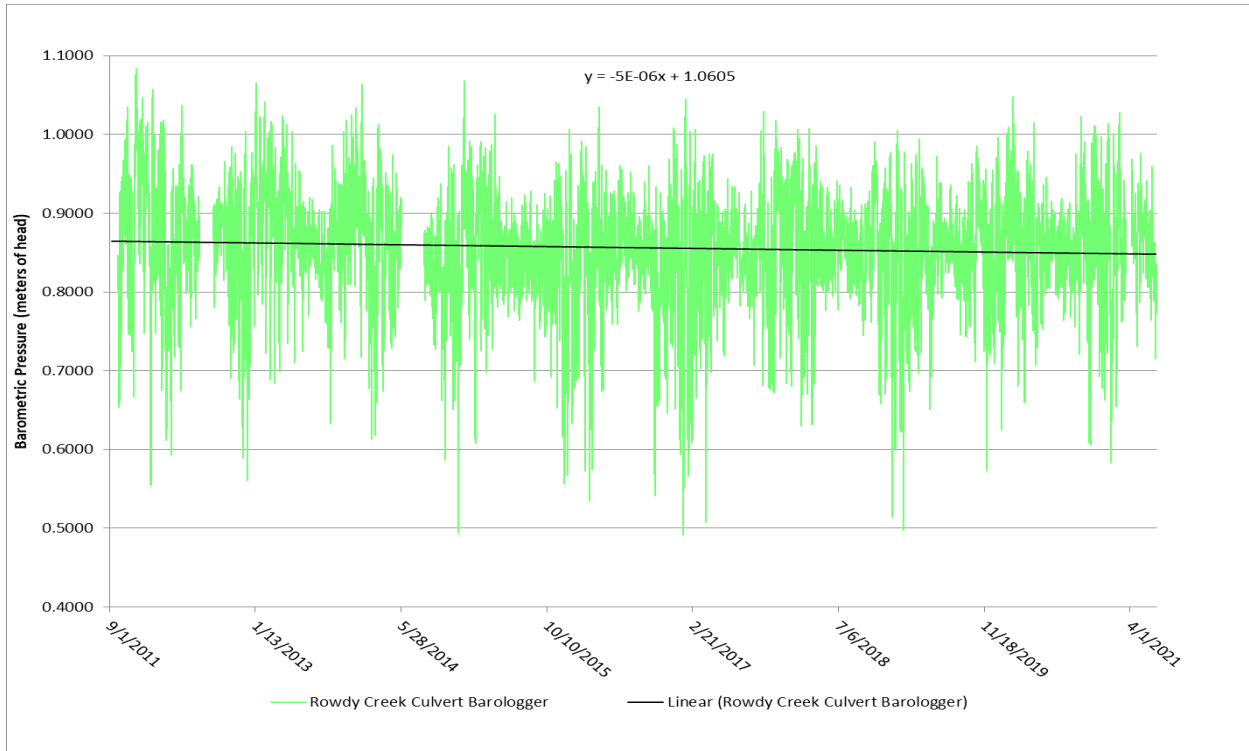
Figure 6.9: Rowdy Creek Culvert Barologger Drift

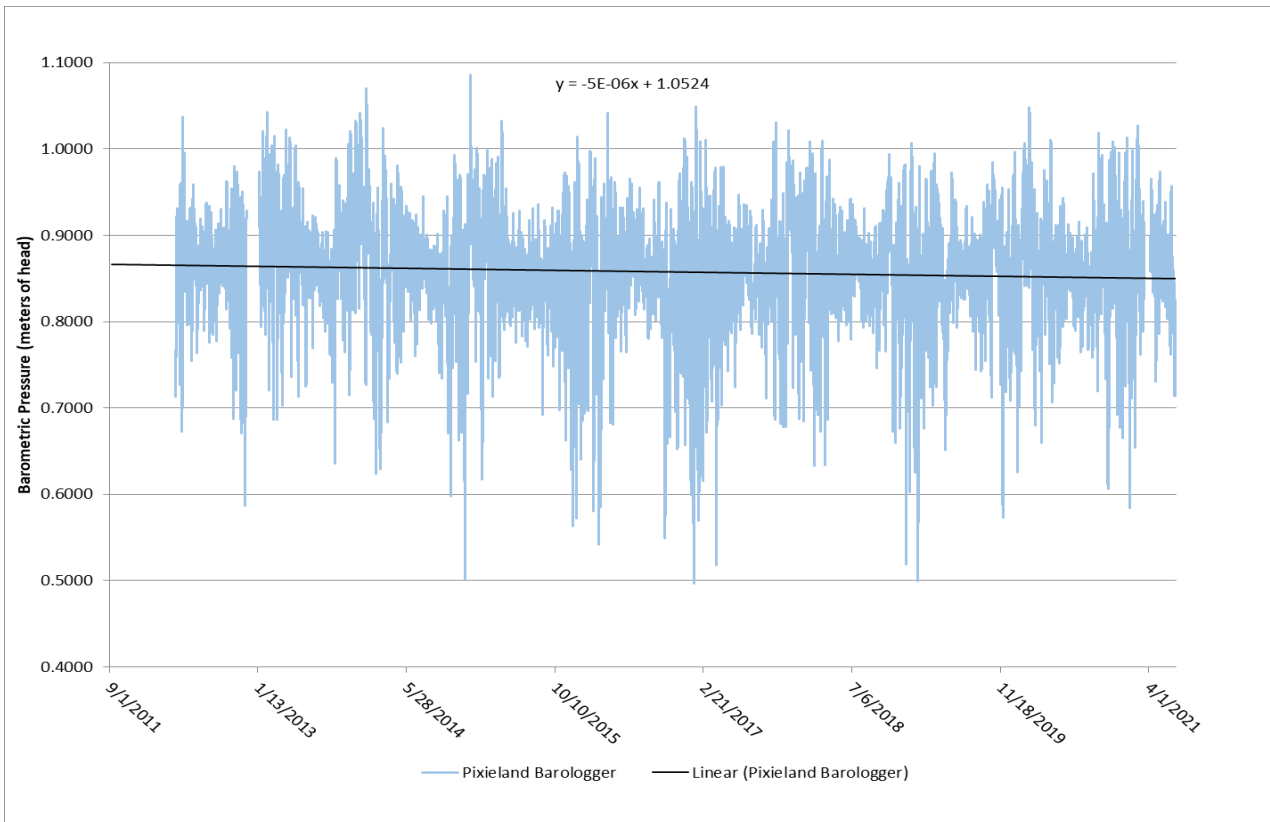
Figure 6.10: Pixieland Barologger Drift

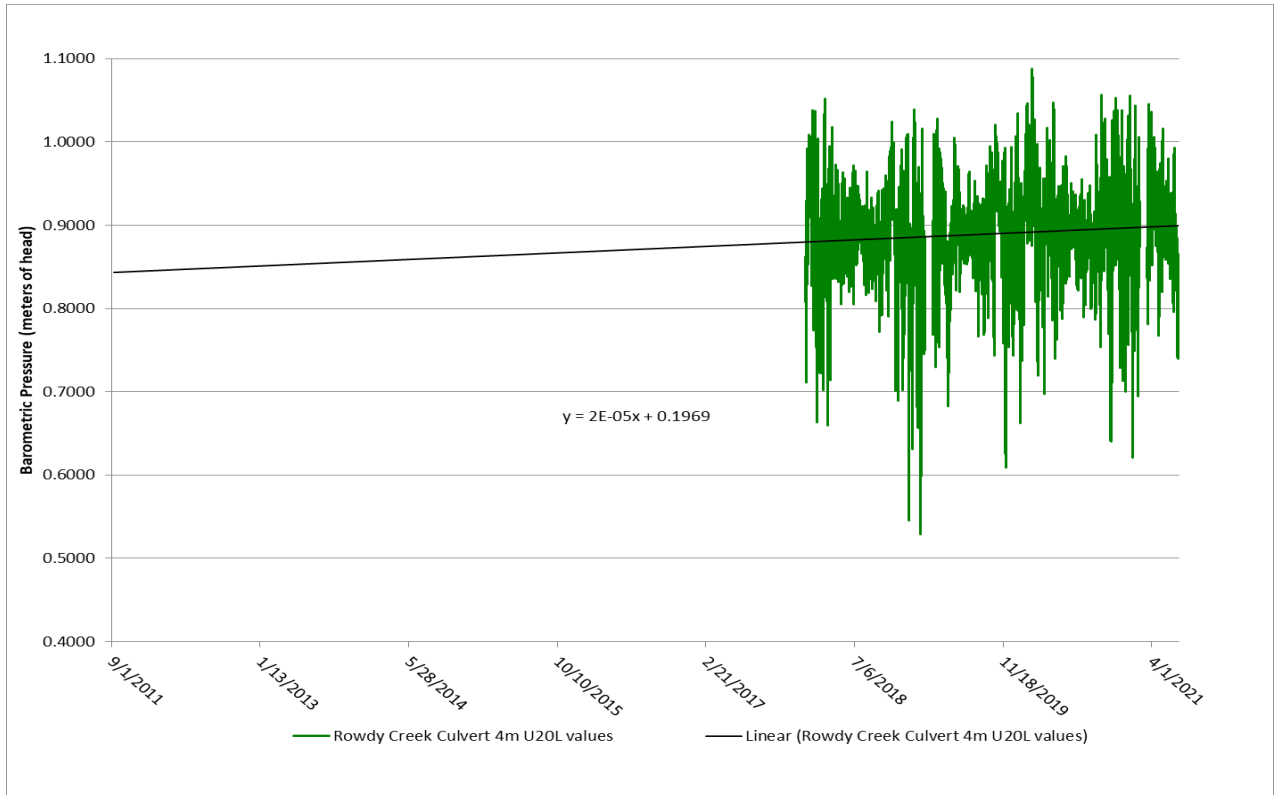
Figure 6.13: Rowdy Creek Culvert 4m U20L Drift
