**SEISMIC RETROFITS FOR SQUARE  
REINFORCED CONCRETE COLUMNS  
USING TITANIUM ALLOY BARS**

**Final Report**

**PROJECT SPR-784**

Oregon Department of Transportation

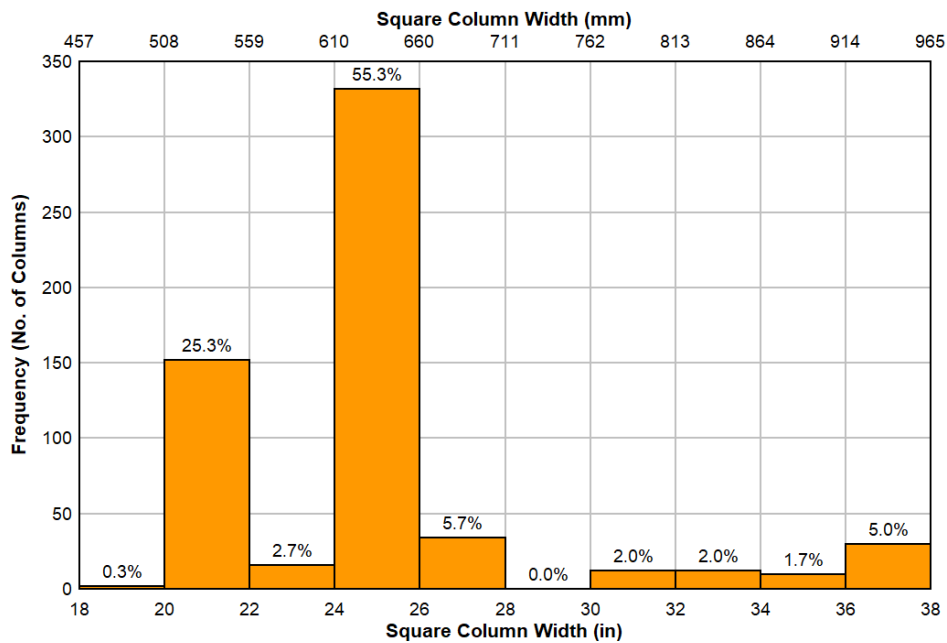
The most common column size is 24 in x 24 in (610 mm x 610 mm) square having a frequency of 55%, the second being 20 in x 20 in (508 mm x 508 mm) square with 25% frequency. The distribution of column section dimensions was grouped together using a bin size of 2 in (50.8 mm) and is shown in Figure 3.1.

**Figure 3.1: ODOT inventory square column width distribution**

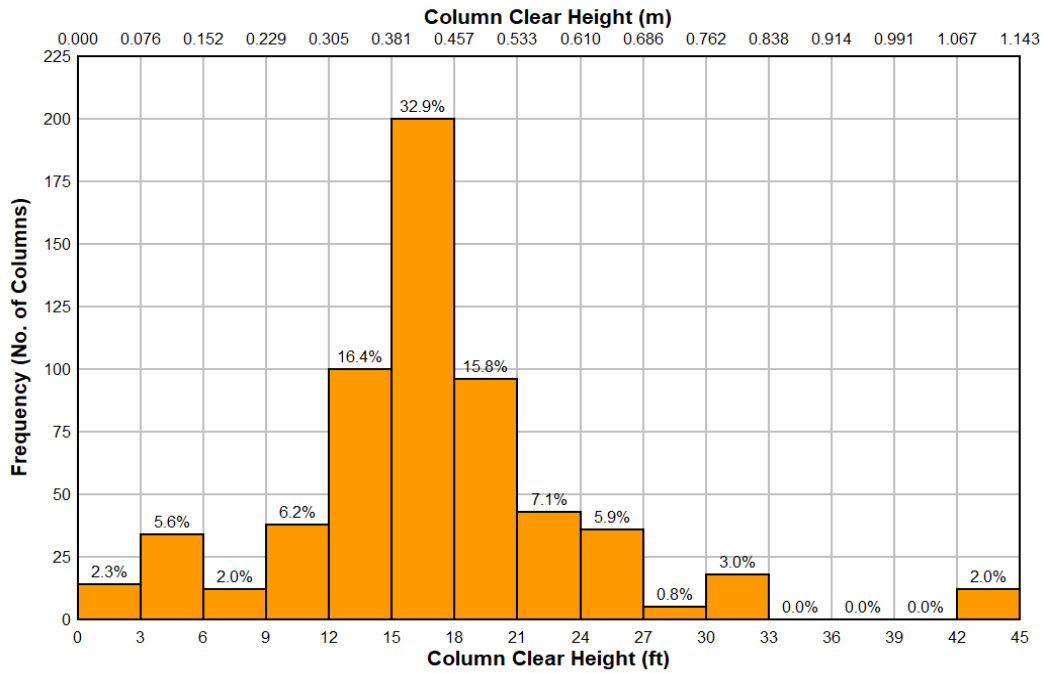
The column clear heights were measured from the bottom of the cap beam to the ground level or the top of footing in each column. The column heights were found to vary even in the same bridge depending on the gradient of the soil profile. The columns were thus treated individually to summarize the distribution of their clear height. Using a 3 ft (0.91 m) bin size, the mean clear height of the columns measured from the foundation top to the bottom of bent caps was 16 ft (5029 mm) with the mode being in the range of 15 ft (4.57 m) to 18 ft (5.49 m), as seen in Figure 3.2

**Figure 3.2: ODOT inventory square column clear height distribution**

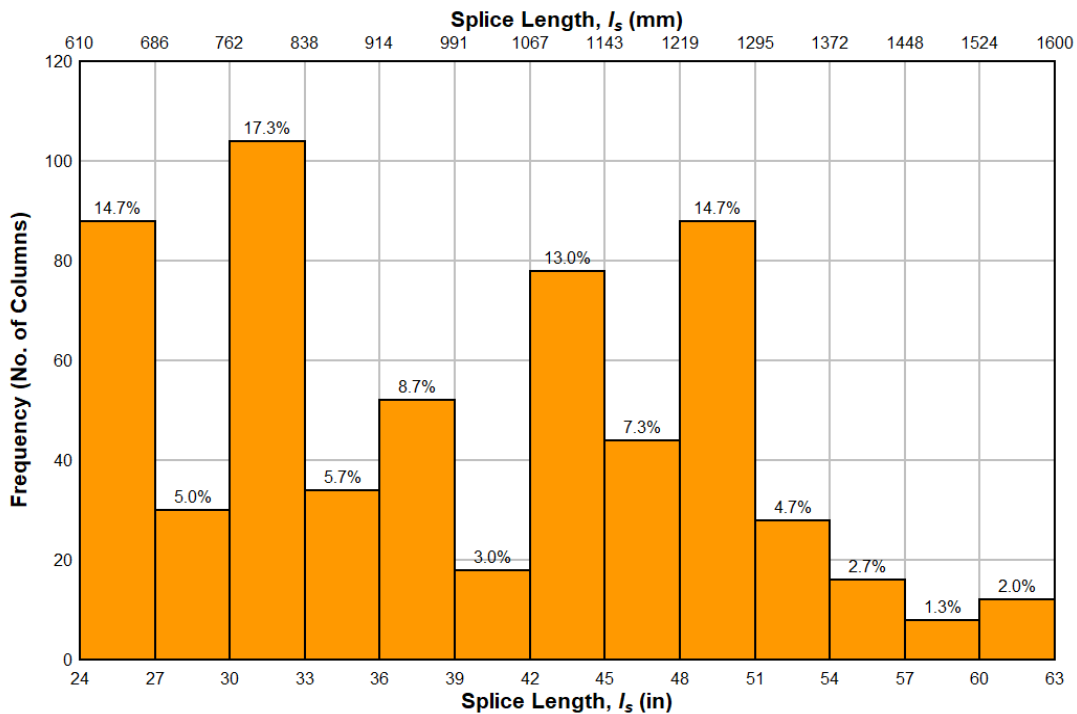
**Figure 3.7: ODOT inventory splice length distribution**

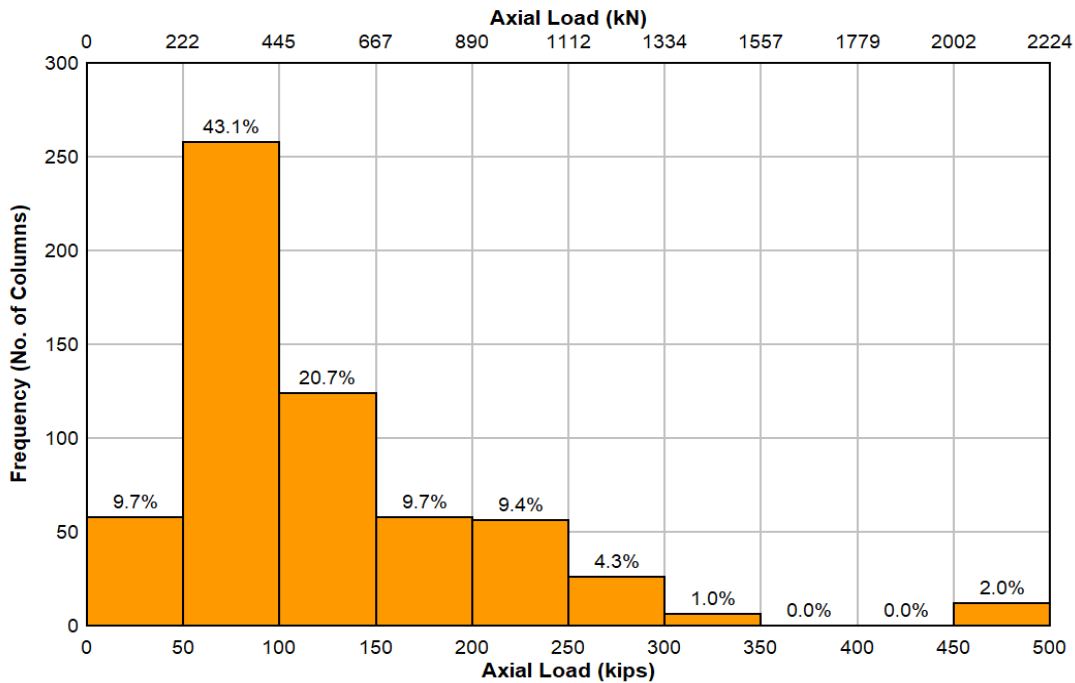
Average service-level axial load per column was calculated to be approximately 120 kips with the modal value ranging from 50 to 100 kips (222 to 444 kN). This was equivalent to an average axial stress of  $0.055f'c$  with the modal range  $0.04f'c$  to  $0.05f'c$ . The distribution is as shown in Figure 3.10.

**Figure 3.10: ODOT inventory square columns axial load distribution**

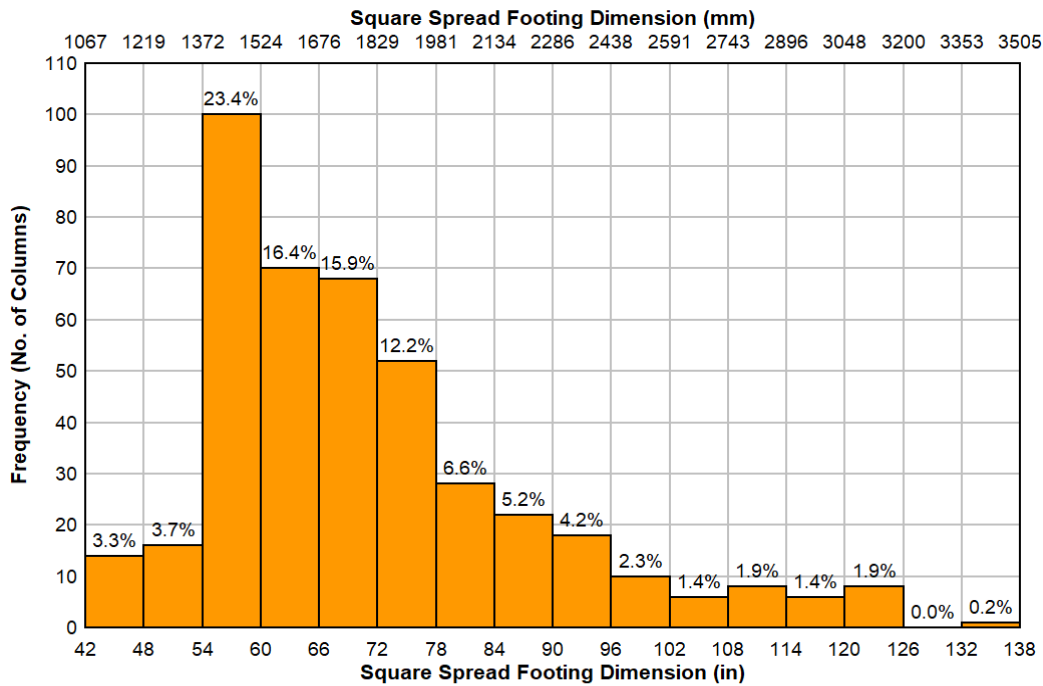
Figure 3.11: ODOT inventory square spread footing width distribution

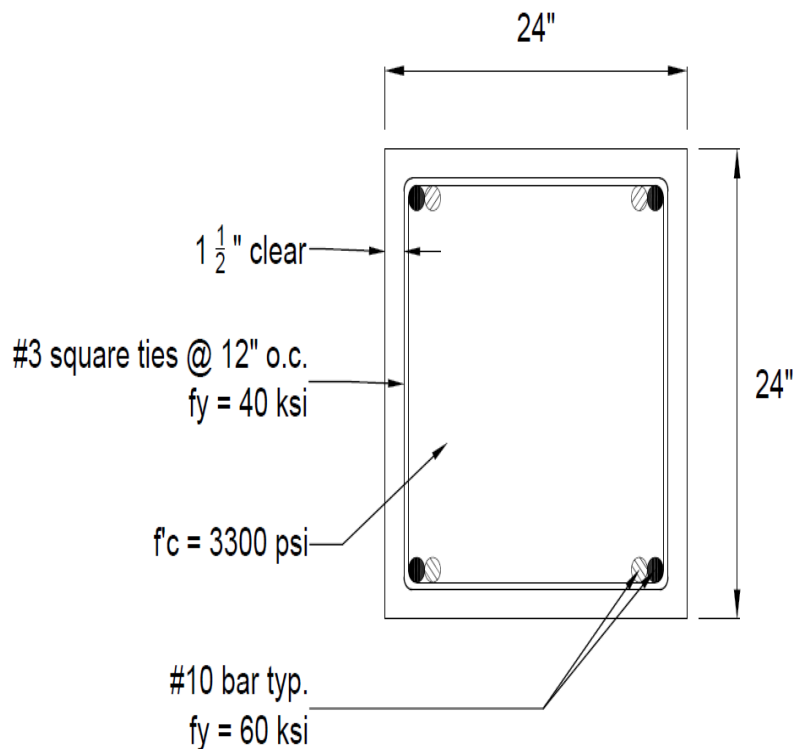
**Figure 3.19: Cross section of column specimen in splice region used to match vintage dimensions and details**

All column specimens were 24 in x 24 in (609 mm x 609 mm) square columns with 4 – #10 (#32M) Gr. 60 longitudinal reinforcing steel bars (i.e.  $\rho_l = 0.88\%$ ) which is equivalent to the most common vintage detail of 4 – #11 (#36M) Gr. 40 longitudinal reinforcement bars (i.e.  $\rho_l = 1.0\%$ ) and #3 (#10M) Gr. 40 square hoops with 90-degree hooks at 12 in (305 mm) on-center (i.e.  $\rho_v = 0.09\%$ ) with 1.5 in (38 mm) concrete cover. The #10 (#32M) Gr. 60 reinforcing bars were used in place of #11 (#36M) intermediate grade reinforcing bars for longitudinal bars since #11 (#36M) intermediate grade reinforcing bars are no longer produced. The specimen cross section is shown in Figure 3.19. The longitudinal reinforcement bars were spliced at the base of the column to the starter bars from the footing with the lap-splice length of 36 in (914 mm: approximately  $28d_b$ ). The first group of specimens comprised of five “tall columns” with 13 ft (3962 mm) overall column height and the second group of specimens had nine “short columns” with 9 ft (2743 mm) overall column height. An extra foot height was provided for attachment of the lateral load assembly. The typical reinforcing steel details are shown along the elevation in Figure 3.20 and Figure 3.21. The column formwork and reinforcing cages and are illustrated in Figure 3.22 and Figure 3.23.

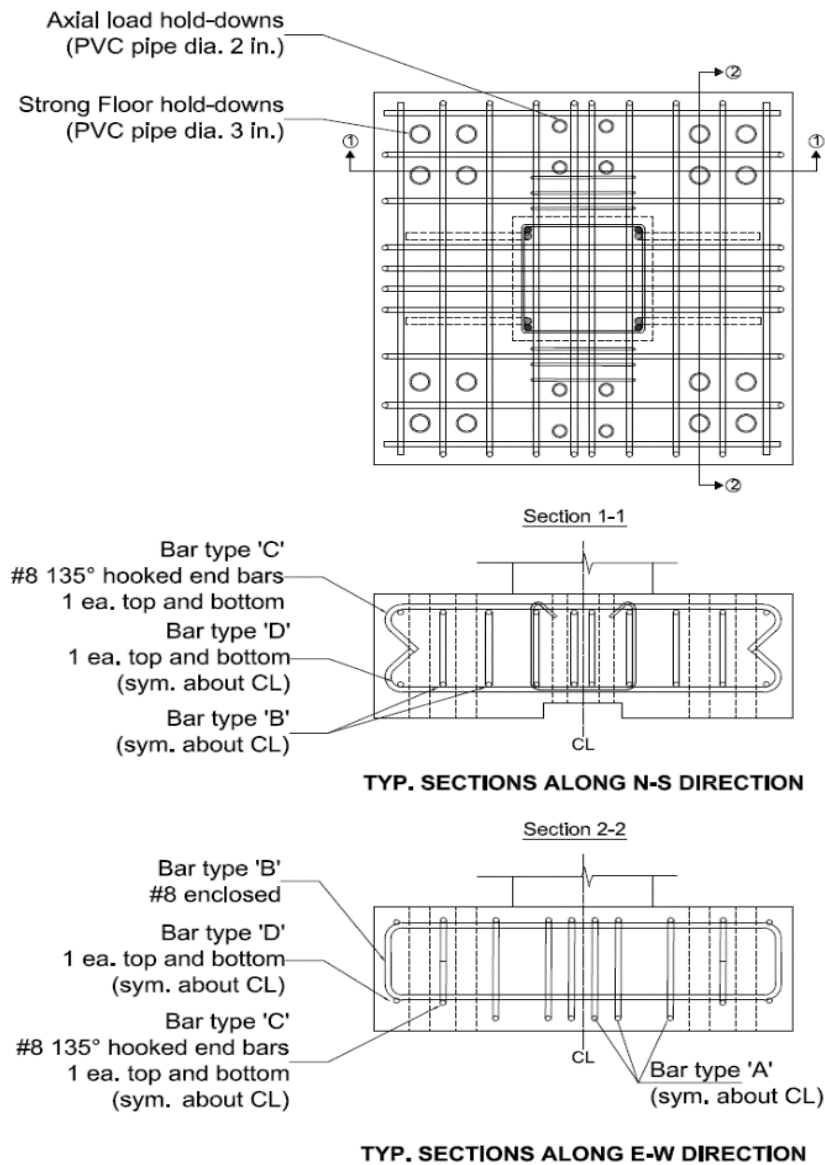
**Figure 3.24: Typical footing reinforcing details for direct attachment to strong floor**

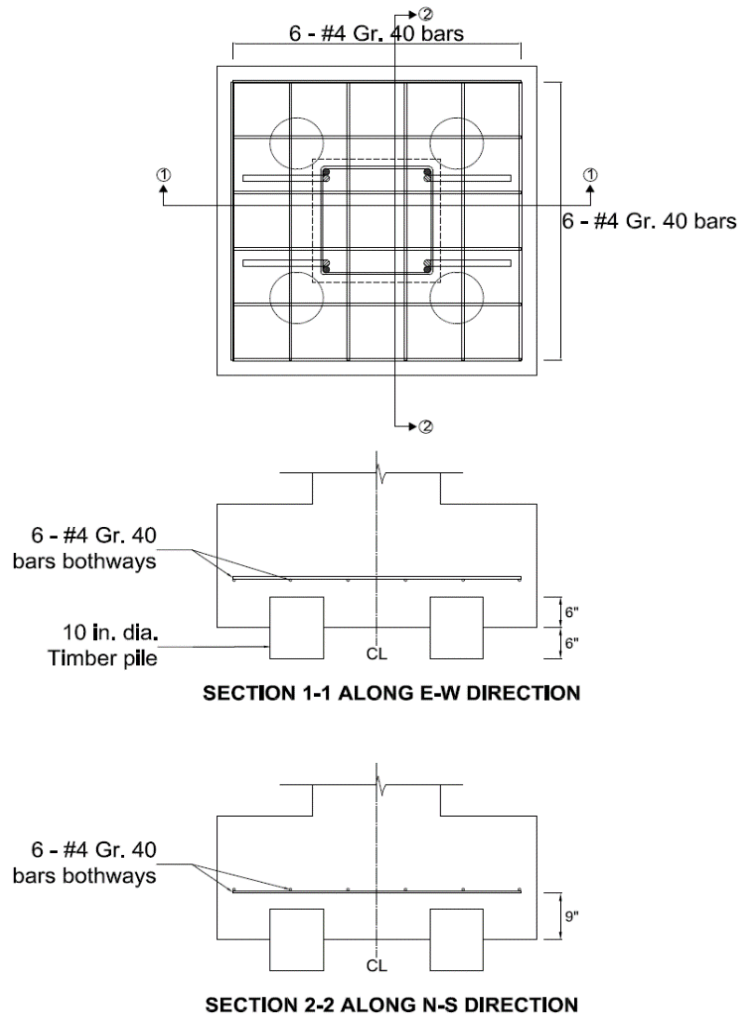
**Figure 3.29: Footing reinforcing steel detail for timber pile cap foundation specimen**

orientation are shown in Figure 3.26. The footings of these specimens were over-designed to isolate the behavior and force the failure to occur in the column stub and not the foundation. These heavily reinforced footings are not representative of the actual details used in vintage bridge construction practice. The remaining two (2) specimens were constructed with footing details that were intended to reflect the actual vintage construction practices. One of the specimens was built with a spread footing containing a single layer of rebar mesh and the other was built with timber pile cap. The timber pile cap specimen contained four (4) Douglas fir timber piles having 10 in (254 mm) butt diameters that extended 6 in into and below the concrete pile cap block. The spread footing details are shown in Figure 3.27 and Figure 3.28. The timber pile cap details are shown in Figure 3.29 and Figure 3.30.

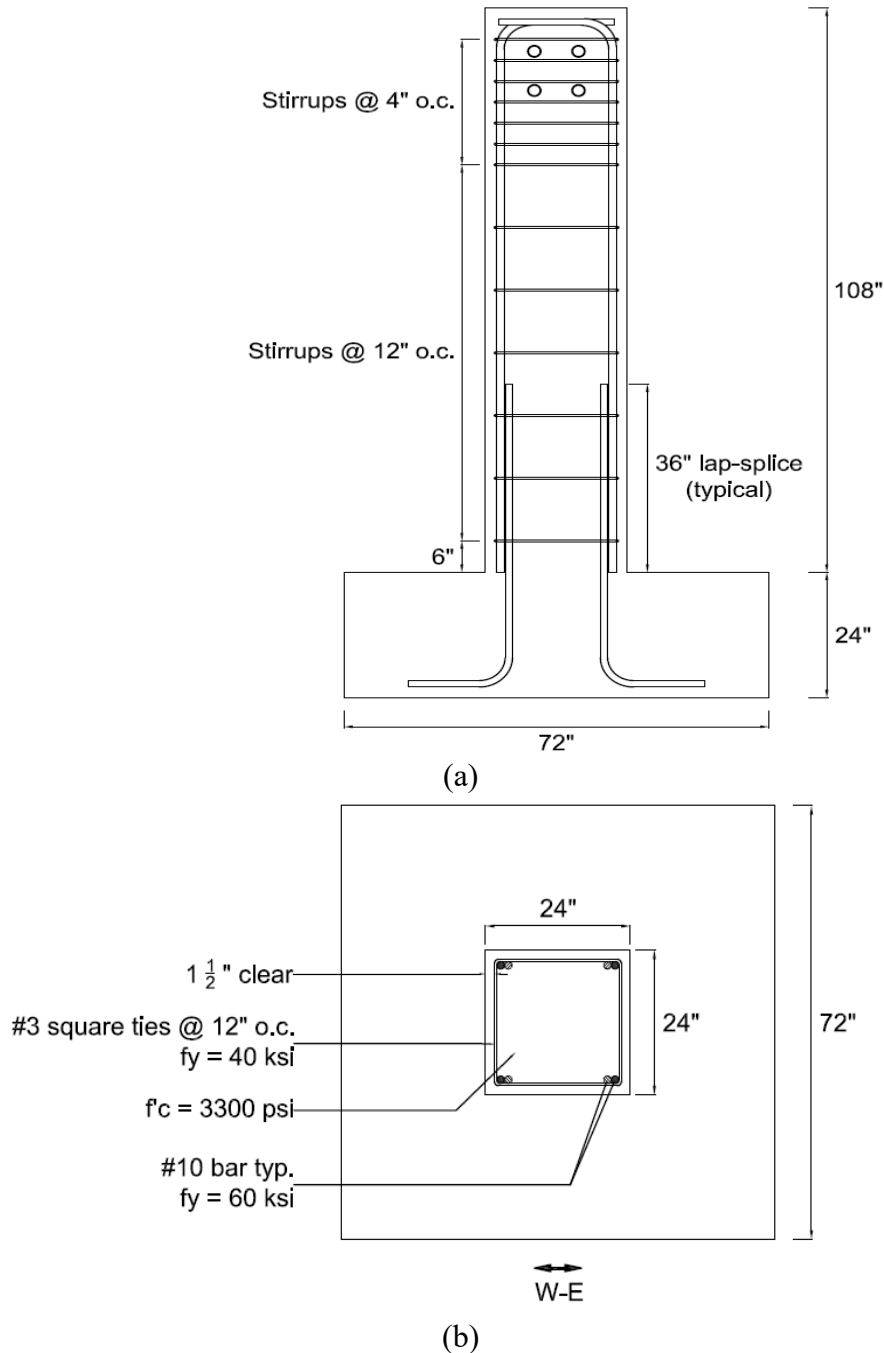
**Figure 3.40: Specimen C-S-R: Dimensions and reinforcing steel details (a) E–W elevation view, (b) plan view (dimensions in inches)**

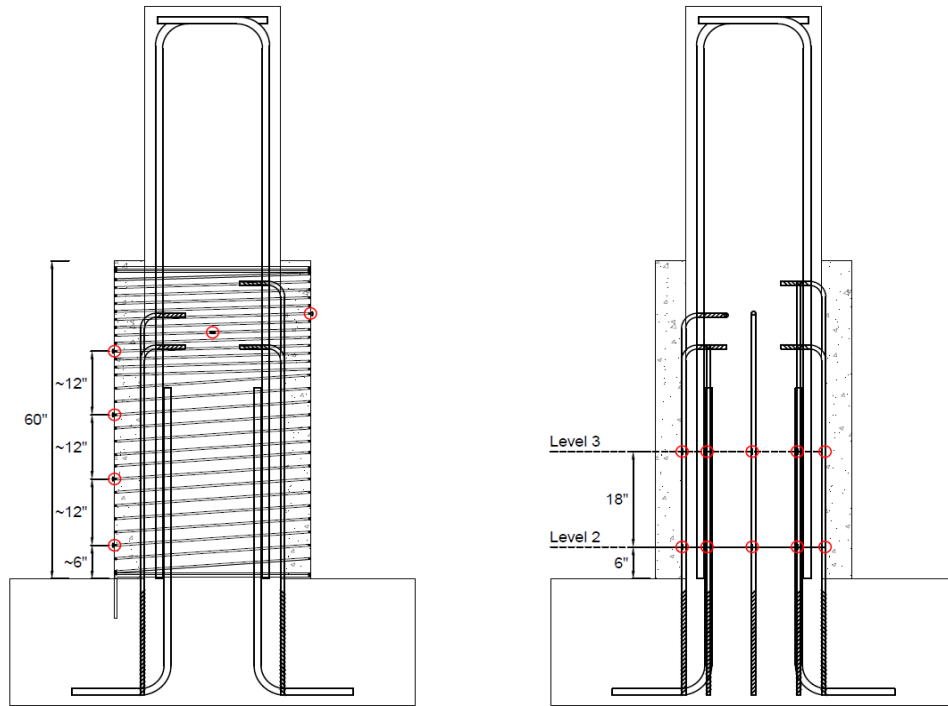
**Figure 3.65: Strain gages layout in TiAB spirals and stainless steel ligaments on south face**

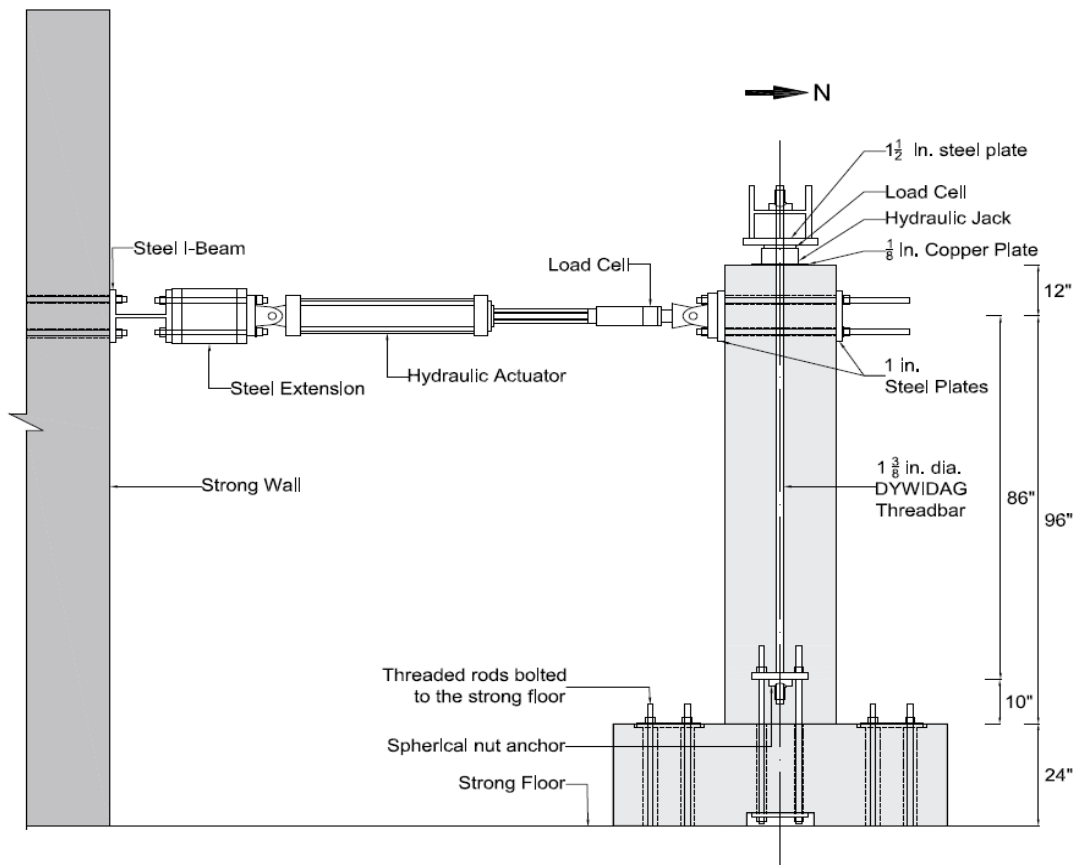
**Figure 3.66: Typical lateral loading setup (East elevation, short specimen shown)**

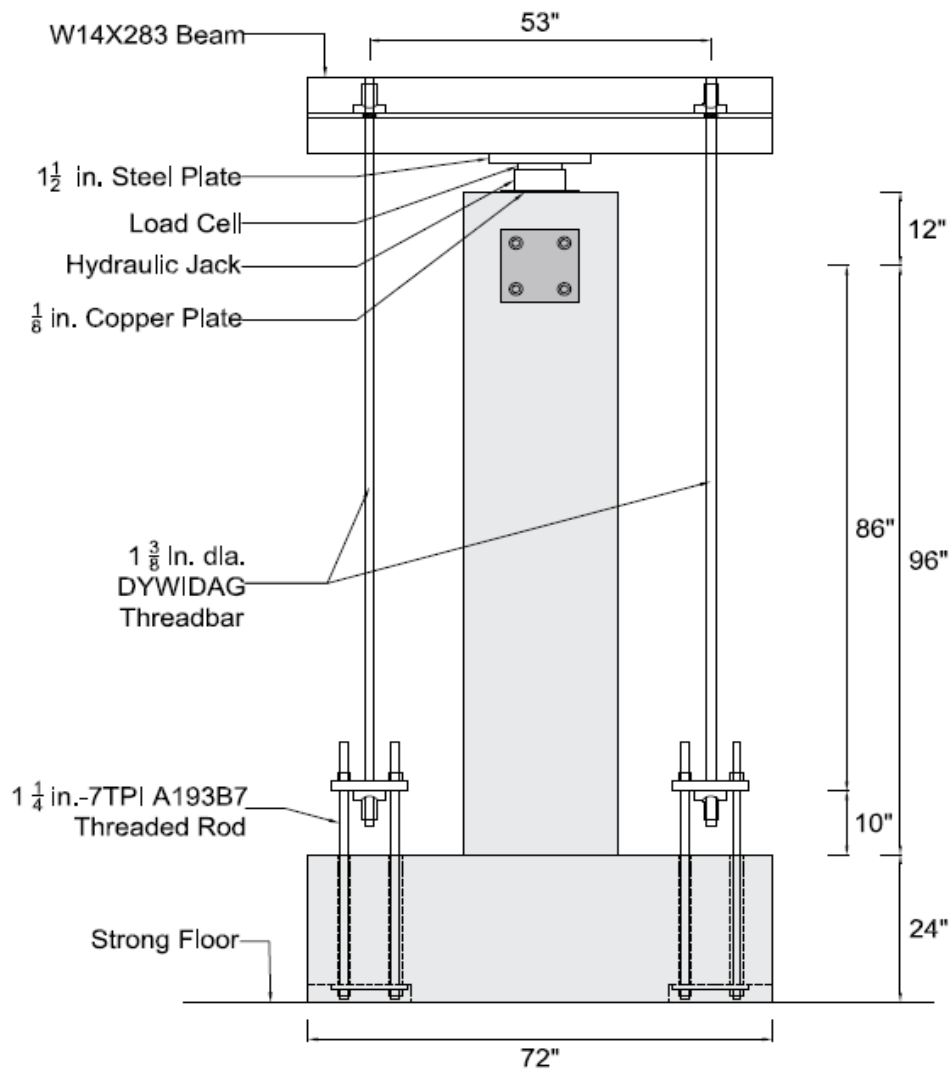
**Figure 3.68: Typical vertical loading setup (North elevation) for typical over reinforced footing foundation**

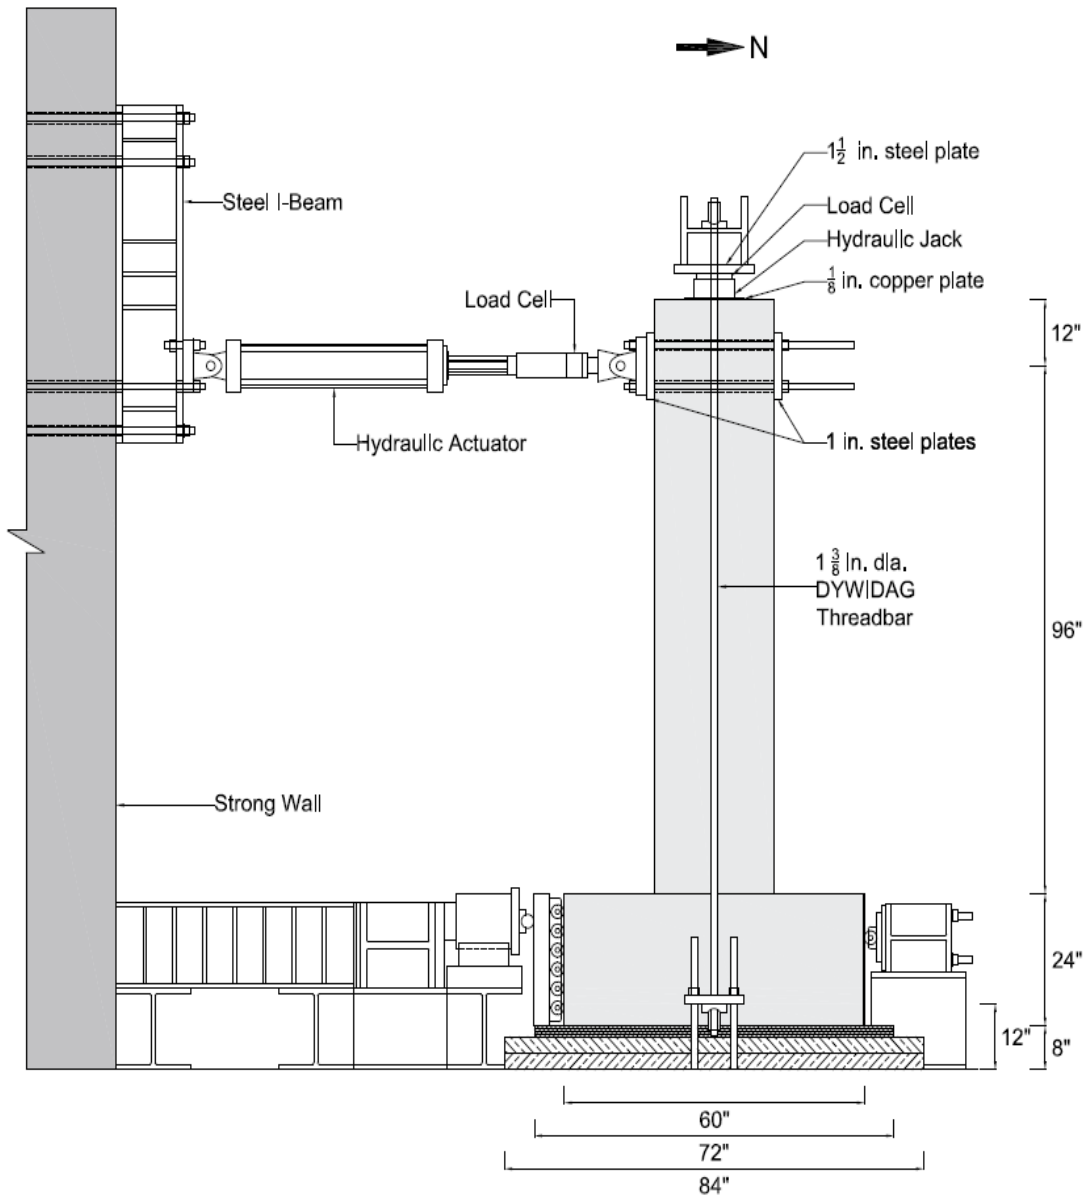
**Figure 3.69: Specimen R-S-R-LTi-90-Spread: Lateral loading setup (East elevation, lateral restraints for footing not shown completely)**

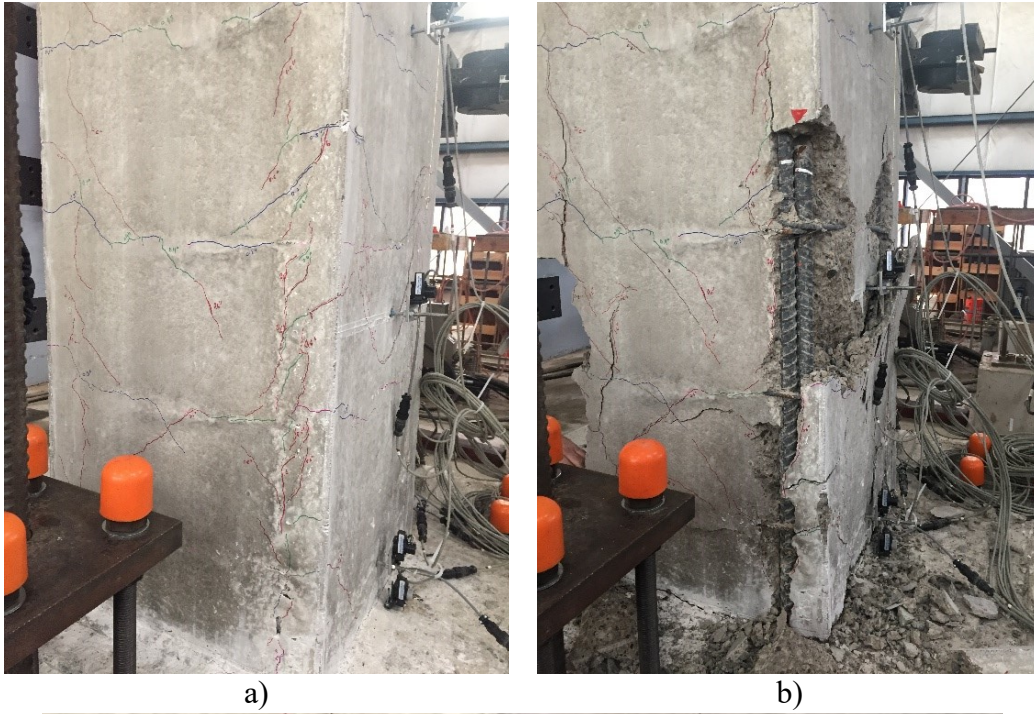
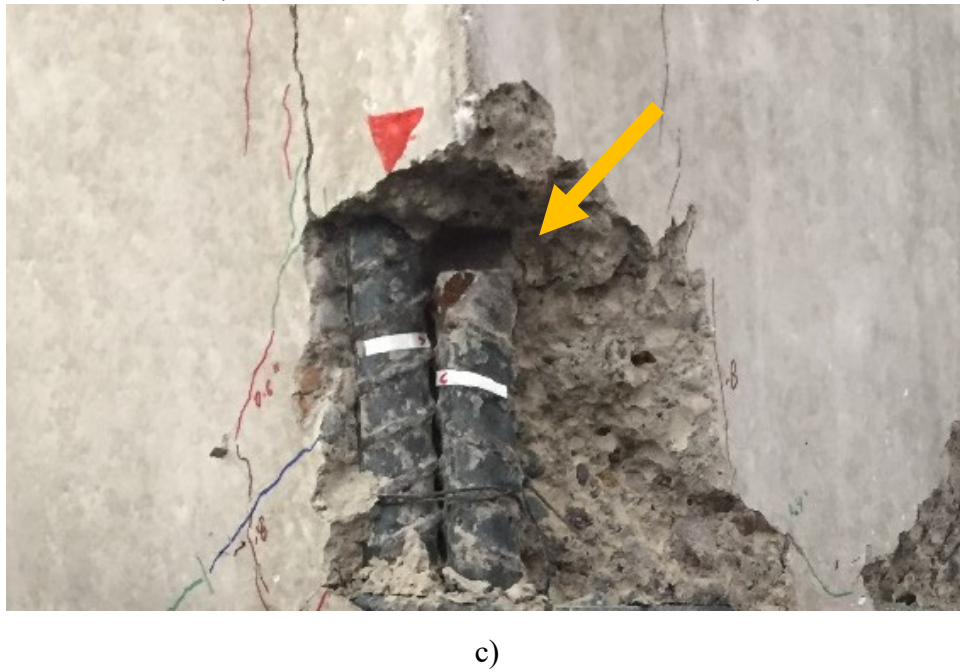
Horizontal flexural cracks started appearing at 0.2 in (5.08 mm) (0.2%) drift level in the North and South face close to the stirrups level. At 0.3 in (7.62 mm) (0.3%) drift level, 45° diagonal cracks started appearing on the East face that extended to the North and South faces. Flexural cracks appeared at this drift level that extended throughout the column width. Additional shear and flexural cracks appeared at 0.4 in (10.2 mm) (0.4%) drift level which was estimated to be the yield displacement. Some splitting cracks began to appear around the splice length at this drift level indicating the beginning of splice failure. Progressive splitting cracks appeared at 0.6 in (15.2 mm) (0.6%) drift level initiating concrete cover spalling that was an indication of the lap-splice bond failure and slippage of the bars as seen in Figure 4.1a. At 0.8 in (20.3 mm) (0.8%) drift level, additional flexural cracks on the North and South sides and additional splitting cracks appeared along the splice length at four corners. For drift levels greater than 0.8 in (20.3 mm) (0.8%), no new cracks appeared; only the existing cracks widened further causing spalling of the cover concrete at 1.2 in (30.5 mm) (1.2%) drift level exposing the column longitudinal and shear reinforcement and footing starter bars (Figure 4.1b). Concrete spalling allowed observation of the slip occurring between column bars relative to the starter bars (Figure 4.1c).

**Figure 4.1: Specimen C-S-R: Progression of visual distress: a) at 0.6 in (approx. 0.6%) drift level, b) at the end of testing (approx. 2.8% drift level), c) Slip between spliced bars (NE corner)**

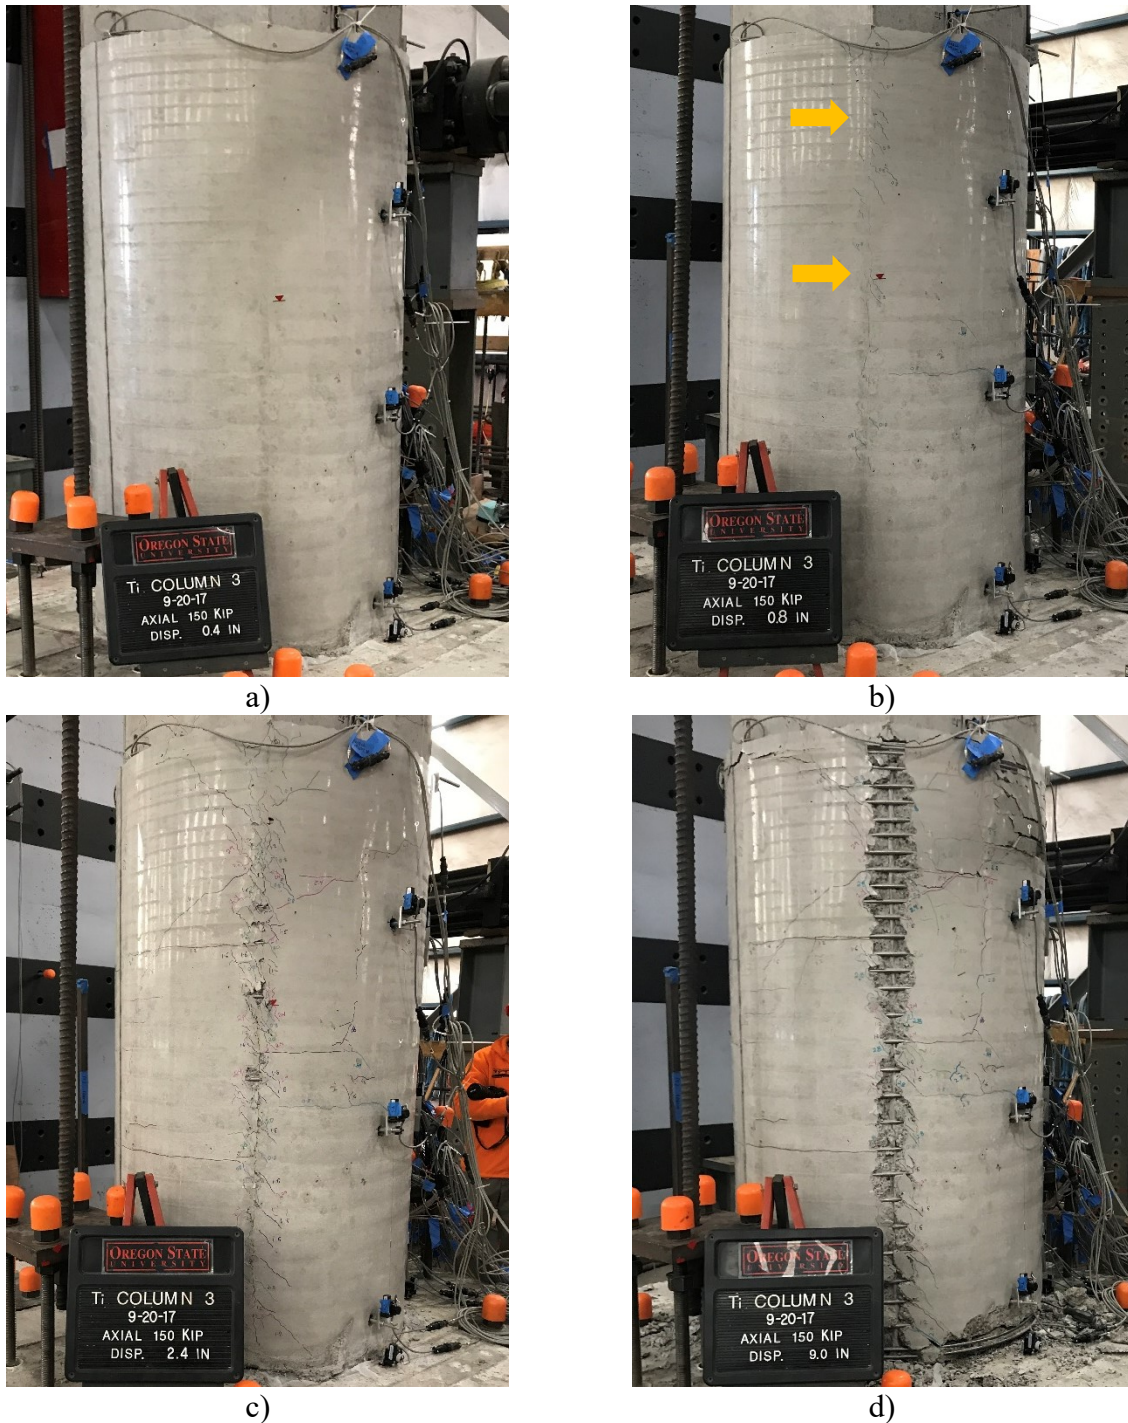
**Figure 4.3: Specimen R-S-R-LTi-90: Progression of visual distress: a) at 0.4 in (approx. 0.4%) drift level, b) at 0.8 in (approx. 0.8%) drift level, c) at 2.4 in (approx. 2.4%) drift level, d) at the end of testing (approx. 9% drift level)**

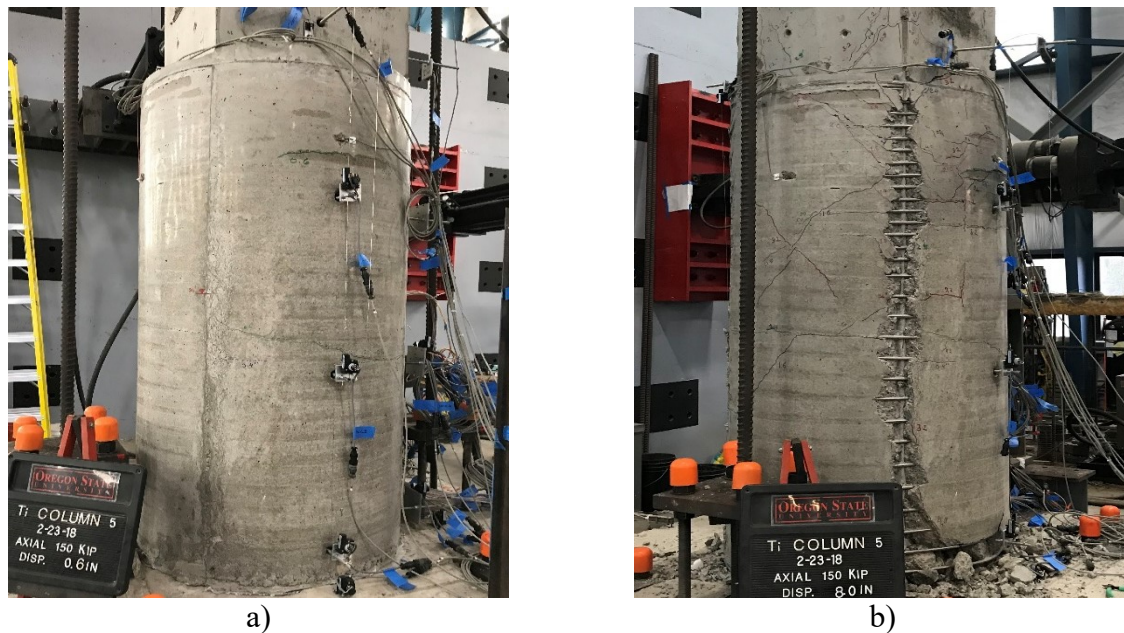
**Figure 4.8: Specimen R-S-R-LTi-135: Progression of visual distress: a) at 0.6 in (approx. 0.6%) drift level, b) at the end of testing (approx. 8% drift level)**

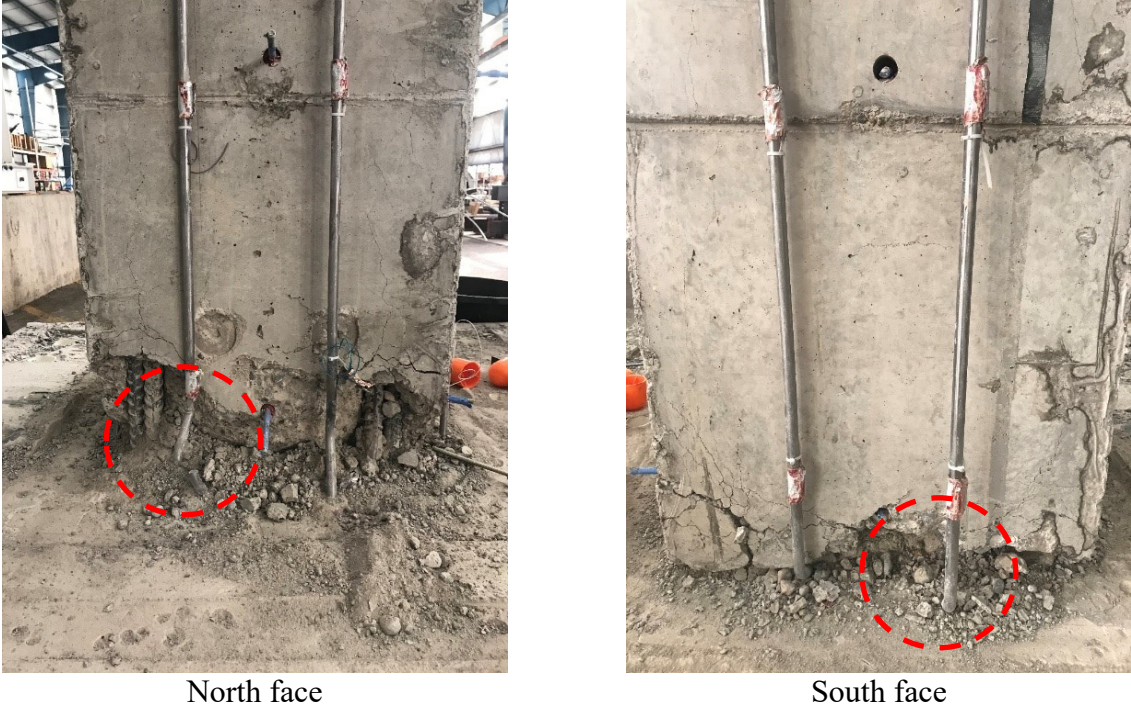
**Figure 4.11: Specimen R-S-R-LTi-135: TiAB ligaments after removal of shell**

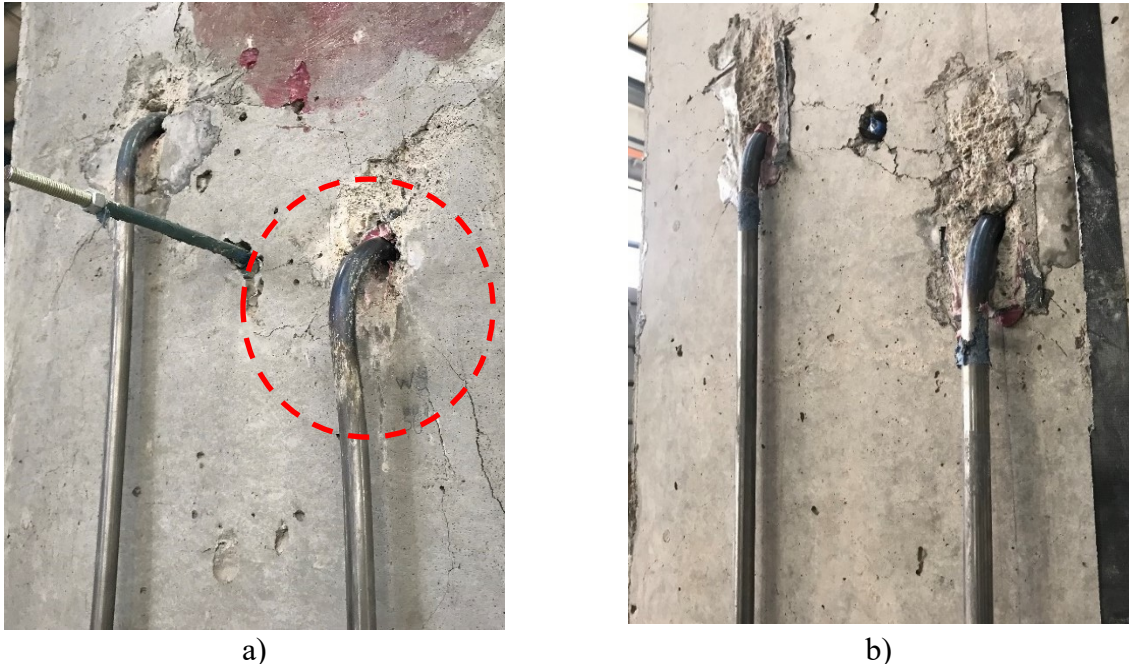
and 135 degree hooks is shown in Figure 4.12. The 90 degree hooks exhibited more distortion at the column face than the 135 degree hooks.

**Figure 4.12: TiAB hooks at the end of testing: a) Specimen R-S-R-LTi-90, b) Specimen R-S-R-LTi-135**

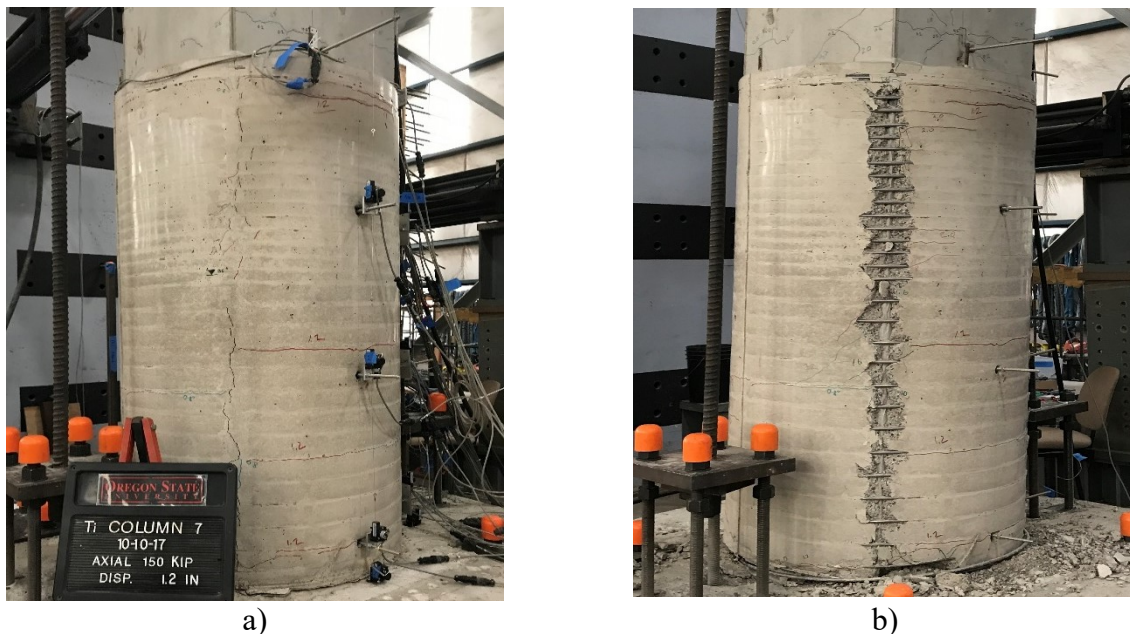
**Figure 4.13: Specimen R-S-R-0: Progression of visual distress: a) at 1.2 in (approx. 1.2%) drift level, b) at the end of testing (approx. 8% drift level)**

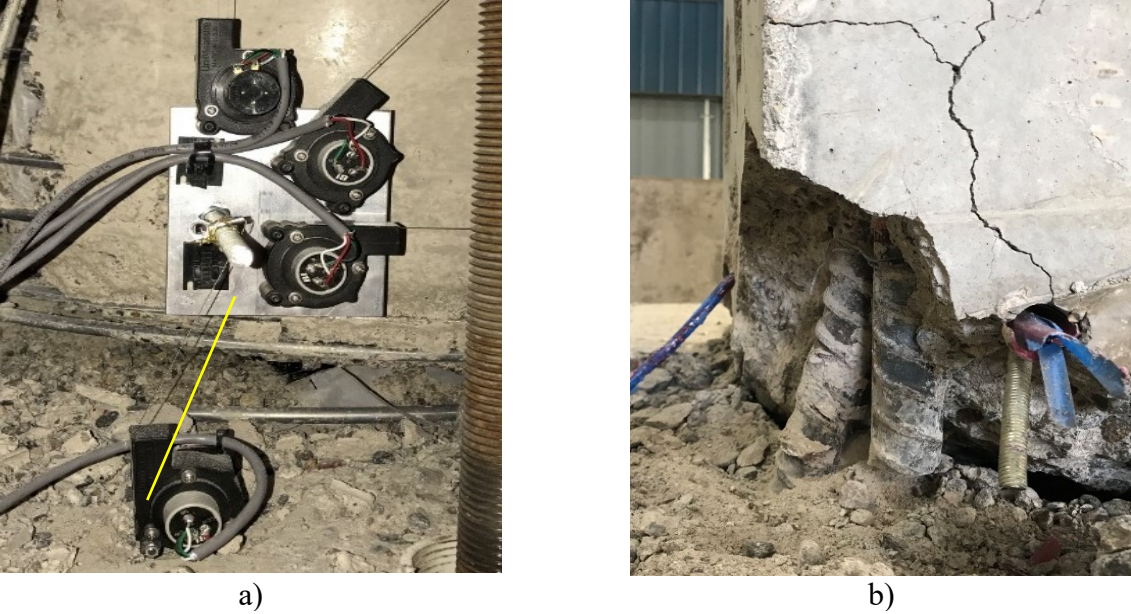
**Figure 4.14: Specimen R-S-R-0: a) String Pot showing the sliding of the column at column-footing interface (string highlighted in yellow), b) NW starter bar bent towards South after testing**

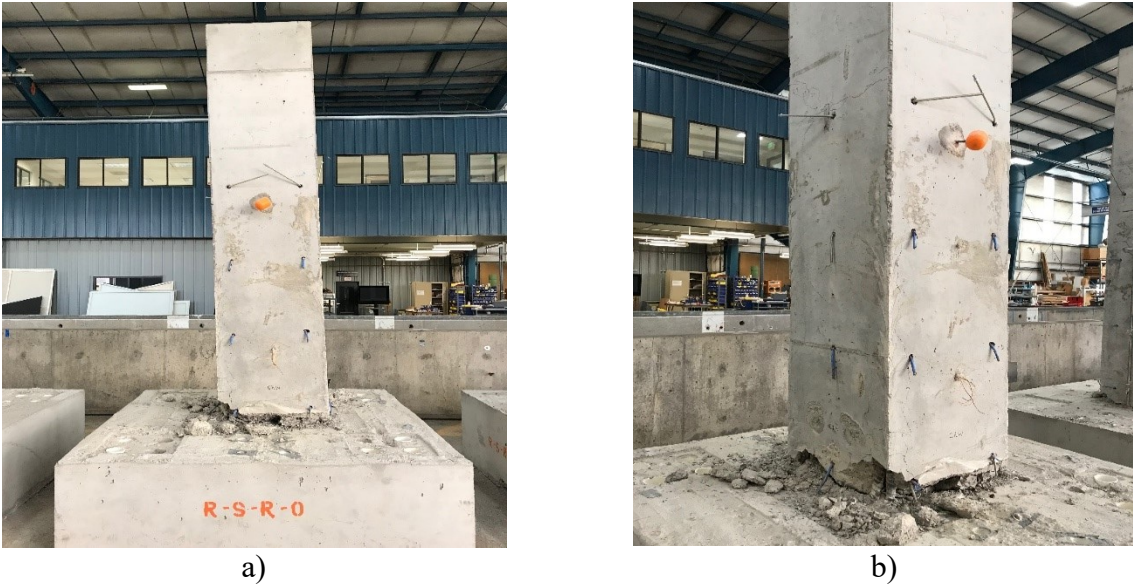
**Figure 4.15: Specimen R-S-R-0: Column after removal of shell: a) Overall, b) Close-up view**

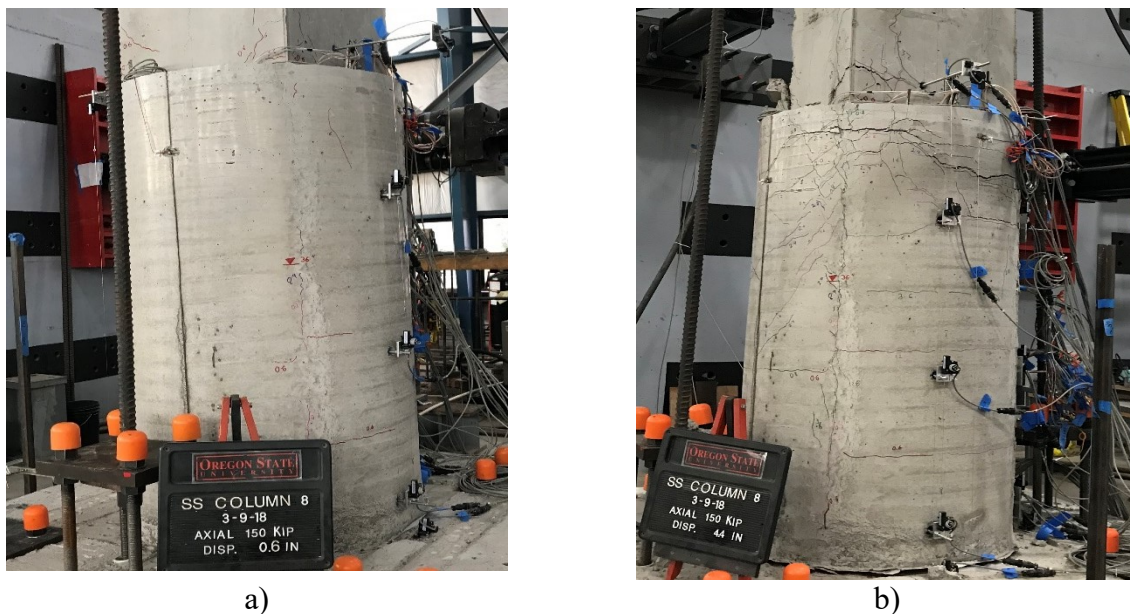
Figure 4.16: Specimen R-S-R-LSS-90: Progression of visual distress: a) at 0.6 in (approx. 0.6%) drift level, b) at 4.4 in drift (approx. 4.4%) drift level

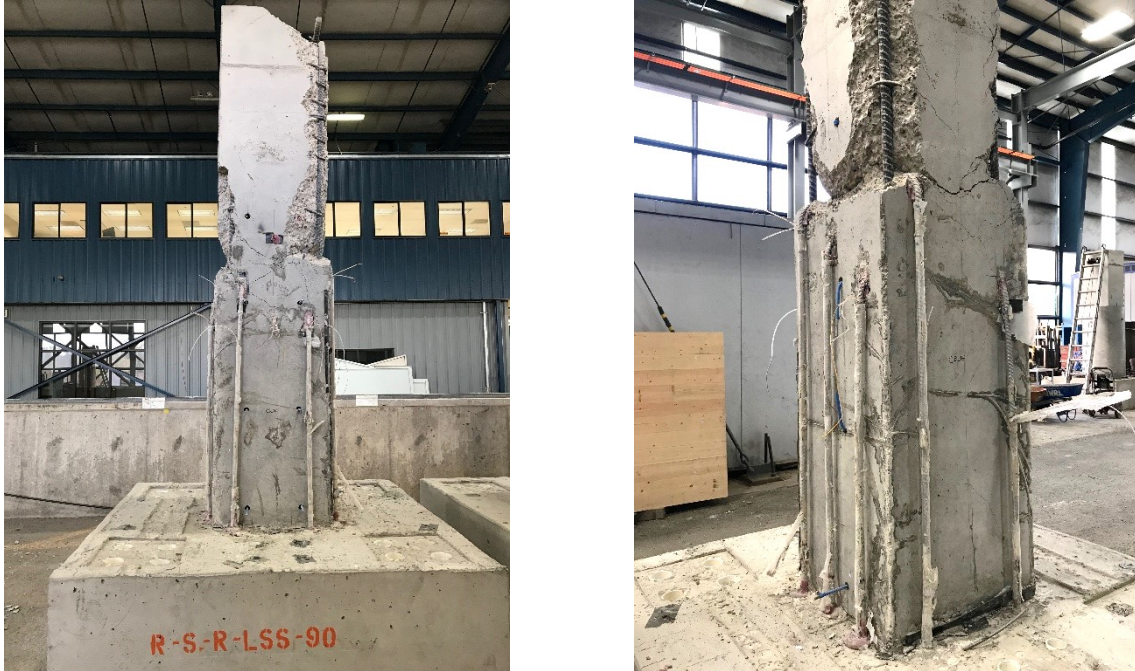
**Figure 4.18: Specimen R-S-R-LSS-90: Column after removal of shell: a) Overall, b) Close-up view**

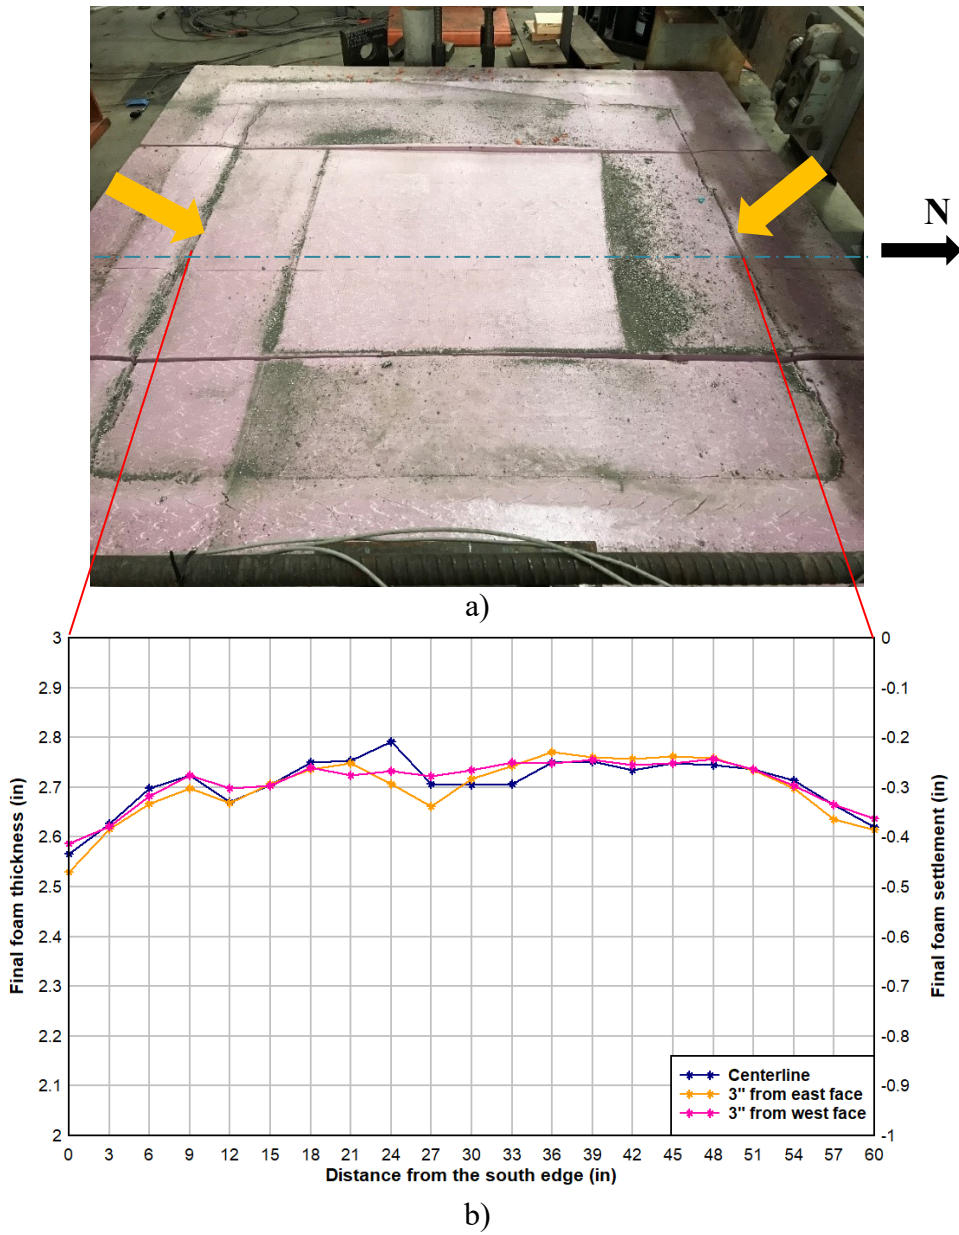
Figure 4.19: Specimen R-S-R-LTi-90-Spread: a) visual damage to top layer of 3 in (76.2 mm) foam “soil” after removal of specimen b) foam profile at the end of testing
