**SEISMIC RETROFITS FOR SQUARE  
REINFORCED CONCRETE COLUMNS  
USING TITANIUM ALLOY BARS**

**Final Report**

**PROJECT SPR-784**

Oregon Department of Transportation

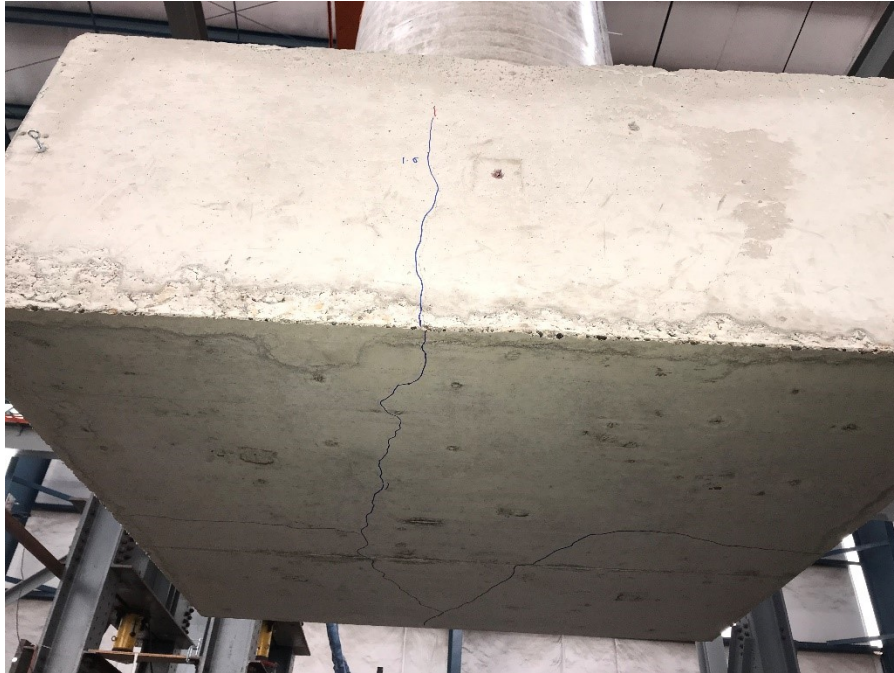
**Figure 4.20: Specimen R-S-R-LTi-90-Spread: Cracking on spread footing**

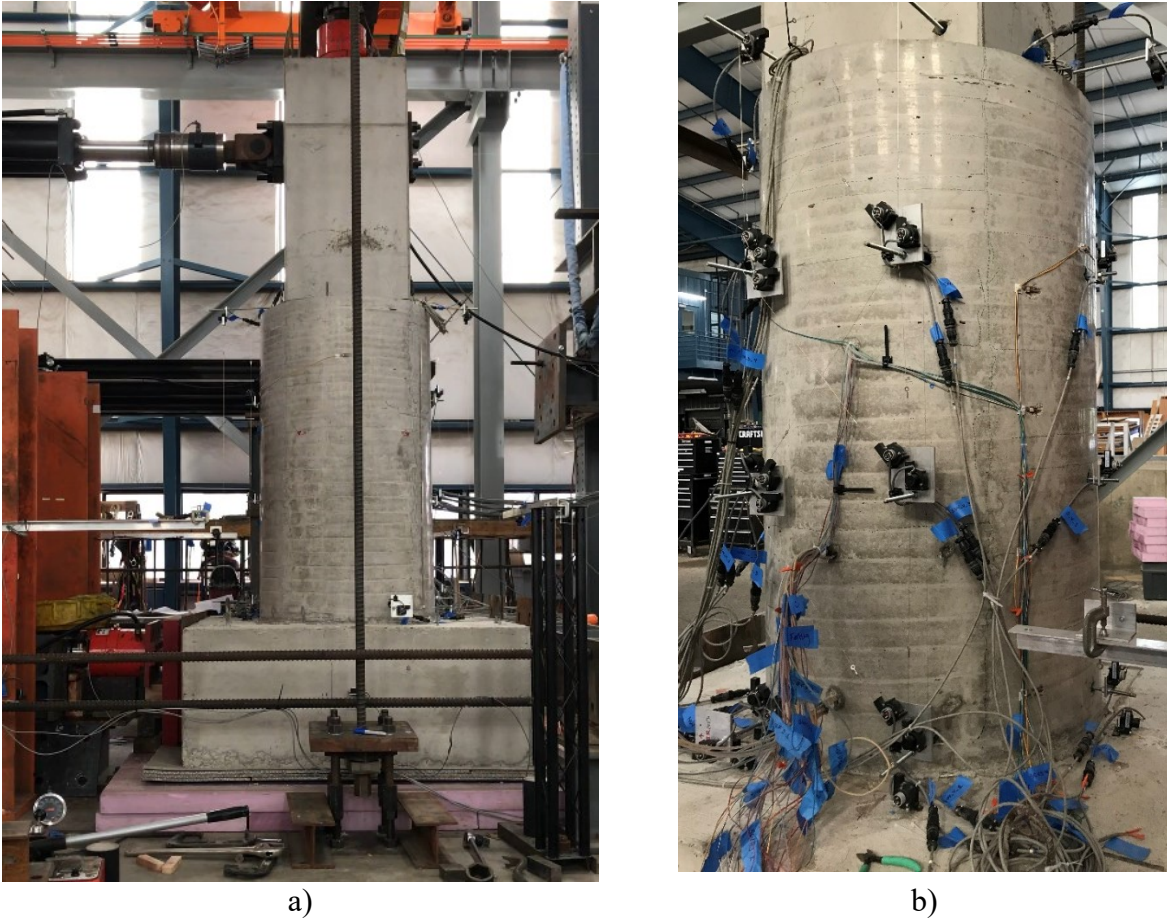
**Figure 4.22: Specimen R-S-R-LTi-90-Spread: a) Column at the end of testing (at approx. 2.1% total drift) cracks observed in footing, b) limited cracking in column and retrofit**

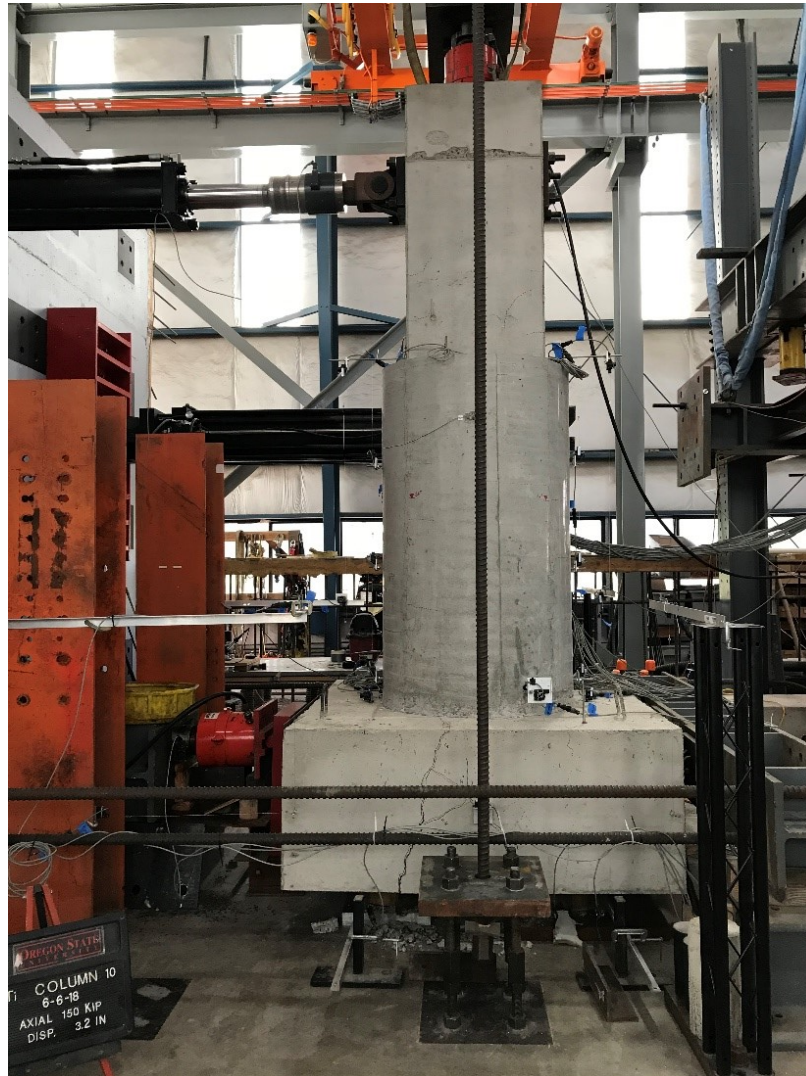
**Figure 4.23: Specimen R-S-R-LTi-90-Pile: Column at the end of testing (at approx. 4% total drift level), limited cracking in column, large cracks in footing**

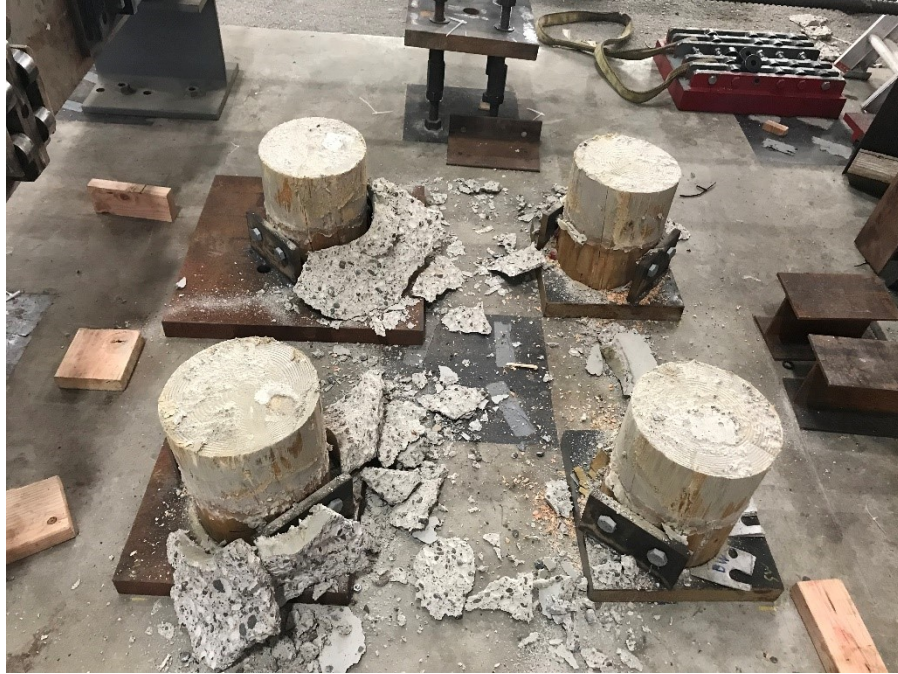
**Figure 4.24: Specimen R-S-R-LTi-90-Pile: Damage around piles on pile footing**

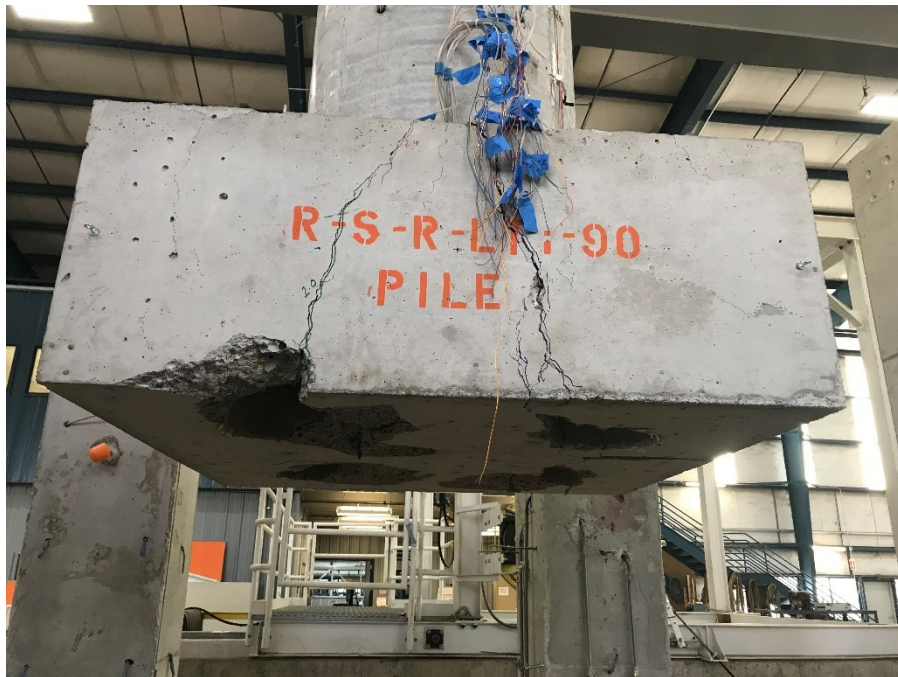
**Figure 4.25: Specimen R-S-R-LTi-90-Pile: Cracking on pile cap**

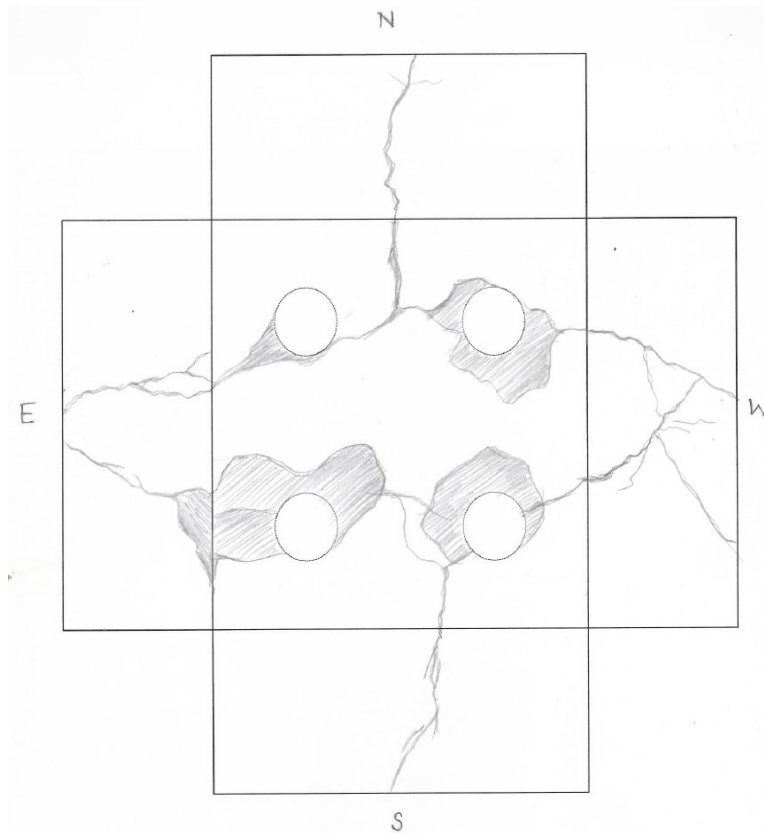
**Figure 4.26: Specimen R-S-R-LTi-90-Pile: Cracking and spalling observed on pile cap**

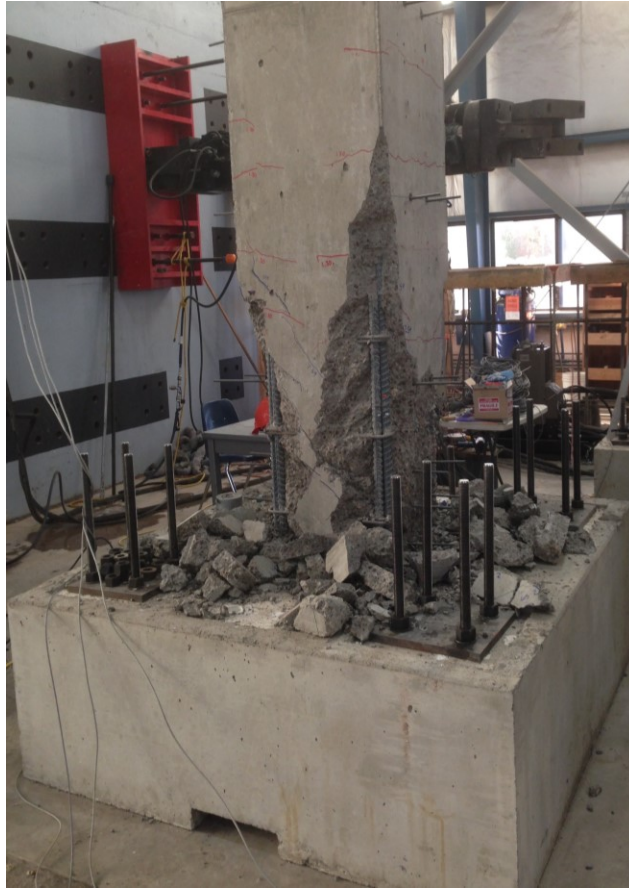
**Figure 4.27: Condition of specimen C-T-R at end of test (maximum 5.4% drift)**

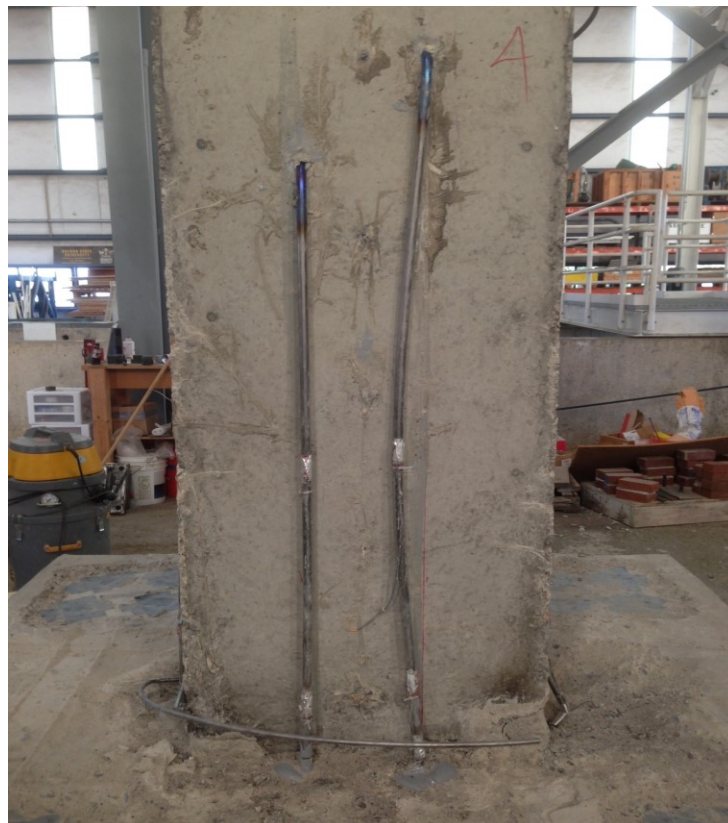
**Figure 4.33: RN-T-R-LTi-90: Buckled deformation to WS TiAB ligament (shell removed after testing)**

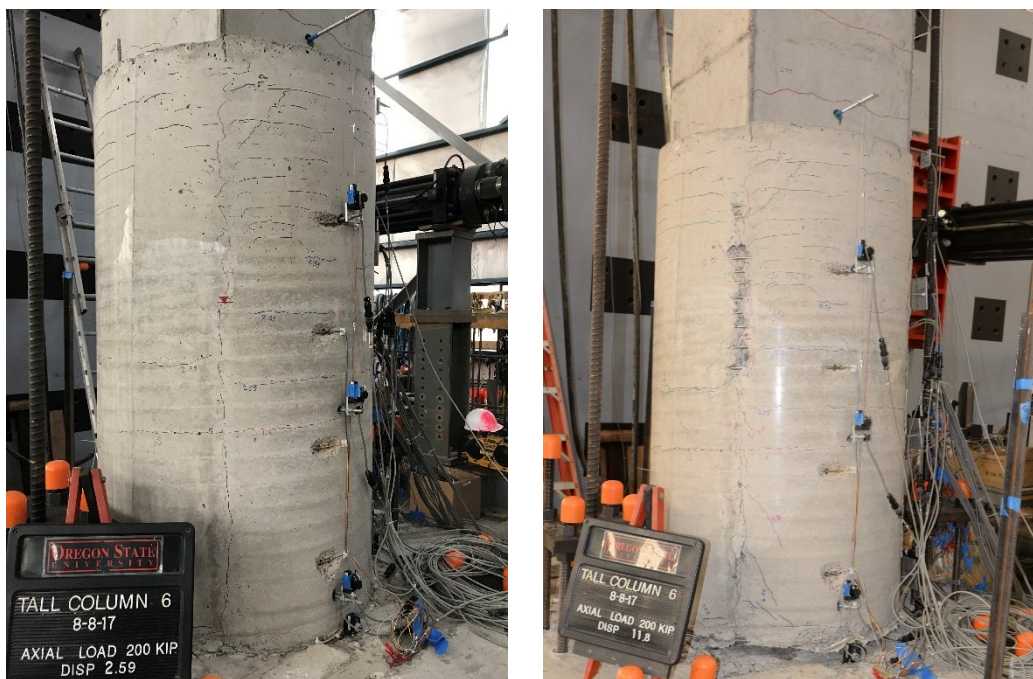
Figure 4.36: Specimen R-T-R-0: Damage progression: (a) at 2.59 in (approx. 1.8%) drift level, (b) at the end of testing (approx. 7% drift level)

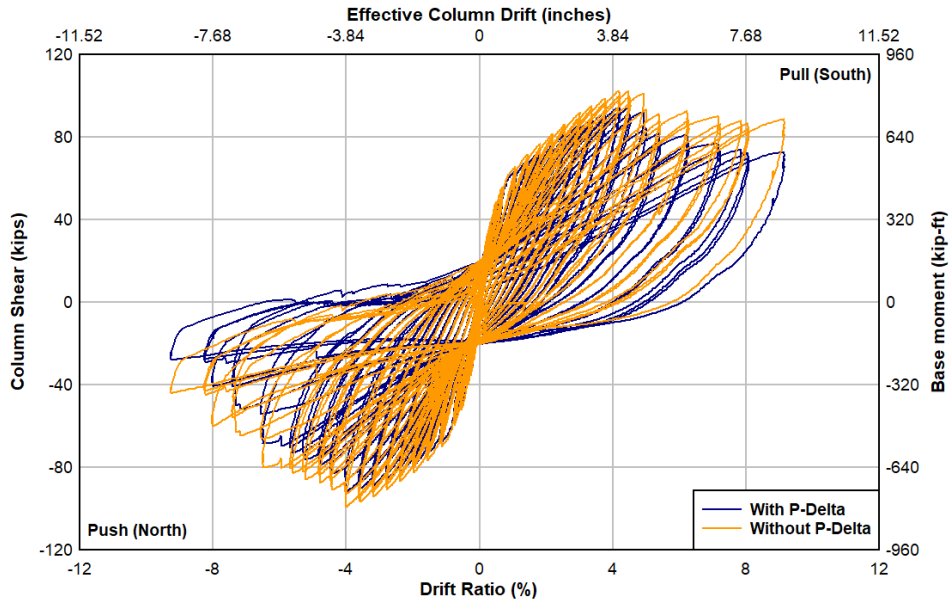
Figure 4.58: Specimen R-S-R-LTi-90: P-Delta effect on load-drift response

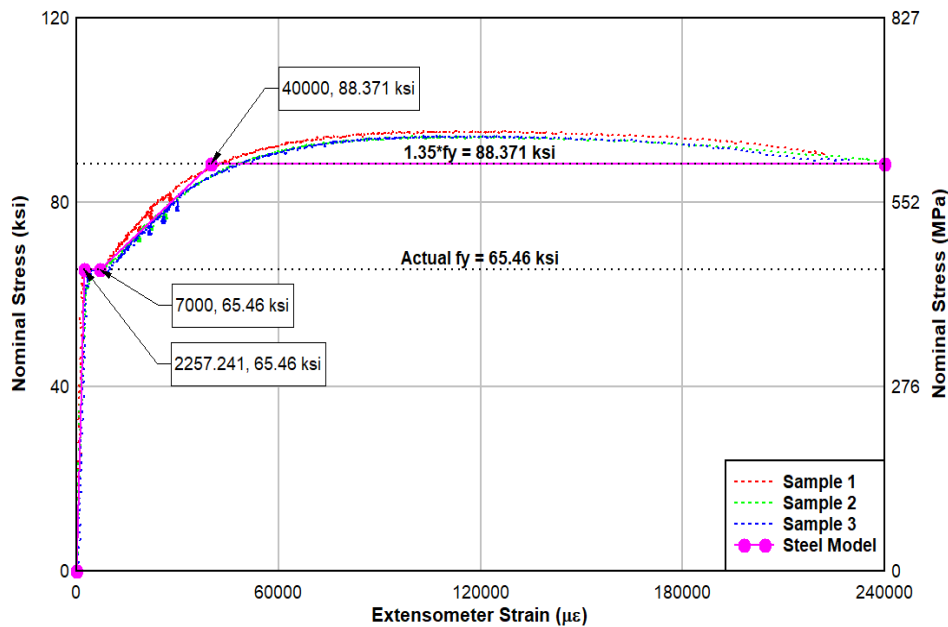
**Figure 4.60: Rebar stress-strain model for #10 (#32M) ASTM Gr. 60 bar based on coupon test results**

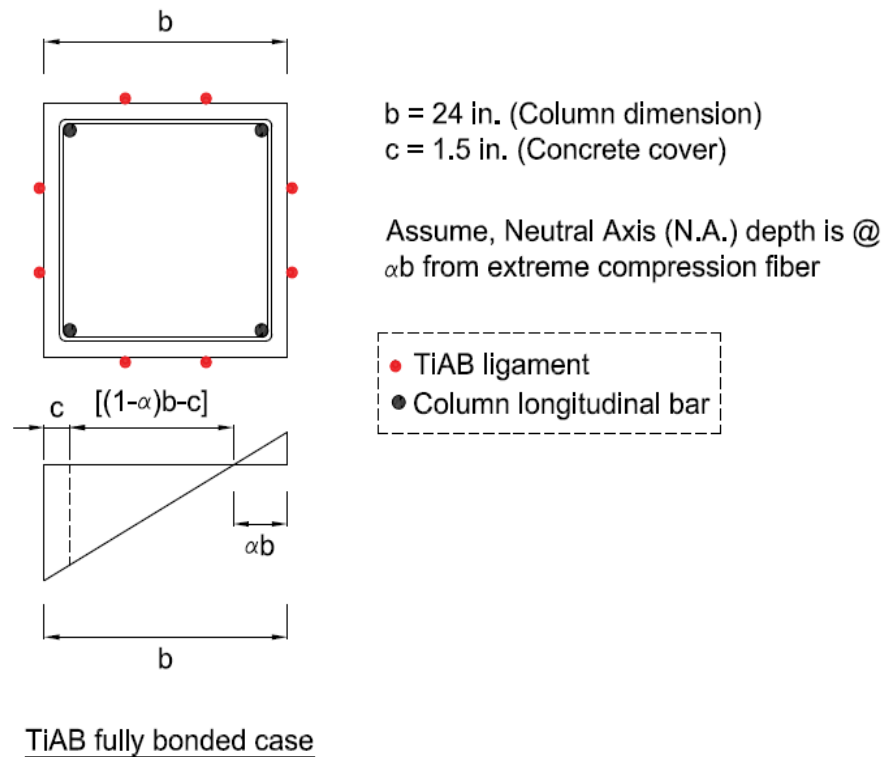
**Figure 4.61: Geometry and strain conditions for estimating strain in TiAB ligaments if fully bonded along length**

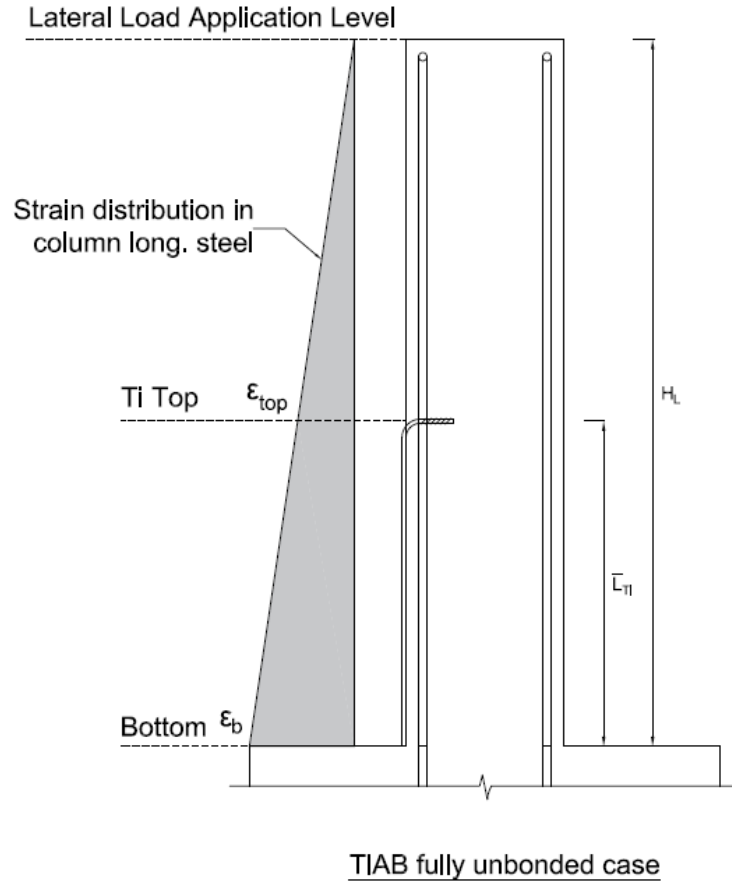
**Figure 4.62: Geometry and strain conditions for estimating strain in TiAB ligaments if fully bonded along length**

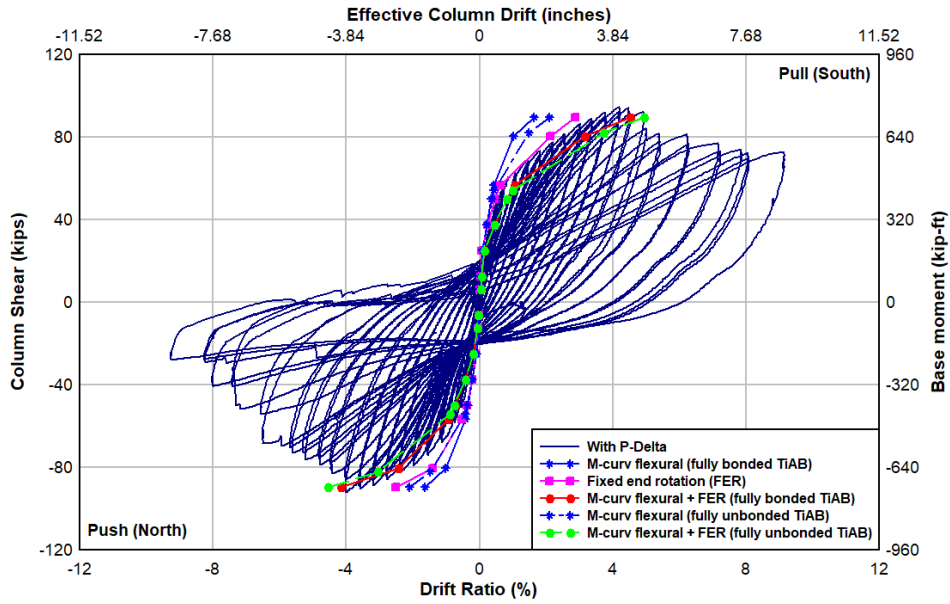
**Figure 4.66: Specimen R-S-R-LTi-90: Predicted response for different assumed TiAB bonding conditions and footing interface rotations (all non-composite)**

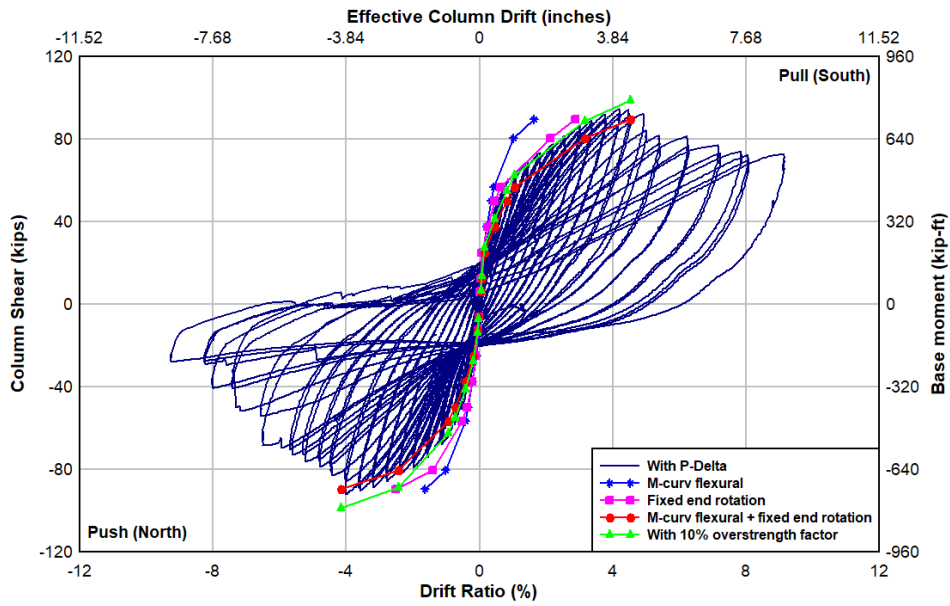
**Figure 4.67: Specimen R-S-R-LTi-90: Predicted contributions to response for selected TiAB bonding conditions, footing interface rotations, and over-strength**

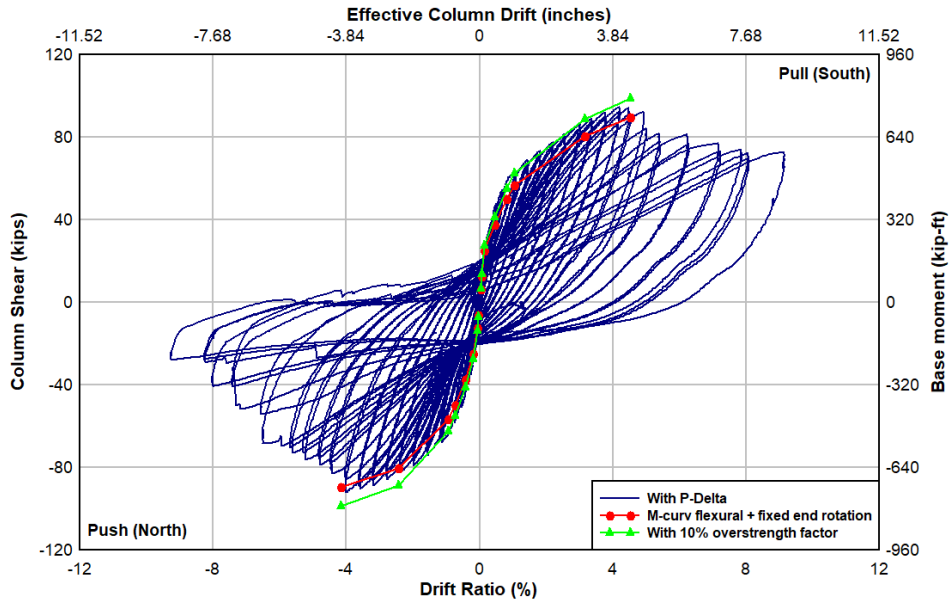
Figure 4.68: Specimen R-S-R-LTi-90: Final predicted response for selected TiAB bonding conditions, footing interface rotations, and over-strength

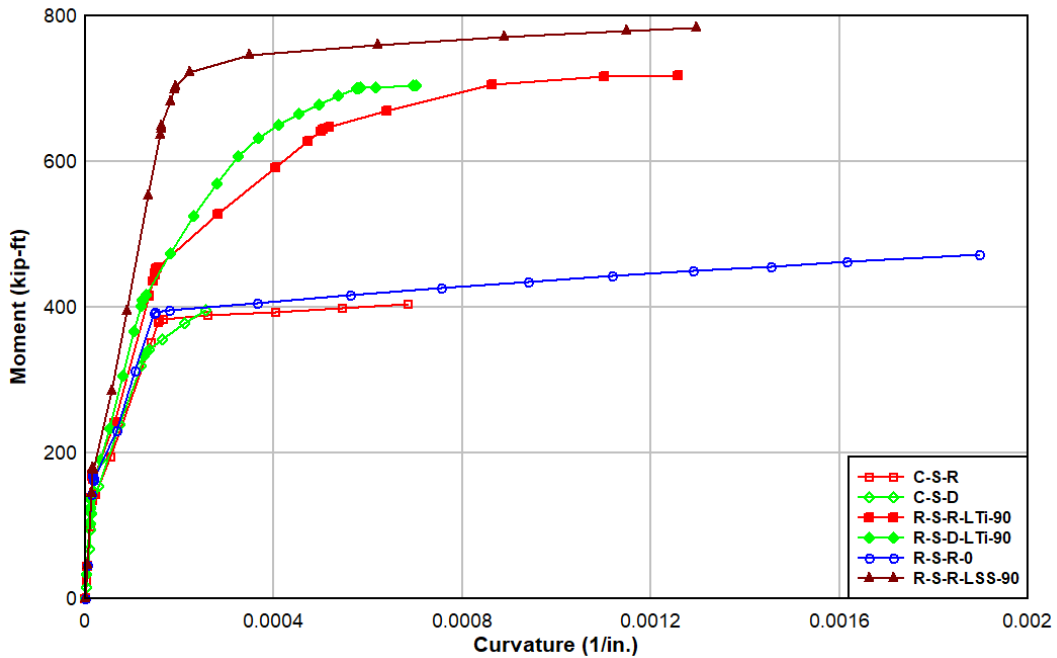
Figure 4.69: Example moment-curvature responses for short columns for selected parameters

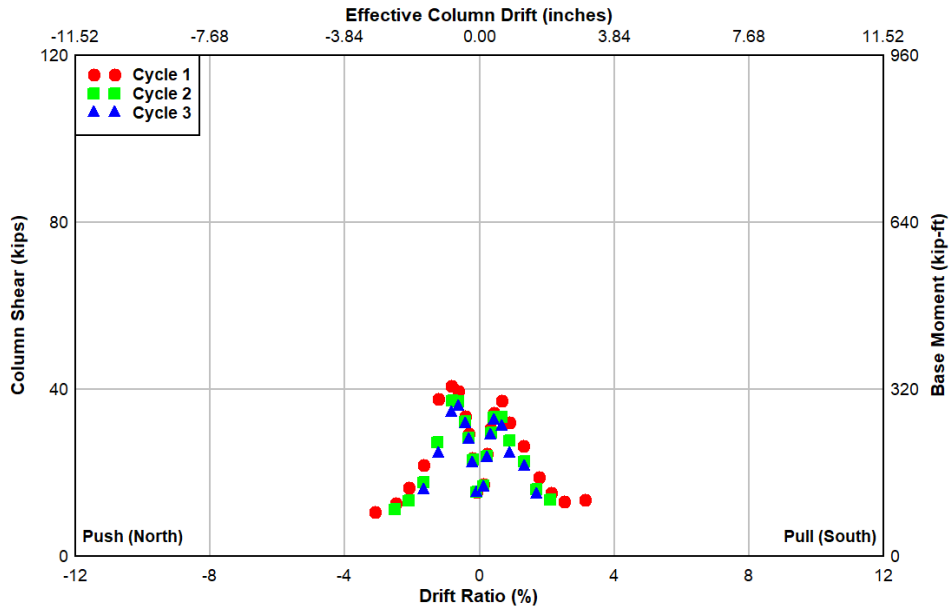
Figure 4.71: Specimen C-S-R: Strength degradation in each cycle

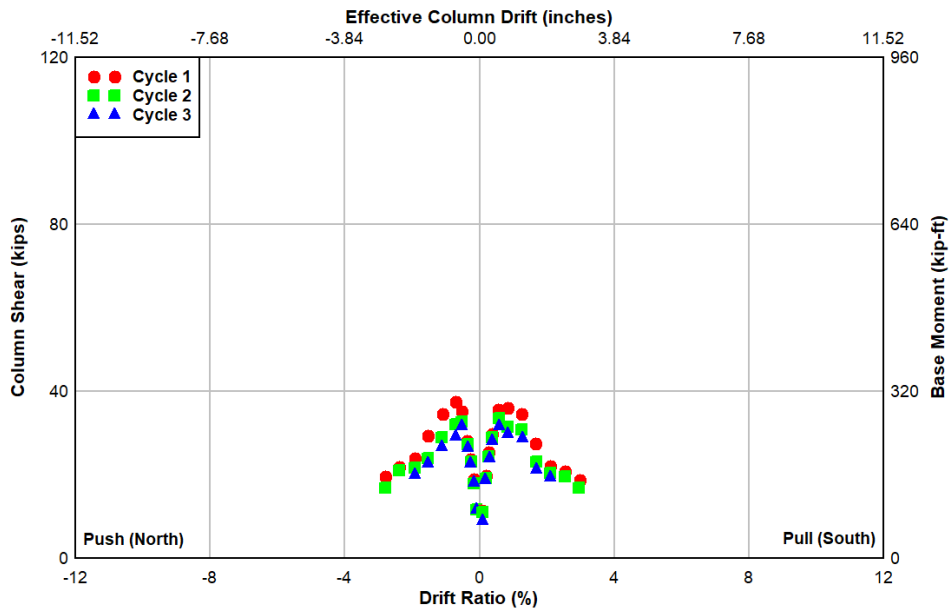
Figure 4.72: Specimen C-S-D: Strength degradation in each cycle

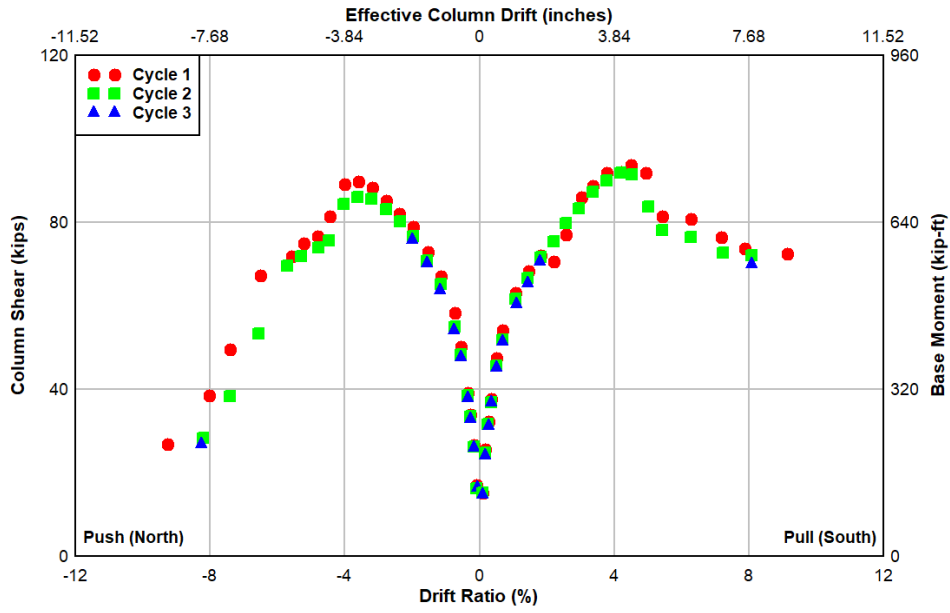
Figure 4.73: Specimen R-S-R-LTi-90: Strength degradation in each cycle

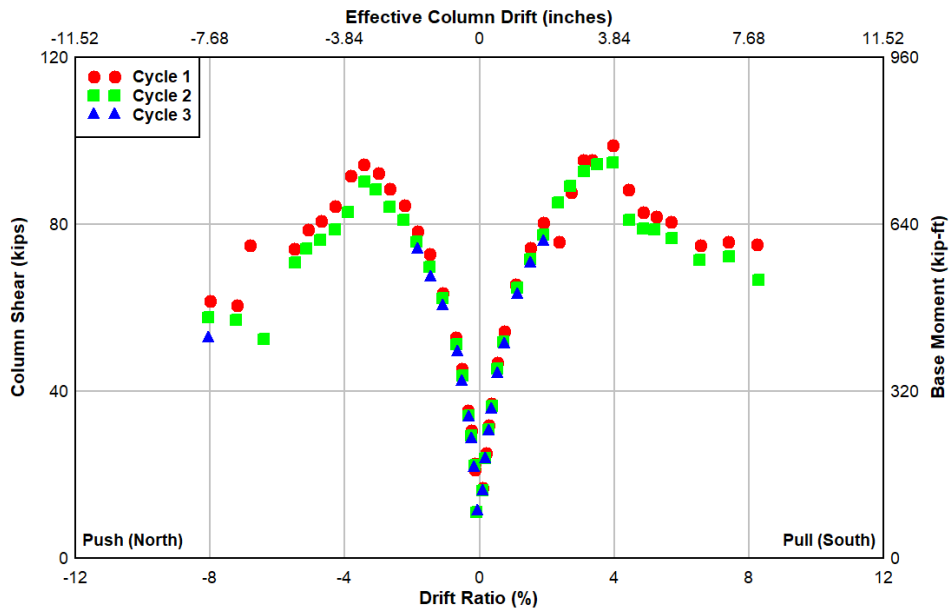
Figure 4.74: Specimen R-S-D-LTi-90: Strength degradation in each cycle

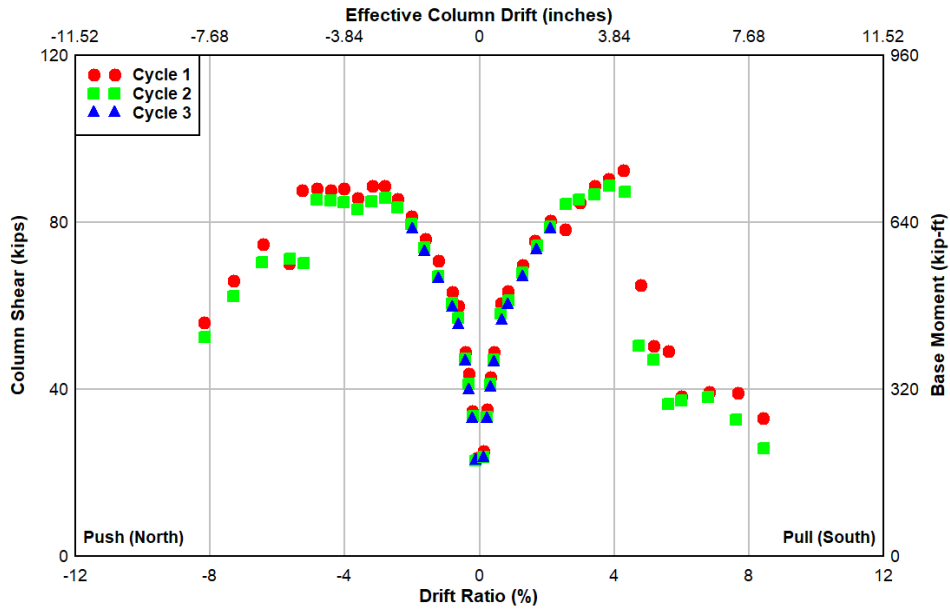
Figure 4.75: Specimen R-S-R-LTi-135: Strength degradation in each cycle

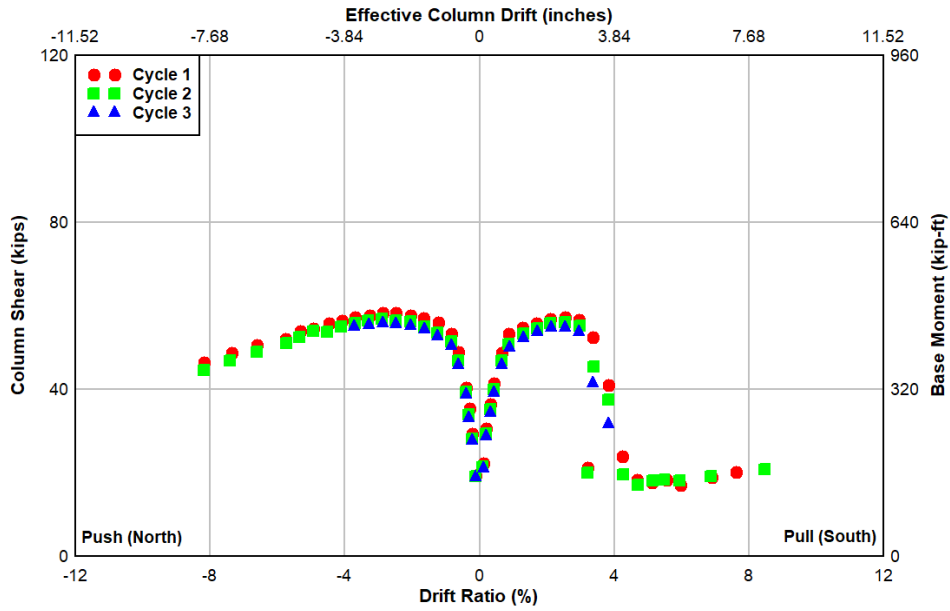
Figure 4.76: Specimen R-S-R-0: Strength degradation in each cycle

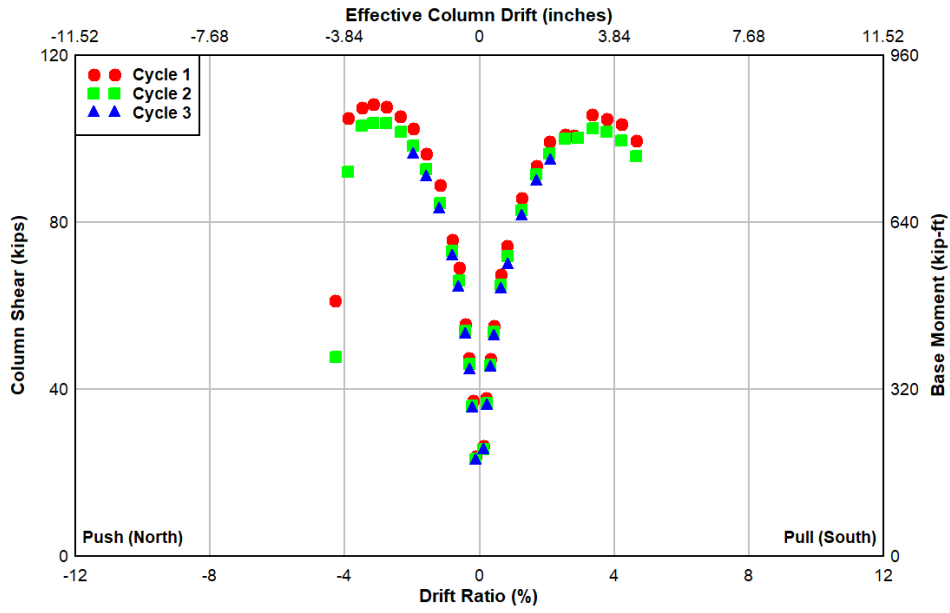
Figure 4.77: Specimen R-S-R-LSS-90: Strength degradation in each cycle

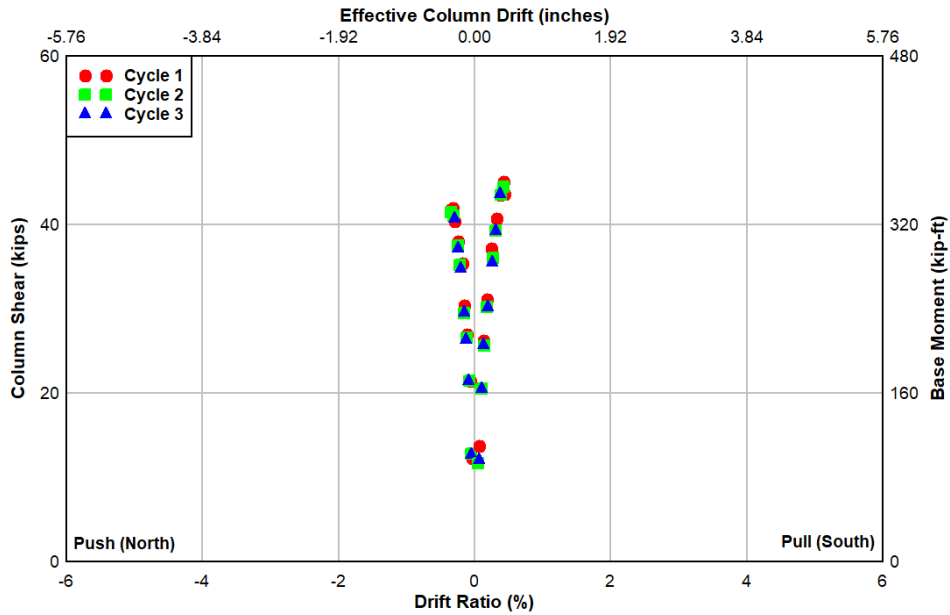
Figure 4.78: Specimen R-S-R-LTi-90-Spread: Strength degradation in each cycle

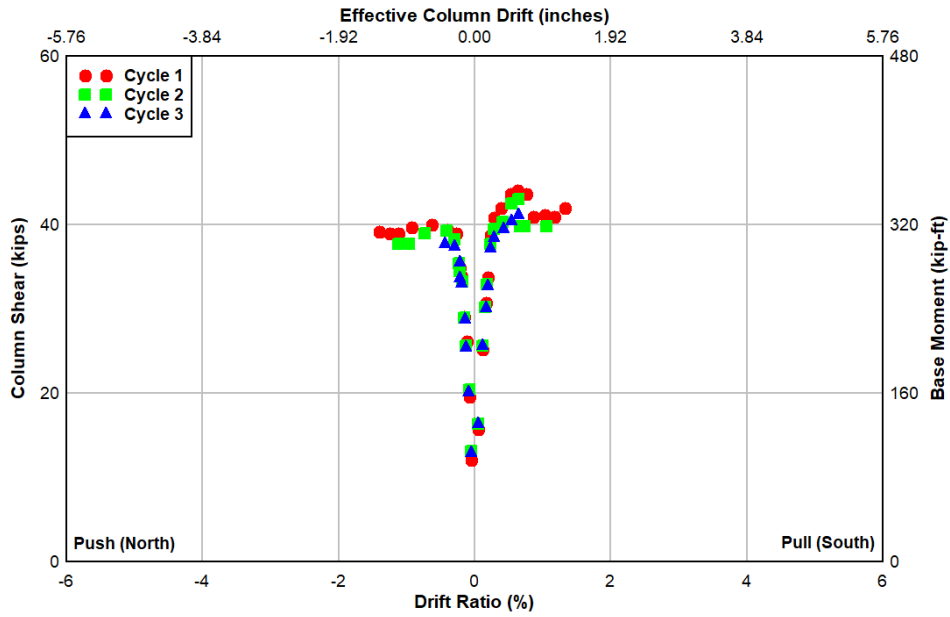
Figure 4.79: Specimen R-S-R-LTi-90-Pile: Strength degradation in each cycle

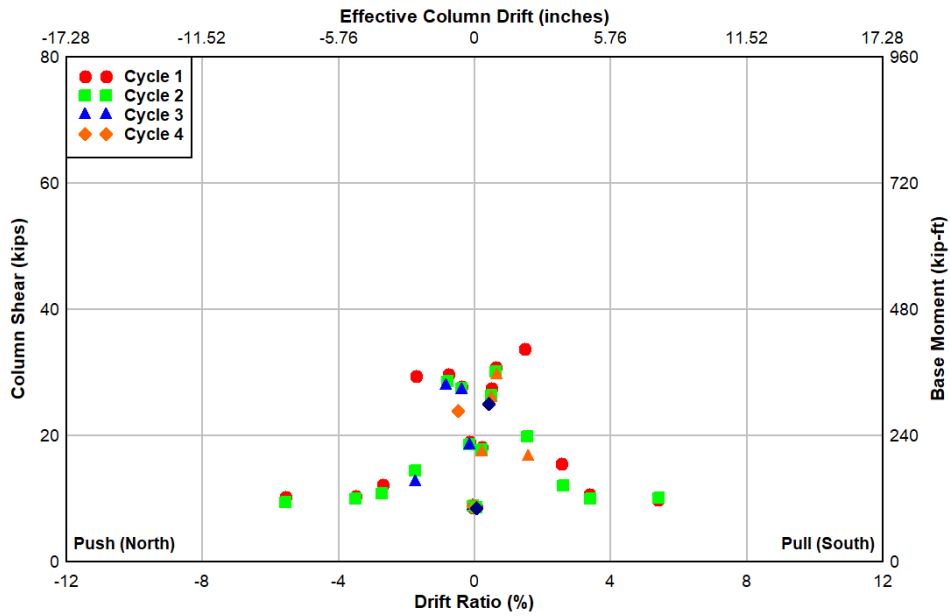
Figure 4.80: Specimen C-T-R: Strength degradation in each cycle

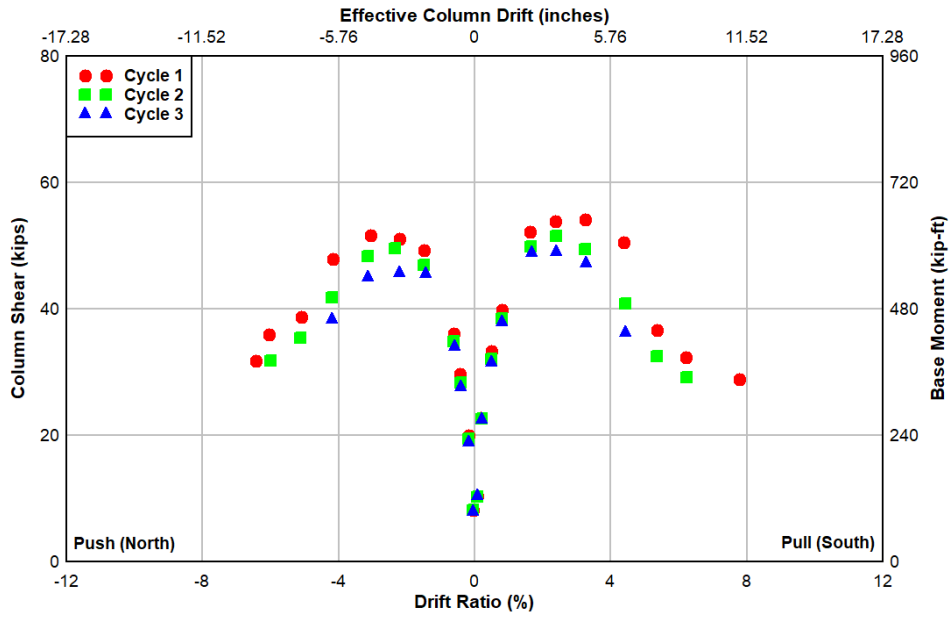
Figure 4.81: Specimen R-T-R-LTi-90: Strength degradation in each cycle

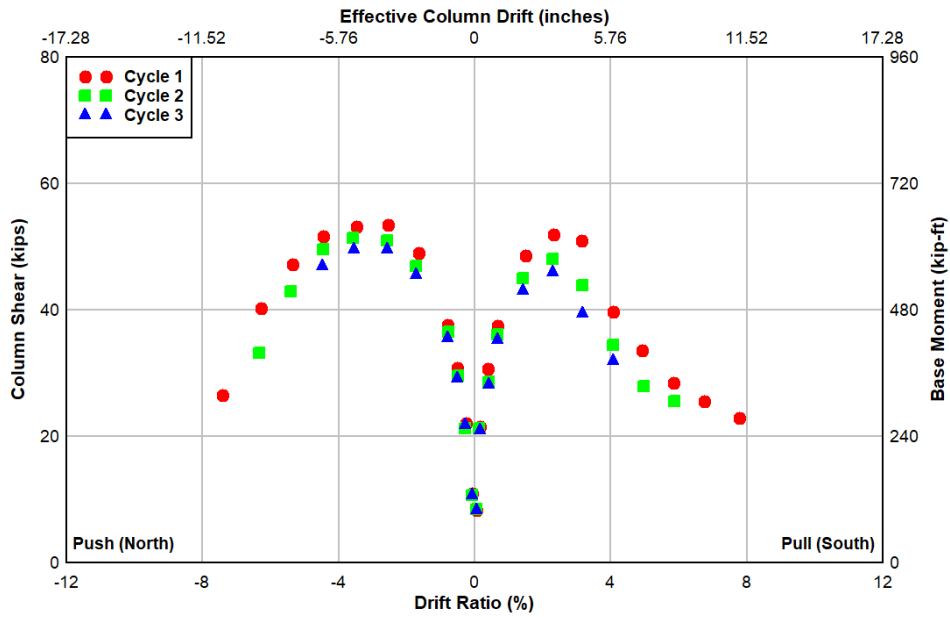
Figure 4.82: Specimen RS-T-R-LTi-90: Strength degradation in each cycle

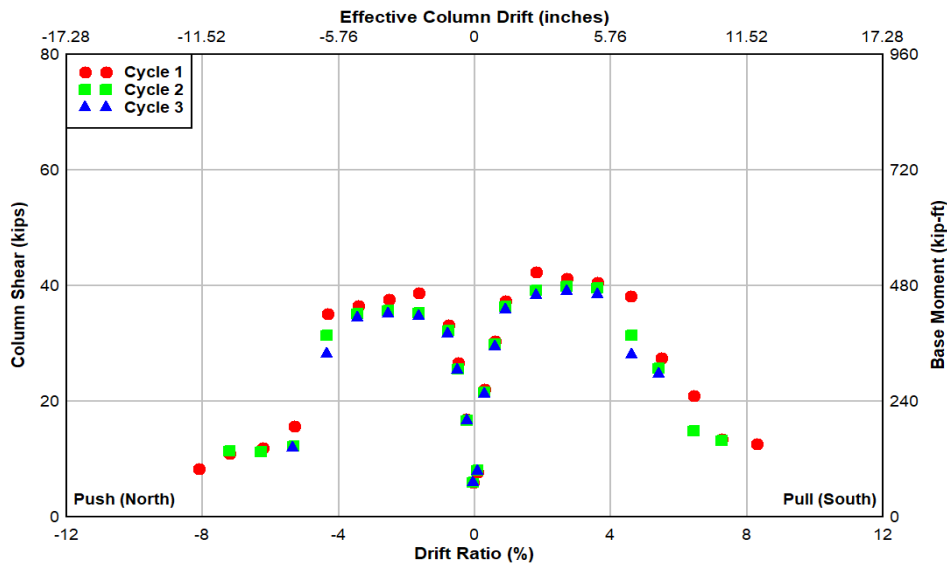
Figure 4.84: Specimen R-T-R-0: Strength degradation in each cycle

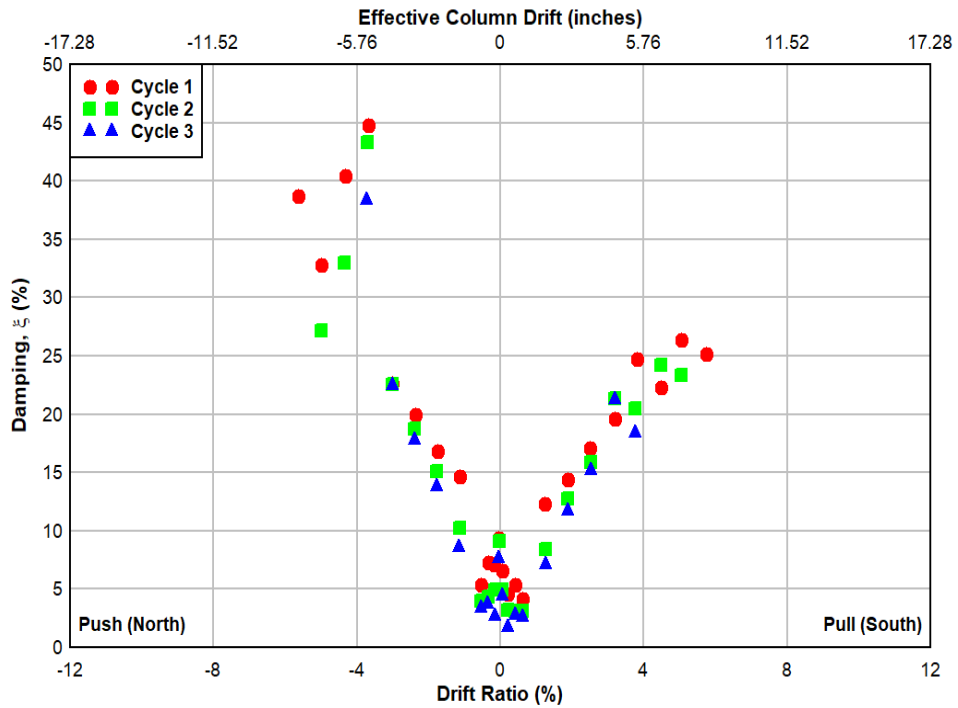
**Figure 4.101: Specimen R-T-R-0: Equivalent viscous damping in each cycle**

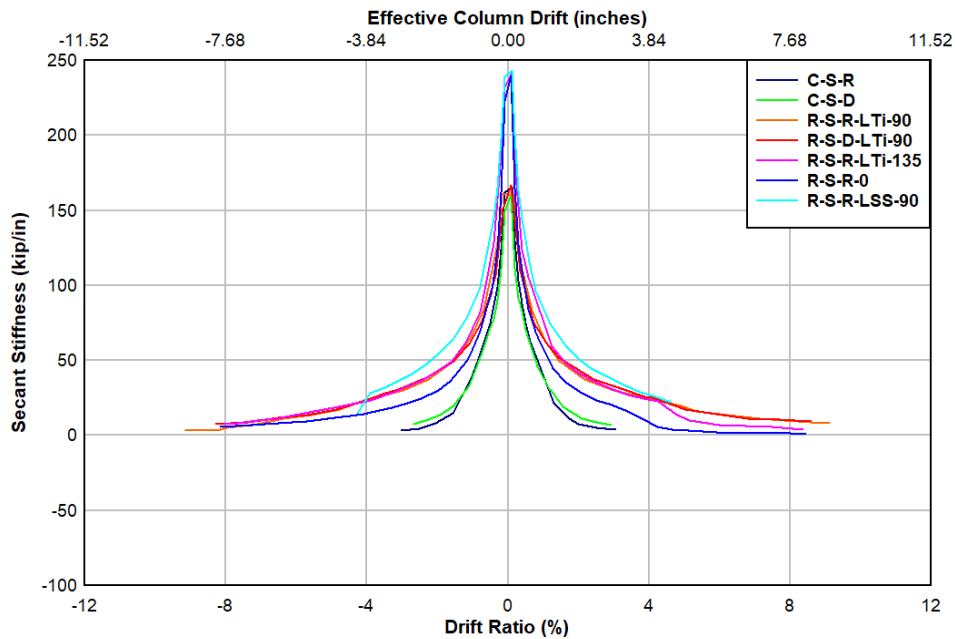
Figure 4.102: Short (8 ft.) specimens: Evolution of secant stiffness

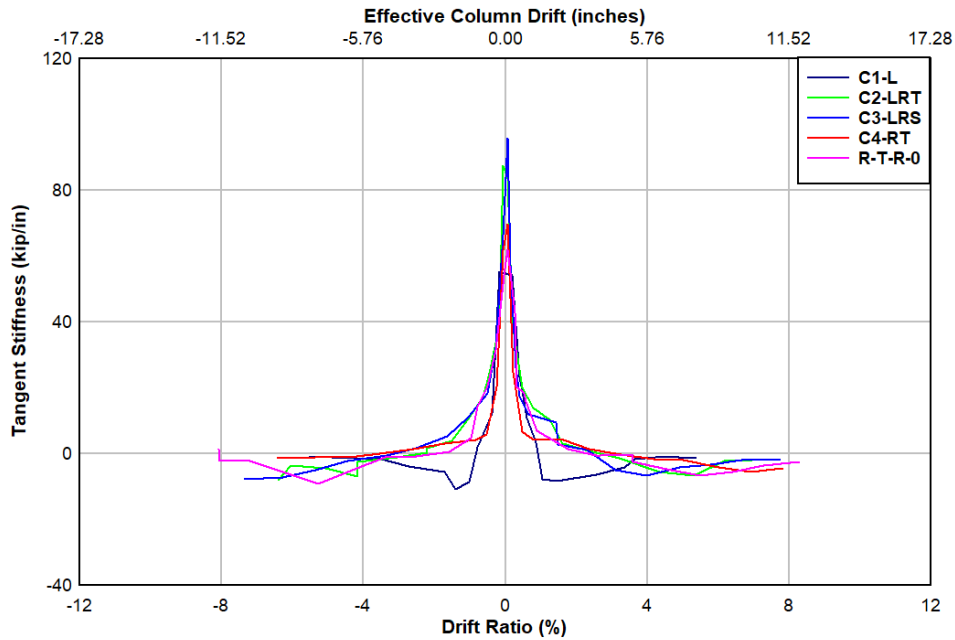
**Figure 4.105: Tall (12 ft.) specimens: Evolution of tangent stiffness**

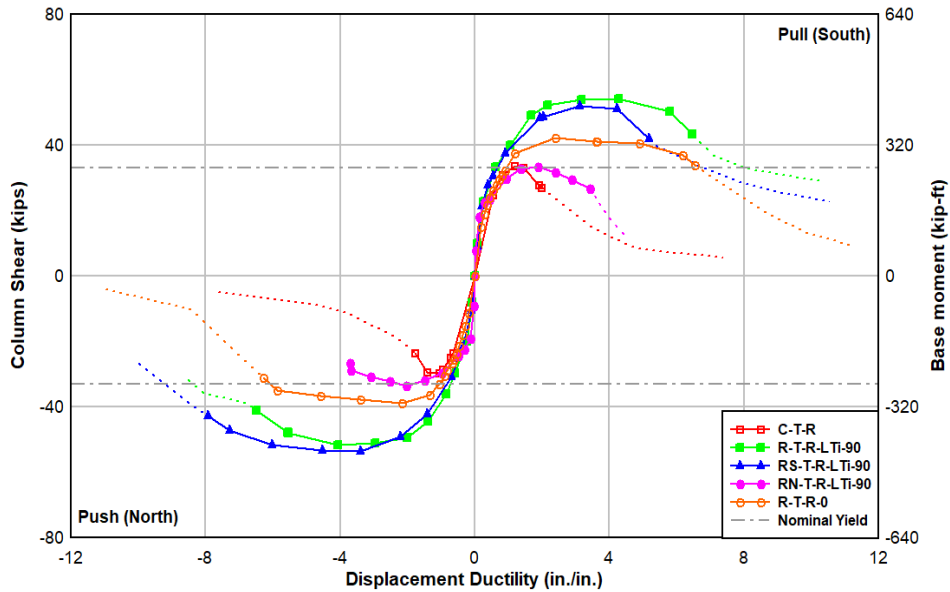
**Figure 4.107: Tall columns: Displacement ductility - backbone overlay**

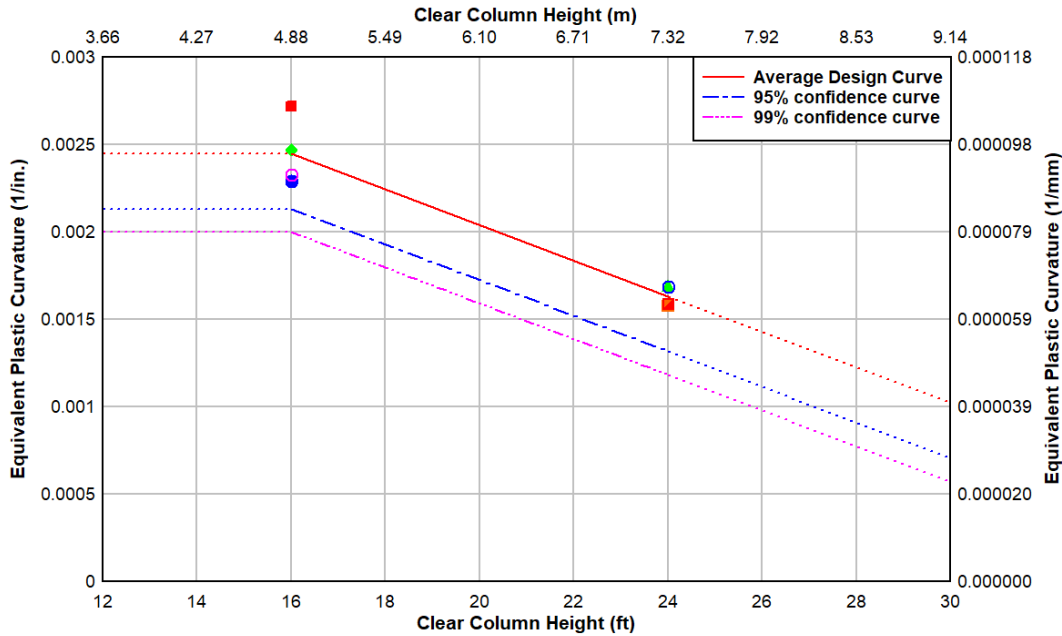
**Figure 4.110: Equivalent plastic curvature design curve**
