**SEISMIC RETROFITS FOR SQUARE  
REINFORCED CONCRETE COLUMNS  
USING TITANIUM ALLOY BARS**

**Final Report**

**PROJECT SPR-784**

Oregon Department of Transportation

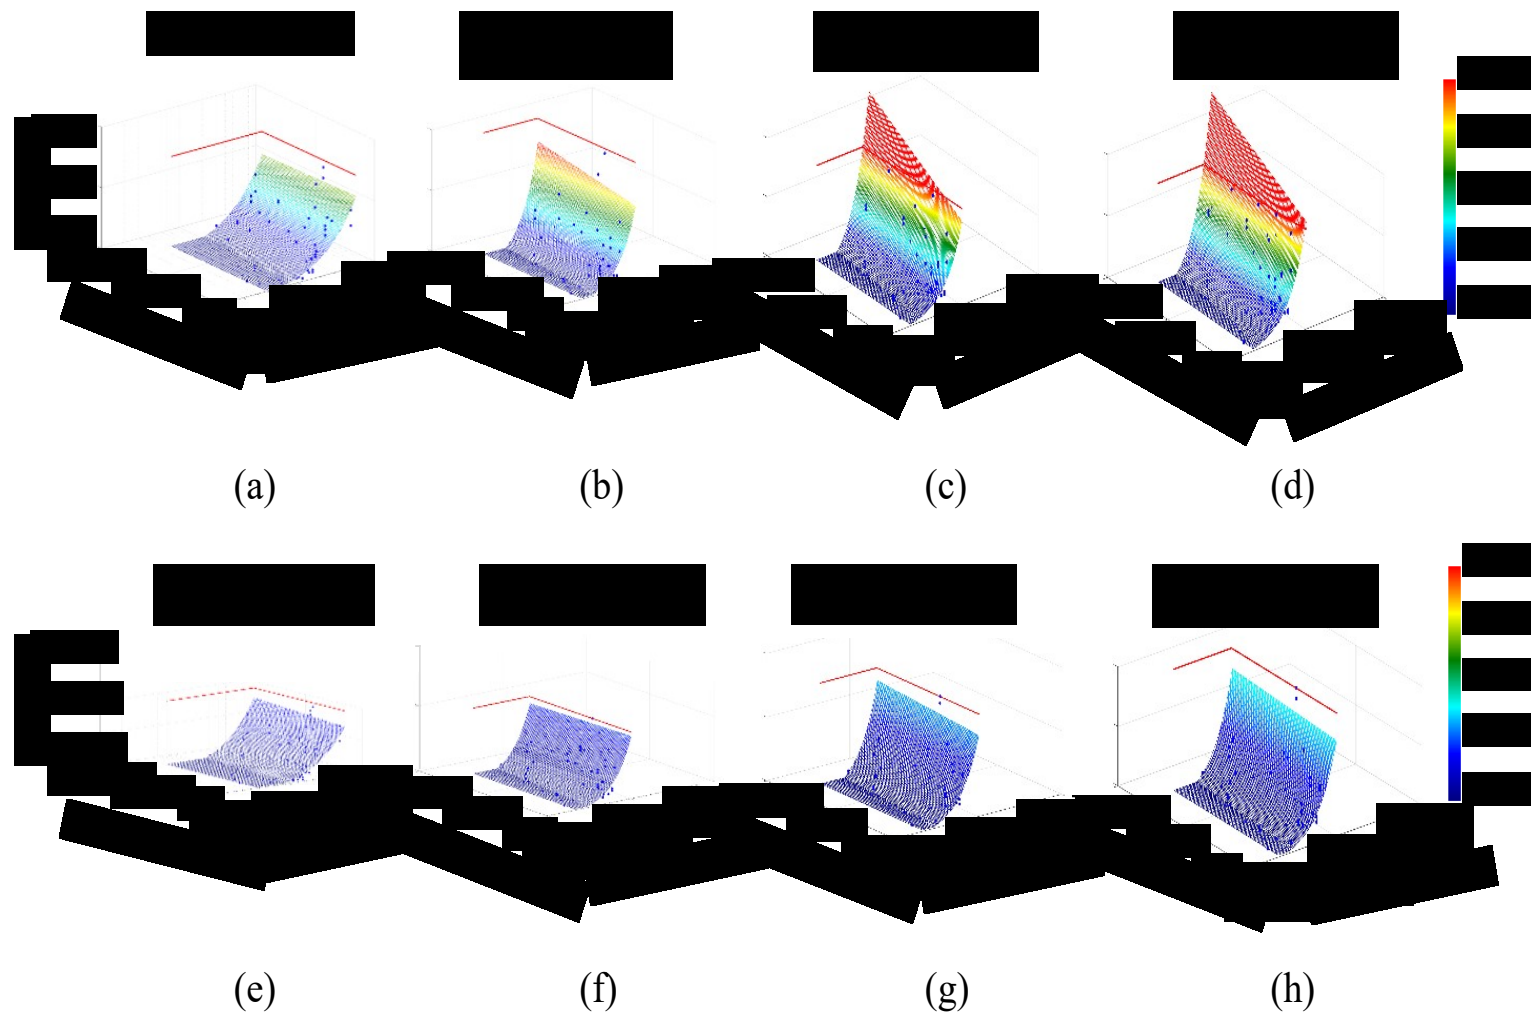
**Figure 5.16: Surface plots that relate  $D_{5-75}$ ,  $S_a(T_1)$  and Reinhorn and Valles Damage Index: (a) Bridge RB1; (b) Bridge RB2 (c) Bridge IB1; (d) Most damaged element of Bridge IB1; (e) Bridge RB1R; (f) Bridge RB2R (g) Bridge IB1R; (h) Most damaged element of Bridge IB1R.**

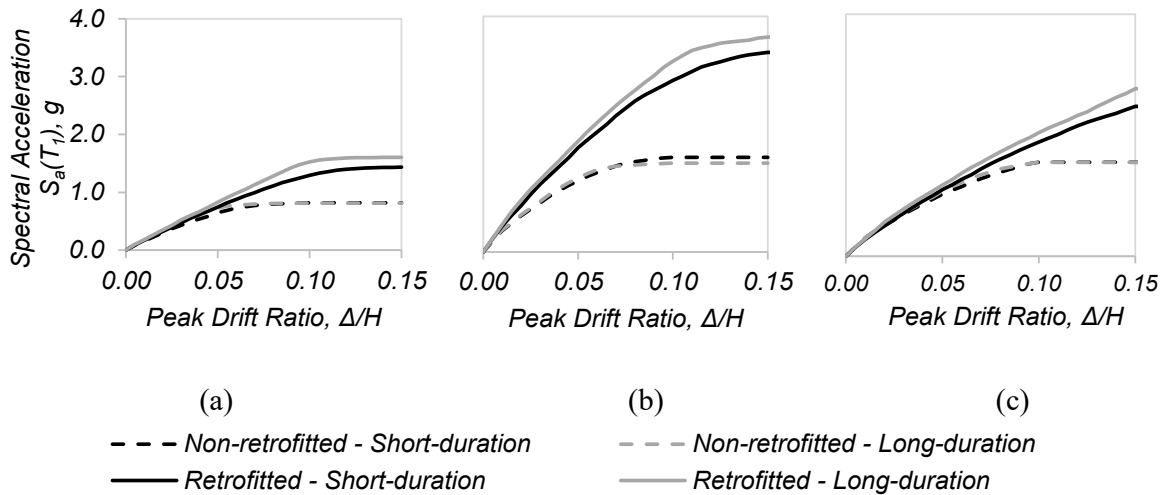
**Figure 5.17: Median incremental dynamic analysis curves for vector sum of peak drift ratios in longitudinal and transverse directions based on results from bridge models: (a) RB1 and RB1R; (b) RB2 and RB2R; and (c) IB1 and IB1R**
