**SEISMIC PERFORMANCE DESIGN  
CRITERIA FOR BRIDGE BENT PLASTIC  
HINGE REGIONS**

**Final Report**

**SPR 802**

Oregon Department of Transportation

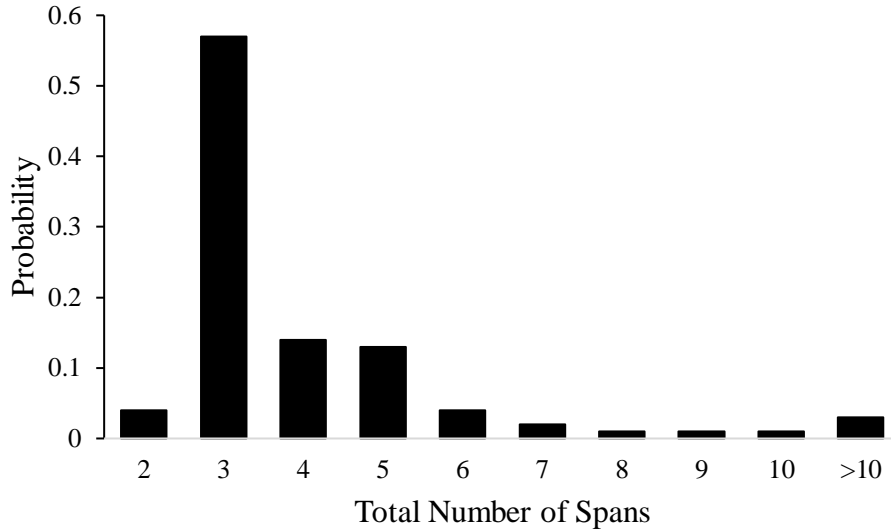
For this case, the number of CCSG bridges with equal number of spans was grouped together and then each group was divided by the total number of CCSG bridges. Figure 3.2 shows the PMF for number of spans.

**Figure 3.2: PMF for number of spans of CCSG bridges built prior to 1990**

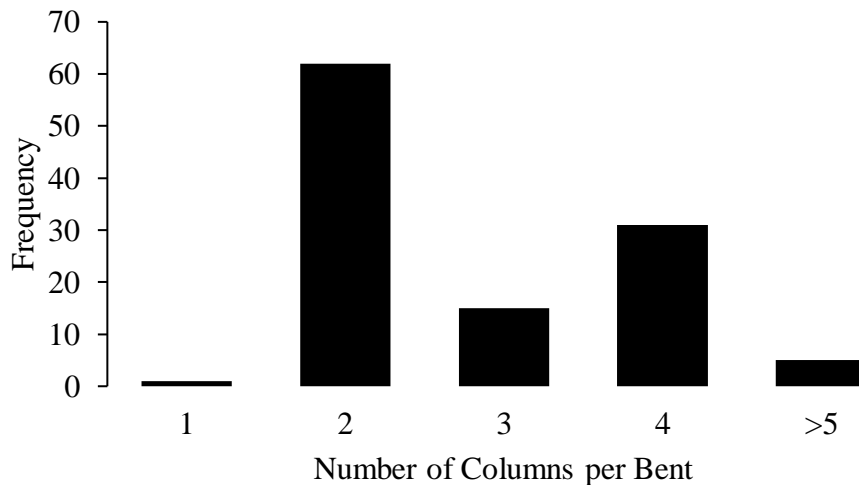
The frequency of bridges with certain number of columns per bent as extracted from the available drawings for CCSG bridges are presented in Figure 3.6. It should be mentioned that only the intermediate bents were taken into consideration for counting the number of columns per bent.

**Figure 3.6: Number of columns per bent for multi-span CCSG bridges built before 1990**

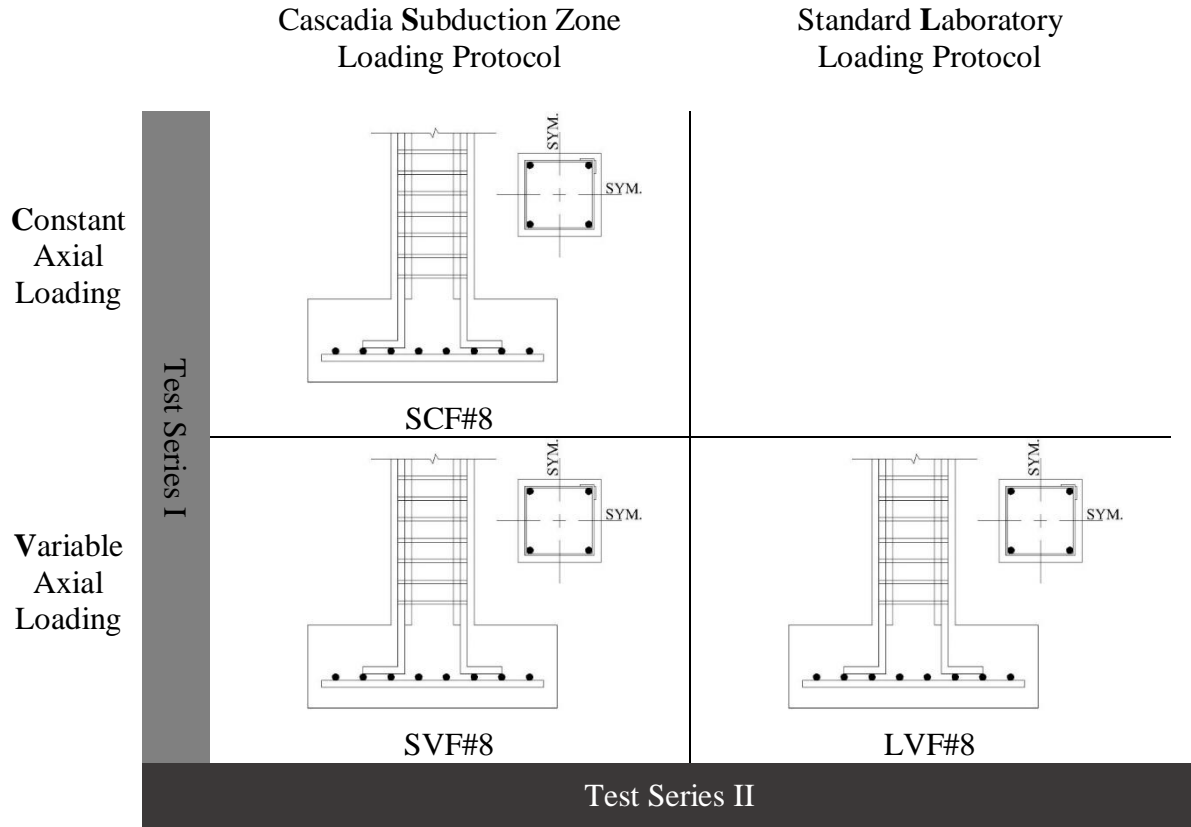
**Figure 4.1: Test matrix**

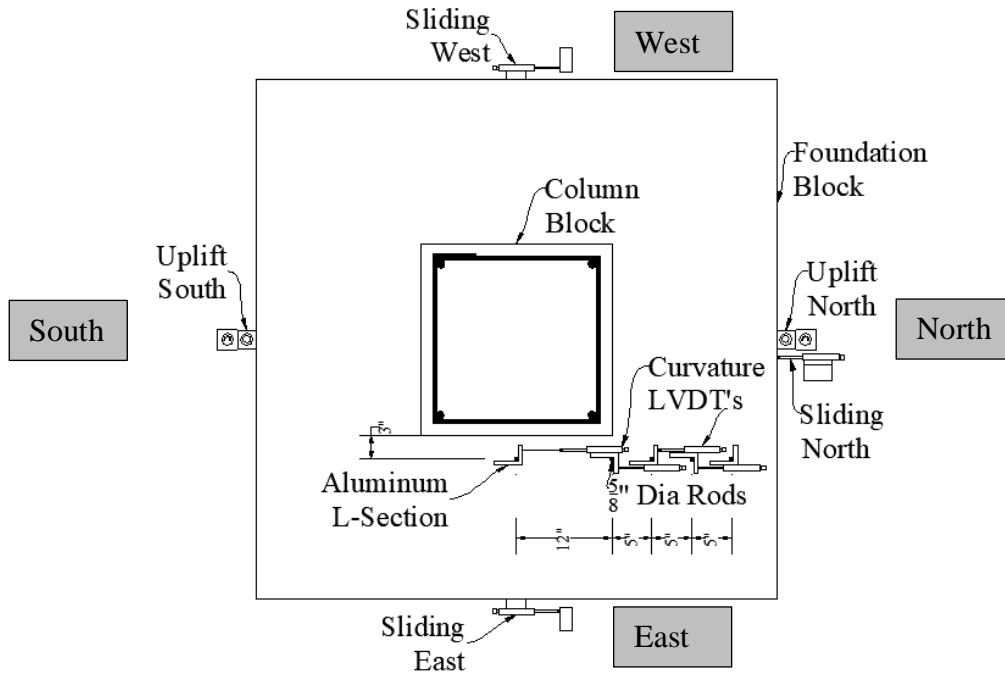
The foundation of the specimen rested on the laboratory floor and was allowed to rotate and translate. In order to quantify the movement of the foundation during a test, its uplift and sliding were measured. Along with these, LVDTs were placed on the footing top surface to measure relative deformation to compute concrete compression and curvature demand in the foundation. Figure 4.7 shows the foundation instrumentation details. Two LVDTs were placed vertically and attached at the mid-length of the foundation north and south face to measure any potential uplift. In order to measure the sliding of the foundation, three LVDTs were positioned in the horizontal direction on east, west and north faces. All three LVDTs reacted against a reference aluminum angle section, which was glued to the floor and allowed a relative measurement of sliding with respect to the laboratory strong floor. In addition, five LVDTs were used to measure the foundation's extreme surface concrete compression and curvature along the direction of lateral loading. These LVDTs were also positioned in the horizontal direction to measure the relative displacement for a certain gauge length. To fix these LVDTs, five zinc-coated steel threaded rods of 5/16 inch diameter were embedded 6 inch into the foundation prior to concrete casting. The first threaded rod was placed along the center of the foundation length at a distance of 3 inch from the column face. The next threaded rod was placed at 12 inches (parallel to the column edge) and the next three at 5 inch intervals as shown in Figure 4.7.

**Figure 4.7: Typical external instrumentation for the foundation.**

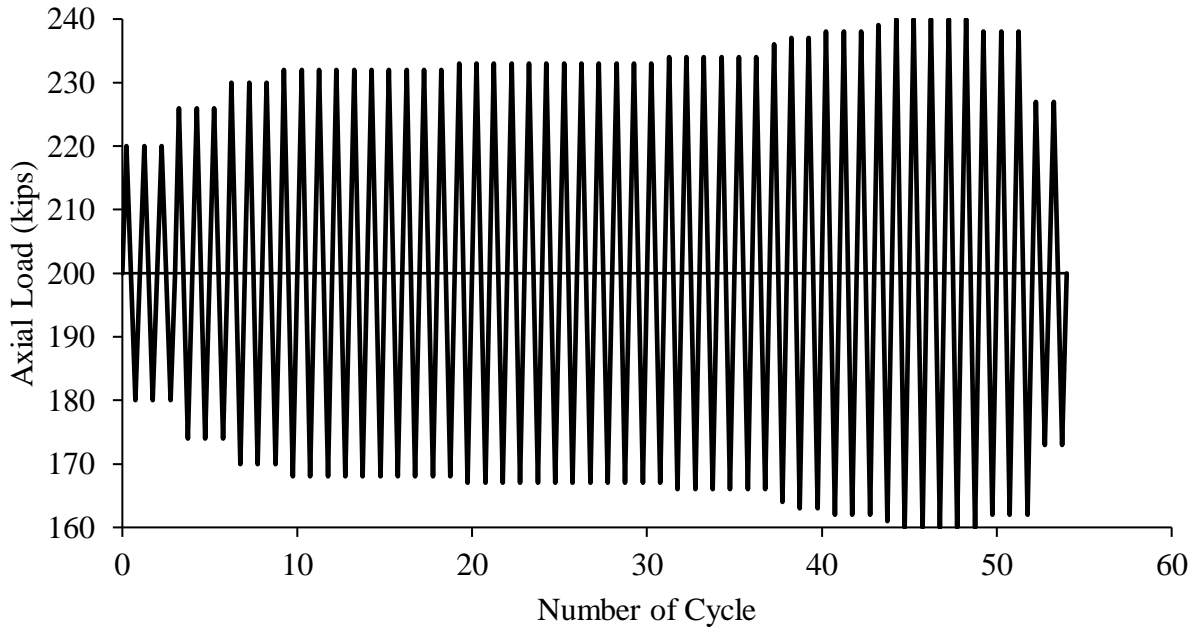
loads, which were found to vary between 50 kips to 275 kip for a typical bridge in Oregon. The average axial load was found to be 130 kip with a standard deviation of 48.5 kip. Because previous research has found that a higher level of damage is associated with higher axial loading, a maximum axial load of 240 kip was considered in the constant axial loading protocol for this research. The variation in axial load resulting from the lateral resistance of a two-column bridge bent was found to be 40 kip. Hence, a base axial load of 200 kip was selected for the variable axial loading protocol with a  $\pm 40$  kip variation from the base value based on lateral strength at each ductility level. The variable axial loading protocol is illustrated in Figure 4.12.

**Figure 4.12: Variable axial loading protocol**

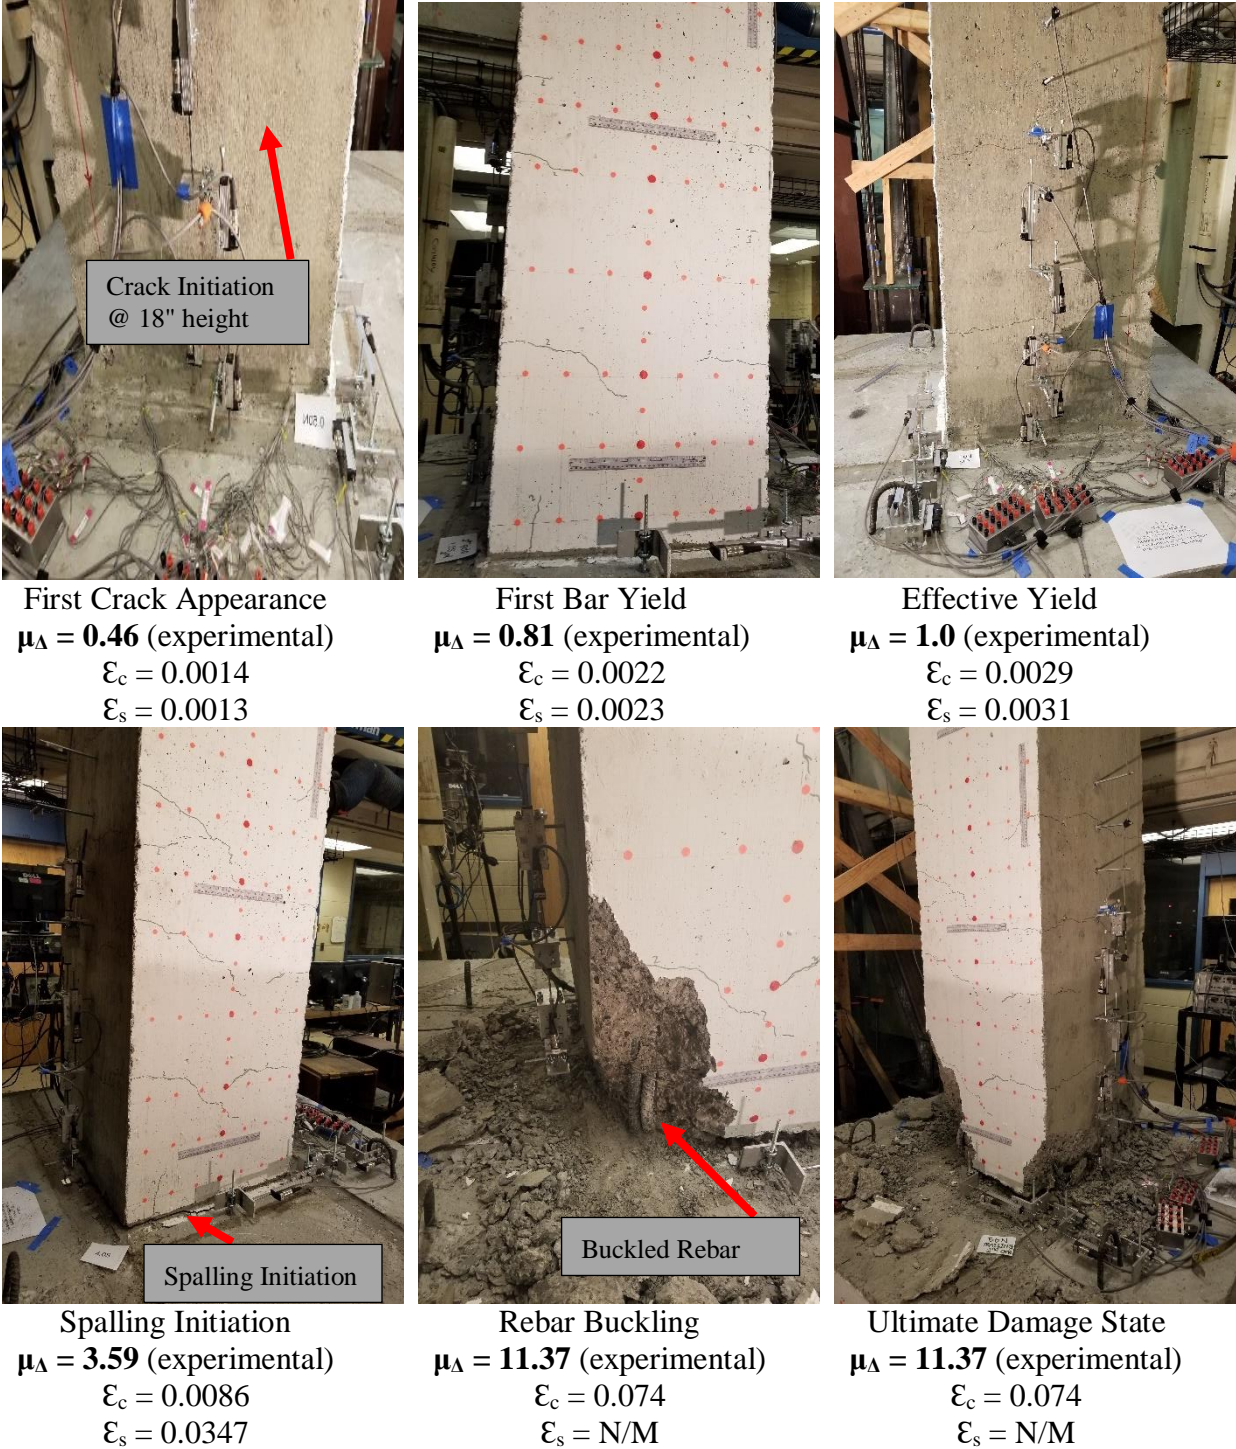
Visual observation of rebar buckling was observed in the southeast corner dowel bar of the column by the end of 104<sup>th</sup> loading cycle (1<sup>st</sup> pull cycle at target displacement ductility,  $\mu = 12.0$ ). The maximum-recorded lateral force at rebar buckling was -26.45 kip. The column top displacement corresponding to the bar buckling in the south side was recorded as -5.91 inch (pull cycle). It is noteworthy to mention that, the buckled bar was visually observed once the spalled cover concrete in the south face was removed at the end of 104<sup>th</sup> cycle. Therefore, it was not evident if the bar buckled during this loading cycle or it was already buckled from the previous pull cycle. However, since the concrete cover was not completely lost in the previous cycle (102<sup>nd</sup> cycle) so, the later cycle (104<sup>th</sup> cycle) was considered as the loading cycle associated with bar buckling damage state.

**Figure 5.1: Different damage states for specimen SCF#8.**

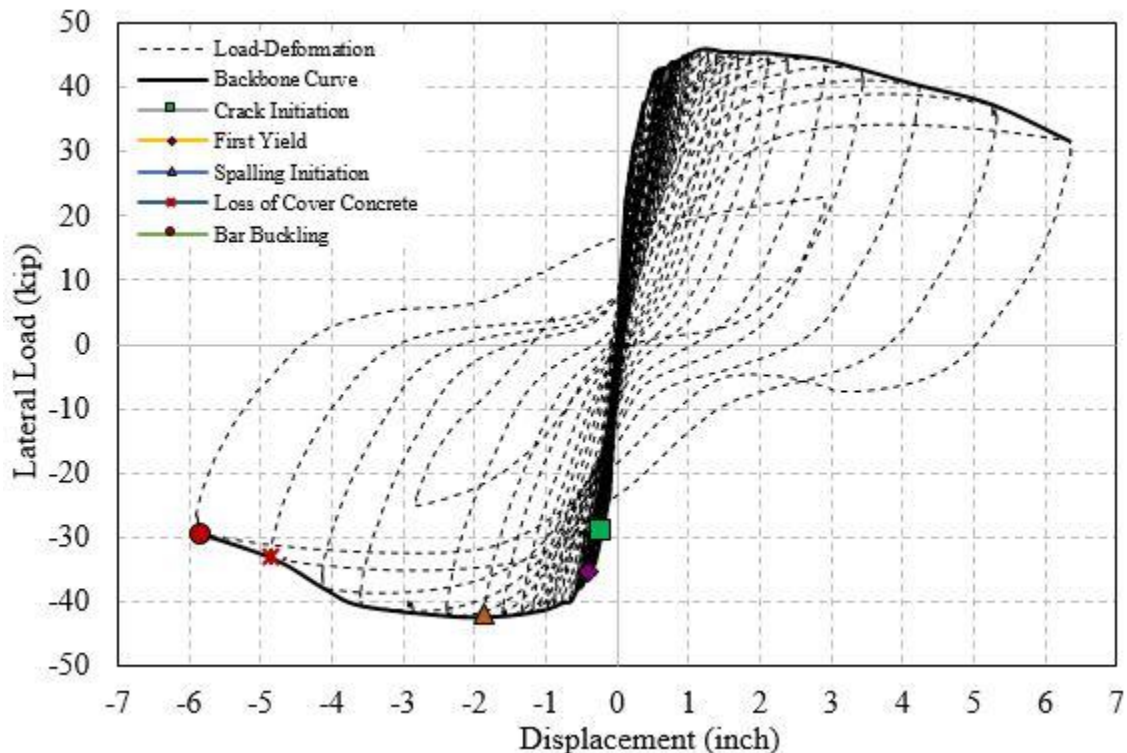
The lateral force-displacement response for SCF#8 is shown in Figure 5.6. The specimen was tested under a constant axial load of 240 kips ( $\approx 0.09A_gf_c$ ) and the subduction zone lateral loading protocol. The specimen showed a ductile behavior reaching an ultimate displacement ductility,  $\mu_\Delta = 10.1$  (5.25 inch) and  $\mu_\Delta = -9.23$  (-4.79 inch) in the push and pull cycle respectively. The peak lateral strength for specimen SCF#8 was 46.0 kips and -42.4 kips in the push and pull cycles, respectively. The displacement ductility corresponding to the peak strengths was  $\mu_\Delta = 2.41$  (1.25 in) and  $\mu_\Delta = -3.52$  (-1.83 inch), respectively.

**Figure 5.6: Force-Displacement response for specimen SCF#8.**

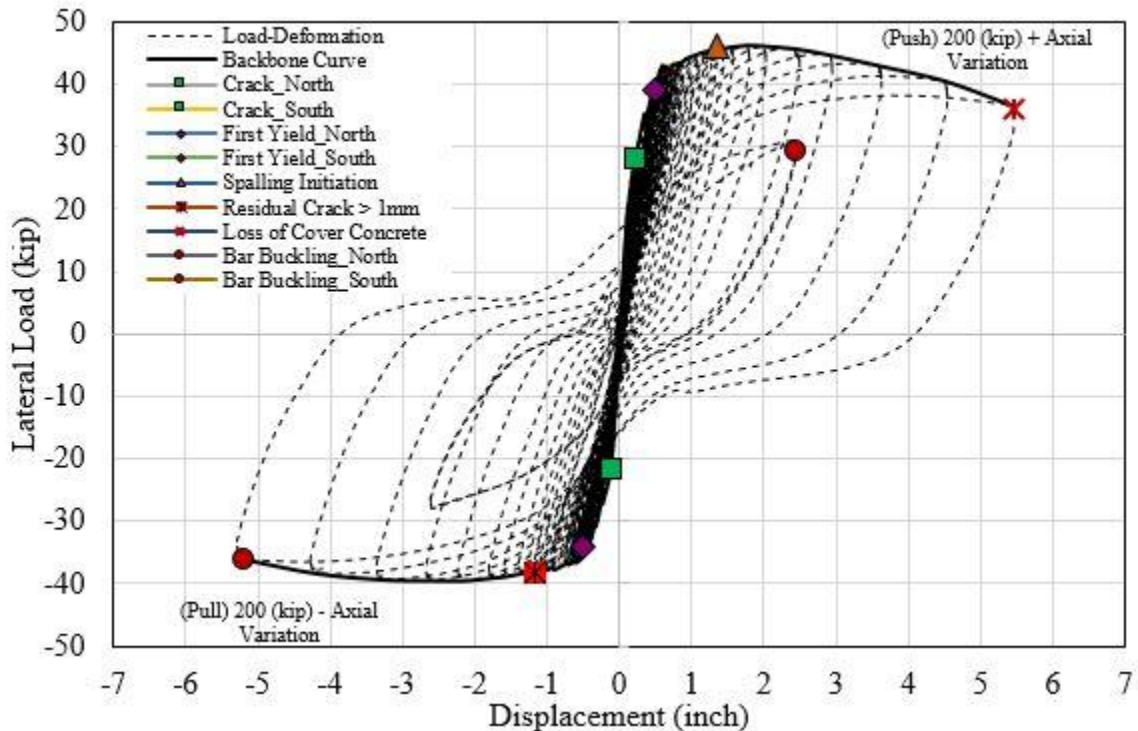
Specimen SVF#8 was tested under variable axial loading and the subduction zone lateral loading protocol. The load-deformation response for the specimen as presented in Figure 5.7 showed that the peak strength achieved in the push and pull cycles was 46.2 kips and -39.6 kips, respectively. The displacement ductility corresponding to the peak strength in the push and pull cycles was  $\mu_{\Delta} = 3.07$  (1.78 inch) and  $\mu_{\Delta} = -3.74$  (-2.17 inch), respectively. The specimen showed ductile behavior reaching an ultimate displacement ductility of  $\mu_{\Delta} = 9.34$  (5.42 inch) in the push cycle and  $\mu_{\Delta} = -9.03$  (-5.24 inch) in the pull cycle.

**Figure 5.7: Force-Displacement response for specimen SVF#8.**

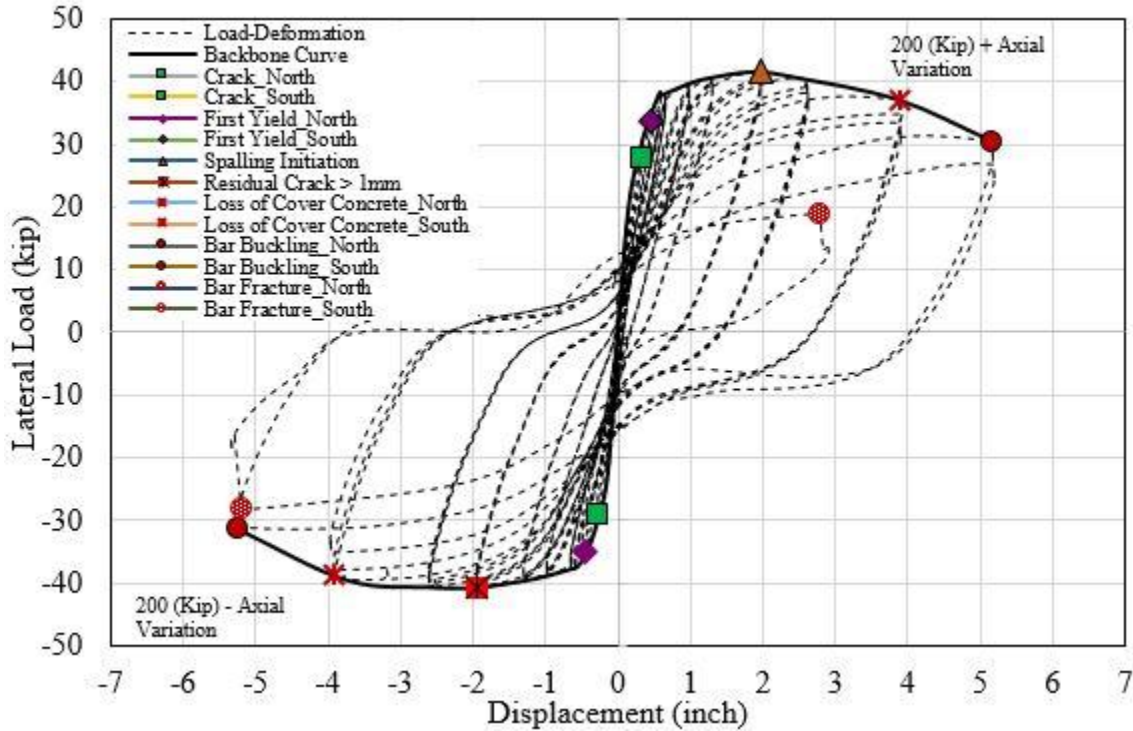
40.7 kips, respectively. The displacement ductility corresponding to the peak column strength in the push and pull cycles was  $\mu_{\Delta} = 2.90$  (1.88 inch) and  $\mu_{\Delta} = -2.97$  (-1.93 inch), respectively. After the peak strength, specimen LVF#8 showed a ductile behavior with almost linear degradation in the subsequent loading cycles.

**Figure 5.8: Force-Displacement response for specimen LVF#8.**
