**COASTAL LANDSLIDE AND SEA CLIFF
RETREAT MONITORING FOR
CLIMATE CHANGE ADAPTATION AND
TARGETED RISK ASSESSMENT**

Interim Report

PROJECT SPR 807

Oregon Department of Transportation

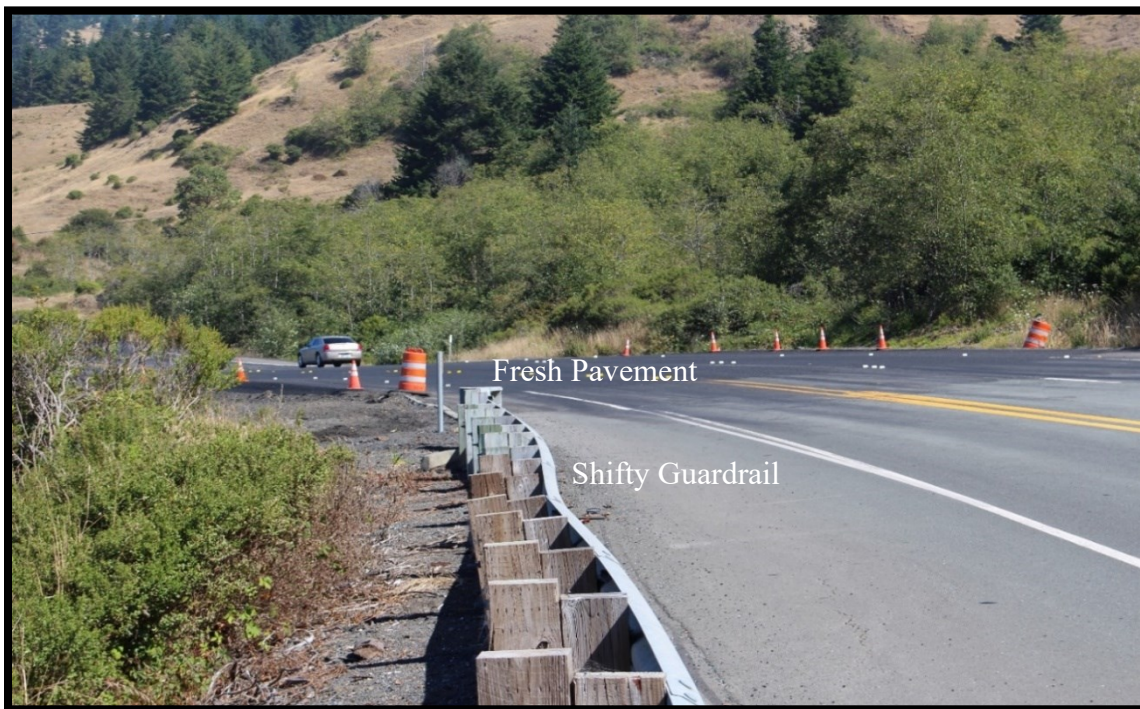
Figure 1.1: Evidence of damage to Highway 101 at the Hooskanaden Slide requiring routine repaving of the road (MP344, August 2016).

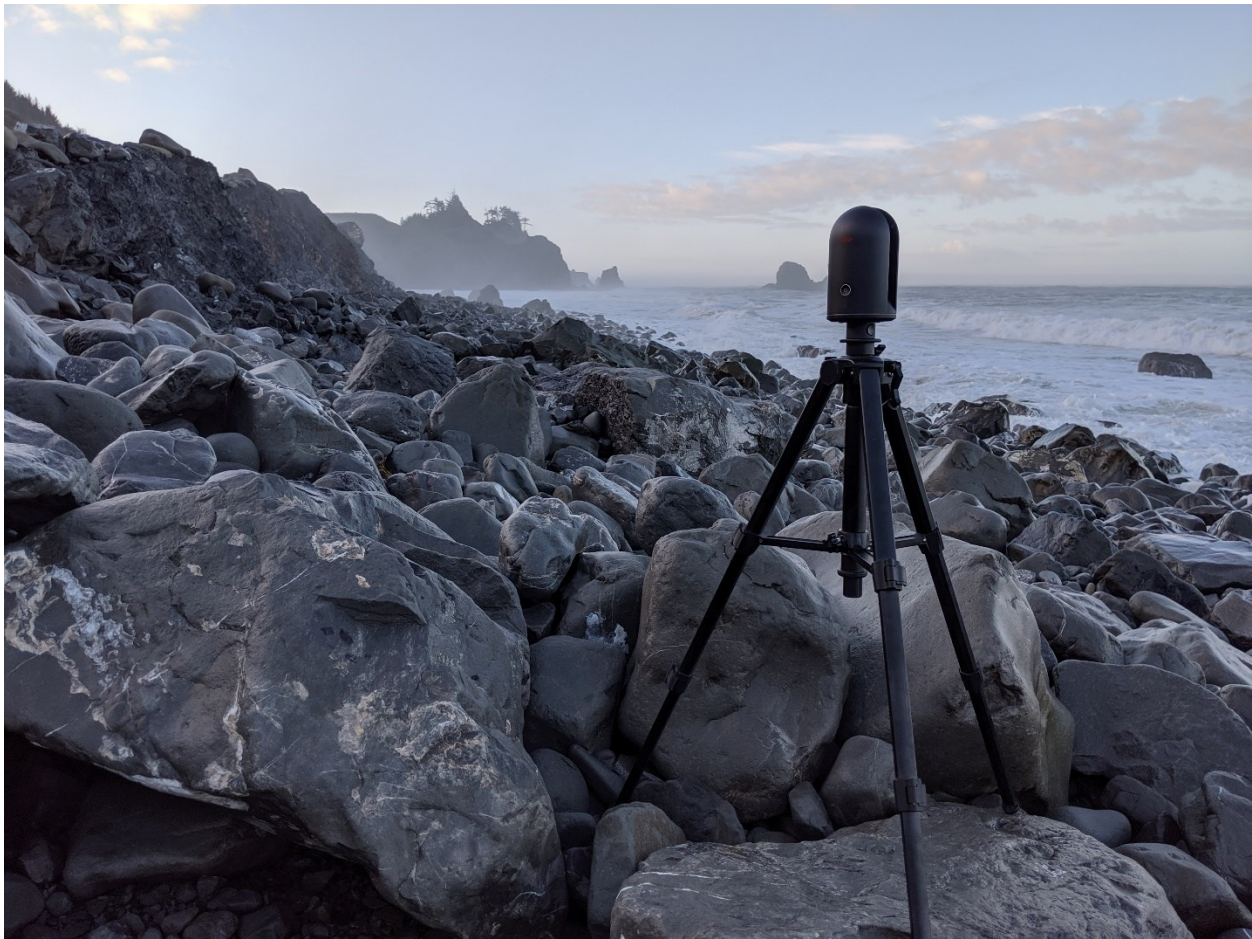
Figure 2.6: Photograph of the BLK360 TLS (terrestrial laser scanner) being used to survey the sea cliff at the Hooskanaden beach during the bi-annual field survey on Oct 4, 2019.

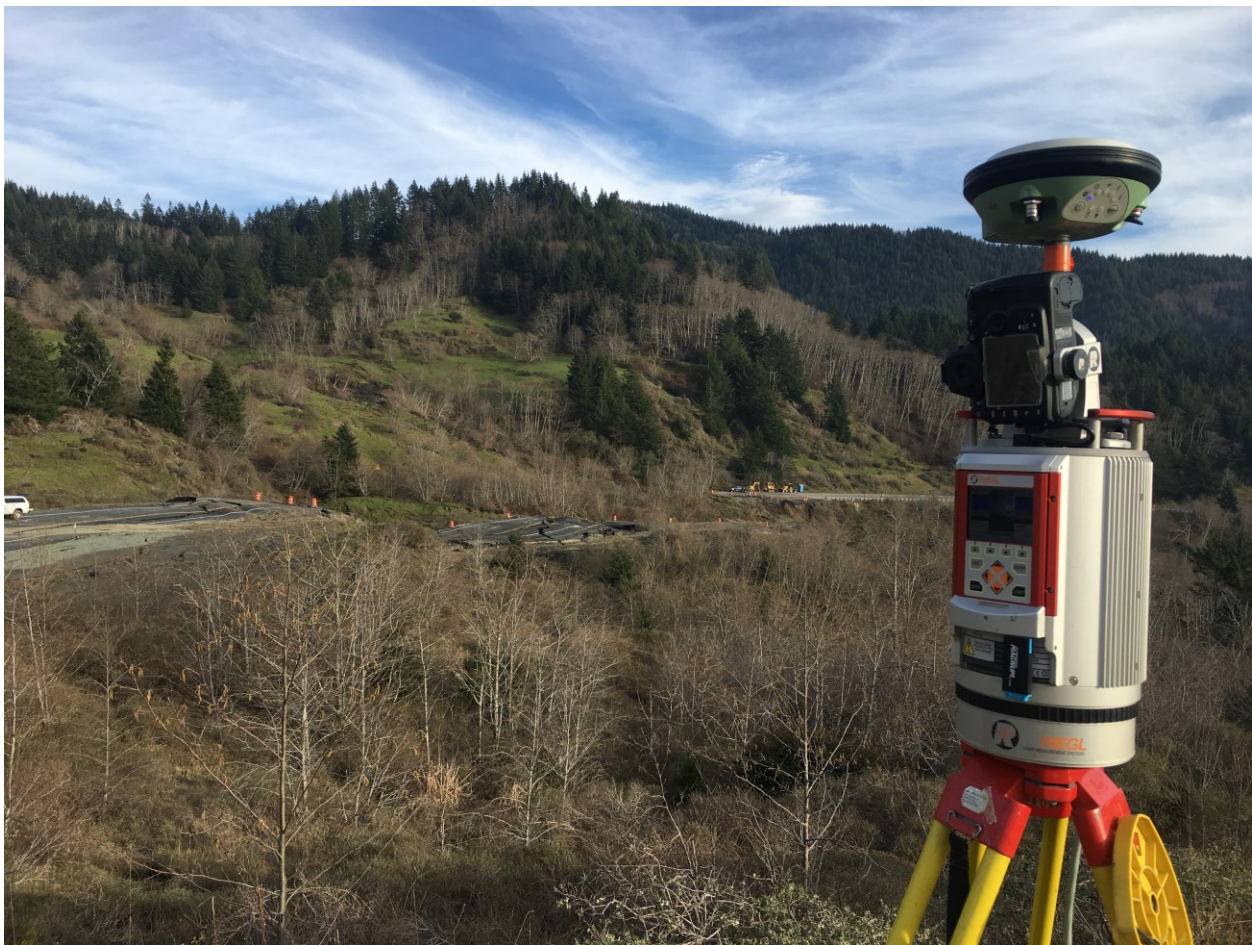
Figure 2.7: Photograph of Riegl VZ-400 TLS setup to conduct high resolution repeat scans of the actively moving Hooskanaden landslide on March 2, 2019.

After the destructive Hooskanaden landslide event in February 2019, we quickly mobilized to the site and conducted repeat TLS scans (Figure 2.7) and UAS SfM/MVS photogrammetric flights on the actively moving landslide on the weekend of March 2, 2019. Several weeks later the OSU team collaborated with the NSF Natural Hazards Research Infrastructure (NHERI) RAPID Facility team at the University of Washington to conduct UAS lidar surveys at Hooskanaden using their Phoenix miniRanger UAS lidar system (Figure 2.8) as well as collect additional TLS scans to serve as validation. This survey was conducted on the weekend of March 15, 2019. These surveys were conducted as bonus surveys to provide data associated with the Hooskanaden landslide event (Figure 2.9). An additional UAS lidar survey was performed later during the regular spring survey (week of June 24, 2019). This was also performed in collaboration with the RAPID Facility with flights conducted at both the Arizona Inn and Hooskanaden sites. Additional UAS SfM/MVS photogrammetric flights were conducted using the DJI Phantom 4 pro as well as the regular TLS survey. Preliminary analysis from data associated with the Hooskanaden landslide event as well as UAS lidar data is described in Section 3.2.

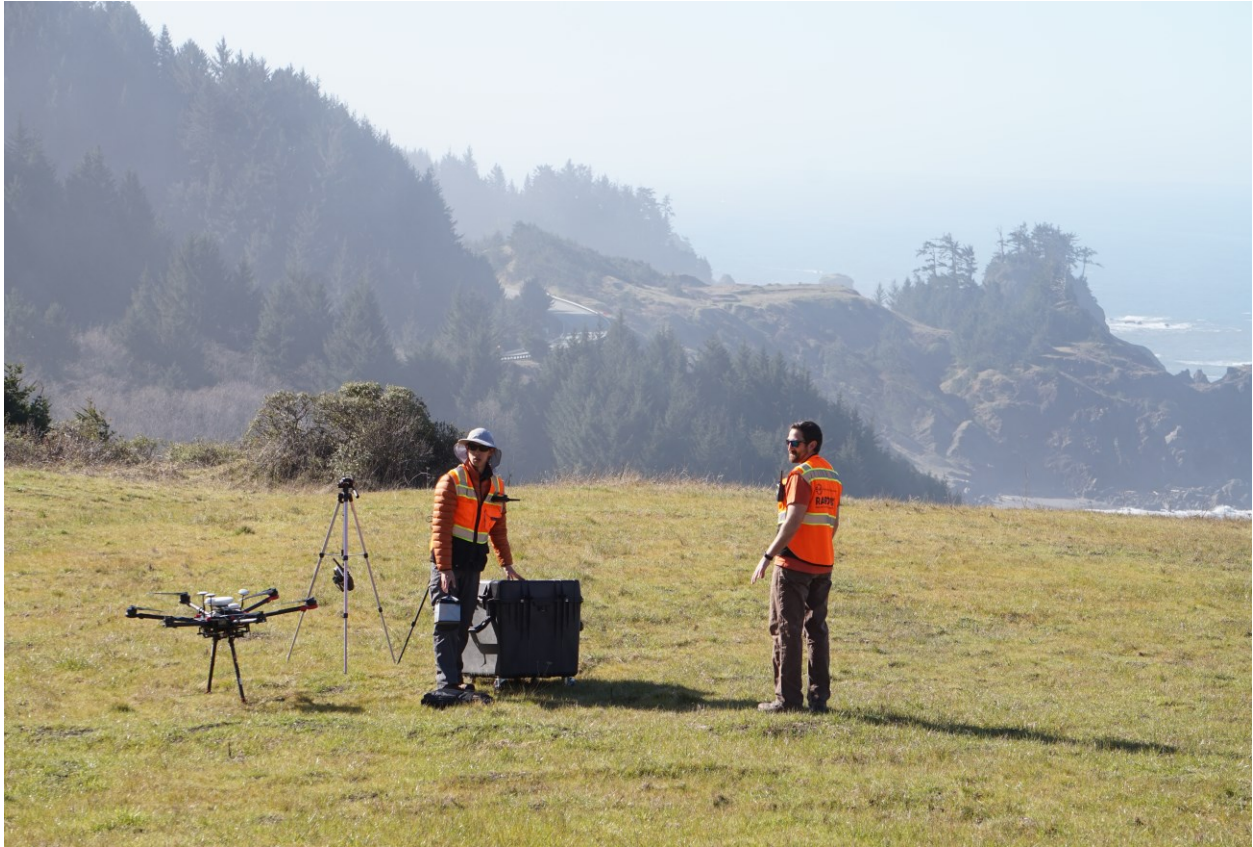
Figure 2.8: Photograph capturing the RAPID Facility’s phoenix lidar miniRanger UAS lidar system being operated at the Hooskanaden landslide on March 15, 2019. Photo Credit: Nick Mathews (OSU).

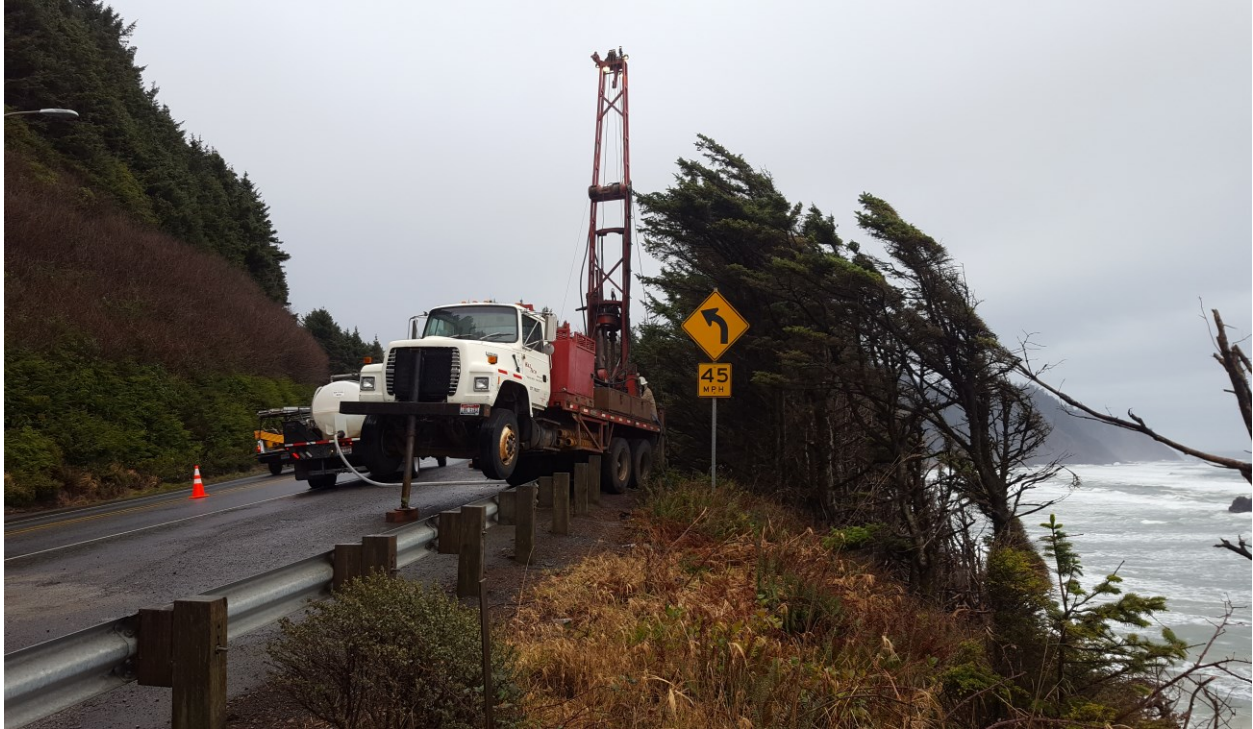
Figure 2.10: Drill rig actively drilling borehole for SAA MEM's installation at Arch Cape on January 20, 2017. Photograph Credit: Dr Michael Bunn.

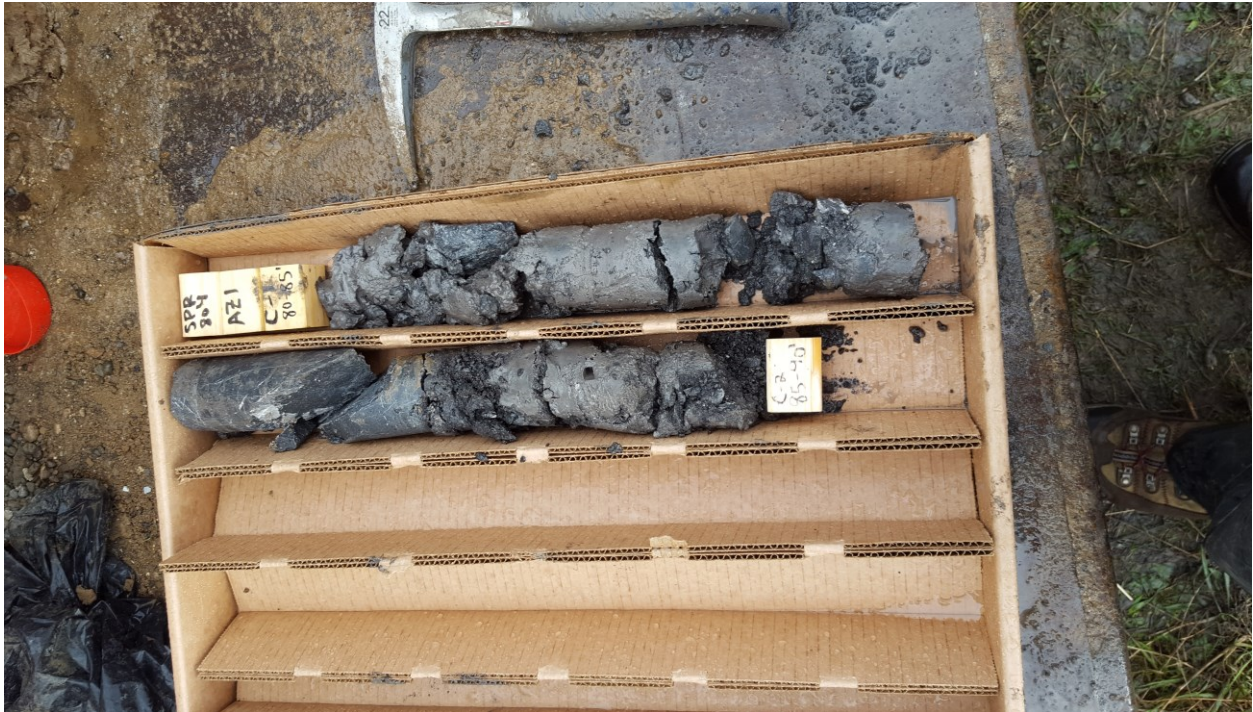
Figure 2.11: Example borehole cores recovered from Arizona Inn during drilling on February 2, 2017. Photograph Credit: Dr Michael Bunn.

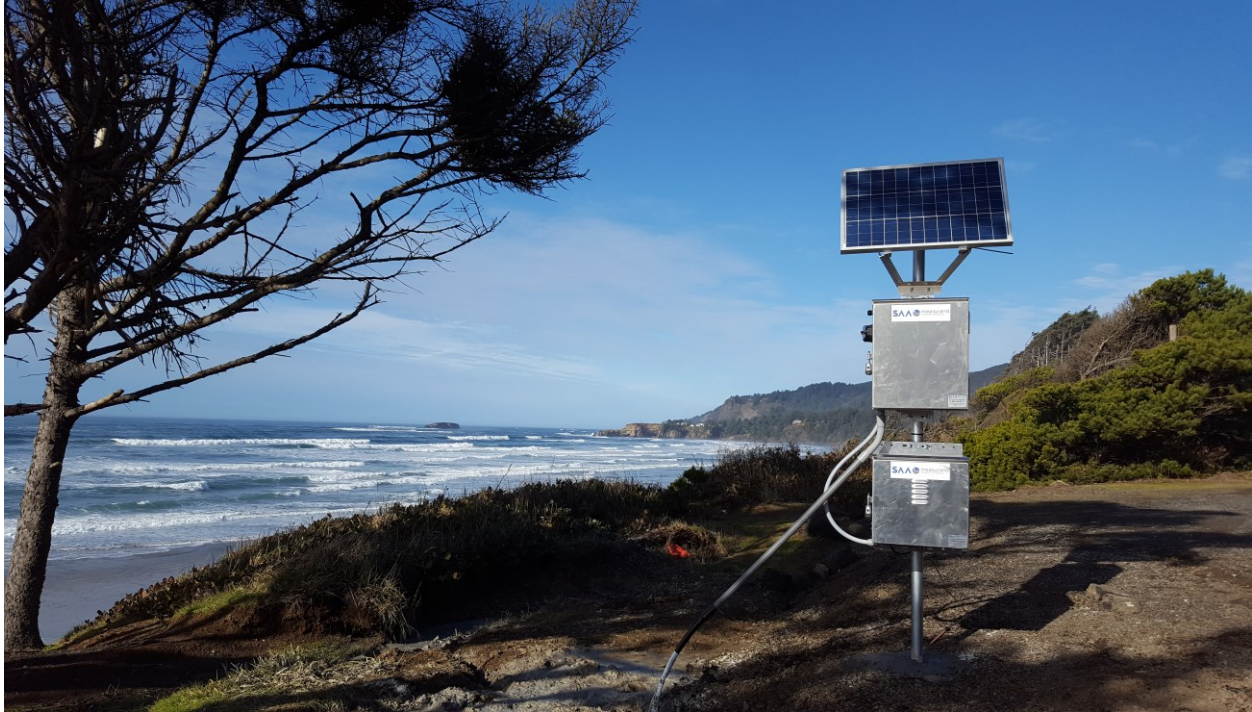
Figure 2.13: Final SAA MEM’s sensor setup at Spencer Creek on January 27, 2017. Composed of solar panel for power supply, SAA electrical components (top box), SAA battery (bottom box), and SAA sensor (in borehole). Photograph Credit: Dr Michael Bunn.

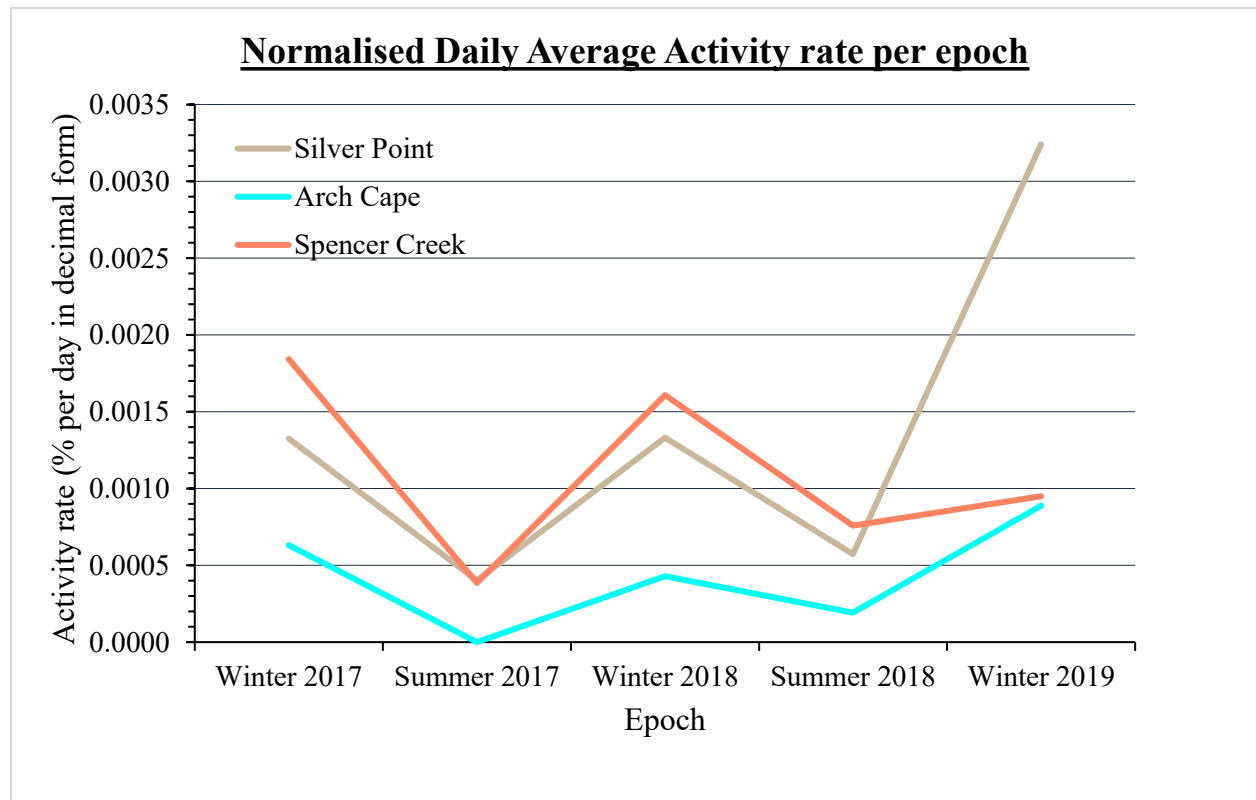
Figure 3.1: Activity rate at each site for each epoch normalized by the number of days between surveys. Note that given the scanner failure in the Spring 2017 survey, a reliable failure depth rate for Arch Cape for Summer 2017 could not be computed.

each survey epoch. The most recent epoch (Winter 2019) received the most volume loss -223 m^3 of material across the site. Figure 3.1 and Figure 3.2 show the change in activity rate and average failure depth across each epoch, the annual activity rate varies between 0.07 in Summer 2018 and up to 0.32 in Winter 2019, whilst the annual failure depth varies between 0.26 m in the Winter 2017 and up to 0.48 m in Winter 2019.

3.2 show the change in activity rate and average failure depth across each epoch, the annual activity rate varies between 0.15 in Summer 2017 and up to 1.00 in Winter 2019, while the annual failure depth varies between 0.22 m in Winter 2017 up to 0.43 m in Summer 2017.

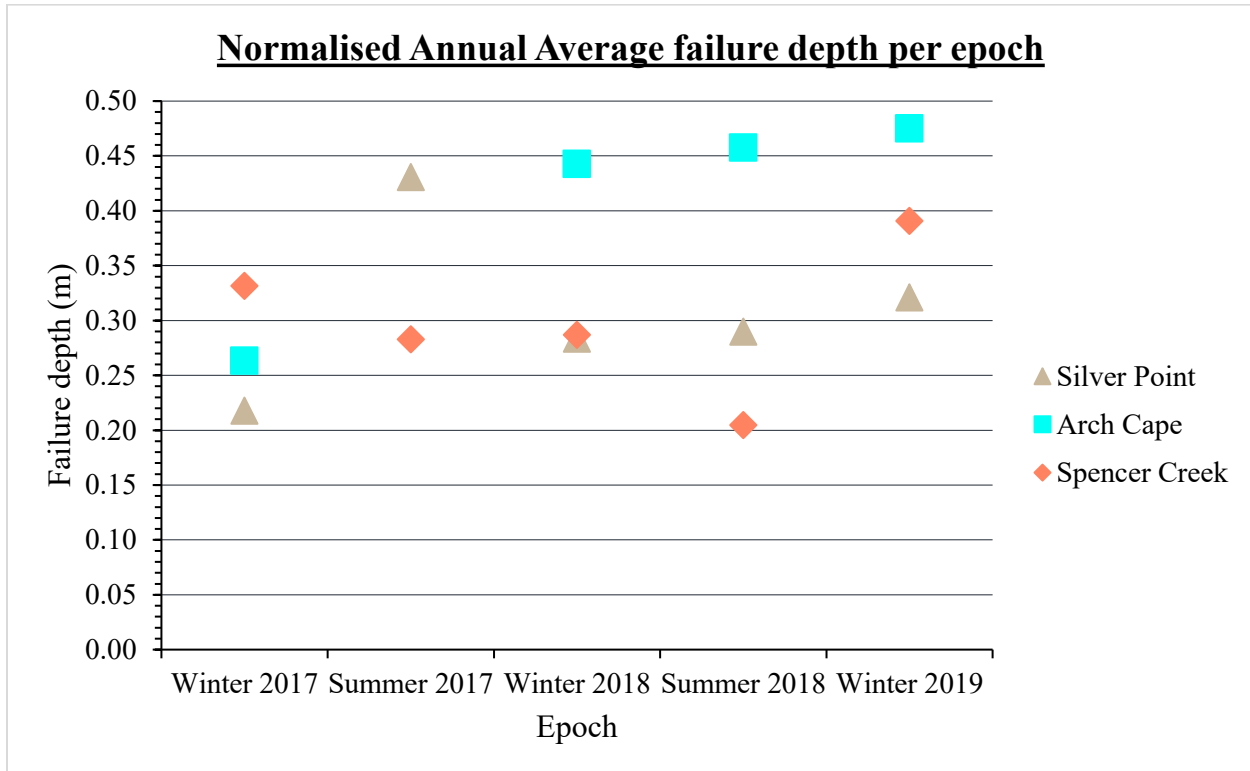
Figure 3.2: Average failure depth for each site per epoch normalized by the number of days between each survey. Note that given the scanner failure in the Spring 2017 survey, a reliable failure depth rate for Arch Cape in Summer 2017 could not be computed.

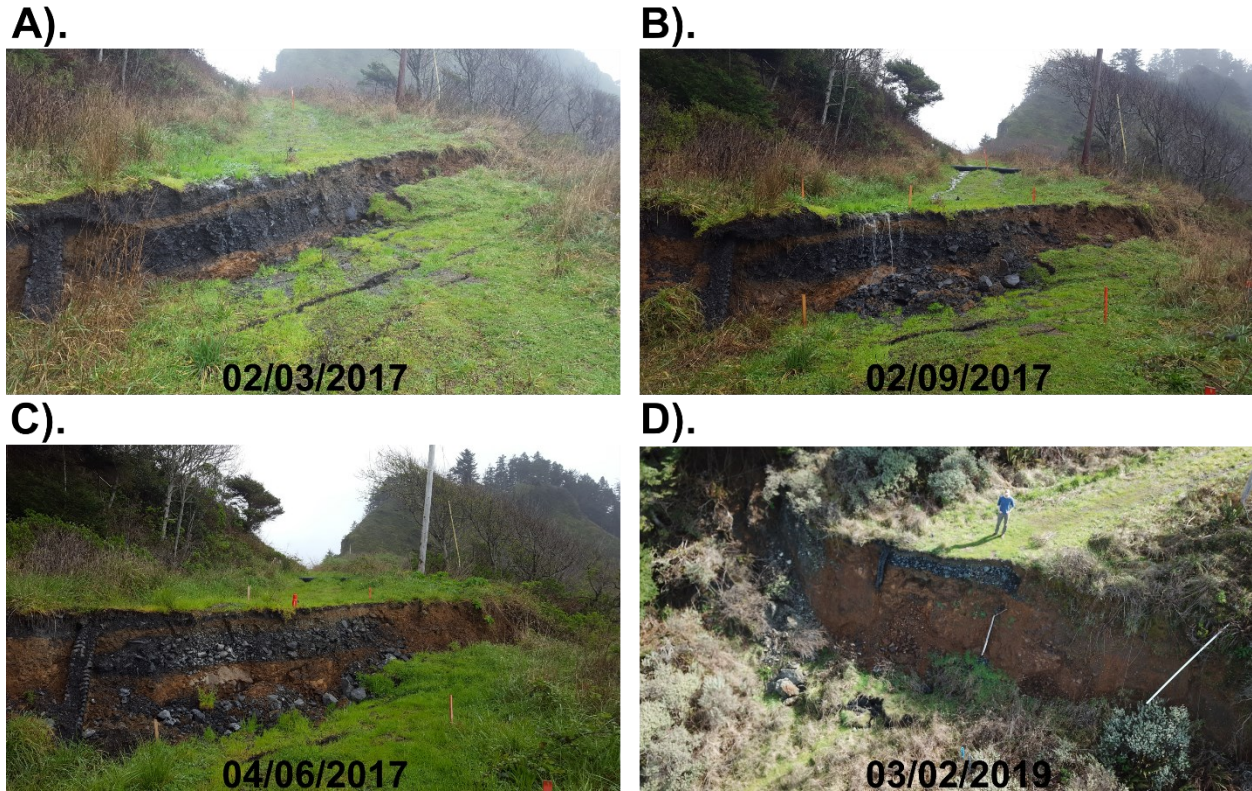
Figure 3.6: Development of a headscarp of a smaller progressive landslide within the main landslide body at Arizona Inn directly above the sea cliff from February 2017 (A) to March 2019 (D).

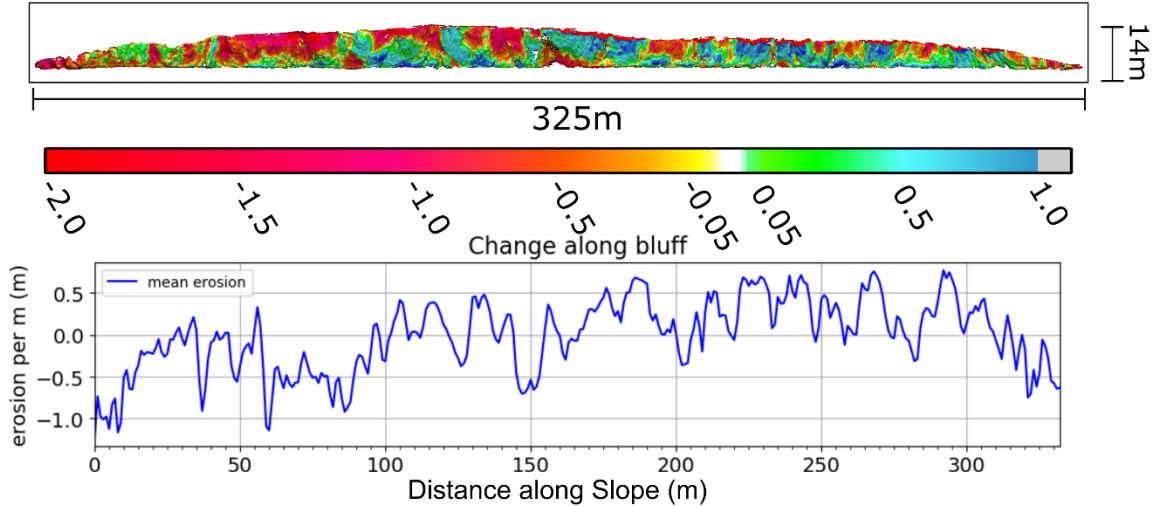
Hooskanaden - Fall 2016 - Fall 2018

Figure 3.7: Change in the bluff at Hooskanaden from Fall 2016 to Fall 2018 derived from TLS pointclouds. Red (negative values) represents erosion while blue (positive values) represents accretion likely due to landslide movement.

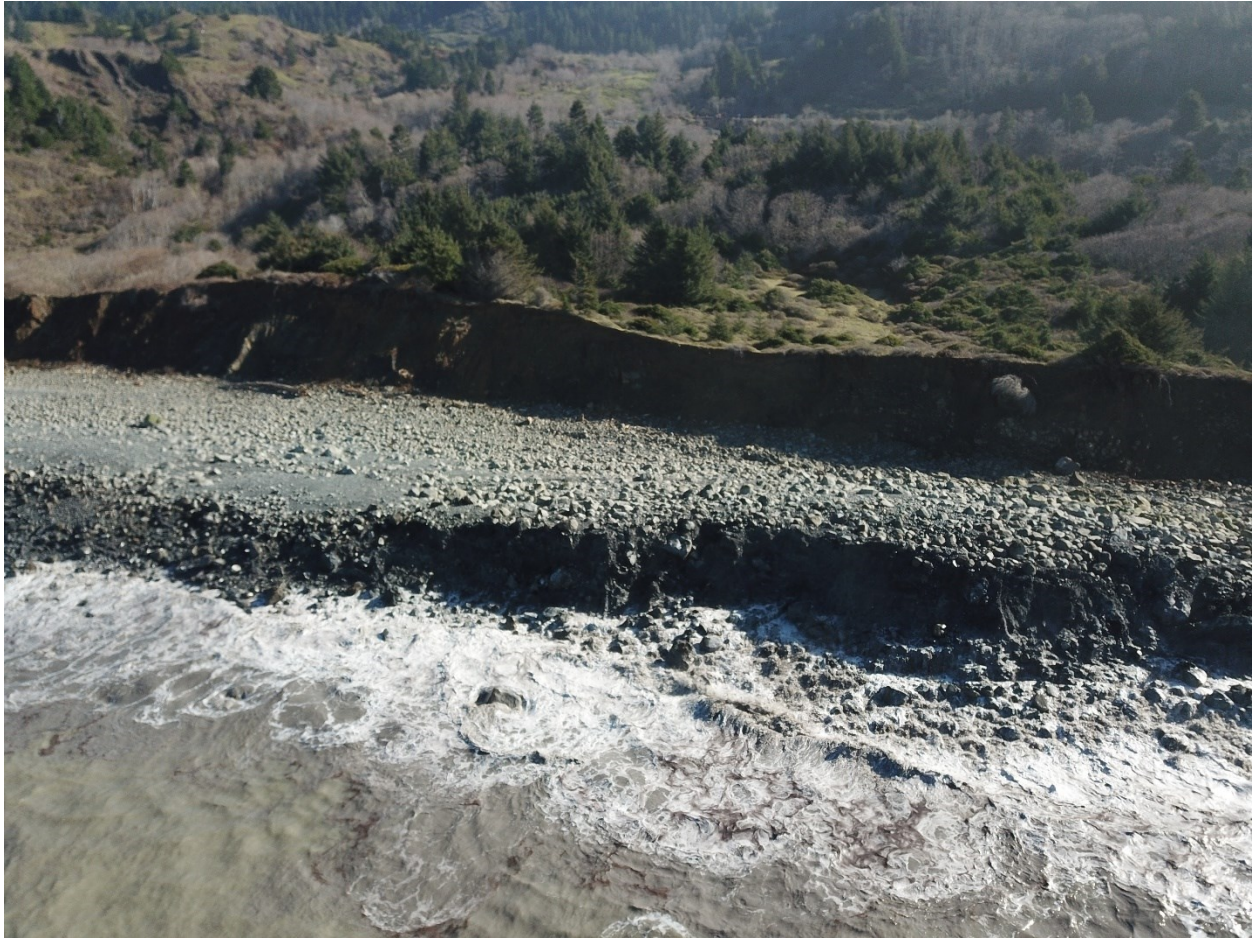
Figure 3.8: Photograph of portion of the sea cliff at Hooskanaden taken from a UAS on March 3, 2019, during the Hooskanaden landslide event. The photograph shows uneven uplift of beach to create secondary sea cliff, where the right (south) of image has been uplifted significantly more than the left (north) and thus the non-rigid movement of the landslide body.

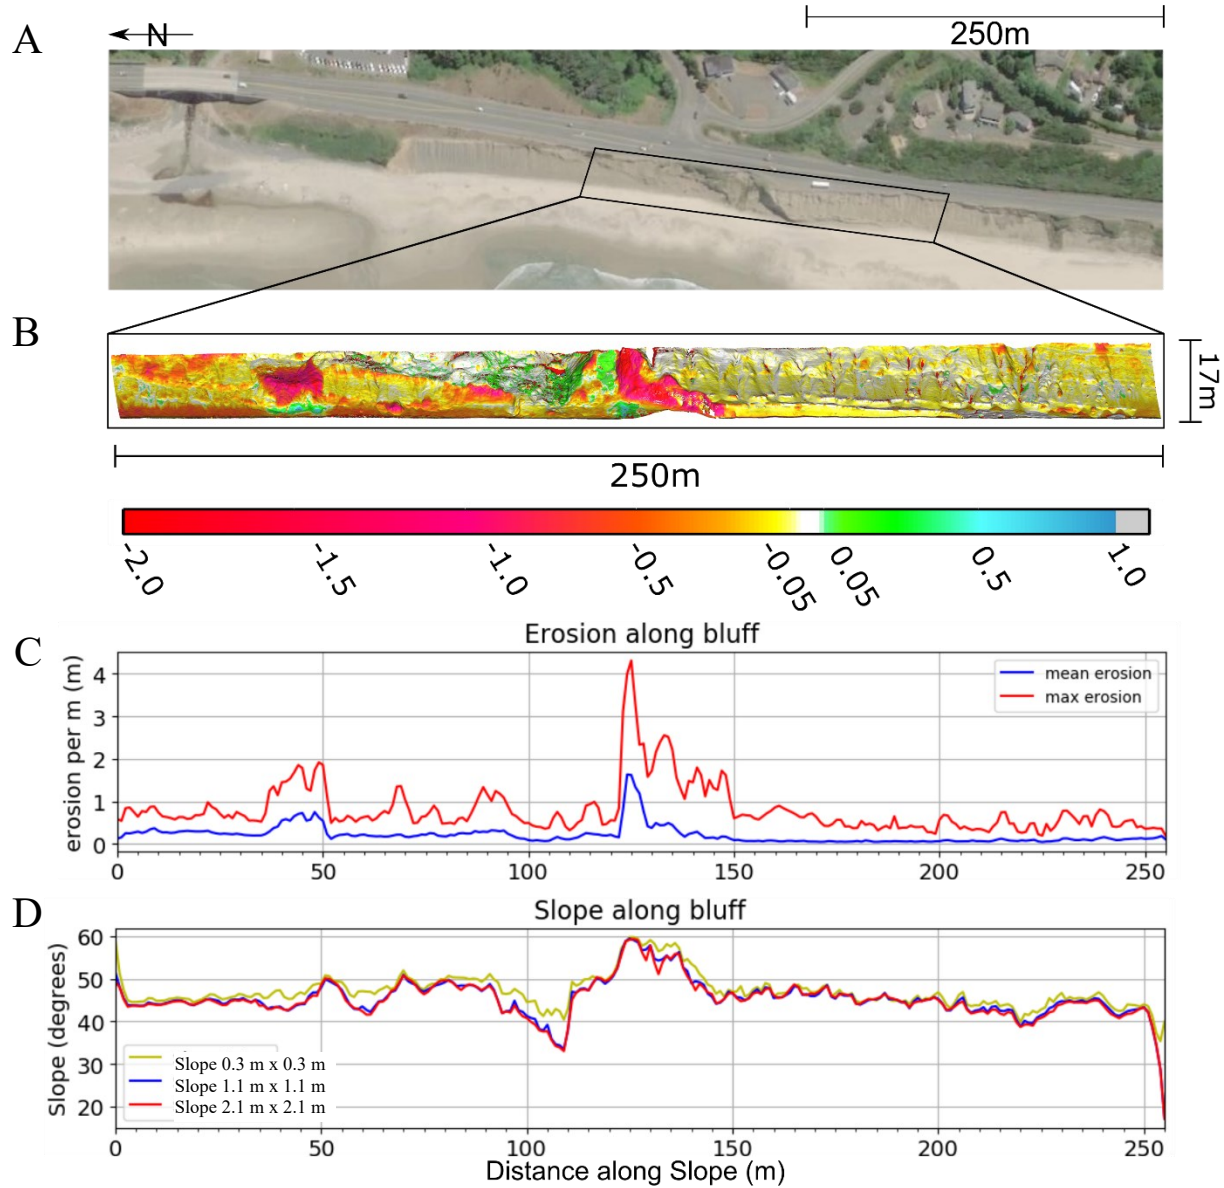
Spencer Creek - Fall 2016 - Spring 2019

Figure 3.10: Erosion occurring between the start of the project (Fall 2016) and the most recent epoch (Spring 2019) along a 250m section just south of Spencer Creek. A) An aerial view of the area of interest. B) Pointcloud displaying change in meters between epochs. C) The mean and max erosion that has occurred in 1m horizontal bins along the sea cliff. D) The mean slope value for various window sizes along 1m horizontal bins, where 1x1 window size corresponds to 10cm x 10cm, 5x5 corresponds to 50cm x 50cm etc.

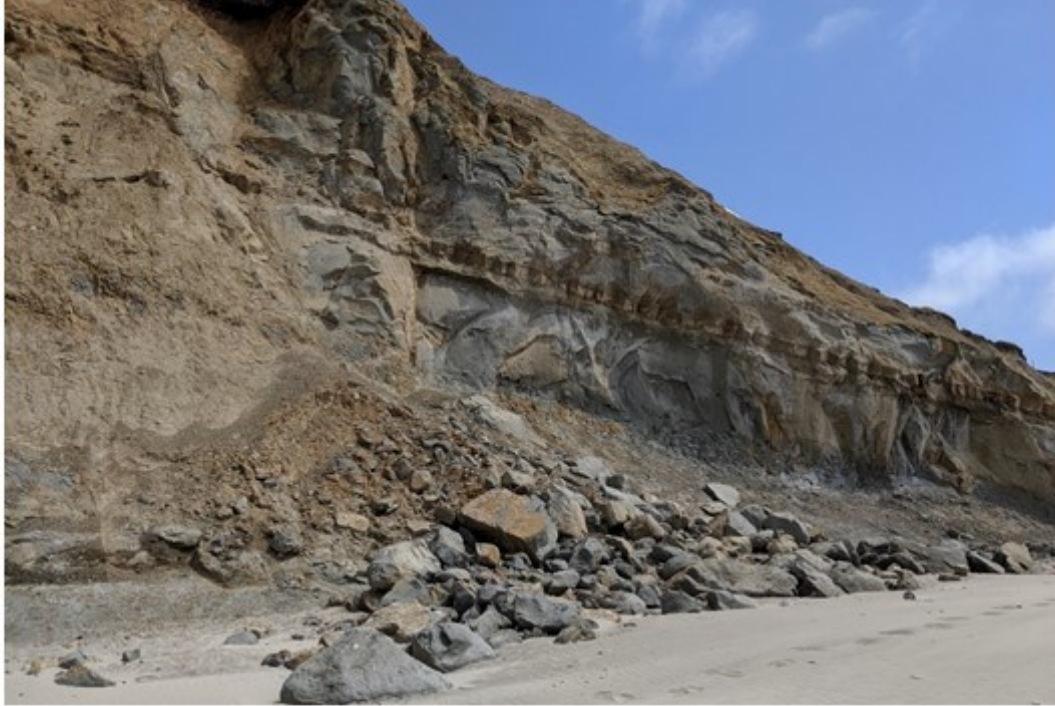
Figure 3.11: Large sea cliff failure that occurred at Beverly beach close to the southern SAA. A). Showing image of debris taken during data collection. B). Pointcloud showing change that occurred between November 8, 2018 and May 31, 2019, red shows erosion and blue/green shows accretion.

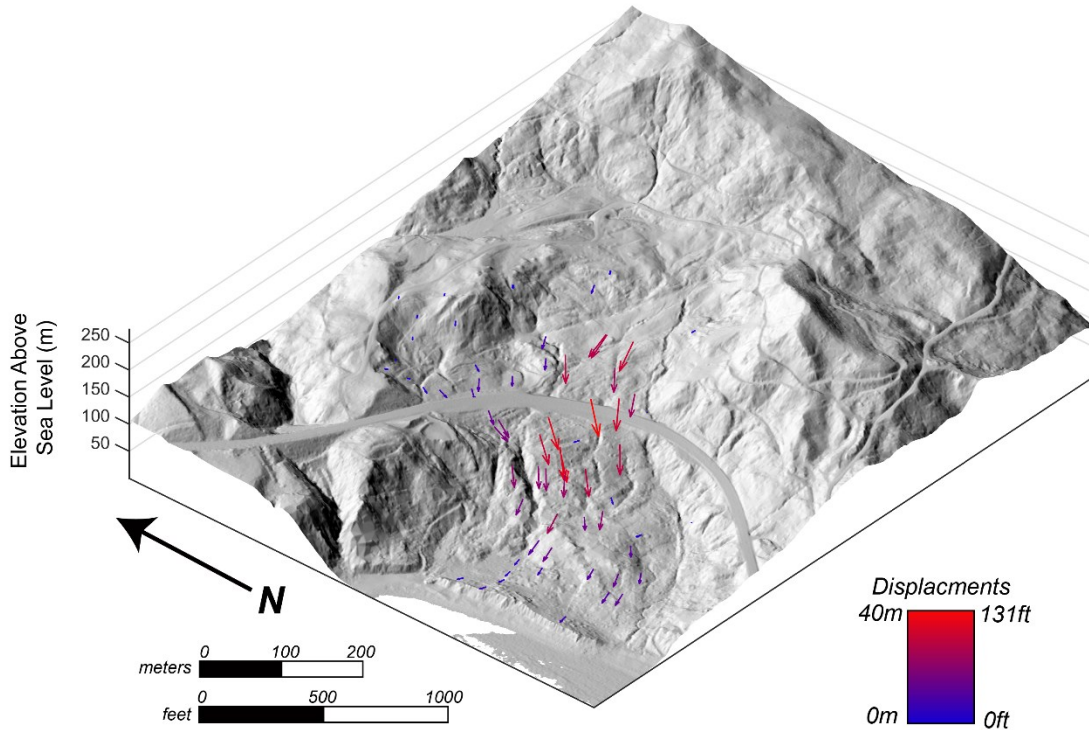
Hooskanaden Landslide Event
*Exaggerated Displacements (x2) estimated from Comparison of
Terrestrial Lidar from October 16, 2018 and March 3, 2019*

Figure 3.12: Showing 3D movement vectors across the Hooskanaden landslide. These vectors were created by extracting similar features (i.e. utility poles, trees, stumps) from TLS derived pointclouds, representing a time period between October 16, 2018 and March 3, 2019.

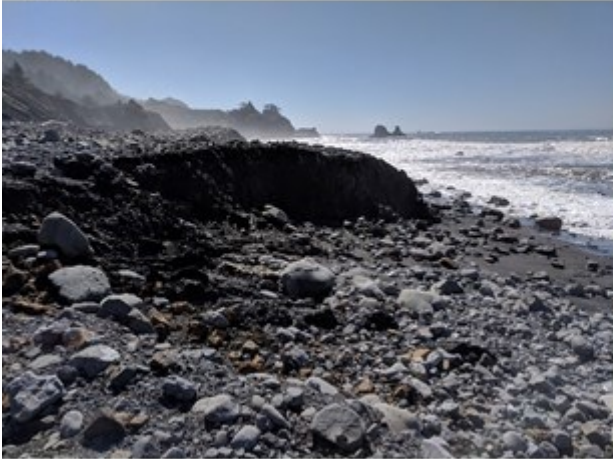
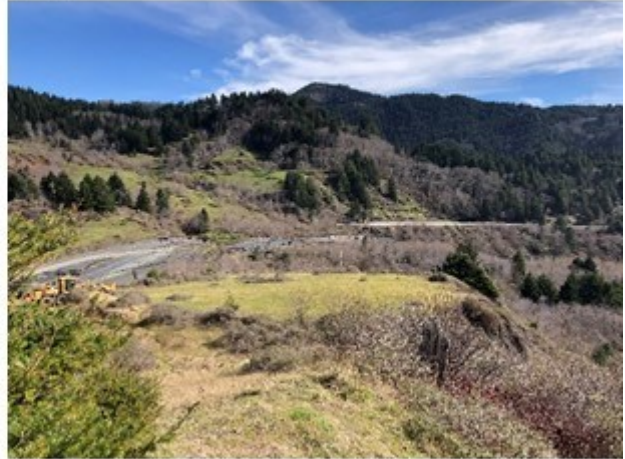
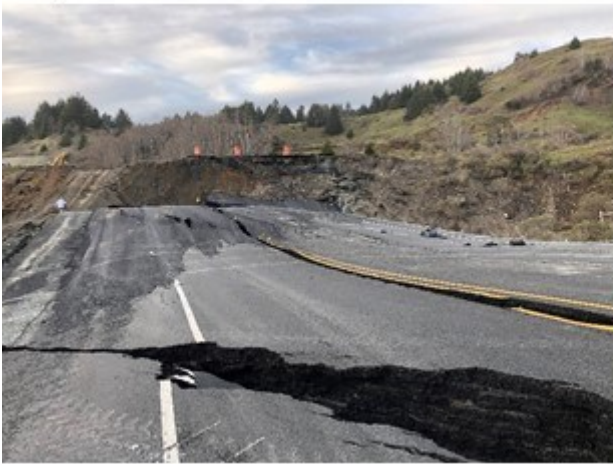
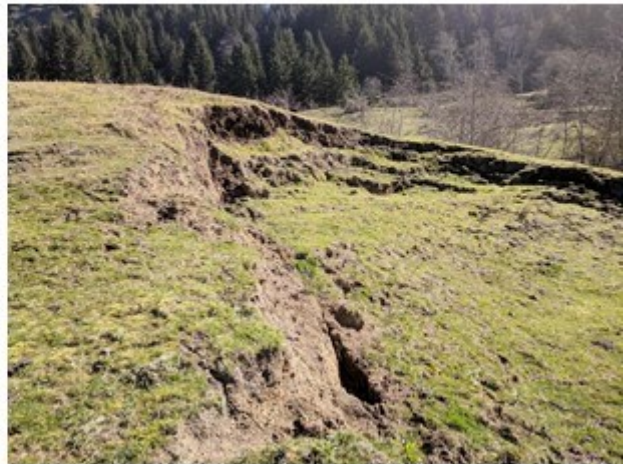
Figure 3.13: Photographs taken in early March 2019 shortly after the Hooskanaden landslide event. A). Shows uplift of the beach at the toe of the landslide. B). Shows an overview of the damage caused to HWY 101. C). Shows close up damage caused to the road by the landslide. D). Shows an example tension crack/scarp from the upper portion of the landslide (above the road).

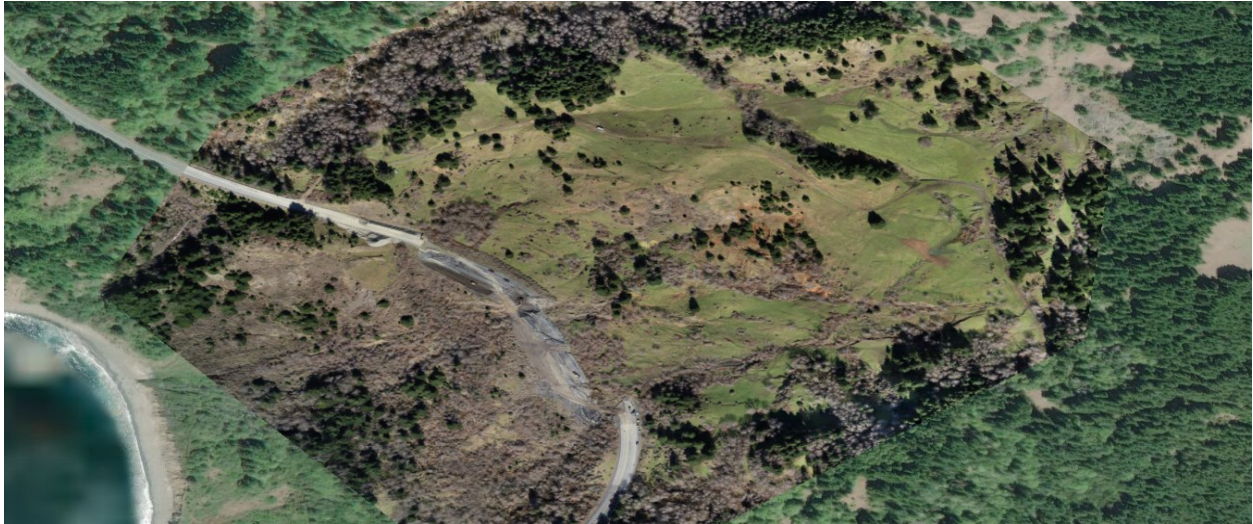
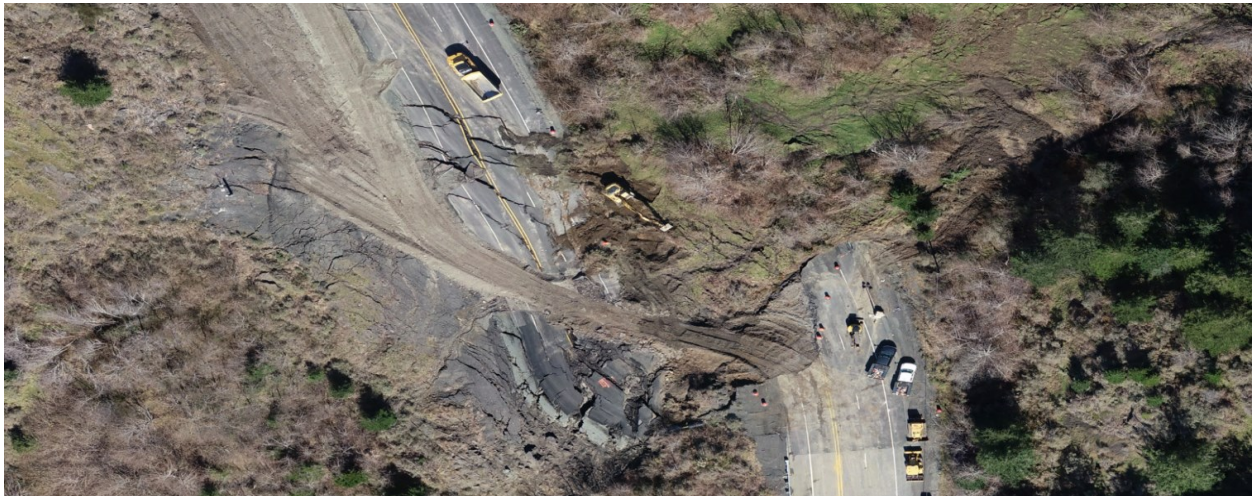
Figure 3.15: Detailed orthophotos acquired for the site on March 3, 2019. The orthophoto and SfM/MVS derived DSM can be explored at: <https://research.engr.oregonstate.edu/geomatics/projects/OregonCoast/Hooskanaden/Feb2019/uas/ortho/>

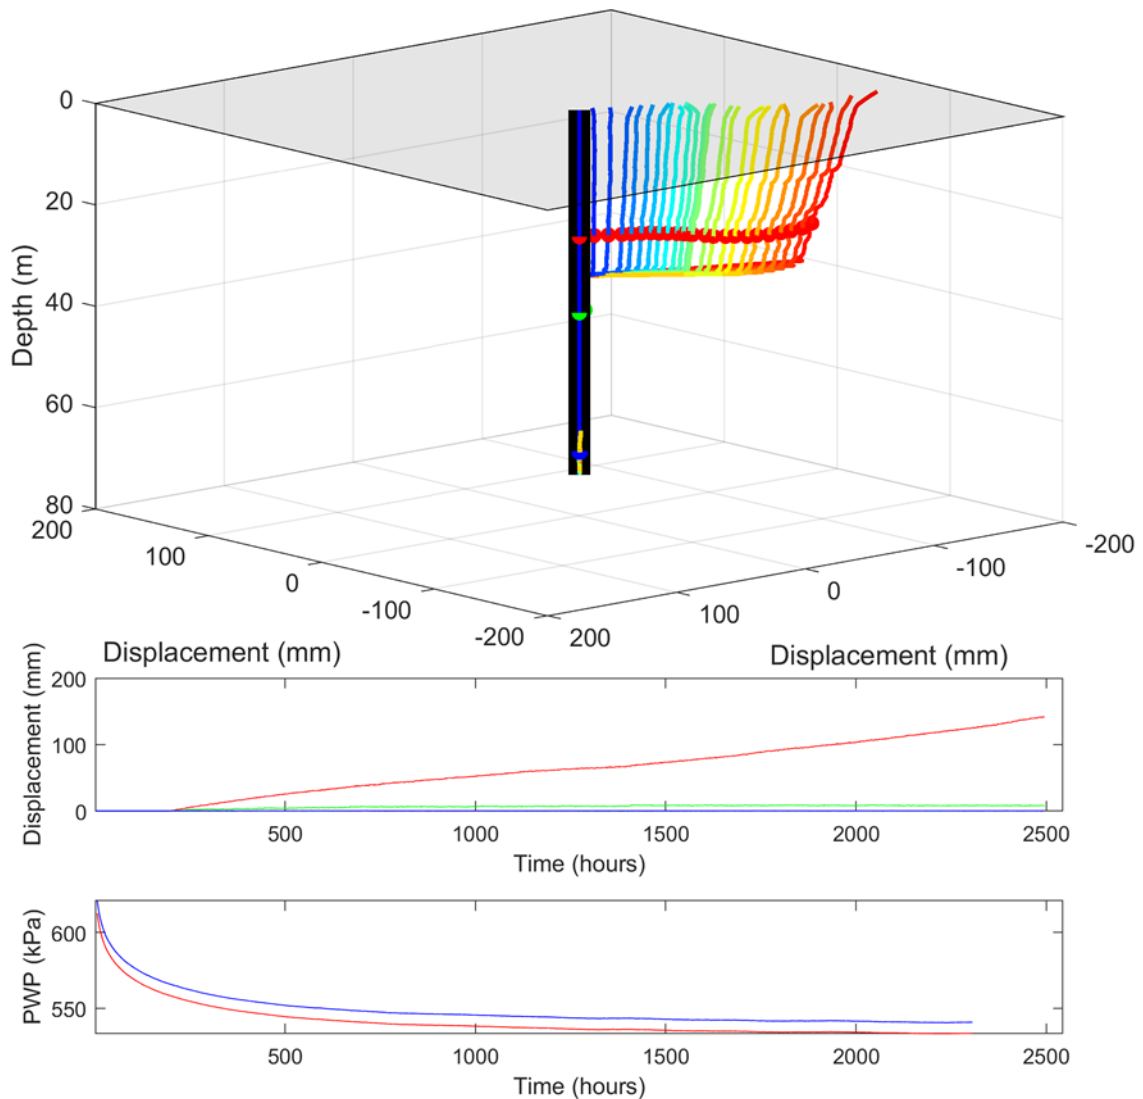
Figure 3.18: Displacements, pore pressures and inclinometer profile from Hooskanaden monitoring site.

Hooskanaden has been the most active landslide of the six monitored sites. An inclinometer was installed in November 2017, and soon thereafter sheared along with piezometers by January of 2018 with over 150 mm of displacement (Figure 3.18). The shear plane was measured at 35 meters, and the shear profile was used by ODOT R3 engineers after the significant movement that occurred in 2019. No borings or monitoring had been installed in the landslide to date, thus this data was invaluable for repair efforts of HWY101 after failure. At the time of installation, Hooskanaden exhibited a relatively constant velocity of 3 mm/day. This is commensurate with yearly velocities of 1-2 meters per year (under progressive, but not catastrophic failure conditions). Piezometric levels did not change significantly after the grout within the borehole had set, but are suggestive of elevated pore pressures that are greater than hydrostatic levels (i.e., 55m of head as compared to 35m of depth). The short lifespan of ground instruments at Hooskanaden has prompted further surface monitoring, including two flights of UAS lidar and installation of a series of GNSS rovers throughout the slide mass (planned for upcoming year – See Section 2.5).

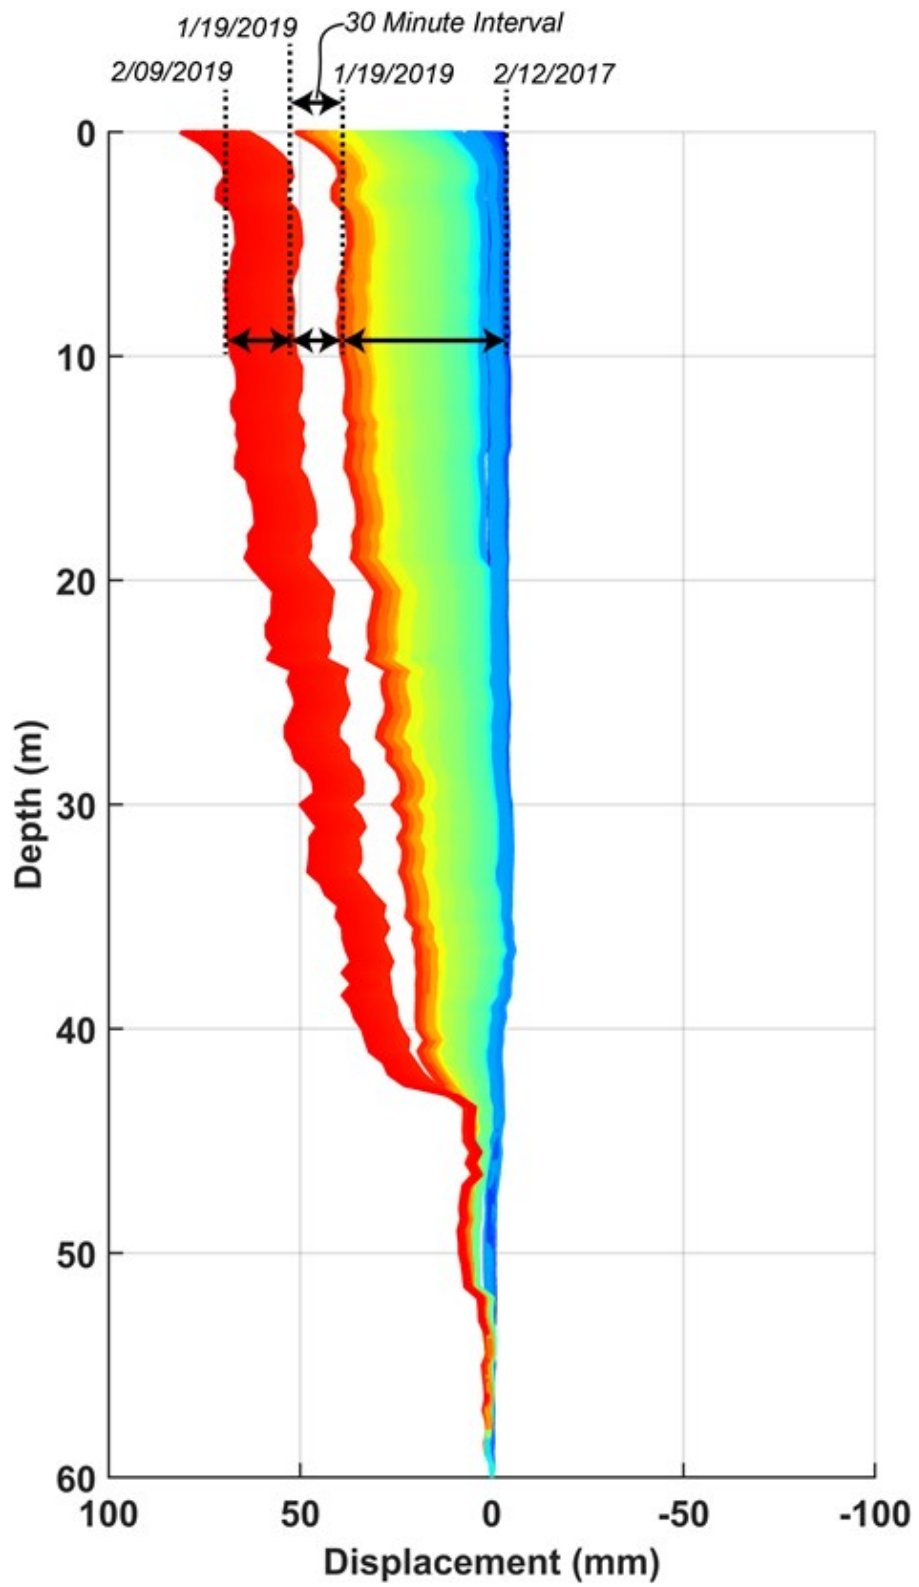
Figure 3.20: Monitored shear profile at the Arizona Inn landslide.

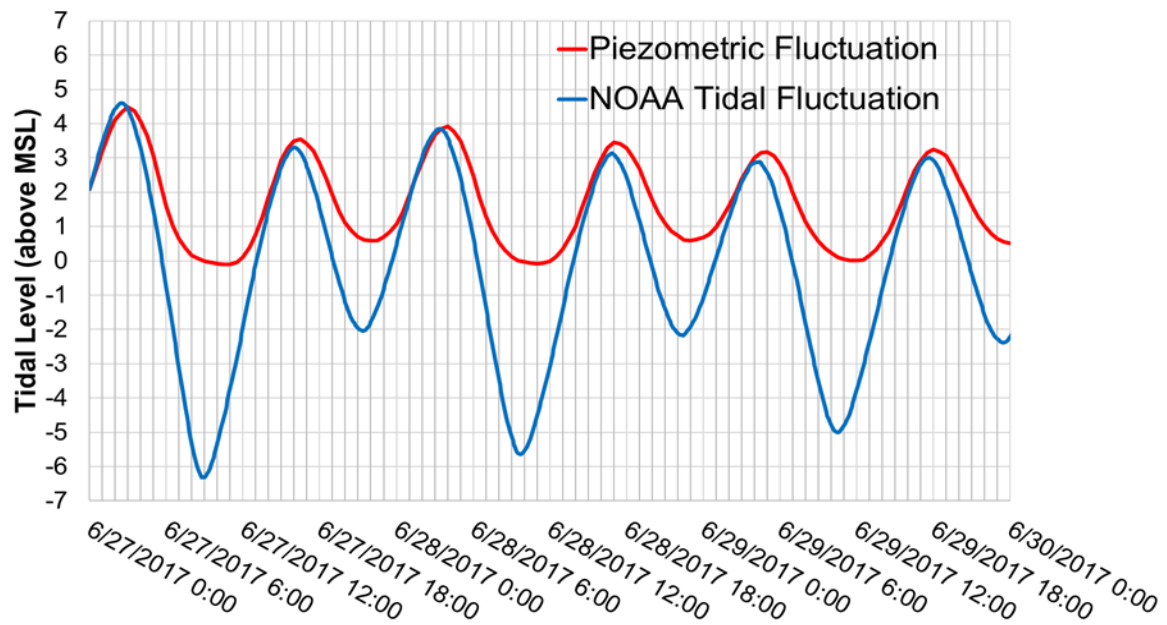
Figure 3.23: Piezometric profile of lower piezometer in comparison to tidal fluctuations.
