**COASTAL LANDSLIDE AND SEA CLIFF
RETREAT MONITORING FOR
CLIMATE CHANGE ADAPTATION AND
TARGETED RISK ASSESSMENT**

Interim Report

PROJECT SPR 807

Oregon Department of Transportation

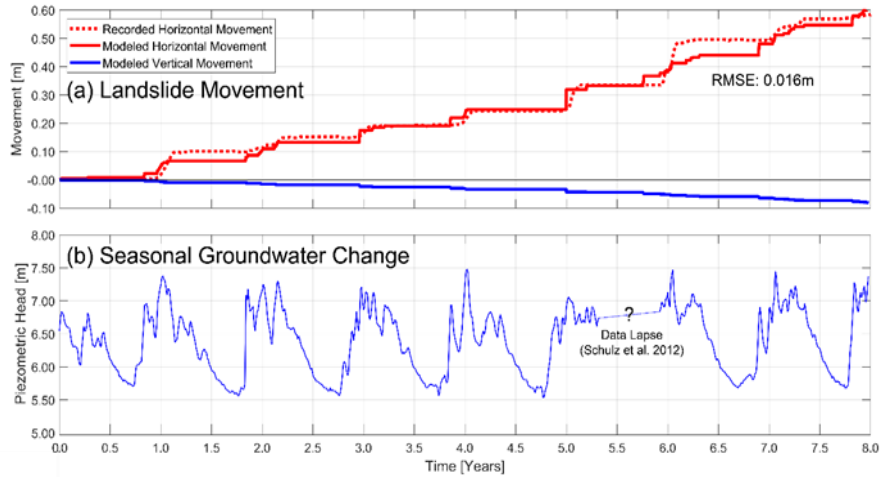
Figure 4.3: After Leshchinsky et al. (2019). (a) Modeled and measured landslide movement for the Johnson Creek Landslide and (b) measured piezometric head from January 2005 to January 2013 (after Schulz et al. 2014).

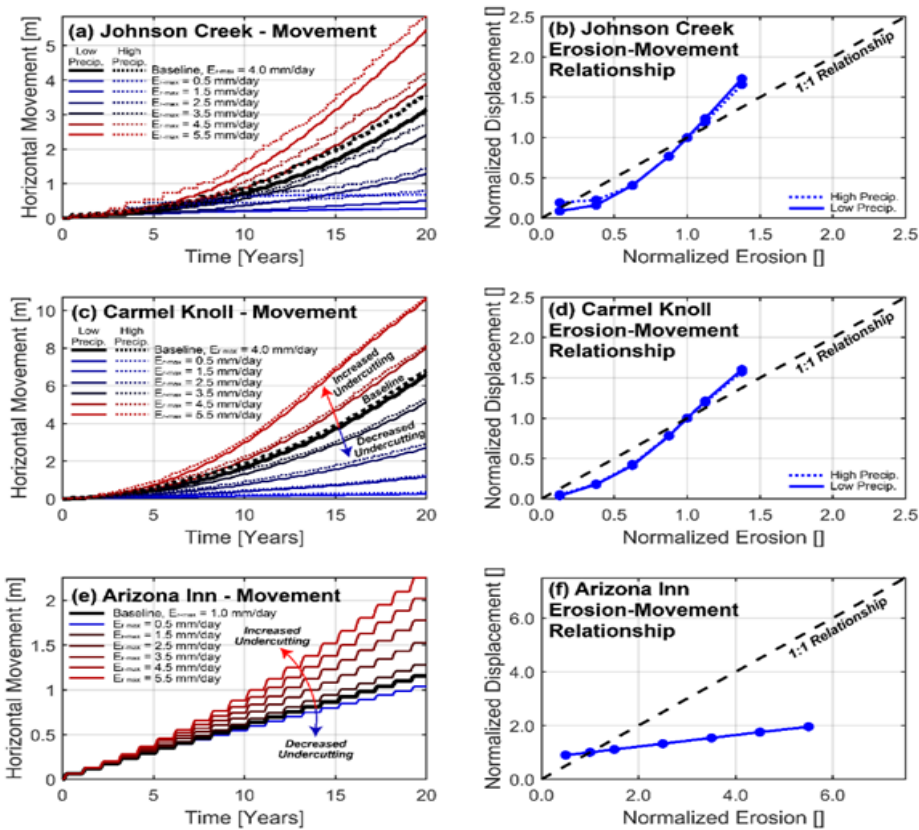
Figure 4.4: After Leshchinsky et al. (2019). Modelled landslide movements for select landslides over 20 years considering high and low precipitation conditions (dashed and solid lines, respectively) and various erosion rates (a) Johnson Creek; (c) Carmel Knoll; and (e) Arizona Inn. Inferred relationship between landslide movement and increased or decreased erosion after 20 years for select landslides (b) Johnson Creek; (d) Carmel Knoll; and (f) Arizona Inn.

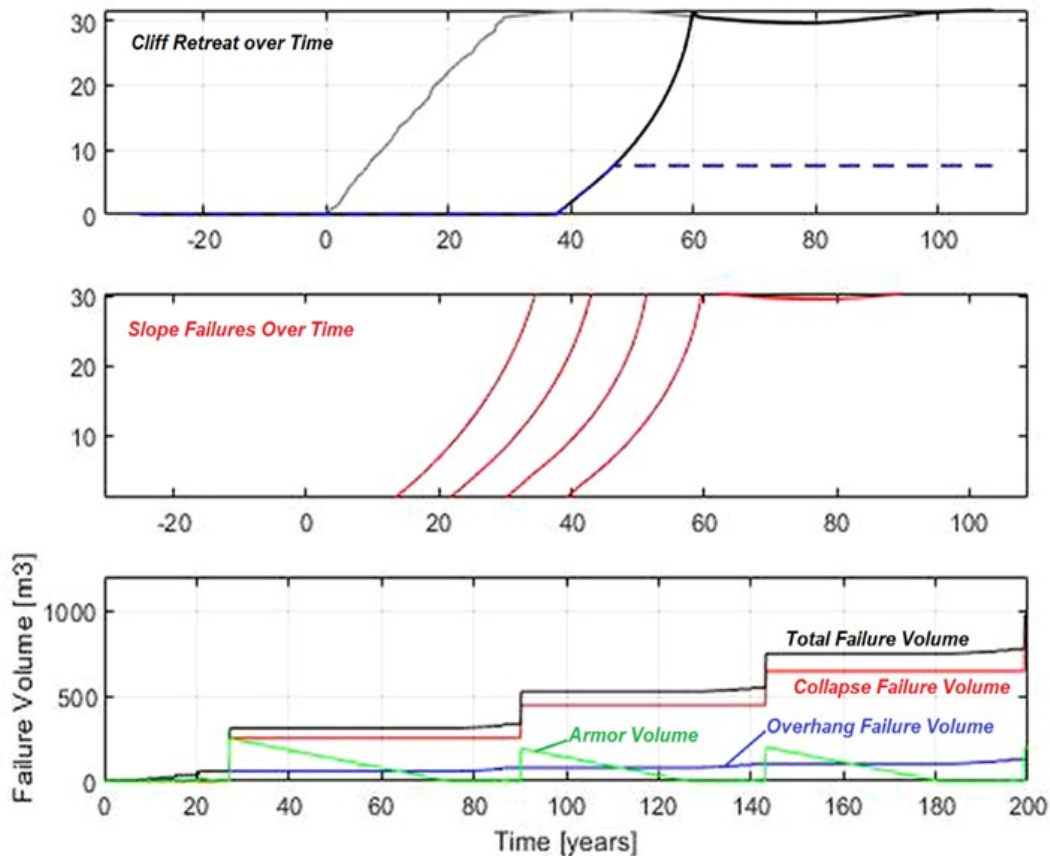
Figure 4.5: Model of sea cliff retreat considering overhang failures, collapse failures, and self-armouring. The retreat of the sea cliff over 200 years is shown in the top figure, with the grey line representing initial conditions and the black line representing final conditions. Retreat over this time period and soil conditions is approximately 35 meters.
