**COASTAL LANDSLIDE AND SEA CLIFF  
RETREAT MONITORING FOR  
CLIMATE ADAPTATION AND  
TARGETED RISK ASSESSMENT**

**Final Report**

**SPR-807**

Oregon Department of Transportation

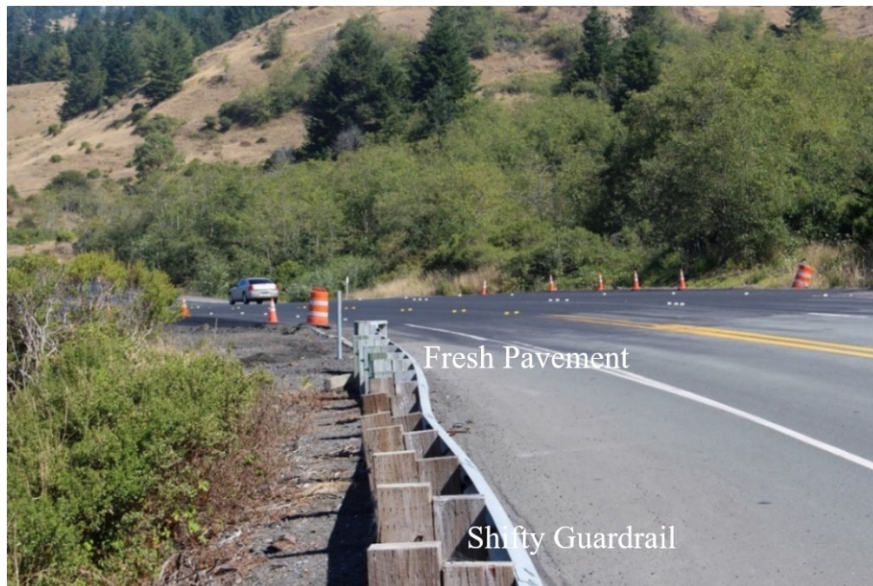
**Figure 1.1: Example Evidence of damage to Highway 101 at the Hooskanaden Slide requiring routine repaving of the road (MP344, August 2016).**

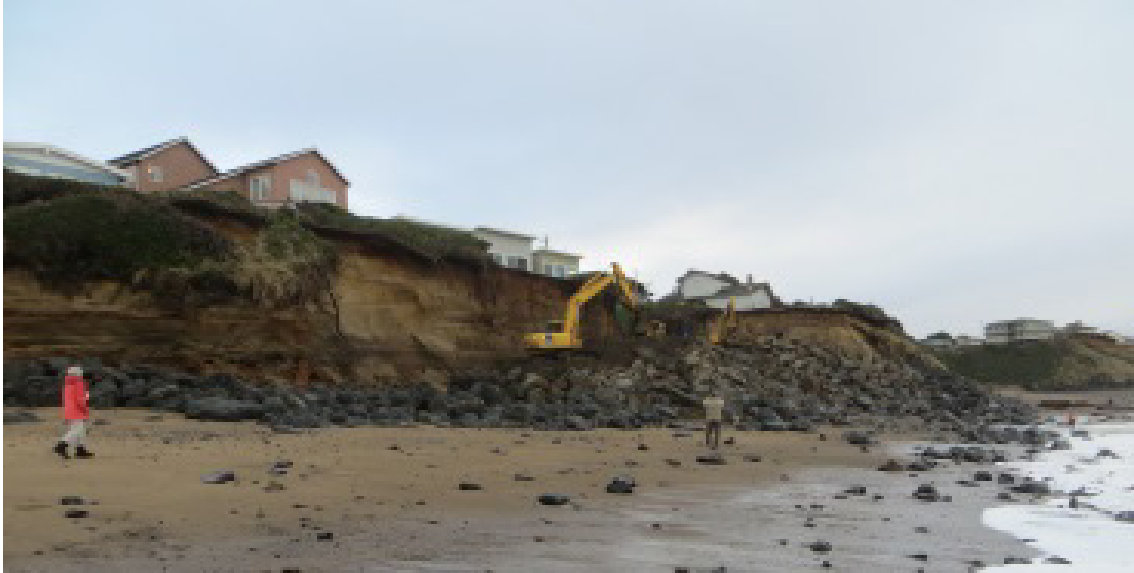
**Figure 2.2: Sea cliff erosion located at Gleneden Beach, Lincoln County. The Photograph shows the presence of terrace sands that are rapidly eroding in response to cliff toe erosion. An emergency riprap structure is being constructed to mitigate the problem (Photo courtesy of J. Allan, DOGAMI, 2013).**

On the cliff-backed shores of the central Oregon coast, between Yachats and Lincoln City, homes are perched precariously close to the edge of receding cliffs (Figure 2.2). In some areas, the erosion has become acute requiring various forms of coastal engineering (commonly riprap) in order to mitigate the problem (Priest and Allan, 2004; Allan et al., 2015a) and in a few cases the landward removal of the homes (Komar, 1997). In other areas, critical infrastructure such as U.S. Highway 101 track close to the coast (Figure 2.3 and Figure 2.4), and in several areas, erosion of the sea cliffs has resulted in expensive remediation (Allan and Stimely, 2013; Allan et al., 2015b). While the processes driving sea cliff erosion depend on a delicate balance between the assailing forces (waves, tides, precipitation etc.) and properties of the rock (bedding, strength, jointing etc.) (Hampton and Griggs, 2004; Sunamura, 1992), increasing development pressure, a lack of quantitative information, and uncertainty of the physical processes are contributing to the need for expensive remediation in many Pacific Northwest (PNW) coastal areas (Allan et al., 2009).

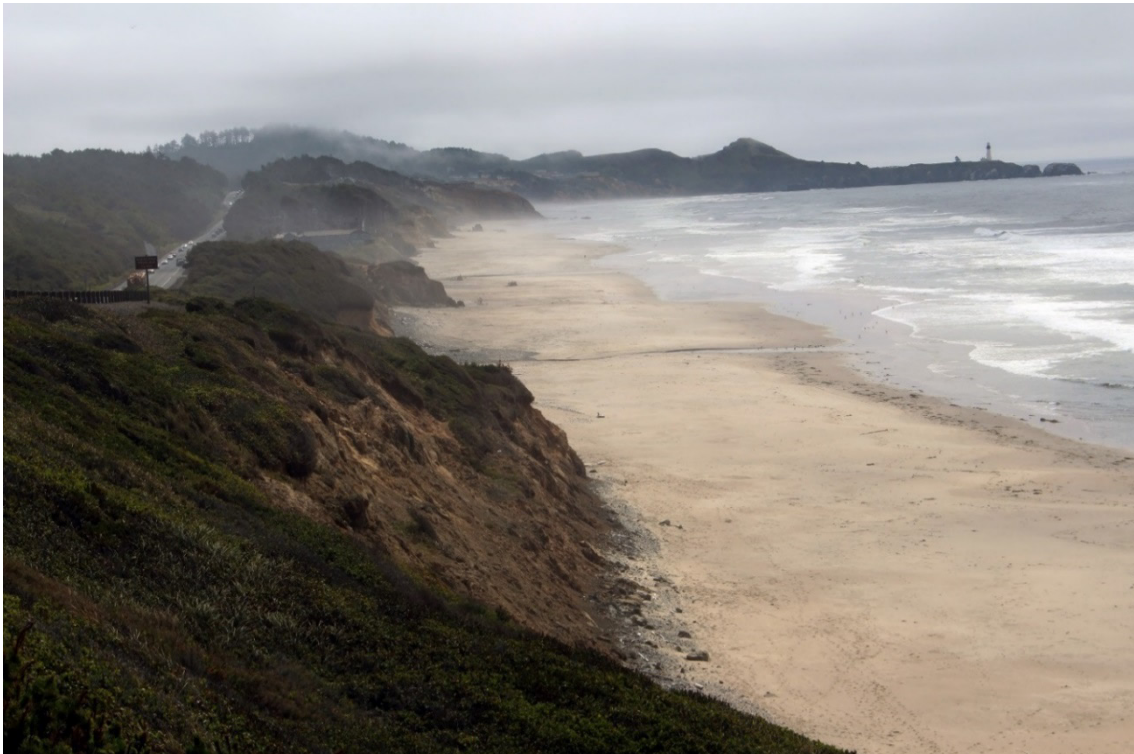
**Figure 2.3: Coastal sea cliffs located at Beverly Beach, Oregon adjacent to Highway 101 (near MP134, August 2016).**

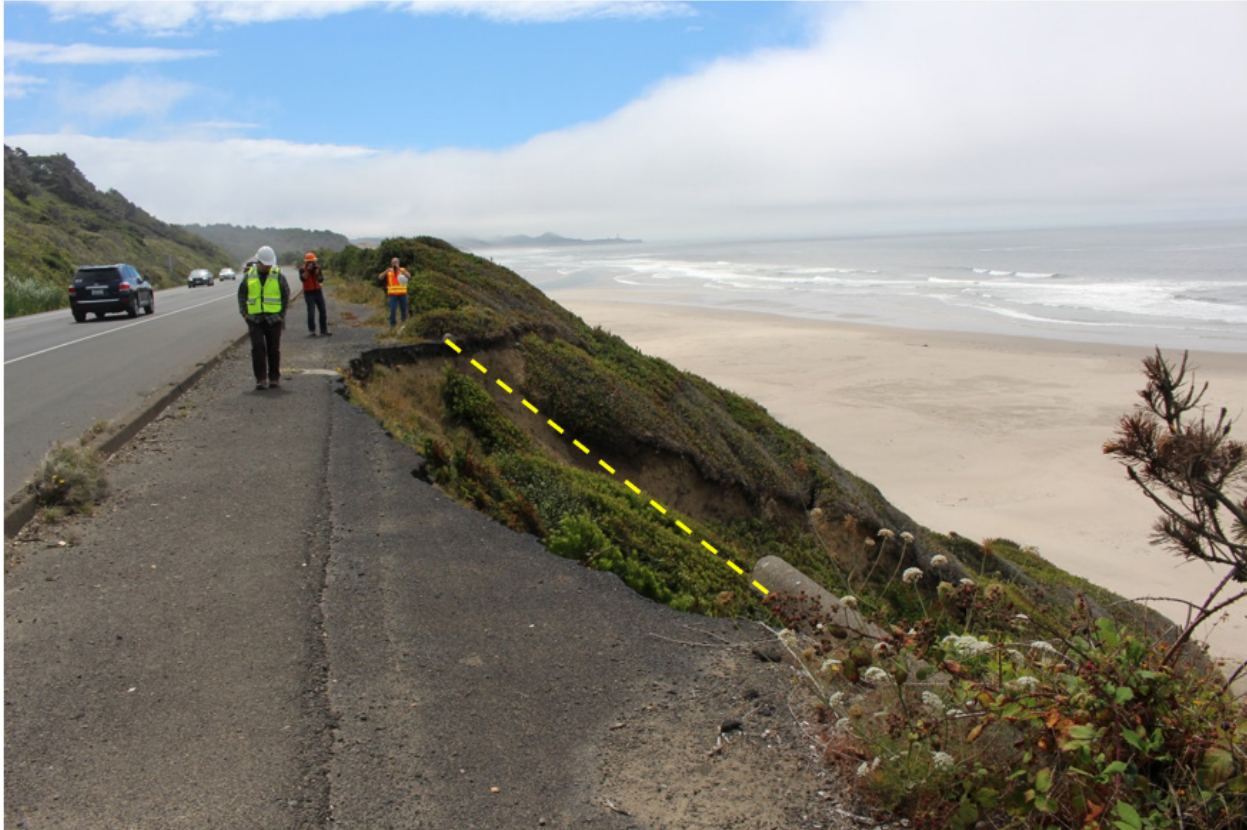
**Figure 2.4: Sea cliff erosion occurring at Beverly Beach, OR. where Highway 101 runs parallel to the sea cliffs. In some cases, coastal landsliding and localized retrogression has resulted in relocation of the highway. The former location of a concrete curb is shown with the yellow, dashed line (near MP134, August 2016).**

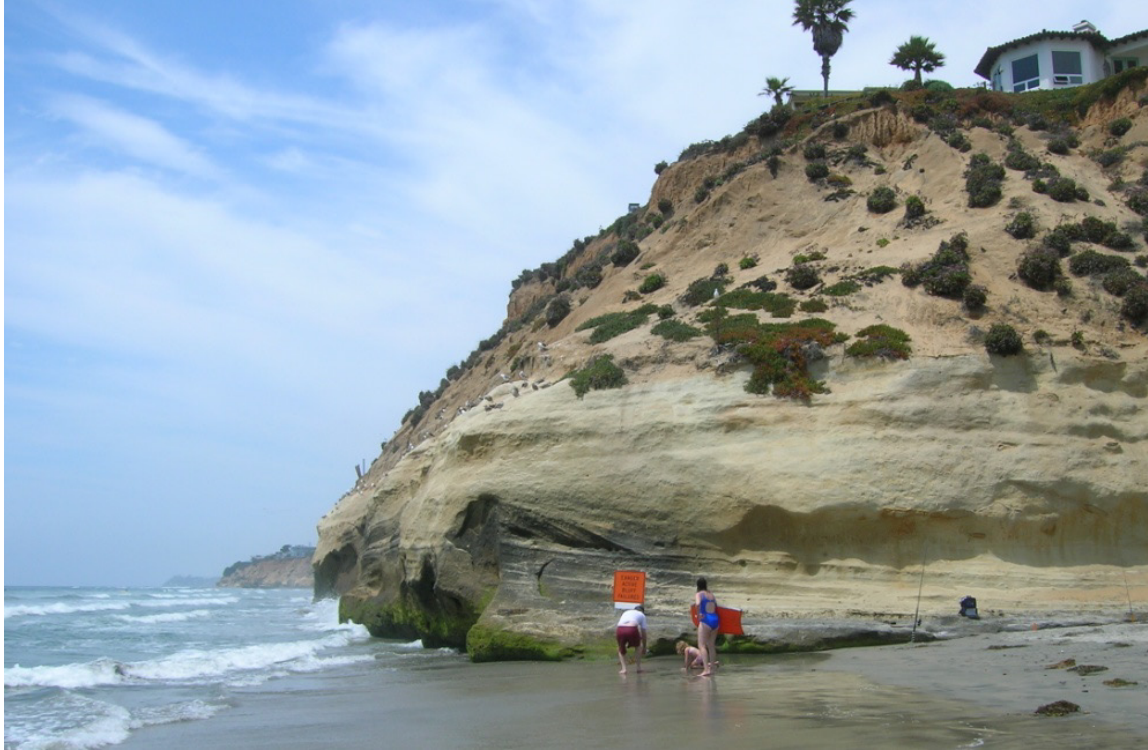
**Figure 2.8: Notches in sea cliffs at Fletcher's Cove, Solana Beach, CA created through wave-based erosion (from Olsen, 2009).**

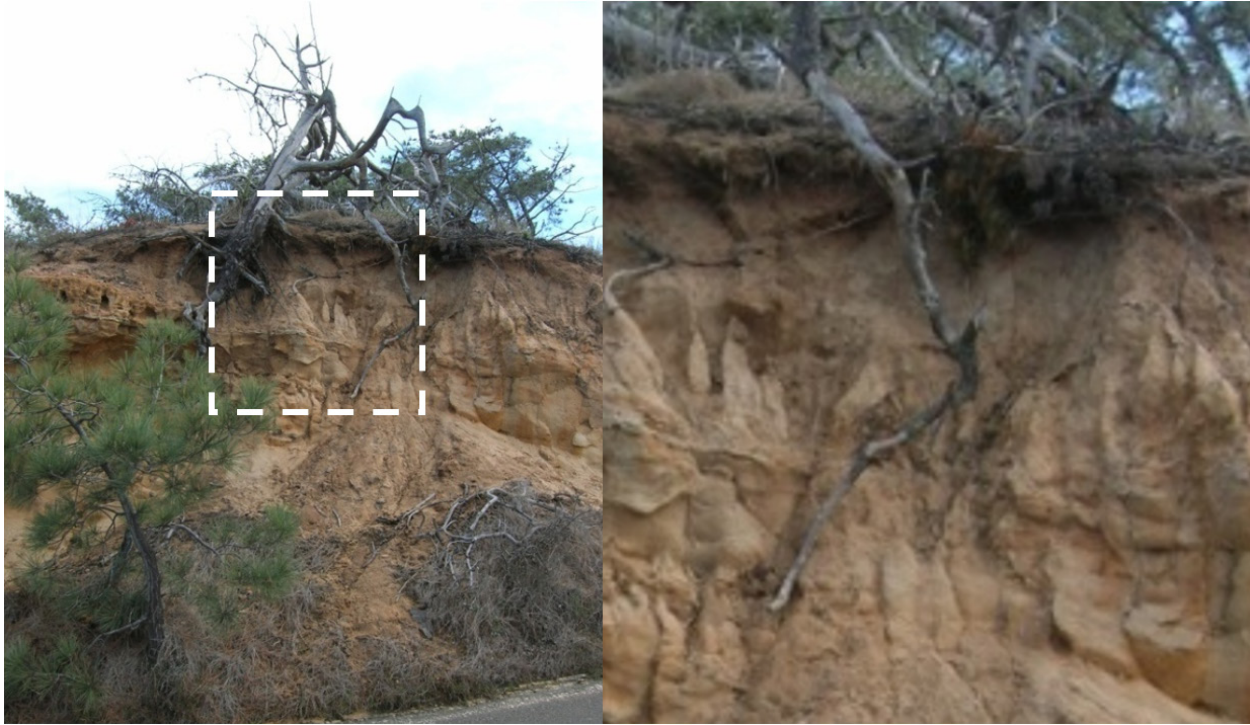
**Figure 2.10. Biological erosion of Torrey Sandstone at Torrey Pines Reserve with close-up on right (from Olsen, 2009).**

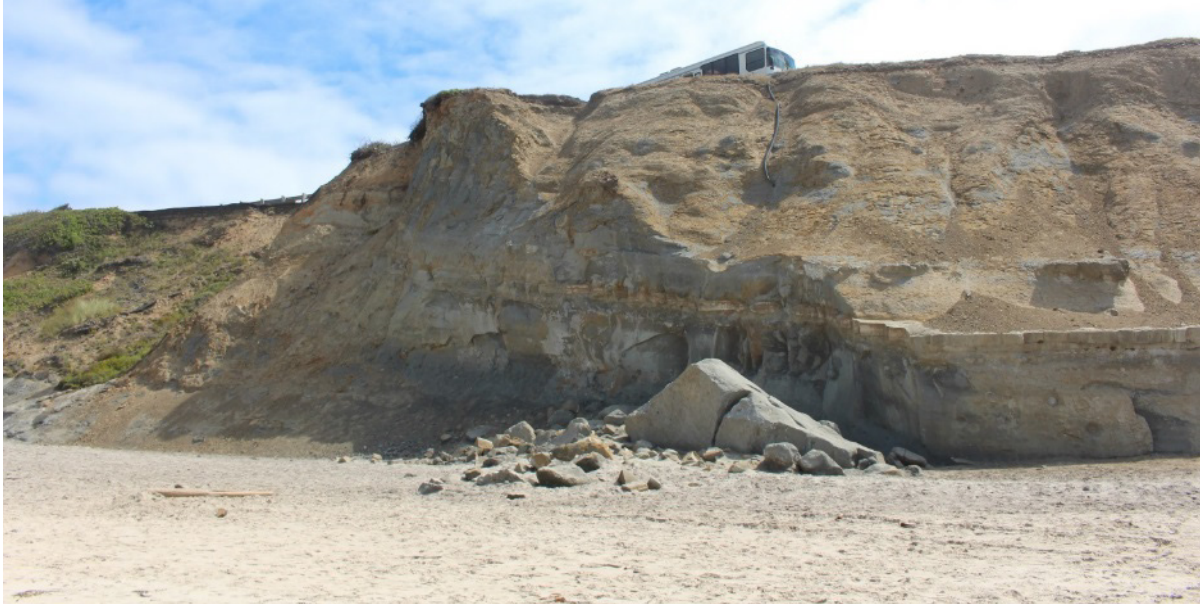
**Figure 2.11: Recent sea cliff collapse at Beverly Beach near a broken drain pipe (near MP134, August 2016).**

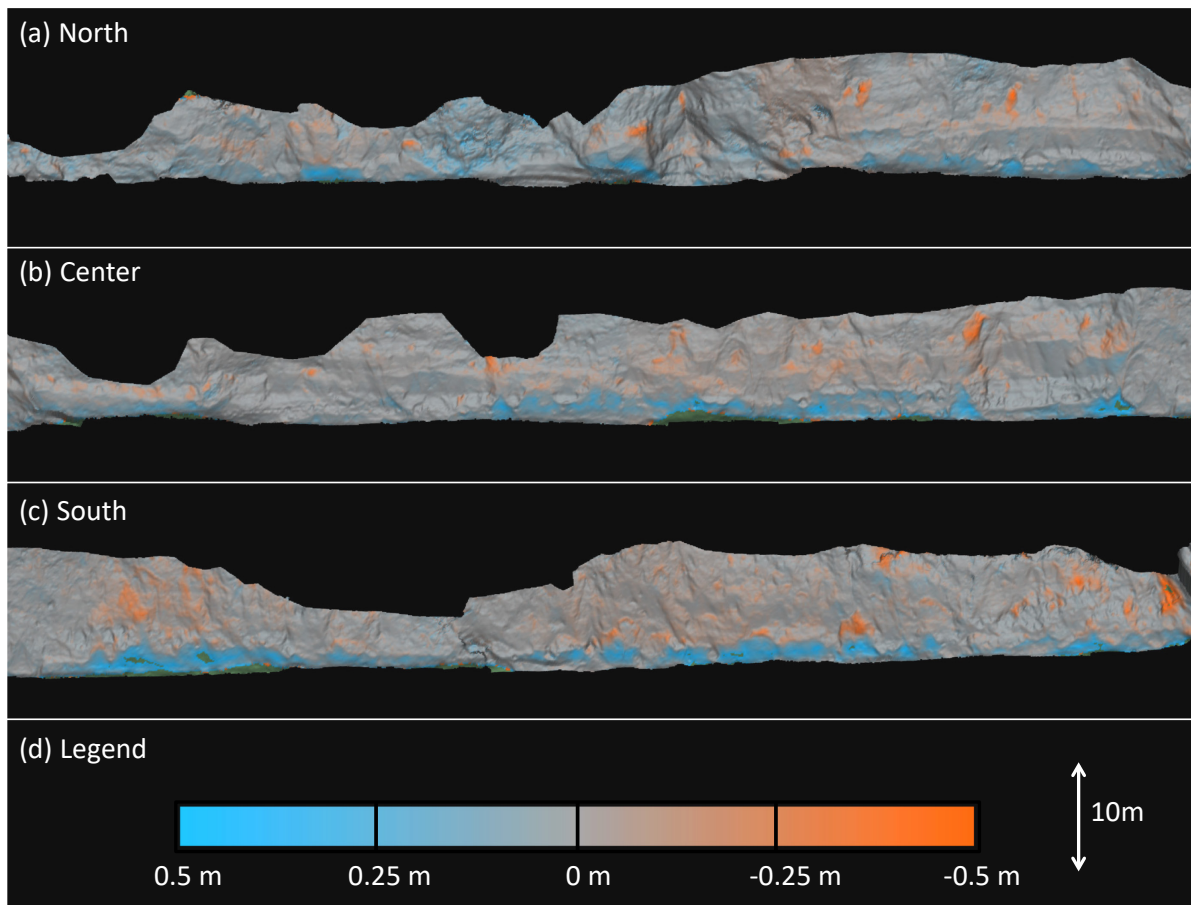
**Figure 2.14: Change analysis between lidar surveys showing advance and retreat of the cliff face at the coastal Johnson Creek Landslide between May and August 2012 (courtesy of Jeremy Conner, OSU Geomatics).**

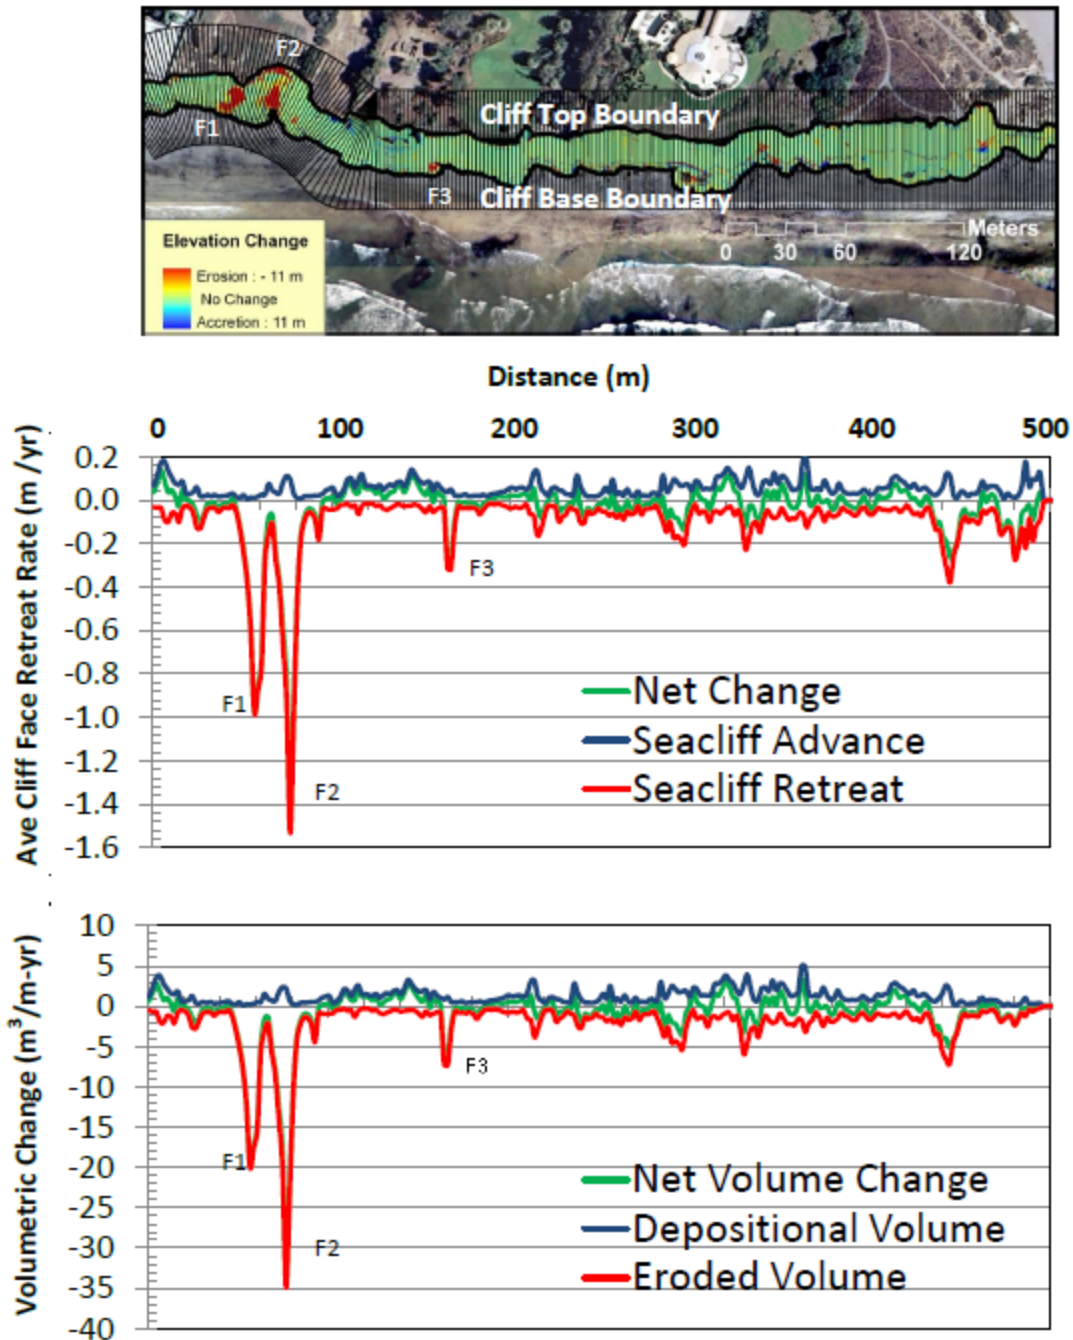
**Figure 2.15: Volumetric and topographic change analysis completed for Dog Beach, CA using the GIS-based tool TopCAT (Olsen et al., 2012).**

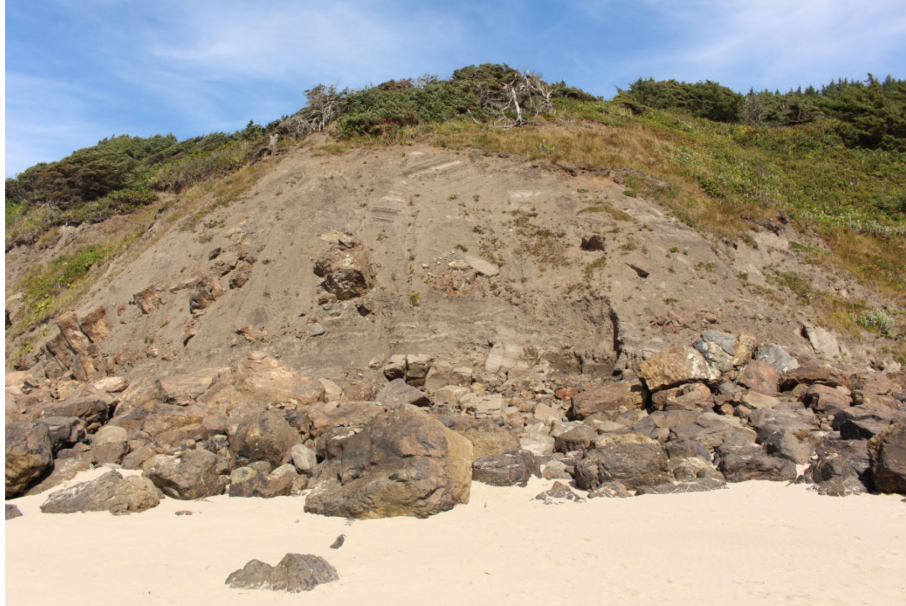
**Figure 3.2: The coastal sea cliff at the most westerly point of Silver Point (facing east) (near MP32, August 2016).**

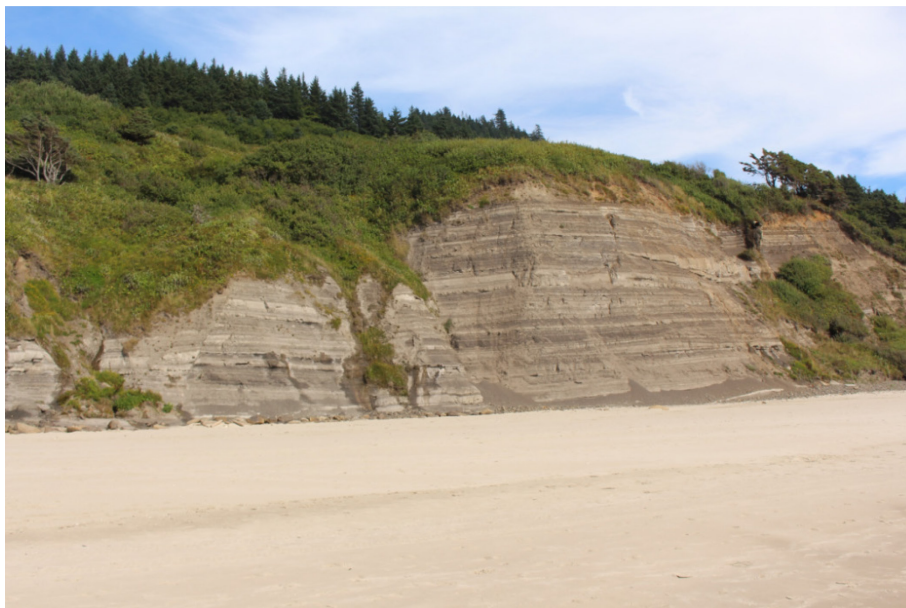
**Figure 3.3: Showing coastal sea cliff at Silver Point study site, containing well defined beds from the Astoria Formation, taken facing south east (near MP32, August 2016).**

The Silver Point site is located south of Cannon Beach, around 700 m south of west Sitka Street on Highway 101 between mileposts 31 & 32. At this point, Highway 101 runs parallel to the coast and is separated by a small sea cliff and gently inclined slope. Figure 3.5 shows the sea cliff at the most seaward point. The study area extends from around 120 m north of the westernmost point to around 150 m south of the point. Moving landward, this site changes from a wide sandy beach to a steep coastal sea cliff that varies from approximately 5 to 30 m in height that shows well-defined seaward dipping bedding planes in places (Figure 3.6). For the most part, the sea cliff is void of vegetation. On top of the sea cliff there is a heavily vegetated gentle slope extending upward to Highway 101. The geology of this varies from late Pleistocene to Holocene landslide deposits mixed with Grande Ronde basalt from the mid-Miocene in the north and middle sections (Witter et al., 2009). The south section is principally comprised of Angola Peak sandstone (Witter et al., 2009) light brown to grey in color, interbedded with siltstone (Schlicker et al., 1972) from the Astoria Formation deposited during the Miocene. This unit consists of arkosic and lithic sandstone containing cross bedding and laminations interbedded with carbonaceous and mica rich siltstones (Niem, 1975). This unit is well exposed in much of the coastal sea cliff as shown in Figure 3.6 where well defined beds 10-50 cm thick can be seen. Geologic maps published by Schlicker et al. (1972) state this area as dipping gently to the southeast at approximately 5 to 10°.

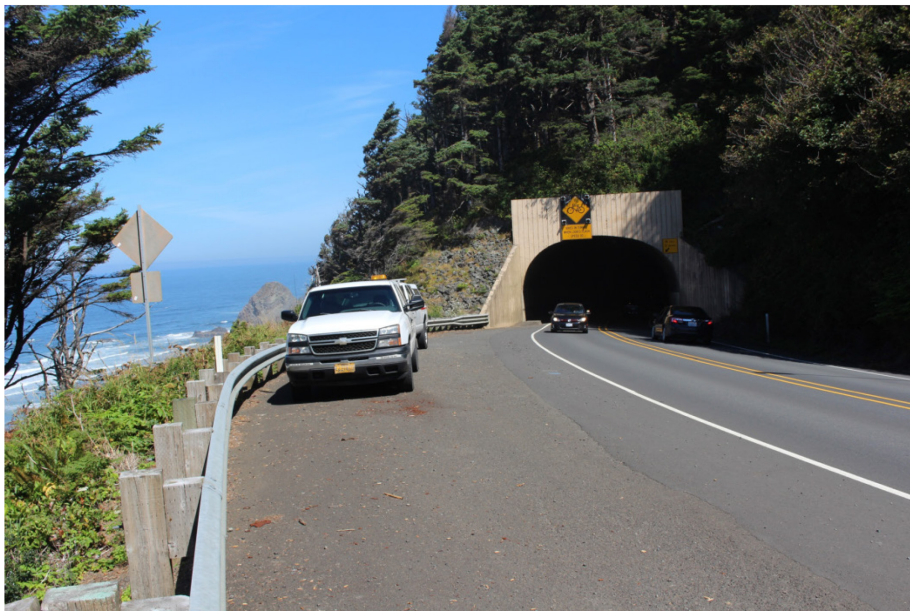
**Figure 3.4: US Highway 101 facing north just before the Arch Cape tunnel (near MP36, August 2016).**

The primary area of study extends seaward from the tunnel about 50 m south. The shoreline at this location (moving landward) changes from a small section of sandy beach to a steep cobble/boulder berm around 10 to 25 m wide that is flush against the sea cliff (Figure 3.4). The cobble berm has a crest elevation of approximately 7 m with a mean grain size of approximately 70 mm (Allan et al., 2005). The cobbles are smooth and well-sorted throughout the berm, increasing in angularity and size, with more abundant presence of boulders towards the north. The coastal sea cliff itself is a landslide deposit around 35 m in height with a gradient of roughly 45° and contains sparse vegetation at its base up until around 10 m where vegetation increases. Highway 101 sits upon this sea cliff and trees also appear around the elevation of the Highway.

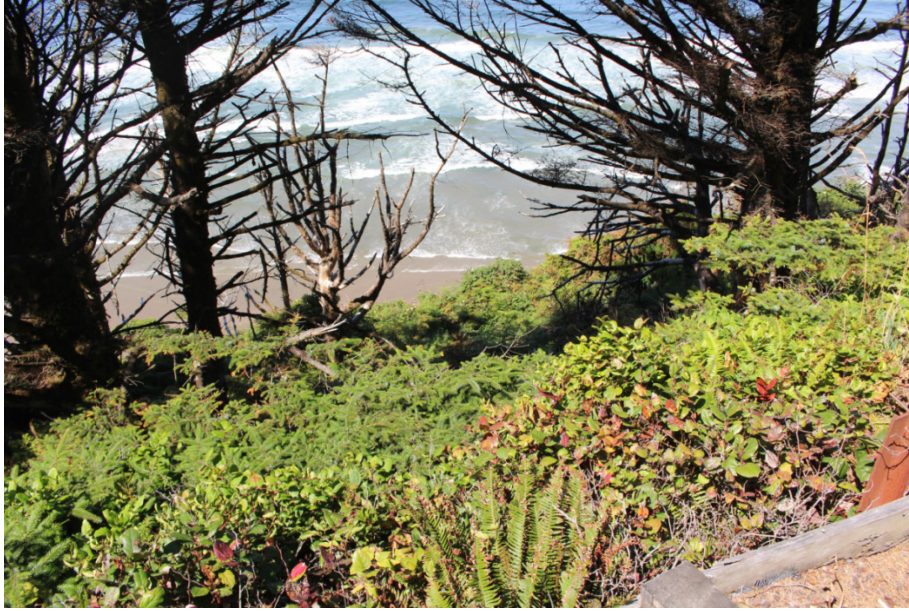
**Figure 3.5: Facing west (towards to ocean) from Highway 101, showing the steep coastal sea cliff rapidly descending to the beach (near MP36, August 2016).**

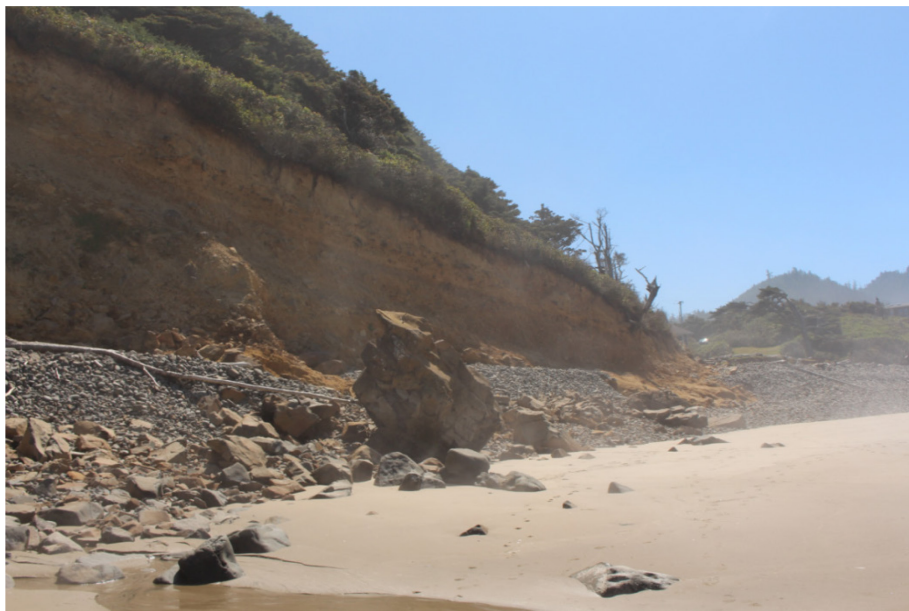
**Figure 3.6: The coastal sea cliff and cobble/boulder berm along the toe of the Arch Cape site (facing southeast) (near MP36, August 2016).**

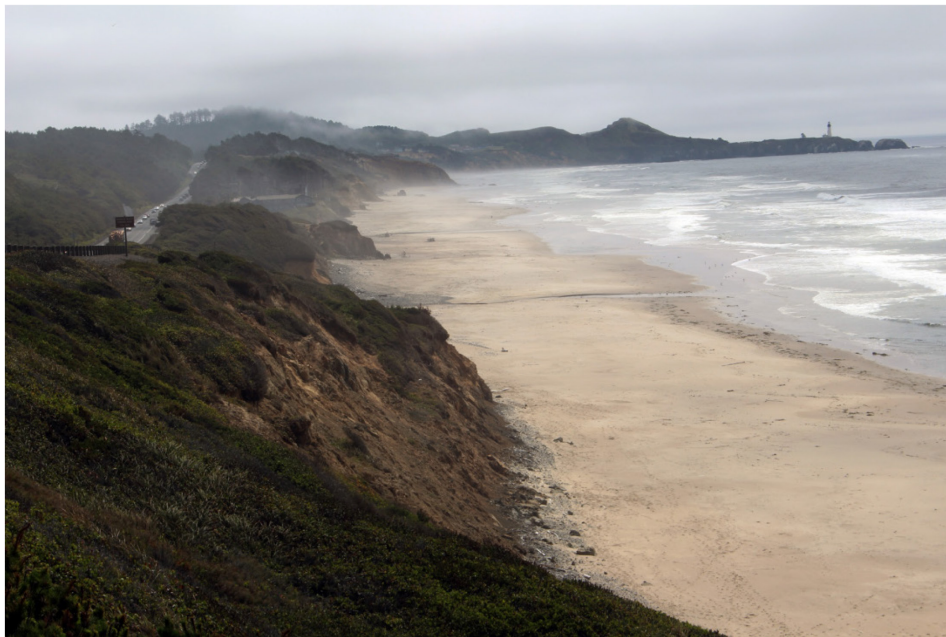
**Figure 3.7: Photograph of the Spencer Creek site, facing south, with Highway 101 on the left separated from ocean by the crumbling coastal sea cliff (Near MP 134, August 2016).**

The Spencer Creek site is located approximately 1 km north from the corner of NE Avery St and NE 115th St, Beverly Beach, just north of milepost 134 on Highway 101. Figure 3.7 shows Highway 101 running parallel to the coastline separated by a coastal sea cliff. The study area extends about 400 m south of the Highway 101 bridge crossing Spencer Creek to about 400 m north of the bridge. Moving landward the area changes from a wide sandy beach to a steep coastal sea cliff around 20 m in height with a gradient of about 30° and varying amounts of vegetation. Typical sea cliffs are shown in Figures 3.7 & 3.9. The typical front face of these sea cliffs is shown in Figure 3.9, while Highway 101 sitting on top of this sea cliff is separated by a 5 to 10 ft (1.5 to 3.0 m) wide shoulder as shown in Figure 3.8.

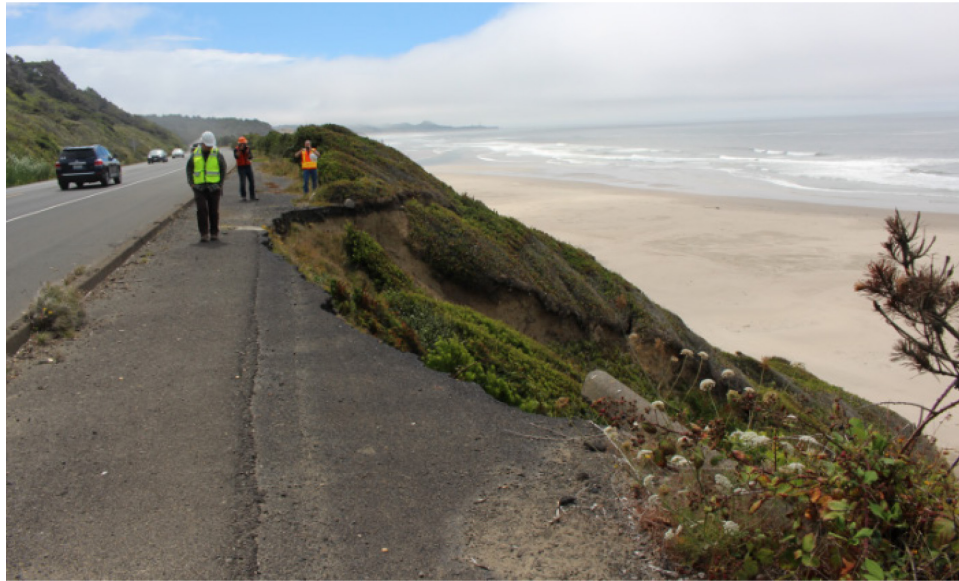
**Figure 3.8: Mass movement and infrastructure damage along Highway 101 at Spencer Creek, (facing south, near MP 134, August 2016).**

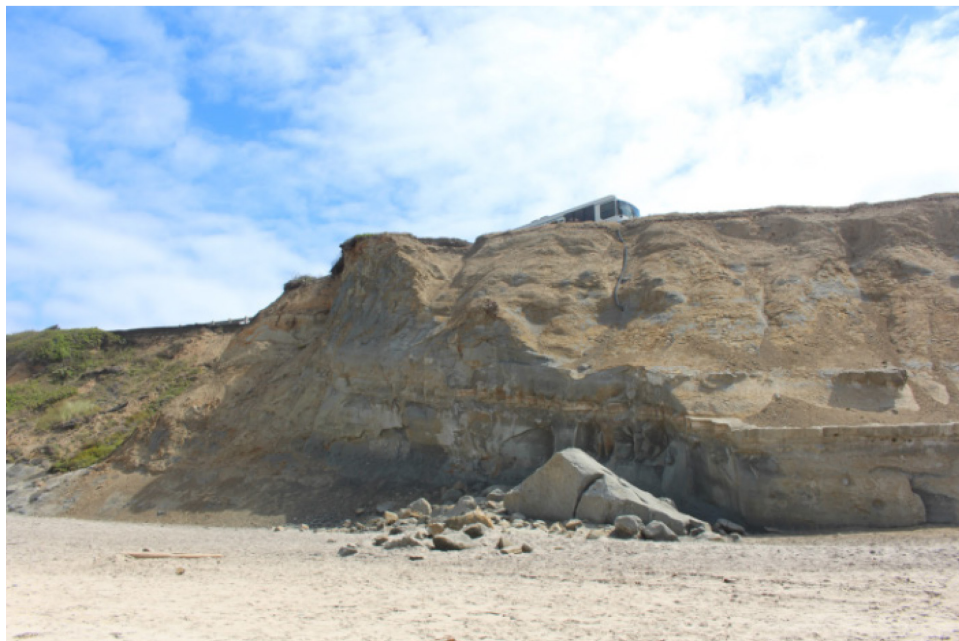
**Figure 3.9: Example coastal sea cliff failure at Spencer Creek (facing east, near MP 134, August 2016).**

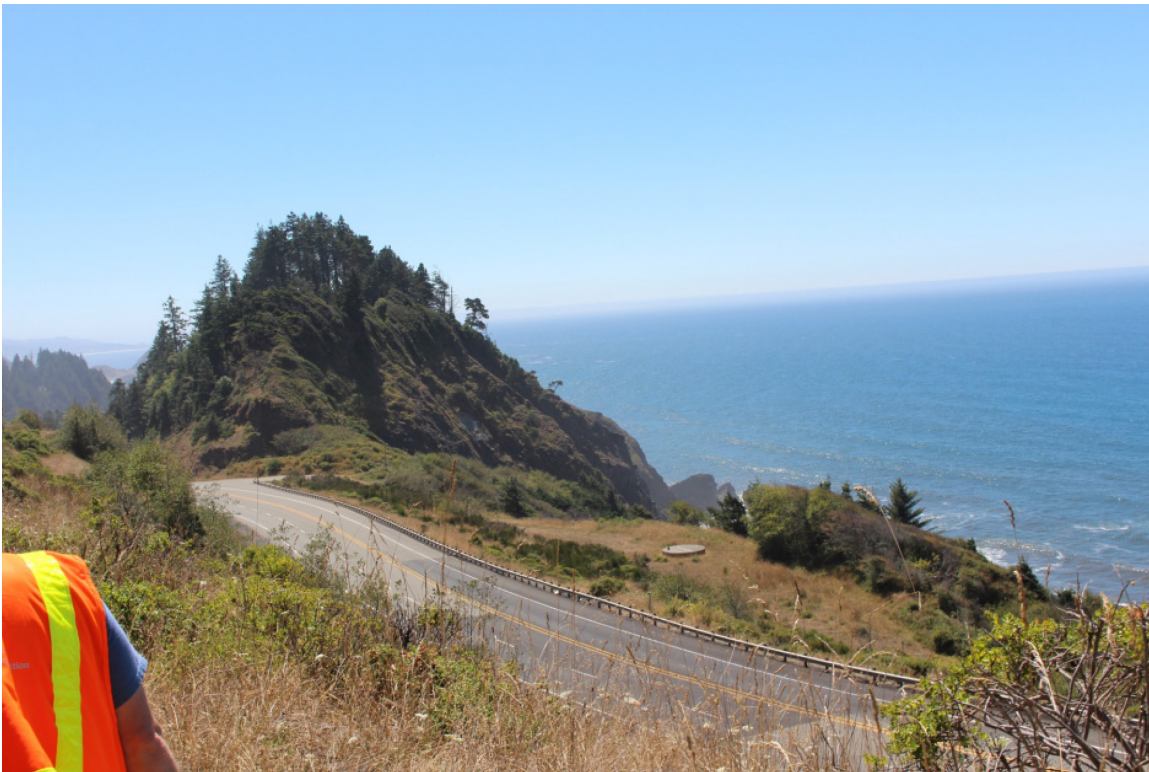
**Figure 3.10: Photograph showing Highway 101 running through Arizona Inn (facing south from the upper section of the landslide deposit). Note the freshly paved section as a repair to the creeping landslide movement (August 2016).**

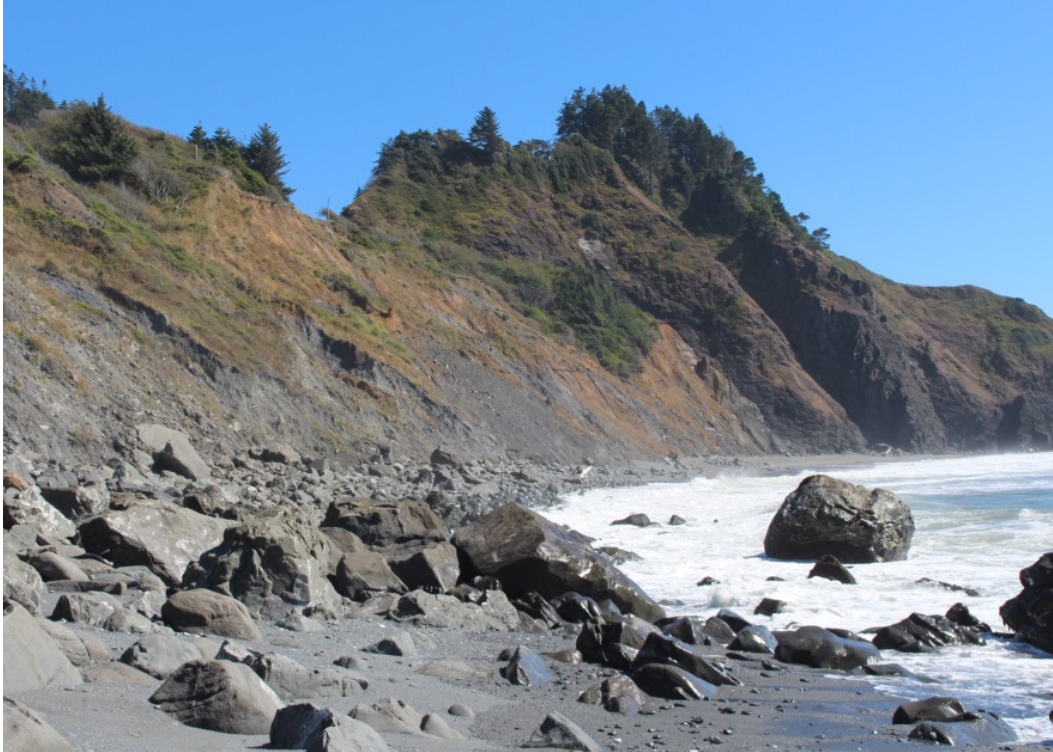
**Figure 3.11: Photograph showing beach and coastal sea cliff at Arizona Inn (facing south, August 2017).**

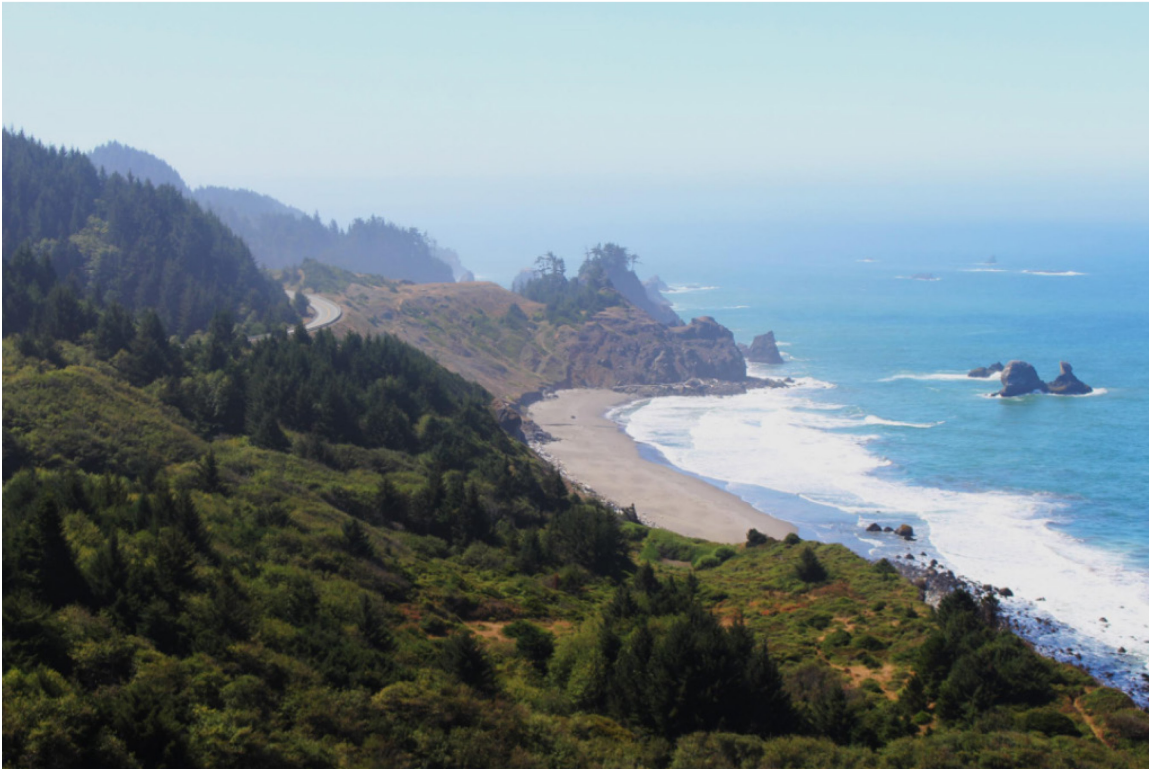
**Figure 3.12: Overview photograph of the Hooskanaden site (facing south, August 2016).**

Hooskanaden is the southernmost site and is located approximately 13 miles SSE of Gold Beach, just north of milepost 344 on Highway 101. Figure 3.12 shows an overview of the site with Highway 101 running parallel to the coastline. The study area at this location extends from the intersection of Hooskanaden Creek and Highway 101 NNW around 850 m and from Highway 101 around 450 m E-SE to the coast. Moving landward, the study area extends from a wide pebble/cobble beach (Figure 3.13) to a coastal sea cliff around 10 m high in sections. On top of the sea cliff, a heavily vegetated landslide extends landward around 400 m W-NW horizontally and 60 m vertically before intersecting Highway 101.

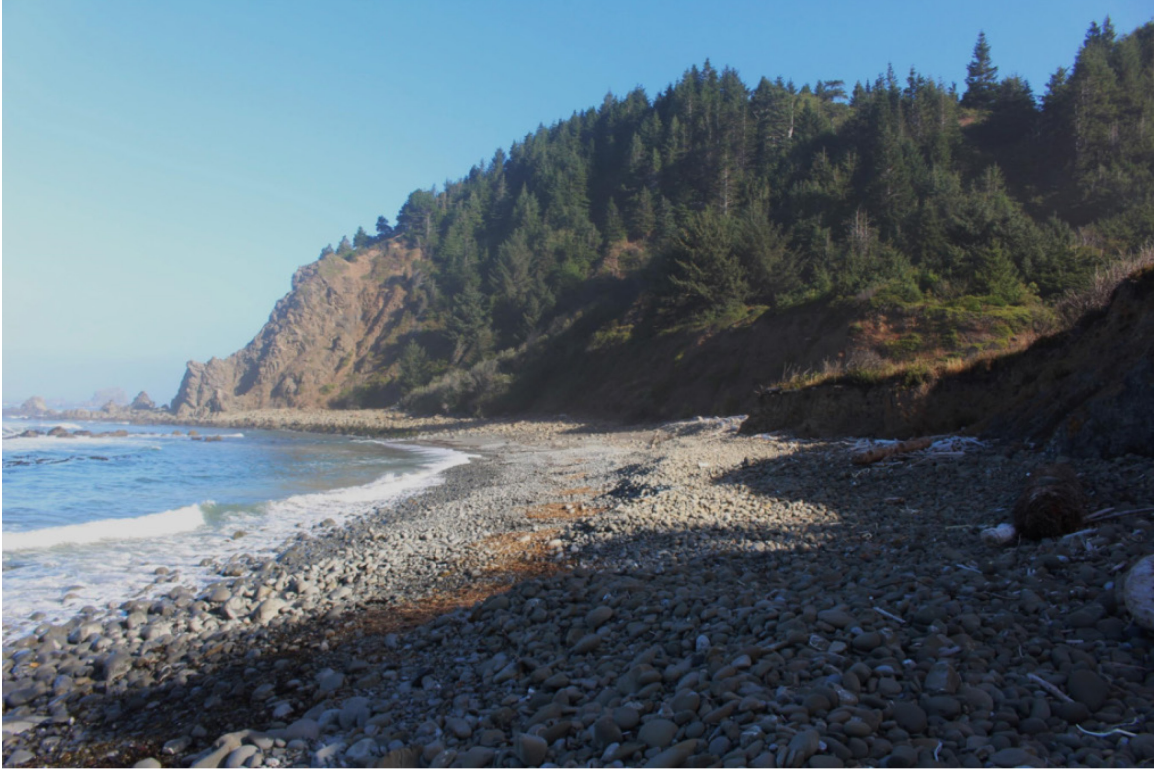
**Figure 3.13: Picture showing beach and coastal sea cliff at Hooskanaden, taken facing north (August 2016).**

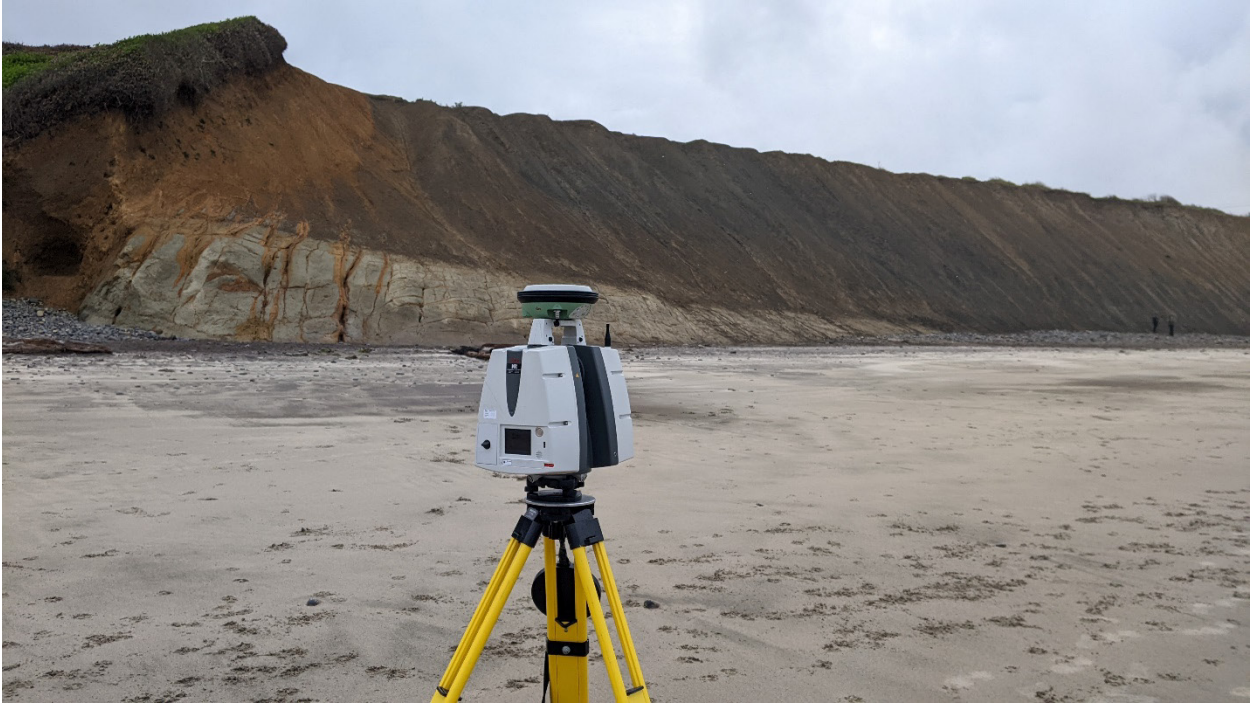
**Figure 4.1: Example terrestrial laser scan setup with GNSS sensor for georeferencing.**

- Leica P40/P50. The Leica P40 (maximum range: 270 m) was upgraded to a Leica P50 (maximum range 1 km) during the project. The scanning process is very efficient (1 million points per second); however, photographic images were not acquired as those take substantial time to capture (~8 minutes per scan). The scanner has a calibrated GNSS mount (Figure 4.1).

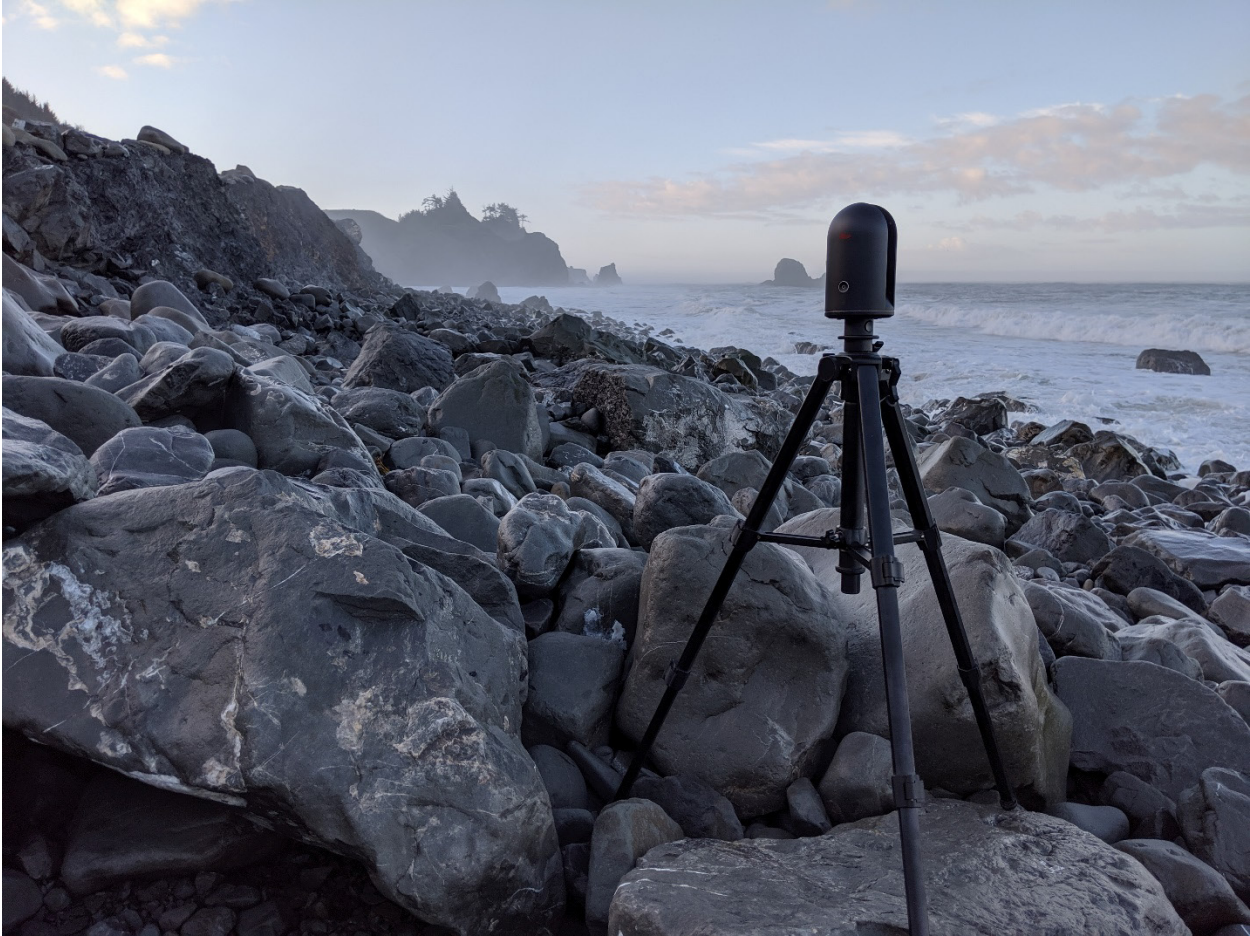
**Figure 4.7: Photograph of the BLK360 TLS (terrestrial laser scanner) being used to survey the sea cliff at the Hooskanaden beach during the bi-annual field survey on October 4, 2019.**

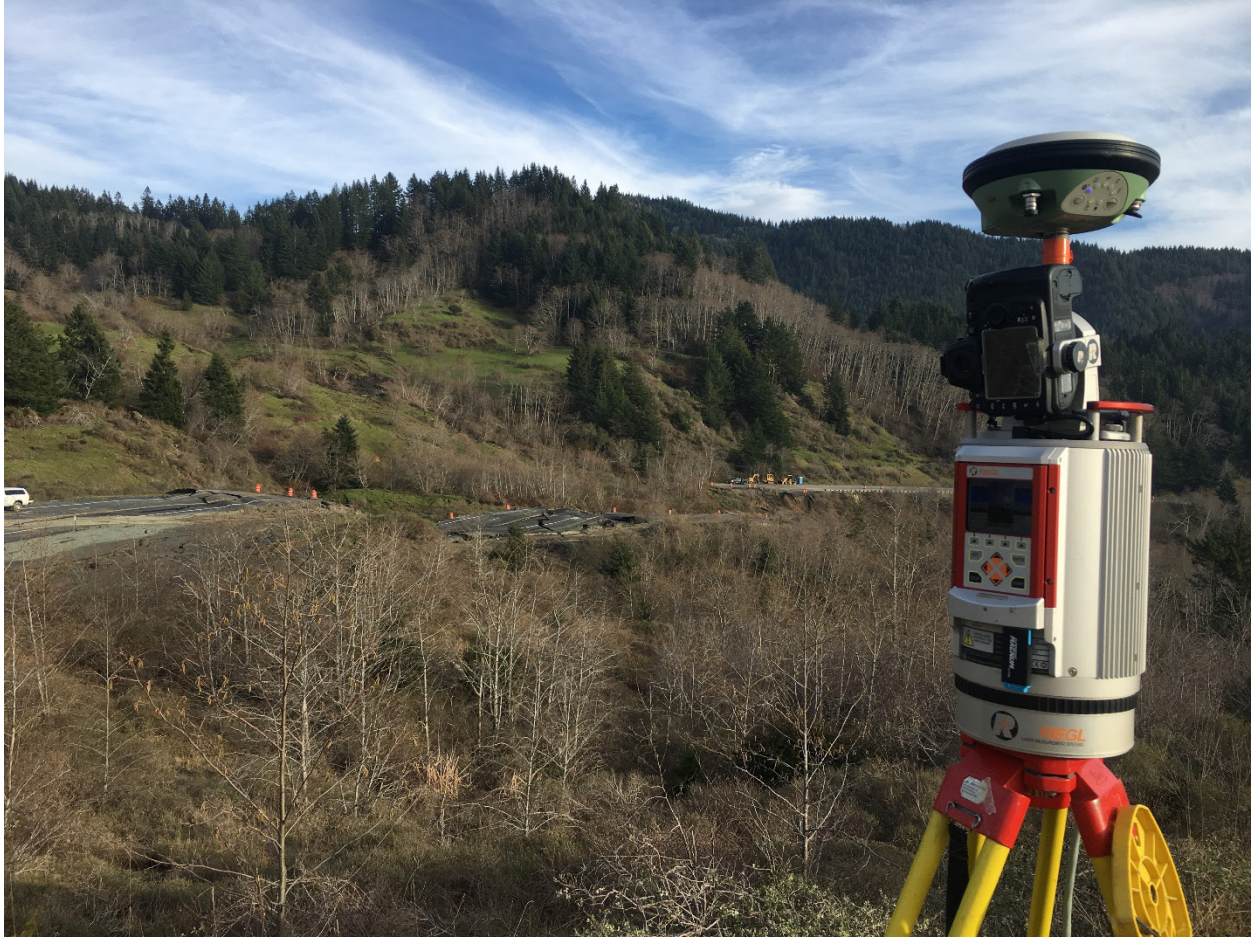
**Figure 4.8: Photograph of Riegl VZ-400 TLS setup to conduct high resolution repeat scans of the actively moving Hooskanaden landslide on March 2, 2019.**

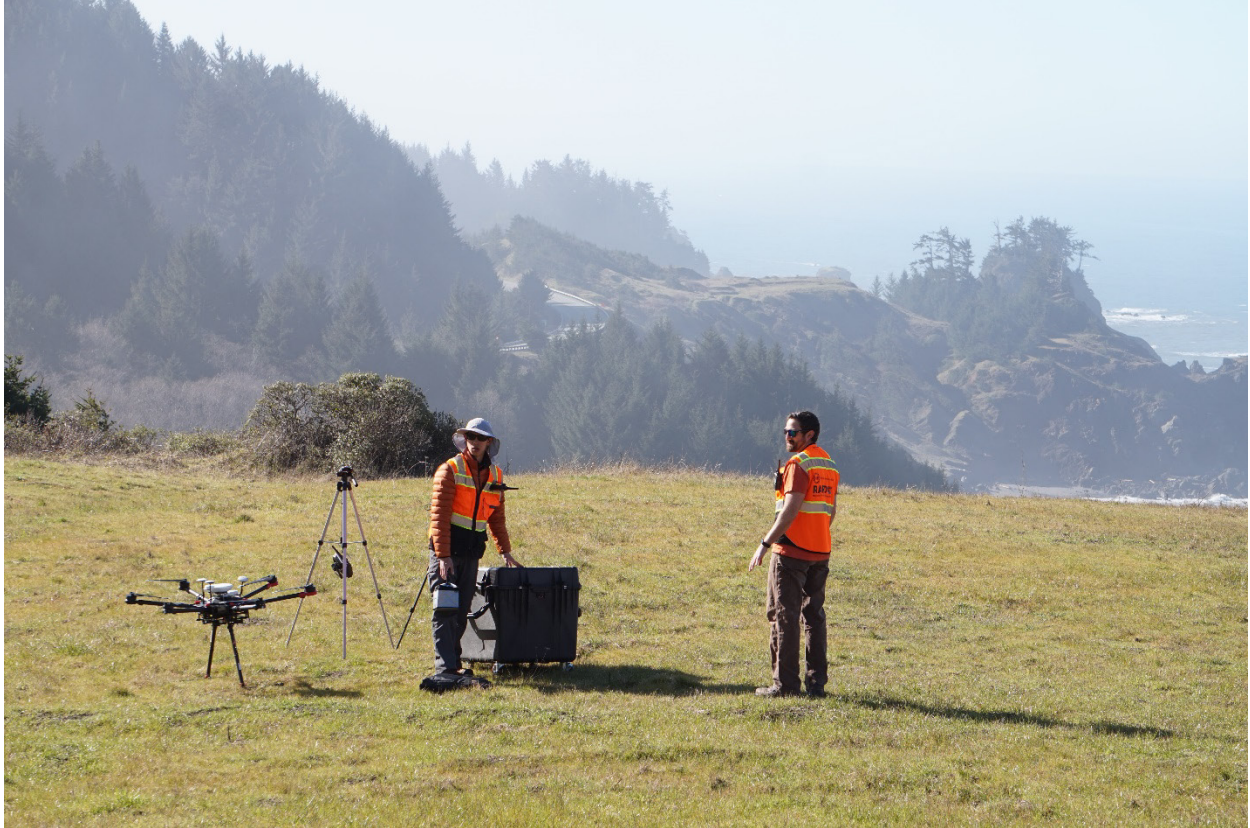
**Figure 4.9: Photograph capturing the RAPID Facility’s phoenix lidar miniRanger UAS lidar system being operated at the Hooskanaden landslide on March 15, 2019. Photo Credit: Nick Mathews (OSU).**
