**COASTAL LANDSLIDE AND SEA CLIFF  
RETREAT MONITORING FOR  
CLIMATE ADAPTATION AND  
TARGETED RISK ASSESSMENT**

**Final Report**

**SPR-807**

Oregon Department of Transportation

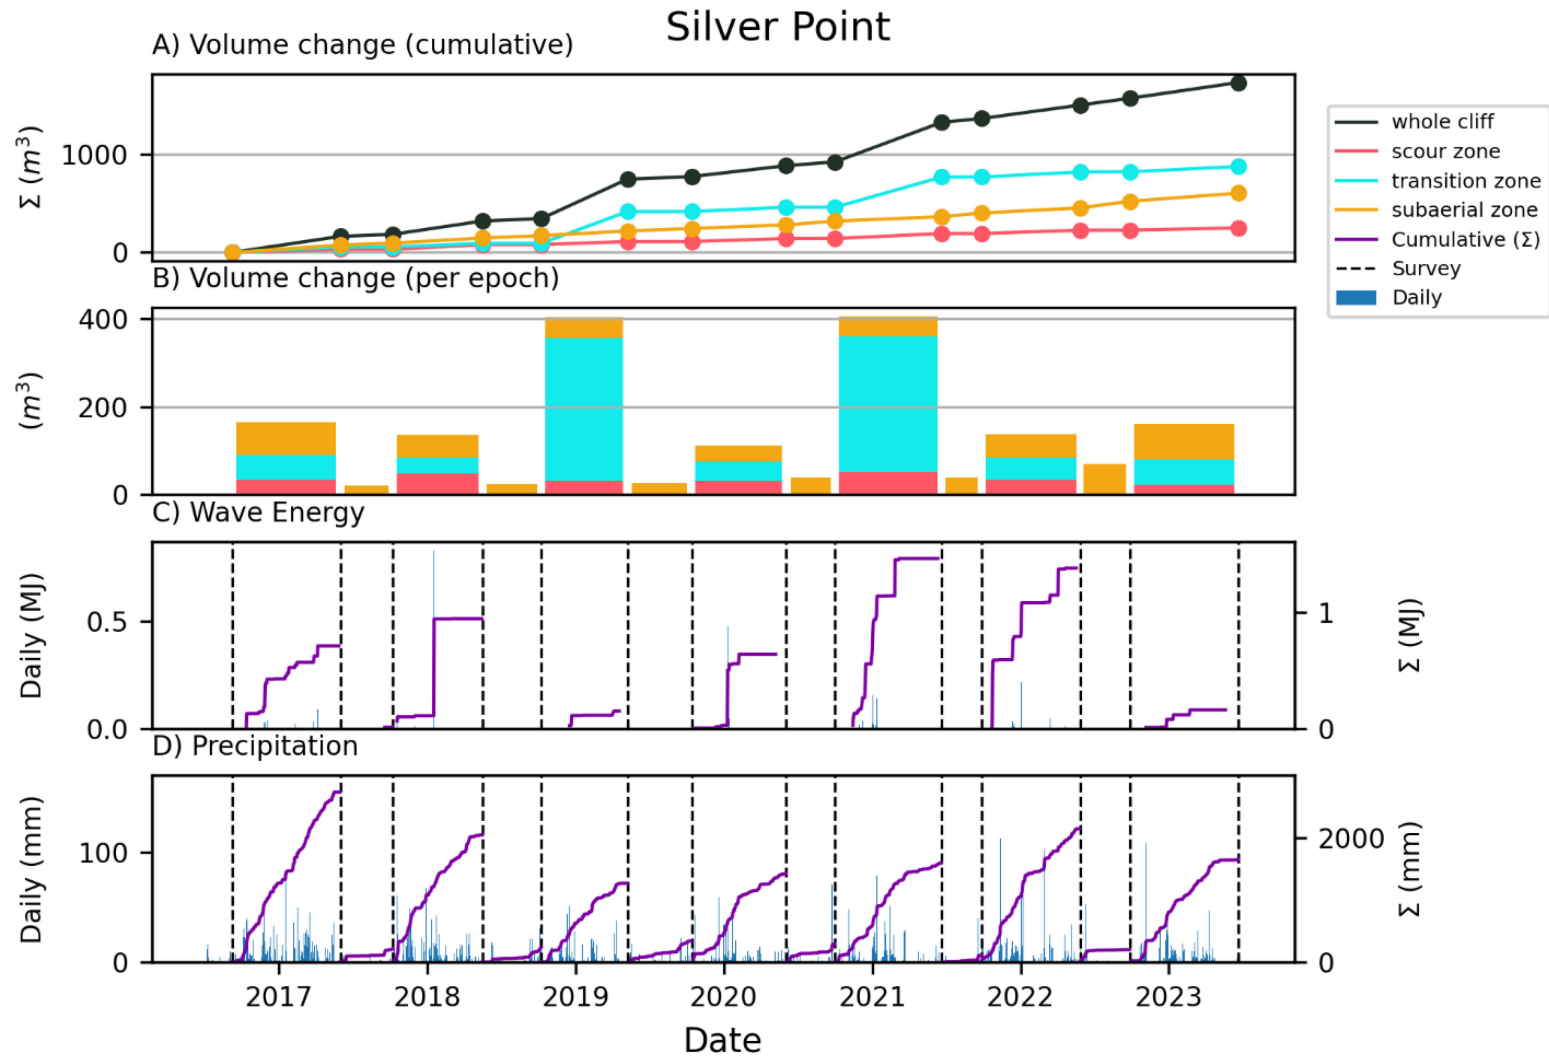
**Figure 7.1: Erosion and environmental data over the study period at Silver Point. A) The cumulative volume loss overall and for each erosional zone, dashed line indicates average over the period. B) The volume loss per epoch for each erosional zone. C) The daily wave energy over the period and the cumulative wave energy between each survey. D) The daily precipitation over the period and the cumulative precipitation between each survey.**

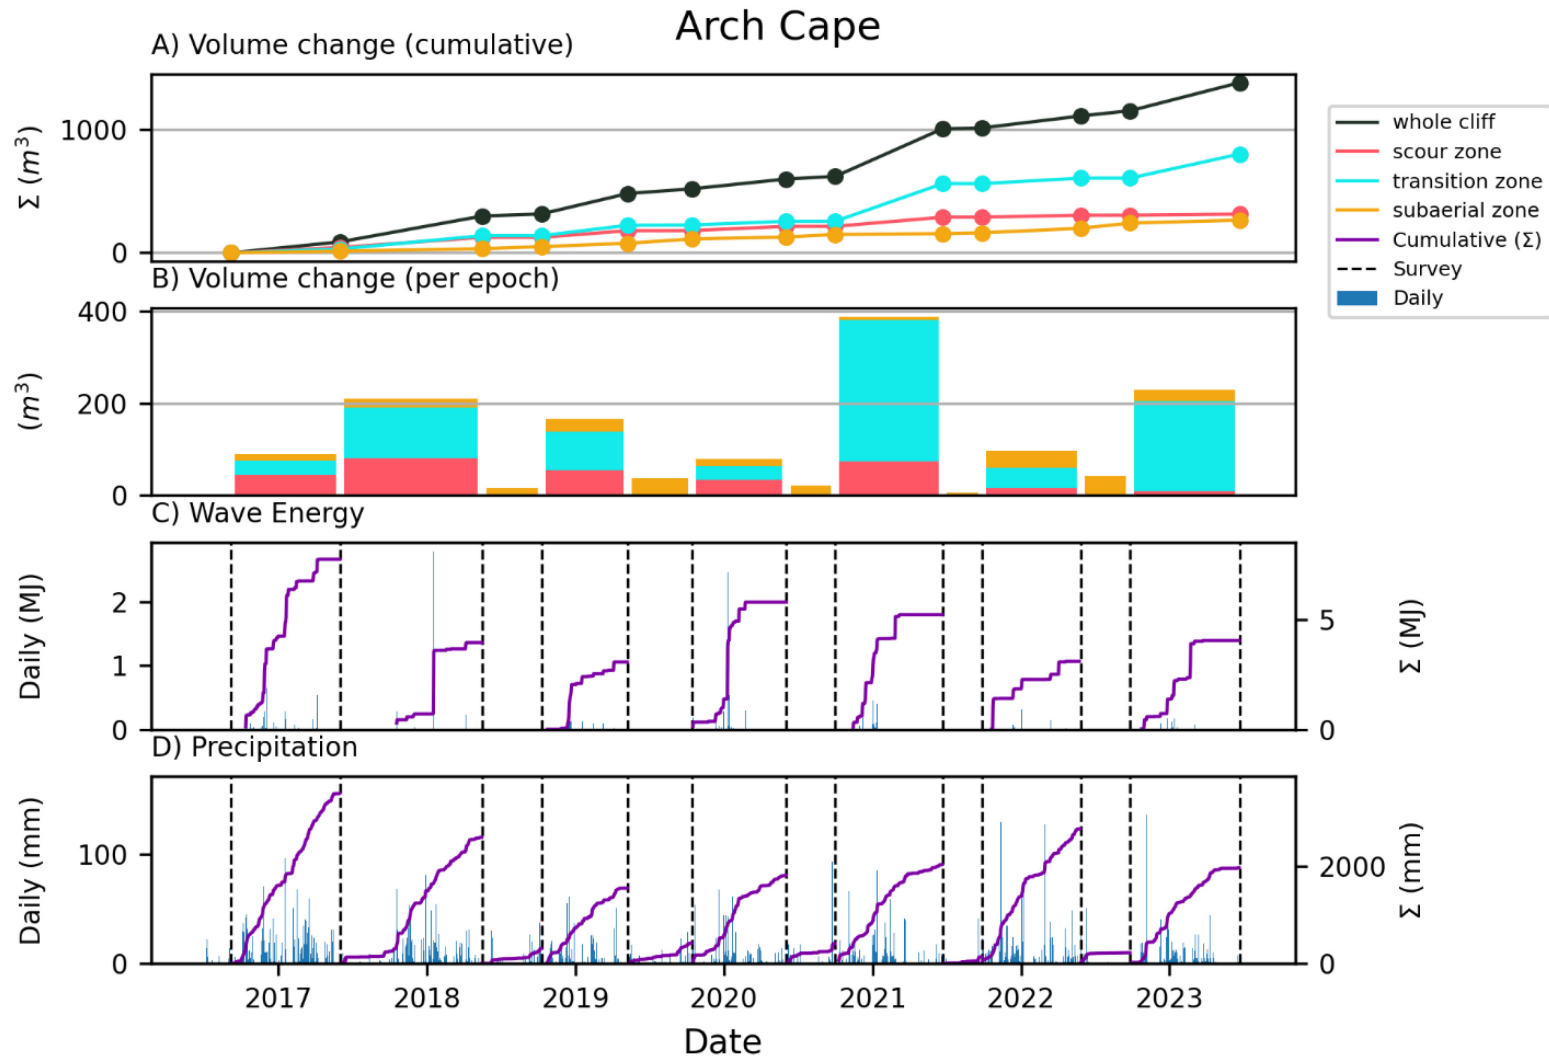
**Figure 7.4: Erosion and environmental data over the study period at Arch Cape. A) The cumulative volume loss overall and for each erosional zone, dashed line indicates average over the period. B) The volume loss per epoch for each erosional zone. C) The daily wave energy over the period and the cumulative wave energy between each survey. D) The daily precipitation over the period and the cumulative precipitation between each survey.**

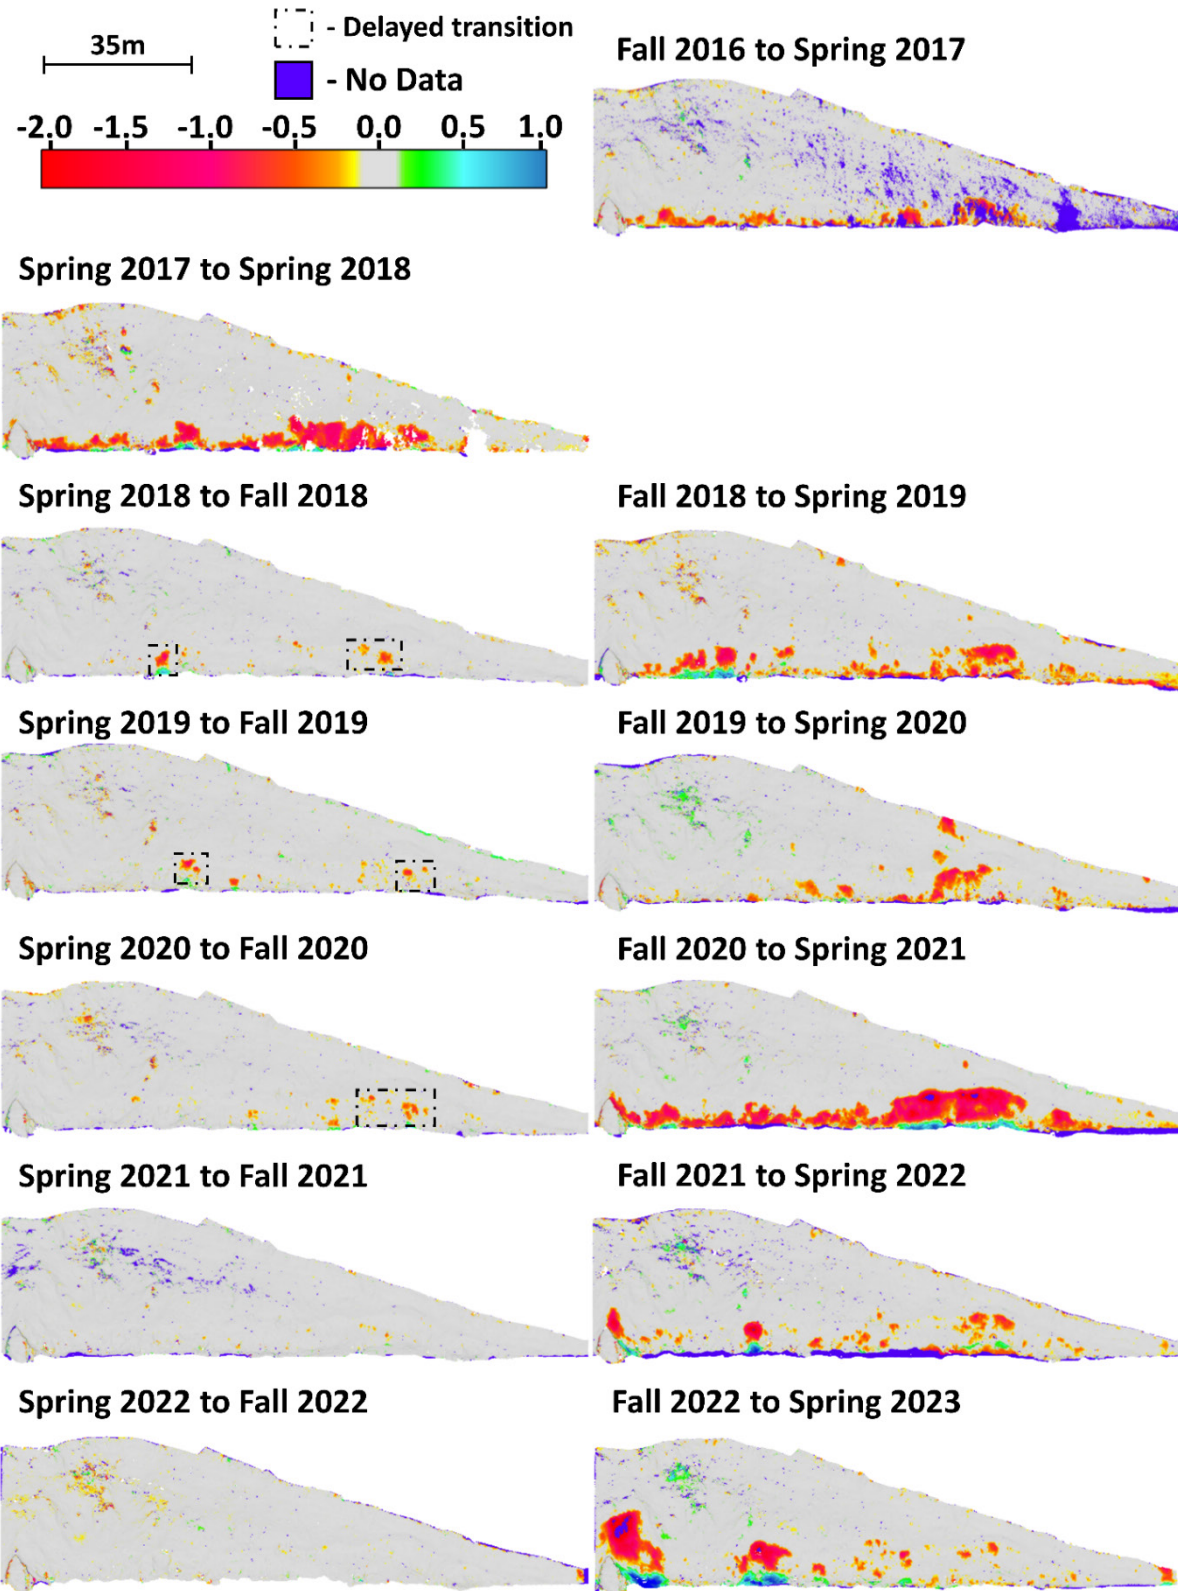
**Figure 7.5: Erosion across the sea cliff at Arch Cape for each epoch. Note missing survey in Fall 2017. Rectangle annotations show examples of failures in the subaerial zone that occurred during the summer, a product of the previous winters scour/transition zone.**

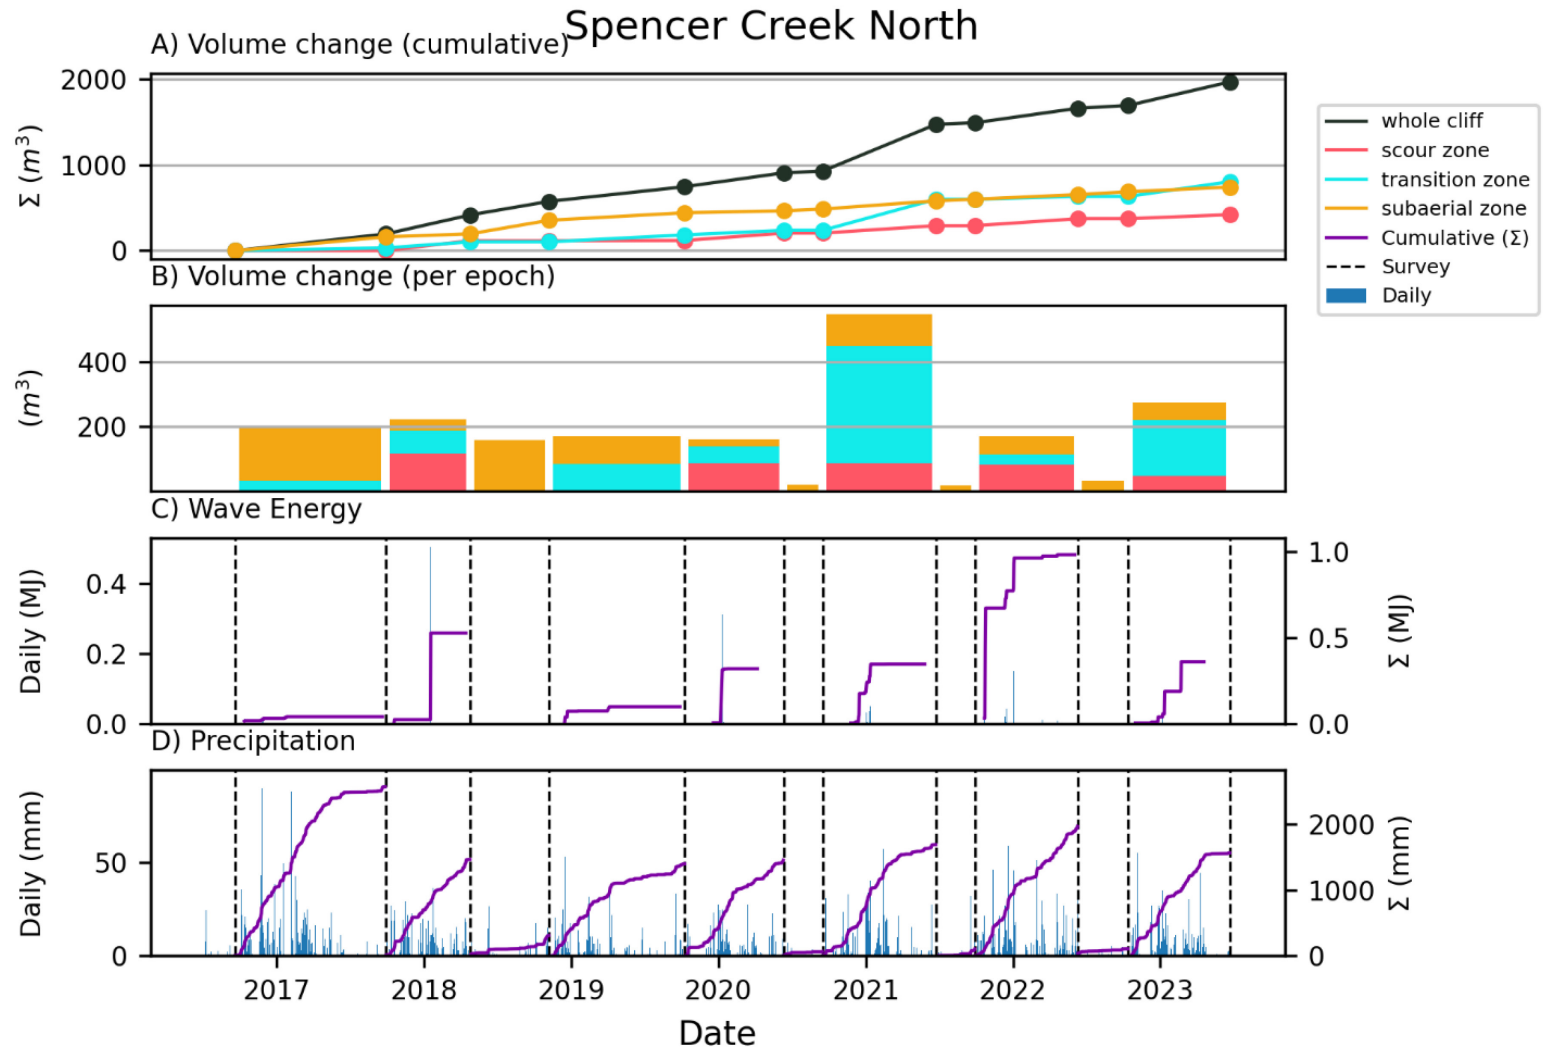
**Figure 7.7: Erosion and environmental data over the study period at Spencer Creek North. A) The cumulative volume loss overall and for each erosional zone, dashed line indicates average over the period. B) The volume loss per epoch for each erosional zone. C) The daily wave energy over the period and the cumulative wave energy between each survey. D) The daily precipitation over the period and the cumulative precipitation between each survey.**

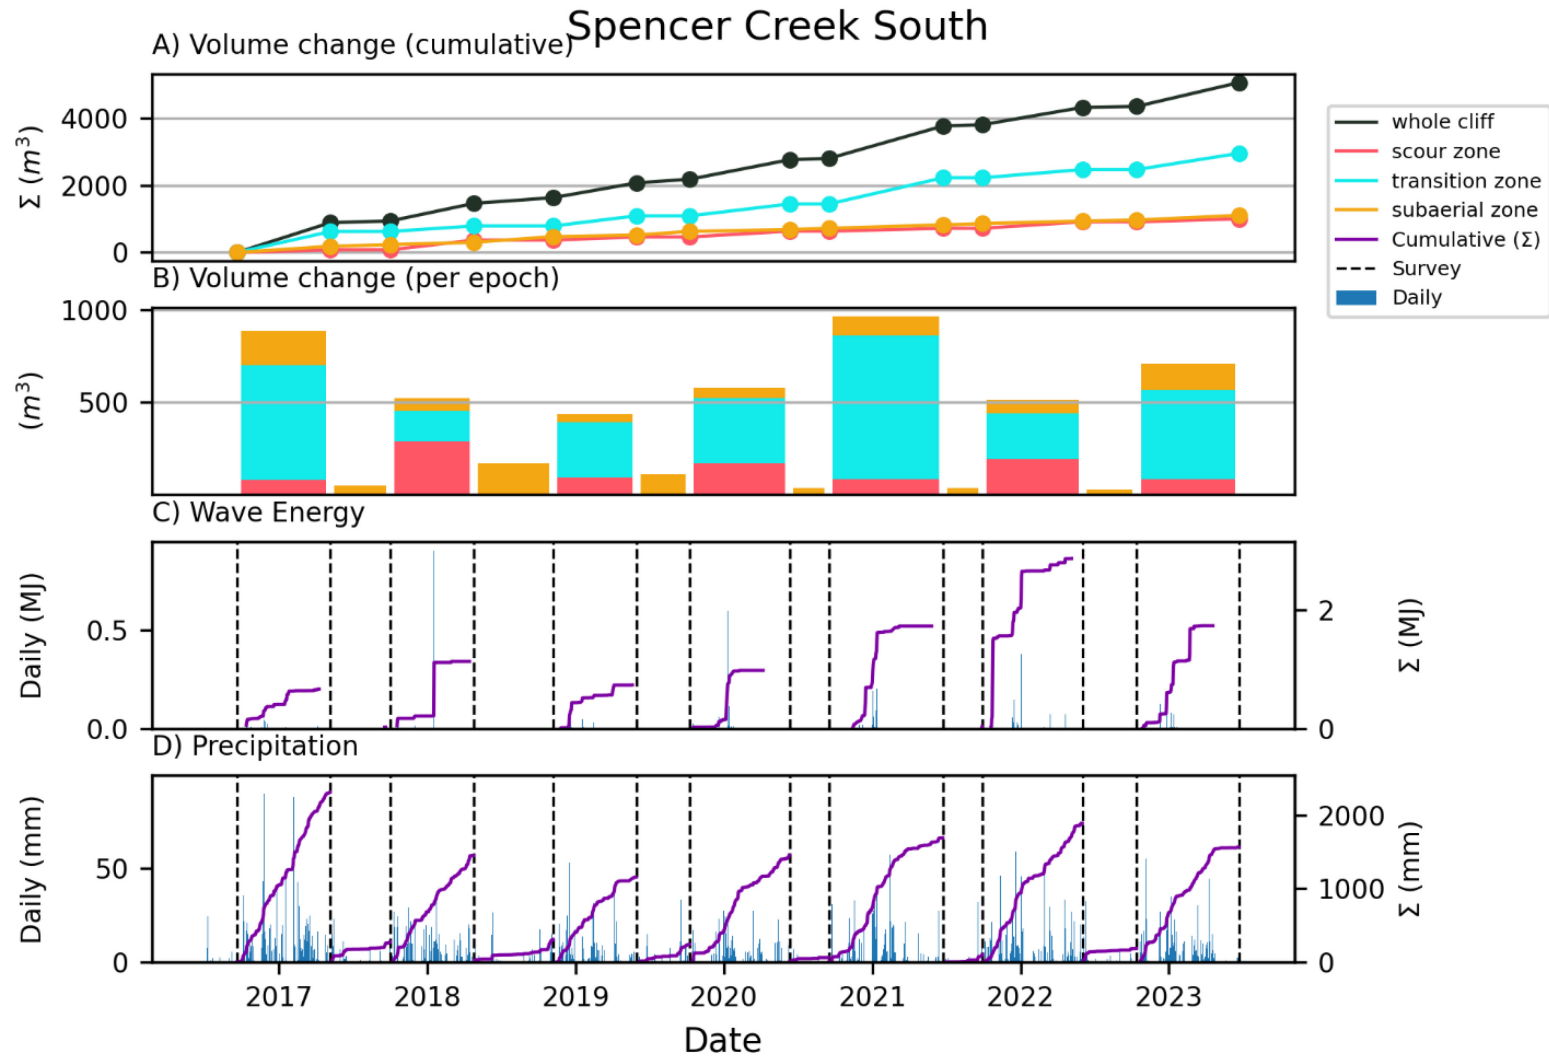
**Figure 7.8: Erosion and environmental data over the study period at Spencer Creek South. A) The cumulative volume loss overall and for each erosional zone, dashed line indicates average over the period. B) The volume loss per epoch for each erosional zone. C) The daily wave energy over the period and the cumulative wave energy between each survey. D) The daily precipitation over the period and the cumulative precipitation between each survey.**

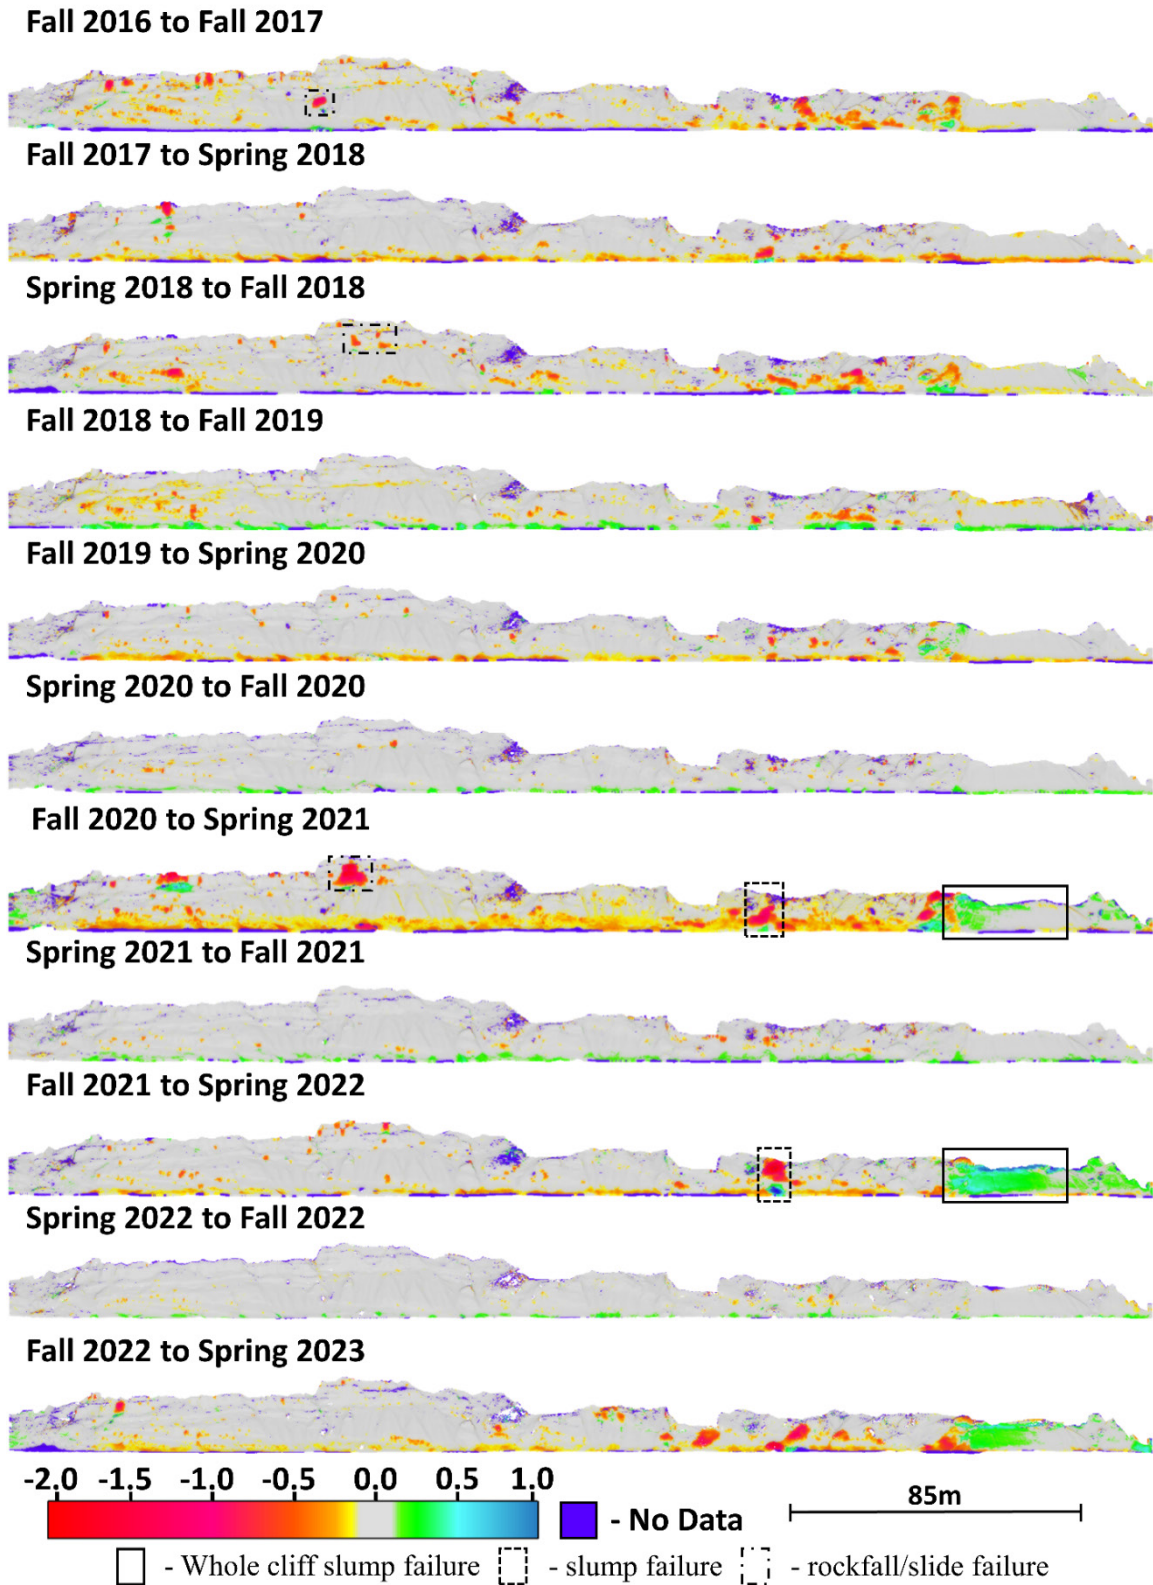
**Figure 7.9: Erosion across the sea cliff at Spencer Creek North for each epoch with annotations showing example failure types. Note the missing surveys in spring 2017 and spring 2019 due to poor GNSS conditions during the time of survey.**

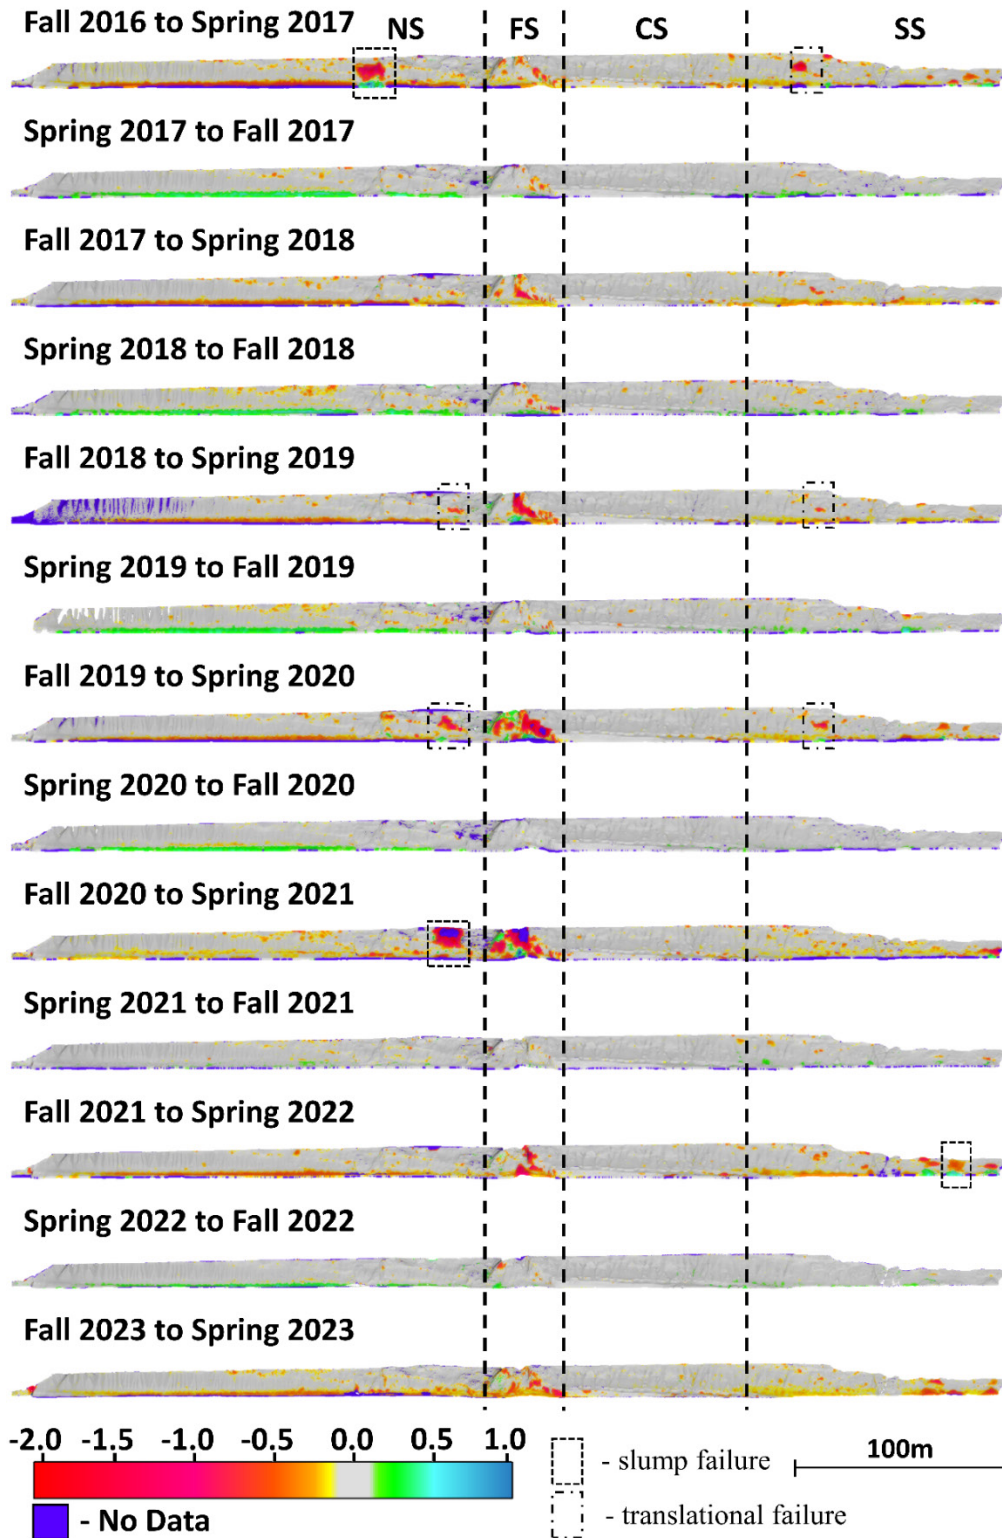
**Figure 7.10: Erosion across the sea cliff for Spencer Creek South for each epoch with annotations for each distinct section. NS = North Section, FS = Fault Section, CS = Center Section, SS = South Section. Rectangle annotations show example slump/translational failures.**

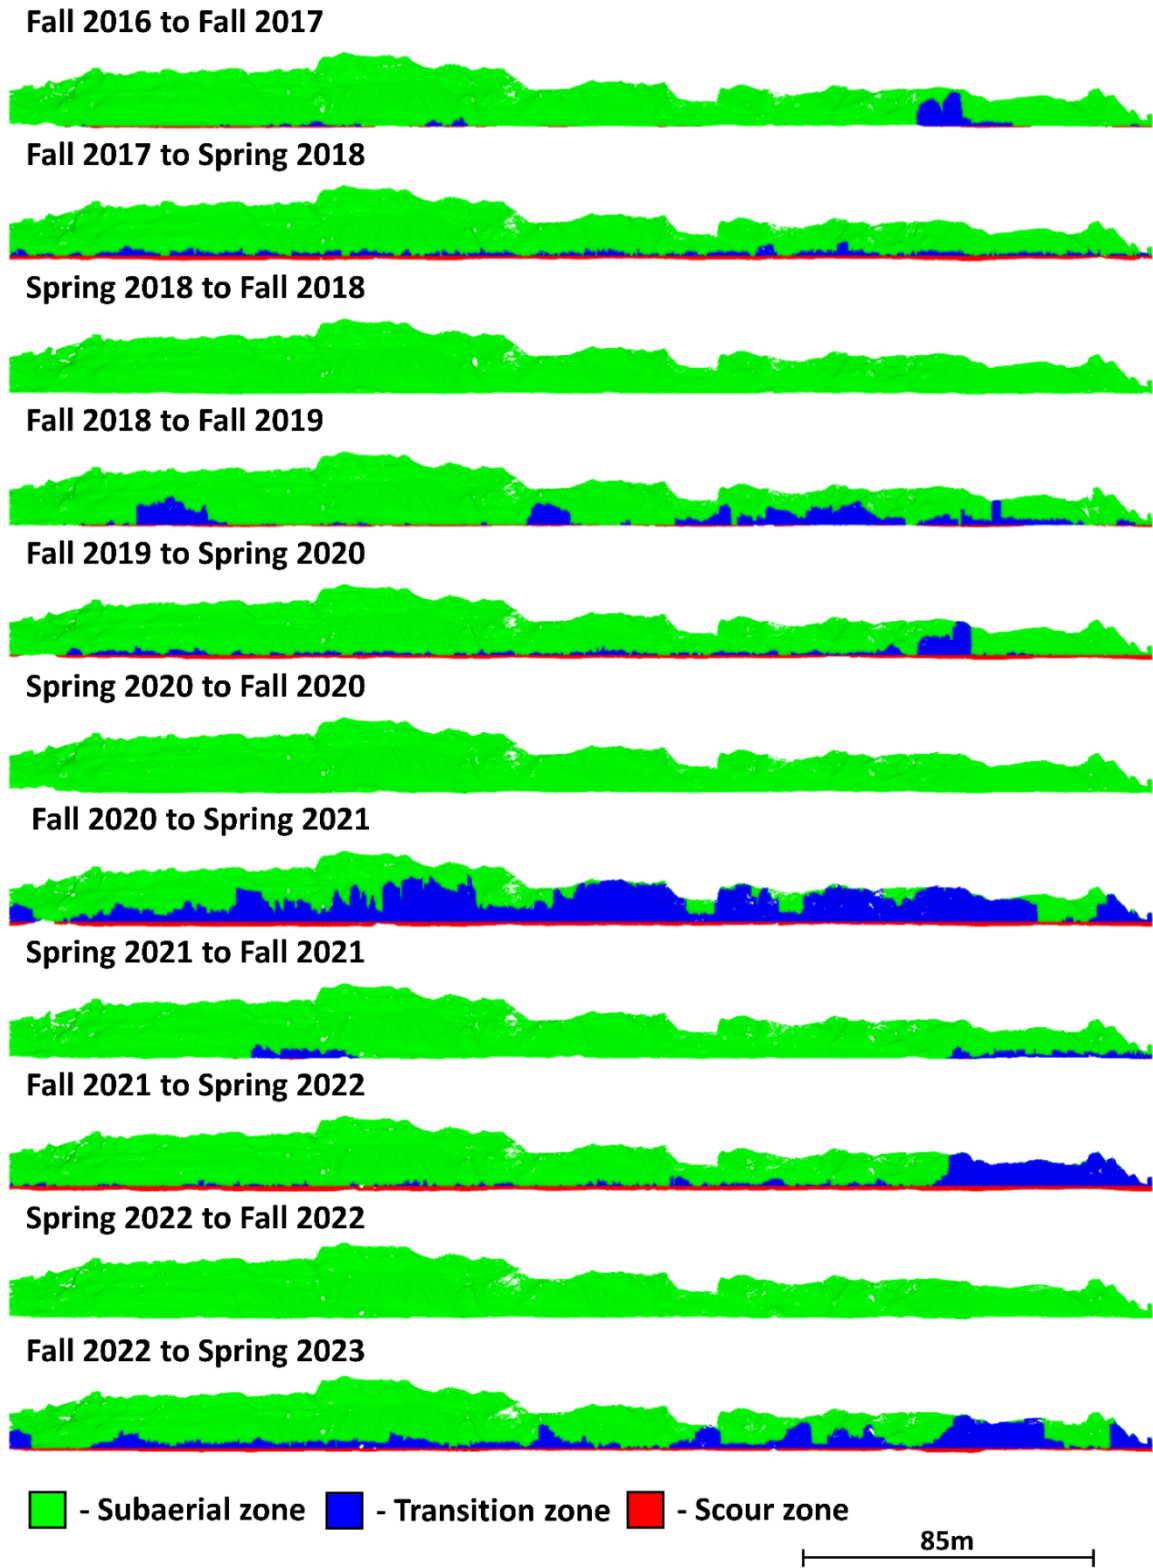
Figure 7.11: Erosion zone classification across the sea cliff at Spencer Creek North for each change epoch. Note the missing surveys in spring 2017 and spring 2019.

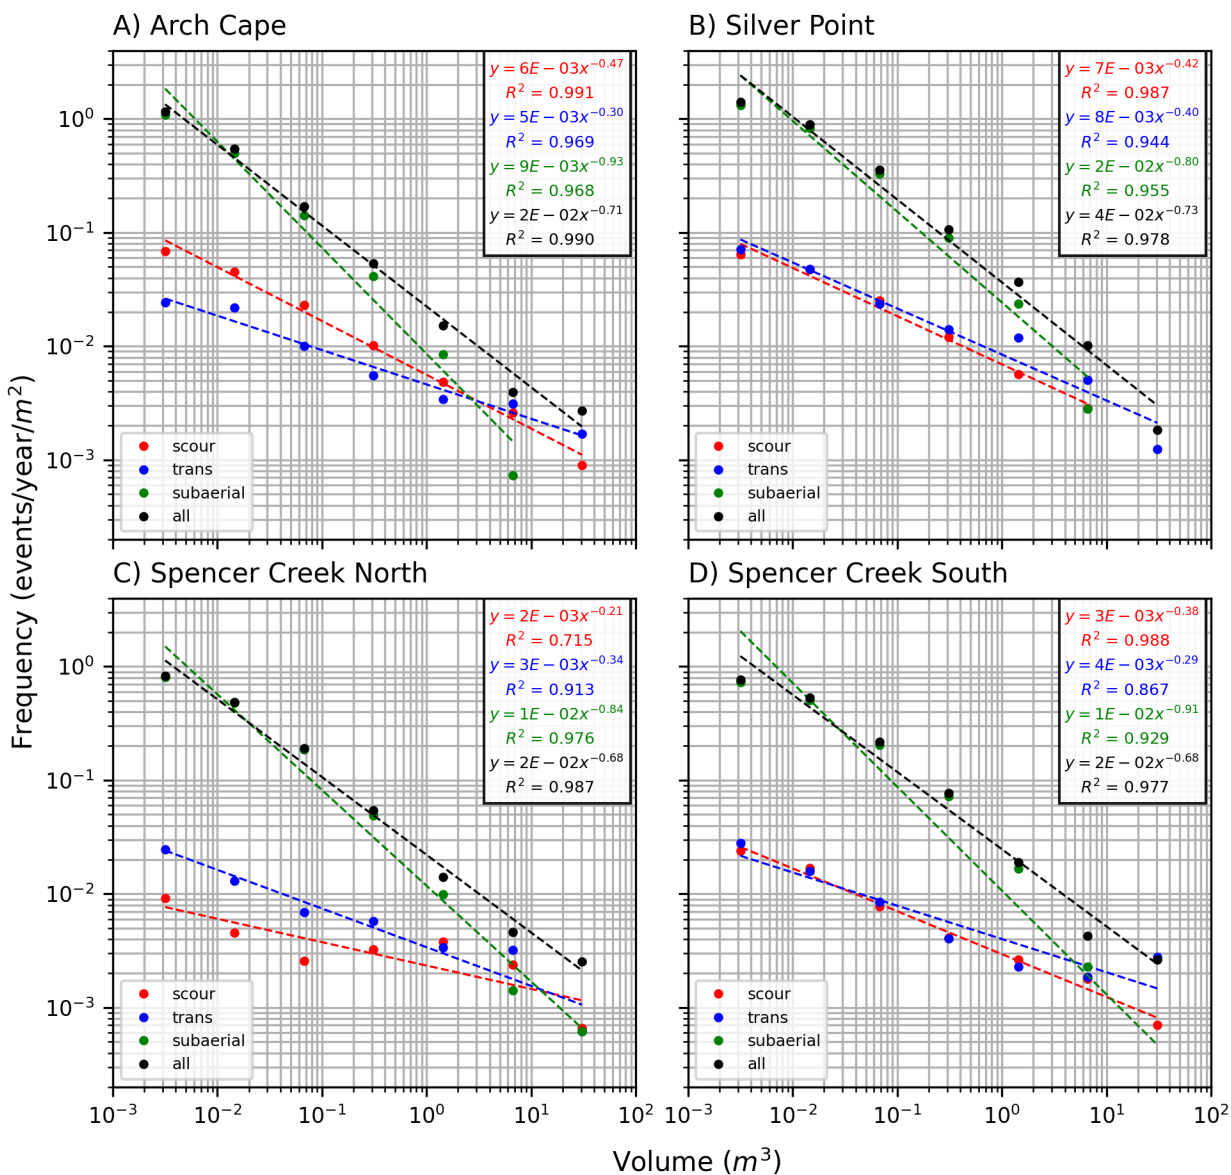
**Figure 7.14: Volume-frequency curves plotted on log – log scale for each erosional zone at: A) Arch Cape, B) Silver Point, C) Spencer Creek North, and D) Spencer Creek South, where frequency is the number of failure events in each volume bin normalized by time and surface area to events/year/m<sup>2</sup>. Power-law equations and R<sup>2</sup> values are provided for each fit. The lower magnitude of the scaling exponent ( $\beta$ ) in the scour and transition zones indicate the relatively higher contribution of large volume failures to the overall volume loss, compared to the subaerial zone.**

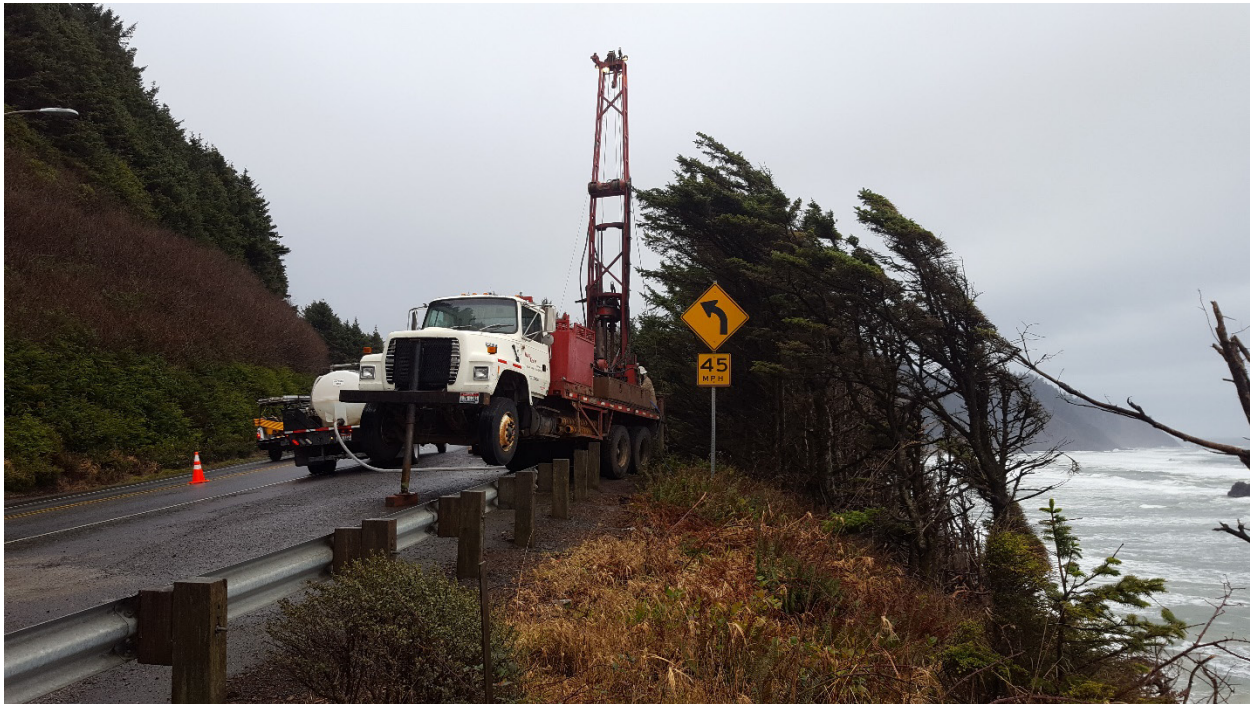
**Figure 8.1: Drill rig actively drilling borehole for SAA MEM's installation at Arch Cape on January 20, 2017. Photograph Credit: Dr Michael Bunn.**

After the selection of the sites, visits to the sites were conducted to verify the proposed locations for drilling boreholes to install the instrumentation. MEMs (consisting of Measurand Shape Accel Array (SAA) systems) and piezometer sensors were installed in the drilled boreholes at Arch Cape, Arizona Inn, Silver Point, and Spencer Creek during the winter of 2016/2017. The same system was then installed at Hooskanaden in late November 2017. Figure 8.1 shows the drill rig utilized for the drilling for this project, whilst Figure 8.2 shows an example of the borehole cores recovered from drilling providing additional information about each of the landslides. After drilling was complete to the planned depth, SAA MEMs and piezometer sensors were installed into the hole. Accelerometers are spaced every meter on the SAA MEMs. Two piezometers were installed at each site below the water table at different elevations. The housing for the electrical components (Figure 8.3) was then installed at the site with concrete and a steel post as shown in Figure 8.4.

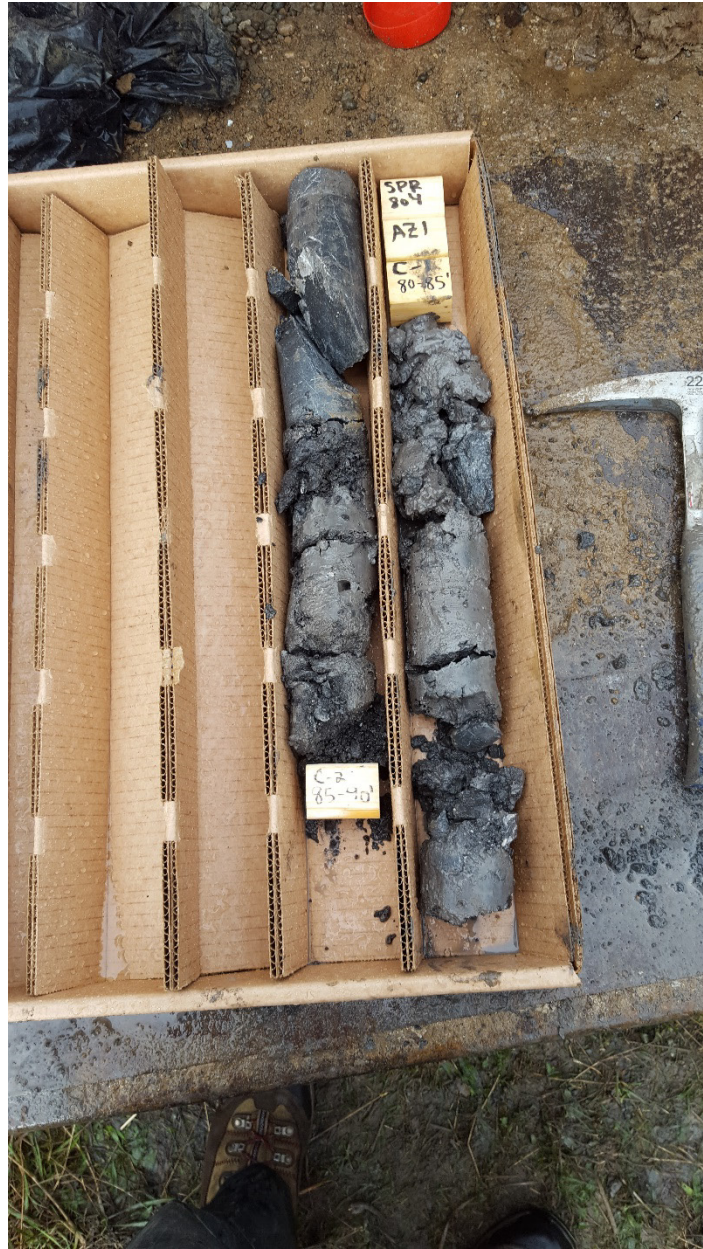
**Figure 8.2: Example borehole cores recovered from Arizona Inn during drilling on February 2, 2017. Photograph Credit: Dr Michael Bunn.**

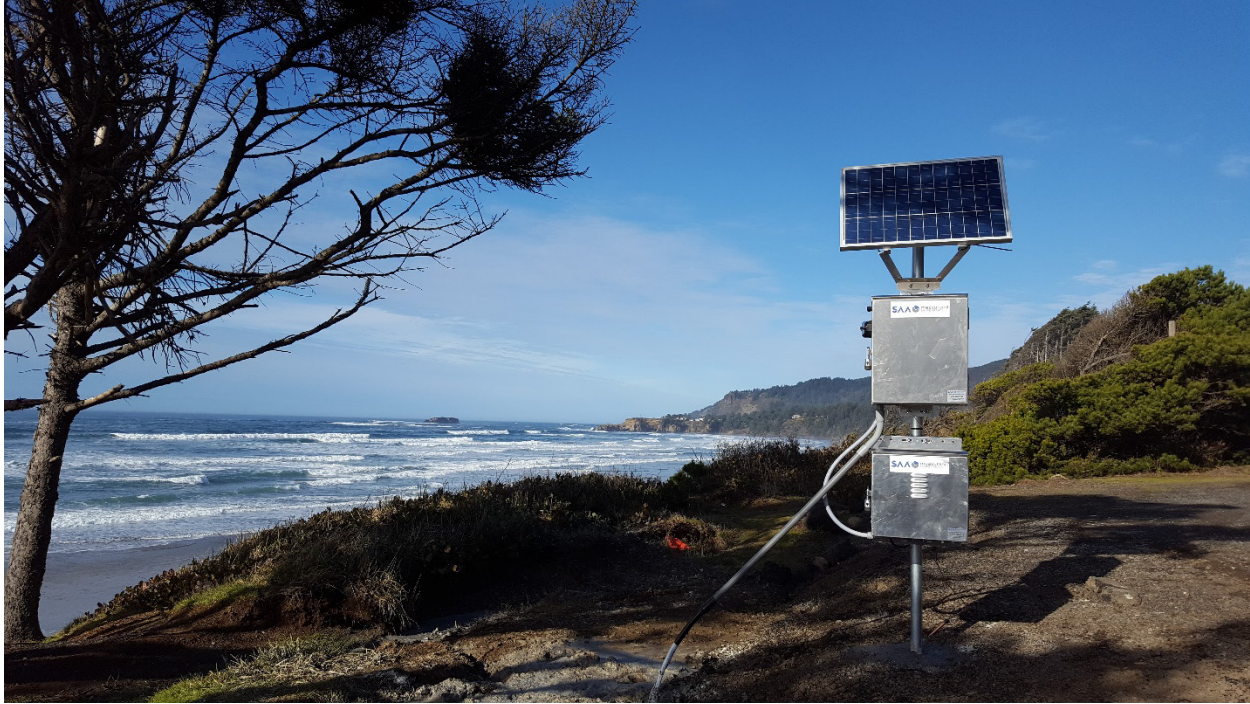
**Figure 8.4: Final SAA MEM’s sensor setup at Spencer Creek on January 27, 2017. Composed of solar panel for power supply, SAA electrical components (top box), SAA battery (bottom box), and SAA sensor (in borehole). Photograph Credit: Dr Michael Bunn.**

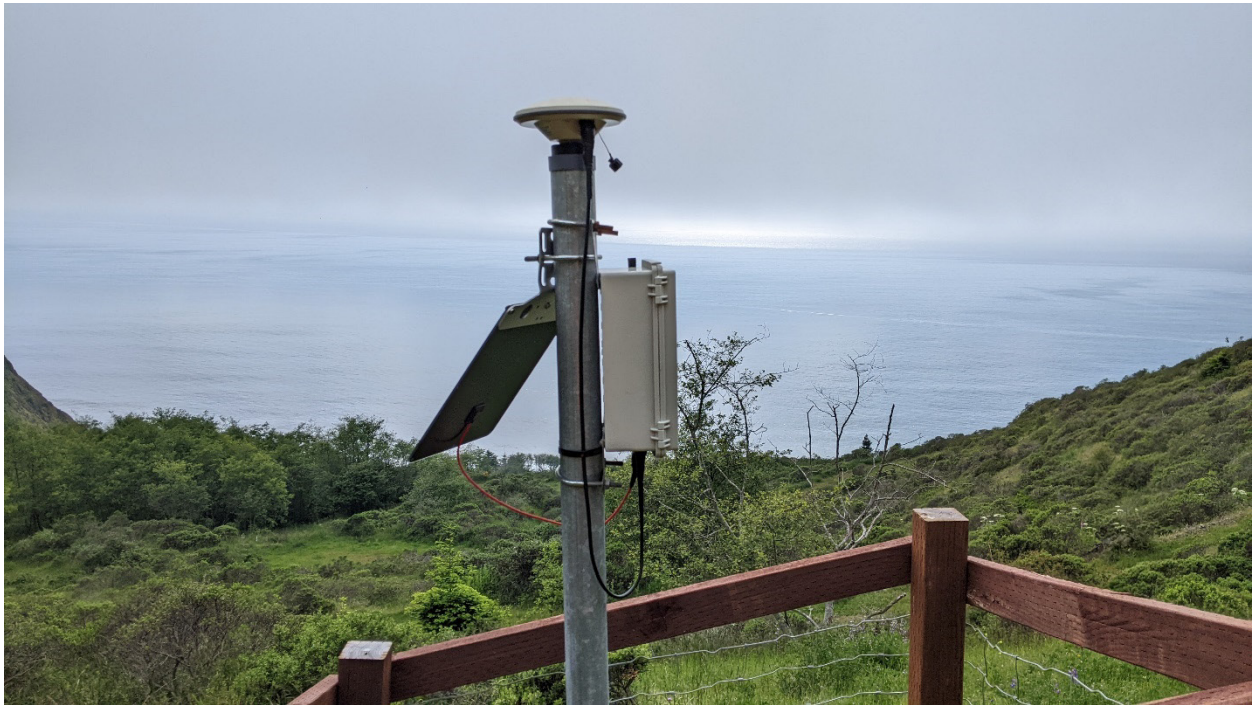
**Figure 8.5. Example RTK GNSS rover system installed at the Arizona Inn site.**

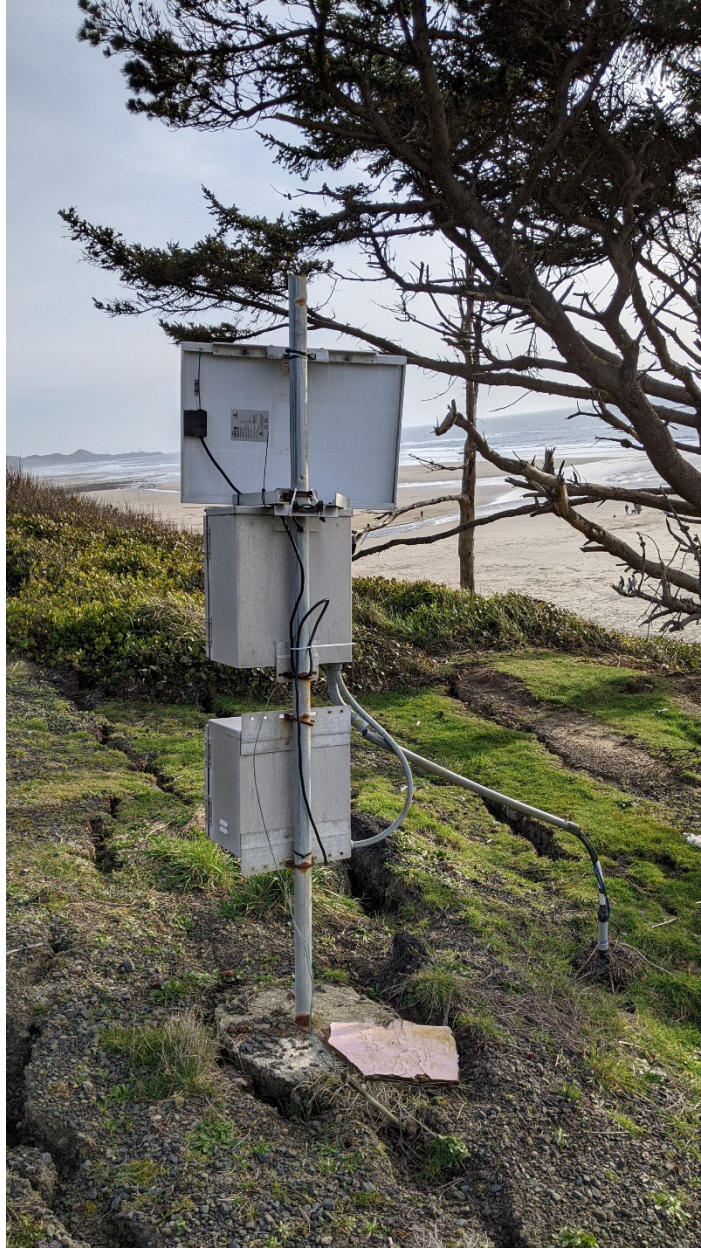
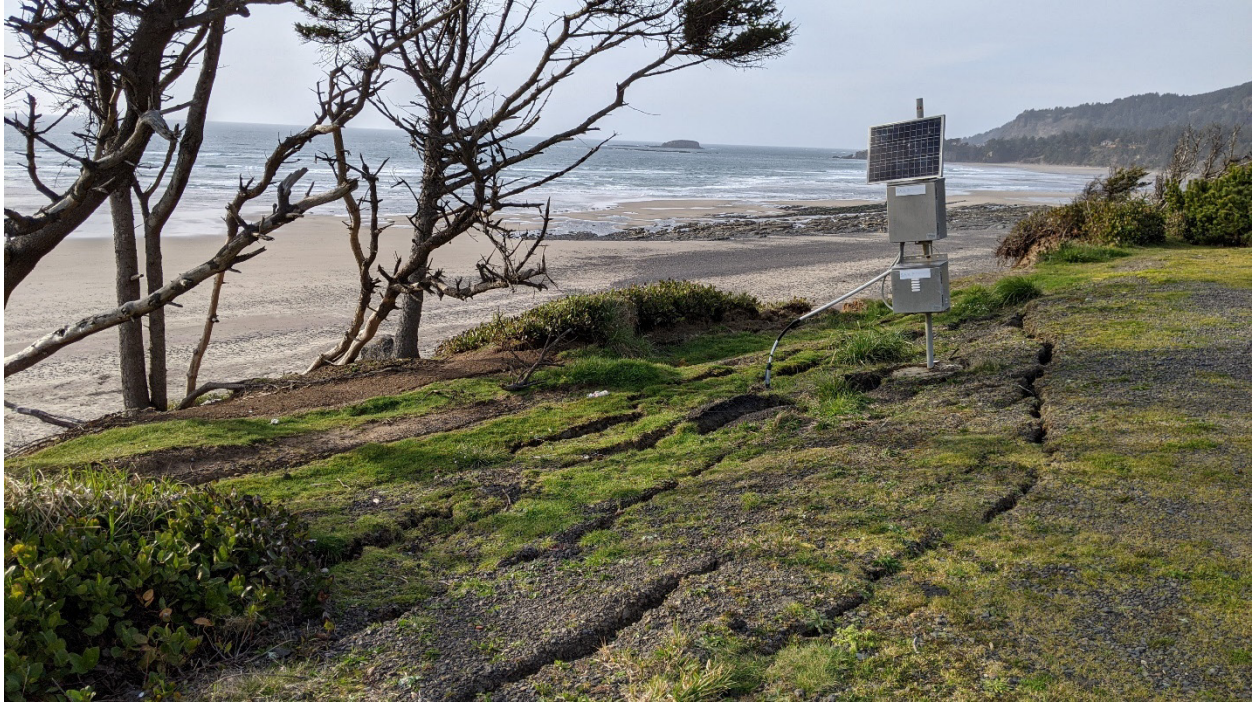
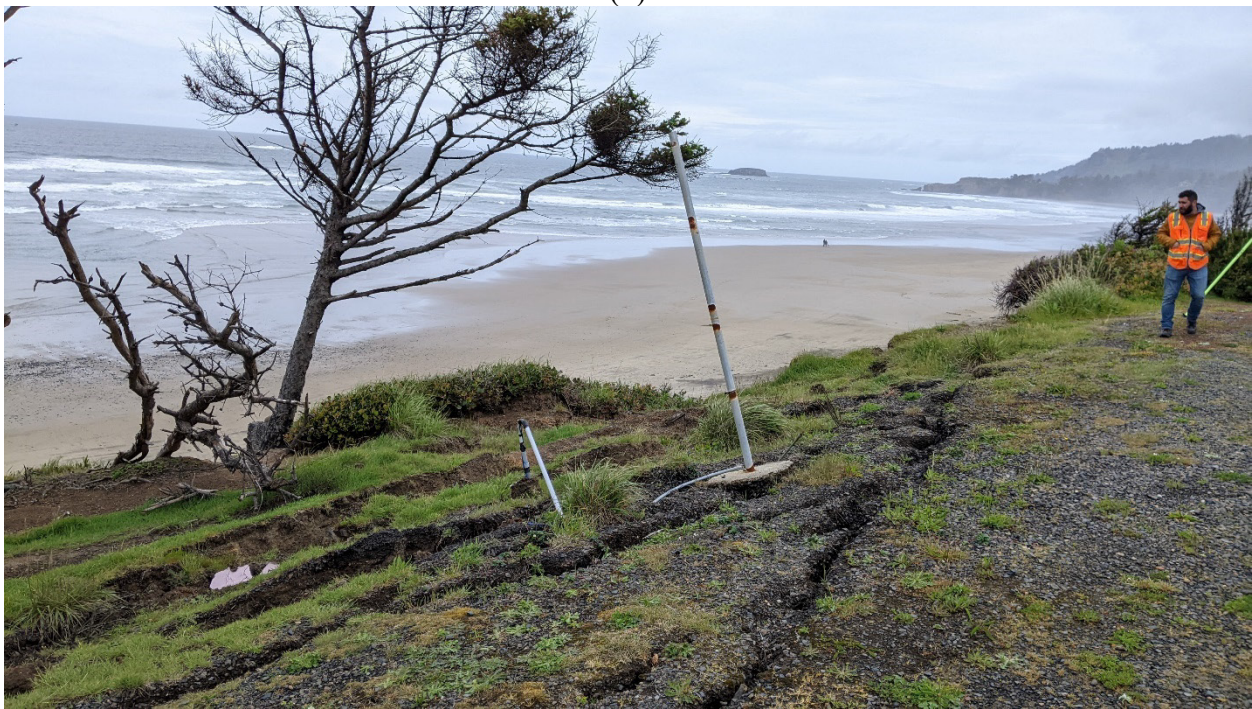
Figure 9.8(b-c). Instrumentation and tension cracks from slump failure occurring in 2021 at the Spencer Creek North Site. (a) close-up view in 2021, (b) larger view in 2021, and (c) larger view in 2022 showing continued slumping at the site.....	122
Figure 9.9: Monitored velocities and pore water pressures in the Spencer Creek South site. The discontinuity (January 22-26, 2022) likely reflects ground movements nearby the inclinometer, which occurred during high groundwater conditions. ....	123
Figure 9.10: Inclinometer Movements at Spencer Creek South. A distinct event occurred in January 2022, with a clear shear zone at approximately 12m b.g.l. This is associated with a nearby complex of sea cliff slumps. ....	124
