**COASTAL LANDSLIDE AND SEA CLIFF  
RETREAT MONITORING FOR  
CLIMATE ADAPTATION AND  
TARGETED RISK ASSESSMENT**

**Final Report**

**SPR-807**

Oregon Department of Transportation

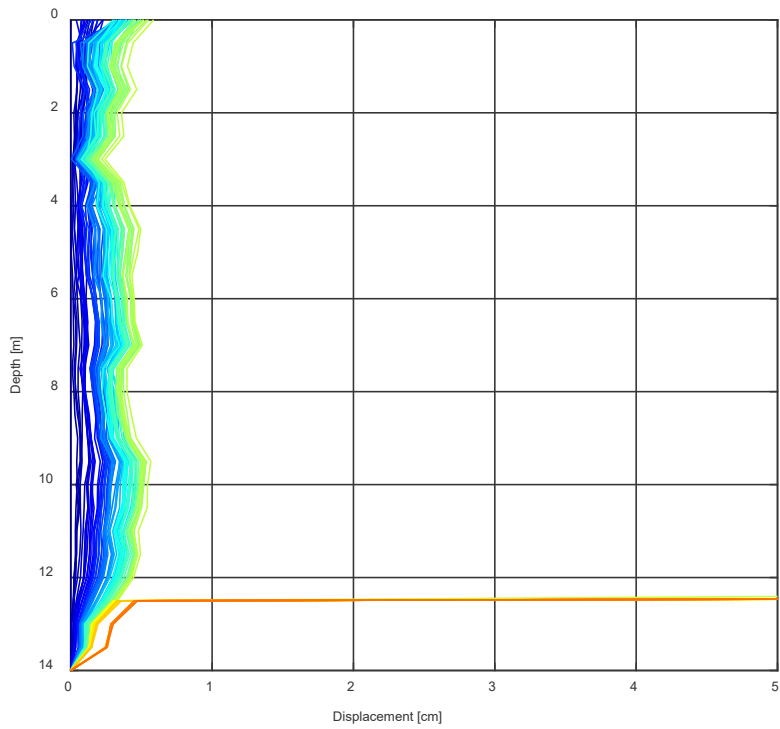
**Figure 9.11: Inclinometer Movements at Spencer Creek South. A distinct event occurred in January 2022, with a clear shear zone at approximately 12m b.g.l. This is associated with a nearby complex of sea cliff slumps.**

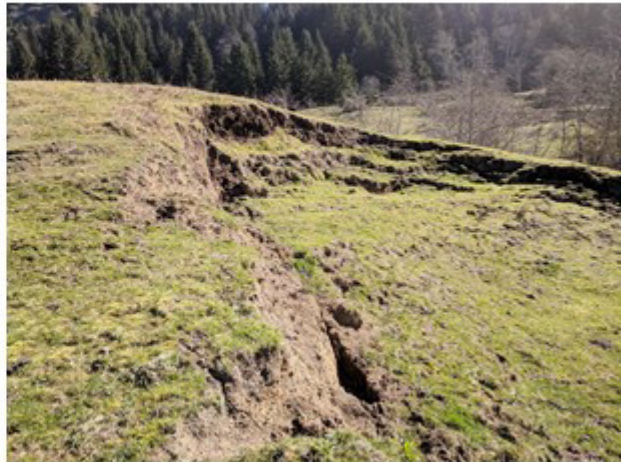
**Figure 11.2: Photographs acquired in early March 2019 shortly after the Hooskanaden landslide event. A). Uplift of the beach at the toe of the landslide. B). Overview of the damage caused to Highway 101. C). Close up damage caused to the road by the landslide. D). An example tension crack/scarp from the upper portion of the landslide (above the road).**

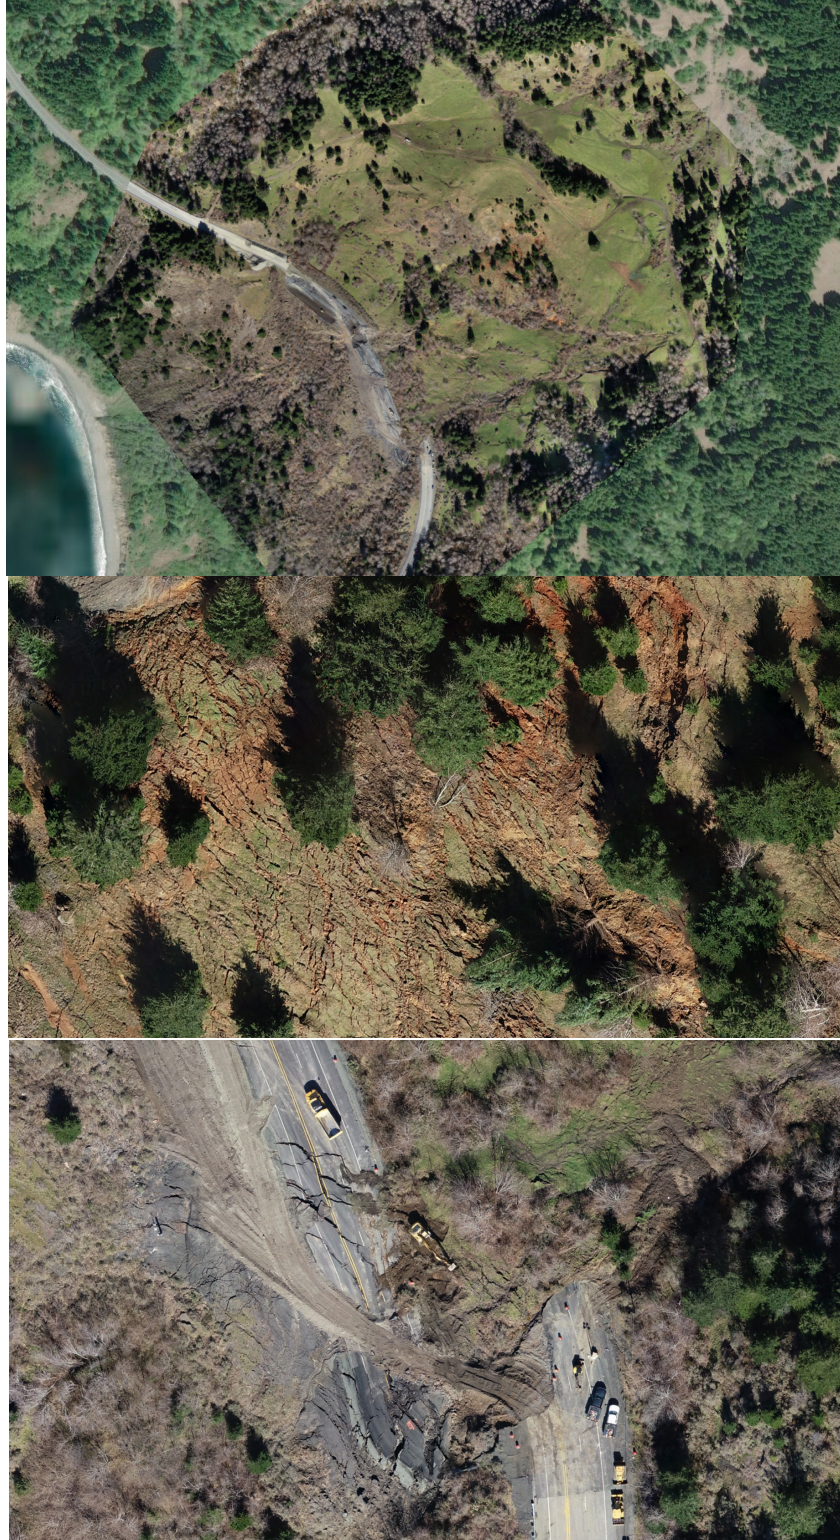
**Figure 11.4: Detailed orthophotos acquired for the site on March 3, 2019. The orthophoto and SfM/MVS derived DSM can be explored at: <https://research.engr.oregonstate.edu/geomatics/projects/OregonCoast/Hooskanaden/Feb2019/uas/ortho/>**

A particle image velocimetry (PIV) analysis (Figure 11.3) was completed to evaluate the horizontal movement occurring at the site. Two composite orthophotos from surveys approximately 24 hours apart on March 2, 2019 and March 3, 2019 were compared. From this analysis compression is observed near the toe of the slide where the horizontal displacement vectors become shorter and shorter. Additionally, it appears to consist of two distinct flows between the northern and southern portion of the slide. Example detail images of the orthophoto collected on March 3, 2019 survey are shown in Figure 11.4.

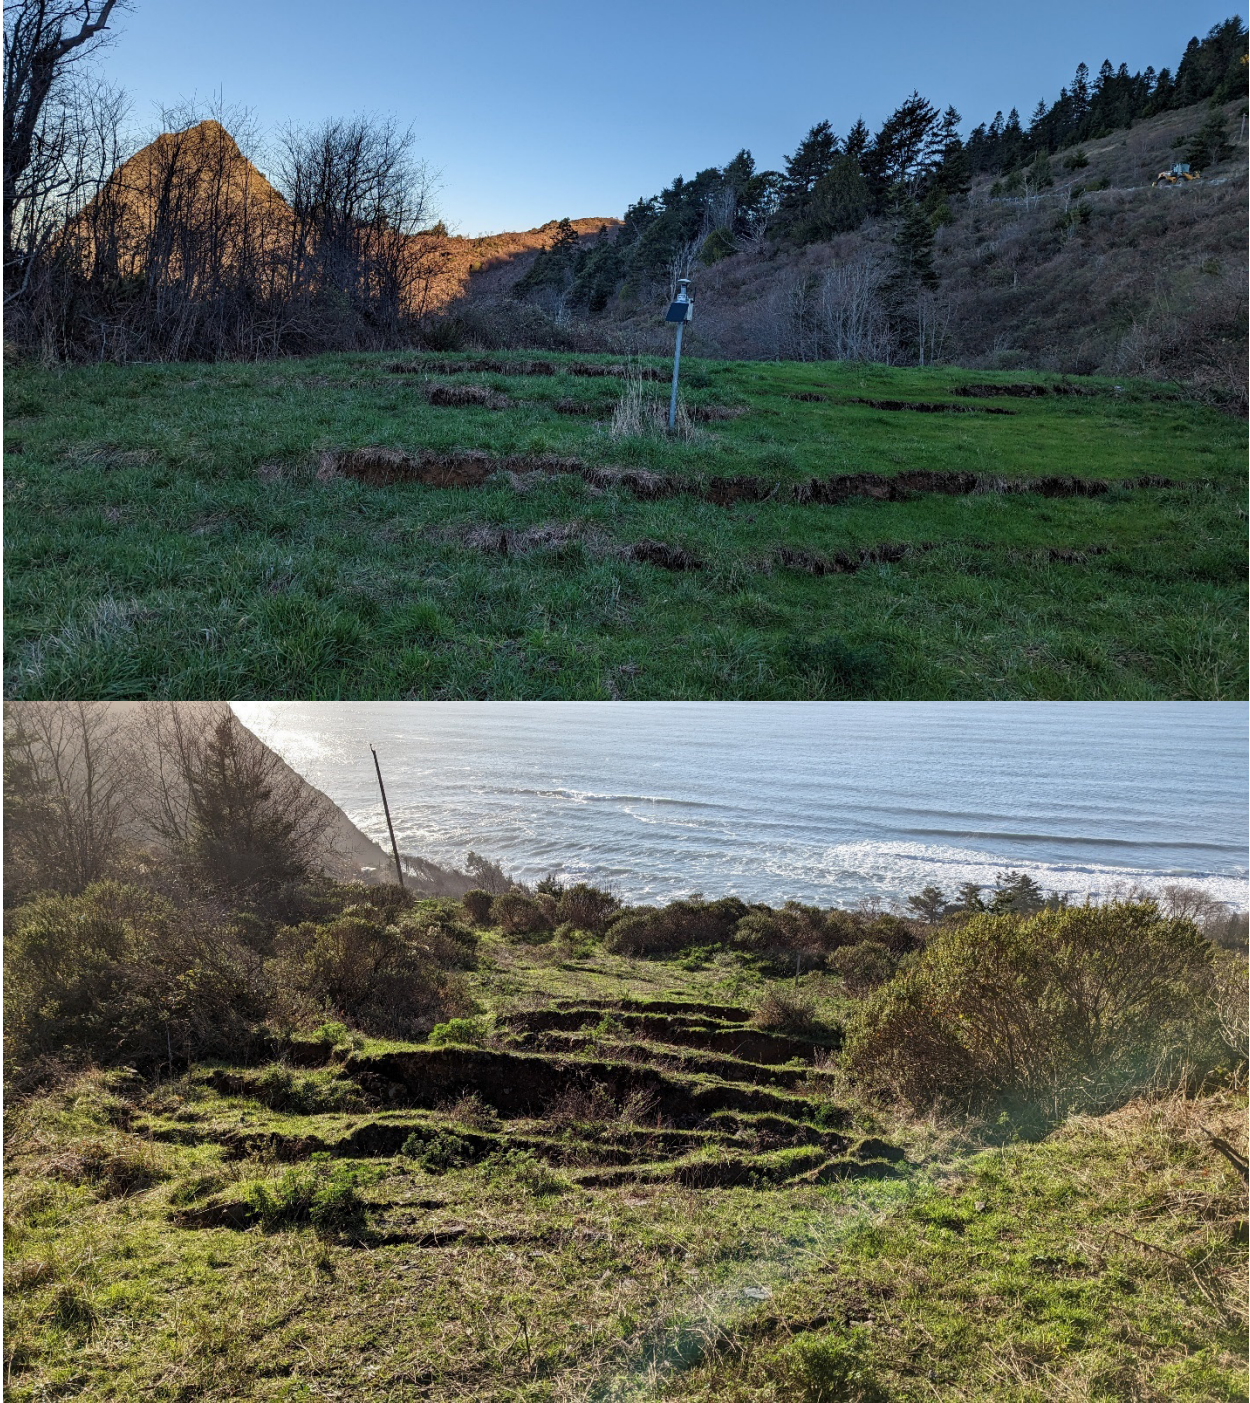
**Figure 12.4: Examples of tension cracks (a) near Rover 1 and the cistern and (b) on the upper slopes above the highway. (January 20, 2023)**

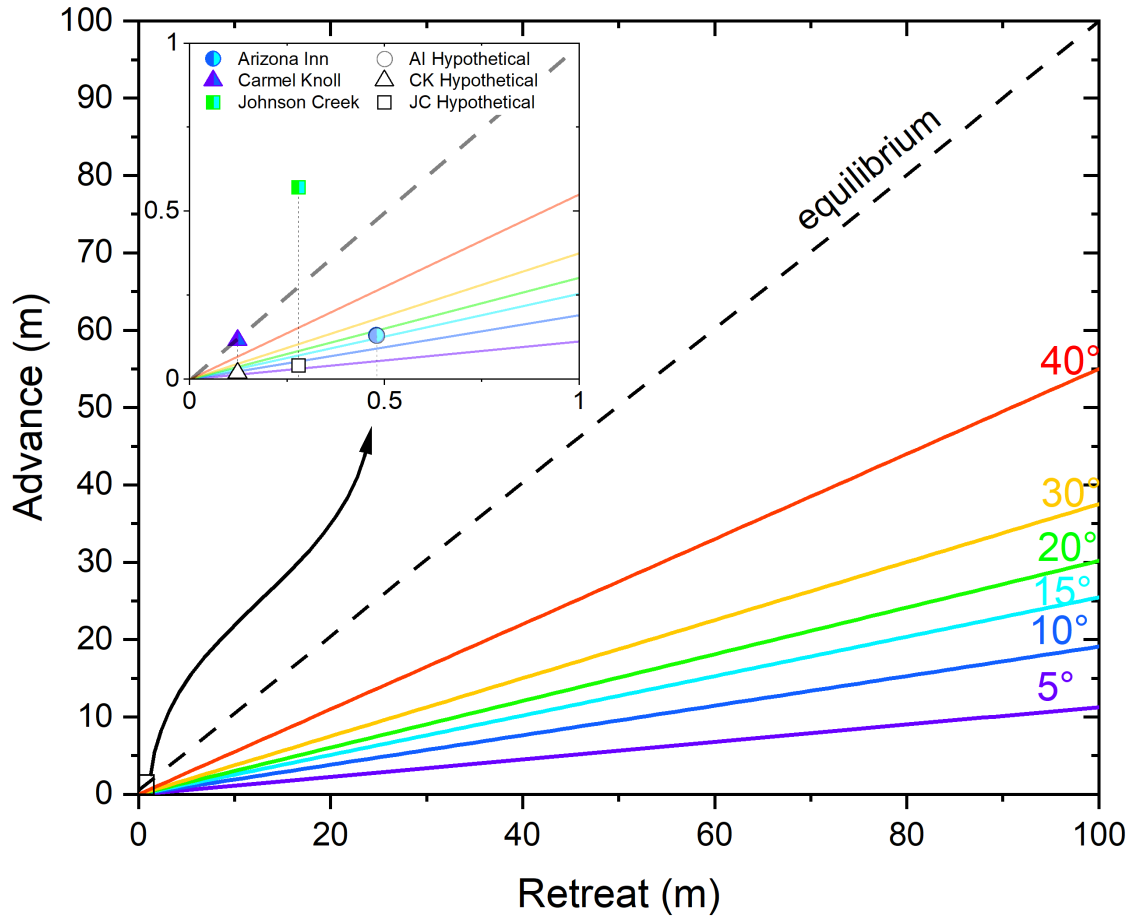
**Figure 13.5: After Alberti et al. (2022)– Relationships between landslide advance and retreat for various landslide angles. Below the equilibrium line (black dashed line) the erosion is dominant, above, groundwater forcing is dominant, shown for various coastal landslides in Oregon. The correspondence of Arizona Inn with its representative geometric line suggests that erosion is a dominant control on landslide advance.**

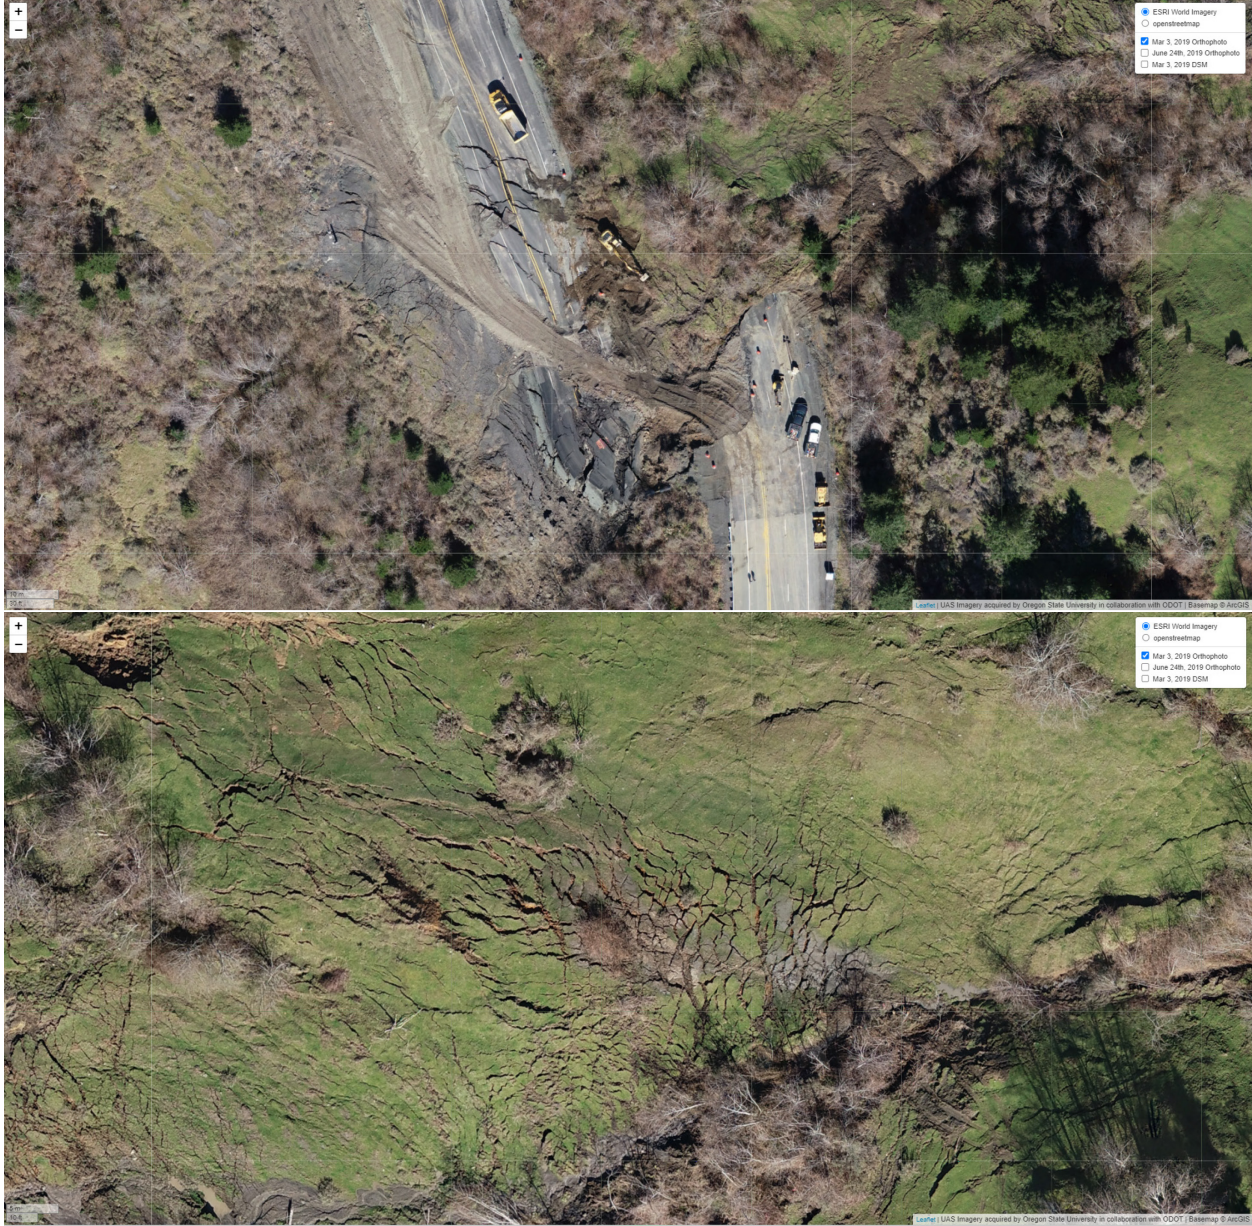
**Figure 14.2: Example screenshots of the interface of interactive web viewer of high resolution orthophotographs following the February 2019 Hooskanaden surge.**

- Orthophoto and Digital Surface Model viewer:  
<https://research.engr.oregonstate.edu/geomatics/projects/OregonCoast/Hooskanaden/Feb2019/uas/ortho/> (This site contains high resolution orthophotographs collected from UAS on March 3, 2019 and June 24, 2019 showing the post-failure conditions and the reconstructed highway, respectively. It also contains a digital surface model from the March 3, 2019, UAS survey).
- Multi epoch point cloud viewer:  
<https://research.engr.oregonstate.edu/geomatics/projects/OregonCoast/Hooskanaden/Feb2019/lidar/> (contains several epochs of point clouds captured at Hooskanaden).
