**RESILIENT AND RAPID REPAIR
MEASURES FOR SEISMICALLY
VULNERABLE BRIDGES FOLLOWING
MAJOR EARTHQUAKES**

Final Report

PROJECT SPR 816

Oregon Department of Transportation

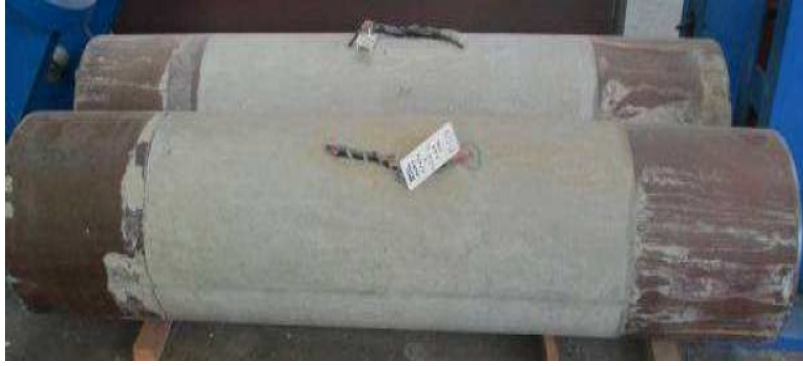
Figure 2.5: Precast Bridge Columns with 10mm steel jackets (Mashal et al. 2014)

The ABC Low-Damage specimen was identical to the High-Damage specimen construction, but the connection was replaced with a hybrid connection. The hybrid connection consisted of a combination of post-tensioning with external replaceable dissipaters. The system provides self-centering with minimal permanent deformation and damping through the hysteretic devices. The expected ABC Low-Damage bent hysteresis curve is flag shaped with no permanent structure drift. The ABC Low-Damage bent was designed using the outline procedures in PRESSS Design Handbook (Pampanin et al. 2001). To prevent concrete spalling at the ends of the precast columns, 10mm steel jackets were installed as shown in Figure 2.5. The steel shells connected to the concrete column core through welded studs. For the low-damage system, the steel shell length was determined based on the MSC column plastic hinge length and a length of 500 mm was used.

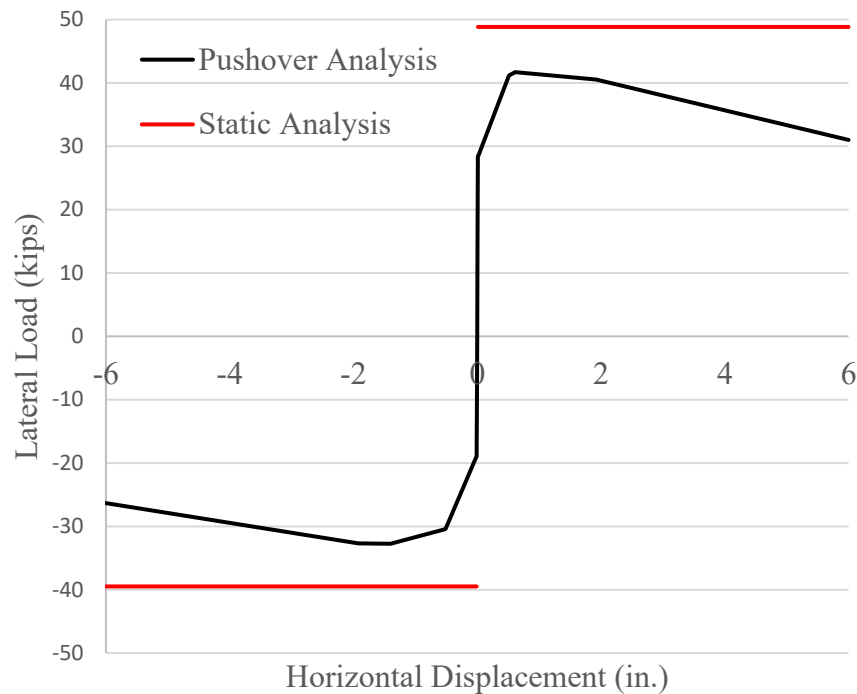
Figure 3.7: Pushover analysis vs. static analysis

Figure 3.7 shows a comparison of the static analysis and the pushover analysis. This figure is for a column that was repaired with hold-downs in the face orientation and with UFPs that have a plastic moment force of 5.4 kips.

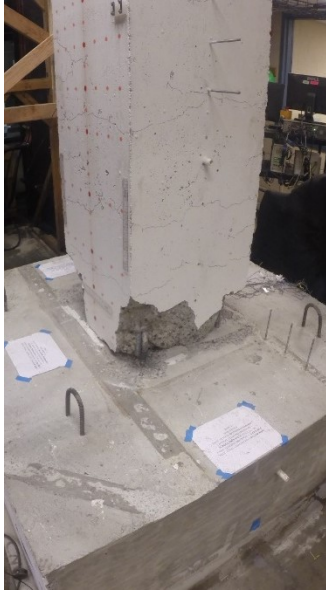
Figure 4.3: Prototype Repair Sequence

The final step of the repair is to attach the ductile fuse hold-downs. Inside of the hold-down, there are four UFPs that act as ductile fuses. One side of the hold down is welded to the steel jacket while the other side is anchored to the foundation via conventional threaded rods with Hilti epoxy. Figure 4.4 shows the ductile fuse hold-down before the outer leg is installed. The UFPs are bolted with two $\frac{5}{8}$ -inch diameter slip-critical A325 bolts on each leg. Nuts are welded to the inside of the UFP such that the bolts can be secured without access to the inside of the UFP. Upon installation of the hold-downs, there is a gap between the hold-down base plate and the foundation. This gap is to be filled with self-leveling grout before the anchor rod nuts are tightened. Figure 4.3(c) shows a picture of temporary forms that were installed for the base plate grout. Figure 4.5 shows the base plate with anchor rods after the forms have been removed.

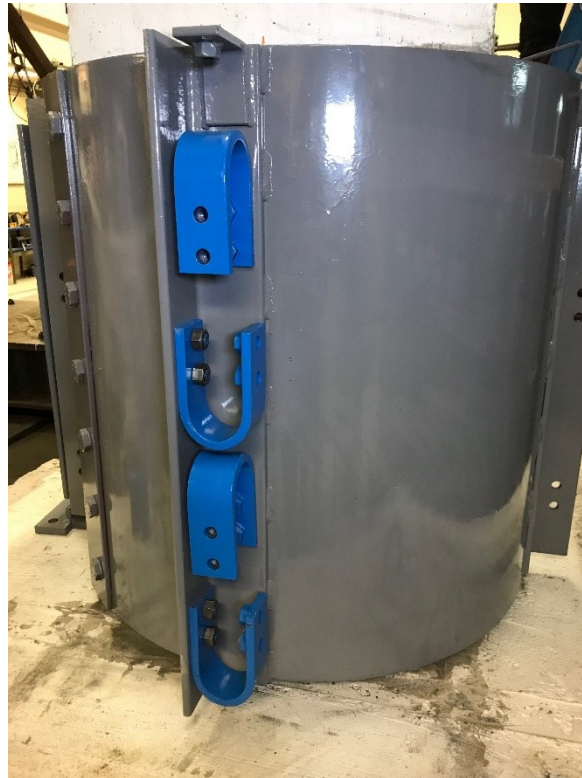
Figure 4.4: UFPs inside hold-down

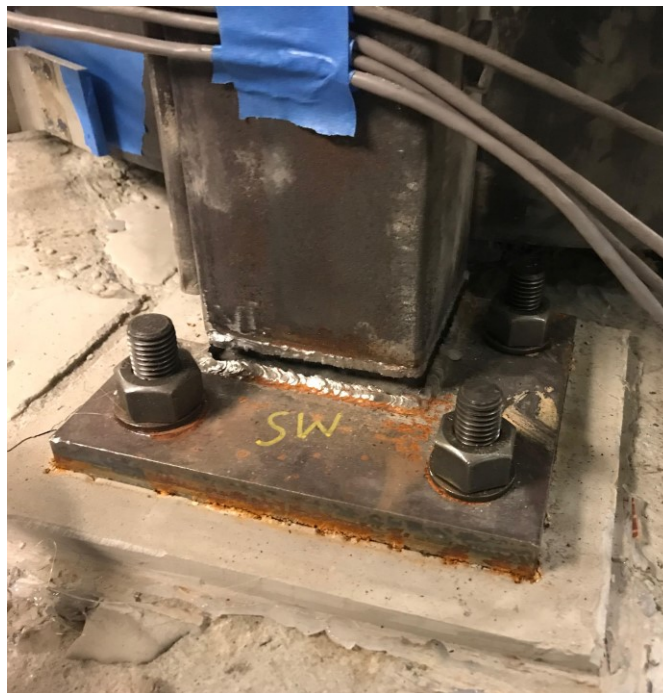
Figure 5.4: Hold-down weld failure

At the final target displacement of 5.4 inches, the axial load actuator stroked out and axial load on the column was lost. The column was returned to its unloaded state while the test set-up was adjusted. The test was resumed, but after three more cycles at the same target displacement of 5.4 inches, the test was terminated when the southeast hold-down failed while in tension. The weld between the L4X4X1/2 and the base plate ruptured. The ruptured weld is pictured in Figure 5.4. The weld was a 5/16-inch fillet weld around the perimeter of the angle. While the weld was sufficient to resist the axial capacity of the hold down, it was not designed for combination axial plus flexural forces.

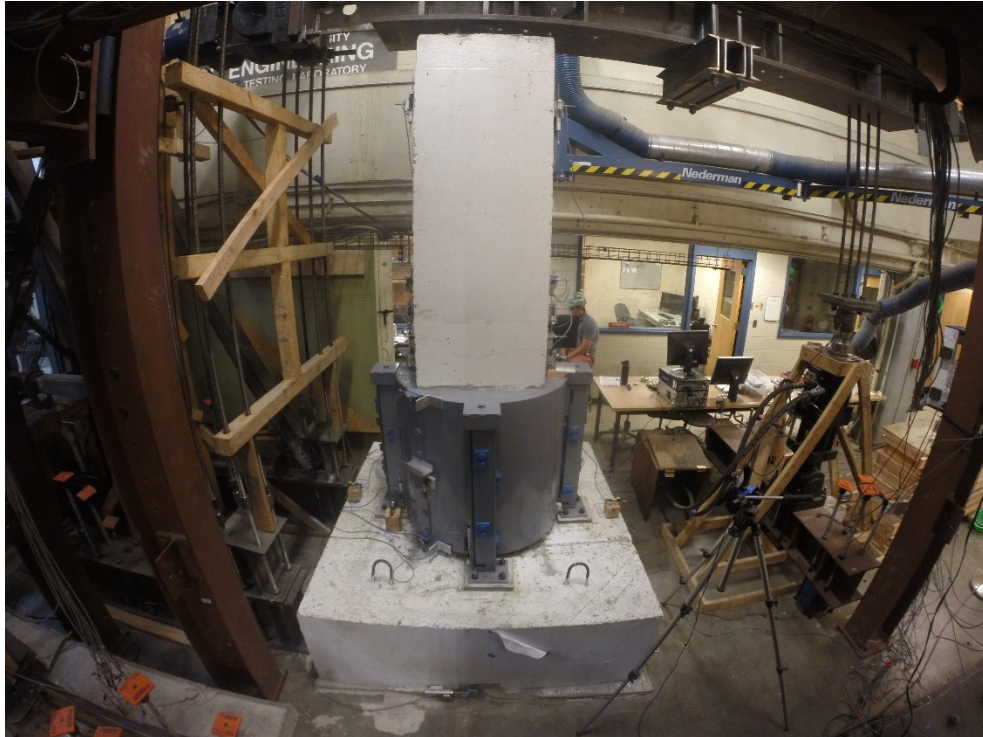
Figure 5.6: Test 2 @ initial state
