**EVALUATION OF CURB RAMP
COMPLIANCE: REVIEW OF TOOLS,
METHODS, AND TIME TO DEVELOP
ERROR TOLERANCES**

Final Report

SPR 844

Oregon Department of Transportation

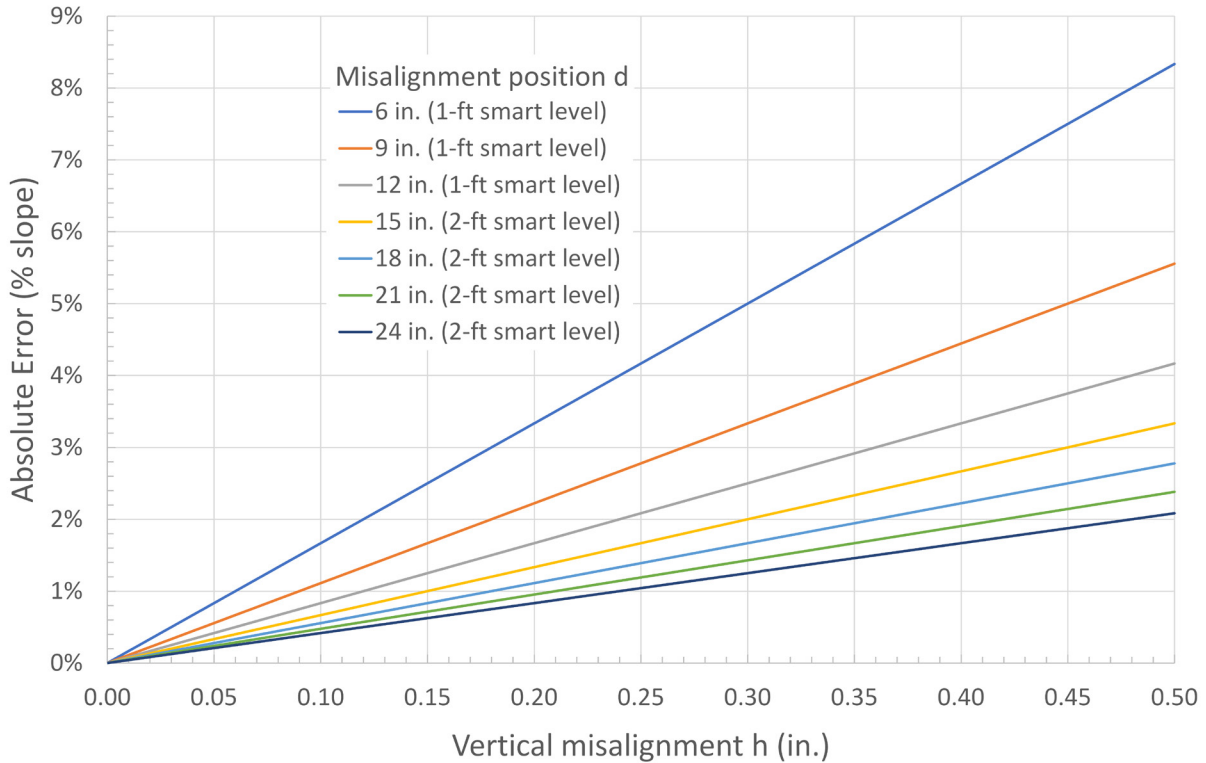
Figure 3.5: Correlation between vertical misalignment and absolute error in the slope measurement.

error increases. Notably, a longer smart level has the advantage in terms of mitigating vertical misalignment. Additionally, it is also worth noting that d_ϕ should be longer than half of the length of the smart level such that it can be stably placed on the surface. A key practical consideration based on ADAAG is that the truncated domes on the detectable warnings are specified as 0.2 in (5 mm) and trip hazards are defined as a change in height over 0.25 in (6 mm). The measurement errors with such vertical displacement are significant and exceed the tolerances for design and construction. Thus, it is necessary to avoid placing the instrument partially on the truncated domes or other objects.

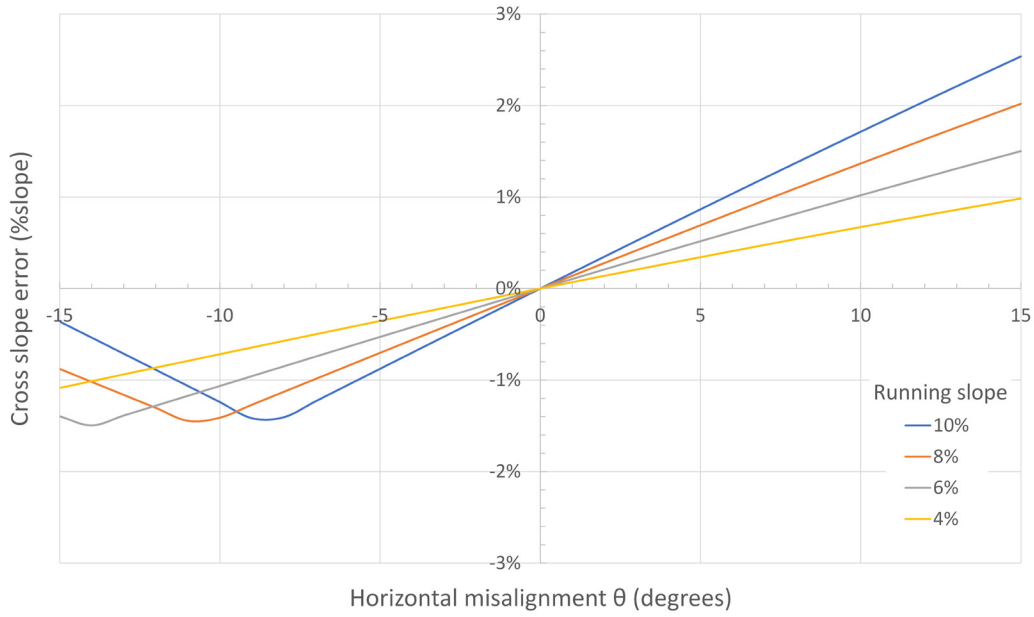
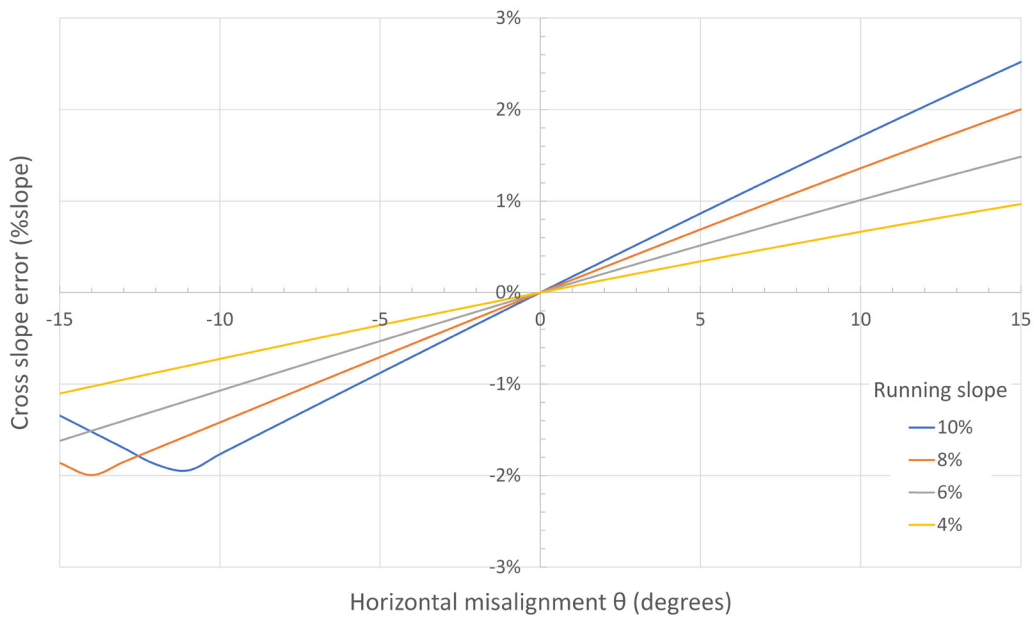
(a) Cross slope = 1.5%

(b) Cross slope = 2.0%

(c) Cross slope = 2.5%

Figure 3.7: Correlation between horizontal misalignment and cross slope error.

The correlation between the horizontal misalignment and slope measurement errors for cross slope and running slope under different combinations are shown in Figure 3.7 and Figure 3.8, respectively. In general, the impact of horizontal misalignment on running slope is less than on cross slope. Additionally, a larger difference between running slope and cross slope is more likely leading to a significant error caused by horizontal misalignment.

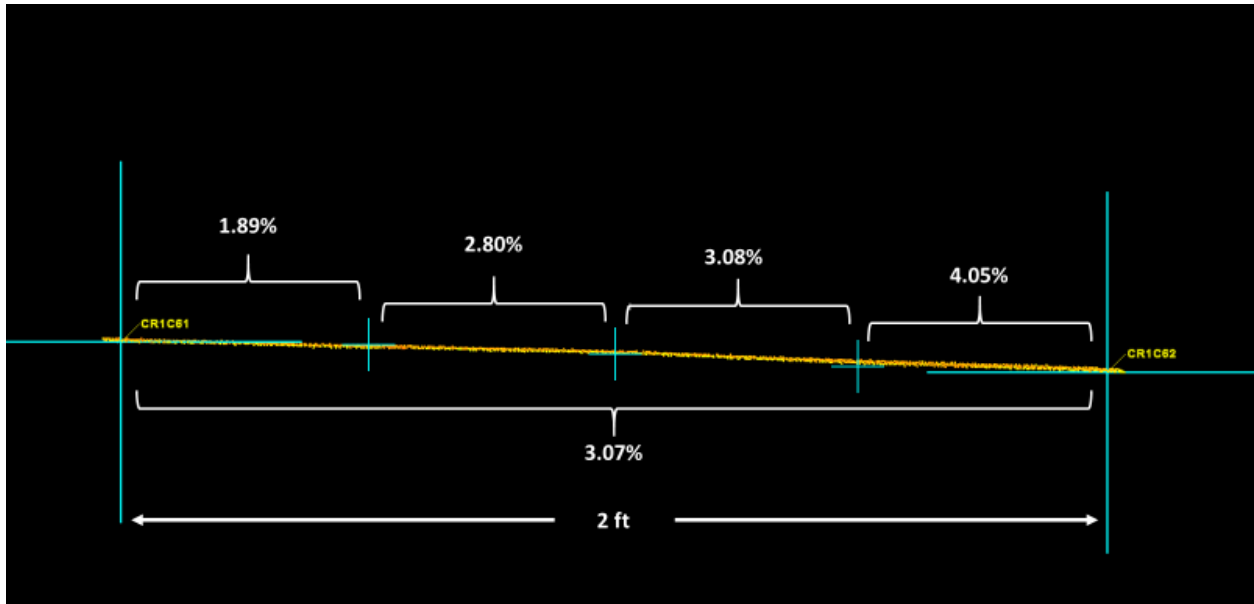
Figure 4.9: Detailed slope measurements in pointclouds for slope "CR1C6".

The research team further investigated the two measurements with large discrepancy between direct and reverse readings, which were removed from the statistical analysis. Because the impact of calibration errors and errors caused by horizontal misalignment were proven to be neglectable, the pointcloud collected by Leica P40 was used to analyze these measurements to provide enhanced geometric information of that portion of the curb ramp. For each of the survey markers under analysis, four discrete slope measurements were obtained by evenly dividing the distance between two survey points into four increments. The slope measurement between “*CRIC21*” and “*CRIC22*” (Figure 4.8), calculated from the total station measurements is 3.94%. Meanwhile, the slope measurement for the four sections ranges from 2.62% to 4.23%. Both the direct and reverse readings (i.e., 3.9% and 4.3%) fall into this range, explaining the large difference between the direct and reverse readings. Similarly, the slope between “*CRIC61*” and “*CRIC62*” ranges from 1.89% to 4.05% (Figure 4.9) when discretized in a similar fashion while the direct and reverse readings from the smart level are 2.6% and 3.3%, respectively. Such phenomenon shows that the impact of the flatness or roughness of the surface can significantly impact the accuracy of the smart level readings. Section 5.2 discusses approaches that will be used to evaluate the flatness of curb ramps.

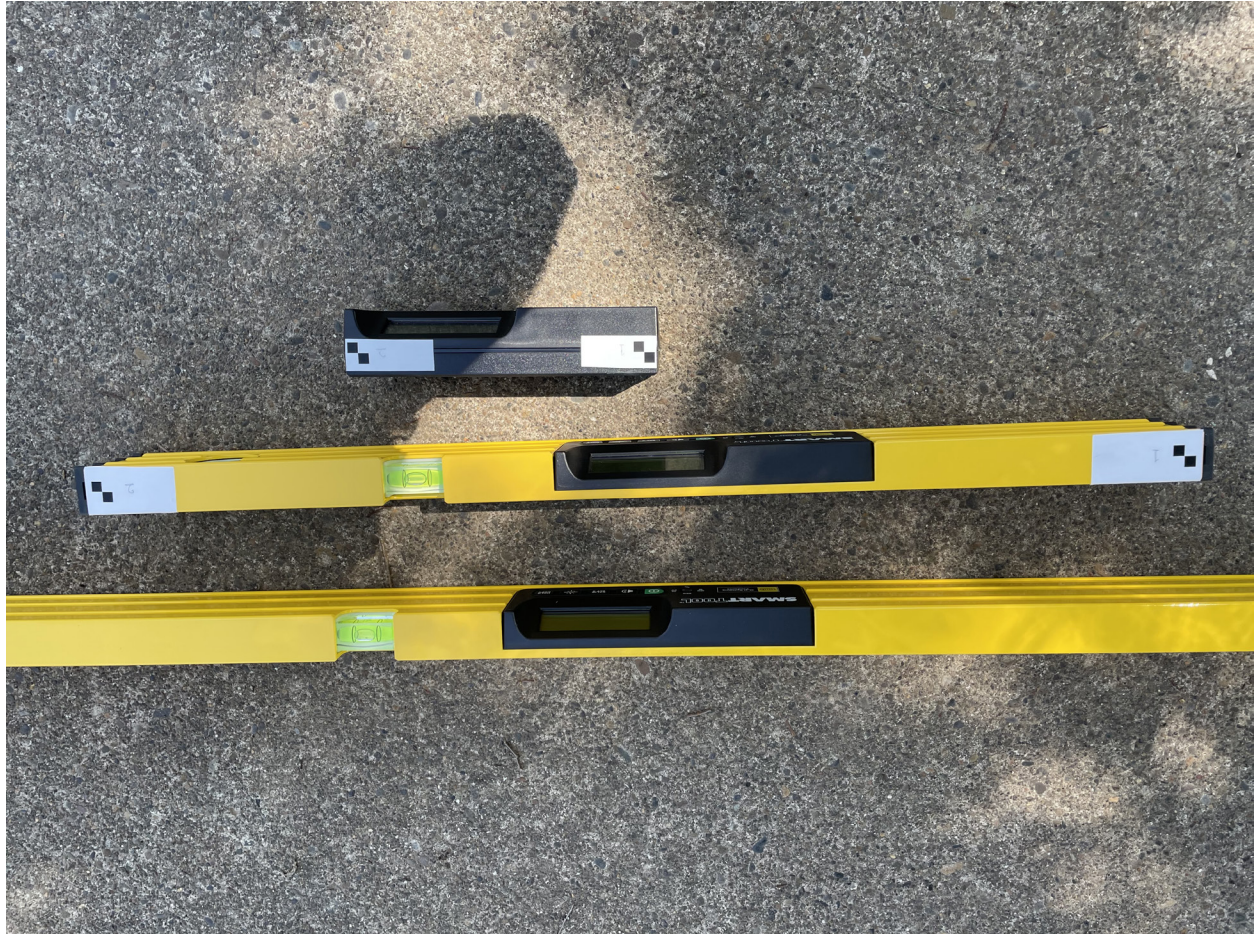
Figure 5.2: Smart levels used in the operator variability test with end points marked.

Each operator was instructed to place the smart level on its direct and reverse face for each set observations. The operator then left the slab and walked to the “reset” area before making another set of observations to keep each set of readings independent. Three instruments were tested in this experiment including a 6-inch, 2-ft, and 4-ft smart level. Both ends of each smart level were marked with targets so that the position and orientation of the smart level could be precisely measured with total station during the test (Figure 5.2).

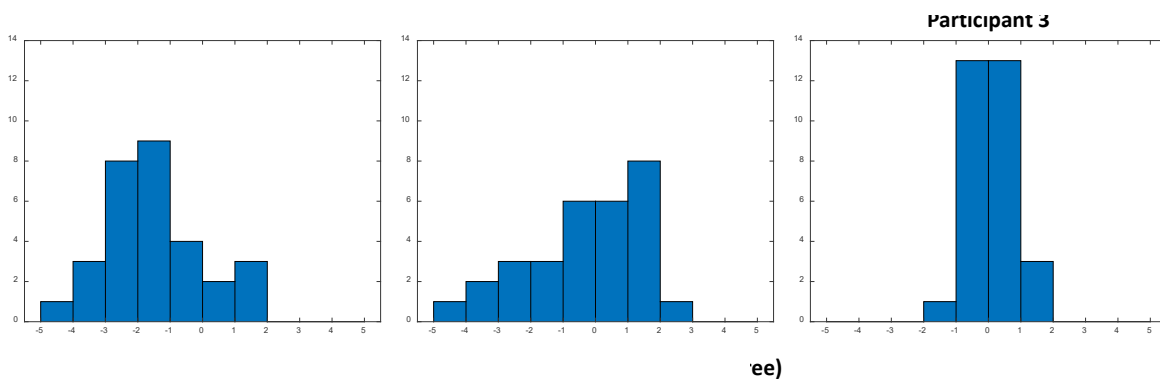
Figure 5.3: Distribution of horizontal misalignment errors for each participant.

Next, to provide more context of the analysis, the distribution of the horizontal misalignment errors for each participant was also plotted to further show the variability between different operators in placing the smart levels (Figure 5.3). A similar case can be found in the centering errors in this test as well (Figure 5.4) where results are more similar between Participants 1 and 2 compared with participant 3. Note that higher centering errors occur in the X direction.

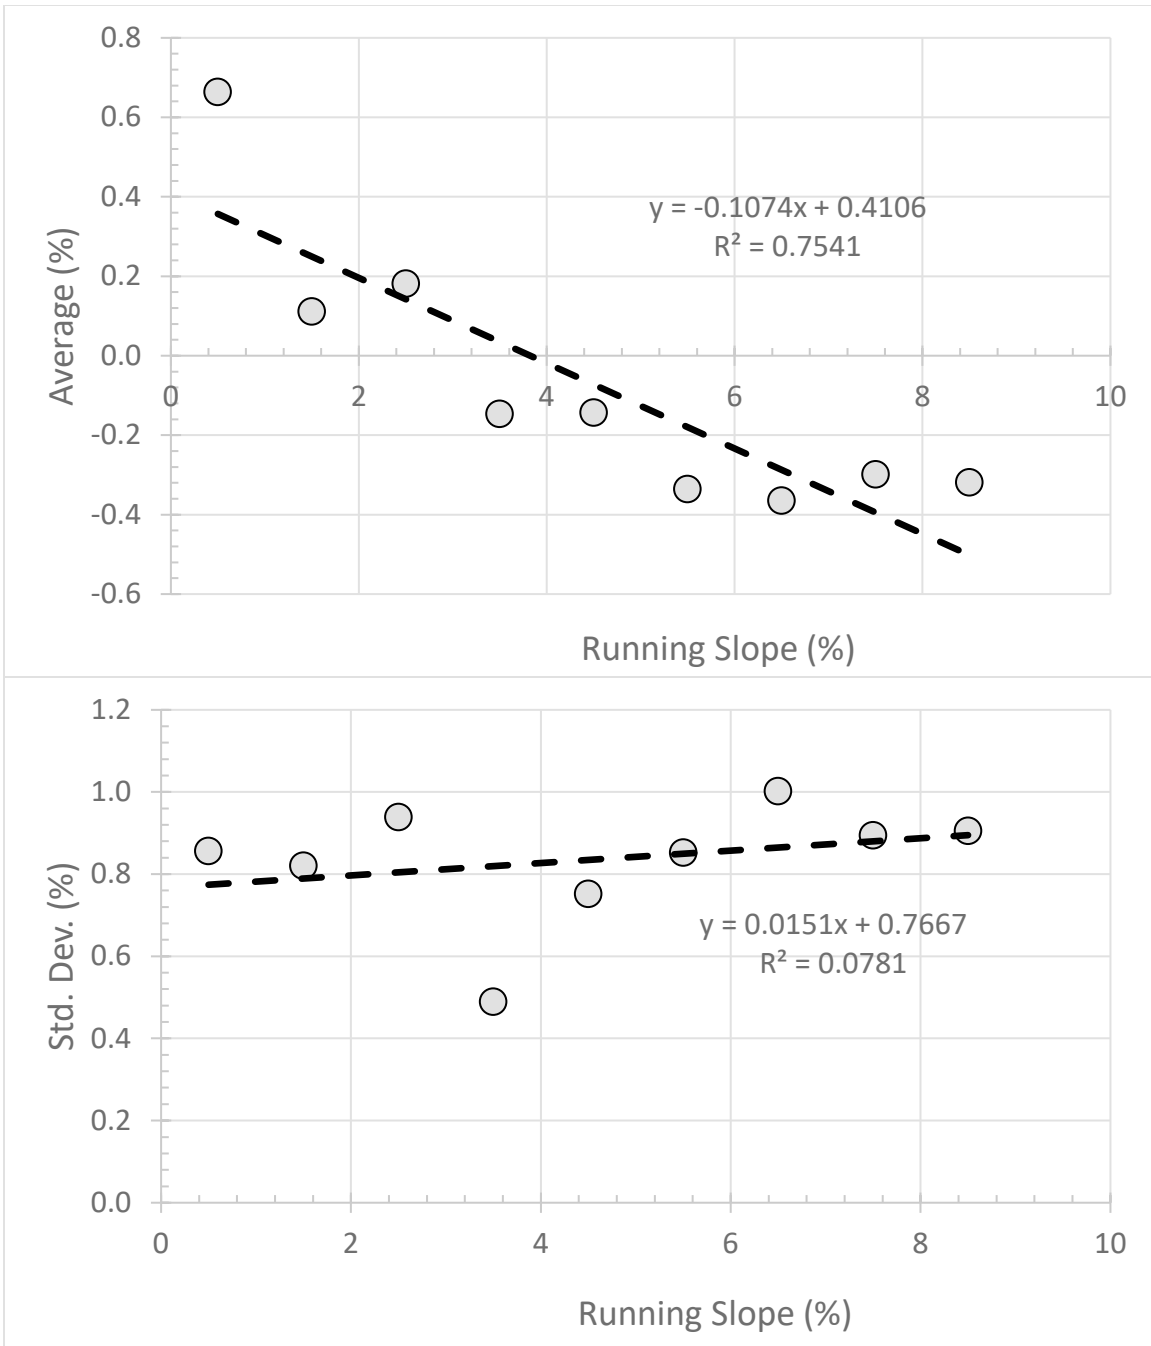
Figure 5.5: (a) Average And (B) Standard Deviation Of Differences In Running Slope Measurements Between Inspectors Undergoing Certification And Ground Truth Measurements In 1% Bin Increments.

All data from runs 1, 2, and 3 were combined and the differences between the inspectors undergoing certification and the ground truth measurements were compared for different slope bins in 1% increments. Table 5.2 provides a statistical analysis of these differences for each of the bins and the dataset as a whole. Figure 5.5 plots the average and standard deviation values for each bin. Notably, a strong trend is observed with the average difference. Substantial differences are observed between the values recorded by the inspectors undergoing certification compared with the ground truth. These inspectors undergoing certification tend to record much higher values on shallow ramps and much lower values on steeper ramps. High standard deviation values (~0.8%) are observed across all slope bins.

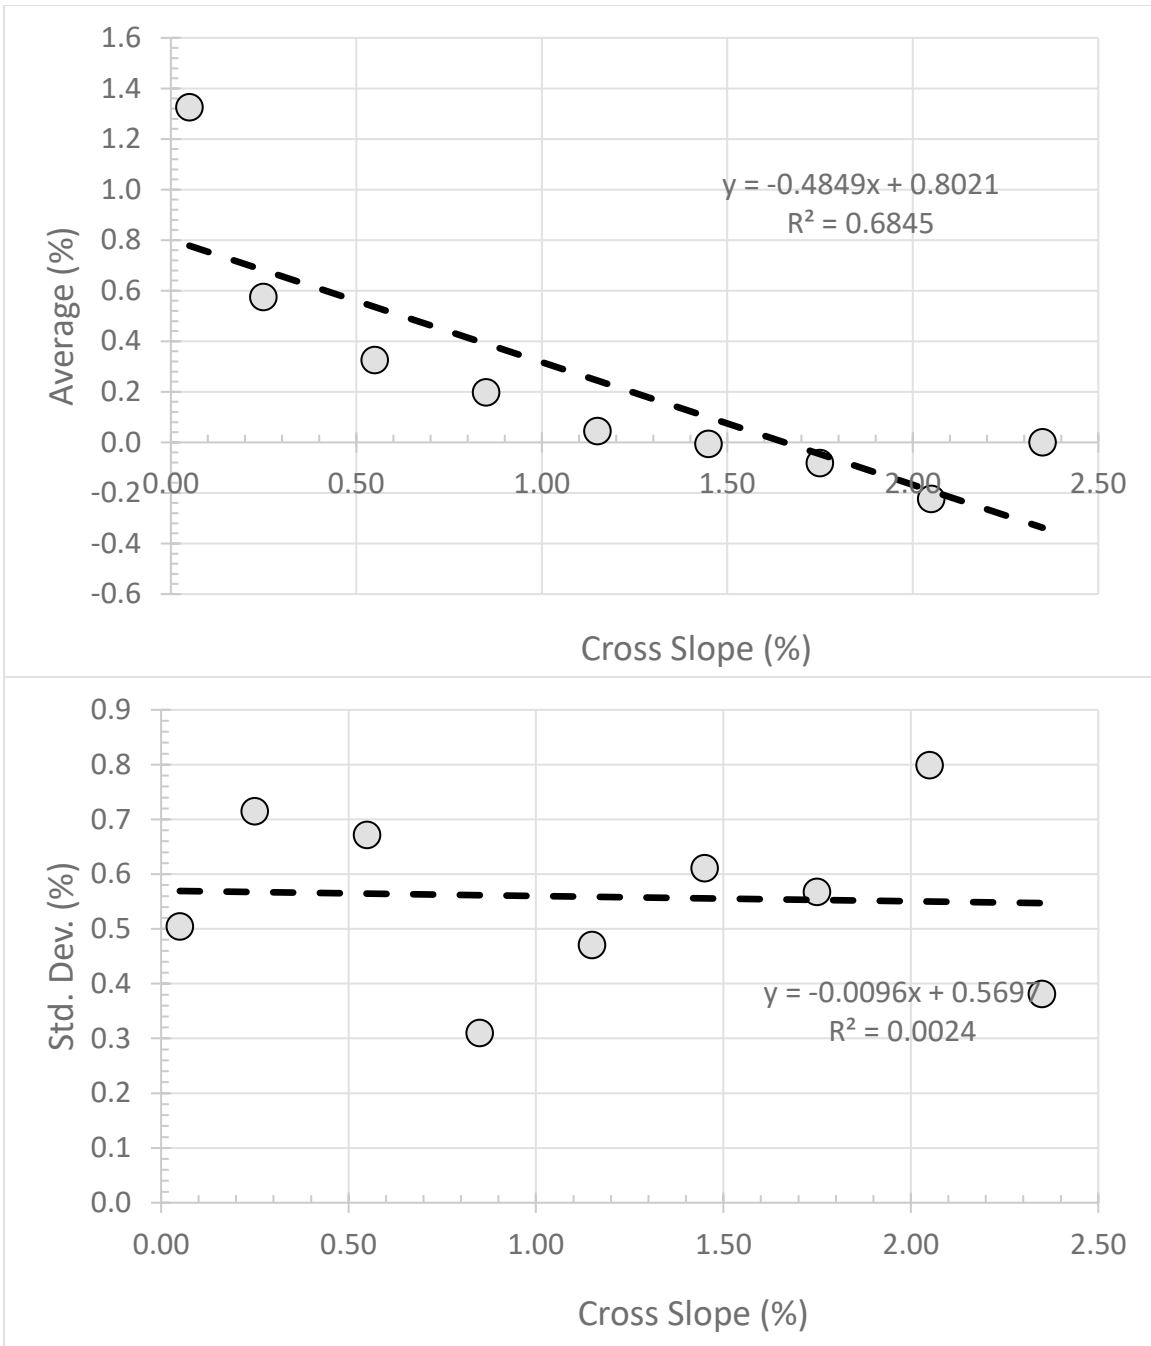
Figure 5.7: (a) Average and (b) standard deviation of differences in cross slope measurements between inspectors undergoing certification and ground truth measurements in 0.3% bin increments.

The same process completed for the running slope in Section 5.2.1 was completed for the cross slopes. Notably, these values have a much smaller range, so the bin size was adjusted to 0.3% increments except for the first bin which ranged from 0-0.1%. Table 5.4 provides a statistical analysis of these differences for each of the bins and the dataset as a whole and Figure 5.6 plots the average and standard deviation values for each bin. Similar trends were observed for the running slope with higher average differences for shallower slopes. A standard deviation of 0.74% was obtained for all data points.

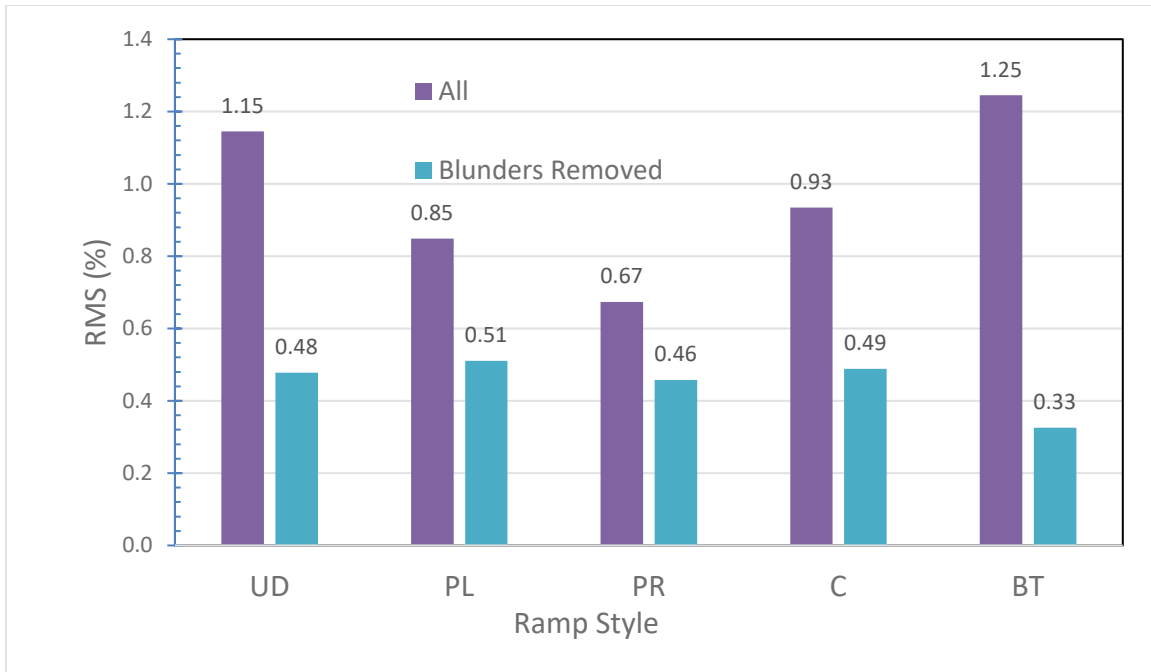
Figure 5.9: RMS differences in running slope measurements between inspectors undergoing certification and ground truth measurements categorized by ramp style with and without blunders removed. Note that BT contains relatively few measurements (11) and so it may not be statistically significant.

The dataset was then categorized by Ramp Style (UD= Unique Design, PL= Parallel, PR= Perpendicular, C= Combination, and BT = Blended Transition) and statistics were calculated for each ramp style to determine if the style of ramp lead to more uncertainty for all values (Table 5.6) and with blunders removed (Table 5.7). It is noted that some ramp types (e.g., UD and BT) resulted in substantially more blunders (~9%) than other ramp types (2-7%), resulting in much higher RMS values (Figure 5.9). This is likely due to more confusion when the inspector is determining where and how to obtain the smart level measurements. In some cases, they may be measuring the turning space instead of the ramp. However, once the blunders are removed, the average differences and standard deviations are more consistent across the ramp styles. Hence, it is possible that the less experienced inspectors commit more errors on some ramp types.

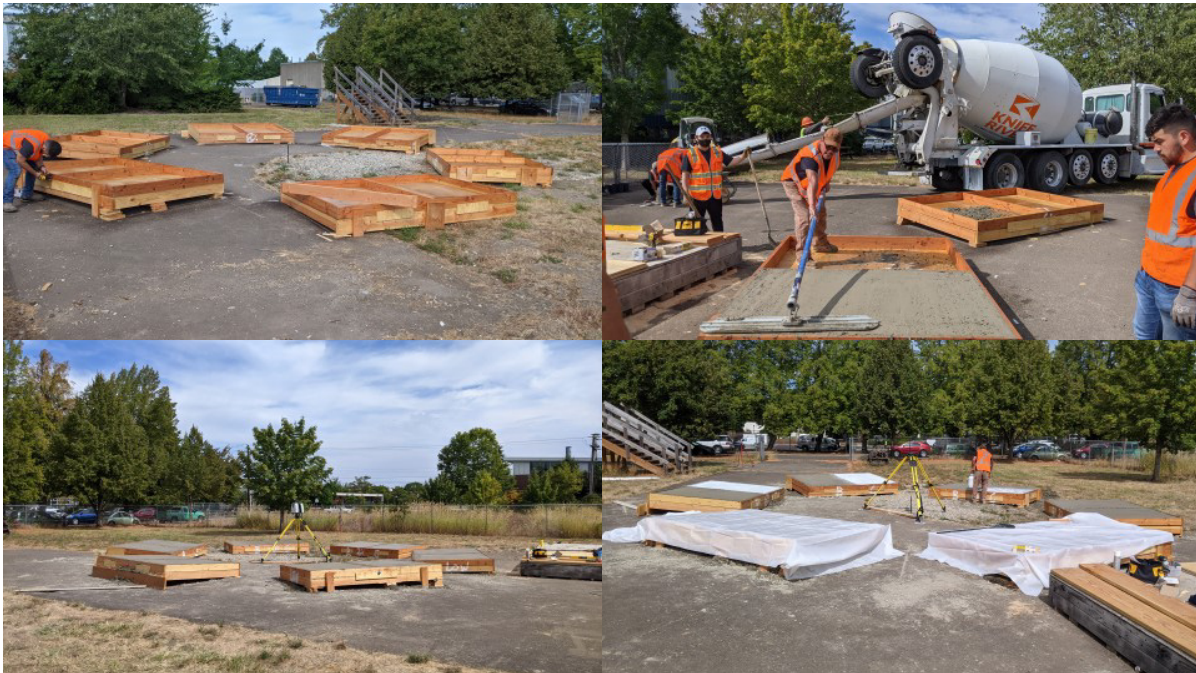
Figure 6.2: Ramp construction and survey configuration of the lab test for the concrete evaluation.

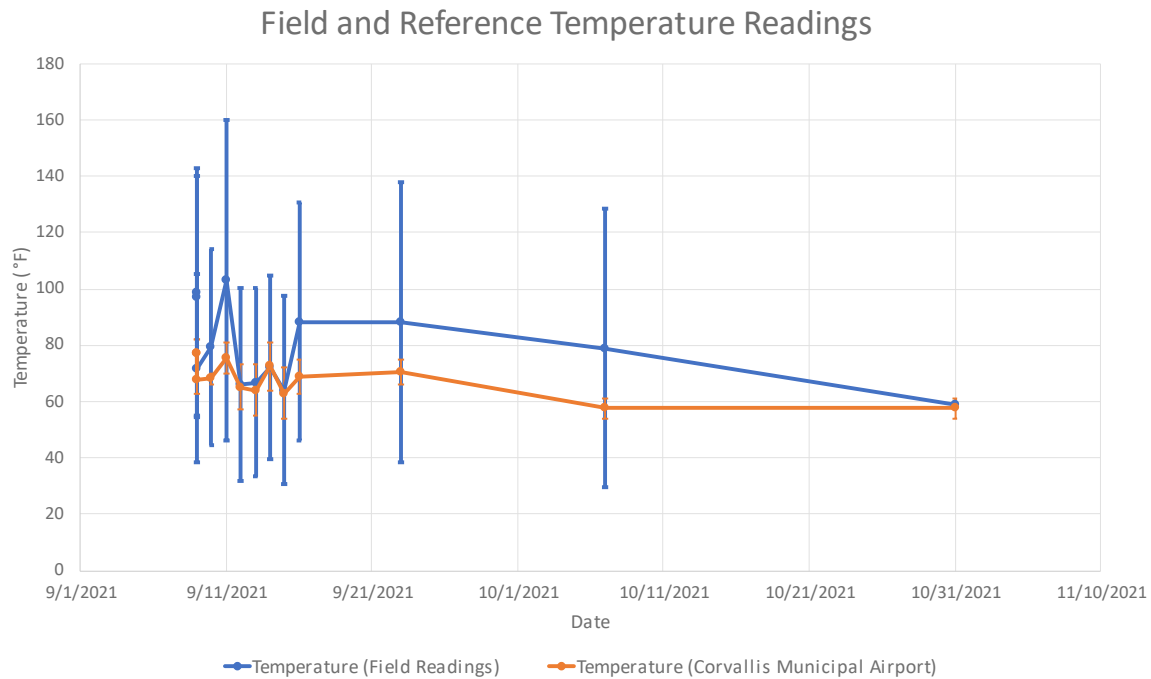
Figure 6.4: Temperature recordings in the field and from the weather station at Corvallis Municipal Airport.

In addition to the laser scans, the research team also collected environmental data with a set of Kestrel DROP D2/D3 sensors. One unit was placed at each wooden platform and logged data throughout the monitoring (Table 6.3) with the exception of the last epoch on 10/31/2021 where data were obtained from the Corvallis Municipal Airport. The units recorded temperature and humidity readings every 30 minutes. The average and standard deviation of the temperature readings from all 6 units were computed at the moment of the survey and compared with the data recorded from the weather station at the Corvallis Municipal Airport (Figure 6.4 and Figure 6.5). The data from the environment sensors in this study share the same overall trend as the readings from the weather station. The difference in the temperature readings as well as the range between the two can be explained by the fact that the recordings were from different instruments. Additionally, the units used in this study were much closer to the ground and hence affected more by the ground surface temperature, which varies significantly more than the air temperature. Furthermore, each unit at the testing site can be impacted by the heat from the curing process, especially when the ramp is covered since the unit is attached to the wood frame. The research team also collected cumulative rainfall recordings from the Hyslop weather station to track the rainfall between epochs.

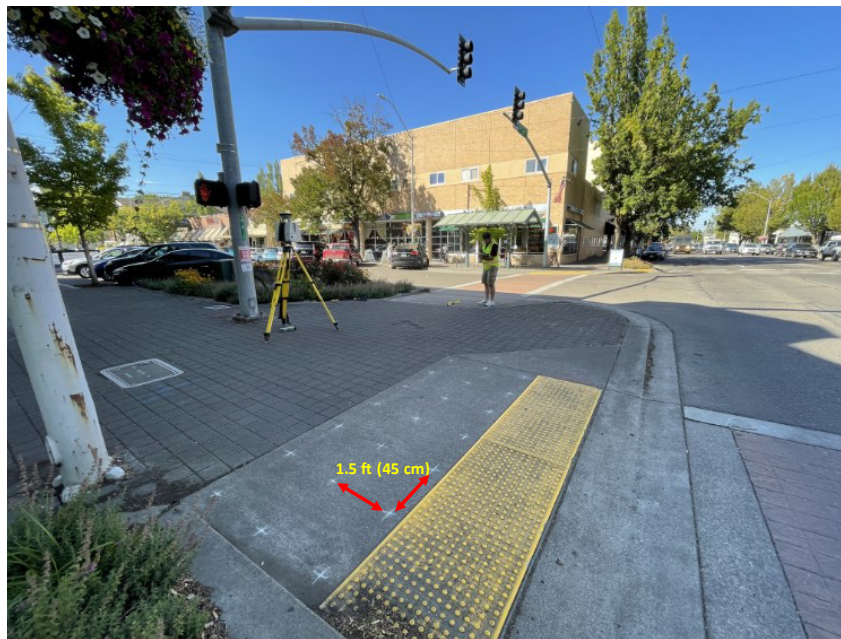
Figure 7.3: Example sampling grid marked with chalk for slope measurements.

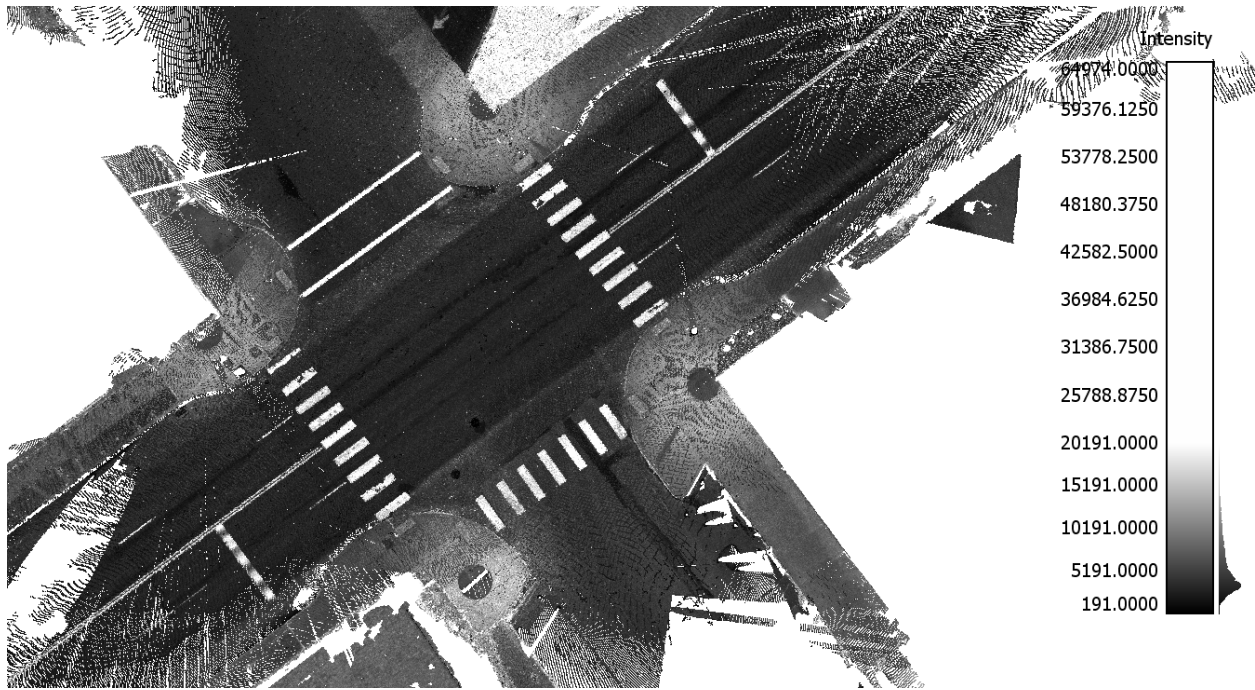
Figure 7.7: Example of the georeferenced terrestrial laser scanning data.
