**PLACEMENT OPTIONS FOR IN-STREET
PEDESTRIAN CROSSING SIGNS**

Final Report

SPR 870

Oregon Department of Transportation

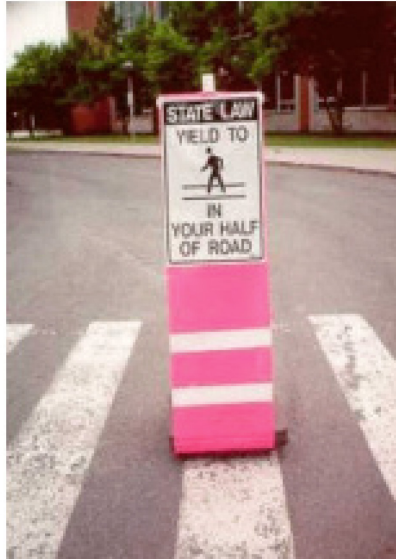
Figure 2.3: Early Version of the In-Street Pedestrian Signs (Huang et al., 2000)

In-street pedestrian signs were first tested in 2000 by Huang et al. for FHWA (Huang et al., 2000). The evaluation consisted of safety cones with a message as shown in Figure 2-3. These signs were tested at 6 sites in New York State and one site in Portland, OR. The study collected pre- and post-treatment data and found that driver yielding increased from 69.8% to 81.2% post treatment across the sites, and the increase in yielding was statistically significant (Huang et al., 2000). The proportion of pedestrians who ran, hesitated, or aborted the crossing decreased but the decrease was not statistically significant.

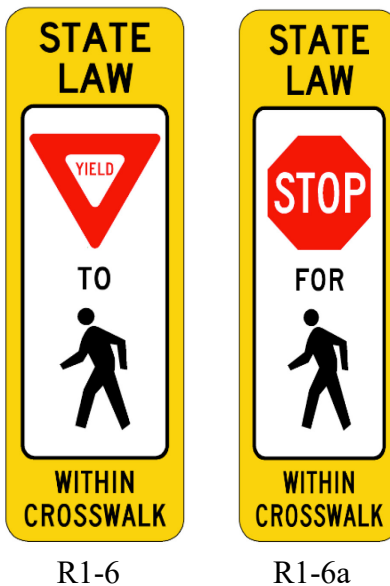
Figure 2.4: In-Street Pedestrian Crossing Signs (FHWA, 2009)

The in-street pedestrian crossing signs (R1-6) were first included in the 2003 edition of the MUTCD. Two versions of this sign exist including the text YIELD TO (R1-6) or STOP FOR (R1-6a) pedestrians in crosswalk depending on the location where they are used and the prevailing laws. MUTCD stipulates that these signs shall not be used at signalized intersections (FHWA, 2009). Oregon law requires that drivers stop and remain stopped at any crosswalk (marked or unmarked) until the pedestrian has cleared the lane the driver is in plus the next lane. Thus, the R1-6a sign is applicable for Oregon. Figure 2-4 shows the R1-6 and R1-6a signs.

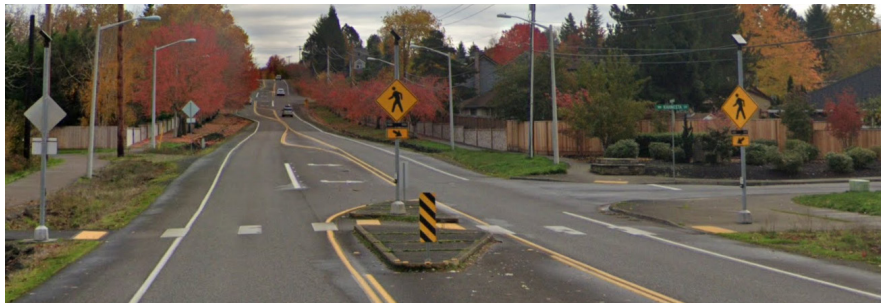
Figure 2.5: RRFB at Rock Creek Trail Crossing on NW West Union Rd.

RRFBs are used at uncontrolled locations to enhance pedestrian safety by incorporating a flash pattern to alert drivers to the presence of pedestrians. RRFBs were first granted interim approval by FHWA in 2008. These are typically activated by pedestrian pushbuttons. shows a RRFB situated at Rock Creek Trail Crossing on NW West Union Rd.

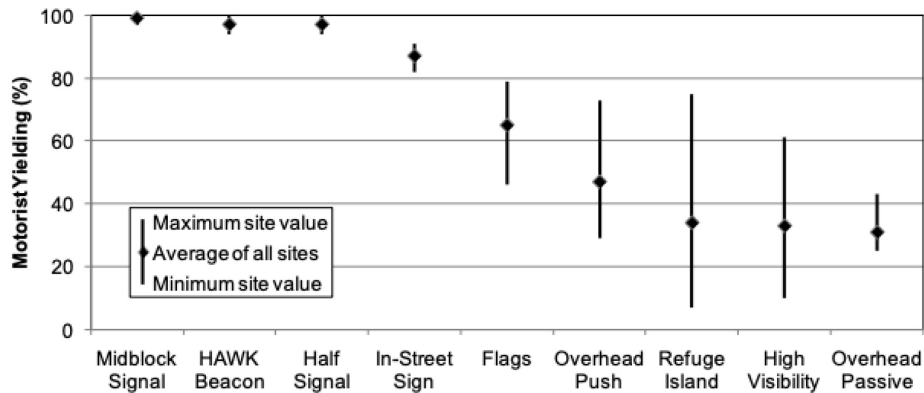
Figure 2.6: Driver Yielding Rates by Countermeasure (FHWA, 2010)

Pedestrian hybrid beacons, also known as High-Intensity Activated CrossWalk (HAWK) were first used in Tucson, AZ in 2000 to enable safe crossings at locations where minor streets intersected with major arterials (Nassi and Barton, 2008). PHBs were included for the first time in the MUTCD in 2009 (FHWA, 2009). Since then, they have been used widely and have been the focus of many research studies evaluating their safety impacts. Fitzpatrick et al. studied motorist and pedestrian behavior at 5 PHB sites in Tucson, AZ using a mixture of staged and naturalistic pedestrians (Fitzpatrick et al., 2006). Their results showed an average yielding rate of 97%, which is in line with yielding rates seen with traffic signals and other beacons as seen in Figure 2-6 (Fitzpatrick et al., 2006).

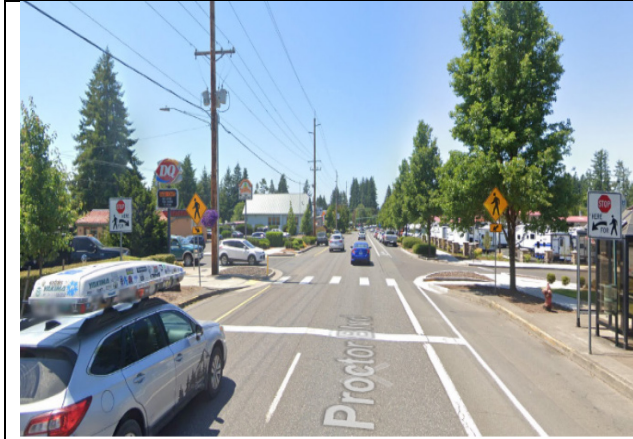
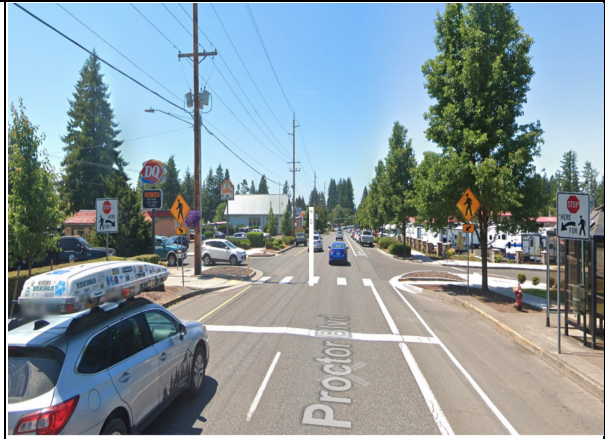
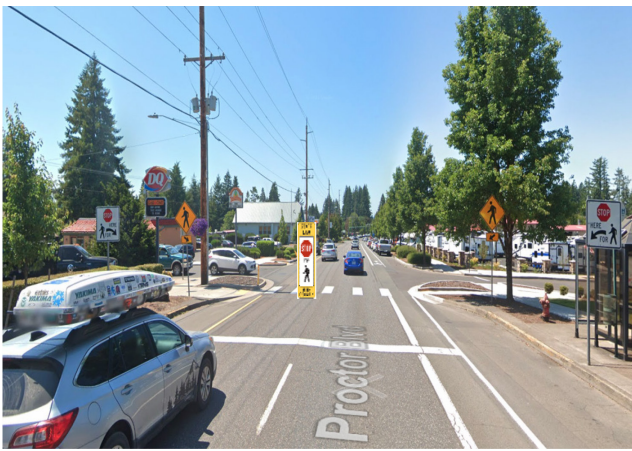
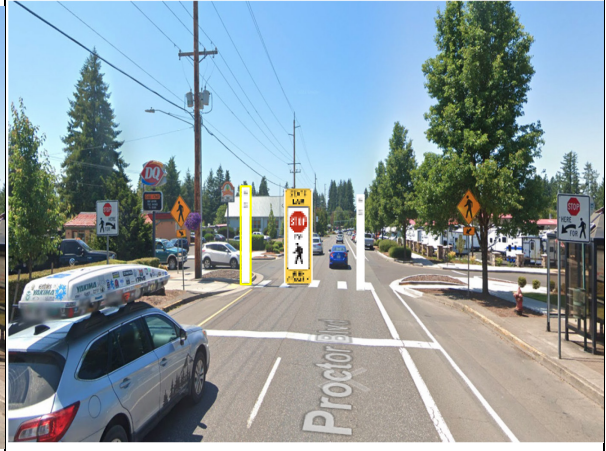
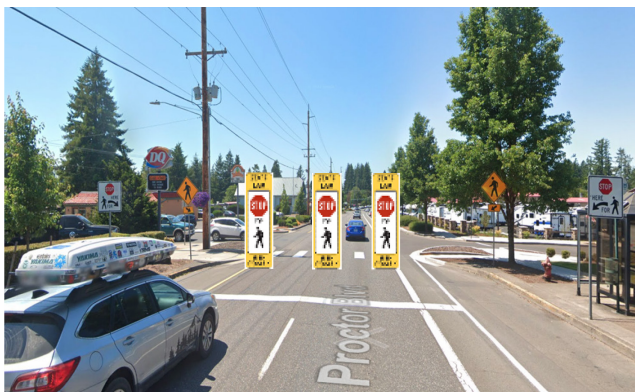
Stage 1 - Baseline condition

(b) Stage 2 – One tubular marker

(c) Stage 3 – One R1-6a sign

(d) Stage 4 – One R1-6a sign and two tubular markers

(e) Stage 5 - Three R1-6a signs

Figure 3.3: Tested Configurations at Proctor Boulevard and Beers Avenue (Sandy)

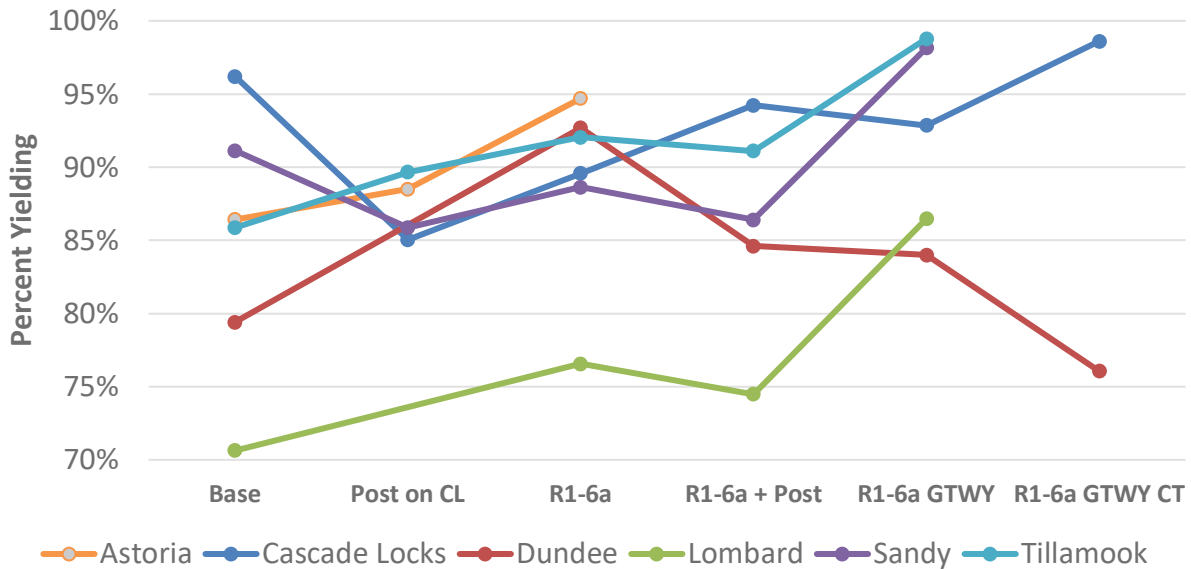
Figure 4.3: Nearside Yielding for All Pedestrian Crossings

Overall, there were 4,634 nearside crossing events observed for pedestrians crossing at the six locations. These included instances where the drivers yielded, did not yield or where the pedestrians had no interaction with a vehicle while crossing. The no interaction events were removed, which resulted in a total of 3,054 crossing events for analysis, which included both staged and naturalistic pedestrians. Table 4.4 shows the yielding proportions for nearside crossings for all pedestrians. Overall across all stages, yielding rates were high (i.e., greater than 90%), except at two locations (Lombard and Dundee). Figure 4.2 and Figure 4.3 show the yielding rates by stage at each location.

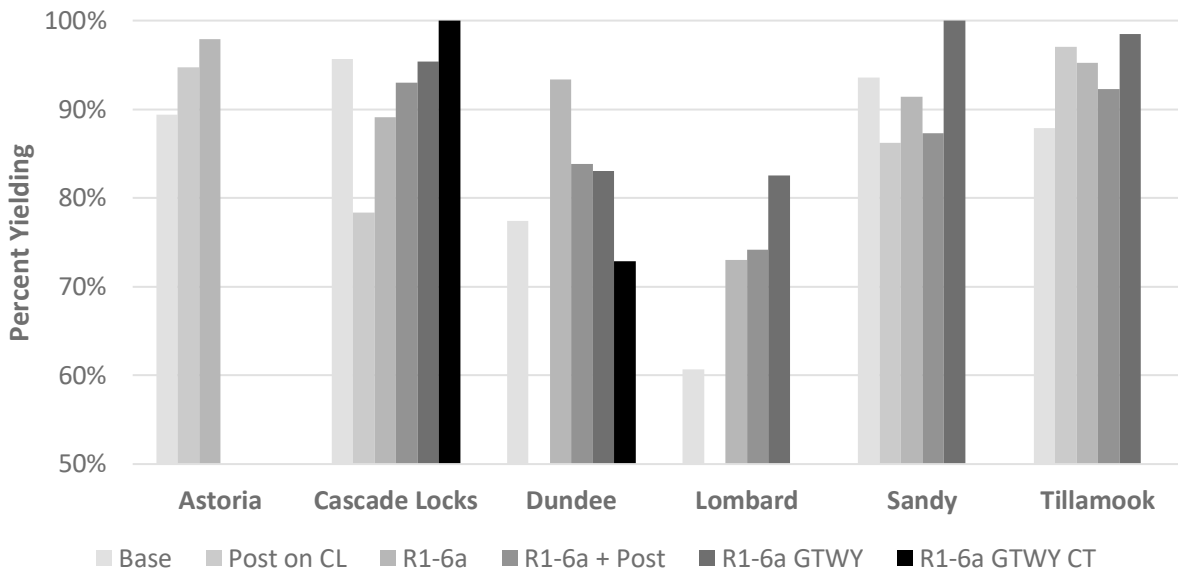
Figure 4.4: Nearside Yielding for Staged Pedestrian Crossings

Overall, there were 1,718 crossing events which involved a staged pedestrian interacting with a vehicle (yield, no yield) at the six locations. Table 4.6 shows the yielding rates for staged pedestrian crossing nearside. These yielding rates closely mirrored the overall yielding rates seen for all pedestrian crossings. At four locations (Astoria, Cascade Locks, Sandy, Tillamook), overall yielding rates across all stages for staged pedestrians were greater than 90%. Similar to the trend seen for all pedestrian crossings, yielding rates for Lombard and Dundee locations were lower compared to the other sites. Figure 4.4 shows the nearside yielding rates for staged pedestrian crossings at all sites.

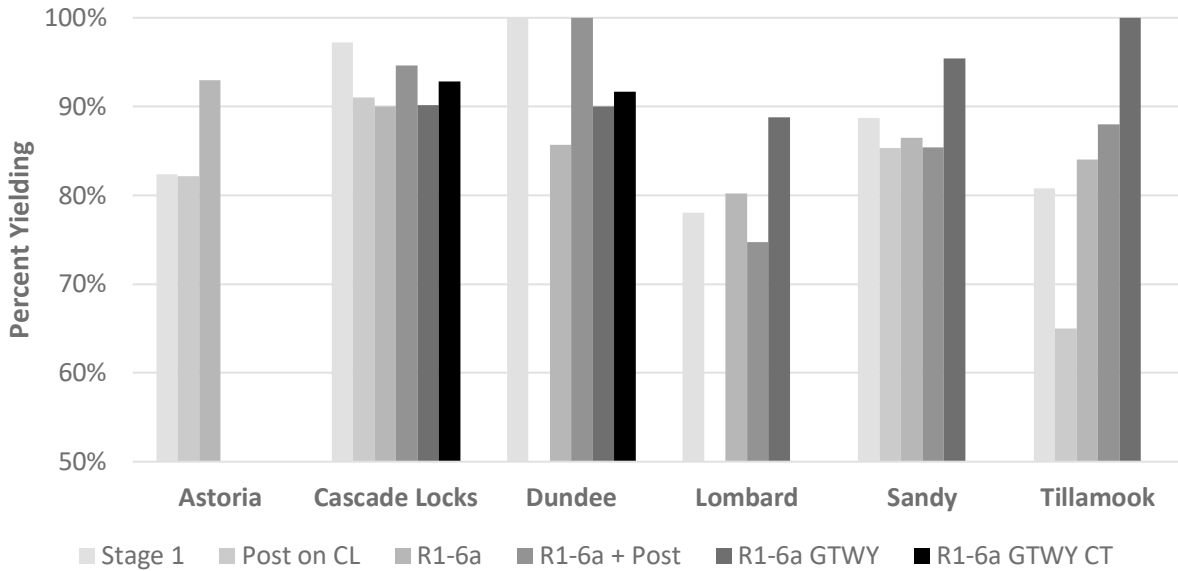
Figure 4.5: Nearside Yielding for Naturalistic Pedestrian Crossings

Overall, there were 1,336 nearside crossing interactions observed for naturalistic pedestrian crossings at the six locations. These included instances where the drivers yielded and did not yield. Table 4.8 shows the yielding proportions for nearside crossings for naturalistic pedestrian crossings. In general, the overall yielding rates observed for naturalistic crossings were lower at four locations (Astoria, Cascade Locks, Sandy, Tillamook) than for staged crossings and higher at two locations (Lombard, Dundee). Figure 4.5 shows the yielding rates by stage at each location.

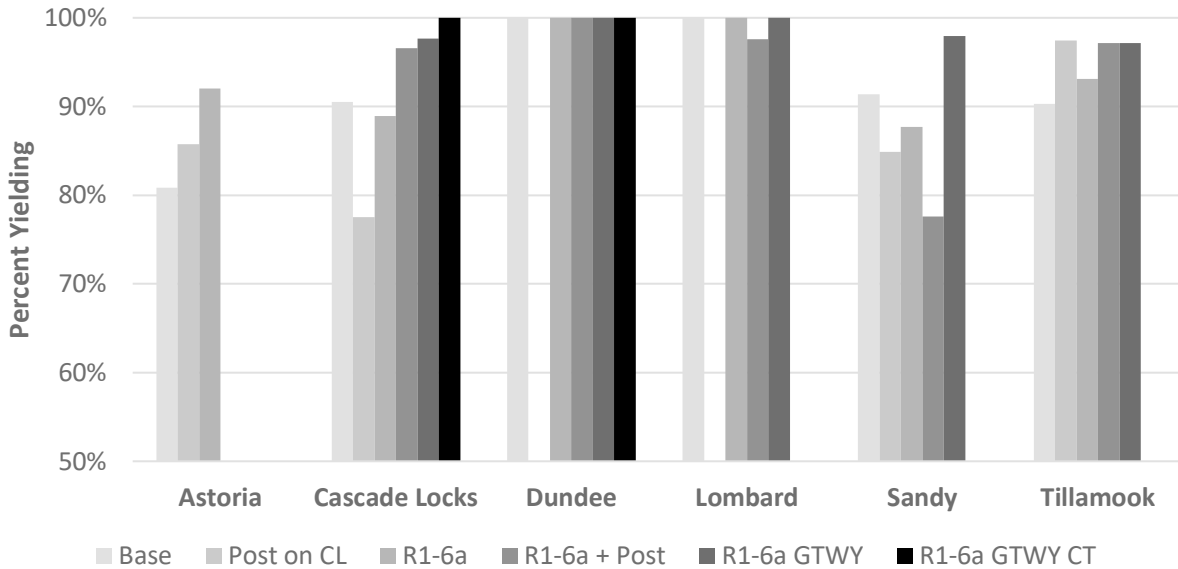
Figure 4.8: Farside Yielding for Staged Pedestrian Crossings

Overall, there were 1,249 crossing events which involved a staged pedestrian interacting with a vehicle (yield, no yield) at the six locations. Table 4.12 shows the yielding rates for staged pedestrian crossings nearside. These yielding rates closely mirrored the overall yielding rates seen for all pedestrian crossings. At four locations (Astoria, Cascade Locks, Sandy, Tillamook), overall yielding rates across all stages for staged pedestrians were greater than 90%. Figure 4.8 shows the nearside yielding rates for staged pedestrian crossings at all sites.

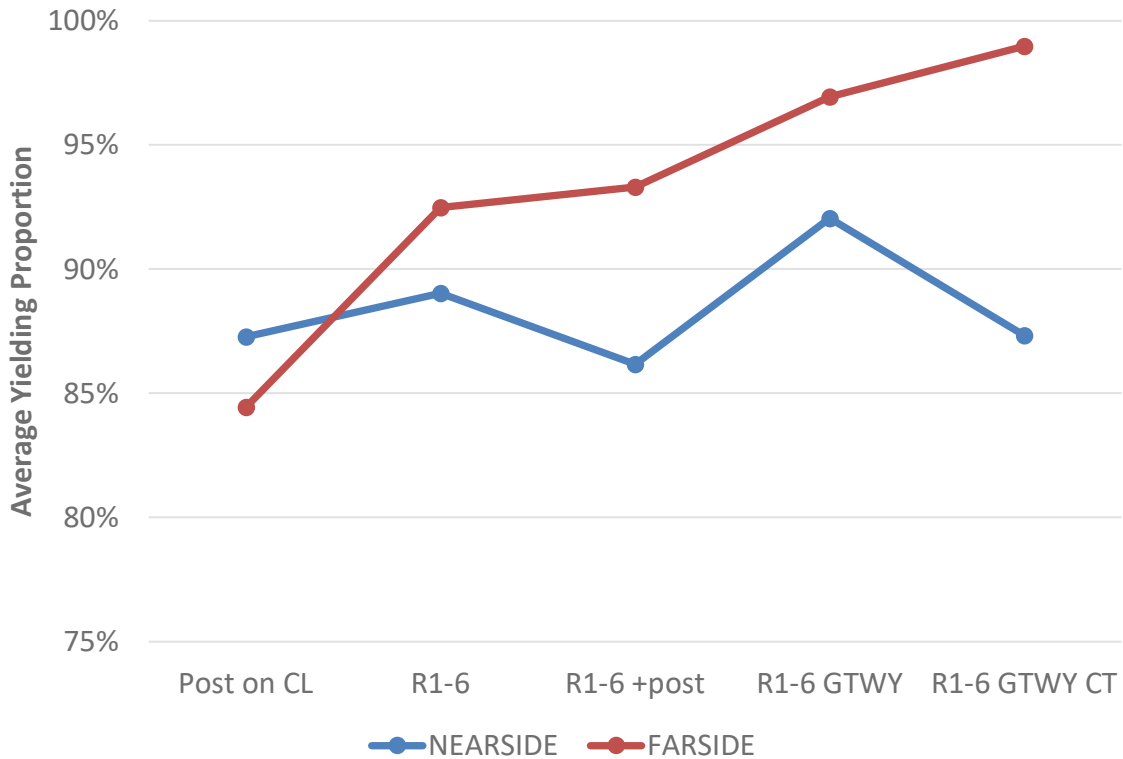
Figure 4.10: Average Yielding Proportion by Treatment for Nearside and Farside Crossings

Table 4.17 shows the average yielding proportions by treatment type across all locations for nearside and farside crossings. The use of tubular markers/posts alone produced 87% and 84% yielding for nearside and farside crossings respectively. Note that the tubular markers/posts alone were not used at the locations with a median island (Dundee, Lombard). Introducing one R1-6a sign increased the average yielding proportions to 89% and 92% for nearside and farside crossings respectively. This indicates that the addition of a single in-street crossing sign is favorable for yielding and produces higher yielding rates than the tubular marker/post alone. The addition of tubular markers/posts on the edge lines to supplement the existing center R1-6a sign produced some mixed results with yielding decreasing nearside and increasing slightly farside when compared to proportions seen with just the one R1-6a sign alone, indicating that the addition of the tubular markers/posts is not beneficial in increasing the yielding proportions. A previous study found that when the most vulnerable signs in the gateway configuration (i.e., the sign in the center) was replaced by a fluorescent traffic post or tubular marker, average yielding decreased compared to the gateway using only R1-6 signs (Bennett and Van Houten, 2015). The highest average yielding proportions across all locations were observed when three R1-6a signs were used in the gateway configuration, mirroring previous research findings (Bennet et al., 2014). When the edge signs were placed on the curb top, results were mixed with yielding lower nearside and higher farside when compared to the rates observed when all three signs were placed in the roadway. However, the yielding rates with this configuration were still similar or higher than the other treatments studied (tubular marker/post alone, one R1-6 sign, one R1-6 sign with tubular markers/posts in a gateway configuration) except for the stage when the gateway configuration included all three signs.

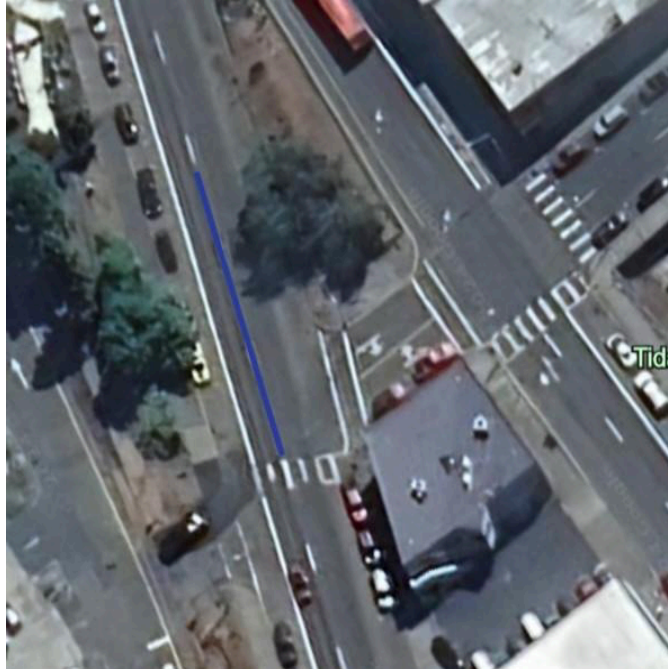
Figure 7.2 Marine Dr. and 15th St.(One-way)

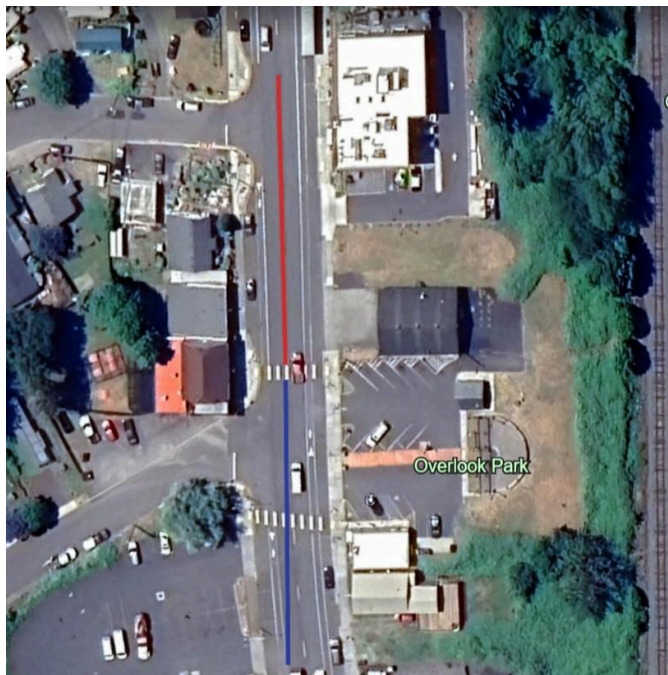
Figure 7.3 Wa Na Pa St. and Regulator St. (Two-way)

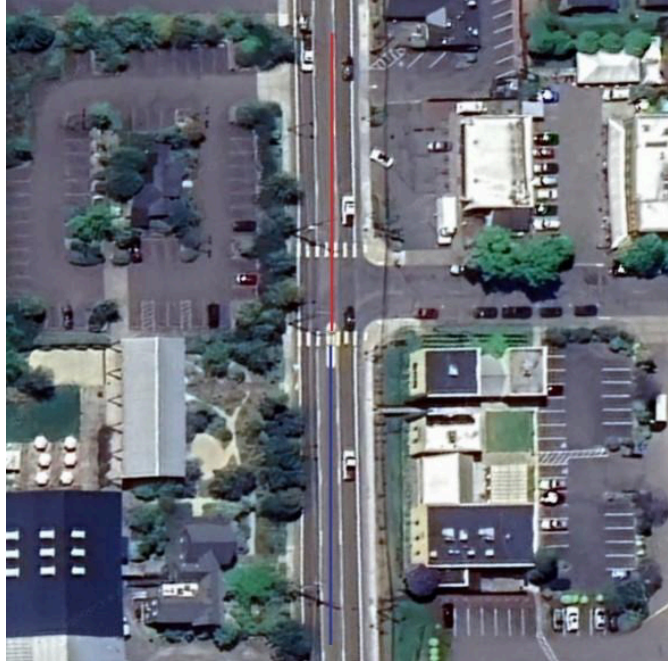
Figure 7.6 OR 99W and 7th St. (Two-way)
