Local Agency Bridge Scour Program

ODOT/OACES Bridge Maintenance Workshop

Presented by: Holly Winston, PE | Senior Local Bridge Standards Engineer April 2023

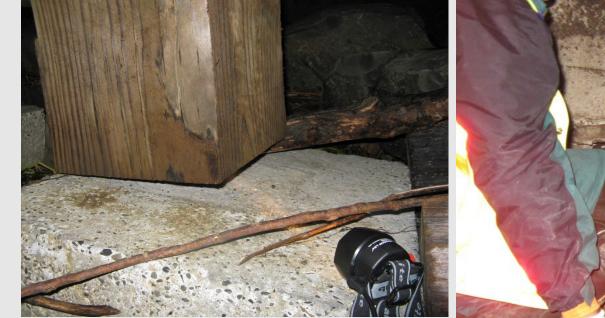
Field observation of the footing vulnerability

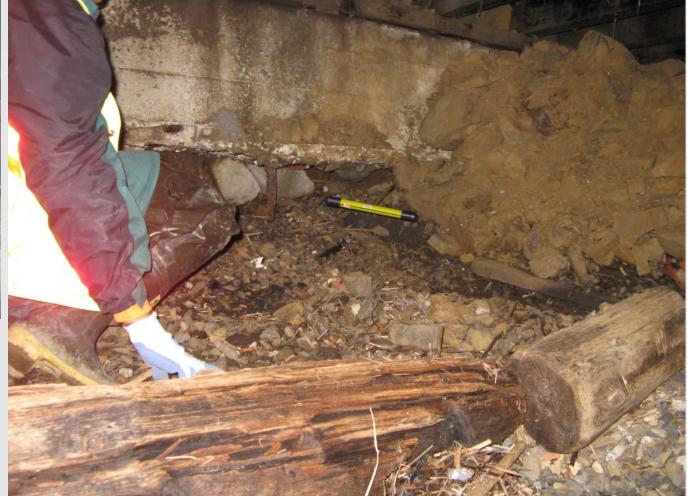
Debris between column & footing

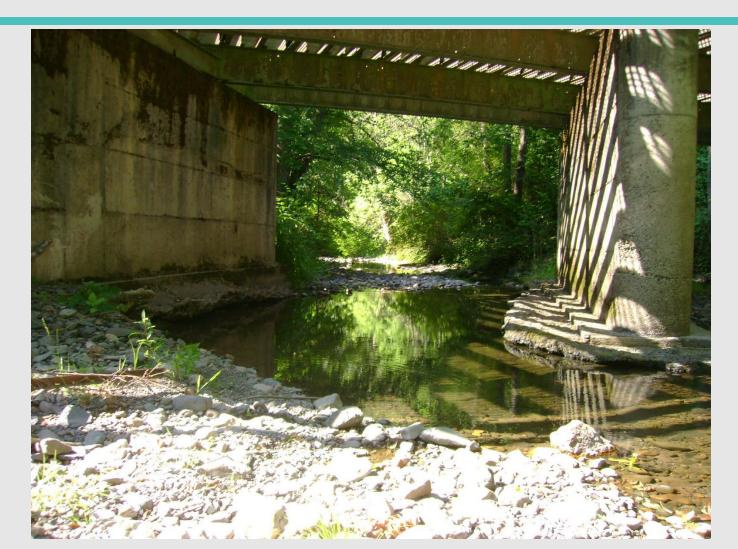
What Plan of Action Needed – provide riprap

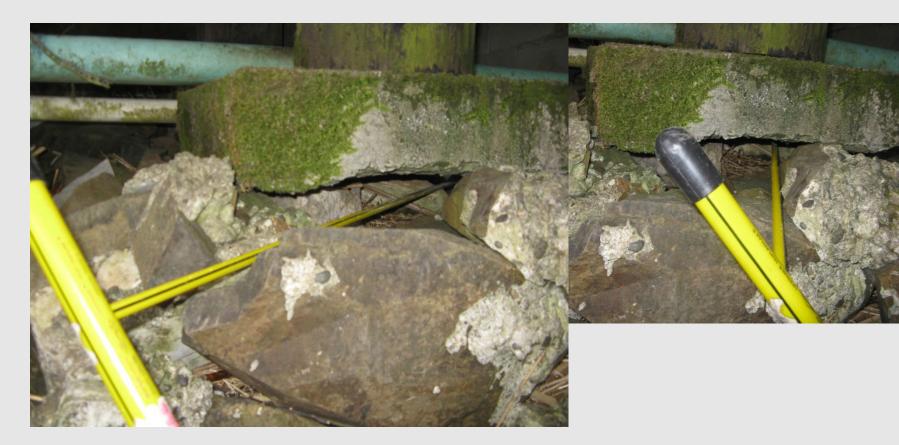
Loss of bearings
