# Memorandum

Project# 270030.003

RE: McLoughlin Investments Strategy – Road Safety Audit “Lite” Summary

## ROAD SAFETY AUDIT “LITE” SUMMARY

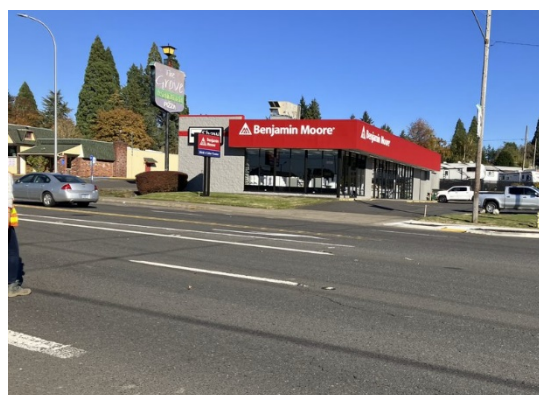
During the site visits, the team identified multiple existing mid-block and intersection crossing locations along the corridor with a center refuge median but no additional signing, striping, or enhancements highlighting the pedestrian crossing. There were also crossings without a center refuge median provided. At these crossings, the team observed that many vehicles failed to yield to pedestrians waiting to cross and noted that crossing was overall

uncomfortable at these unenhanced locations. Many pedestrian and bicycle crashes recorded in the crash data and presented during the RSA Kick-Off meeting also involved people crossing at non-enhanced crossing locations. It was discussed that even at existing crossings with rectangular rapid-flashing beacons (RRFBs), some team members felt uncomfortable while crossing because it was hard to tell if approaching vehicles were going to stop. Additionally,

- Enhance crossings with one, or a combination of:
  - Additional crosswalk striping (ex: continental striping)
  - Additional signs in the refuge median
  - Enhanced treatments, preferably red devices (pedestrian hybrid beacon or signal)
- Provide street lighting placed before pedestrian crossings to light the pedestrian
- Reduce crossing spacing by providing enhanced crossings at the following locations:

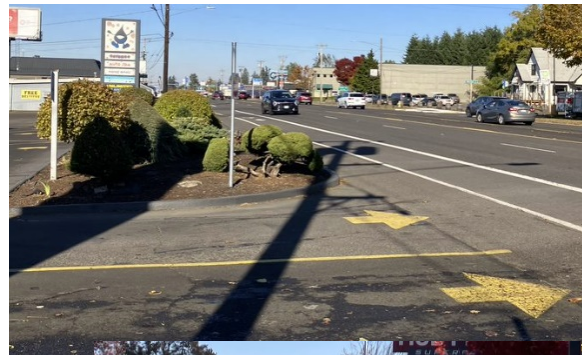
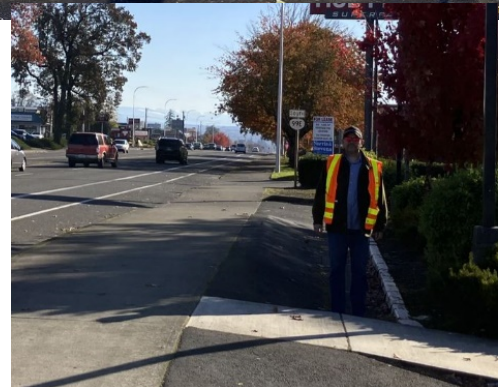
One of the key issues the team observed was multiple existing sidewalk gaps along the corridor. Pedestrians in these locations generally walked on the side of the road or through an adjacent parking lot. Additionally, the team noted the sidewalk was narrow in areas and there were many locations with ADA issues (non-ADA compliant ramps and driveways and steep slopes adjacent to the sidewalk with no barrier). There are also many existing driveways along the corridor which are very wide and sometimes undefined. These undefined or wide driveways create more opportunities for conflict points and allow for faster turns into and out of driveways, creating safety and comfort challenges for people walking and biking.

- Fill in existing sidewalk gaps
- Provide wider sidewalks (i.e., 8 feet per Clackamas County Transportation System Plan [TSP]) and a landscape buffer, where possible
- Narrow, define, and delineate driveway widths

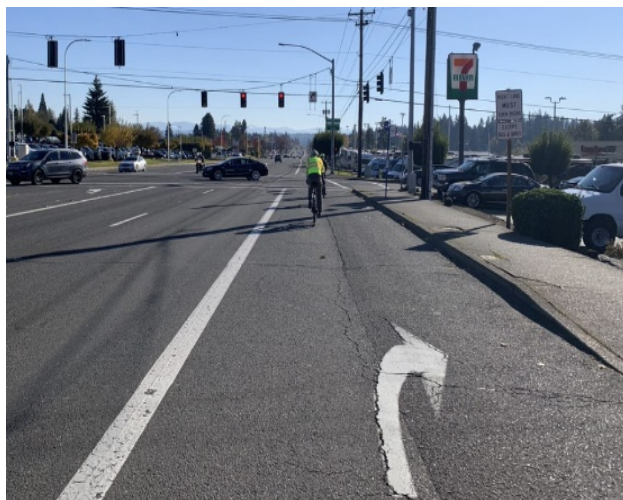
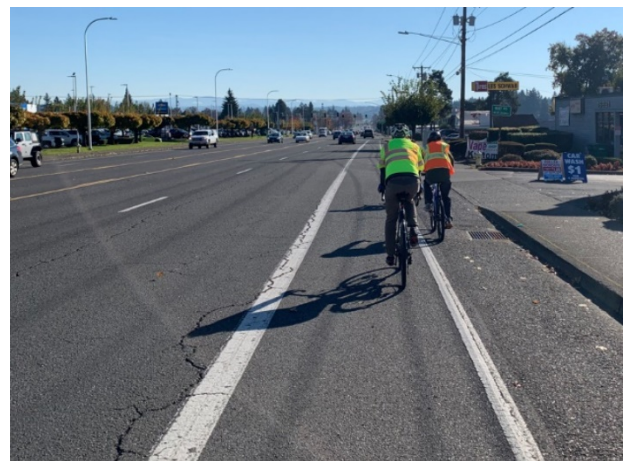
A group of the RSA team biked the corridor during the site visits. Their key observation was that biking along the corridor felt overall uncomfortable due to the narrow bike lanes with no physical vertical separation from the high speed and volumes traffic. They also

noted poor pavement condition, a lack of maintenance within the existing bike lanes, as there was quite a bit of glass and other debris within the bike lane, and undesirable grid inlets in the travel path. The team also noted that the bike lane striping is inconsistent throughout the corridor. In some locations

there is no buffer, others there is a buffer between the bike lane and motor vehicle traffic, others there is a buffer between the bike lane and curb, and at most signalized intersections the bike lane becomes a shared lane with right turning traffic.

- Restriping to provide buffered bike lanes along the entire corridor and add physical vertical separation (ex: Tuff-Curb) where driveways do not exist

- Provide bike-friendly stormwater inlets
- Remove existing right-turn lanes at intersections to provide continuous bike lanes to and through the intersections
- Provide high visibility green skip striping at intersections and evaluate need for bike boxes to support left turns onto and from side streets. Side streets with bicycle facilities should be prioritized for the addition of bike boxes.

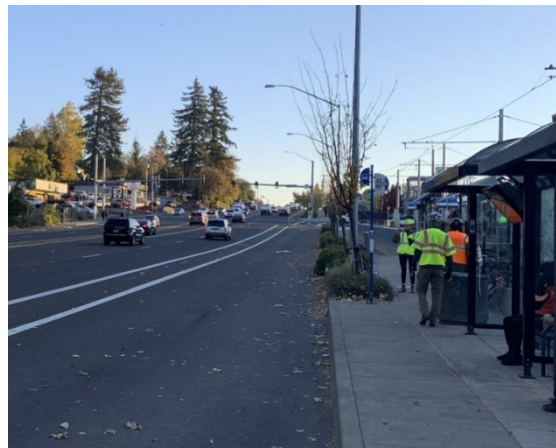
One major transit observation from the site visits was the large number of people waiting for the bus along the corridor during every site visit, which reinforced to the team that transit use along the corridor is high and is consistent with the high TriMet ridership data along this segment. A few key transit issues include inconsistencies with the pull out versus in-lane bus stops along the corridor, (recognizing this not only impacts vehicles, but bikes along the corridor). Additionally, there were stop locations without a covered waiting area. At the Park Avenue intersection in particular, the team noticed pedestrians running across McLoughlin Boulevard without waiting for a walk signal when they saw their bus or train arriving. The team also noted long signal lengths at that signal and others along the corridor.

- Consider queue jumps at targeted intersections (ex: Concord, Roethe, Courtney, and Oak Grove intersections) and other enhanced transit corridor recommendations
- Consider transit signal priority opportunities
- Add bus shelters along the corridor
- Create consistent bus pull outs along the corridor or drop speeds to 35 mph to allow for buses to stop in lane
- Evaluate the potential consolidation of the Lakewood transit stop, or improve access to the existing bus stop

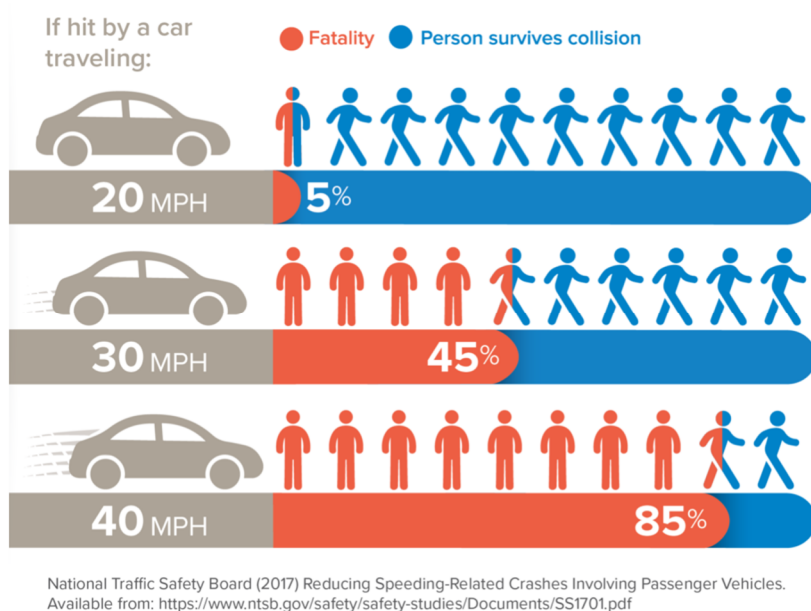
Figure 1: Likelihood of Pedestrian Fatality Compared to Vehicle Speed

The team noticed higher vehicle speeds along the corridor, particularly near the Clackamas River Bridge and at the north end of the corridor heading southbound from Milwaukie approaching the Park Avenue signal. It was discussed that higher speeds in these areas and along the entire corridor impact the safety and comfort of people walking and biking along the corridor. As seen in Figure 1, there is a much higher likelihood that a pedestrian will survive a crash when a driver is travelling 30 mph than 40 mph. In general, the team observed that speeds seemed to stay relatively consistent throughout the day and night. Speeds did not seem to drop during the weekday PM peak hour or increase much at night after traffic volumes dropped as in seen in some other corridors.

- Consider landscape medians at locations without conflicting access points or driveways (for example, just north of Park Avenue)
- Install speed feedback signs at strategic locations
- Implement automated speed enforcement (would require partnership with local police, i.e., Gladstone Police Department)
- Reduce travel lane widths to 11 feet to encourage slower speeds
- Work towards lowering speed on McLoughlin Boulevard to 35 mph by adding speed management treatments. It is noted other proposed solutions, such as adding a vertical bike lane buffer will also contribute to speed reduction.

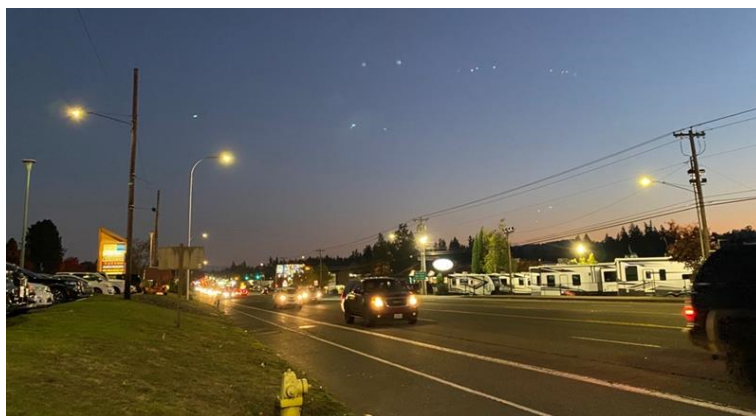
The team identified inadequate lighting at the southern end of the corridor, particularly along the Clackamas River Bridge. It is noted that Clackamas County has completed lighting infill along their section of the corridor, however the segment within the City of Gladstone (MP 10.3, Glen Echo Avenue to 11.2, the Clackamas River Bridge) has inconsistent lighting. Additionally, the team noticed no lighting on the east side of McLoughlin north of Park Avenue. Ambient lighting from businesses along the corridor made it difficult for people driving to see people crossing the roadway. The RSA team also observed that the existing street lighting at current RRFB locations do not always highlight the correct side of the pedestrian crossing, resulting in back lighting.

- Improve lighting within Gladstone, along the Clackamas River Bridge, and on the east side of McLoughlin Boulevard north of Park Avenue
- Implement advanced lighting at all intersections and crossings along the corridor

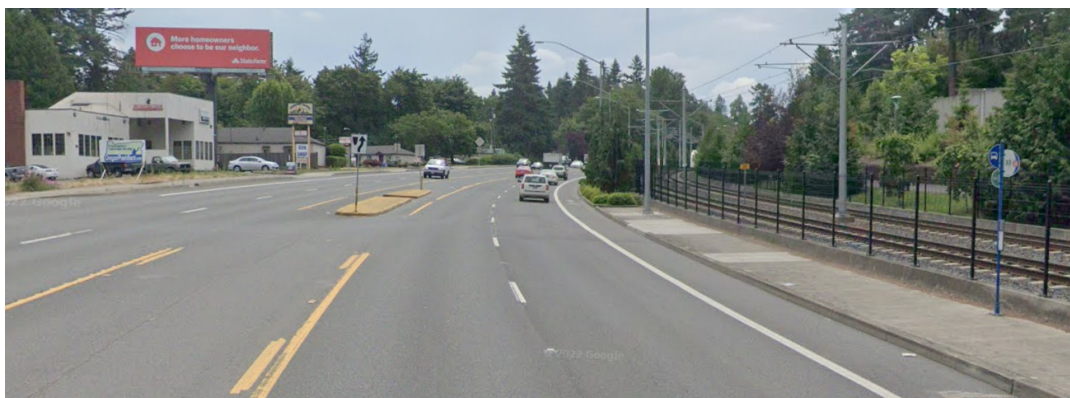
The team discussed the need for improvements at or consolidation of the existing transit stop at Lakewood Drive, located at the north end of the corridor. The existing bus stop (serving southbound trips) currently has no sidewalk connections or pedestrian crossing to support access to the transit stop.

- Provide an enhance pedestrian crossing to connect to the bus stop
- Consider consolidating this bus stop with the existing stop at Park Avenue, as boarding and alighting data indicates that this stop is not utilized frequently. TriMet data from 2017-2021 reports a weekday average of 6 riders using this stop (2 boarding/4 alighting).

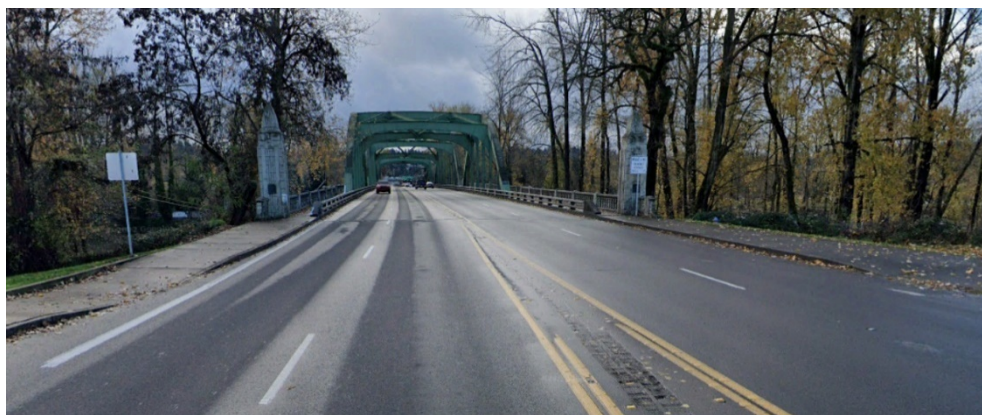
The team identified multiple safety issues around the Clackamas River Bridge and the McLoughlin Boulevard signalized intersection with Arlington Street and River Road at the southern end of the study corridor. One issue is the existing sidewalk on the bridge is very narrow, potentially narrower than 3.5 feet in pinch point locations. There are no bike lanes on the bridge, forcing bikes to use the sidewalk or share the travel lanes. Most bicyclists were observed biking on the bridge sidewalks, indicating that it is more comfortable to ride on the narrow, shared sidewalks than in the travel lane. It was also noted that the bridge does not have any lighting and was therefore very dark at night, and the team noticed that some vehicles seemed to be traveling faster than the 40mph speed limit over the bridge.

Finally, a major conflict location was identified on the north side of the bridge between people driving and biking. For bikes traveling northbound (using the shared pedestrian/bike sidewalk on the east side of the bridge), there is an existing ramp down from the sidewalk that conflicts with an existing northbound right-turn lane entrance that serves local development and Arlington Road.

- Extra delineation for bike ramp onto bridge and additional signage to indicate that bicyclists may use sidewalk
- Actuated flashing “Bikes on Bridge” beacon
- Multi-use path or wide sidewalk from bridge to intersection with Arlington Street to accommodate people biking northbound or removal of the right turn lane northbound at Arlington (see below)
- Additional lighting on bridge

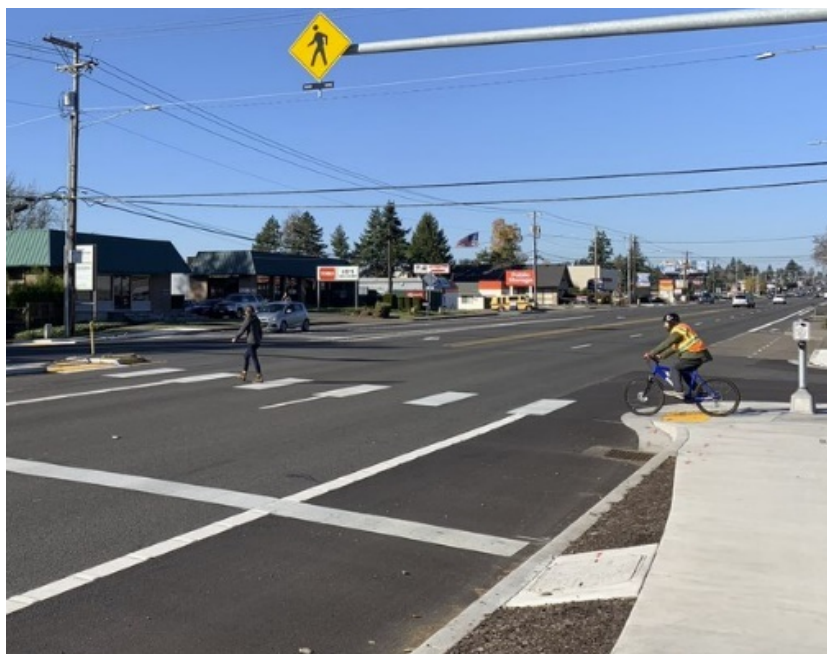
- At the transit stop north of Park Avenue, unless the transit stop is removed
- Between Park Avenue and Courtney Avenue
- Between Courtney Avenue and Oak Grove Boulevard
- At Risley Avenue (Proposed RRFB in 2024-2027 STIP)
- At Meldrum Avenue (Proposed RRFB in 2024-2027 STIP)
- Between Glen Echo Avenue and Gloucester Street

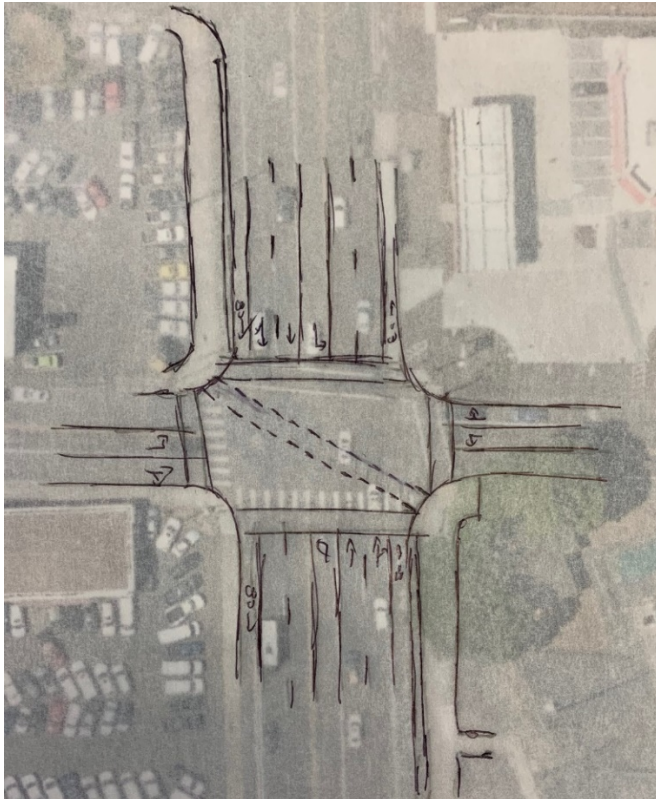
**Alternative 1: Diagonal Bike Signal**

- Provide improved wayfinding to the Trolley Trail
- Install a diagonal bike signal to provide a direct route across the intersection for people biking
- Add enhanced crosswalk striping to emphasize trail connection
- Add protected intersection treatments
- Formalize the sidewalk connections for two-way biking and walking travel from the intersection to the trail

The team sketched these potential intersection alternatives, which are provided below.

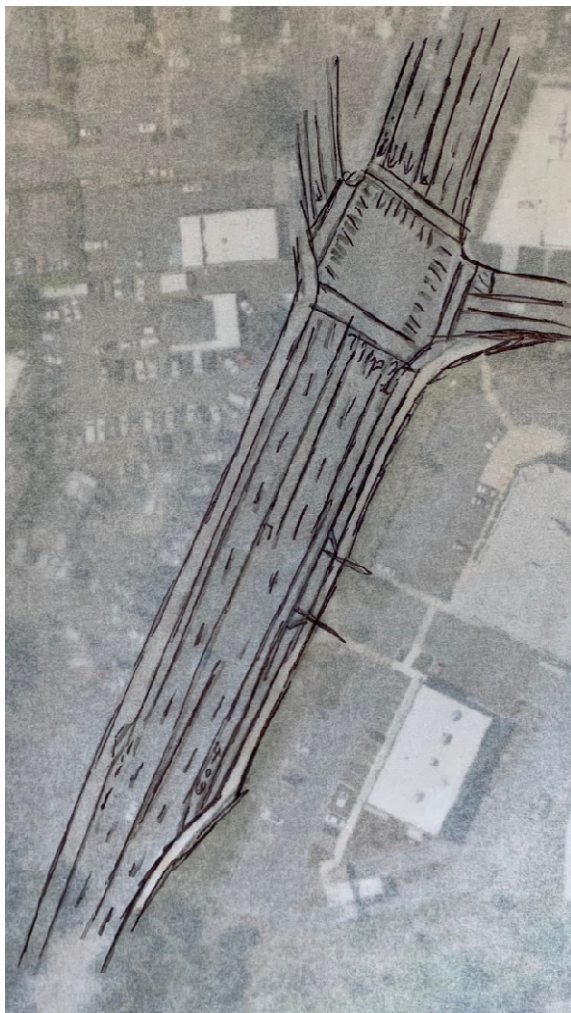
### Alternative 1: Remove Exclusive Right Turn Lane

Potential solutions to the bicycle conflict between the intersection and bridge are provided below.
