OR 39 South Sixth Street Facility Plan

TM#3.2 – Land Use and Transportation System Inventory

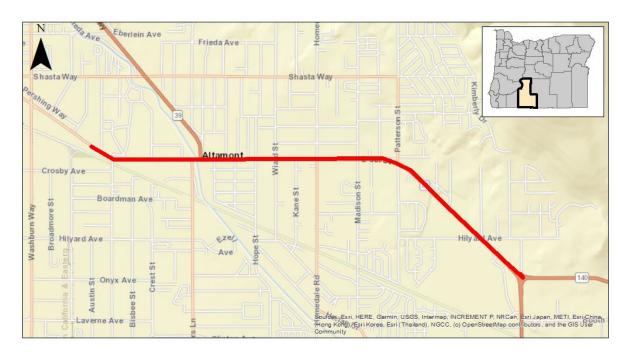
Figure 1: Project Area Map

The study area for the Facility Plan is OR 39 from the border of Klamath Falls to the intersection of OR 39/OR 140 (Figure 1). The corridor project limits are approximately 3 miles long.

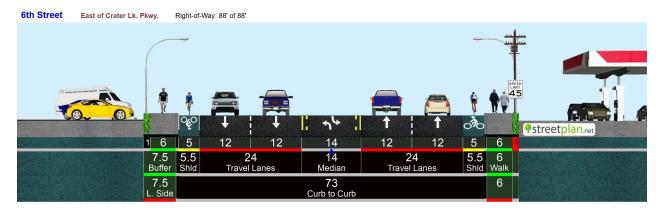
Figure 3 OR 39 General Cross Section: East of Crater Lake Parkway

Shoulders are ACP and 6' or wider from MP 2.3 to MP 3.28, and are only 4'-5' from MP 3.28 to MP 5.5, and are striped as bike lanes. Shoulders have drainage inlets throughout as curb or curb/gutter also persist throughout the study limits. Figure 2 and Figure 3 show general cross sections on OR 39 east and west of the Crater Lake Parkway intersection.

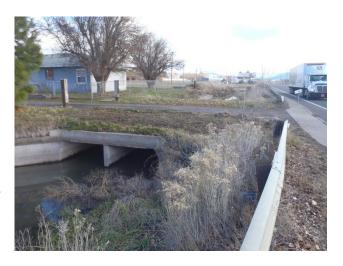
Figure 6: Bridge Structure BR 13579

- Structure is located just west of the intersection of Hwy 20 and Hwy 50.
- The culvert carries a frontage road over the Enterprise Irrigation Canal.
- o The culvert was built in 1972.
- This is culvert is a cast in place reinforced concrete box culvert, that consists of two- 8' spans that are 4' tall and an estimated 40' in length.
- The road going over the canal appears to lead to a private property.
- There are no observed issues with the culvert.

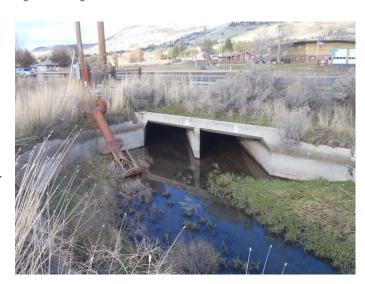
Figure 7: Bridge Structure BR13587

- BR13587 HWY 20 at MP 5.19
 - Structure is located just west of the intersection of Hwy 20 and Hwy 50.
 - The culvert carries Hwy 20 over the Enterprise Irrigation Canal.
 - The culvert was built in 1972.
 - This is culvert is a cast in place reinforced concrete box culvert, that consists of two-8' spans that are 4' tall and an estimated 140' in length.
 - There are no observed issues with the culvert.

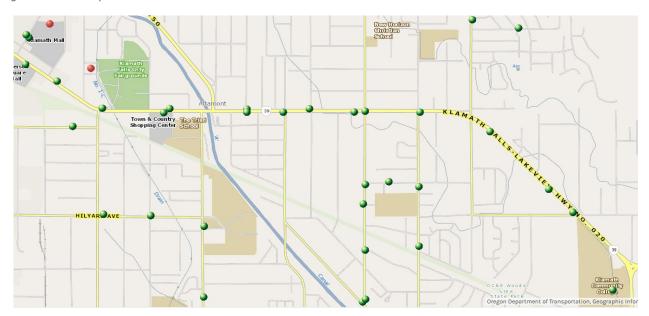
Figure 8: Transit Stop Locations on OR 39

The project area has several fixed transit routes passing through with service provided by the Modoc County Sage Stage, Klamath Tribes Quail Trail Bus service, and regular service by Basin Transit Service. The Sage Stage Klamath Falls – Alturas bus service operates one deviated fixed-route service in each direction once-a-week on Thursdays, with no fixed stops along the project corridor (but pickups/drop-offs within one mile of the route are allowed if scheduled in advance). The Klamath Tribes Quail Trail Bus service also operates along ODOT's OR39/S Sixth St corridor as a fixed-route service. There are no Quail Trail stops directly on the corridor but there are stops at the Klamath Falls Senior Center ~850' from OR39/S Sixth St north on Arthur St (at the west end of the segment) and Sherm's Thunderbird Market, a quarter mile west of the project segment. Figure 8 shows all transit stops in and near the OR 39 corridor.

Basin Transit Service is the local Transportation District that provides fixed route service to the Klamath Falls area, with Route 1 and Route 2 running along the project corridor and fixed paired stops spaced roughly 2,000' apart along both sides of the highway. Basin Transit has a large stop at the Fairground Transit Center/Altamont station near the Altamont Dr intersection and, similar to the Quail Trail service, Basin Transit also has a fixed stop at the Klamath Falls Senior Center ~850' north of the project.

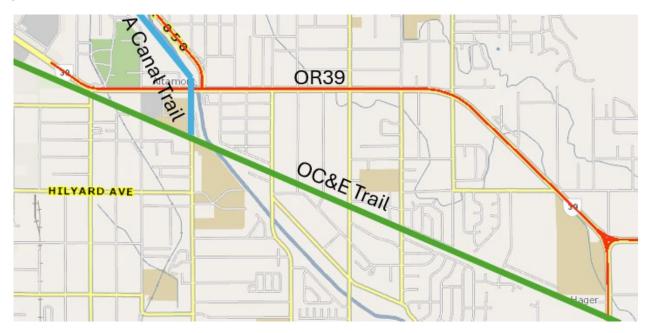
The OC&E Trail runs east-west diagonally roughly parallel to but varying in distance from OR39/S

Sixth St by ~150' at Altamont Drive, ~4,000' at Patterson Street, and 2,000' at OR140. Figure 9: OC&E Trail

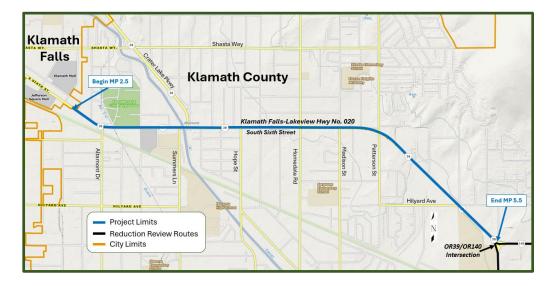
Figure 10: OR 39 Project Limits and Location of Reduction Review Routes

Although the project section of OR39 is a NON – Reduction Review Route (NON - ORS366.215), if permanent features, such as raised medians/barriers/curbs or structures over the highway are proposed as new or modify existing features that reduce the width or height across/over the highway, ODOT policy is to share the proposed design impacts with the Mobility Advisory Committee (MAC) for feedback. Depending on level of impact in reducing vehicle carrying capacity or 'hole in the air,' the action may be shared and documented via email (low/moderate) or presented and shared at a MAC meeting (high). The *Mobility Advisory Committee Charter Appendix C* provides criteria in determining level of impact.

The intersection of OR39/OR140 (eastern project limit) is subject to ORS366.215 – Reduction of Vehicle Carrying Capacity as an identified reduction review route. If permanent features, such as raised medians/barriers/curbs or structures over the highway are proposed as new or modify existing features that reduce the width or height across/over the highway, will require presenting proposed design to the MAC Stakeholder Forum for record of support to ensure compliance with the ORS366.215 statute.

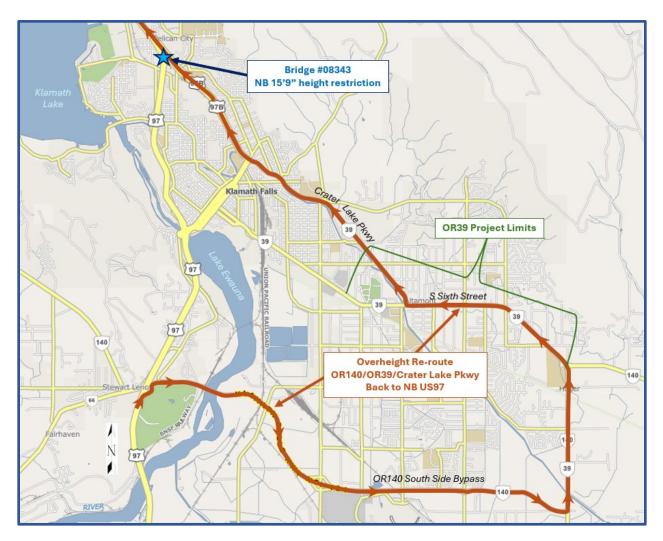
Figure 11. Location of Bridge Height Restriction and NB Overheight Re-Route

In addition, the Southbound Bridge structure #08343 at MP 272.8 (Hwy 50 SB over Hwy 4 NB – aka Shilo Bridge) on the north end of Klamath Falls has a height restriction for loads over 15'9" travelling Northbound on US97. CCD policy is to re-route over-dimension loads by keeping on State highways as much as possible. Therefore NB US97 loads over 15'9" re-route to OR140 Southside Bypass/OR39/Crater Lake Pkwy and back to US97 Northbound. Figure 11 shows the location of the bridge and the northbound re-route. Mobility Services Team provided a 5-year permit summary from 2020 – 2024 which found a total of 3 permits (modular unit, rock drill and loader) that used this OR140/OR39 re-route due to the height restriction.

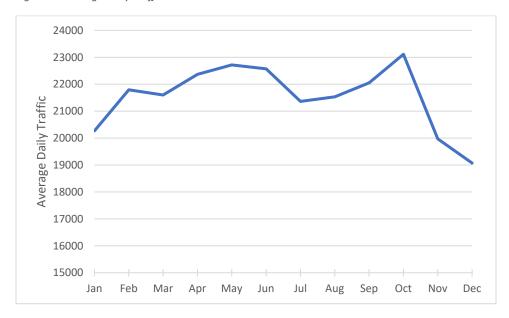
Figure 17 Average Daily Traffic in 2022

Figure 17 presents 2022 Average Daily Traffic for ATR 18-018. While the ATR is on Crater Lake Parkway, it is reasonable to assume that South 6^{th} Street would have a similar volume profile due to similar roadway origin/destination travel patterns.

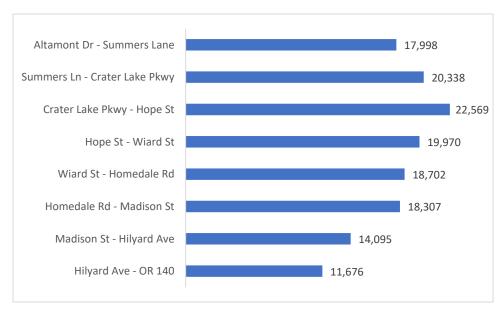
Figure 18 South 6th Street AADT (2023)

Figure 18 presents 2023 AADT along the corridor from the ODOT TransGIS database, which shows that the segment between Crater Lake Parkway and Hope is the busiest section of the facility with an AADT of 22,569.

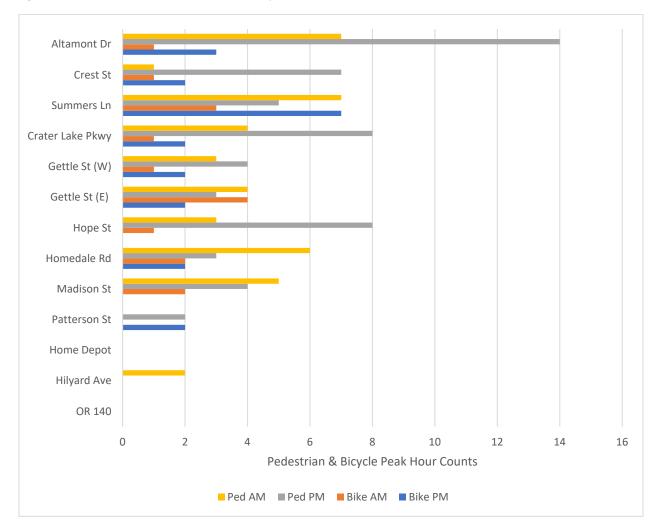
Figure 19 AM and PM Peak Hour Pedestrian and Bicycle Counts

Figure 19 presents pedestrian and bicycle counts for the AM and PM peak hours, which demonstrates moderate pedestrian and bicycle activity along the corridor in both the AM and PM peak hours.

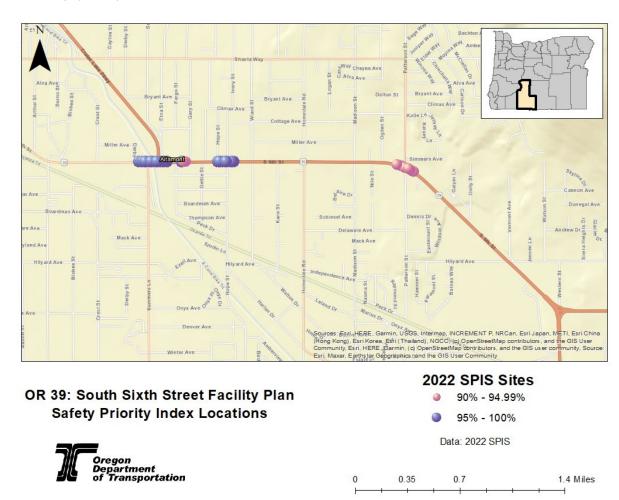
Figure 20: State Safety Priority Index Locations

- 95th percentile for 2021-2022 from MP 3.13 to MP 3.45 (west of Derby St to east of Gary St)
- 90th percentile for 2021 from MP 3.46 to 3.53 (east of Gary St to east of Gettle St)
- 95th percentile for 2022 from MP 3.53 to 3.70 (east of Gettle St to west of Wiard St)
- 90th percentile for 2022 from MP 4.42 to 4.59 (east of Ogden St to east of Patterson St)

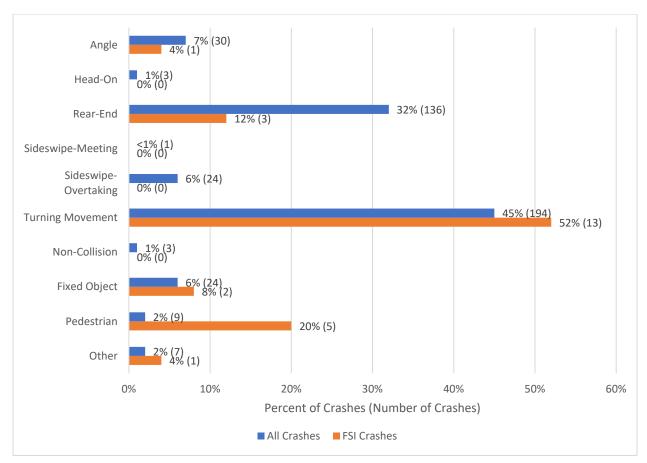
Figure 21 Crashes by Crash Type

Figure 21 provides an overview of crashes by crash type for the corridor, comparing the distribution of crash type by all crashes and by FSI crashes. As shown, turning movement crashes were the most common crash type along the corridor for both all crashes (45%) and FSI crashes (52%). Rear-end crashes were the second most common crash type for all crashes (32%) but made up only 12% of FSI crashes. Pedestrian crashes were 2% of all crashes but were the second most common FSI crash type (20%). Angle, sideswipe-overtaking, and fixed object crashes were present along the corridor, but were significantly overshadowed by rear-end, turning, and pedestrian crashes. Head-on, sideswipe-meeting, non-collision, and other crashes were infrequent crash types.

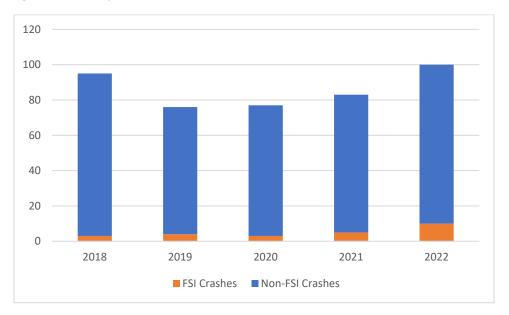
Figure 22 Crashes by Year

Figure 22 presents crashes by year, which shows that 2022 was the worst year for both all crashes and FSI crashes. Years 2018 through 2021 experienced three to five FSI crashes a year; Year 2022 experienced 10 FSI crashes.

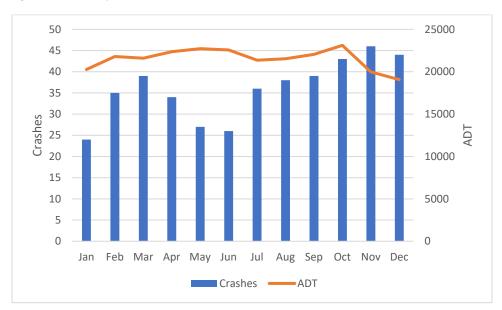
Figure 23 Crashes by Month

Figure 23 presents crashes by month with ADT overlayed, which shows that there is not a correlation between traffic volume and crashes by time of year given high volumes months such as May and June were among the lowest crash months while high crash months such as November and December were among the lowest volume months. Given January was also a low crash month, its unlikely there's a correlation between crashes and either weather or sunlight. The following presents a summary of roadway conditions and lighting conditions:

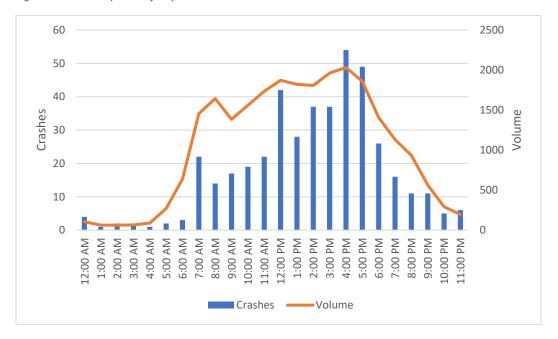
Figure 24 Crashes by Time of Day

Figure 24 presents crashes by time of day overlayed with a sample of traffic volumes. Both crash and volume profiles share a similar pattern, suggesting that crashes are correlated with traffic volumes by time of day.

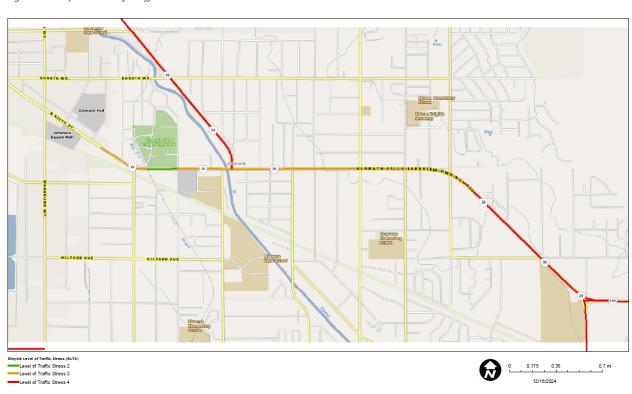
Figure 25 Bicycle Level of Traffic Stress

Striped bike lanes are provided on OR 39. The bicycle facilities appear to be in fair to good condition, there is no marked parking along the facility, and the bike lanes are between 5 and 10 feet in width along the study area. Figure 25 shows the BLTS scores for sections of the study area. For the majority of the study area the BLTS rating is a 3, it does become a BLTS 4 when the speed of the facility increases to 45 mph.
