INNER POWELL BOULEVARD

SE 9th to I-205 State of Good Repair Study

Final Report | December 2019

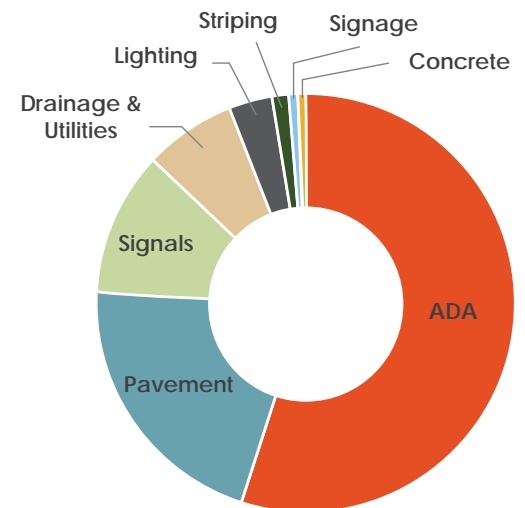
Figure 4. Breakdown of estimated costs by corridor element. ADA costs are approximately 57% of the total base cost estimate.

The estimated total cost to achieve a state of good repair on Inner Powell, including program costs and contingencies, is approximately \$30,837,557 (in 2019 dollars). The cost is subject to change depending on construction year. The breakdown of costs is shown in Table 2 and Figure 4. As shown in Table 2 and Figure 4, ADA costs are approximately 57% of the total base cost estimate.

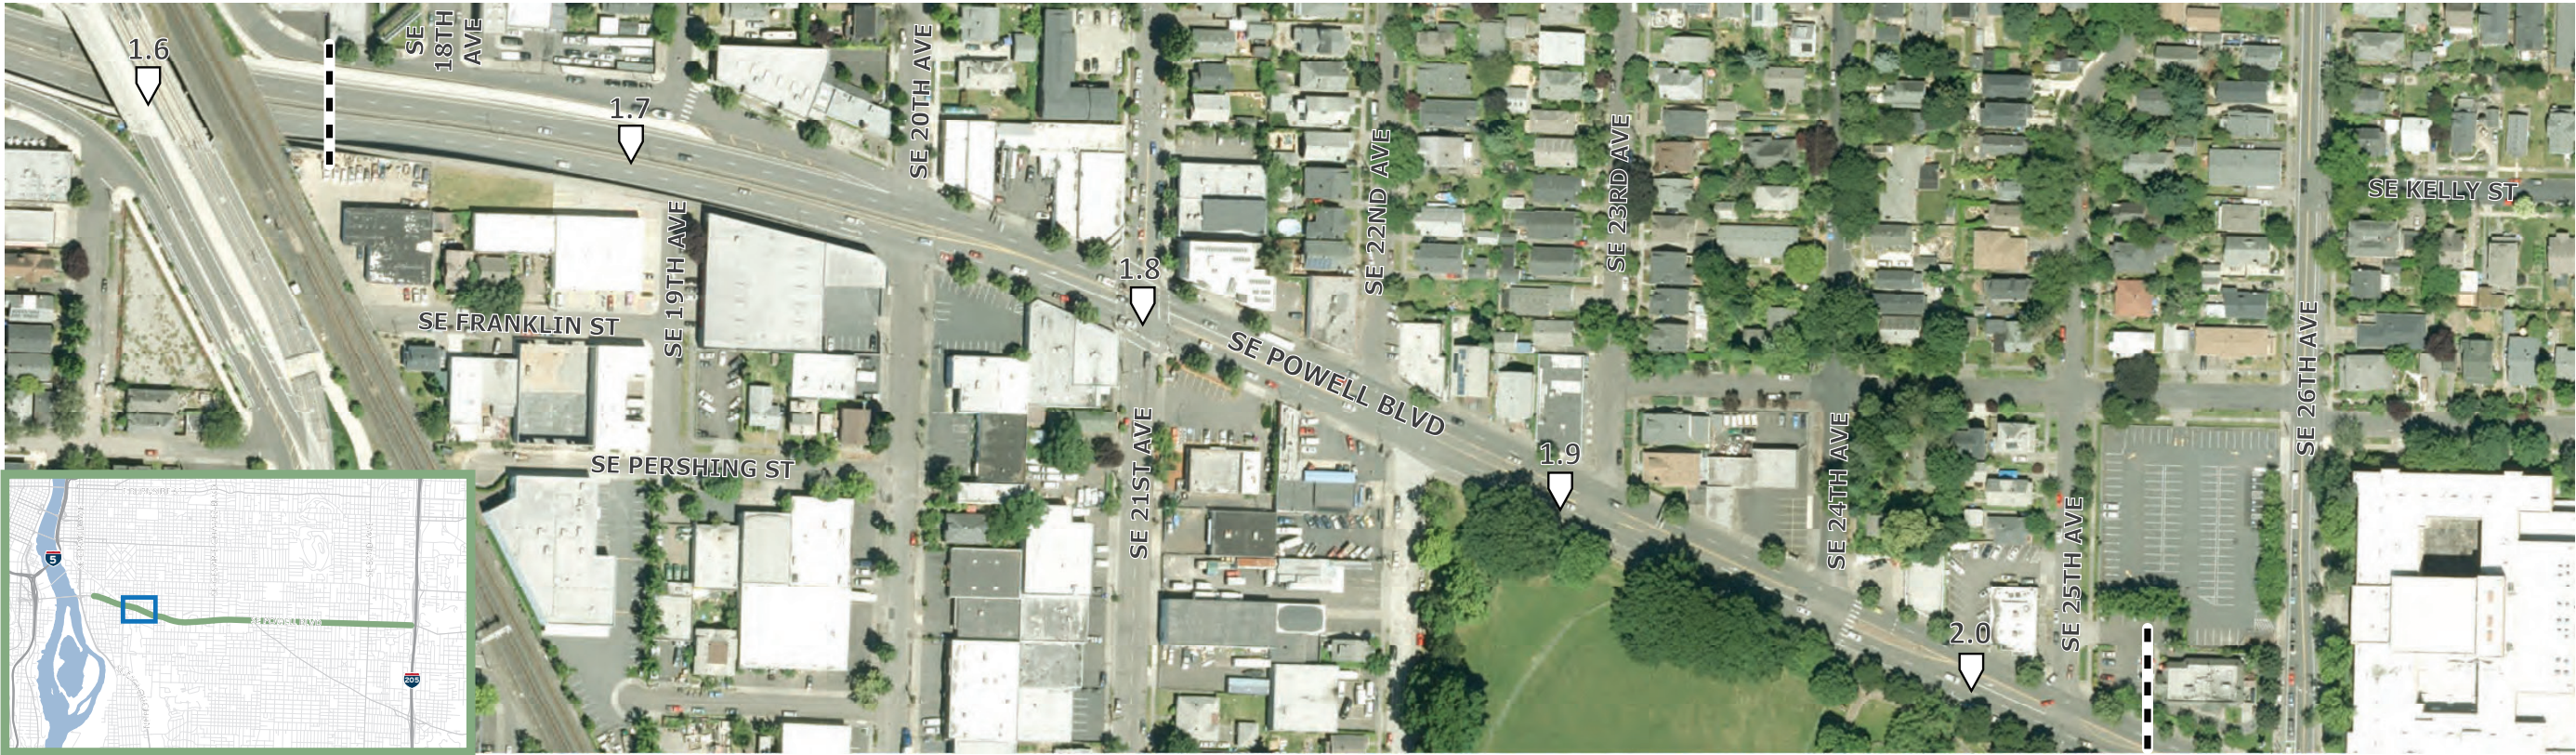
Pavement	Signals	Signage	Lighting	ADA Pushbuttons and Curb Ramps	Sidewalks and Concrete Median Curbs
Poor, reconstruct pavement	Poor, replace with new 12" aspect and wiring system as needed	Poor, replace with new sign(s)	Poor, install new light pole(s), luminaires and wiring system as needed	Poor, replace ramp	Fair, repair median curb
Fair, resurface pavement	Intersection requires full replacement	Poor, replace sign support		Poor, replace pedestrian pushbuttons	
		Fair, replace sign support			
		Fair, replace with new sign(s)

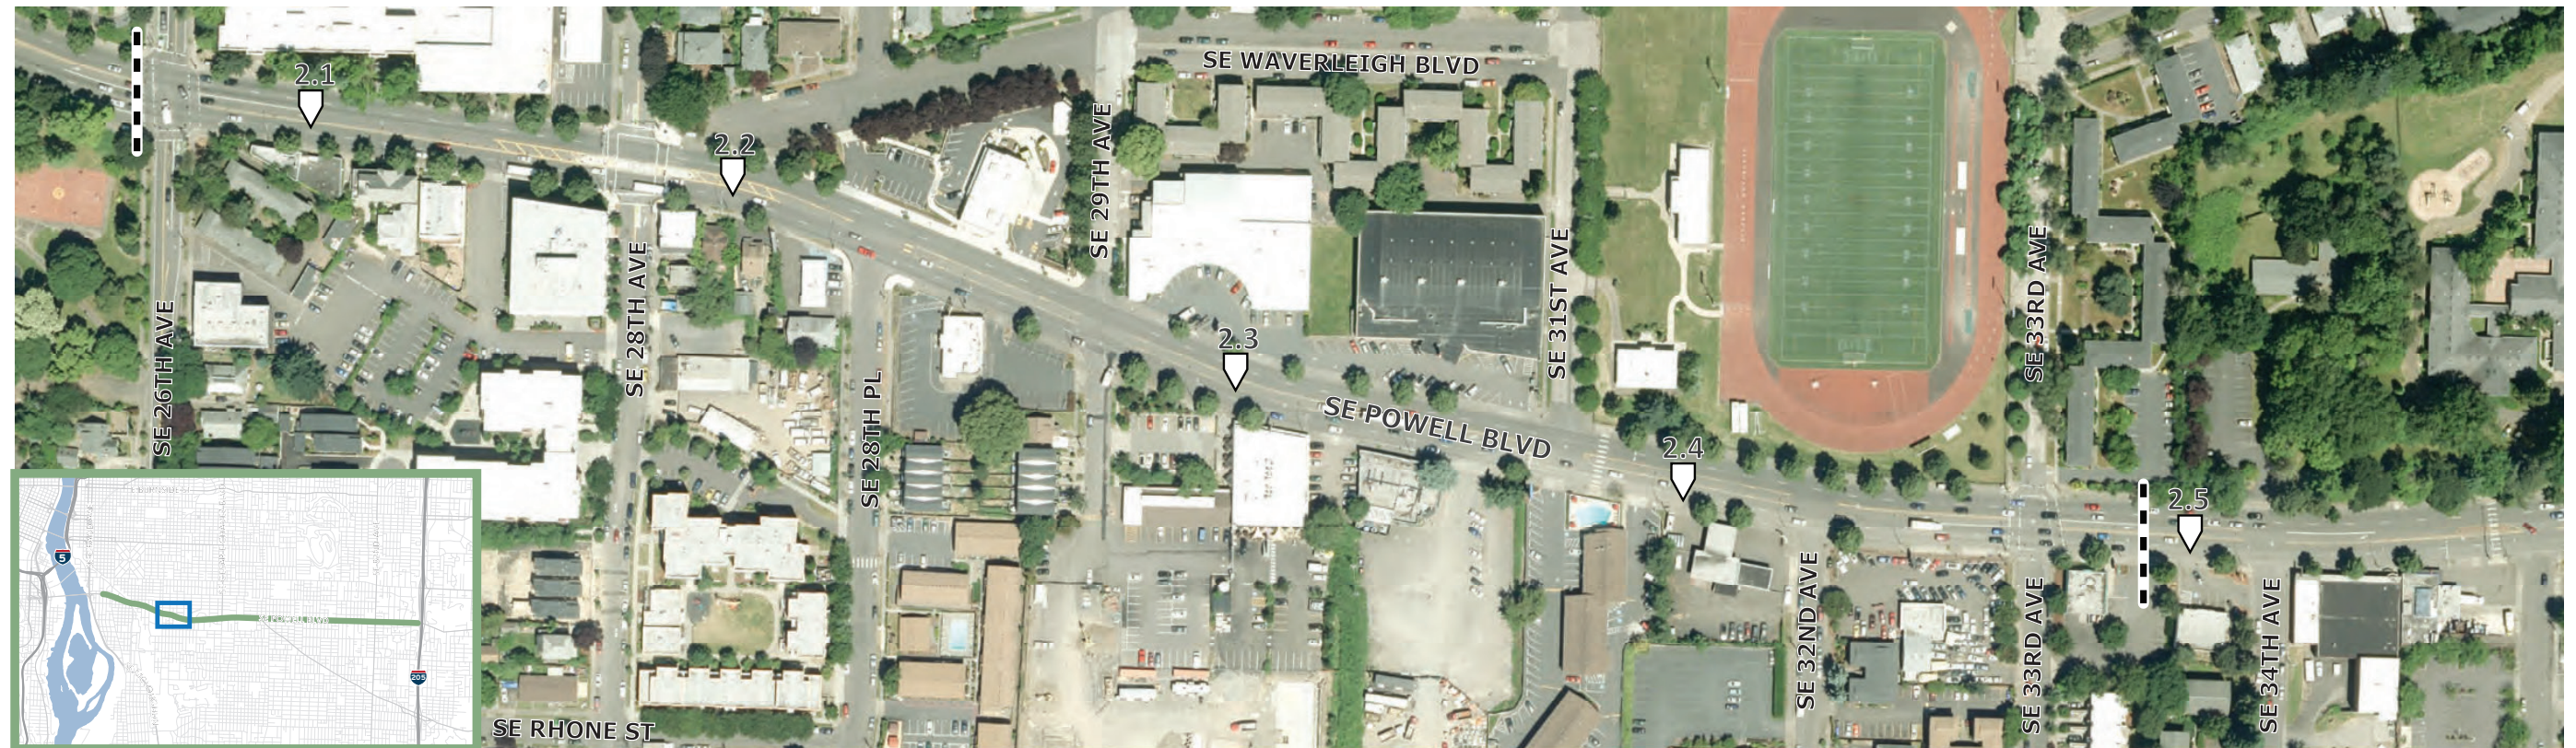
Pavement	Signage	ADA Pushbuttons and Curb Ramps
Poor, reconstruct pavement	Poor, replace with new sign(s)	Poor, replace ramp
Fair, resurface pavement	Poor, replace sign support	Poor, replace diagonal ramp with 2 ramps
	Fair, replace with new sign(s)	Poor, replace pedestrian pushbuttons

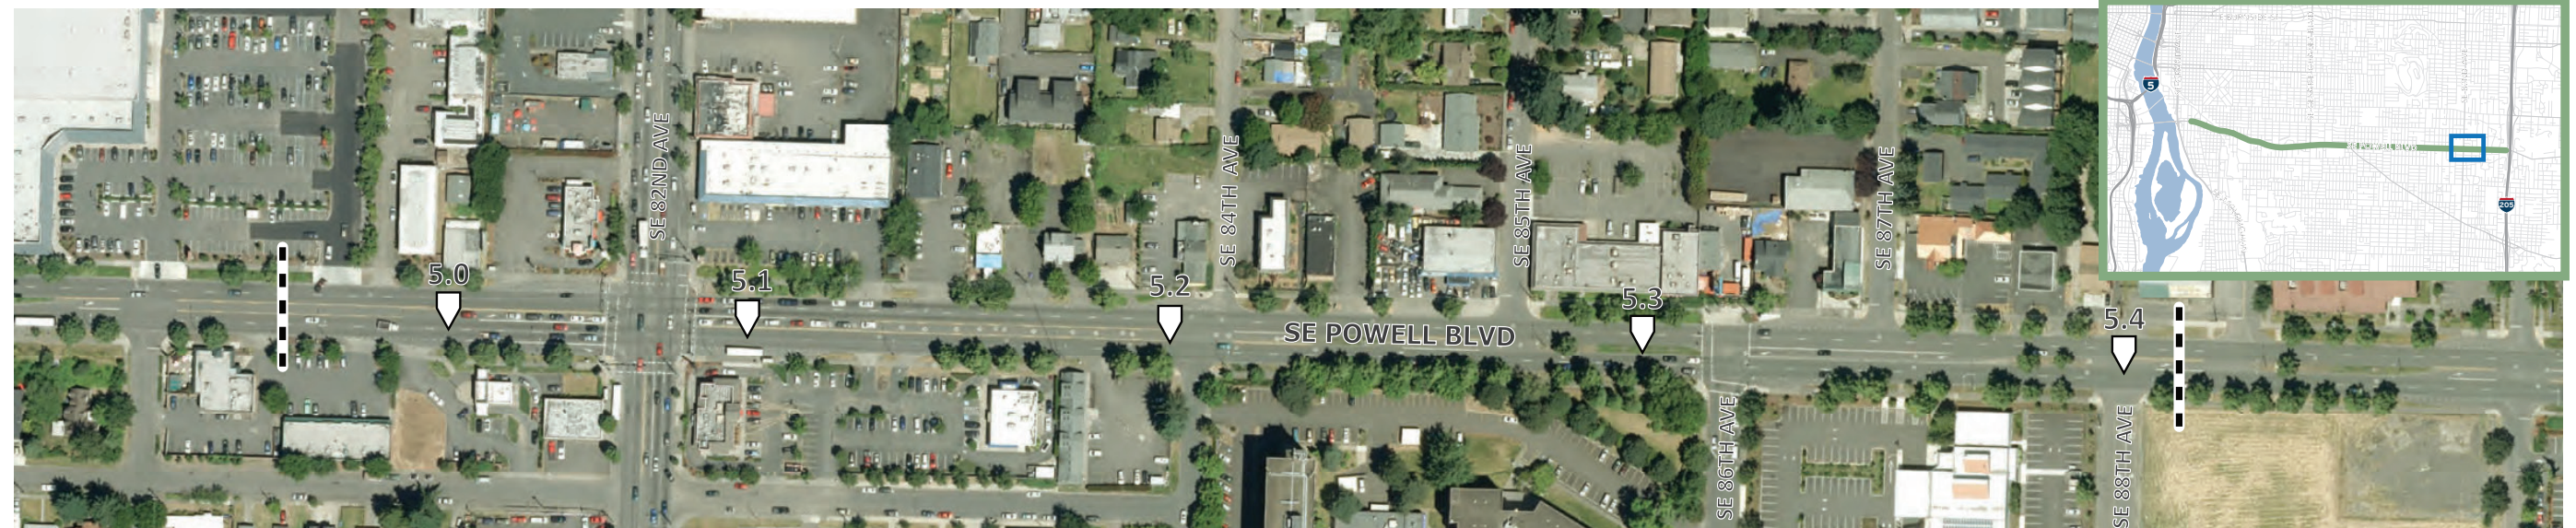
| Pavement <ul style="list-style-type: none"> Poor, reconstruct pavement Fair, apply joint sealing Fair, resurface pavement | Striping <ul style="list-style-type: none"> Fair, spot treatment of striping | Signage <ul style="list-style-type: none"> Poor, replace with new sign(s) Poor, replace sign support Fair, replace sign support | ADA Pushbuttons and Curb Ramps <ul style="list-style-type: none"> Poor, replace ramp Poor, replace diagonal ramp with 2 ramps Poor, replace pedestrian pushbuttons | Potential ramp and crossing closure |

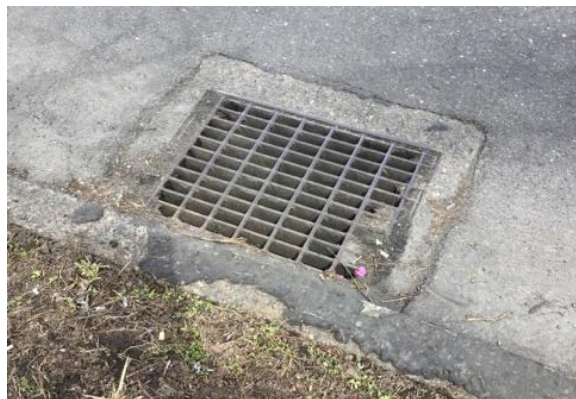
Pavement around drainage inlet is uneven (fair)

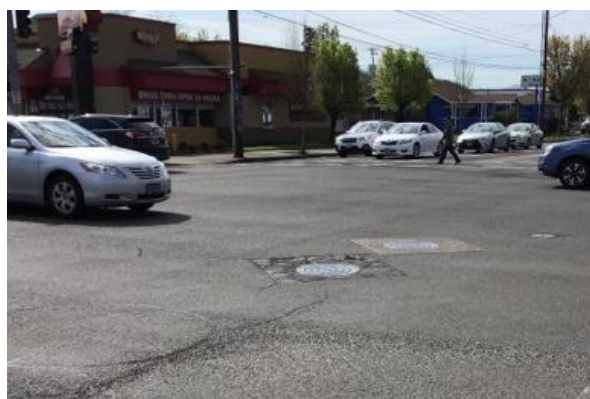
Concrete around utility cover is broken (poor)
