HIGHWAY OR 99W SOUTH CORVALLIS ROAD SAFETY AUDIT

Road Safety Audit

Highway OR 99W South Corvallis Road Safety Audit

Project No. 23021.035

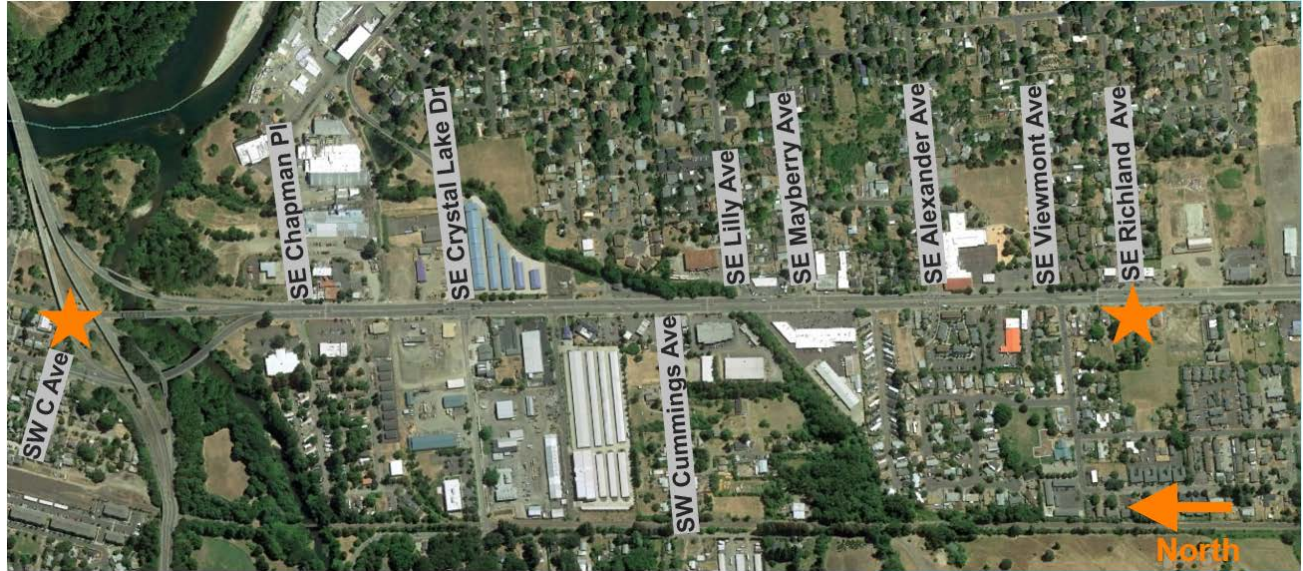
Figure 1: RSA Corridor Extents

The Road Safety Audit (RSA) team studied a segment of OR 99W from SW C Avenue (milepost 84.1) to SW Richland Avenue (milepost 85.2) in Corvallis, Oregon. Figure 1 illustrates the extent of the RSA corridor.

OR 99W starts in Junction City in Southern Oregon and extends north to Southwest Portland. As shown in Figure 1, the approximately 1-mile-long RSA corridor connects the downtown of Corvallis to the southern portion of the city.

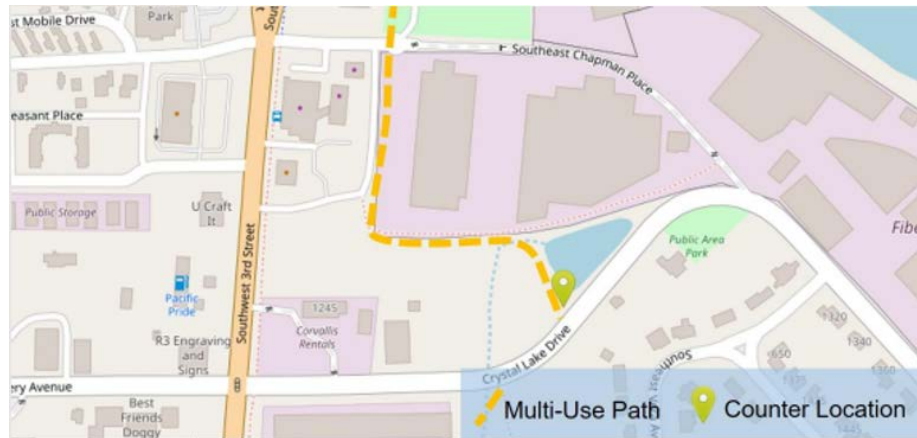
Figure 9: Bicycle and Pedestrian Counter Location

In addition to the turning movement counts above, the Corvallis Area MPO provided pedestrian and bicycle volumes at the Eric E. Austin Memorial Bypass path near the OR 99W corridor. The counts were collected at the south end of the path, near Crystal Lake Drive (see Figure 9) between November 23rd, 2020 and December 6th, 2020. Notably, the multi-use path was opened a month prior to when the counts were collected, therefore the volumes are expected to be lower due to people’s unfamiliarity with this alternative route. In addition, the counts were collected during the Covid-19 pandemic, in early December and during a Thanksgiving week, which also do not represent typical weeks at other time of a year. Table 3 below summarizes the total counts observed. Figure 10 and Figure 11 present a sum of total hourly volume distribution for two weekdays (Wednesday, December 2nd & Thursday, December 3rd) and two weekend days (Saturday, November 28th & Sunday, November 29th).

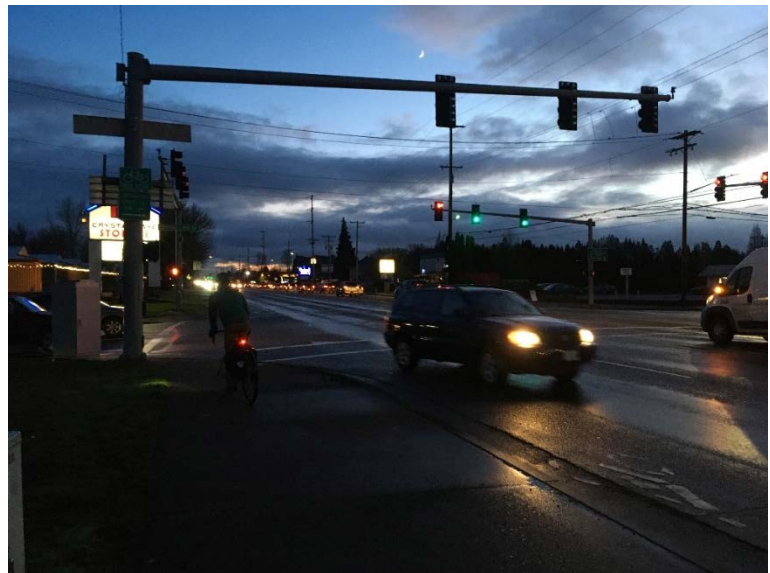
The RSA team observed that reduced or minimal lighting is an issue along corridor, especially the east side of OR 99W and to the south of Crystal Lake Drive. Insufficient lighting creates an uncomfortable environment for people using the sidewalks and the bicycle lanes. Reduced or inconsistent lighting at crossings and intersections makes it difficult for the drivers to see people crossing the roadway, including the RRFB locations. In addition, back lighting from land uses obstructs drivers and people walking and biking from seeing signage, especially regulatory signs, such as speed limit signs.

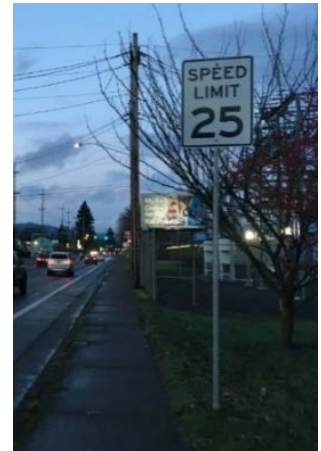
The RSA team identified multiple signage issues along the corridor. The team observed sign clutter, consisting of roadway signs and those from private properties, throughout the corridor. Another issue is the mounting of speed limit signs: the RSA team observed that some signs were mounted at a height above that which would allow many headlights to trigger signage retroreflectivity. Some speed limit signs are also hard to see due to insufficient illumination. The team also observed an absence of wayfinding signs for people walking and biking, especially through the interchange area. Finally, southbound on OR 99W approaching the ramps to OR 34 and US 20, the right

lane becomes a trap lane but does not have signage and pavement markings to indicate this prior to the ramp.

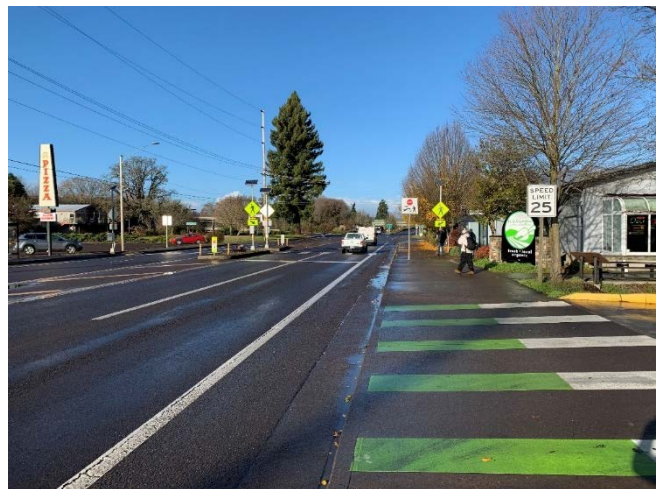
Limited lighting or visibility at multiple existing crossings throughout the corridor make it difficult for drivers to see crossing pedestrians. This also results in pedestrians and drivers being unable to make eye contact at night. Further, the lighting at some of the crossings is not appropriately located and does not provide lighting onto crossing pedestrians for approaching motorists (see Figure 17).

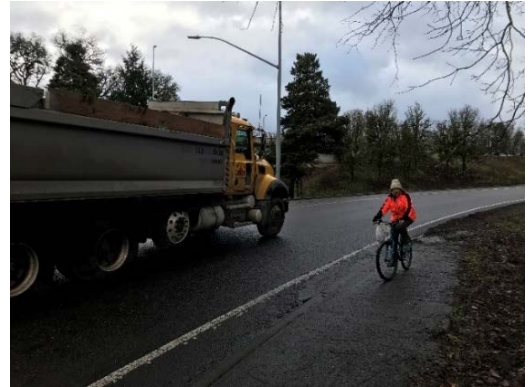
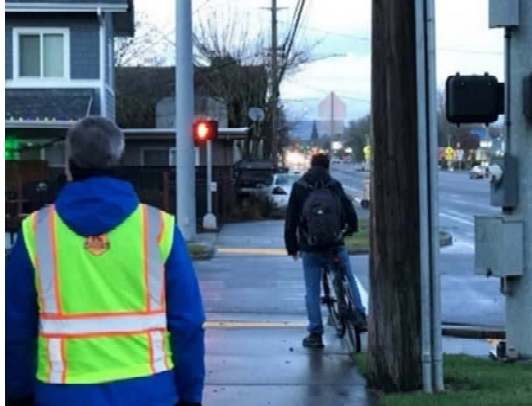
Many people travel by bicycle in South Corvallis. During multiple site visits, the RSA team observed many bicyclists riding on sidewalks, indicating that people are not comfortable riding in the bicycle lanes. Facilities with no buffer from faster moving motor vehicle traffic and poor bicycle lane conditions can create an unsafe or uncomfortable environment and can lead to unpredictable bicycling behavior.

uncomfortable environment and can lead to unpredictable bicycling behavior.

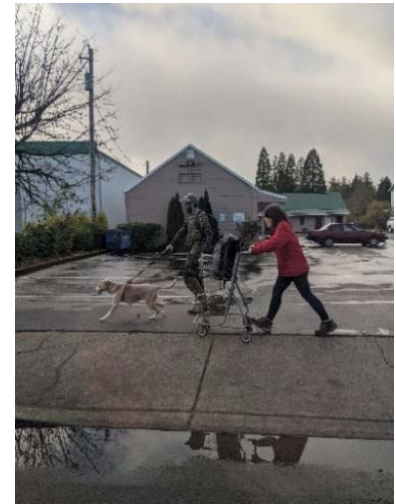
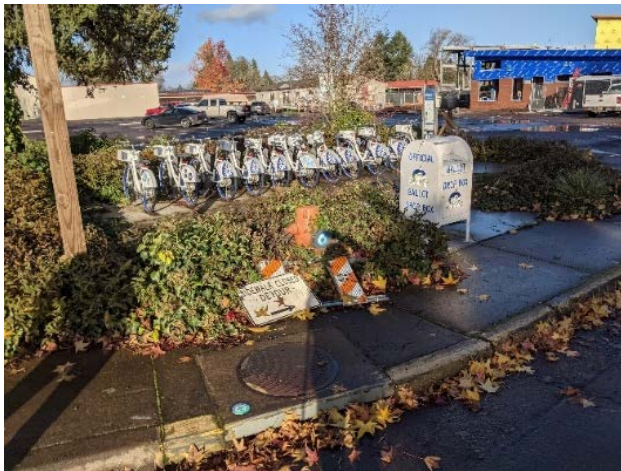
The RSA team also observed that there are many obstacles experienced by people walking: garbage &

recycling bins, mailboxes, and vegetation often times blocks sidewalks. In addition, the proximity of vehicle traffic to the sidewalks and the absence of any buffers creates a loud and uncomfortable environment for people using the sidewalks. Condition of travel ways is further discussed in the section below.

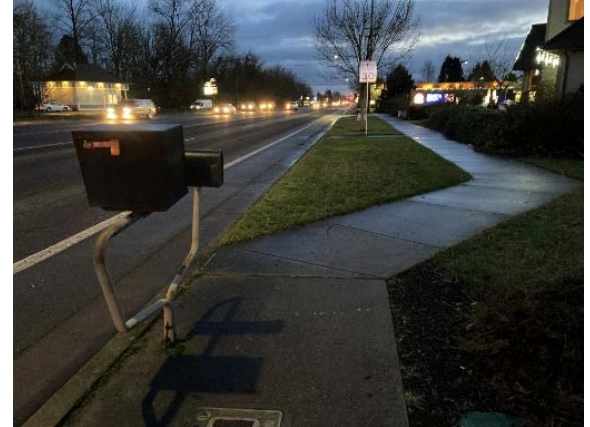
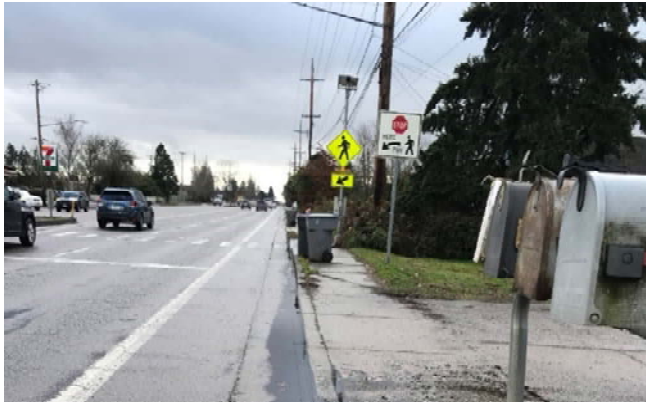
The current condition of existing sidewalks, bicycle lanes, and travel lanes create additional challenges. Poor drainage causes water to settle in bicycle lanes resulting in bicyclists moving into travel lanes or onto the sidewalk. The pavement quality of the roadway, sidewalks, and the multi-use path is poor. Uplifts in the sidewalk pavement creates tripping hazards. Many permanent and temporary obstacles are present in bicycle lanes and on the sidewalks. The sidewalks and intersections are not compliant with the Americans with Disability Act (ADA) at many locations throughout the corridor, though many curb ramps will be reconstructed in 2021.

- Evaluate and improve ADA compliance of bus stops, ramps, crossings, and intersections
- Repave the roadway, and repave or replace the sidewalks and multi-use path segments in poor condition
- Improve drainage throughout the corridor
- Remove and/or reduce obstacles

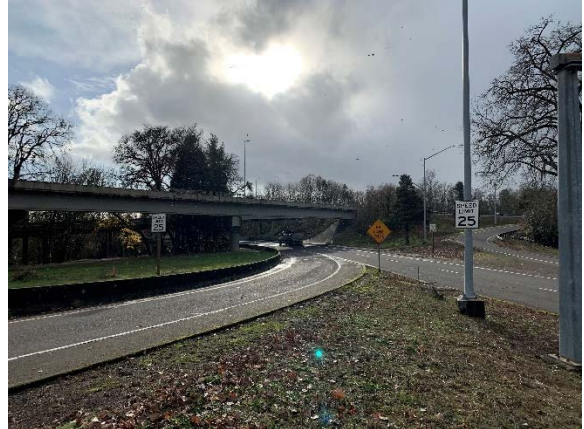
The connection of downtown Corvallis to the southern part of the city through the interchange of OR 99W, US 20, and OR 34 is highly challenging and uncomfortable for people walking and biking. The routes through this area are undefined and appear piecemealed with indirect connections between curb ramps. Inconsistent sidewalks and trail portions make pedestrians to cut through open space and crossing at undesirable locations. A lack of wayfinding with a variety of potential routes creates confusion for users who might be unfamiliar with the area. These behaviors are evident by the number of desire lines (user paths) through this area. In addition, the northbound Marys River bridge, which is one of the OR 99W one-way couplets, has bridge girders interfering the sidewalk which creates a confined walking space.

Vehicular speeds vary through this area as well. Many people driving are accelerating on the ramps to match the higher speeds of the connecting roadways or maintain high speeds as they come from the connecting highway. Design speeds through this area generally exceed the posted speed limit, further encouraging higher operating speeds.

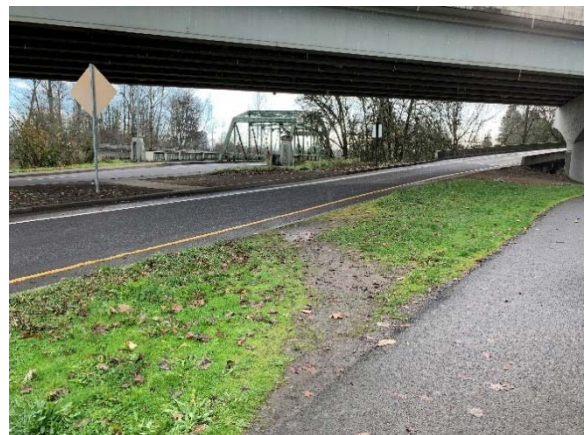
The bicycling connection is very poor through the interchange as well. The southbound road of the OR 99W couplet provides a standard bicycle lane but there is no connection for bicyclists to stay on OR 99W through the lane drop to the westbound on-ramp. There is a multi-use trail next to Willamette River that people can use to avoid riding through the interchange. The connection of the trail to the bicycle lane on the west side of OR 99W is not well signed and is out of direction for those traveling southbound from west of OR 99W.

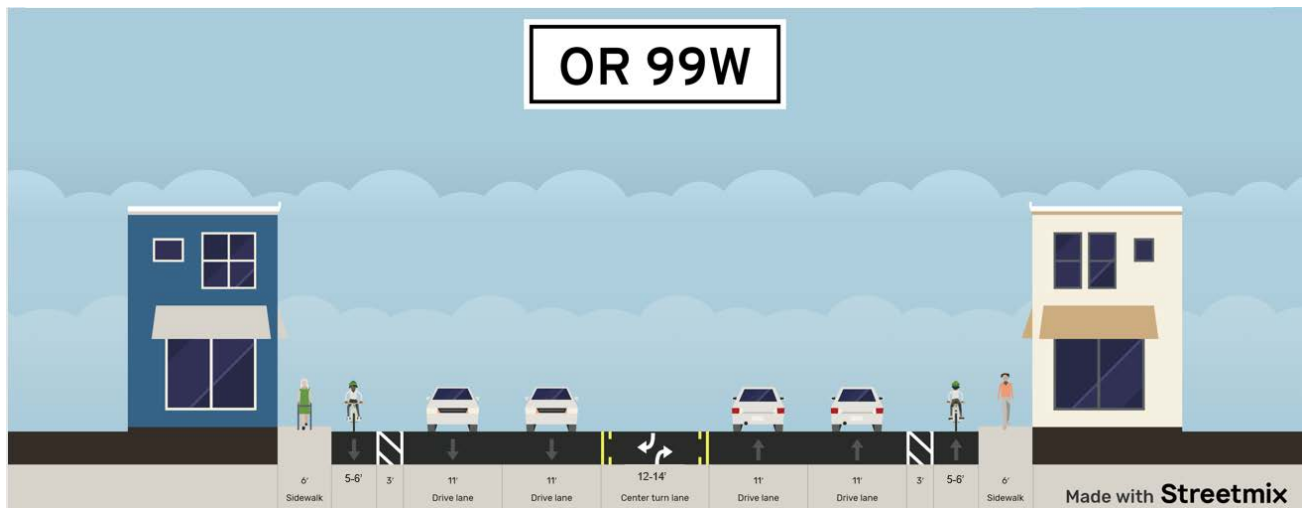
Figure 16: Future Potential Cross-Section

A modified layout of the roadway would create more of a boulevard feeling and would increase the comfort and have a positive influence on the safety of the people using the corridor. This implementation can occur primarily through restriping. Narrower lanes would encourage slower and more careful driving behavior. An additional buffer for the bicycle lanes, preferably with vertical elements such as flexposts, would create a safer and more comfortable environment for bicyclists. Additional medians (with landscaping) where feasible would also encourage more careful driving.

Figure 16 below presents a potential typical future cross-section of OR 99W. The presented cross-section is just one of the possible options and the lane widths can be finalized once the exact roadway measurement is available.

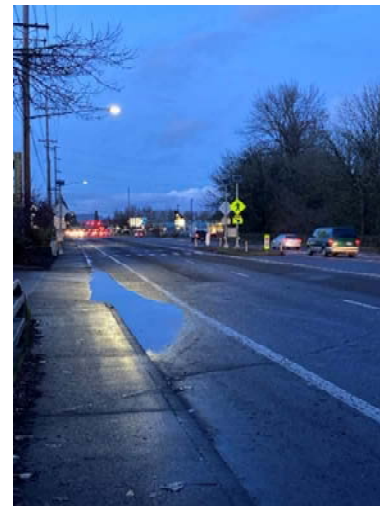
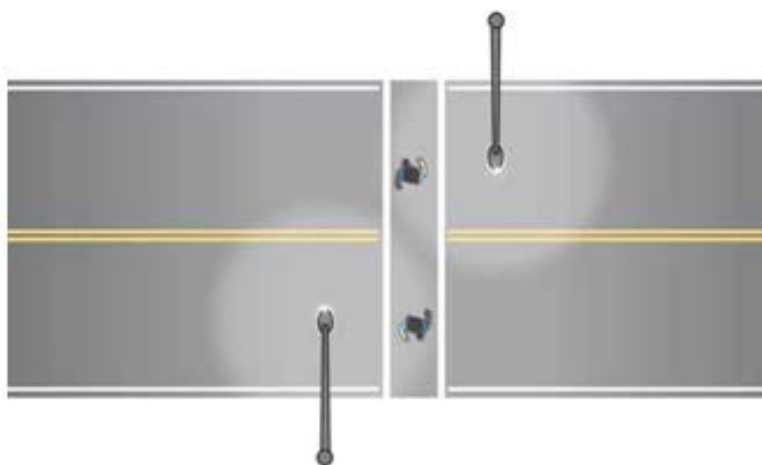
Figure 17: Illustration of Illumination located in advance of pedestrian crossing

- Striping double white lines leading to crossings to reduce the likelihood of a double threat
- Improving lighting, especially on the motor vehicle approach side of the pedestrian crossing to make those crossing more visible to the approaching people driving

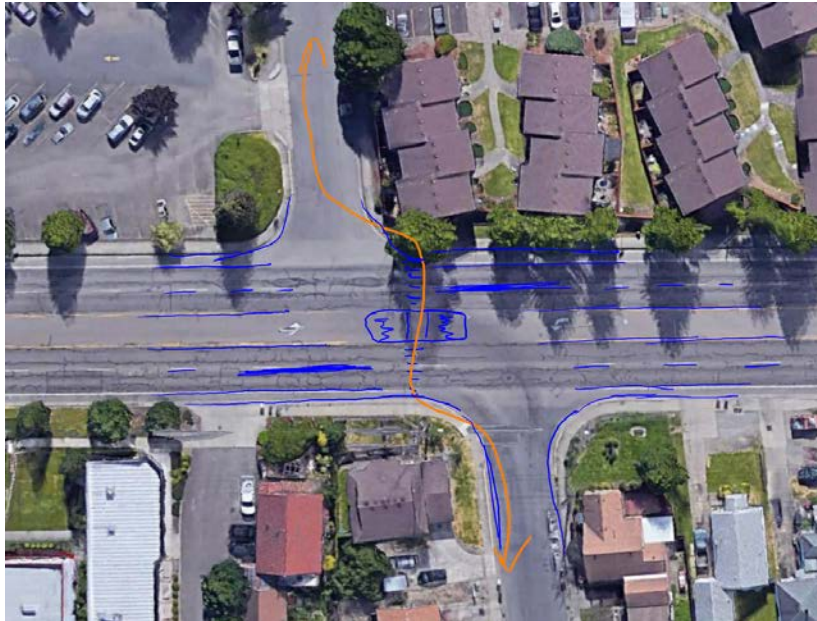
Figure 18: Potential Crossing Improvement at SW Tunison Ave/SE Viewmont Ave

Figure 18 **Error! Reference source not found.** below presents a crossing layout that is proposed by the RSA team. It includes marked crosswalk striping and a median. A pedestrian hybrid beacon (PHB) should be considered at this midblock location, especially because of the proximity to the school. Pedestrian Hybrid Beacon is a traffic control device that remains dark for drivers until activated by a pedestrian. Once activated, it begins to flash yellow to warn motorists, which is then followed by a steady yellow and a steady red phases⁴. (see Figure 19 **Error! Reference source not found.**) This would replace the RRFB that currently exists between SW Tunison Avenue and SE Richland Avenue (approximately 230 feet to the south). If a PHB is not feasible, an overhead RRFB should be considered. Unlike an PHB, an RRFB does

Notably, a median at this location is likely to interfere with the emergency vehicles entering and exiting the fire station on SW Tunison Avenue. The fire station is likely to be relocated in the next five years. If a PHB or overhead RRFB is installed before the relocation of the fire station, the RSA team suggests working with the fire department when designing the crossing to come up with a feasible design that does not interfere with emergency vehicle access.

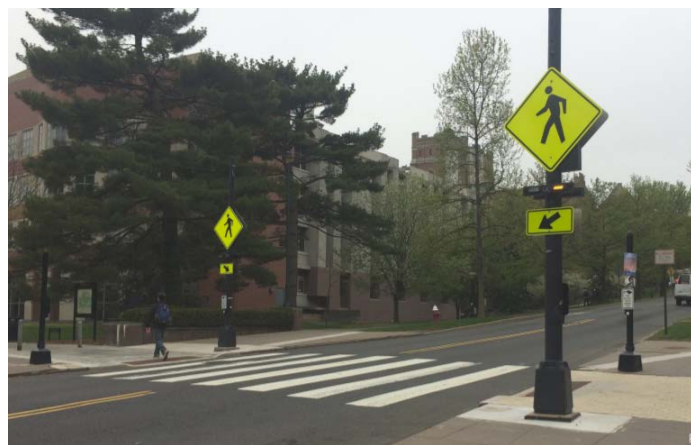
Figure 20: An Example of a Rectangular Rapid Flashing Beacon (RRFB)

not provide a steady red phase and uses an irregular flash pattern⁵. (see Figure 20) According to ODOT's crash reduction factors, a PHB is a more effective treatment than an RRFB⁶, therefore it is more desired to be installed at this location.

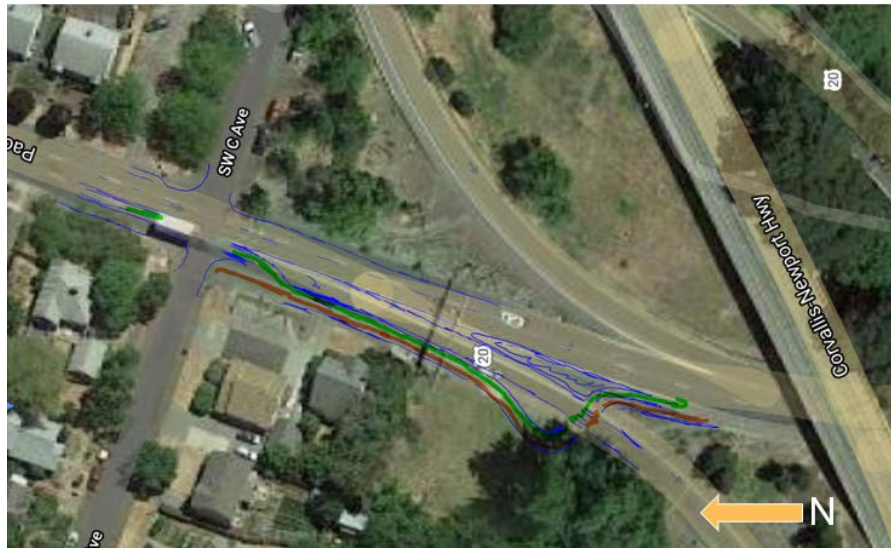
Figure 21: Trap Lane Removal: Option 1
 Source: Base Image from Google Earth

Figure 21 and Figure 22 below present two options for the proposed improvement. Option #1 would widen the current sidewalk to a shared use path, shift the people biking onto the path, and provide an enhanced crossing across the ramp. Option #2 preserves the dedicated bicycle lane by creating a typical right-turn pocket with the bicycle lane between the right-turn and through lane cross over. Option #2 still adds an enhanced crossing for pedestrians crossing the ramp. Both options assume a lane reconfiguration along southbound 4th Street that could be incorporated into a future pavement preservation/restriping project and addressed by a downtown circulation study (Corvallis Transportation System Plan project M104).

The RSA team developed several ideas to improve direct connections and wayfinding through the interchange. The team suggests improving bicycle and pedestrian connectivity at the current OR 99W/4th Street southbound to OR 34/US 20 west ramp.

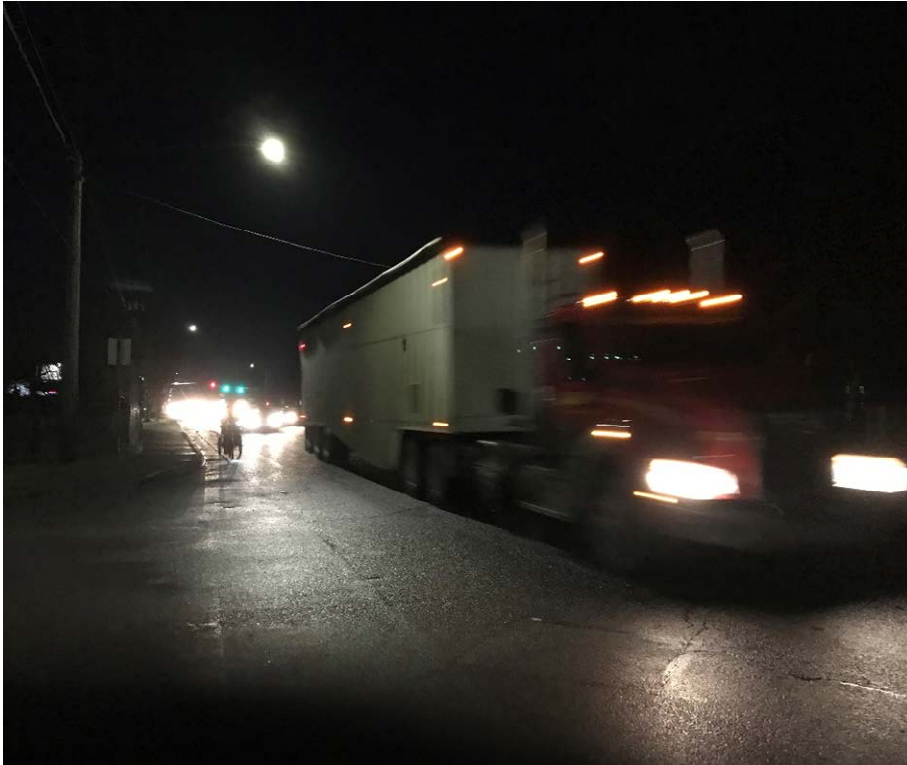
Issue: Speed (1 of 2)

- **High speeds** means less reaction time
 - Witnessed one rear end crash when a motorist stopped for a pedestrian and
 - Multiple cars stopping for pedestrians put their hazard lights on when they stopped

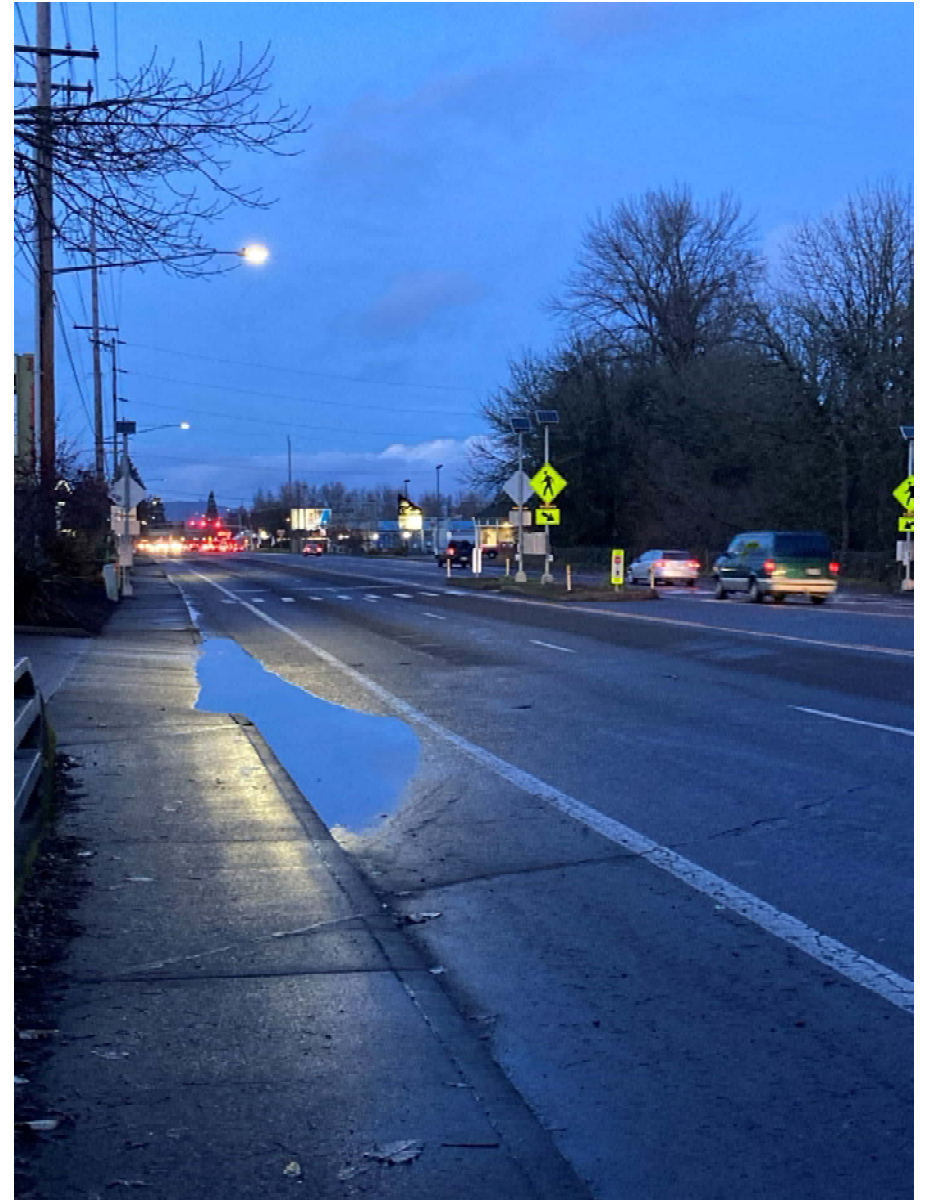
Issue: Crossings

- Double threat
- Can't make eye contact at night
- Poor lighting or visibility at some crossings: can't see the pedestrian crossing
- Strong desire to cross north of Chapman where there is no enhanced crossing

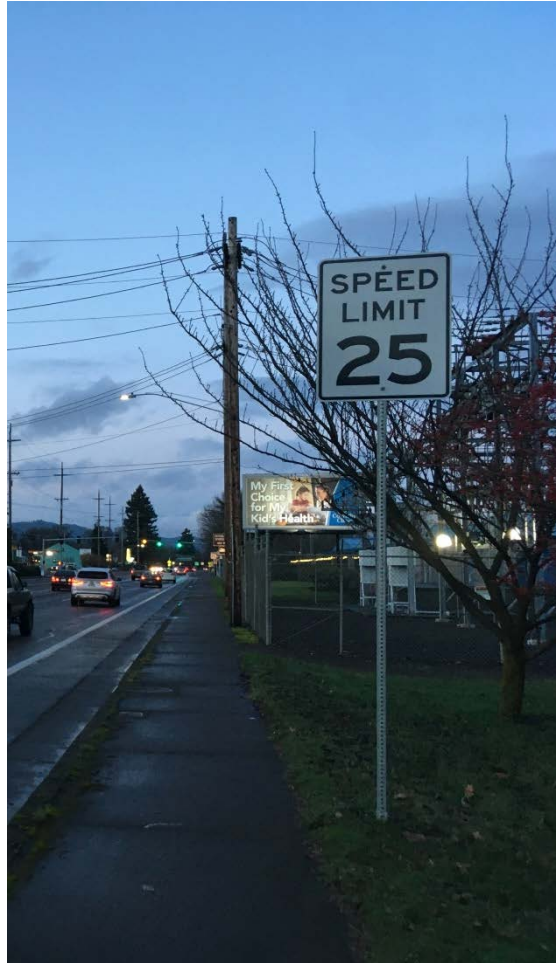
Issue: Signage

- Some sign clutter, including from private properties
- Speed signs mounted high makes it difficult to see
- Poor wayfinding for people walking/biking
- Need lighting to illuminate speed limit signs

- Remove **less critical** signs
- Lower, **better emphasize**, and light speed limit signs
- Add **wayfinding** for people walking/biking
- Move **side street signs** closer to the corridor

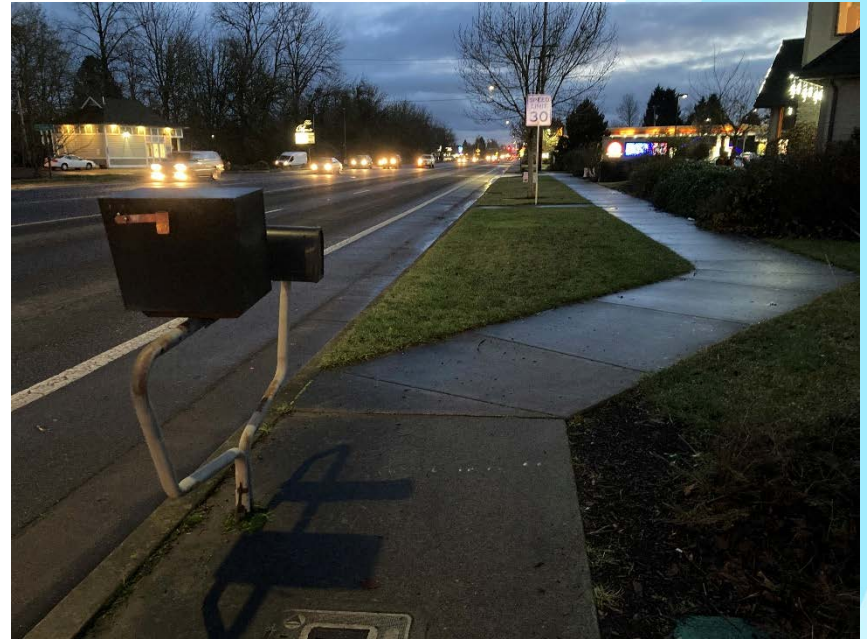
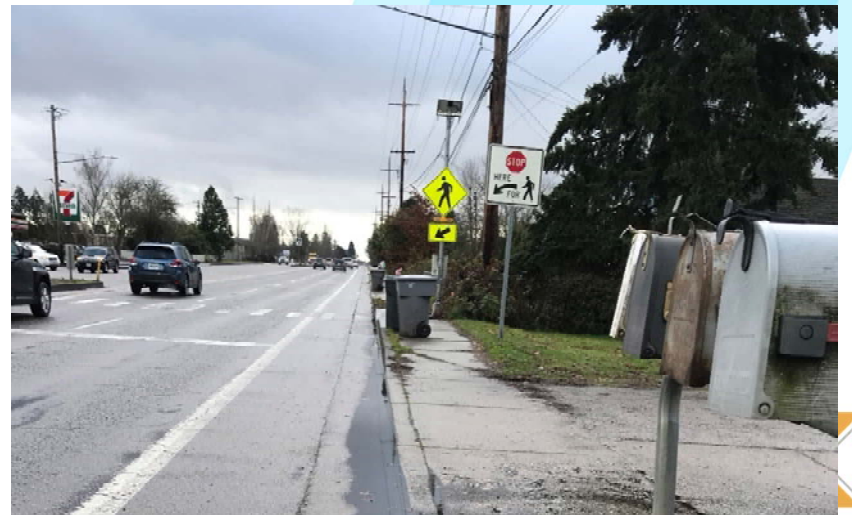
Issue: Conditions of Travelways (1 of 2)

- Poor drainage causes water to settle in bike lane, causing bikes to move into travel lane
- Permanent and temporary obstacles in sidewalk & bike lane
- Poor pavement quality on roadway, sidewalk, and path
- Uplift leads to tripping hazards
- Not ADA accessible throughout the entire corridor

- Add ADA ramps
- Remove/reduce obstacles
- Repave roadway and replace sidewalk/path segments with poor condition
- Improve drainage

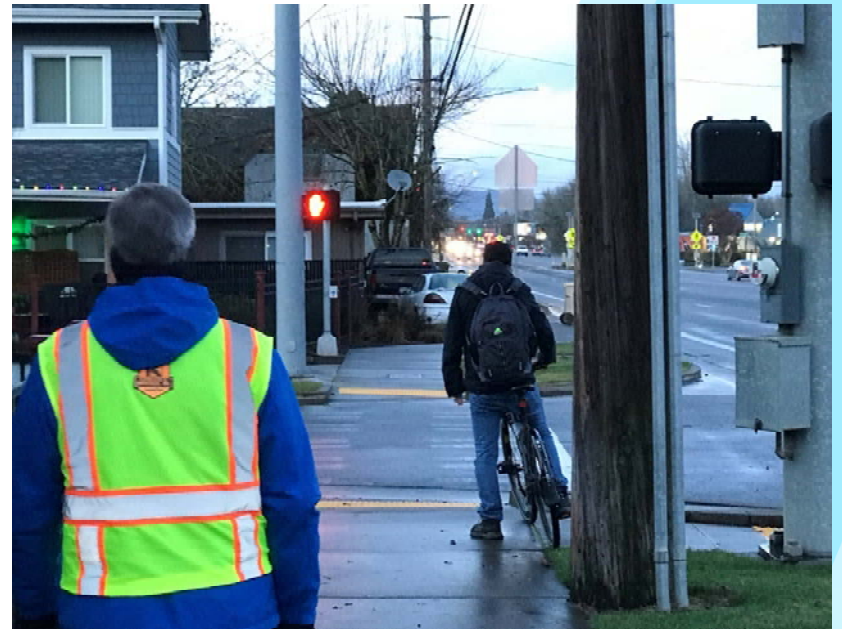
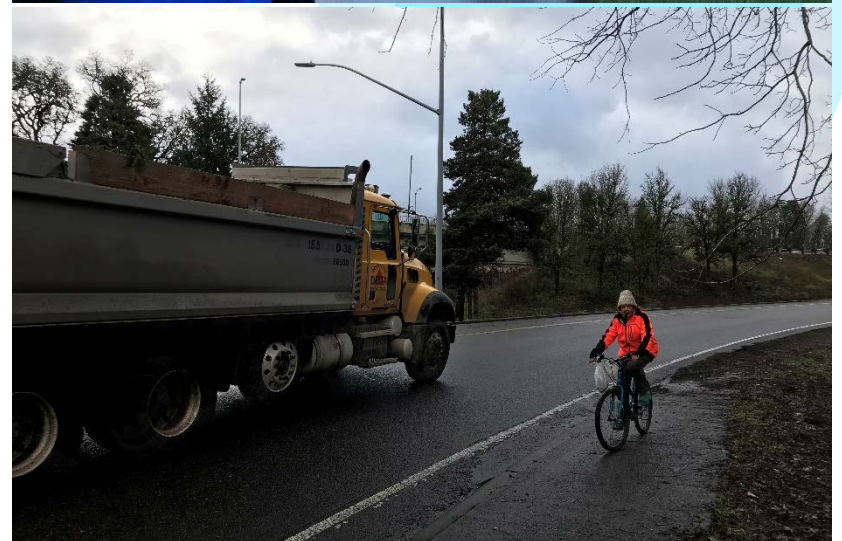
Issue: Bike Comfort

- Sidewalk riding indicates bicyclists are **uncomfortable** in the bike lanes
- Uncomfortable facilities or poor conditions lead to **unpredictable behavior** from people biking
- **Difficult connection** from path (east side) to bike lane (west side) at Crystal Lake Dr.
 - ARTS project will help improve

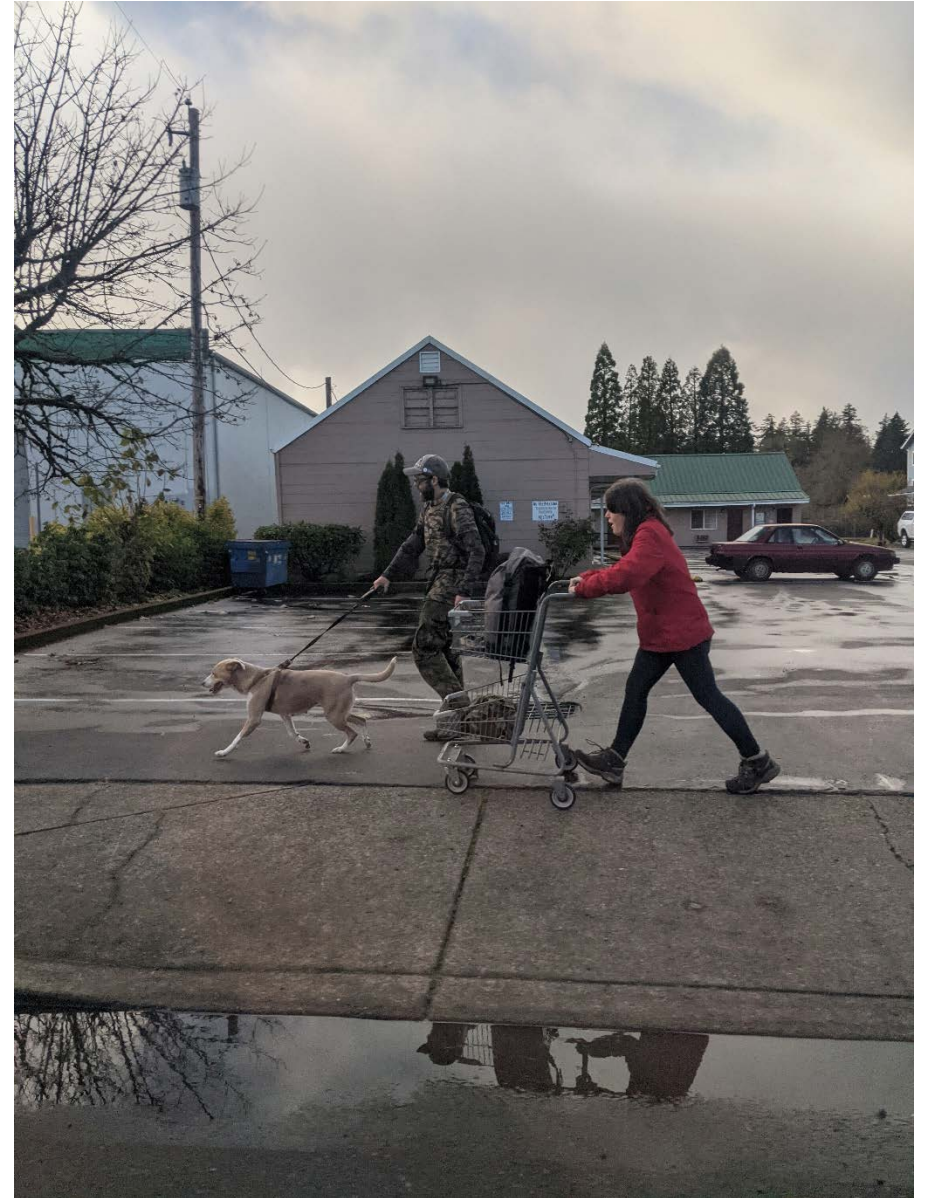
Issue: Pedestrian Comfort

- Obstacles/tripping hazards
- Loud corridor
- Walking close to traffic with little to no buffer

- Add buffered bicycle lanes
- Improve wayfinding
- Remove obstacles
- Future development: include buffer strip
- Add bulb outs on side streets to reduce crossing distance
- Improve bicycle crossings at signalized intersections

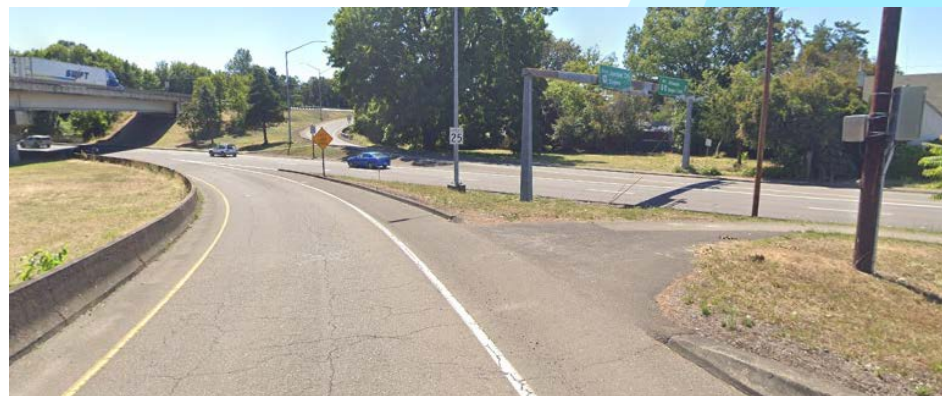
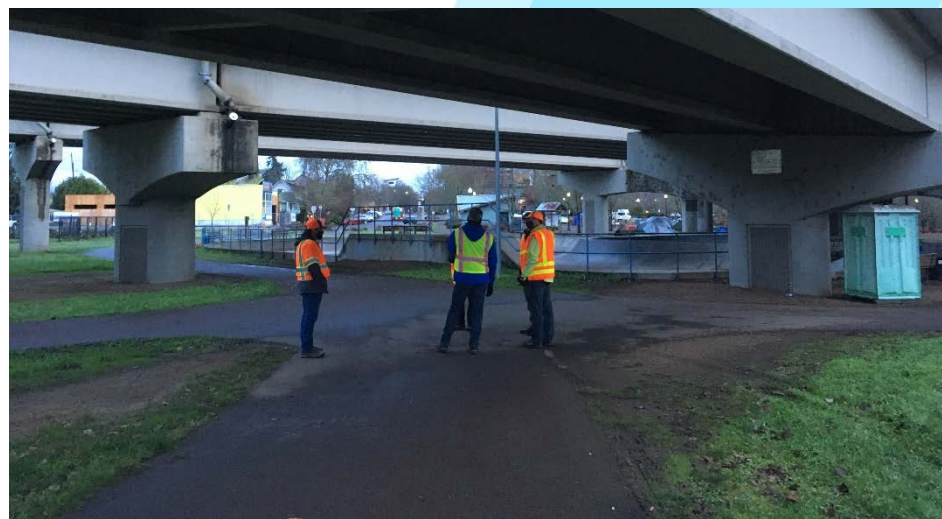
Issue: Bike/Ped Connections North/South Through Interchange

- Undefined routes
- Several curb cuts, sidewalk, and trail pieces that do not provide direct connections
- Poor wayfinding
- High design speeds for motorists
- Difficult to cross high-speed ramps

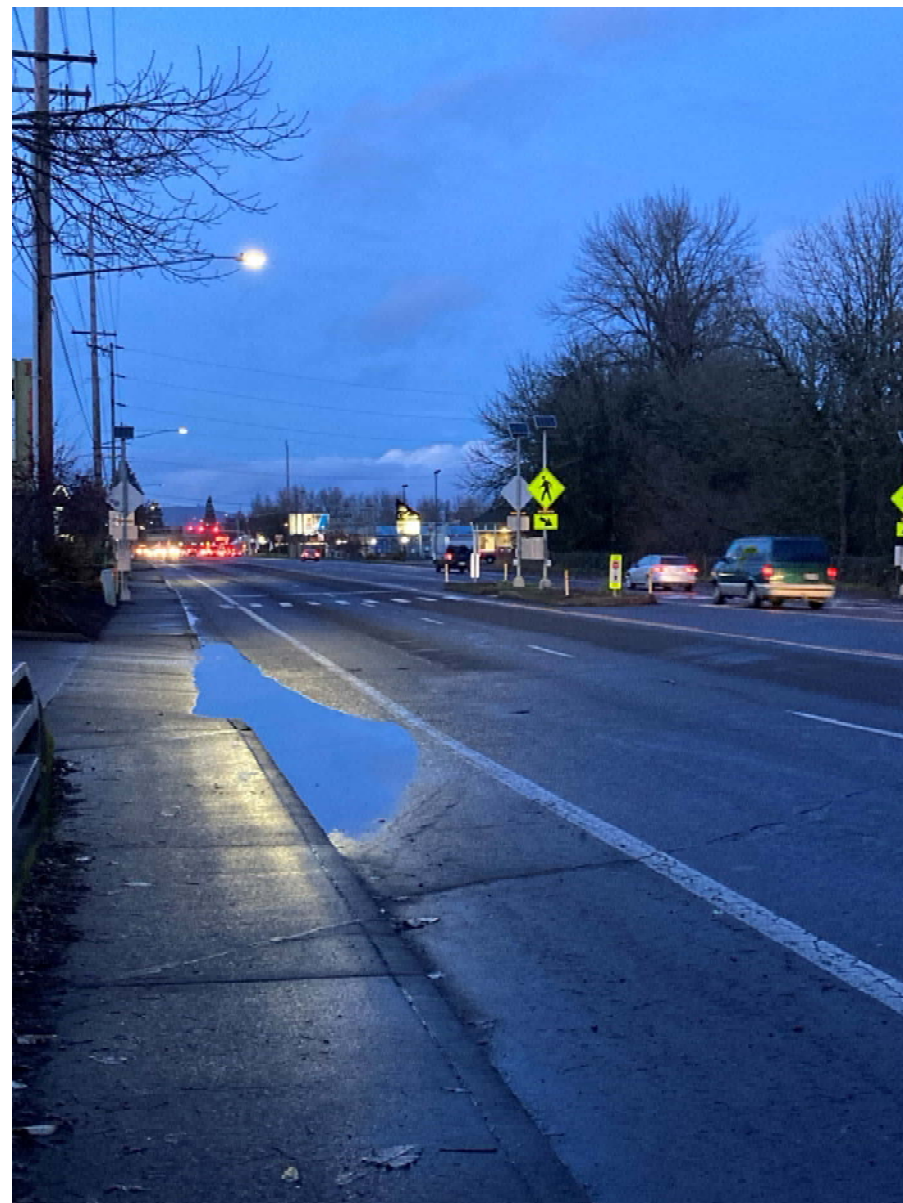
Crossing Solution: Offset Tunison/Viewmont

- Potentially move crossing north to school
- Based on redevelopment

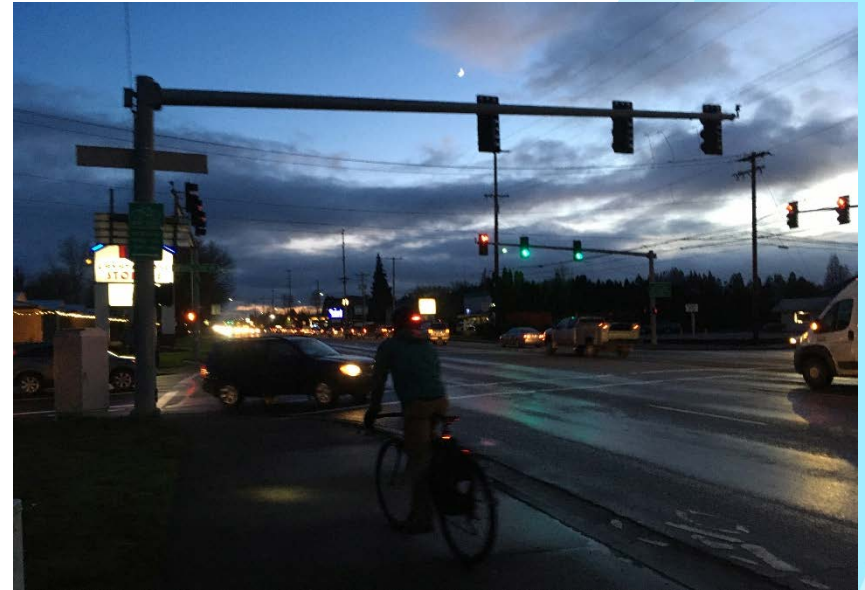
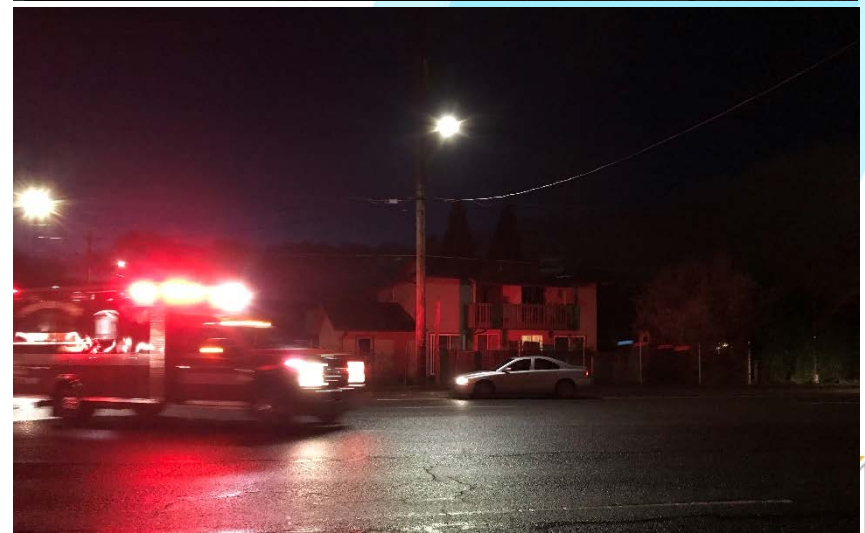
Lighting Solutions

- Add lighting:
 - Consistently along the corridor
 - At crossings: on the motorist side of the pedestrian crossing
 - At intersections: all four corners

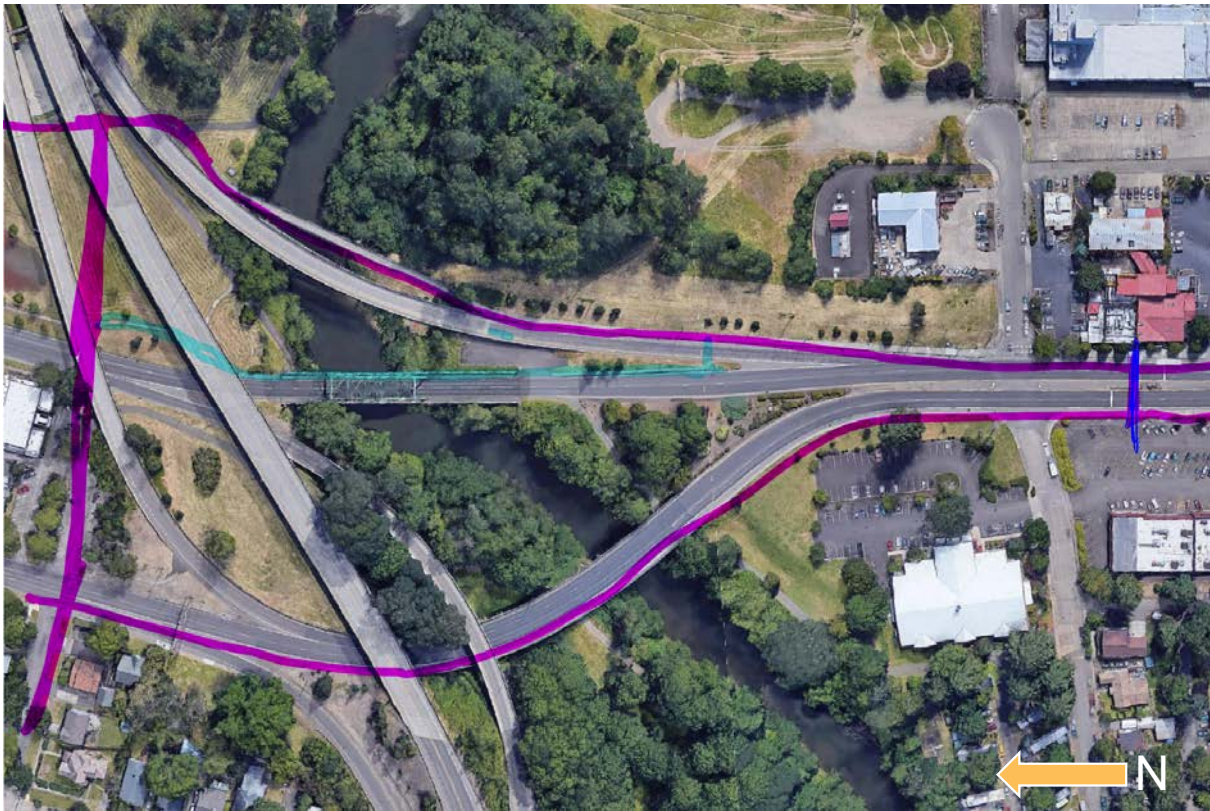
North-South Ped/Bike Connections

- Improve direct connections and improve wayfinding

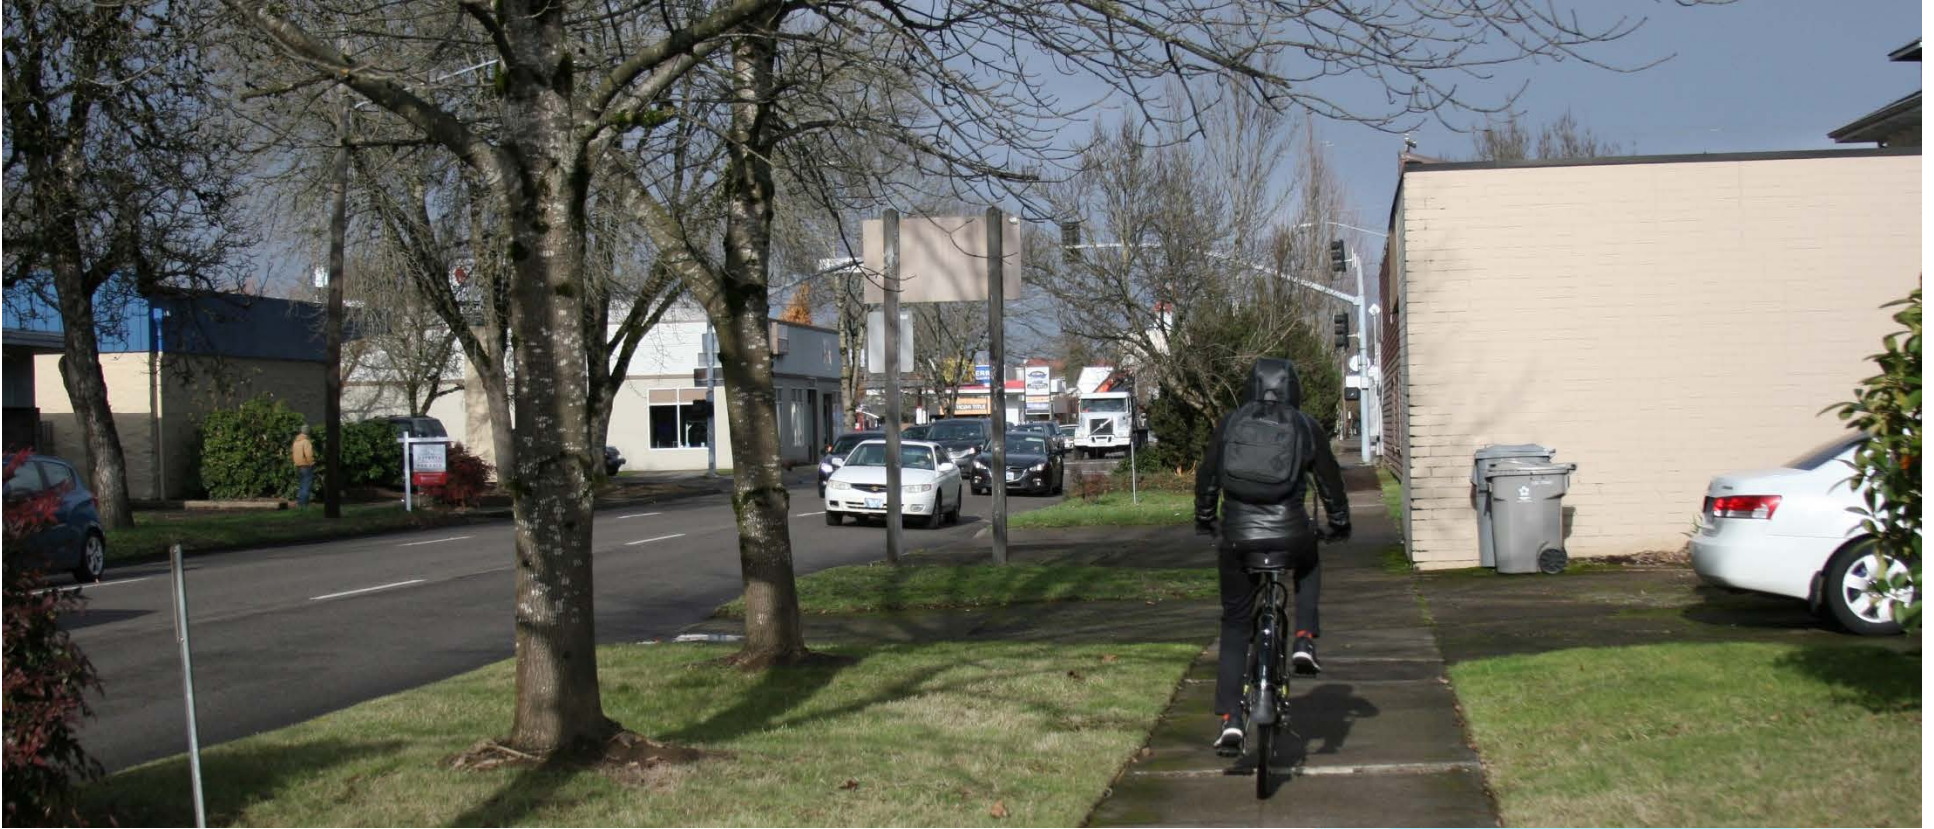
Outside of RSA Limits

Potential road reorganization south of Tunison
