MEMORANDUM

From: Camilla Dartnell, Polina Polikakhina, Phill Worth
Project: Highway OR 99W South Corvallis Facility Plan
Subject: Draft TM #5: Summary of Corridor Issues, Constraints, and Opportunities

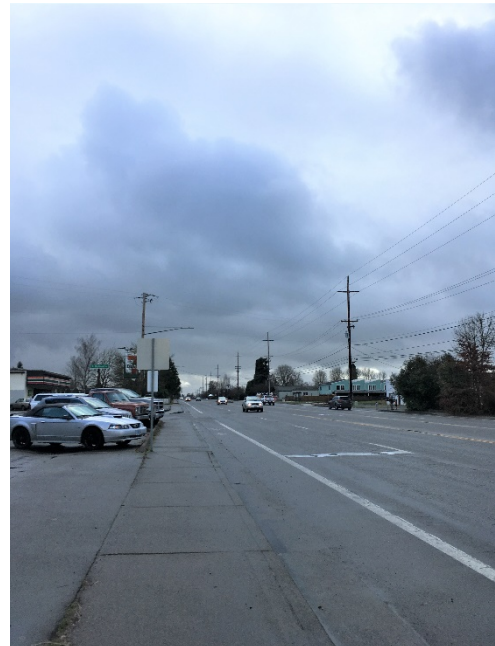
**Highway segment near SE Lily Avenue
with curb-tight sidewalk and
no landscaping buffer**

People noted that when walking on the sidewalks, the proximity to traffic makes them feel uncomfortable and that having a green buffer strip would create a more welcoming environment while using the sidewalks. It was also noted that adding trees and bushes would help to reduce the noise coming from vehicles. Others cautioned that trees may potentially obstruct the view of drivers, bicyclists, and pedestrians. It would be important to select the right plantings and maintain sufficient sight distance with any trees that will be planted along the corridor. It will also be important to evaluate any necessary maintenance required for the added greenery.

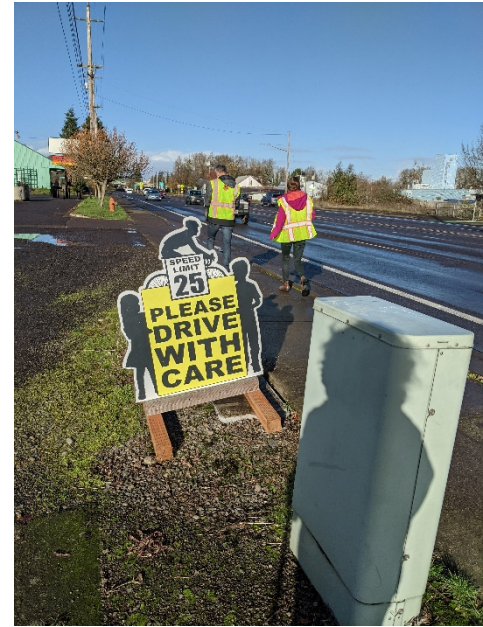
Property owner adjacent to the highway has erected signs to encourage slower driving

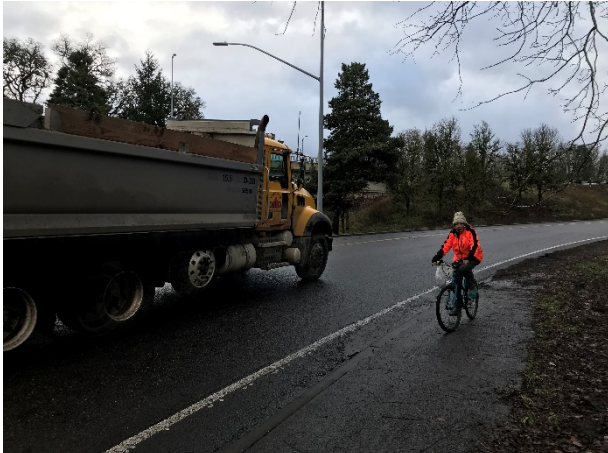
Bicycle facility gaps at the UE 20-OR 34 interchange result in people biking on the sidewalk

Respondents indicate that the bicycling connection is very poor through the interchange as well. The southbound section of the OR 99W couplet provides a standard bicycle lane but there is no connection for bicyclists to stay on OR 99W through the lane drop to the westbound US 20-OR 34 on-ramp.

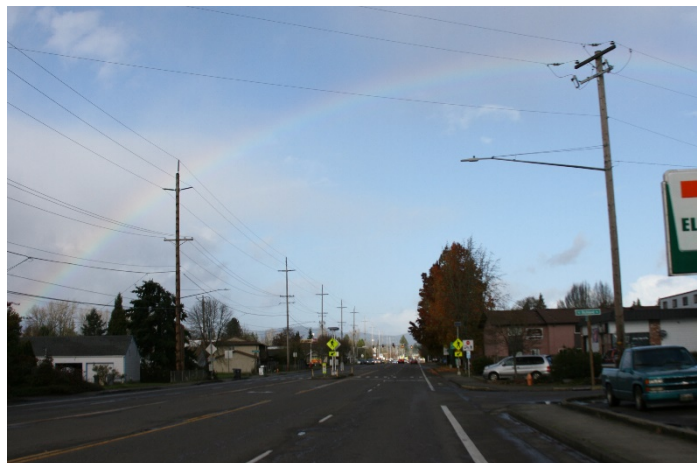
Enhanced crossing near SE Richland Avenue

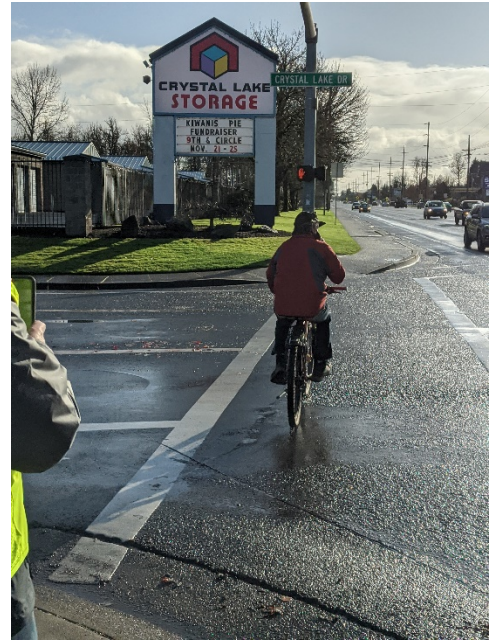
- The signalized intersection with **SW Avery Avenue/Crystal Lake Drive** experiences the second-highest number of crashes along the corridor. This intersection is used by people bicycling on the shared use path on the east side of the road and then accessing the southbound bicycle lane on the west side of the road. The RSA team proposes a protected intersection at this location.
- The unsignalized intersection with **SE Lilly Avenue**: Multiple people commented about the “awkward” curb cuts on SE Lilly Avenue. They said that crossing this street north-south is difficult as a pedestrian and on bicycle. In addition, “cars turning at every direction within this intersection are not aware of pedestrians”. People expressed desire for a marked crossing at this location.

Intersection at SE Crystal Lake Drive/SW Avery Avenue

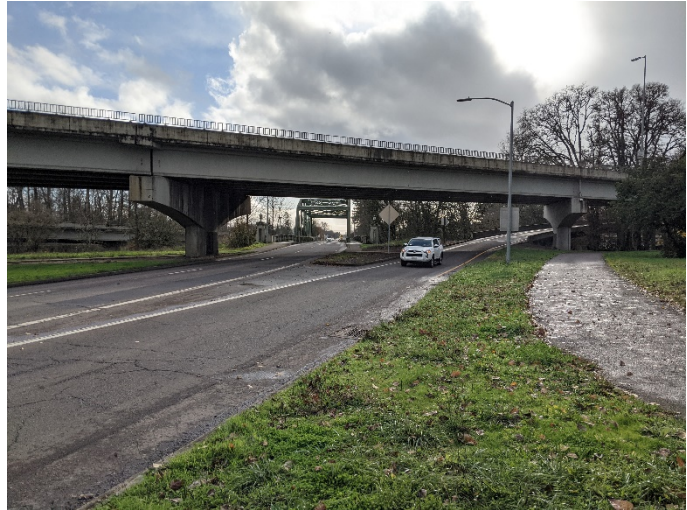
One of the topics brought up repeatedly by the public and stakeholders are the challenges that are created by the interchange of OR 99W with US 20-OR 34. The connection of downtown Corvallis to the southern part of the city through the interchange is highly difficult and uncomfortable for people walking and bicycling. The routes through this area are undefined and appear piecemealed with indirect connections between curb ramps. Inconsistent sidewalks and trail portions cause pedestrians to cut through open space and cross at undesirable locations. A lack of wayfinding with a variety of potential routes creates confusion for users who might be unfamiliar with the area. These behaviors are evident by the number of desire lines (user paths) through this area. In addition, the northbound Marys River bridge, which is one of the OR 99W one-way couplets, has bridge girders interfering with the sidewalk, creating a confined walking space.

US 20/OR 34 Interchange and historic Marys River Bridge

- Infrastructure:
 - Urbanizing the interchange in order to set contextual differences between high-speed highways and the urban setting of Corvallis
 - Restoring the historic Marys River Bridge, including the original lighting fixtures

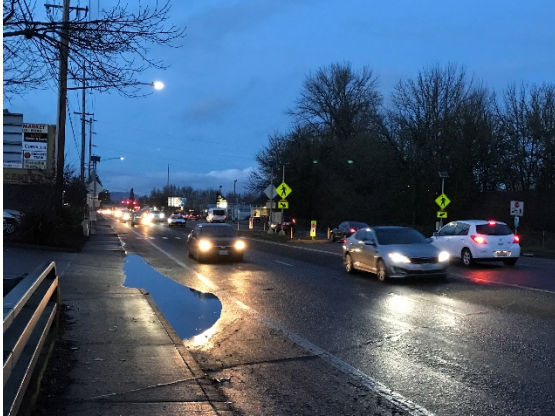
Community members, local property owners, and the RSA team identified that reduced or minimal lighting is an issue along the corridor, especially the east side of OR 99W, to the south of Crystal Lake

Drive. Insufficient lighting creates poor visibility and uncomfortable environment for people using the sidewalks and the bicycle lanes. Reduced or inconsistent lighting at crossings and intersections makes it difficult for the drivers to see people crossing the roadway, including the RRFB locations. In addition, back lighting from adjacent land use monument signs obstructs drivers and people walking and bicycling from seeing signage, especially regulatory signs, such as speed limit signs.

Insufficient lighting and drainage near Mill Race bridge

- Modifying the roadway cross-section to provide separation from traffic to bicyclists and pedestrians and to encourage more careful driving
 - Providing additional lighting along the corridor

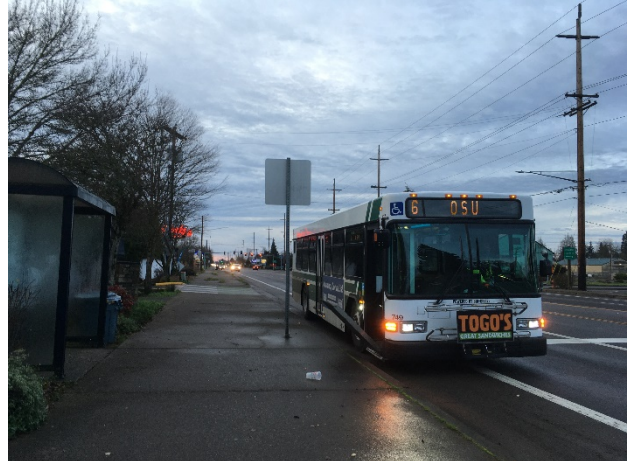
Bus stop near SE Chapam Place

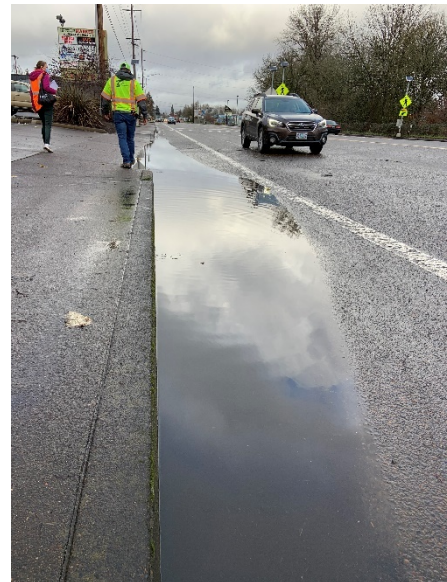
The RSA team noticed that insufficient drainage causes water to settle in bicycle lanes after rain events, resulting in bicyclists moving into travel lanes or onto the sidewalk. A number of public members also provided location-specific input about poor drainage.

Standing water spans the bike lane near Mill Race Bridge

- Surface Conditions and Maintenance:
 - Improving drainage
 - Improving conditions of travel ways
 - Evaluating and improving ADA compliance of bus stops, ramps, crossings, and intersections

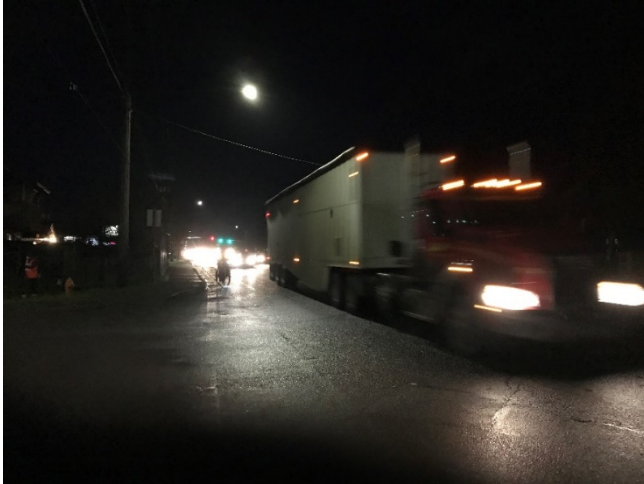
Winter night-time conditions near SW Tunison Avenue

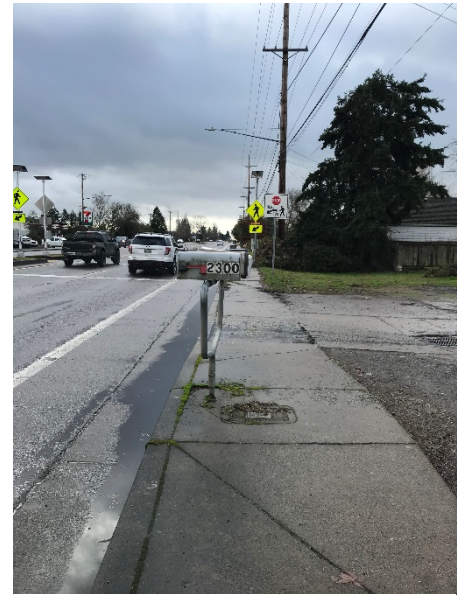
Mailboxes block a portions if the sidewalk near enhanced crossing south of SW Tunison Street

- Repaving the roadway, and repaving or replacing the sidewalks and shared-use path segments in poor condition
 - Removing and/or reducing obstacles from bicycle lanes and sidewalks

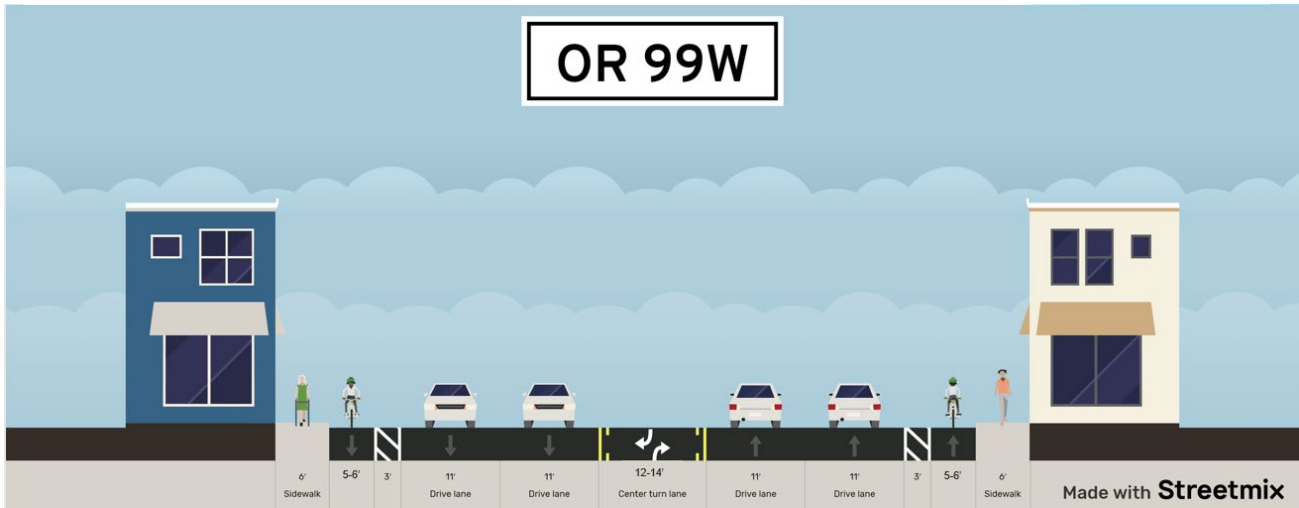
Figure 2: Future Potential Cross-Section
Source: Made with Streetmix

Figure 2 below presents a potential typical future cross-section of OR 99W. The presented cross-section, as suggested from input, is just one of the possible options and the lane widths could be finalized once the exact roadway measurement is available.

Several sources suggested opportunities for a modified layout of the roadway to create more of a boulevard feeling that would increase the comfort and have a positive influence on the safety of the people using the corridor. A common terminology that is used for this kind of a cross-section modification is *road diet*. This implementation could occur primarily through restriping. Narrower lanes would encourage slower and more careful driving behavior. An additional buffer for the bicycle lanes, preferably with vertical elements such as flex-posts, would create a safer and more comfortable environment for bicyclists. Additional medians (with landscaping), where feasible, would also encourage more careful driving.
