MEMORANDUM

Date:	April 21, 2021	Project #: 23021.35
To:	James Feldmann	
From:	Nick Gross, Camilla Dartnell, Phill Worth, Bincy Koshy, Polina Polikakhina	
Project:	Highway OR 99W South Corvallis Facility Plan	
Subject:	TM #10: Existing Safety and Active Transportation Inventory and Conditions

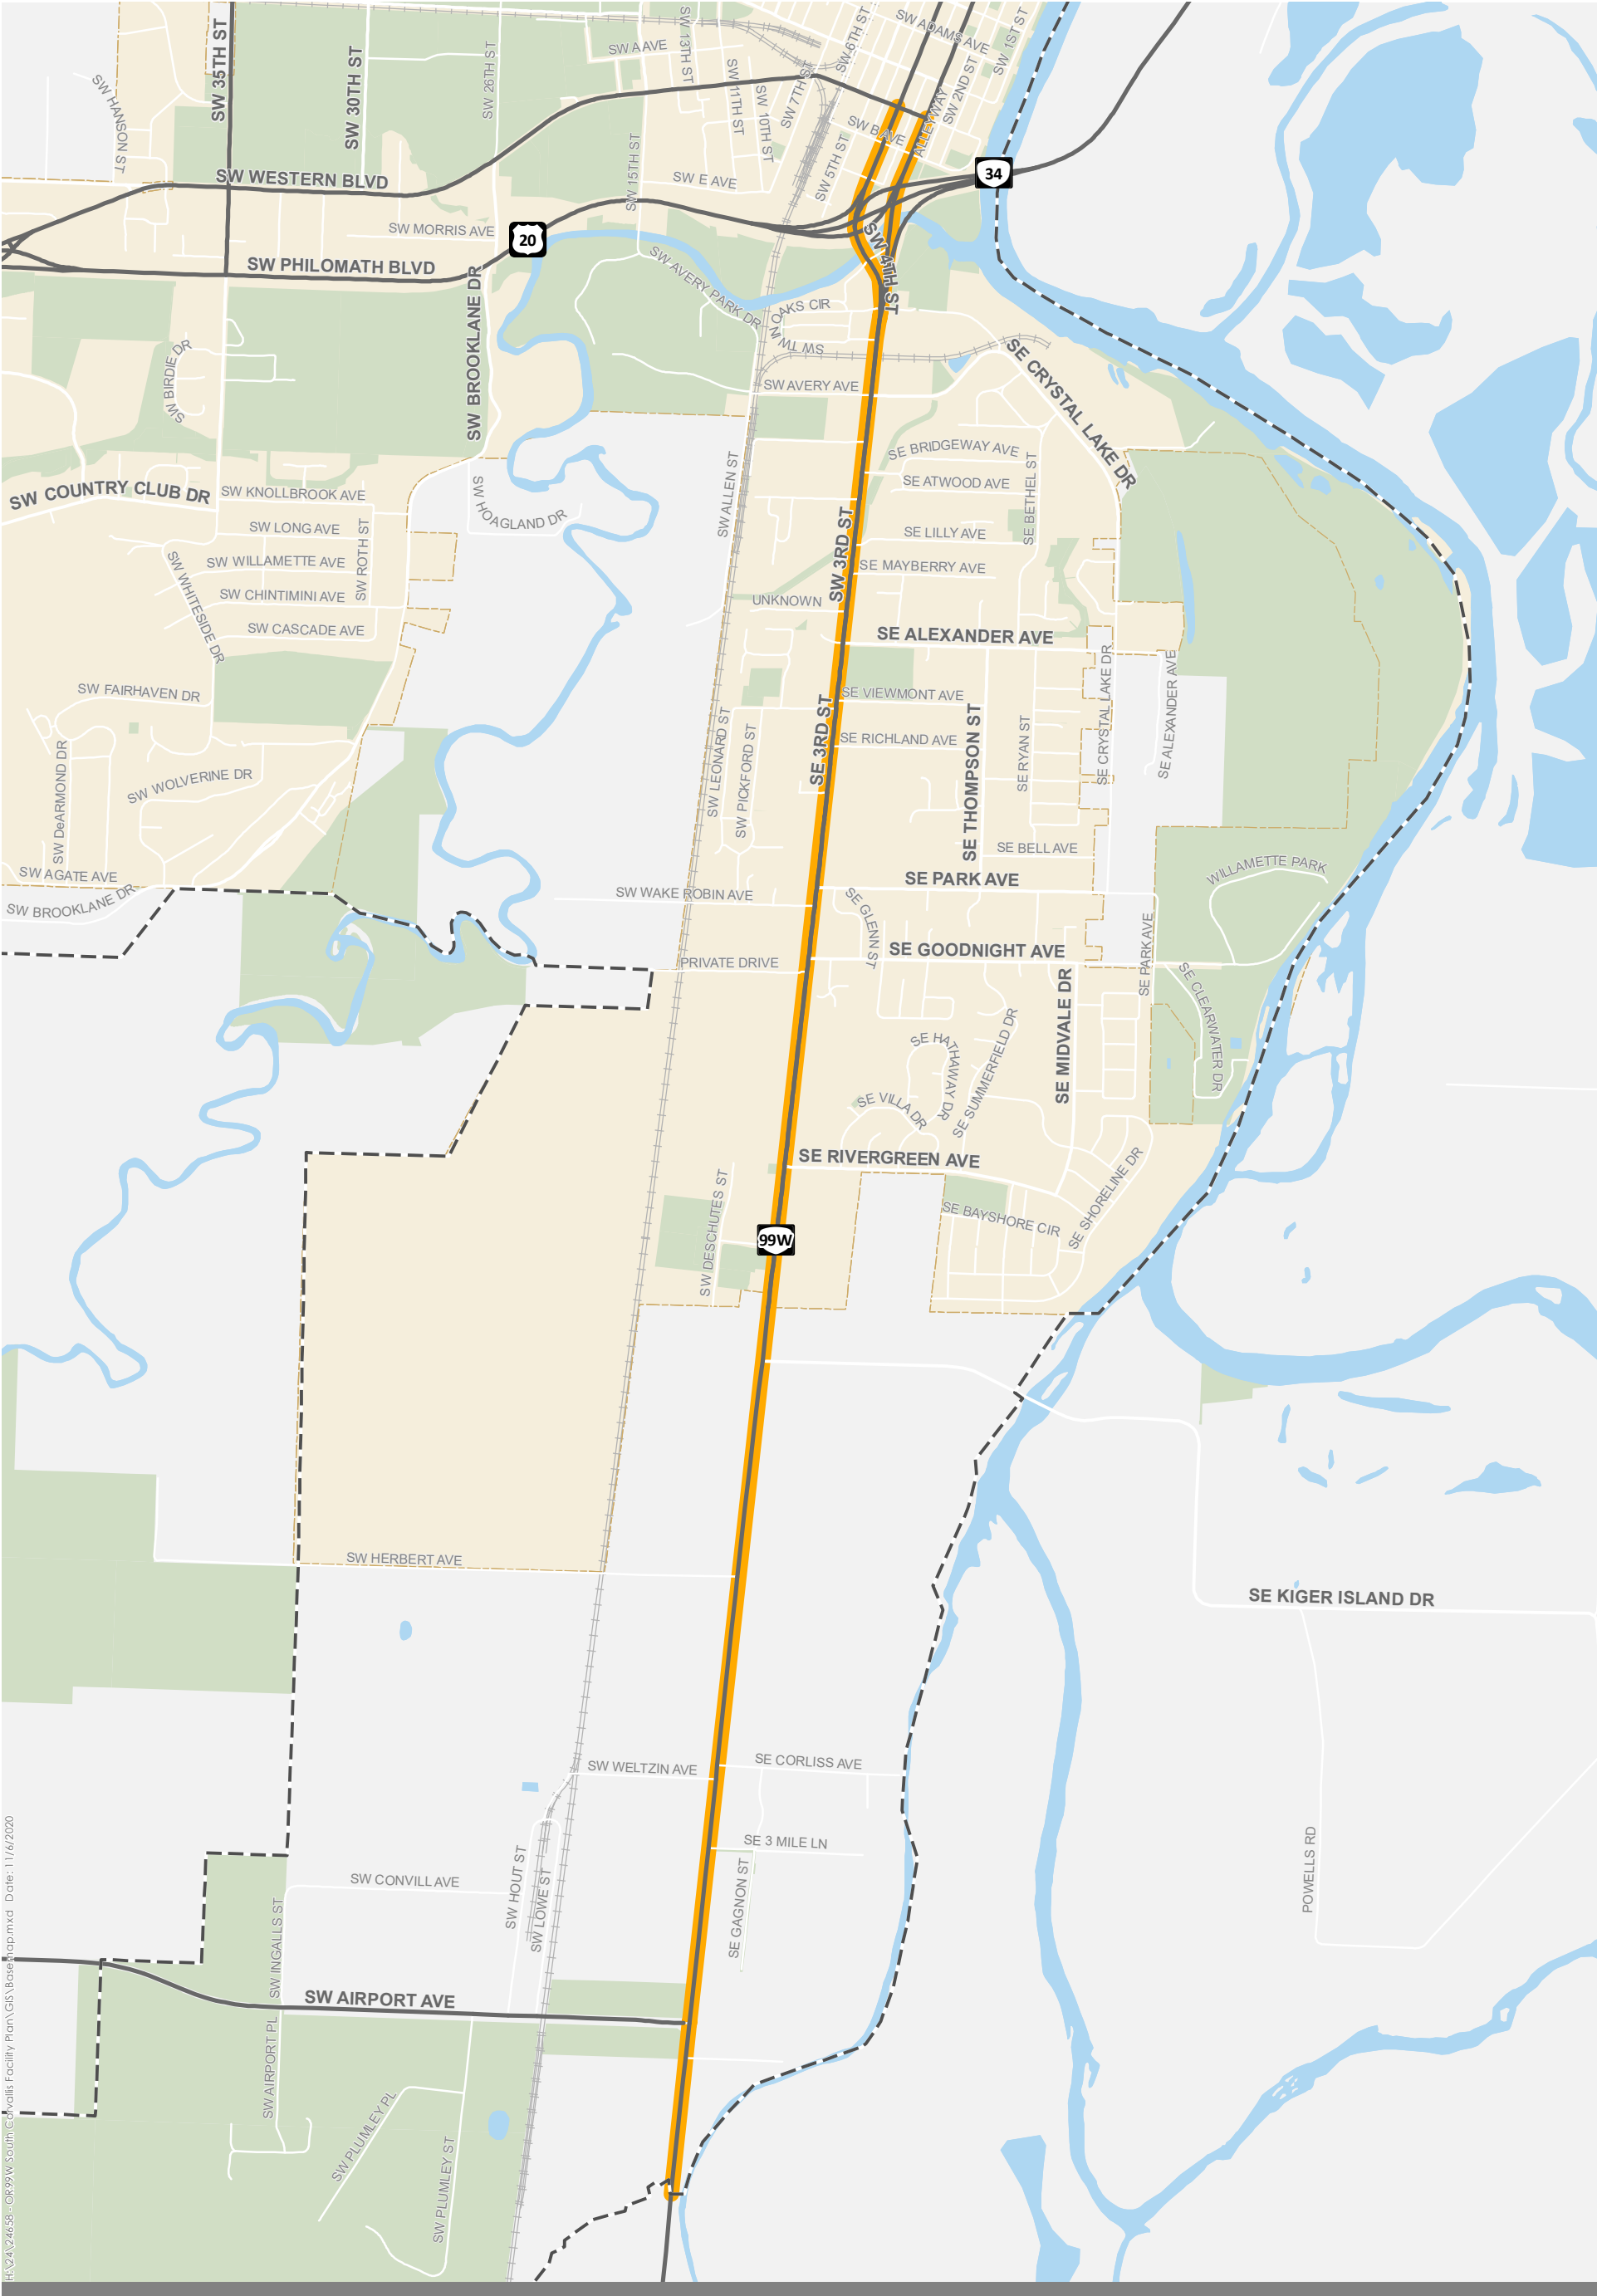
Figure 1 illustrates the study area extents of OR 99W, study area intersections and study area public streets intersecting the highway.

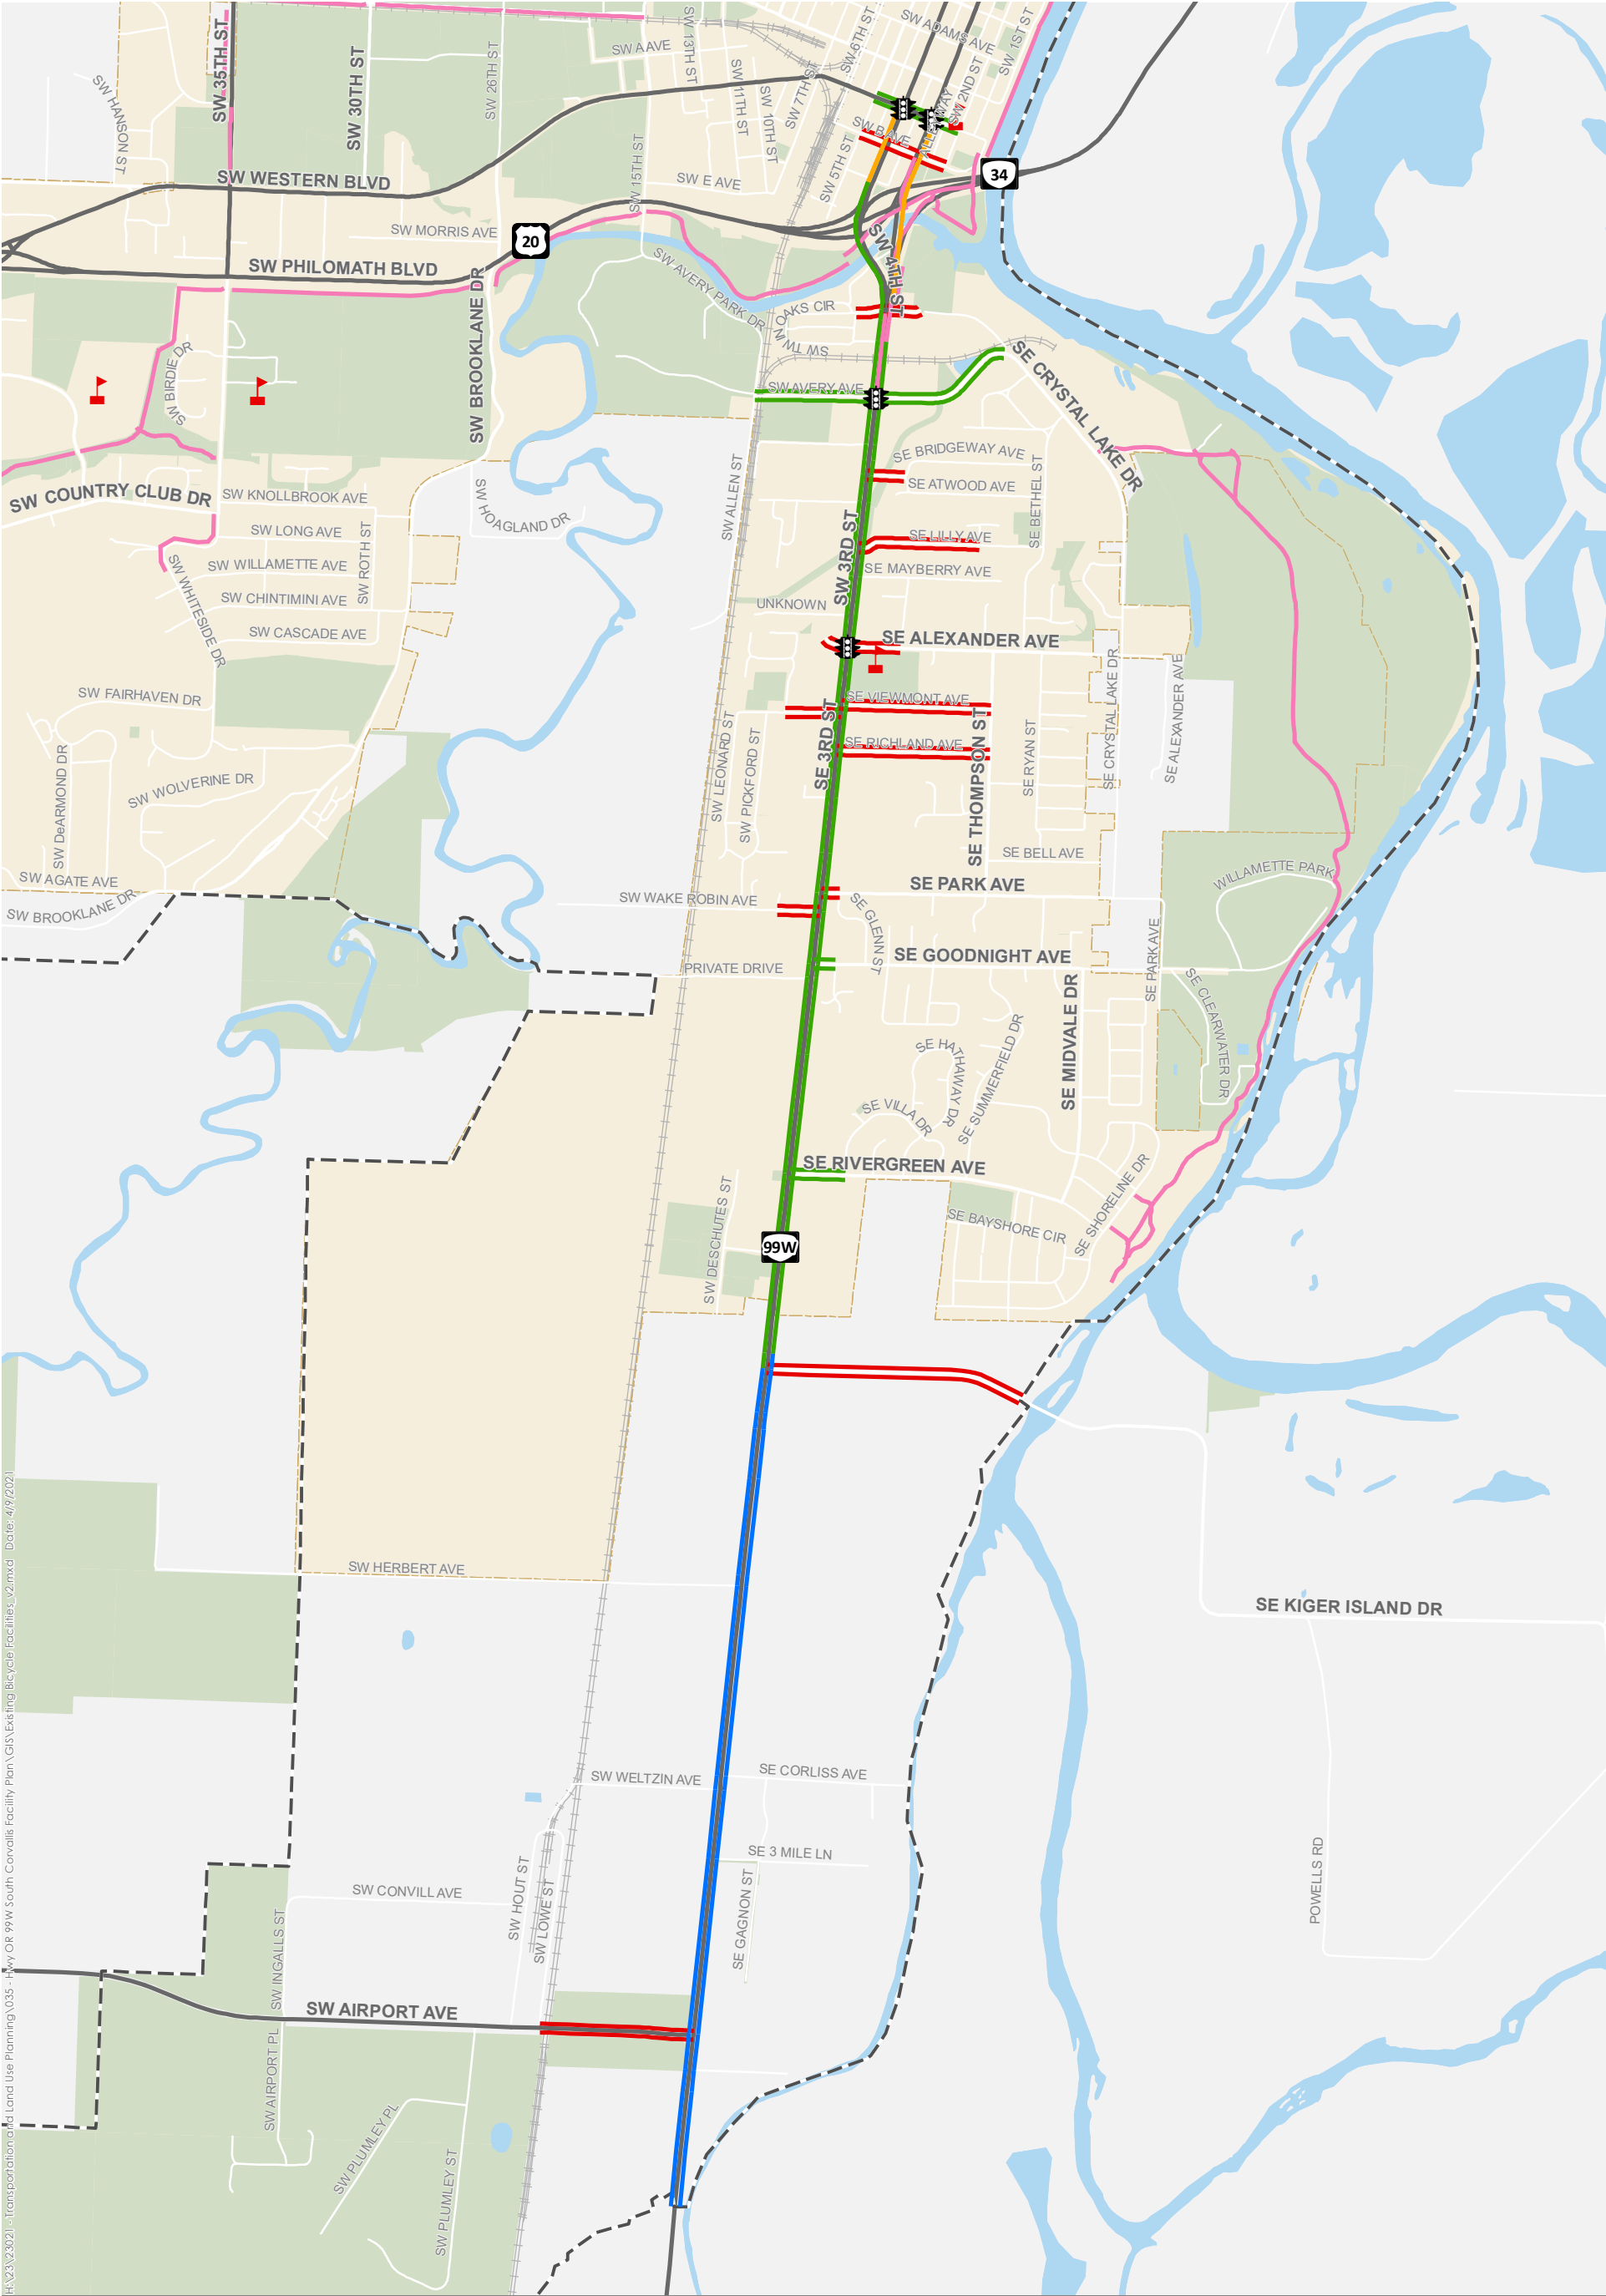
Shoulder bikeways are located along OR 99W south of SE Kiger Island Drive in the southbound direction, and from the southern boundary of the study area to approximately 500 feet south of SE Kiger Island Drive in the northbound direction. Shoulder bikeways are shoulders that can be used for biking and do not hold the same requirements as bike lanes that prohibit motor vehicles from stopping or parking in the space. A shoulder includes a 4" white stripe between the shoulder and travel lanes.

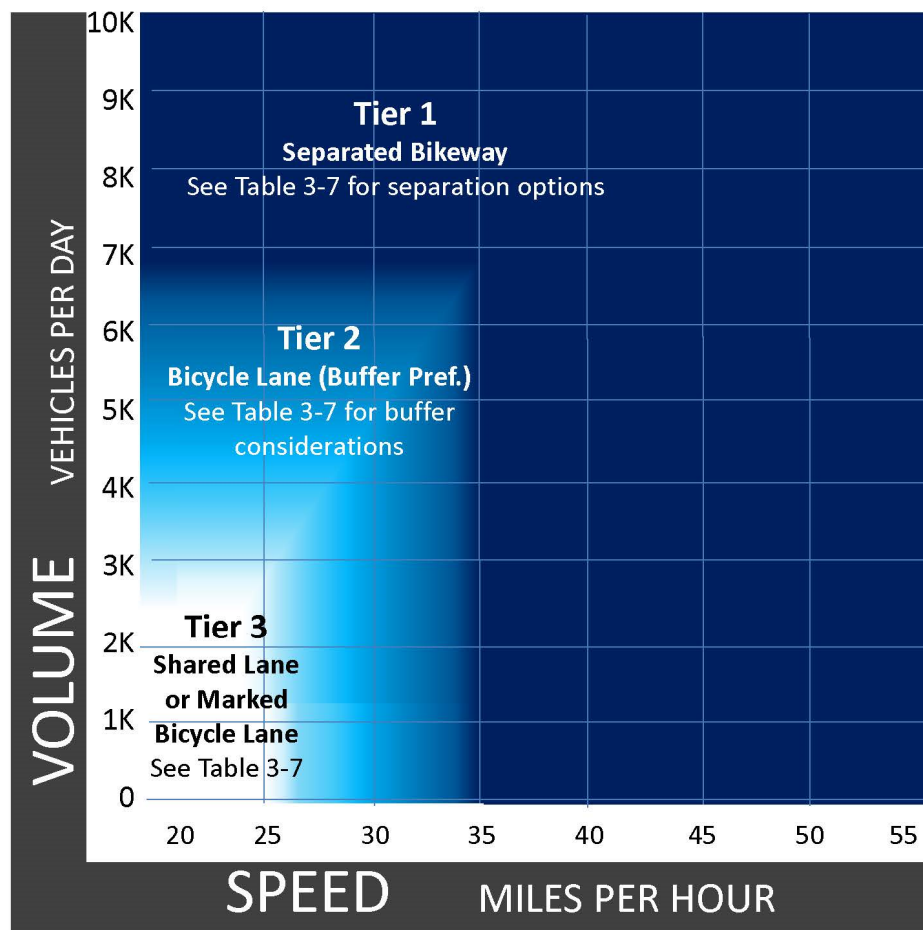
Figure 5: Bicycle Facility Tier Identification Matrix

The BLTS score is determined based on the speed of the roadway, the number of travel lanes per direction, the presence and width of an on-street bike lane and/or adjacent parking lane, and several other factors such as the presence of a centerline. Figure 5 illustrates the recommended facility treatments (Tier 1 – Tier 3) necessary to achieve a low-stress experience for someone biking based on posted speed and average daily traffic (ADT).

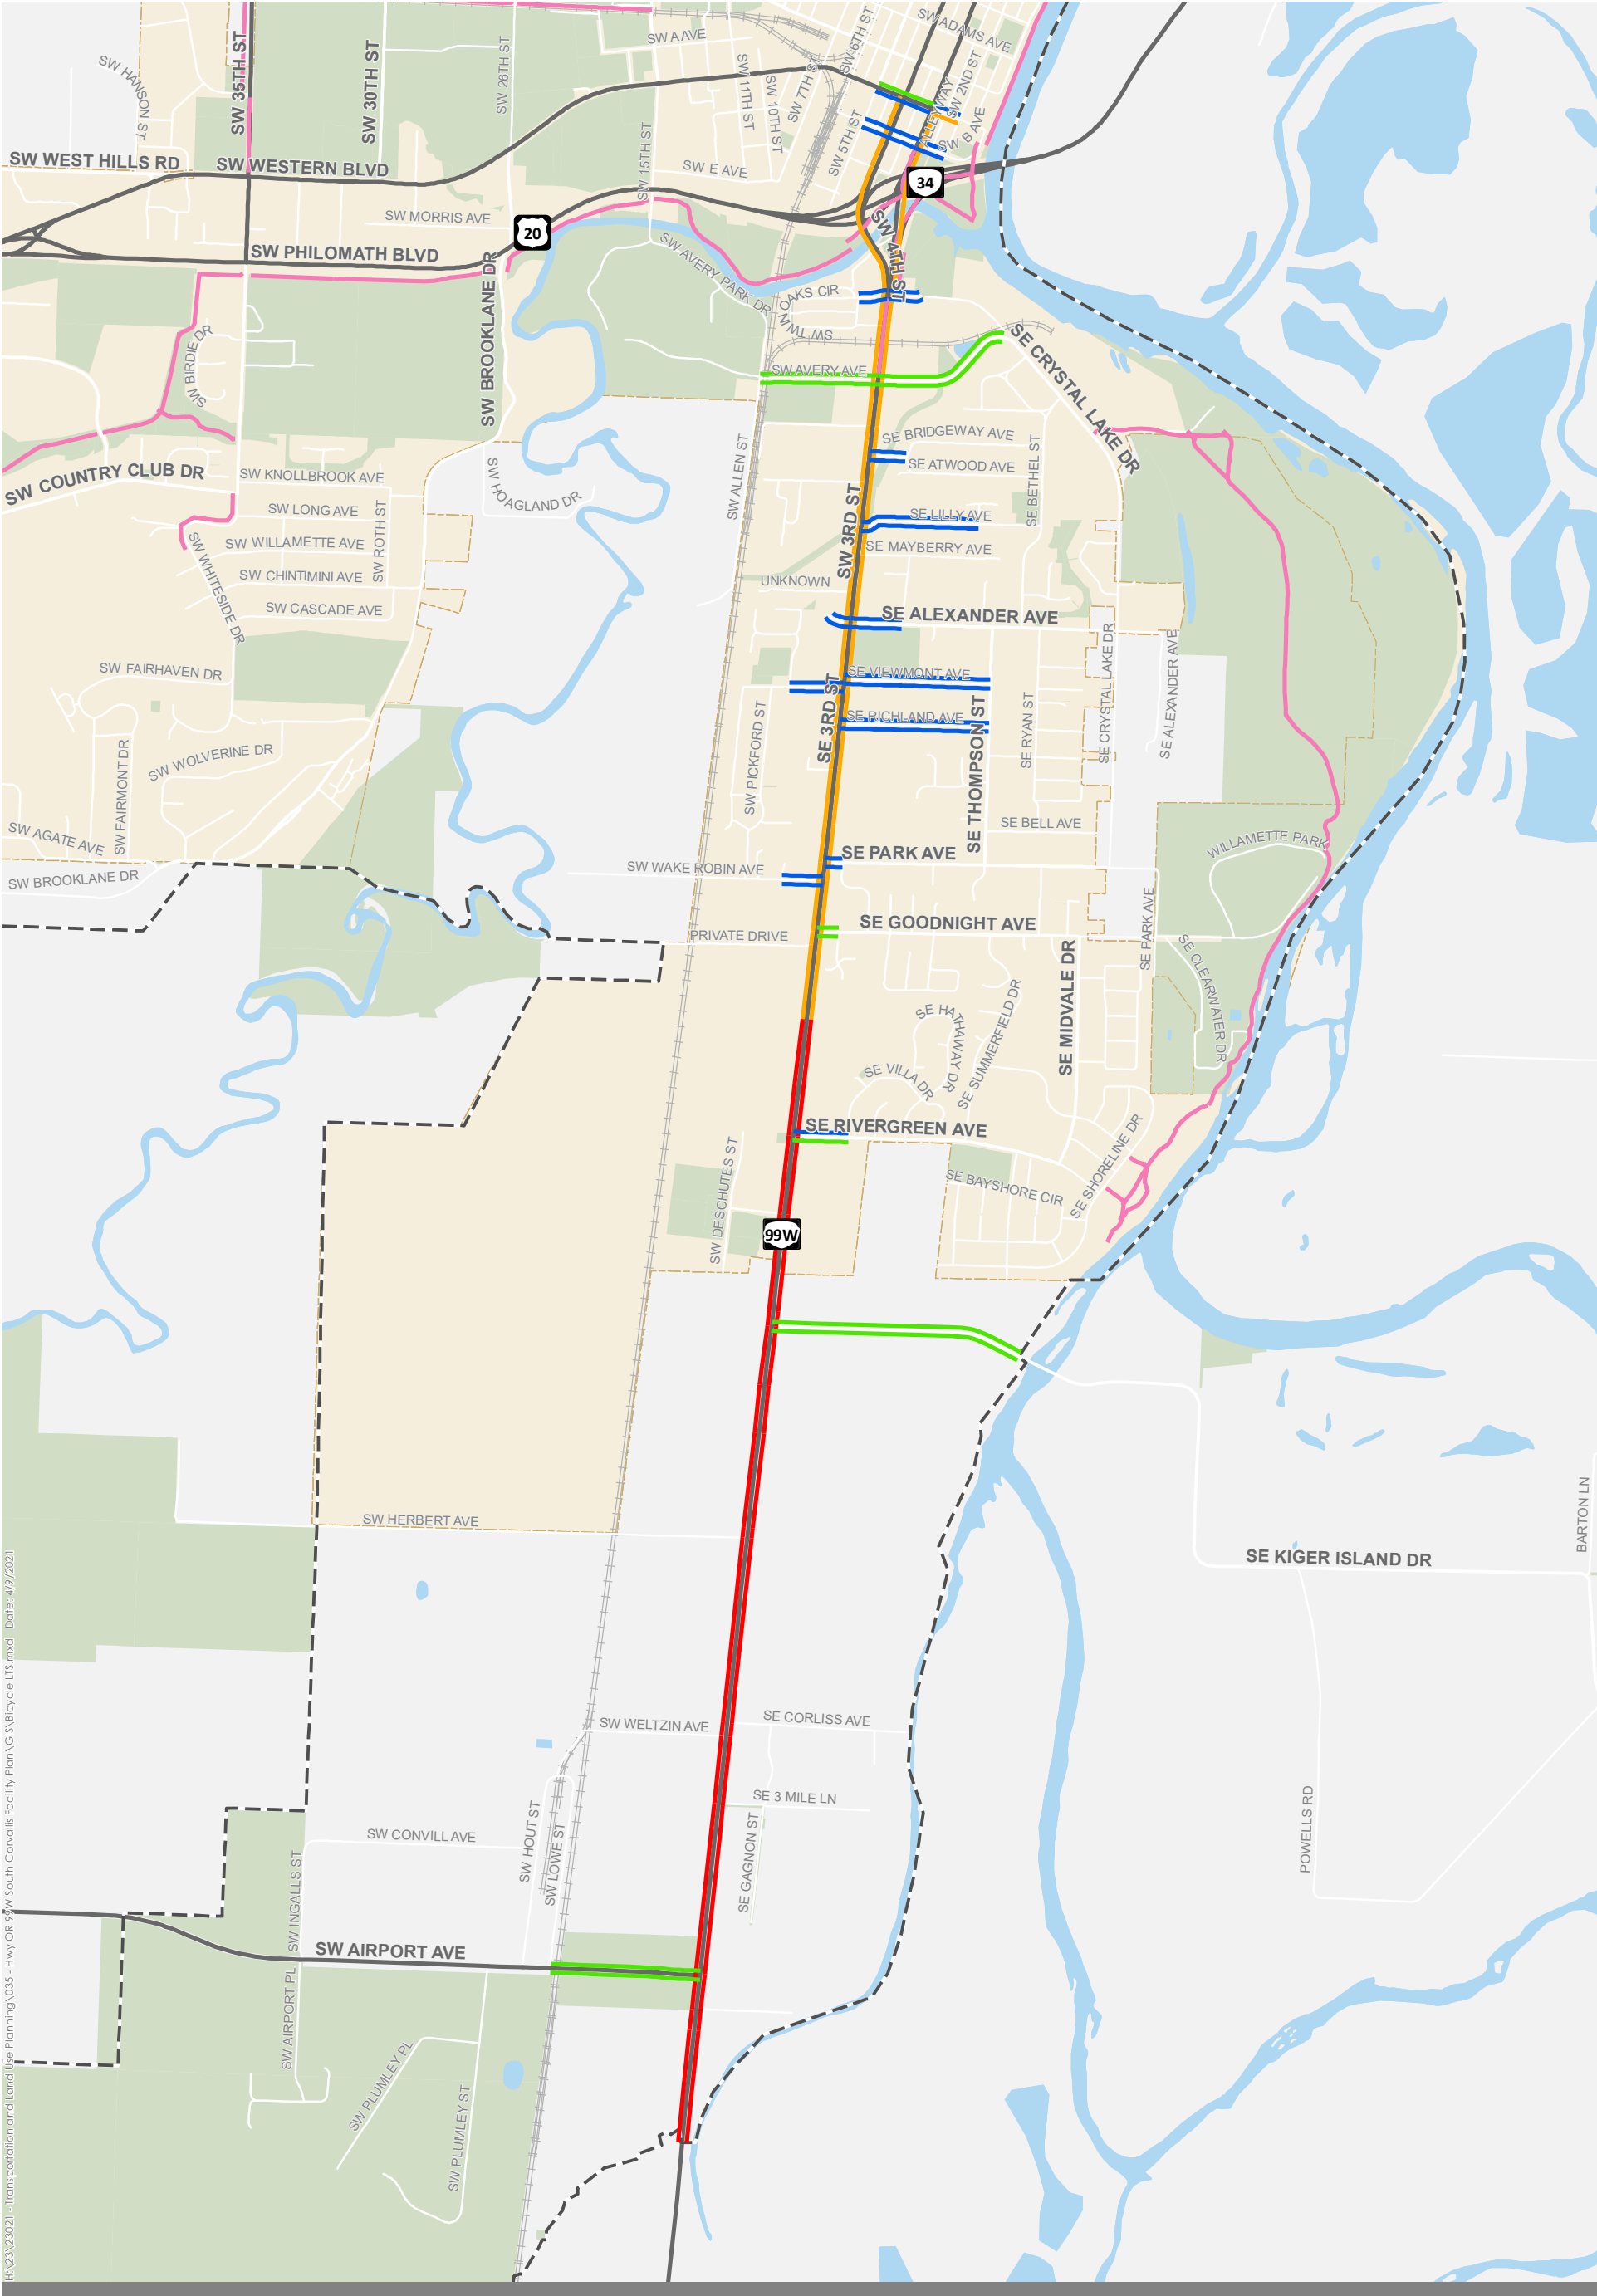
Figure 6 illustrates the results of the BLTS analysis conducted within the project study area. It is important to note that while some segments are shown as BLTS 3 or 4, these may contain shorter segments with better BLTS scores. Table 2 summarizes the detailed results of the BLTS analysis. As shown, there are seven segments rated BLTS 3 and three segments rated BLTS 4.

Most of the segments rated BLTS 3 have striped bike lanes, however they are too narrow for roadway conditions (less than 6 feet). For these segments to be rated BLTS 2, the combination of the striped bike lane and additional buffer space would need to achieve a minimum width of 7 feet. Other segments rated BLTS 3 were evaluated as shared roadways. For these segments to be rated BLTS 2, a similar treatment of buffered bike lanes would be needed.

It is worth noting that all abutting City owned streets achieve a LTS 2 or better. This is primarily due to a posted speed of 25 mph or less, and adequate bike lane widths when present. On public streets with no bike lanes, LTS 2 or better is achieved due to a combination of posted speeds of 25 mph or less and no center line striping.

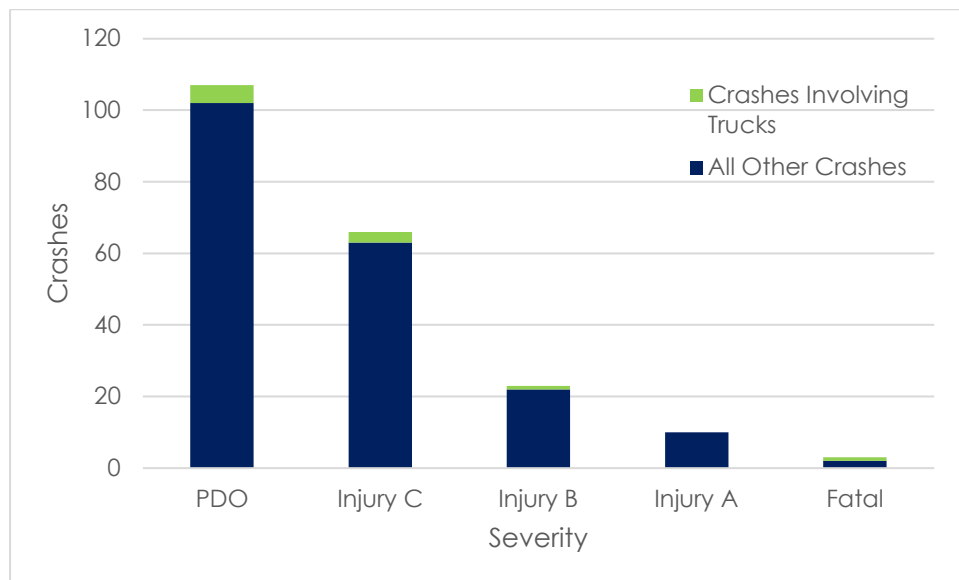
Figure 17: 2014-2018 Reported Crashes Involving Trucks

Figure 17 presents that 5% of the total reported crashes involved trucks. Most of the truck involved crashes were PDO or injury C crashes, one truck involved crash was an injury B crash, and one truck

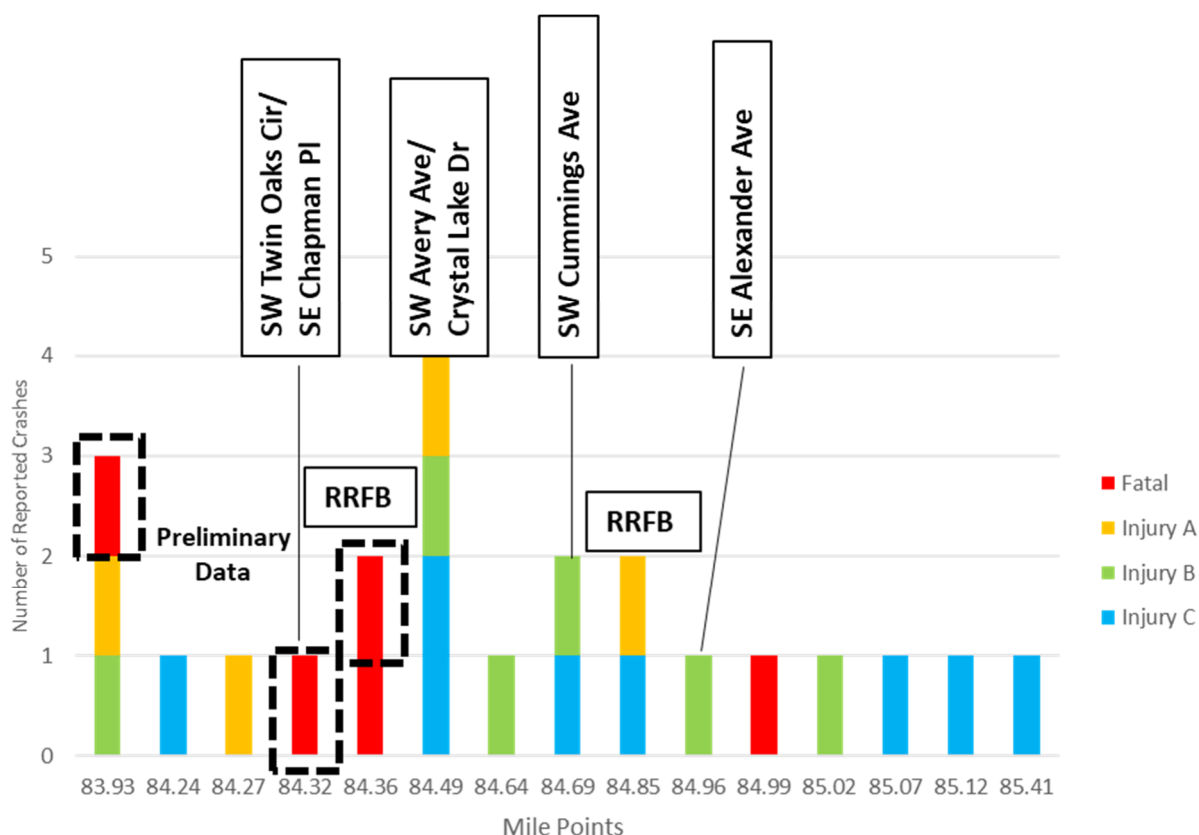
Figure 18: 2014-2018 Reported and 2019-2021 Preliminary Pedestrian and Bicycle Crashes by Milepost

As noted above, pedestrian and bicycle crashes represent 10% of the total and 46% of the high severity (injury A and fatal) 2014-2018 reported crashes.

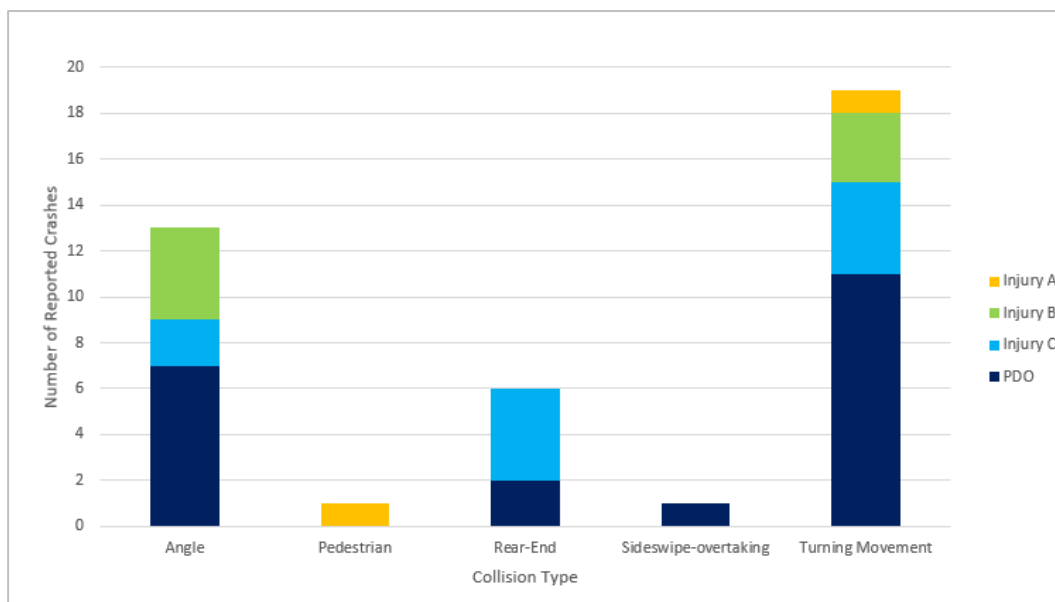
Figure 19: 2014-2018 Reported Crashes at OR 99W & SW Western Boulevard by Collision Type

By reviewing the crash data at the OR 99W with SW Western Boulevard intersections more closely, the consultant team identified the following collision patterns that stand out the most:

In summary, most crashes at the intersections of OR 99W with SW Western Boulevard occur in fall and winter seasons, with Wednesdays and Fridays being the most common days of the week. Sixty-three percent of the crashes take place in clear conditions and 60% occur in daylight. Two out of the 40 crashes have been flagged for speeding, and none were flagged for alcohol or drug use.

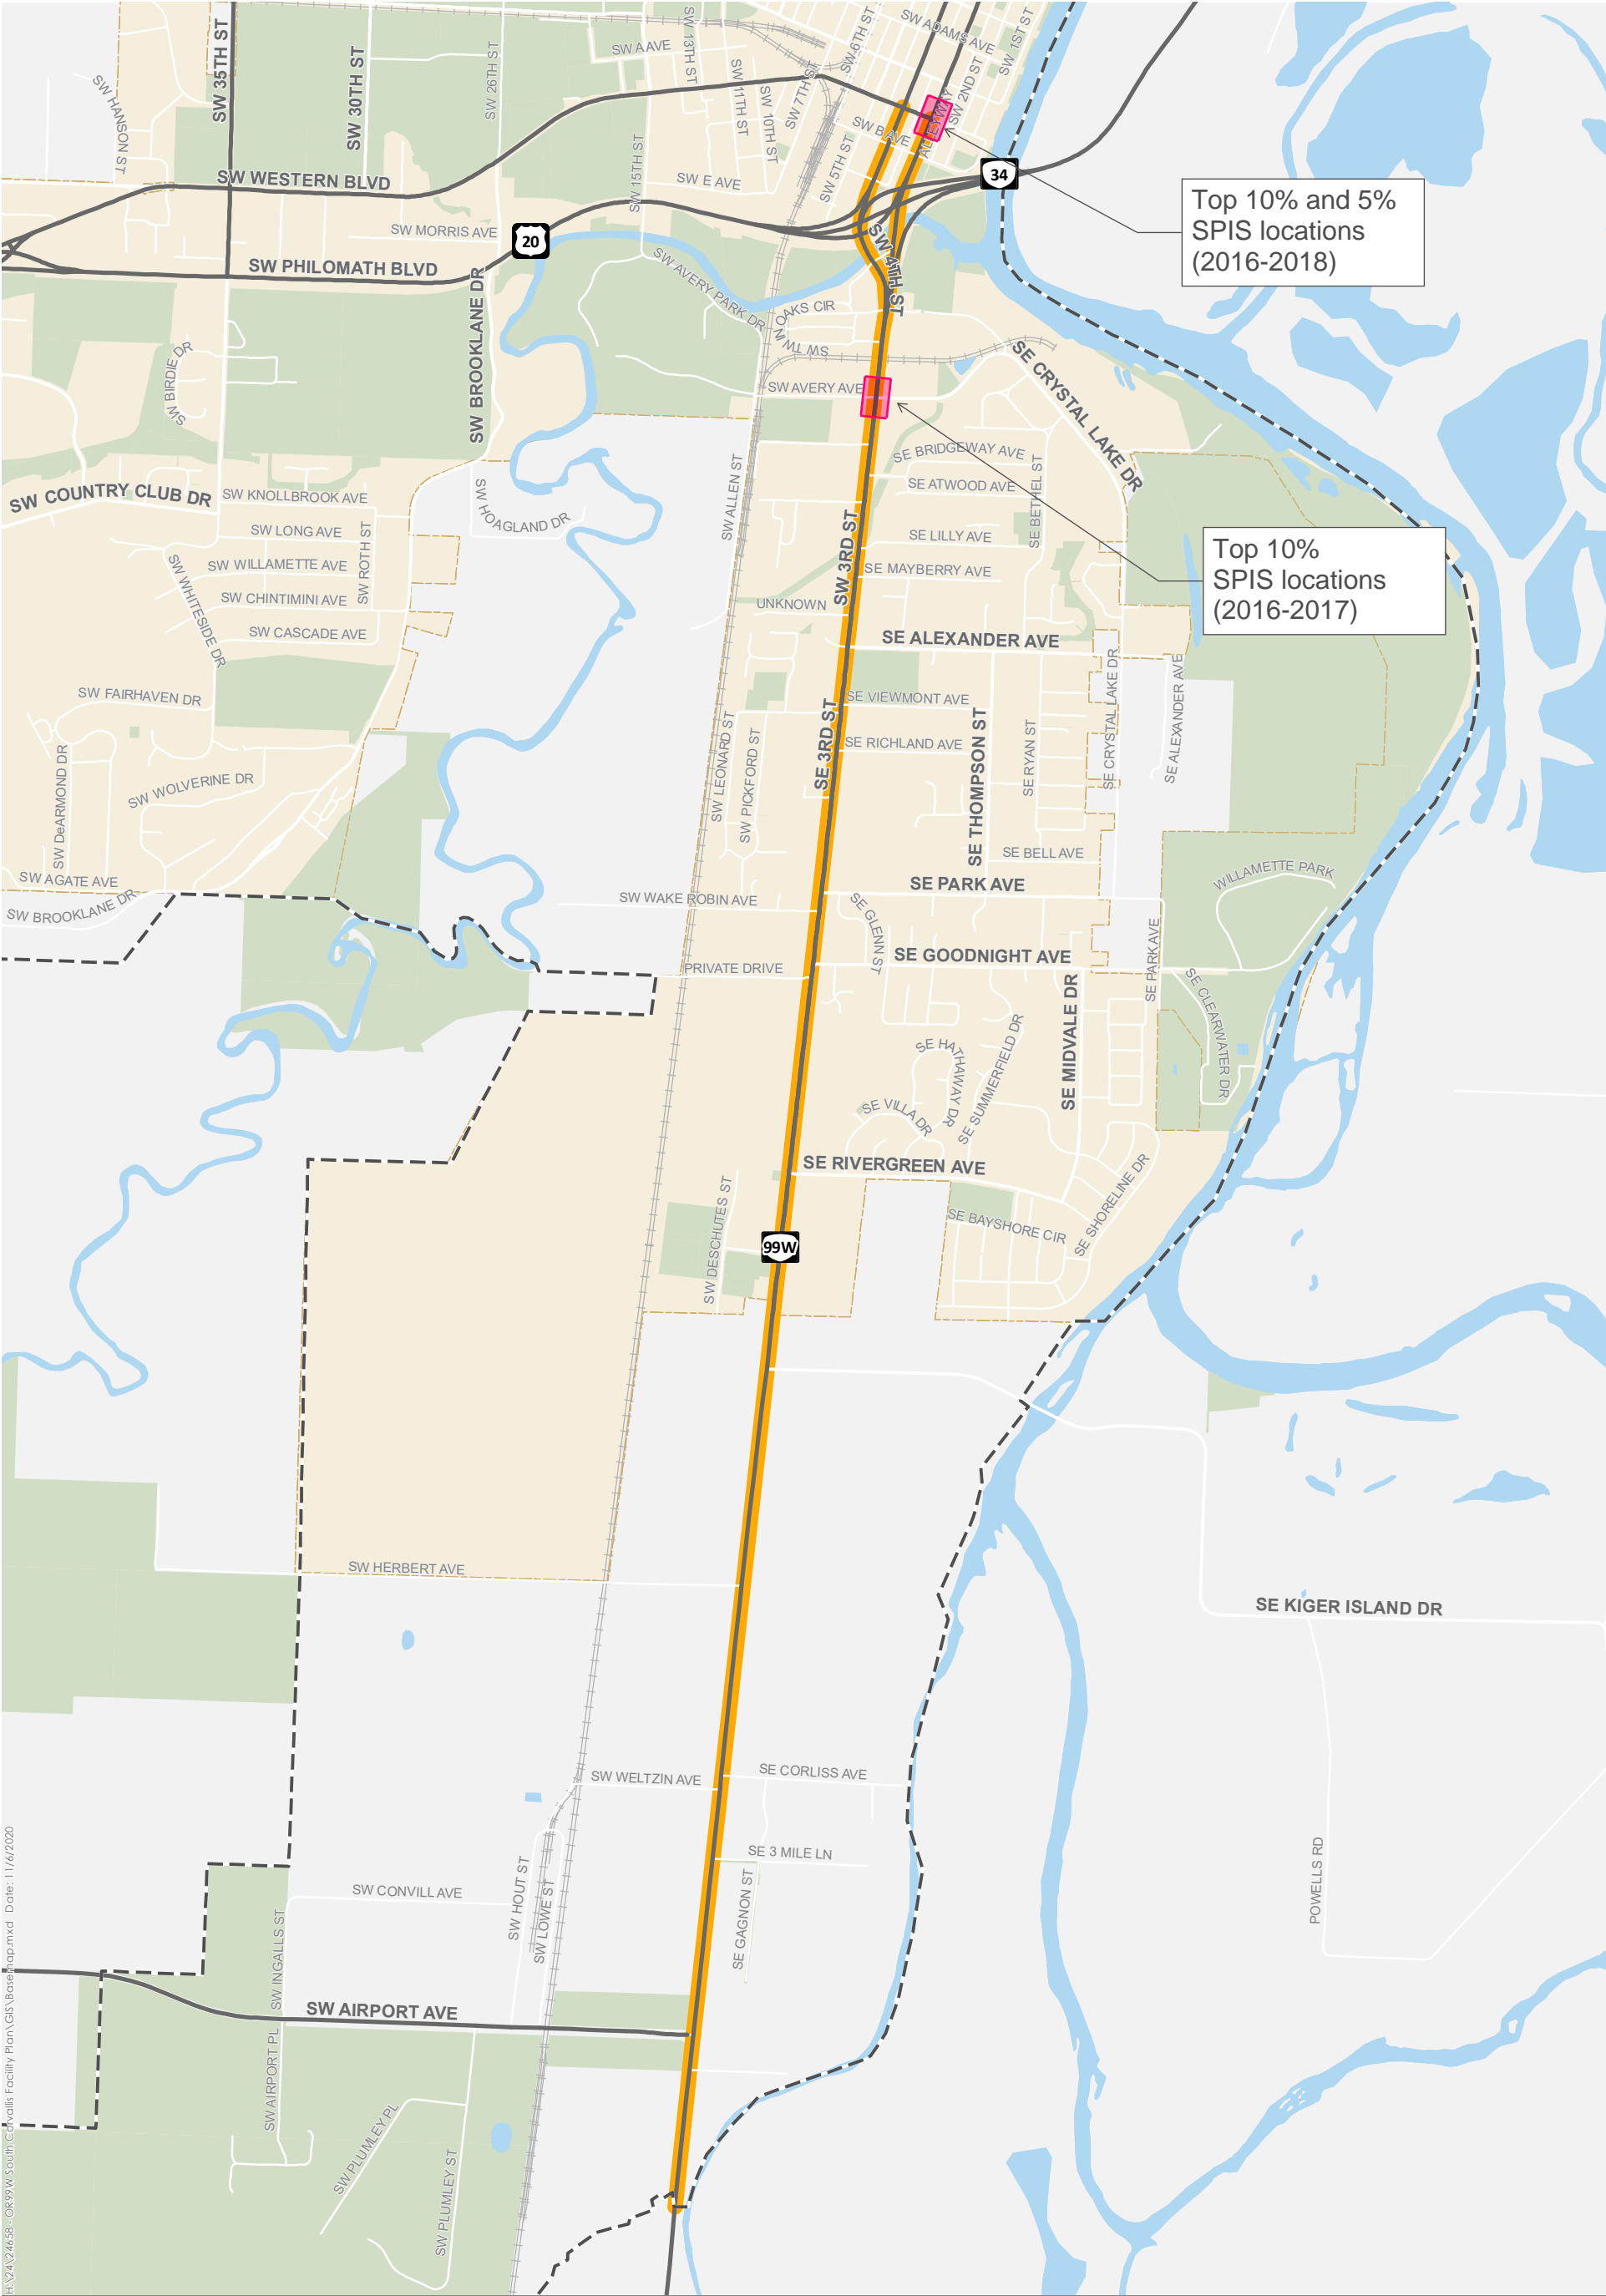
Figure 21 presents the two locations along the study corridor that are within top 5% and top 10% SPIS sites: OR 99W intersections with SW Avery Avenue (SE Crystal Lake Drive) and SW Western Boulevard.

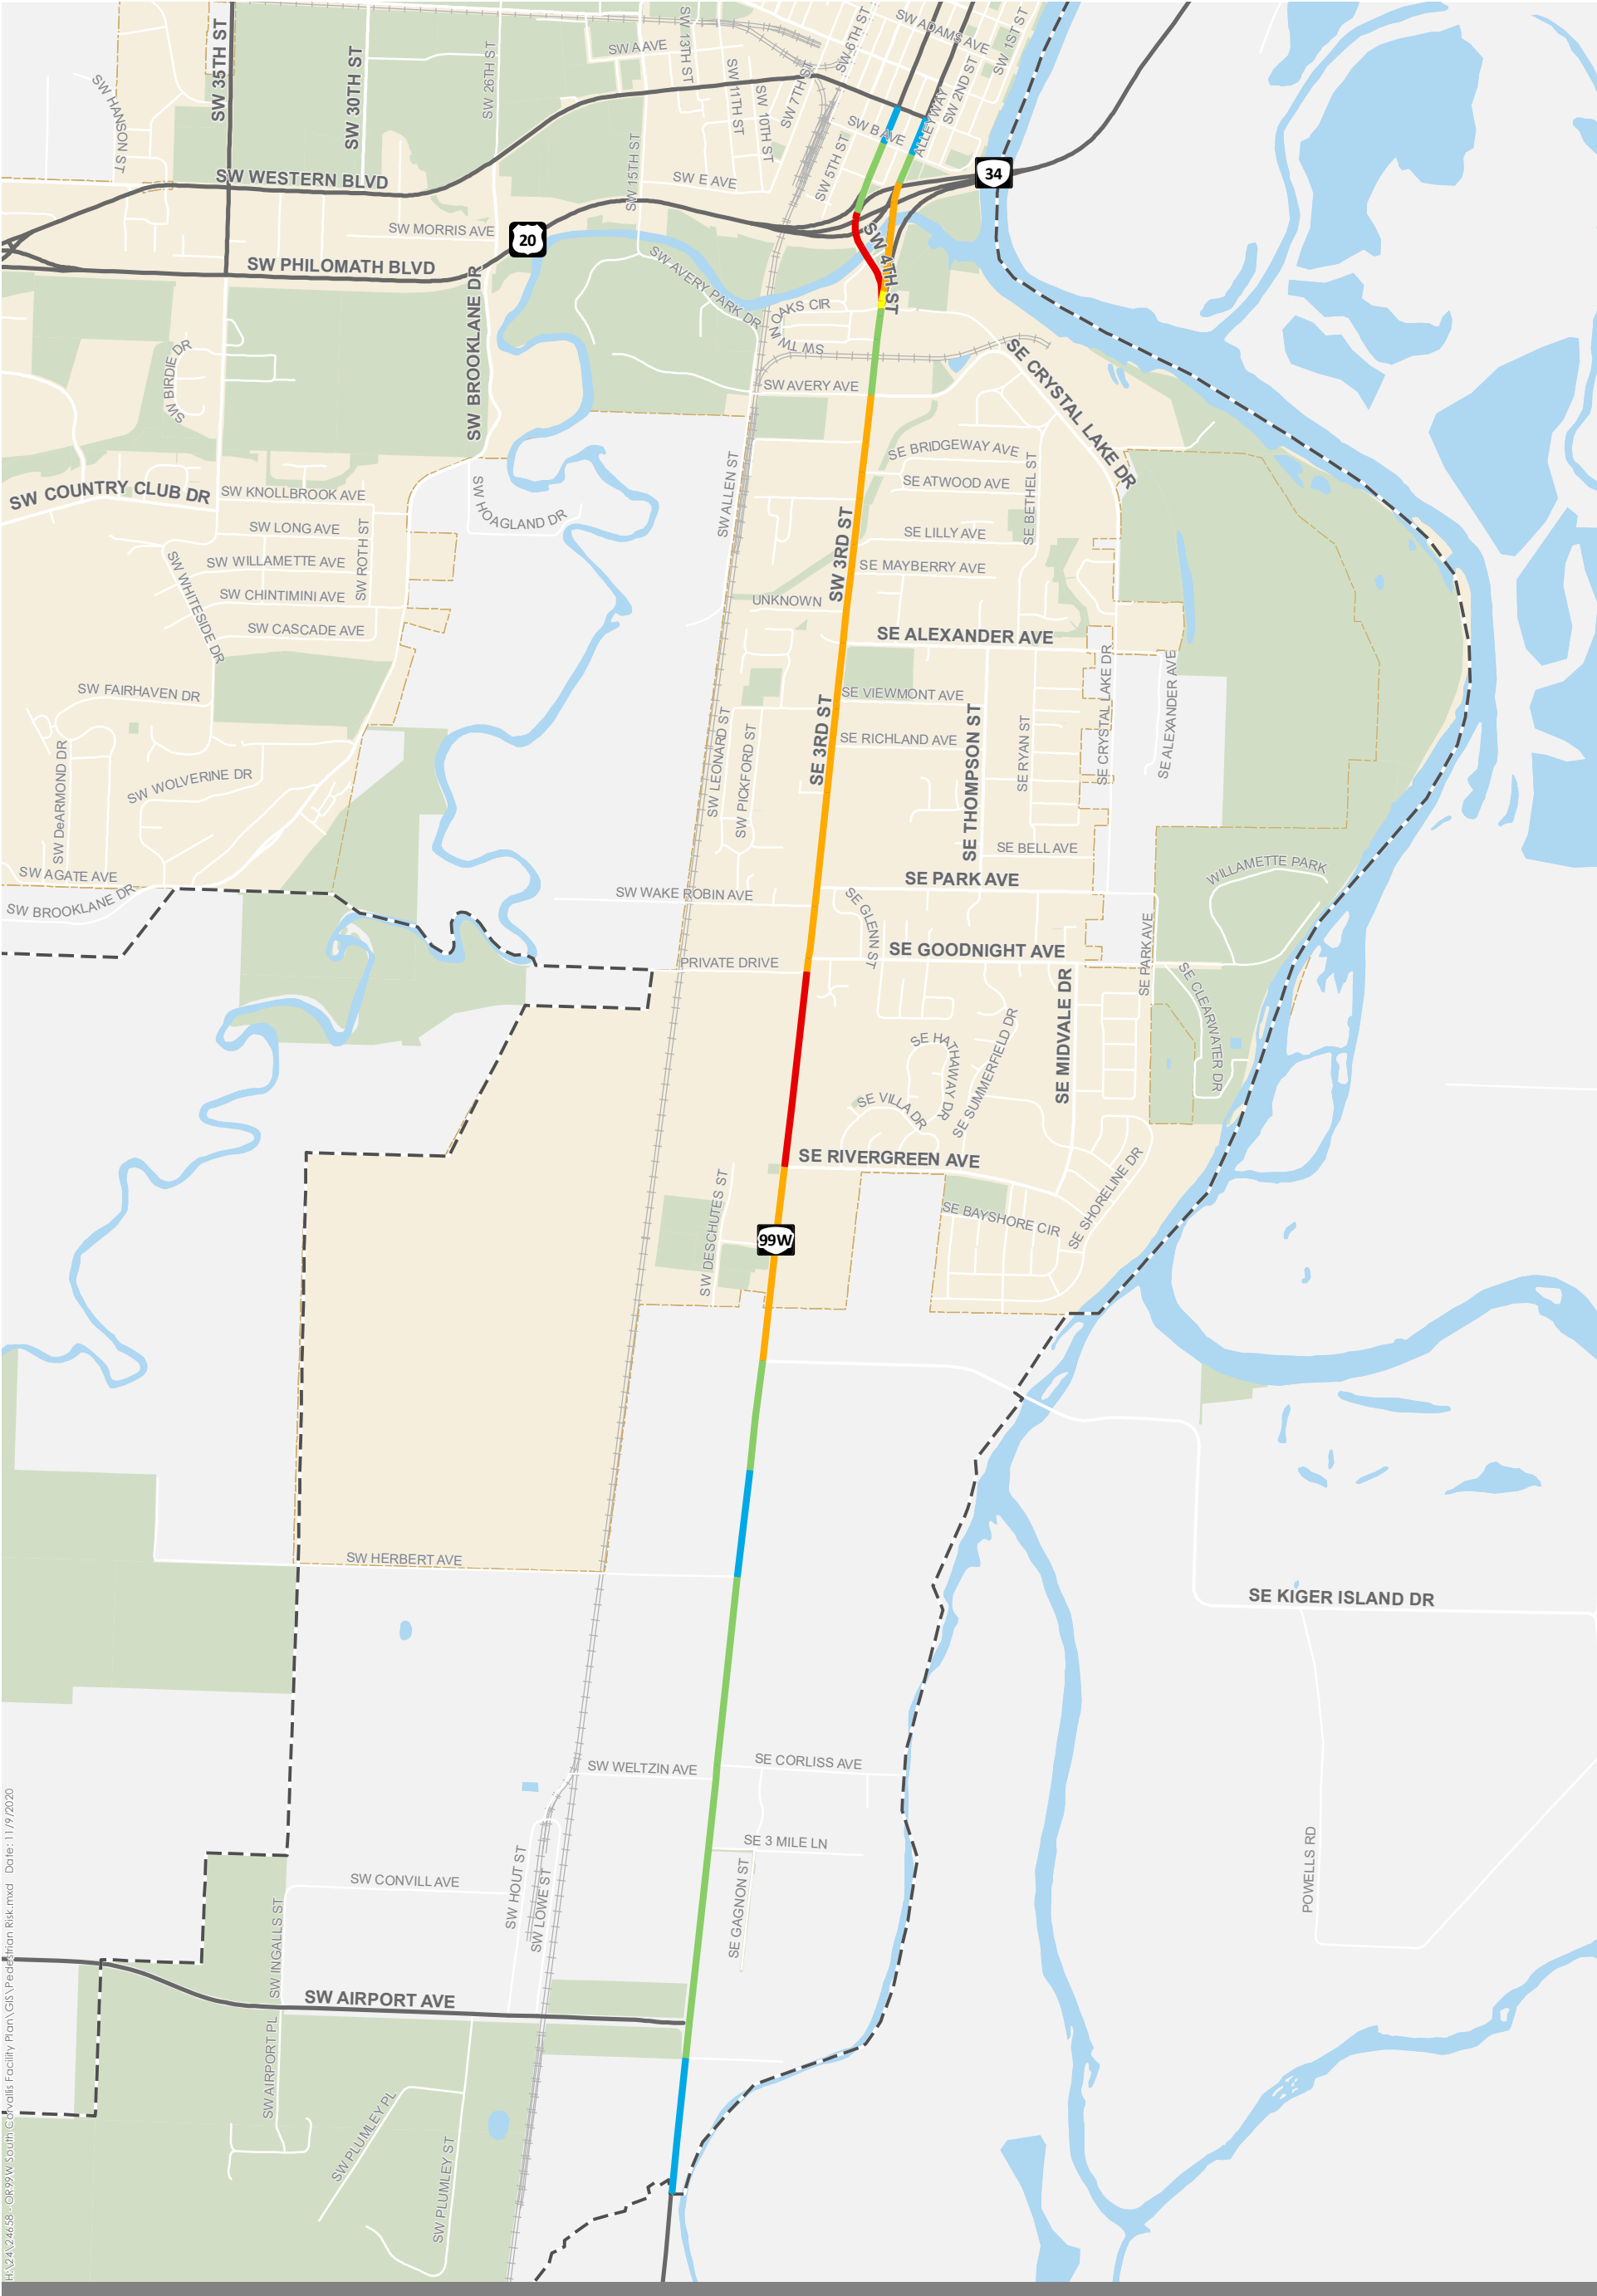
Figure 22 illustrates the results of the pedestrian risk analysis conducted as part of ODOT's statewide systemic safety analysis along the project extents for the Facility Plan. Several segments, including the southbound couplet through the interchange and the segments approximately between SE Goodnight Avenue and SE Rivergreen Avenue score in the top 20% in the state for pedestrian risk factors. Much of the corridor, especially between SW Avery Avenue and SE Goodnight Avenue, scores in the second 20% in the state for pedestrian risk factors. The pedestrian risk factors used as part of the analysis include:
