MEMORANDUM

Date:	April 21, 2021	Project #: 23021.35
To:	James Feldmann	
From:	Nick Gross, Camilla Dartnell, Phill Worth, Bincy Koshy, Polina Polikakhina	
Project:	Highway OR 99W South Corvallis Facility Plan	
Subject:	TM #10: Existing Safety and Active Transportation Inventory and Conditions

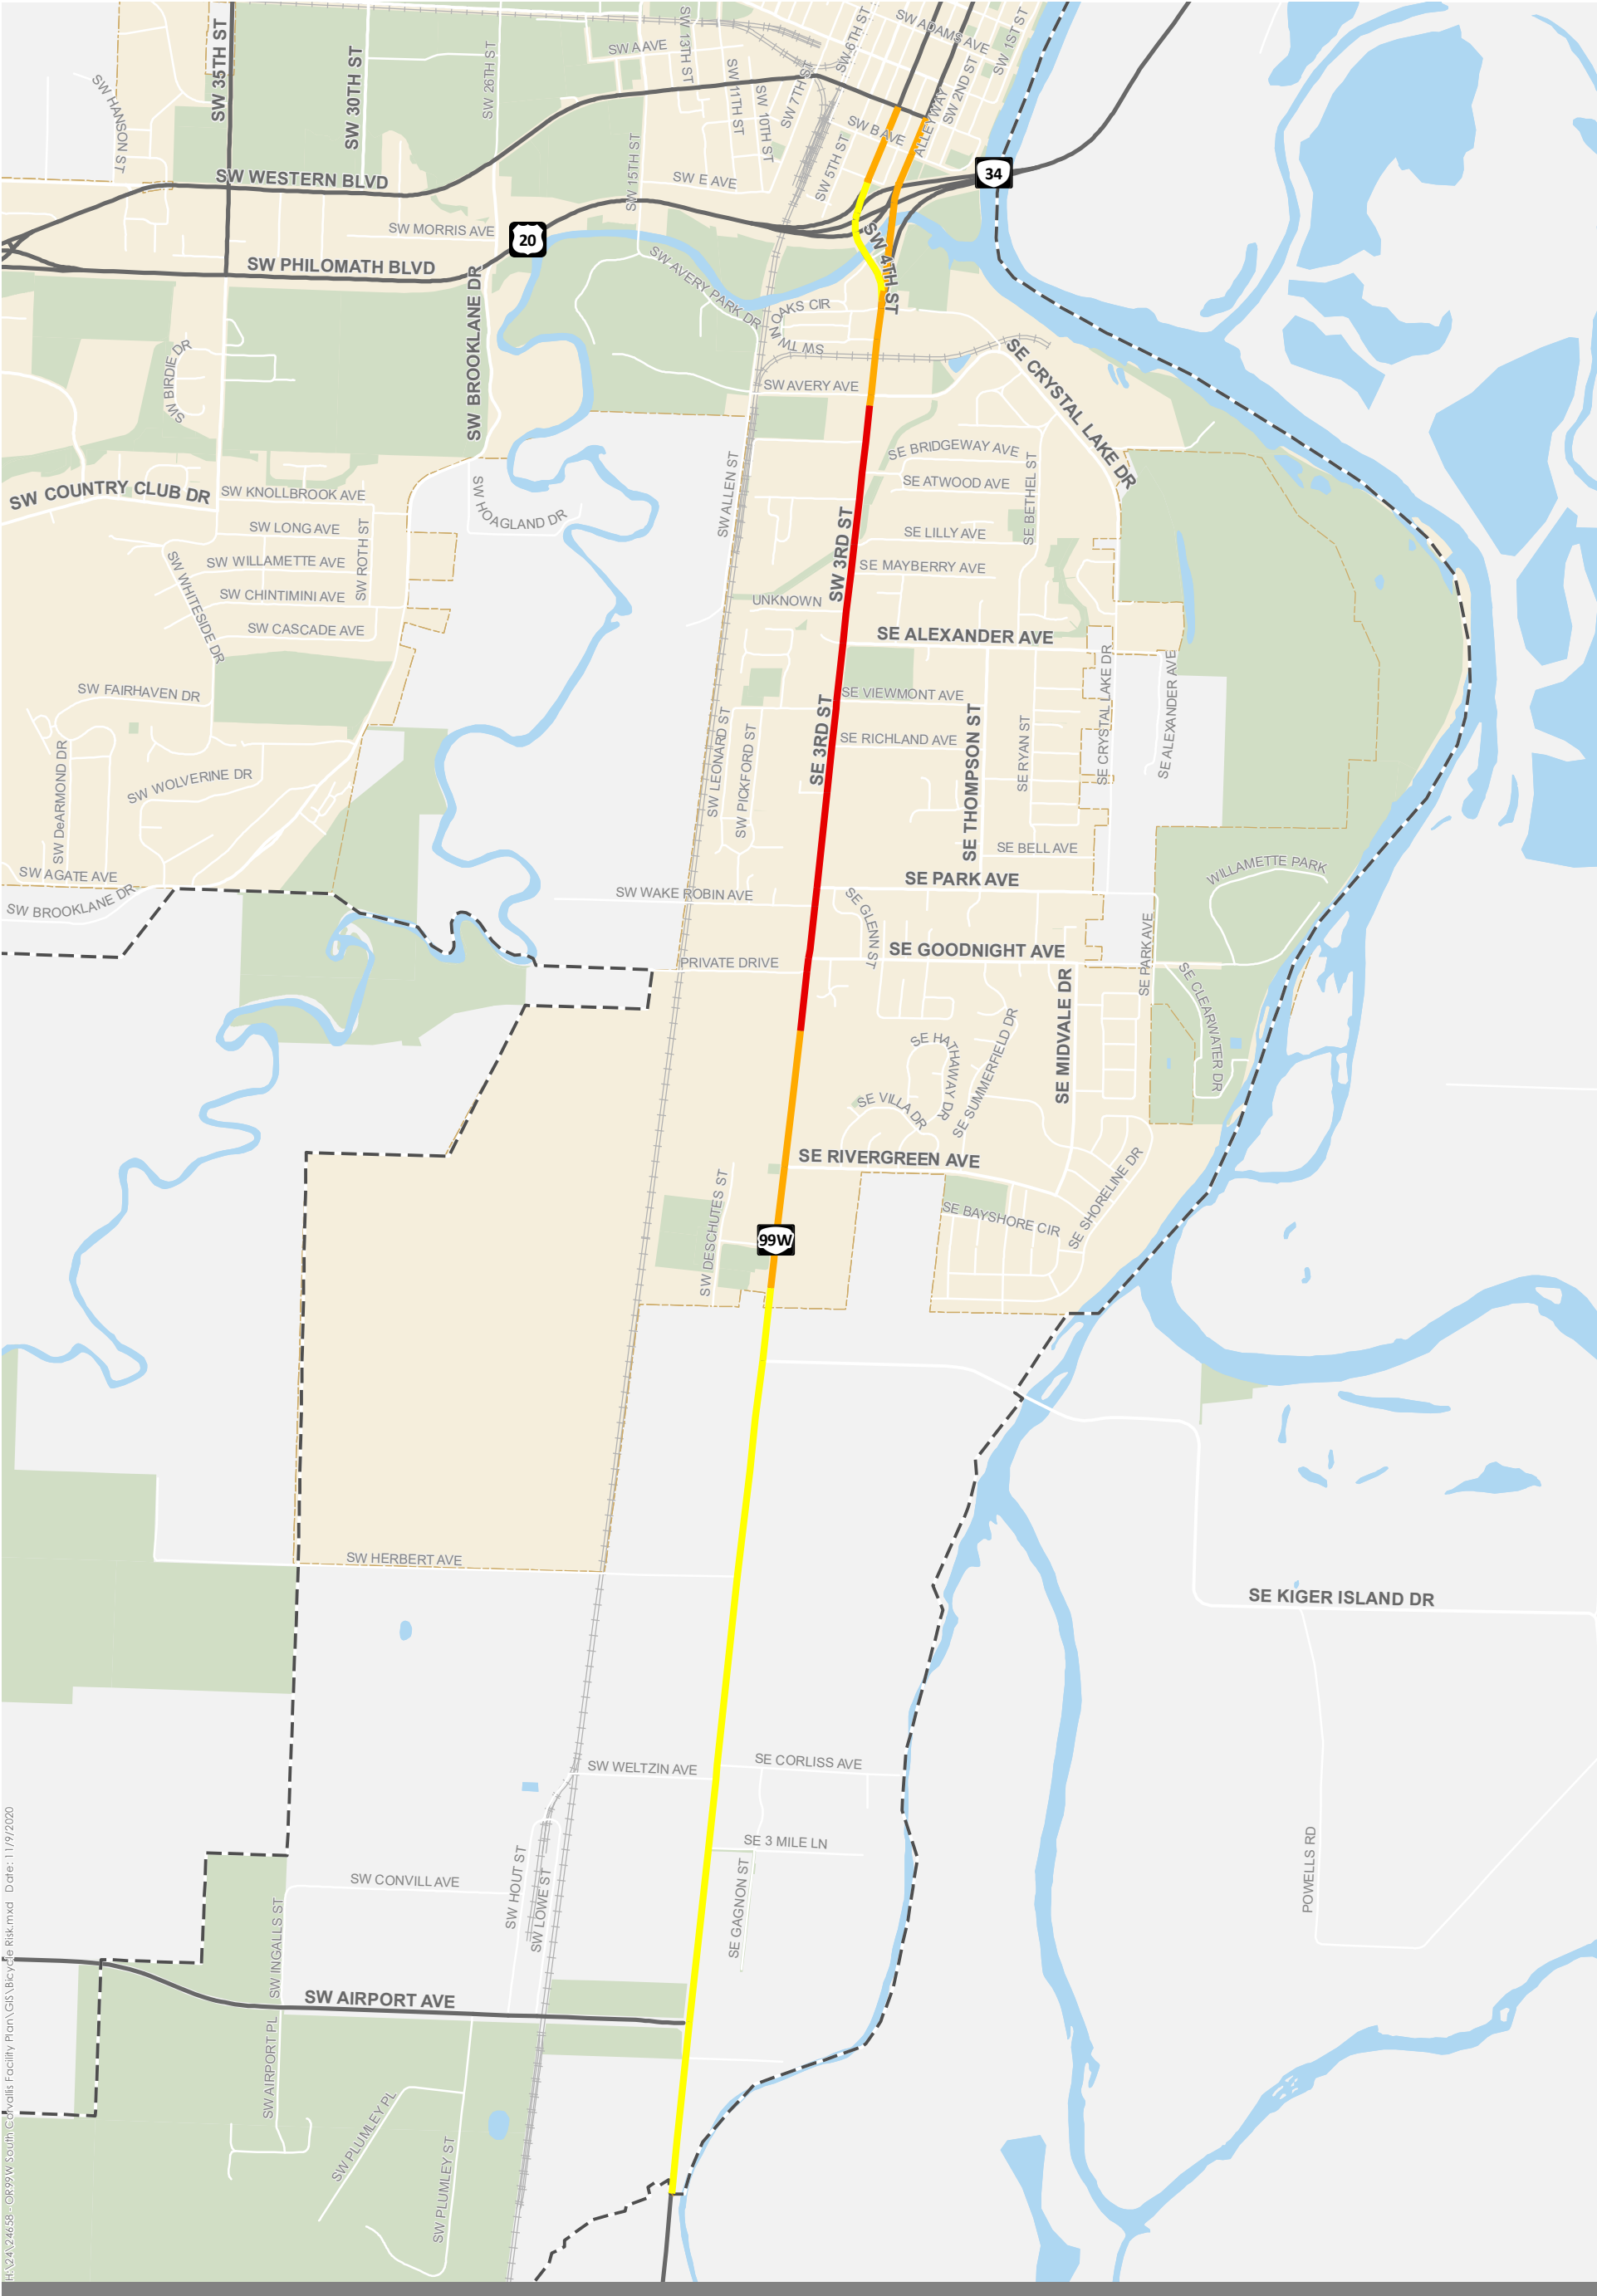
Figure 23 illustrates the results of the bicycle risk analysis conducted as part of ODOT's statewide systemic safety analysis along the project extents for the Facility Plan. The entire corridor study area scores in the top 60% in the state for bicycle risk factors, and the segment approximately between SW Avery Avenue and just south of SE Goodnight Avenue scores in the top 20% in the state for bicycle risk factors. The bicycle risk factors used as part of the analysis include:

- Principal Arterial
- Minor Arterials
- Number of Lanes (\geq Four Lanes)
- High-access Density
- No Bike Lane
- Posted Speed (\geq 35mph)
- Mixed Use Zoning
- Proximity to Schools (one mile)
- Proximity to Transit Stops (1/4 mile)
- High Population over the Age of 64

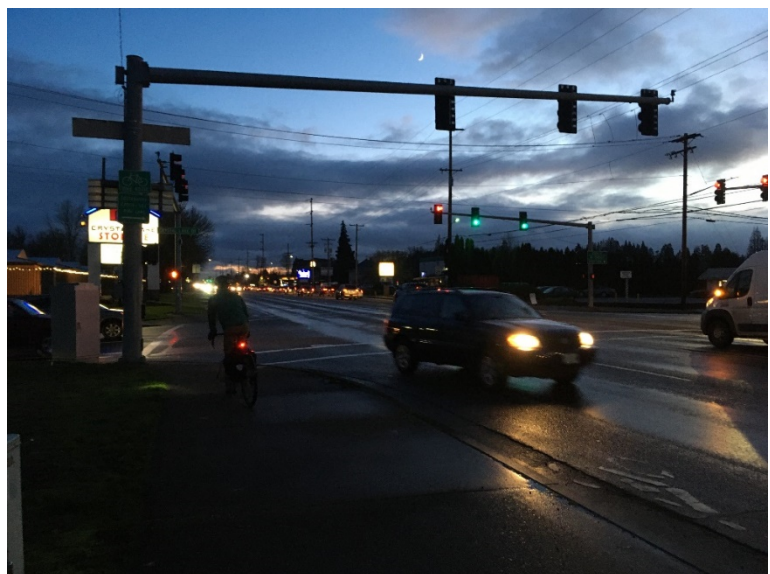
The consultant team observed that reduced or minimal lighting is an issue along the corridor, especially the east side of OR 99W and to the south of Crystal Lake Drive. Insufficient lighting creates an uncomfortable environment for people using the sidewalks and the bicycle lanes. Reduced or inconsistent lighting at crossings and intersections makes it difficult for the drivers to see people crossing the roadway. In addition, back lighting from land uses obstructs drivers, and people walking and biking from seeing signage, especially, regulatory signs, such as speed limit signs.

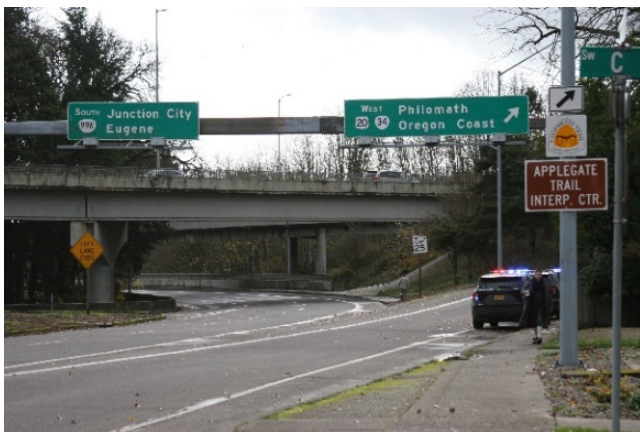
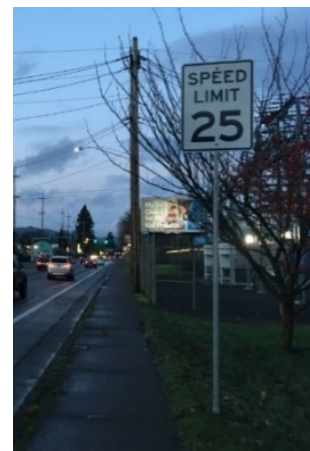
The consultant team identified multiple signage issues along the corridor. The team observed sign clutter, consisting of roadway signs and those from private properties, throughout the corridor. Another issue is the mounting of speed limit signs: the consultant team observed that some signs were mounted at a height above that which would allow many headlights to trigger signage retroreflectivity. Some speed limit signs are also hard to see due to insufficient overhead lighting. The team also observed an absence of wayfinding signs for people walking and biking. Finally, southbound on OR 99W approaching the ramps to US 20/OR 34, the right lane becomes a trap lane but does not have signage and pavement markings to indicate this prior to the ramp.

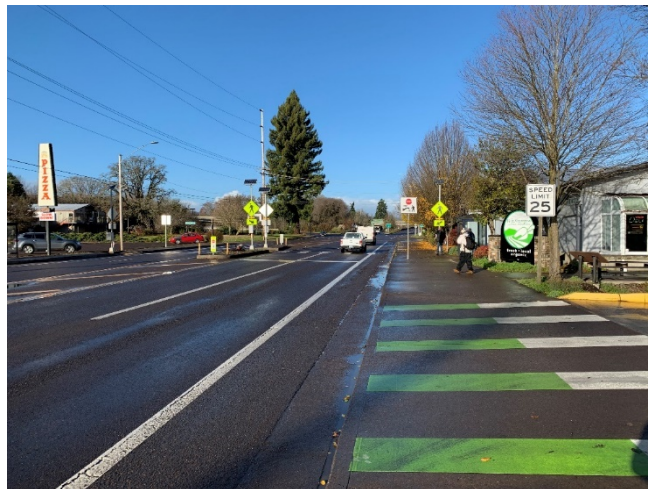
Limited lighting or visibility at multiple existing crossings throughout the corridor make it difficult for drivers to see crossing pedestrians. This also results in pedestrians and drivers being unable to make eye contact at night. Further, the lighting at some of the crossings is not appropriately located and does not provide lighting onto crossing pedestrians for approaching motorists.

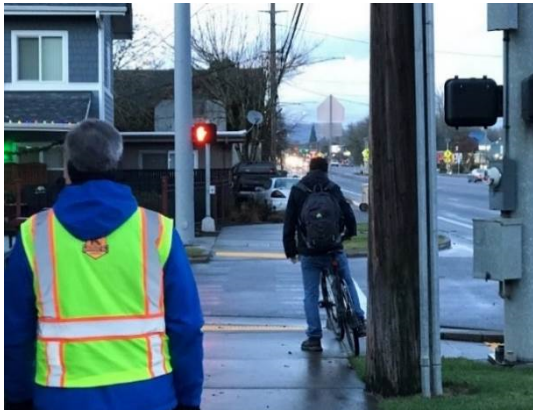
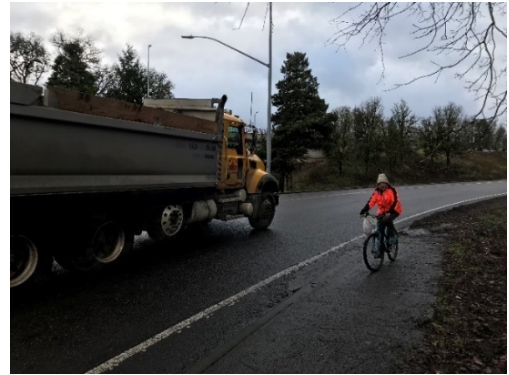
Many people travel by bicycle in South Corvallis, especially in the more urban portion of the city. During multiple site visits, the consultant team observed many bicyclists riding on sidewalks, indicating that people are not comfortable riding in the bicycle lanes. Facilities with no buffer from faster moving motor vehicles and poor bicycle lane conditions can create an unsafe or uncomfortable environment and can lead to

unpredictable
bicycling
behavior.

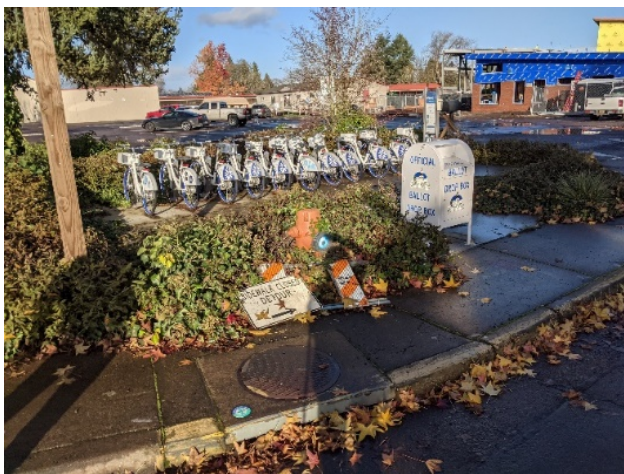
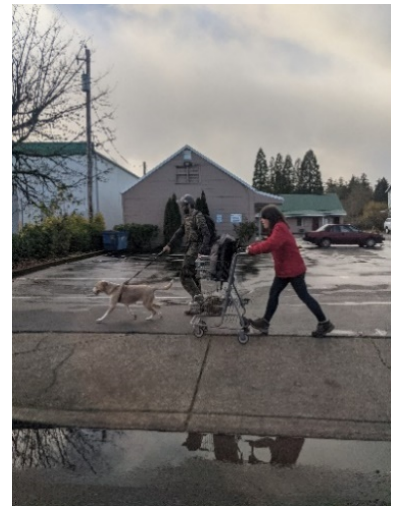
Sidewalks are available in the northern portion of the corridor, but they end at SW Goodnight Avenue. In addition, the consultant team observed that there are many obstacles experienced by people walking on the sidewalks: garbage and recycling bins, mailboxes, and vegetation often times block sidewalks. In addition, the proximity of vehicle traffic to the sidewalks and the absence of any buffers creates a loud and uncomfortable environment for people using the sidewalks. Condition of travelways is further discussed in the section below.

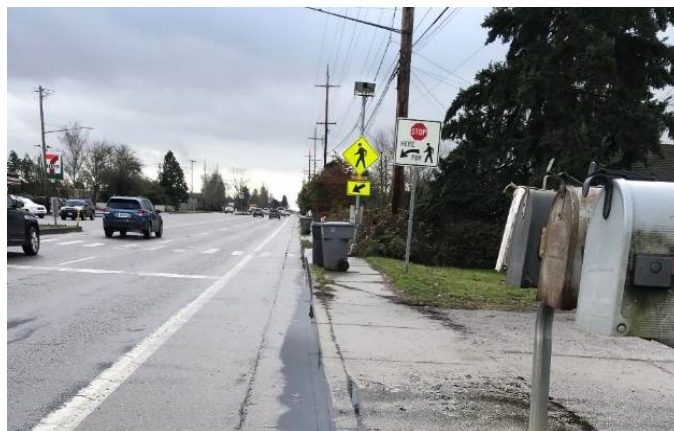
The current condition of existing sidewalks, bicycle lanes, and travel lanes create additional challenges. Poor drainage causes water to settle in bicycle lanes resulting in bicyclists moving into travel lanes or onto the sidewalk. The pavement quality of the roadway, sidewalks, and the shared use path is poor. Uplifts in the sidewalk pavement creates tripping hazards. Many permanent and temporary obstacles are present in bicycle lanes and on the sidewalks. The sidewalks and intersections are not

compliant with the Americans with Disability Act (ADA) at many locations throughout the corridor, though many curb ramps will be reconstructed in 2021.

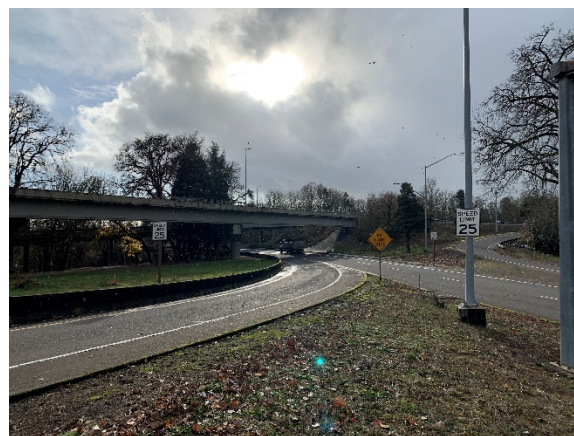
The connection of downtown Corvallis to the southern part of the city through the interchange of OR 99W, US 20, and OR 34 is highly challenging and uncomfortable for people walking and biking. The routes through this area are undefined and appear piecemealed with indirect connections between curb ramps. Inconsistent sidewalks and trail portions make pedestrians cut through open space and cross at undesirable locations. A lack of wayfinding with a variety of potential routes creates confusion for users who might be unfamiliar with the area. These behaviors are evident by the number of desire lines (user paths) through this area. In addition, the northbound Marys River bridge, which is one of the OR 99W one-way couplets, has bridge girders extending into the sidewalk, which creates a confined walking space.

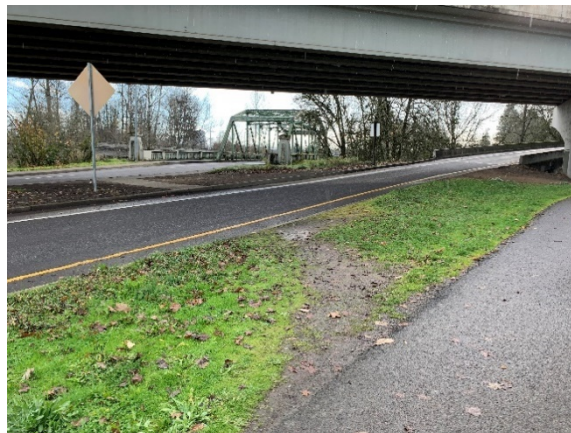
The bicycling connection is very poor through the interchange as well. The southbound road of the OR 99W couplet provides a standard bicycle lane but there is no connection for bicyclists to stay on OR 99W through the lane drop to the westbound on-ramp. There is a shared use trail next to the Willamette River that people can use to avoid riding through the interchange. The connection of the trail to the bicycle lane on the west side of OR 99W is not well signed and is out of direction for those traveling southbound from west of OR 99W.

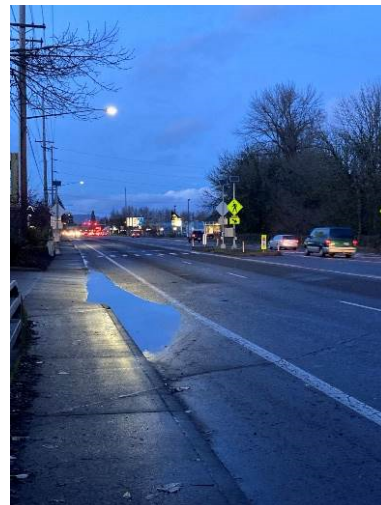
Figure 25: Illustration of illumination located in advance of pedestrian crossing

- Striping double white lines leading to crossings to reduce the likelihood of a double threat from a vehicle changing lanes to avoid stopping.
- Improving lighting, especially on the motor vehicle approach side of the pedestrian crossing to make those in the crossing more visible to the approaching people driving as shown in Figure 25.

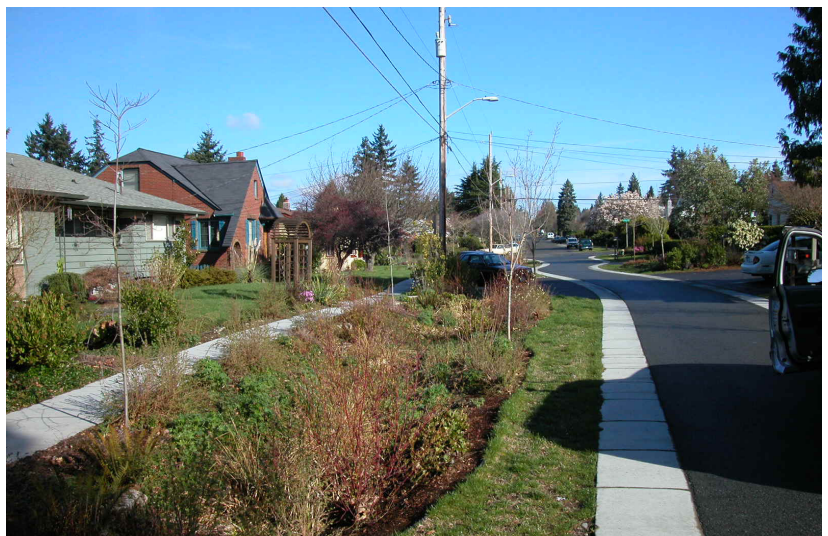
Seattle, WA

Median Stormwater Planter

- Depth of planter from growing medium to overflow elevation: 9" average
- Longitudinal slope of swale: 6% or less
- Flat bottom width: 2'
- Side slope of swale: 3:1 maximum
- Depth of growing medium: 24"
- At least one side of roadway slopes towards center of ROW.

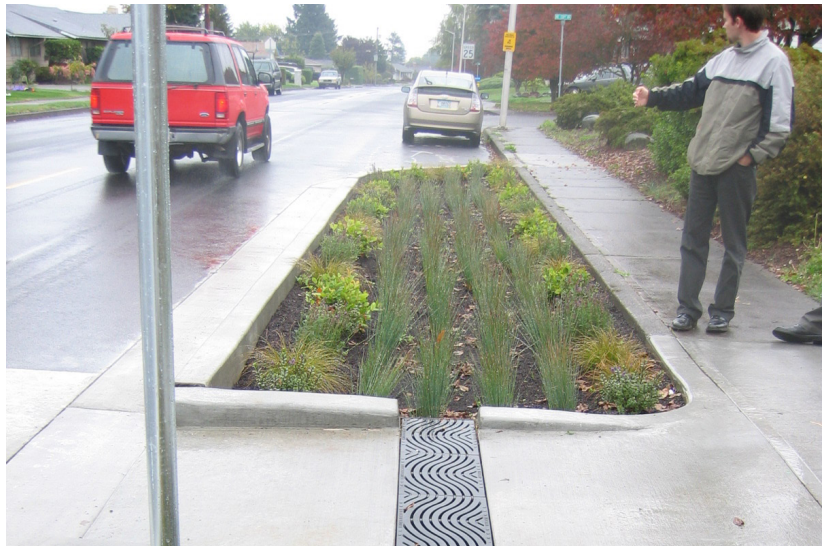
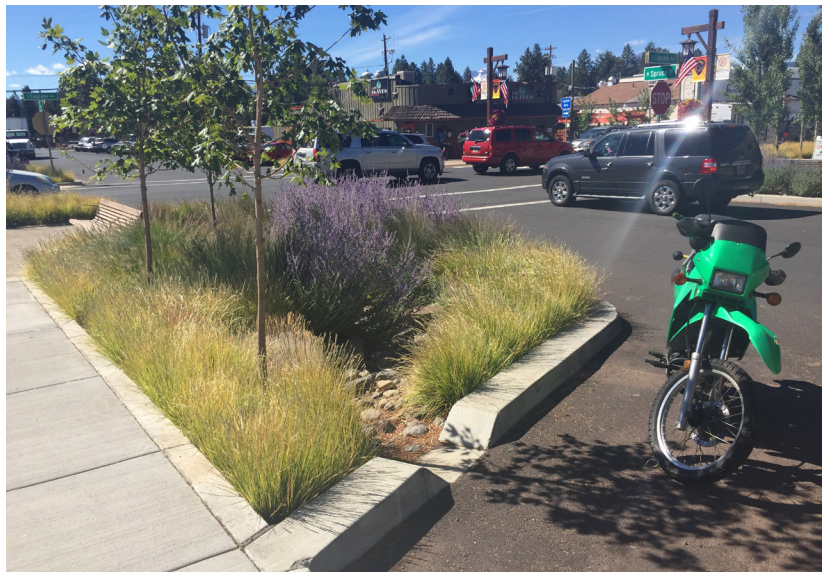
Curb Extensions

- Extend no less than 4' from face of curb, up to the width of a parking lane
- Swale (with side slopes), or a variety of stormwater planter designs can be used.
- If introduced at an intersection, turning radii must be considered.
- Placement should take into consideration how bicyclists will navigate around the facility.

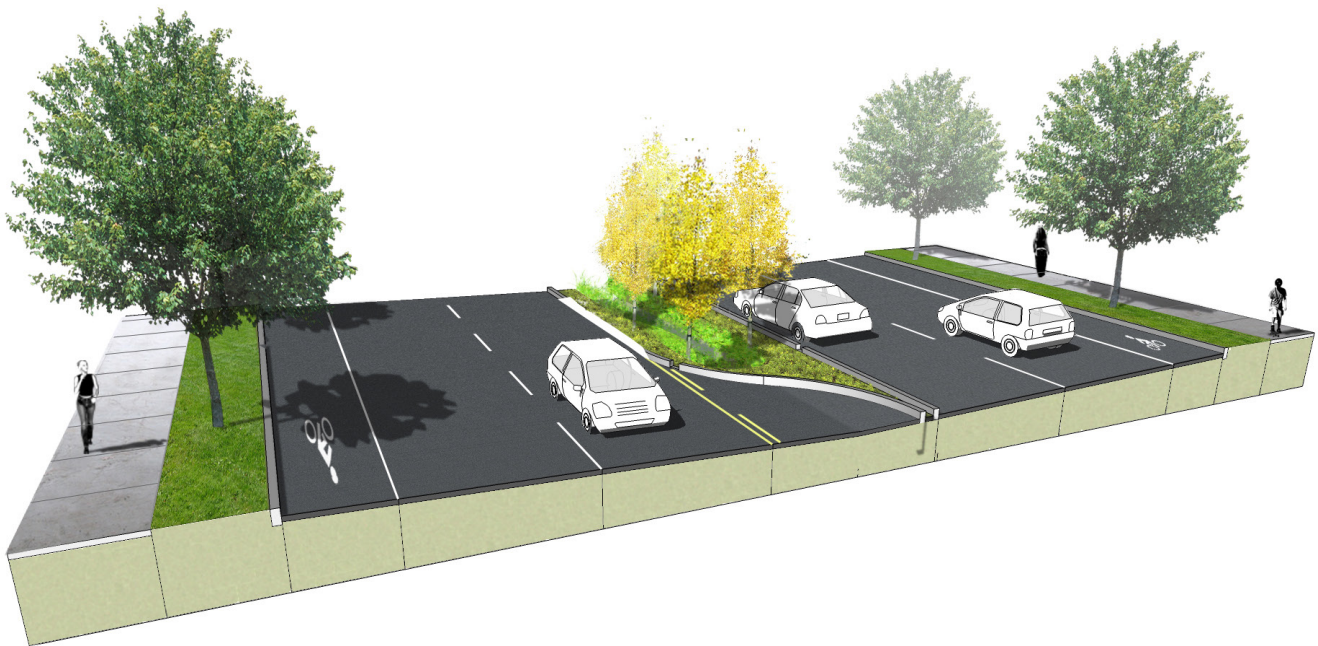
5 Lane roadway with central median stormwater planter. Planter strip planted with street trees. In locations where road crown does not support a median stormwater planter, planter strips may be replaced with curbside stormwater planters

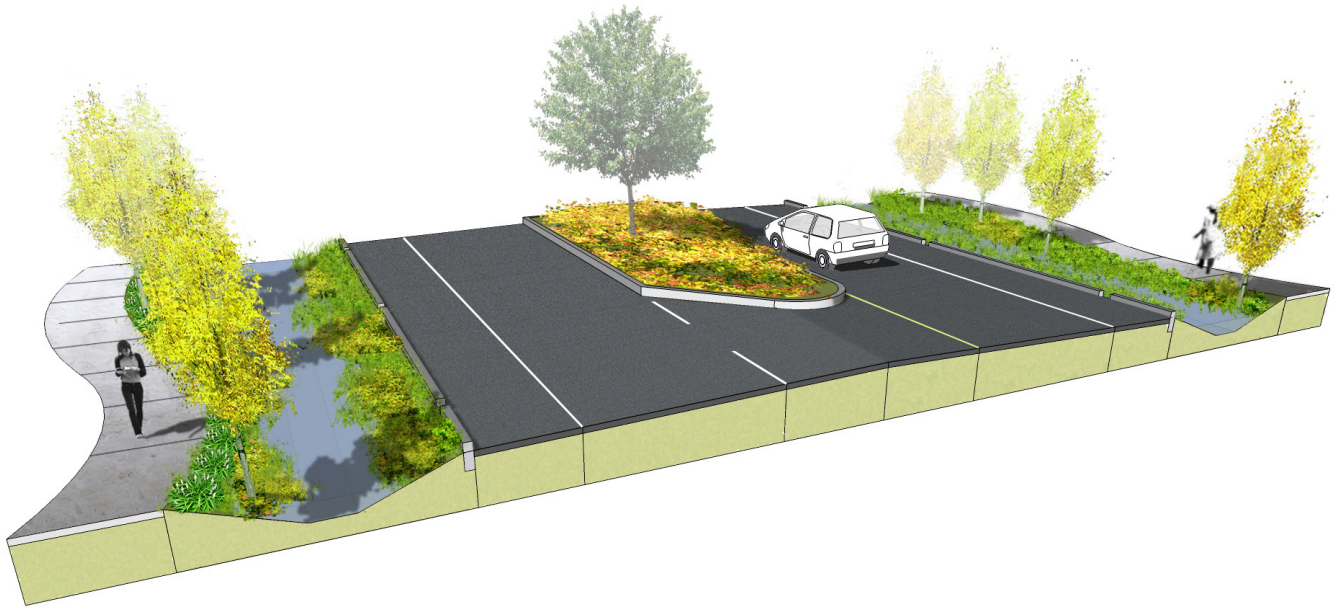
3 Lane roadway with central median swale (or stormwater planter) and street trees. Street side vegetated swale and street trees provided in expanded planter strip.

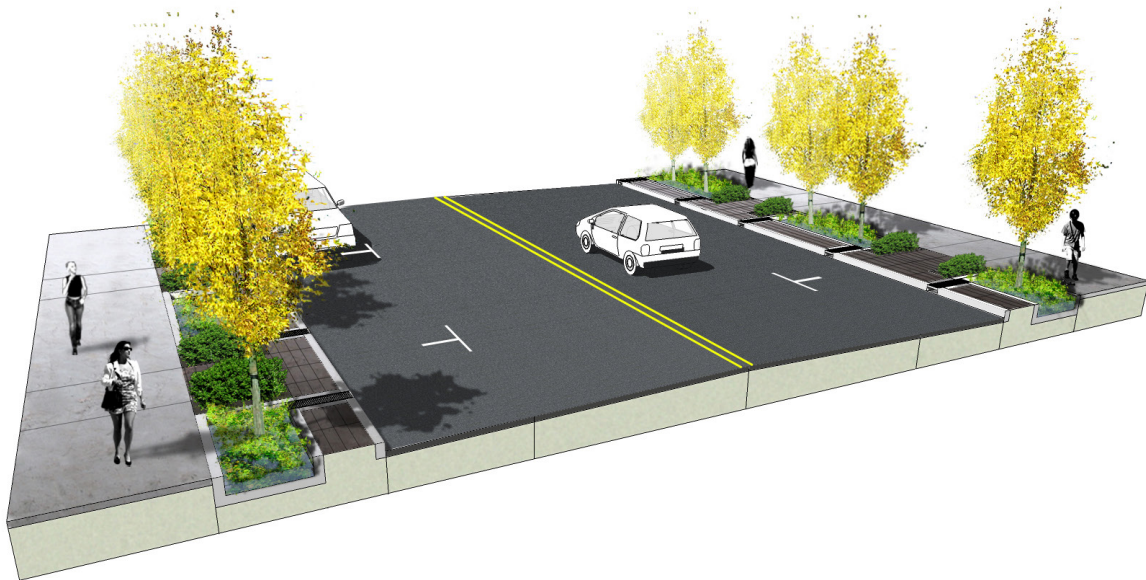
2 Lane roadway with curbside stormwater planters and street trees.

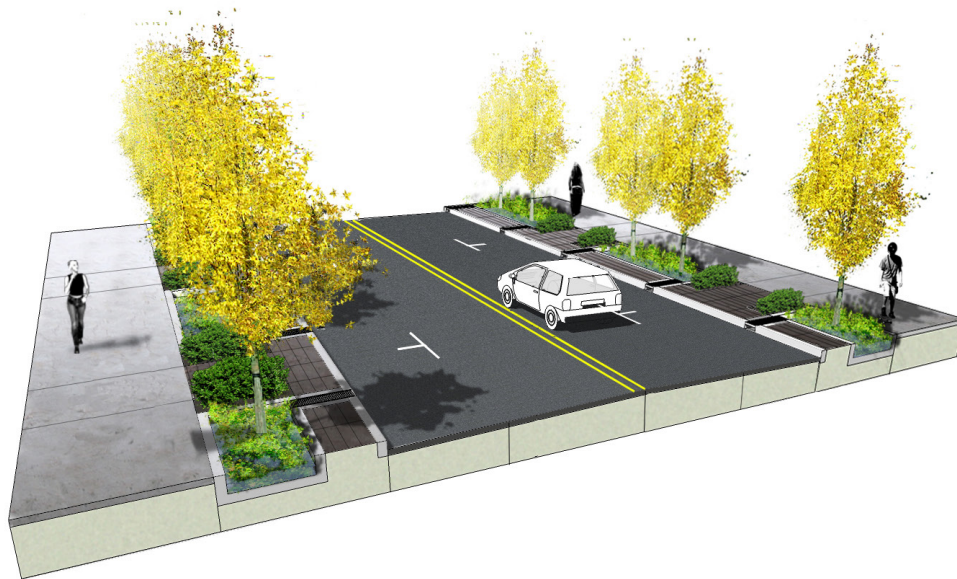
2 Lane roadway with curbside stormwater planters and street trees.

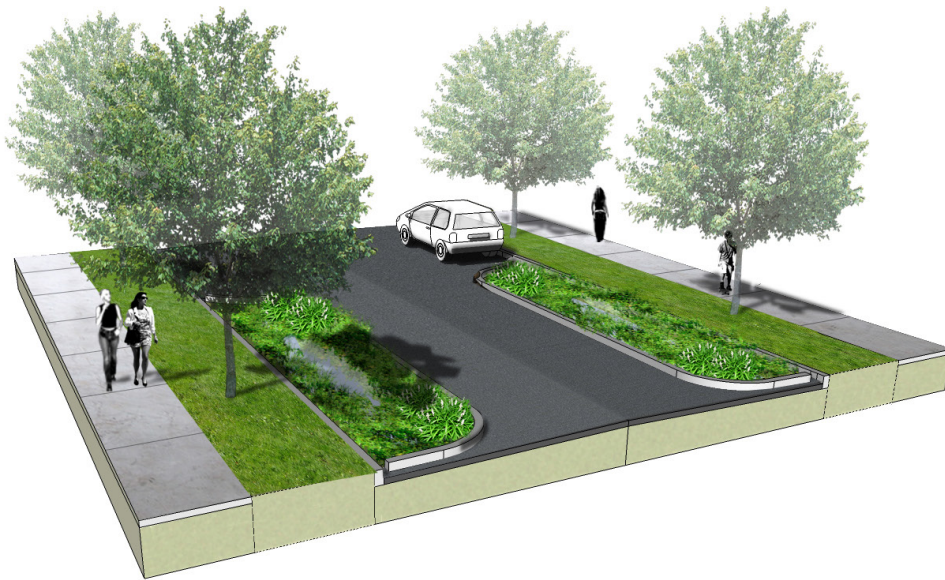
2 Lane roadway with curb extension and pervious paving in parking stalls..
