TECHNICAL MEMORANDUM 2

SUBJECT: US 20 Bend Facility Plan: Project #22140-000
Existing Transportation System Conditions

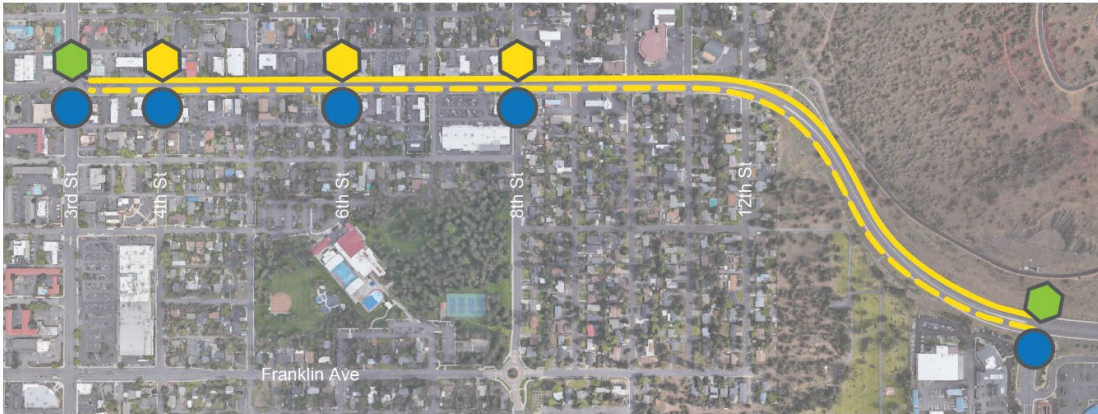
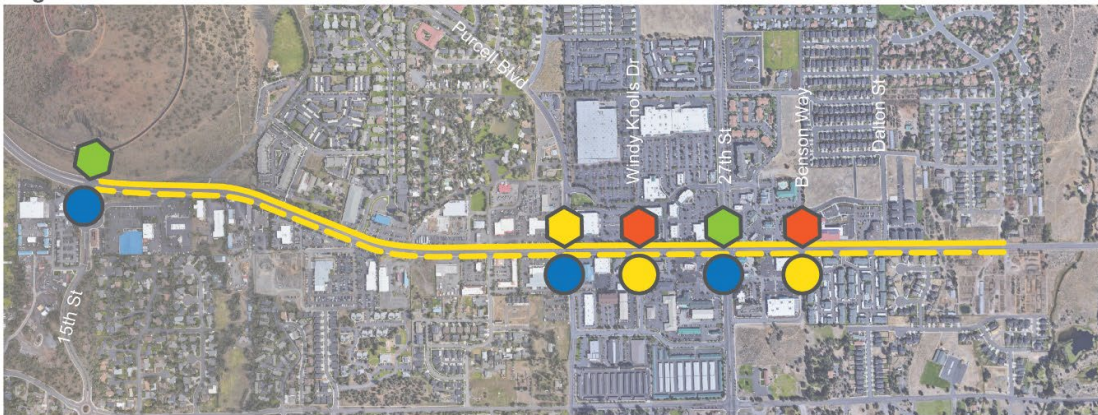
FIGURE 7. SEGMENT AND INTERSECTION EXISTING PEDESTRIAN AND BICYCLE LTS ALONG US 20

INTERSECTION	OVERALL PLTS	MAJOR STREET PLTS	MINOR STREET PLTS	OVERALL BLTS	MAJOR STREET BLTS	MINOR STREET BLTS
NE 3 RD STREET	2	2	2	1	1	1
NE 4 TH STREET	3	3	2	1	1	1
NE 6 TH STREET	3	3	1	1	1	1
NE 8 TH STREET	3	3	3	1	1	1
NE 15 TH STREET	2	2	2	1	1	1
NE PURCELL BOULEVARD	3	2	3	1	1	1
NE WINDY KNOLLS DRIVE	4	4	2	3	3	1
NE 27 TH STREET	2	1	2	1	1	1
NE BENSON WAY	4	4	2	3	3	1
HAMBY ROAD	1	1	1	2	2	2
ERICKSON ROAD	4	4	4	4	4	4
POWELL BUTTE HIGHWAY	4	4	4	4	4	4

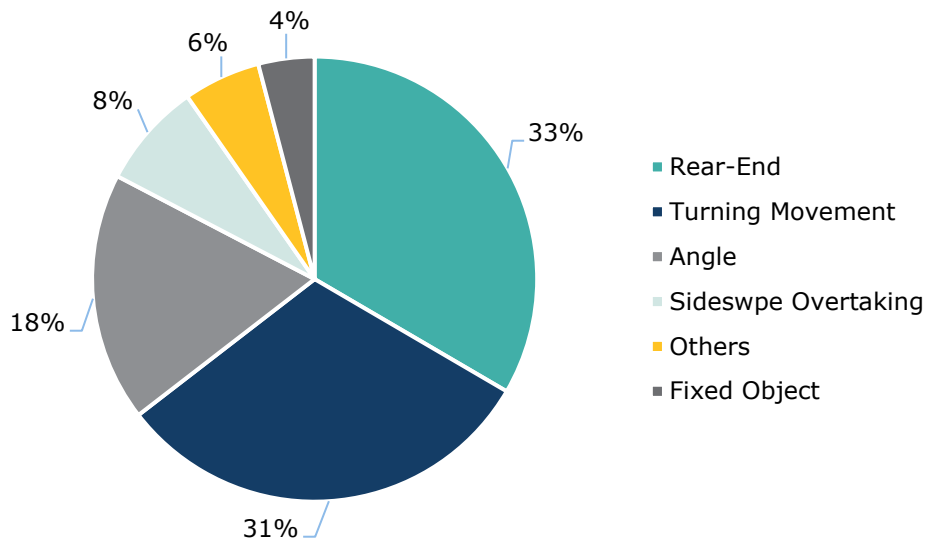
FIGURE 10. CRASH TYPES WITHIN THE STUDY AREA (2016-2020)

Crash types vary within the study area, but the majority involved rear-end (33 percent), turning movement (31 percent), and angle (18 percent) collisions, as shown in Figure 10.
