ODOT crossing closures in Region 1

(March 22, 2023)

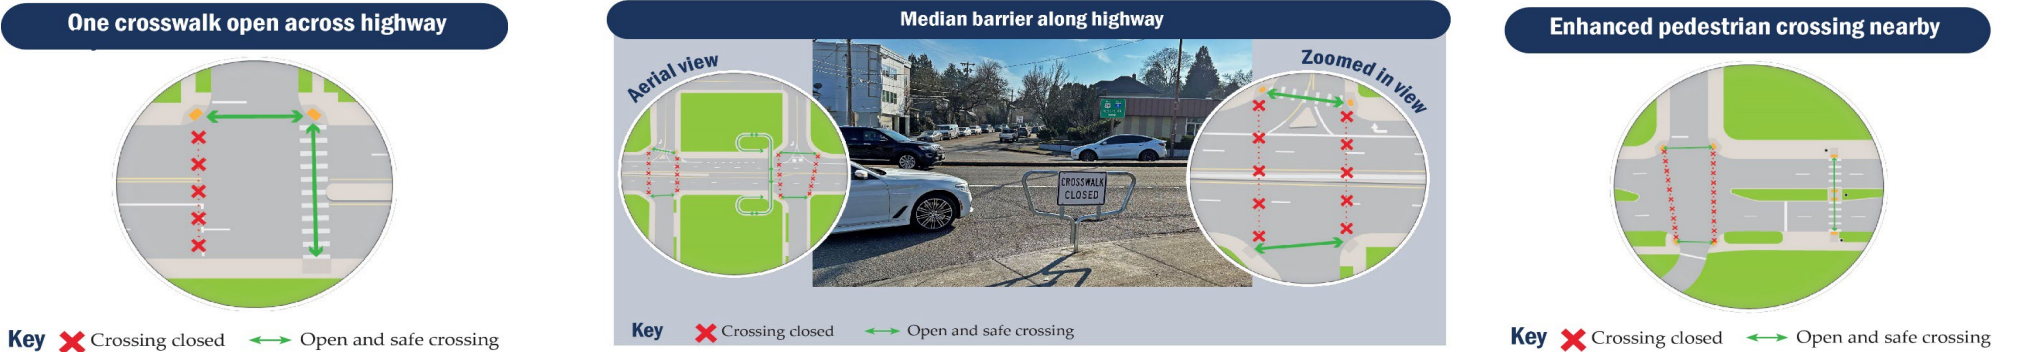
The graphics below show some types of situations where crossings are closed. In some cases it only impacts one crossing at an intersection, in other cases there is a safe crossing nearby. Sometimes there is a barrier in the middle of the crossing making it impassable.

No marked crossings are closing and many noted below are just one leg of an intersection.
