Examples of Significant Deficiencies for GW Systems and Survey Prep Tips

DWS Partner Spring training

May 10, 2022

PUBLIC HEALTH DIVISION
Drinking Water Services

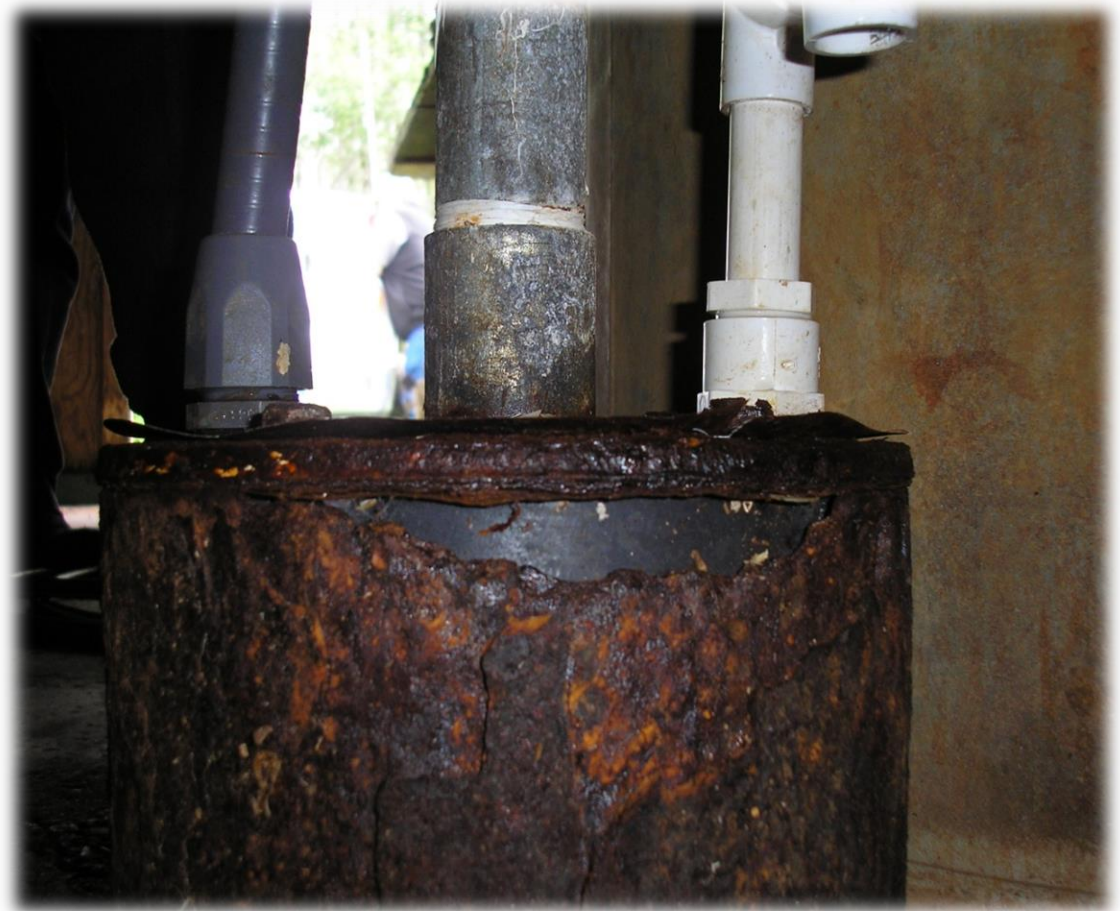
- Sanitary seal and casing not watertight.
- No screen on existing well vent.

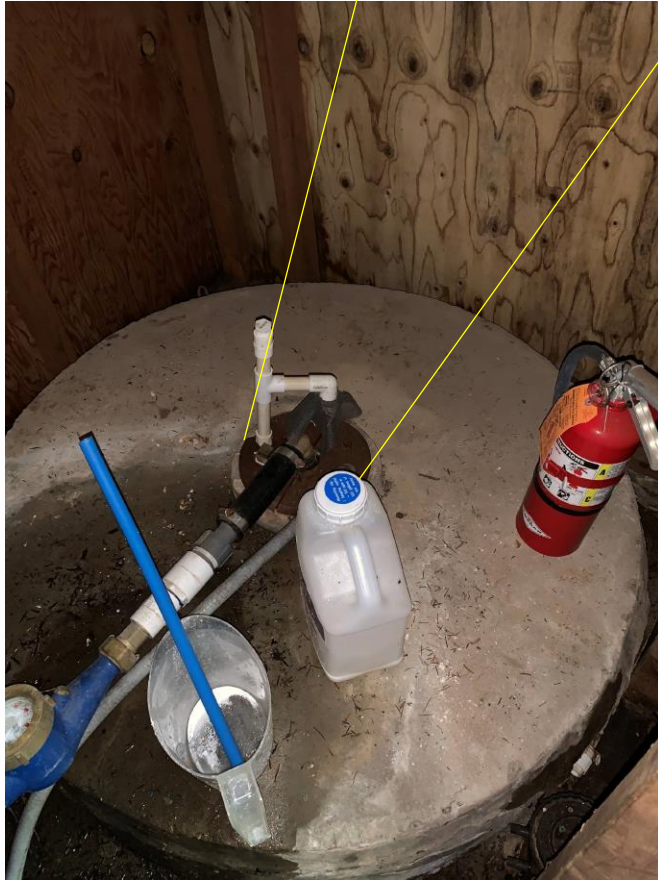
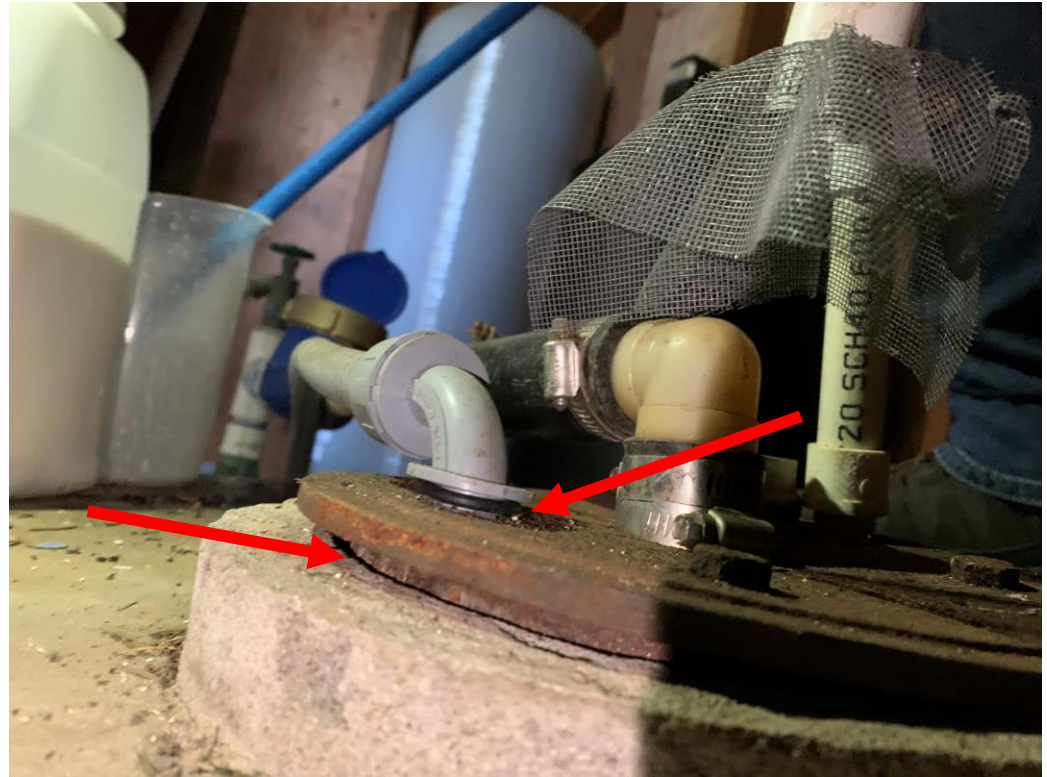
Well cap

Well casing not watertight

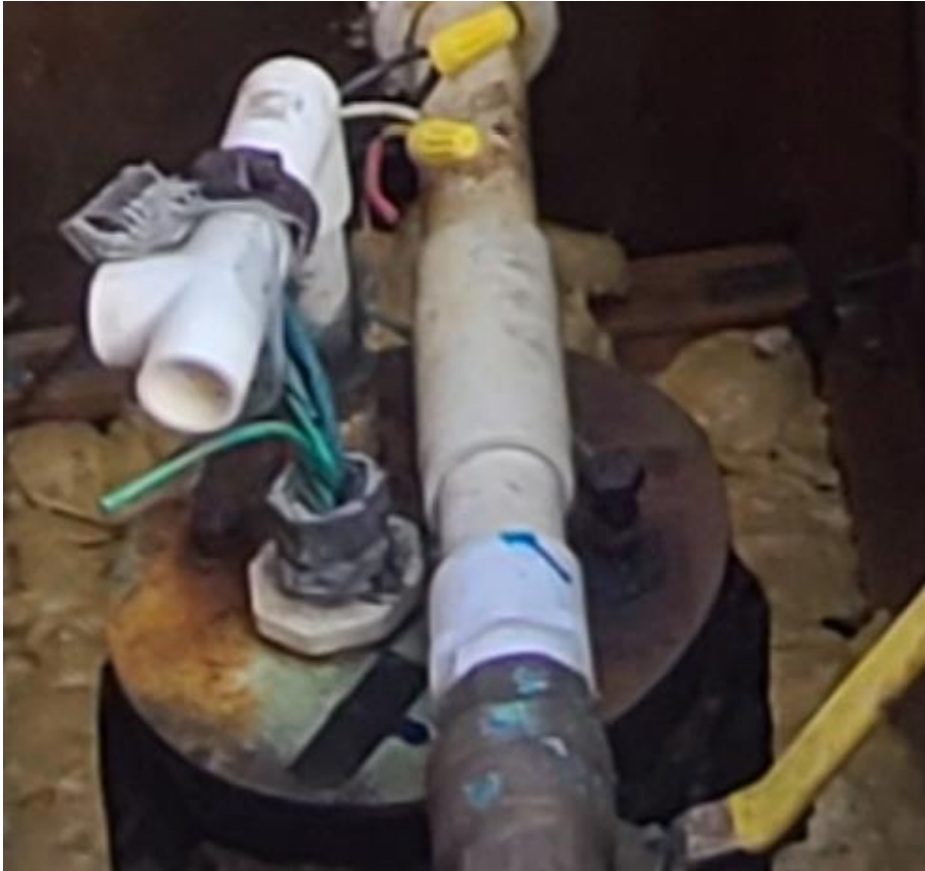
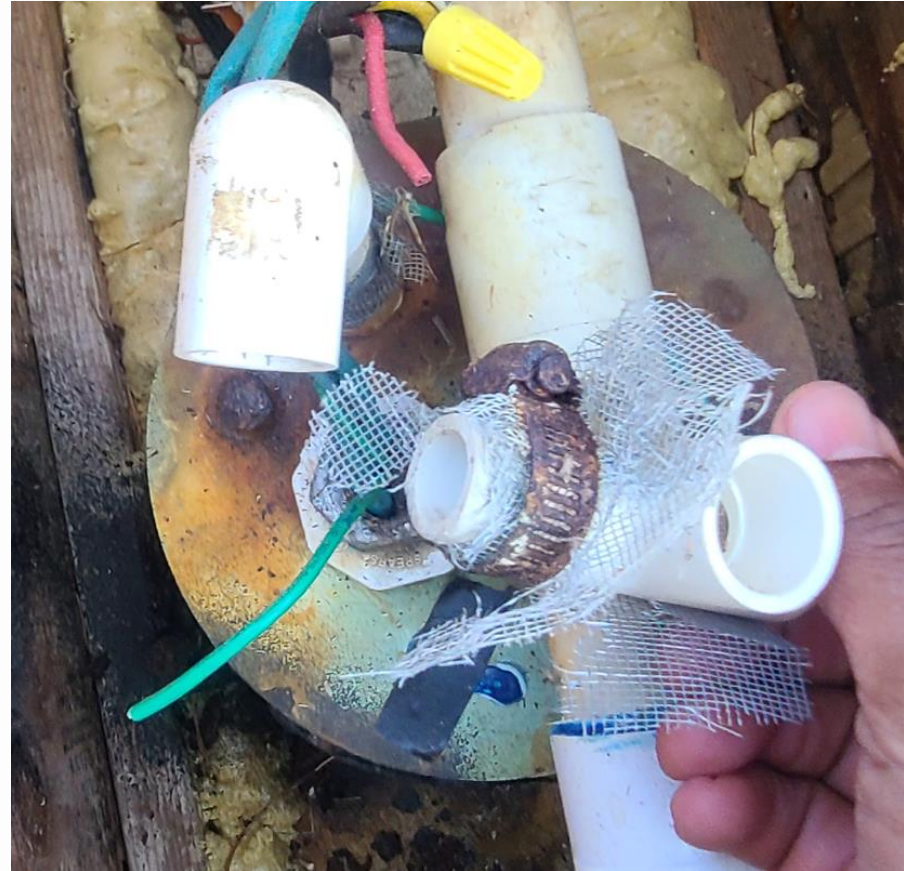
- ✓ No screen on well vent

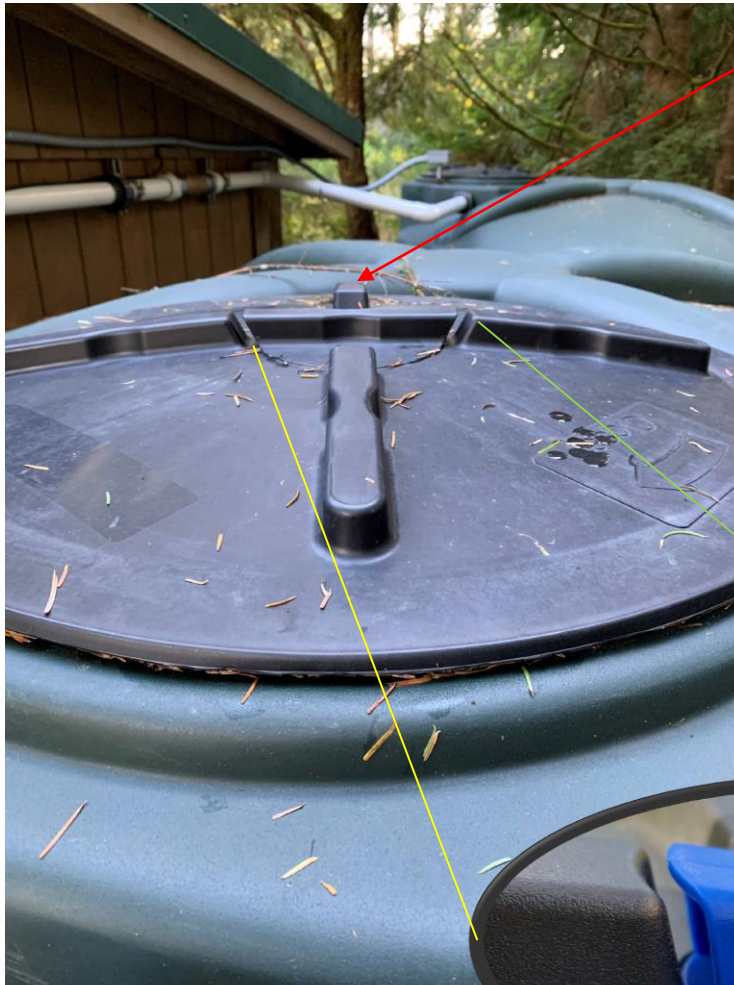
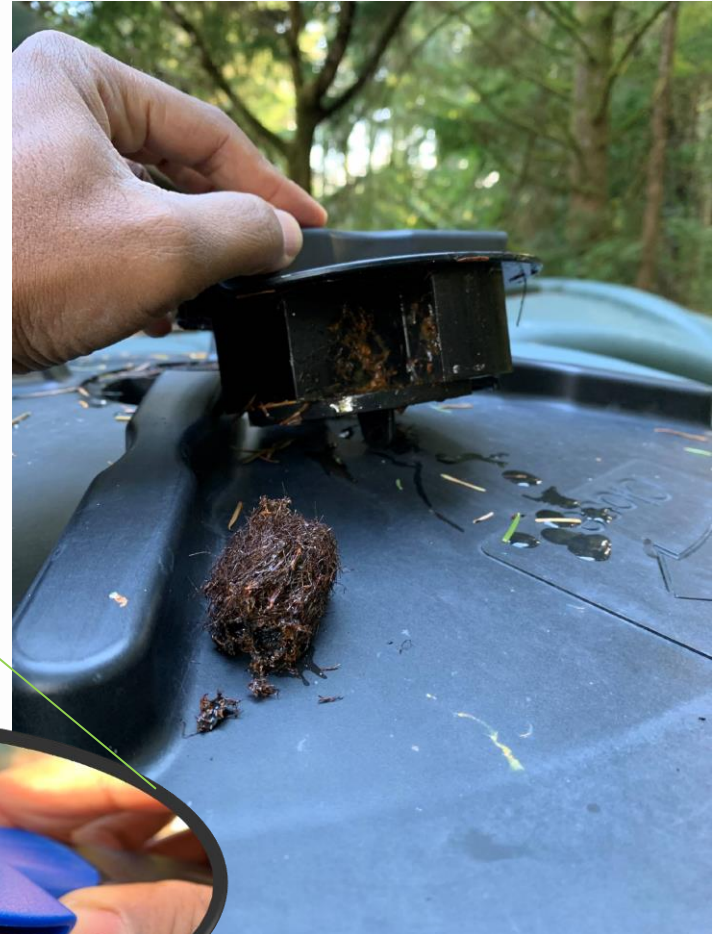
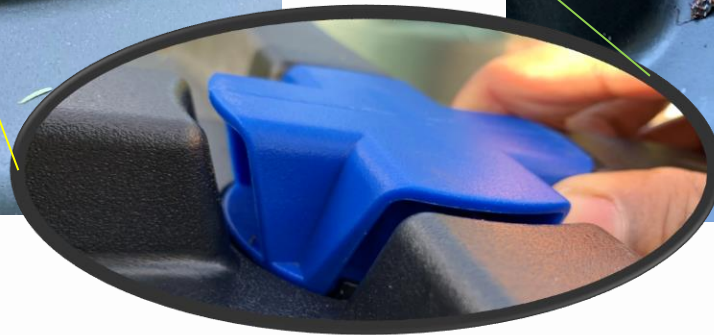
Vent cap

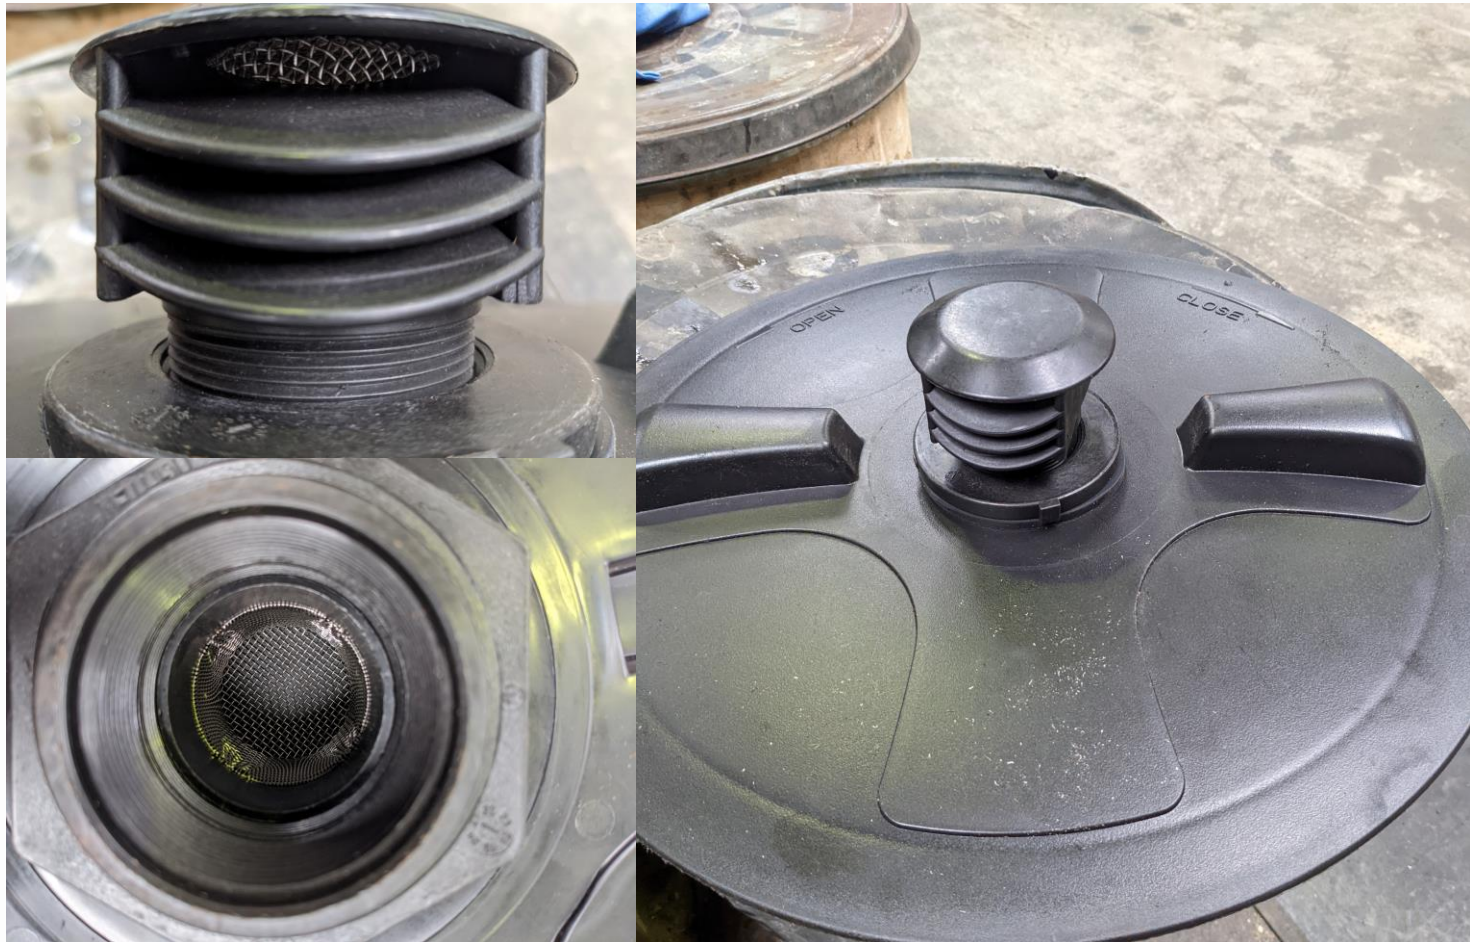
Screened
vent cap

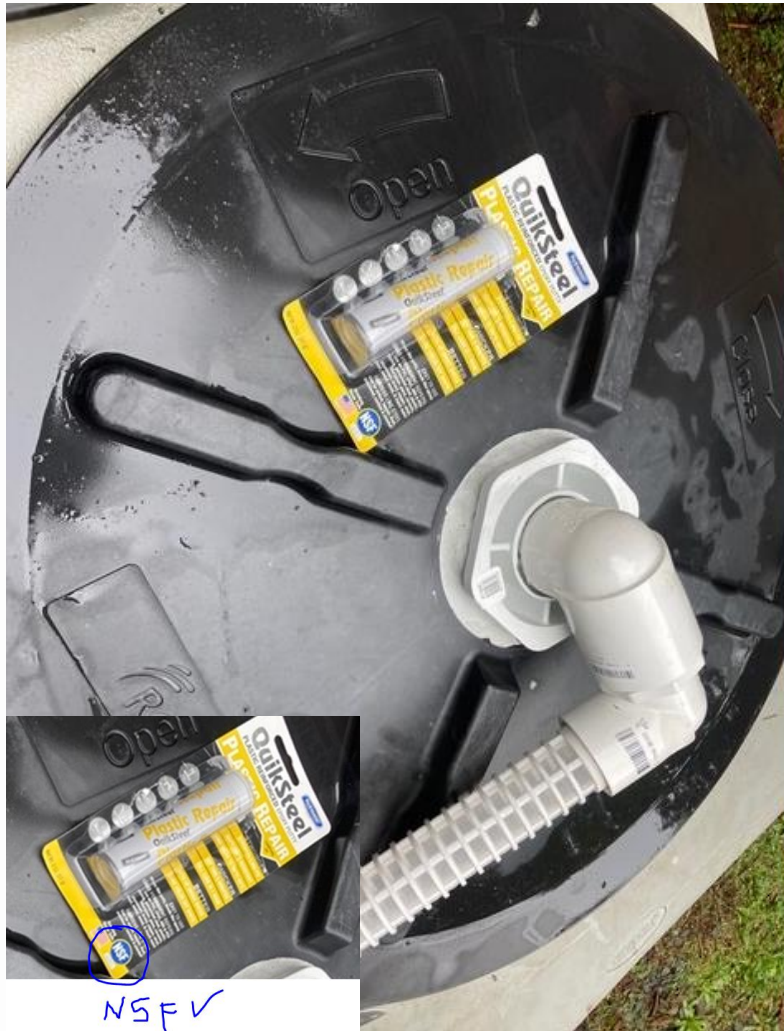
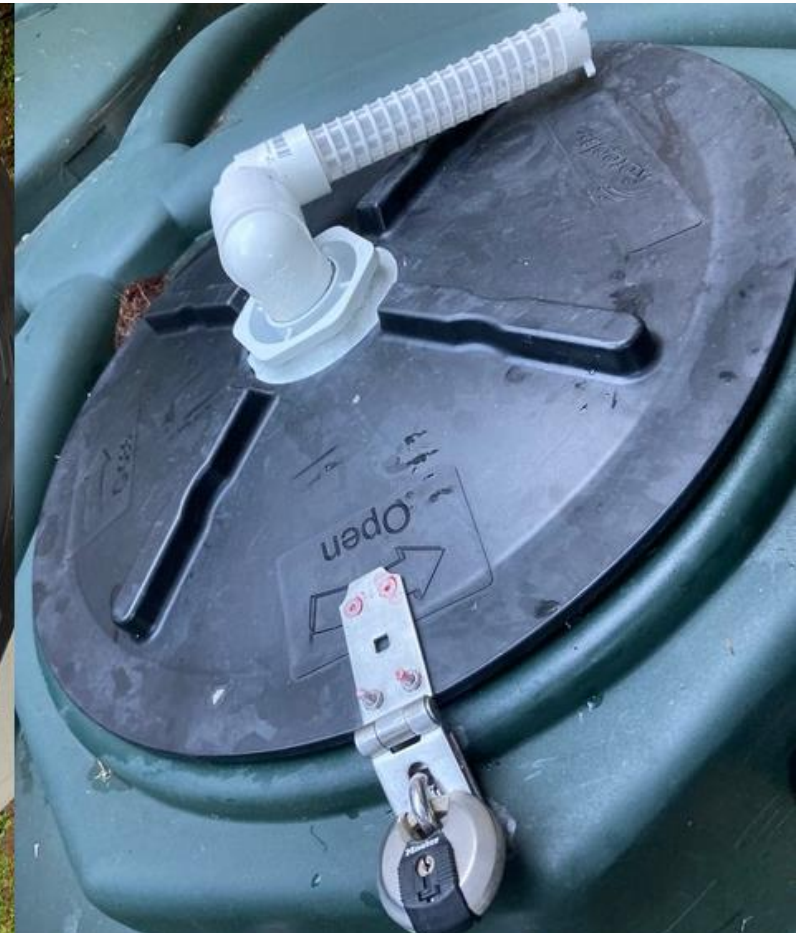
Hatch adequately secured

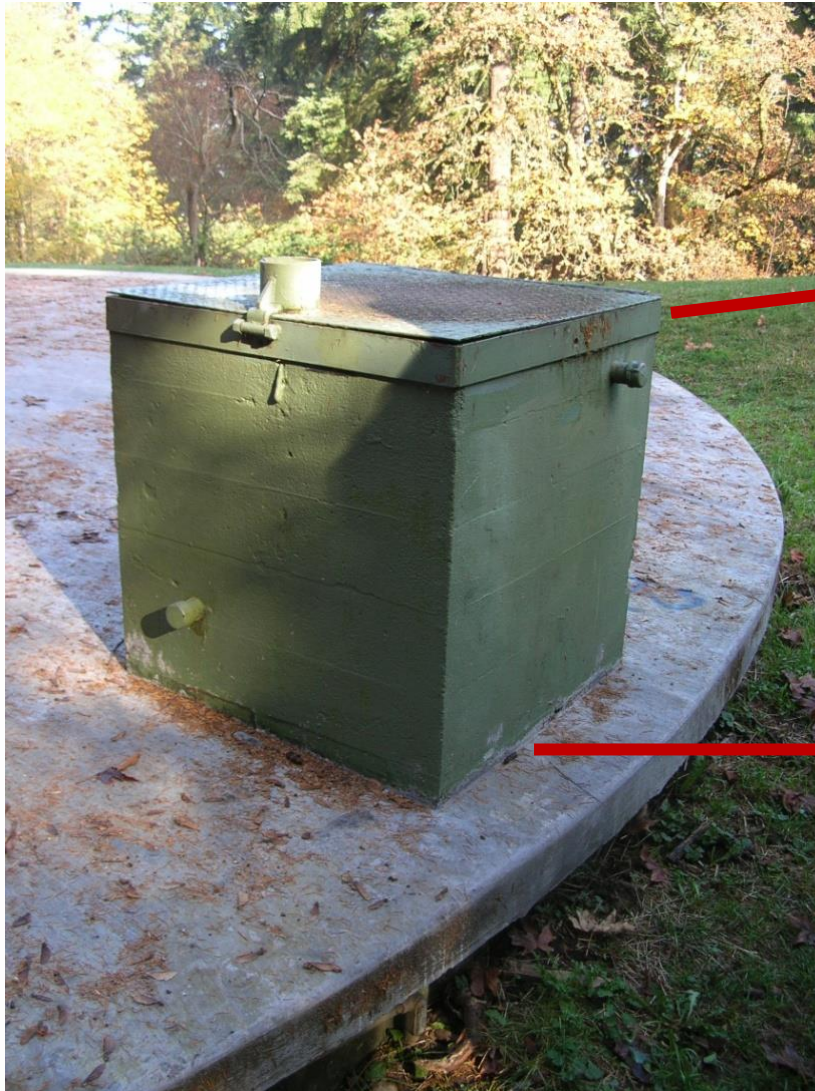
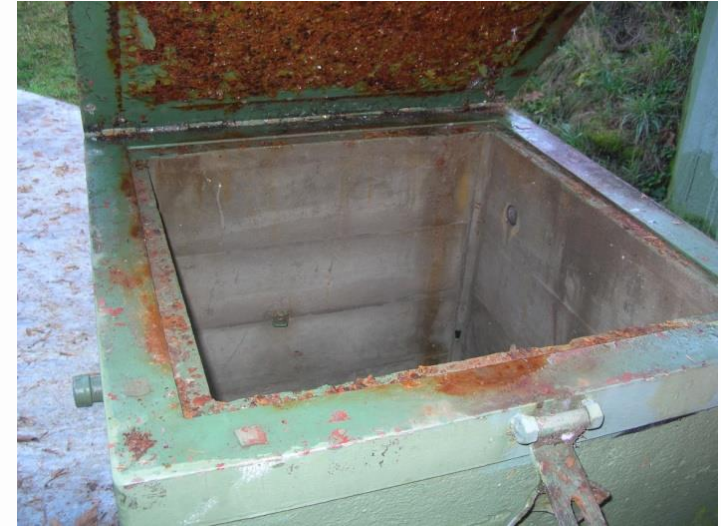
Overlapping lid?

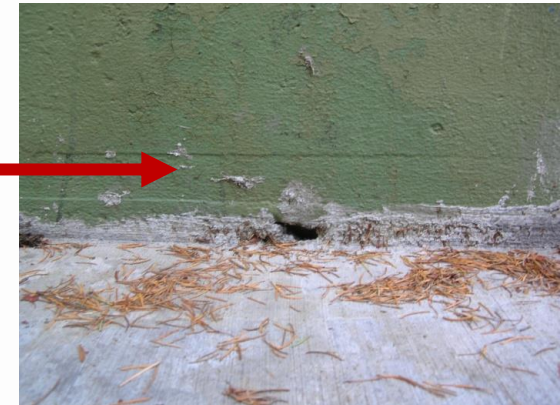
Hole in
the hatch?

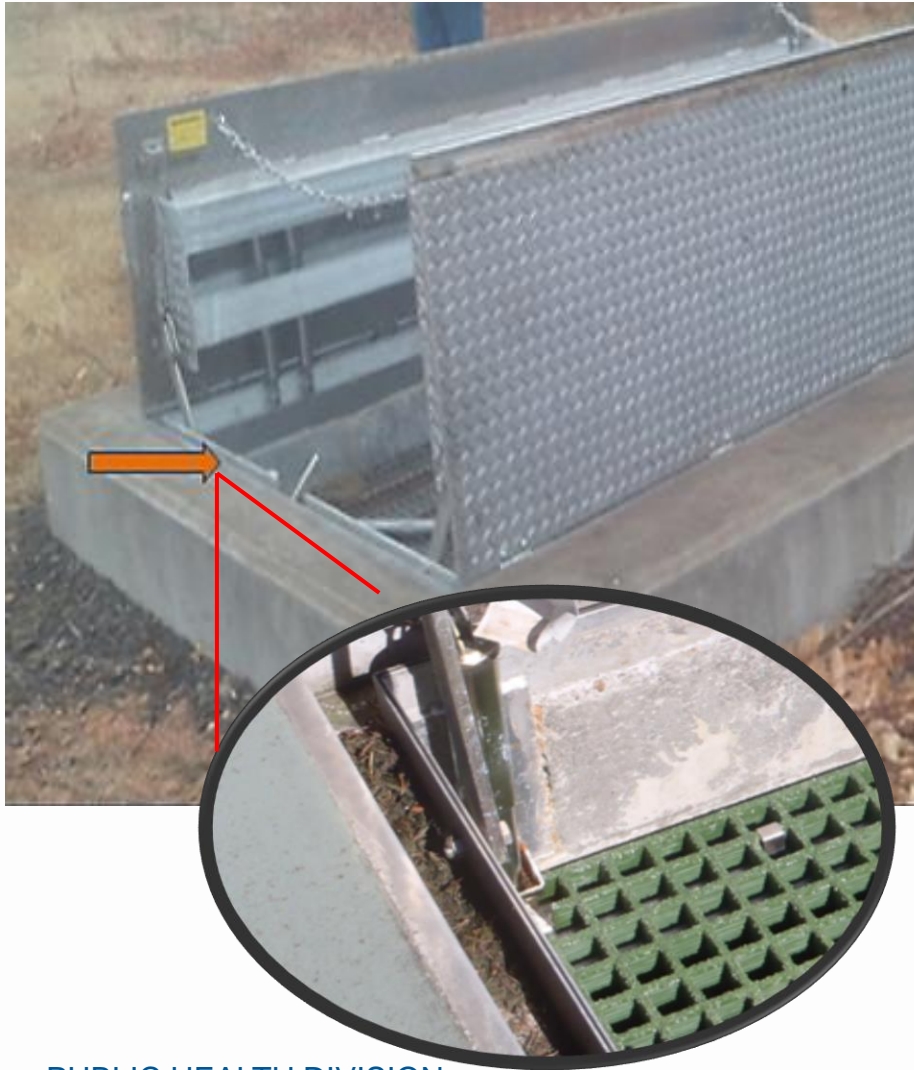
Gutter style hatch and drain

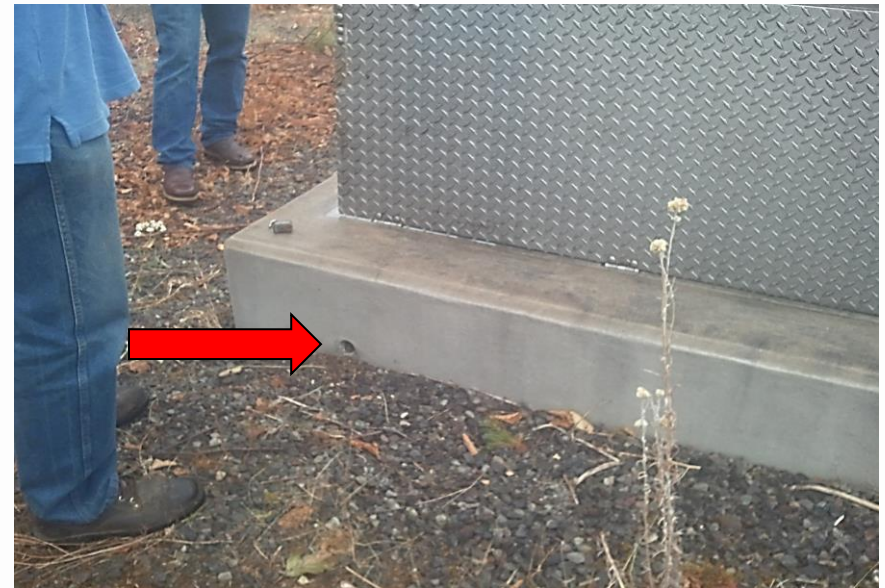
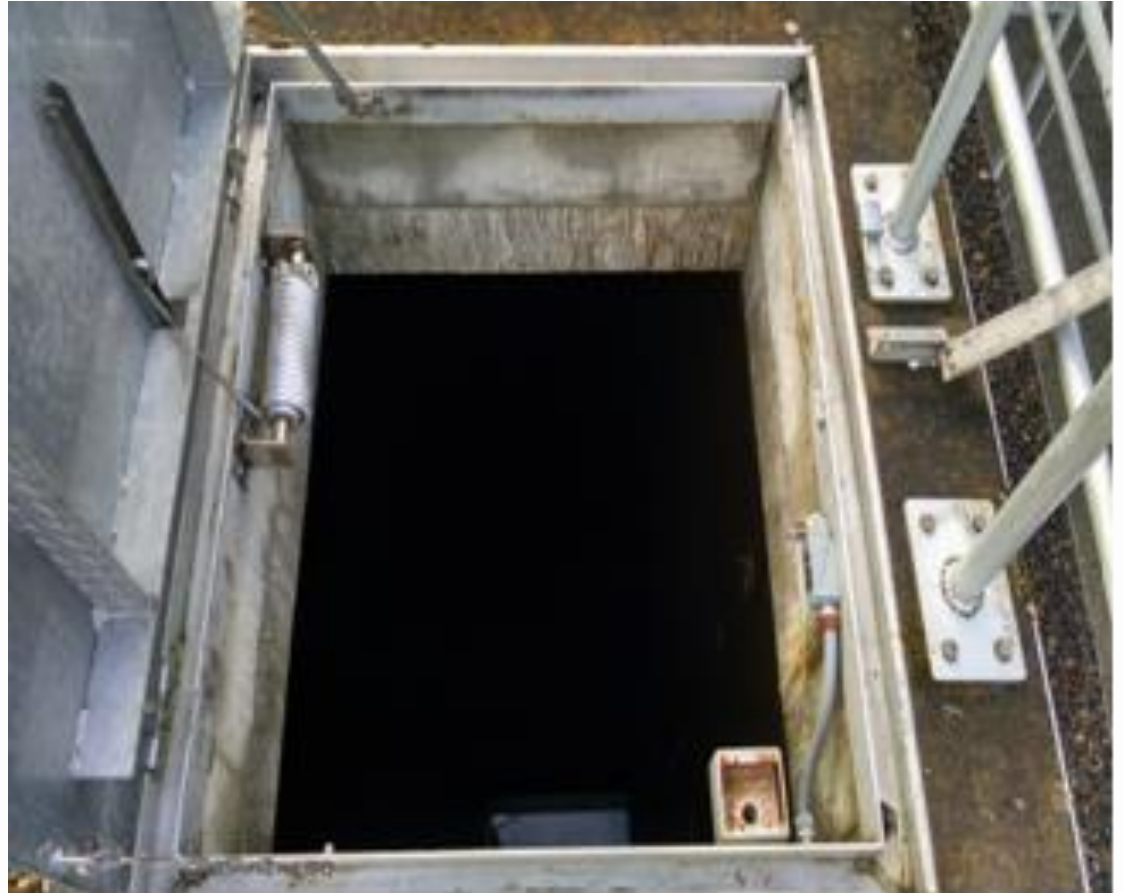
Clean gutter-drain

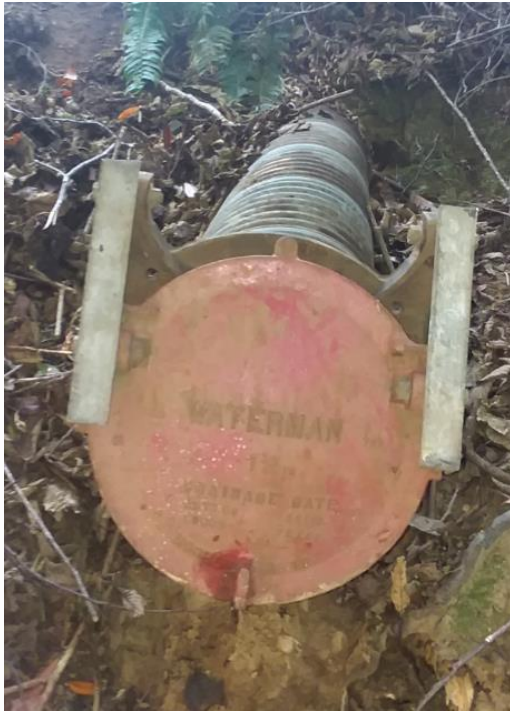
Pic shows the protective flap on drain lines

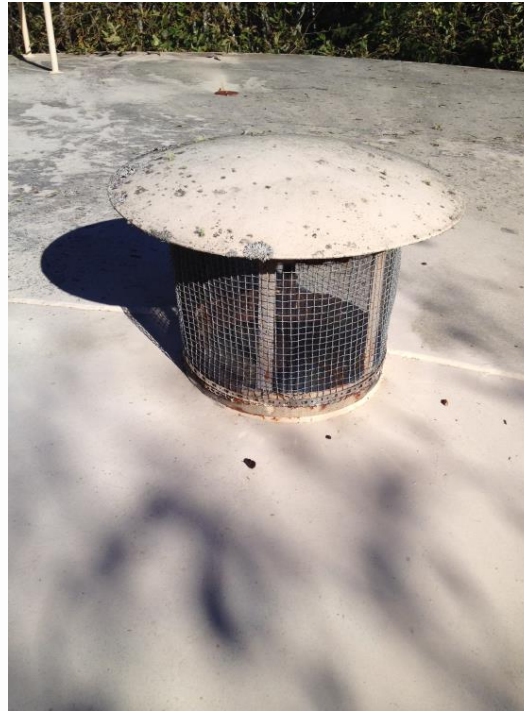
Pic shows the screened vent

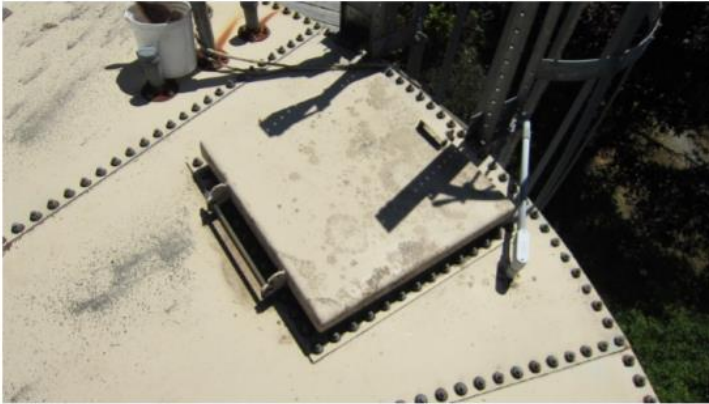
Hatch access to inside of the storage tank - hatch in closed position. Note the ladder on the upper right. View to the southwest.

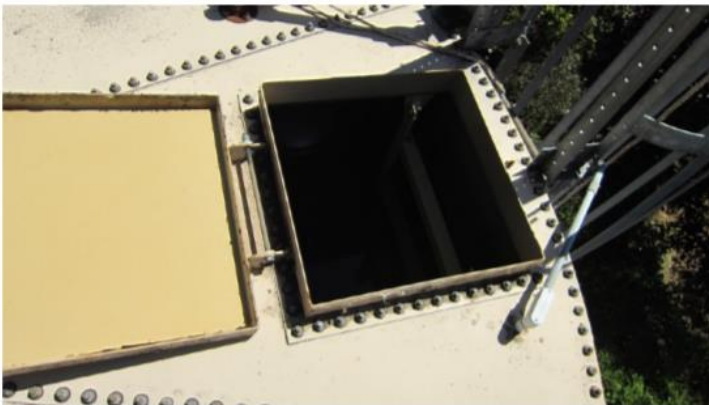
Hatch access to inside of the storage tank - hatch in open position. View to the southwest.

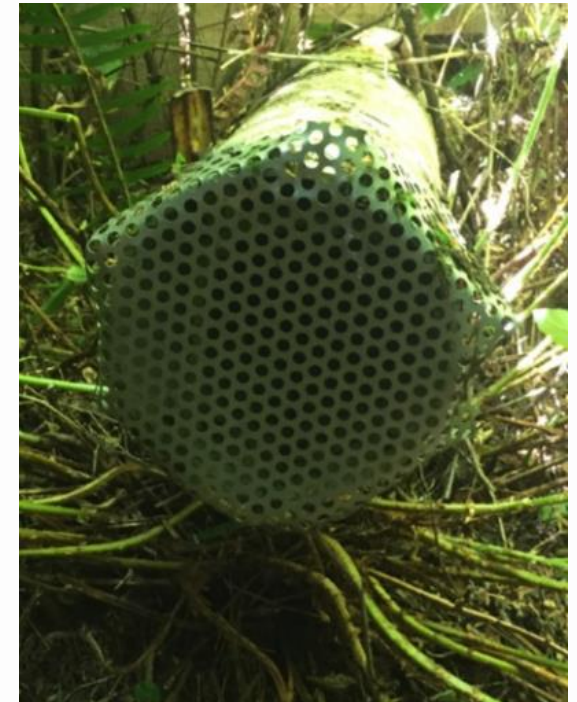
Drain/overflow protected with screen

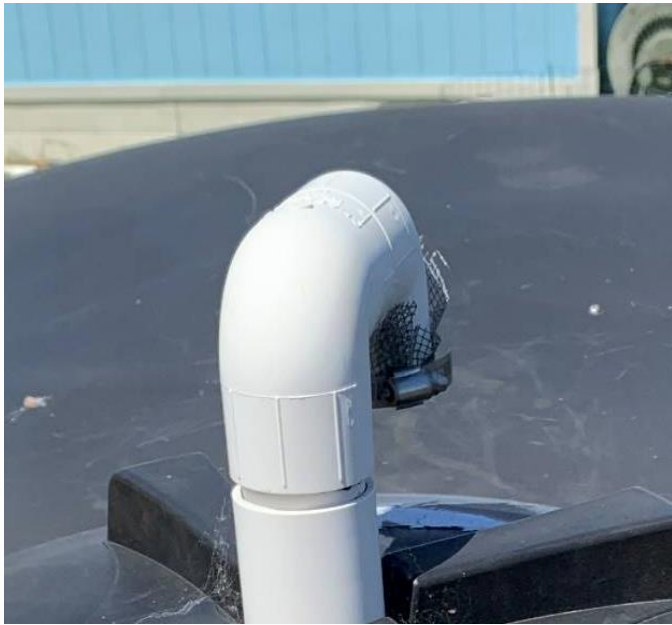
Screened vent

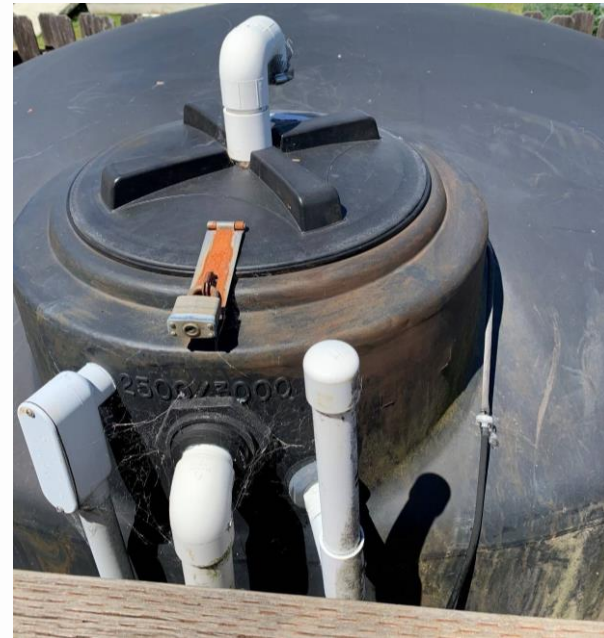
Hatch is secured with lock
and watertight
