PUBLIC HEALTH CONSULTATION

Burns Air Force Range
(also known as Burns Air Force Radar Station)
T23S R30E Section 20 WM
Harney County, Burns, Oregon 97720
EPA Facility Number: OR0001096957

Prepared by the
Oregon Department of Human Services
Superfund Health Investigation & Education Program
Under Cooperative Agreement with the
Agency for Toxic Substances and Disease Registry (ATSDR)
Division of Health Assessment & Consultation
Atlanta, Georgia

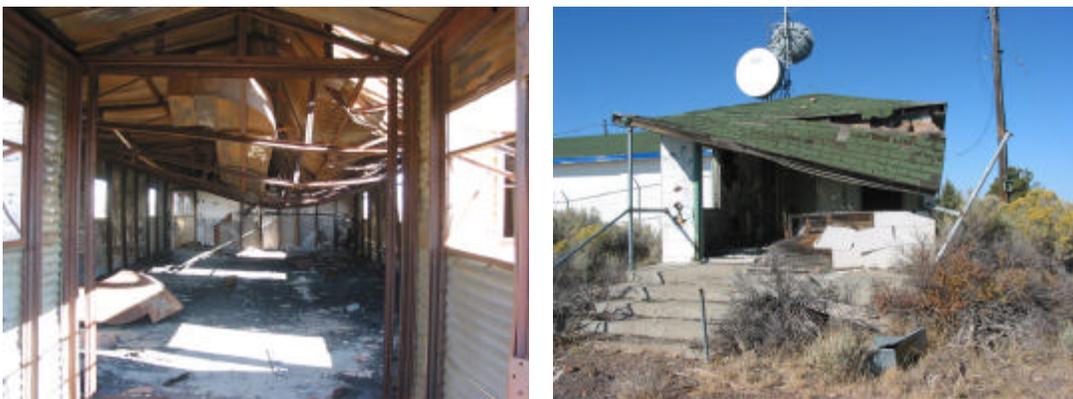
Figure 2 – Collapsed beams and roofing

holes in numerous walls; scattered rifle shell casings; and burst paint balls. There were ATV tracks on the inside and outside of buildings. Roofing was collapsed on some buildings, and there were collapsed beams in the fire-damaged former hospital. (See Figure 2) All windows were broken, and many buildings appeared to have been extensively salvaged for any usable wood or other materials. (See Figure 3) Salvage activities, fire, and vandalism have created numerous physical hazards inside the buildings. Outside of the buildings are open pits and formerly used water tanks. (See Figure 3)

1. ODHS recommends that friable asbestos and physical hazards be remediated throughout the site by ODEQ, EPA, or COE.
2. Until the site is remediated, ODHS recommends that the current property owner or the appropriate state or federal agency restrict access to the property . An inventory of physical hazards is also recommended.
3. ODHS recommends that the responsible agency (ODEQ or COE) evaluate the contamination at the two former disposal sites and the radome building.

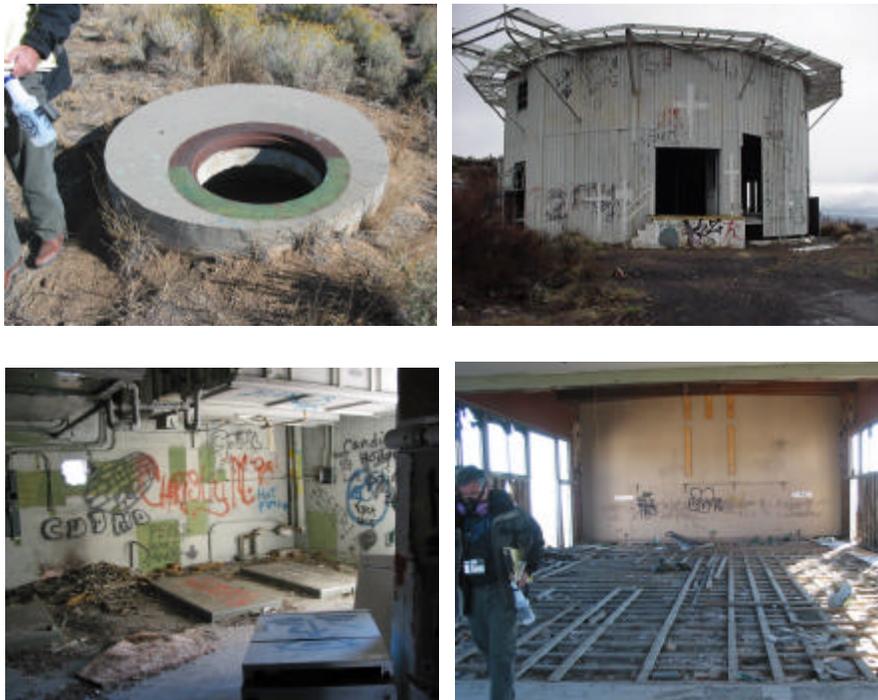
Figure 3 – Open hole, Radome structure, graffiti and salvaging at former station buildings

As indicated, there are numerous physical hazards inside and outside of buildings throughout the property. An inventory of physical hazards is recommended to identify hazards that pose potentially serious physical harm and allow better planning for removal and remediation activities. Until physical hazards are removed or remediated, additional barriers to access (such as fencing) should be provided.
