TITLE: Report of the Cultural Resource Survey: SPARTA DITCH and SHANGHAI GULCH, Areas of the Wallowa-Whitman National Forest VOLUME: II	AUTHOR(S): Tim Riordan Roger Walke Ricky Hoff DATE: May 1979
<p>ABSTRACT: In November 1978, Professional Analysts conducted a cultural resources survey along the Sparta Ditch (T6,7, & 8S, R43 & 44E) and in the Shanghai Gulch area (section 3, T8S, R44E) of the Wallowa Whitman National Forest in northeast Oregon. We located seven historic sites associated with the mining theme established for the Forest. Several of the sites may be representative of the livestock/settlement as well.</p> <p>We provide a brief historic overview of the study area and describe the identified historic sites. We evaluate cultural/historic significance in the light of legal requirements for historic preservation, and outline management options for the sites.</p>	
PREPARED BY: Pro-Lysts, Inc. Eugene, OR ASSIGNMENT NUMBER: FS-315	SUBMITTED TO: United States Forest Service, Wallowa-Whitman National Forest CONTRACT NUMBER: 53-04H1-8-7063N

REPORT OF THE
CULTURAL RESOURCES SURVEY
SPARTA DITCH AND SHANGHAI GULCH
AREAS OF THE
WALLOWA-WHITMAN NATIONAL FOREST
VOLUME II

Final report

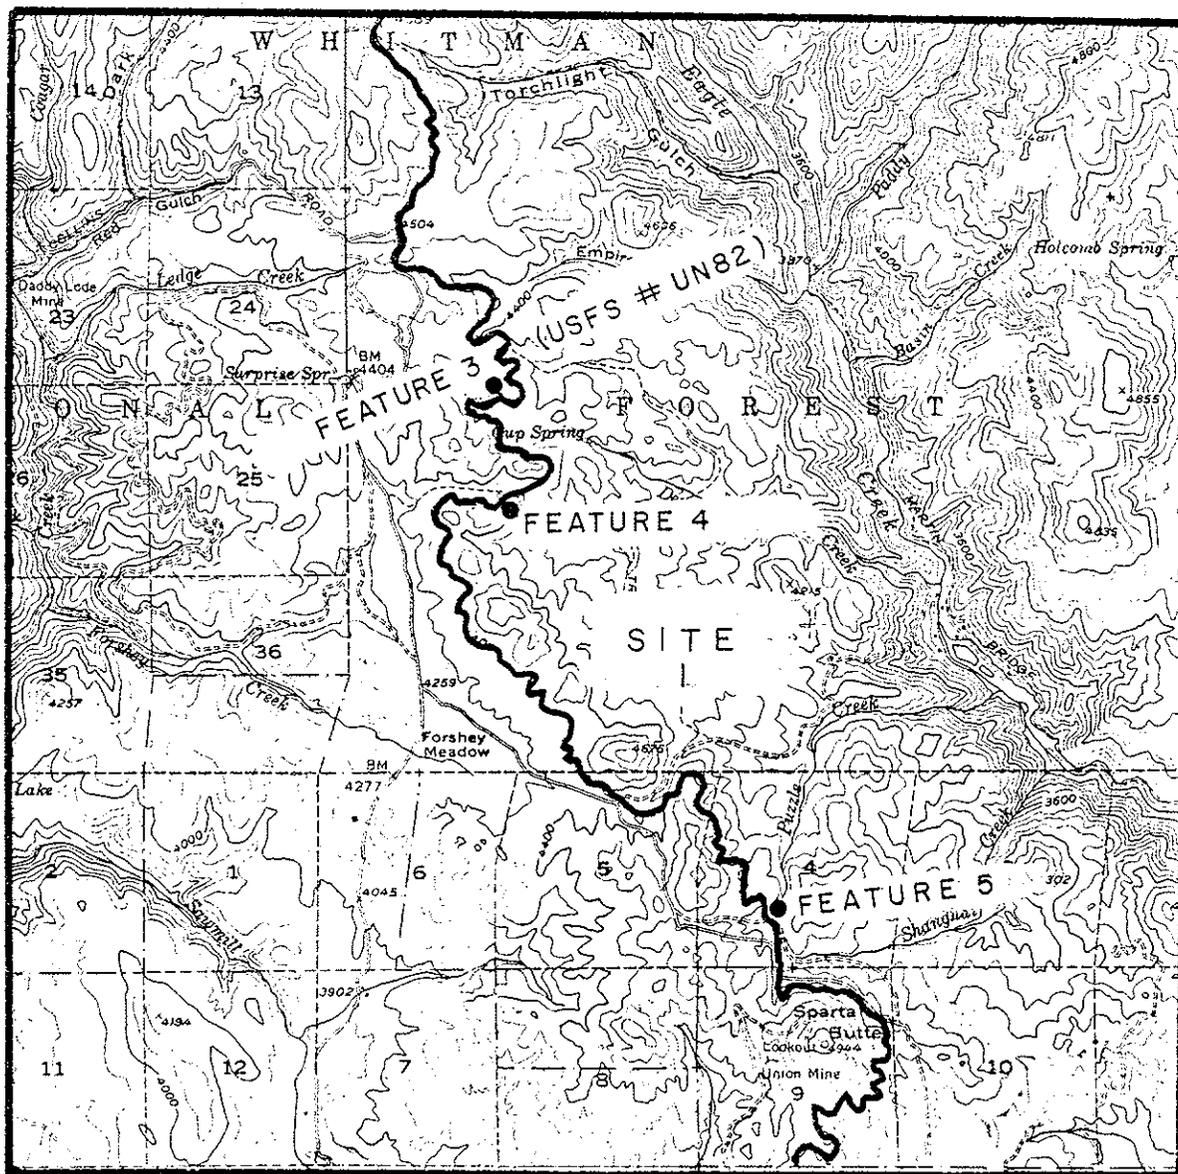
SPARTA DITCH STUDY AREA
 WALLOWA-WHITMAN NATIONAL FOREST
 PART II
 USGS SPARTA QUADRANGLE

THE HEAD OF
TCH HAS
BEEN DESTROYED

ROCKSLIDES HAVE
DESTROYED MUCH OF
THE DITCH IN THIS
SECTION

THE OLD SPARTA DITCH
ROAD IS BUILT ON TOP
OF THE DITCH

ROAD S700N IS
BUILT ON TOP OF
THE DITCH

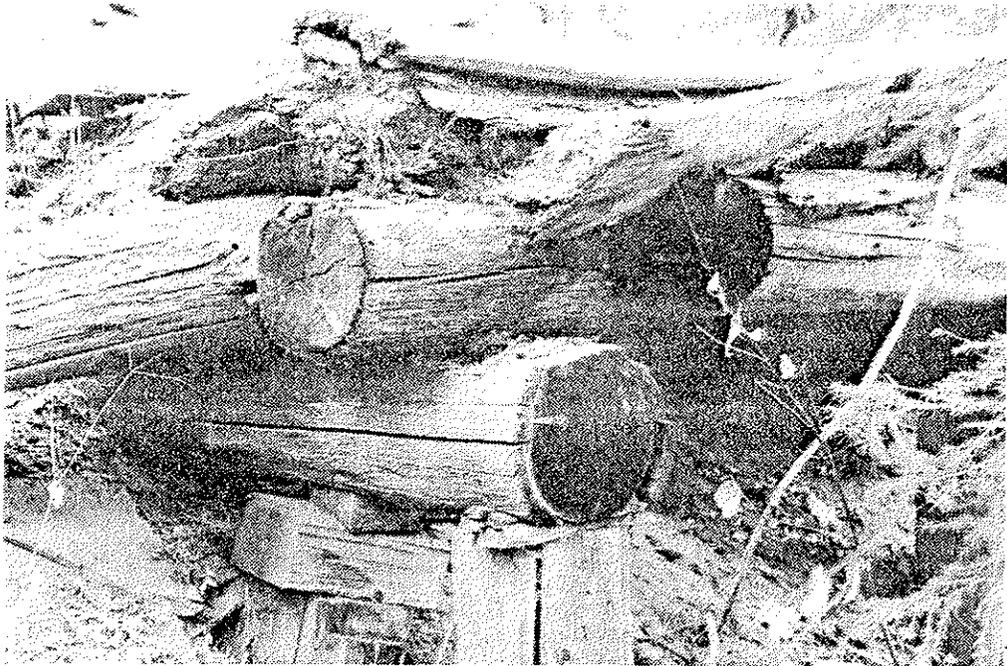
Feature # 2
 Very little remains of this flume. Scattered braces and supports lie roughly in a line from one end of the ditch to the other. Logs, planks, 2 x 4's and 4 x 4's. Both round and square nails were observed, indicating that it had been repaired at some time in the past.

FEATURE 1
REMAINS OF NORTH SPARTA DITCH FLUME

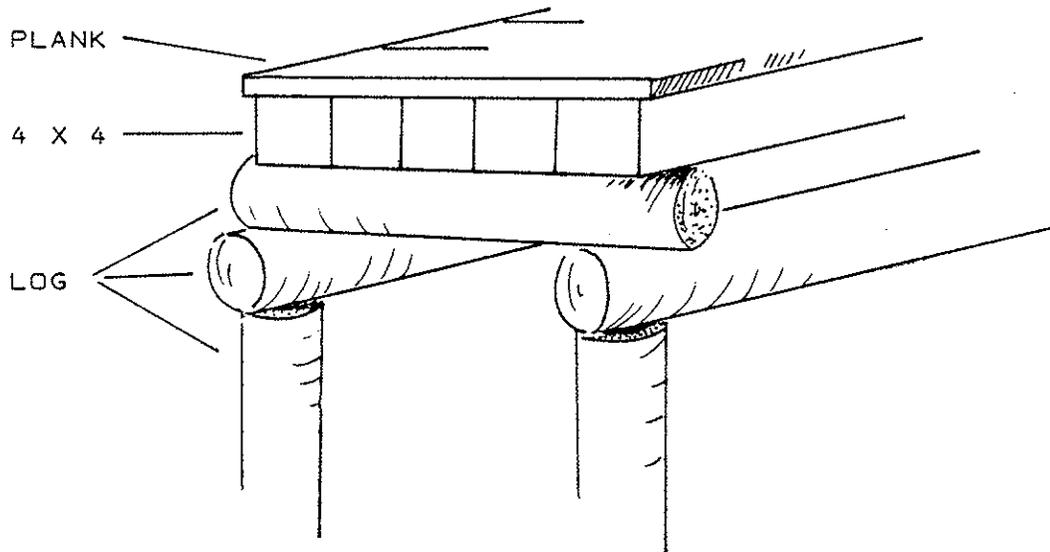
RECONSTRUCTION DRAWING

FEATURE 1
NORTH SPARTA DITCH FLUME

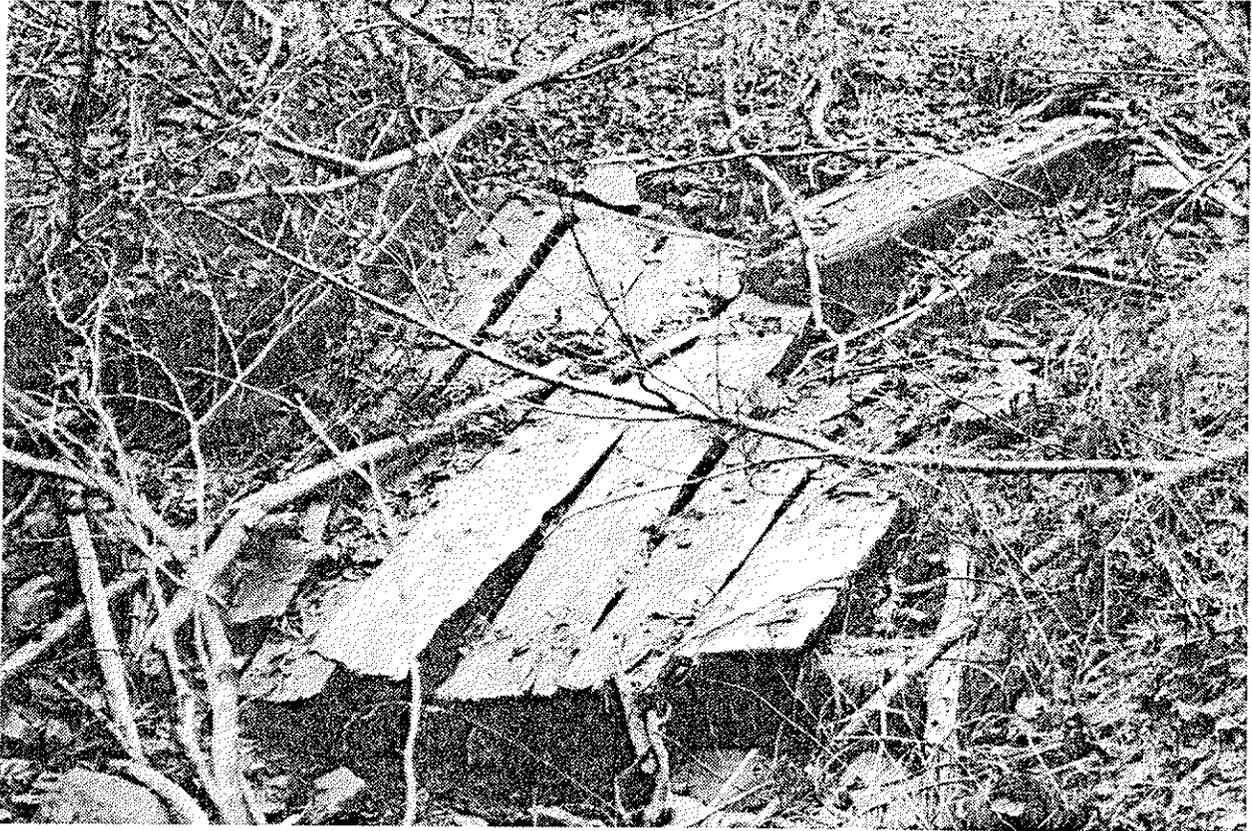
Feature 2

Remains of footbridge over Sparta Ditch

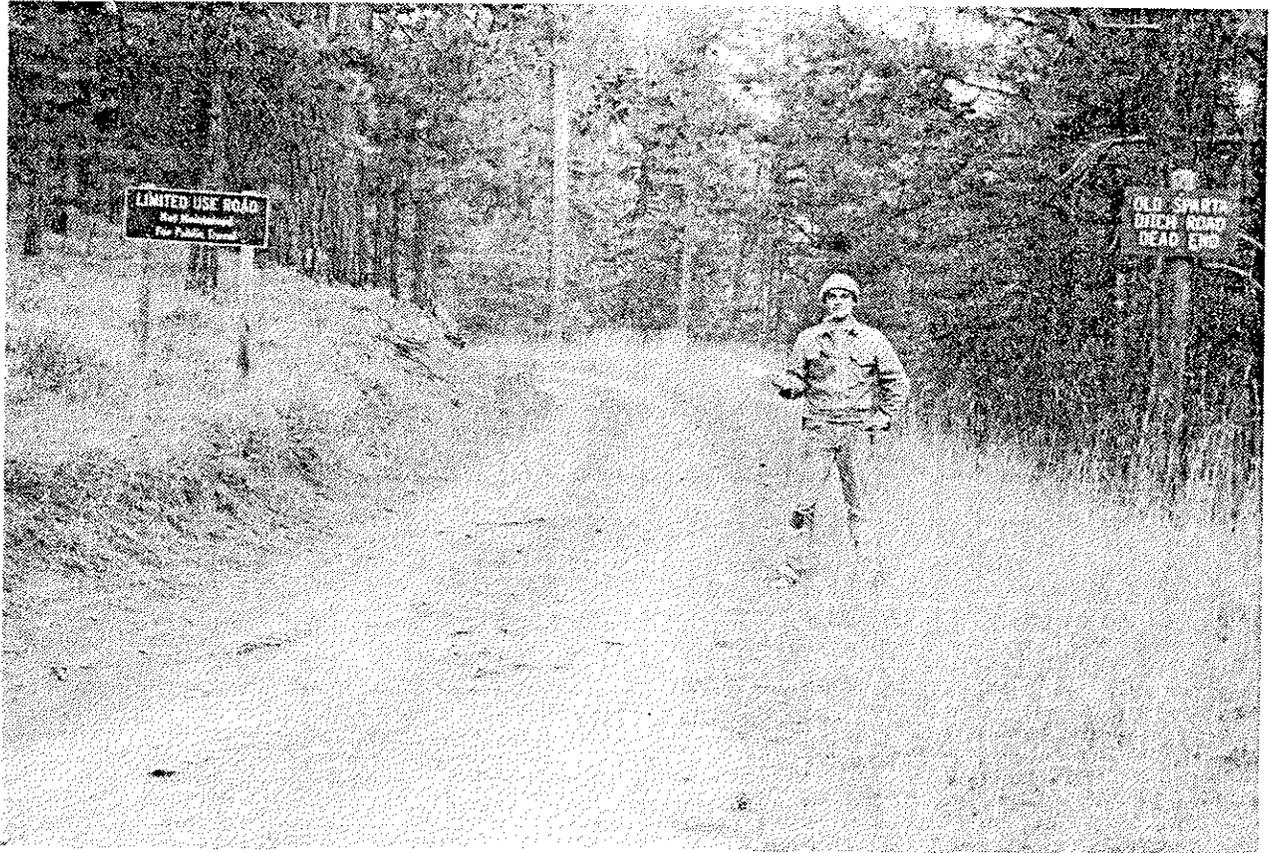
Beginning of the old Sparta Ditch Road

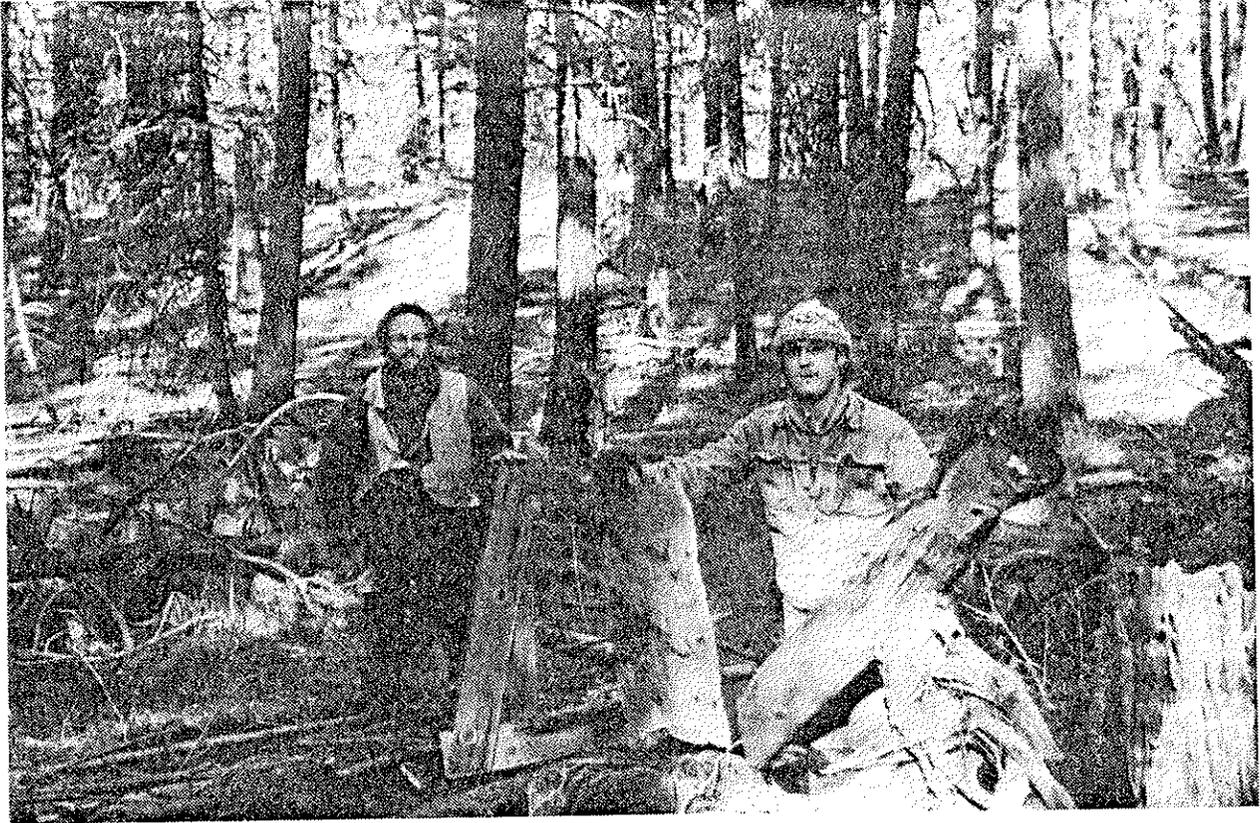
Feature 4

All that is left of this site are some planks on a log base lying in the ditch. NE $\frac{1}{4}$ SE $\frac{1}{4}$ Sec. 29 T 6S R 43E Elev. 1463 UTM Zone 11 E 463400 N 4984200.

South Sparta Ditch flume

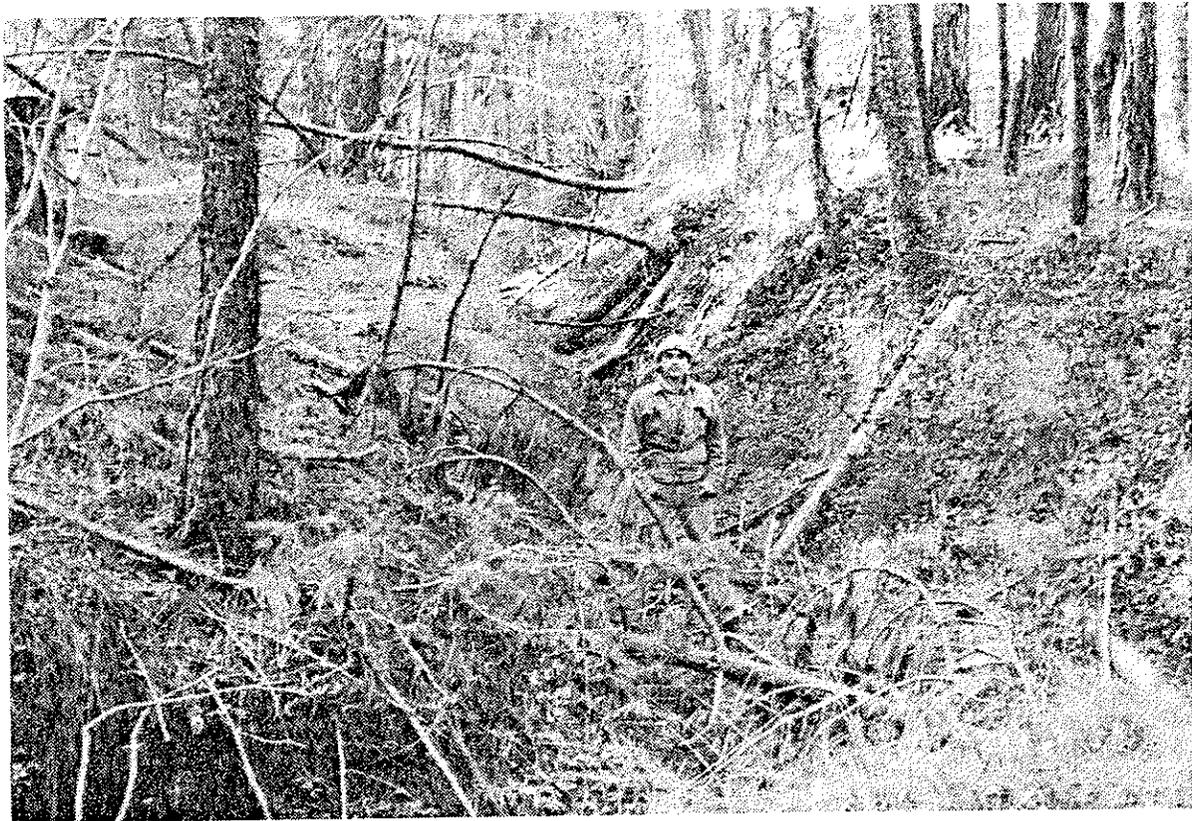
Feature 5

Log base with log uprights. Plank floor- 4 x 4's for floor base. One 4 x 4 has 'No 2 88 11" scratched on it. SE $\frac{1}{4}$ NE $\frac{1}{4}$ Sec. 20 T 6S R 43E Elev. 1463 UTM Zone 11 E 464400 N 4986200.

Ditch leading to Placer mining area

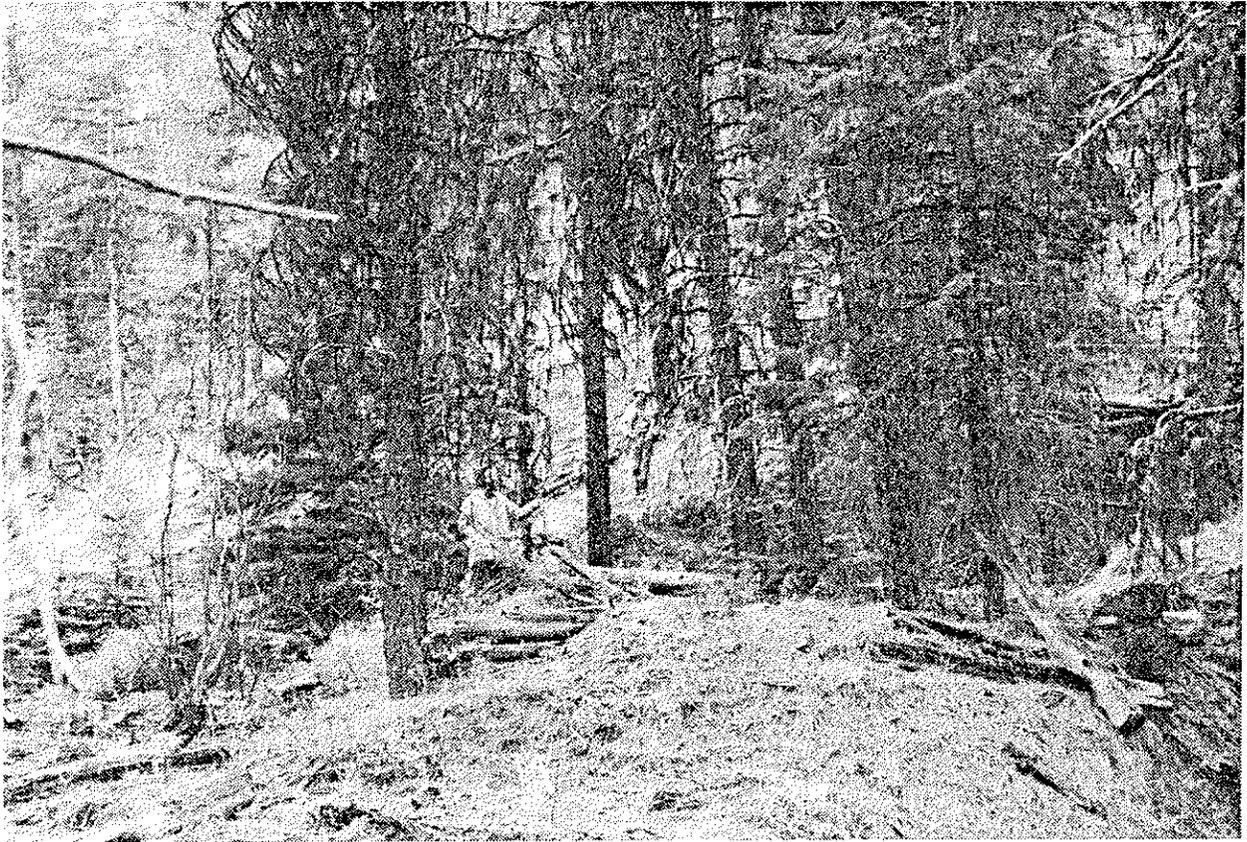
Site includes rectangular log cain remains, cultural debris, and associated mining ditch and placer tailings. Cabin walls have 3-4 log courses left. Logs are 6-10" in diameter, saddle-notched. Cabin is 7.49 m. E-W and 5.62 m. N-S. In E. wall of cabin are remains of cobble and earth hearth.

Site Number 2
1870's Log Cabin site

Expected Impacts: <input checked="" type="checkbox"/> Yes <input type="checkbox"/> No <input type="checkbox"/> Maybe Source <u>Logging</u> Mitigation Recommendations: 1. Avoid Area. 2. Excavate and record	Recorded By <u>Riordan, Tim</u> Date <u>11-25-78</u> Inventory Type: <input type="checkbox"/> Tickler (Verified? <input type="checkbox"/> Yes <input type="checkbox"/> No) <input type="checkbox"/> Overview <input type="checkbox"/> Recon. <input type="checkbox"/> Survey <input type="checkbox"/> Incidental Reference: _____ Attachments: <input type="checkbox"/> Sketch <input checked="" type="checkbox"/> Map <input checked="" type="checkbox"/> Photos <input checked="" type="checkbox"/> USGS <input type="checkbox"/> Catalog <input type="checkbox"/> Report <input type="checkbox"/> _____
--	--

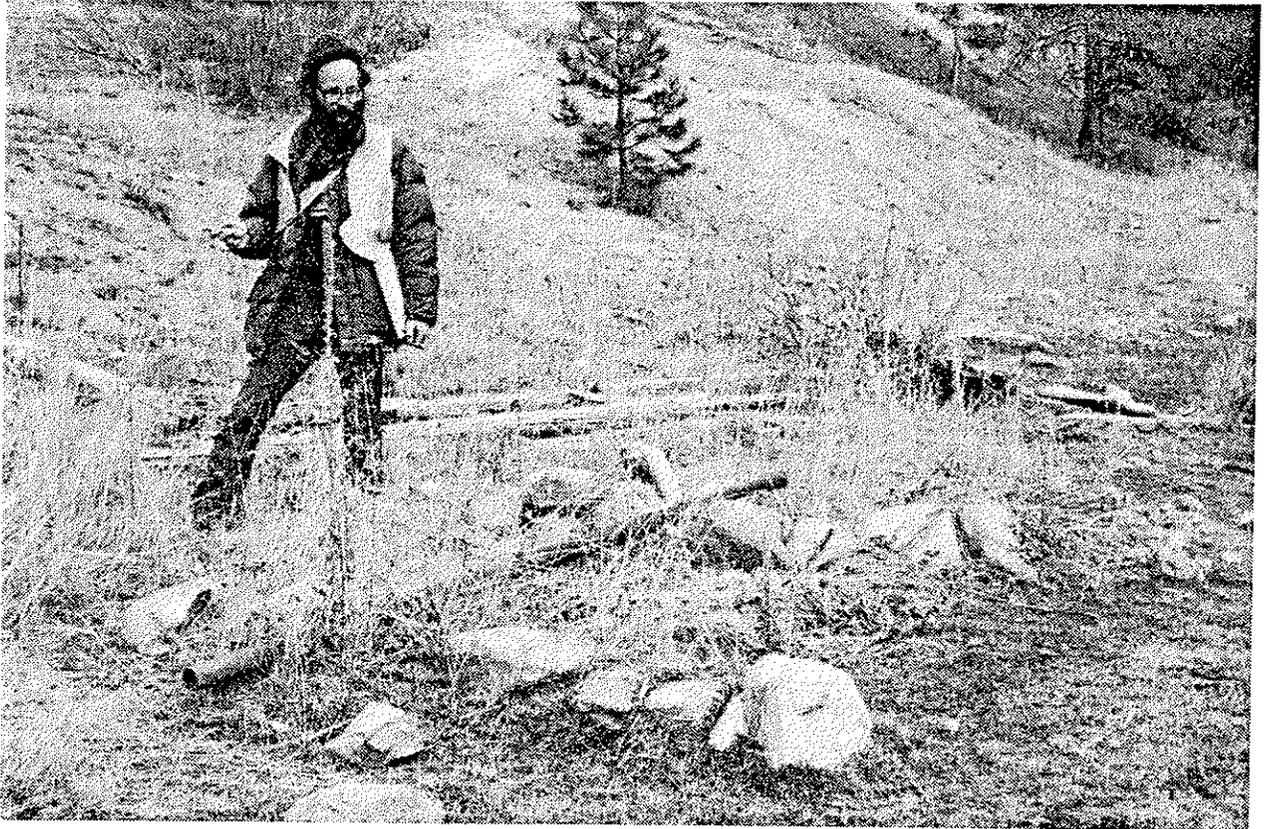
Physical Data (See Instructions)
 Site is around and in SE end of marsh; site is c. 40 m. NE-SW, 20 m. SE-NW. Site includes remains of 2 wood cabins, several trash piles and other cultural debris, a possible mine shaft, and a spring. Mining ditches run along both banks of unnamed creek, below marsh. Cabin remains include logs and boards. Cabin on SE edge of marsh is almost completely burned, as is associated trash pile 2 m. S. Metal stove remains found near trash pile; metal springs (for bed or sifting machine) in marsh c. 4 m. E. of this cabin. Cabin on NE edge of marsh includes logs, boards, and stone foundation. Possible mine shaft consists of large timbers in deep cut in SE bank of marsh. Spring located up SE tributary of marsh. Cultural debris includes glass bottles and shards, metal cans, other metal objects, leather and rubber pieces, and dates to c. 1900-1920.

Site Number 3
Homestead Site
Stone Foundation

Expected Impacts: <input checked="" type="checkbox"/> Yes <input type="checkbox"/> No <input type="checkbox"/> Maybe Source <u>Any activity in area</u> Mitigation Recommendations: 1. Avoid Area 2. Excavate and record.	Recorded By <u>Riordan, Tim</u> Date <u>11-25-78</u> Inventory Type: <input type="checkbox"/> Tickler (Verified? <input type="checkbox"/> Yes <input type="checkbox"/> No) <input type="checkbox"/> Overview <input type="checkbox"/> Recon. <input checked="" type="checkbox"/> Survey <input type="checkbox"/> Incidental Reference: _____ Attachments: <input type="checkbox"/> Sketch <input checked="" type="checkbox"/> Map <input checked="" type="checkbox"/> Photos <input checked="" type="checkbox"/> USGS <input type="checkbox"/> Catalog <input type="checkbox"/> Report <input type="checkbox"/> _____
---	--

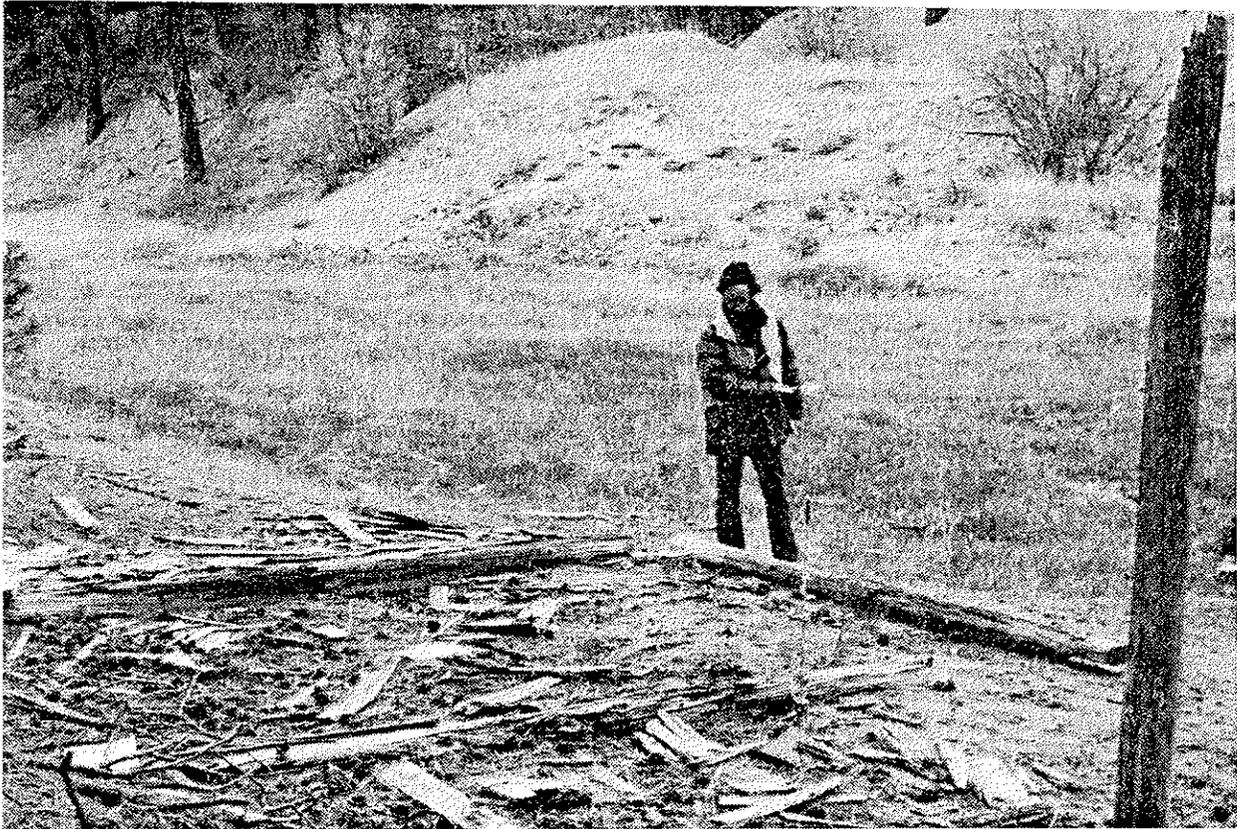
Site Number 3
Homestead Site
Remains of Log Cabin

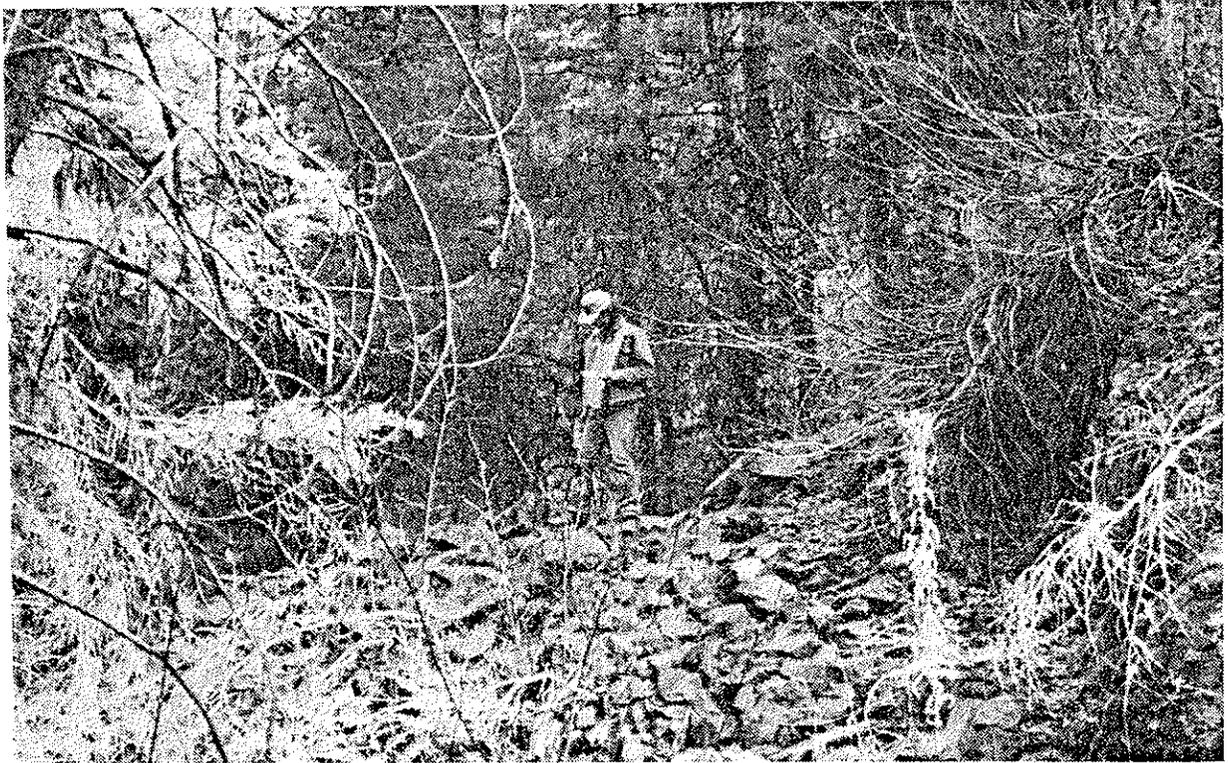
Shanghai Gulch Mining District
Mine tailings
