# National Register of Historic Places Registration Form

Bolton School  
Name of Property

Clackamas Co., OR  
County and State

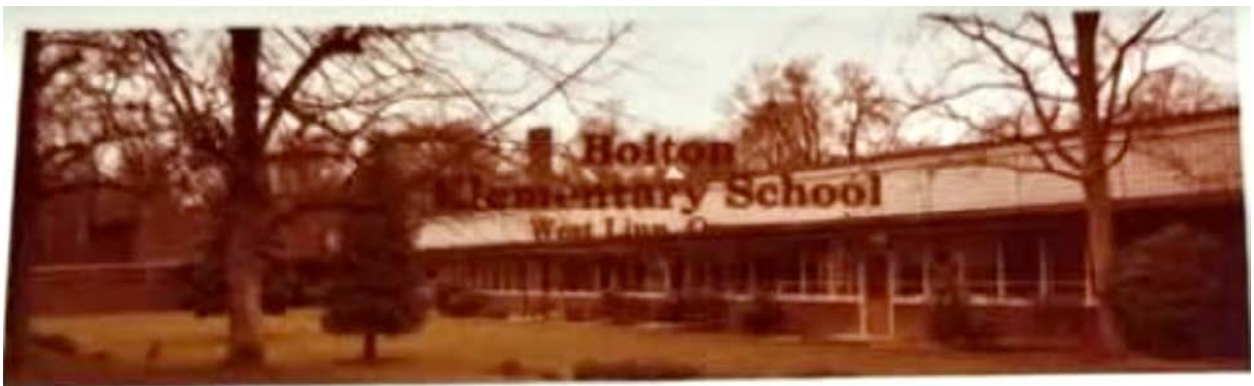
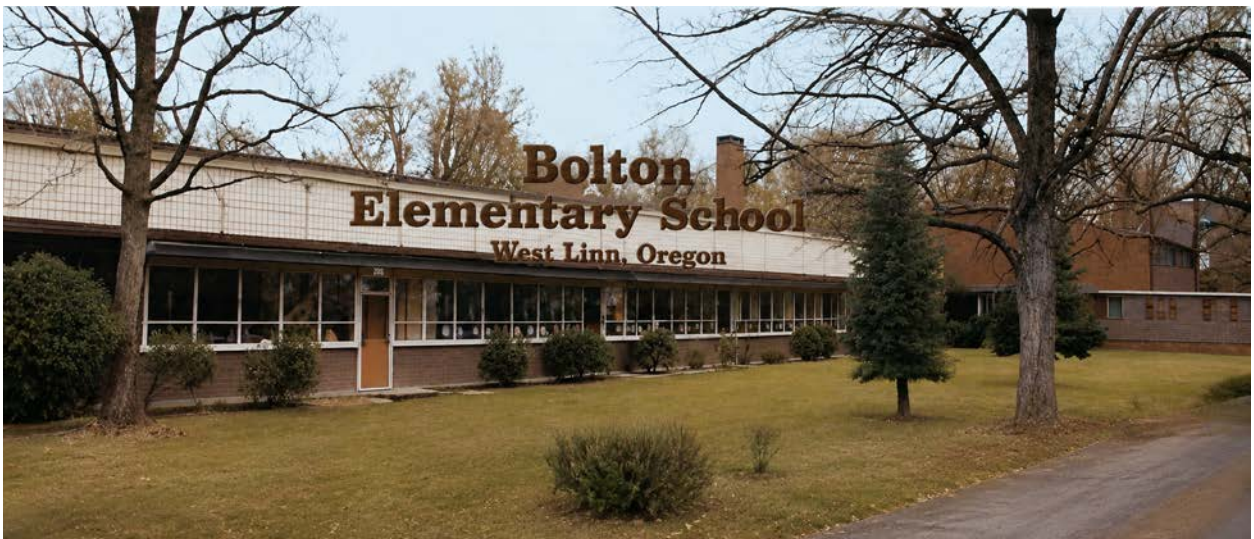
**Figure 16.** Front (southwest) elevation of the 1950 classroom wing, pre-1965, showing the roof monitor with original glass-block glazing along nearly its full length; the gymnasium volume at the southeast end identifies the elevation. The photograph as republished in the 1979–80 Bolton yearbook staff composite is printed mirror-reversed (see corresponding corrected photo below) and carries yearbook lettering reading “Bolton Elementary School,” a name retired in 1965. Reproduced in same reversed orientation as Photo 3 in Continuum Preservation Consulting report, June 18, 2026 [mis-labeled as the rear elevation]. Orientation corrected below.

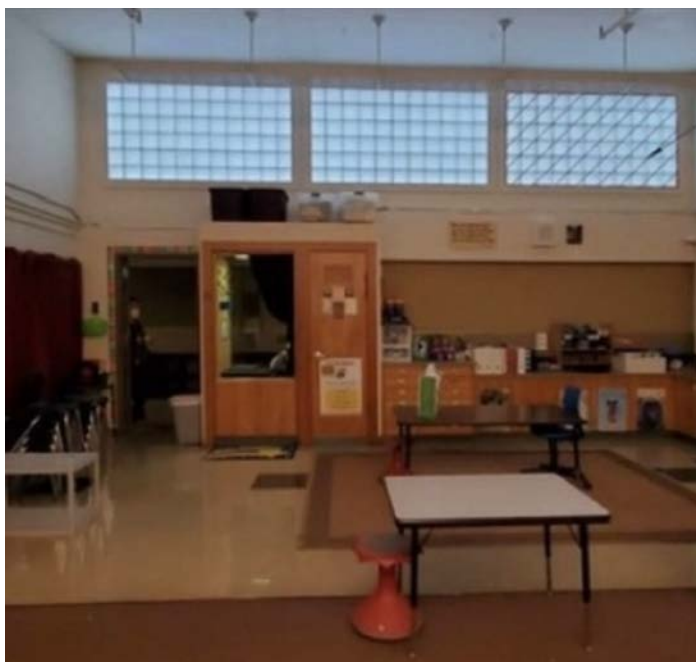
**Figure 23** 1965 classroom addition, glass-block clerestory windows in existing condition prior to the 2021 systems renovation. Source: Bolton Primary School Renovations, Project No. 19049.009, existing-condition documentation sheets A4301--A4302, Bid and Permit Set, January 15, 2021.

block in each of the three classrooms for mechanical penetration. The ductwork is surface-mounted, and the glass-block band survives across all three classrooms, partially obstructed by the ductwork and equipment but continuing to admit daylight; its pre-project condition is documented in the district's own existing-condition sheets (Figure 23), and its current condition in Photographs 16 and 23–24. The district formally documented the building's existing condition in photographic documentation sheets (A4301, A4302) prior to commencing work (Figure 23).<sup>63</sup>

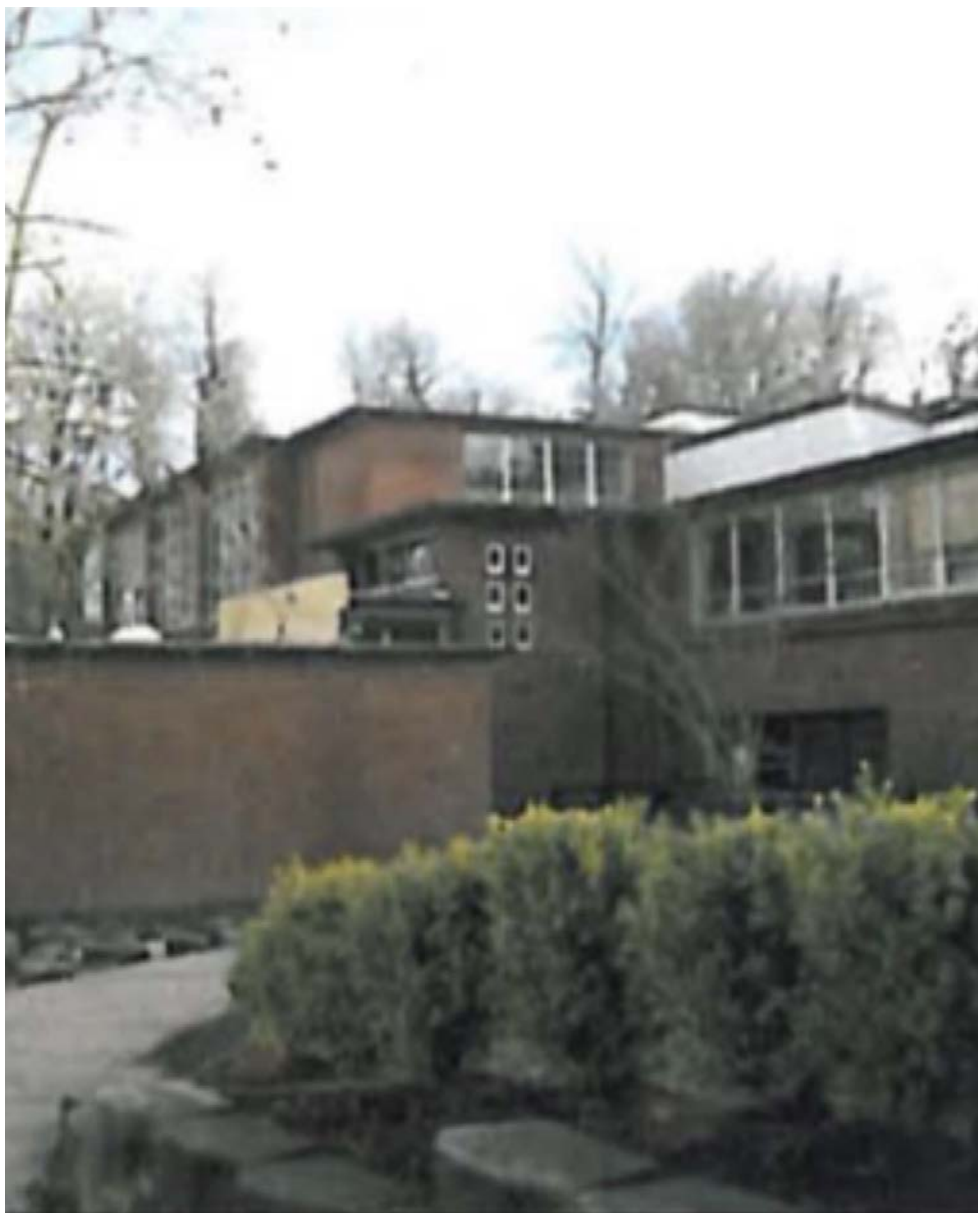
**Figure 24.** Rear (northeast) elevation prior to construction of the 2012 library addition, showing the perforated brick pier, stairwell glazing, and exterior brick surfaces subsequently enclosed within and preserved by the addition. Source: City of West Linn, Conditional Use Permit CUP-10-02 application materials, 2010.

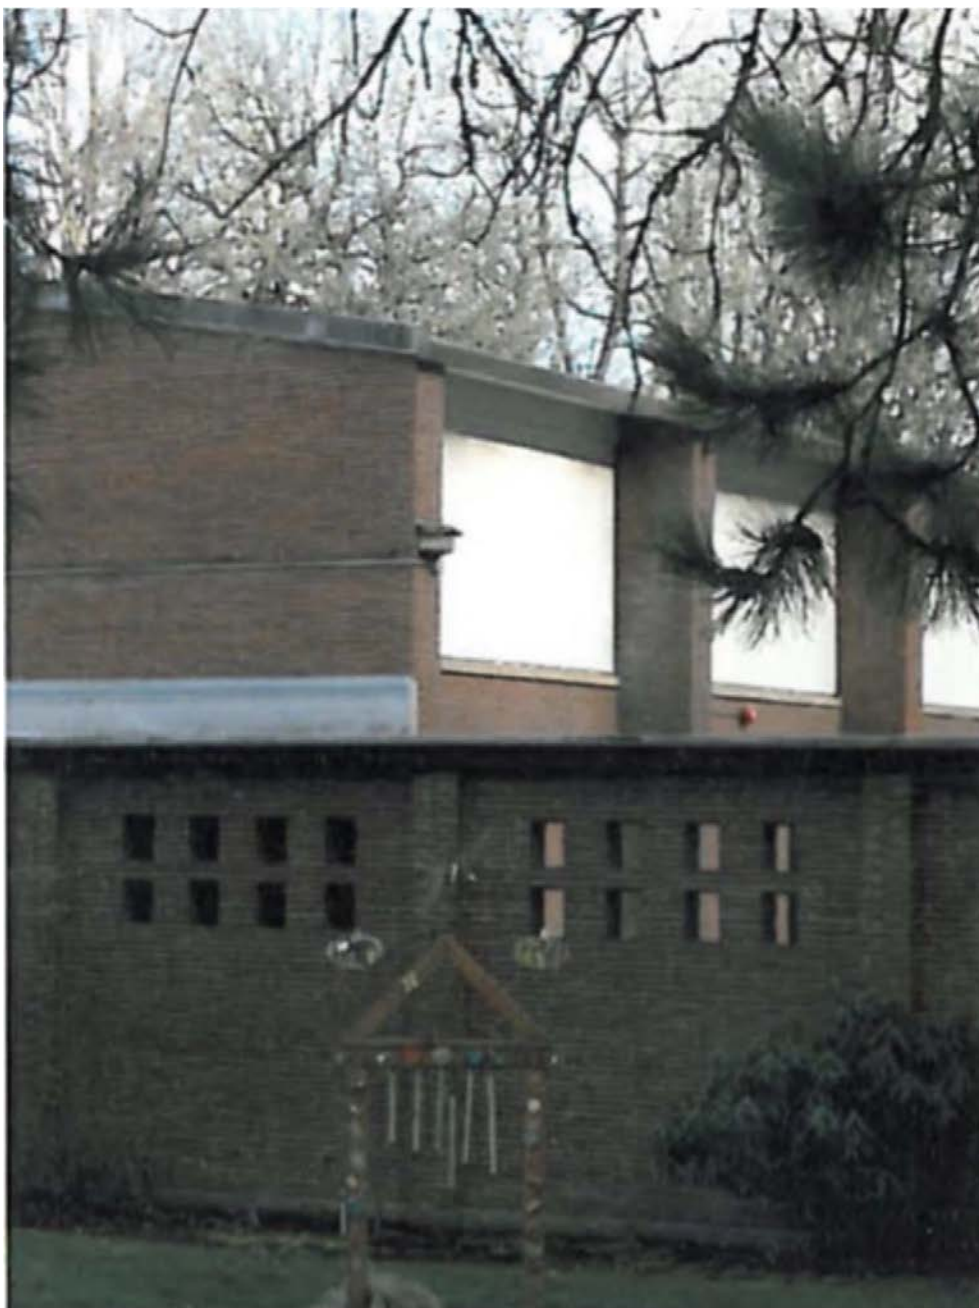
**Figure 25** Main entrance screen wall, 2010, showing the original small perforated openings prior to their enlargement under the 2014 Capital Bond, and the gymnasium monitor band with opaque infill panels. Source: City of West Linn, Conditional Use Permit CUP-10-02 application materials, 2010.

prior to their enlargement. This work followed a district-wide hazard assessment conducted by the district's security consultant, Elert & Associates, in 2015–2016; the enlargement gave office staff a clear line of sight to persons approaching the entrance, consistent with the project's purpose of providing a secure, controlled entrance.<sup>28</sup> Beneath these windows are built-in, child sized benches decorated in ceramic tile murals, created by a fifth-grade class project. The covered walkway creates a transitional outdoor-indoor space characteristic of mid-century school design in the Pacific Northwest, where sheltered circulation was a practical response to the regional climate. Steps at the center of the walkway ascend toward the parking area and Holmes Street, reinforcing the building's siting on the sloped terrain. Historic photographs show a low flight of steps at the entrance screen wall that is no longer present (Figure 17; Continuum photo 7 1960). This change is consistent with the 2014 secure-entry remodel. In the primary façade beneath the canopy, paired glass doors with sidelites and transoms provide access to the main corridor; these doors replace the original wood entrance doors documented in period photographs and were most recently updated as part of the 2014 bond cycle secure-entry vestibule project, incorporating intrusion-limiting glass.<sup>29</sup> The address "5933" is displayed on the eaves of the entry overhang. A continuous raised planter extends along the base of the entry façade between the canopy and the parking area, with terra cotta pots flanking the entrance walkway. Period photographs document that this edge originally consisted of a low brick wall with a central stair ascending from the parking area (Figure 17; Continuum Photo 1960); the present board-formed concrete retaining wall and planter, without the central stair, replaced that configuration at an undocumented date. The planter's long, low mass continues the horizontal emphasis of the original composition, echoing the projecting eaves. exemplifies the modernist approach to institutional entry design: functional, welcoming, and architecturally integrated rather than monumental.

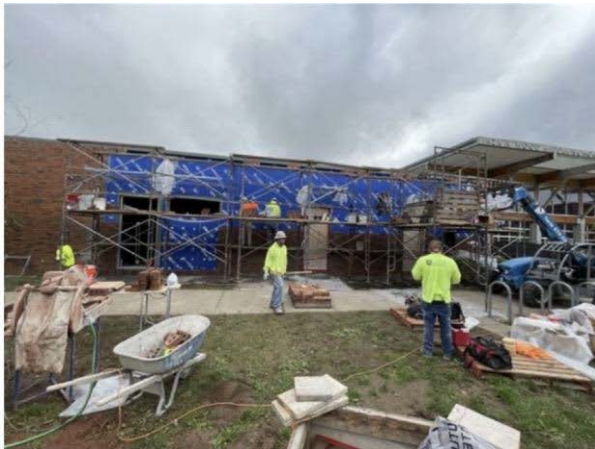
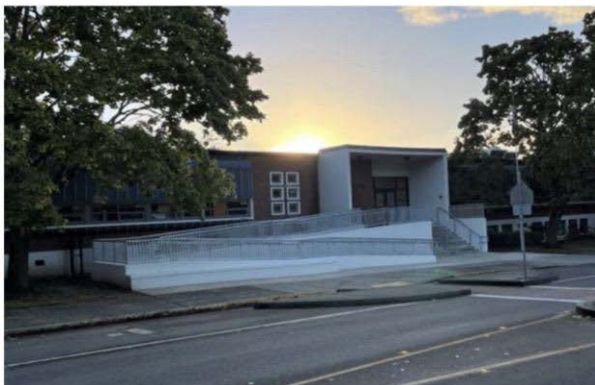
**Figure 42.** West Linn–Wilsonville School District bond website, “19049.009 – Renovations at Stafford Primary School & Willamette Primary School,” documenting renovation work at Willamette Primary School, including reconstruction of exterior wall fabric (top) and the remodeled main entrance (bottom). District website <https://www.wlww.k12.or.us/Page/16169>, archived March 27, 2022, Internet Archive Wayback Machine. Screenshot by author, 2026. The district requested bids for renovations at Stafford, Willamette, and Bolton schools under the single project number 19049.009; the Bolton bid and permit set cited throughout this nomination carries the same number. The project was later split and Bolton and Cedaroak were given project number 19050.009 under which they were completed.

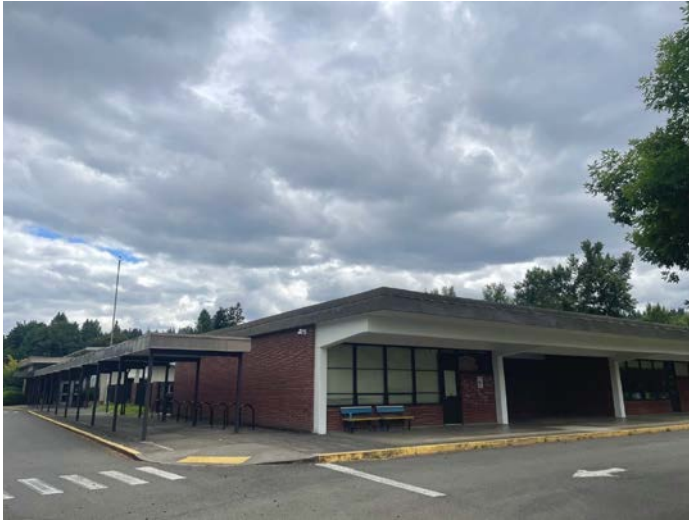
**Figure 43.** Cedaroak Park Primary School (1958–1966, Annand and Boone), showing dispersed building phases connected by open-air covered walkways and classrooms opening directly to the exterior. Photograph by author from the public right-of-way, June 2026.

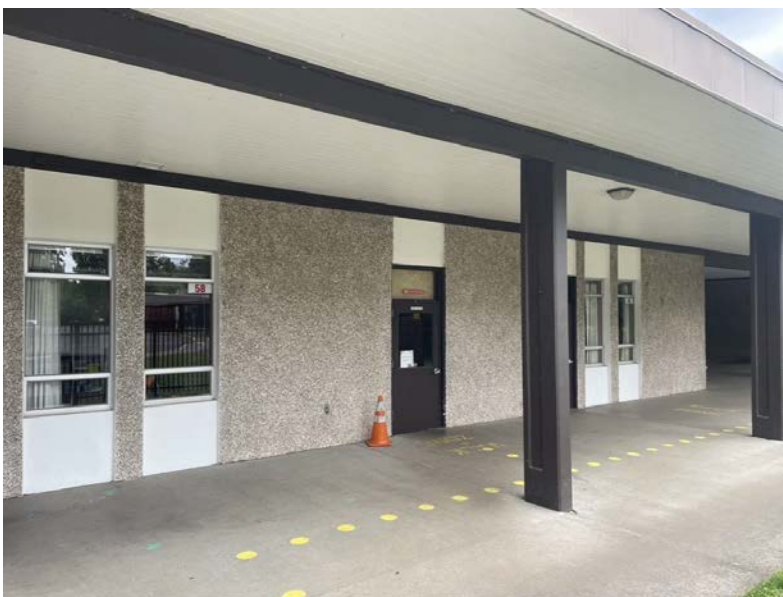
**Figure 44.** Cedaroak Park Primary School: a later addition clad in exposed-aggregate concrete panel with steel posts and metal soffit, differing in material and vocabulary from earlier phases of the same campus. Unlike Bolton, where brick and fascia carry across additions through 1965, Cedaroak's campaigns introduced non-matching cladding. Photograph by author from the public right-of-way, June 2026.

**Figure 44.** Cedaroak Park Primary School: a later addition clad in exposed-aggregate concrete panel with steel posts and metal soffit, differing in material and vocabulary from earlier phases of the same campus. Unlike Bolton, where brick and fascia carry across additions through 1965, Cedaroak's campaigns introduced non-matching cladding. Photograph by author from the public right-of-way, June 2026.

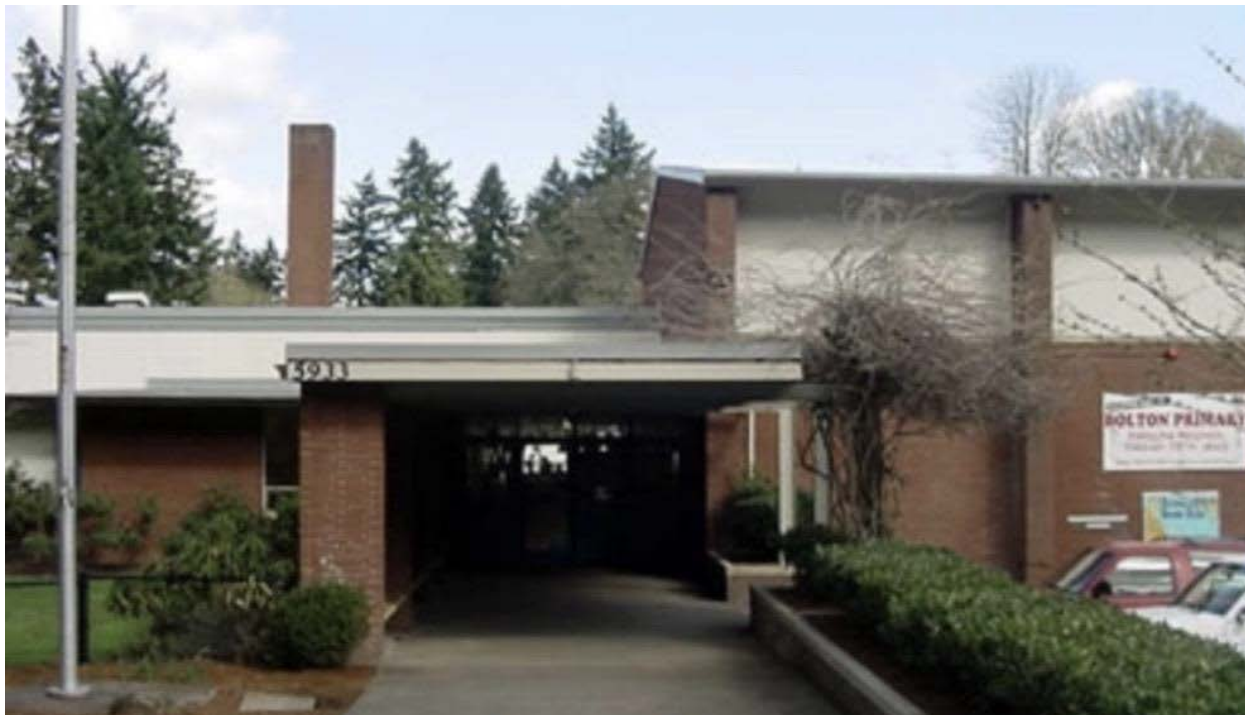
**Figure 46.** Front entrance per district 2008 bond website before secure front entrance remodel [www.bond.wlwy.k12.or.us](http://www.bond.wlwy.k12.or.us) , wayback machine, archived 2012, compare with Photograph 1.

**Figure 46.** Front entrance per district 2008 bond website before secure front entrance remodel [www.bond.wlww.k12.or.us](http://www.bond.wlww.k12.or.us), wayback machine, archived 2012, compare with Photograph 36

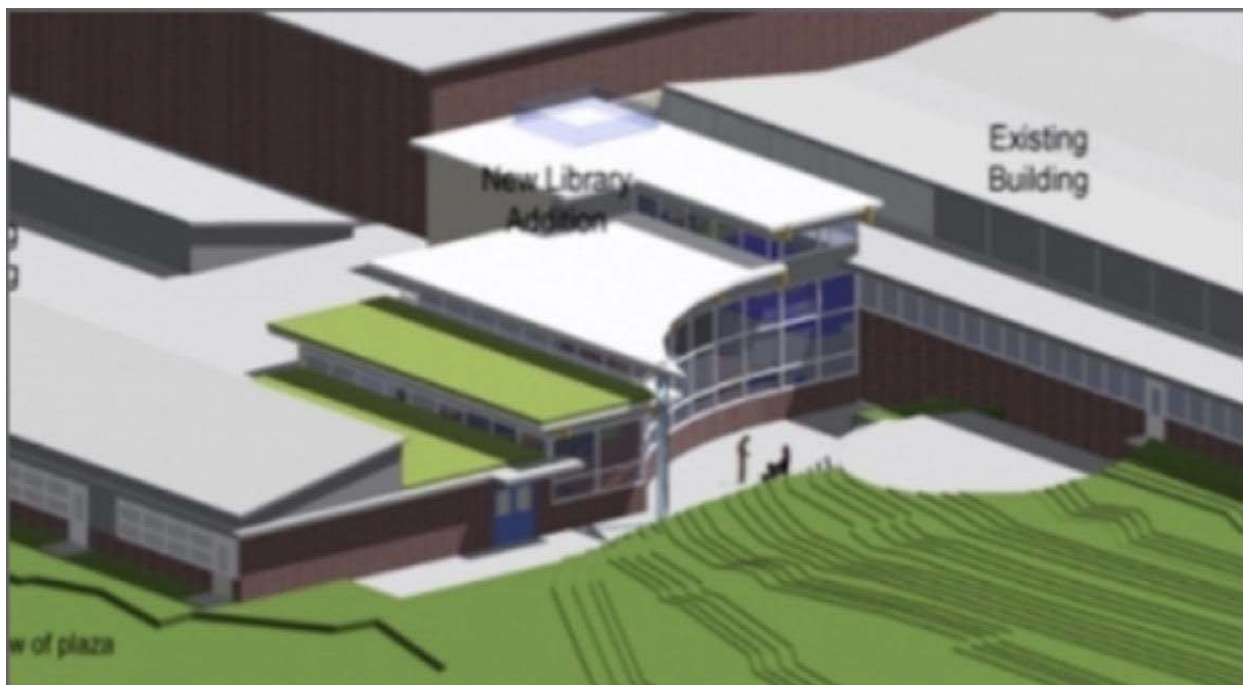
**Figure 49.** Figure 49. West Linn–Wilsonville School District 2008 bond website, rendering of the proposed library addition at Bolton Primary School, showing the addition in the ell between the existing wings and labeled “New Library Addition” and “Existing Building.” District website [www.bond.wlww.k12.or.us](http://www.bond.wlww.k12.or.us), archived 2012, Internet Archive Wayback Machine. Screenshot by author, 2026.

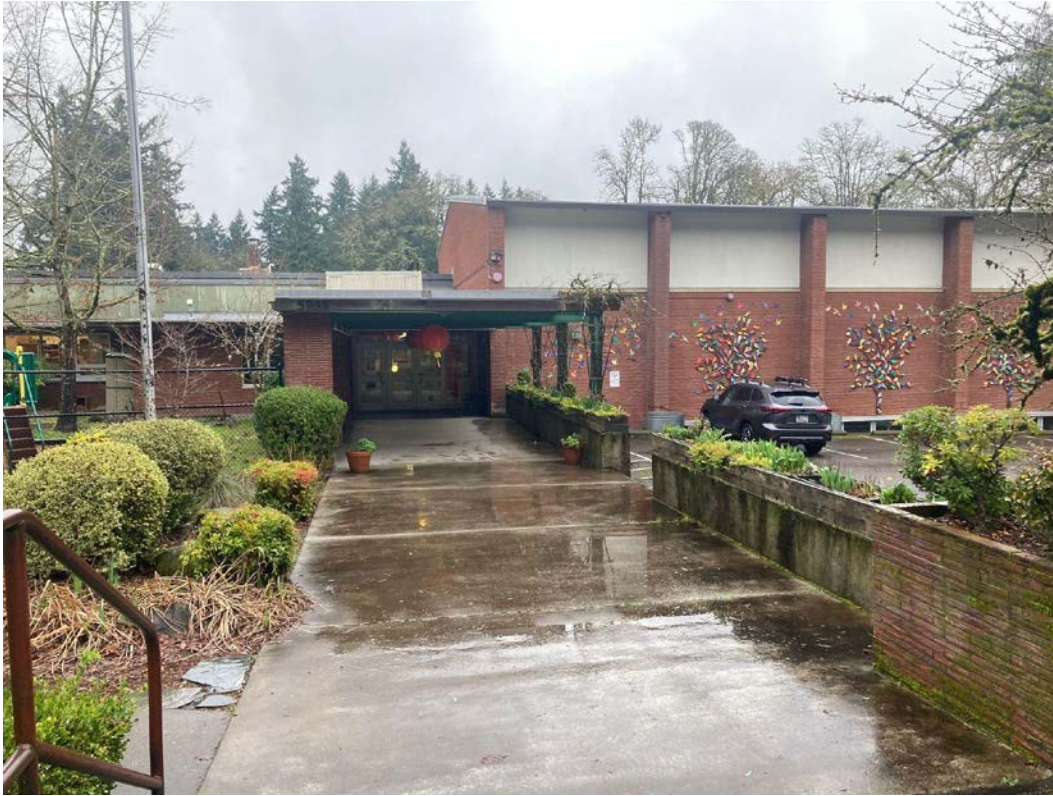
**Photograph 1 of 69:** OR\_ClackamasCounty\_BoltonSchool\_0001  
Looking northeast at southwest (primary) façade, primary entrance and gymnasium. Compare with Figure 47 for front entrance after secure remodel.

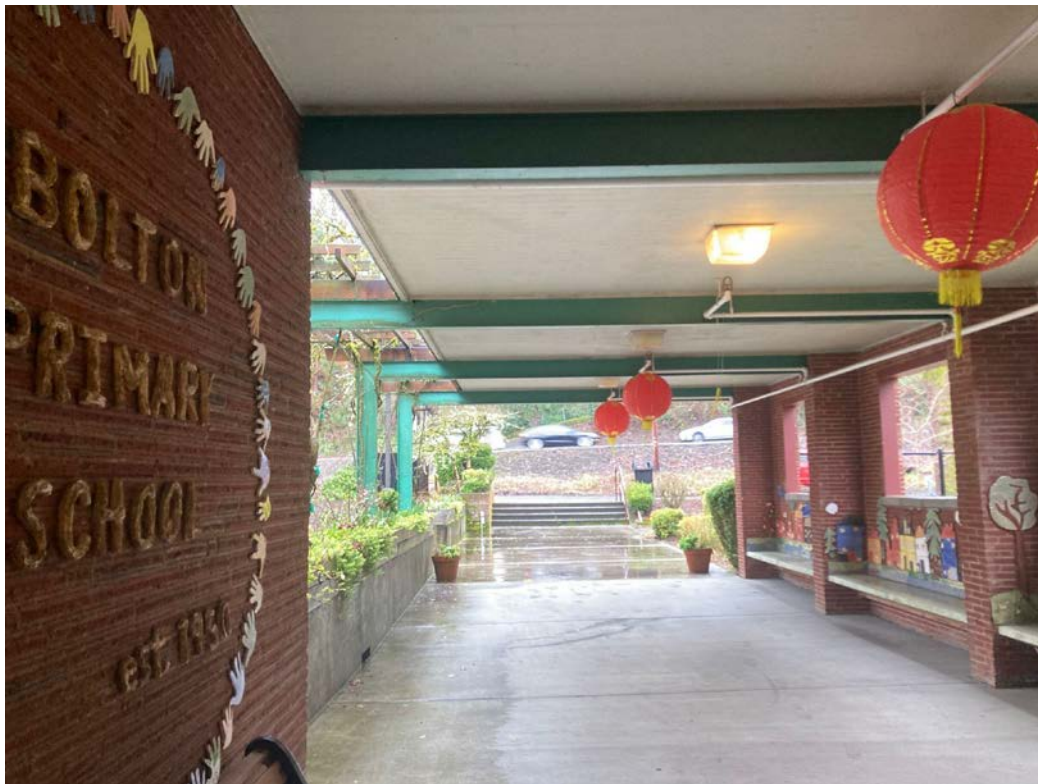
**Photograph 3 of 69:** OR\_ClackamasCounty\_BoltonSchool\_0003  
Looking north from under the entrance canopy, bricked openings with built-in benches decorated in ceramic tile mural and main entry doors.

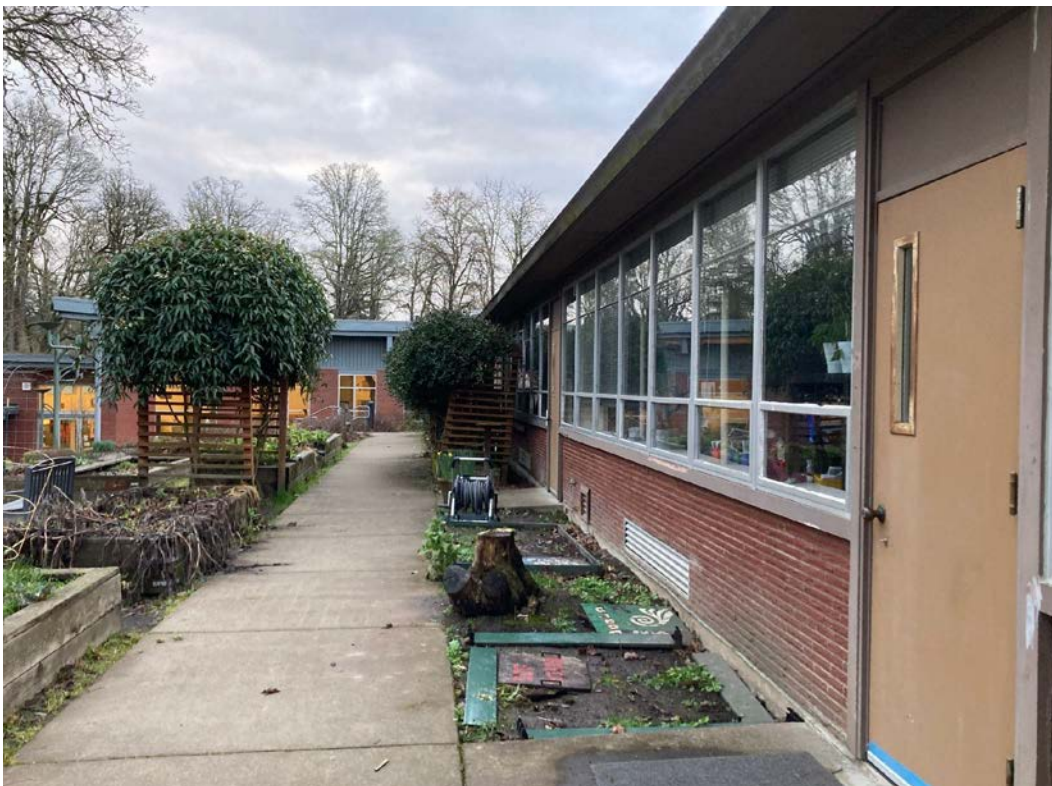
**Photograph 8 of 69:** OR\_ClackamasCounty\_BoltonSchool\_0008  
Looking northeast along rear (northwest) elevation, classroom wing with ribbon  
windows and teaching garden. Library addition at left.

- *Windows.* Energy-efficient units replaced windows in portions of the building, documented in the district's project list as cafeteria window replacement with additional replacement in the secure-entry project area, which included the southwest classroom-wing elevation. The replacement units are double-glazed, aluminum-framed sash set within the original openings, reproducing the horizontal proportions of the originals but differing in their wider, flat-profile frames, uniform factory finish, and insulated glazing, in contrast to the slender sash with fine divided-lite grids that survive on the rear elevation of the 1950 classroom wing (compare Photographs 5, 7 and 8).

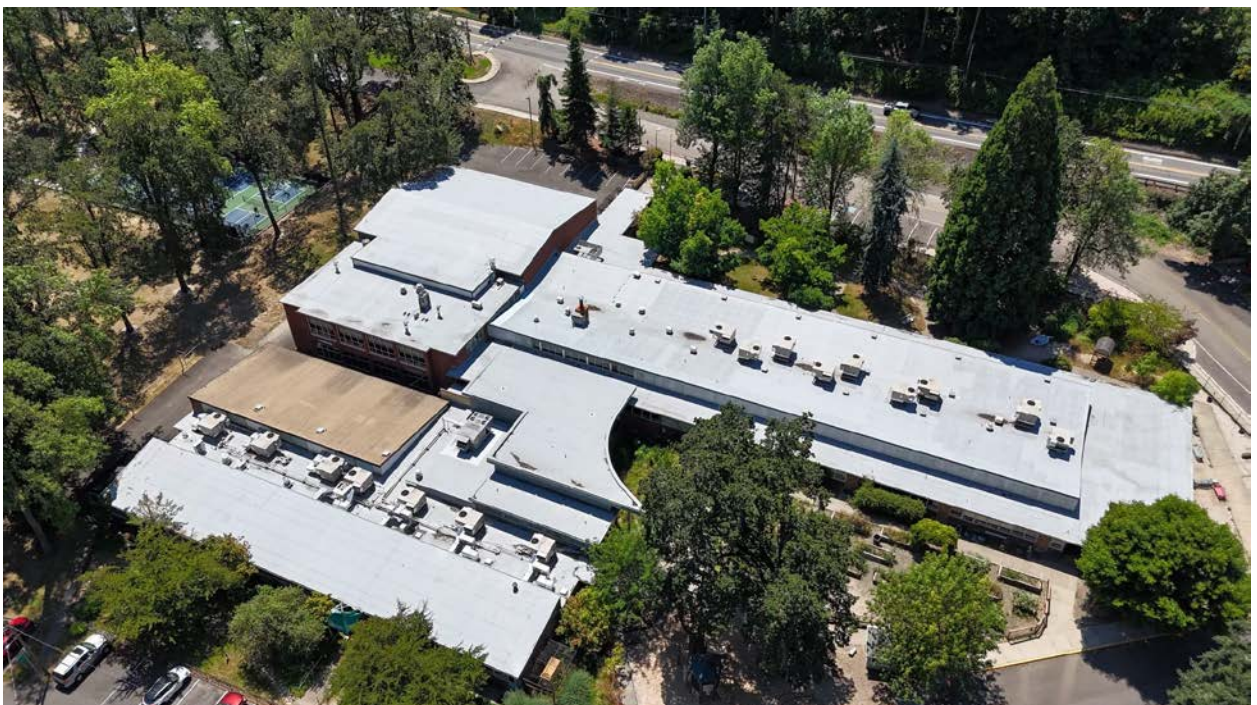
OR\_ClackamasCounty\_BoltonSchool\_0017

Aerial oblique view showing the modified finger-plan organization, the 1950 classroom wing and gymnasium volume, the 1954/1957/1965 additions, and the 2012 library addition within the ell. Camera facing southeast.

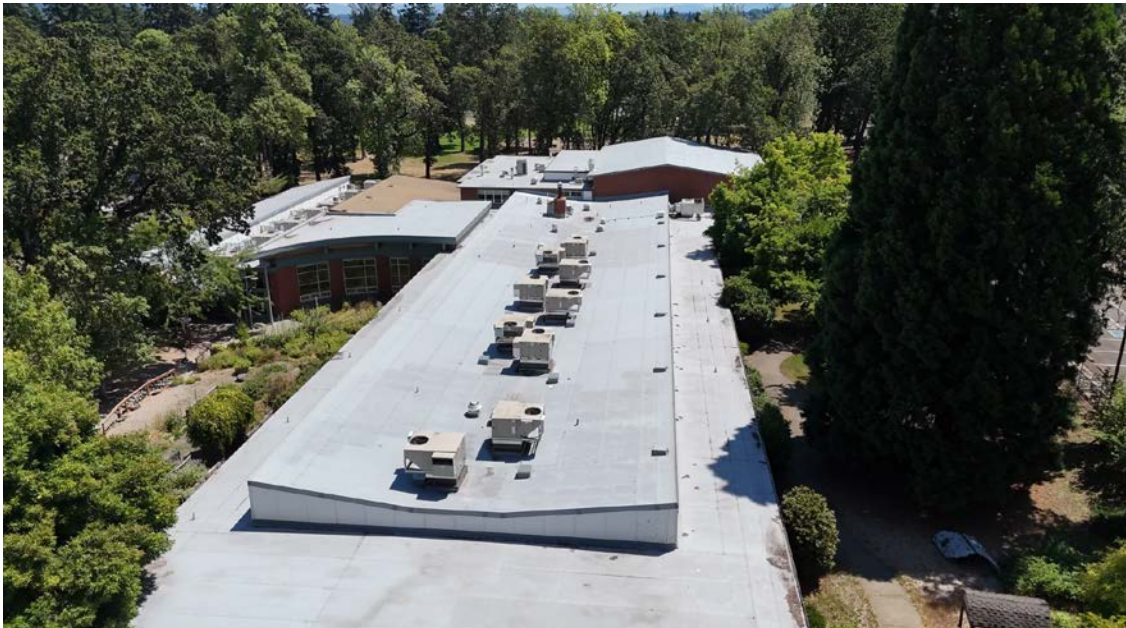
OR\_ClackamasCounty\_BoltonSchool\_0019

Aerial oblique view of the rear (northeast) elevation of the 1950 classroom wing, showing ribbon fenestration, individual classroom doors, and the teaching-garden terrace. Camera facing southwest.

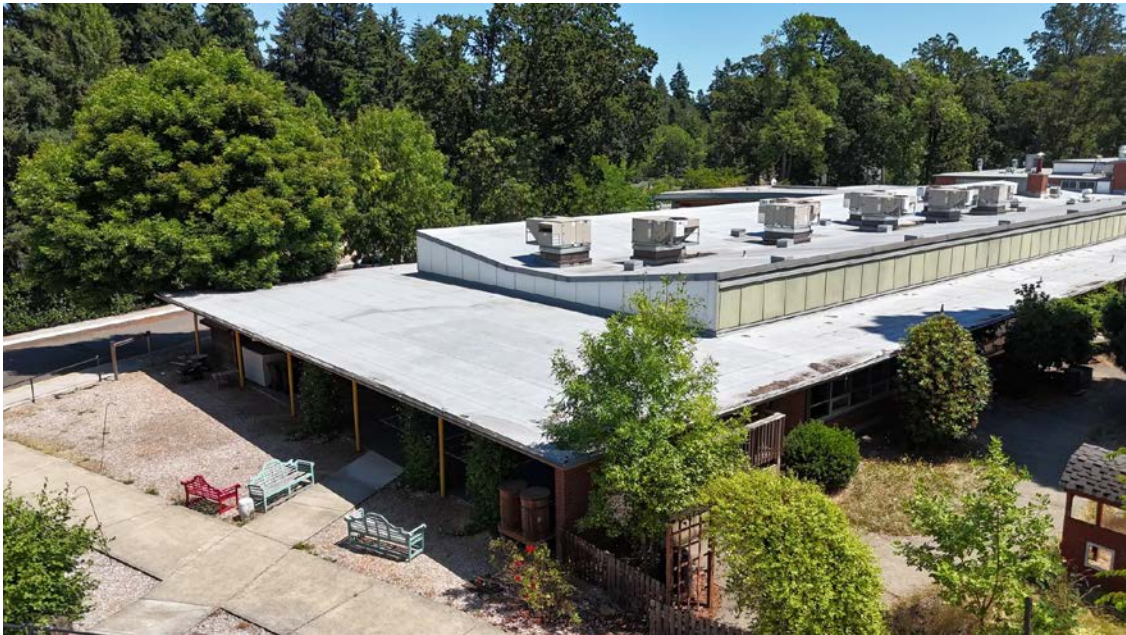
OR\_ClackamasCounty\_BoltonSchool\_0021

Aerial view of the monitor roof rising above the 1950 classroom wing, clerestory band enclosed with opaque panels within the original openings; monitor roof form fully intact. Camera facing northeast.

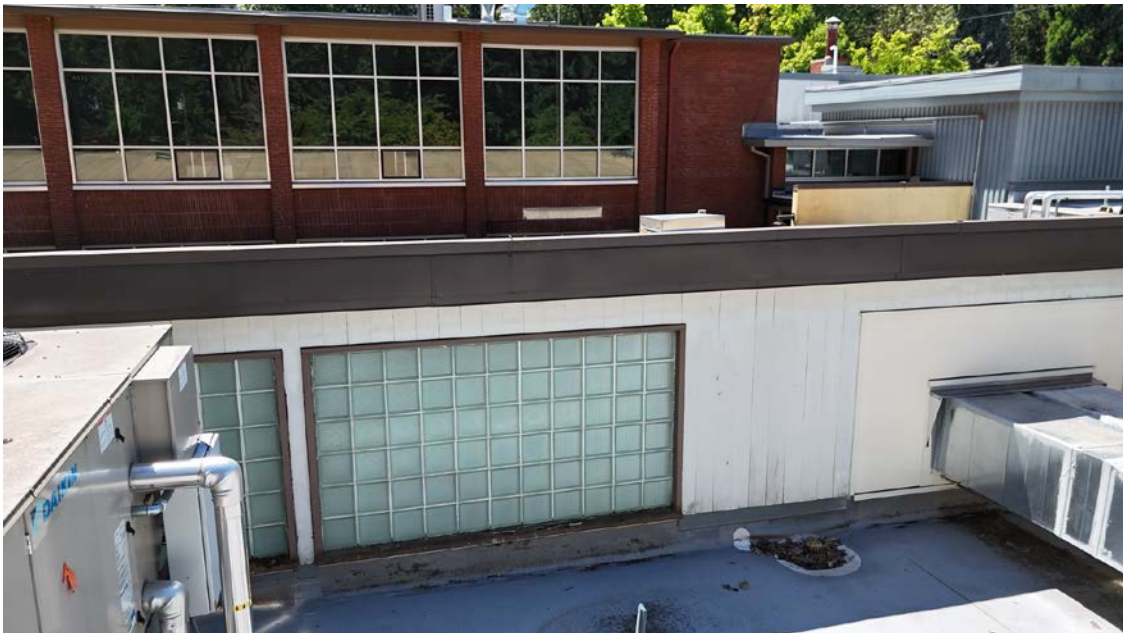
OR\_ClackamasCounty\_BoltonSchool\_0023

Roof-level view of the 1965 addition monitor, showing original glass-block clerestory glazing surviving as a continuous band across all three classroom bays, partially obstructed by mechanical equipment installed 2021. Camera facing southeast

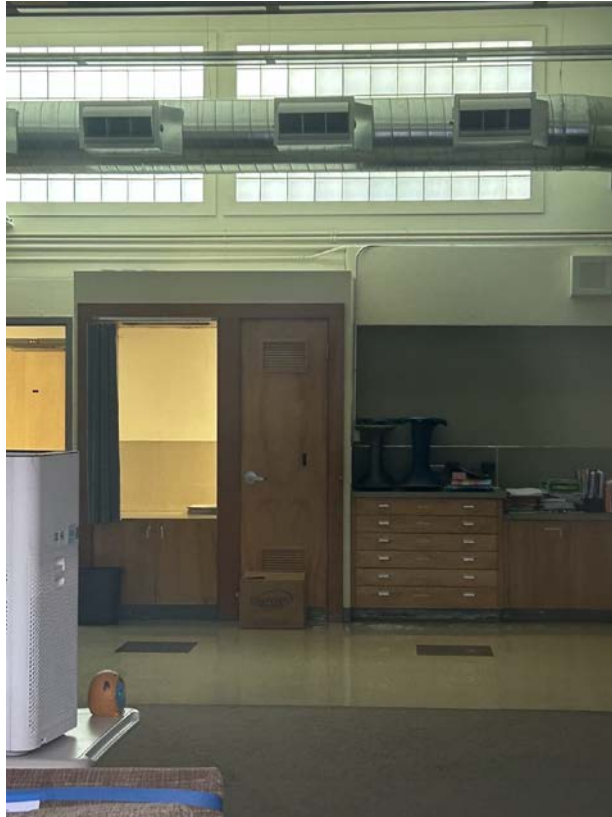
OR\_ClackamasCounty\_BoltonSchool\_0024

Detail, original glass-block monitor glazing in its original opening, 1965 addition. Camera facing southwest.

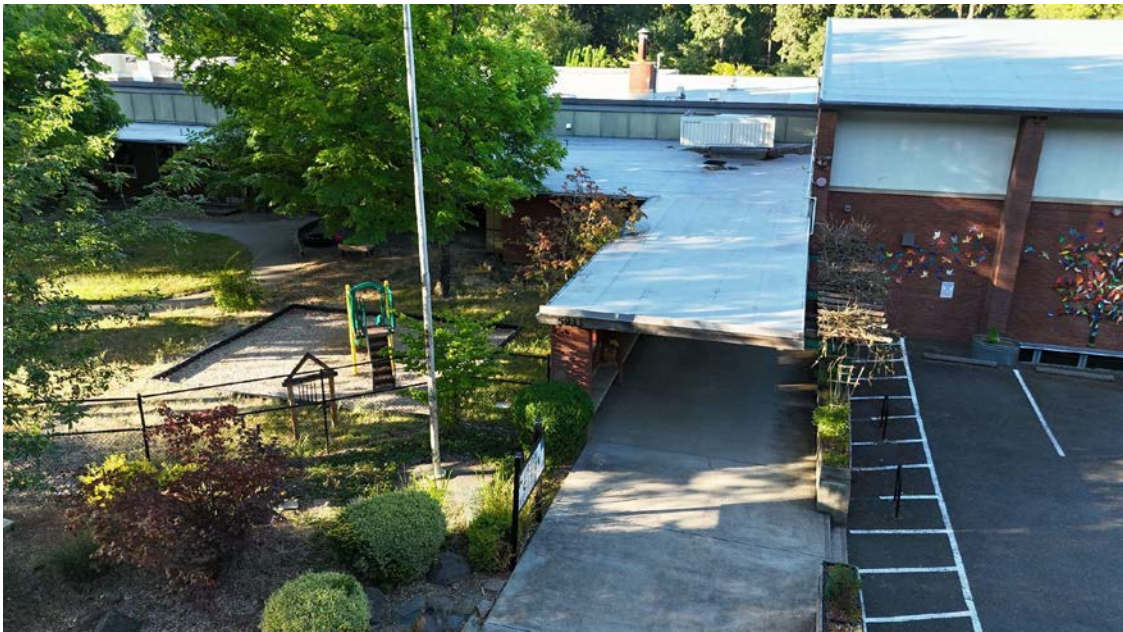
**Photograph 29 of 69:** OR\_ClackamasCounty\_BoltonSchool\_0029

Detail, perforated brick screen wall at the northwest covered play area, retaining original opening configuration; compare the enlarged openings at the main entrance (Photograph 3; Figure 25). Camera facing northeast.

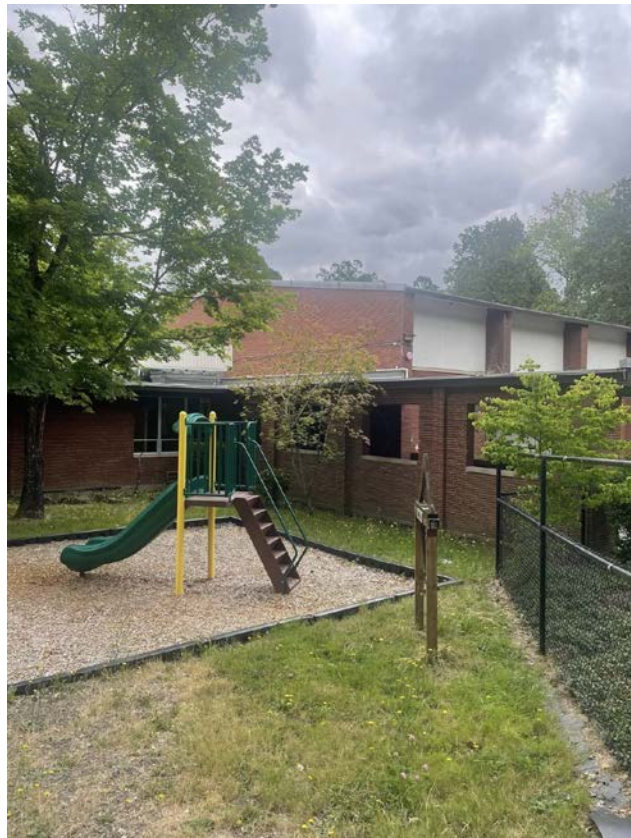
**Photograph 31 of 69:** OR\_ClackamasCounty\_BoltonSchool\_0031

View along the southwest face of the 1950 classroom wing at the covered play area, showing the perforated brick screen wall retaining its original opening configuration; compare the enlarged openings at the main entrance (Photograph 3; Figure 25). Camera facing southeast.
