National Register of Historic Places Registration Form

historic name Pass Creek Covered Bridge

other names/site number Krewson Covered Bridge; Pass Creek-Krewson Bridge

Douglas Co., Oregon
County and State

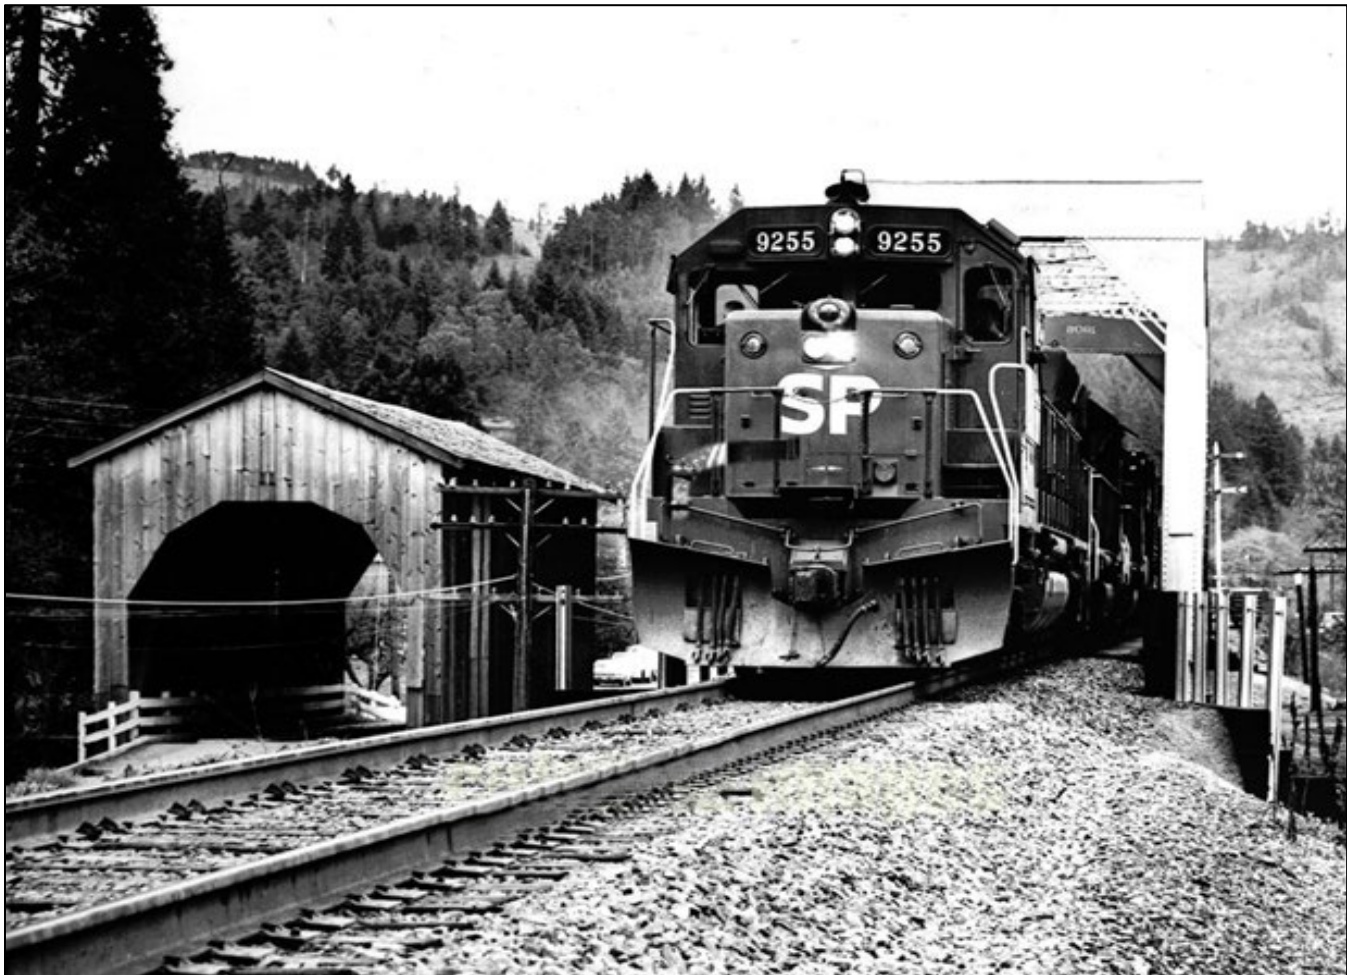
Figure 8. View of the Pass Creek Covered Bridge in its original location on North First Street beside the steel railroad bridge over Pass Creek (circa 1972).

The bridge's character-defining Howe truss configuration, segmented portals, vertical board siding without battens, and gabled housing remain clearly legible (Figures 7 and 8, Photograph 1). Reinforcements and roof and siding replacements have not altered the underlying truss form or the overall massing of the structure. As a result, the bridge retains integrity of design.

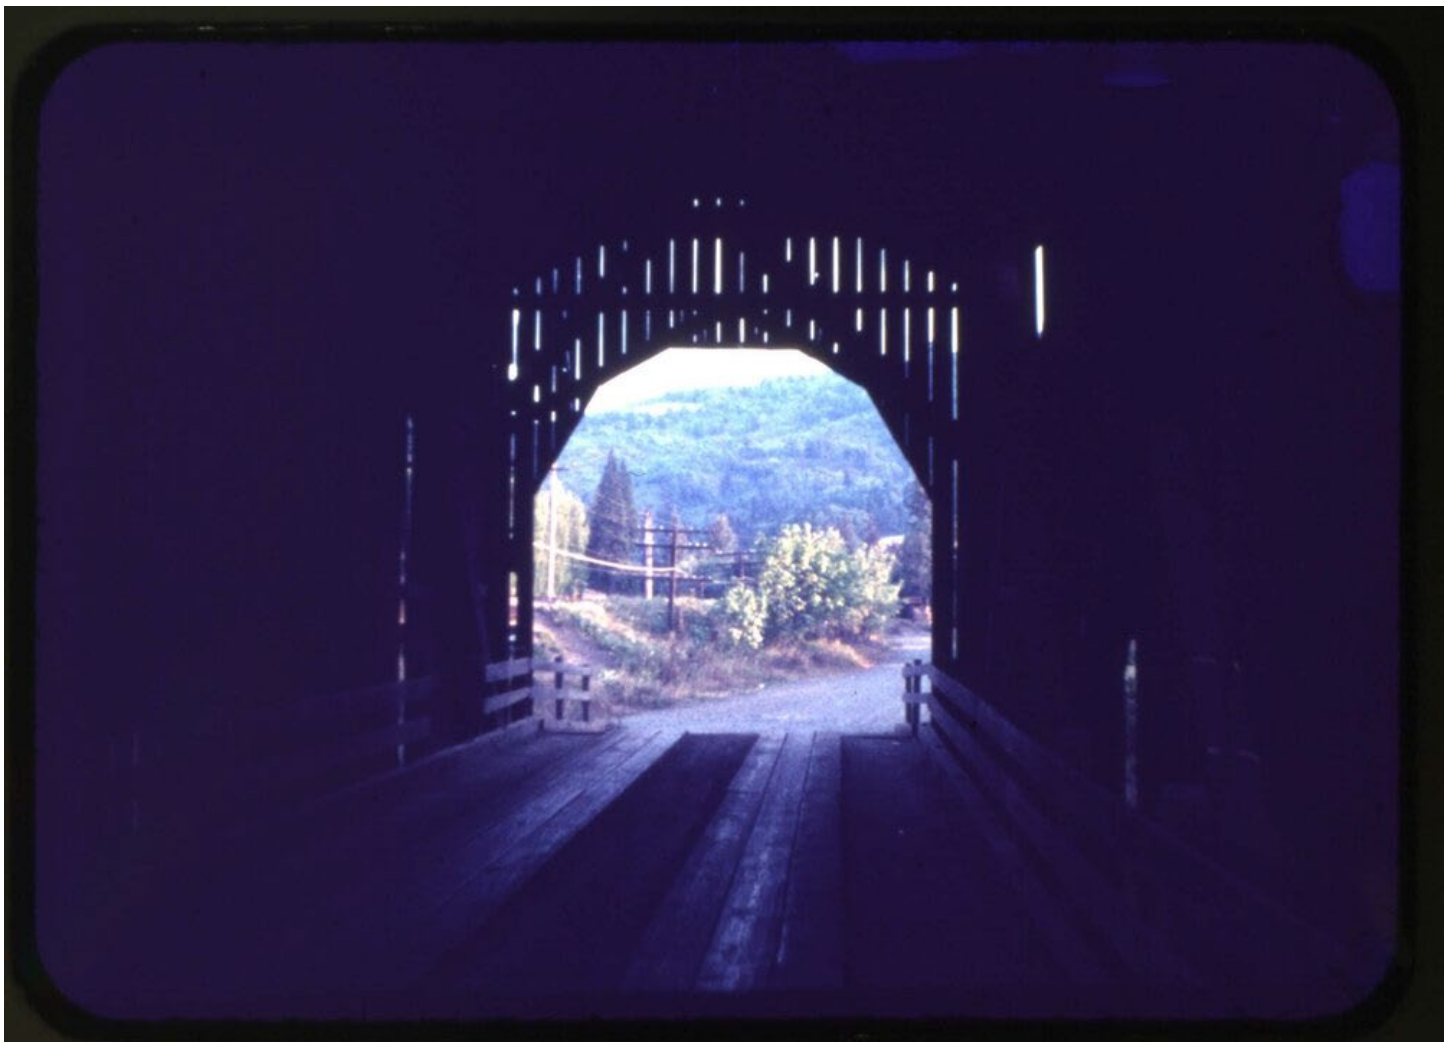
Figure 9. Interior view looking out through the portal of the Pass Creek Covered Bridge in its original location, showing the plank deck, slatted timber siding, and portal framing typical of Oregon covered bridge construction, facing south (circa 1970s).

Despite its relocation, the reconstruction of piers and approaches, and targeted replacement or reinforcement of materials, the bridge retains substantial historic fabric. This includes the hand-hewn bottom chords and the timber Howe truss superstructure. Traditional timber truss joinery remains visible beneath the gabled housing and continues to convey early twentieth-century timber truss construction methods (Photographs 8 and 9). The bridge therefore retains integrity of materials and workmanship.

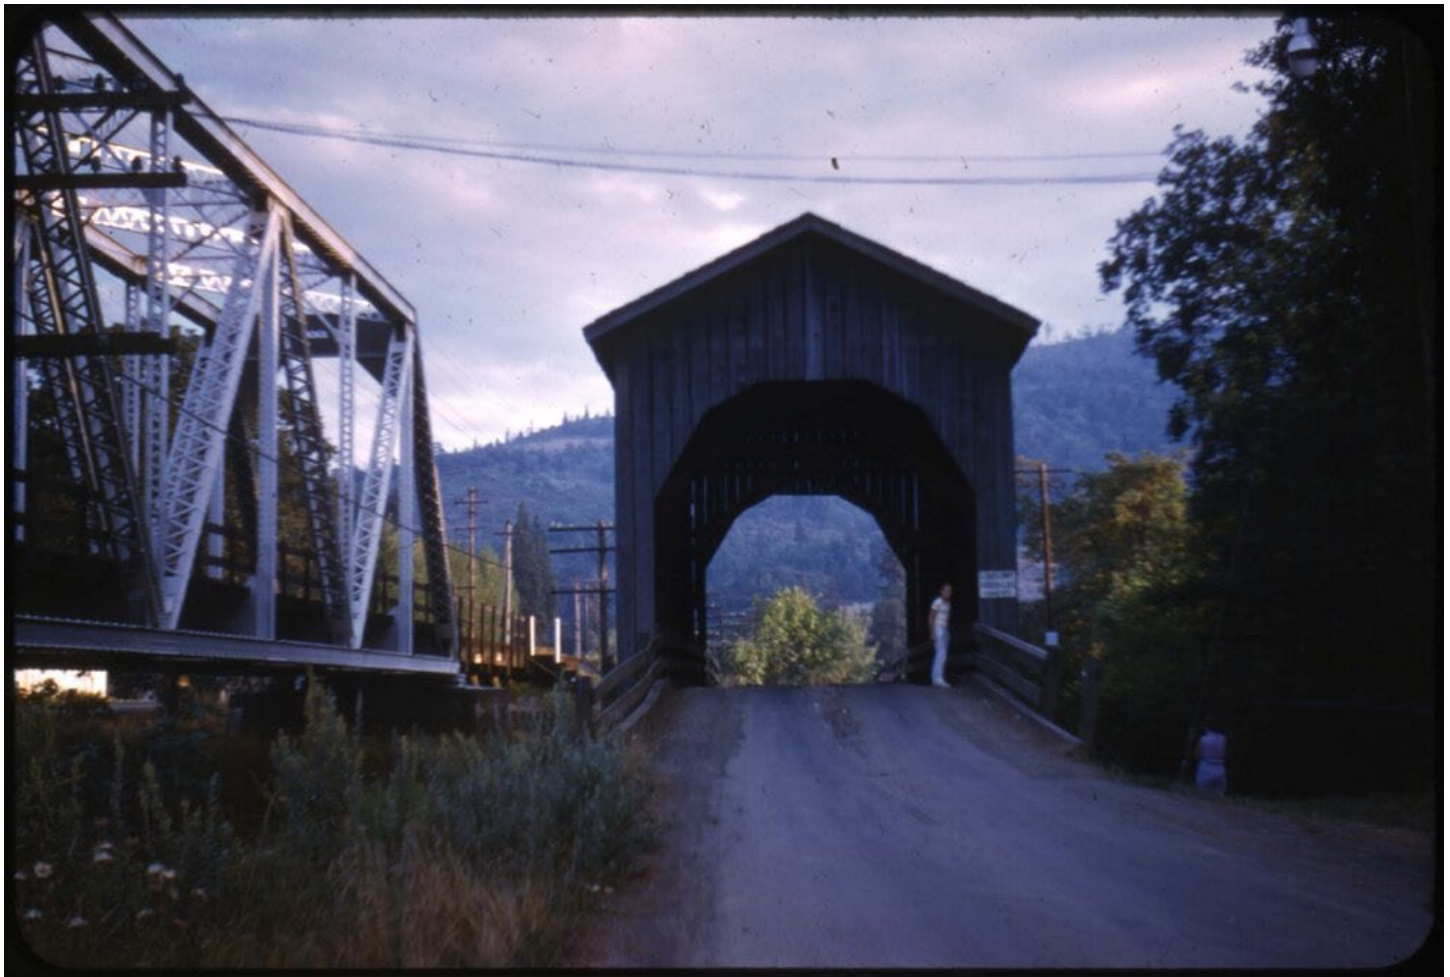
Figure 10. Pass Creek Covered Bridge in its original location on North First Street with the steel railroad truss adjacent to the east, illustrating the juxtaposition of covered wagon-road infrastructure and early twentieth-century rail transportation at this crossing (circa 1965-1980).

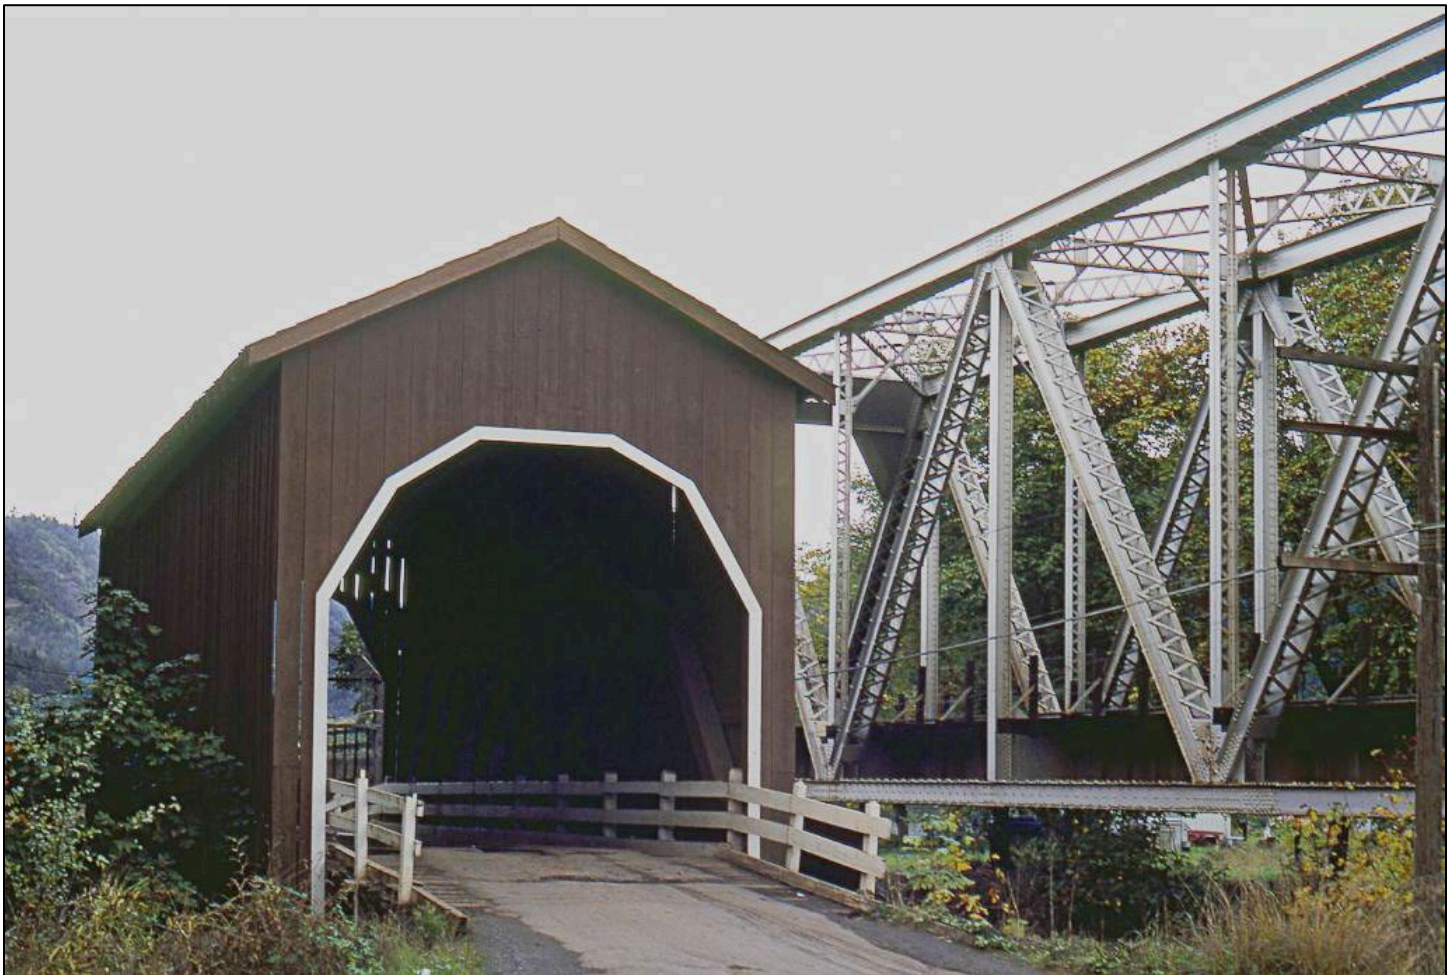
Figure 11. Pass Creek Covered Bridge in its original location on North First Street with the steel railroad truss adjacent to the east (1977, documenting the bridge in its original roadway setting shortly before relocation).

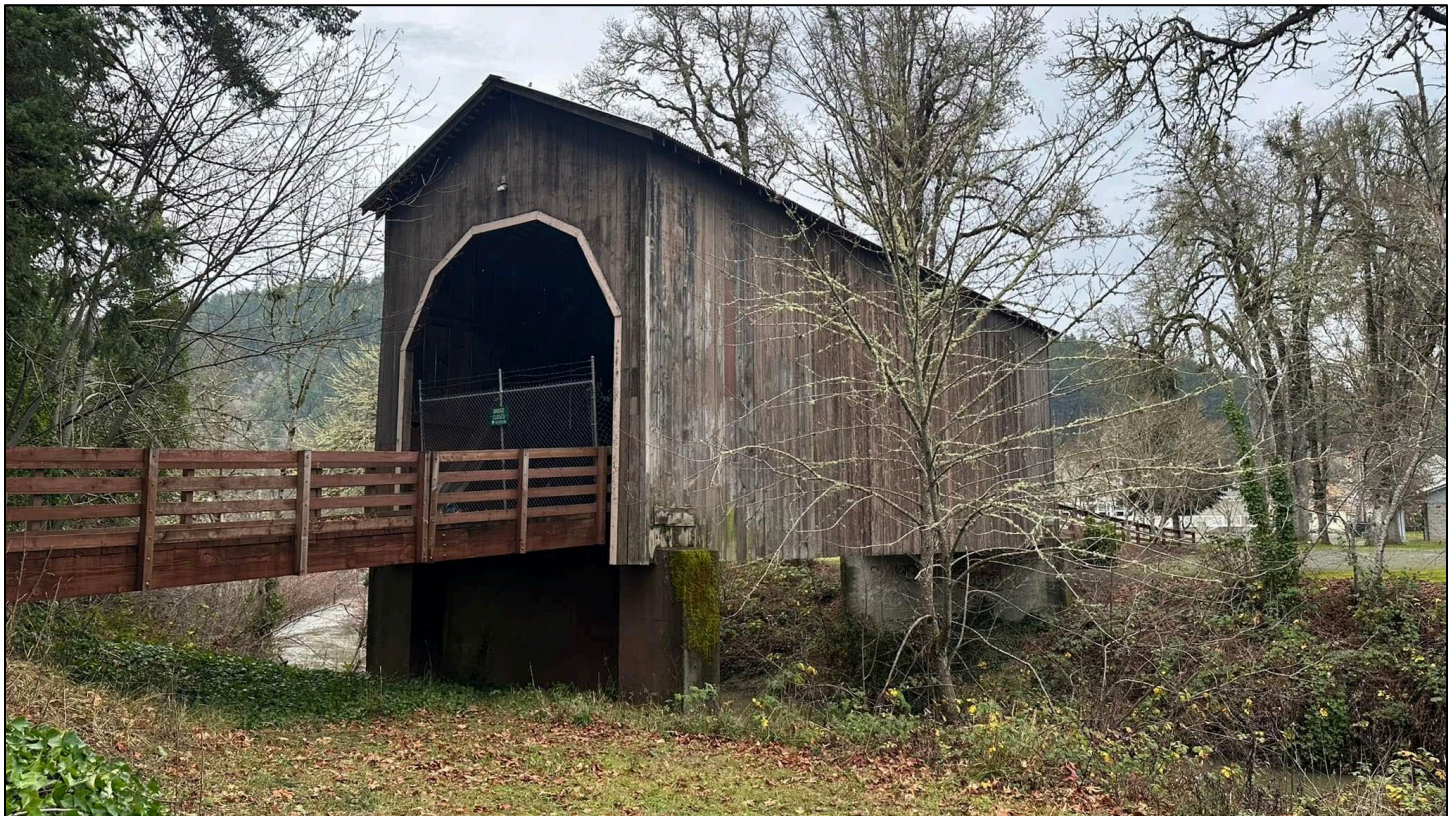
Figure 14. Pass Creek Covered Bridge in its current location, showing the covered timber superstructure and pedestrian decking within its present park setting (circa 2024).

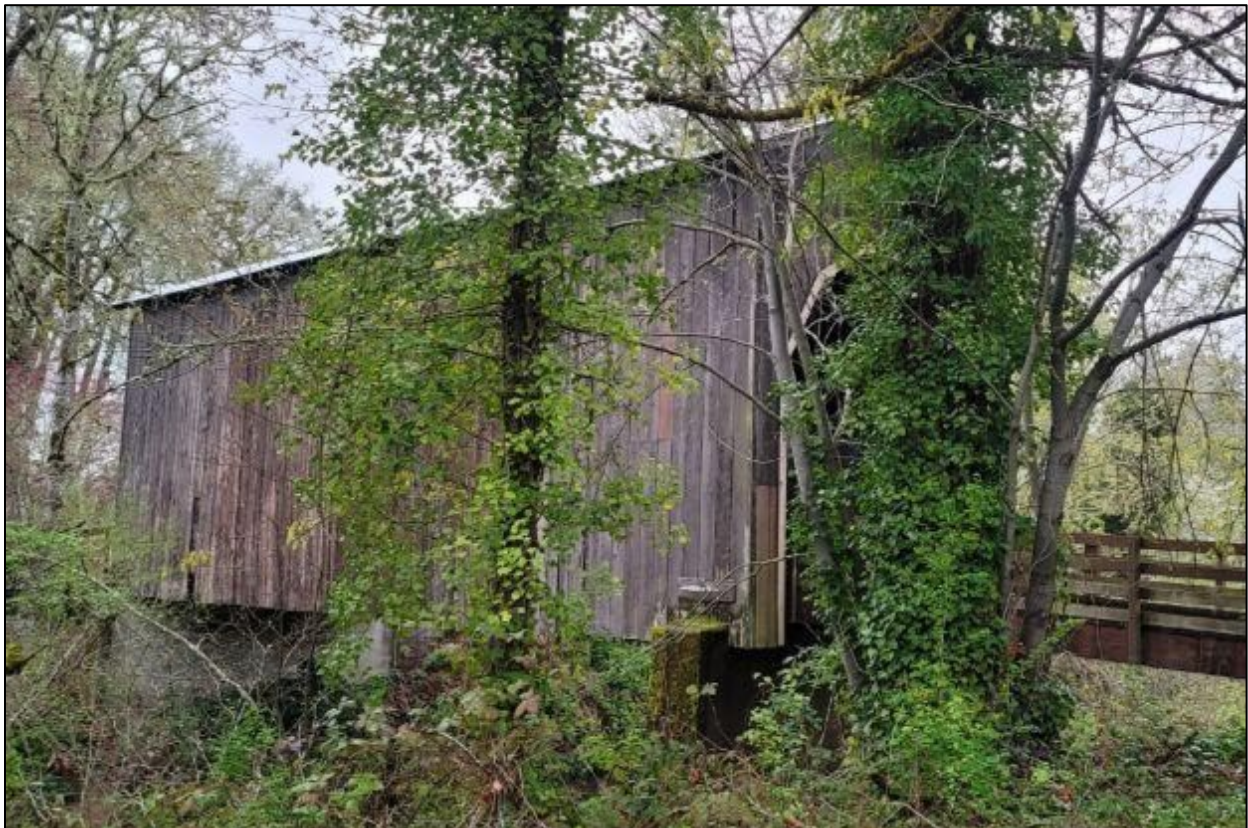
Photograph 1 of 9: OR_DouglasCounty_PassCreekCoveredBridge_0001
Overview of Pass Creek Covered Bridge, camera facing northwest.

the gable peak (Figure 3).⁴ The housing is clad in vertical 1-inch by 12-inch cedar boards without battens, painted brown (Photograph 1). Although some siding was installed new during the 1988 reassembly, it is consistent with historic photographs that show the bridge's traditionally unadorned and utilitarian appearance (Figure 8). The housing has segmented portal openings characteristic of Oregon covered bridges but, somewhat unusually for this resource type, lacks any portal "wraparound" (a feature where the siding wraps around the end of the truss and into the bridge interior for a short distance, to provide additional weather protection to the truss). This absence is thought to be an original design characteristic (Figure 9, Photographs 5 and 7) The decking, floor beams, and roof rafters are wood, and the roof is clad in galvanized sheet metal installed in 2014.⁵

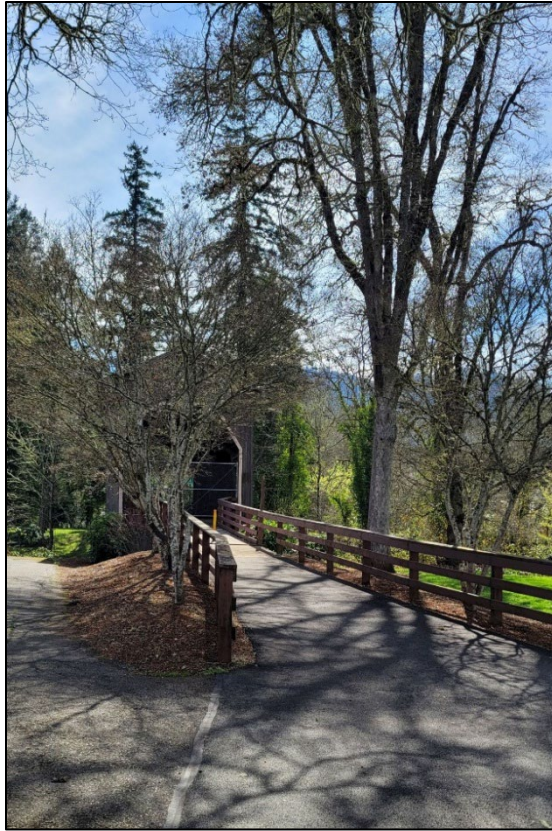
Photograph 2 of 9: OR_DouglasCounty_PassCreekCoveredBridge_0002
West wall and south portal of Pass Creek Covered Bridge, camera facing northeast.

The concrete piers supporting the structure date to the 1988 reassembly (Photographs 2 and 5). The approach spans, constructed during the relocation and rebuilt intermittently since, utilize untreated timber stringers, decking, and railings consistent with their functional purpose and modern construction period. One intermediate bent on the north approach incorporates salvaged rail material from another local bridge reconstructed in 2005 (Photograph 6).⁶ Bridge historians have noted that the craftsmanship and existing holes in the hand-hewn bottom chords suggest they may be original components of an 1876 bridge associated with the Overland Stagecoach Route, which the Pass Creek Covered Bridge was constructed to replace in 1925.⁷ These chords were reinforced with 6-inch by 14-inch helper timbers during the 1988 reassembly.⁸

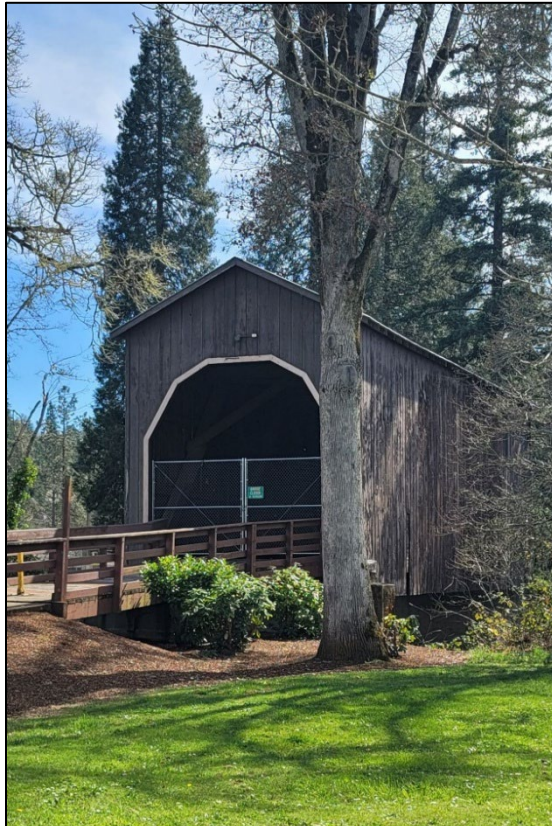
Photograph 4 of 9: OR_DouglasCounty_PassCreekCoveredBridge_0004
North portal and west wall of Pass Creek Covered Bridge, camera facing southeast.

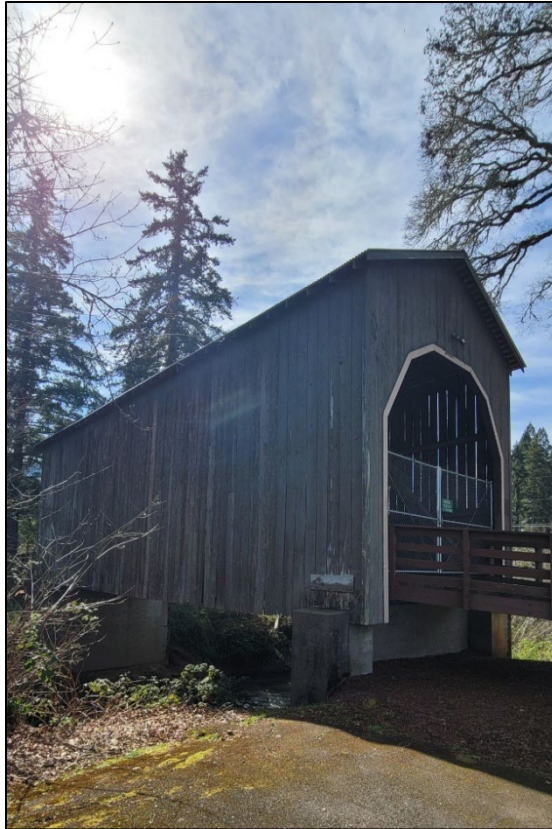
Photograph 5 of 9: OR_DouglasCounty_PassCreekCoveredBridge_0005
East wall and north portal of Pass Creek Covered Bridge, camera facing southwest.

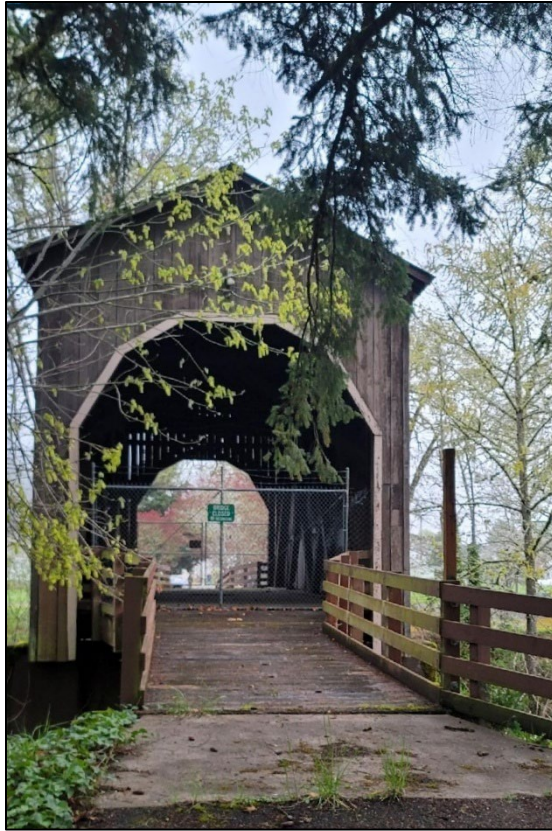
Photograph 6 of 9: OR_DouglasCounty_PassCreekCoveredBridge_0006
North portal of Pass Creek Covered Bridge and replacement approach span, camera facing south.

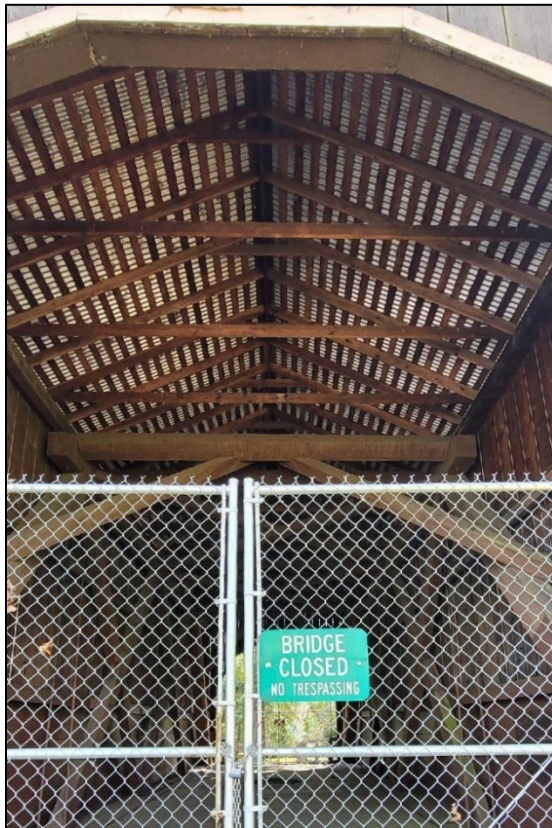
Photograph 7 of 9: OR_DouglasCounty_PassCreekCoveredBridge_0007
South portal of Pass Creek Covered Bridge and replacement approach span, camera facing north.
