National Register of Historic Places Registration Form

historic name Eastmoreland Historic District

Name of Multiple Property Listing Historic Residential Suburbs in the United States, 1830-1960

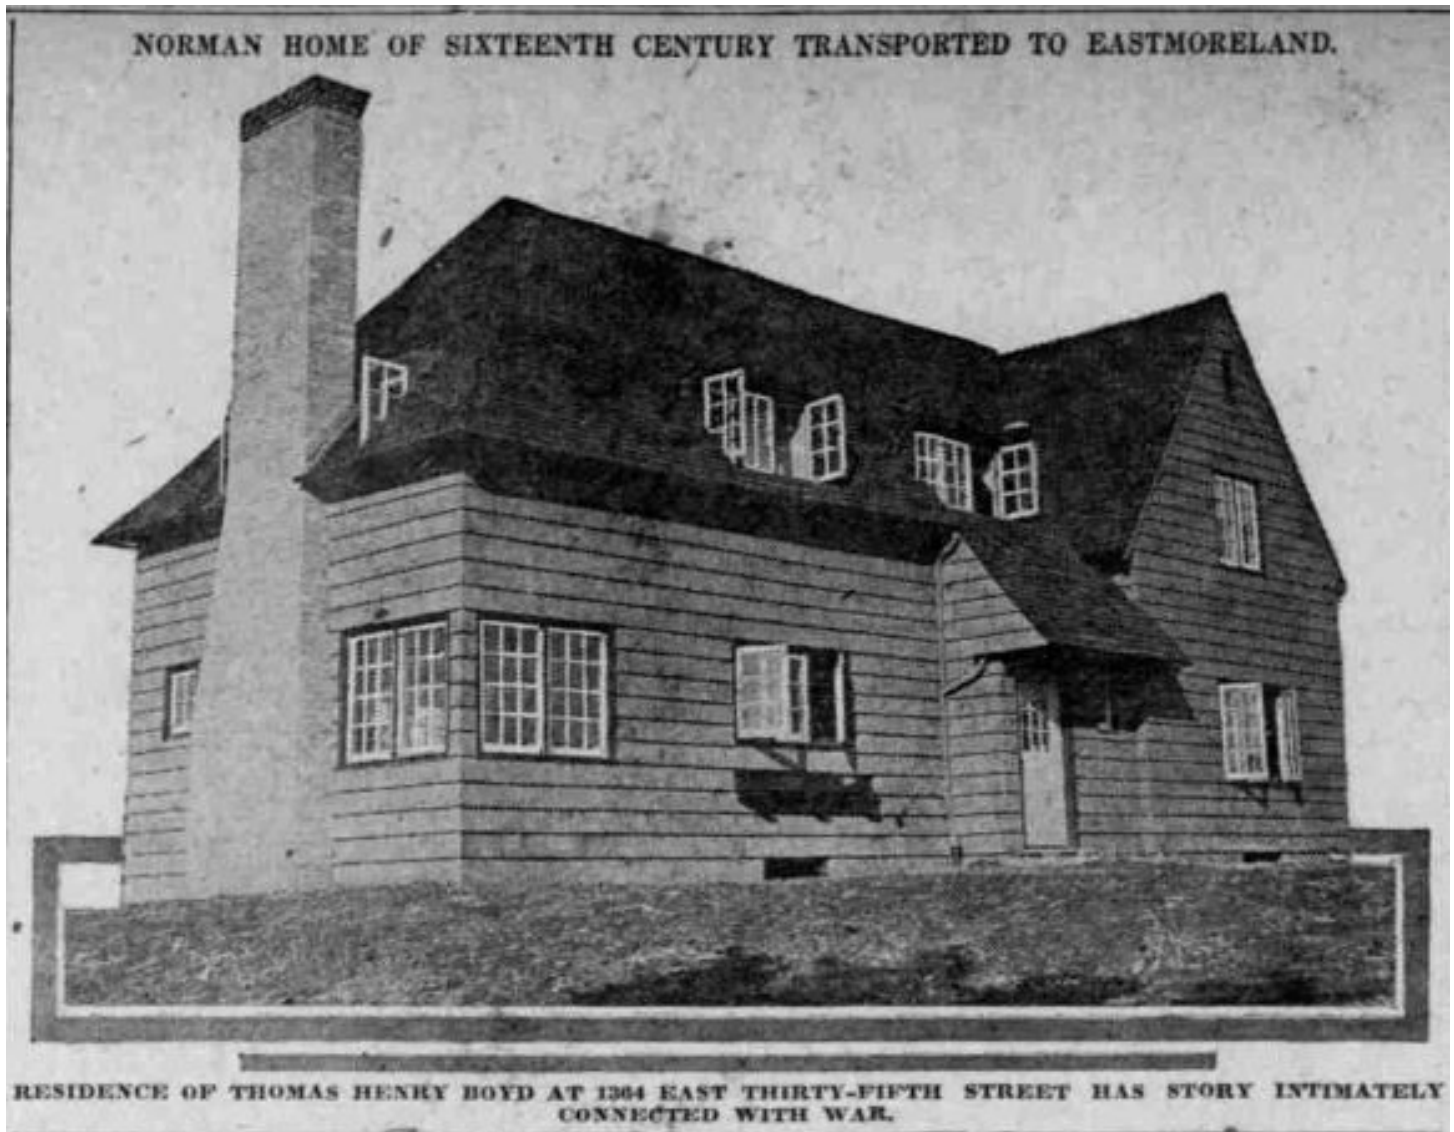
This residence, located at what is now 6740 SE 35th Avenue, was modeled after the gate warden's stone house at the fortified city of Langres in France's Normandy region. Architect Harold W. Doty sketched the Langres house while serving in Europe during World War I. The replica house was constructed in Eastmoreland for Thomas Henry Boyd by World War I veterans. "Feudal Home is 4 Centuries Old," *Oregonian*, October 9, 1921.

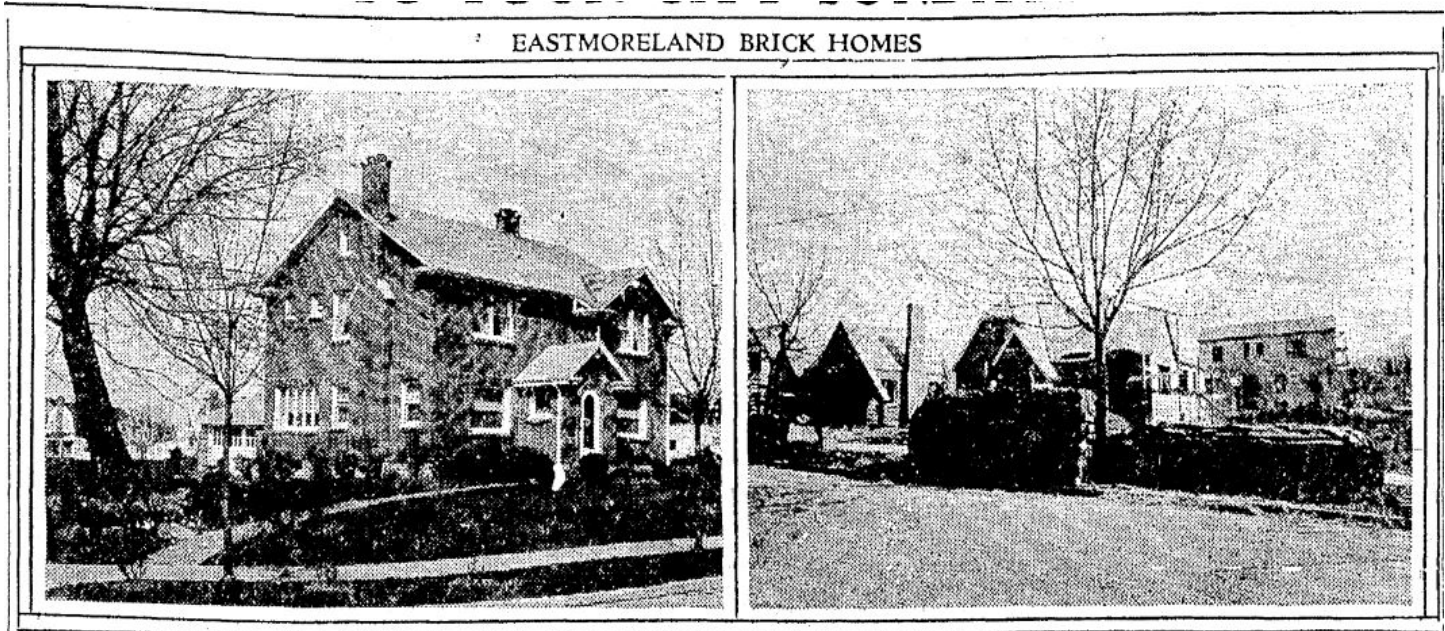
Figure 25: Photograph of brick house at 7225 SE 32nd Avenue, 2016.
Photograph by AECOM.

Clarence W. Michael constructed this house at 1427 East 32nd Street (now 7225 SE 32nd Avenue) in Eastmoreland. Brick house construction was promoted in Portland during the Better Homes movement. "Portlanders Urged To Tour City Sundays For Inspection Of Brick Homes," *Oregonian*, April 7, 1927.

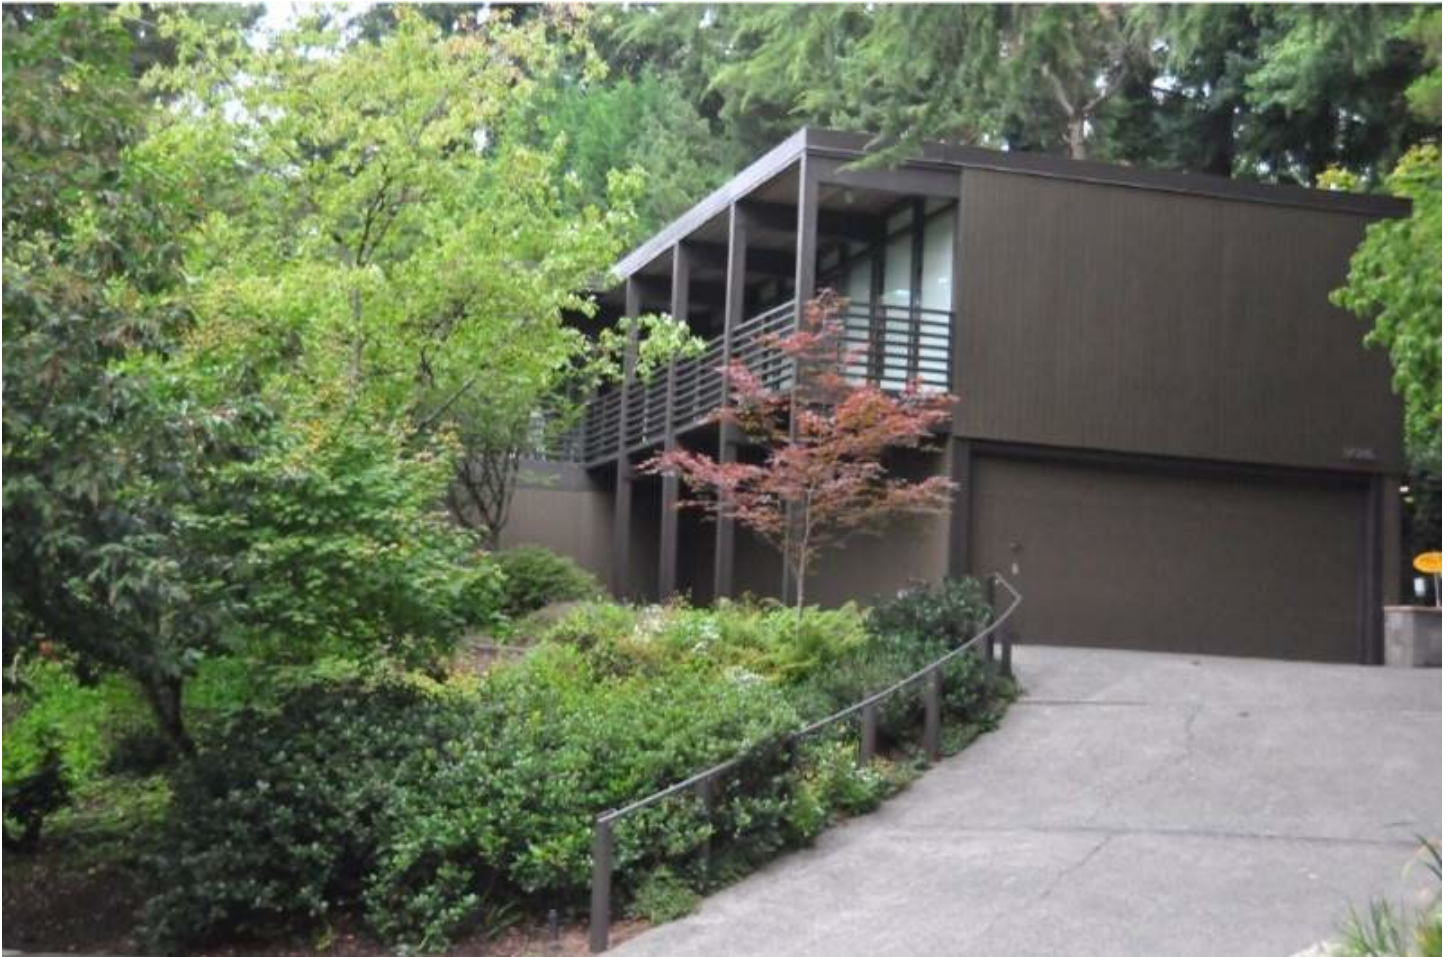
This contemporary style house was designed by Frank L. Shell and completed in 1961. Dorothy Blosser Whitehead and Carleton Whitehead, assistant to the Reed College president and 1941 graduate of the college, were notable residents. Photograph by AECOM.

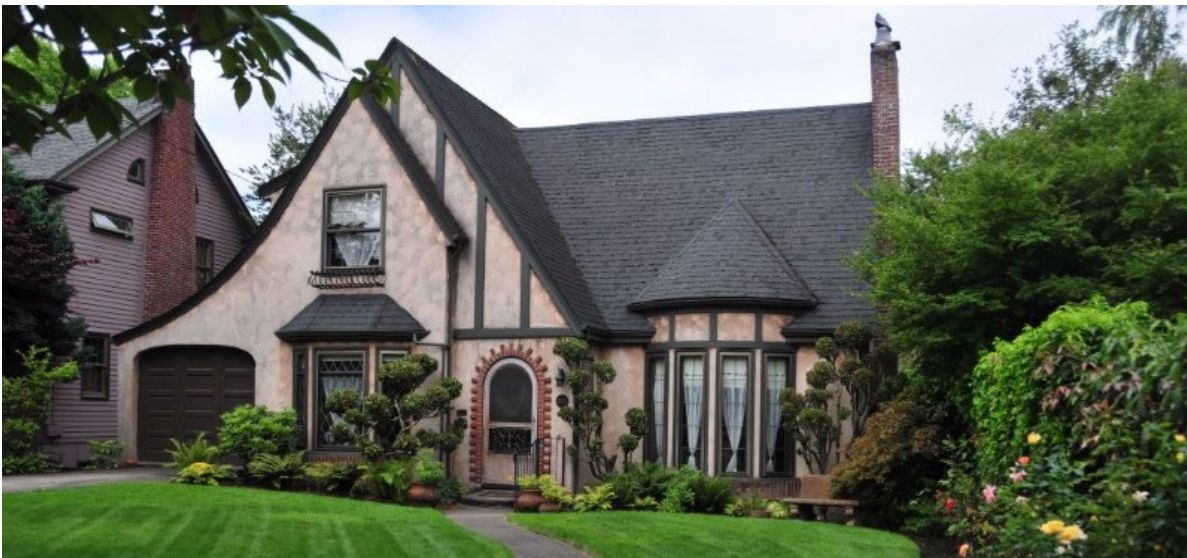
8012 SE 29th: Leaded windows, projecting front room, separated gables, side entry,
