National Register of Historic Places Registration Form

historic name Patton Home

street & number 4619 N. Michigan Avenue not for publication

city or town Portland vicinity

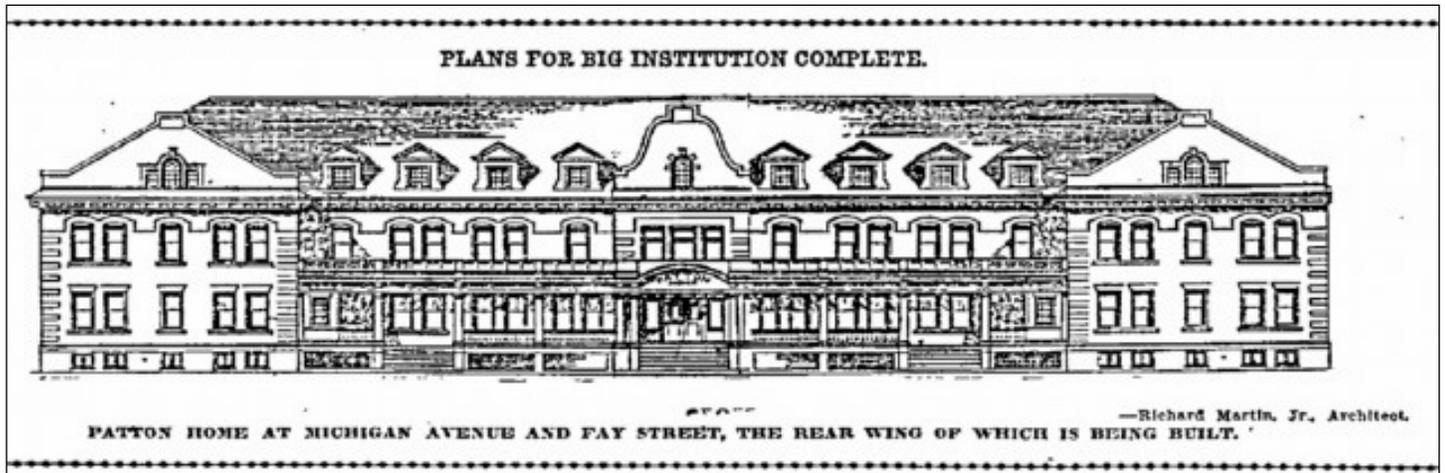
Figure 13: Richard Martin Jr.'s 1909 design for Patton Home.⁹⁵

Connecting to the west side of the wood-frame section is a red brick wing constructed in 1909, shown in Photo 7. This wing was designed by Richard Martin Jr. and was part of a larger design for a masonry building (Figure 13) that would replace the wood-frame buildings, of which only this wing was built as designed. Based on the rendering of the proposed south elevation, the design could be classified as Flemish Revival due to the decorative parapet walls at the gables. However, Colonial Revival details were also incorporated such as the heavy dentilated cornice molding at the eaves, classical columns at the porch, Palladian windows, and attic dormer windows.

In 1909, architect Richard Martin Jr. designed a grand masonry building, shown in Figure 13, to replace the frame buildings.²⁹ It is not known how Martin initially became connected with the home; however, he did architectural work for the Association for nearly two decades and his wife served as president of Patton Home’s board in the 1920s. Construction commenced on the south wing of Martin’s design in 1909, but they did not have the funds to complete the rest of the structure.³⁰ This addition increased the facility’s capacity to 40 residents. A photo of this wing shortly after completion is seen in Figure 14.

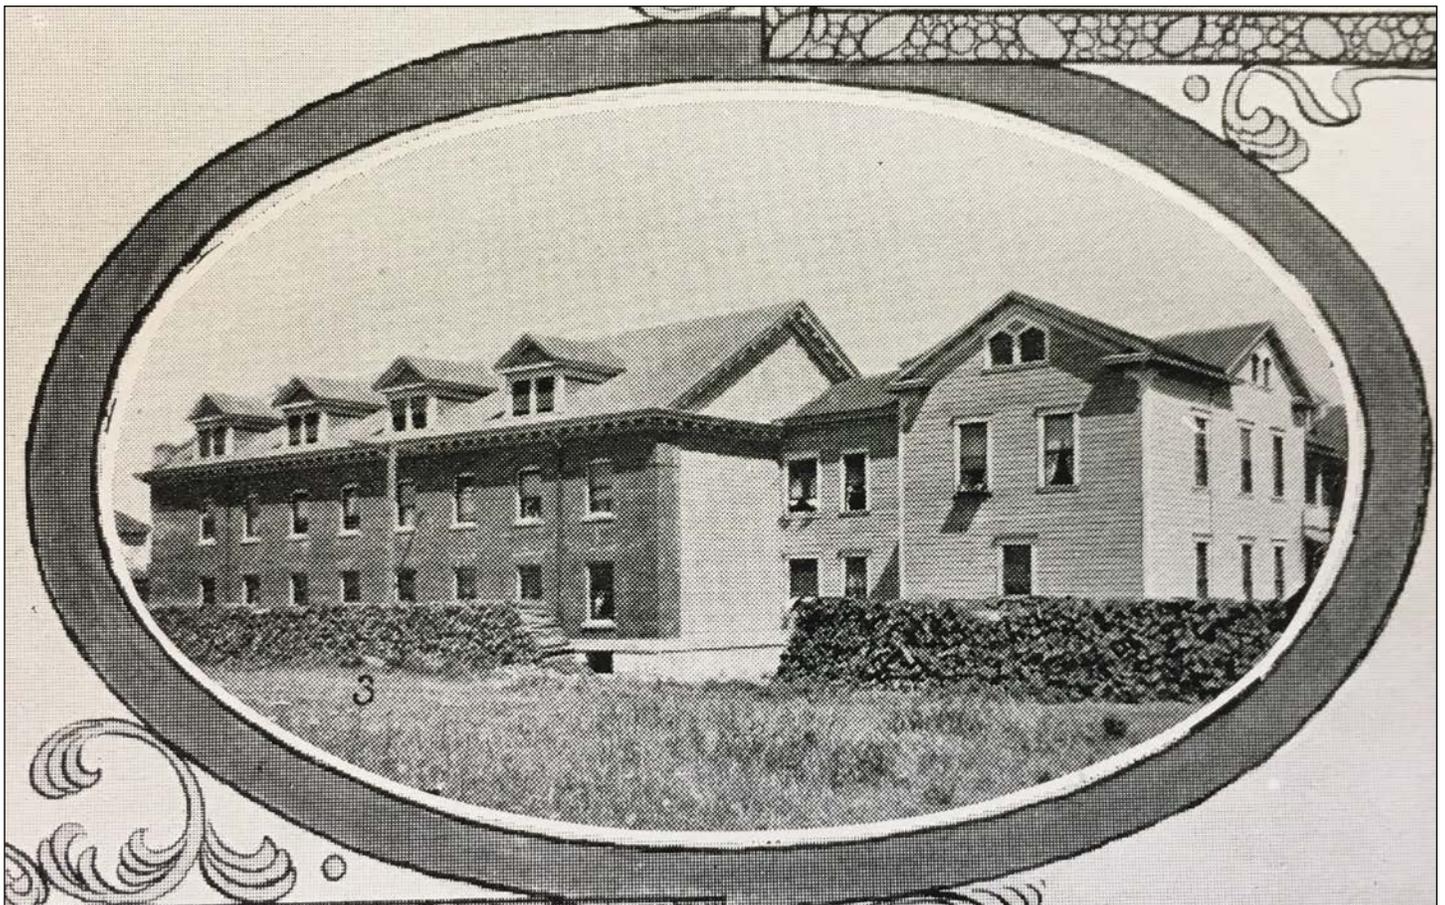
Figure 14: South elevation of Patton Home, c. 1910.⁹⁶

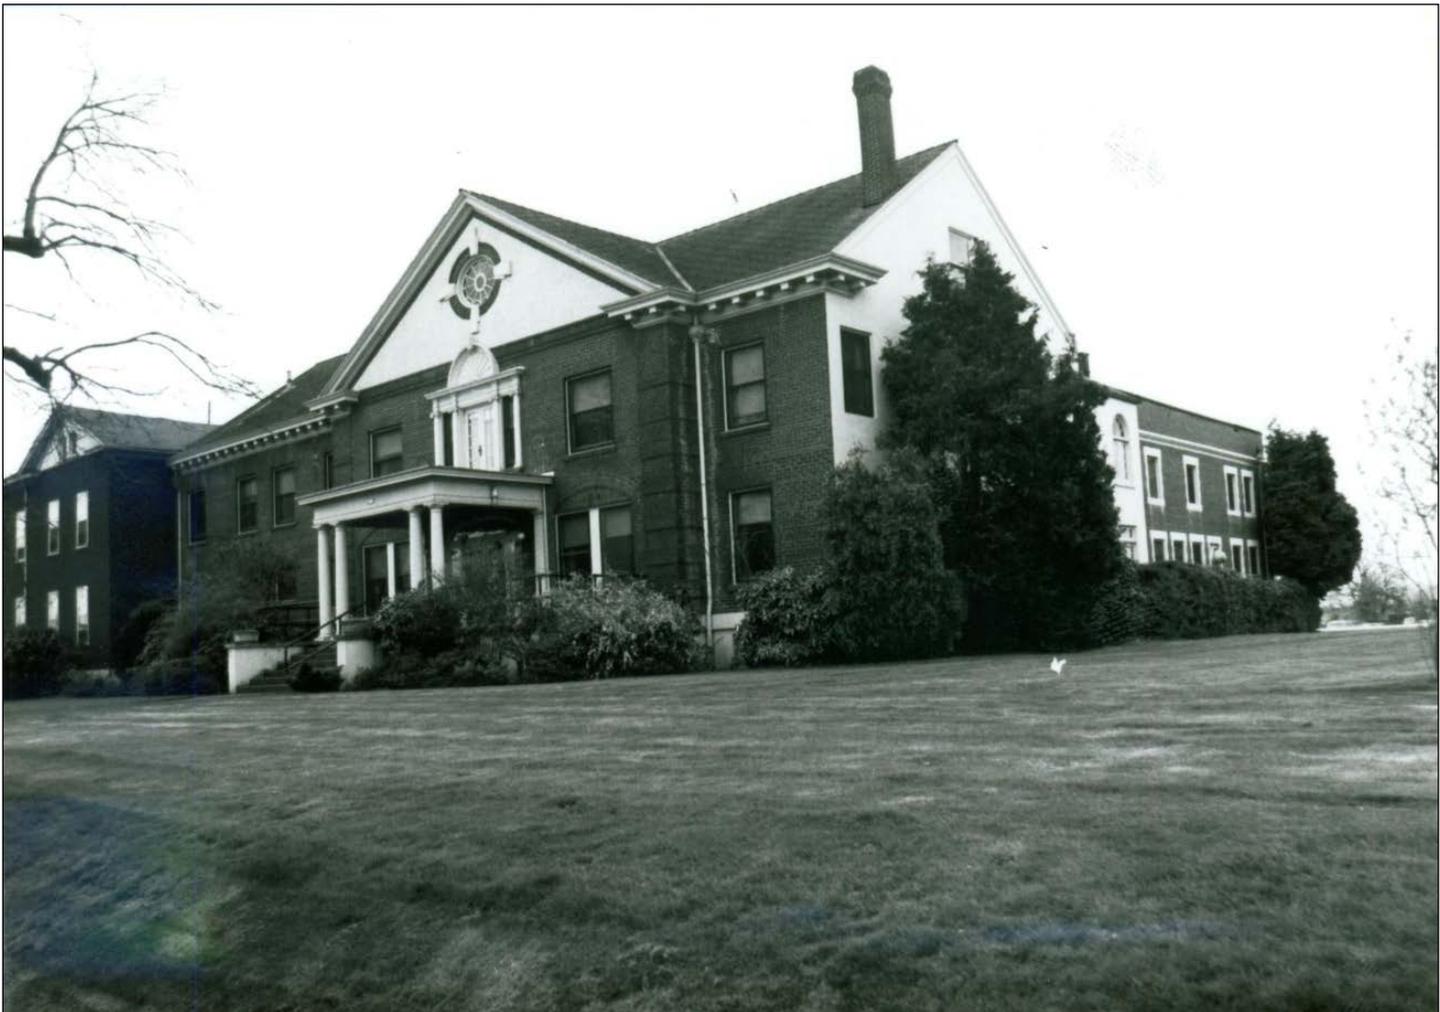
Figure 16: Patton Home, c. 1983.⁹⁸

It is unclear how this wood-frame section of the building changed between 1910 and 1999. However, while not easily visualized, the 1983 photo from the Portland Historic Resources inventory in Figure 16 shows that the windows had been replaced, the window trim removed, and the wood lap siding had been replaced by this date.

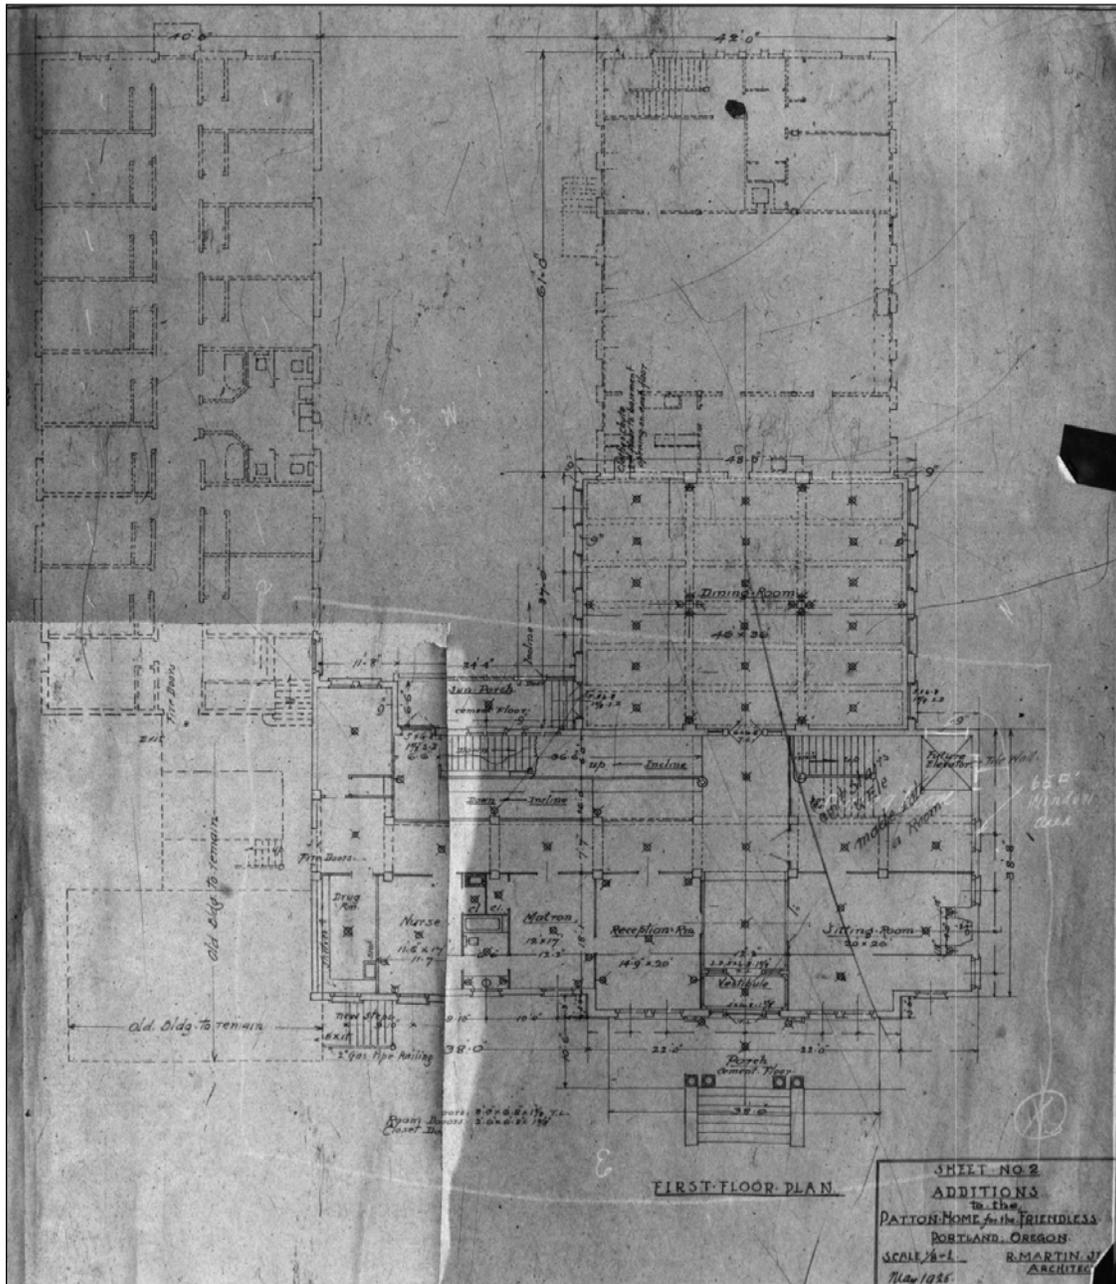
Figure 23: First Floor Plan by Richard Martin Jr., May 1925.¹⁰⁵

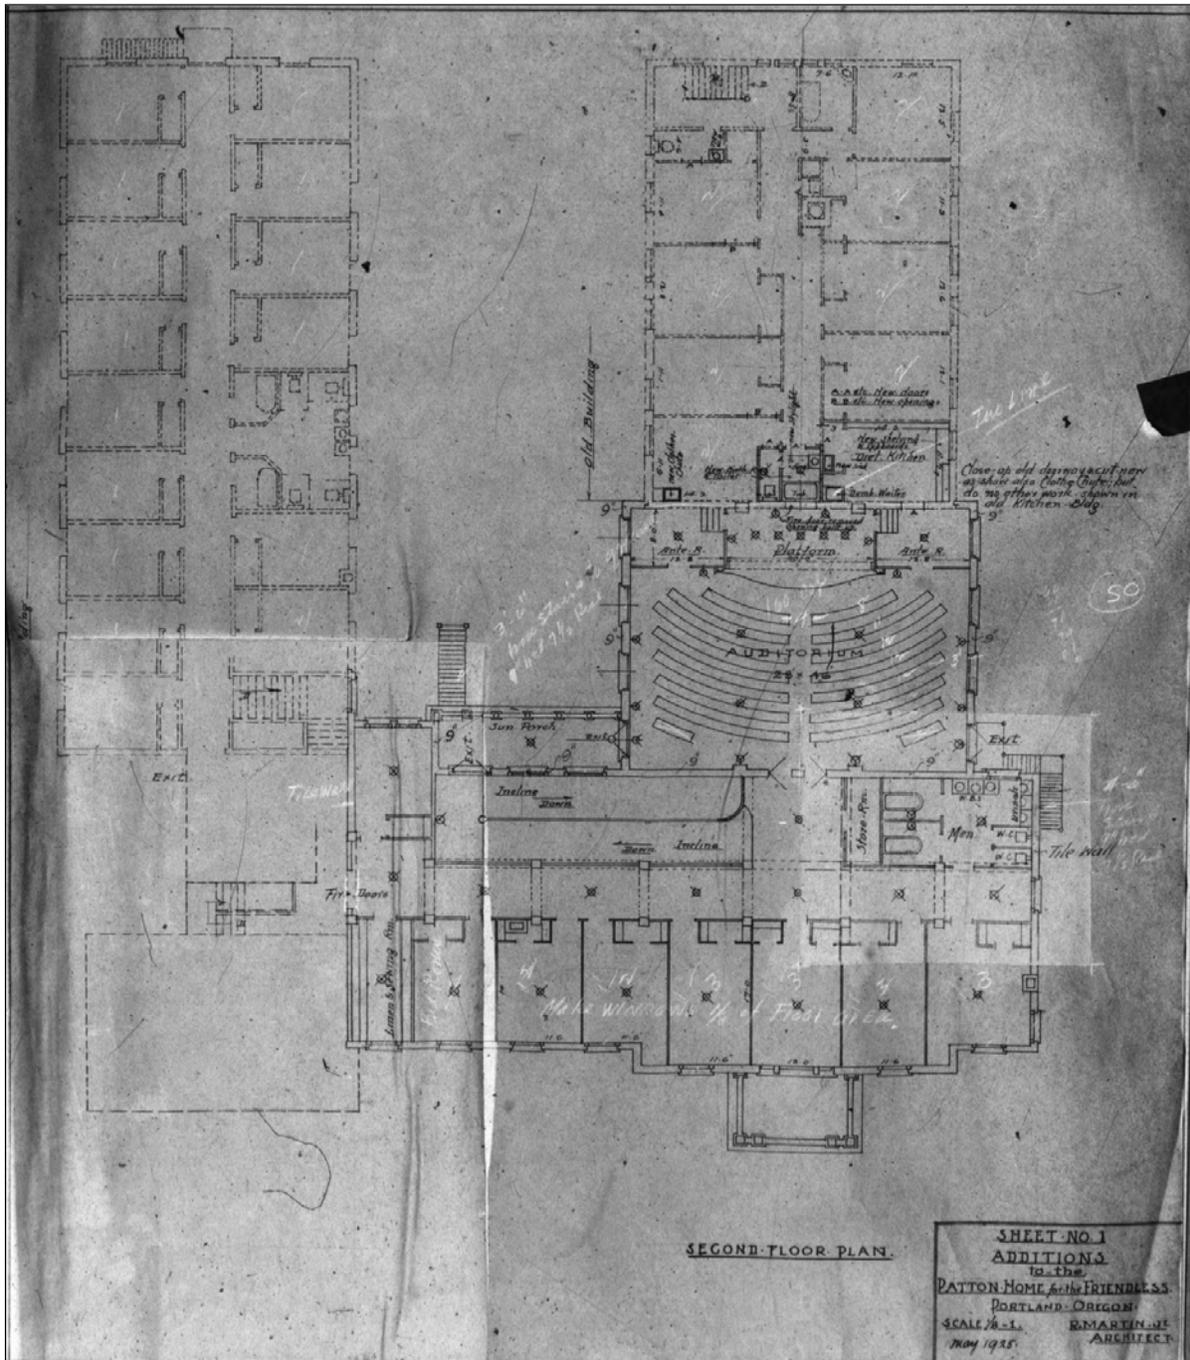
Figure 24: Second Floor Plan by Richard Martin Jr., May 1925.¹⁰⁶

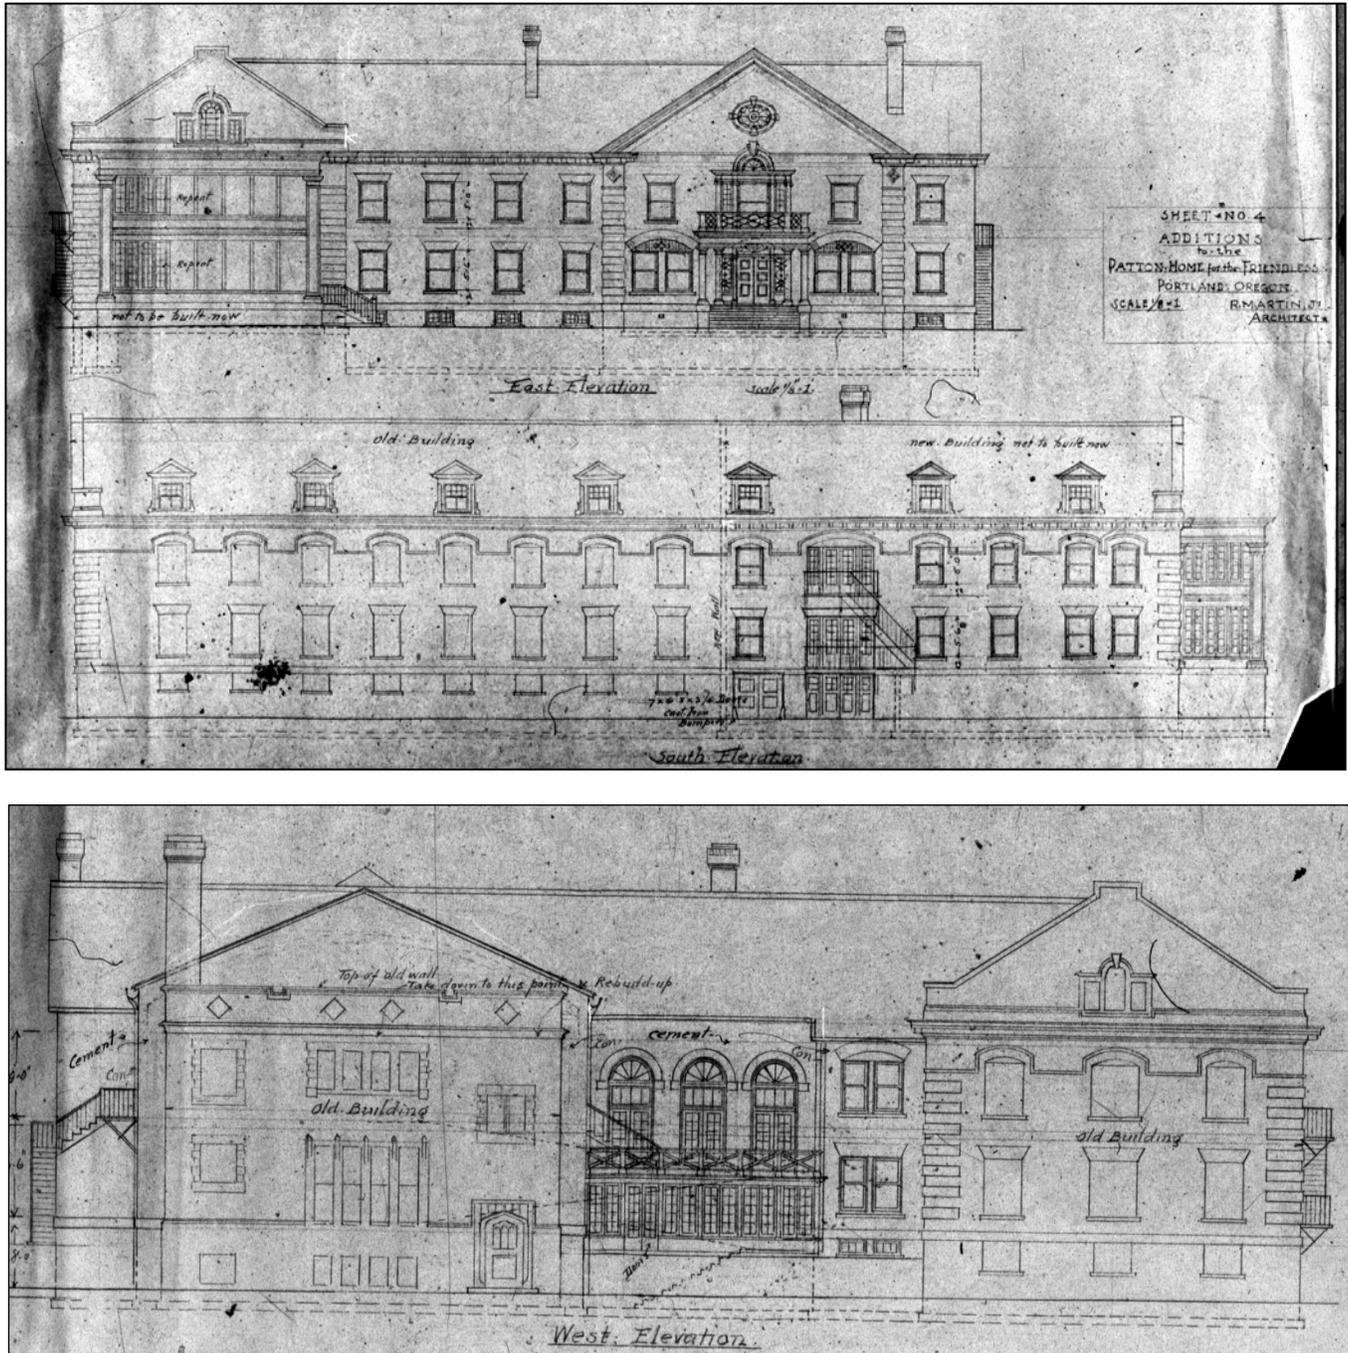
Figure 25: East, South, and West Elevations by Richard Martin Jr., May 1925.¹⁰⁷
