# National Register of Historic Places Registration Form

historic name Union Station (Additional Documentation)

other names/site number Grand Central (Passenger) Station; (Grand) Union Depot

Name of Multiple Property Listing African American Resources in Portland, Oregon, from 1851 to 1973 MPS

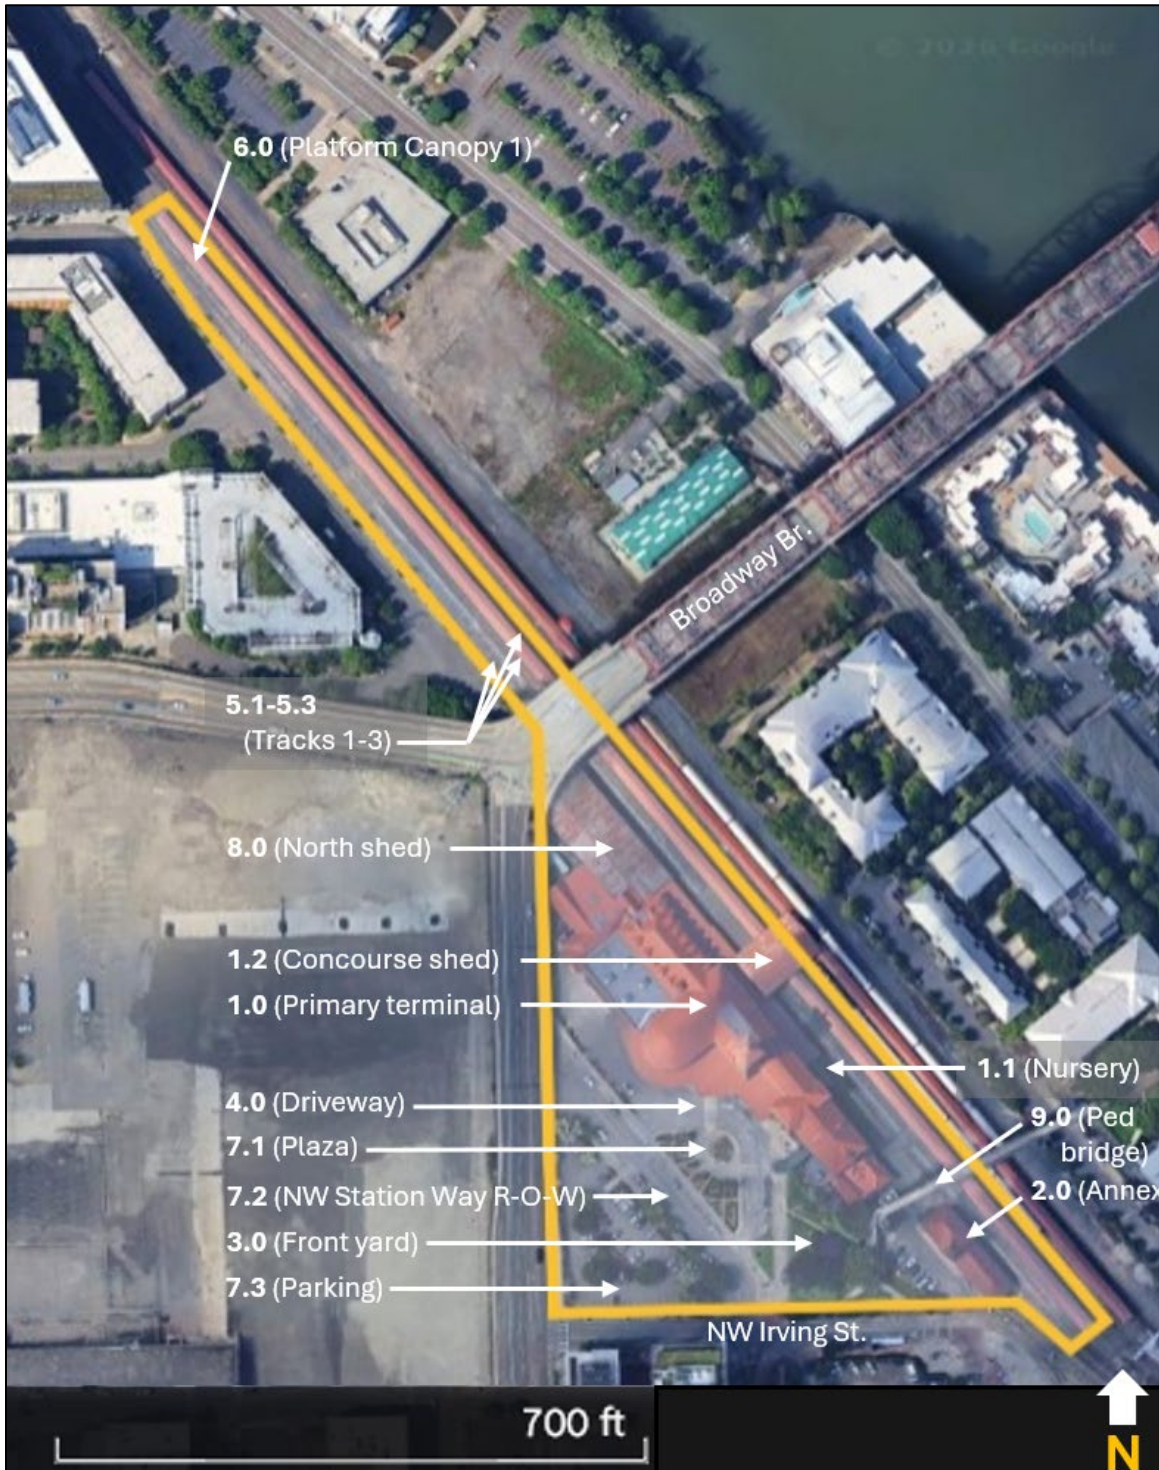
**Figure 4.** Site Plan (Keyed to Table 1, Section 7).  
Nominated boundary (unchanged from 1989 Boundary Clarification) is shown in gold.

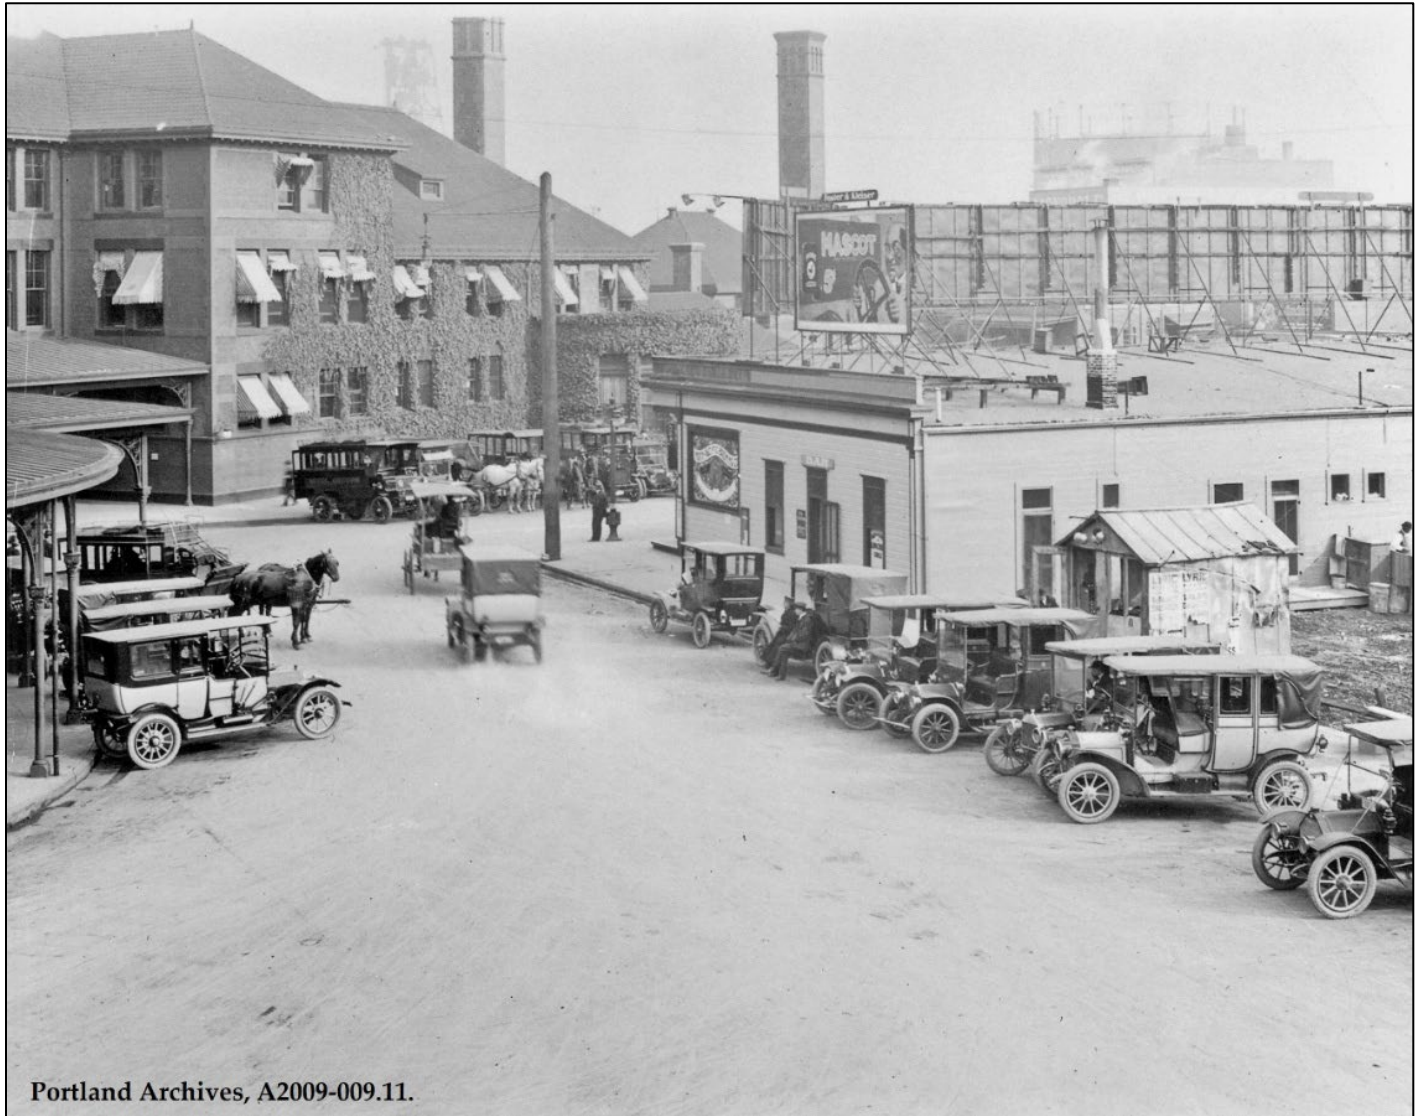
**Figure 7.** 1913 Union Station photograph looking southeast. "Block Y" on the right has a commercial building on it supporting billboard signs. Portland City Archives, A2009-009.11.

**Figure 7.** 1913 Union Station photograph looking southeast. "Block Y" on the right has a commercial building on it supporting billboard signs. Portland City Archives, A2009-009.11.

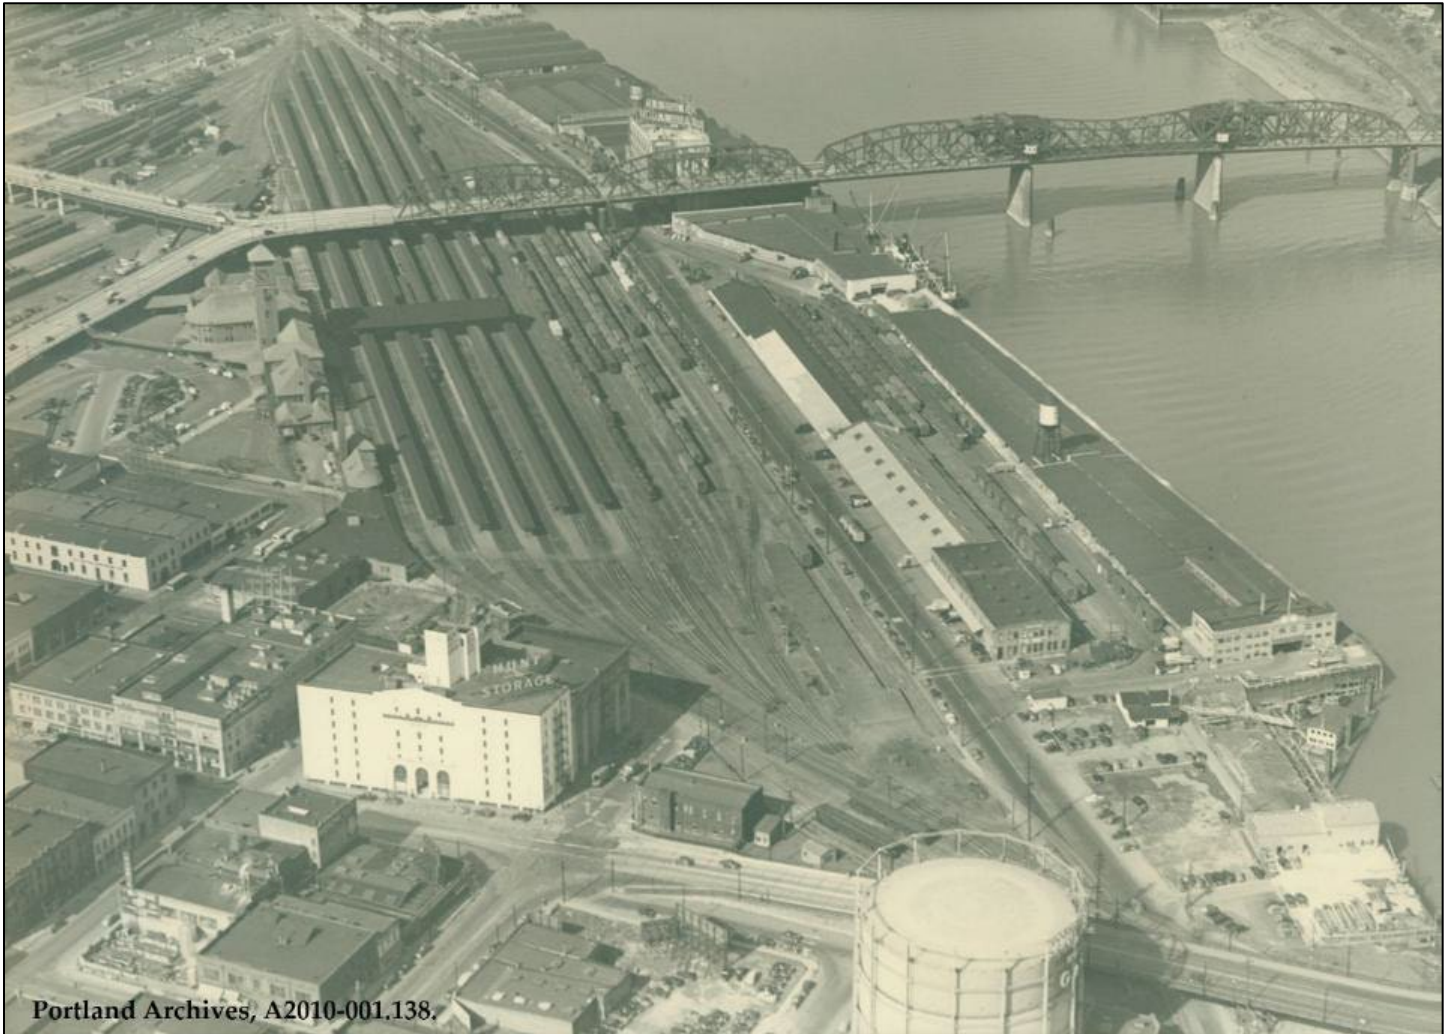
**Figure 9:** 1938 aerial photograph looking northwest at Union Station and the Broadway Bridge. Portland City Archives, A2010-001.138.

**Figure 9.** 1938 aerial photograph looking northwest at Union Station and the Broadway Bridge. Portland City Archives, A2010-001.138.

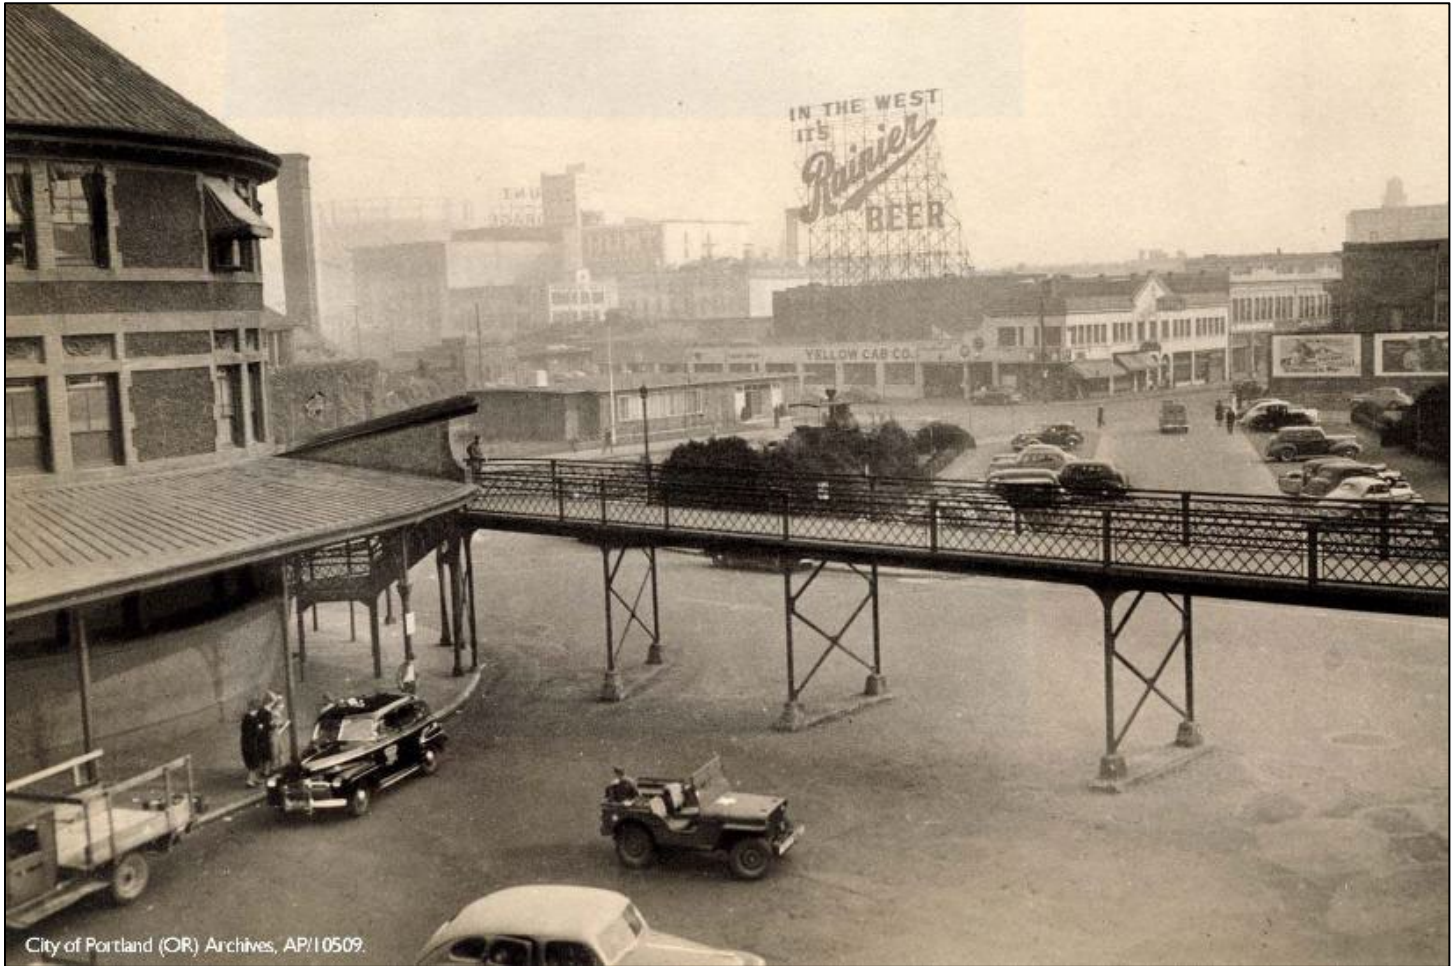
**Figure 10.** 1943 image looking southeast at the Union Station forecourt plaza and front parking areas, with pedestrian ramp in the foreground and Red Cross canteen in back. Portland City archives AP/10509.

**Figure 10.** 1943 image looking southeast at the Union Station forecourt plaza and front parking areas, with pedestrian ramp in the foreground and Red Cross canteen in back. Portland City archives AP/10509.

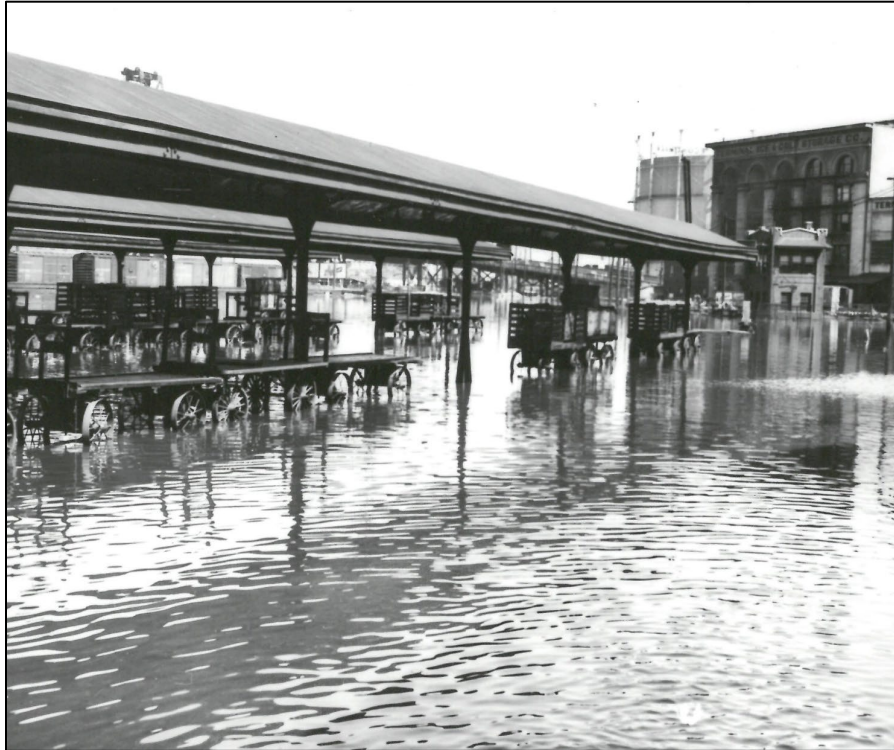
**Figure 11.** June 1948. Looking east at baggage carts surrounded by floodwaters at the southeast end of Platform canopy 1. Oregon Historical Society, #007947.

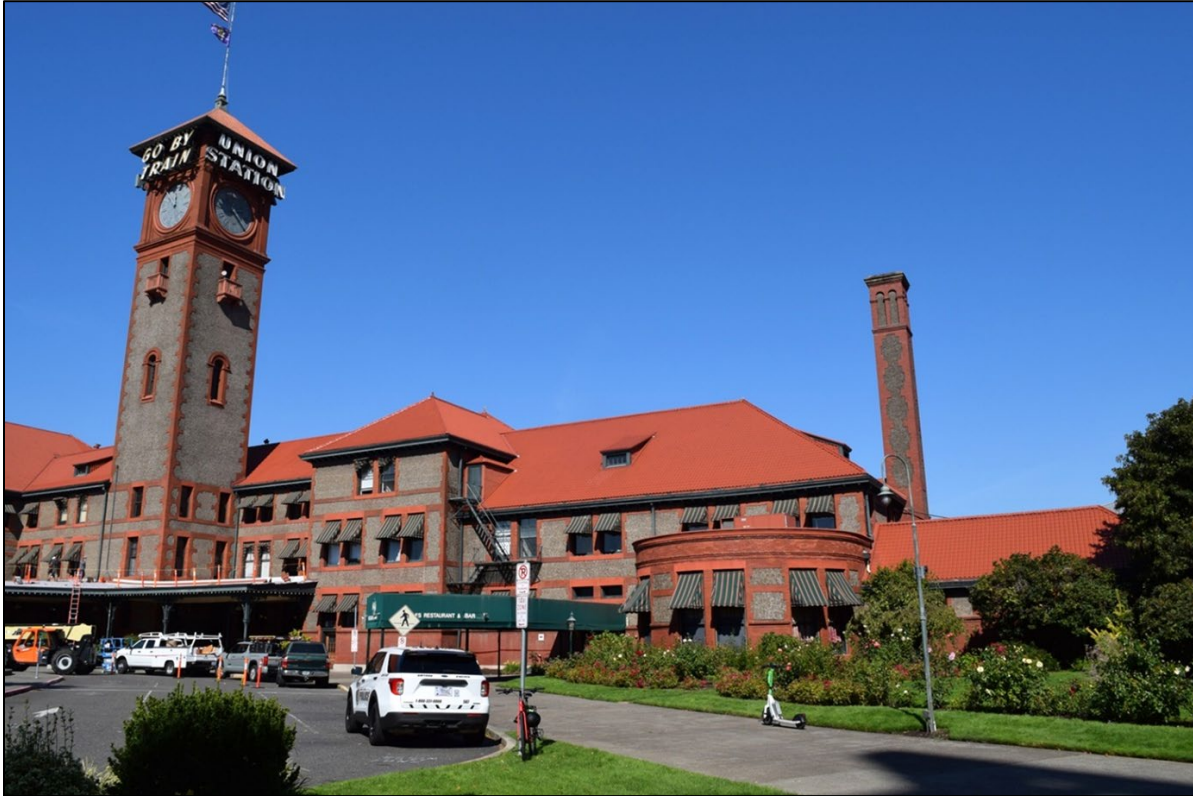
**Photograph 1 of 18: OR\_MultnomahCounty\_UnionStationAmendment\_0001**  
Clock tower, south wing, and front yard; looking north.

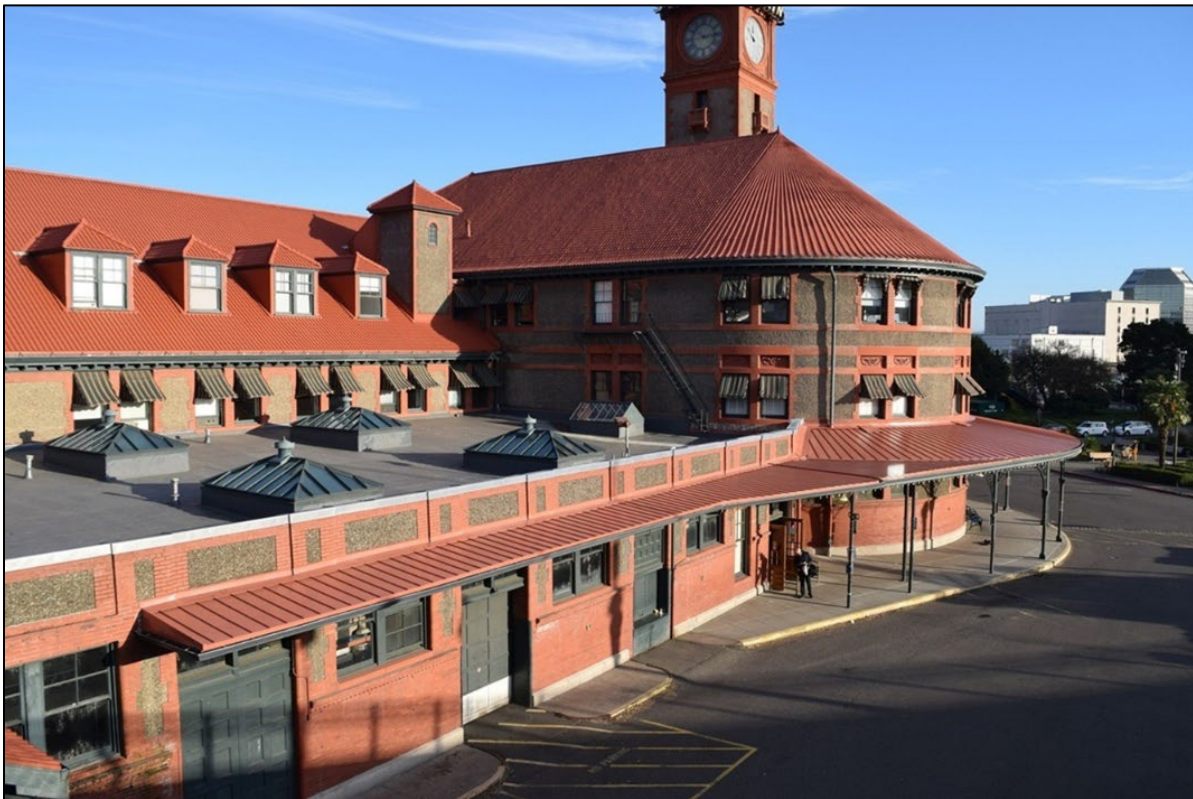
**Photograph 2 of 18: OR\_MultnomahCounty\_UnionStationAmendment\_0002**  
North wing on left and Main hall, looking southeast.

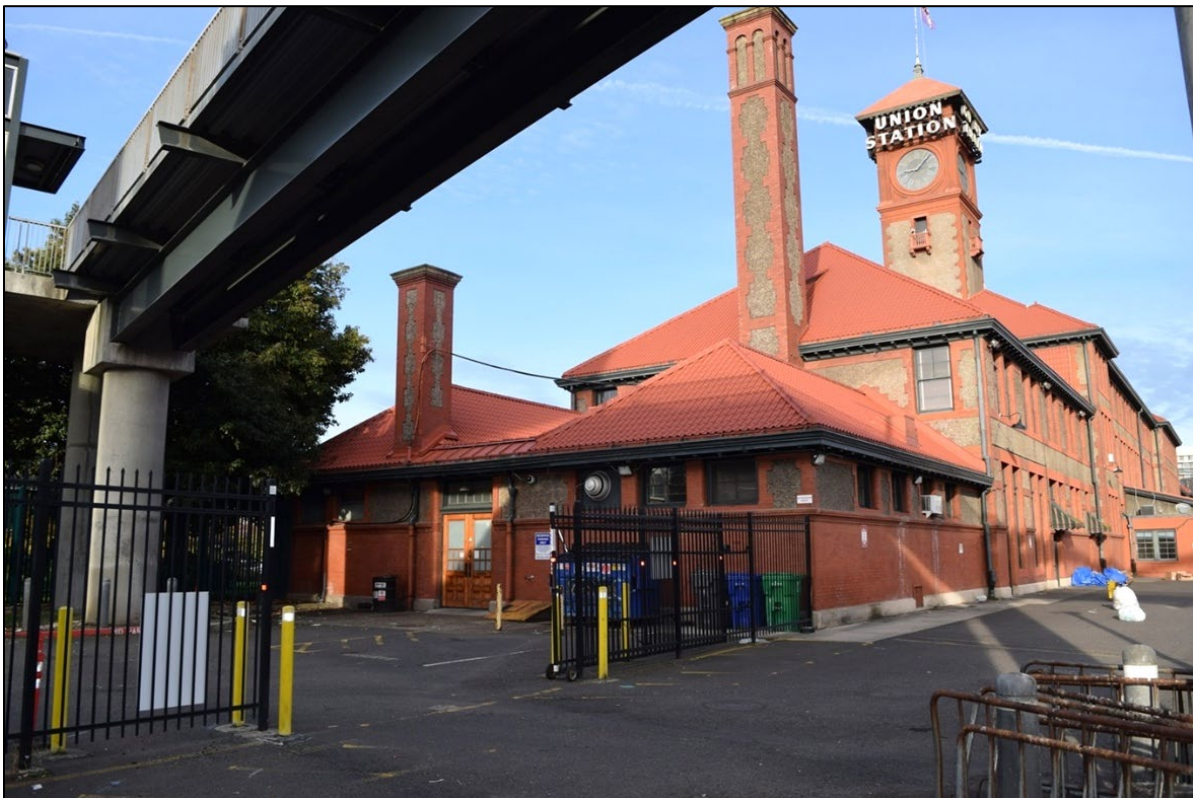
**Photograph 4 of 18:** OR\_MultnomahCounty\_UnionStationAmendment\_0004 ]  
Southeast end of Primary Terminal; looking north.

The single-story façade at the southeast end (**Photograph 4**) continues the tall brick base of the building with five high windows above it, interspersed with panels of pebbled stucco trimmed with brick "quoining." A pair of wood and glass doors (likely not original) with a multipane transom is centered on the elevation. Only two of the five windows are the original four-pane configuration; two on the left have been replaced and the center one infilled with a round duct and panel. Tall black vertical metal fencing extends the planes of the

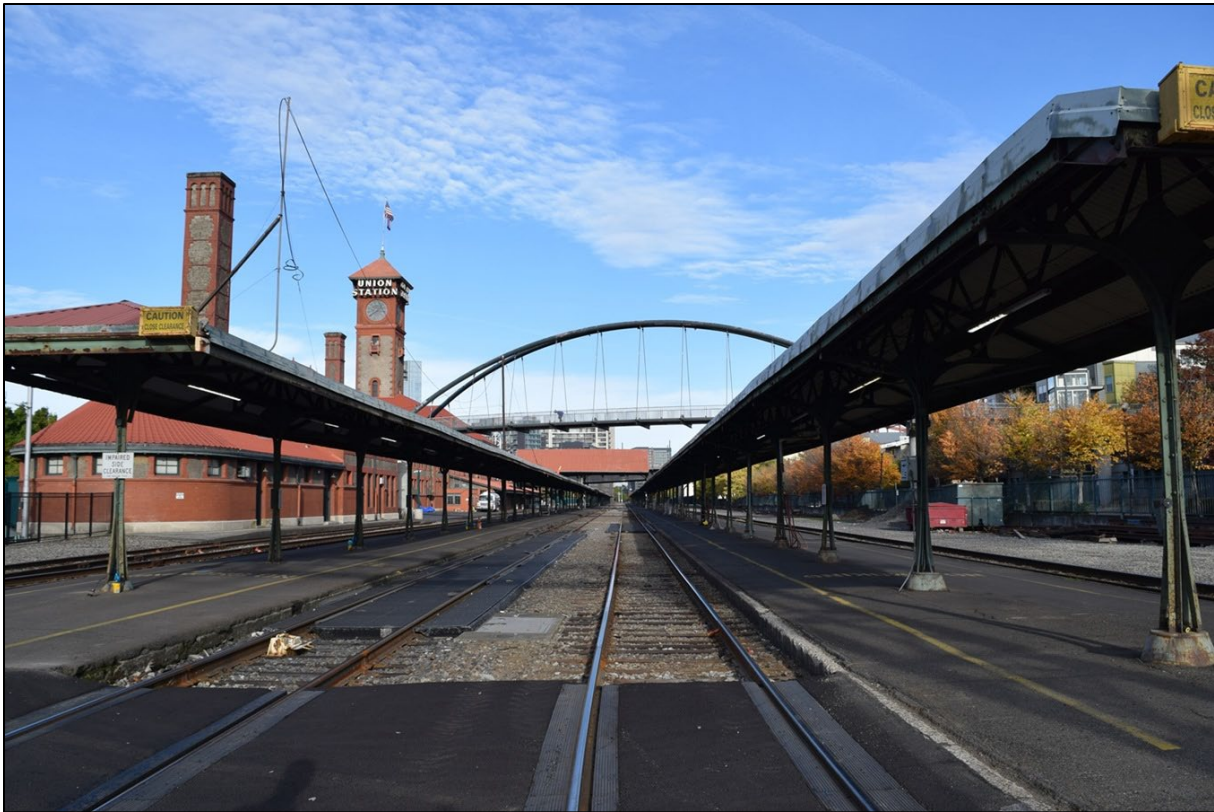
**Photograph 5 of 18:** OR\_MultnomahCounty\_UnionStationAmendment\_0005  
Southeast end of Annex on left, Platform Canopy 1 on left; looking northwest.

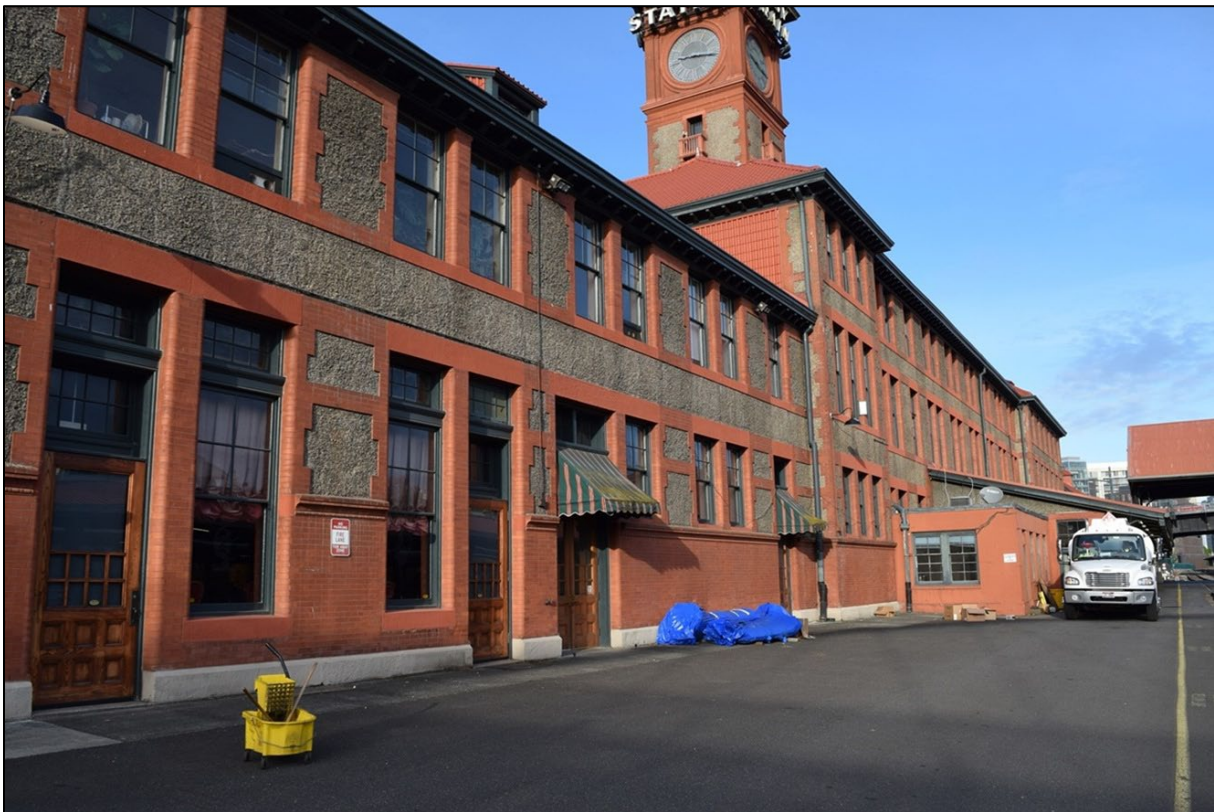
**Photograph 6 of 18:** OR\_MultnomahCounty\_UnionStationAmendment\_0006  
Northeast façade and Nursery addition, looking east.

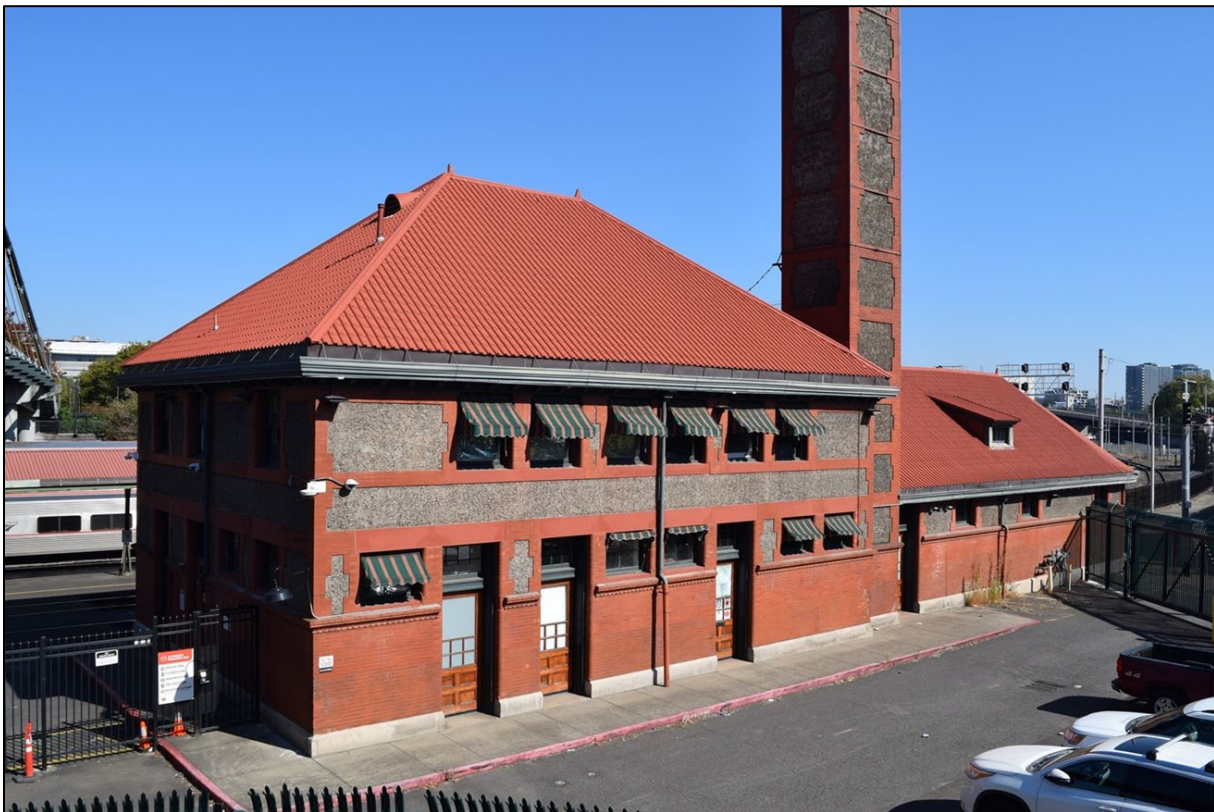
**Photograph 8 of 18:** OR\_MultnomahCounty\_UnionStationAmendment\_0008  
Annex northwest and southwest façades, looking east.

- Photograph 8 of 18:** OR\_MultnomahCounty\_UnionStationAmendment\_0008  
Annex northwest and southwest façades, looking east.
- Photograph 9 of 18:** OR\_MultnomahCounty\_UnionStationAmendment\_0009 [November 22, 2025]  
Interior main hall and information desk, looking east.

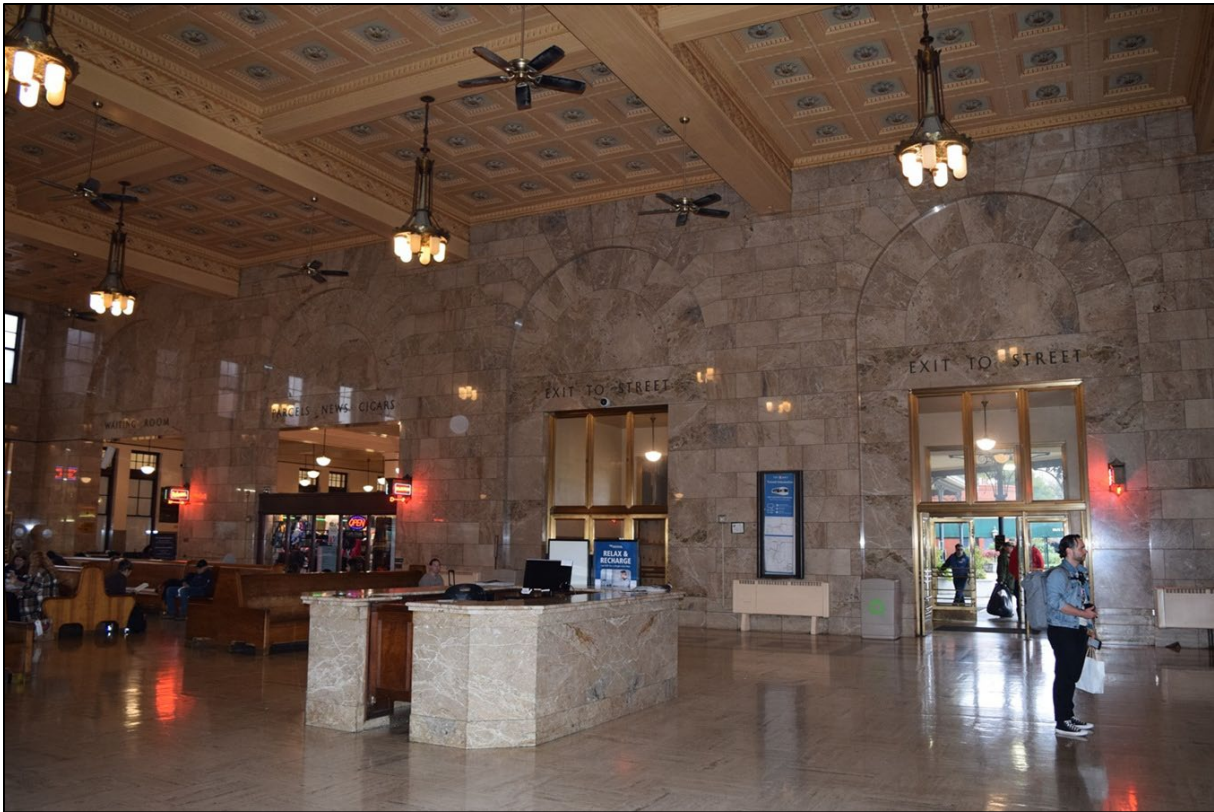
**Photograph 9 of 18:** OR\_MultnomahCounty\_UnionStationAmendment\_0009  
Interior main hall and information desk, looking east.

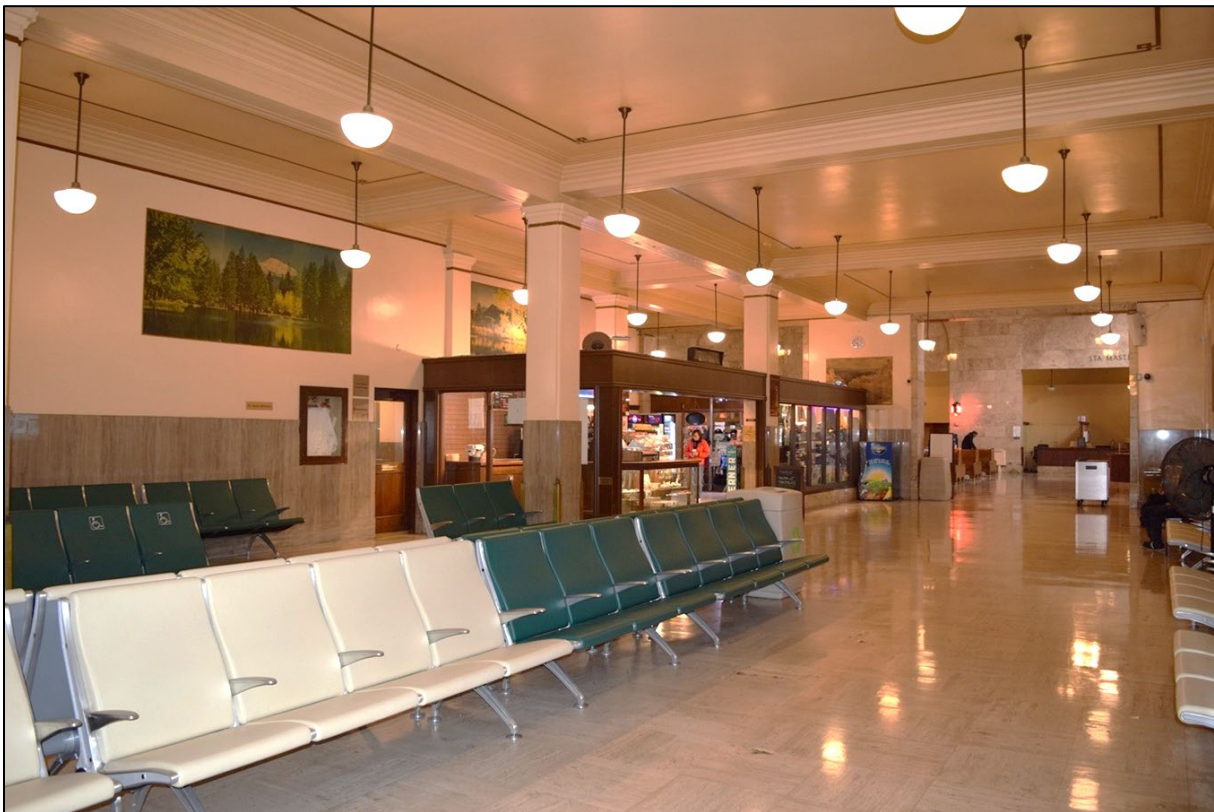
**Photograph 10 of 18:** OR\_MultnomahCounty\_UnionStationAmendment\_0010  
Interior secondary waiting room and café/gift shop, looking north.

- Photograph 10 of 18:** OR\_MultnomahCounty\_UnionStationAmendment\_0010 [October 23, 2025]  
Interior secondary waiting room and café/gift shop, looking north.

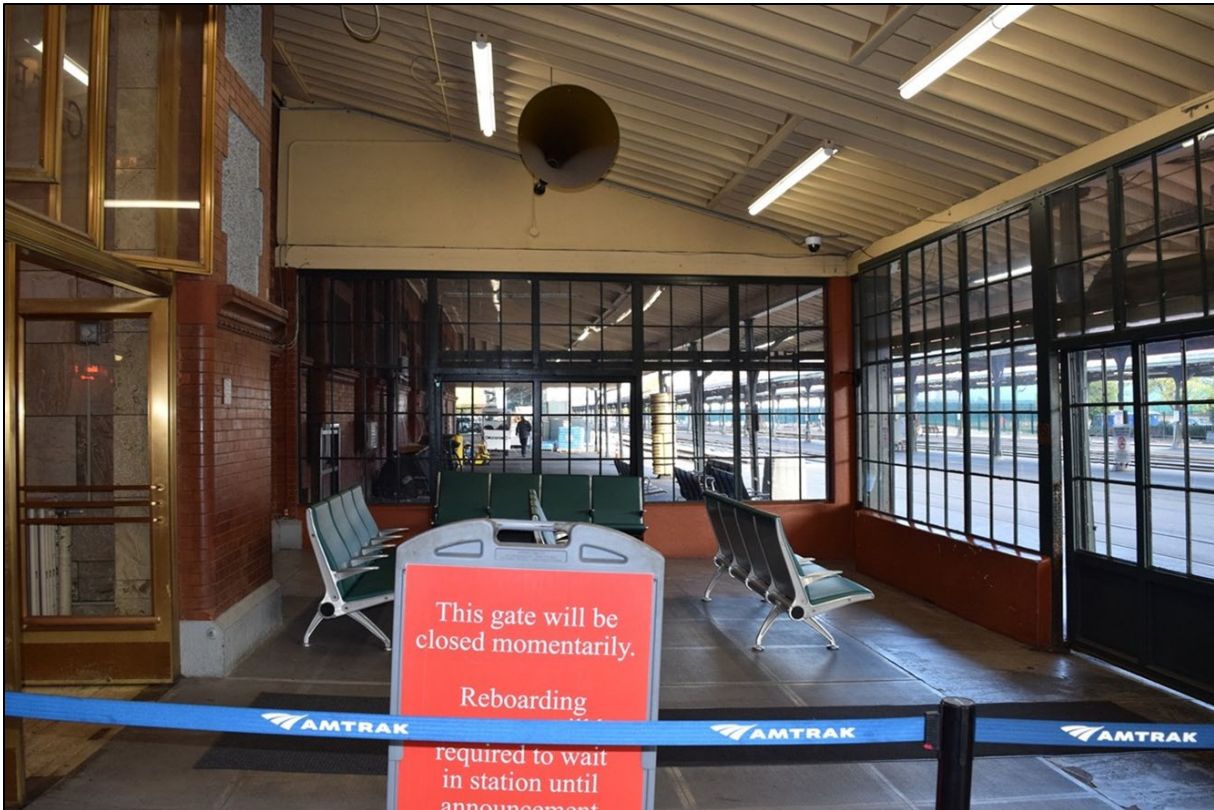
**Photograph 11 of 18: OR\_MultnomahCounty\_UnionStationAmendment\_0011**  
Interior passenger vestibule, looking northwest at the north end.

- Photograph 11 of 18:** OR\_MultnomahCounty\_UnionStationAmendment\_0011 [October 23, 2025]  
Interior passenger vestibule, looking northwest at the north end.

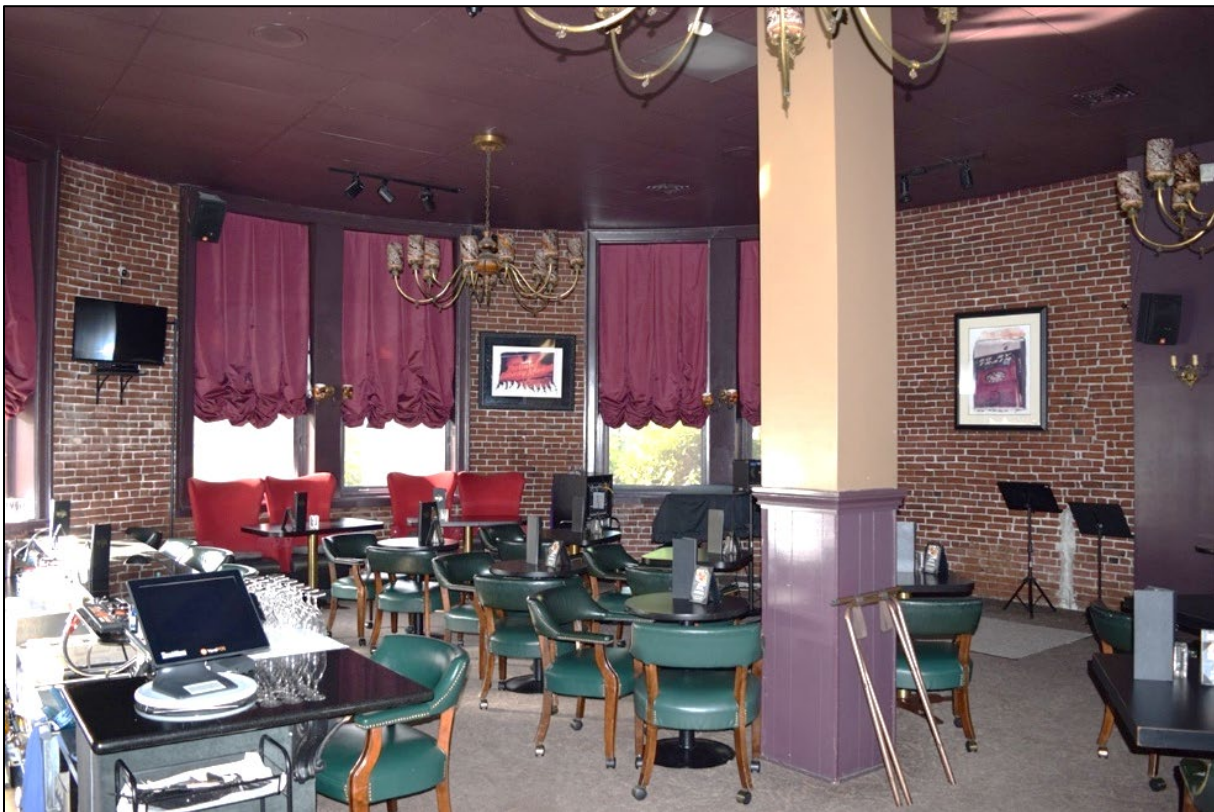
**Photograph 12 of 18: OR\_MultnomahCounty\_UnionStationAmendment\_0012**  
Interior restaurant dining room, looking west.

- Photograph 12 of 18:** OR\_MultnomahCounty\_UnionStationAmendment\_0012 [November 7, 2025]  
Interior restaurant dining room, looking west.

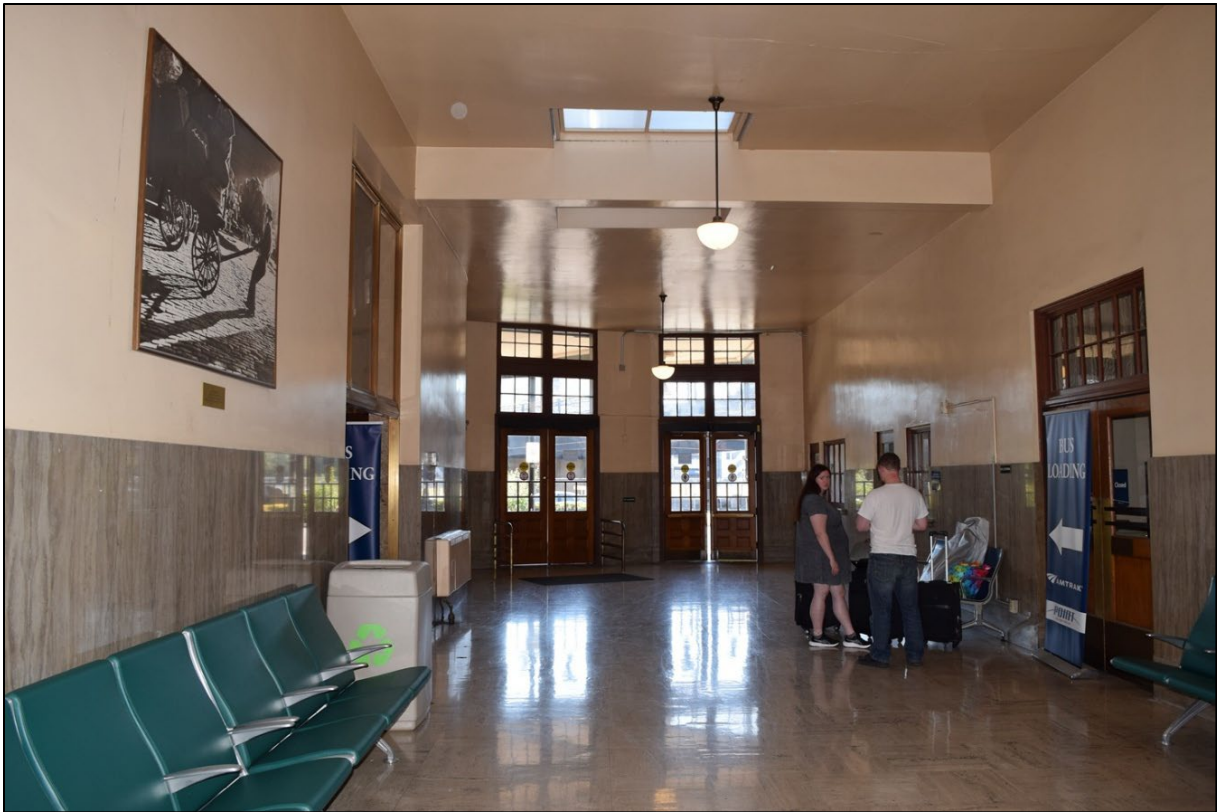
**Photograph 13 of 18: OR\_MultnomahCounty\_UnionStationAmendment\_0013**  
Interior North foyer, looking southeast.

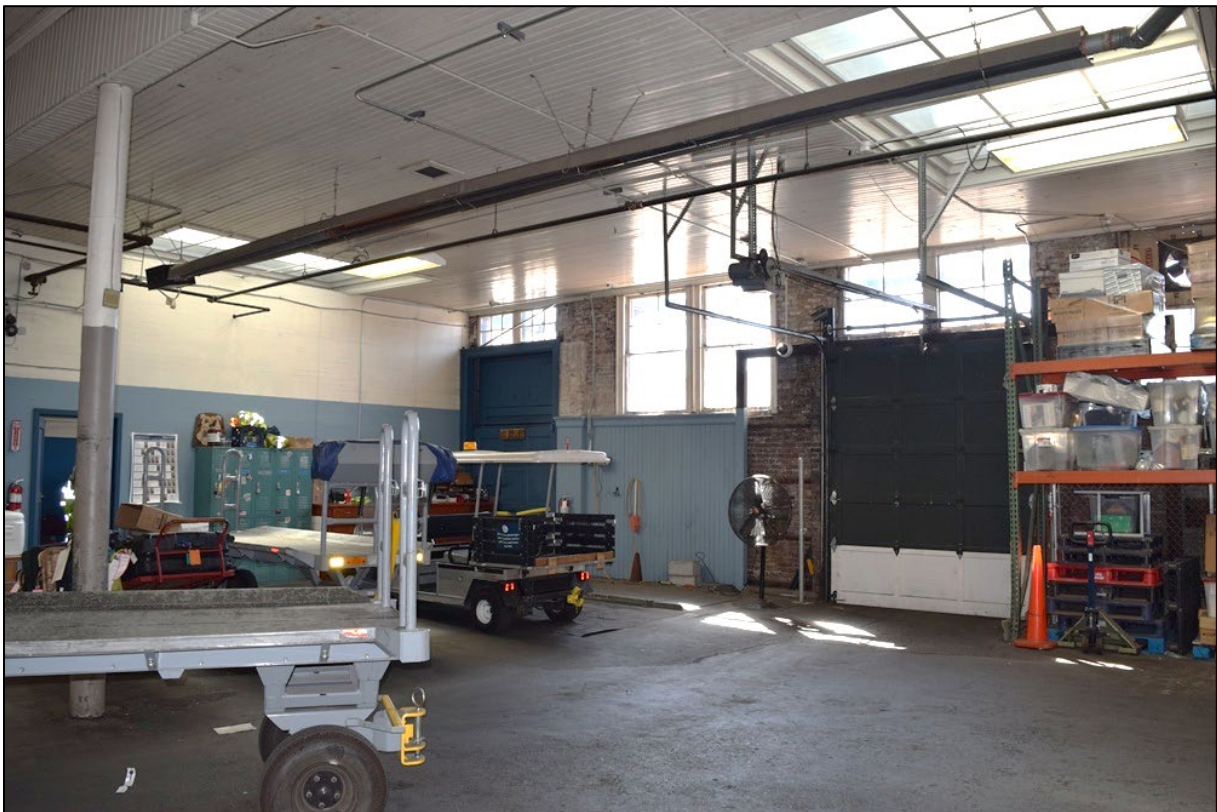
**Photograph 14 of 18: OR\_MultnomahCounty\_UnionStationAmendment\_0014**  
Interior of baggage handling room, looking south.

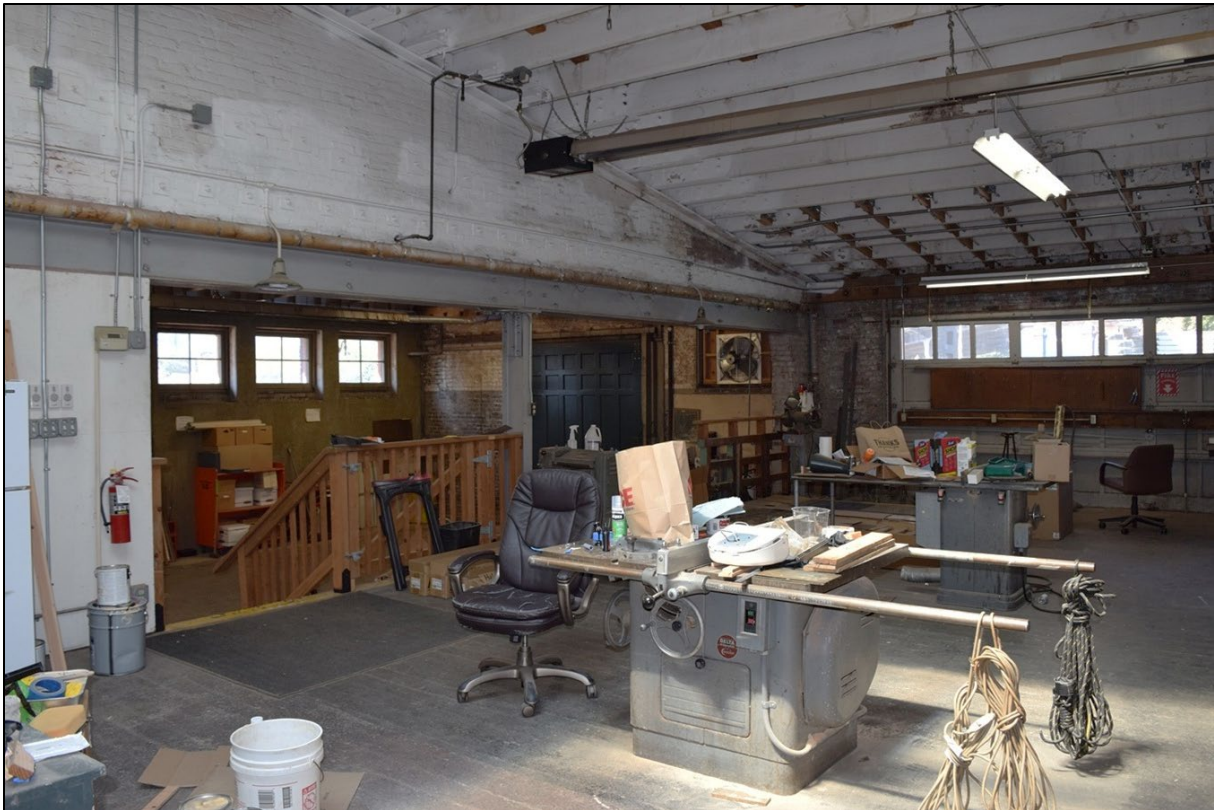
**Photograph 15 of 18: OR\_MultnomahCounty\_UnionStationAmendment\_0015**  
Interior of shop, looking north from higher floor level.

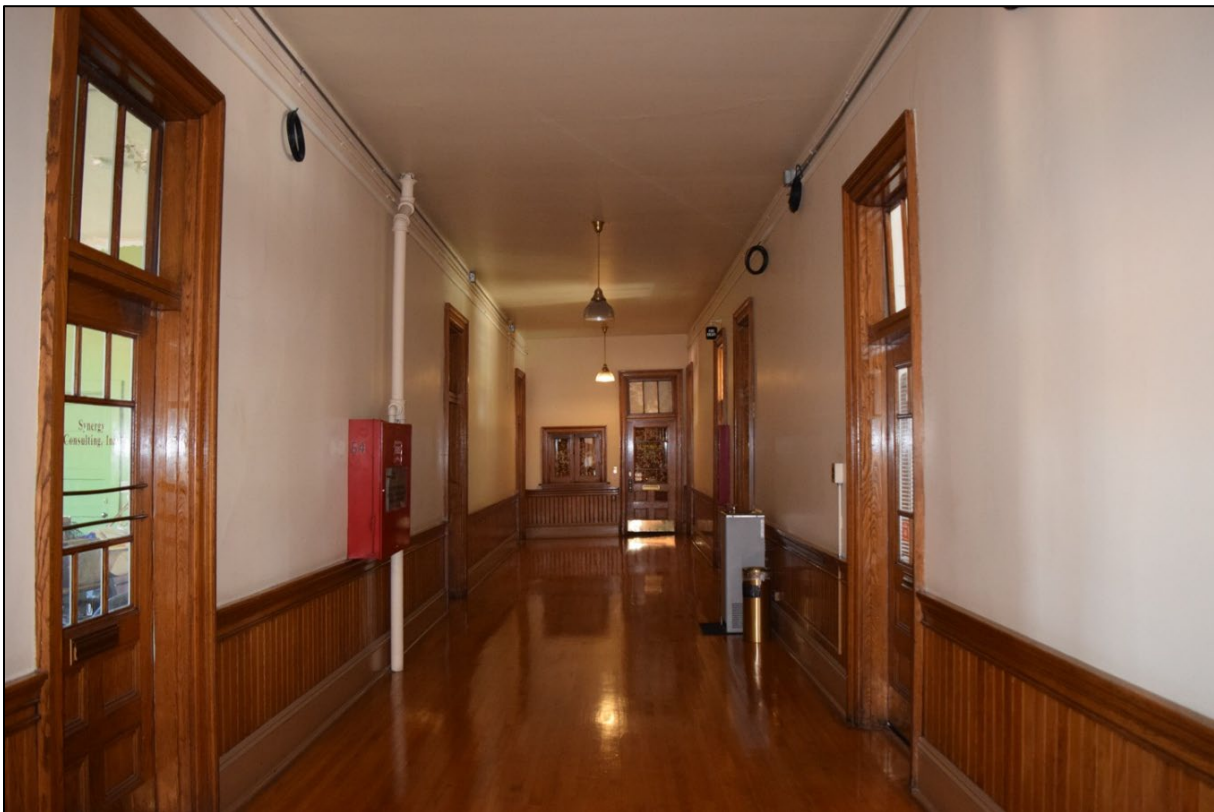
**Photograph 16 of 18: OR\_MultnomahCounty\_UnionStationAmendment\_0016**  
Interior second floor (south) primary hallway, looking southeast.

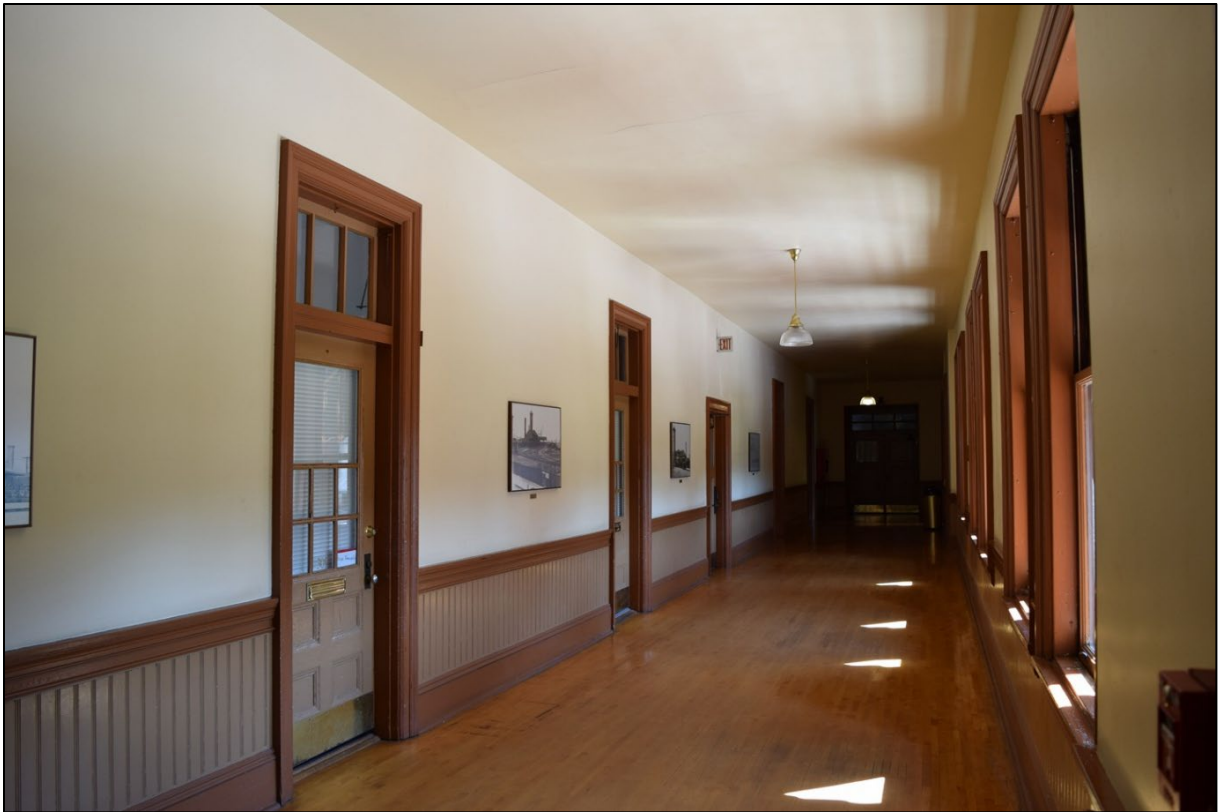
**Photograph 17 of 18:** OR\_MultnomahCounty\_UnionStationAmendment\_0017  
Interior third floor (north) primary hallway, looking southeast.
