# National Register of Historic Places Registration Form

historic name Union Station (Additional Documentation)

other names/site number Grand Central (Passenger) Station; (Grand) Union Depot

Name of Multiple Property Listing African American Resources in Portland, Oregon, from 1851 to 1973 MPS

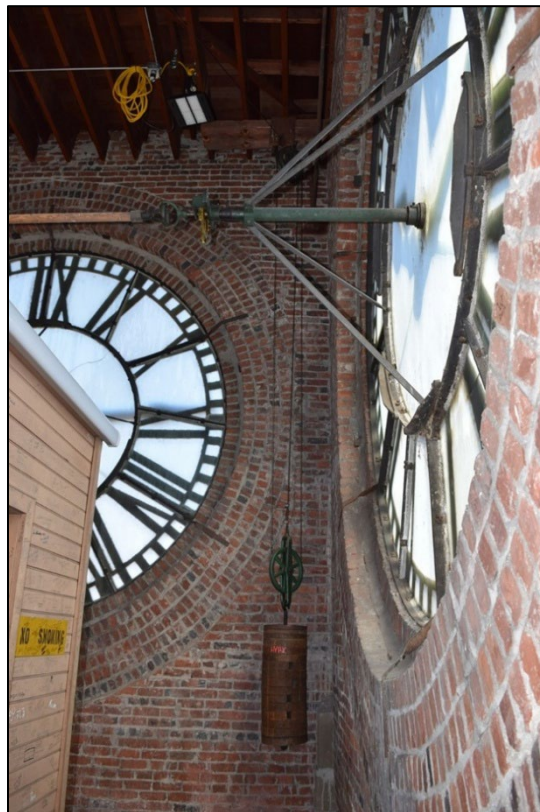
**Photograph 18 of 18:** OR\_MultnomahCounty\_UnionStationAmendment\_0018  
Interior clock tower at top, looking southwest.
