Amendment:**Administration Building**8th Street and K Avenue

La Grande, Oregon

The purpose of this additional documentation is to update the National Register nomination for the Administration Building to provide additional information on the Grand Staircase, which was listed as a contributing structure in the original nomination. In 2024, the original Grand Staircase was demolished and a new Grand Staircase has been built in its place.

historic name Administration Building, Eastern Oregon State College (Additional Documentation)

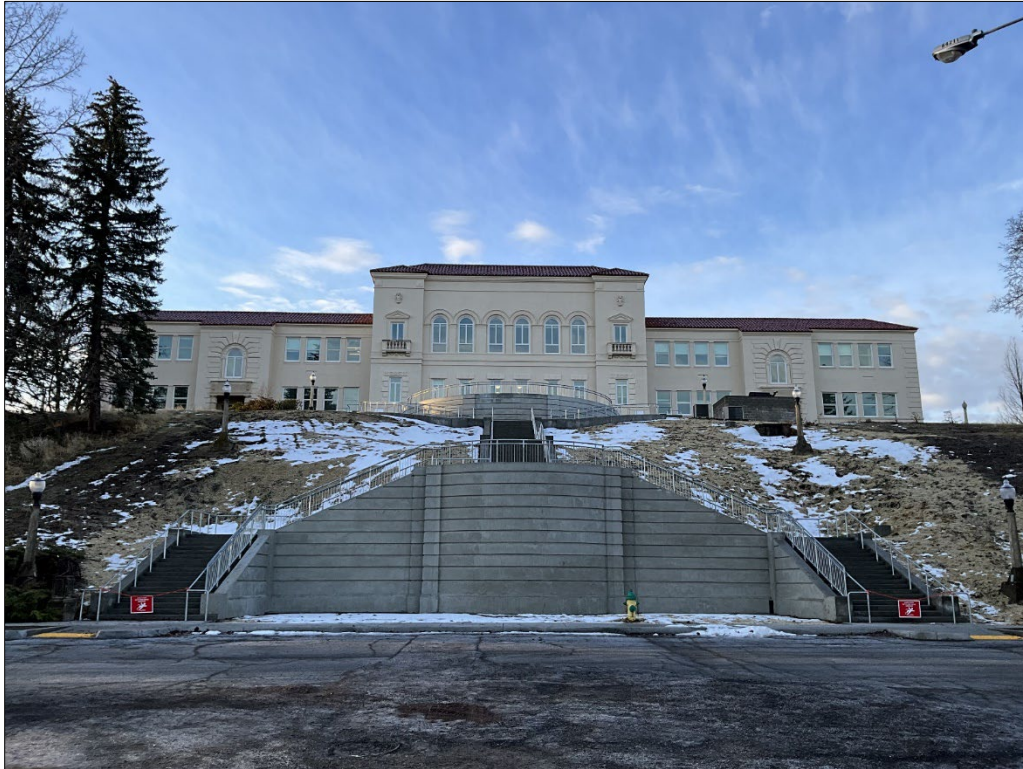
Photo 1 of 9: OR_UnionCounty_AdministrationBuilding_0001
View of north elevation, facing south.

- Photo 1 of 9:** OR_UnionCounty_AdministrationBuilding_0001
View of north elevation, facing south.
- Photo 2 of 9:** OR_UnionCounty_AdministrationBuilding_0002
View of northeast corner, facing southwest.

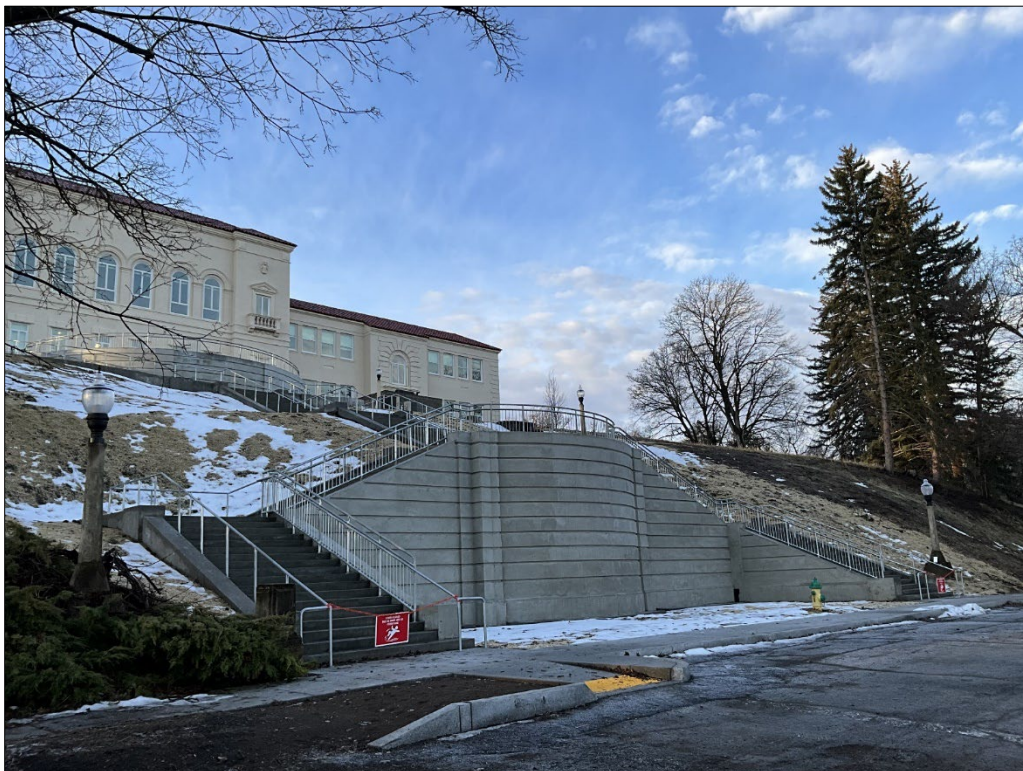
Photo 2 of 9: OR_UnionCounty_AdministrationBuilding_0002
View of northeast corner, facing southwest.

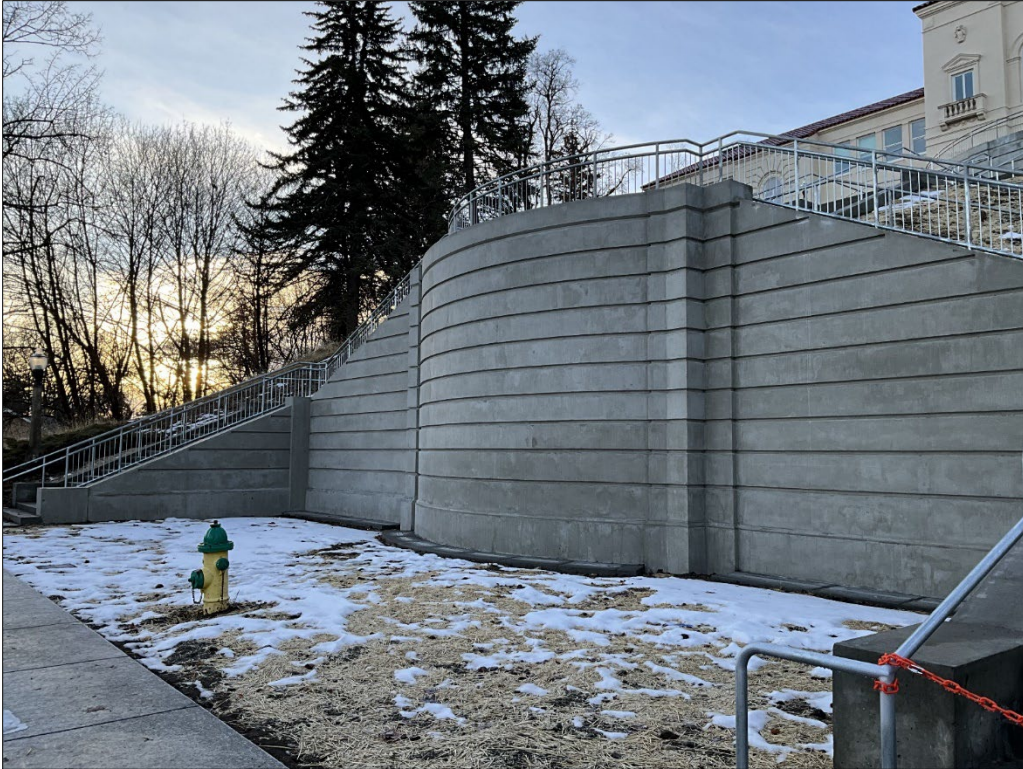
Photo 3 of 9: OR_UnionCounty_AdministrationBuilding_0003
View of northern retaining wall from northwest corner, facing southeast.

The views and sightlines of the property have not changed drastically with the construction of the new Grand Staircase, although the northernmost retaining wall was designed two feet higher than the original. Other additions to the property include two new, identical, updated interpretive signs telling the history of the Grand Staircase, one each at the north and south entrances of the Staircase. Additionally, the six existing light poles were restored and reinstalled with new globes. Existing landscaping, which has changed throughout the history of the original Grand Staircase, was removed in order to demolish and rebuild the Grand Staircase. The larger trees nearby were retained, and new landscaping is planned surrounding the Grand Staircase in the future.

- Photo 3 of 9:** OR_UnionCounty_AdministrationBuilding_0003
View of northern retaining wall from northwest corner, facing southeast.
- Photo 4 of 9:** OR_UnionCounty_AdministrationBuilding_0004
View of central straight run of stairs between north and south entrances from northern landing, facing south.

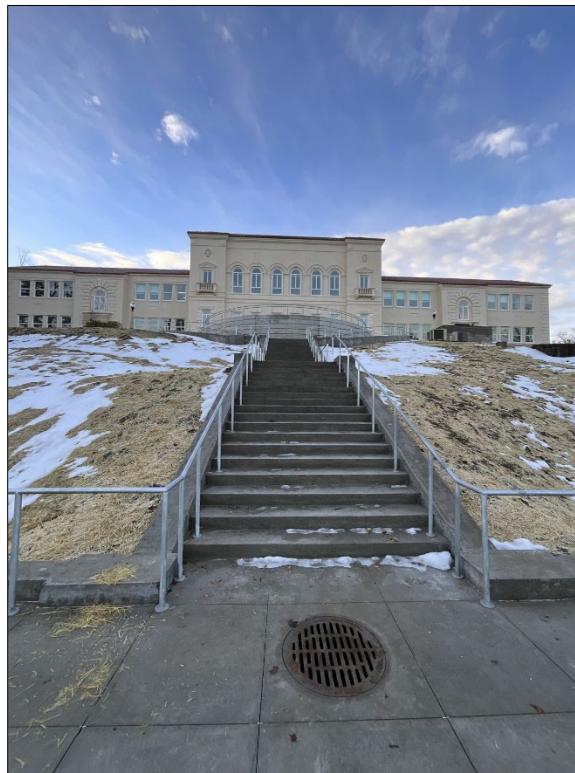
Photo 4 of 9: OR_UnionCounty_AdministrationBuilding_0004
View of central straight run of stairs between north and south entrances from northern landing, facing south.

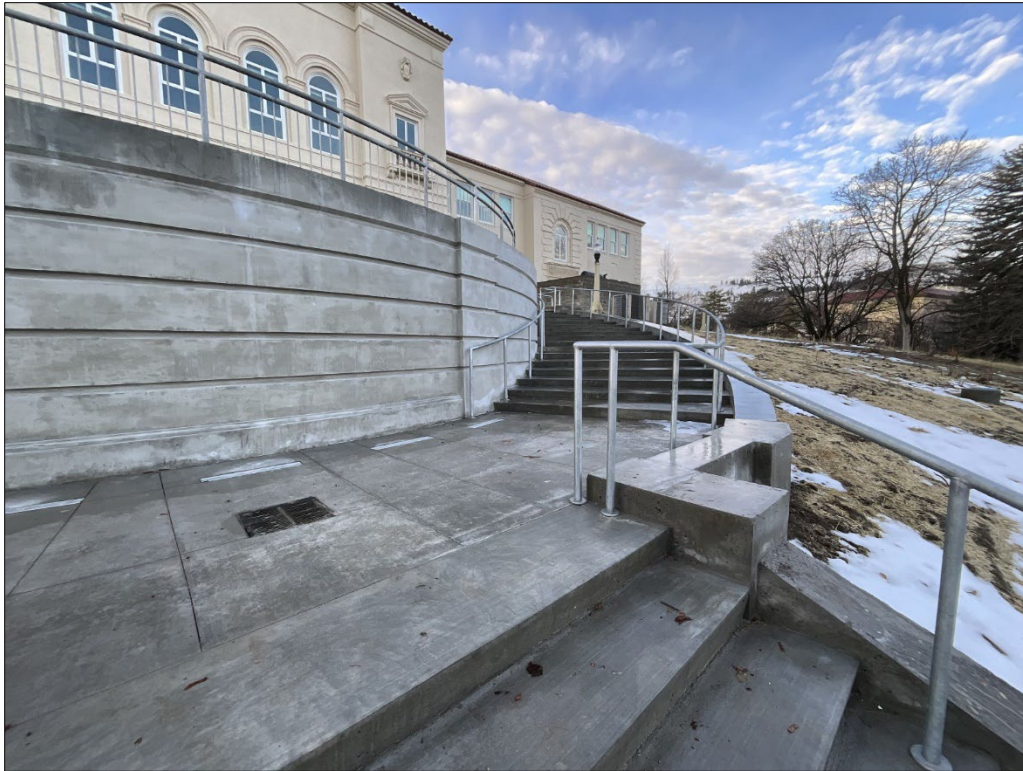
Photo 5 of 9: OR_UnionCounty_AdministrationBuilding_0005
View of the southernmost landing at the bottom of the southern retaining wall and the concave arc stairs that lead to the overlook terrace, facing southwest.

- Photo 5 of 9:** OR_UnionCounty_AdministrationBuilding_0005
View of the southernmost landing at the bottom of the southern retaining wall and the concave arc stairs that lead to the overlook terrace, facing southwest.

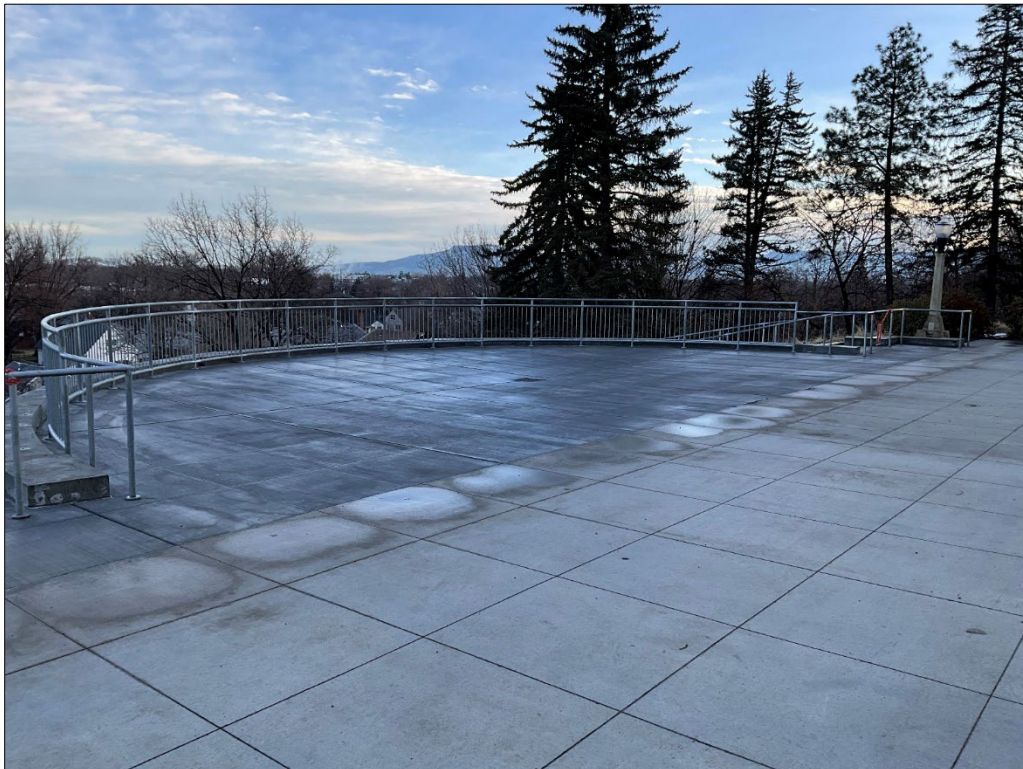
Photo 6 of 9: OR_UnionCounty_AdministrationBuilding_0006
View of the overlook terrace and southern entrance to staircase, facing northeast.

- Photo 6 of 9:** OR_UnionCounty_AdministrationBuilding_0006
View of the overlook terrace and southern entrance to staircase, facing northeast.
- Photo 7 of 9:** OR_UnionCounty_AdministrationBuilding_0007
View of staircase from overlook terrace, facing north.

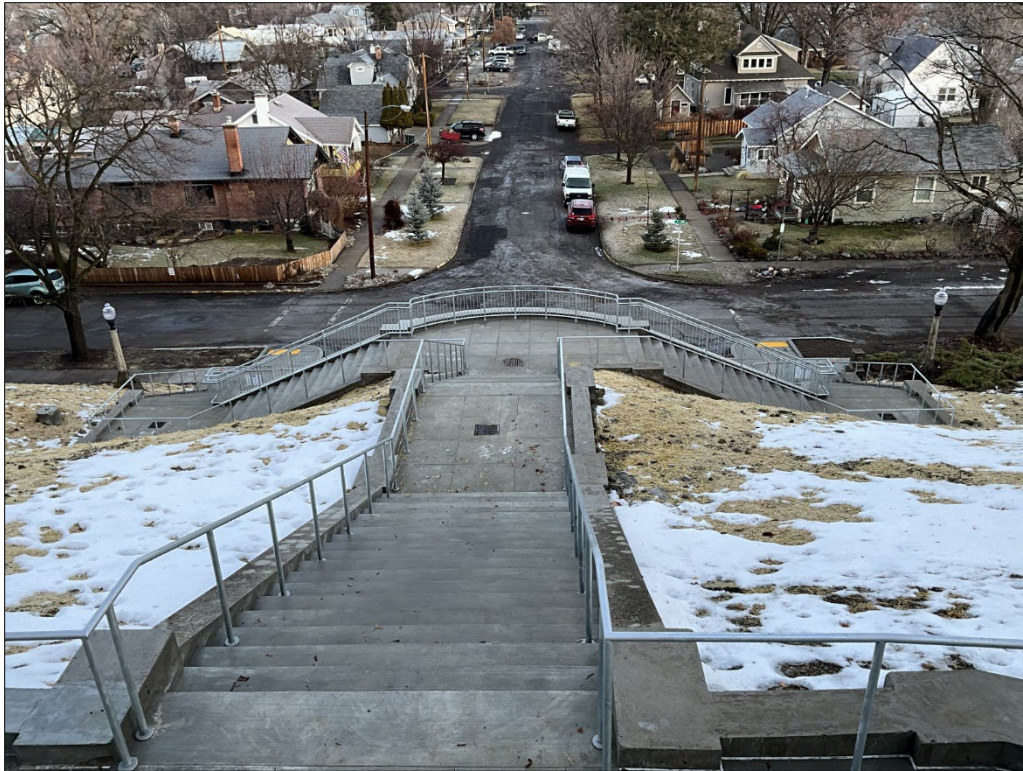
Photo 7 of 9: OR_UnionCounty_AdministrationBuilding_0007
View of staircase from overlook terrace, facing north.

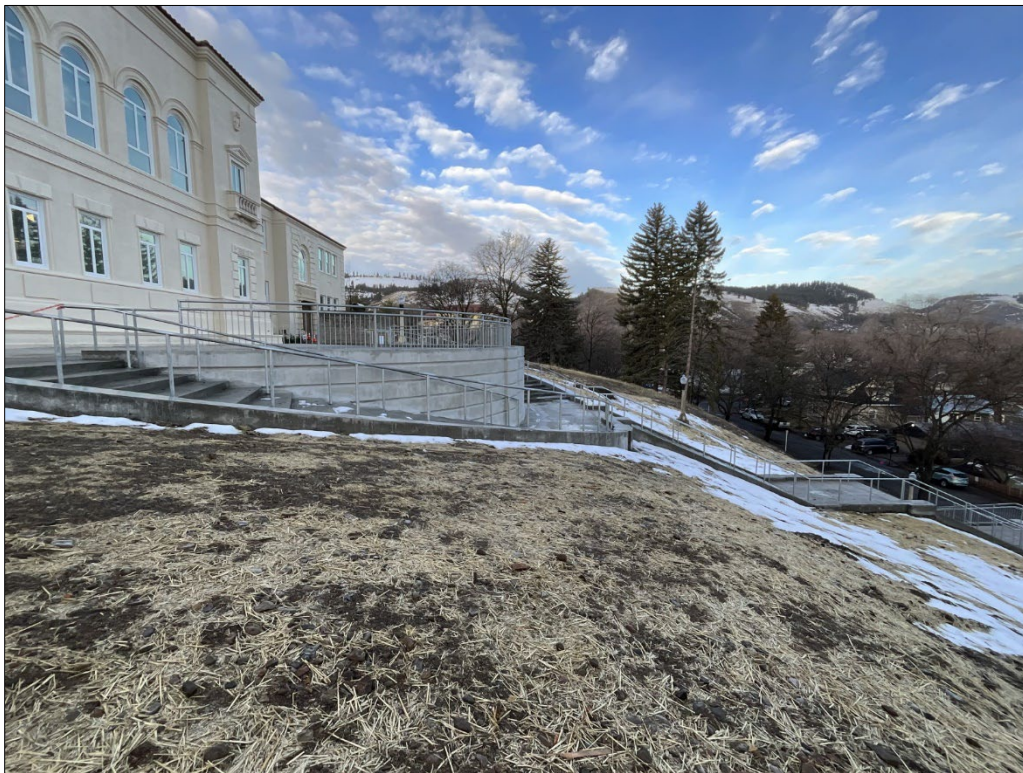
Photo 8 of 9: OR_UnionCounty_AdministrationBuilding_0008
View of the southern portion of the staircase, facing west.

- Photo 8 of 9:** OR_UnionCounty_AdministrationBuilding_0008
View of the southern portion of the staircase, facing west.
- Photo 9 of 9:** OR_UnionCounty_AdministrationBuilding_0009
View of staircase from the southeast, facing northwest.

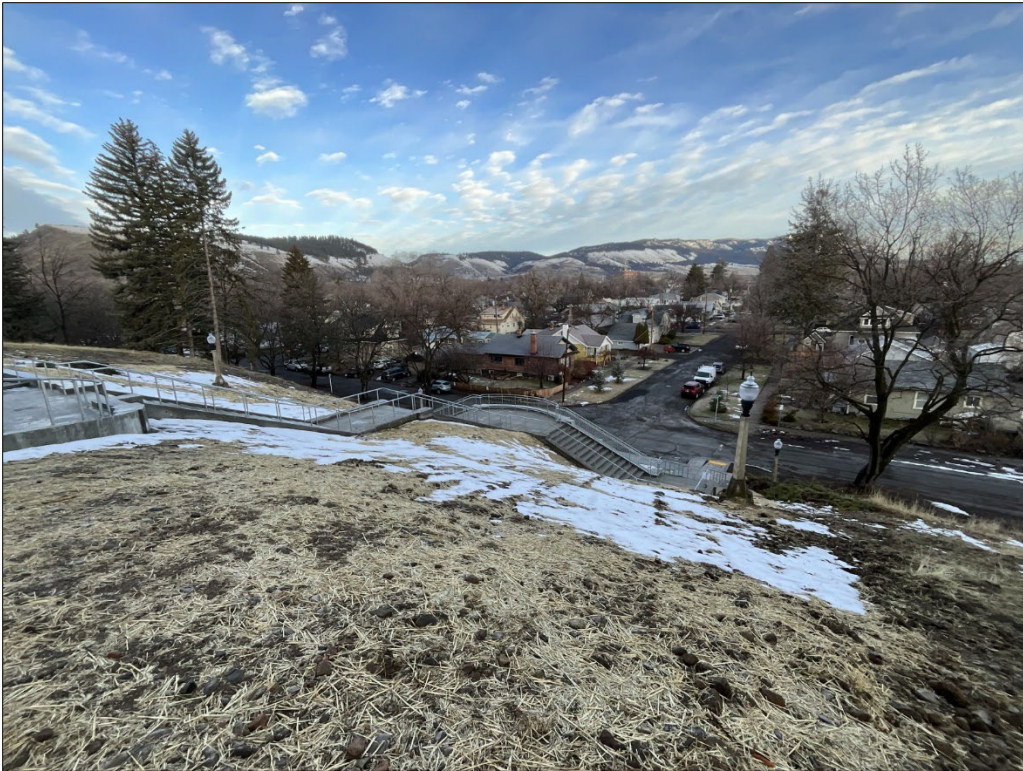
Photo 9 of 9: OR_UnionCounty_AdministrationBuilding_0009
View of staircase from the southeast, facing northwest.
