OREGON PARKS AND RECREATION DEPARTMENT OCEAN SHORE PERMIT APPLICATION

SHORELINE PROTECTION STRUCTURES

Construct an riprap revetment along approximately 105' of shoreline to a height of 33' to mitigate wave erosion and overtopping and protect the structure at 145 Salishan Drive.

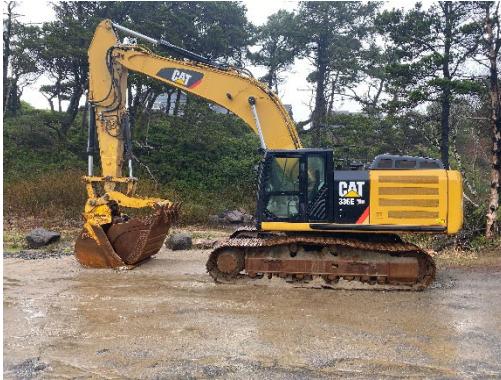
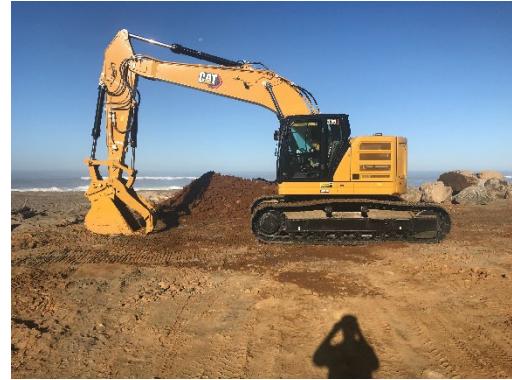
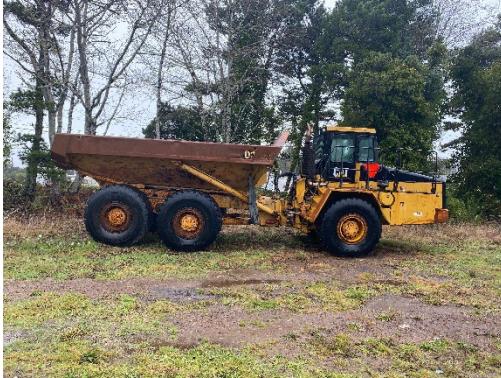
- **Equipment:** Morris Excavation plans to use the following equipment to construct the proposed revetment, as pictured below (respectively): up to four yellow CAT excavators, one a model 335, and the other a 336; and two of yellow CAT off road trucks, model 250. Service trucks will be used to bring fuel and perform maintenance on the equipment, and on-road dump trucks will be used to place materials in the staging area.

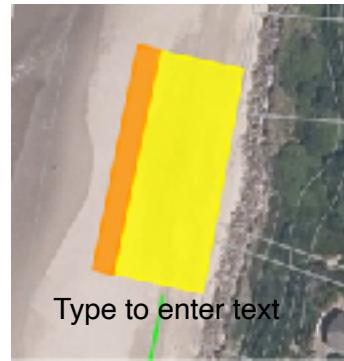
Project site

- Yellow: work zone to extend 60'-100' west of proposed toe location. 40' north and south of proposed revetment to make tie in. In total work zone will be 100'(E&W) x 185' (N&S).
- Orange: placement of signage and barrier (sand berm, rock).

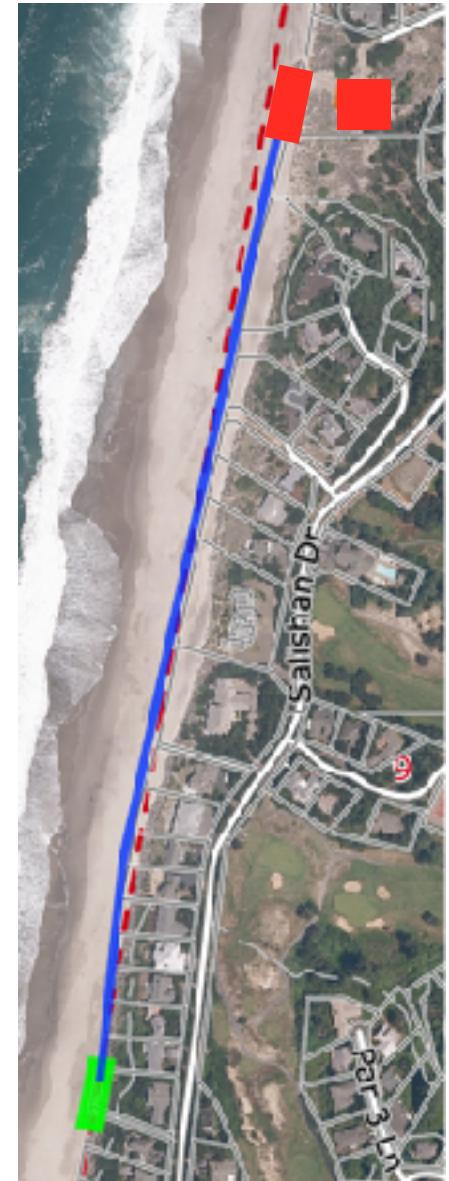
- Blue: 15' Haul route for Off Road Truck and excavators.

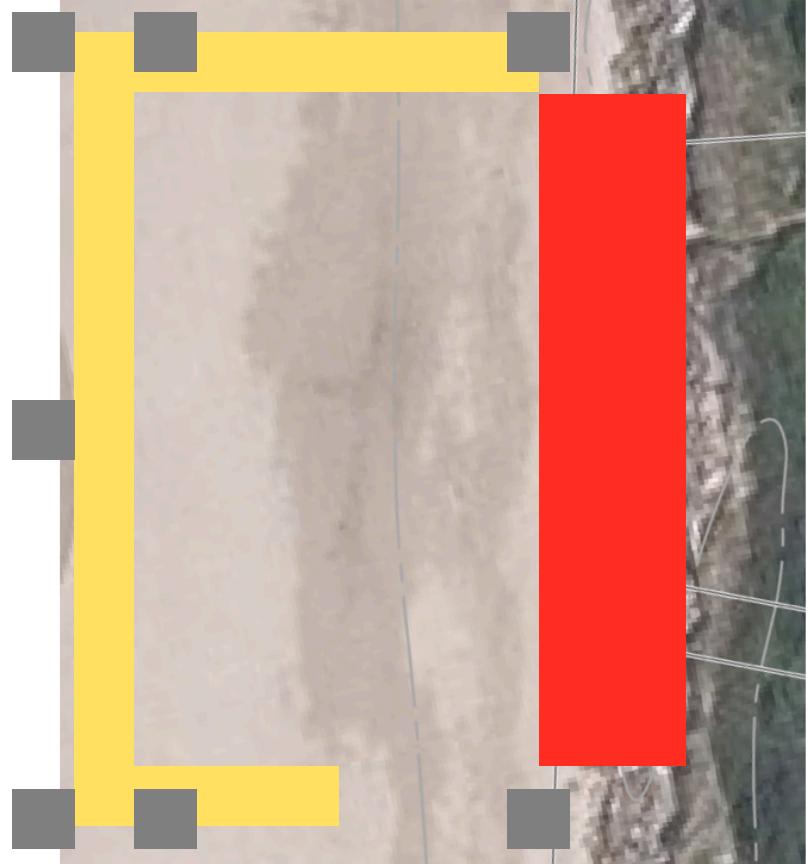
- Gray box represents signage (visible from 100'). Construction Area and Pedestrian route.
- Yellow represents sand berm.
- Red represents Revetment.

Off Road Truck and excavator access from the south. All construction activities will be inside the work zone with the exception of turning around in the Off Road truck, and berm maintenance.

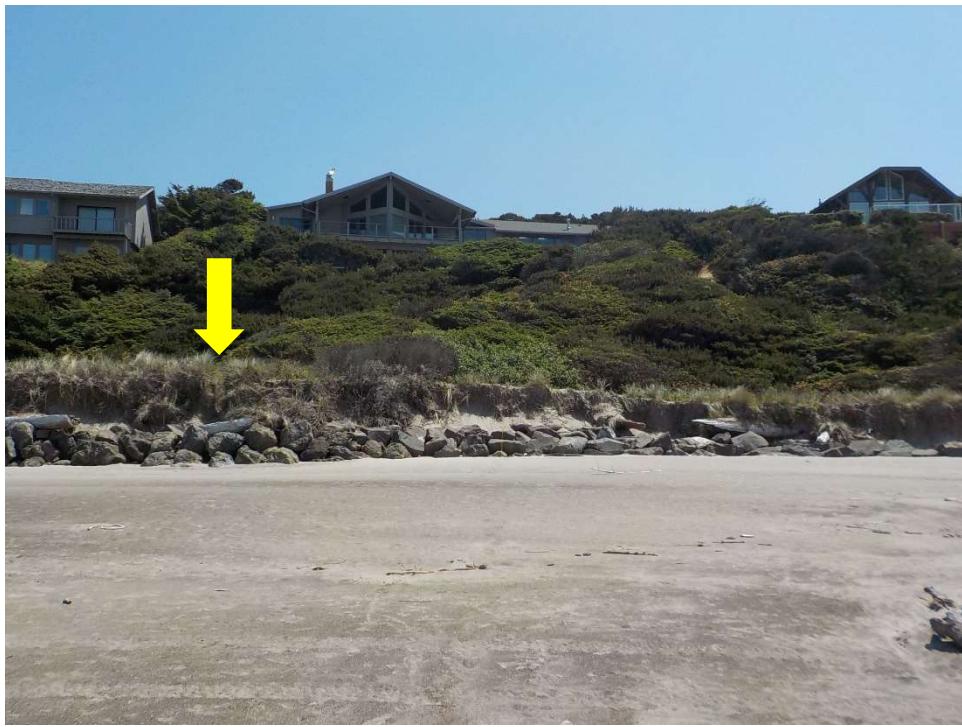
Photo 1 – Easterly view of the site from the beach. Photo taken May 31, 2019. Note the erosion scarp present above the revetment indicating overtopping by waves. Approximate location of existing walkway indicated with yellow arrow.

Photo 3 – Easterly view of the site from the beach. Photo taken June 10, 2022. Note that the revetment has been damaged since our 2019 visit (Photo 1), and adjacent revetments had been recently repaired and covered with sand. Approximate location of existing walkway indicated with yellow arrow.

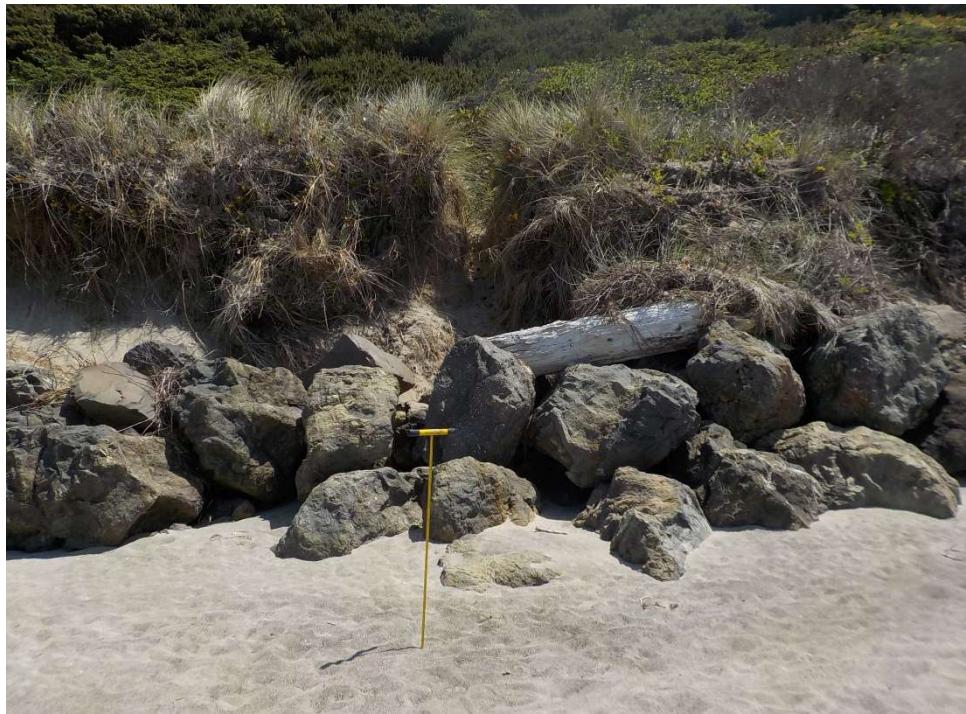
Photo 2 – View of the revetment fronting the existing walkway. Photo taken May 31, 2019.

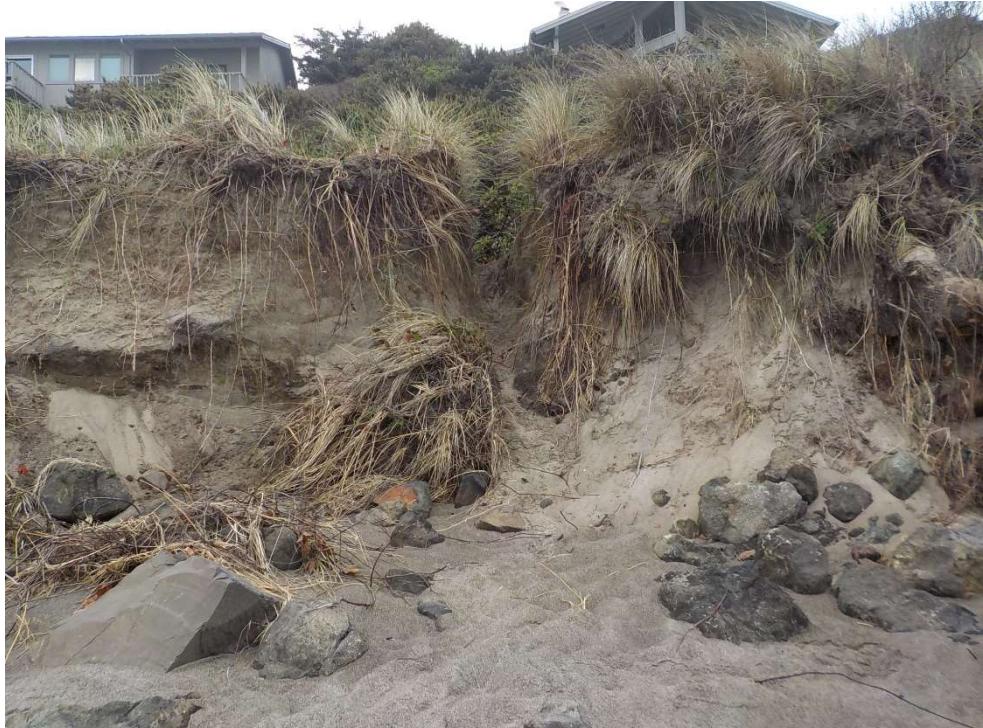
Photo 4 – View of the revetment fronting the existing walkway. Photo taken May 27, 2022.

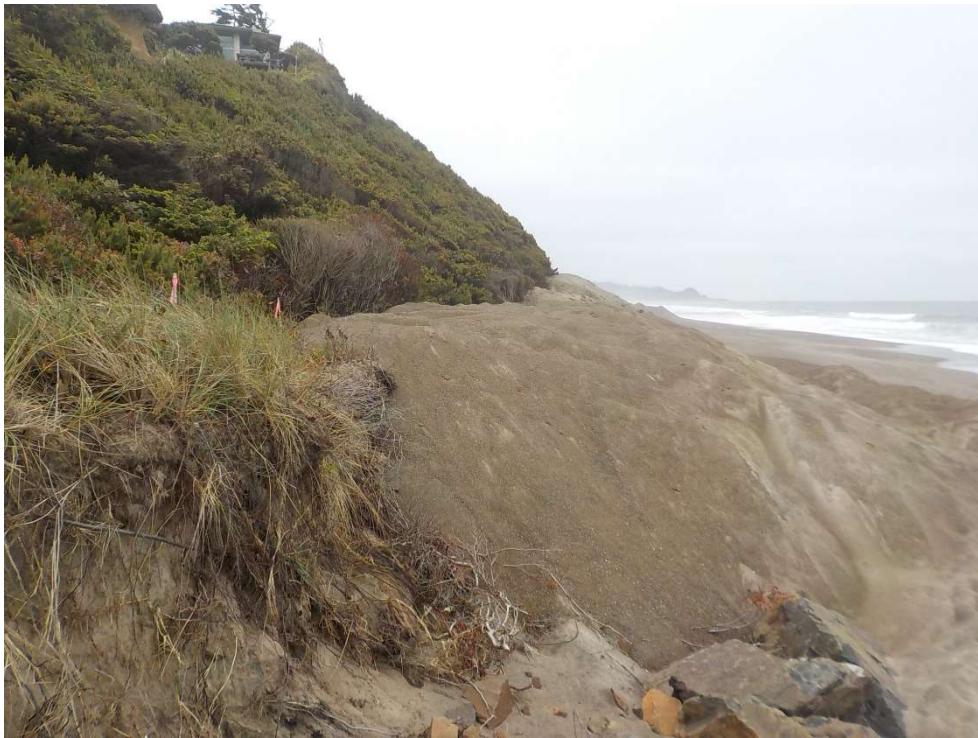
Photo 5 – Southerly view of the adjacent, recently repaired revetment. Note the two pink-flagged stakes on the bluff slope indicating the platted area of the “walkway” Tax Lot 399. Photo taken May 27, 2022.

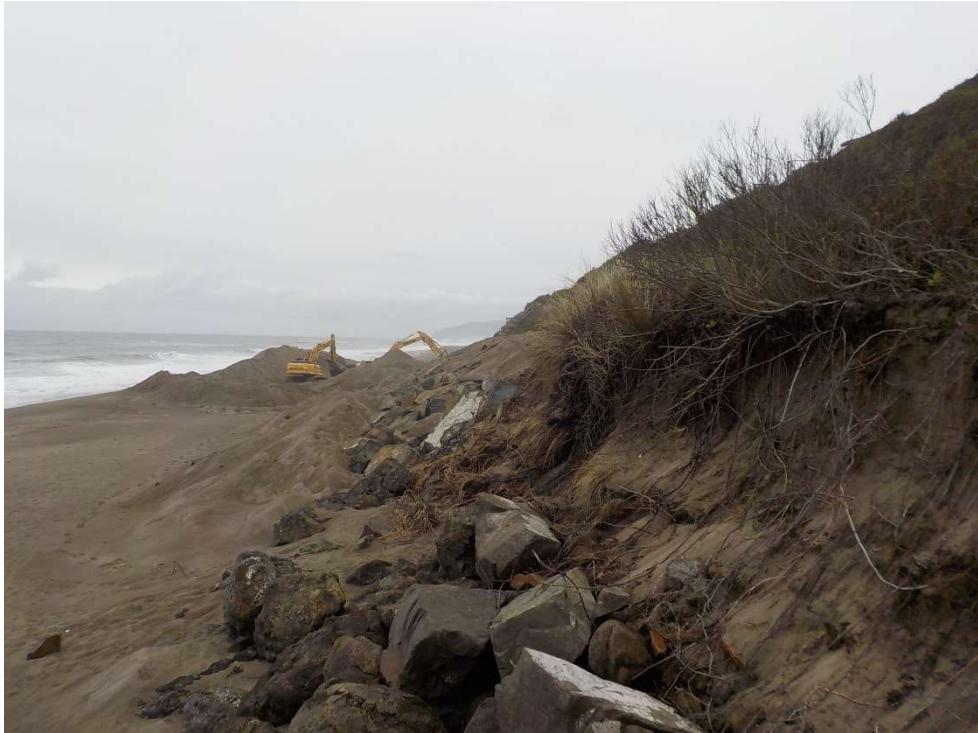
Photo 6 – Northerly view along the top of the existing damaged revetment at the site and the adjacent, recently repaired revetment. Photo taken May 27, 2022.

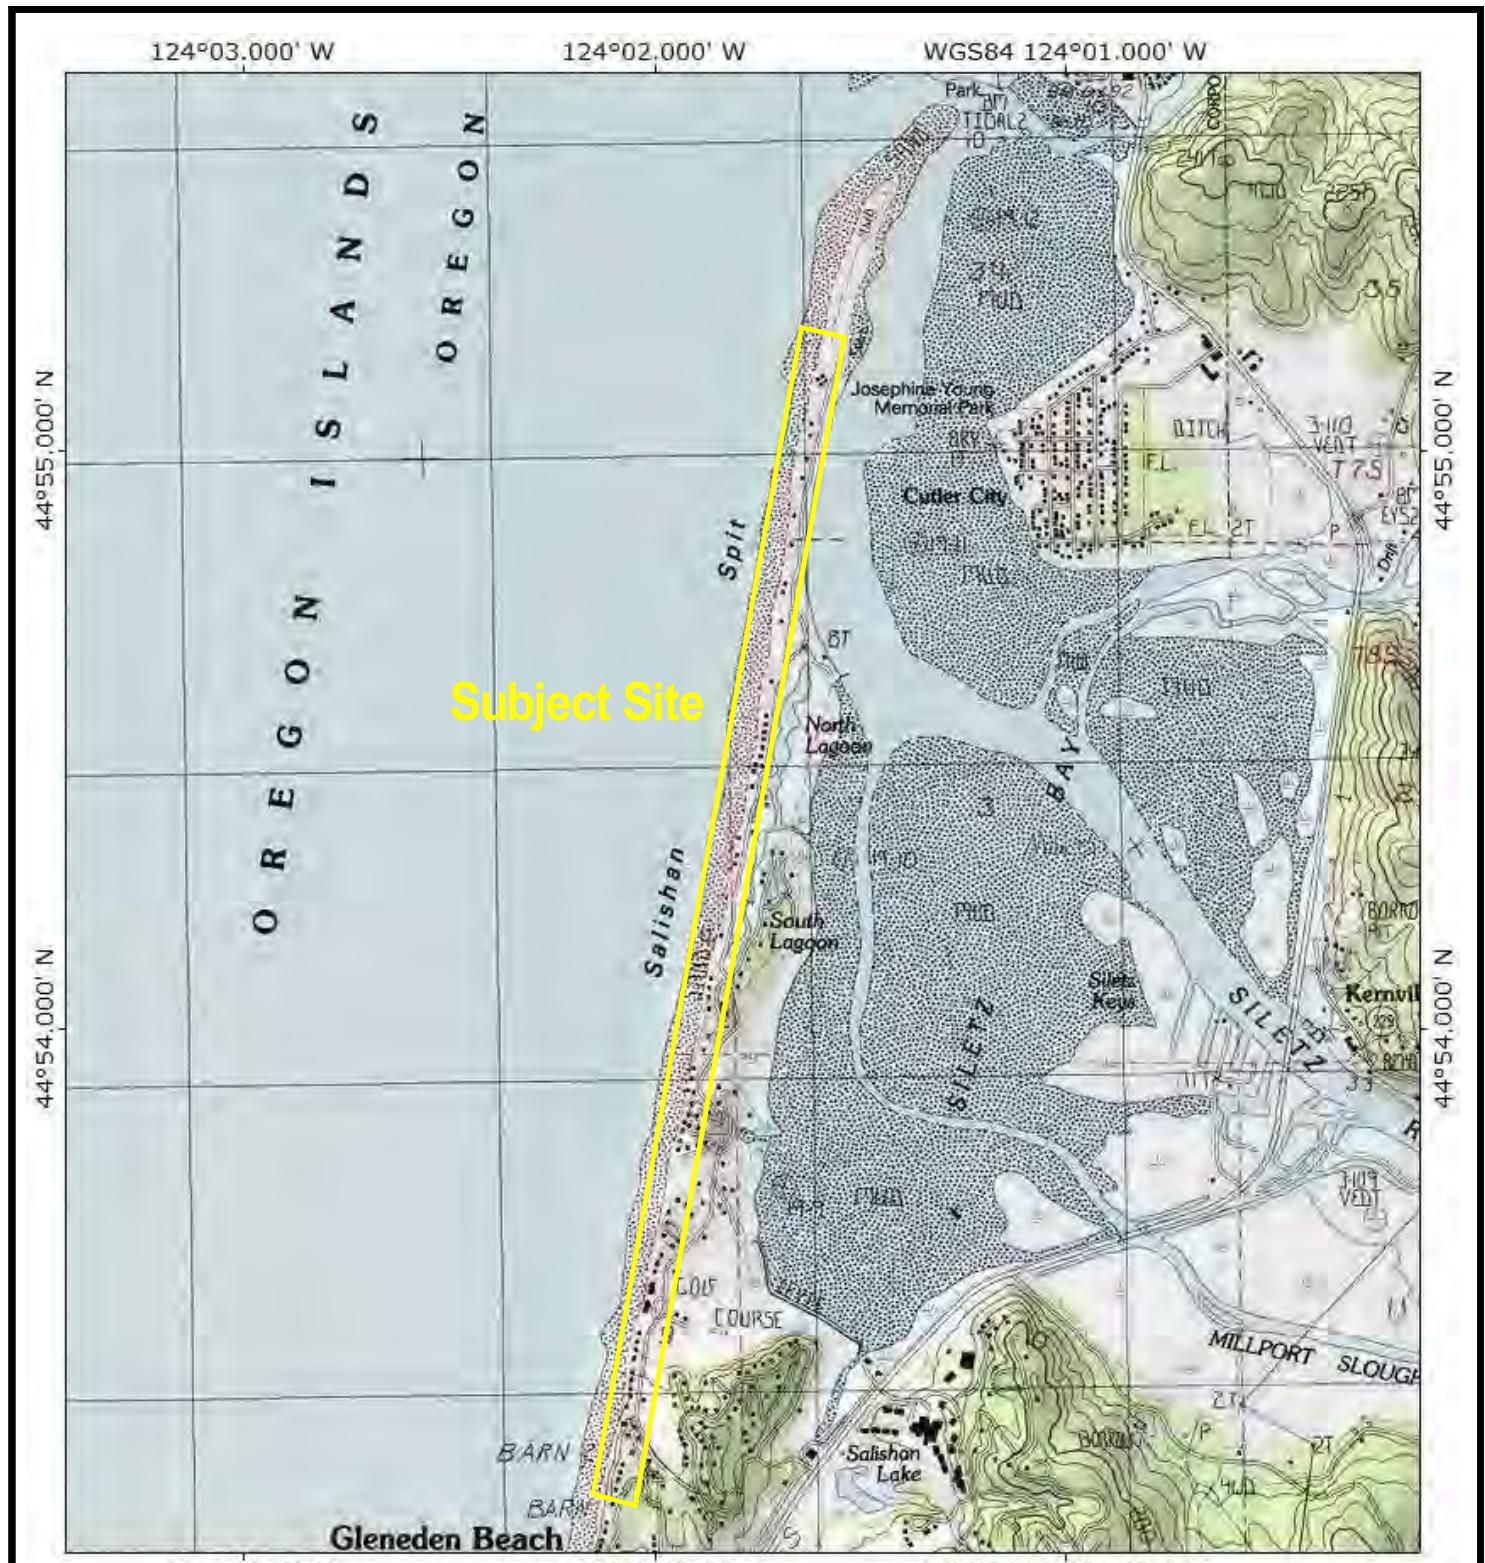
GRADATIONS		
Armor Stone		
Stone Size (ft)*	Stone Weight (tons)	% Smaller Than Or Equal To
6.7 to 8.0	27 to 45	100
5.9 to 6.5	18 to 25	80
4.7 to 5.3	9 to 14	50
2.1 to 2.7	1 to 2	10
* Long Dimension < 2.5× Short Dimension		
Filter Rock (Underlayer Stone)		
ODOT Class 200 Standard Riprap		
Bedding Rock / Fill		
Quarry Run 4" minus with minimal fines		
Trip Tickets Shall Be Provided For All Material Brought Onsite

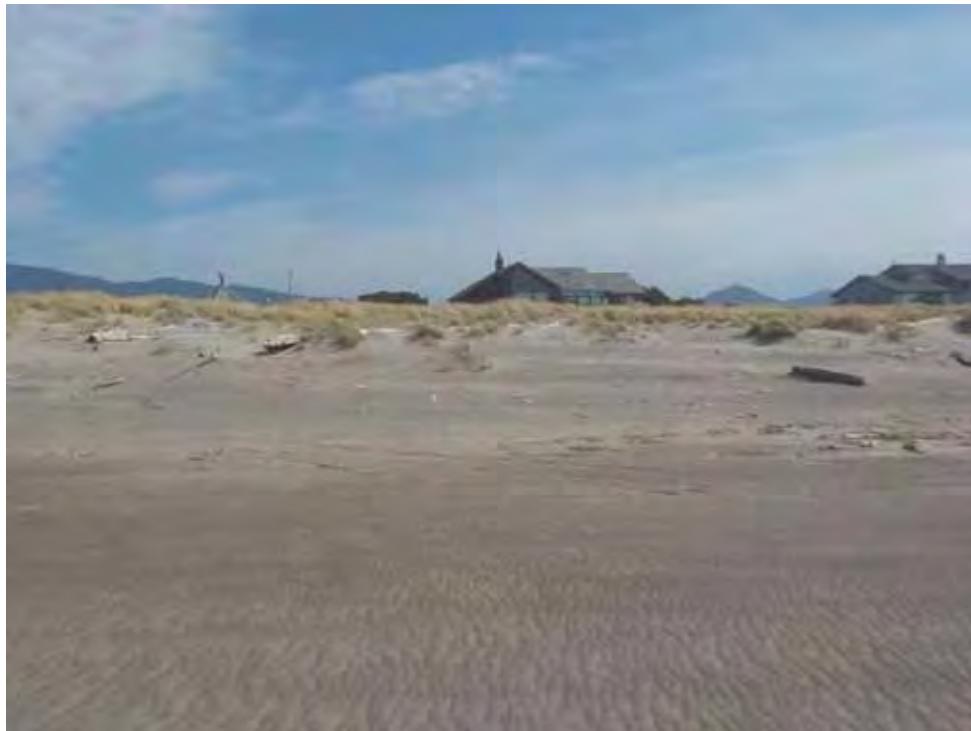
Photo 4 – Easterly view of the beach and vegetated foredune fronting the northernmost houses. Note the sand ramp and lack of well-defined erosion scarp along the beach-dune junction.

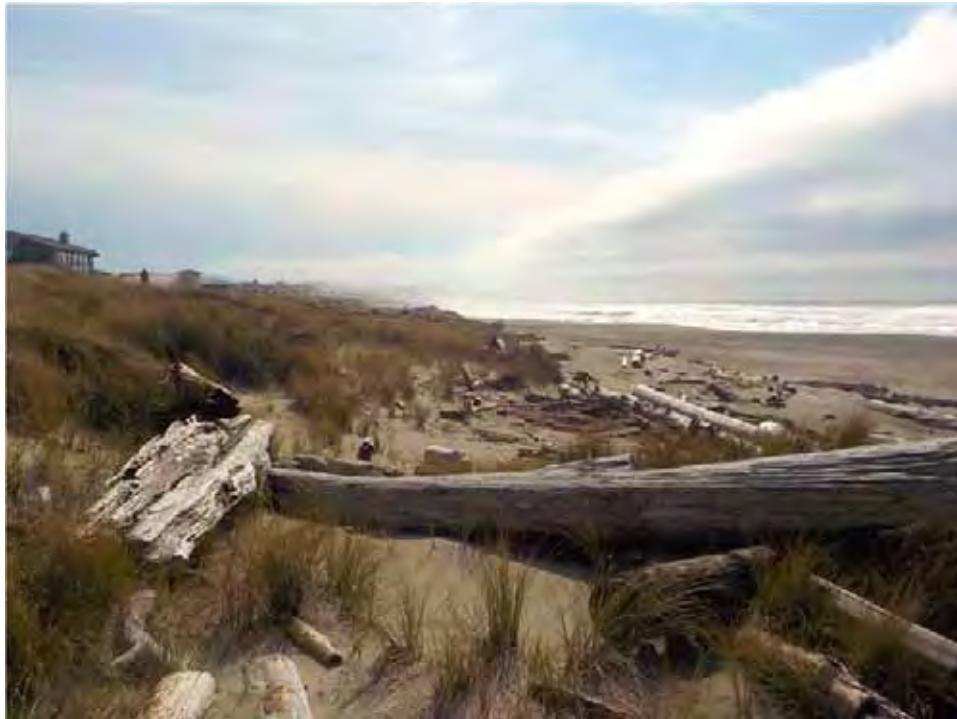
Photo 6 – Southerly view of the beach-dune junction in the area of Tax Lot 103, Map 7-11-34CC. Well-defined erosion scarps were present along the beach-dune junction south of this area.

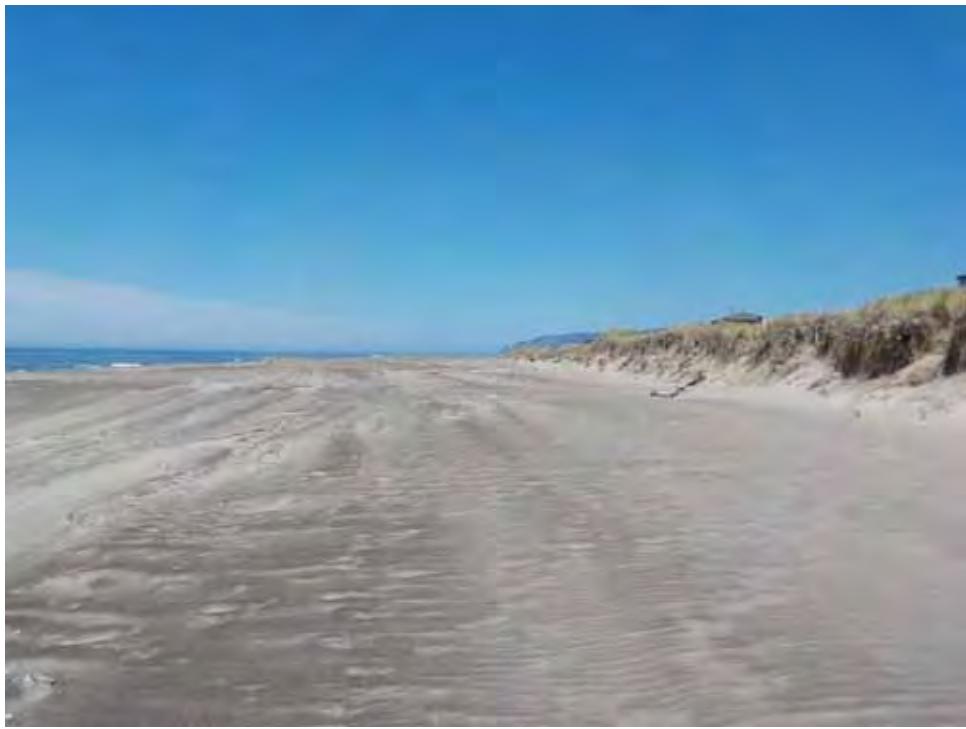
Photo 7 – Northerly view of the beach and beach-dune junction near Tax Lot 800, Map 08-11-03BB. Note the well-defined erosion scarp along the beach-dune junction.

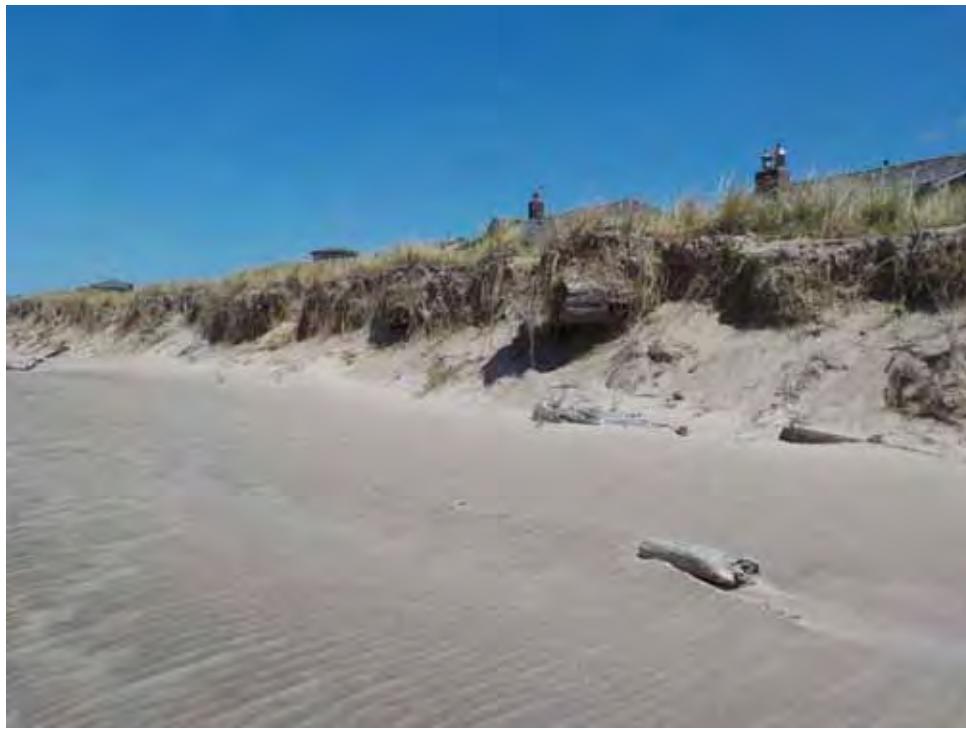
Photo 8 – View of the erosion scarp along the beach-dune junction near Tax Lot 900, Map 08-11-03BB. Note the buried drift logs having sawn ends exposed in the erosion scarp.

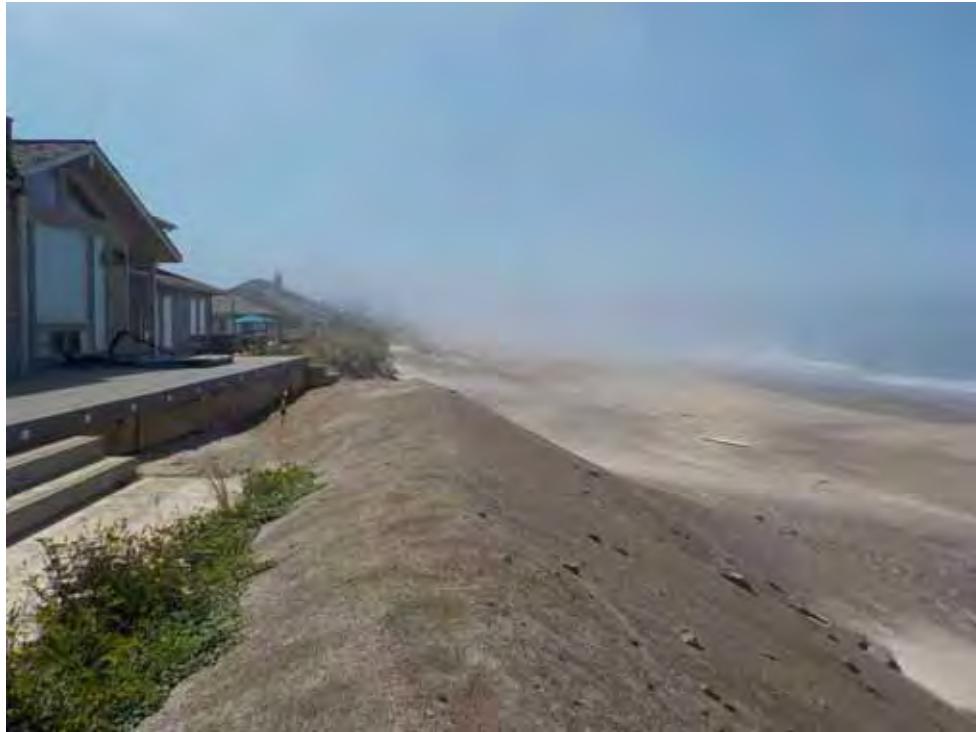
Photo 9 – Southerly view along the top of a recently built revetment fronting Tax Lot 1000, Map 08-11-03CB. Severe erosion during winter 2018/2019 necessitated emergency construction of this revetment to prevent further damage to the house. (Also see Appendix A-2)

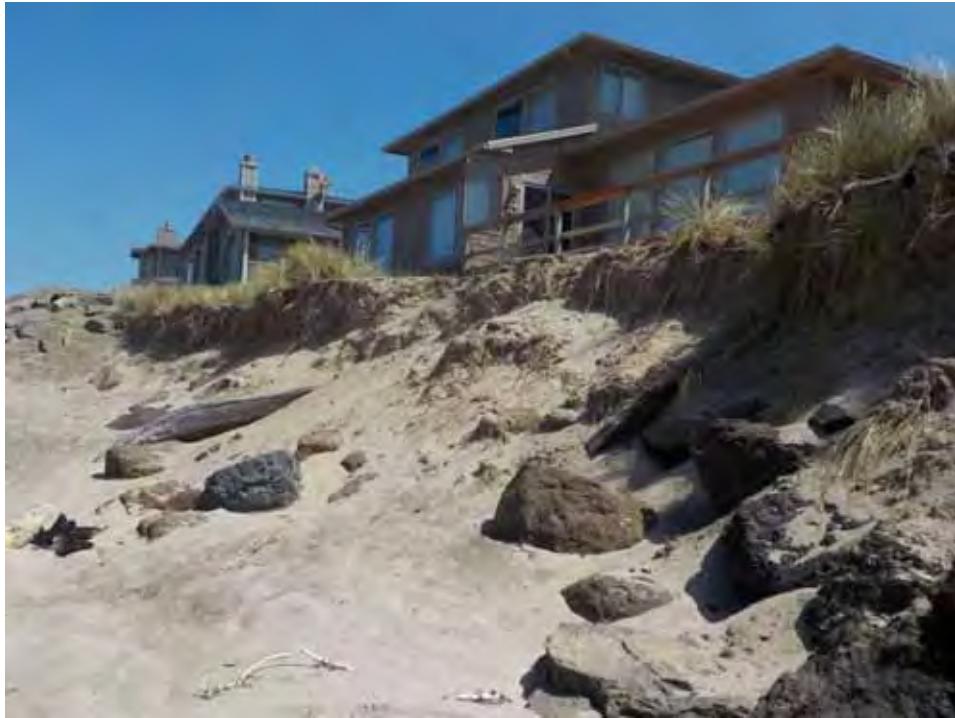
Photo 10 – View of the erosion scarp and damaged revetment fronting Tax Lot 900, Map 08-11-03CB. Note the inadequate size and poor quality of the armor stone of the damaged revetment. (Also see Appendix A-2)

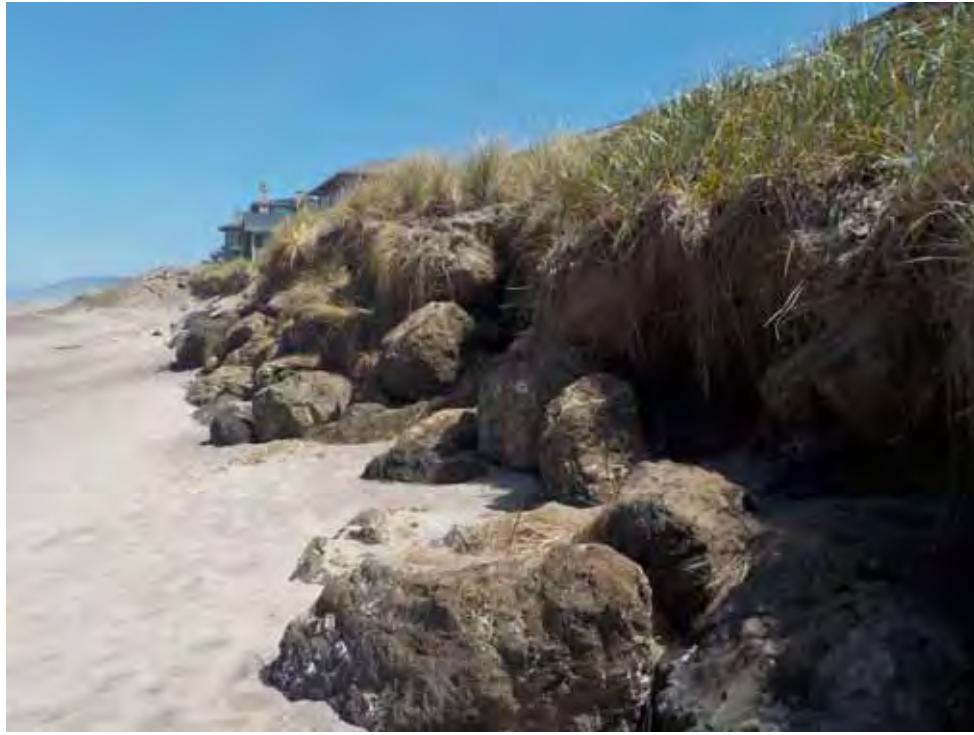
Photo 11 – Close-up view of the inadequate armor stone exposed during the winter of 2018/2019.

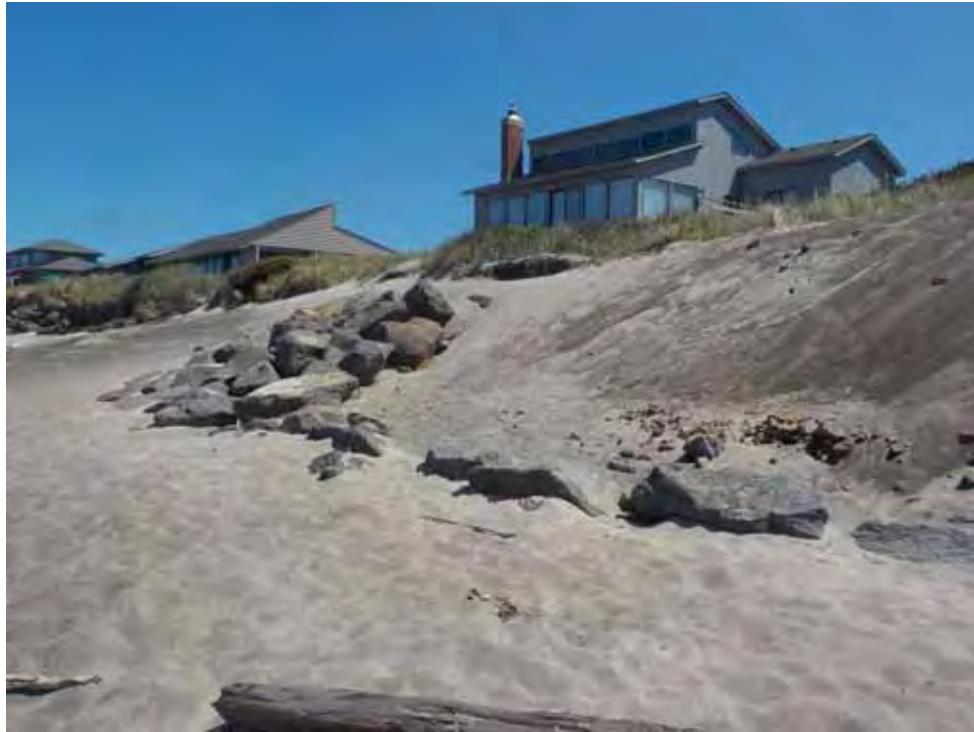
Photo 12 – View of the revetments fronting the beach in the area of Tax Lot 700, Map 08-11-03CB where the rock quality improves. Reconstruction of revetments occurred between Tax Lot 700, Map 08-11-03CB and Tax lot 204, Map 08-11-03CC to the south after severe erosion along this stretch of beach in 2016. (Also see Appendix A-2)

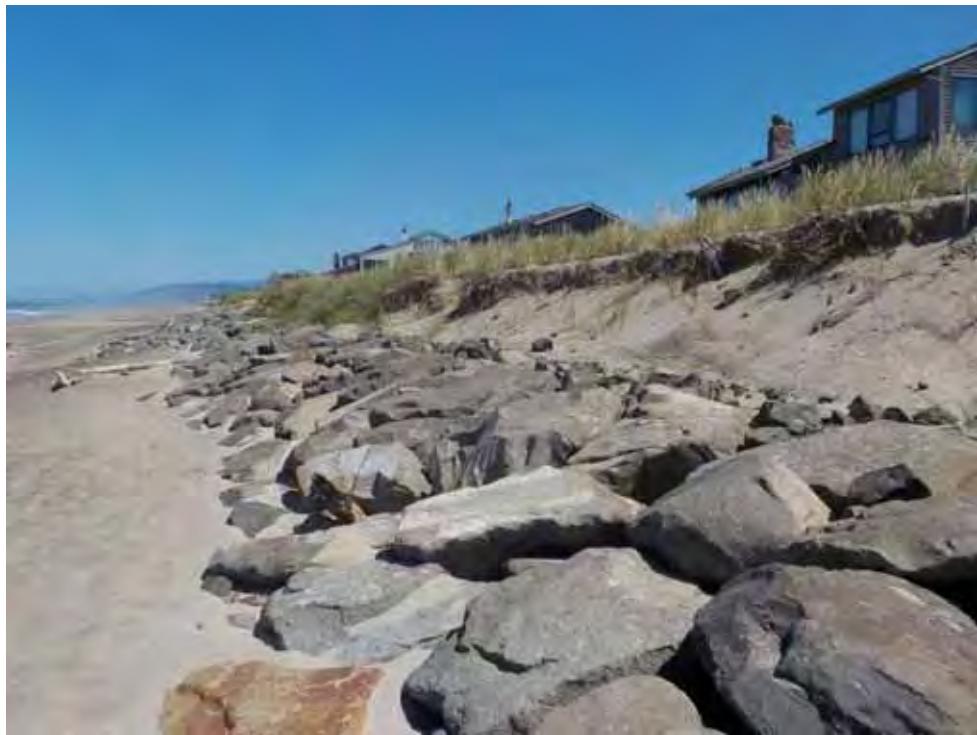
Photo 13 – Close-up view of the top of the revetment fronting Tax Lot 401, Map 08-11-03CB. Note the shallow revetment angle (~15°; ~3.5H:1V) and the erosion on the dune east of the revetment caused by overtopping of the revetment.

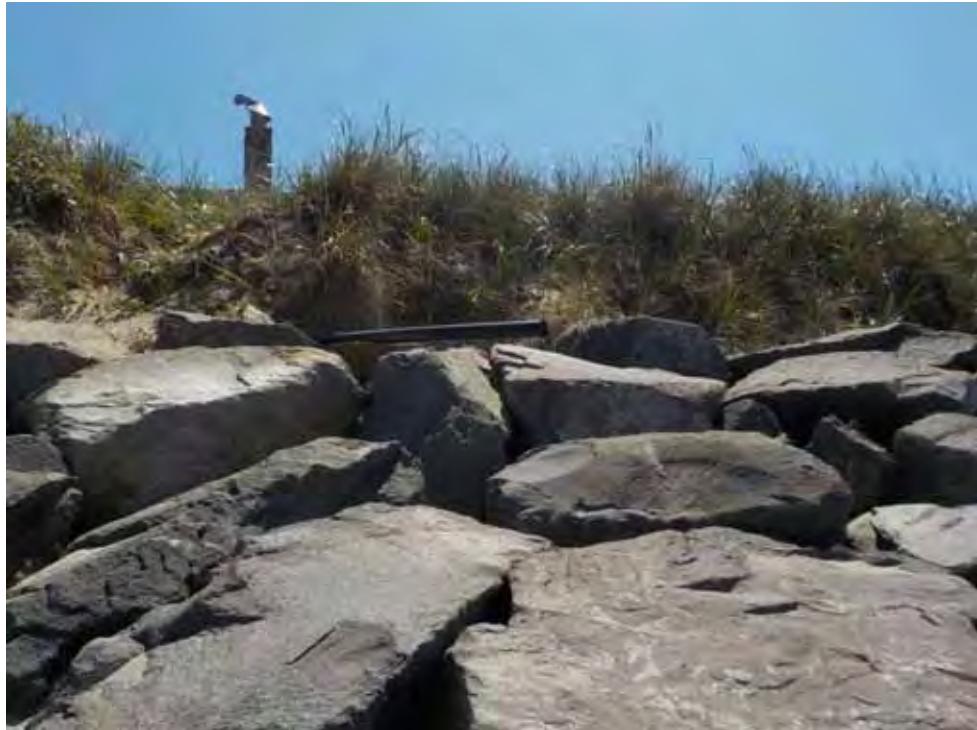
Photo 14 – View of drain pipe discharging to the riprap armor stone.

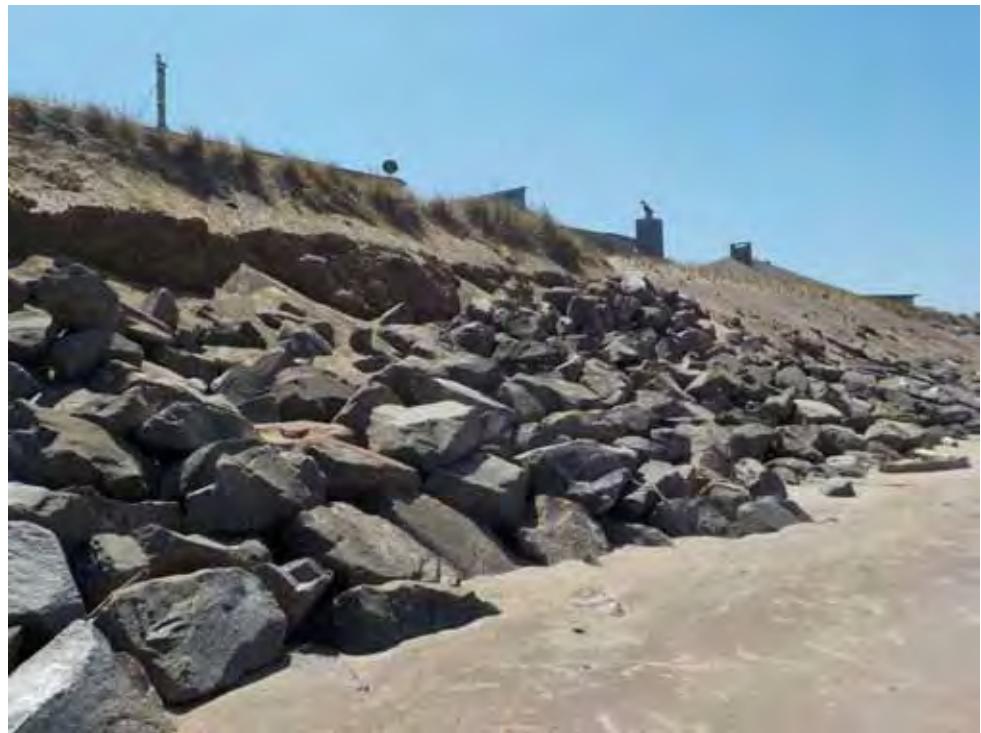
Photo 15 – View of damaged recently constructed revetment fronting Tax Lot 219, 08-11-03CC (Also see Appendix A-2).

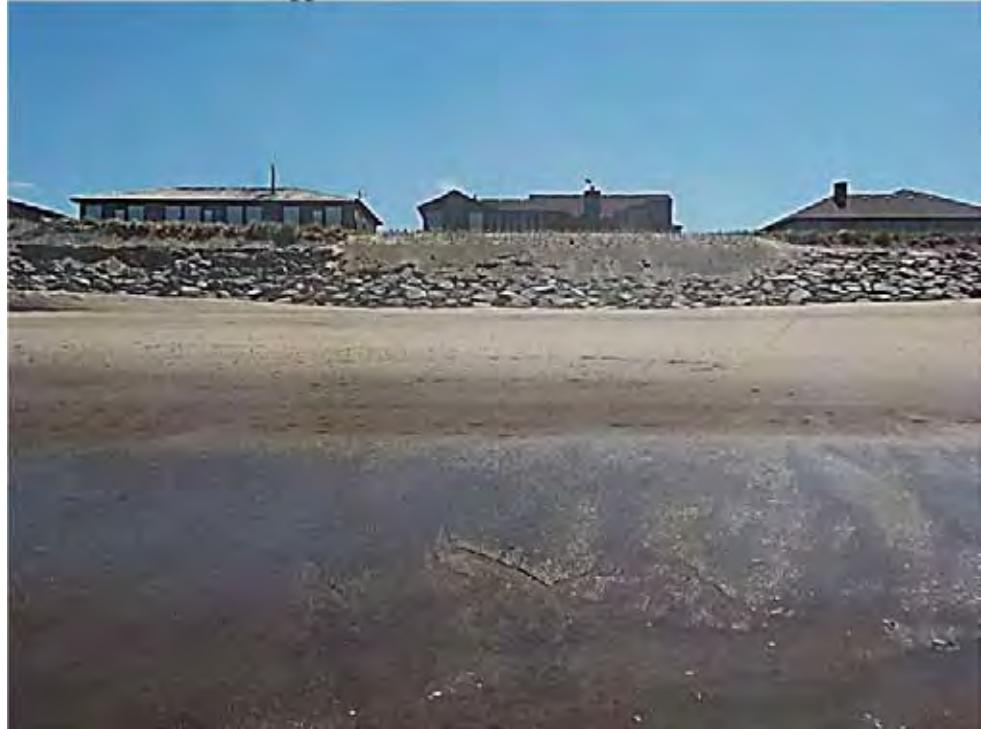
Photo 16 – View to the west of the revetments fronting Tax Lots 217 (right), 218 (center) and 219 (left), Map 08-11-03CC. The height of the revetment fronting Tax Lot 218 was recently raised to help mitigate overtopping (Also see Appendix A-2).

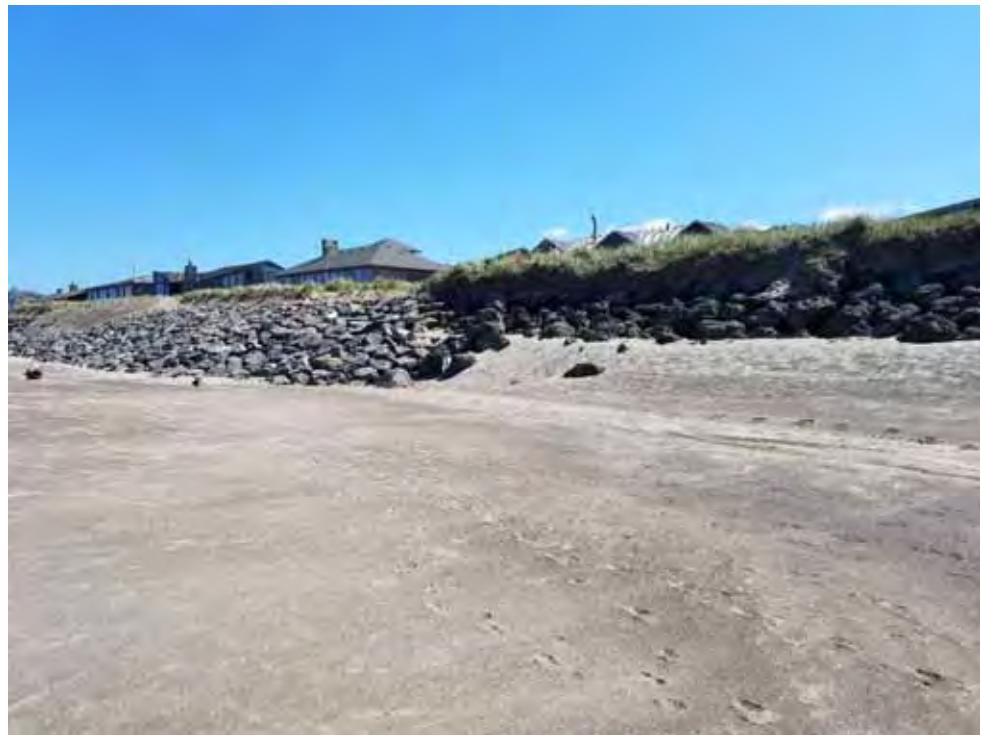
Photo 17 – Southeasterly view of the transition from competent high-quality rock at the southern extent of the recently constructed (2016) revetments to low-quality basalt breccia rock to the south.

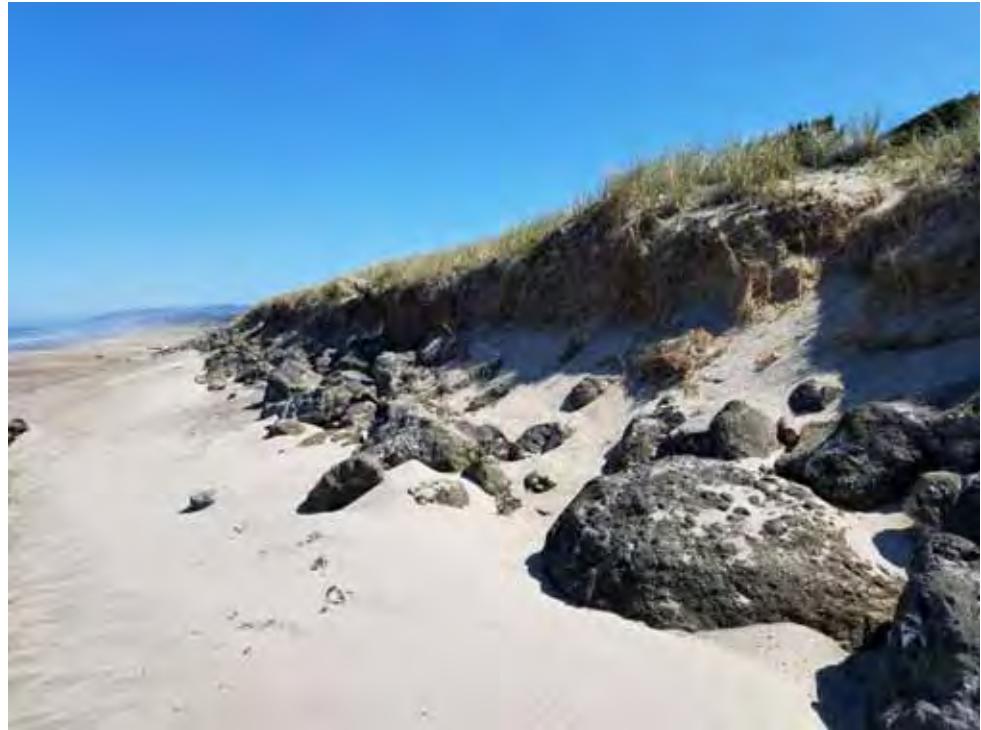
Photo 18 – View of the loosely stacked basalt breccia armor stones used in construction of the original revetments.

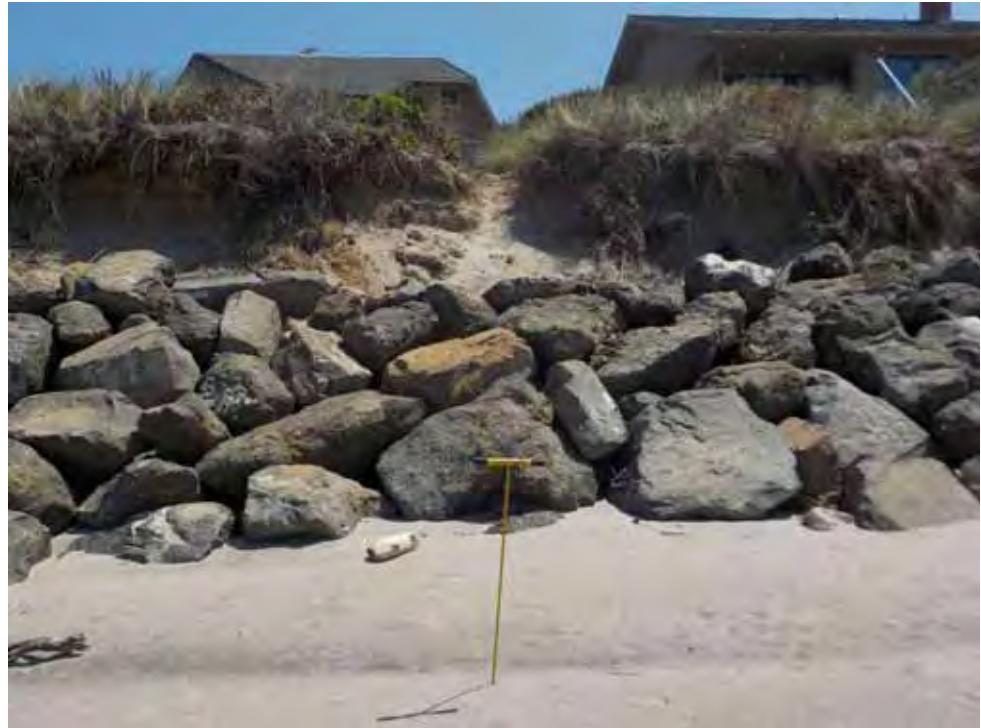
Photo 20 – View of a revetment where competent rock is mixed with poor-quality basaltic breccia.

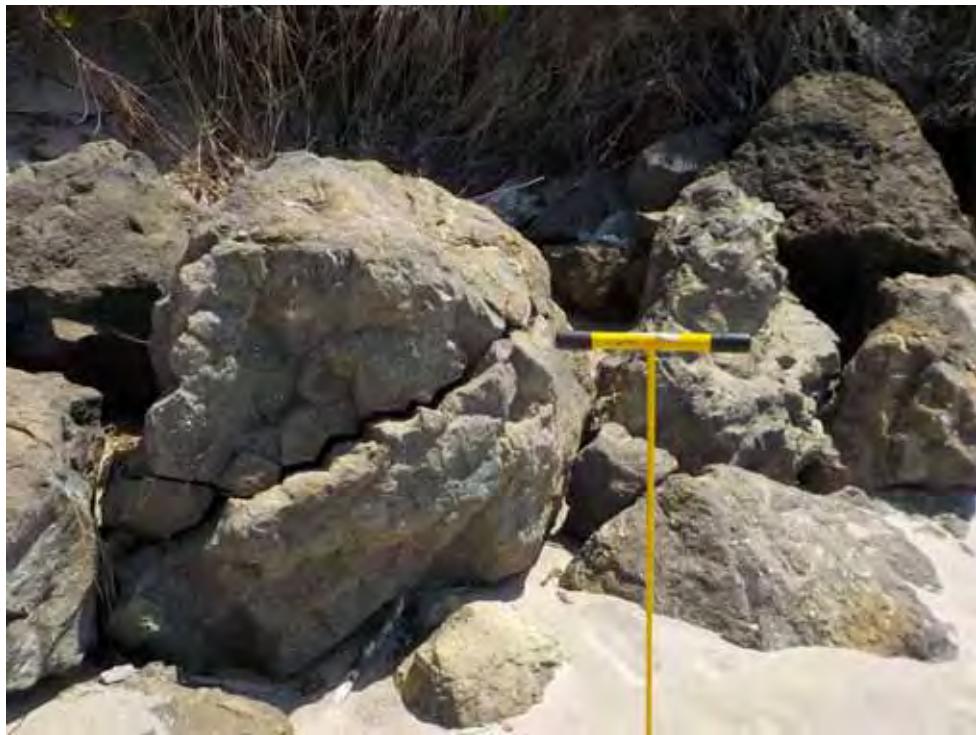
Photo 21 – Close-up view of poor-quality basaltic breccia and pillow basalt armor stones. Note the fractures in the stones.

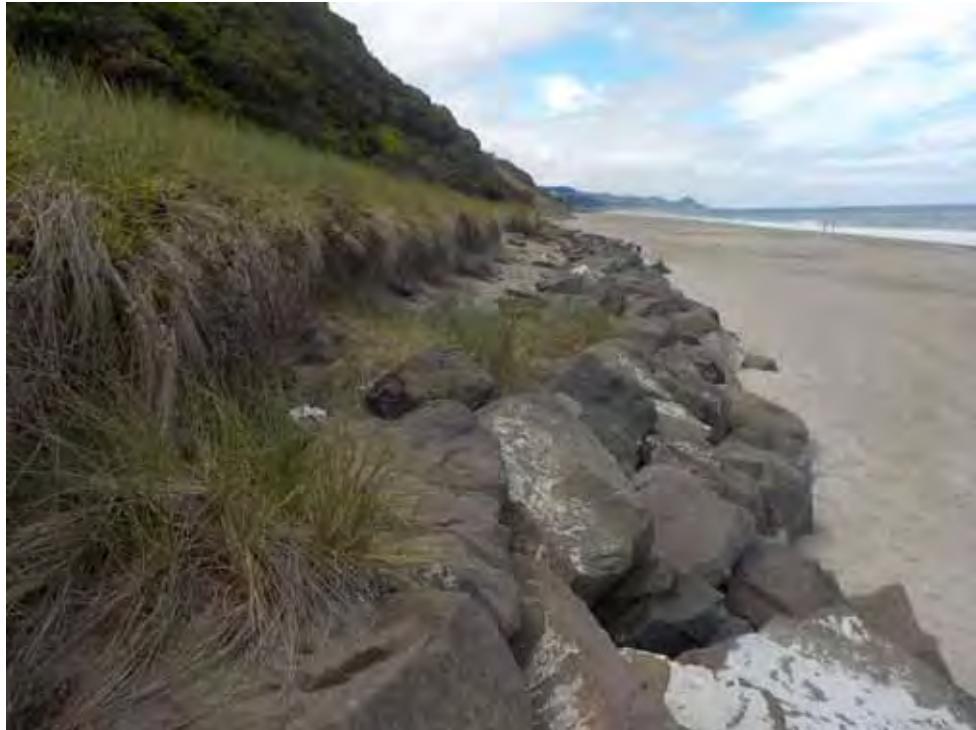
Photo 22 – View of the revetment near the southern extent of the site. Note the erosion above and behind the top of the revetment indicating previous overtopping of the revetment. (Photo taken 07/06/2018)

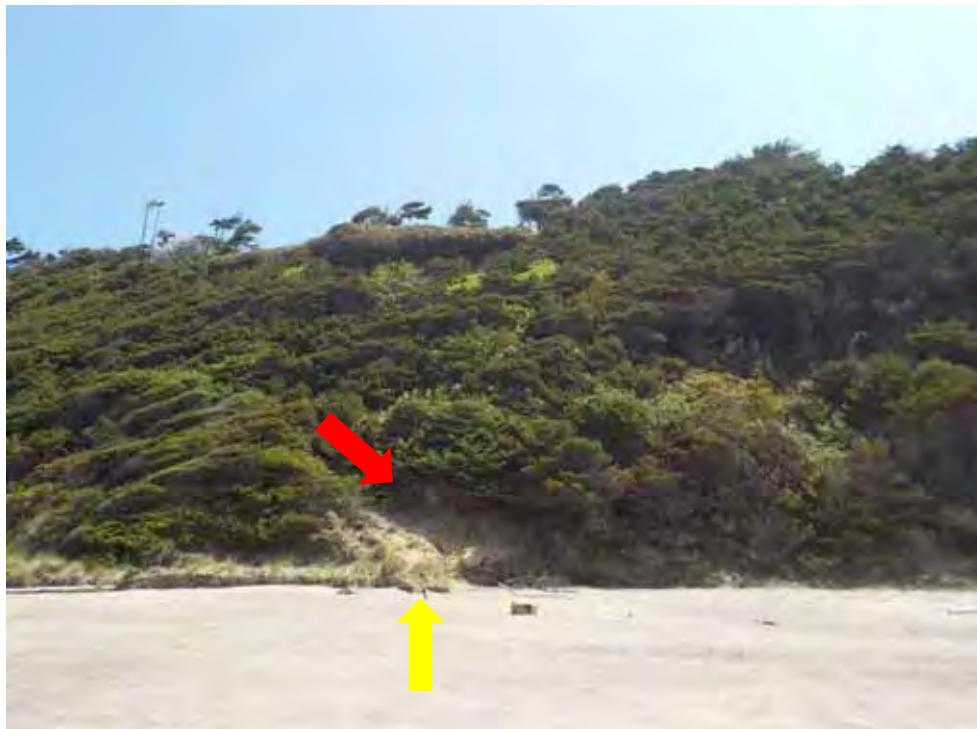
Photo 23 – Westerly view of the southern termination of the revetment (indicated with yellow arrow) along the northern property boundary of Tax Lot 156, Map 08-11-09DD. Note the erosion at the toe of the bluff immediately south of the termination of the revetment (indicated with red arrow). (Photo taken 05/31/2019)

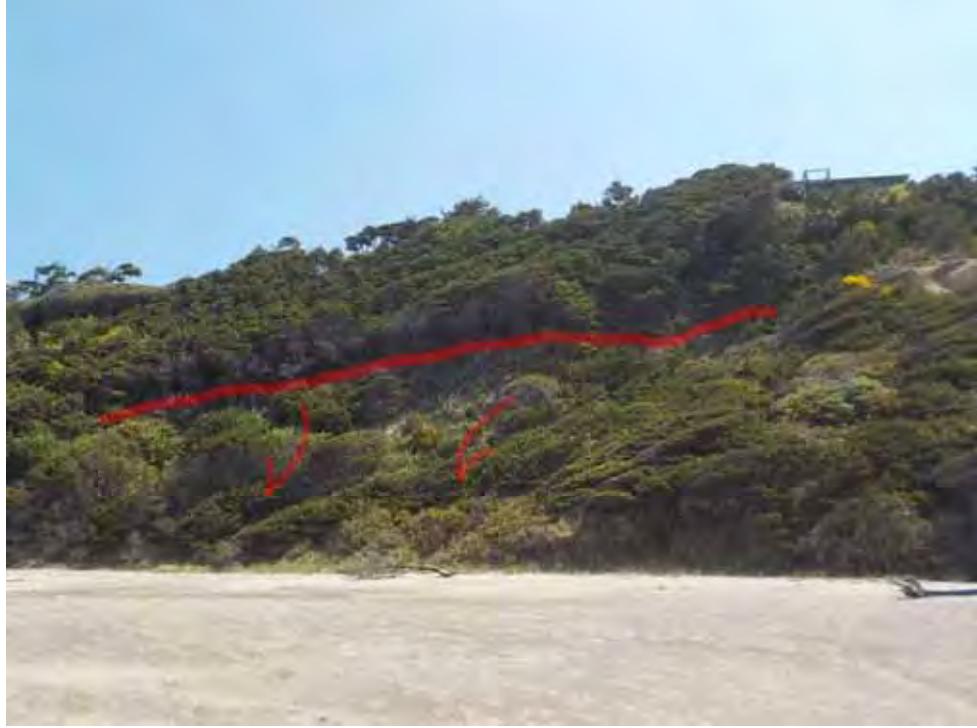
Photo 24 – View of the bluff slope on the western portion of Tax Lot 156, Map 08-11-09DD that has experienced shallow failures due to erosion of the toe of the bluff. Shallow landslide scarp indicated with red line; direction of movement indicated with red arrows.
