OREGON PARKS AND RECREATION DEPARTMENT OCEAN SHORE PERMIT APPLICATION

SHORELINE PROTECTION STRUCTURES

Construct an riprap revetment along approximately 105' of shoreline to a height of 33' to mitigate wave erosion and overtopping and protect the structure at 145 Salishan Drive.

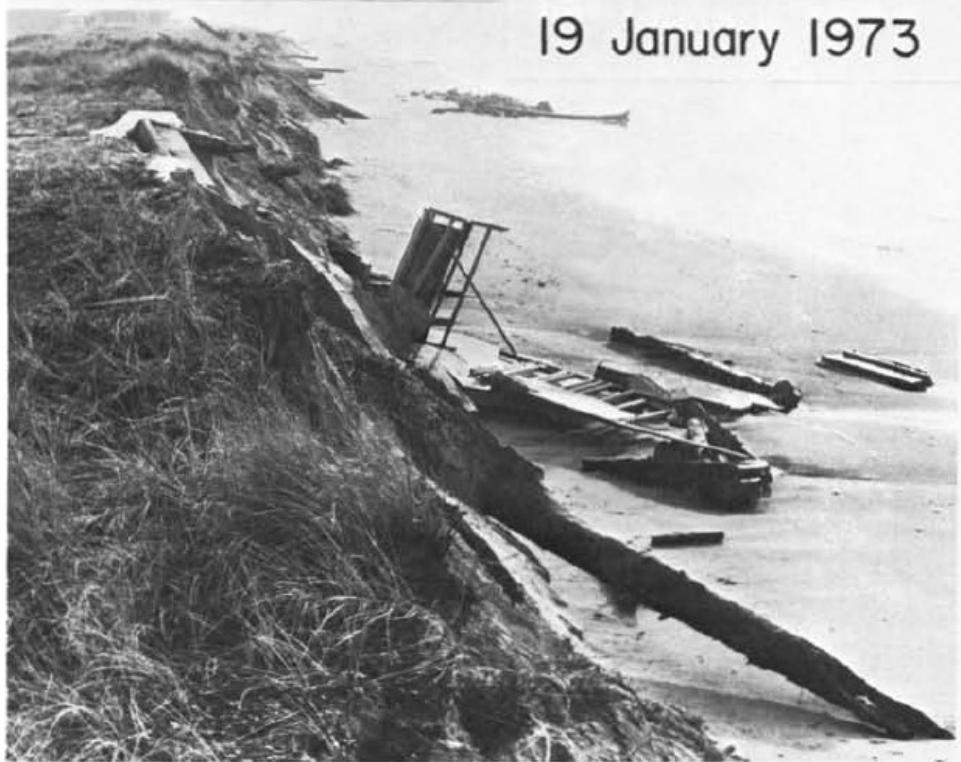
Figure 2. Erosion and destruction of the house under construction on lot 226 of Siletz Spit.

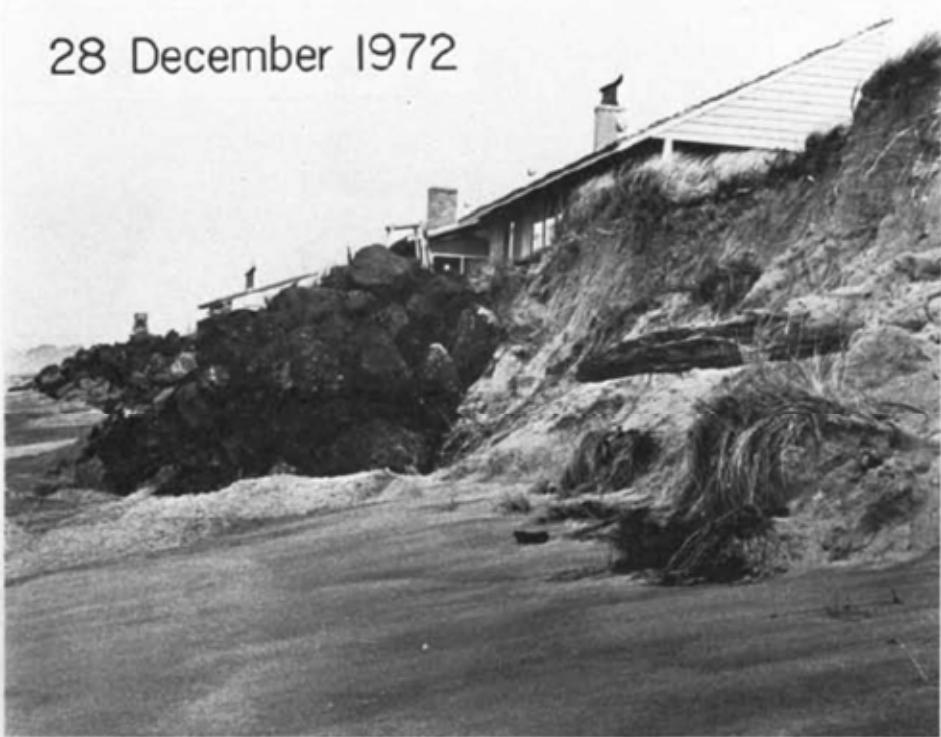
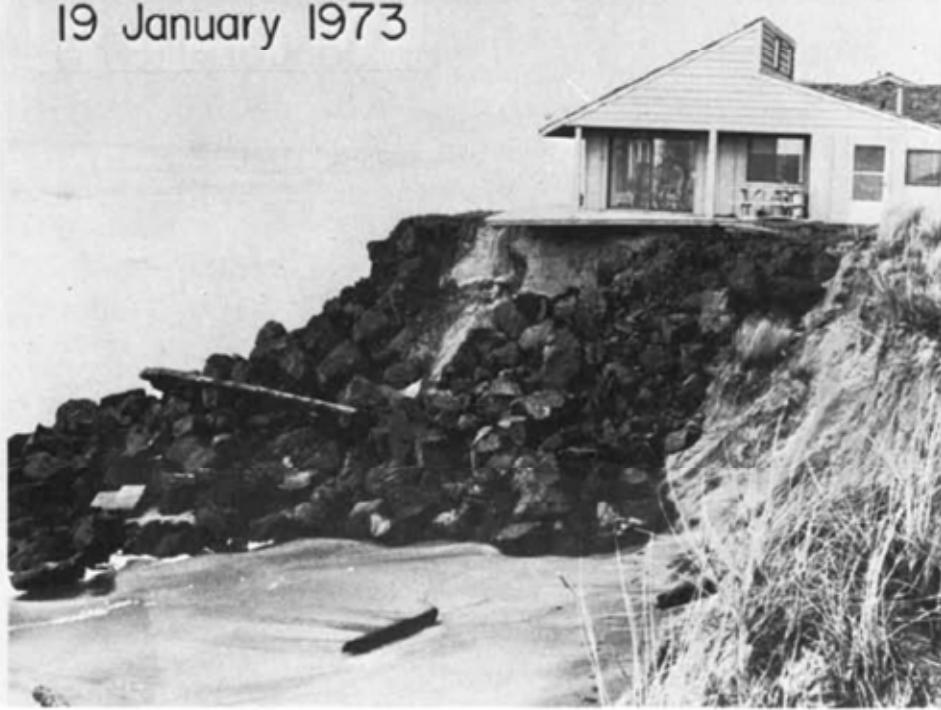
Photo 2 - From Komar and Rea (1976)

Figure 3. Erosion around the house on lot 229-A. Rapid erosion required placement of riprap fronting home in upper photo; but no riprap was installed in adjacent vacant lot, so erosion continued along the side as seen in lower photo.

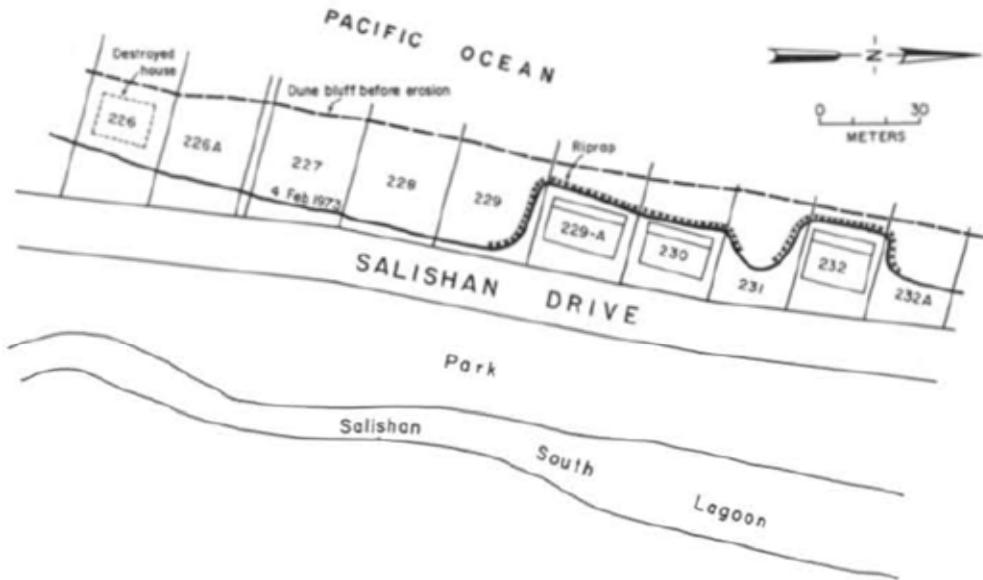
Figure 5. Successive surveys showing the retreat of the edge of the dune bluff. Riprap around lots 229-A through 232 prevented their erosion, but the erosion of the adjacent lots left them on a promontory extending out onto the beach.

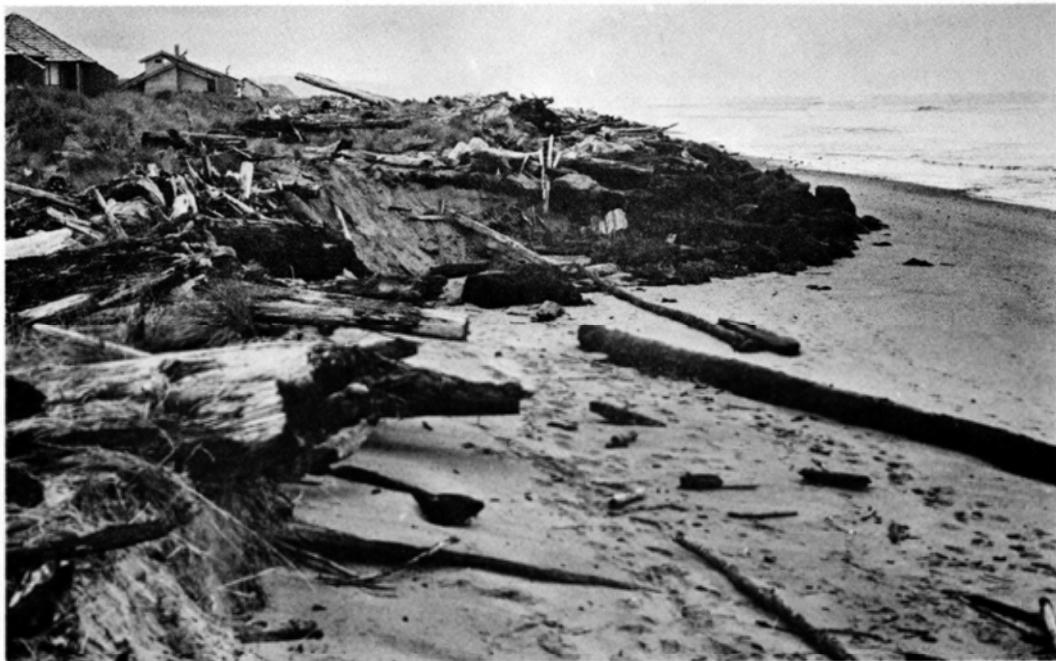
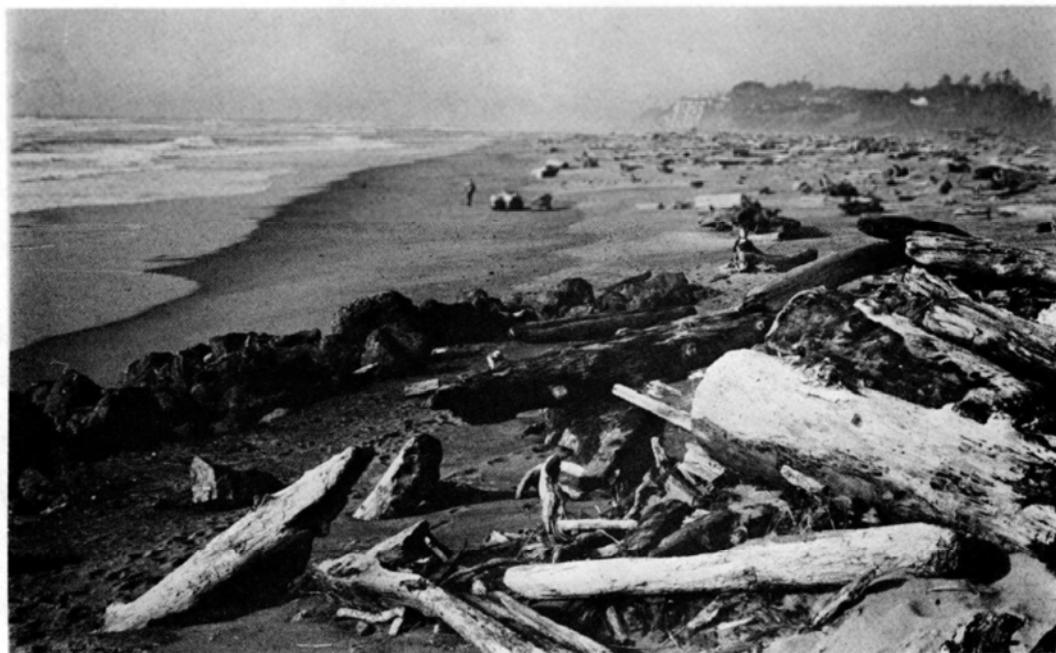
Photo 4 – From McKinney (1976)

Figure 5. (Upper) Erosional dune bluff on 2 January 1976, north of the northern-most house on the spit.

(lower) Same area as in upper photo (except viewed north) on 20 March 1976, after major storm has washed over the dune bluff of the upper photo, flattening it into an even slope.

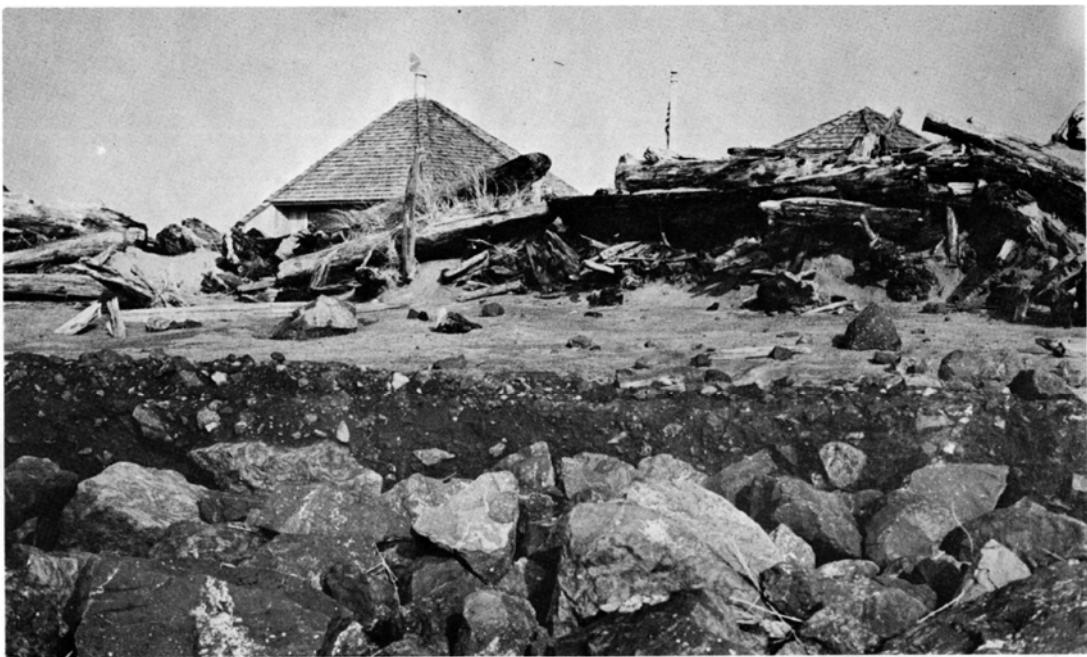
Photo 5 – From McKinney (1976)

Figure 8. Erosion of the riprap seaward of the northern-most house, photographed on 20 March 1976. It is seen that some of the finer-grained material backing the larger rocks has been eroded away. Waves washed over the riprap pushing back the drift logs into a pile.

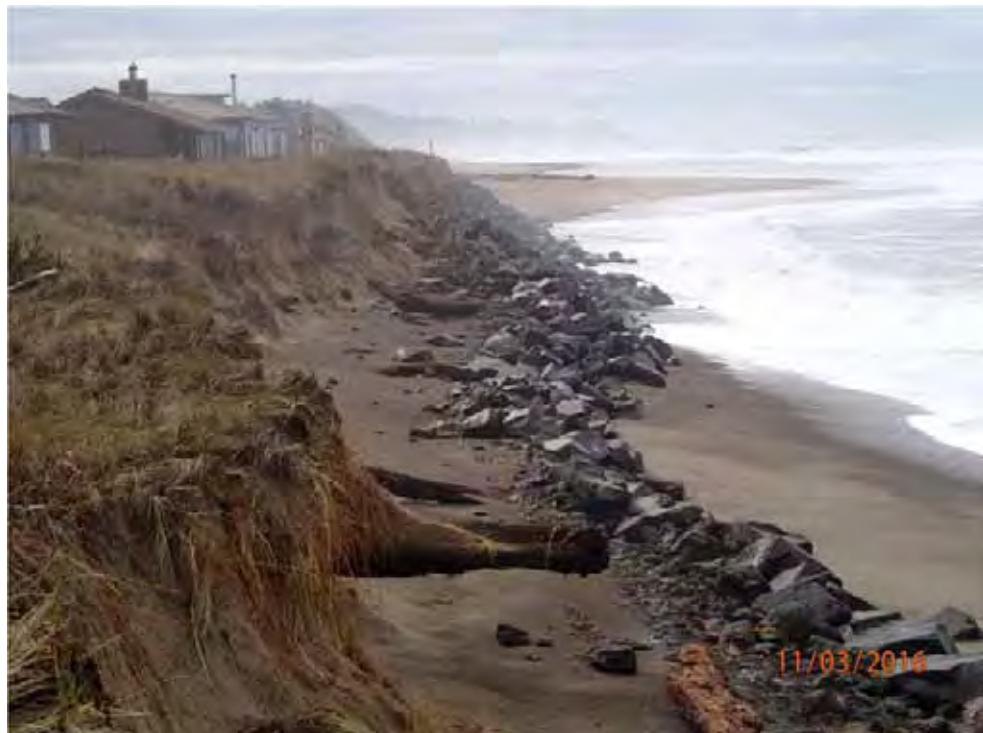
Photo 6 – March 2016 storm damage to riprap at Salishan affected 11 properties. Wave overtopping, inadequate design and poor construction contributed to the problem. From Sennewald (2018)

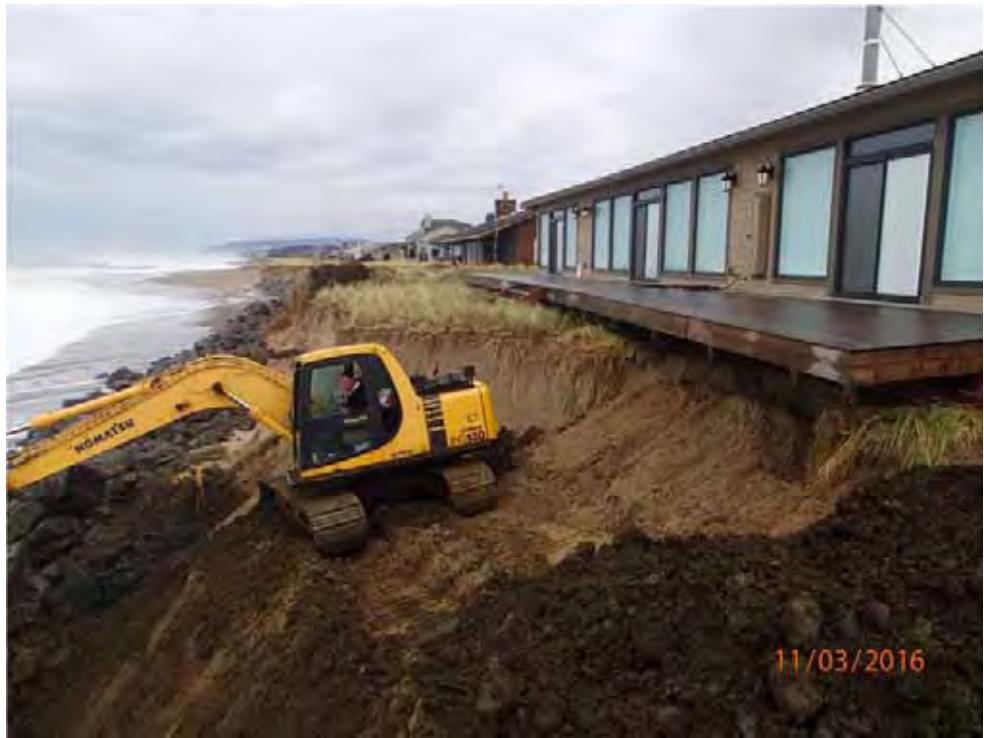
Photo 7 – Photo of emergency repairs underway to protect Tax Lot 219, Map 08-11-03CC. From Sennewald (2018)

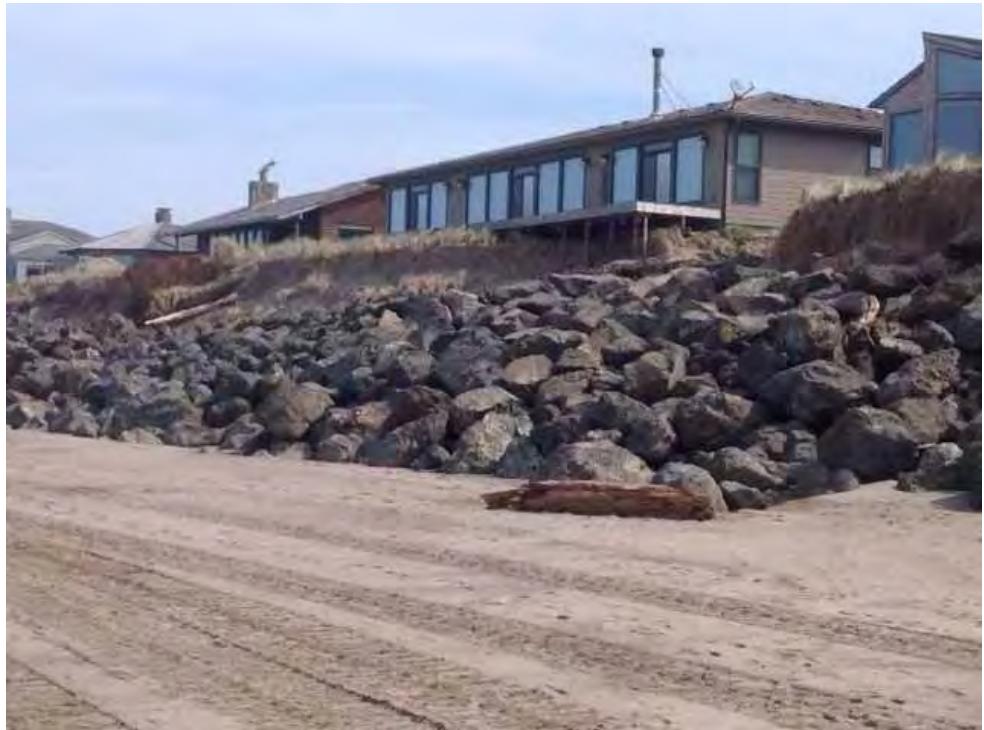
Photo 8 – Photograph taken 16 March, 2016, of emergency repairs completed at Tax Lot 219, Map 08-11-03CC. Provided to HGSA by a Salishan Leaseholder.

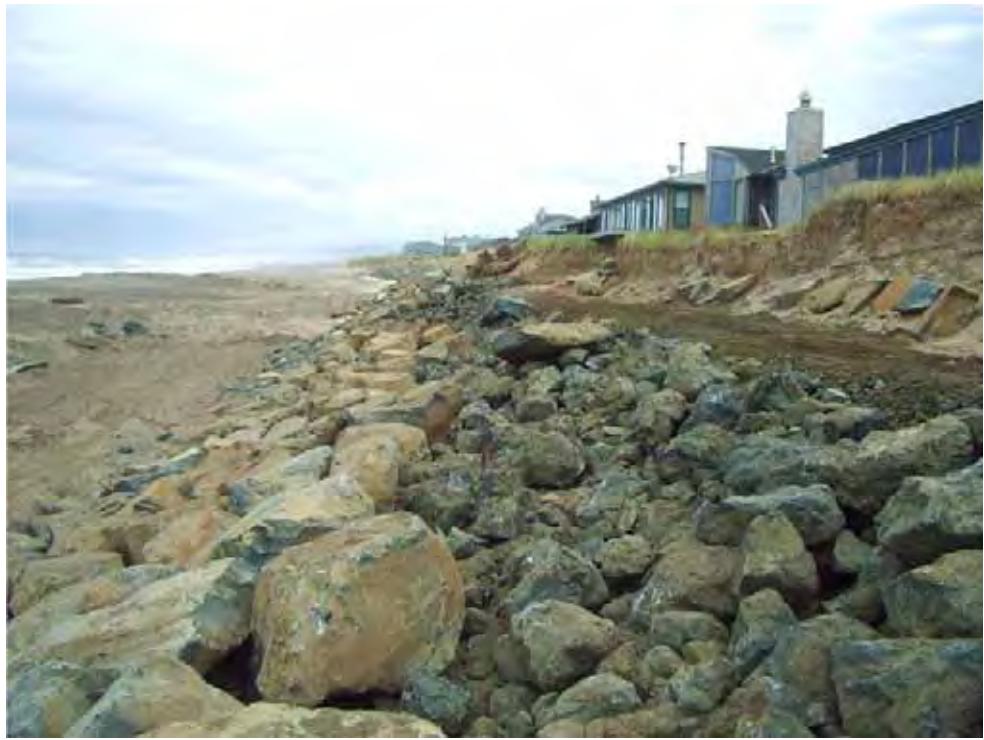
Photo 9 – Northerly view of the revetment fronting Tax Lot 218, Map 08-11-03CC during permitted repair work. Note the single layer of armor stone and lack of filter fabric backing the revetment. Photo taken by HGSA on 05/21/2016.

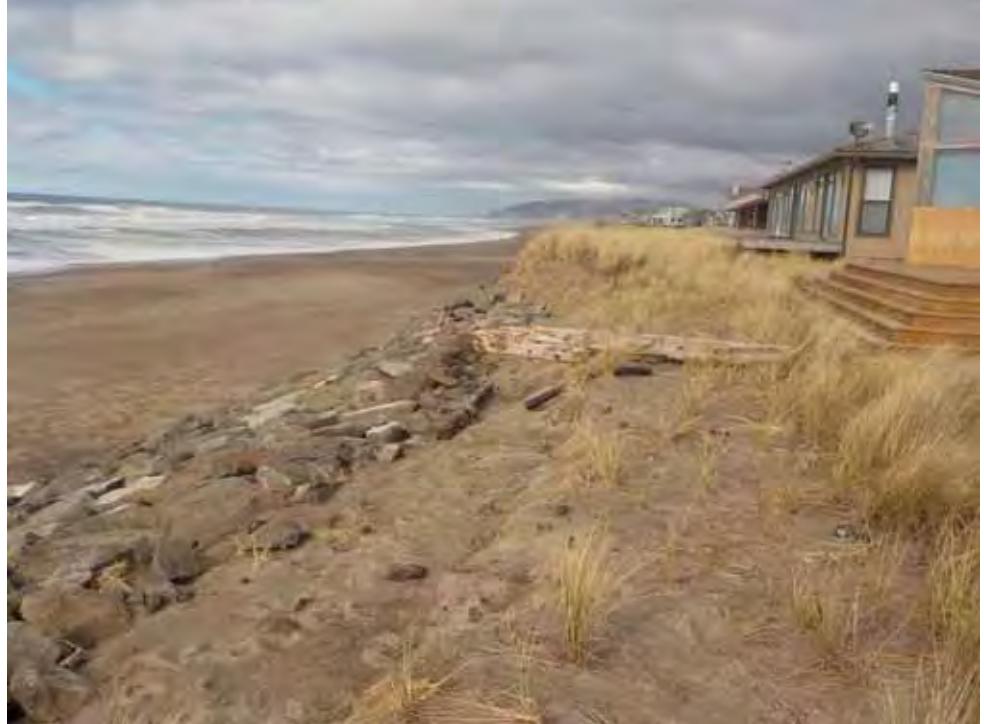
Photo 10 – Northerly view of the top of the revetment at Tax Lot 218, Map 08-11-03CC after the 2018/2019 winter when the revetment was overtopped. Note the erosion of the topping sand, the drift log on the top of the dune, and the plywood used to protect the windows. Photo taken by HGSA on 03/01/2019.

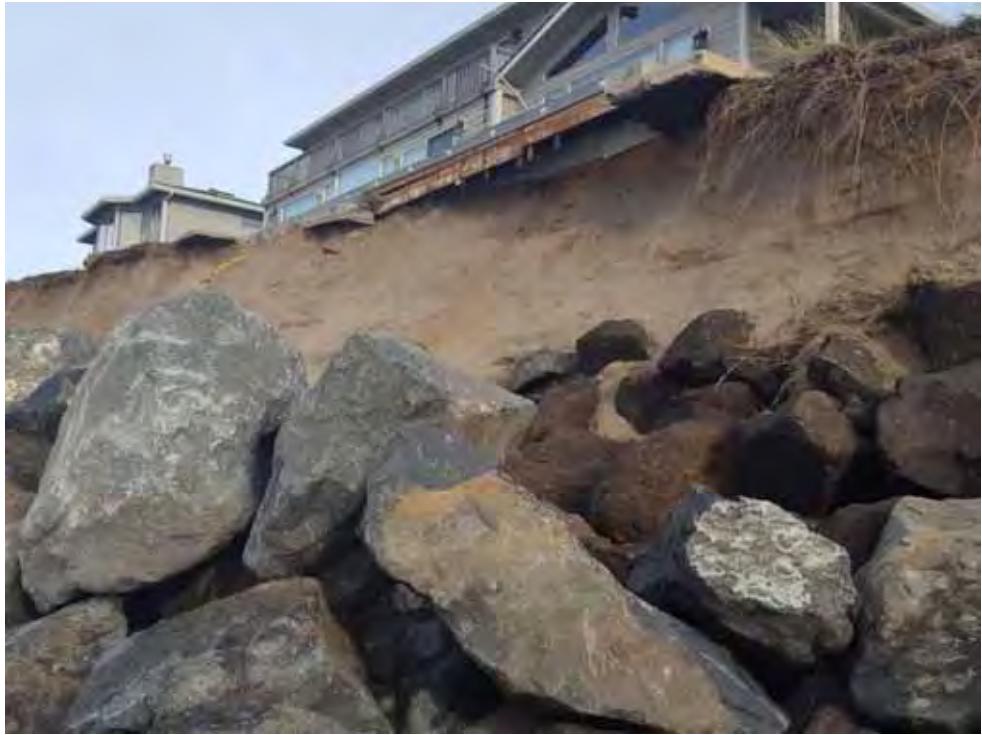
Photo 11 – View of the erosion that damaged the structure at Tax Lot 1000, Map 08-11-03CB, and riprap placed under an emergency permit. Photo taken on January 7, 2019 and submitted to oregonshores.org by user “ORbeach”.

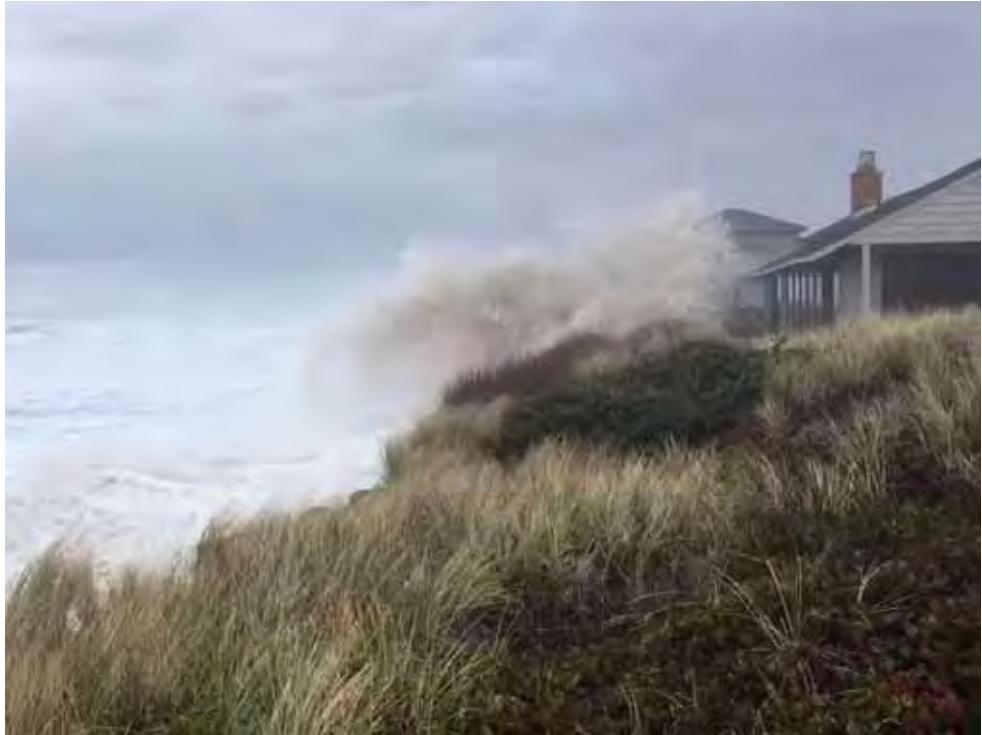
Photo 12 – View of wave splash overtopping the revetment fronting Tax Lot 701, Map 08-11-03CB, and landing on the roof of the house. Photo extracted from video provided by Jay Sennewald.

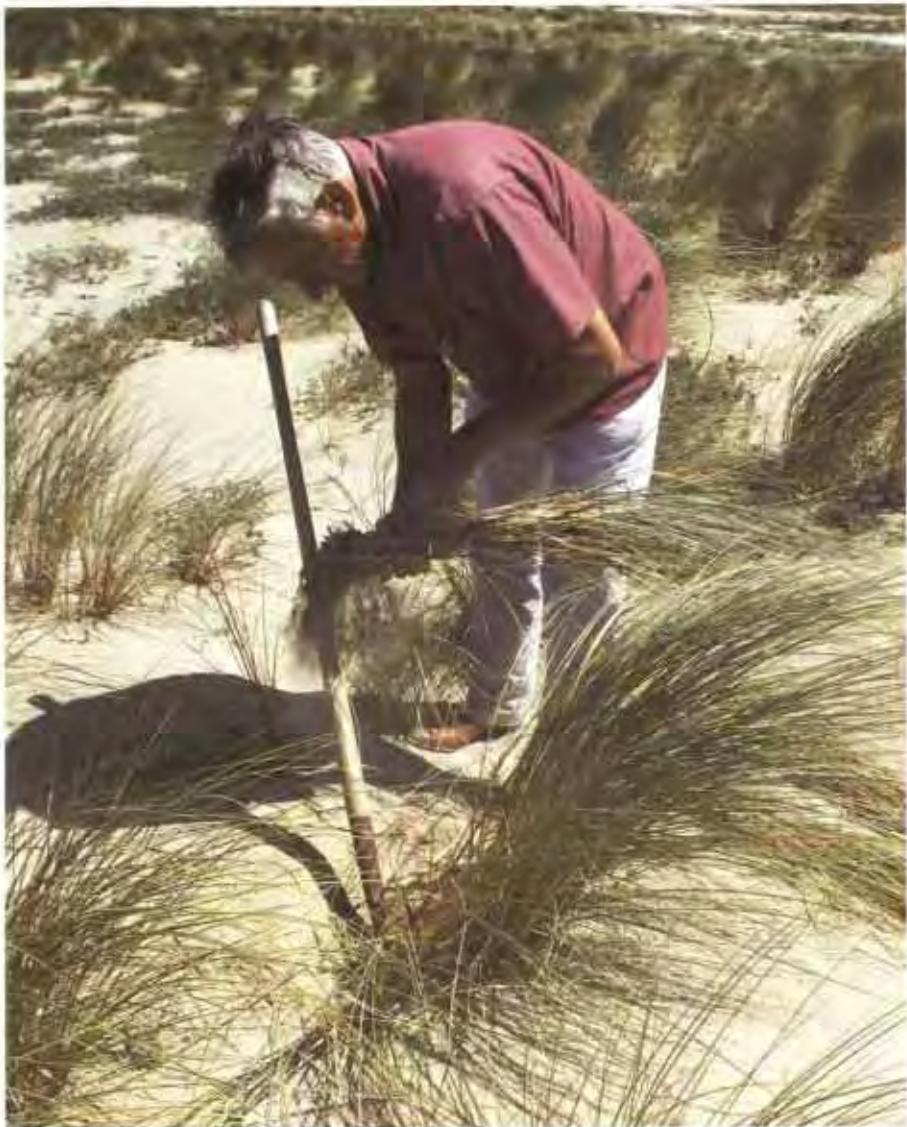
Shown here is a properly spaced planting of European beachgrass about 4 months after planting.

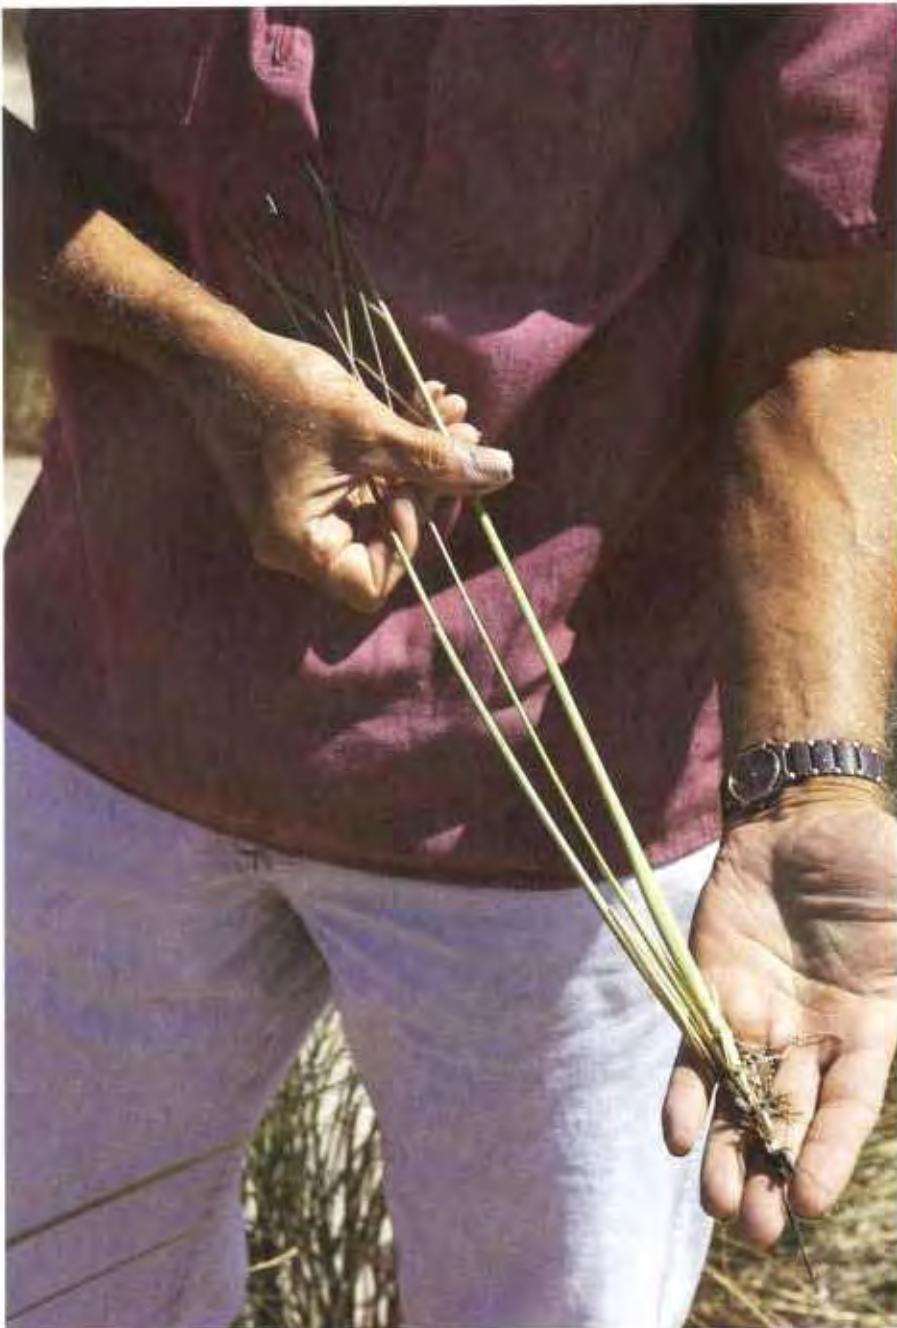
A three-culm propagule is approximately 20 inches long.

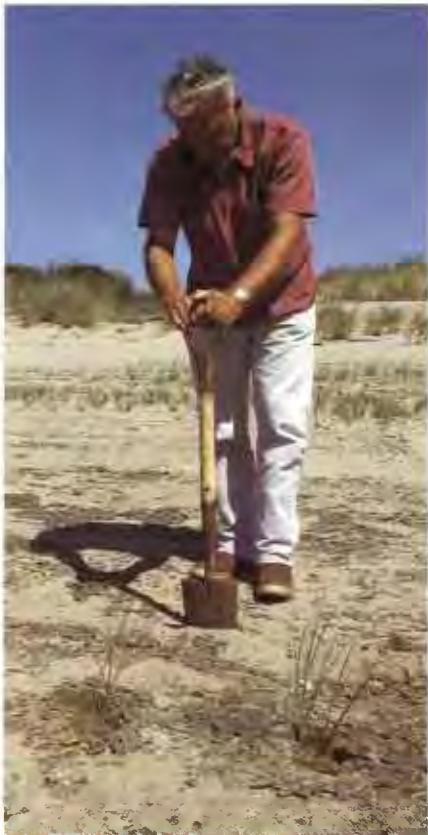
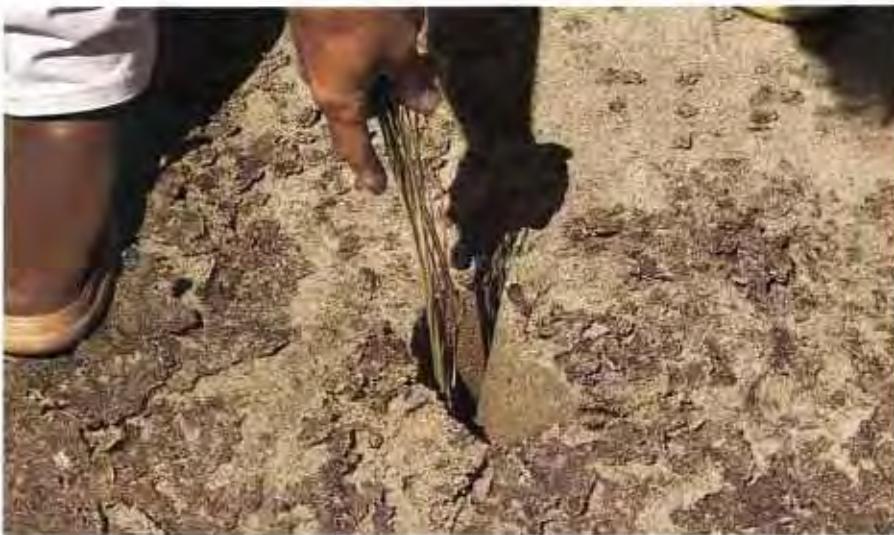
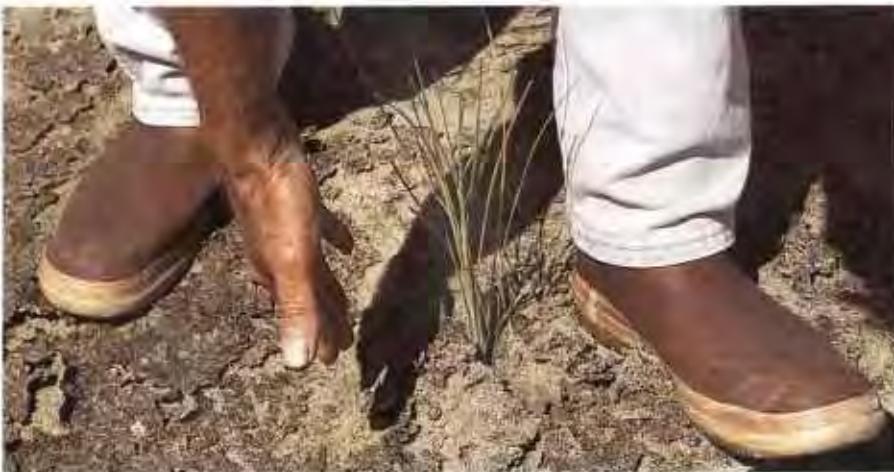
A beachgrass hand-planting operation includes (a) opening a 12-inch-deep hole in wet sand with a tile spade, (b) placing a beachgrass propagule in the hole and leaving an 8-inch top, and (c) tamping sand around the propagule with the heel of a boot.

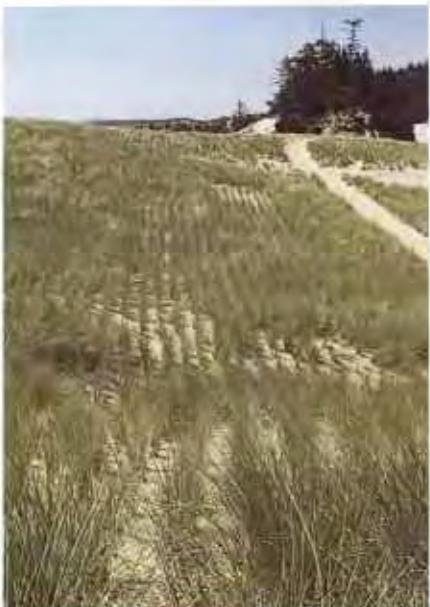
This site needs fertilizer to maintain adequate cover.
