**Oregon Parks & Recreation Department**  
**Ocean Shore Permit Application**

Lincoln Beach/Pacific Panorama Properties  
13-LUCS-22 – DeSlyvia – 4755 Lincoln Avenue

**SHORELINE PROTECTION STRUCTURES**

**Engineering Geologic Investigation,  
Recommendations for Oceanfront Protection,  
and Applications for a Shoreline Protection Structure  
Tax Lots 14800, 14900, 15000,  
Public Walkway/Utility Access Easement  
and 15100, Map 8-11-21CD; Lincoln County, Oregon**

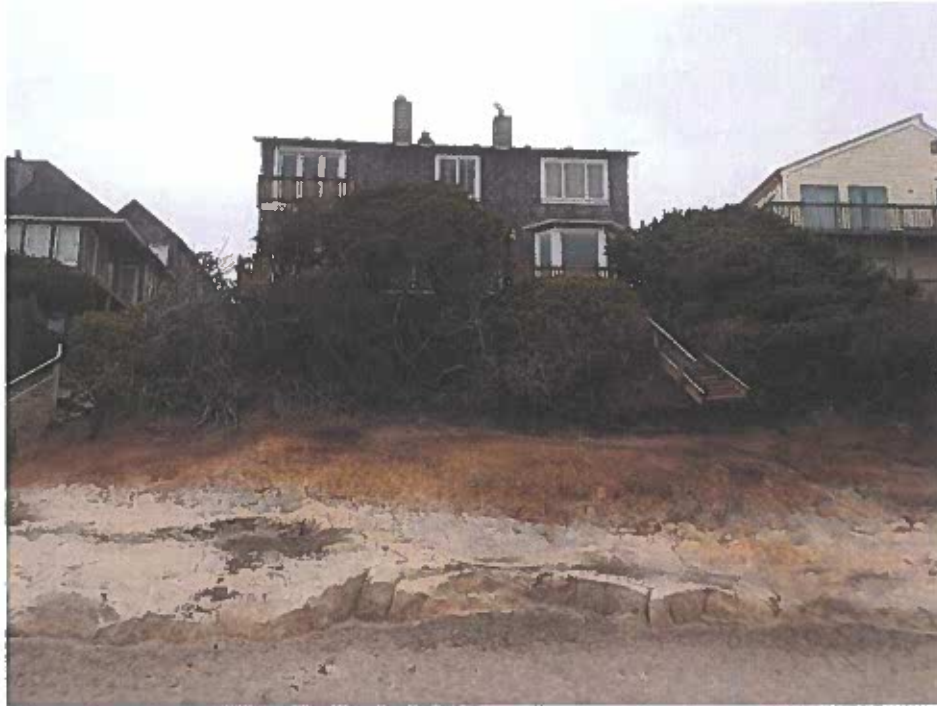
Photo 1 – Easterly view of the bluff slope fronting Tax Lot 14800. Note the wooden access stairs are hanging above the slope and the erosion scarp at the toe of the slope. Photograph taken August 17, 2021.

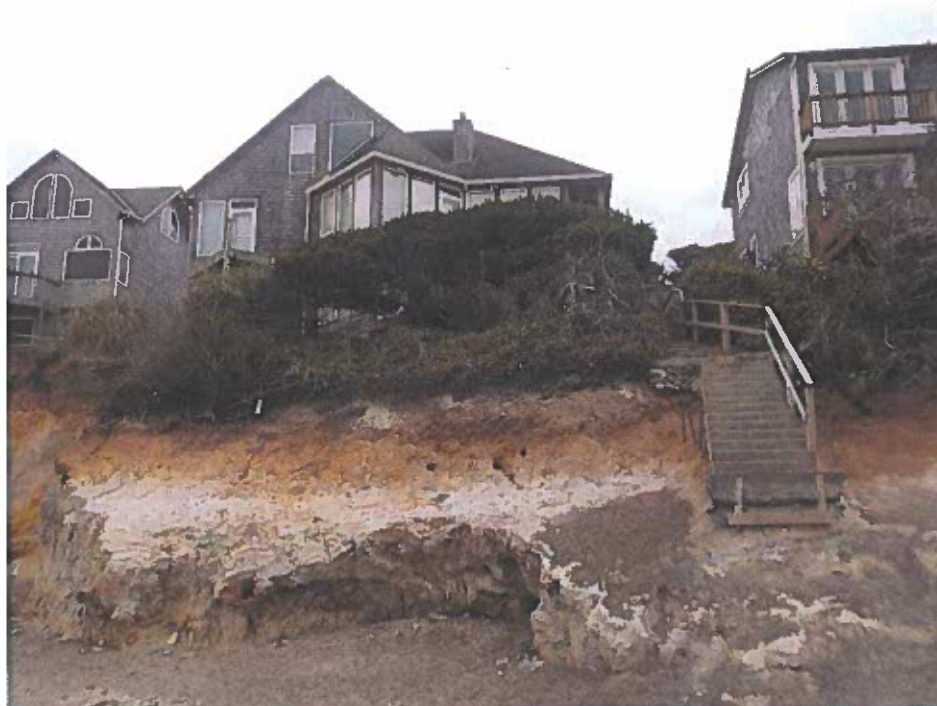
Photo 2 – Easterly view of the bluff slope fronting Tax Lot 14900. Note the erosion is undermining the concrete access stairs and the erosion scarp at the toe of the slope. Photograph taken August 17, 2021.

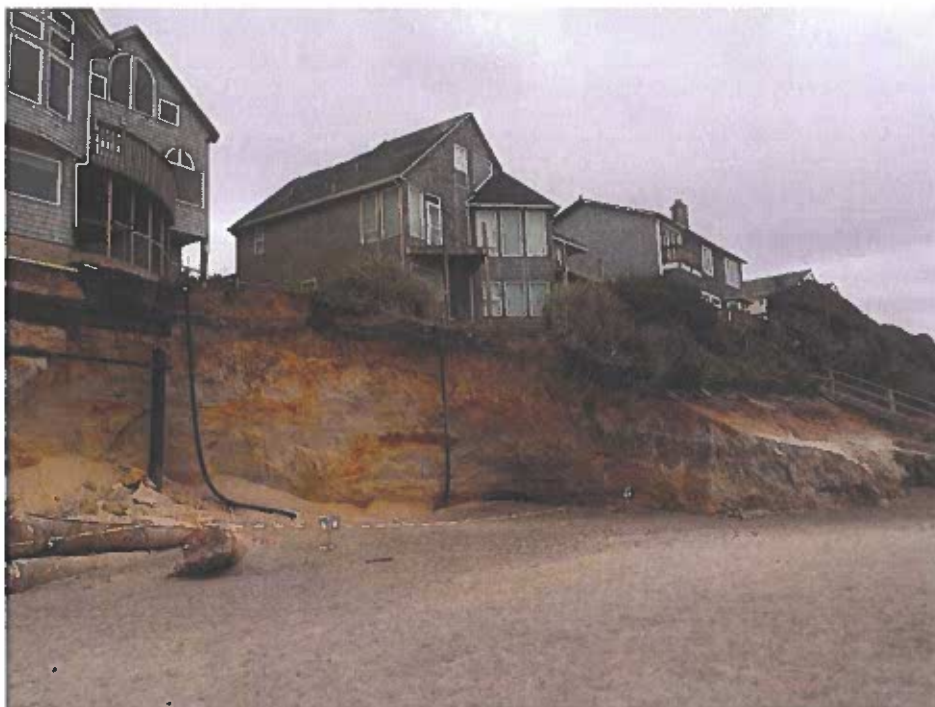
**Photo 3 – Southeasterly view of the bluff slope fronting Tax Lot 14900. The recent severe erosion undercut the more resistant gray sandy silt and rapidly eroded the underlying weakly cemented sand. Photograph taken August 17, 2021.**

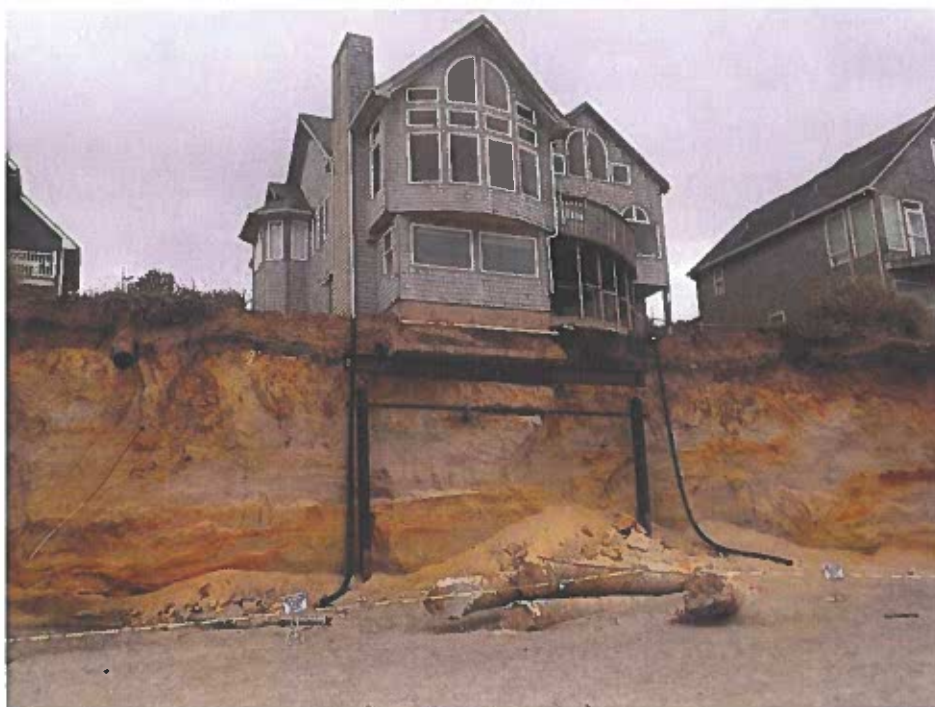
**Photo 4 – Easterly view of Tax Lot 15000. The recent severe erosion undermined the house foundation, and new pile supporting the foundation were installed to prevent damage or collapse of the house. Photograph taken August 17, 2021.**

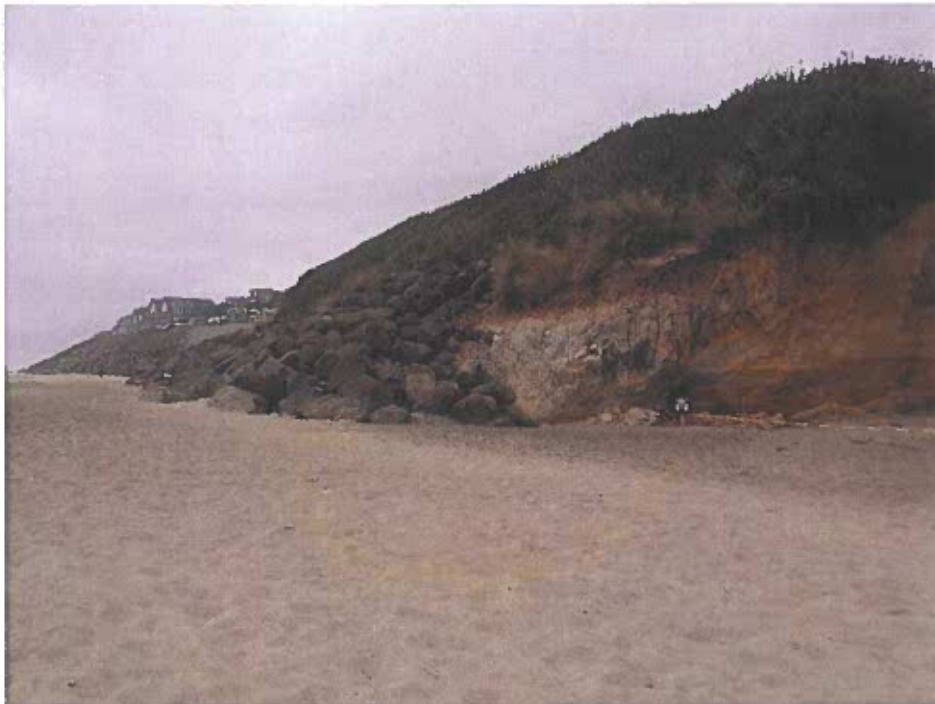
**Photo 6 – Northeasterly view of the bluff and existing rip rap immediately north of the site. Photograph taken August 17, 2021.**

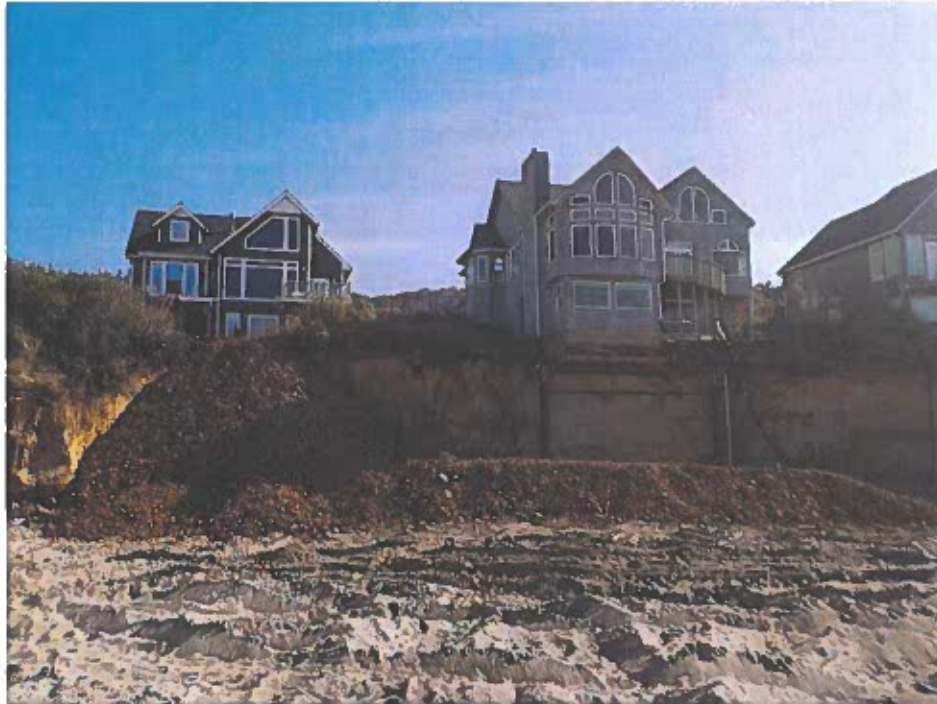
**Photo 7 – Easterly view of Tax Lots 15000, 15100 and the public walkway/utility easement during placement of quarry-run rock to provide emergency protection. Photograph taken August 17, 2021.**

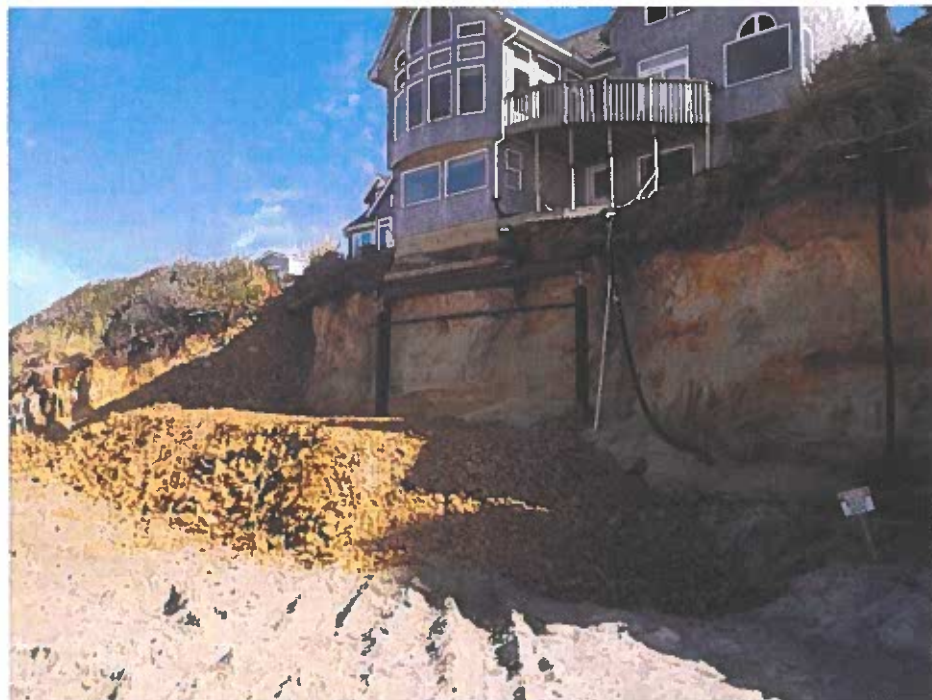
**Photo 8 – Northeasterly view of Tax Lots 15000, 15100 and the public walkway/utility easement during placement of quarry-run rock to provide emergency protection. Photograph taken August 17, 2021.**
